# **Relicensing Study 3.5.1**

# BASELINE INVENTORY OF WETLAND, RIPARIAN, AND LITTORAL HABITAT IN THE TURNERS FALLS IMPOUNDMENT, AND ASSESSMENT OF OPERATIONAL IMPACTS ON SPECIAL STATUS SPECIES

# **ADDENDUM**

Northfield Mountain Pumped Storage Project (No. 2485) and Turners Falls Hydroelectric Project (No. 1889)

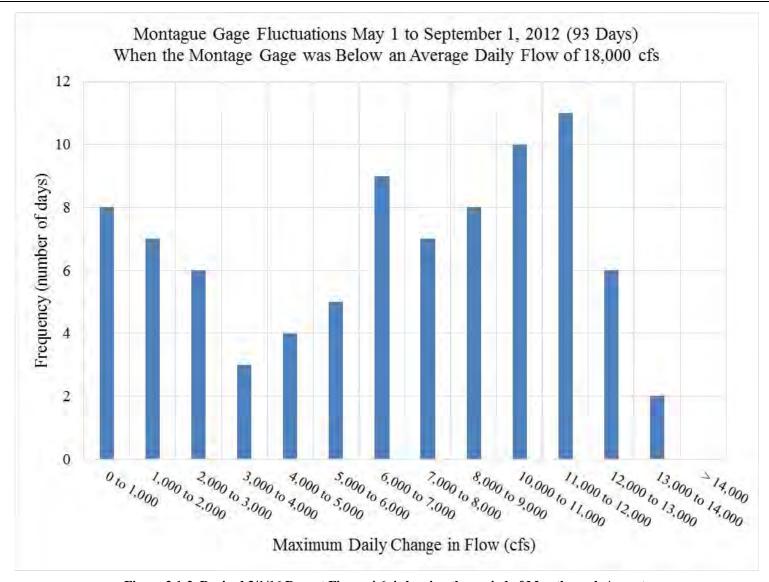
Figure 2.1-2. Revised 3/1/16 Report Figure 4.6-4 showing the period of May through August.

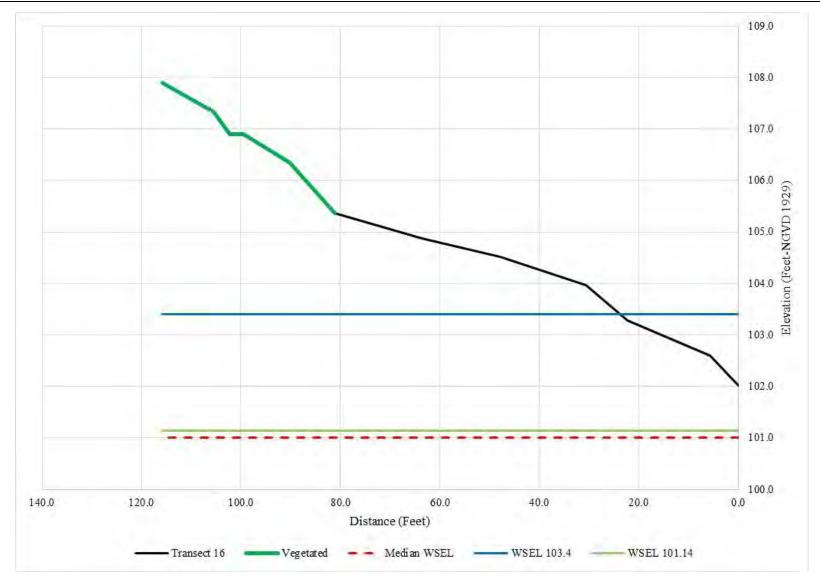
Figure 2.1-7. Revised 3/1/16 Report Figure 4.6-10 Transect 16 showing the period of May through August.

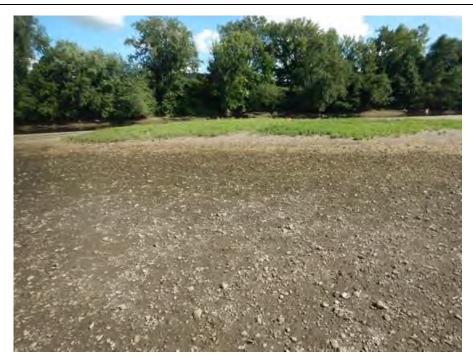
Figure 2.5-1 Representative view of Transect 1 looking to the east along the transect.

Transect 1, located on the upstream end of First Island, is an exposed cobble and gravel bar with varying densities of sandbar willow mixed with low growing herbaceous vegetation. The dominant plant associated with the sandbar willow at Transect 1 is spreading dogbane (Apocynum androsaemifolium) which is found in most vegetated areas along the transect. Additional species observed include rough cocklebur (Xanthium strumarium), purple loosestrife (Lythrum salicaria), and beggar's tick (Bidens frondosa). Substrate along the transects is dominated by areas of cobble occurring primarily in un-vegetated areas and gravel occurring in areas of low (0-25%) to moderate (26-50%) vegetative cover. Figure 2.5-1 shows a representative view of Transect 1 looking easterly across the un-vegetated and vegetated portion of the Transect. Figure 2.5-2 shows a representative view of the dominant substrate observed in areas occupied by sandbar willow. The photo presented as Figure 2.5-2 was taken at Station 35.0 Meters, and one clump of sandbar willow is identified at this plot location. Table 2.5-1 presents the survey station, elevation, estimated percent cover of vegetation, and dominant substrate observed at each sample plot location. In 2014 a total of eight sandbar willows were identified at this location, and in 2015 nine sandbar willows were identified along Transect 1 (Figure 2.5-3). Following a review of the elevation data, substrate information, and percent vegetative cover and based on where clumps of sandbar willow were located in 2015, it appears that sandbar willow is likely to occupy areas of gravel with a medium density of vegetative cover at elevations ranging from 104.6 to 106.0 feet; elevation 106.0 is the highest elevation observed on Transect 1. This habitat is present at Transect 1 from station 26.2 meters to 42.7 meters.

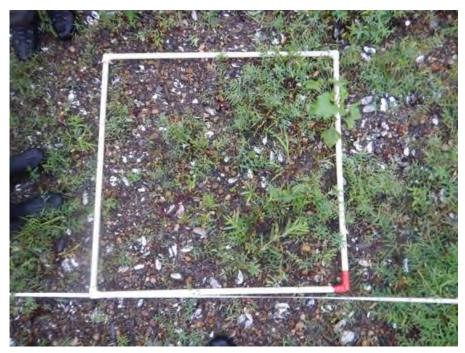
Figure 2.5-2. Representative view of Station 35.0 (Meters), one sandbar willow clump, medium density Apocynum and cocklebur, and gravel substrate present.

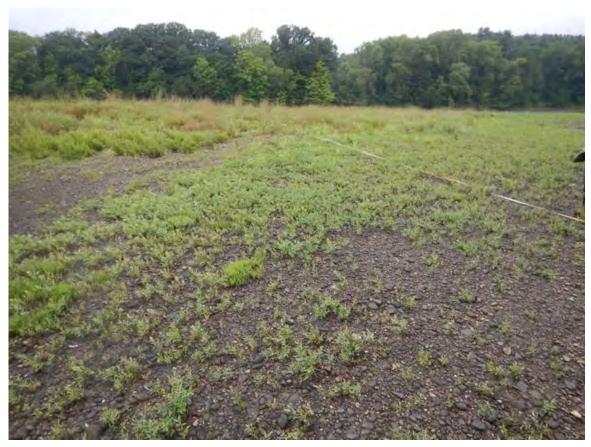
Figure 2.5-4. Representative view, looking west of habitat surveyed on Transect 2

Transect 2 is located at the northern end of Second Island. The habitat is similar to the Transect 1 location, although the transect bisects an area of higher elevation, which is more vegetated than any plot located at Transect 1. Figure 2.5-4 shows a representative view of Transect 2, looking to the west from the start pin across both un-vegetated and vegetated habitat. Most of the transect is dominated by sand and gravel, and in general, plots in sandy substrates supported areas of denser vegetation. These locations are generally observed above elevation 106.0 feet at Transect 2. Vegetation in these areas is dense (51-100% cover) and dominated by big bluestem (*Andropogon gerardii*) and switchgrass (*Panicum virgatum*) (Figure 2.5-5). Vegetation in the less dense and gravel dominated areas is primarily spreading dogbane (Figure 2.5-6). Portions of the transect are dominated by cobble, and these areas are all located on the western end of Transect 2, and range from un-vegetated to densely vegetated spreading dogbane. The sandbar willows at Transect 2 were observed above elevation 106.4 feet and in areas of medium density vegetation (26-50%) with sand and gravel dominated substrates (Table 2.5-2).

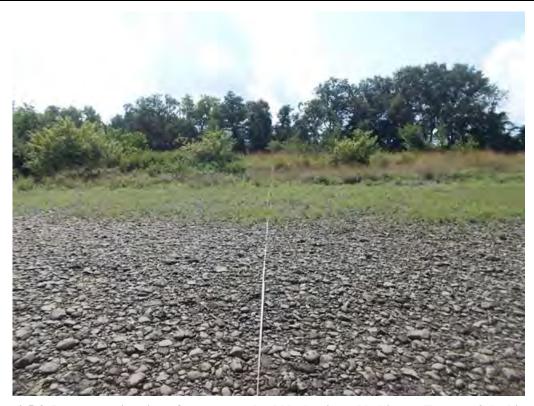
Figure 2.5-8. Representative view of un-vegetated cobble dominated habitat at Transect 3, looking west from the start pin.

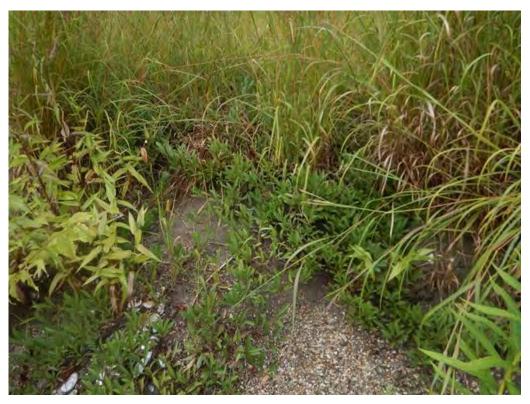
Figure 2.5-9. Representative view of habitat present from station 37.2 to 93.9 Meters.

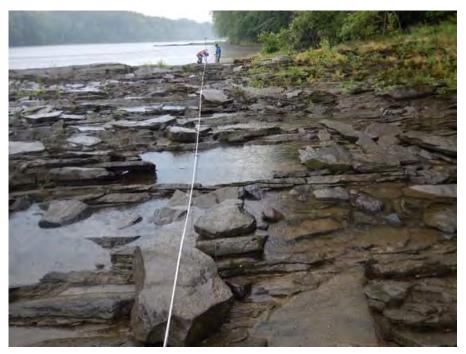
Figure 2.5-13. Representative view of habitat and substrate observed along Transect 4.

Transect 4 is dominated by bedrock and percent cover of vegetation is very low for the entire transect; habitat is comparable along the entirety of Transect 4. <u>Table 2.5-4</u> contains elevation, density of Tradescant's aster, estimated percent cover of vegetation and observed substrate at each of the sample plot locations. Vegetation, when it does occur on the transect, is found within small cracks and crevices within the bedrock (<u>Figure 2.5-13</u>). Based on observations made in the field, habitat within the population at this location is similar throughout the area. Factors that may play a role in the presence of Tradescant's aster are likely related to the availability of cracks or crevices large enough to support growth of vegetation, or the absence of pools with standing water trapped by the bedrock (see <u>Figure 2.5-13</u>), or possibly a lack of competing vegetation. The majority of the Tradescant's asters were found in areas of exposed and scoured bedrock which allows for very little competing vegetation to become established. At higher elevations, more vegetation is present (<u>Figure 2.5-13</u>). The duration of inundation during the growing season was also examined and described in <u>Section 2.4</u>.

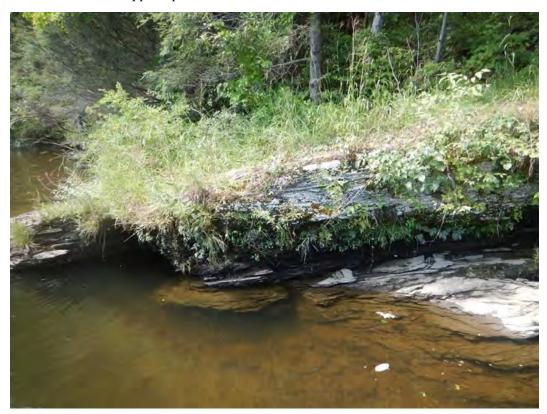
Figure 2.5-17. Representative view of suitable upland white aster habitat at the Transect 6A-6C location.

Transects 6A and 6C were all established within similar habitat (<u>Table 2.5-8</u>, <u>2.5-9</u>, and <u>2.5-10</u>). At this location there is a bedrock shelf which rises nearly vertically from the water's edge. Habitat is dominated by herbaceous vegetation such as big bluestem, calico aster (Symphyotrichum lateriflorum), common St. Johns wort (*Hypericum perforatum*) growing in a thin layer of soil over bedrock (<u>Figure 2.5-17</u>). This herbaceous extends a short distance (i.e., six to 11 feet) before the bank steepens and an overstory white pine (*Pinus strobus*) and eastern hemlock (*Tsuga canadensis*) provide significant shading. Transect 6B is similar topographically, although the entire transect up to the forest transition is exposed bedrock with very sparse vegetation. The transects all extend from the water's edge to the interface of the open meadow and forest. Within the forest there is very little herbaceous understory due to overystory shading. No upland white asters were observed within the forested habitat at this location in 2014 or 2015. Based on observations, the transects are established within the suitable habitat of the upland white aster; areas further upslope appear to be unsuitable due to the shading provided by pine and hemlock. <u>Figure 2.5-18</u> shows the location of identified and mapped upland white aster at this location in 2014 and 2015.

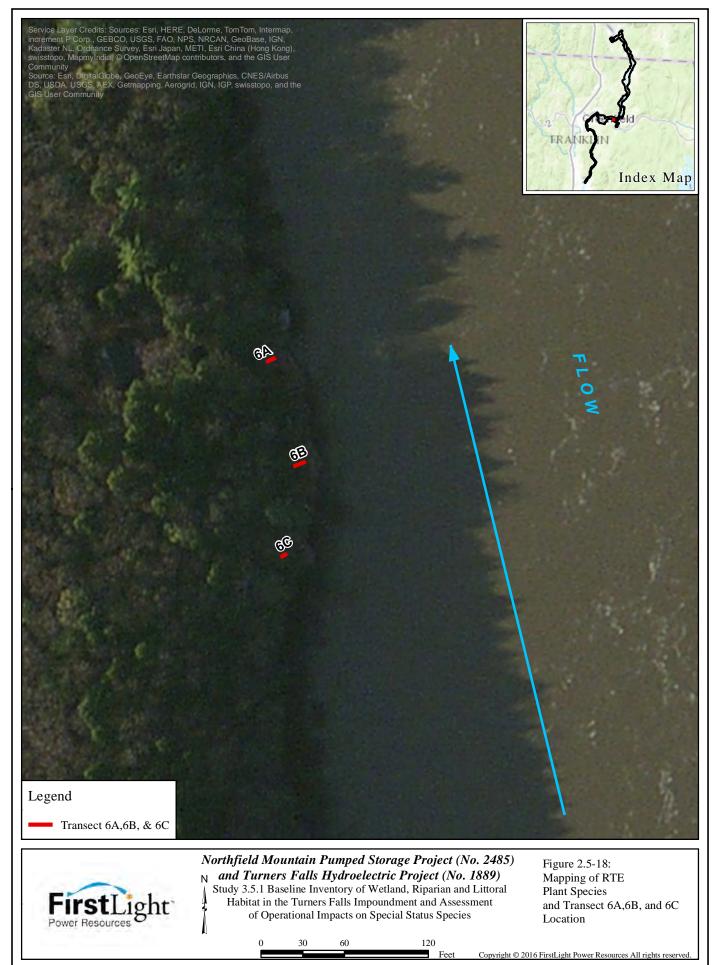
Figure 2.5-19. Updated study report Figure 4.3-19 identifying the location of Frank's love grass on Transect 11.

In 2014 intermediate spike sedge was identified at the Pauchaug survey location, however, no elevation data was collected in 2014. The location of intermediate spike sedge was not relocated in 2015, and therefore it is not possible to identify the elevation at which the sedge occurred at in 2015. Frank's love grass was identified at elevation 187.2 on Transect 11D, an updated Figure 4.3-49 is included here as Figure 2.5-19 which identifies the location of Frank's love grass on Transect 11D.

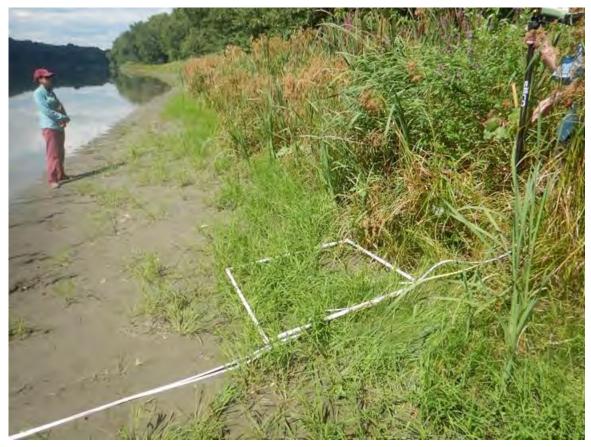
Figure 2.5-21. Representative view of habitat observed at Transect 11A-11D showing un-vegetated and vegetated areas.

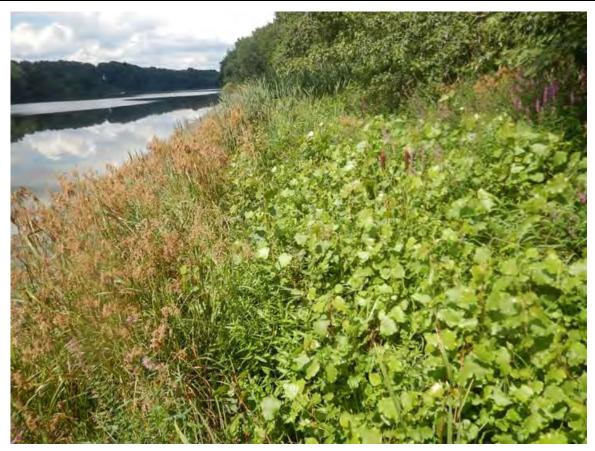
Figure 2.5-22. Representative view of habitat observed at Transect 11A-11D showing the transition from wool grass to spiny cocklebur vegetation.

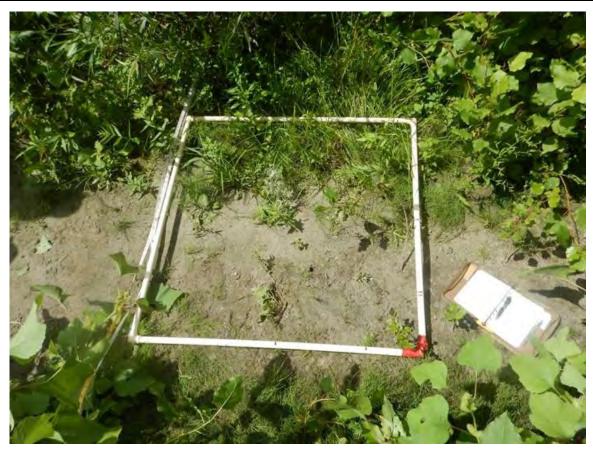
Figure 5.2-24. View of walking path where observation of Frank's love grass was made at Transect 11D.

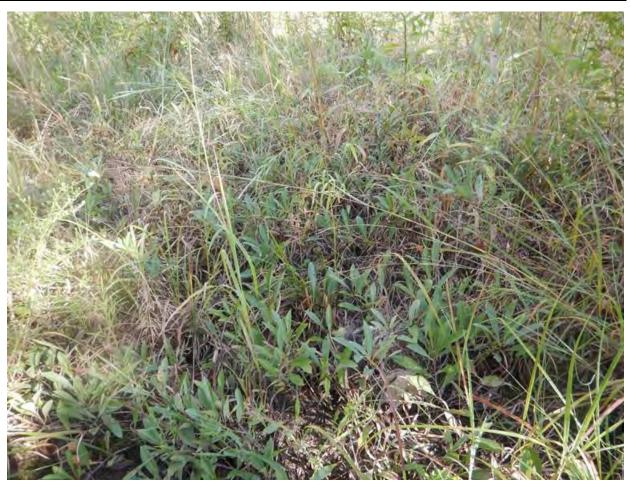
Figure 2.5-25. View of representative vegetated habitat along Transect 8.

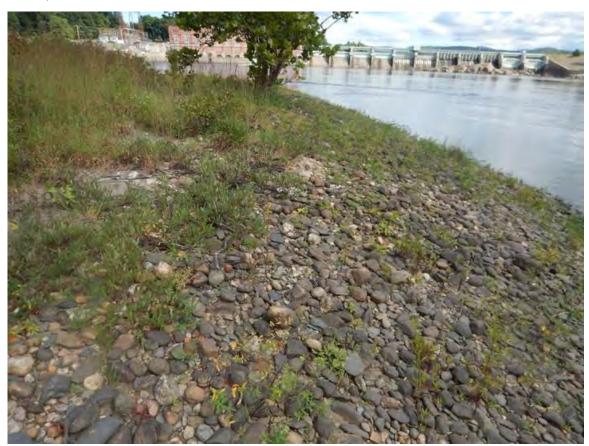
Figure 2.5-27. Representative habitat at Transect 9A and 9B, view looing to the north.

Two transects were established at this location. Habitat on the small island is dominated by low to medium cover and substrates are dominated by cobble and sand. Figure 2.5-27 shows representative habitat found along 9A and 9B. In general, areas of cobble were less vegetated and dominated by spreading dogbane and sandbar cherry. Sandy areas were more vegetated and were dominated by Indiangrass (*Sorghastrum nutans*) and spreading dogbane. As with other sandbar cherry locations, sandy soils seem to be the preferred habitat, although at the Transect 9 location sandbar cherries were observed within cobble substrates (<u>Table 2.5-16</u> and <u>2.5-17</u>).

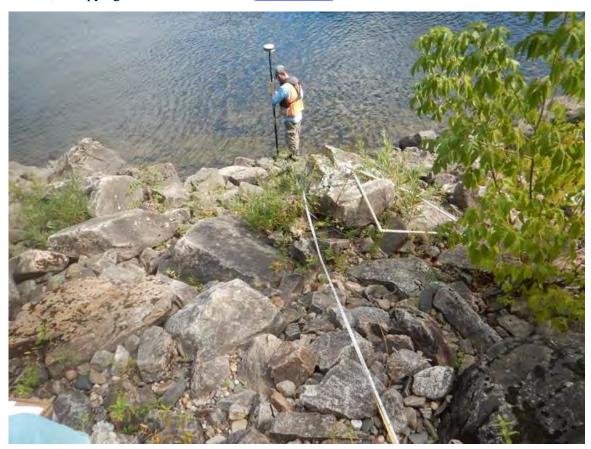
Figure 2.5-28. Representative view of habitat on Transect 10.

Transect 10 is a steeply sloping transect that extends up a boulder dominated hillside. Vegetation here is sparse (0-25%) and dominated by spreading dogbane, mountain alder, and sandbar willow (Figure 2.5-28). Sandbar willow occurs primarily at the lower elevations while the mountain alder occurs much higher on the transect, occupying elevation 197.67 feet (Table 2.5-18).
