Relicensing Study 3.1.2

NORTHFIELD MOUNTAIN/TURNERS FALLS OPERATIONS IMPACT ON EXISTING EROSION AND POTENTIAL BANK INSTABILITY

Initial Study Report Summary

Northfield Mountain Pumped Storage Project (No. 2485)
and Turners Falls Hydroelectric Project (No. 1889)

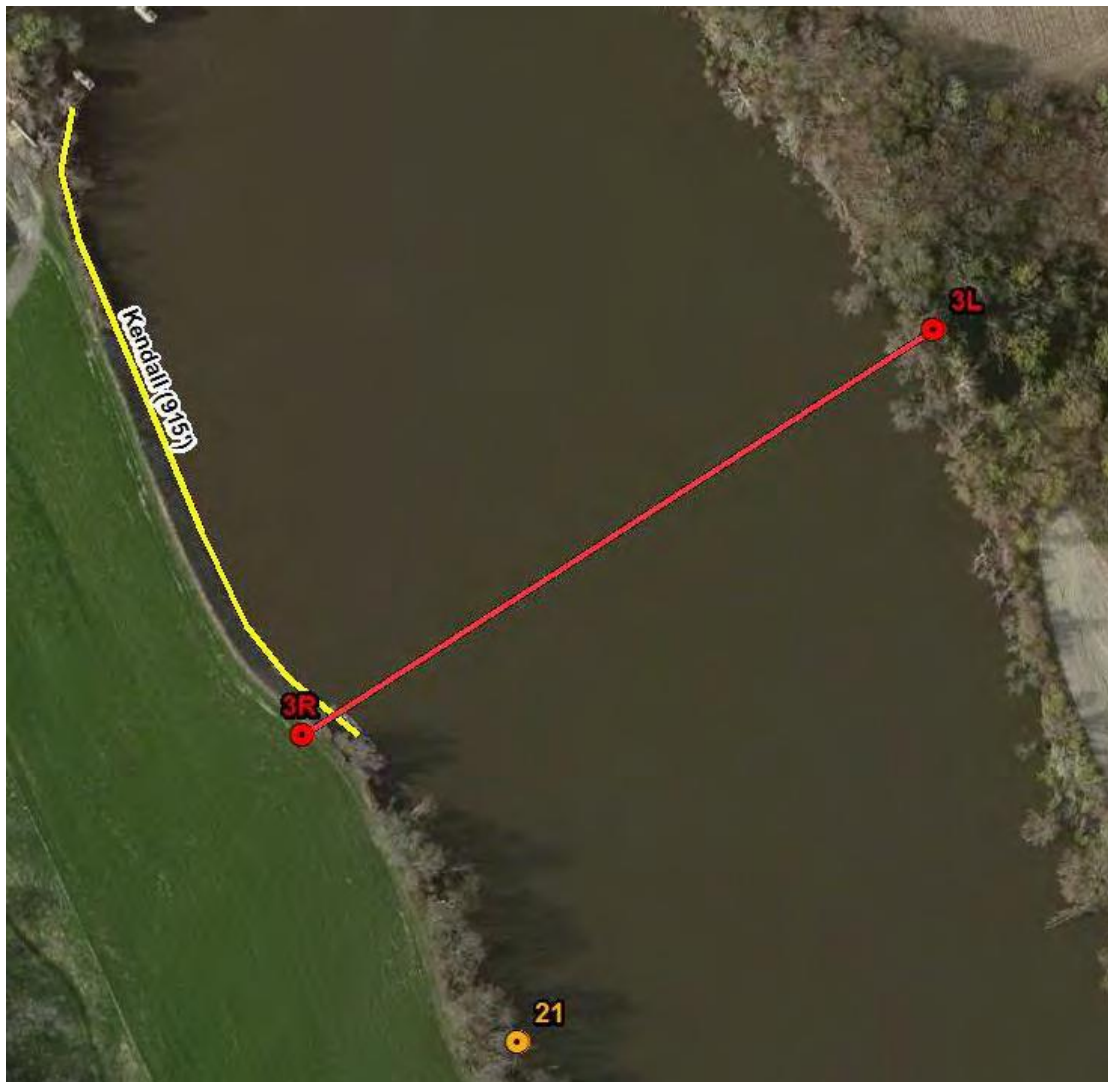
Site Complex Example

An example of one such data complex is shown below. Restoration occurred at Site 3R (Kendall) in 2007. Based on this, approximately 8 years of data before restoration and 6 years of data after can be examined. Site 3L has not been restored and exhibits a different set of riverbank features and characteristics. Nearby, Site 21 provides a location with some degree of erosion and similar riverbank features and characteristics as to what likely existed prior to the Kendall site restoration. Together this data complex, like a few others, provides a good set of sites to analyze and evaluate erosion under a wide variety of riverbank conditions but very similar hydraulics.

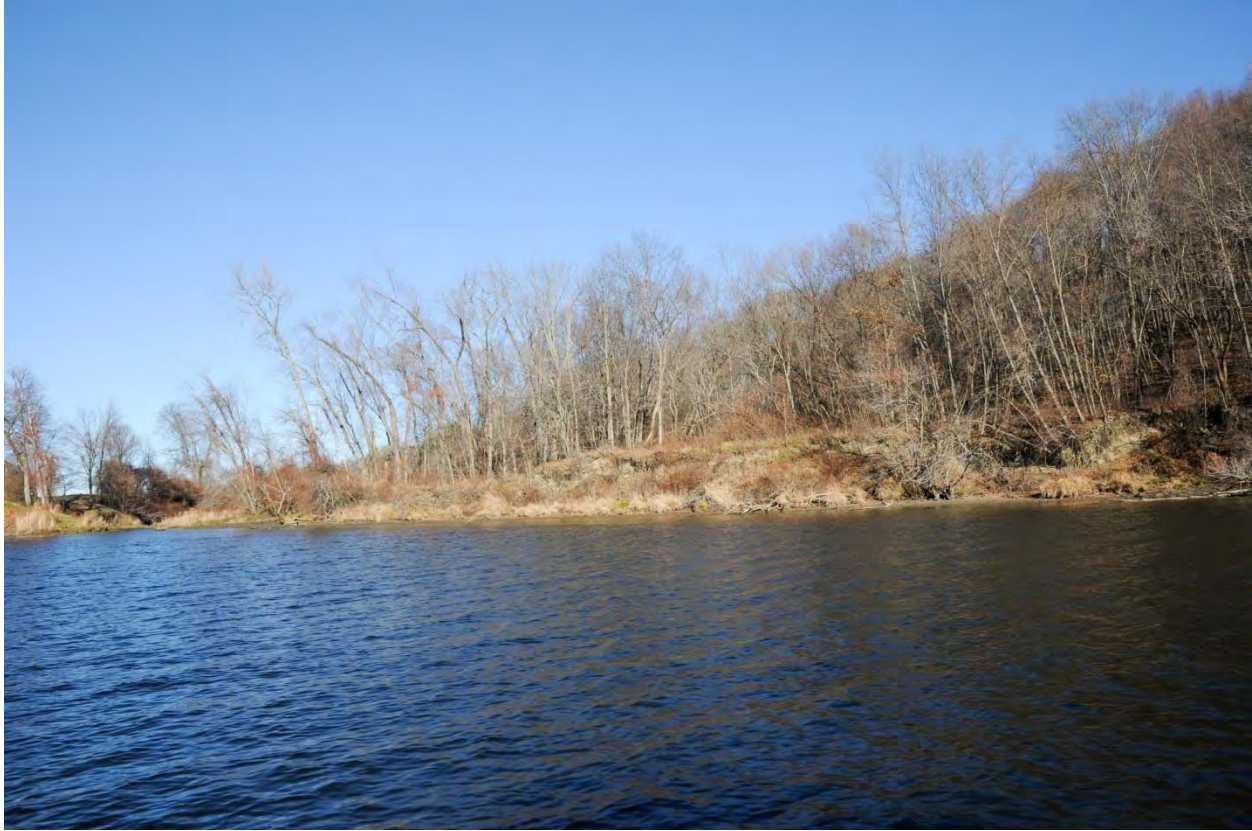
Site 87(B) (photo #605)

Attachment C – Site Recommendations**Riverbank features and characteristics – Site 87(B)**

As shown in the above matrix of river segments, significant gaps exist for representative sites for the river segments in the proposed Hydraulic Forces category. These gaps are highlighted in blue. Additional sites should be selected to fill these gaps and even the distribution of sites among categories. We have suggested sites from the 2013 Land Based Survey data sheets, which are shown in red font. We do not have the 2013 Full River Reconnaissance data so are unable to suggest sites from that data set. We recommend that Boat Based site 87B be included.

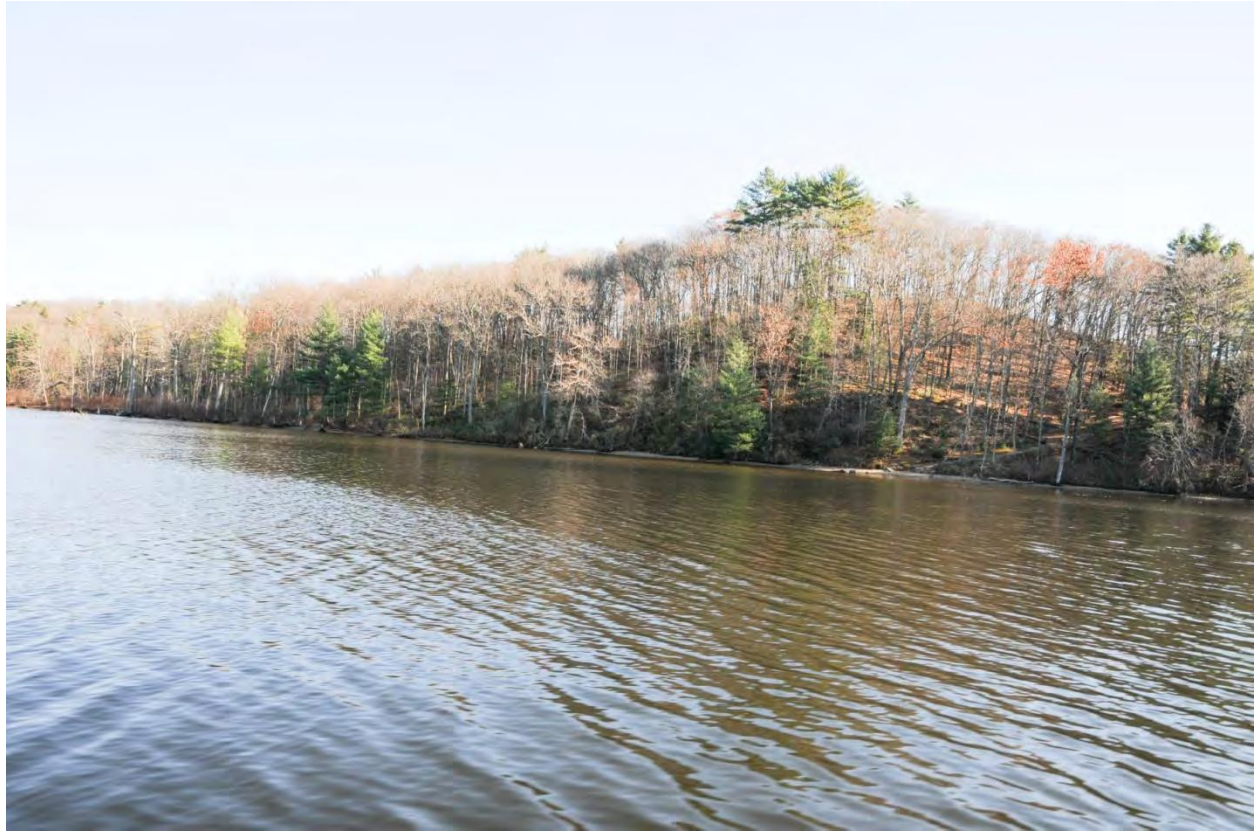
Site BC-1R (photo #377)

Riverbank features and characteristics – Site BC-1R

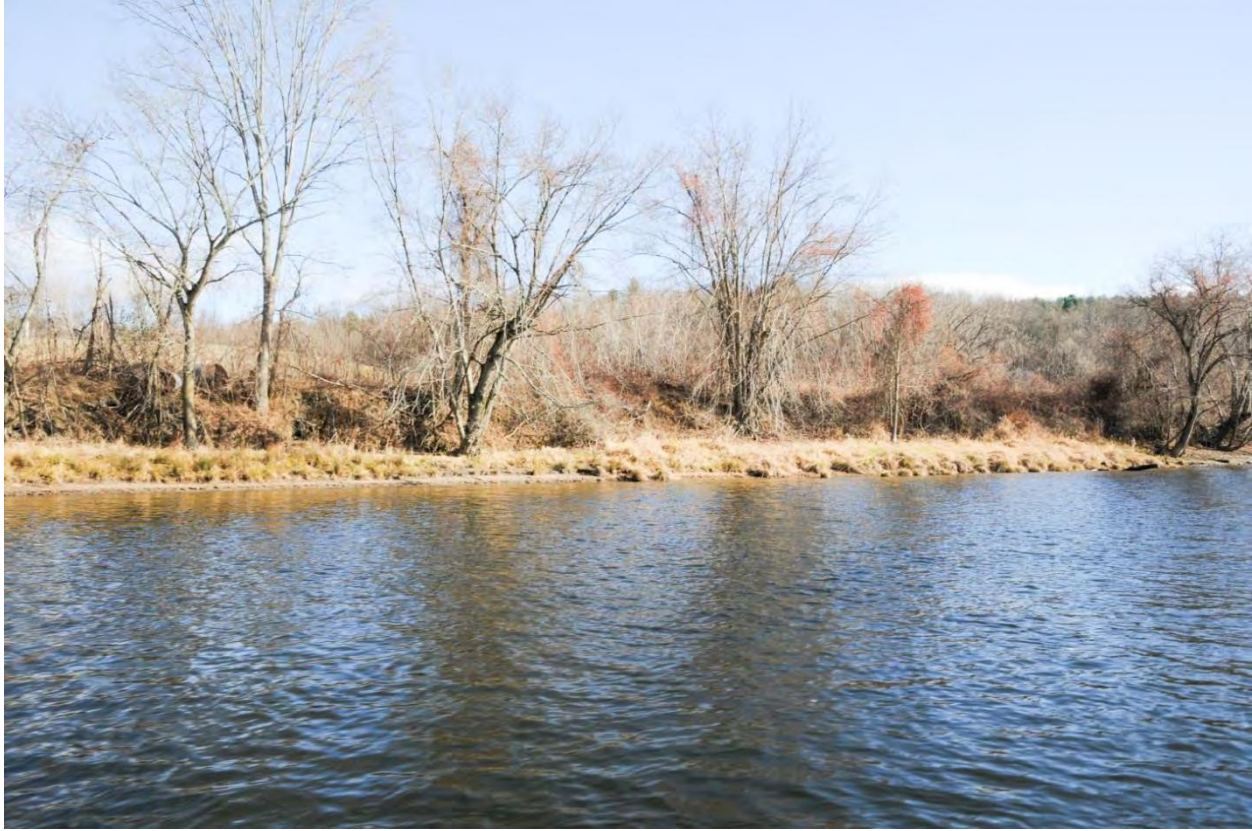
Site 303 (photo #1577)

Riverbank features and characteristics – Site 303(B)

Riverbank Features	Characteristics
Upper Riverbank Slope	Moderate
Upper Riverbank Height	Medium
Upper Riverbank Sediment	Silt/Sand
Upper Riverbank Vegetation	Heavy
Lower Riverbank Slope	Flat/Beach
Lower Riverbank Sediment	Silt/Sand
Lower Riverbank Vegetation	Heavy
Type of Erosion	
Potential Erosion Indicators	None
Stage of Erosion	Stable
Extent of Erosion	None/little

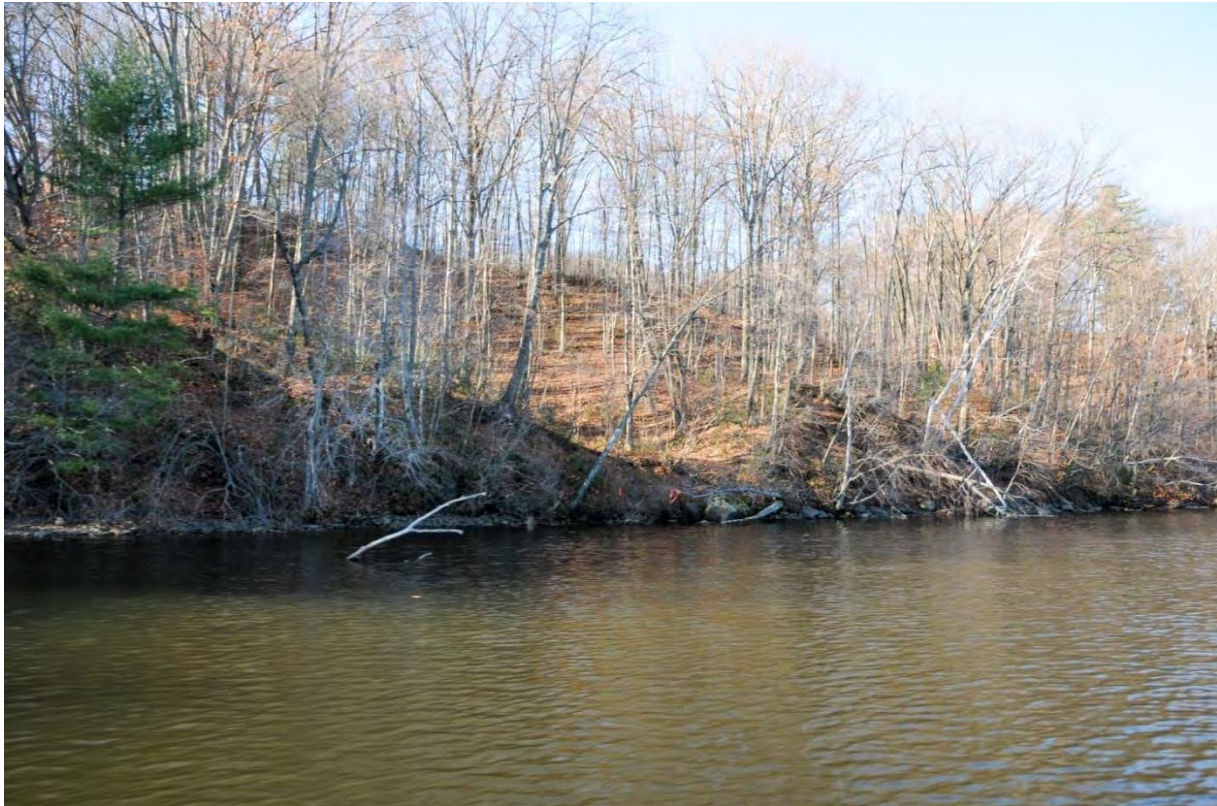
TRANSECT #BC1 - Left Bank (274)

Riverbank Features	Left Bank	Right Bank
Upper Riverbank Slope	Moderate	Moderate
Upper Riverbank Height	High	High
Upper Riverbank Sediment	Silt/Sand	Silt/Sand
Upper Riverbank Vegetation	Heavy	Heavy
Lower Riverbank Slope	Moderate	Flat/Beach
Lower Riverbank Sediment	Boulders	Silt/Sand
Lower Riverbank Vegetation	None/Very Sparse	None/Very Sparse
Type of Erosion	None	Undercut
Potential Erosion Indicators	None	Creep/Leaning Trees
Stage of Erosion	Stable	Stable
Extent of Current Erosion	None/Little	None/Little

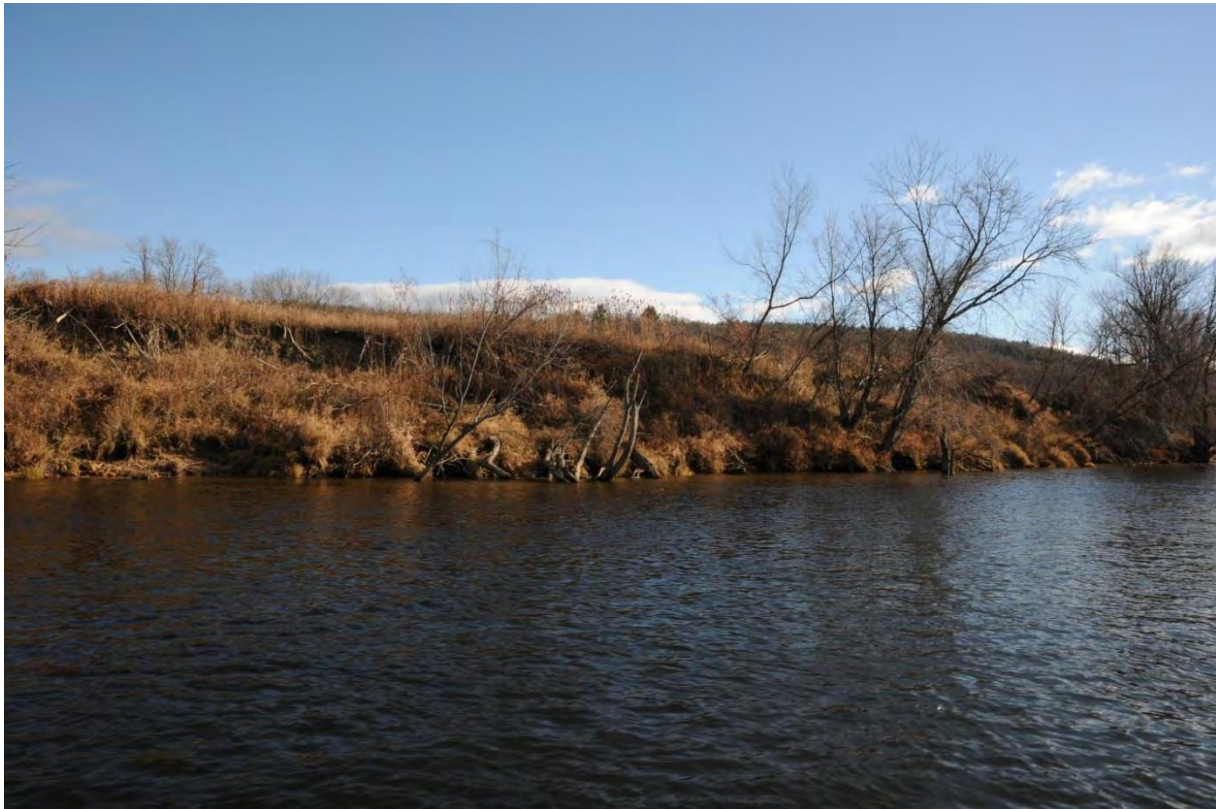
TRANSECT #2 - Left Bank (1573)

Riverbank Features	Left Bank	Right Bank
Upper Riverbank Slope	Vertical	Steep
Upper Riverbank Height	High	Low
Upper Riverbank Sediment	Silt/Sand	Silt/Sand
Upper Riverbank Vegetation	Moderate	Moderate
Lower Riverbank Slope	Flat/Beach	Flat/Beach
Lower Riverbank Sediment	Silt/Sand	Silt/Sand
Lower Riverbank Vegetation	None to very sparse	None to very sparse
Type of Erosion	Rotational slump	Undercut
Potential Erosion Indicators	Creep/Leaning trees	Creep/Leaning Trees, Other
Stage of Erosion	Eroded	Stable
Extent of Current Erosion	Some	None/Little

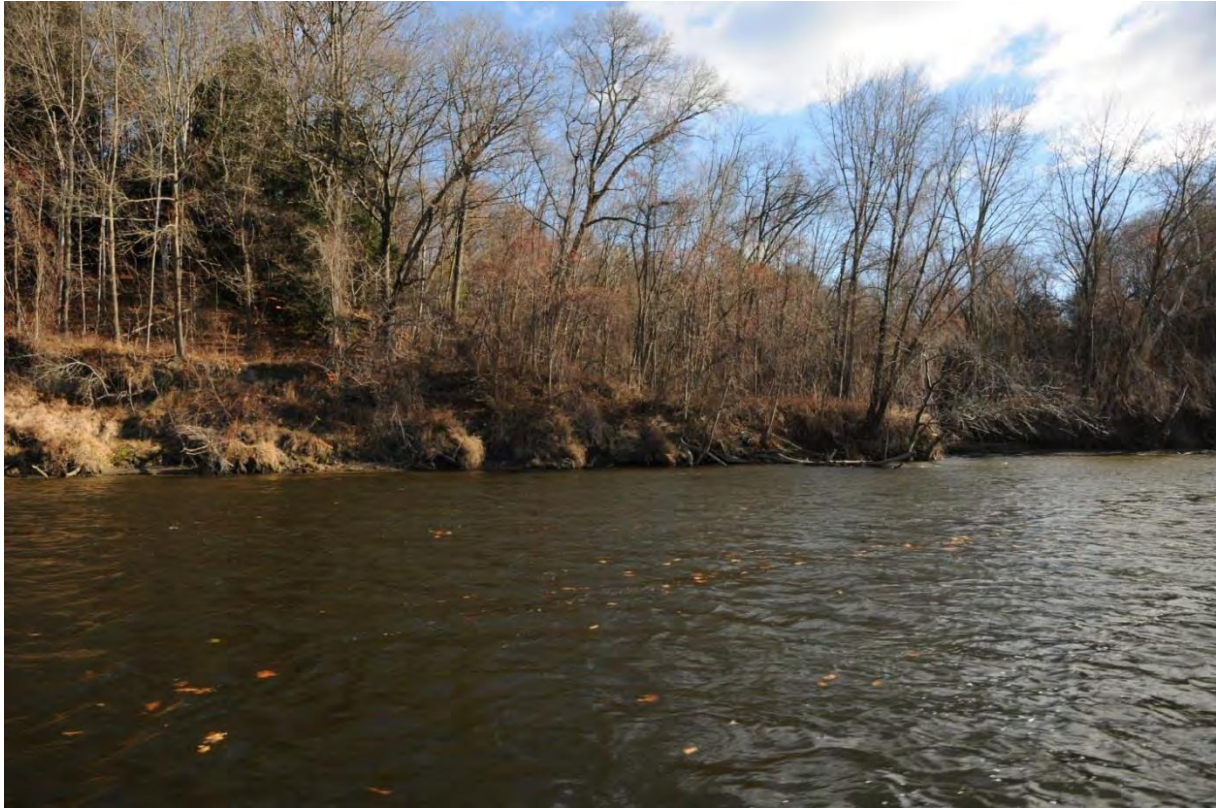
**TRANSECT #3 - Left Bank (1673)**

Riverbank Features	Left Bank	Right Bank
Upper Riverbank Slope	Moderate	Moderate
Upper Riverbank Height	Low	High
Upper Riverbank Sediment	Silt/Sand	Silt/Sand
Upper Riverbank Vegetation	Heavy	Heavy
Lower Riverbank Slope	Flat/Beach	Moderate
Lower Riverbank Sediment	Silt/Sand	Gravel
Lower Riverbank Vegetation	None to very sparse	None to very sparse
Type of Erosion	Undercut, Rotational Slump	
Potential Erosion Indicators	Creep/Leaning trees, Overhanging	
Stage of Erosion	Eroded	Stable
Extent of Current Erosion	Some	None/Little

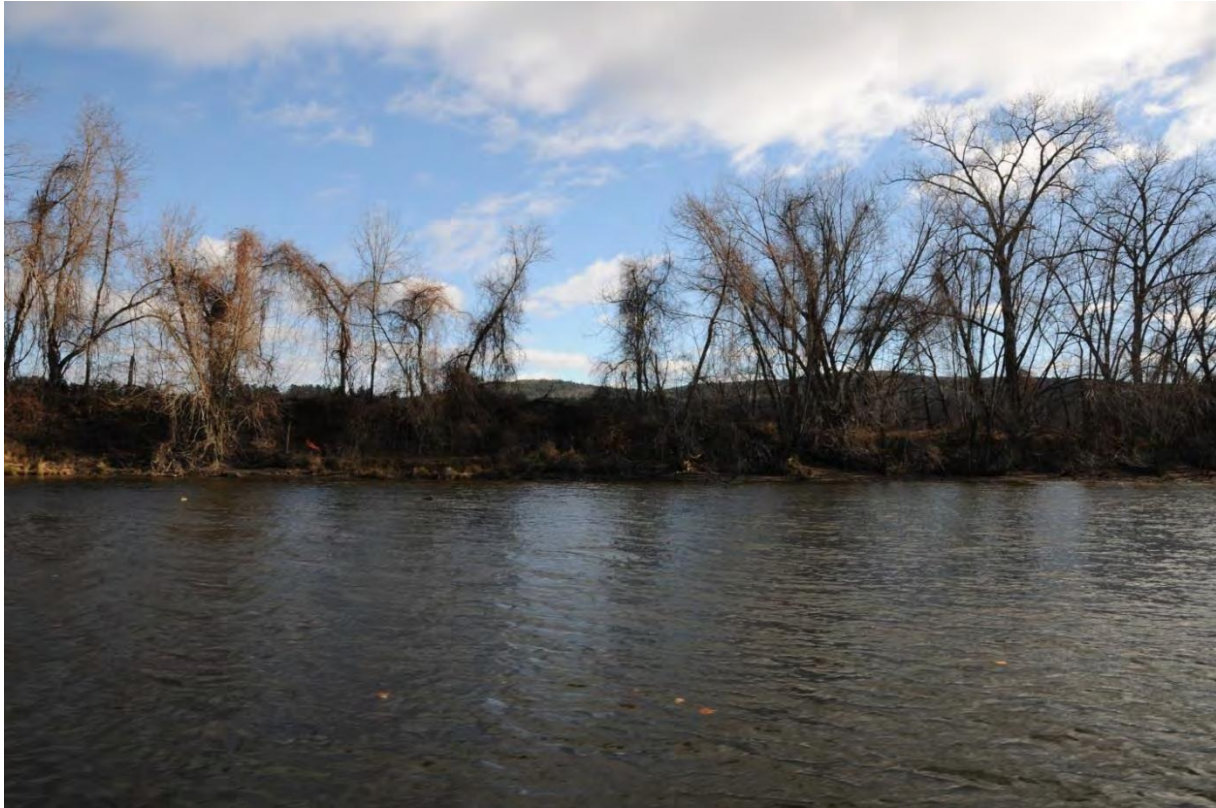
**TRANSECT #4 - Left Bank (1708)**

Riverbank Features	Left Bank	Right Bank
Upper Riverbank Slope	Moderate	Moderate
Upper Riverbank Height	Medium	High
Upper Riverbank Sediment	Silt/Sand	Silt/Sand
Upper Riverbank Vegetation	Heavy	Heavy
Lower Riverbank Slope	Flat/Beach	Flat/Beach
Lower Riverbank Sediment	Silt/Sand	Silt/Sand
Lower Riverbank Vegetation	None to very sparse	None to very sparse
Type of Erosion		Undercut
Potential Erosion Indicators	Creep/Leaning trees	Creep/Leaning trees
Stage of Erosion	Stable	Stable
Extent of Current Erosion	None/Little	None/Little

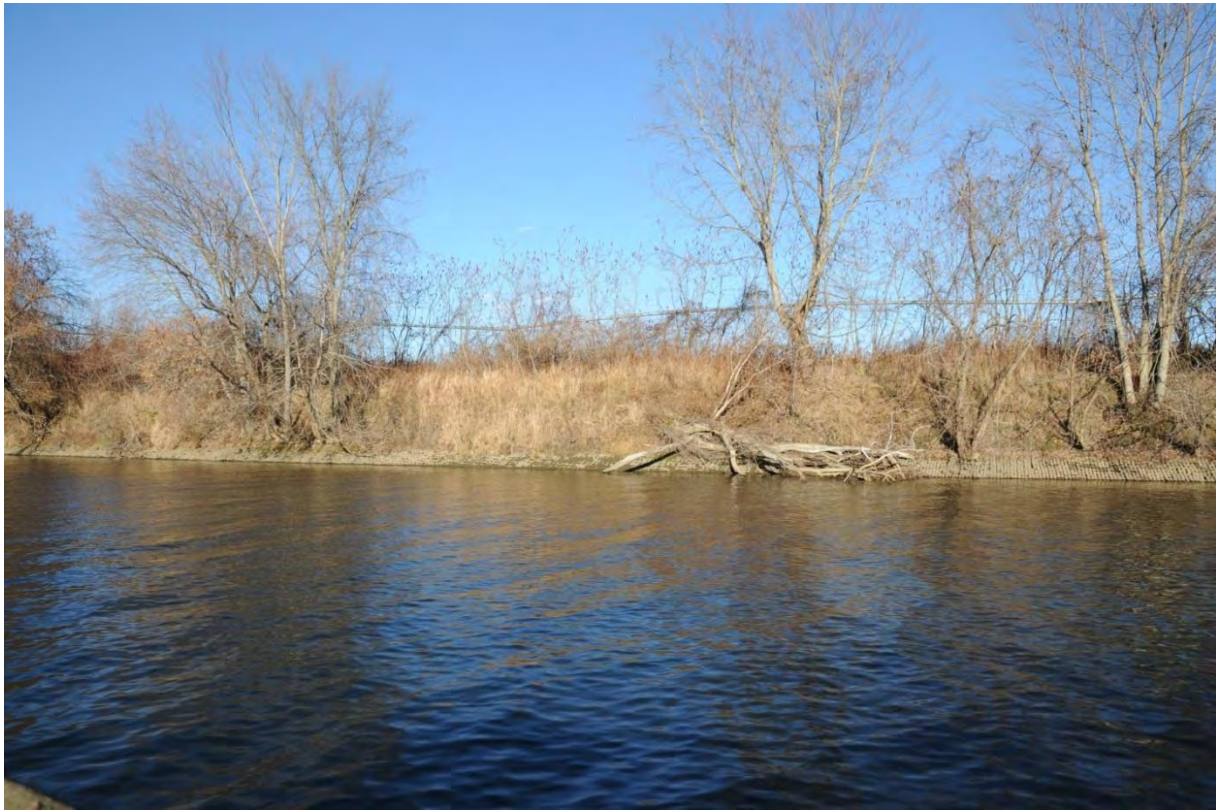
**TRANSECT #5C - Left Bank (809)**

Riverbank Features	Left Bank	Right Bank
Upper Riverbank Slope	Steep	Steep
Upper Riverbank Height	High	High
Upper Riverbank Sediment	Silt/Sand	Silt/Sand
Upper Riverbank Vegetation	Heavy	Moderate
Lower Riverbank Slope	Moderate	Flat/Beach
Lower Riverbank Sediment	Boulders	Silt/Sand
Lower Riverbank Vegetation	None to very sparse	None to very sparse
Type of Erosion	Slide or Flow	Slide or Flow
Potential Erosion Indicators		Overhanging bank, Exposed Roots, Creep/Leaning Trees
Stage of Erosion	Stable	Eroded
Extent of Current Erosion	None/Little	Some

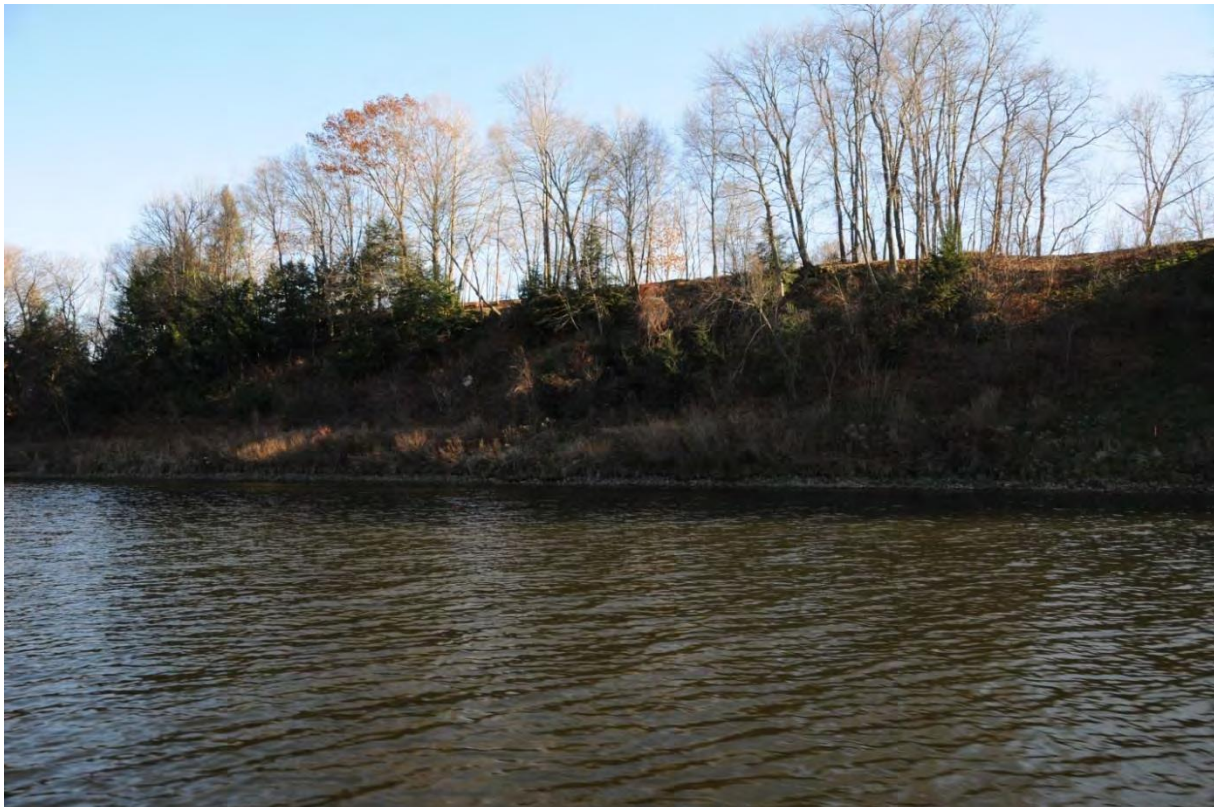
TRANSECT #6A - Left Bank (678)

Riverbank Features	Left Bank	Right Bank
Upper Riverbank Slope	Moderate	Steep
Upper Riverbank Height	High	High
Upper Riverbank Sediment	Silt/Sand	Silt/Sand
Upper Riverbank Vegetation	Heavy	Heavy
Lower Riverbank Slope	Moderate	Flat/Beach
Lower Riverbank Sediment	Cobbles	Silt/Sand
Lower Riverbank Vegetation	None to very sparse	Heavy
Type of Erosion		
Potential Erosion Indicators		
Stage of Erosion	Stable	Stable
Extent of Current Erosion	None/Little	None/Little

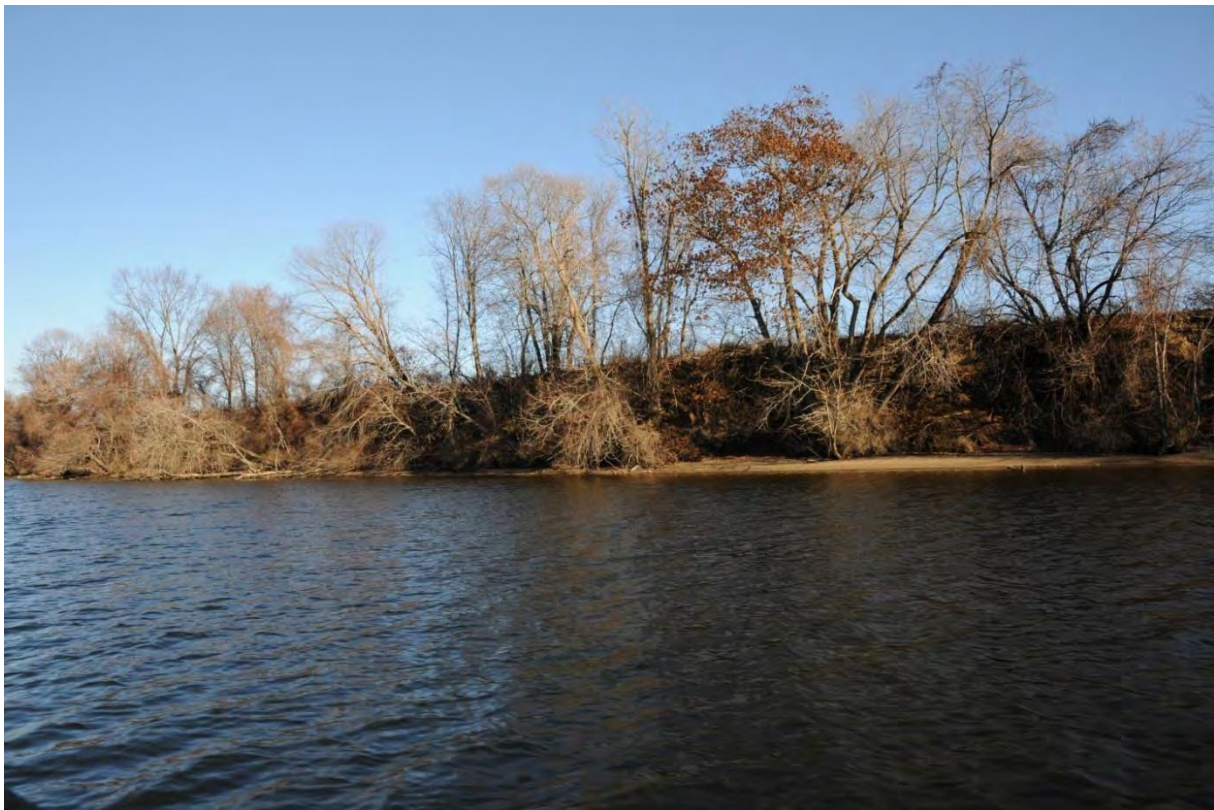
TRANSECT #7 - Left Bank (651)

Riverbank Features	Left Bank	Right Bank
Upper Riverbank Slope	Steep	Moderate
Upper Riverbank Height	High	High
Upper Riverbank Sediment	Silt/Sand	Silt/Sand
Upper Riverbank Vegetation	Heavy	Heavy
Lower Riverbank Slope	Flat/Beach	Moderate
Lower Riverbank Sediment	Silt/Sand	Boulders
Lower Riverbank Vegetation	None to very sparse	None to very sparse
Type of Erosion	Undercut	
Potential Erosion Indicators	Creep/Leaning trees	
Stage of Erosion	Potential Future Erosion	Stable
Extent of Current Erosion	None/Little	None/Little

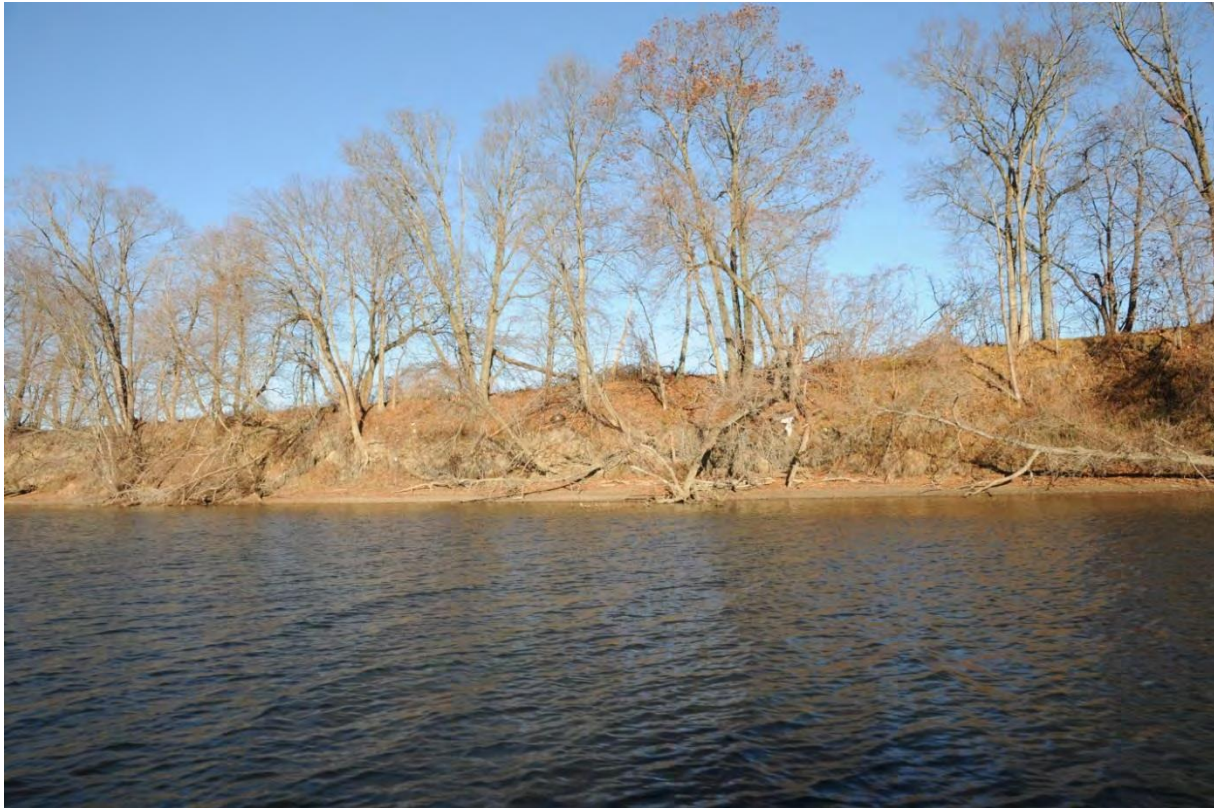
TRANSECT #8B - Left Bank (620)

Riverbank Features	Left Bank	Right Bank
Upper Riverbank Slope	Steep	Steep/Overhanging
Upper Riverbank Height	High	High
Upper Riverbank Sediment	Silt/Sand	Silt/Sand
Upper Riverbank Vegetation	Moderate	Heavy
Lower Riverbank Slope	Flat/Beach	Flat/Beach
Lower Riverbank Sediment	Silt/Sand	Gravel
Lower Riverbank Vegetation	None to very sparse	None to very sparse
Type of Erosion	Undercut	
Potential Erosion Indicators	Creep/Leaning trees, Exposed roots, Overhanging Bank	Overhanging
Stage of Erosion	Potential Future Erosion	In process of stabilization
Extent of Current Erosion	Some	None/Little

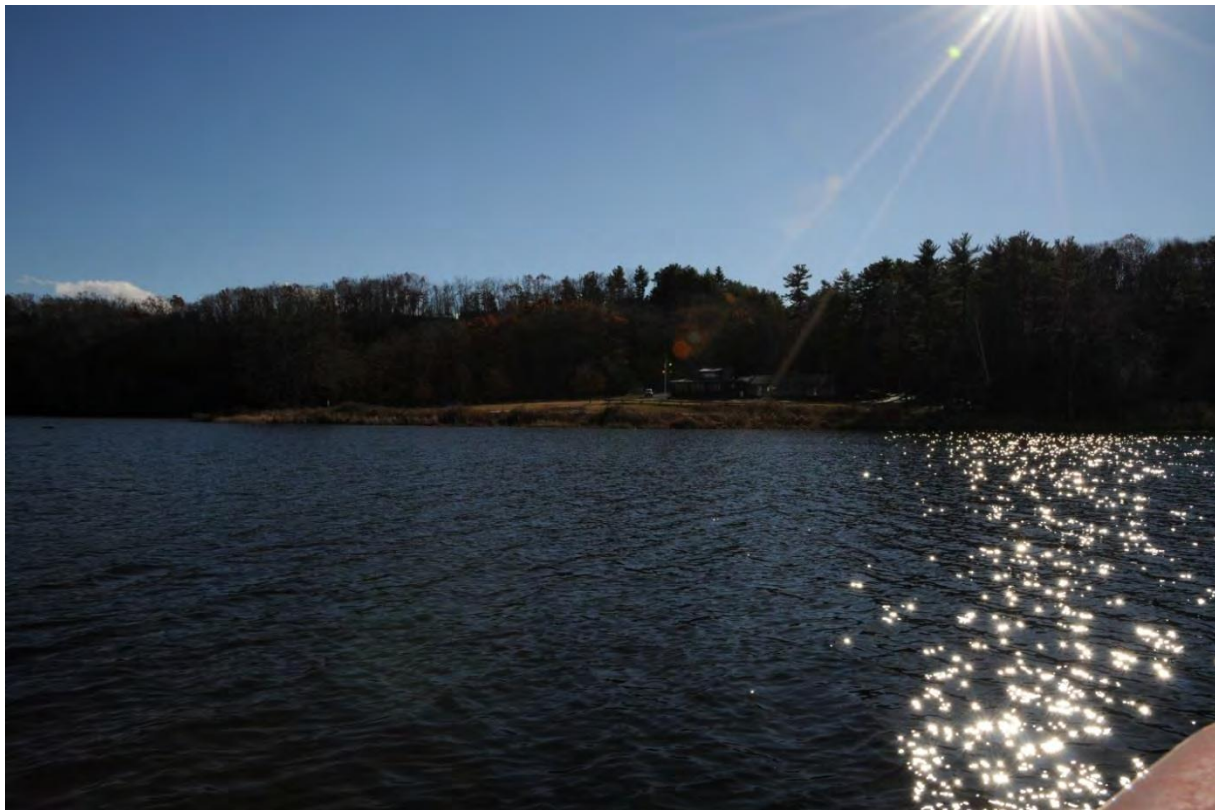
TRANSECT #9 - Left Bank (247)

Riverbank Features	Left Bank	Right Bank
Upper Riverbank Slope	Flat	Moderate
Upper Riverbank Height	Low	High
Upper Riverbank Sediment	Silt/Sand	Silt/Sand
Upper Riverbank Vegetation	Heavy	Moderate
Lower Riverbank Slope	Flat/Beach	Flat/Beach
Lower Riverbank Sediment	Silt/Sand	Silt/Sand
Lower Riverbank Vegetation	Moderate	None to very sparse
Type of Erosion		
Potential Erosion Indicators		Creep/Leaning trees
Stage of Erosion	Stable	Stable
Extent of Current Erosion	None/Little	None/Little

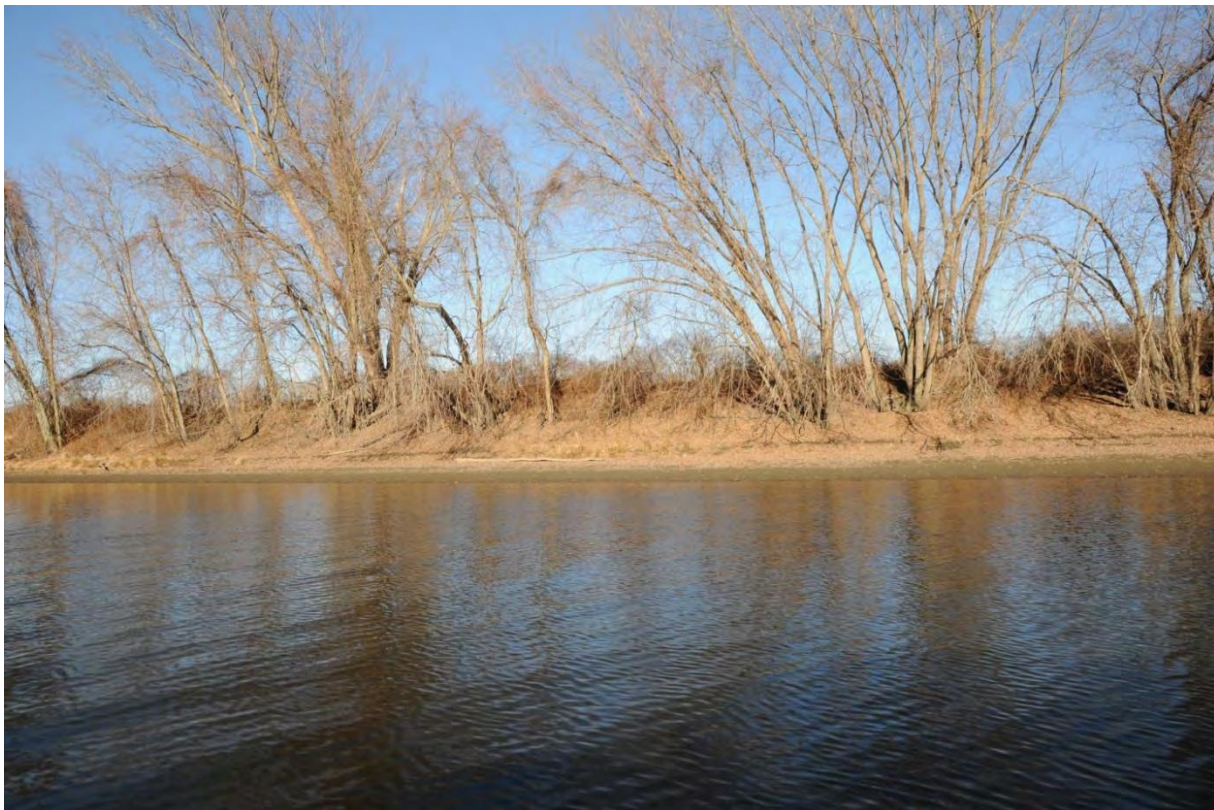
TRANSECT #10 - Left Bank (740)

Riverbank Features	Left Bank	Right Bank
Upper Riverbank Slope	Moderate	Moderate
Upper Riverbank Height	High	High
Upper Riverbank Sediment	Silt/Sand	Silt/Sand
Upper Riverbank Vegetation	Heavy	Heavy
Lower Riverbank Slope	Flat/Beach	Moderate
Lower Riverbank Sediment	Silt/Sand	Cobbles
Lower Riverbank Vegetation	None to very sparse	Sparse
Type of Erosion		
Potential Erosion Indicators		
Stage of Erosion	Stable	Stable
Extent of Current Erosion	None/Little	None/Little

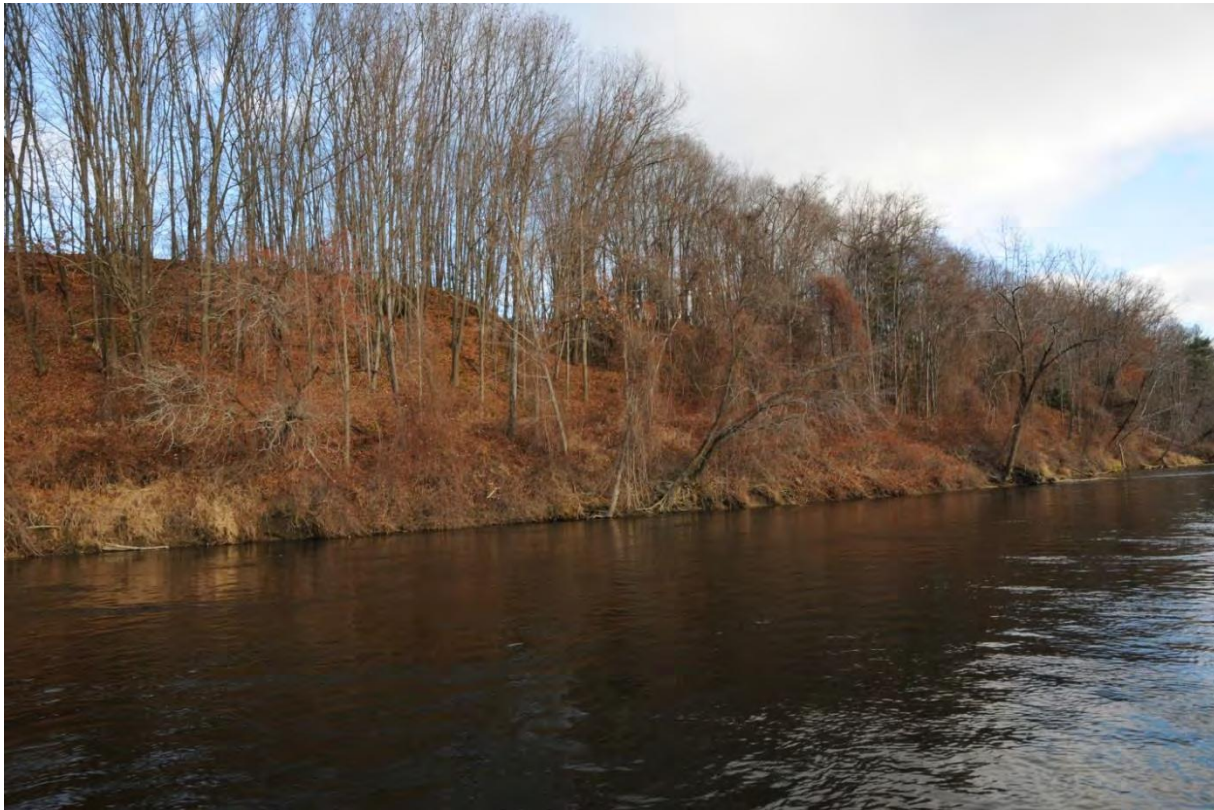
TRANSECT #11 - Left Bank (1447)

Riverbank Features	Left Bank	Right Bank
Upper Riverbank Slope	Moderate	Moderate
Upper Riverbank Height	High	Medium
Upper Riverbank Sediment	Silt/Sand	Silt/Sand
Upper Riverbank Vegetation	Heavy	Heavy
Lower Riverbank Slope	Flat/Beach	Moderate
Lower Riverbank Sediment	Silt/Sand	Silt/Sand
Lower Riverbank Vegetation	None to very sparse	None to very sparse
Type of Erosion	Undercut	
Potential Erosion Indicators	Undercut, Creep/Leaning trees	
Stage of Erosion	Stable	Stable
Extent of Current Erosion	None/Little	None/Little

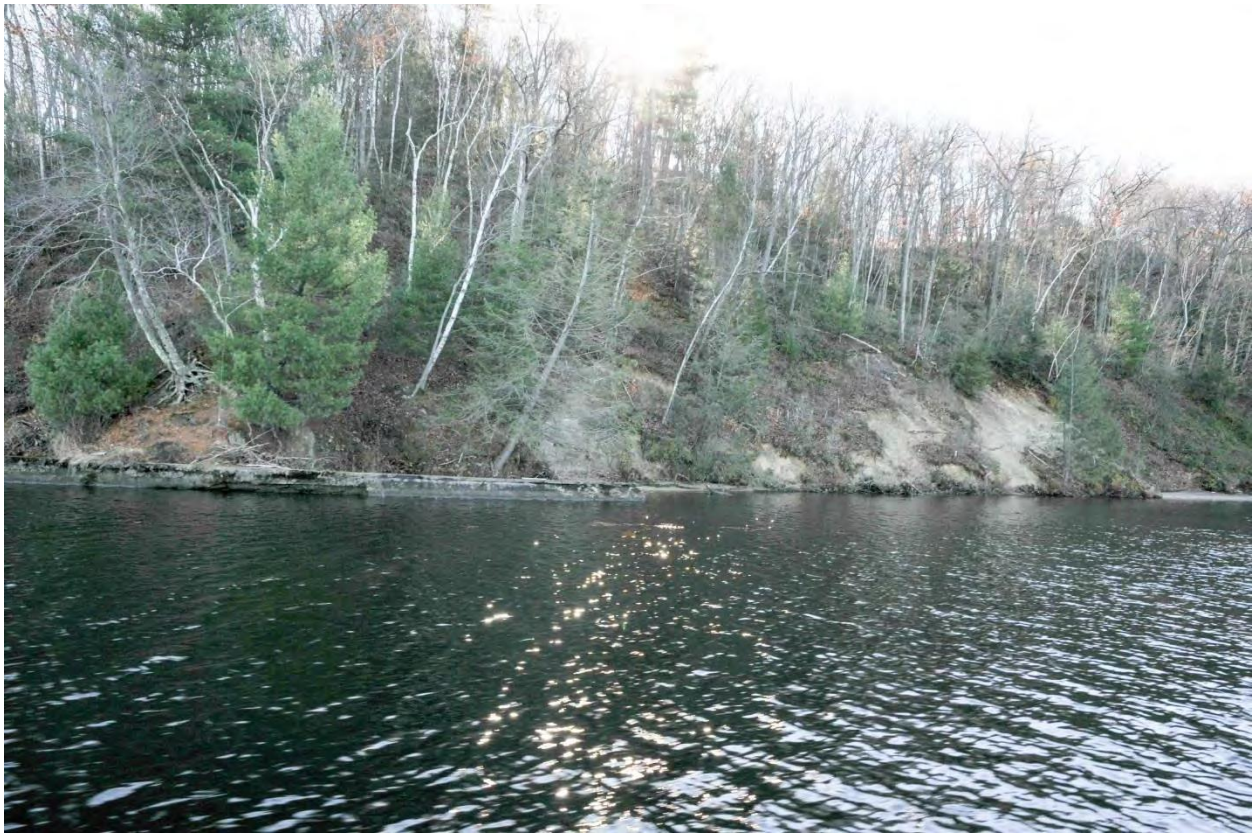
**BOAT-BASED SITE #12**

Riverbank Features	Characteristics
Upper Riverbank Slope	Steep
Upper Riverbank Height	High
Upper Riverbank Sediment	Silt/Sand
Upper Riverbank Vegetation	Sparse
Lower Riverbank Slope	Flat/Beach
Lower Riverbank Sediment	Silt/Sand
Lower Riverbank Vegetation	None to Very Sparse
Type of Erosion	Undercut
Potential Erosion Indicators	Exposed Roots, Overhanging Bank
Stage of Erosion	Active
Extent of Current Erosion	Extensive

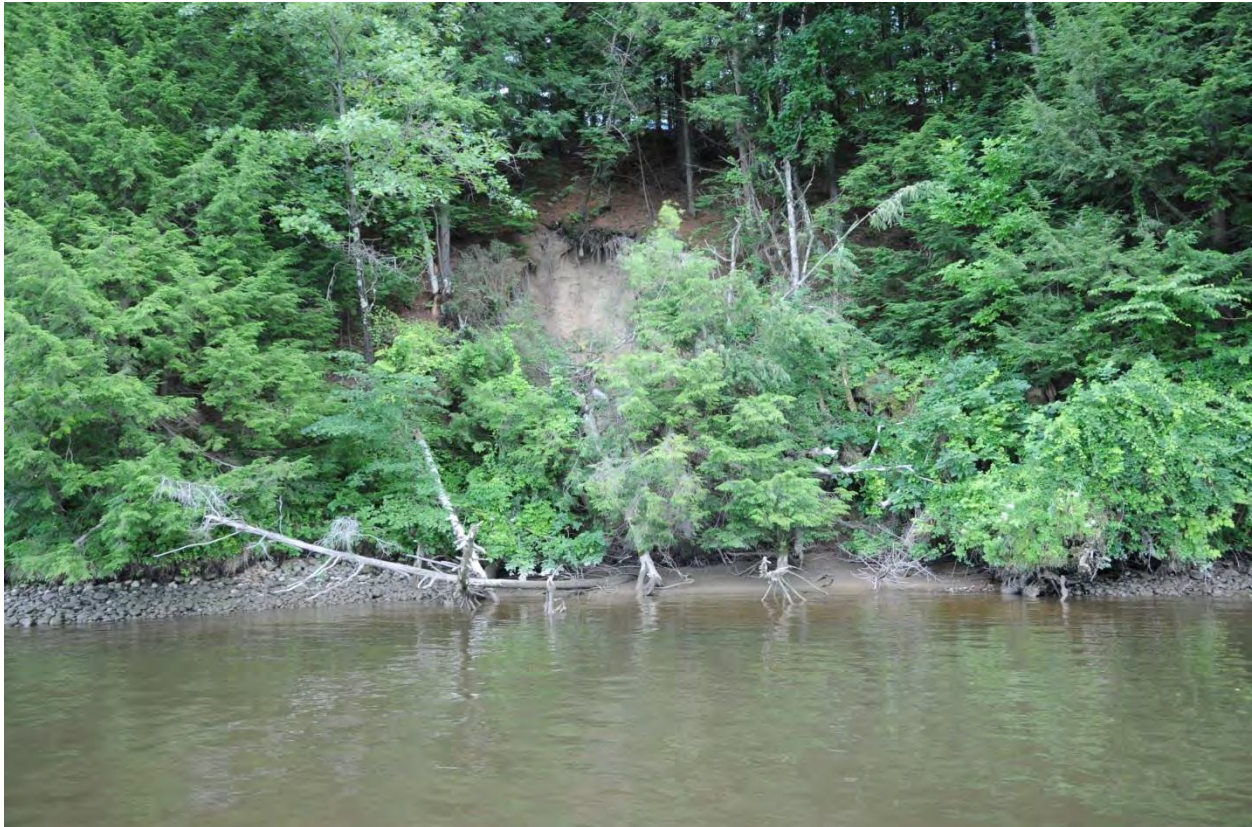
**BOAT-BASED SITE #75**

Riverbank Features	Characteristics
Upper Riverbank Slope	Vertical
Upper Riverbank Height	High
Upper Riverbank Sediment	Silt/Sand
Upper Riverbank Vegetation	Sparse
Lower Riverbank Slope	Flat/Beach
Lower Riverbank Sediment	Silt/Sand
Lower Riverbank Vegetation	None to Very Sparse
Type of Erosion	Topple, Overhanging Bank
Potential Erosion Indicators	Creep/Leaning Tree, Overhanging Bank
Stage of Erosion	Active
Extent of Current Erosion	Extensive

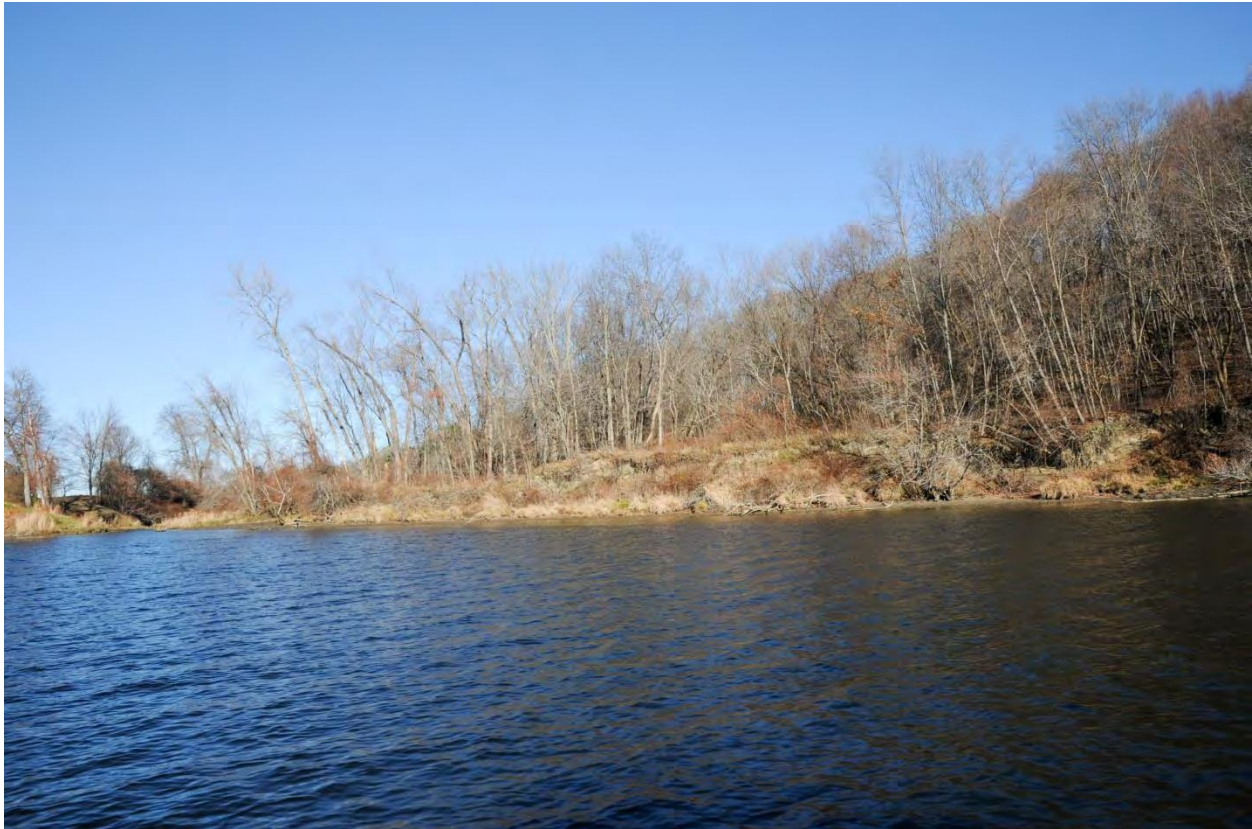
**BOAT-BASED SITE #87**

Riverbank Features	Characteristics
Upper Riverbank Slope	Overhanging
Upper Riverbank Height	High
Upper Riverbank Sediment	Silt/Sand
Upper Riverbank Vegetation	Sparse
Lower Riverbank Slope	Flat/Beach
Lower Riverbank Sediment	Silt/Sand
Lower Riverbank Vegetation	None to Very Sparse
Type of Erosion	Undercut, Rotational Slump
Potential Erosion Indicators	Exposed Roots, Creep/Leaning Trees, Overhanging Bank
Stage of Erosion	Eroded
Extent of Current Erosion	Some to Extensive

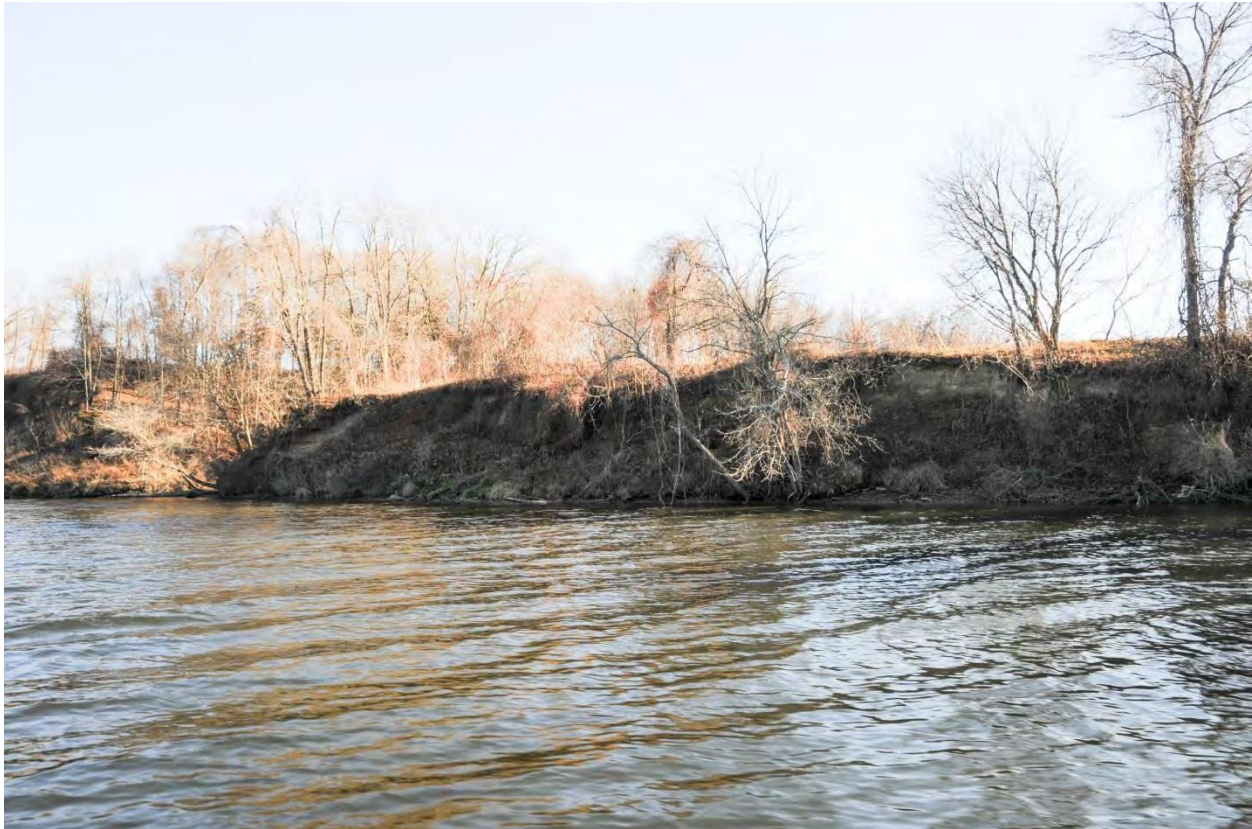
**BOAT-BASED SITE #119**

Riverbank Features	Characteristics
Upper Riverbank Slope	Steep
Upper Riverbank Height	High
Upper Riverbank Sediment	Silt/Sand
Upper Riverbank Vegetation	Sparse
Lower Riverbank Slope	Flat/Beach
Lower Riverbank Sediment	Silt/Sand
Lower Riverbank Vegetation	None to Very Sparse
Type of Erosion	Slide or Flow
Potential Erosion Indicators	Exposed Roots, Creep/Leaning Trees, Overhanging Bank
Stage of Erosion	Eroded
Extent of Current Erosion	Some to Extensive
