Relicensing Study 3.1.2

NORTHFIELD MOUNTAIN/TURNERS FALLS OPERATIONS IMPACT ON EXISTING EROSION AND POTENTIAL BANK INSTABILITY

Initial Study Report Summary

Northfield Mountain Pumped Storage Project (No. 2485)
and Turners Falls Hydroelectric Project (No. 1889)

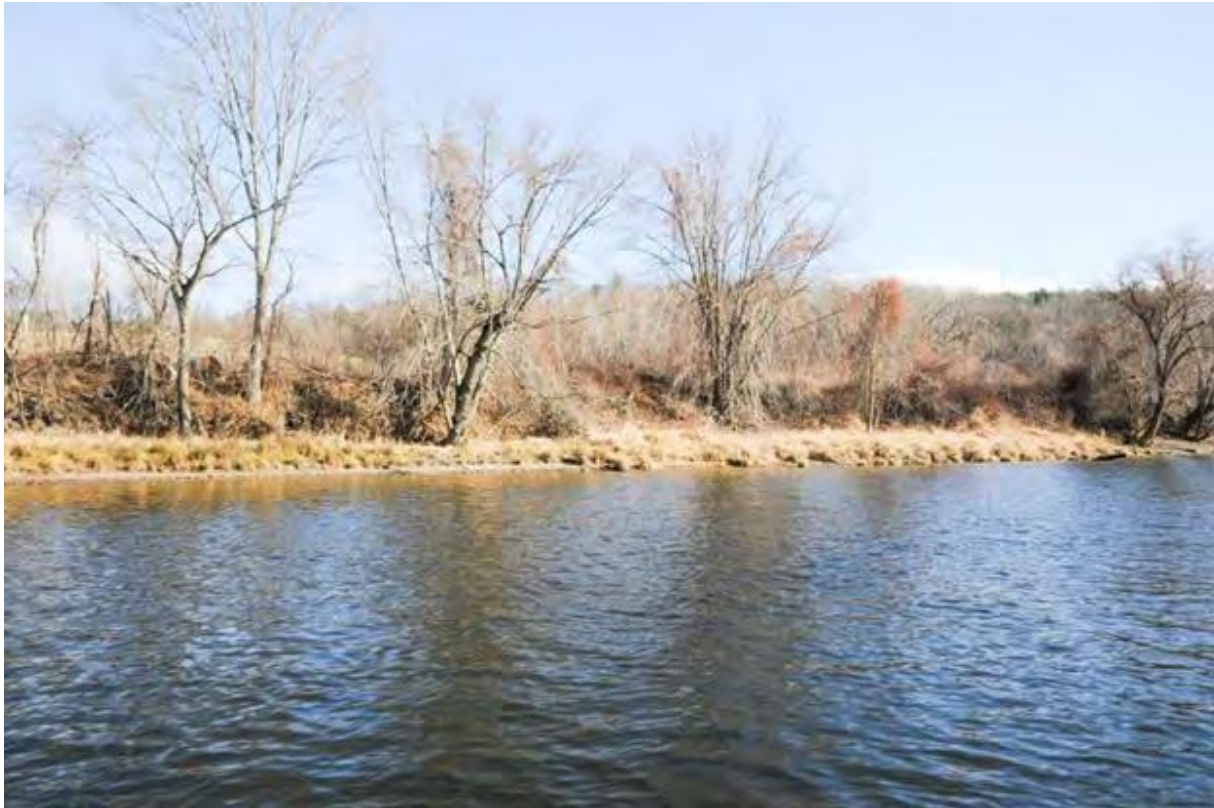
**BOAT-BASED SITE #303**

Riverbank Features	Characteristics
Upper Riverbank Slope	Moderate
Upper Riverbank Height	Medium
Upper Riverbank Sediment	Silt/Sand
Upper Riverbank Vegetation	Heavy
Lower Riverbank Slope	Flat/Beach
Lower Riverbank Sediment	Silt/Sand
Lower Riverbank Vegetation	Heavy
Type of Erosion	
Potential Erosion Indicators	None
Stage of Erosion	Stable
Extent of Current Erosion	None/Little
