**Relicensing Study 3.1.2**

**Northfield Mountain / Turners Falls**

**Operations Impact on Existing Erosion and**

**Potential Bank Instability**

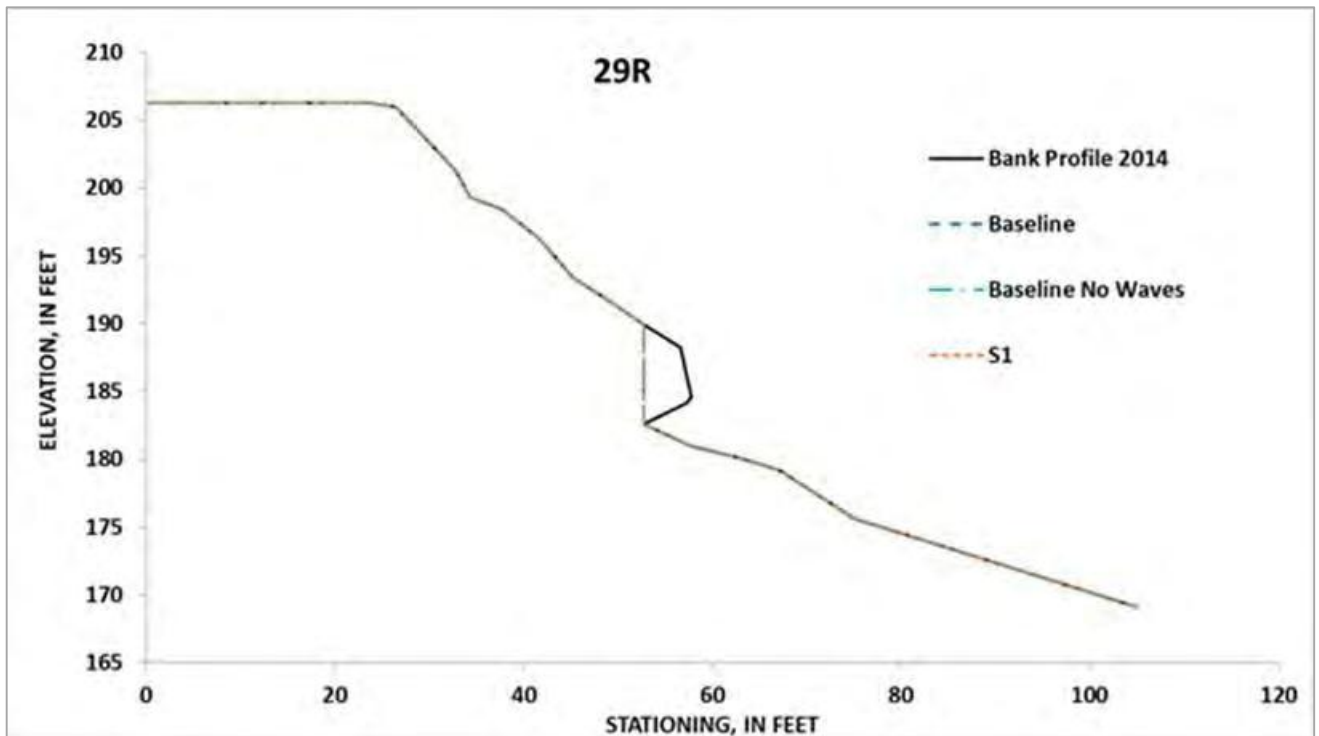
Figure 5.4.3.11-2: Simulated, future unit-erosion for the Baseline Condition (with boat waves on and off) and Scenarios 1 at site 29R for the period 2000-2014

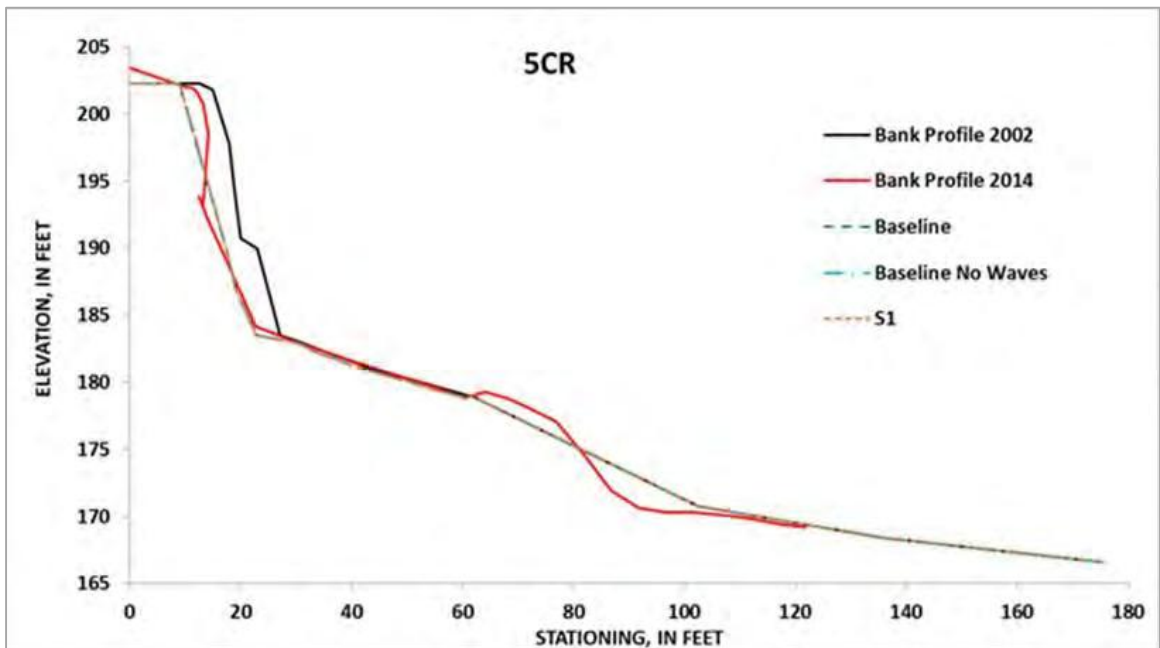
Figure 5.4.3.12-2: Simulated, future unit-erosion for the Baseline Condition (with boat waves on and off) and Scenarios 1 at site 5CR for the period 2002-2014

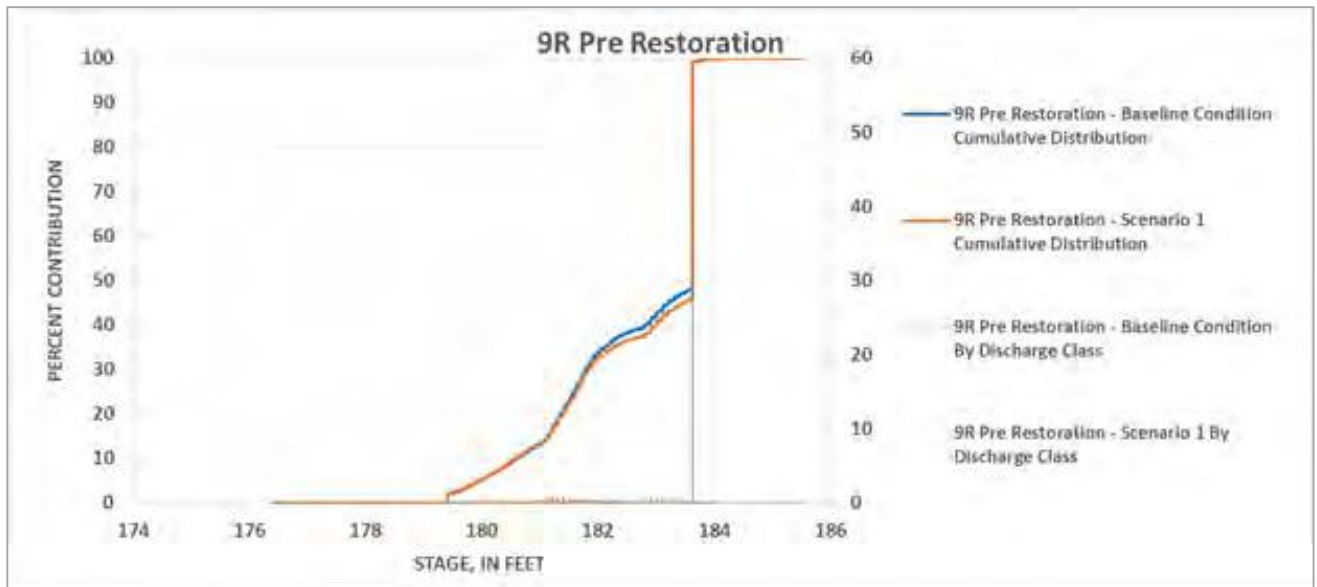
**Figure 5.4.3.27-5: Simulated, percent contribution of total erosion by stage for the Baseline Condition and Scenario 1 at site 9R Pre Restoration for the period 2000-2008. As no stage-discharge relationship could be developed, stage was used**

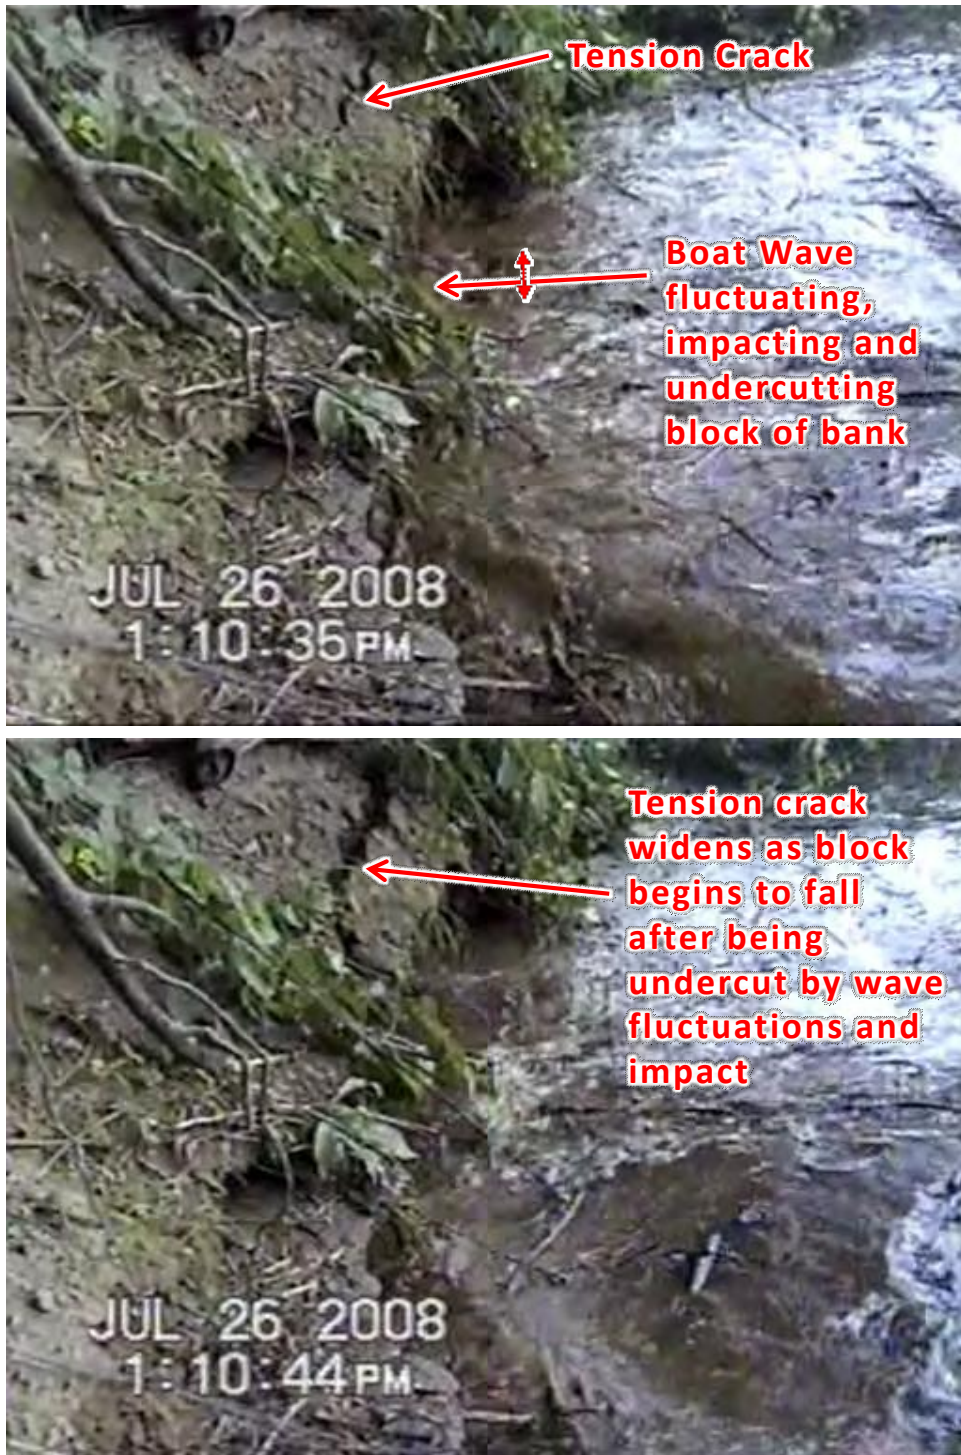
Figure 5.5.3-6a: Boat Wave Erosion Sequence
