DEPARTMENT OF THE ARMY
NEW ENGLAND DIVISION, CORPS OF ENGINEERS
424 TRAPELO ROAD
WALTHAM, MASSACHUSETTS 02154

This report brings to a conclusion the Connecticut River Streambank Erosion Study which was authorized by a resolution adopted by the Committee on Public Works of the United States House of Representatives on 11 April 1974.

The objectives of the study were to delineate the causes of bank erosion on the Connecticut River between Turners Falls Dam in Massachusetts and the headwaters of Wilder Dam in New Hampshire and Vermont, and to determine and evaluate the various erosional forces acting on the banks of the river. In addition, comparison of the various erosional forces with the types of erosion found on the river was made. For each type of erosion, remedial measures are suggested, together with their potential impact on the river. Figure 1 indicates the study reach as defined in conjunction with the watershed area. The erosion sites subjected to detailed study are identified in Appendix A.

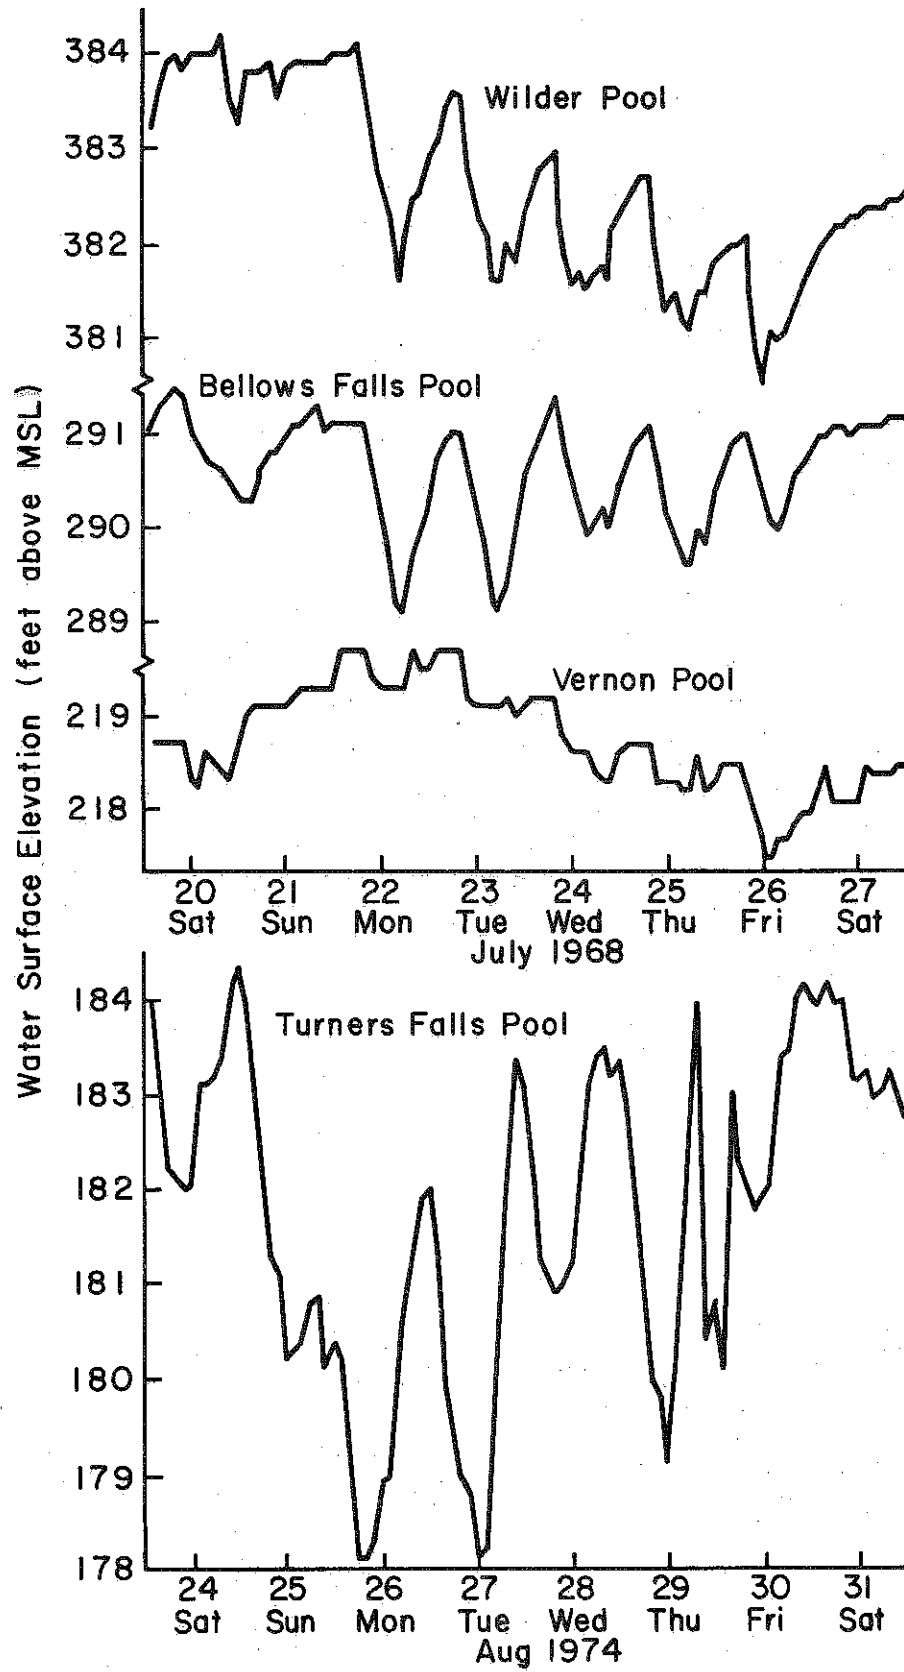
Figure 9. Pool stage compared to time at the four study reaches.

In a hydraulic analysis, the New England Division of the U.S. Army Corps of Engineers (1976) applied an unsteady flow model to evaluate the pool stages with time for the Wilder Pool during a typical period of operation. The period from November 1 through 15, 1972 was analyzed because it included both continuous low flow and high flow periods. In addition, the U.S. Geological Survey had maintained three water level recording gages on the Wilder Pool during that period. Data from these gages were used to calibrate the function coefficients used in the computer model. Pool profiles at two-hour intervals were calculated using this program and are plotted in Figure 10. In addition, pool stages at Wilder Dam have been recorded by the New England Power Company since construction of the project in 1952. Wilder Dam makes flow releases during weekday power demand periods, usually between 1100 and 1800 hours, and closes for the remainder of the day and on weekends. Figures 11 and 12 show the average weekday pool fluctuations during the months of July and December for several three-year periods. Because hydraulic conditions are more severe in Turners Falls Pool additional background data are provided.
