FERC Scoping Meeting
January 30, 2013
Relicensing of Northfield Mountain Pumped Storage Project

Michael Bathory, presenting landowner representing Maryanne Gallagher, Alan Wallace, and Barbara Watson River Road conservation land owners. Conservation Restrictions held by the Massachusetts Department of Conservation and Recreation in Gill, Massachusetts. Flowage rights held by the landowners.

Phase III Bank Restoration for the Connecticut River
in the Town of Gill, Massachusetts
Bathory/Gallagher & Wallace/Watson
Conservation Land

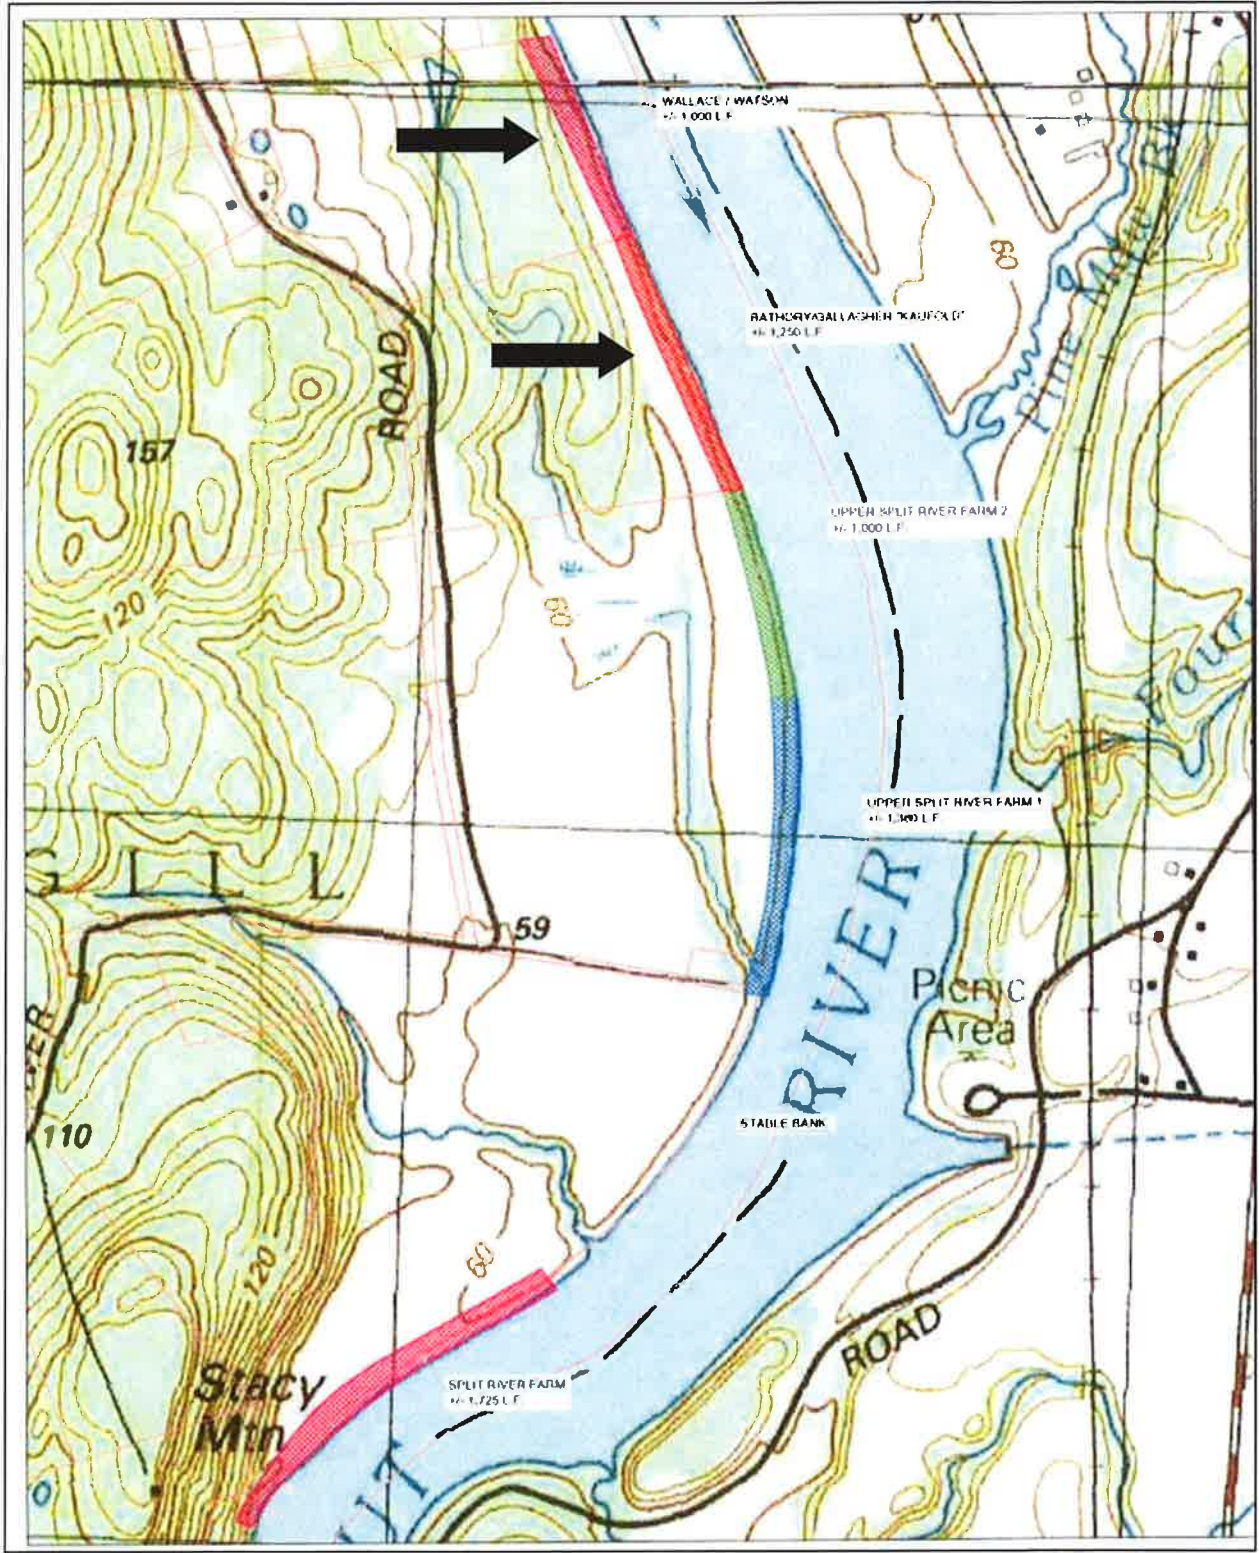
Arrows indicate the Wallace/Watson and Bathory/Gallagher sections of riverbank upstream from Northfield Mountain picnic area and tailrace.

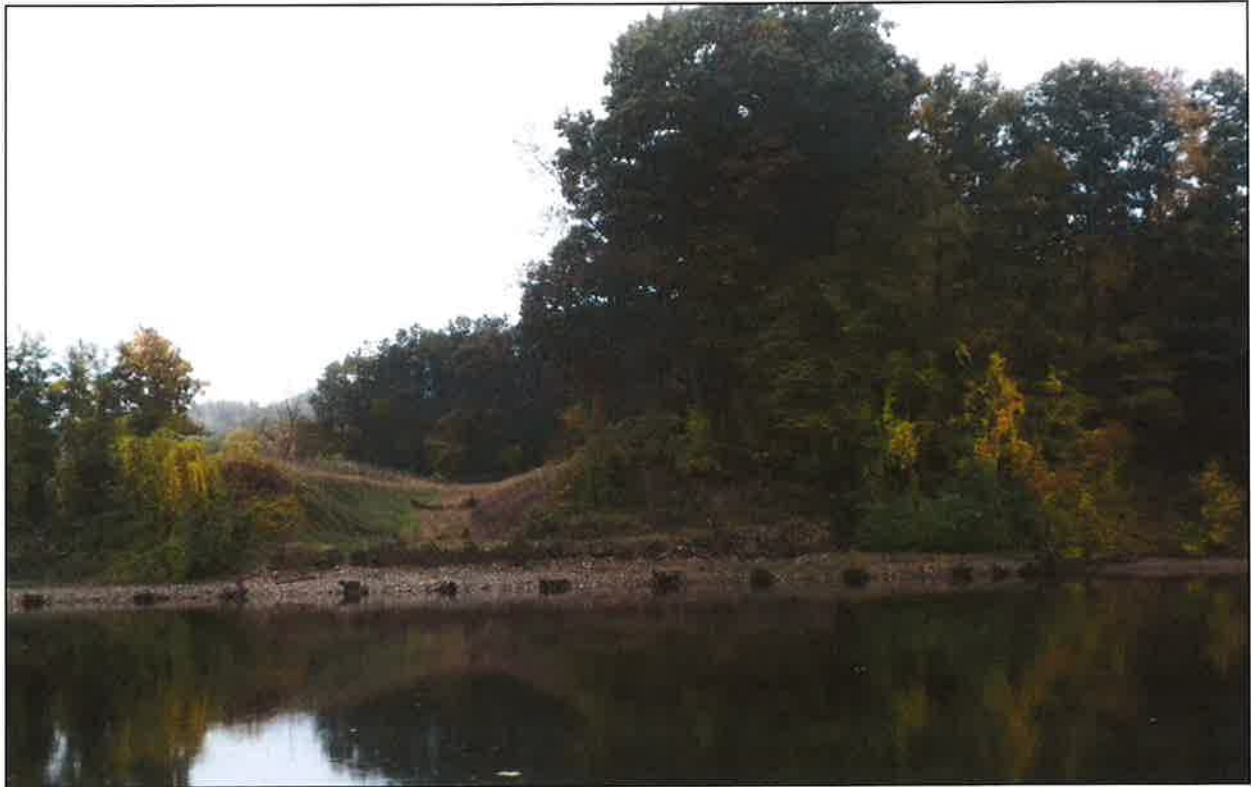
Construction access road
as seen during October 5, 2012 Relicensing Site Tour.

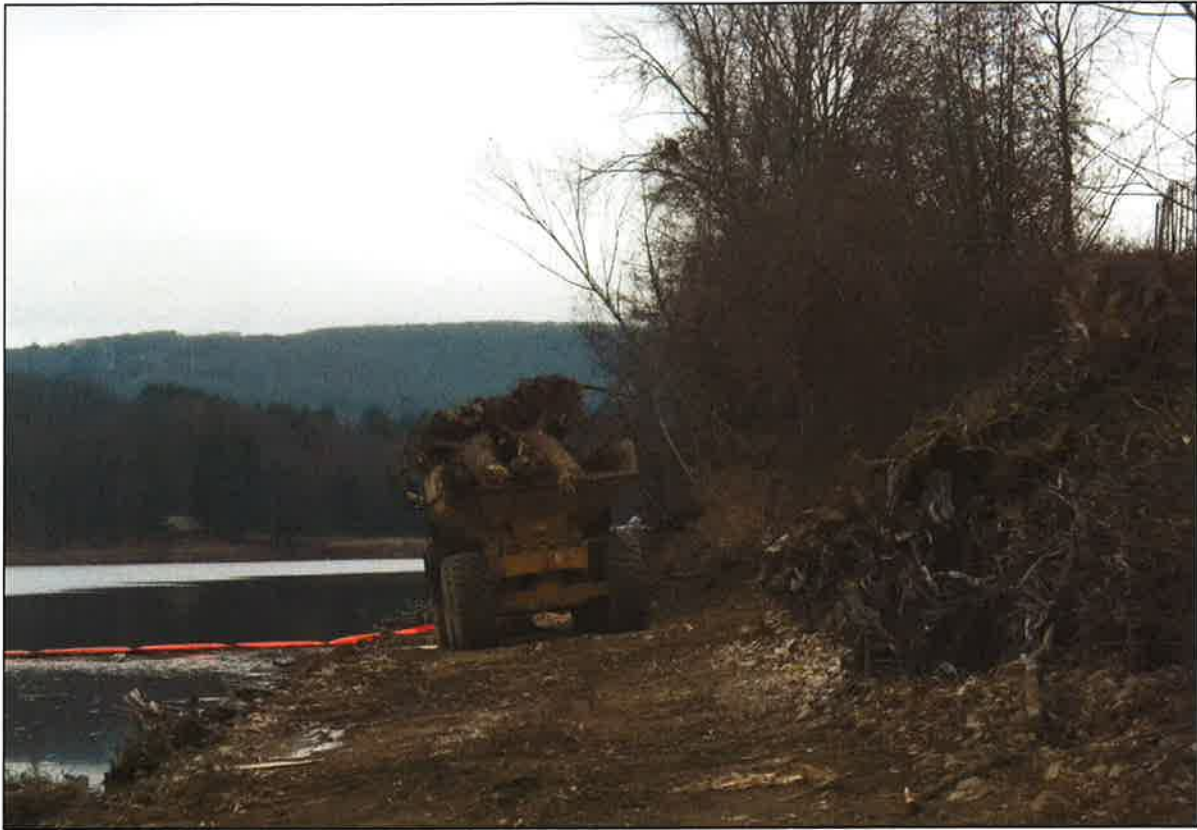
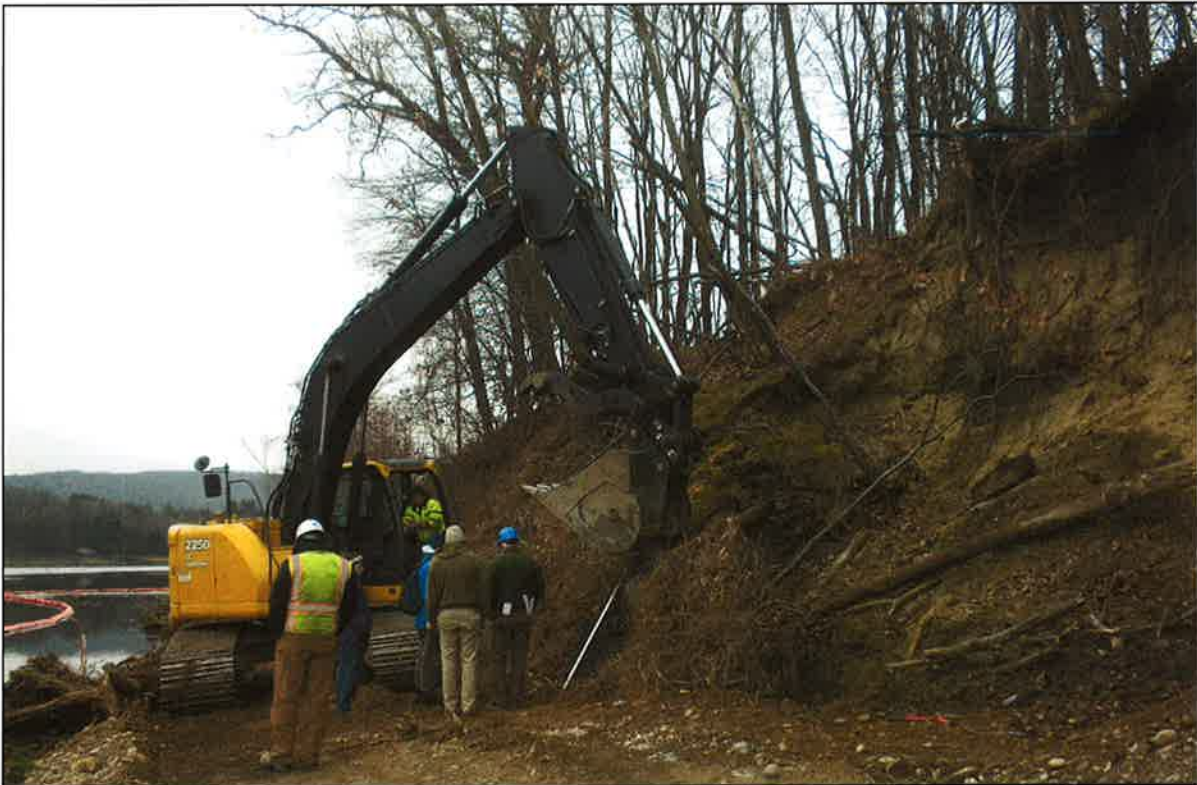
Year 1 construction on Bathory/Gallagher and Wallace/Watson riverbanks December 2012. Year 2 to be completed in Fall 2013.

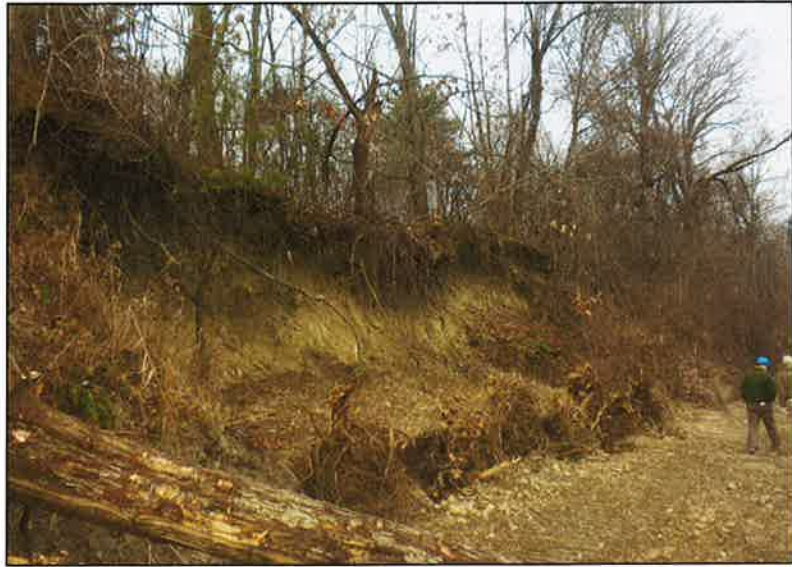
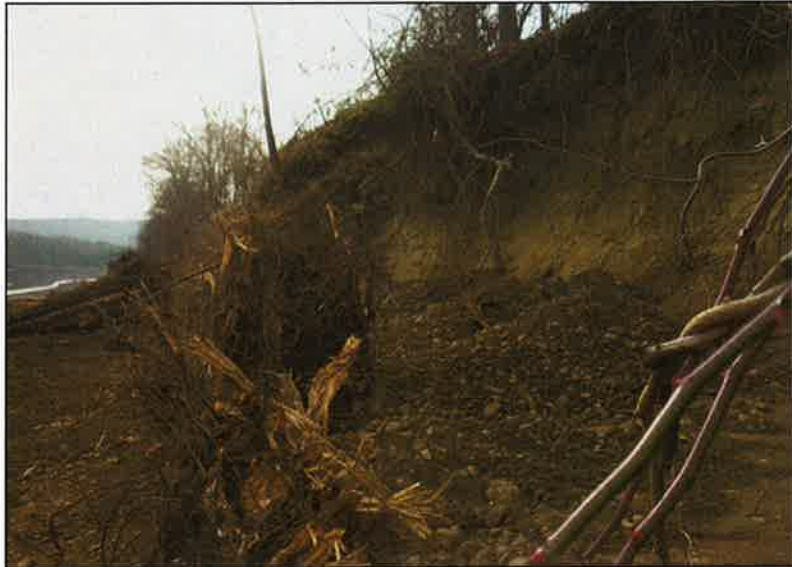
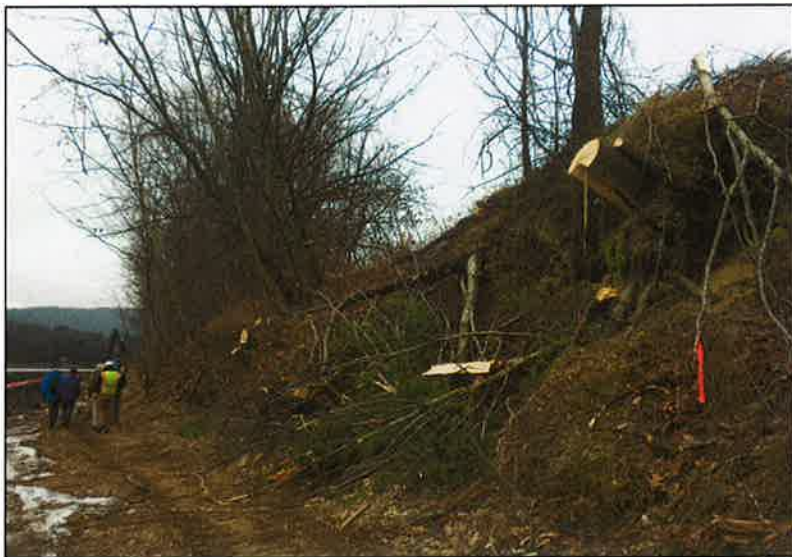
Attempts to buttress eroding Bathory/Gallagher banks, December 2012. ⁵

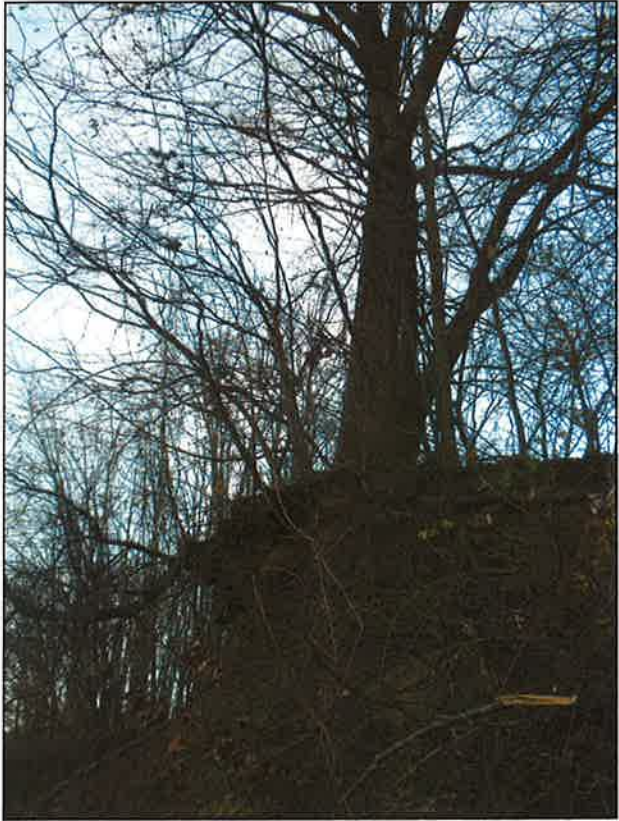
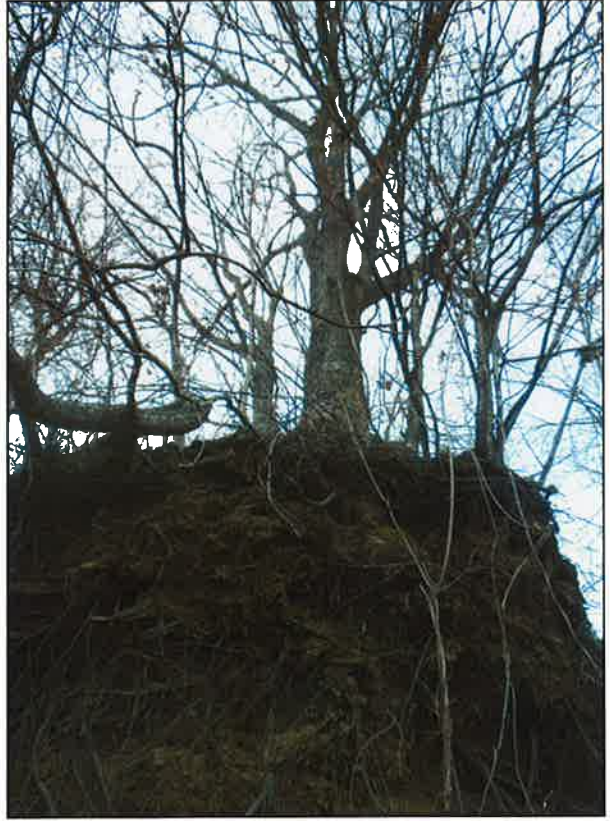
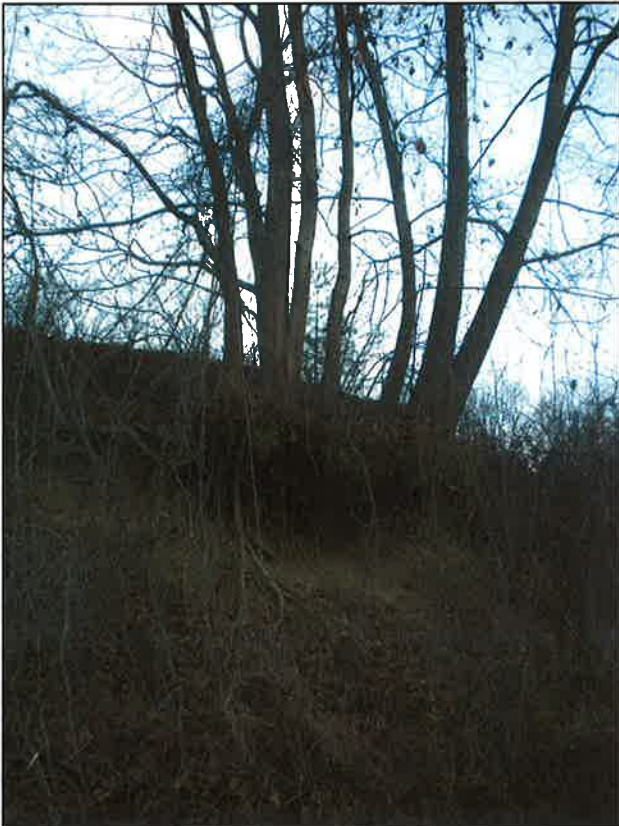
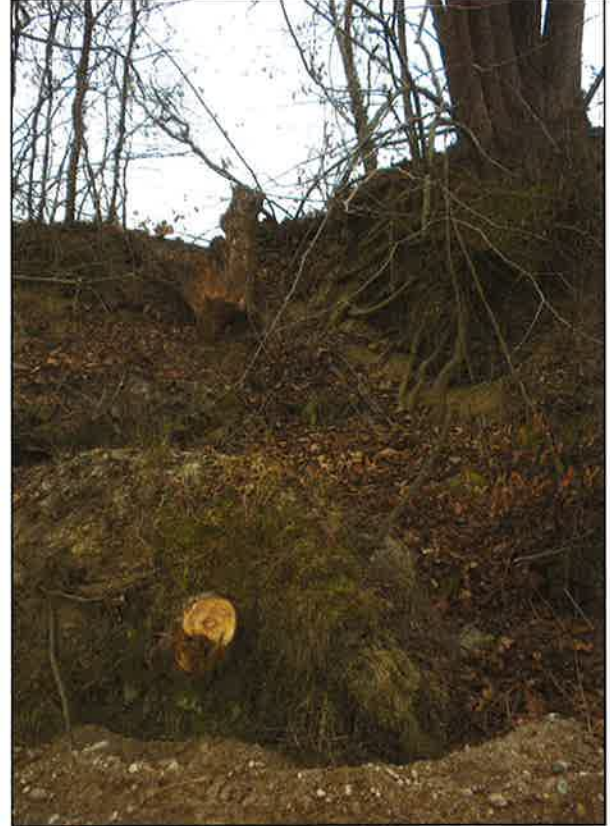
Examples of erosion on Bathory/Gallagher riverbank as seen from construction road, December 2012.

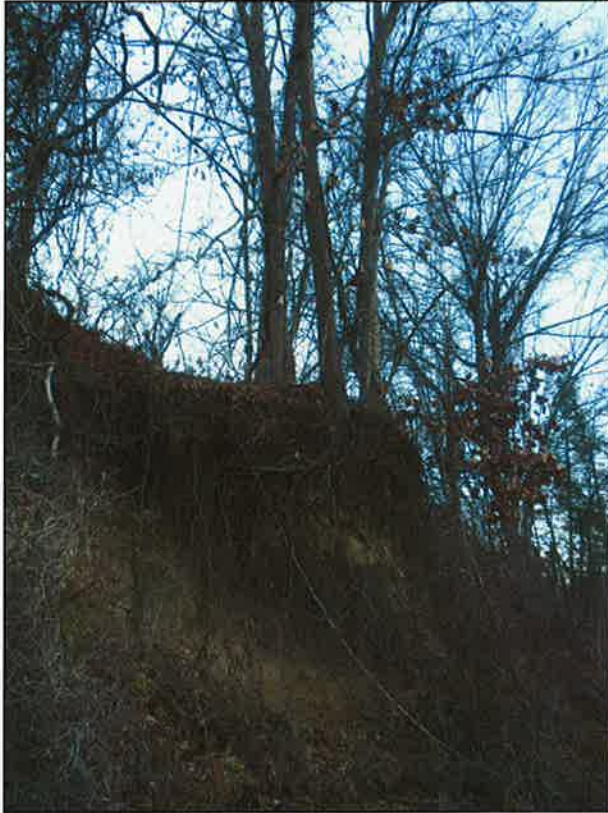
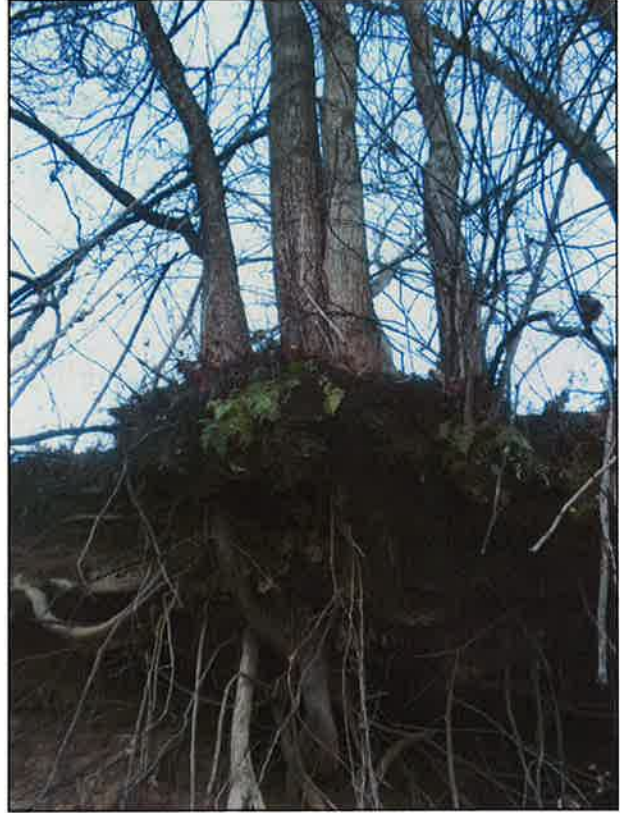
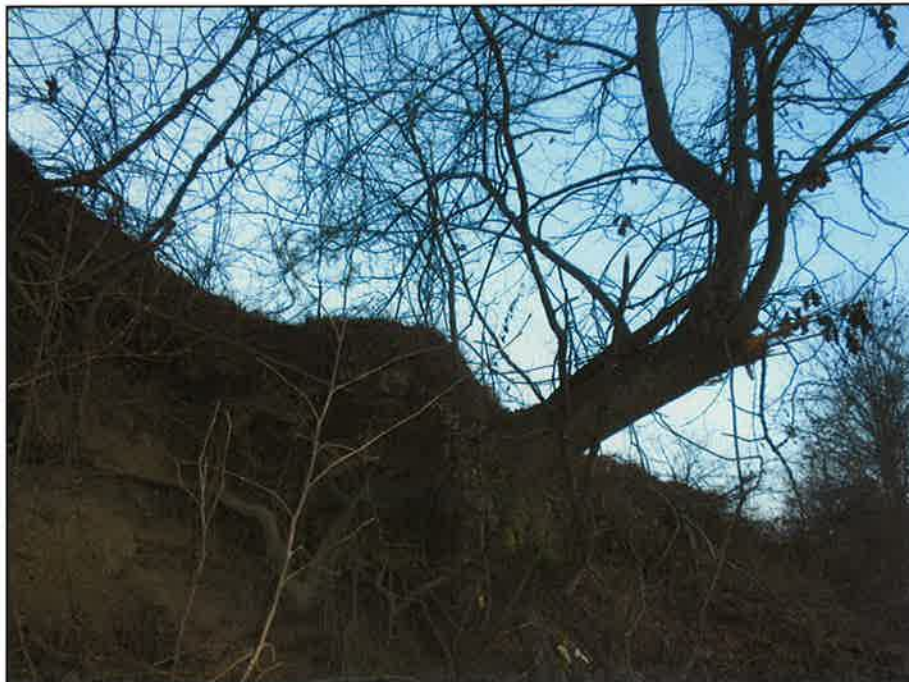
More examples of erosion on Bathory/Gallagher riverbank
as seen from construction road, December 2012.

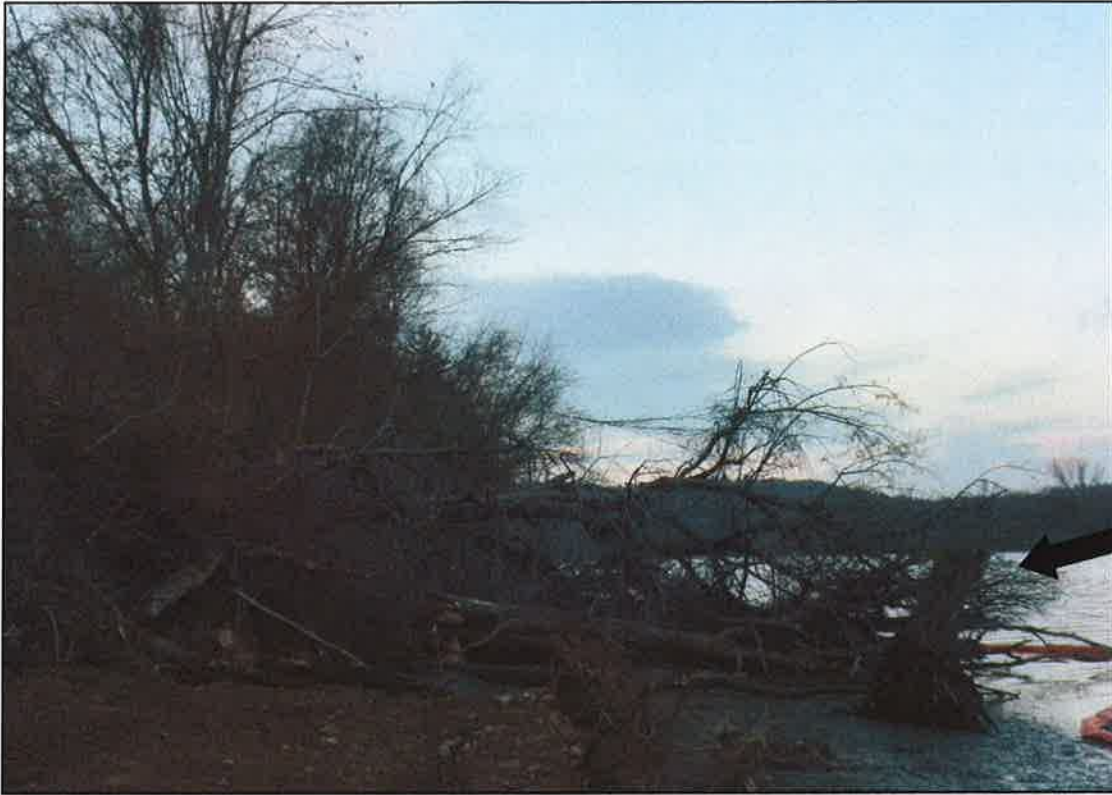
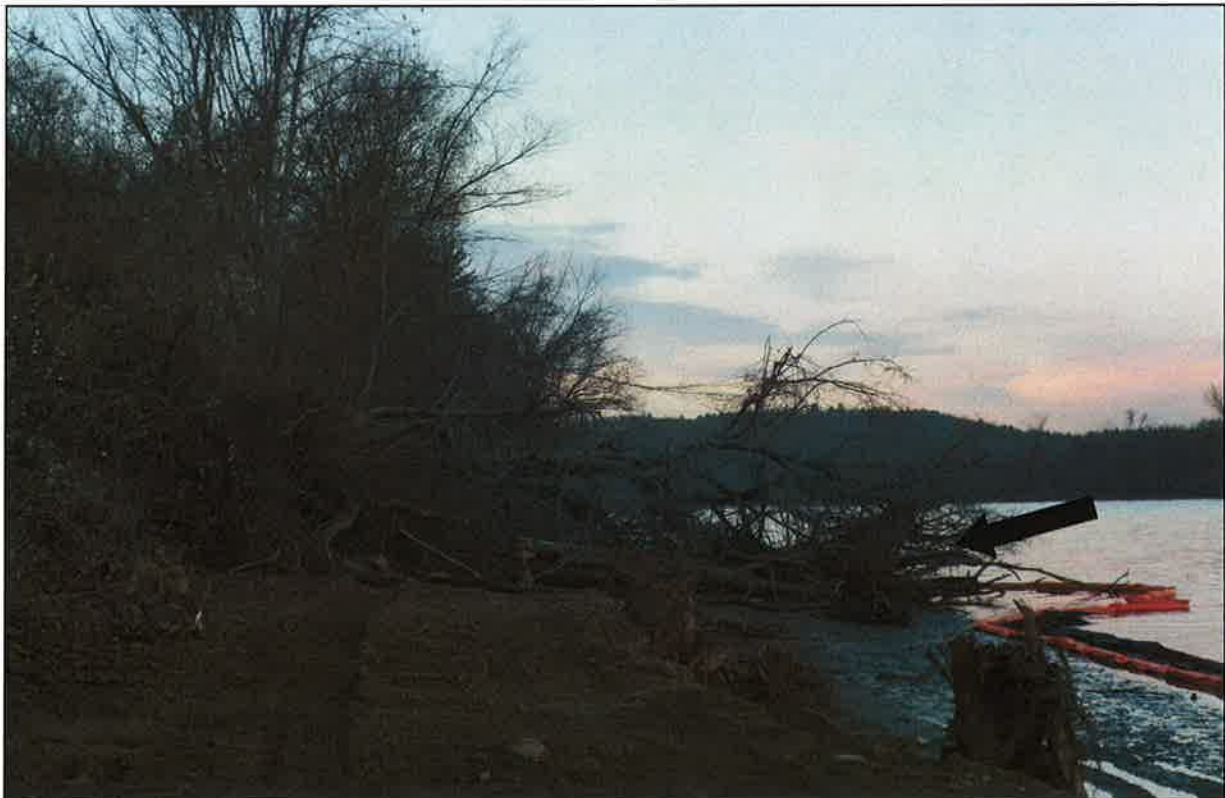
Examples of erosion on Wallace/Watson riverbank
as seen from construction road, December 2012.
Arrows indicate tree stump seen in next set of photos.

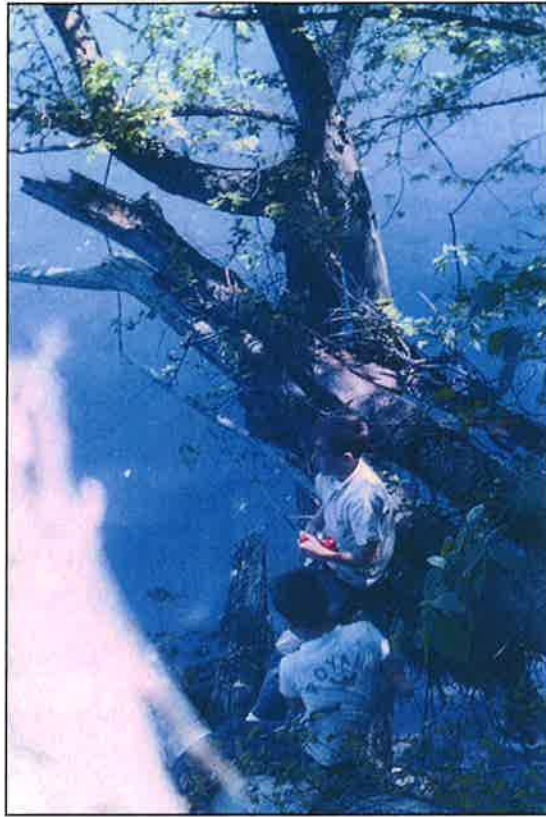
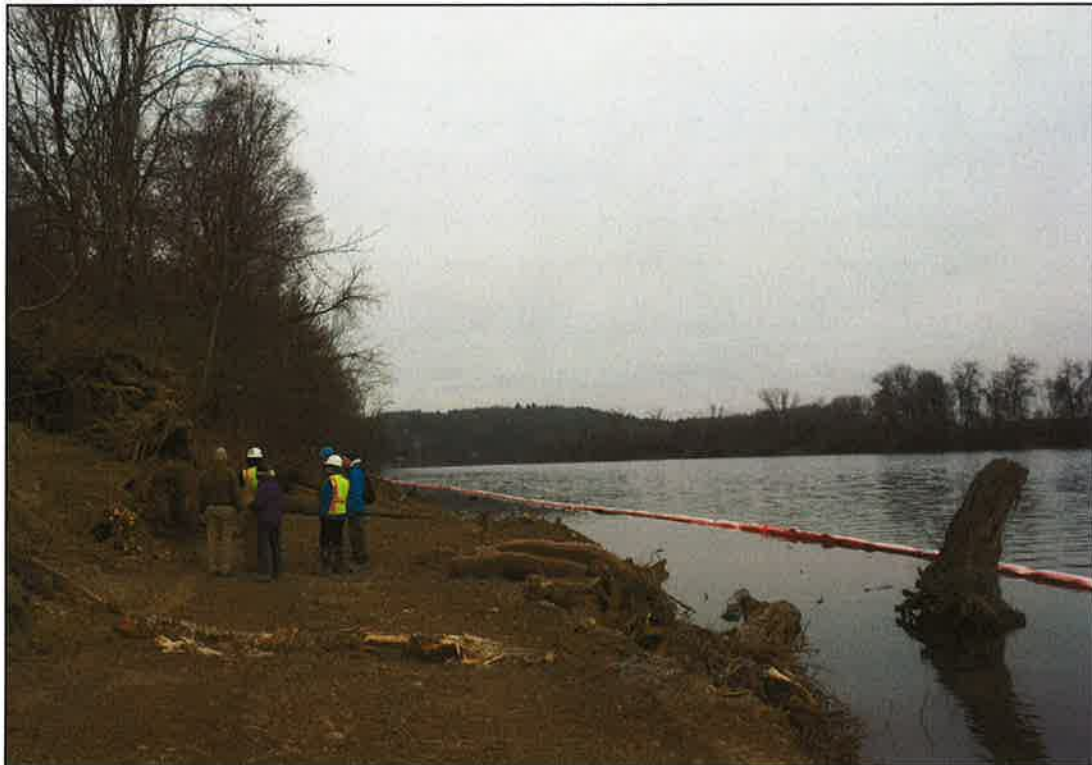
Photos of tree at toe of bank in 1960 and the stump of the same tree in 2012 demonstrating the erosion that has occurred over 52 years.
