Relicensing Study 3.3.4

EVALUATE UPSTREAM PASSAGE OF AMERICAN EEL AT THE TURNERS FALLS PROJECT

Study Report

**Northfield Mountain Pumped Storage Project (No. 2485)
and Turners Falls Hydroelectric Project (No. 1889)**

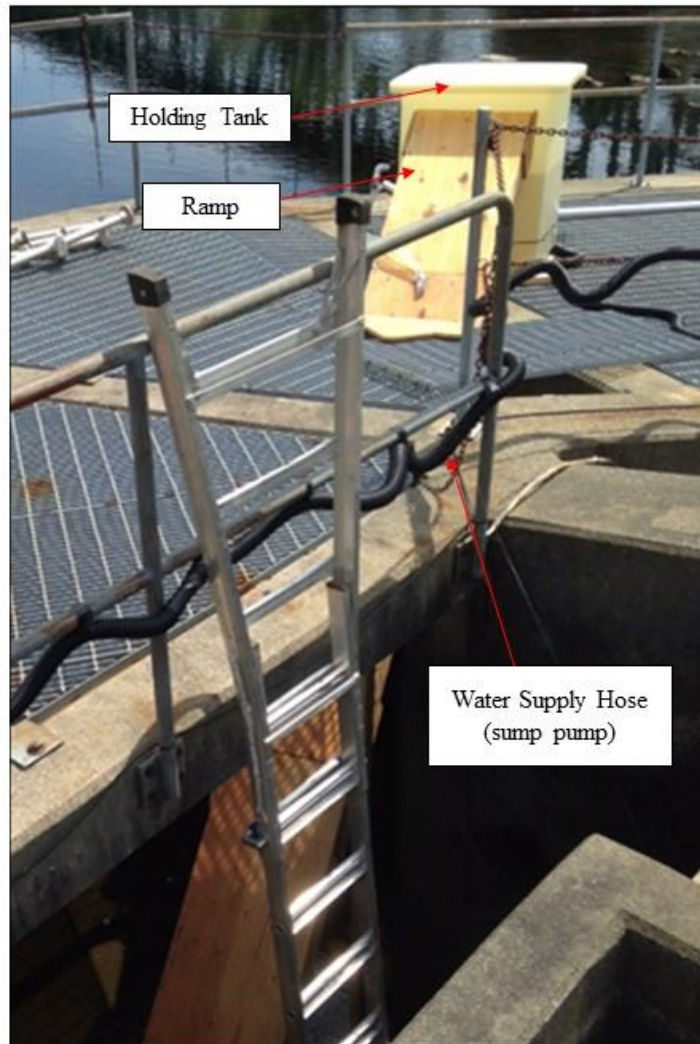
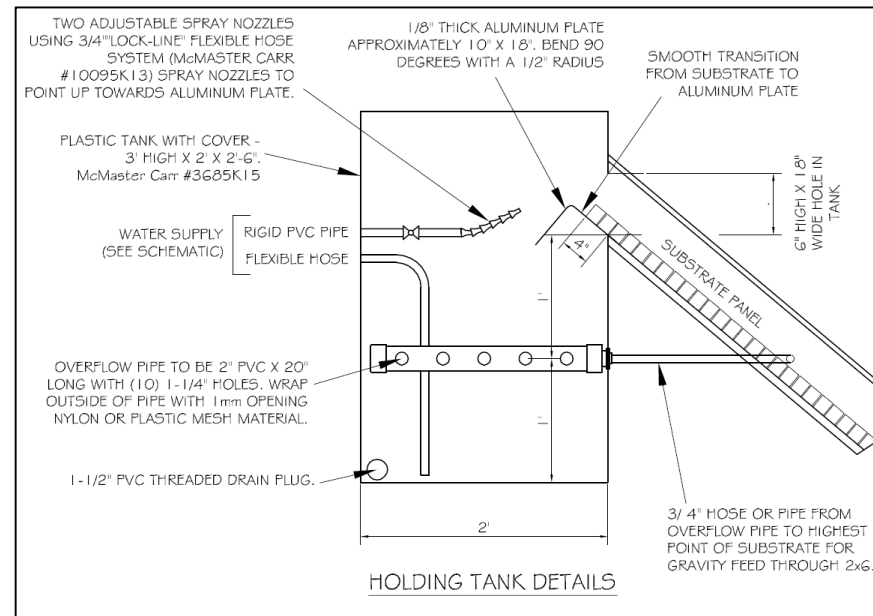
Figure 3.0-1: The Eel Trap Employed at the Spillway Fishway at the Project, Turners Falls, MA

- The **Spillway Fishway Eel Trap** was located within the second turn pool of the Spillway Fishway ([Figure 2.0-1](#)). It consisted of a ramp, collection tank and attraction/conveyance flow system ([Figure 3.0-1](#)). A single wooden ramp overlain with was employed. The covered ramp was 19 feet long by 1.5 feet wide with 6 inch high side walls. The ramp was constructed at a 38° incline; at the top it transitioned to an aluminum plate with a 90 degree bend to guide eel into a collection tank ([Figures 3.0-1](#) and [3.0-2](#)). The ramp entrance was located immediately downstream from an orifice (one of two) in the fishway weir upstream of the turn pool. The orifices are located at the bottom of the weir, and under typical fishway operation, the orifices provides a path to the next pool. One orifice was partially blocked to pool water for attraction/conveyance flow. The other orifice was completely blocked using plywood. The partial block was constructed with a 90° bend at the top to prevent eel from climbing over the block. Leakage through the shutdown gate at the upper end of the fishway provided flow into the turn pool sufficient to supply flow to the ramp. . Attraction/conveyance flow was pumped from the turn pool using a ¼ horsepower electric sump pump. The pump conveyed water continuously to the top of the ramp, where it passed through two adjustable spray nozzles. The nozzles were oriented such that flow was both conveyed down the ramp and into the collection tank ([Figure 3.0-2](#)). The covered collection tank was 3 feet high, 2 feet deep and 2.5 feet wide. Additional flow was pumped to the tank to maintain good water quality. An overflow pipe was used to maintain the water level within the tank. Drain water was conveyed back to the ramp such that the scent of trapped eels would be propagated into the attraction flow. A net bag (1/8 inch knotless mesh) was deployed within the tank to aid in collection of trapped eels. The Spillway Fishway was not in operation but 125 cfs was discharged from the fishway entrance via the fishway attraction water throughout this study, except on July 11 and 12, 2015 during necessary maintenance. The flow control gate was set at 1.86 feet, which corresponds to a water level differential of 1 foot at the entrance when there is no spill at the dam.

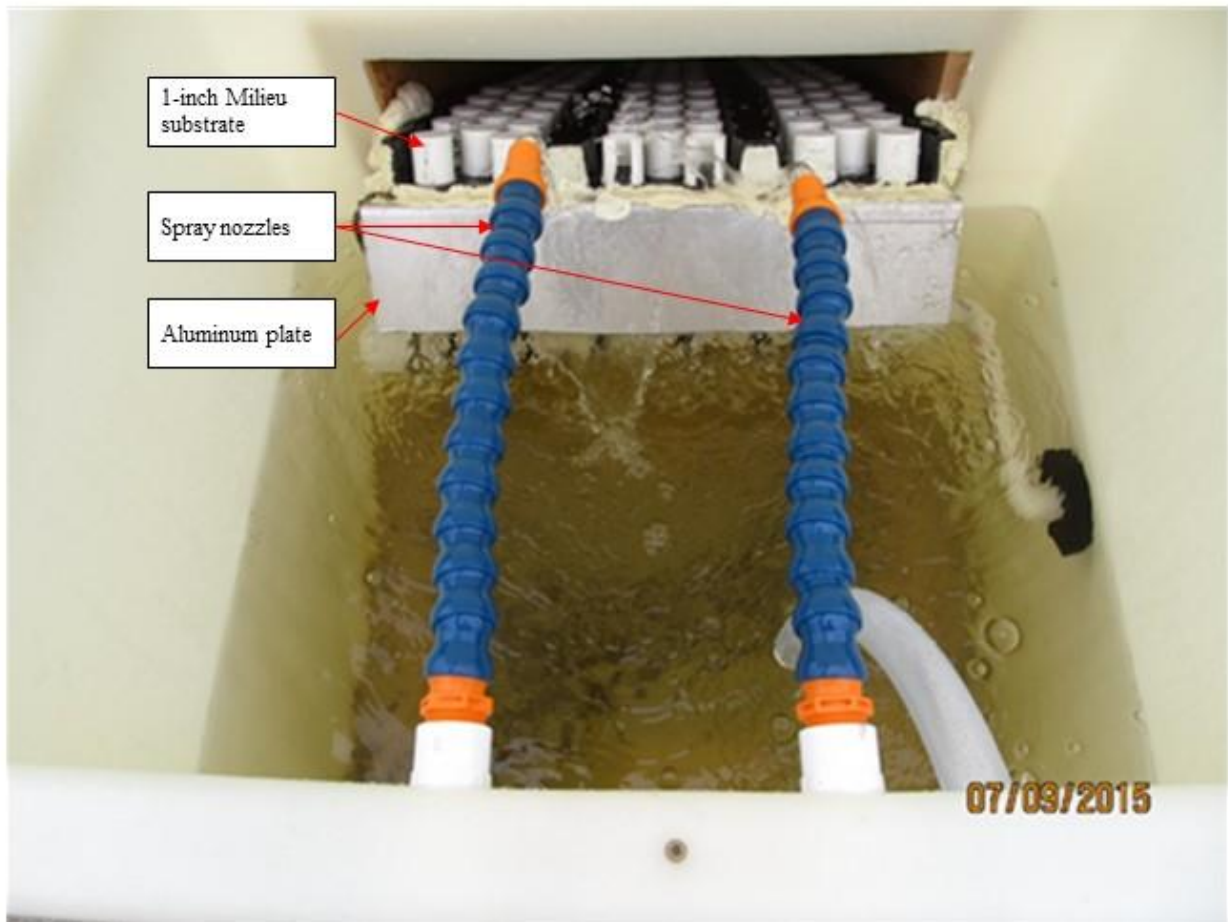
Figure 3.0-2: The Transition between the Ramp Substrate to the Aluminum Plate¹ and spray nozzles

¹ Note that the spray nozzles were adjusted to provide flow down the ramp as well as down the aluminum plate to entice eel to drop down into the collection tank. Also, the gap between the Milieu substrate and the aluminum plate was filled with silicon caulk for a smooth transition.

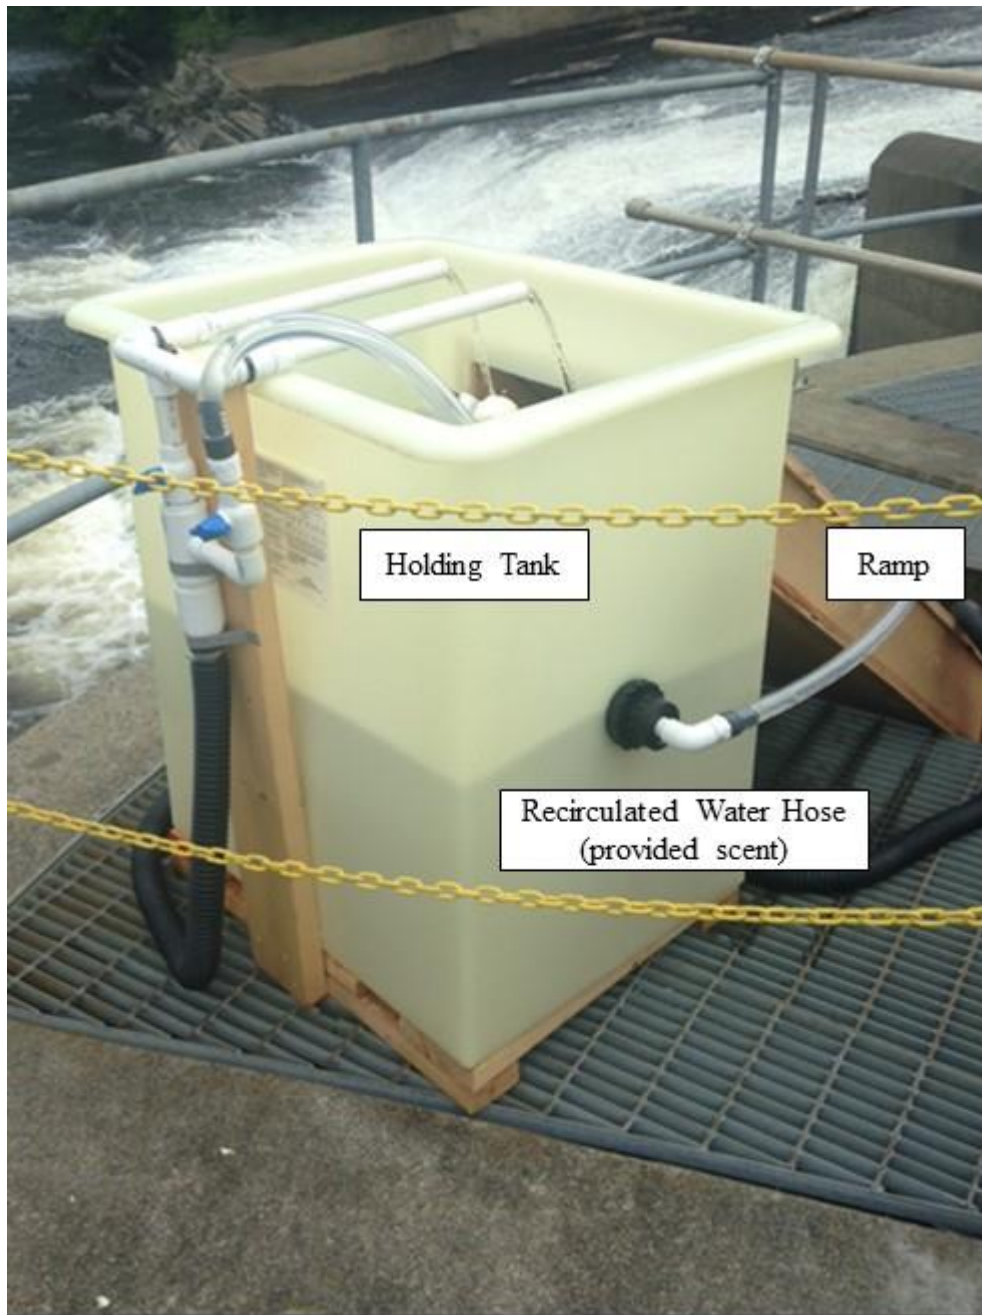
Figure 3.0-3. The Cabot Fishway Eel Trap, Turners Falls, MA²

² The photo was taken prior to the installation of the adjustable spray nozzles, which were installed on July 9, 2015.

- The **Cabot Fishway Eel Trap** was located in the third turn pool (turn pool C) of the Cabot Fishway ([Figure 2.0 -2](#)). The trap arrangement was similar to that of the Spillway Fishway trap, except that the ramp was longer, approximately 21.5 feet with an incline of 40° ([Figure 3.0-3](#)). The Cabot Fishway was not operational during the study, but attraction flow was discharged throughout the study period, set to maintain a 1-foot differential at the Fishway entrance. The flow rate associated with the 1-ft differential varies and depends on water surface elevation in the Cabot tailrace. It is generally less than 350 cfs. Entrance conditions were similar to conditions maintained at the spillway fishway entrance for the spillway eel trap.

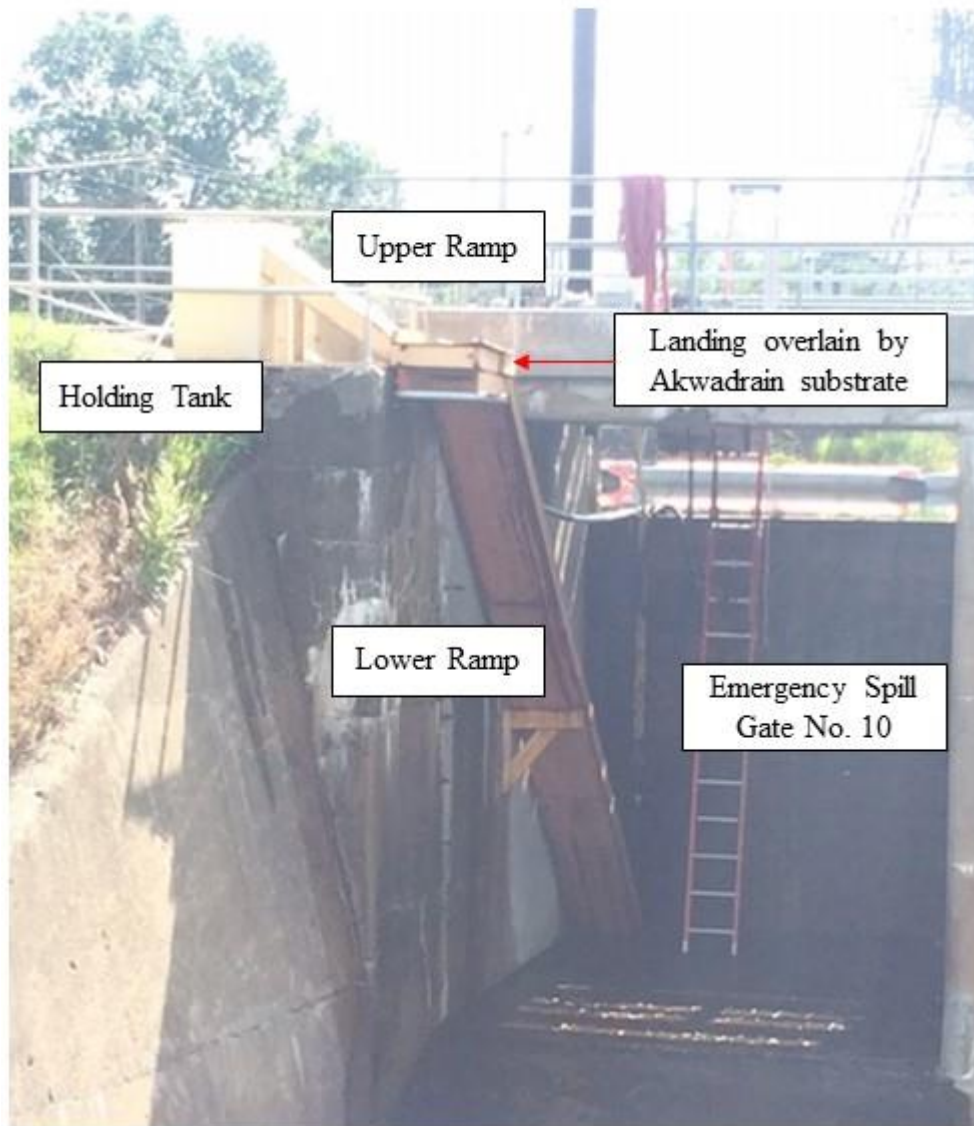
Figure 3.0-4: The Temporary Eel Trap Located at Gate No. 10 of the Cabot Emergency Spillway at the Project, Turners Falls, MA

- The **Cabot Emergency Spillway Eel Trap** was located at Emergency Spill Gate No. 10, on the northern side of the spillway ([Figure 2.0-2](#)). The holding tank and plumbing were identical to the Spillway and Cabot Fish Ladder traps. The Emergency Spillway Eel Trap employed a dual level ramp with a landing ([Figure 3.0-4](#)). The upper and lower ramps were overlain with 1 inch Milieu substrate and inclined at 34° and 43°, respectively. The two ramp sections were joined by a landing. The landing was flat, approximately 2 feet by 2 feet and was overlain by Akwadrain substrate. The lower ramp was approximately 24 feet long and positioned such that the ramp entrance was located approximately 1 foot downstream of gate No. 10. The upper ramp was approximately 4 feet long.

Attraction/conveyance flow came from the power canal and was provided by a ¼ hp electric sump pump and gate leakage.

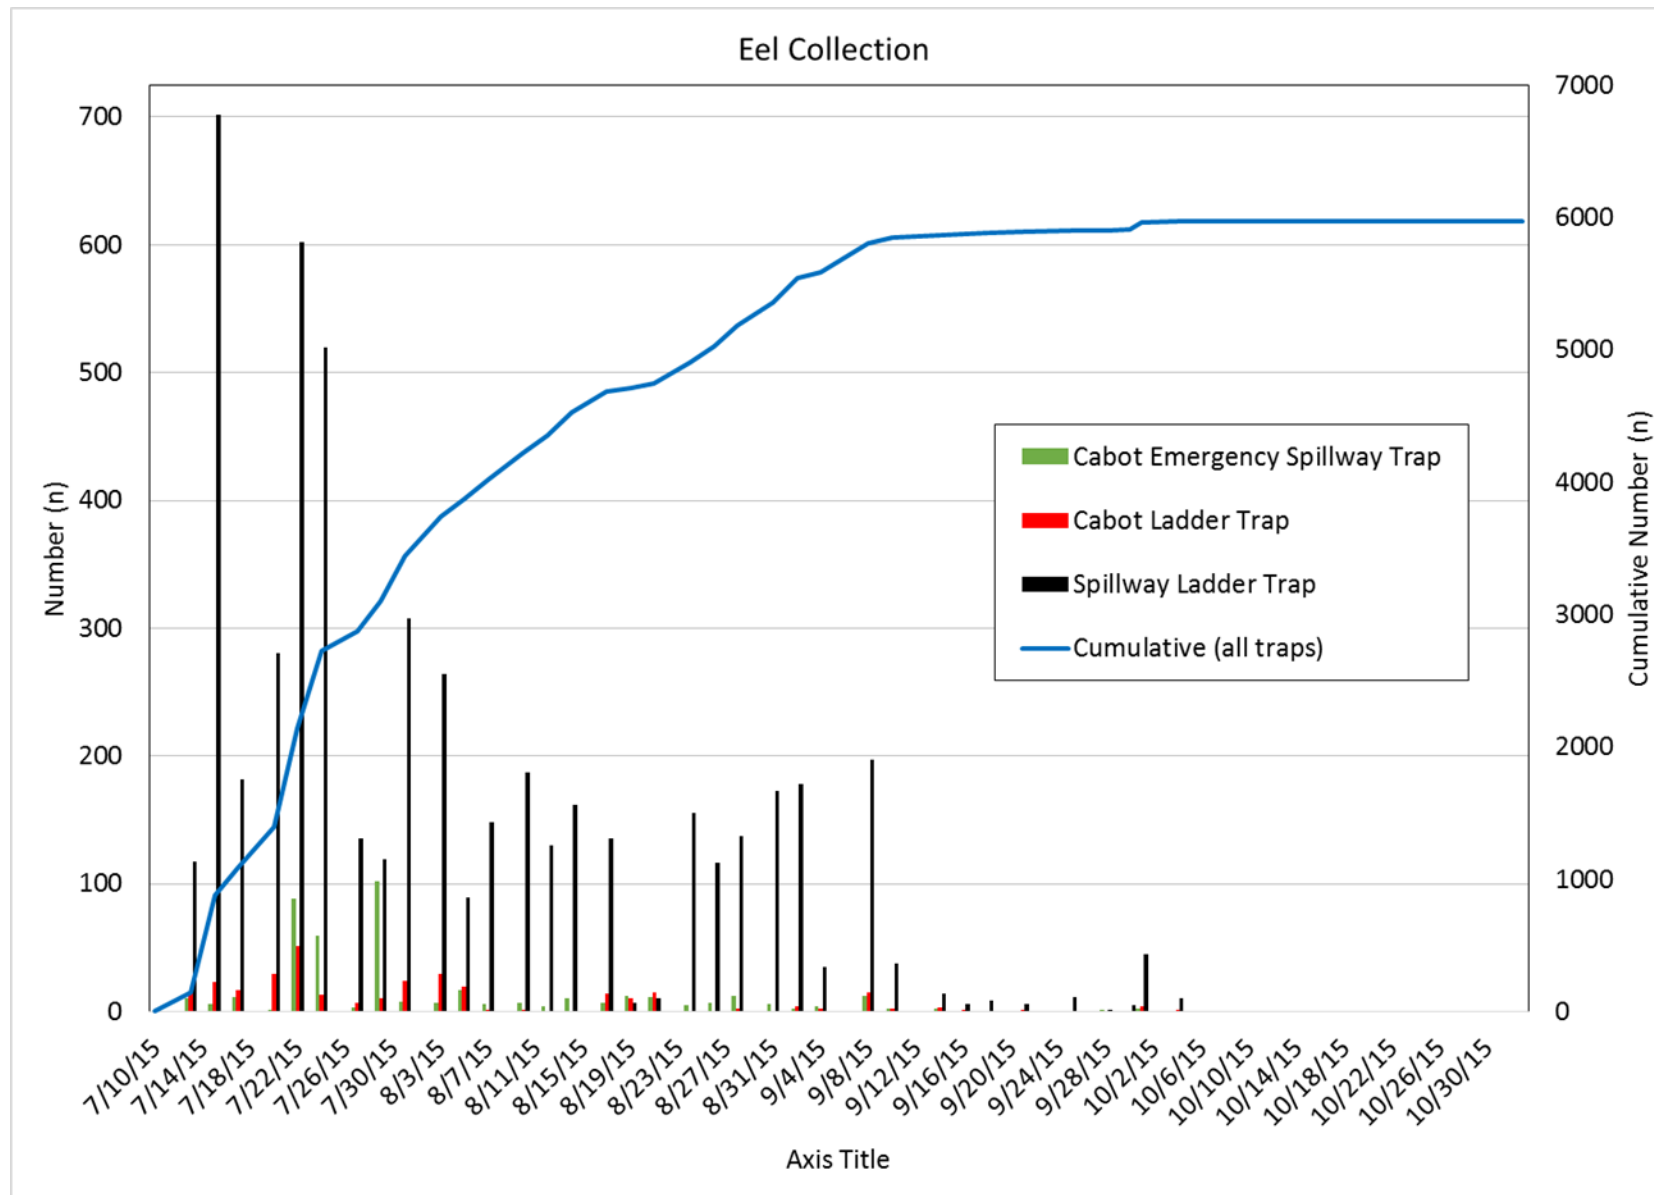
Figure 4.1-1: Eel Collections at the Project, Turners Falls, MA

Forty (40) eel collection events occurred at the ramp traps between July 9 and November 2, 2015; and 35 occurred at the Medusa traps between July 24 and November 2, 2015. [Table 4.1-1](#) summarizes the number of eel collected at each location during the study. A total of 5,972 eels were collected; the majority, 87.7% (n=5,235) were collected at the Spillway Fishway Trap, followed by the Cabot Emergency Spillway Trap and Cabot Fishway Trap, which collected 7.1% (n=424) and 5.2% (n=319), respectively ([Figure 4.1-1](#)). No eels were collected at the Medusa Traps.

During the study period, the upstream eel migration occurred between July 10 and October 14, 2015. Peak migration, during the study period, occurred in July, with the peak events on July 15, 2015 at the Spillway Fishway Trap (n=702); July 22, 2015 at the Cabot Fishway Trap (n=51) and on July 29, 2015 at the Cabot Emergency Spillway Trap (n=102). Very few eels were trapped after August ([Table 4.1-1](#) and [Figure 4.1-1](#)).

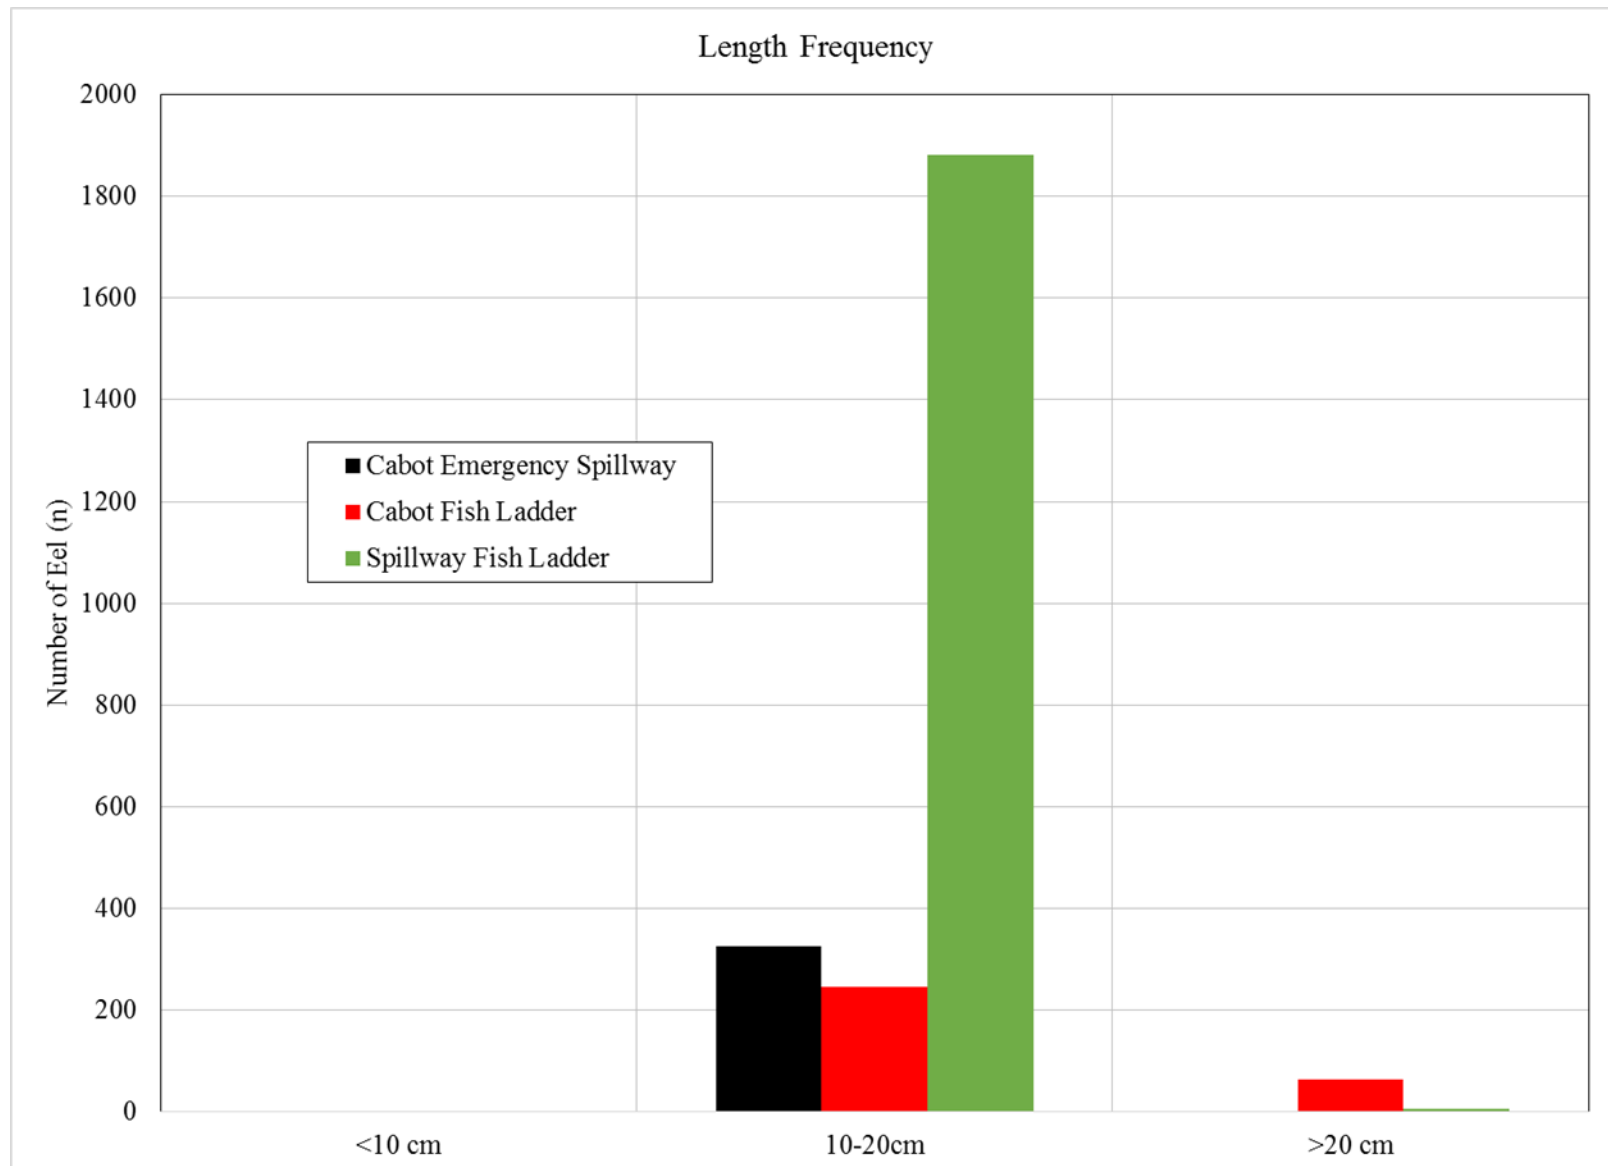
Figure 4.1-2: Length Frequency of a Sub-Sample (n=2,526) of the Eels Collected at the Turners Falls Project, Turners Falls, MA

A subsample of collected eels was sorted into one (1) of three (3) size categories during each collection event: less than 10cm; between 10cm and 20cm; and greater than 20cm. A total of 2,526 eel were sorted into the three size categories. The majority (97.1%) were between 10cm and 20cm in length, with only 0.04% less than 10cm and 2.85% greater than 20cm ([Figure 4.1-2](#)).

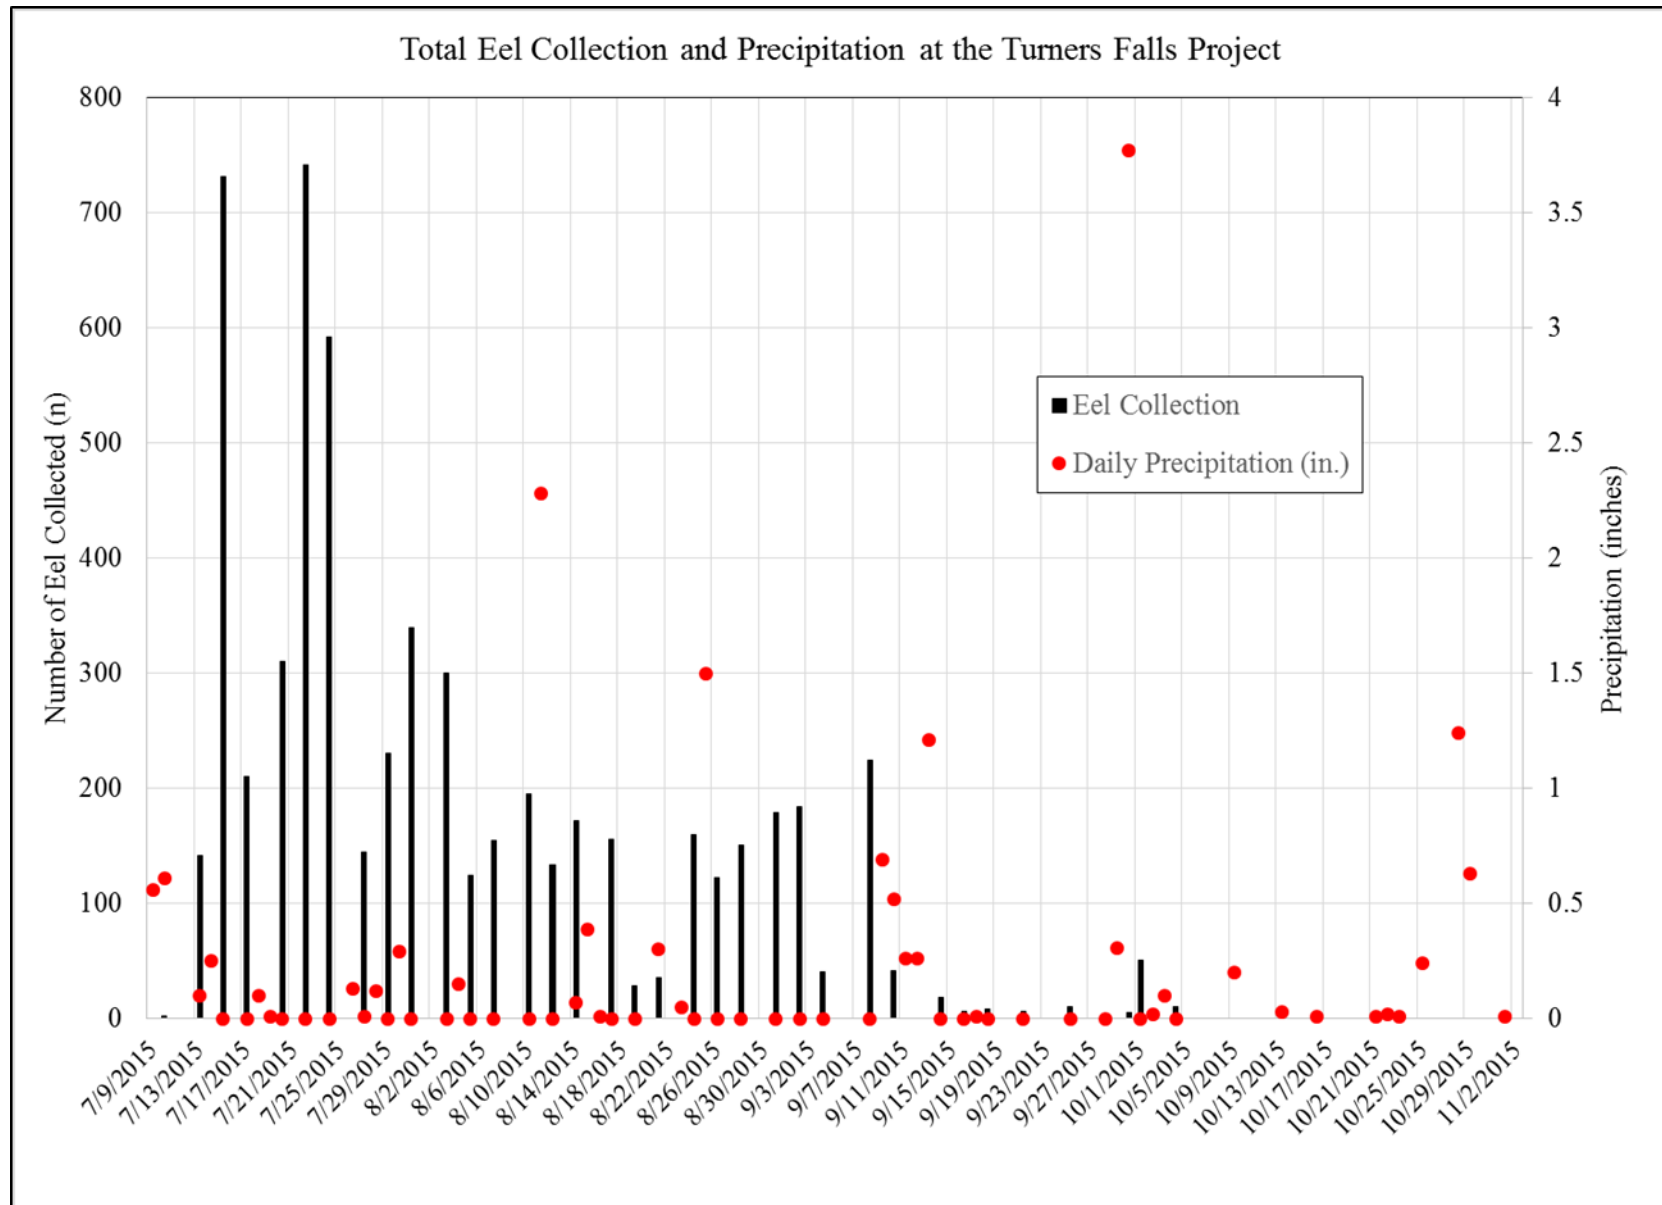
Figure 4.2-2: Daily Precipitation and Total Eel Collections (All Three Traps) at the Turners Falls Project, Turners Falls, MA

Based on the Pearson Correlation Coefficient test, there was no significant correlation ($r = -0.1962$) between precipitation and eel collection rate at the Project ([Figure 4.2-2](#)).

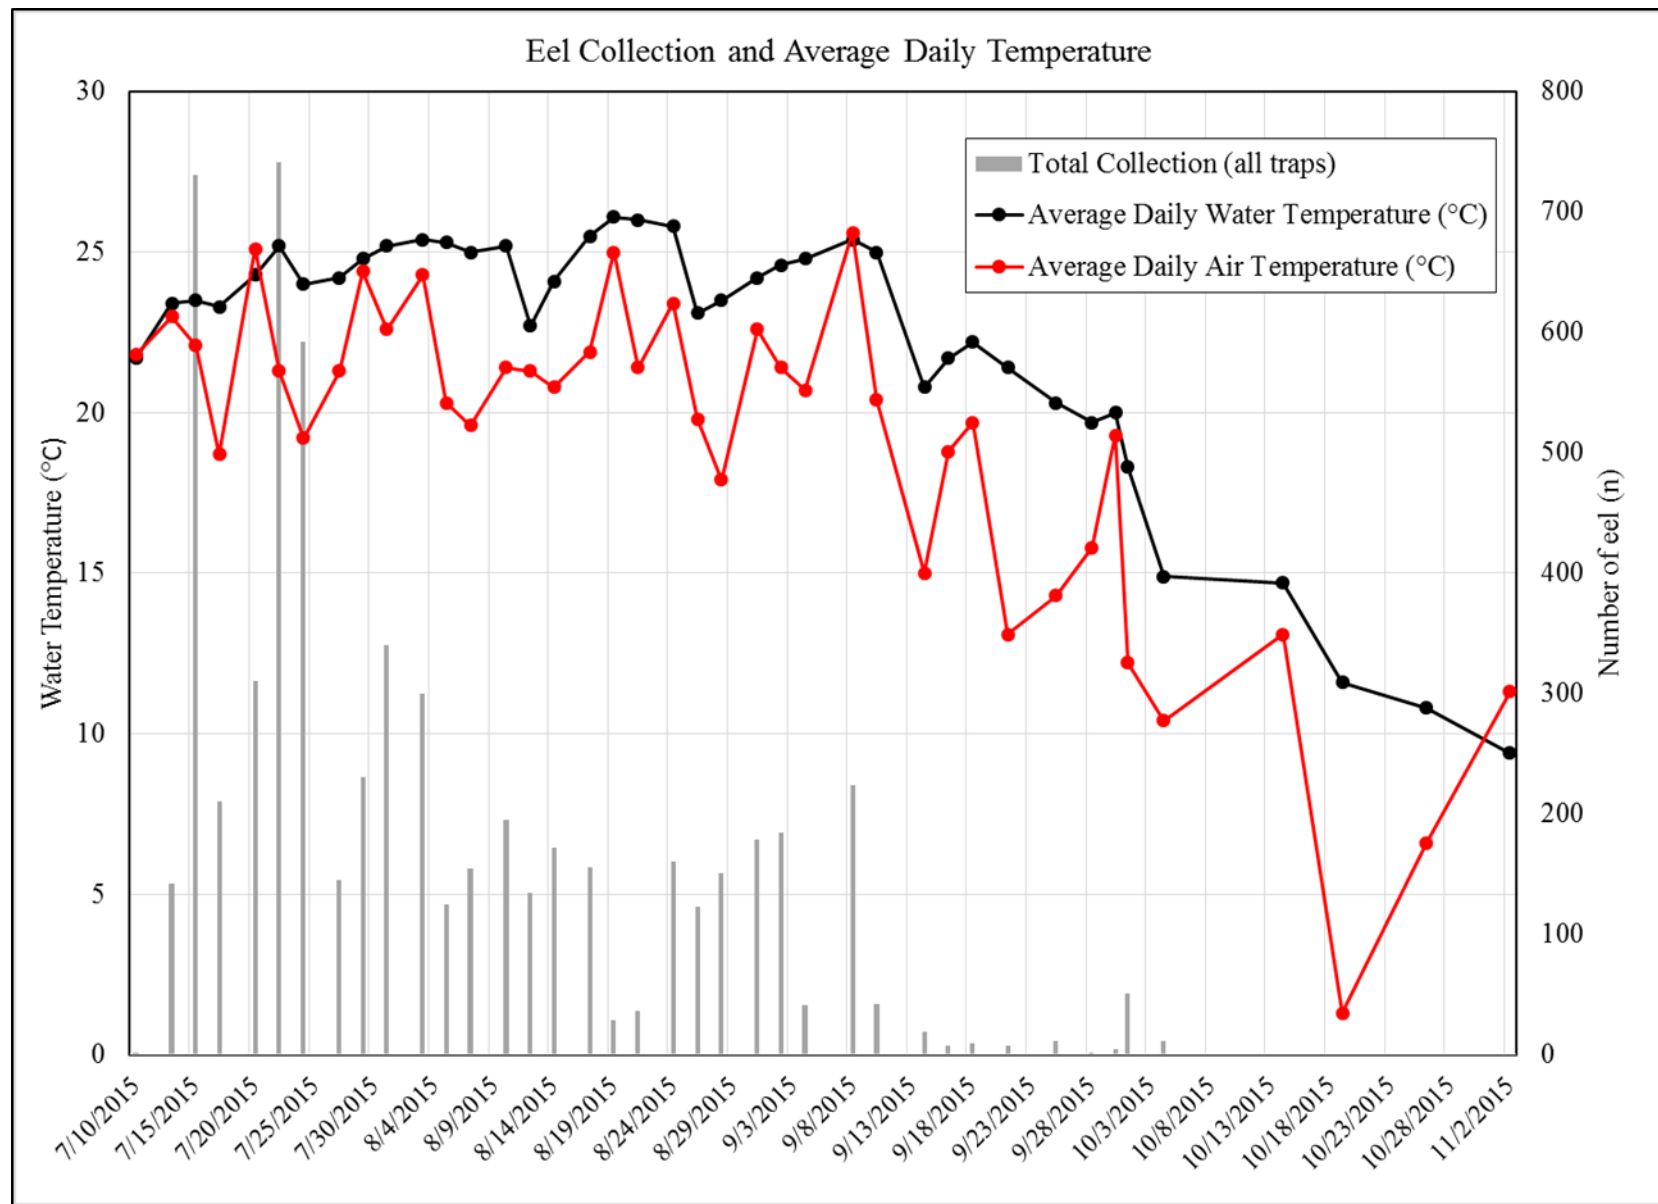
Figure 4.2-4: Average Daily Air and Water Temperature and number of American eel collected daily (all traps) at the Turners Falls Project, MA

Air and water temperature, predominant weather conditions and cloud cover data were collected throughout the study period and are summarized in [Table 4.2-1](#). Air temperature ranged from a low of 1.3°C on October 19, to a high of 25.6°C on September 8, 2015. Water temperature ranged from a low of 9.4°C on November 2, to a high of 26.1°C on August 19, 2015. Eel collection occurred from the onset of collection on July 10, 2015 at a water temperature of 21.7°C through October 4, 2015 when the water temperature fell to 14.9°C ([Figure 4.2-4](#)).

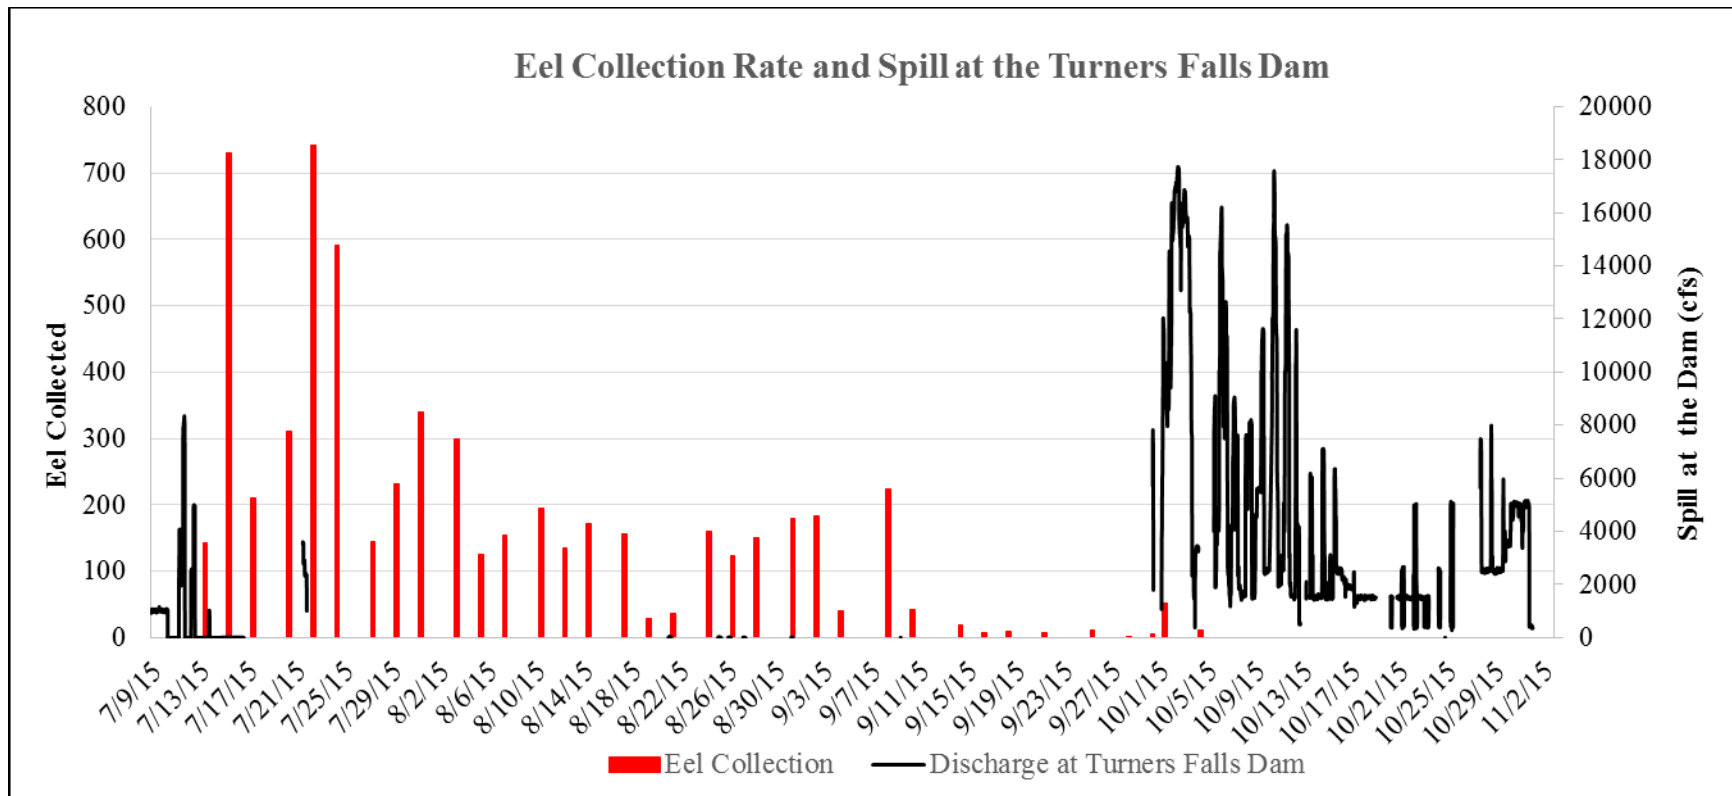
Figure 4.2-6. Spill at the Turners Falls Dam, Turners Falls, MA

Spill at the Turners Falls Dam occurred during the study period ([Figure 4.2-6](#)), but was infrequent until 3.77 inches of rain fell on September 30, 2015. Following the rain event, flow in the Connecticut River, as measured at the Montague USGS Gage, spiked to over 37,700 cfs. Flow in excess of Project capacity (approximately 18,000 cfs) was diverted into the bypass reach via the bascule gates. The high flow event coincided with peak discharge into the bypass reach of nearly 18,000 cfs. A brief period of spill (peak of 8,343 cfs on 7/11/15) into the bypass reach occurred between July 9 and 13, 2015 after a rainfall of 1.17 inches on July 9 and 10, 2015. During the annual canal outage all flow was routed into the bypass reach (October 4-11, 2015). Spill occurring after October 14, 2015 was generally associated with survival testing of juvenile American shad, Study No. 3.3.3 (*Evaluate Downstream Passage of Juvenile American Shad*). Data suggests that spill at the Turners Falls Dam does not affect collection rate at the traps.

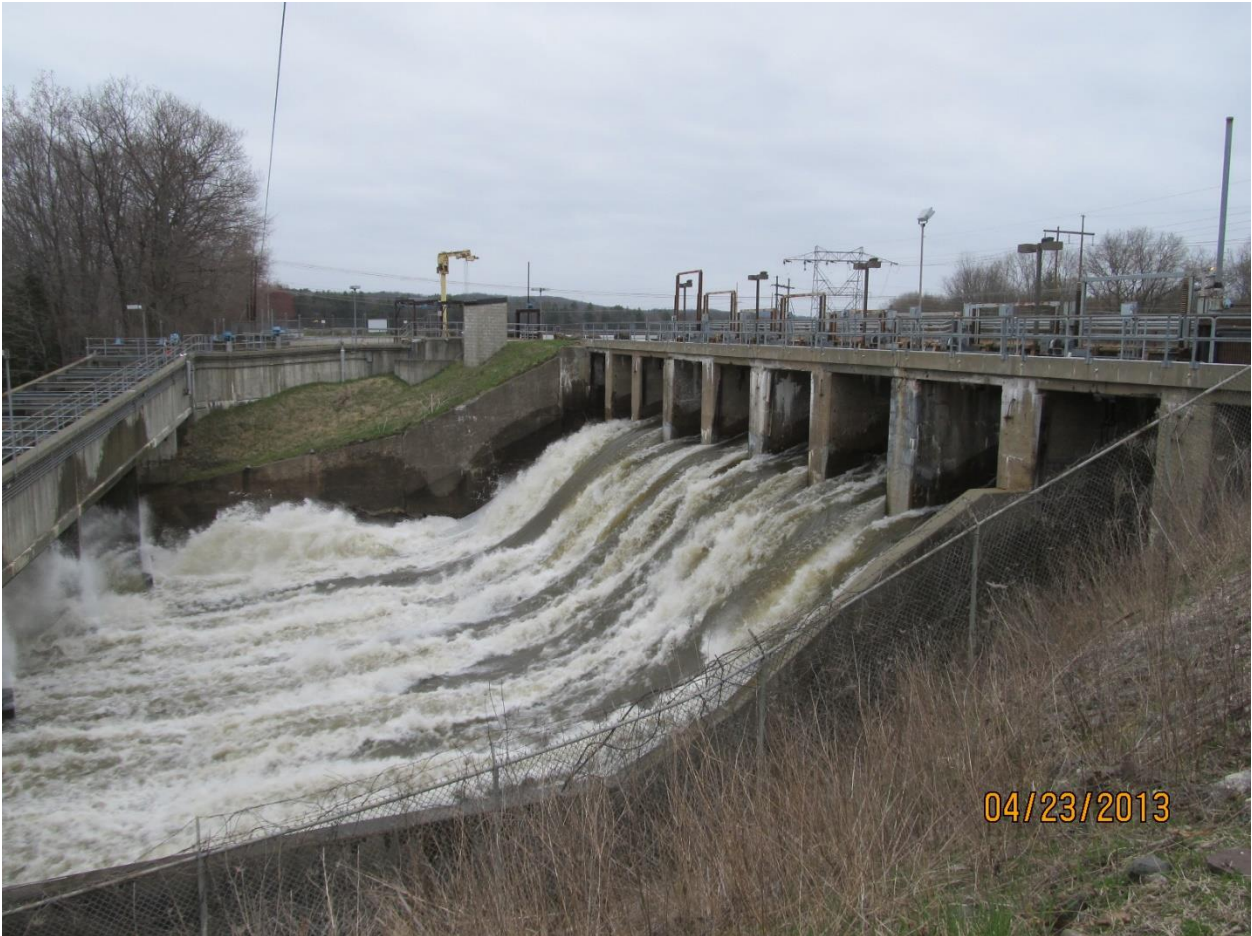
Figure 5.0-1: Cabot Emergency Spillway, Turners Falls, MA

Illustrates the flow conditions within the Emergency spillway during a full load rejection at Cabot Station, Turners Falls, MA.

Eels were observed and trapped at other locations, most notably at the Emergency Spillway and within the Cabot Fishway. However, the number of eels collected at these locations was much lower than the number collected at the Spillway Fishway. Further, the Emergency Spillway is not an appropriate location for a permanent passage structure. Its operation is intended to rapidly draw down the power canal in the event of a Cabot Station load rejection or canal dike breach or to sluice ice and debris downstream. During such events, the gates open automatically and without warning, discharging excess water to the spillway. Should a passage structure be built at this location, discharge at the Emergency Spillway has the potential to damage the Emergency Spillway and passage structures. [Figure 5.0-1](#) is a photo that illustrates the flow conditions in the Emergency Spillway during a full load rejection.
