# **Fluvial Geomorphology Study of the Turners Falls Pool on the Connecticut River Between Turners Falls, MA and Vernon, VT**

Northfield Mountain Pumped Storage Project  
FERC License No. 2485  
Northfield, Massachusetts

Field Geology Services  
Farmington, ME

November 2007

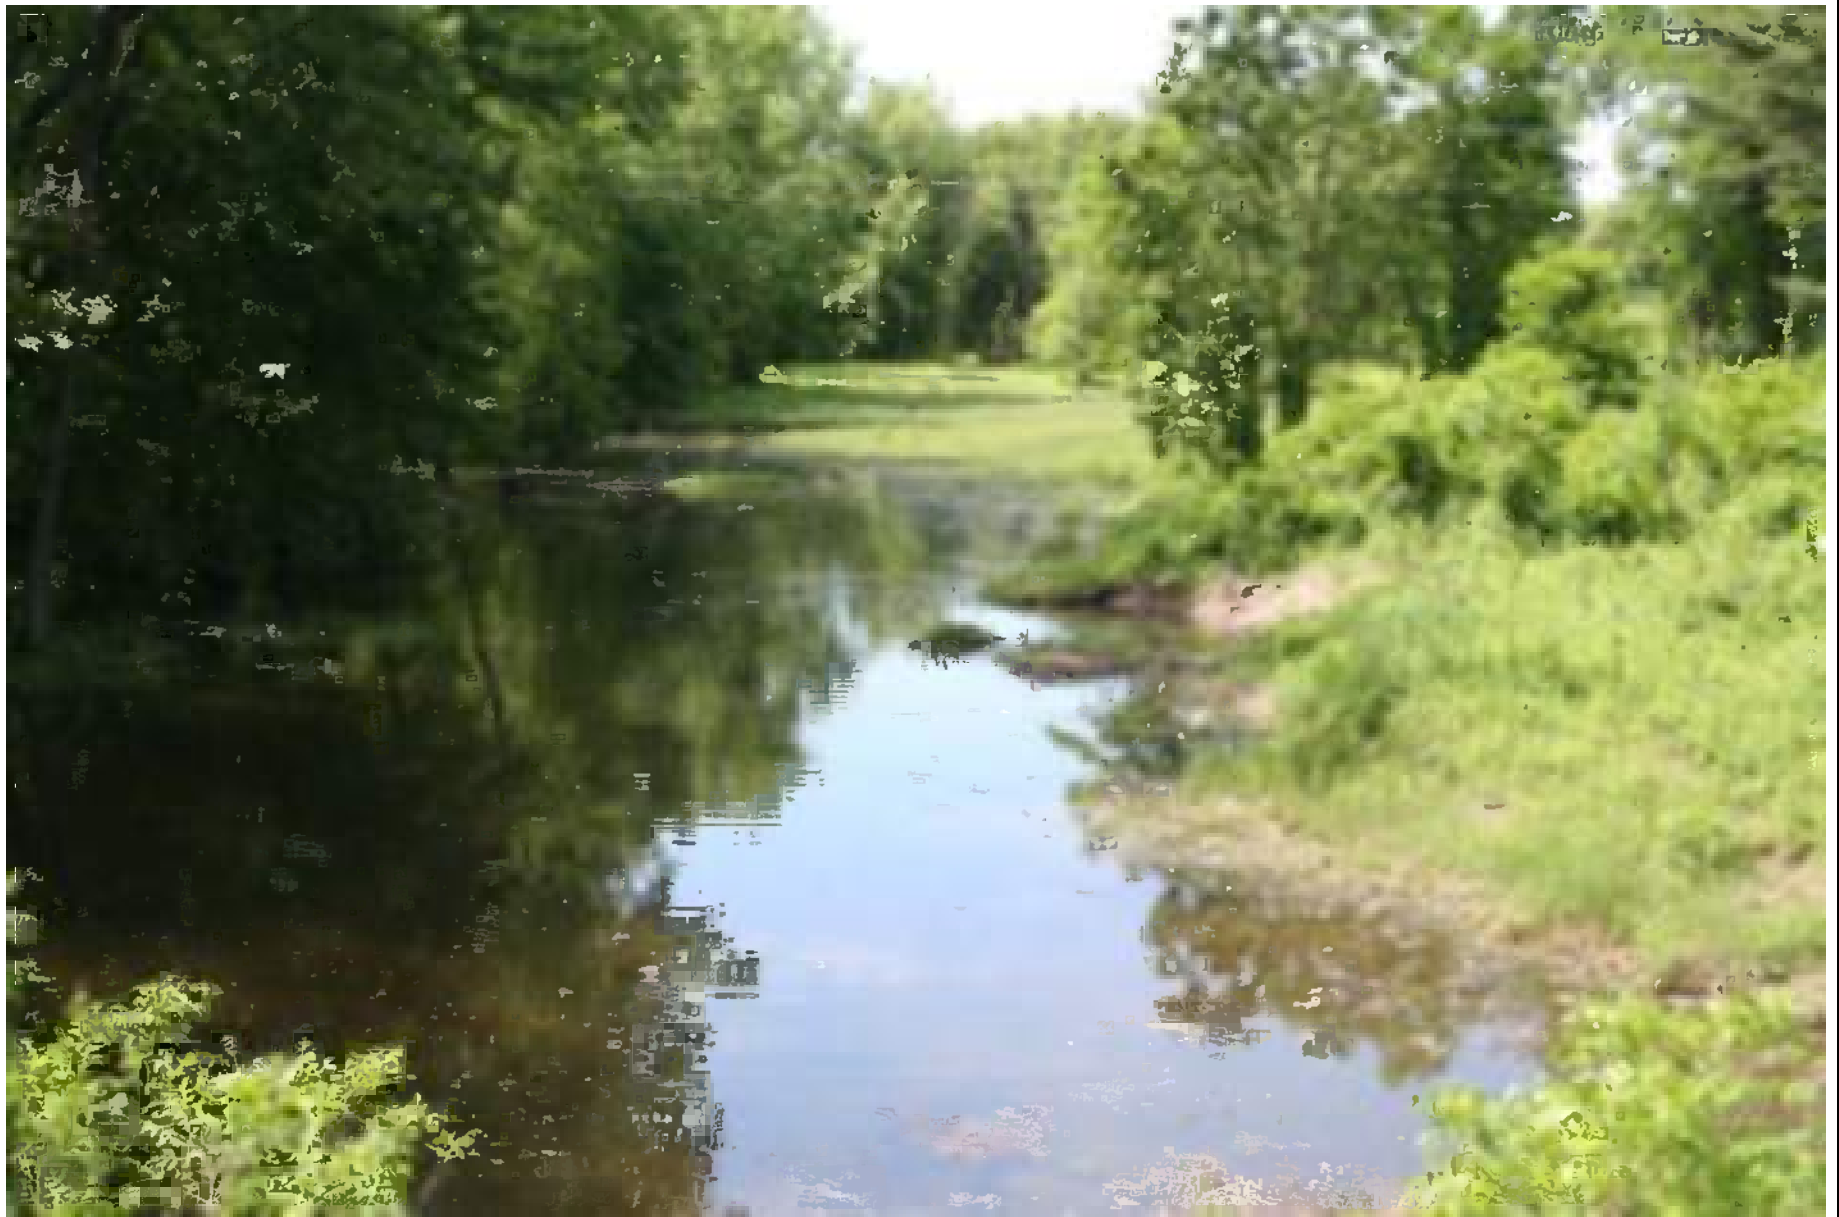
Figure 6: Abandoned avulsion channel formed across Moose Plain during the 1936 flood.

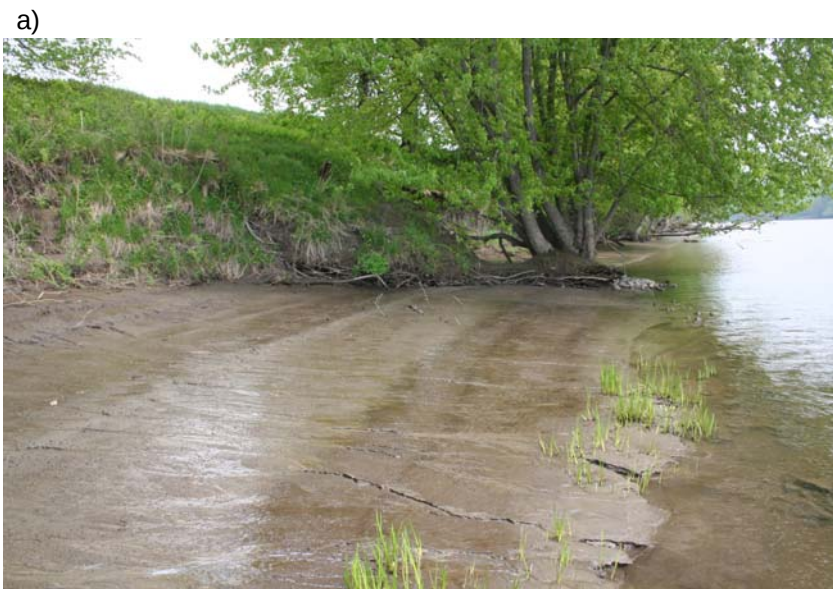
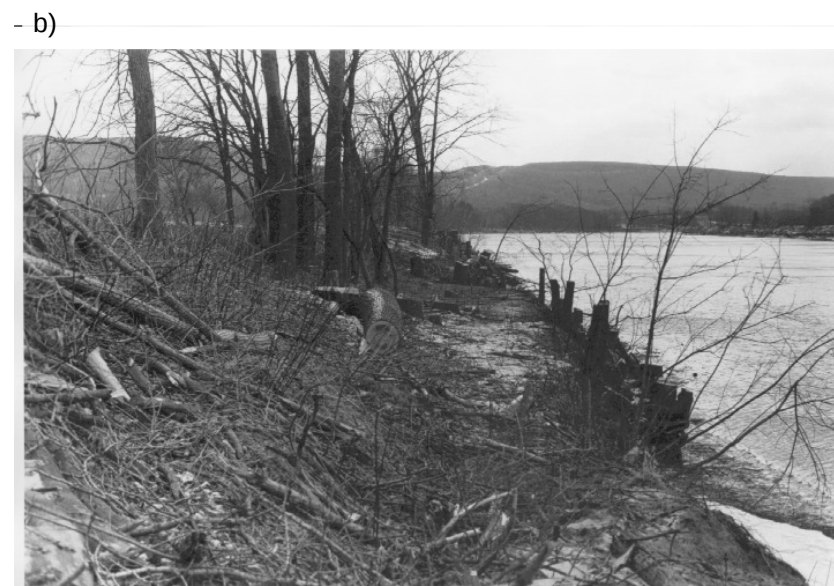
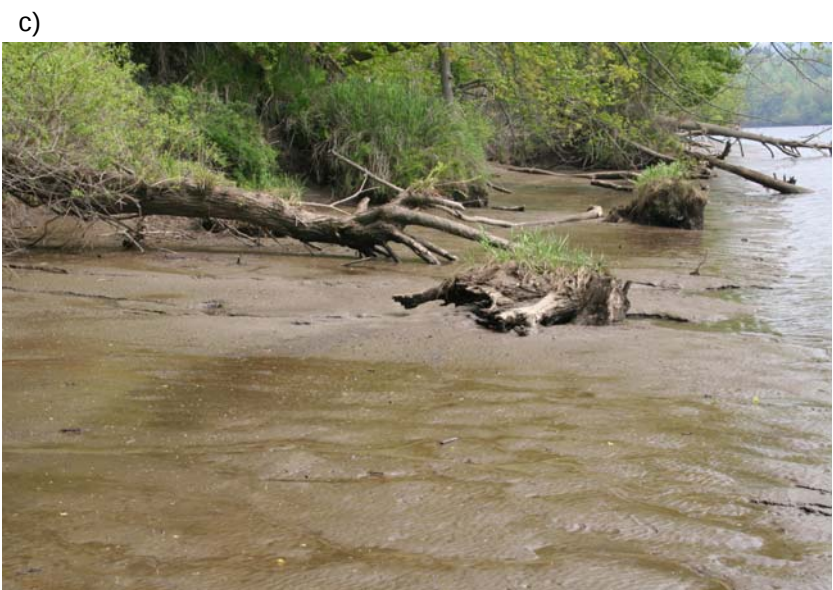
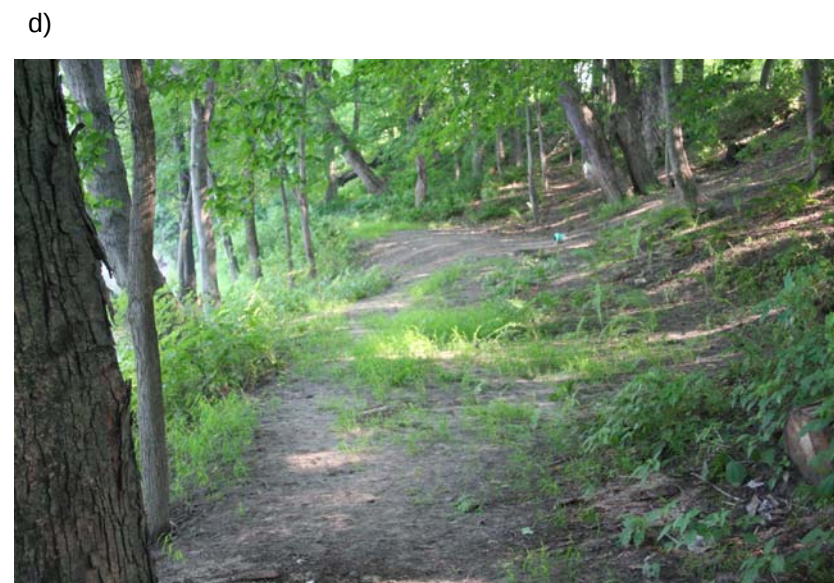
may have accelerated bank erosion. The original bank profile and low bench are still preserved in some locations where trees were not removed (Figure 7a).

Figure 7: a) Remnant of low bench protected by tree that was once more continuous in the Turners Falls Pool, b) historical photograph of the bench, c) tree stumps at the edge of water once growing on bench, and d) a similar bench located approximately 1.6 miles downstream of the Deerfield River.

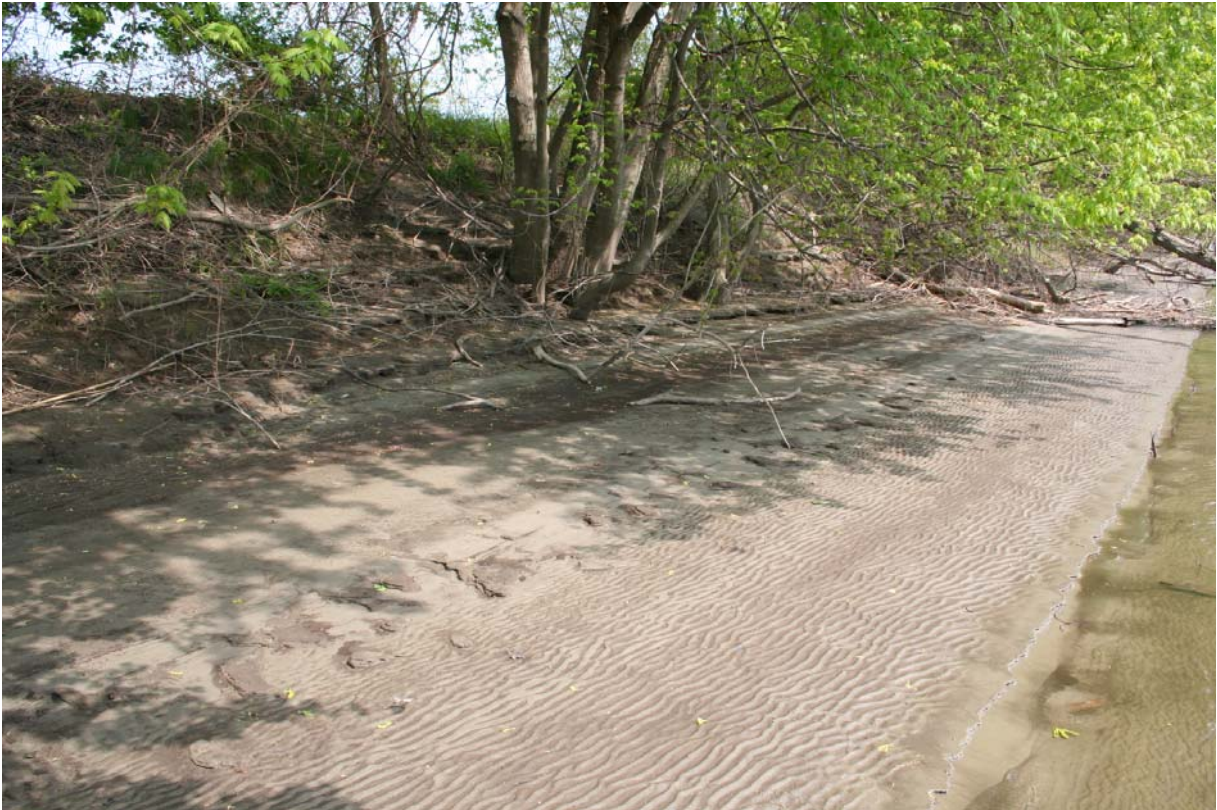
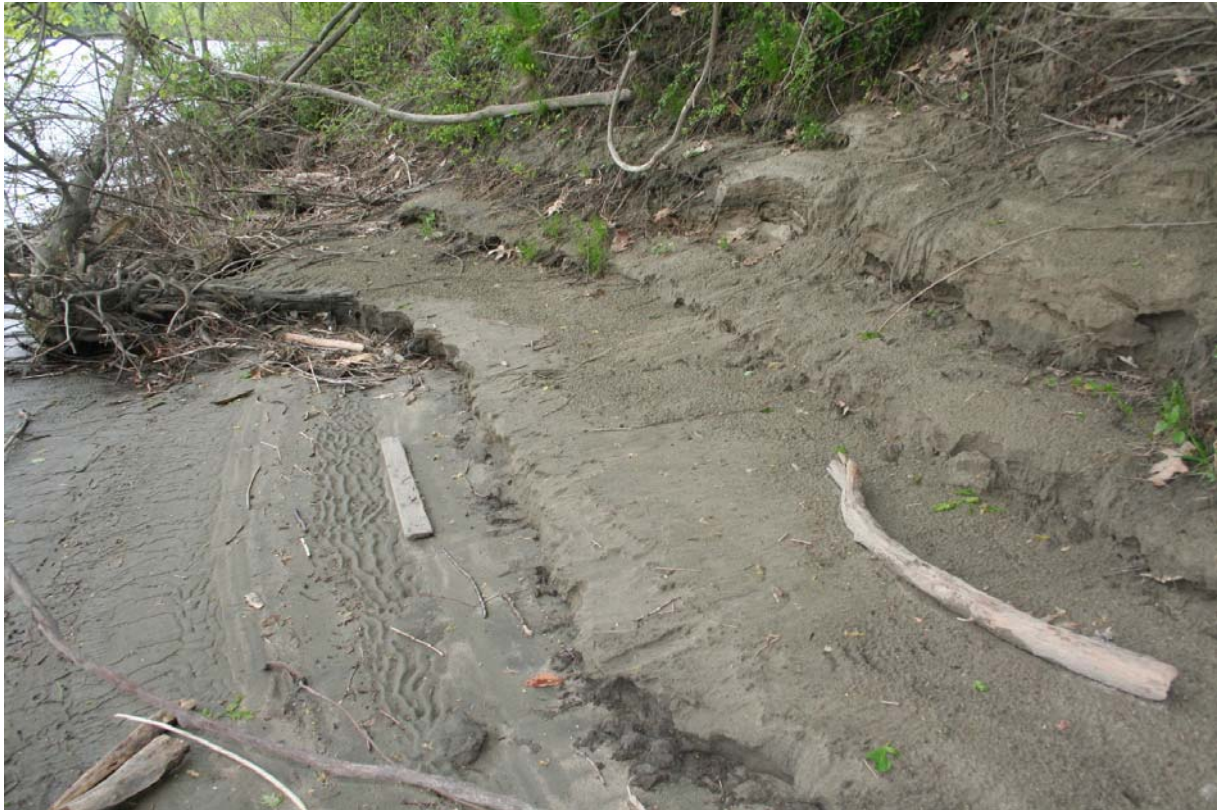
Figure 8: a) Active beach face and b) remnants of a higher beach.

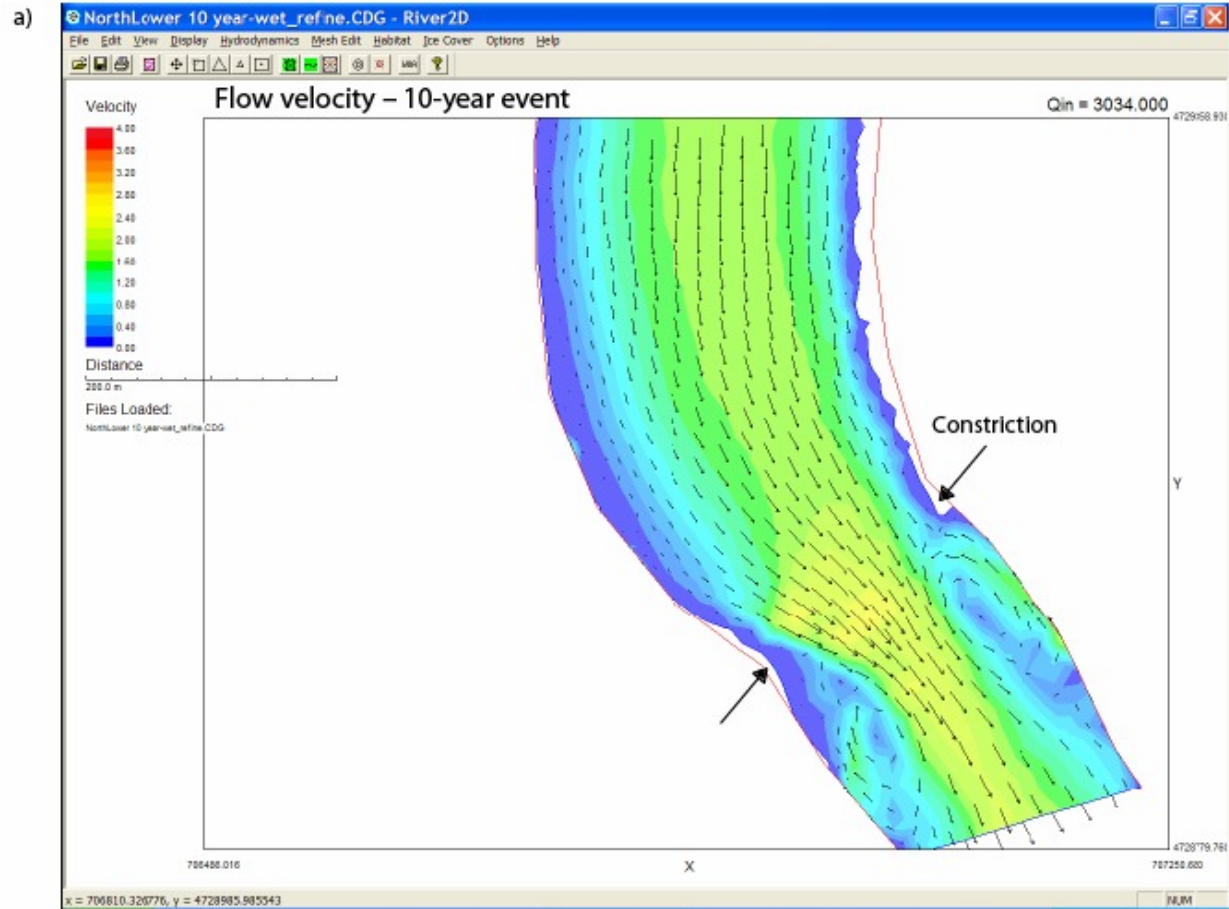
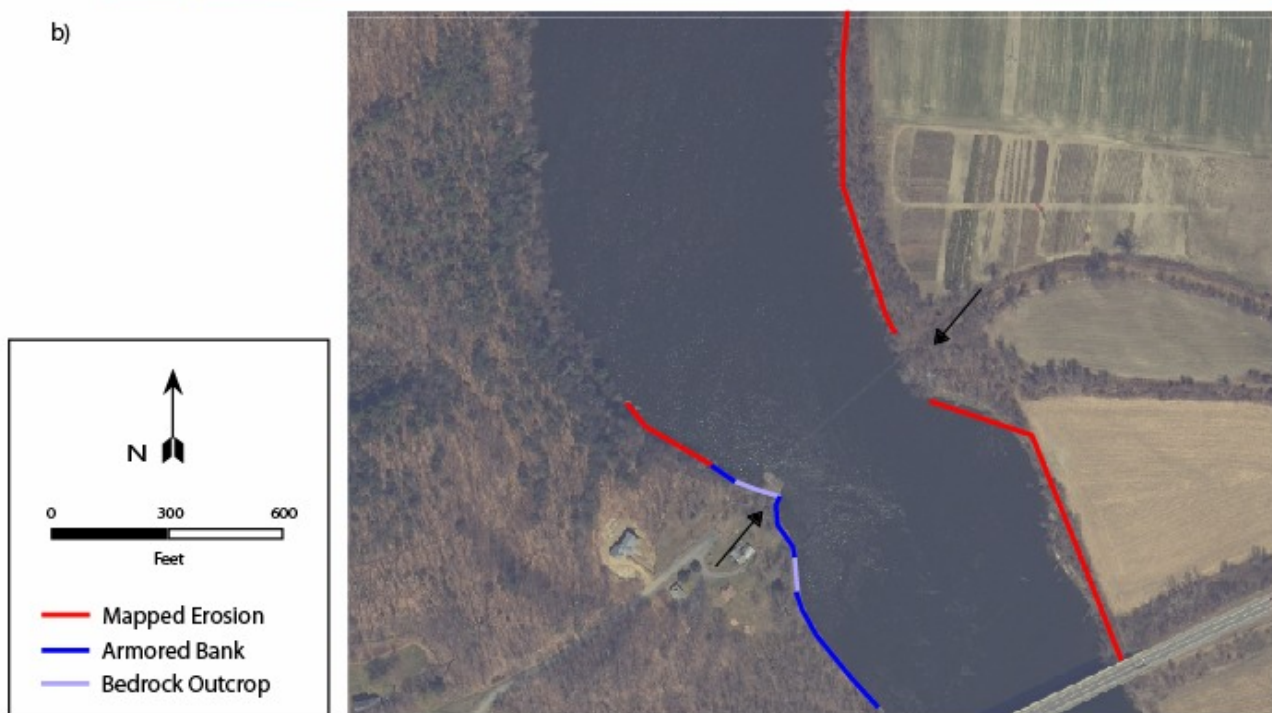
Figure 18: Comparison of a) eddy locations near Route 10 Bridge and b) bank erosion and bank armoring sites. Arrows on both maps are at same location. Note that location of erosion and bank armoring is largely congruent with eddy formation.

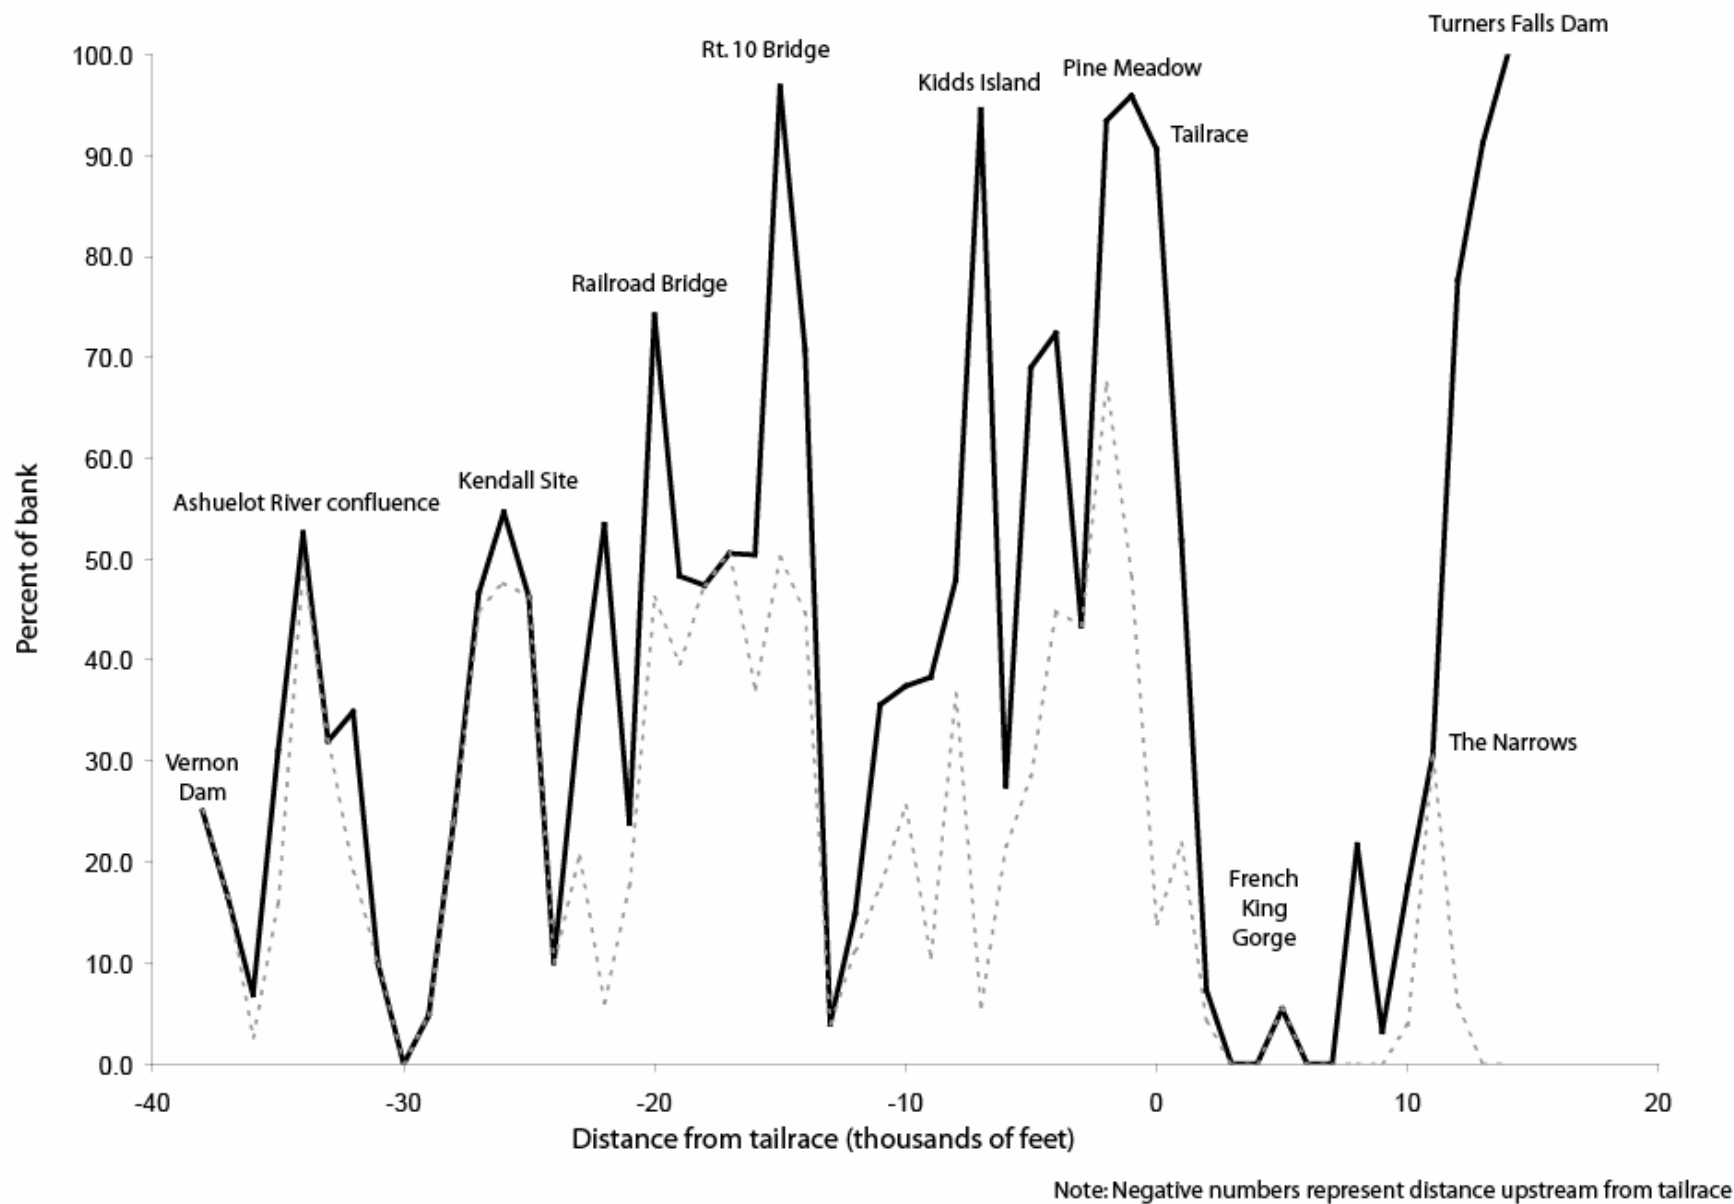
Figure 26: Density of bank erosion (dashed line) and bank erosion with rock armoring (solid line) as a function of distance from the Northfield Mountain Pumped Storage Project tailrace. Percentage calculated by comparing total length of eroding and armored banks within each two thousand foot length of river (4000 ft of bank) upstream or downstream of the tailrace.

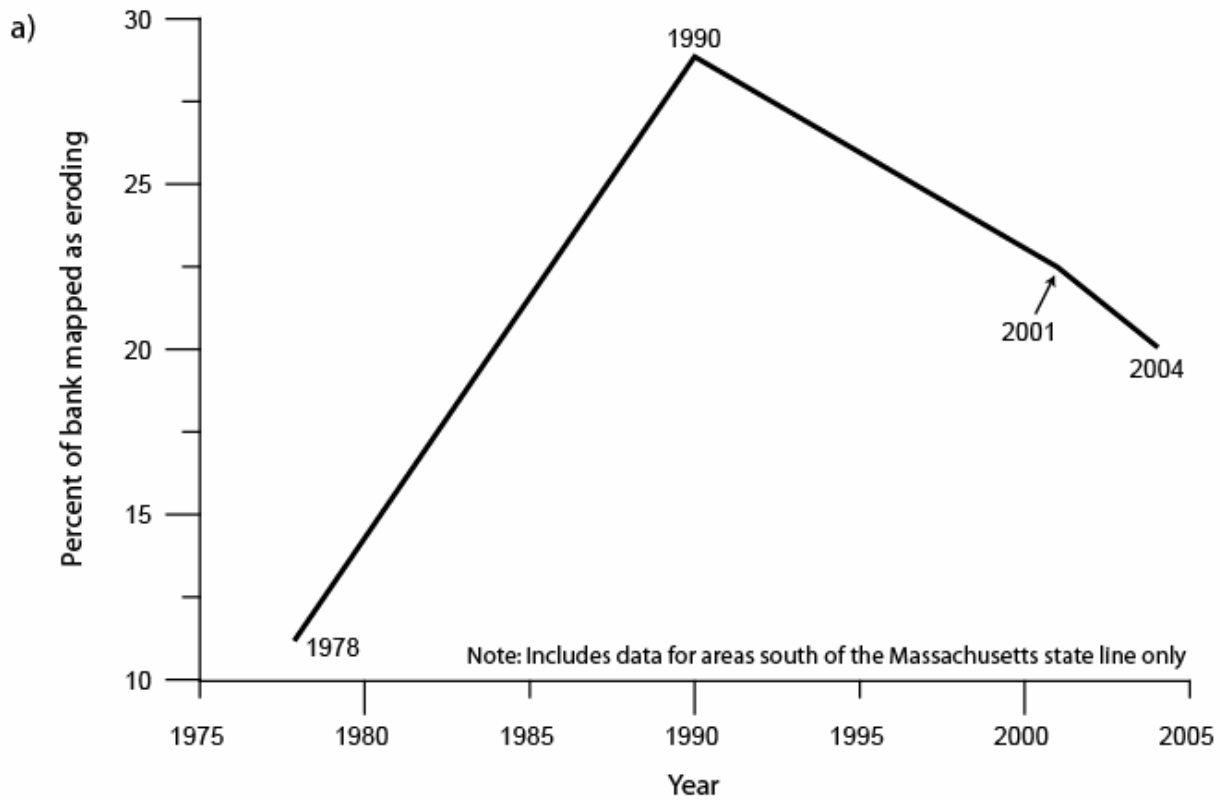
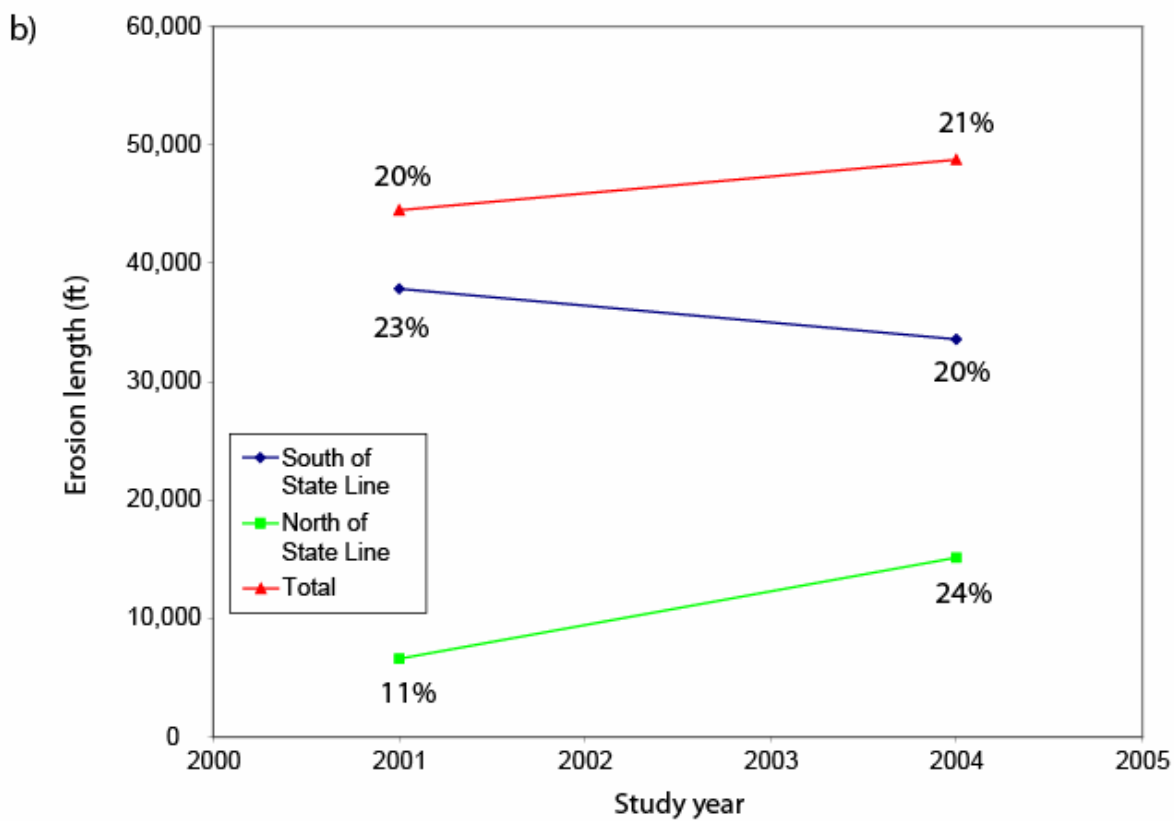
Figure 28: a) Changes in the percentage of banks mapped as eroding south of the state line in various years and b) changes in total mapped erosion between 2001 and 2004 and changes north and south of the state line.

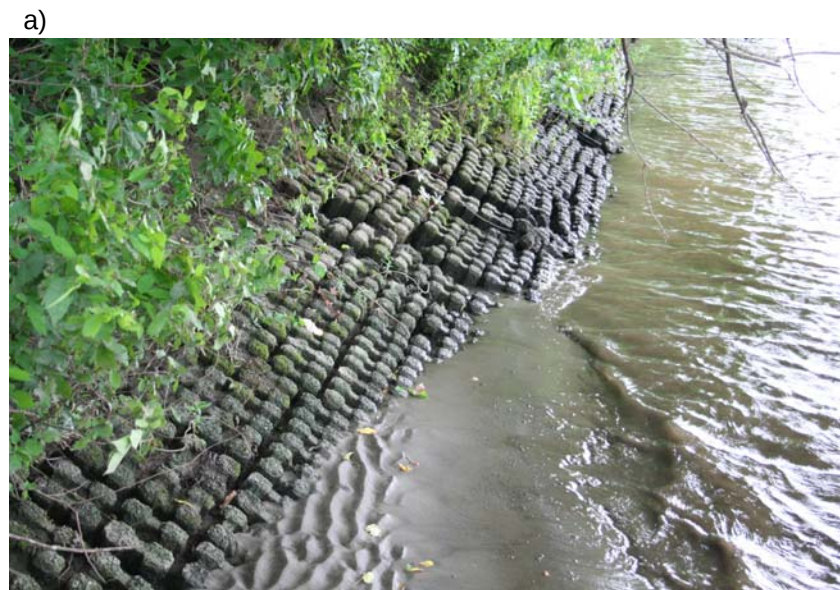
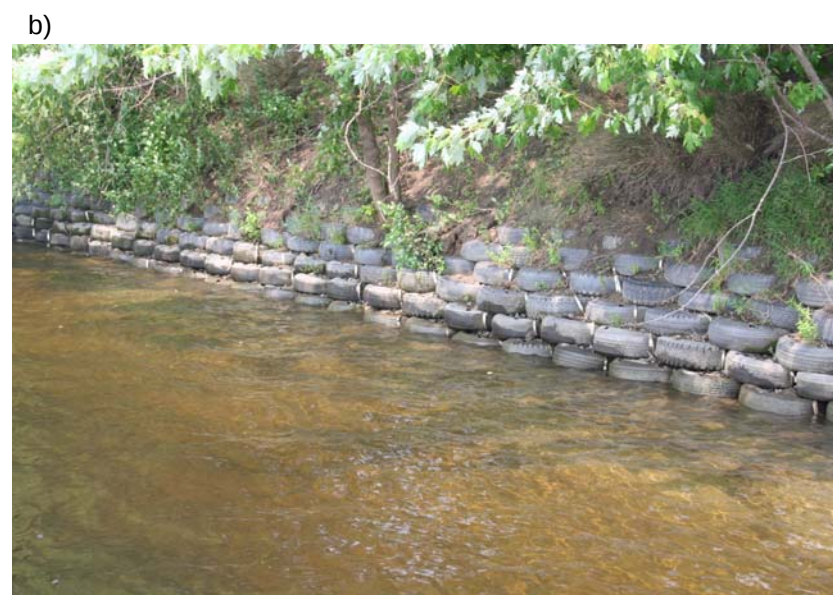
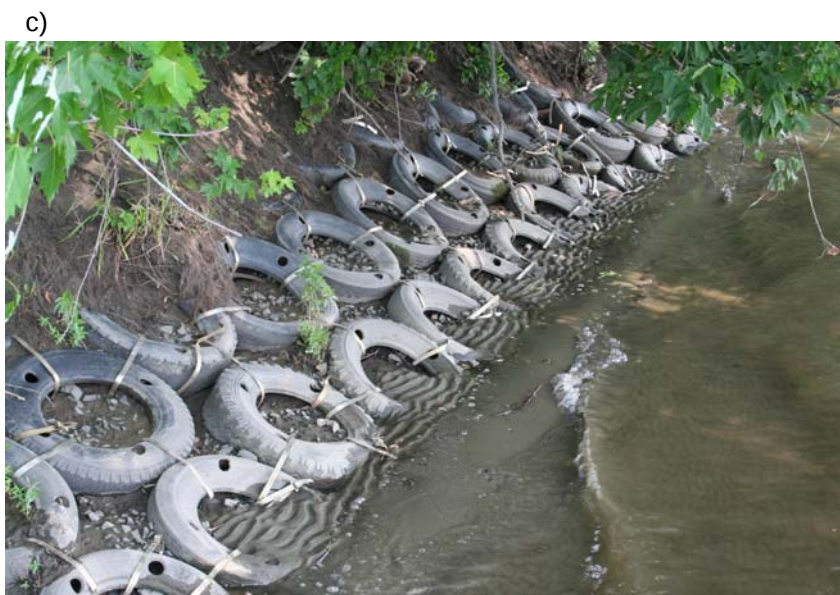
Figure 37: Experimental bank protection efforts using a) concrete mattress, b) tire wall, and c) tire mattress downstream of Route 10 Bridge.

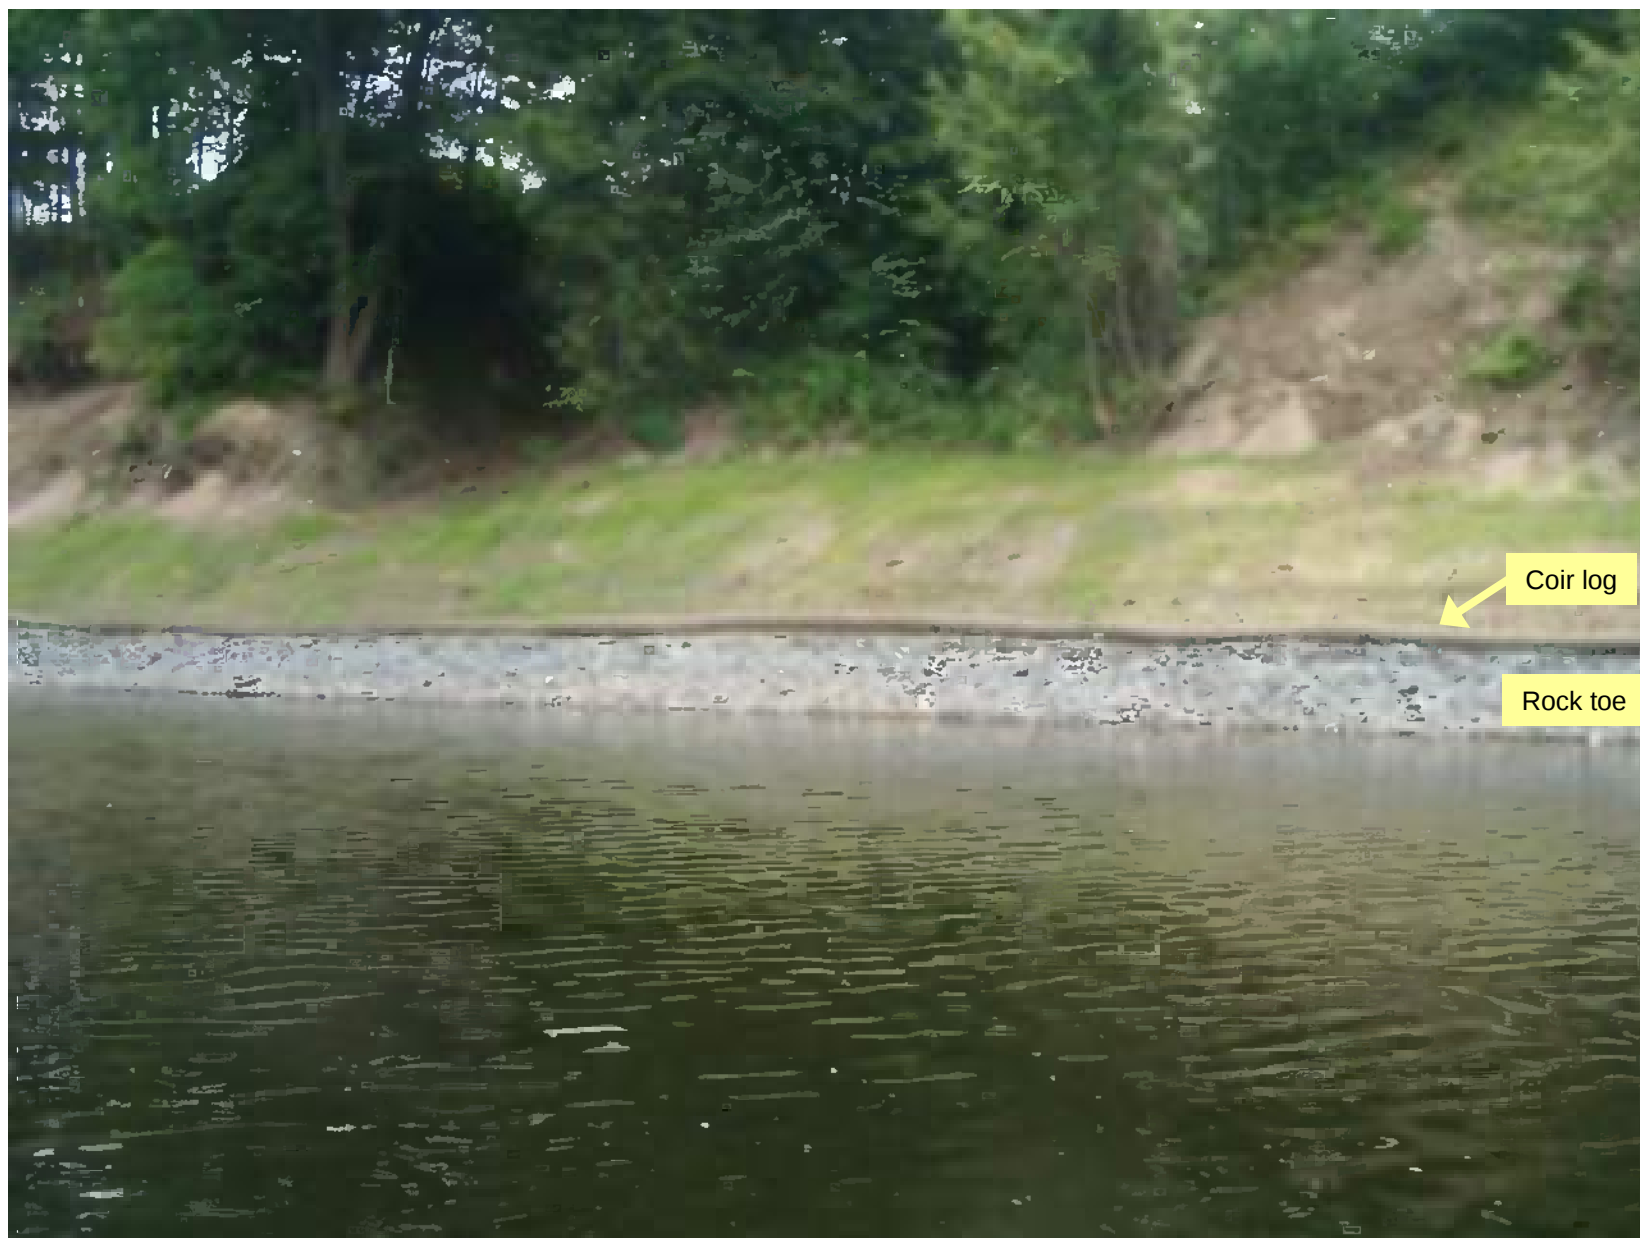
Figure 38: Bioengineering project (Skalski Site) with rock toe and coir log above.

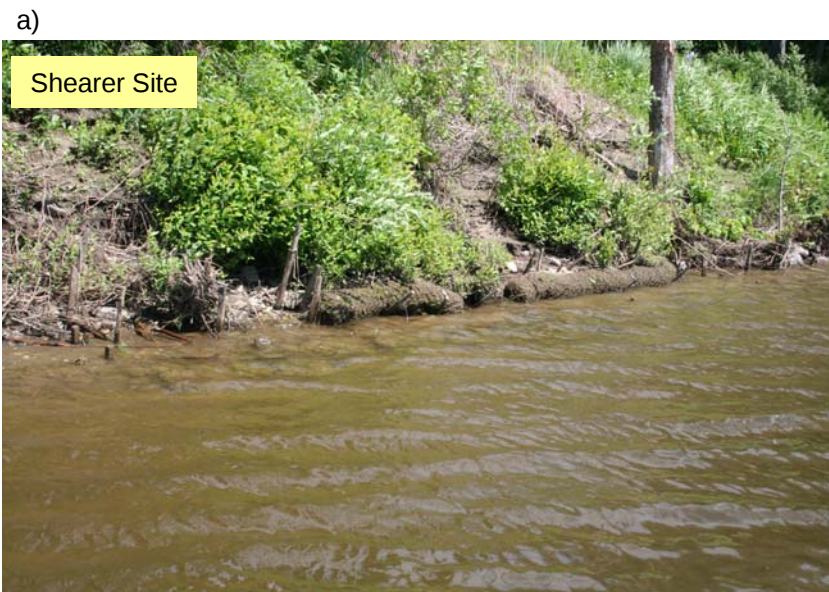
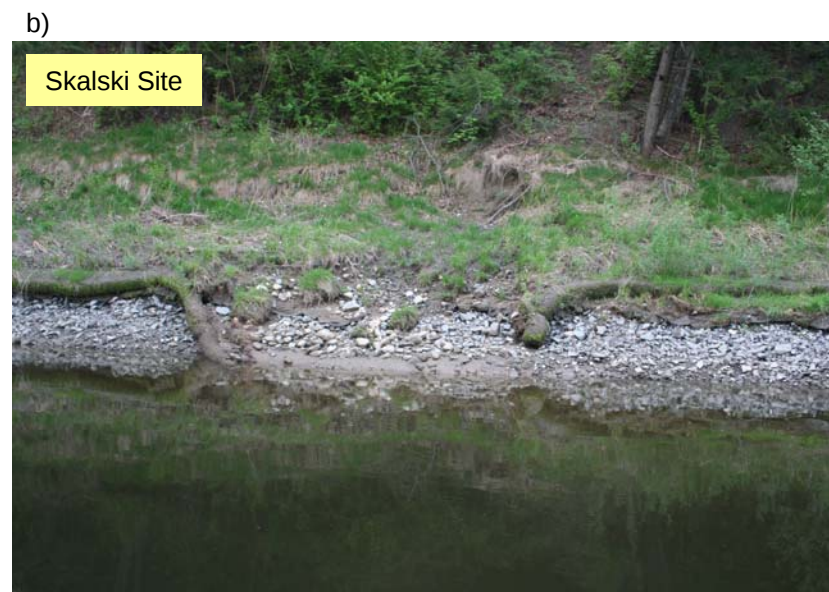
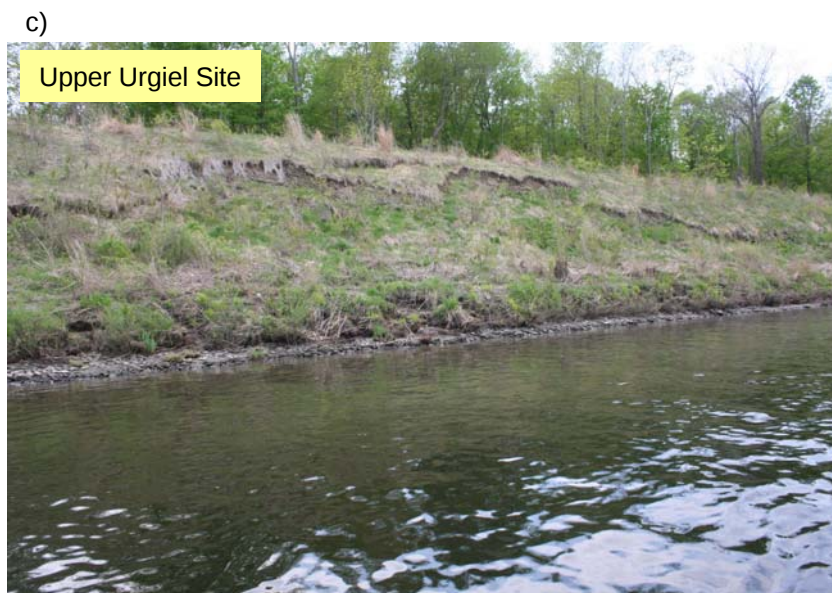
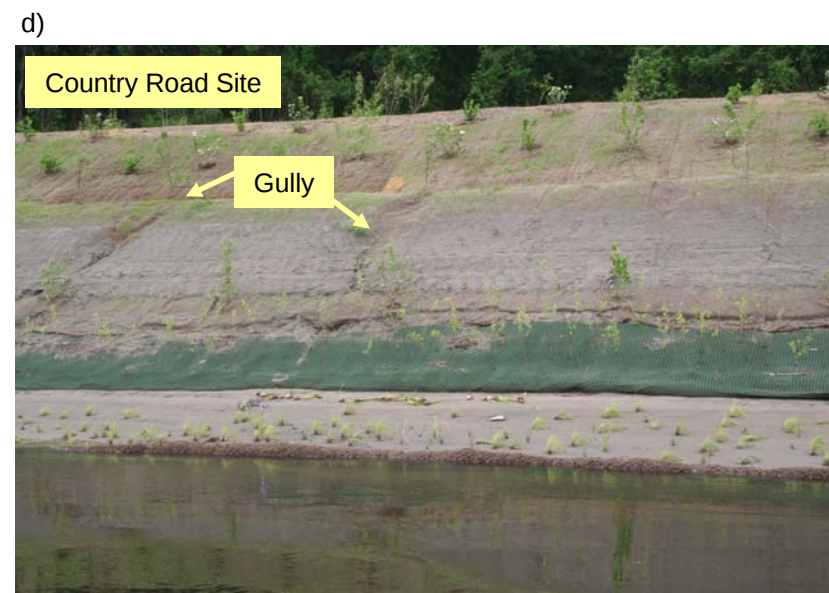
Figure 39: a) Coir logs removed by water currents, b) coir logs detached from bank by mass movements on upper slope, c) planar slips on upper slope resulting from removal of coir logs and notching at the base of the slope, and d) gully on the slope of a recently shaped bank.

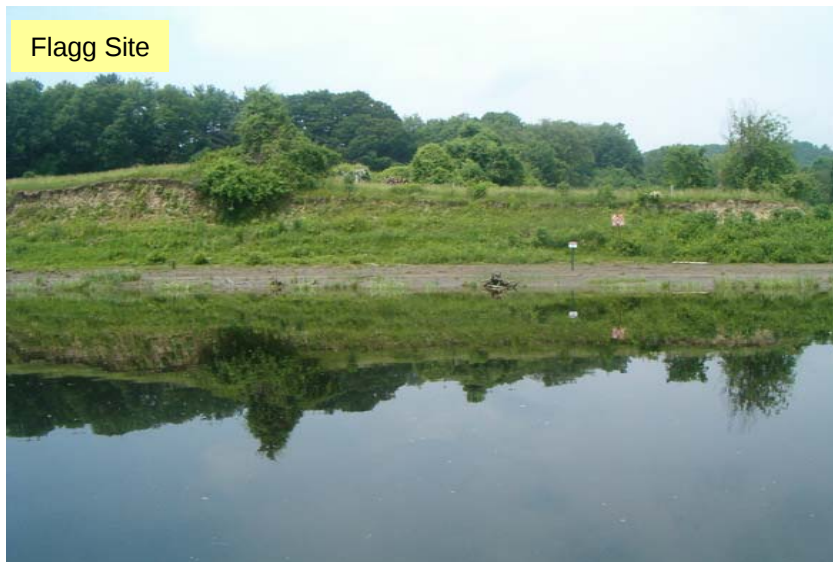
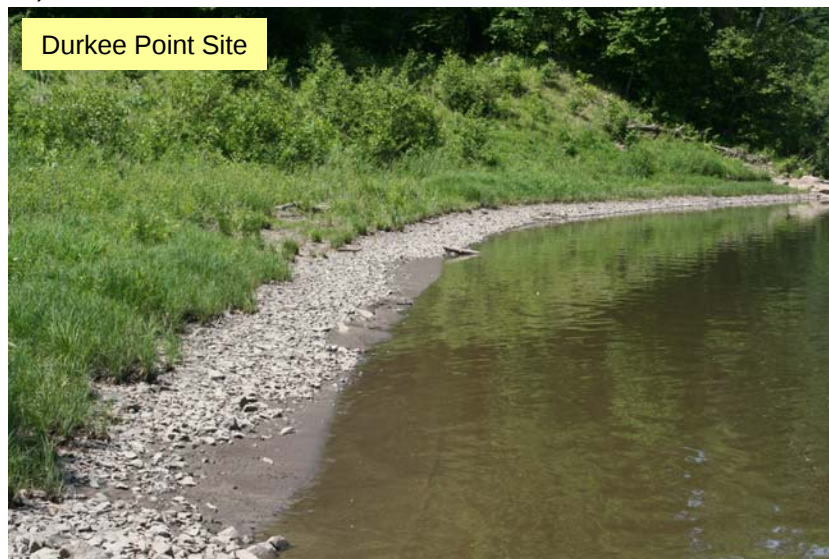
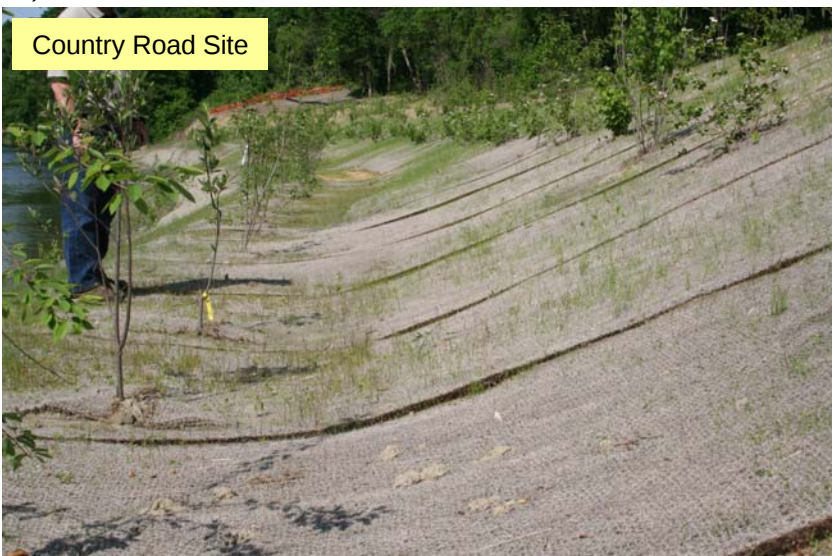
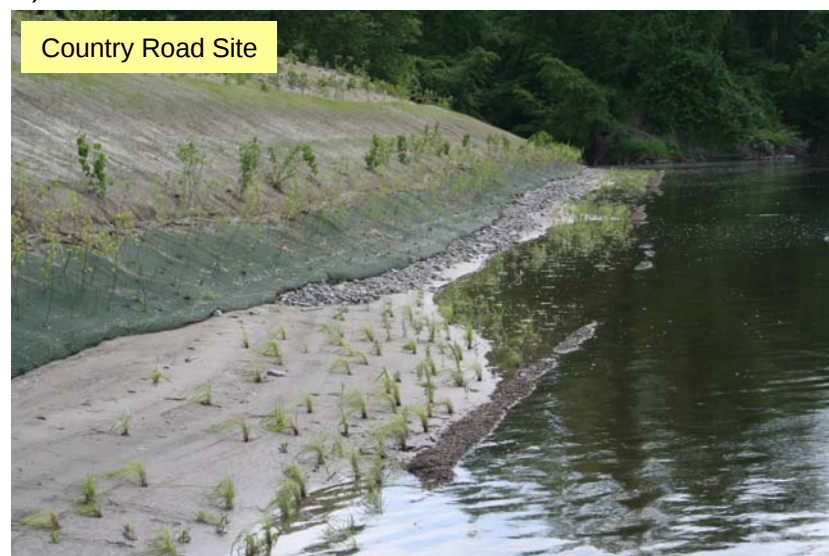
Figure 41: a) Vegetating bank face protected by beach despite logs removed from beach, b) low bench created during construction, c) floodplain bench created during construction, and d) coir logs placed under the water surface to encourage beach development.

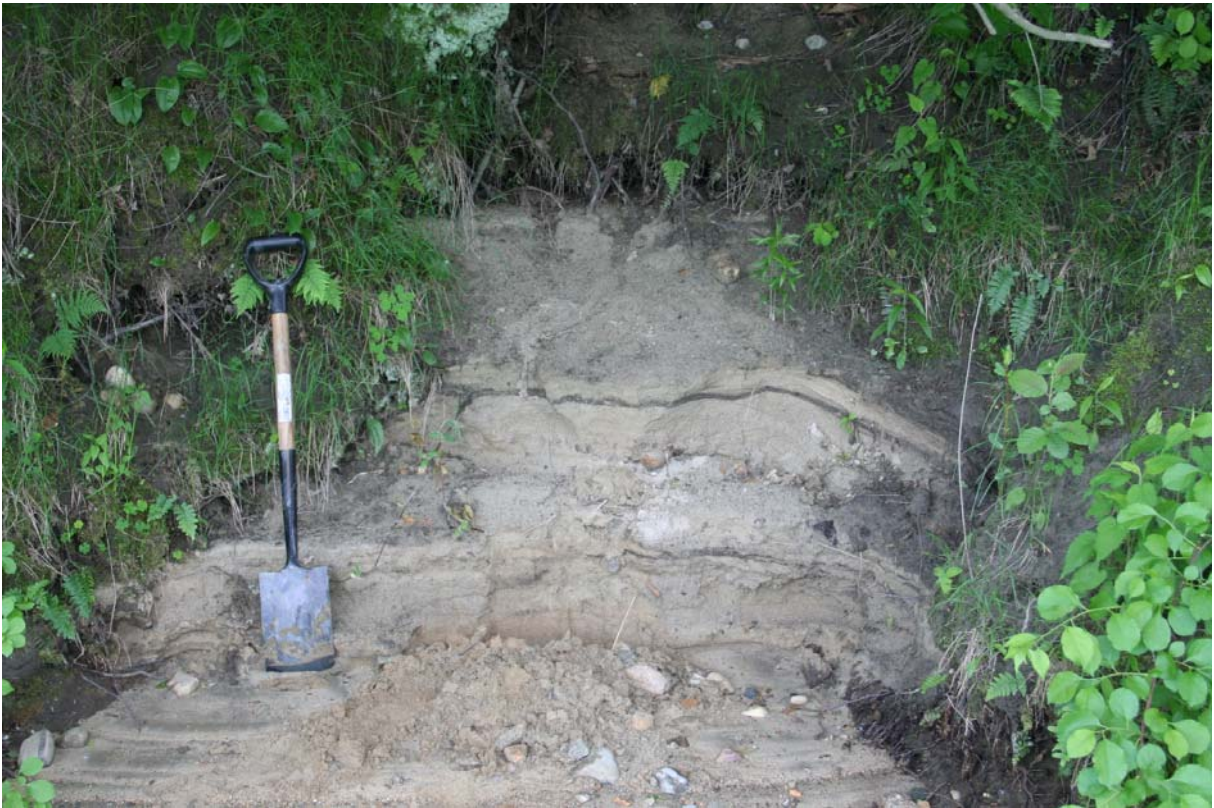
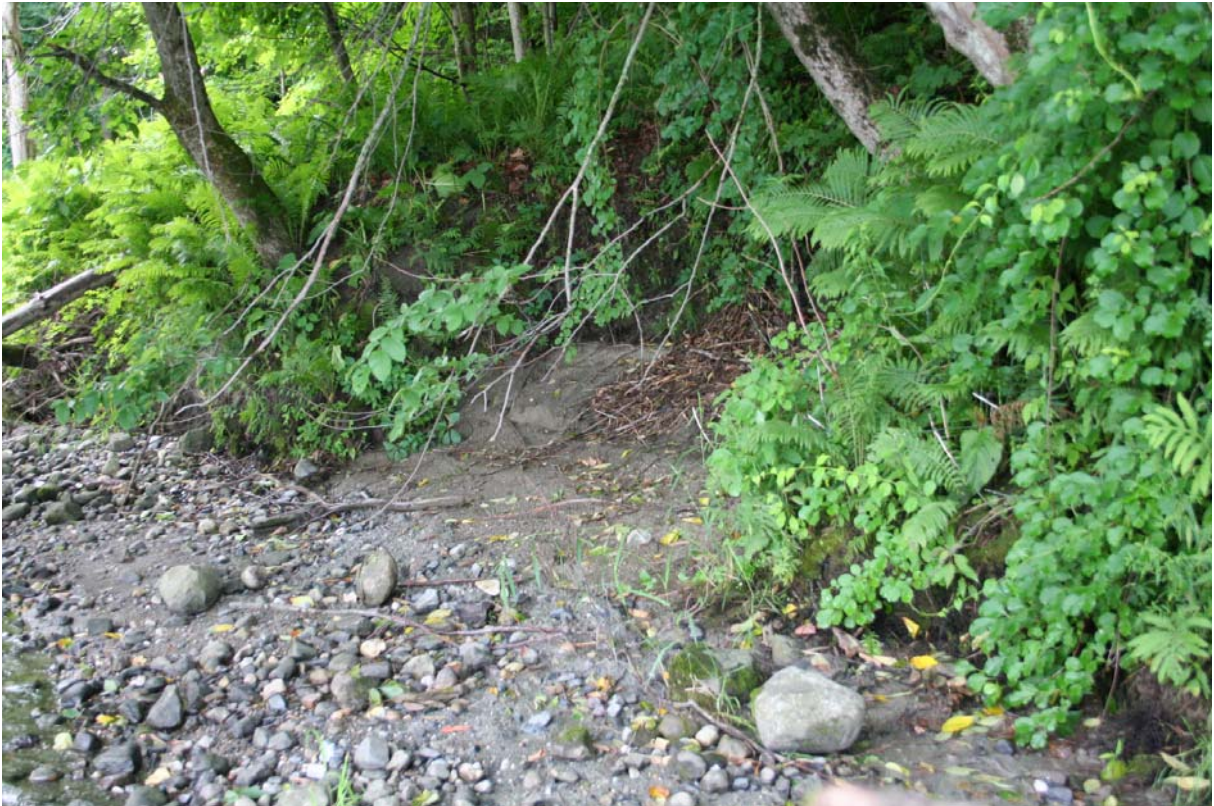
Figure 45: Beach deposits accumulating in a) a crevice in the bank and b) at the mouth of a small gully.
