# **Fluvial Geomorphology Study of the Turners Falls Pool on the Connecticut River Between Turners Falls, MA and Vernon, VT**

Northfield Mountain Pumped Storage Project  
FERC License No. 2485  
Northfield, Massachusetts

Field Geology Services  
Farmington, ME

November 2007

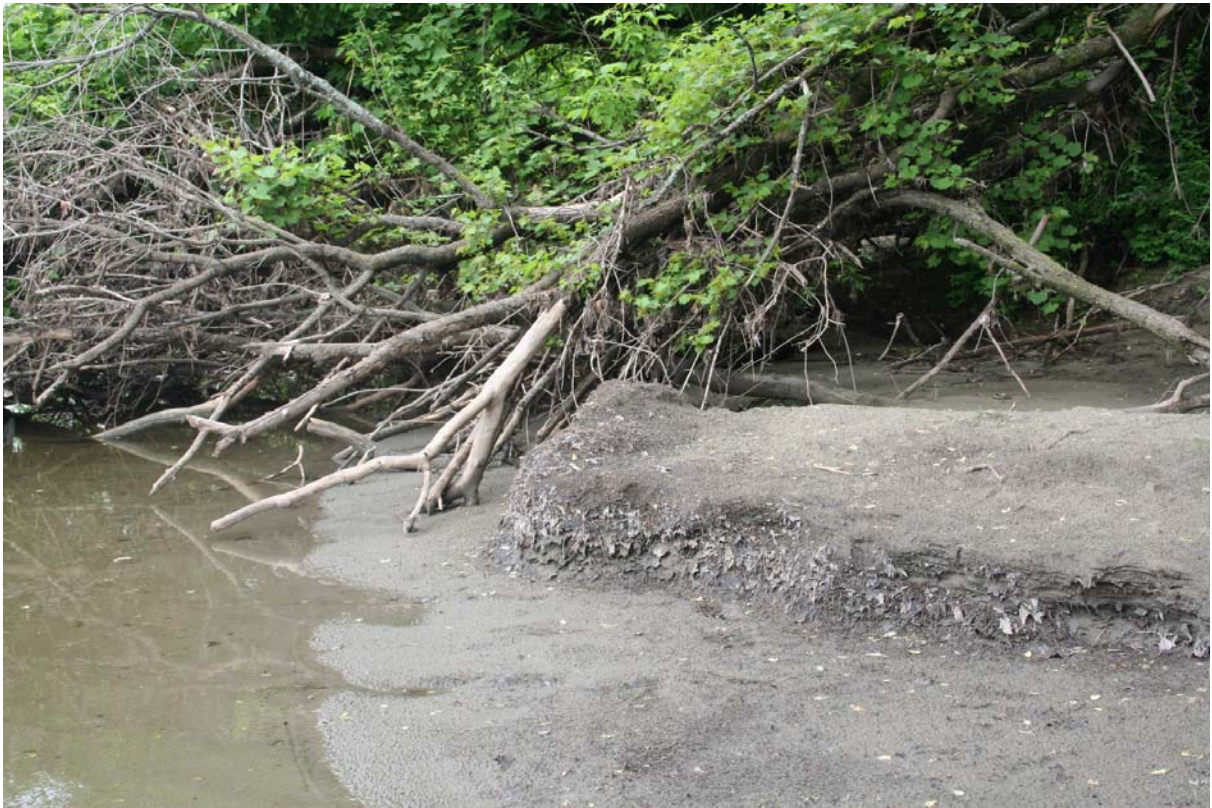
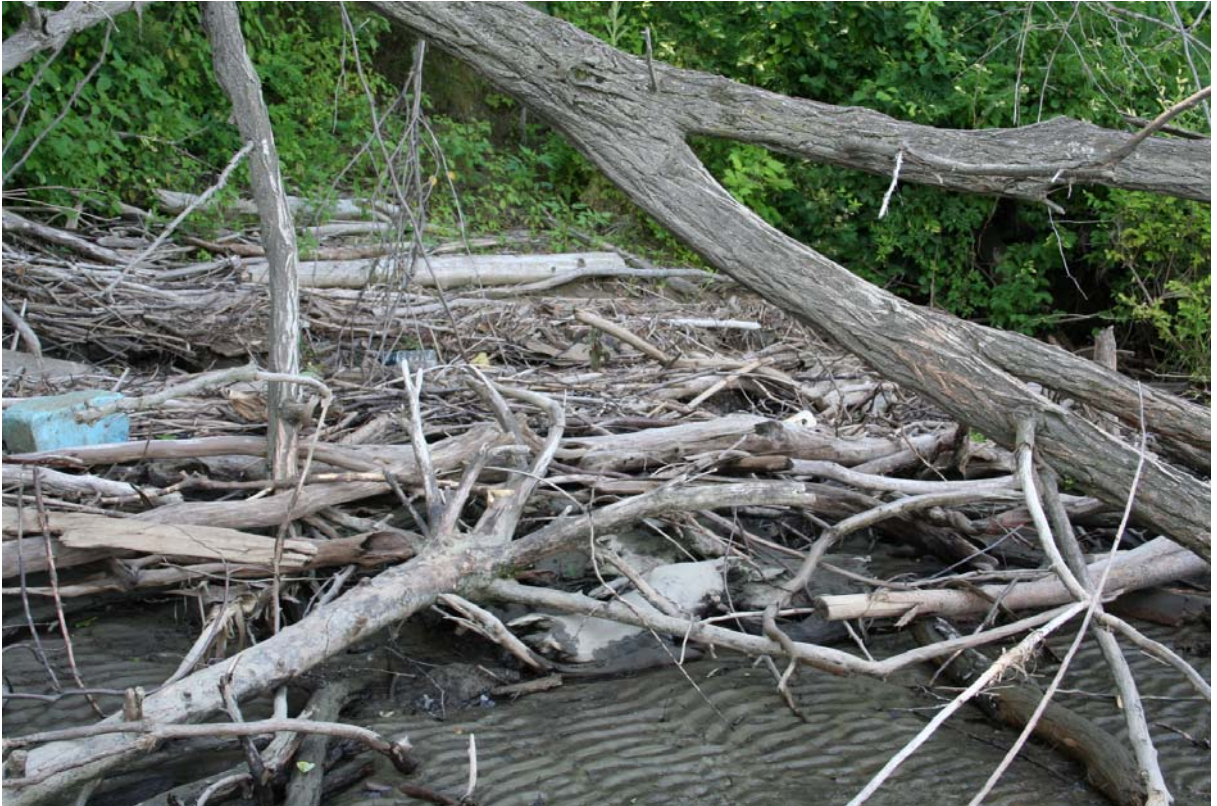
Dense concentrations of large woody debris would be necessary for the proposed efforts to be successful. Loosely arranged accumulations do not effectively trap sediment (Figure 46b). Even without sediment accumulation, wood placed at the base of the bank could improve bank stability by buttressing the upper bank and baffling currents operating at the bank toe. Wood would need to be anchored in place as the low concentrations of wood moving from upstream mean that the natural recruitment of wood will be limited. Dense accumulations of wood along the banks of the river may have been typical 400 years ago, prior to European settlement, when the entire watershed was heavily wooded and flood flows were loaded with wood floating downstream. The

Figure 46: a) Sediment accumulation downstream of a tree lying on a beach and b) wood accumulation on a beach.
