Relicensing Study 3.1.2

**Northfield Mountain / Turners Falls
Operations Impact on Existing Erosion and
Potential Bank Instability
Study Report**

**Northfield Mountain Pumped Storage Project (No. 2485) and
Turners Falls Hydroelectric Project (No. 1889)**

SEPTEMBER 2016

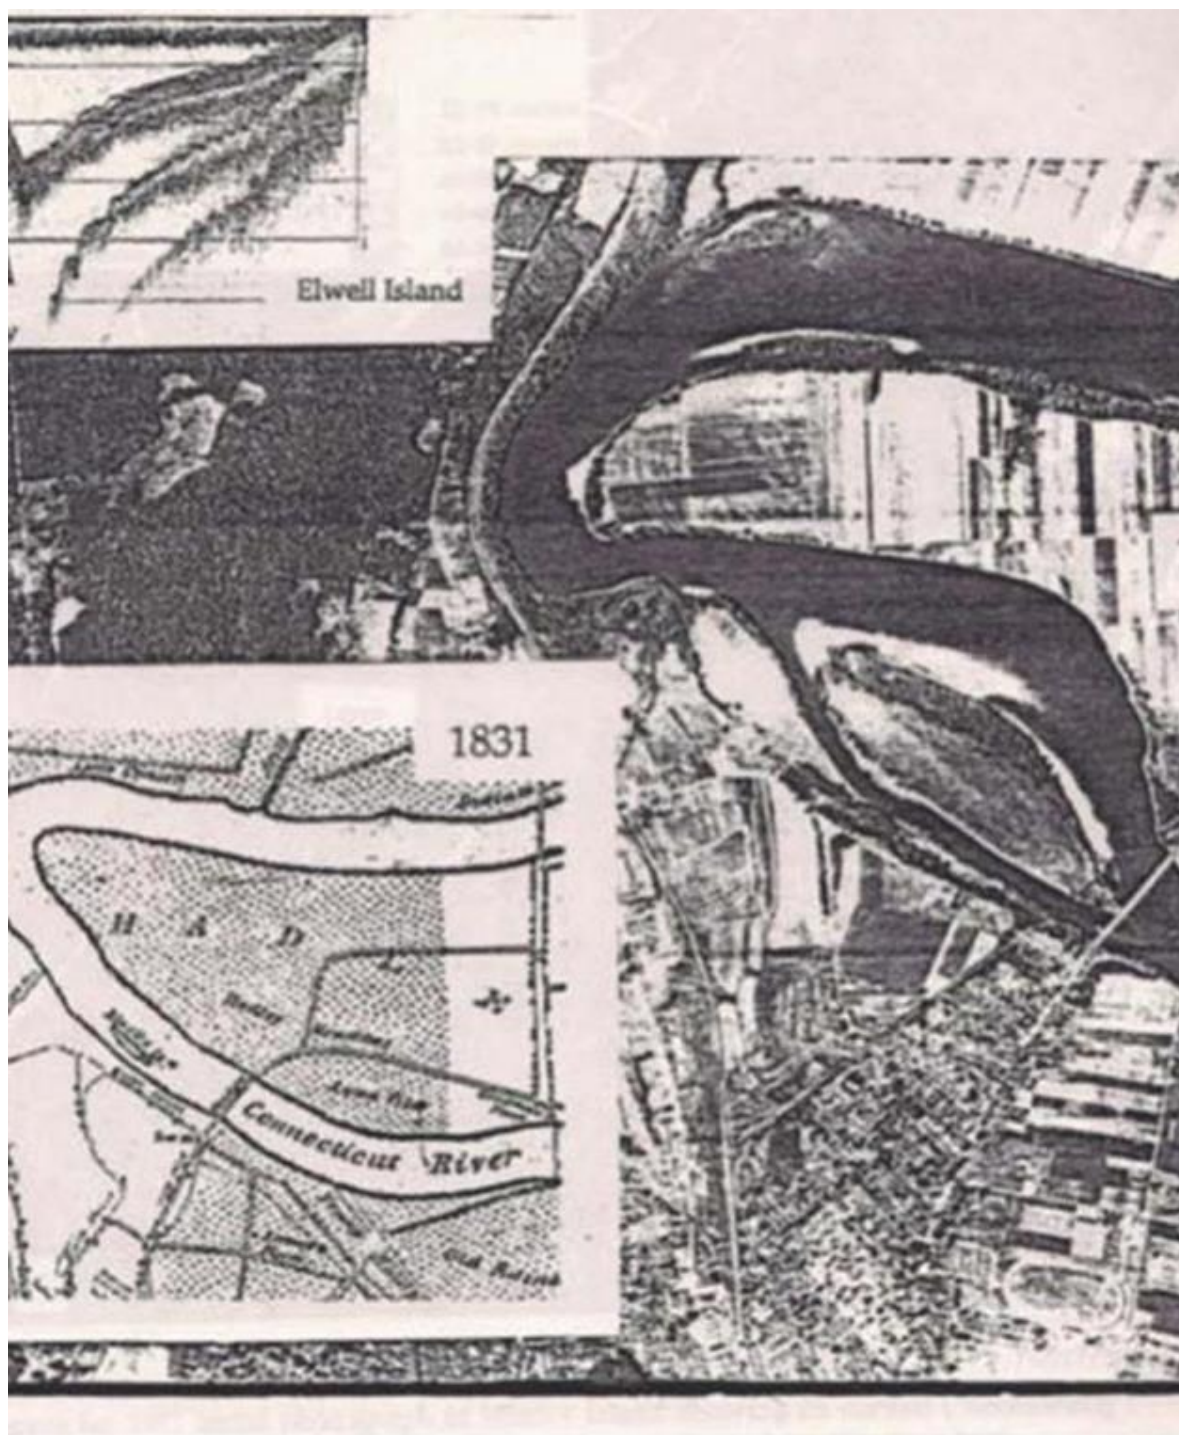
In “*Riverbank Erosion on the Connecticut River at Gill, Massachusetts: its Causes and its Timing*” ([Reid, 1990](#)) historic maps and datasets from the late 1800's and early to mid-1900's were analyzed to determine geomorphic changes over time. Specifically, this analysis compared historic maps and aerial photographs at several locations along the river.

Figure 2.3.2-1 Riverbank Comparison 1831 to 1958 (Reid, 1990)

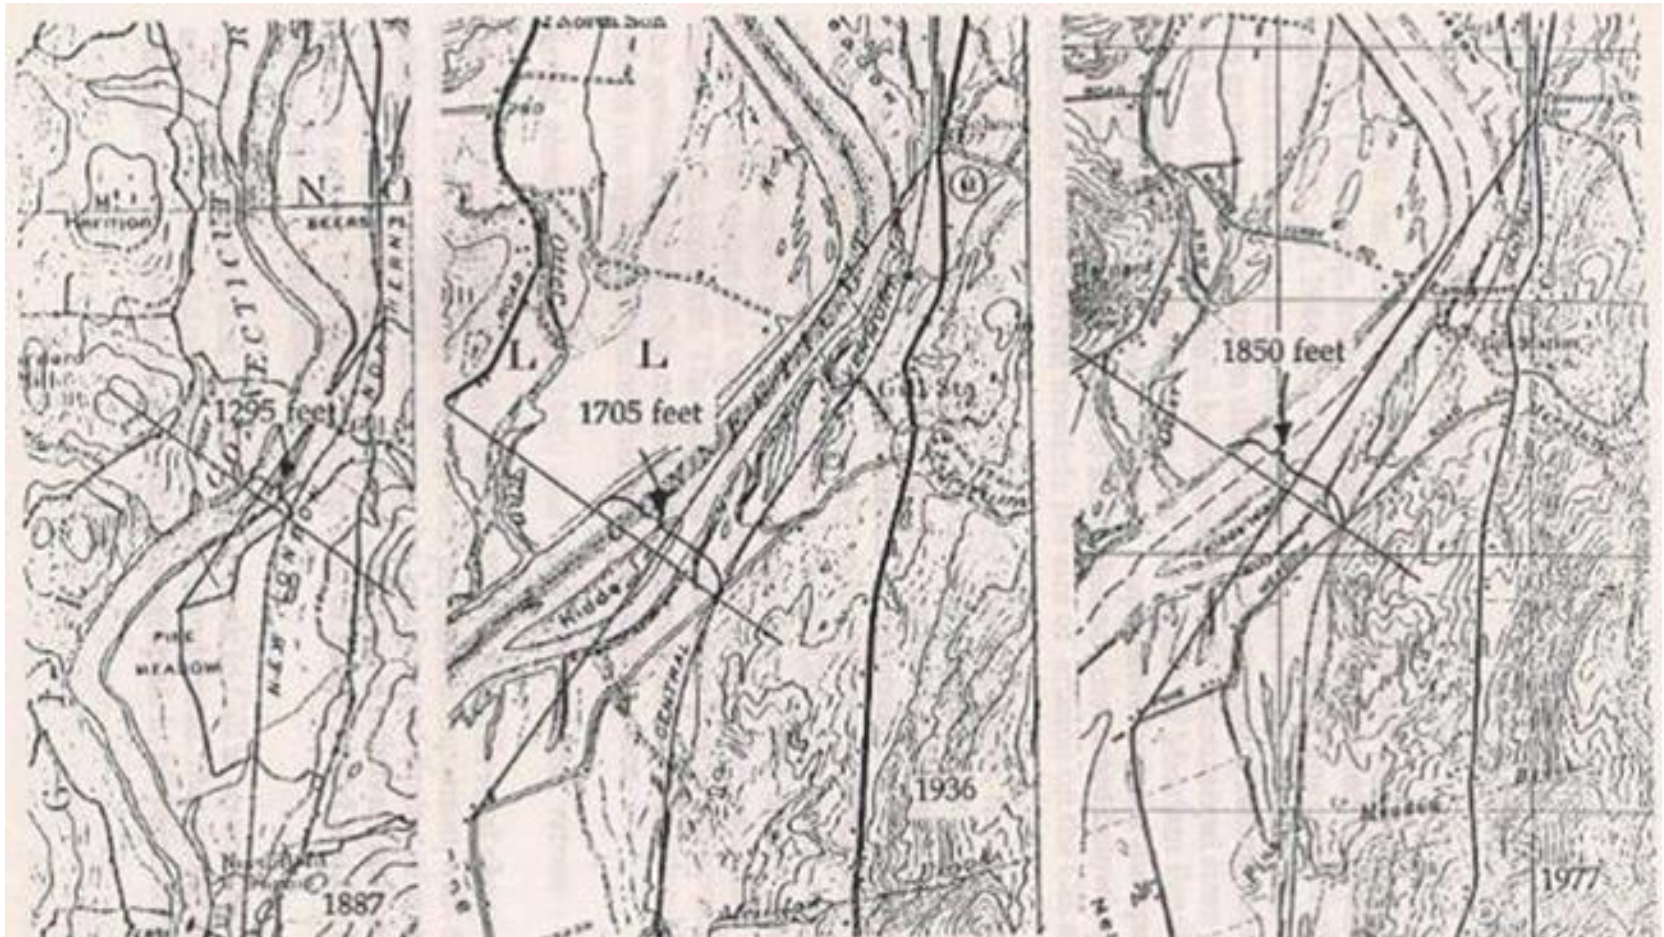
Figure 2.3.2-2 Riverbank Comparison 1887, 1936, and 1977 (Reid, 1990)

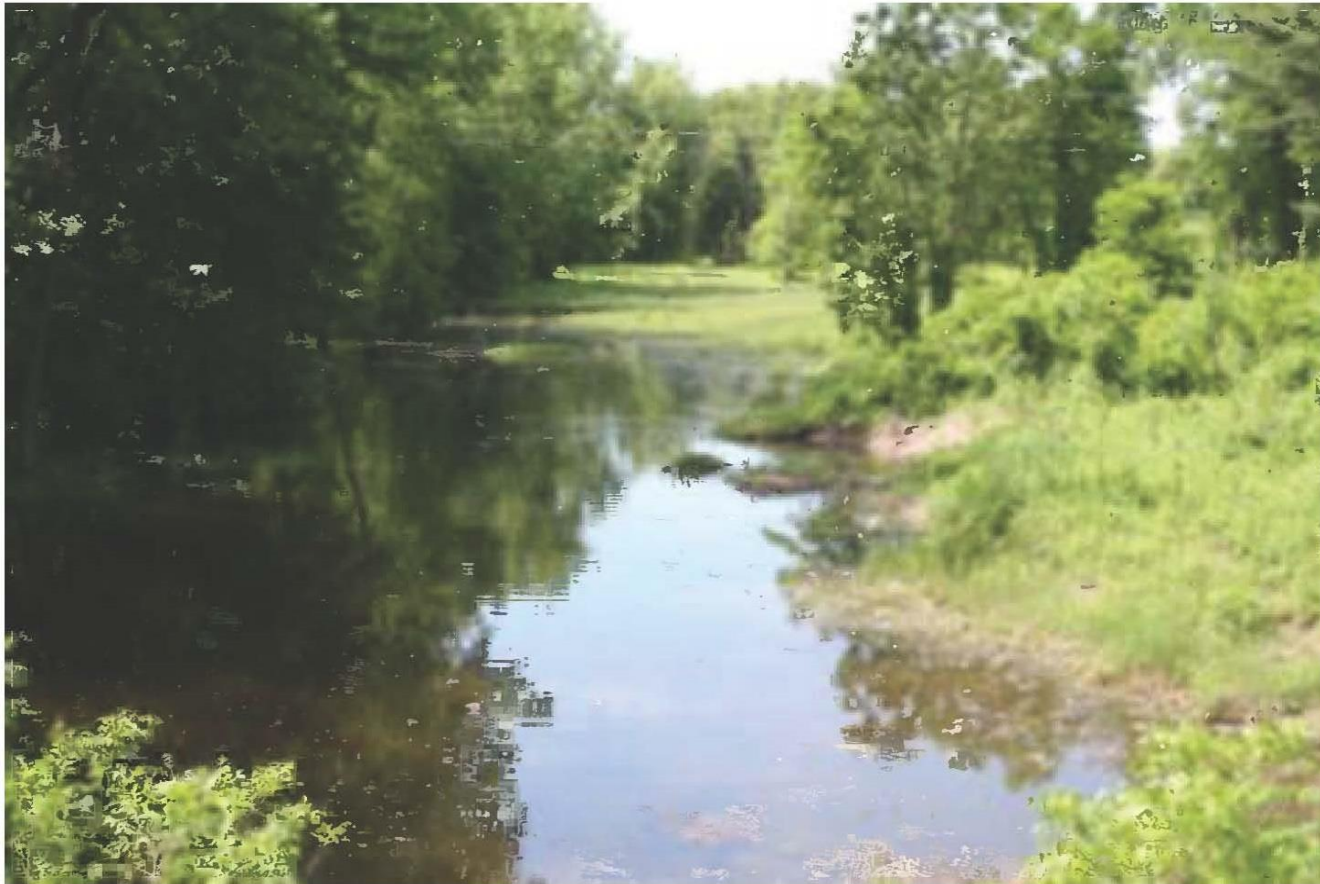
Figure 2.3.2-7 Abandoned avulsion channel behind Schell Bridge (d) (Field, 2007)

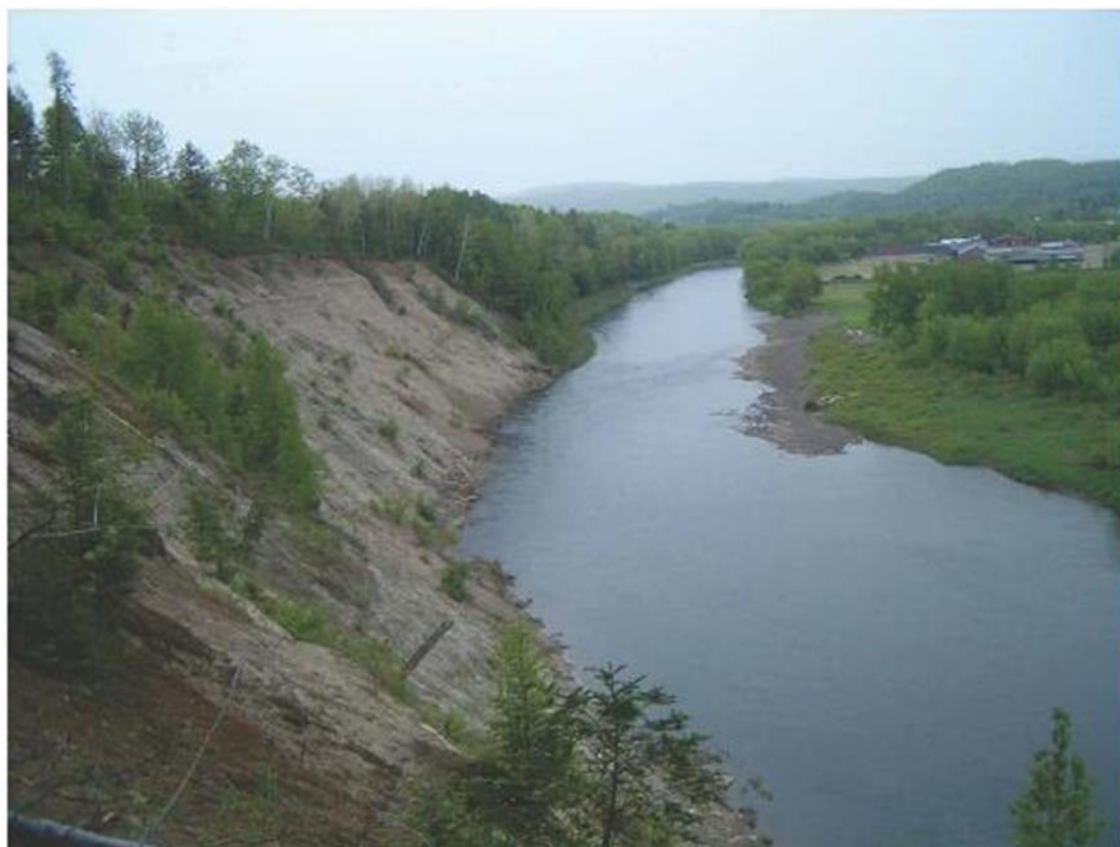
Significant erosion has been occurring and is ongoing in the un-impounded (free-flowing) reaches of the Connecticut River as well as in the impoundments other than the TFI as documented in the comparison report. Examples of erosion in these reaches of river are shown photographically in [Figures 2.5-1](#) through [2.5-10](#). [Figure 2.5-1](#) shows large-scale and severe erosion in a free-flowing reach of the river. An example of some of the erosion sites located in 1997 in the Bellows Falls Impoundment is shown in [Figure 2.5-2](#), while other erosion examples in the Vernon and Holyoke Impoundments are shown in [Figures 2.5-3](#) and [2.5-4](#).

Note: Near Brunswick Springs, VT

**Figure 2.5-1: Erosion of Glacial Outwash Deposits in Un-impounded Reach of Connecticut River
(Field, 2004)**

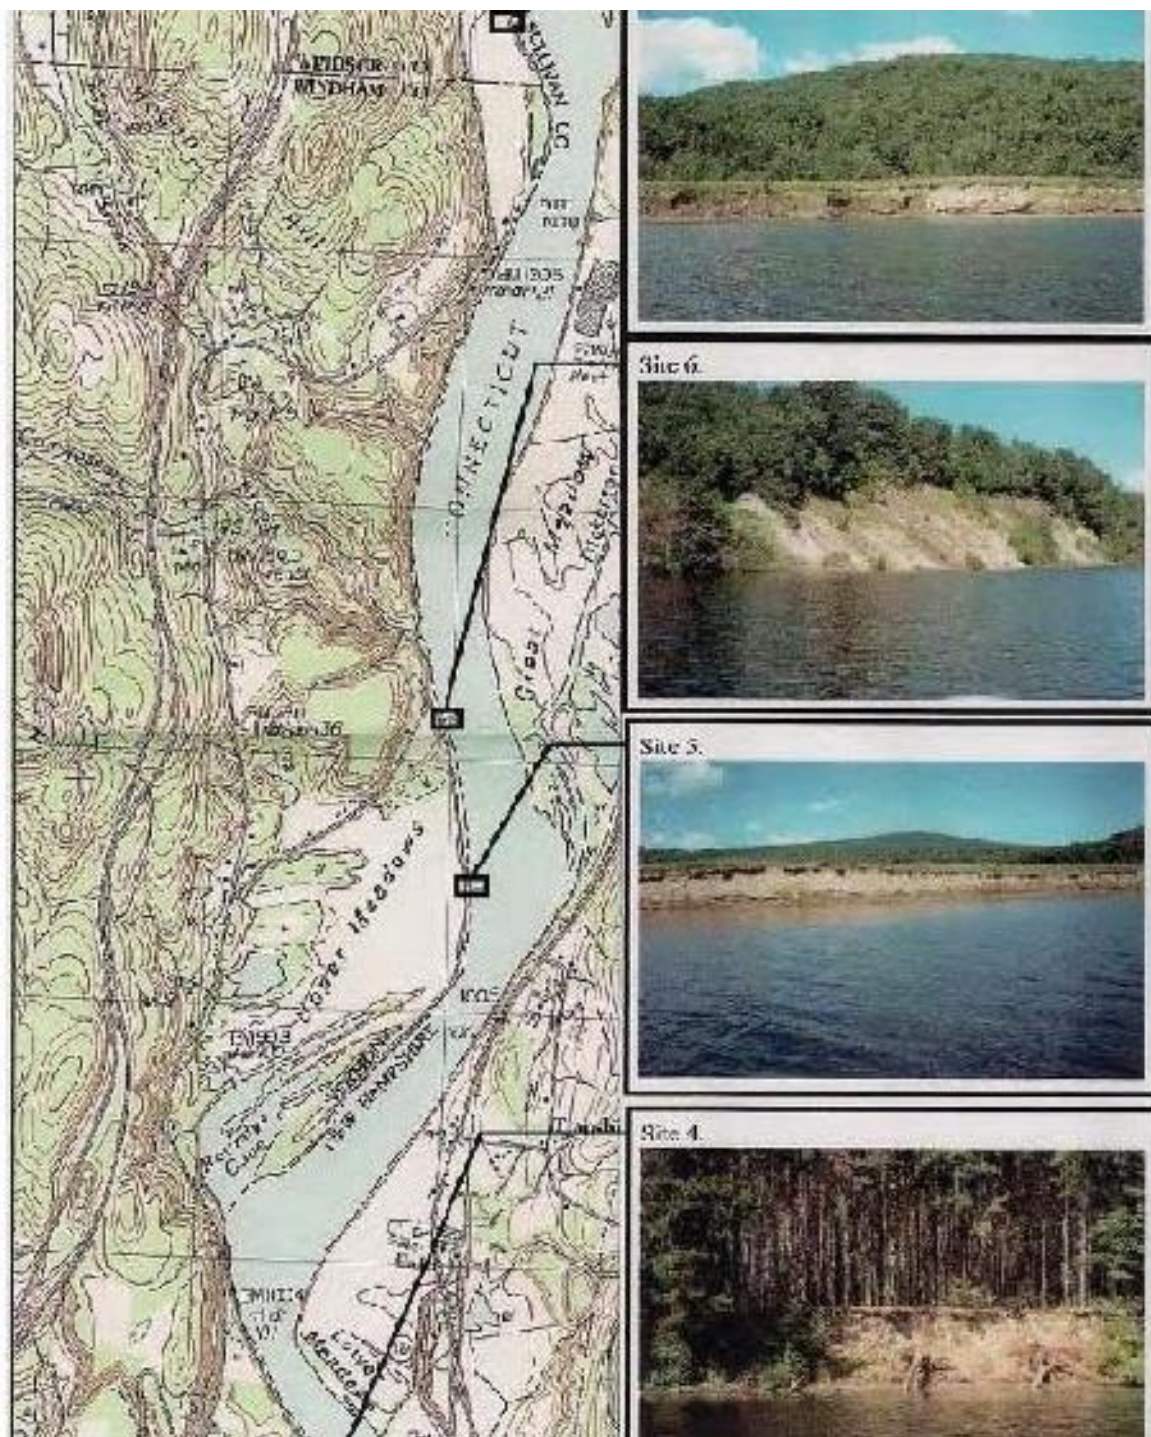
Figure 2.5-2: Erosion sites 4-7, Bellows Falls Impoundment (1997)

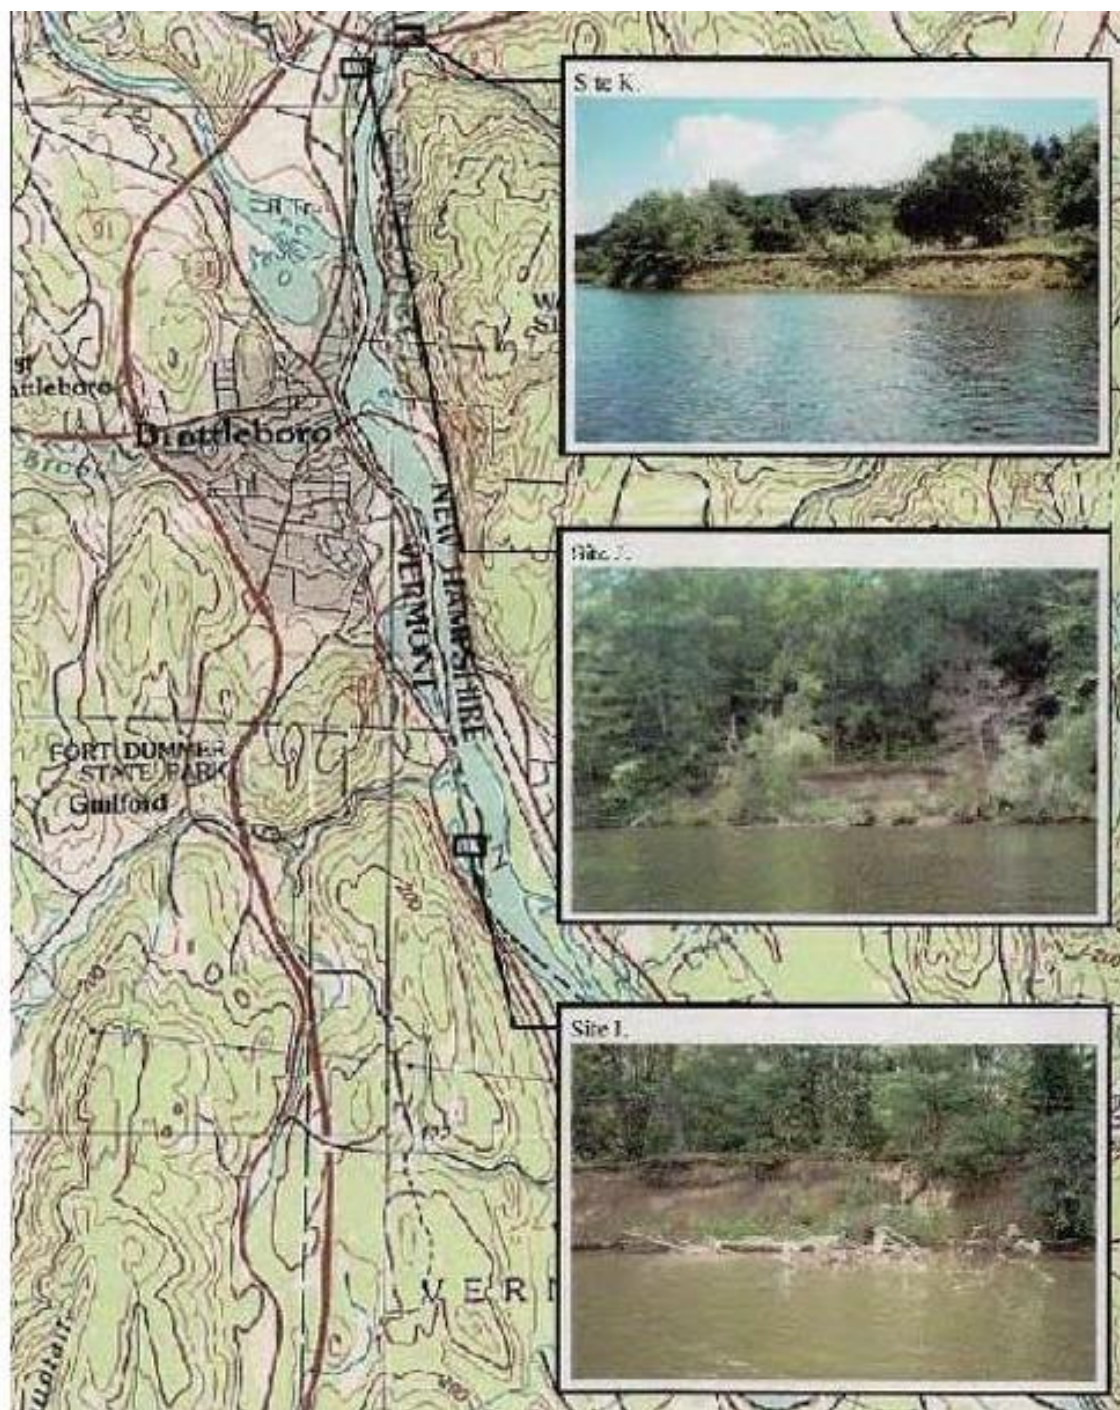
Figure 2.5-3: Erosion sites I-K, Vernon Impoundment (1997)

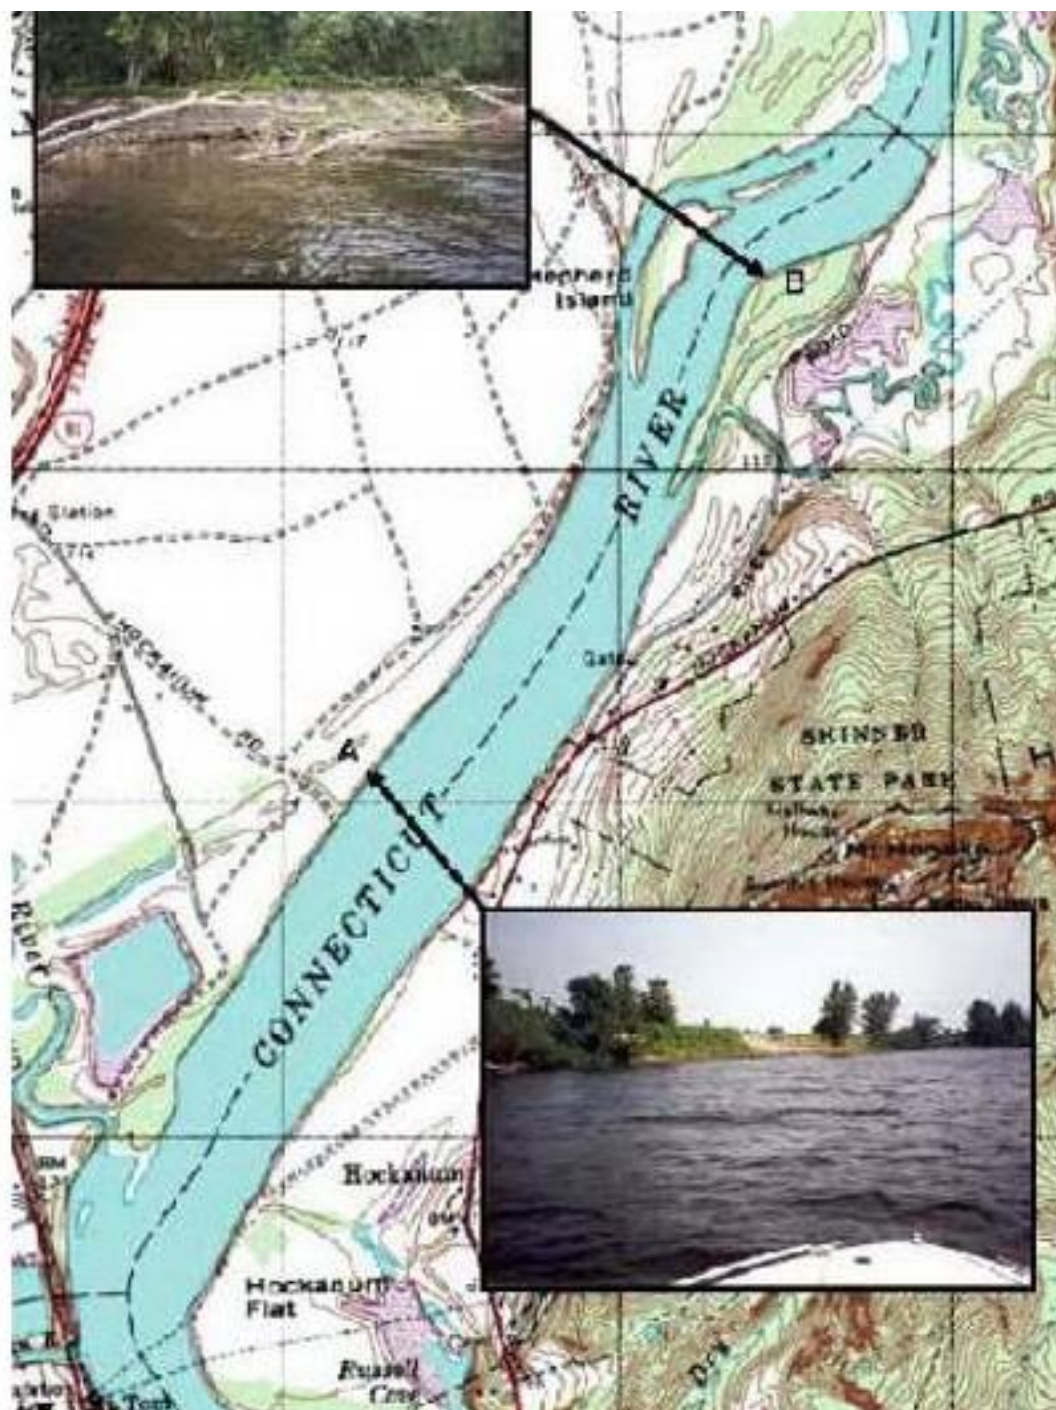
Figure 2.5-4 Erosion sites A and B, Holyoke Impoundment (1997)

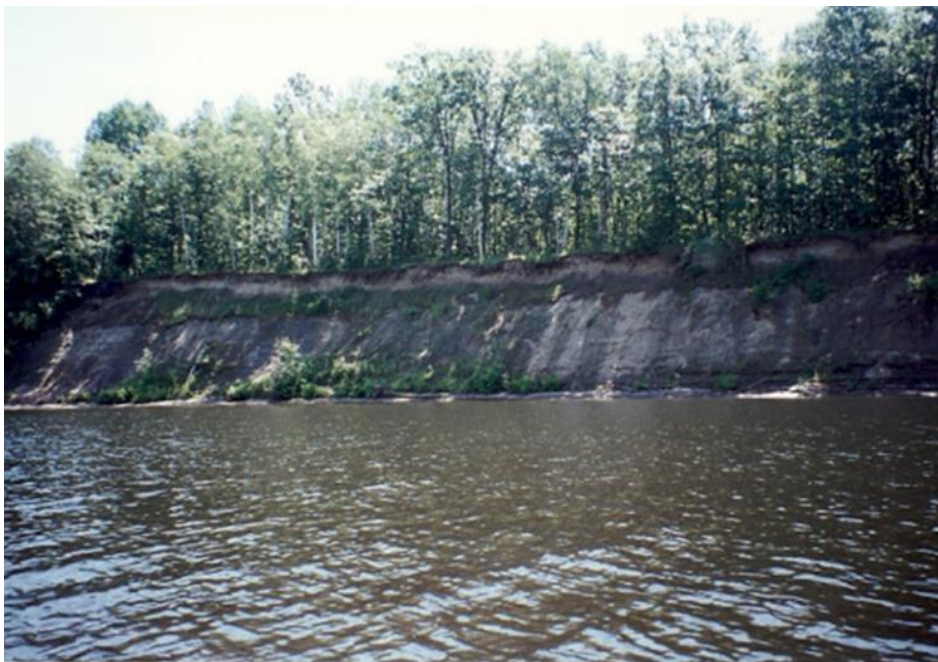
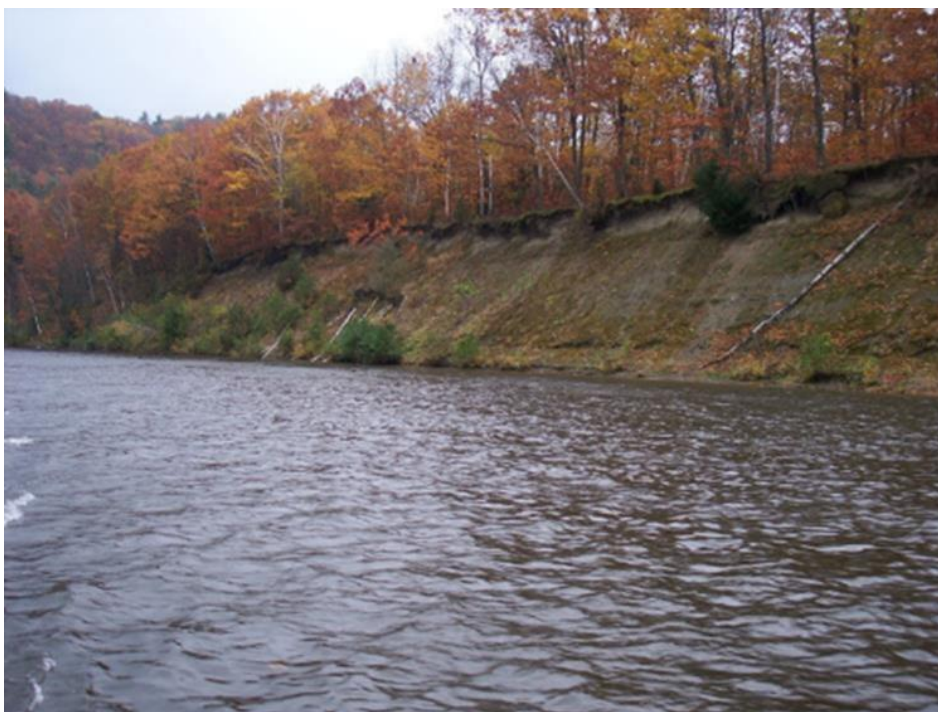
The erosion sites identified in 1997 were revisited in 2008 to photographically document any changes that might have occurred since 1997. Sets of photographs showing 1997 and 2008 images at the same sites are presented in [Figures 2.5-5](#) and [2.5-6](#) for the Bellows Falls Impoundment; Vernon – [Figures 2.5-7](#) and [2.5-8](#); and Holyoke – [Figures 2.5-9](#) and [2.5-10](#). For these three impoundments, erosion sites in 1997 were observed to be in the same eroding condition in 2008.

Figure 2.5-5: Bellows Falls Impoundment – Location 8 (1997)

Figure 2.5-6: Bellows Falls Impoundment – Location 8 (2008)

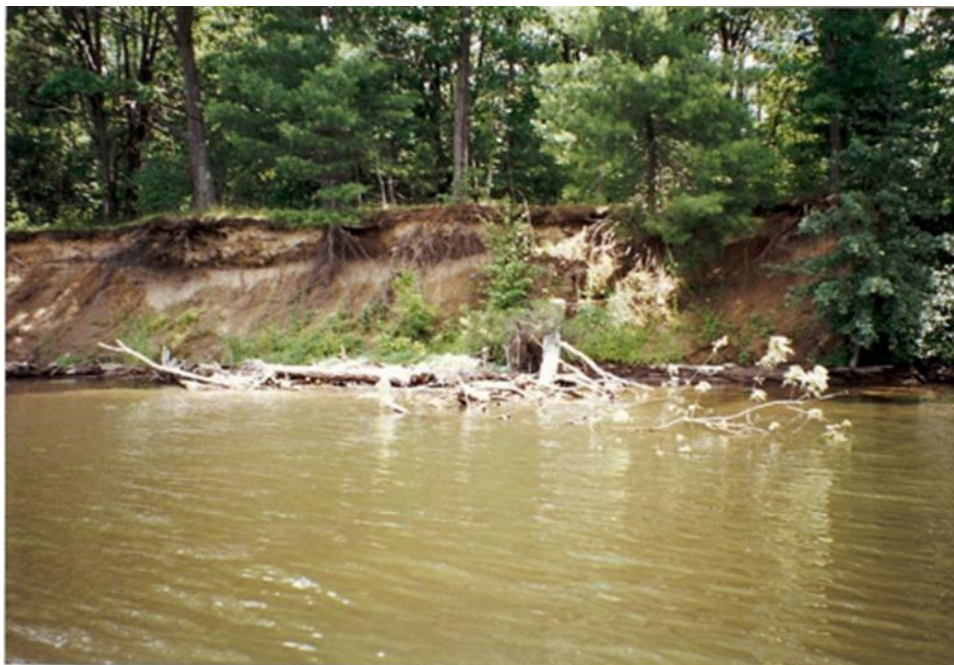
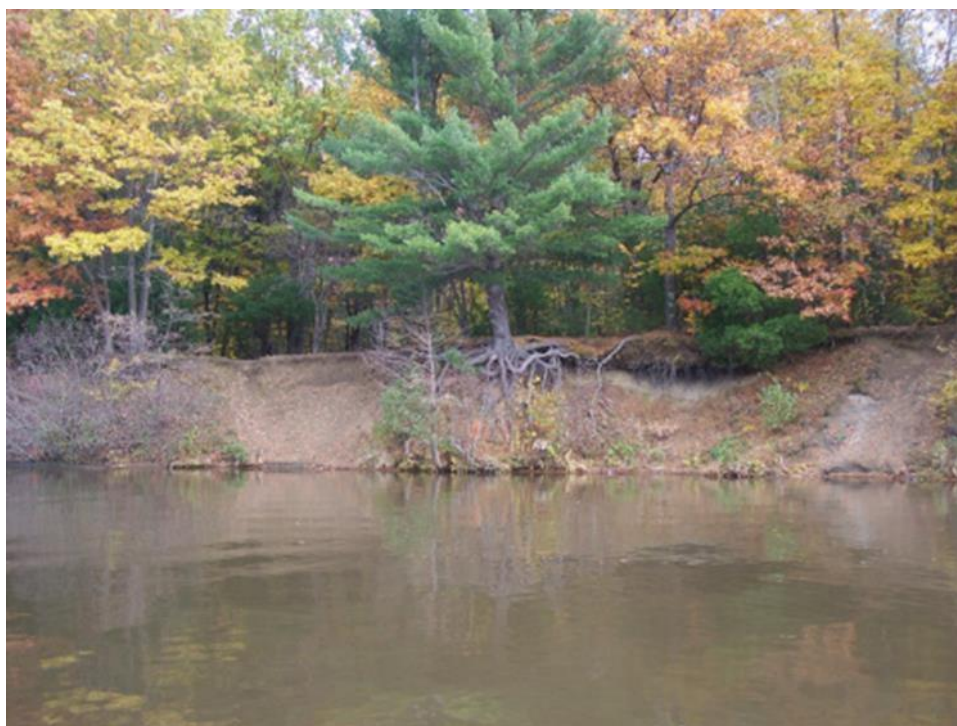
Figure 2.5-7: Vernon Impoundment – Location I (1997)

Figure 2.5-8: Vernon Impoundment – Location I (2008)

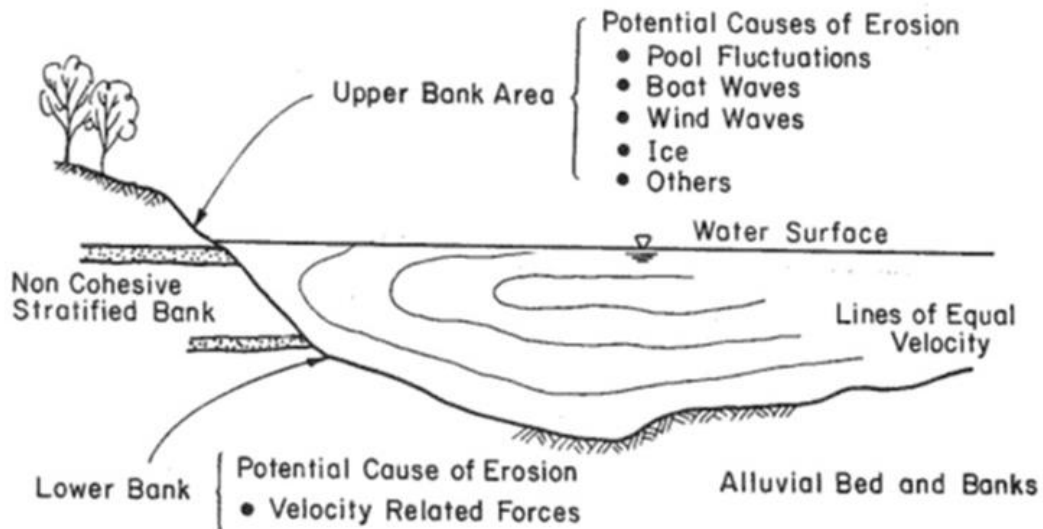
Figure 5.1.3-5: Assumed Initial Channel Conditions (USACE, 1979)

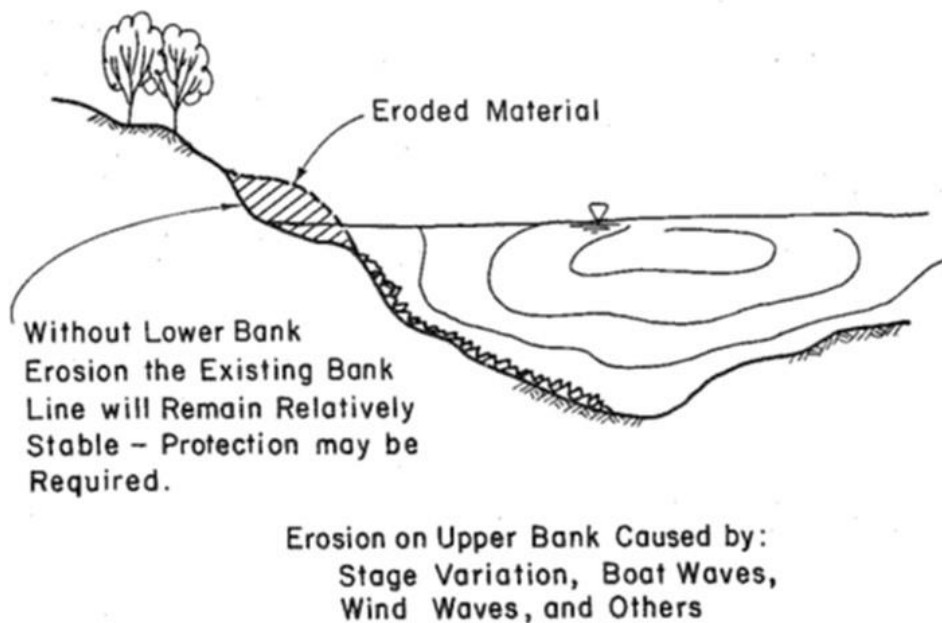
Figure 5.1.3-6: Potential Bank Line Geometry by Erosive Force Acting on the Bank near the Water Surface (USACE, 1979)

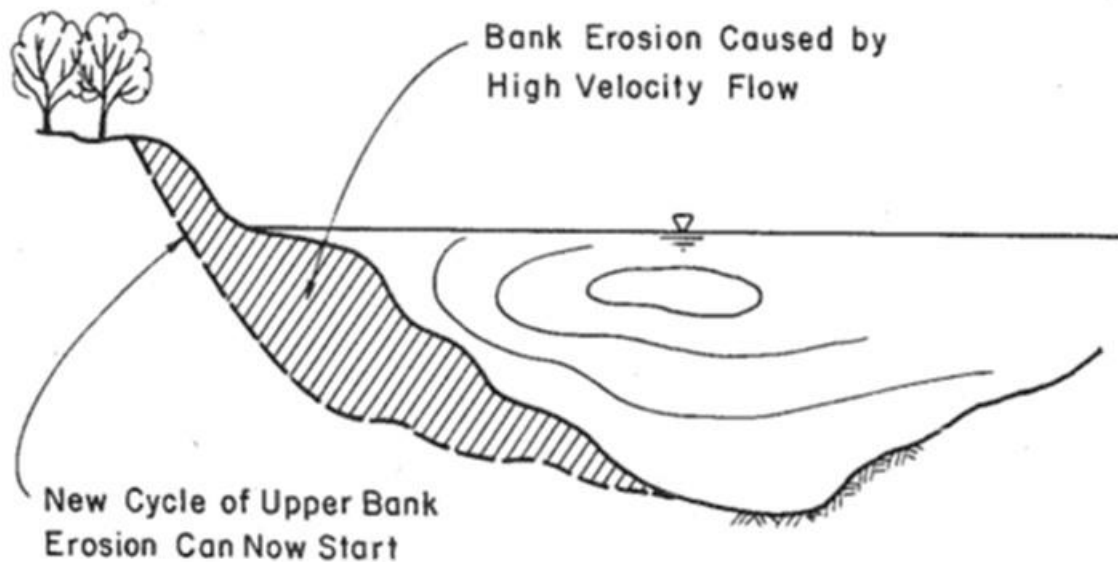
Figure 5.1.3-7: Bank Erosion Caused by Flood Stage High Velocity Flow (USACE, 1979)

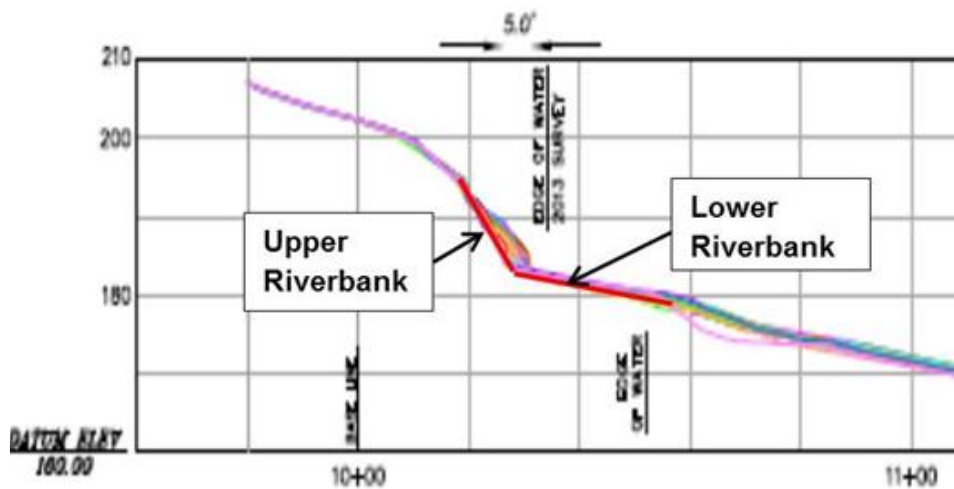
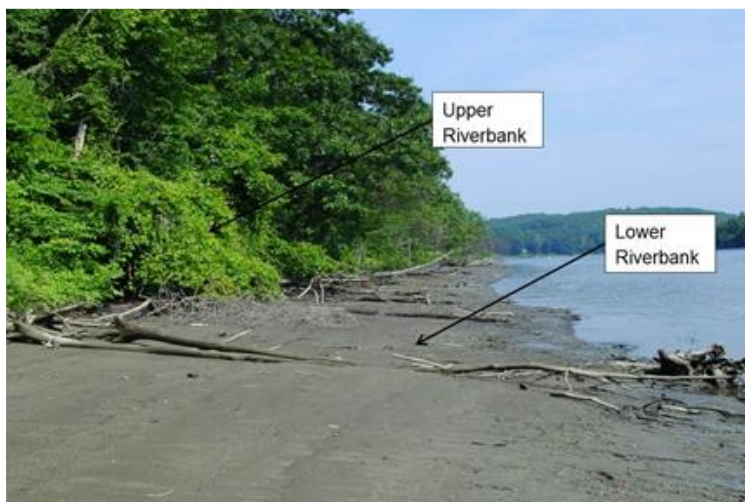
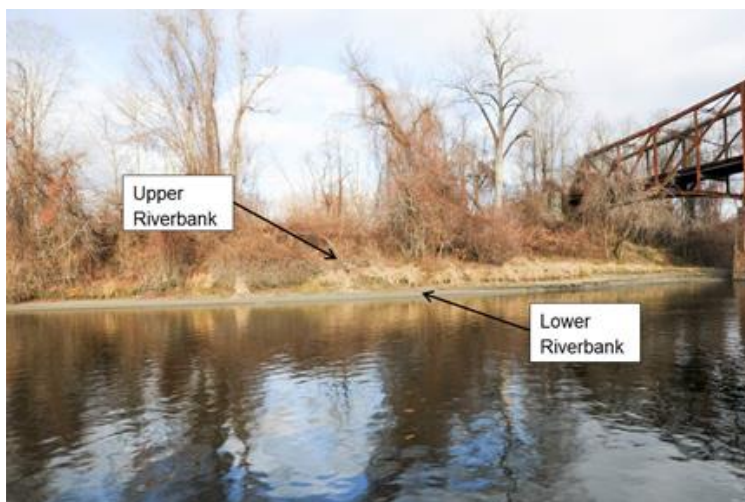
The distinction between the lower and upper bank is an important one given that the BSTEM modeling results and the results of the supplemental analyses found that forces acting at the water surface and along the submerged banks typically do not cause erosion at lower flows and minimal erosion at moderate flows when the water surface rests on the lower bank (i.e., below the toe of the upper bank). It is not until the water surface rises and rests on the upper bank during high flow events that riverbank erosion potentially commences; even then the flow threshold to initiate erosion was found to be greater than 37,000 cfs at the majority of detailed study sites.

Figure 5.1.3-8: TFI Lower and Upper Riverbank Example

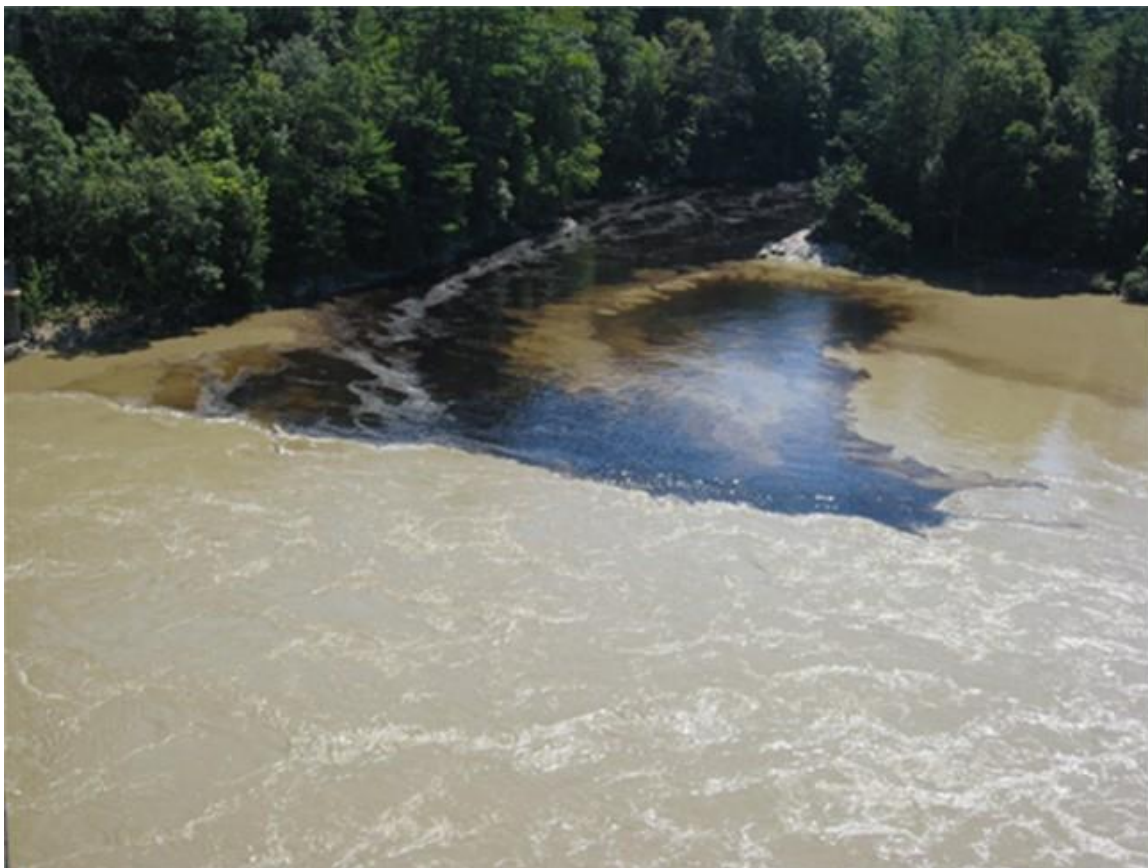
Figure 5.3-3 Millers River Confluence with the Connecticut River (TFI), August 2011

Historic suspended sediment samples and photographs collected during Tropical Storm Irene further demonstrate the strong relationship between flow and SSC values. [Figure 5.3-3](#) demonstrates the contrast between the Millers River and the Connecticut River as affected by Tropical Storm Irene in August 2011. As observed in the figure, the relatively clear water from the Millers River flowed into the sediment laden Connecticut River in a classic, swirling mixing zone. SSC values taken from the Millers River ranged from non-detect (ND, <5 mg/L) to 6.5 mg/L while SSC values measured in the Connecticut River during the same period ranged from 140 to 1,900 mg/L.⁴⁰ As a point of comparison, the median SSC value observed during Study No. 3.1.3 for flows greater than 35,000 cfs was 145 mg/L.

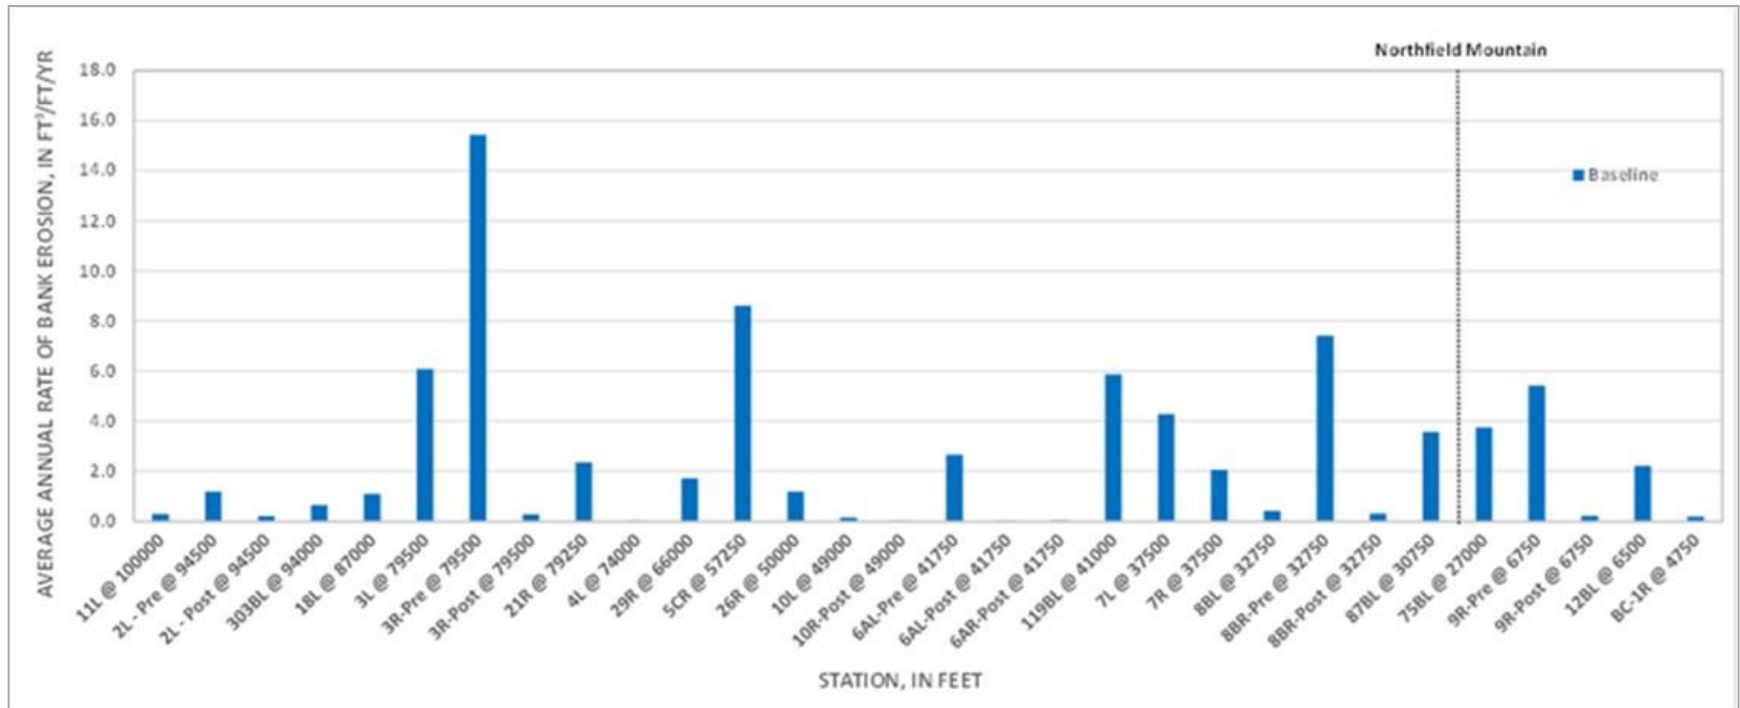
For the Baseline Condition, simulated rates of bank erosion along the reach range from very close to zero $\text{ft}^3/\text{ft}/\text{y}$ to $15.4 \text{ ft}^3/\text{ft}/\text{y}$ at site 3R under pre-restoration conditions. Other sites with bank-erosion rates higher than the 75th percentile for the non-restored sites include 5CR ($8.6 \text{ ft}^3/\text{ft}/\text{y}$), 8BR-pre-restoration ($7.4 \text{ ft}^3/\text{ft}/\text{y}$), 3L ($6.1 \text{ ft}^3/\text{ft}/\text{y}$), 119 BL ($5.9 \text{ ft}^3/\text{ft}/\text{y}$) and 9R pre-restoration ($5.4 \text{ ft}^3/\text{ft}/\text{y}$). Of these six highest rates, three of the sites have been restored. Specific information regarding the erosion rates at these and the other sites will be provided in the following section. The spatial distribution of erosion rates along the reach are shown schematically in [Figure 5.4.2.1-1](#).

Figure 5.4.2.1-1: Spatial Distribution of Bank-erosion Rates for all Sites under Baseline Conditions

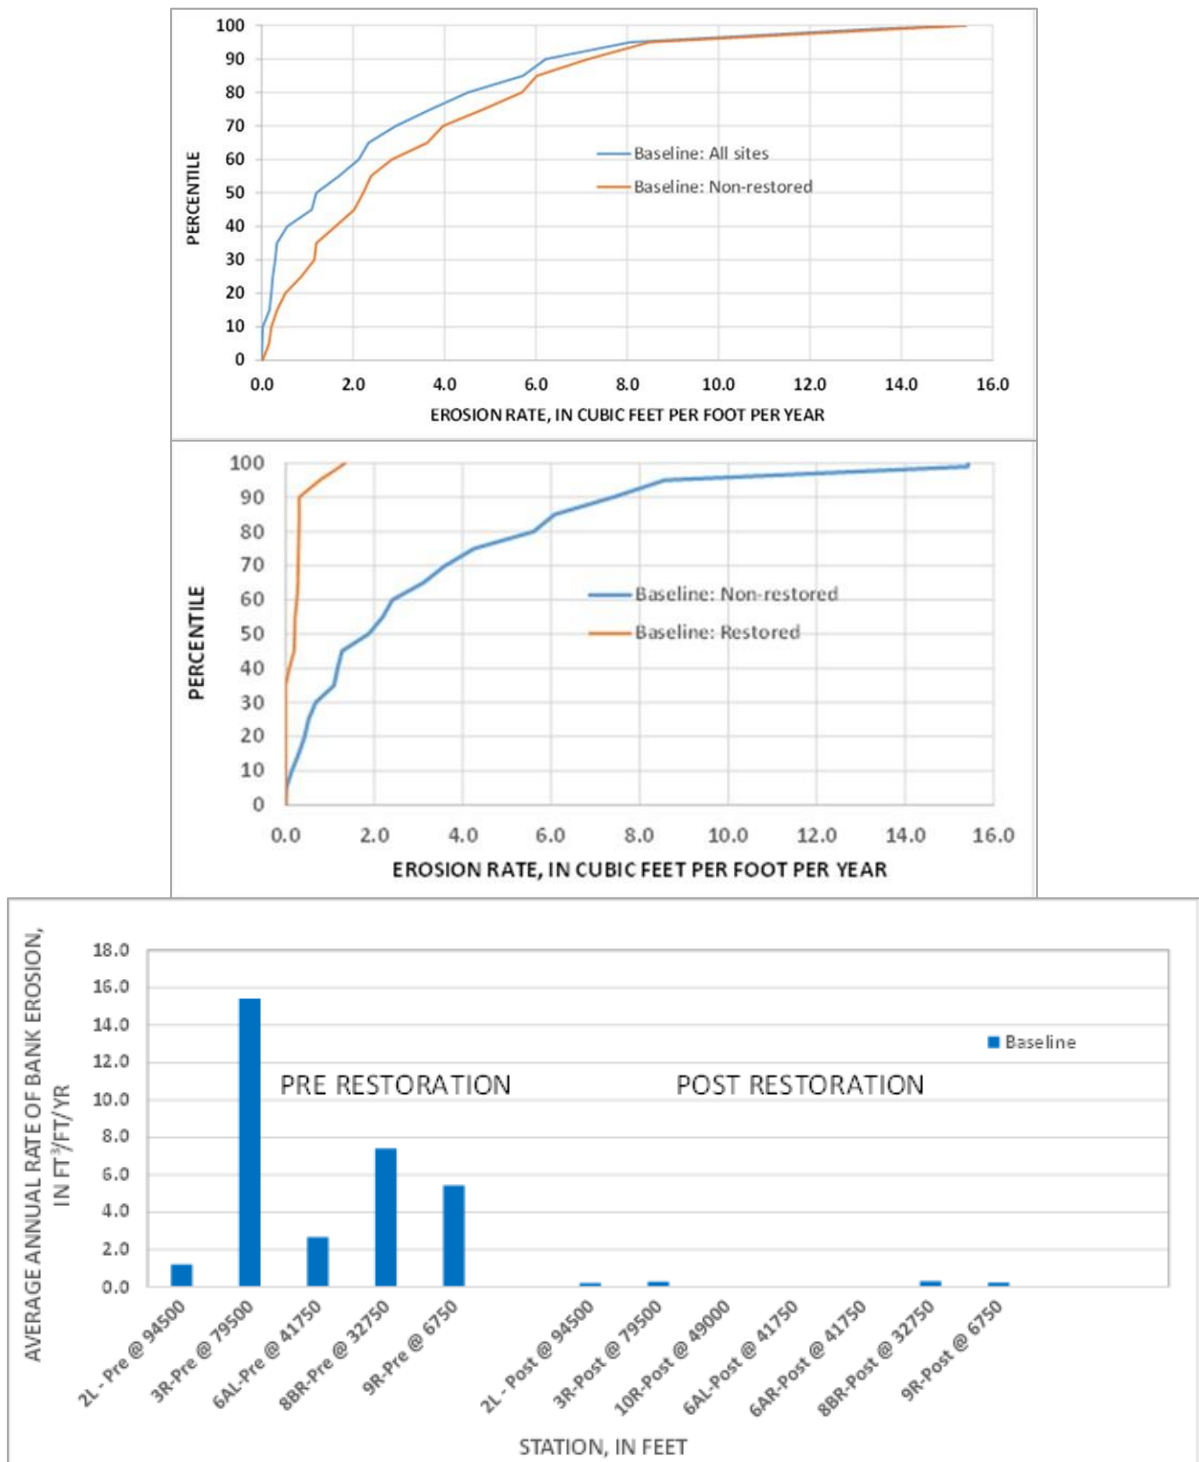
The median value for all sites and conditions (including restored conditions) along the reach is about $1.2 \text{ ft}^3/\text{ft}/\text{y}$ compared to $2.2 \text{ ft}^3/\text{ft}/\text{y}$ including just the non-restored sites. The difference in the distributions for the Baseline Condition can be clearly seen in the [Figure 5.4.2.1-2](#) showing the greater erosion rates when the restored sites are not included in the data set. Restoration measures have been very effective in reducing bank-erosion rates by about an order of magnitude throughout the reach ([Figure 5.4.2.1-2](#); Middle and Bottom), with an average reduction of 93%. Median bank-erosion rates for the non-restored and restored sites are 1.9 and $0.21 \text{ ft}^3/\text{ft}/\text{y}$, respectively.

Figure 5.4.2.1-2: Distribution of Bank-erosion Rates for the Baseline Condition for All Sites/conditions versus Non-restored (Top), and for Restored versus Non-restored Simulations (Middle) and Direct Comparison (Bottom)

The exception appears to be at site 8BR pre-restoration (station 32,750) where a large geotechnical failure occurred at a high flow of about 99,000 cfs but only under Baseline Conditions. The other model scenario for the site does not show this failure. Given that mass wasting are not a linear, continuous process such as entrainment of bed sediments under excess stress, it is reasonable that slightly more hydraulic erosion occurred during the Baseline Condition causing the failure. In comparison to site 8L which does not show a dominant impact from Northfield Mountain, 8BR is much steeper and less vegetated. Current and future erosion rates at this site, however, reflect the effect of restoration activities in 2012 that greatly reduced bank-erosion rates from about 7.4 ft³/ft/y to about 0.3 ft³/ft/y ([Figure 5.4.2.1-2](#); Bottom).

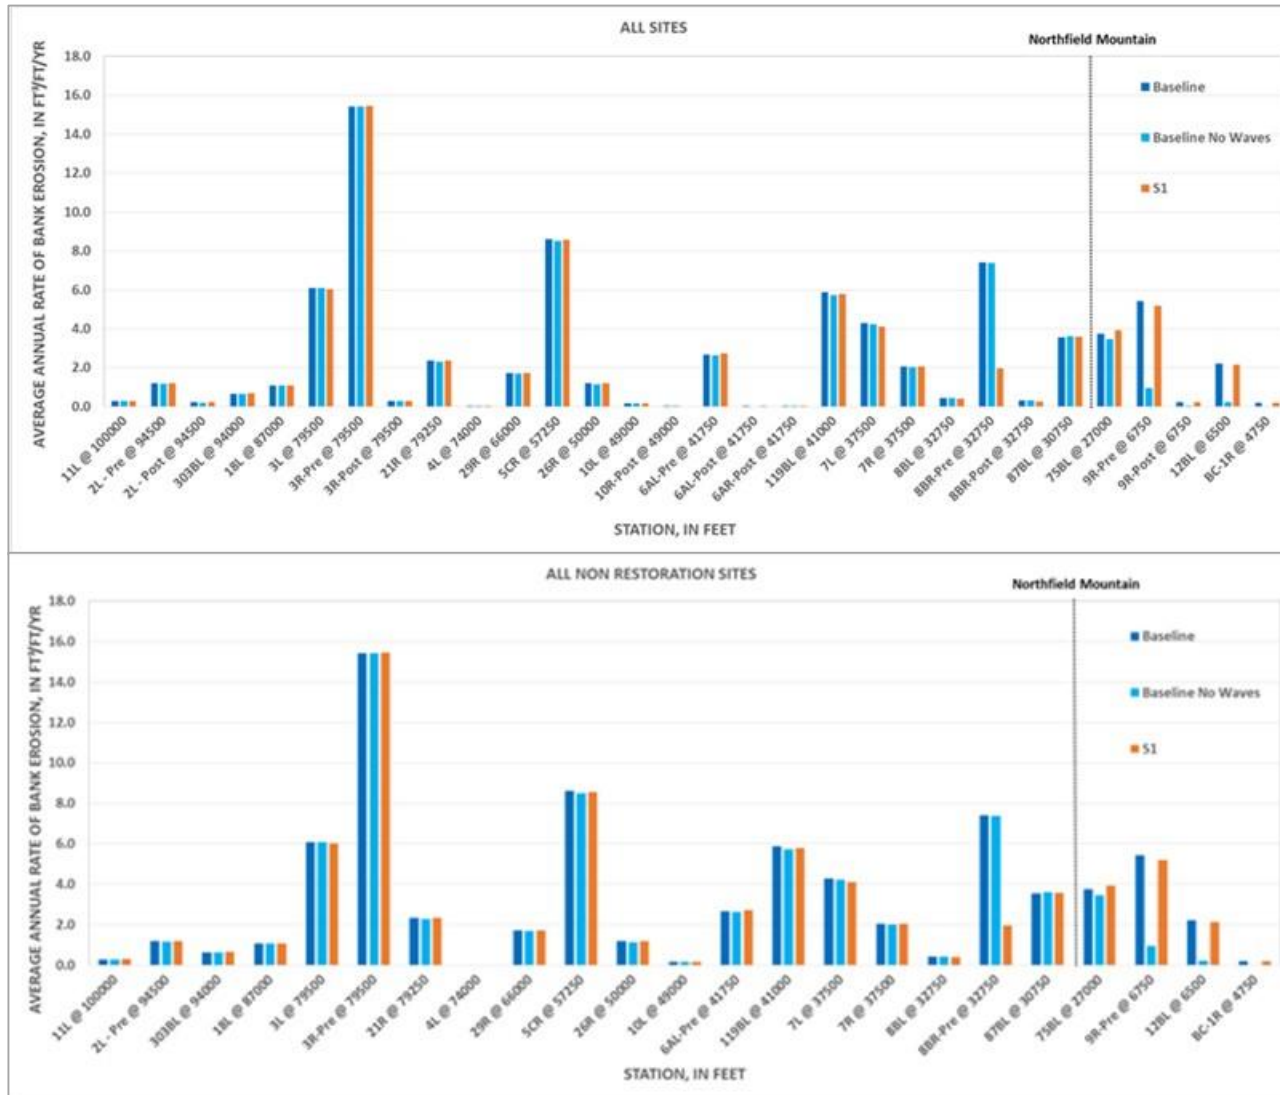
Figure 5.4.2.2-1: Summary of Bank-erosion Rates for All Sites (including restored conditions) and Modeling Scenarios along the Study Reach (Top) and for only the Non-restored Sites/Conditions (Bottom)
