Relicensing Study 3.1.2

**Northfield Mountain / Turners Falls
Operations Impact on Existing Erosion and
Potential Bank Instability
Study Report**

**Northfield Mountain Pumped Storage Project (No. 2485) and
Turners Falls Hydroelectric Project (No. 1889)**

SEPTEMBER 2016

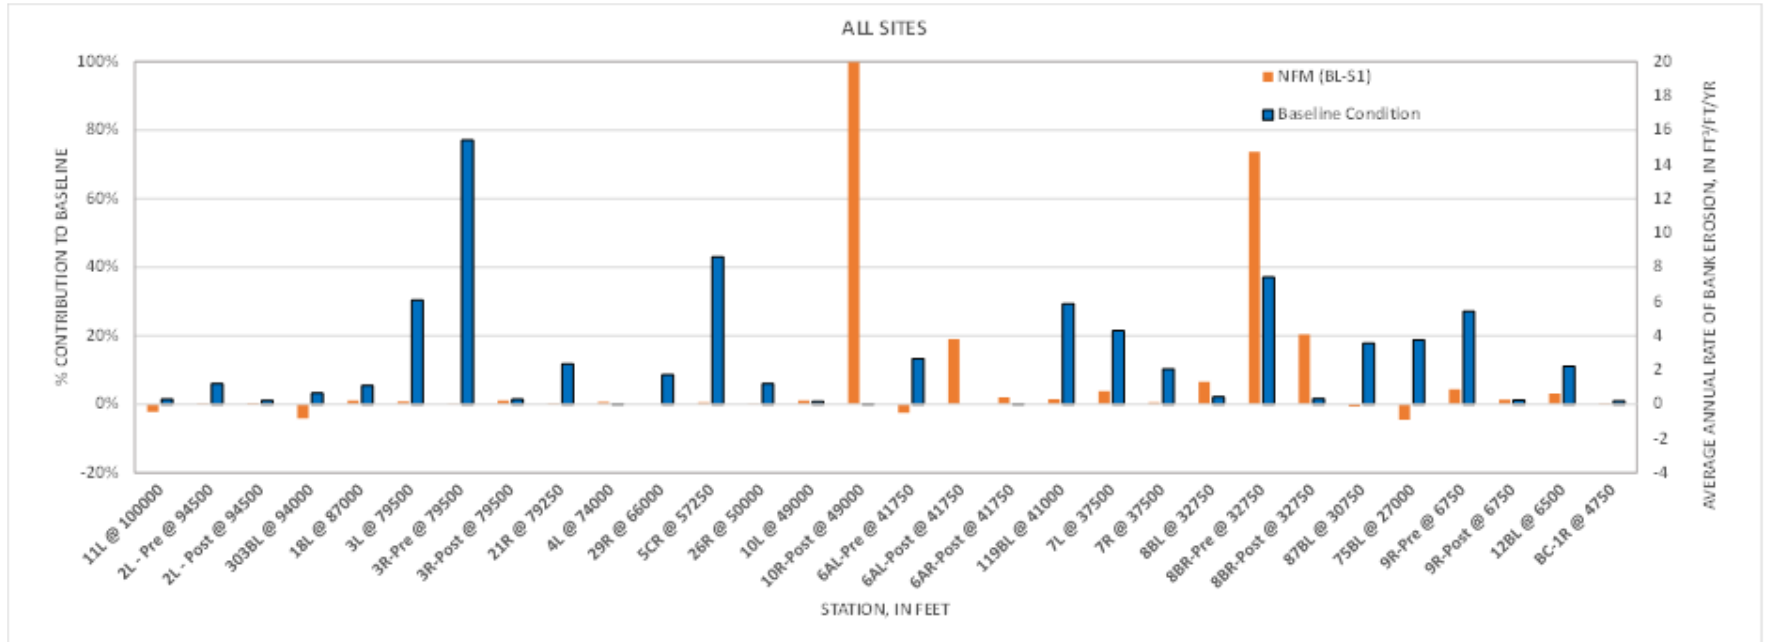
Overall contributions of Northfield Mountain Project operations on bank-erosion rates can be seen by comparing the BL-S1 erosion rate with the total erosion rate under Baseline Conditions. The contribution in percent (%) is plotted schematically (in orange) by site/station along with the bank-erosion rate (in blue) under the Baseline Condition ([Figure 5.4.2.2-3](#)). If looking at just the contributions from Northfield Mountain Project operations (BL-S1), values are generally low (less than 5%) with a few exceptions; sites 10R post-restoration (station 49,000), 6AL post-restoration (station 41,750), 8BR pre- and post-restoration (station 32,750) and 8BL (station 32,750). When including the information on erosion rates as well, we see that aside from 8BR pre-restoration, the remaining sites just mentioned are experiencing very low rates of erosion, with most representing restored conditions ([Table 5.4.2.2-2](#)).

Figure 5.4.2.2-3: Contribution of Erosion Rates Due to Project Operations Compared to Erosion Rates for the Baseline Condition

Results need to be taken in context of the total amount of erosion at a particular site to interpret relative impact of the Project

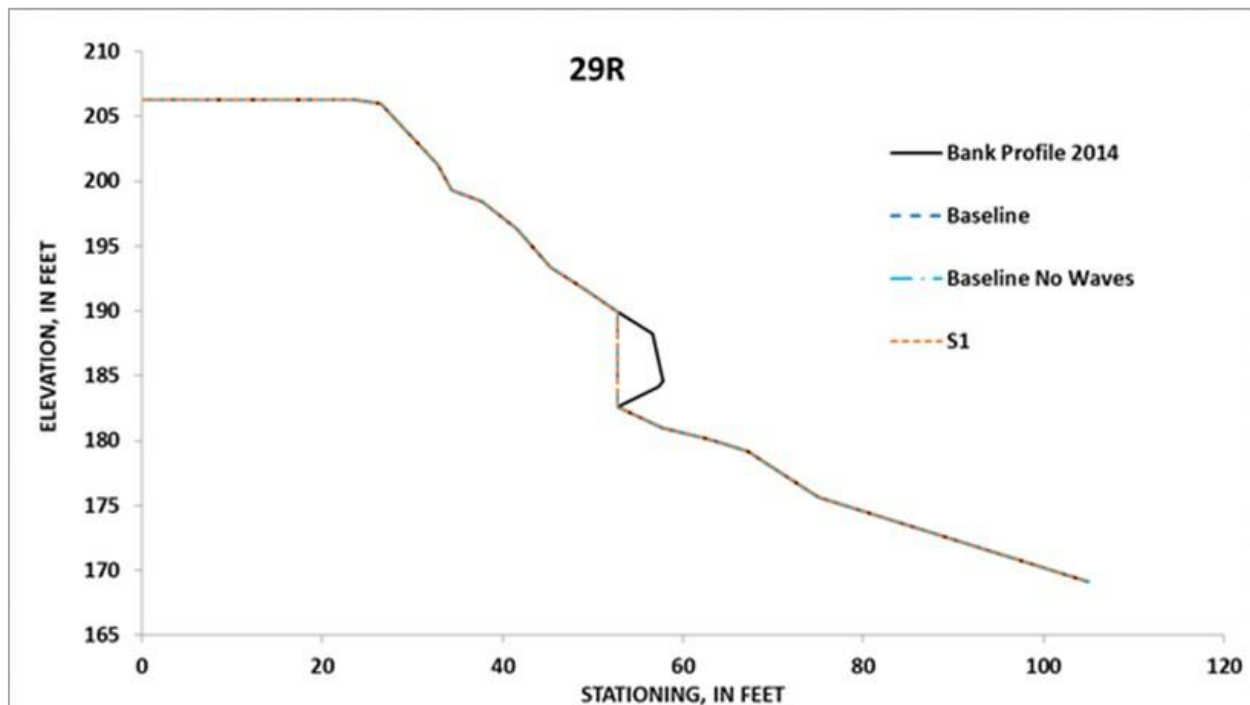
Figure 5.4.2.2-6: Bank profile for site 29R at Station 66,000 Showing Pronounced Undercut at the Start of the Simulations

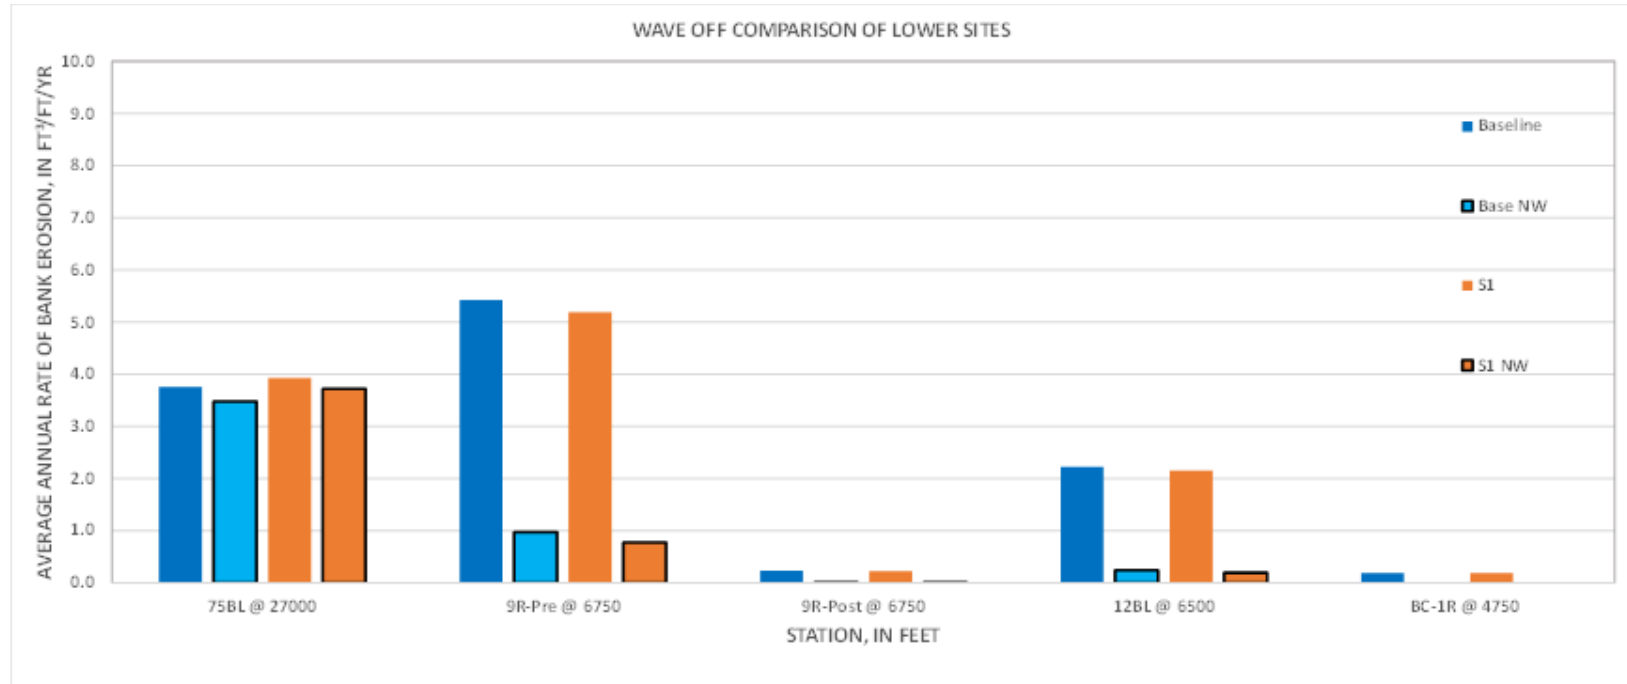
Acknowledging the importance of boat-generated waves for the Baseline Condition in the lower TFI led to re-running the other Operational scenarios without waves as well. A comparison of erosion rates with and without boat-generated waves for the four sites in the lower TFI is shown in [Figure 5.4.2.3-1](#). Clearly, erosion rates drop significantly for all scenarios when the effects of waves are removed. As one moves upstream in the TFI, however, the effect is reduced to the point that at site 75BL (station 27,000), there is enough vertical flow variability that differences in erosion rates with and without waves become small ([Figure 5.4.2.3-1](#)). A summary of the bank-erosion rates in the lower TFI with and without waves for all Operational scenarios is provided in [Table 5.4.2.3-1](#).

Figure 5.4.2.3-1 Comparison of Bank-erosion Rates with and without Boat-generated Waves for Sites in the Lower Turners Falls Impoundment

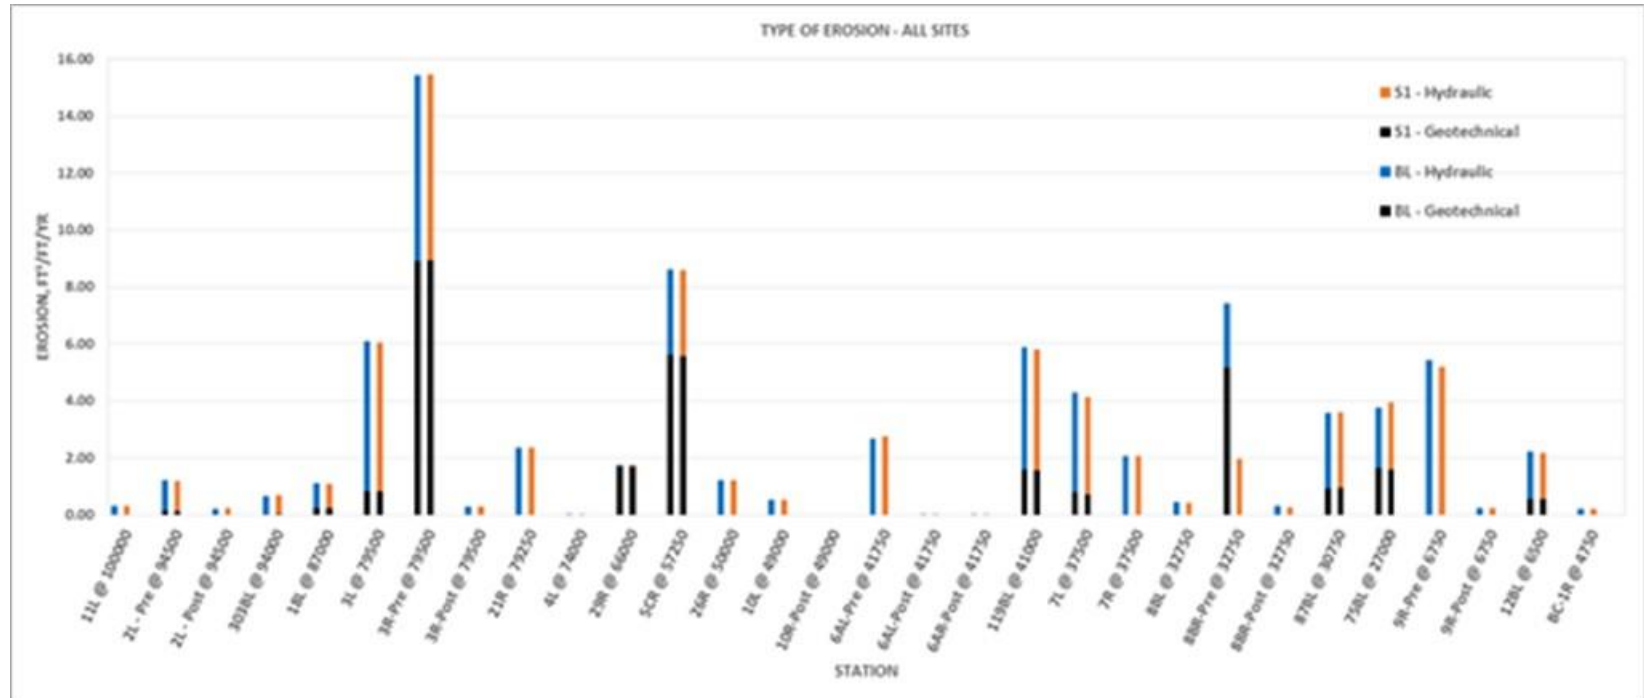
Figure 5.4.3-1: Bank-erosion Rates for all Sites, Conditions and Modeling Scenarios shown schematically from Upstream to Downstream along the Study Reach

Results represented by the vertical bars are separated into erosion by hydraulic (black sections) and geotechnical (mass failure) processes

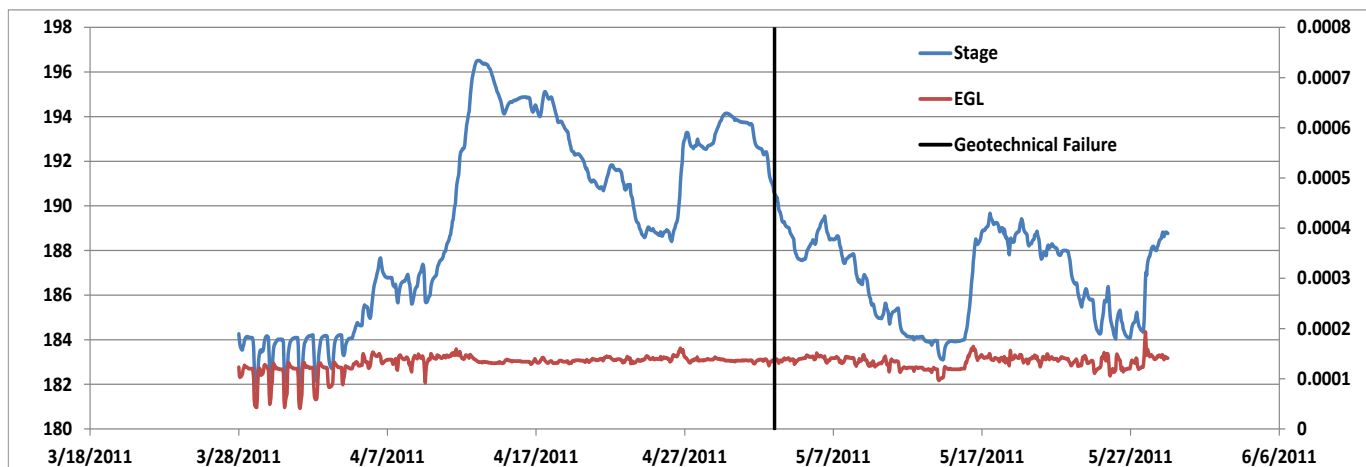
Figure 5.4.3.4-5: Stage and Energy Grade Line (EGL) of flows at Site 303BL under Scenario 1 around the time of the geotechnical failure on 05/03/2011 at 1:00AM (denoted by vertical black line).

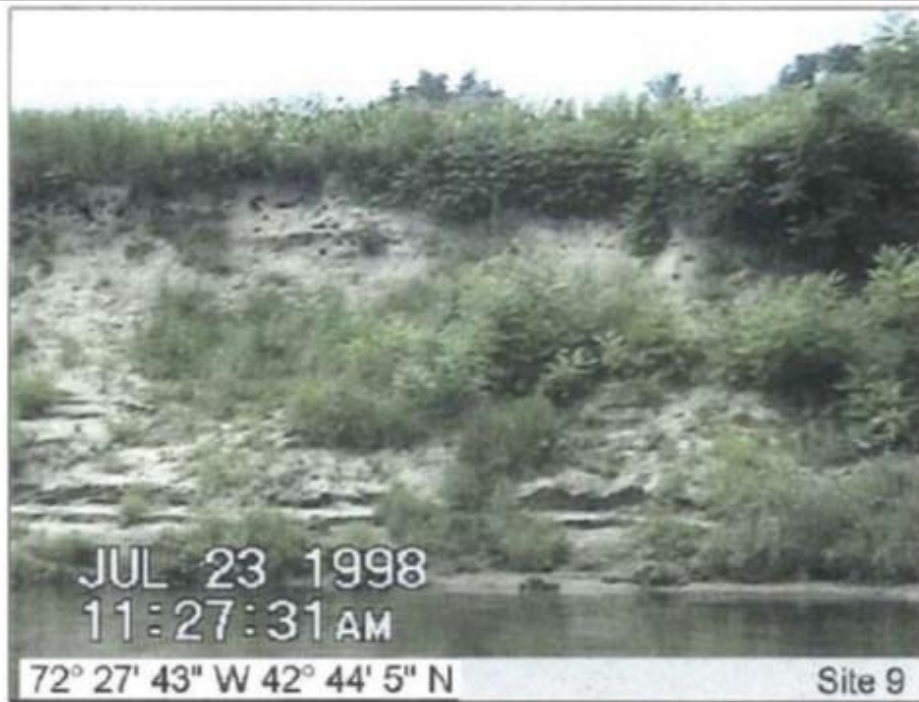
Figure 5.4.3.7-1 Photos from 1998 at site 3R Pre Restoration (Labeled as 1998 FRR/ECP-Site 9)

BSTEM runs at this site show that under the Baseline Condition, about 100 ft³ of erosion occurred per foot of bank, during the 2000 to 2006 flow period prior to restoration, averaging 15.4 ft³/ft/y ([Table 5.4.3-1](#)). This results in the highest erosion rate for the Baseline Condition, placing it between the 95th and 100th percentiles of erosion rates along the reach. The modeling also indicates that 42% (6.51 ft³/ft/y) of the erosion is due directly to hydraulic processes, whereas the other 58% (8.91 ft³/ft/y) is the result of geotechnical processes and associated mass failures.

Right bank, 1998

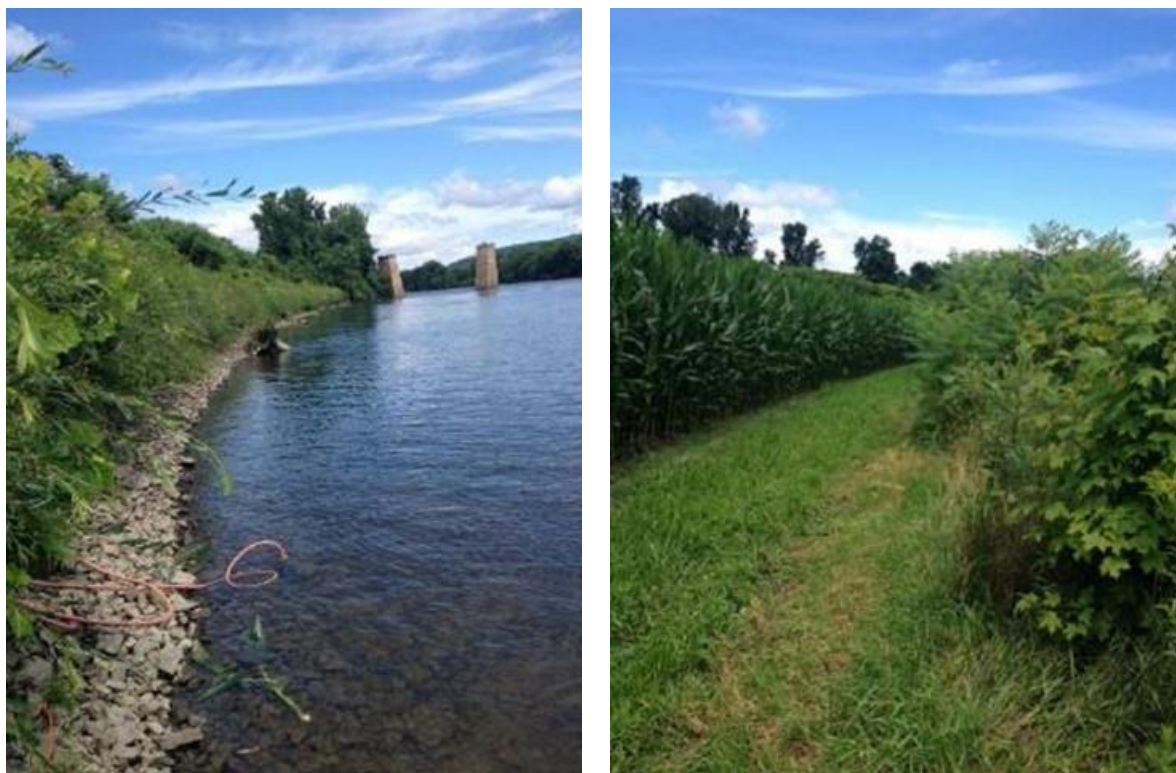
Figure 5.4.3.8-1 Photos at site 3R Post Restoration

BSTEM runs at this site show that under the Baseline Condition, 1.75 ft^3 of erosion occurred per foot of bank, during the 2006 to 2014 flow period after restoration activities, averaging $0.285 \text{ ft}^3/\text{ft}/\text{y}$ ([Table 5.4.3-1](#)). This results in the 9th lowest erosion rate for the Baseline Condition, placing it between the 20th and 25th percentiles of erosion rates along the reach. The modeling also indicates that all 100% ($0.285 \text{ ft}^3/\text{ft}/\text{y}$) of the erosion is due directly to hydraulic processes, and none of the bank erosion is the result of larger geotechnical failures. The minimal amount of hydraulic erosion that is occurring is within the level of the placed rock at the toe, indicating that the rock may be slightly undersized for the flows.

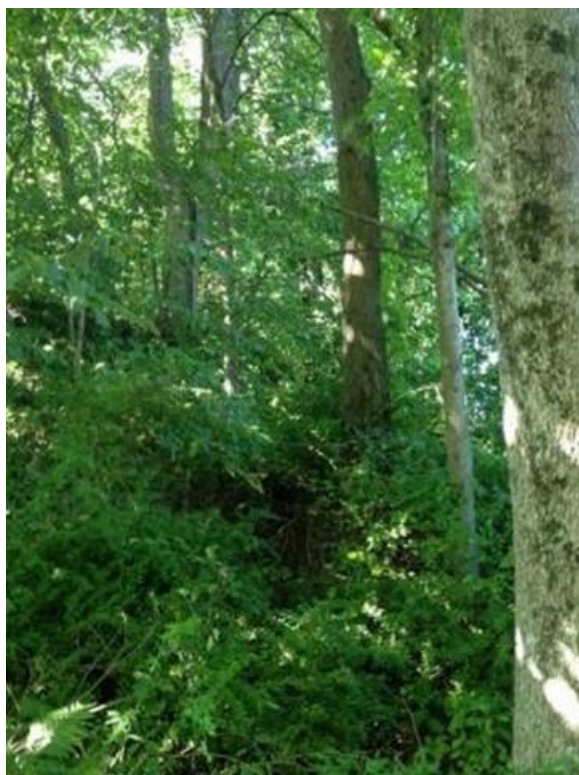
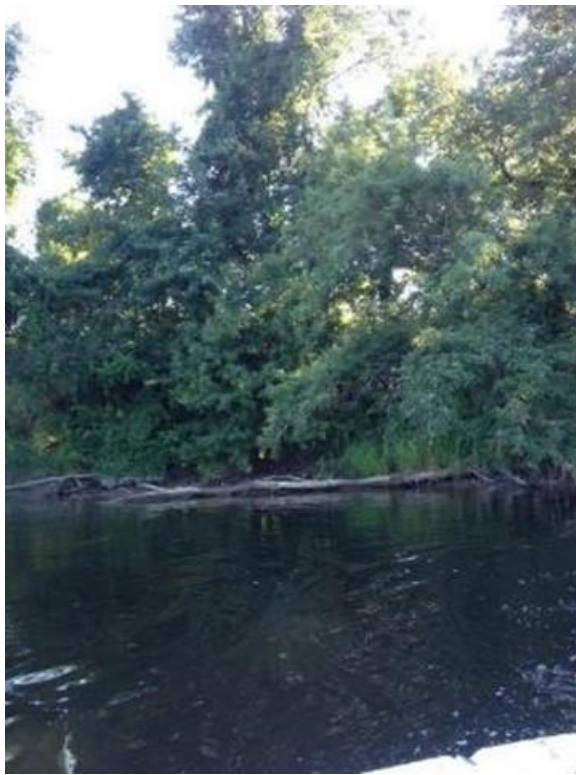
Figure 5.4.3.9-1: Photos at site 21R

The river at site 21R has a steep bank face, sparsely vegetated banks, and is located at station 79,250, just north of the Massachusetts-Vermont Border. The bank is roughly 27 feet tall, with a sandy-loam bank toe and upper bank. The bank is vegetated mostly with grasses and small shrubs, but contains a few American basswood, Green ash, and Northern red oak trees. A significant amount of bare soil was noted on the bank face. No historical cross sections existed for this site. A survey conducted in 2014 was used as the initial bank geometry for the model runs ([Figure 5.4.3.9-1](#)).

BSTEM runs at this site show that under the Baseline Condition, 34.6 ft³ of erosion occurred per foot of bank, during the 2000-2014 flow period, averaging 2.36 ft³/ft/y ([Table 5.4.3-1](#)). This results in the 11th highest erosion rate for the Baseline Condition, placing it between the 65th and 70th percentiles of erosion rates along the reach. The modeling also indicates that all 100% (2.36 ft³/ft/y) of the erosion is due directly to hydraulic processes, and that none of the bank erosion is the result of larger geotechnical failures.

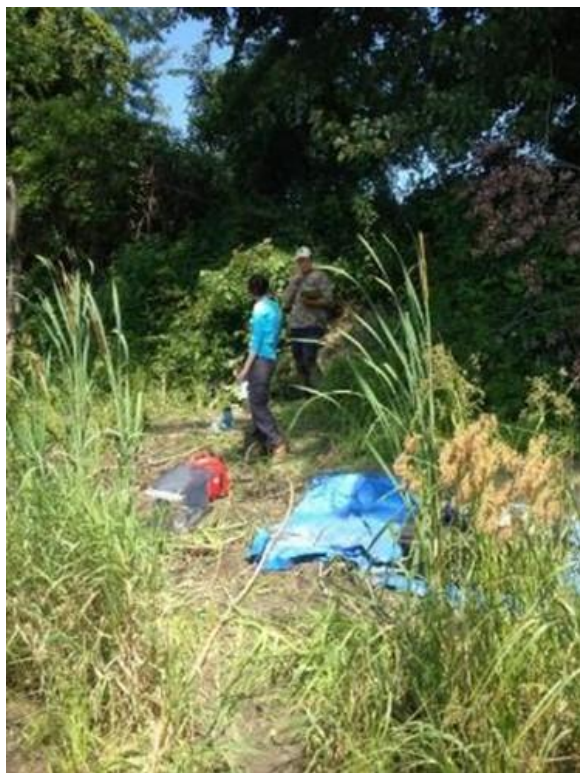
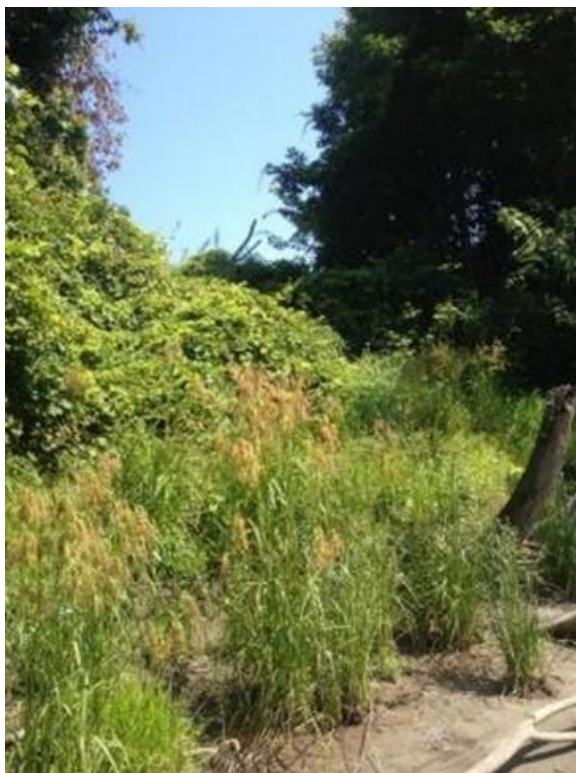
Figure 5.4.3.10-1 Photos at site 4L

BSTEM runs at this site show that under the Baseline Condition, 0.25 ft³ of erosion occurred per foot of bank, during the 2000-2014 flow period, averaging 0.017 ft³/ft/y ([Table 5.4.3-1](#)). This results in the 3rd lowest erosion rate for the Baseline Condition, placing it between the 5th and 10th percentiles of erosion rates along the reach. The modeling also indicates that all 100% (0.0173 ft³/ft/y) of the erosion is due directly to hydraulic processes, and that none of the bank erosion is the result of geotechnical failures.

The erosion modeled at this site does not account for the depositional material that has been placed at the toe. The model does not recognize depositional material, and the slight erosion that is happening under the Baseline Condition, is happening at the toe. As material from the bank toe is being eroded, the river is re-depositing additional sediment to compensate. In general though, very little erosion is occurring at this site.

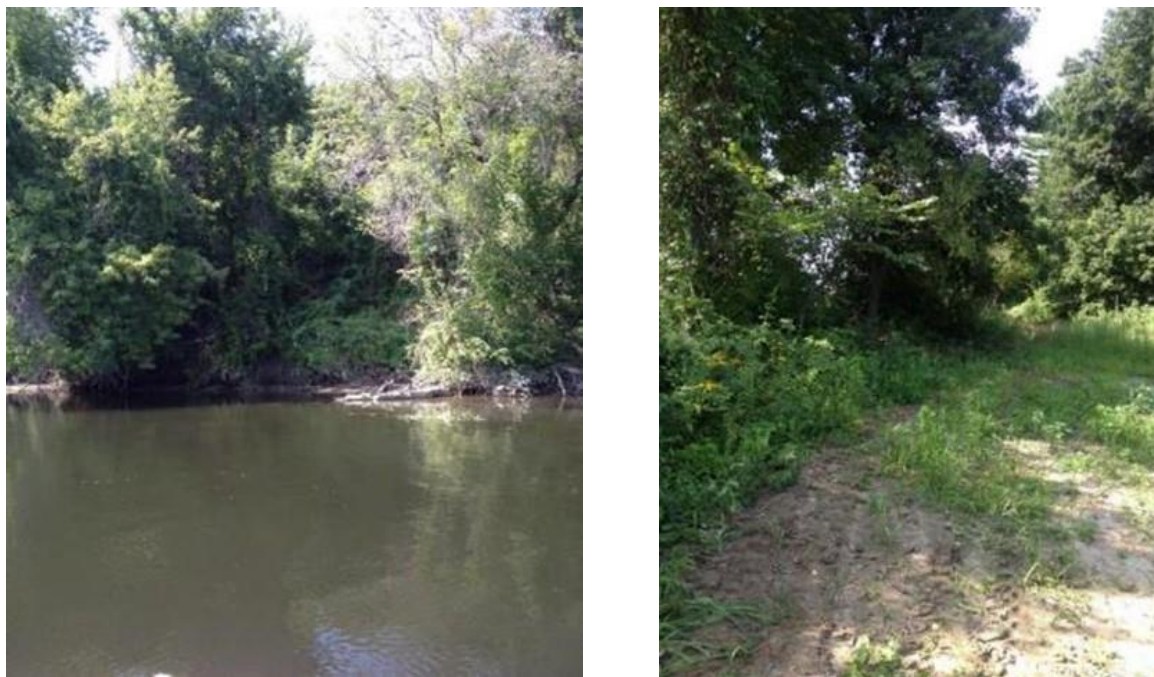
Figure 5.4.3.11-1 Photos at site 29R

The river at site 29R (at station 66,000) has a steep bank face, sparsely vegetated banks, and is located between Mallory Brook and the Pauchaug Boat Ramp. The bank is roughly 26 feet tall, with a sandy loam toe and upper bank slope. The bank contains only patchy vegetation with Green ash and Silver maple trees. A significant amount of bare soil was noted on the bank face. No historical cross sections exist for this site, however this site was surveyed in 2014 and this was used as the initial geometry for the model runs ([Figure 5.4.3.11-1](#)).

BSTEM runs at this site show that under the Baseline Condition, 25.2 ft³ of erosion occurred per foot of bank during the 2000-2014 flow period, averaging 1.72 ft³/ft/y ([Table 5.4.3-1](#)). This results in the 14th highest erosion rate for the Baseline Condition, placing it between the 55th and 60th percentiles of erosion rates along the reach. The modeling also indicates that only 1% (about 0.009 ft³/ft/y) of the erosion is due directly to hydraulic processes, whereas the other 99% (1.71 ft³/ft/y) is the result of geotechnical processes and associated mass failures. Looking at the starting cross section, with the existing undercut, it becomes obvious that a large geotechnical failure is imminent ([Figure 5.4.3.11-2](#)). In fact, failure of the upper bank here represents the single, significant erosion event at this site that occurred early on in the simulation period.

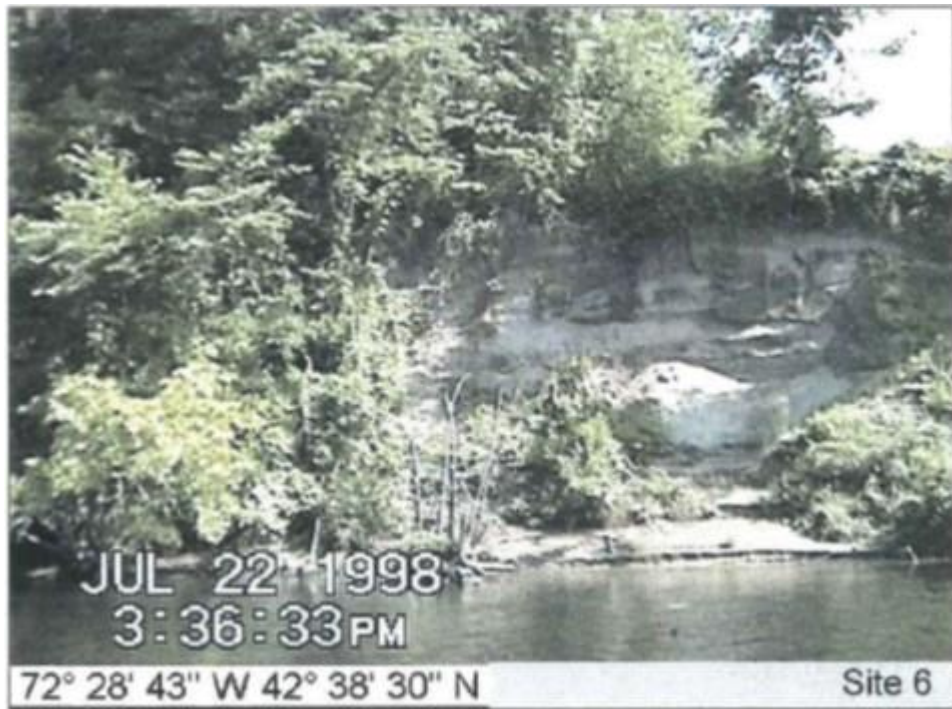
Figure 5.4.3.16-1 Photos at site 6AL Pre Restoration (Labeled as 1998 FRR/ECP-Site 6)

Left bank, 1998

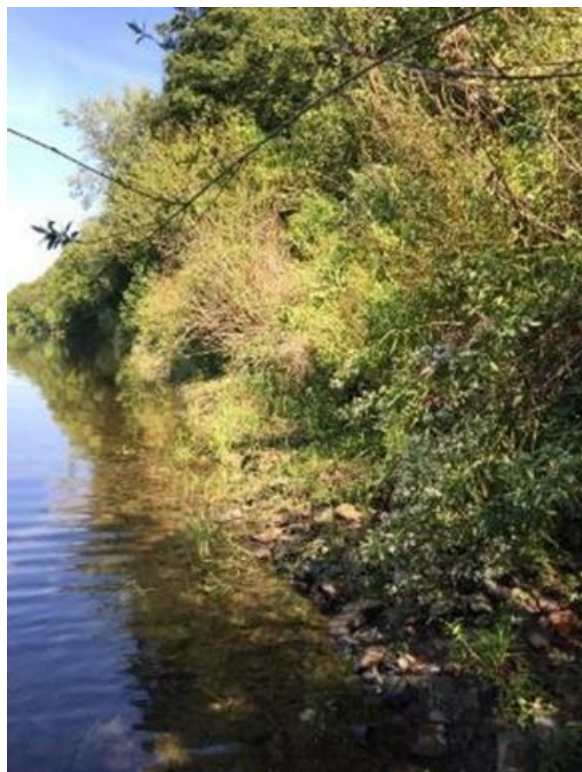
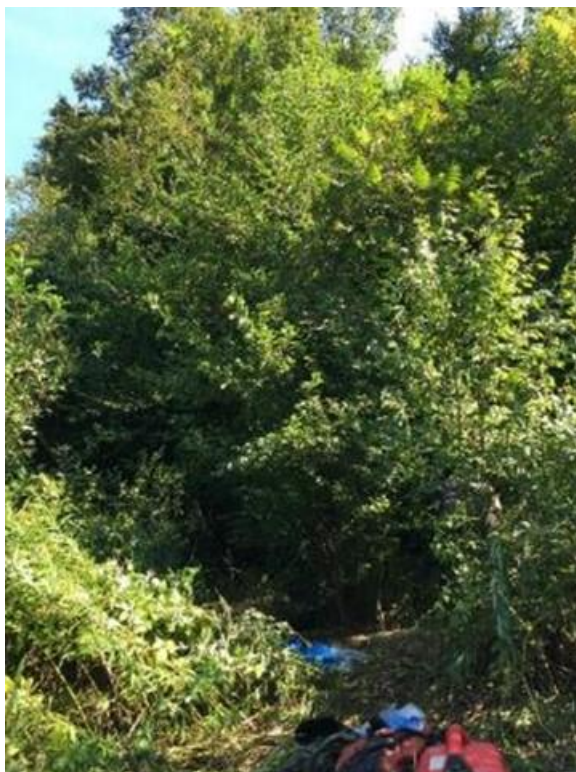
Figure 5.4.3.17-1 Photos at site 6AL Post Restoration

The Post Restoration condition at site 6AL is characterized by steep, heavily vegetated banks. The bank is roughly 37 feet tall, with a rock toe ($d_{50}=55$ mm) and a silt loam bank. The replanted bank is heavily vegetated with large shrubs, Northern red oak, and Sugar maple ([Figure 5.4.3.17-1](#)).

BSTEM runs at this site show that the restoration activities have been highly successful with erosion rates under the Baseline Condition of $5.5\text{E-}05$ ft^3 per foot of bank, during the 2004 to 2014 flow period, averaging $5.45\text{E-}06$ $\text{ft}^3/\text{ft}/\text{y}$ ([Table 5.4.3-1](#)). This results in the lowest erosion rate for the Baseline Condition. The modeling also indicates that all 100% ($5.45\text{E-}06$ $\text{ft}^3/\text{ft}/\text{y}$) of the erosion is due directly to hydraulic processes, and there are no geotechnical failures.

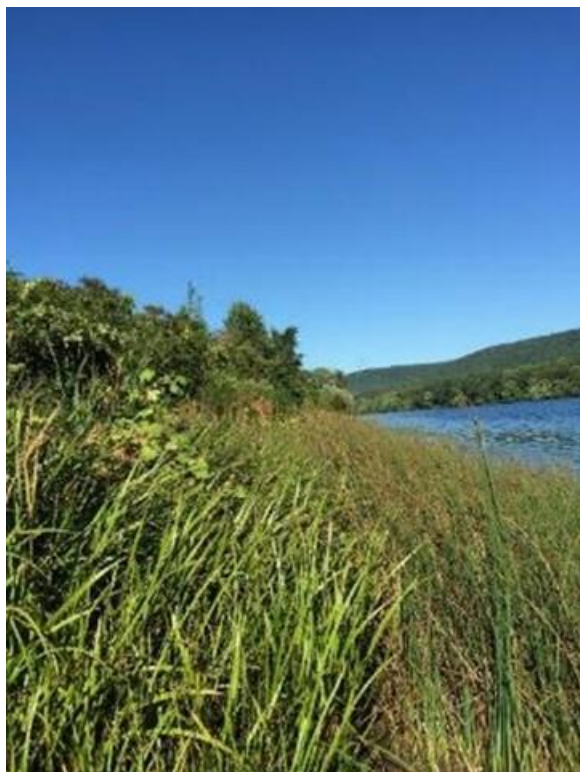
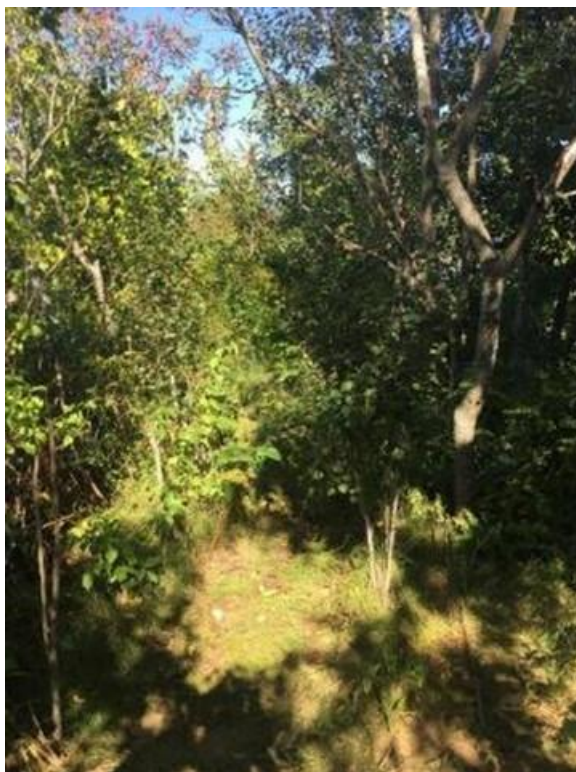
Figure 5.4.3.18-1 Photos at site 6AR Post Restoration

BSTEM runs for the Post Restoration Condition at this site show that under the Baseline Condition, 0.295 ft^3 of erosion occurred per foot of bank, during the 2000 to 2014 flow period after restoration, averaging 0.0209 $\text{ft}^3/\text{ft}/\text{y}$ ([Table 5.4.3-1](#)). This results in the 4th lowest erosion rate for the Baseline Condition, placing it between the 10th and 15th percentiles of erosion rates along the reach. The modeling also indicates that all 100% (0.021 $\text{ft}^3/\text{ft}/\text{y}$) of the erosion is due directly to hydraulic processes, and none of the bank erosion is the result of larger, geotechnical failures.

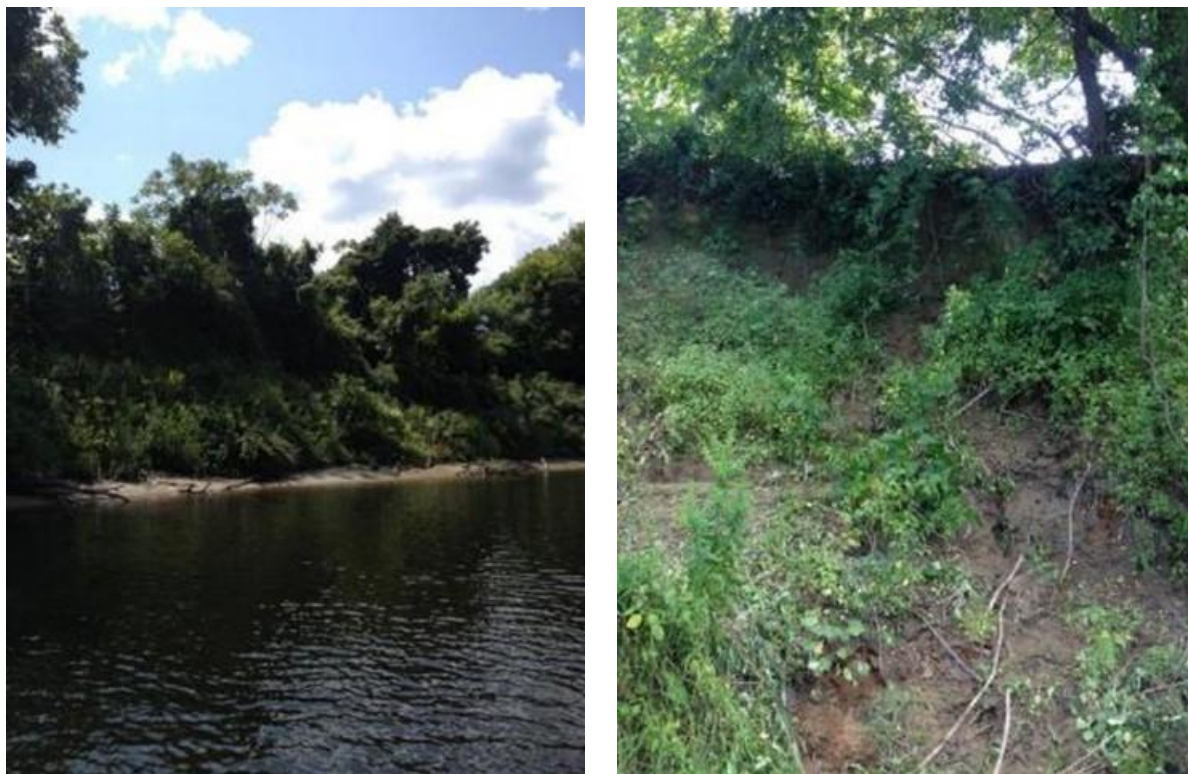
Figure 5.4.3.19-1 Photos at site 119BL

BSTEM runs at this site show that under the Baseline Condition 86.1 ft^3 of erosion occurred per feet of bank, during the 2000 to 2014 flow period modeled, averaging 5.88 $\text{ft}^3/\text{ft}/\text{y}$ ([Table 5.4.3-1](#)). This results in the 5th highest erosion amongst the model sites, placing it between the 85th and 90th percentiles of erosion rates along the reach. The modeling also indicates that roughly 73% (4.26 $\text{ft}^3/\text{ft}/\text{y}$) of erosion is due to hydraulic processes, whereas the other 27% (1.62 $\text{ft}^3/\text{ft}/\text{y}$) is due to geotechnical processes and mass failures. This is also shown in the Percent Contribution of Total Erosion by Discharge plot for Site 119BL ([Figure 5.4.3.19-4](#)), as the graph has a very gradual smooth shape, with few large spikes indicating mass wasting.

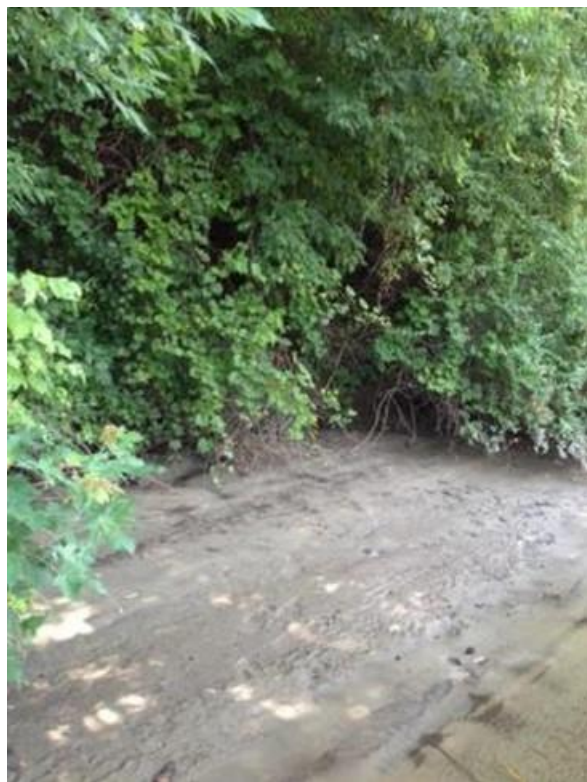
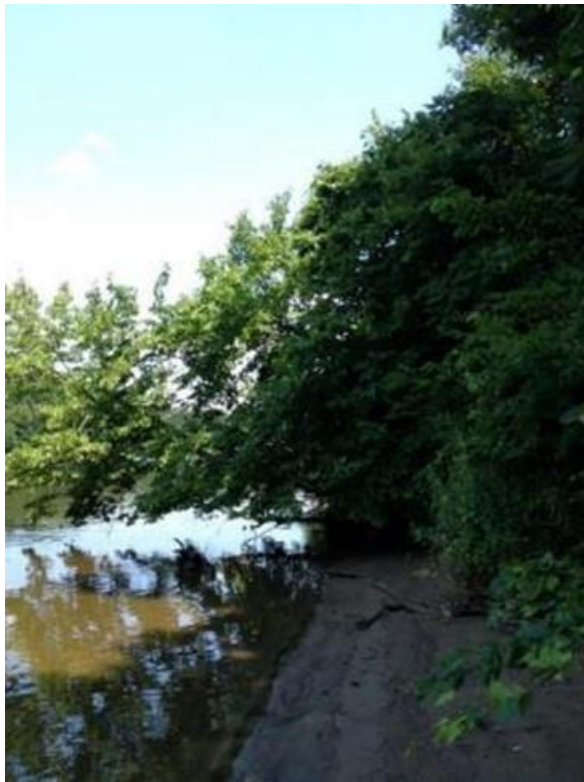
Figure 5.4.3.20-1 Photos at site 7L

BSTEM runs at this site show that under the Baseline Condition, 62.9 ft³ of erosion occurred per foot of bank, during the 2000 to 2014 flow period, averaging 4.29 ft³/ft/y ([Table 5.4.3-1](#)). This results in the 7th highest erosion rate for the Baseline Condition, placing it between the 75th and 80th percentiles of erosion rates along the reach. The modeling also indicates that roughly 81% (3.48 ft³/ft/y) of the erosion is due directly to hydraulic processes, whereas the other 19% (0.81 ft³/ft/y) is the result of geotechnical processes and associated mass failures.

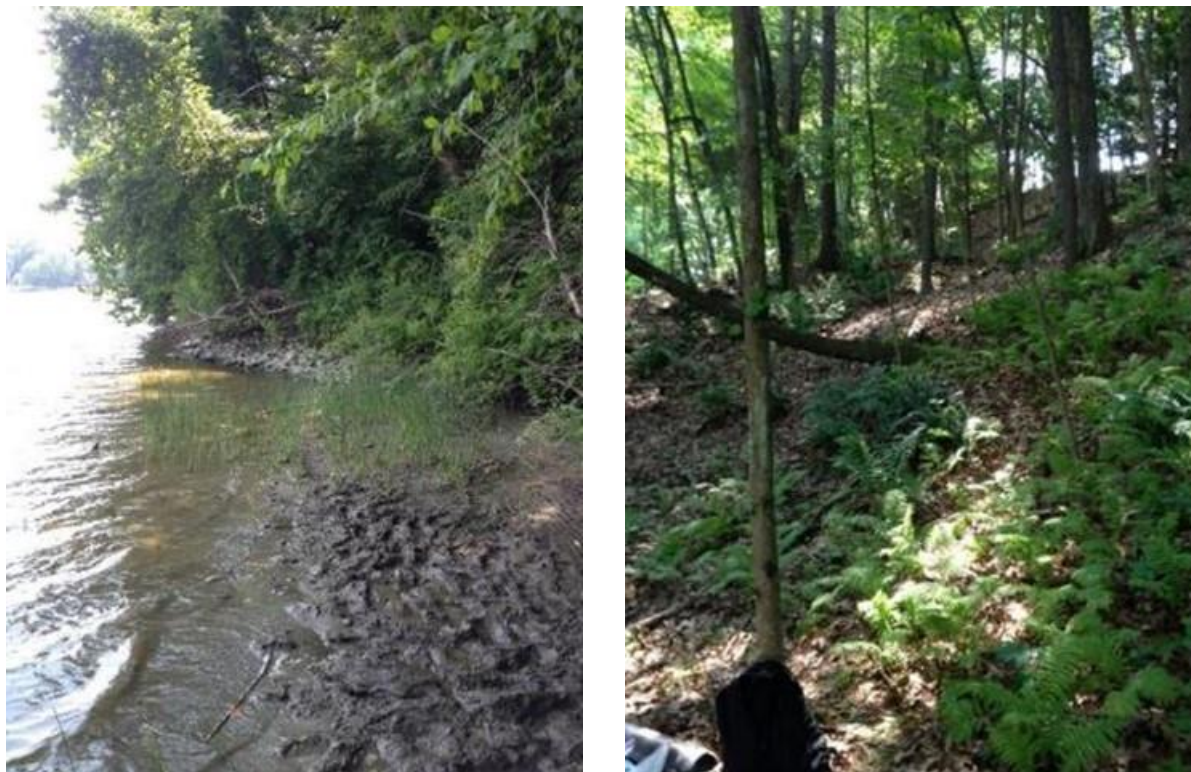
Figure 5.4.3.21-1 Photos at site 7R

Site 7R (station 37,500) is located between Kidds Island and the Northfield Mountain Tailrace, just upstream of Dry Brook. The site has steep, partially vegetated banks that are roughly 24 feet tall, with a sandy toe and a sandy-loam upper bank. The bank is vegetated with 20 to 50 year-old Hemlock, Pine, and Silver maple. There was a significant amount of bare soil noted on the upper bank, likely due to the dense tree canopy ([Figure 5.4.3.21-1](#)).

BSTEM runs at this site show that under the Baseline Condition, 30.1 ft³ of erosion occurred per foot of bank, during the 2000 to 2014 flow period, averaging 2.06 ft³/ft/y ([Table 5.4.3-1](#)). This results in the 13th highest erosion rate for the Baseline Condition, placing it between the 55th and 60th percentiles of erosion rates along the reach. The modeling also indicates that all 100% (2.06 ft³/ft/y) of the erosion is due directly to hydraulic processes, and none of the bank erosion is the result of larger, geotechnical failures.

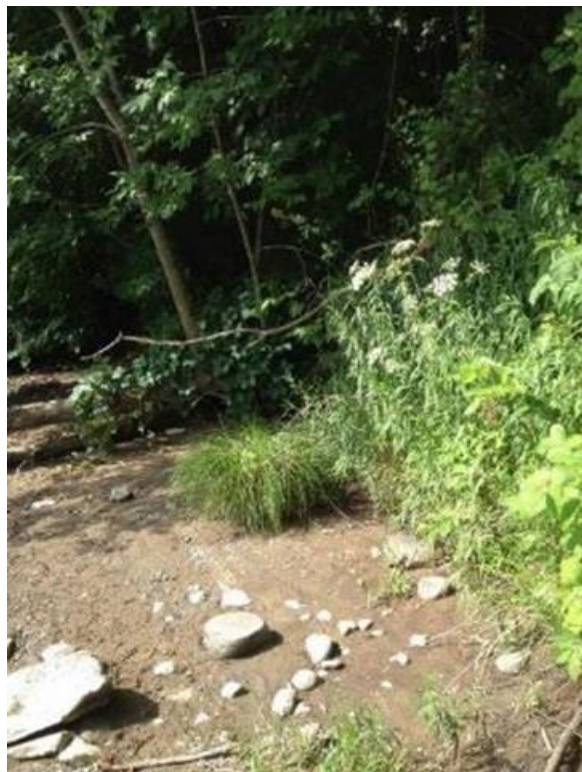
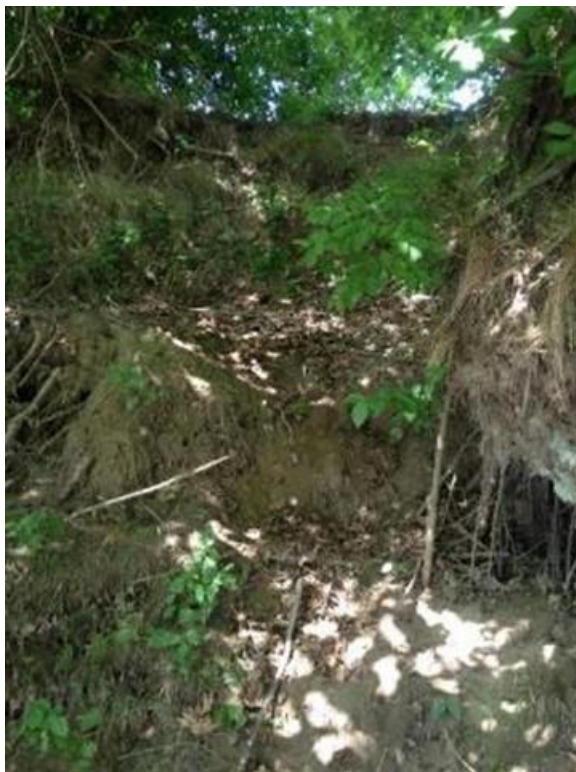
Figure 5.4.3.22-1 Photos at site 8BL

The river at site 8BL (station 32,750) has steep, vegetated banks and is located between Kidds Island and the Northfield Mountain Tailrace, just upstream of Pine Meadow Brook. The bank is roughly 24 feet tall, with a sandy toe and a sandy-loam upper bank. The bank is highly vegetated with 20 to 50 year old Hemlock, Pine, and Silver maple. There was a significant amount of bare soil noted, likely due to the dense tree canopy ([Figure 5.4.3.22-1](#)).

BSTEM runs at this site show that under the Baseline Condition, 6.09 ft³ of erosion occurred per foot of bank, during the 2000 to 2014 flow period, averaging 0.43 ft³/ft/y ([Table 5.4.3-1](#)). This results in the 19th highest erosion rate for the Baseline Condition, placing it between the 35th and 40th percentiles of erosion rates along the reach. The modeling also indicates that all 100% (0.428 ft³/ft/y) of the erosion is due directly to hydraulic processes, and none of the bank erosion is the result of geotechnical processes and associated mass failures.

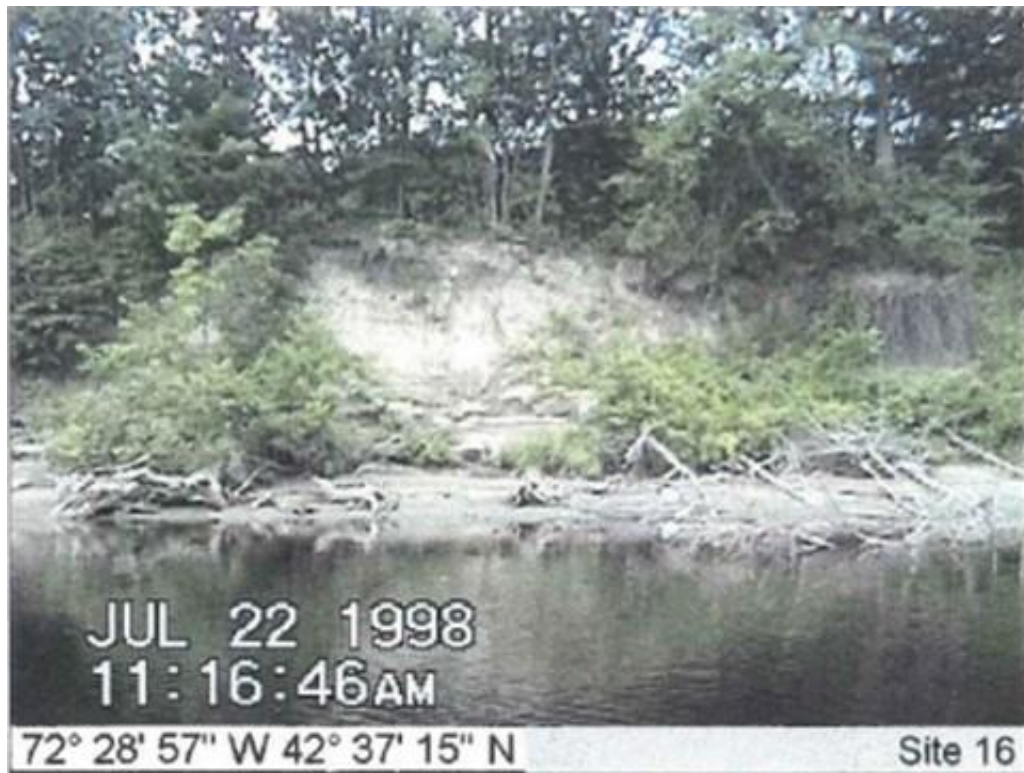
Figure 5.4.3.23-1 Photos at site 8BR Pre Restoration (Labeled as 1998 FRR/ECP-Site 16)

The river at site 8BR (station 32,750) has steep, sparsely vegetated banks and is located between Kidds Island and Northfield Mountain Tailrace, just upstream of Pine Meadow Brook. The bank is roughly 19 feet tall, with a sandy toe and a sandy-loam upper bank. The bank is thinly vegetated with Northern red oak and Green ash. There was also significant amount of bare soil noted ([Figure 5.4.3.23-1](#)).

BSTEM runs for the Pre-Restoration Condition at this site show that under the Baseline Condition, 89.6 ft³ of erosion occurred per foot of bank, during the 2000 to 2012 flow period prior to restoration, averaging 7.42 ft³/ft/y ([Table 5.4.3-1](#)). This results in the 3rd highest erosion rate for the Baseline Condition, placing it between the 90th and 95th percentiles of erosion rates along the reach. The modeling also indicates that roughly 30% (2.23 ft³/y) of the erosion is due to hydraulic processes, whereas the other 70% (5.19 ft³/y) is the result of geotechnical processes and associated mass failures.

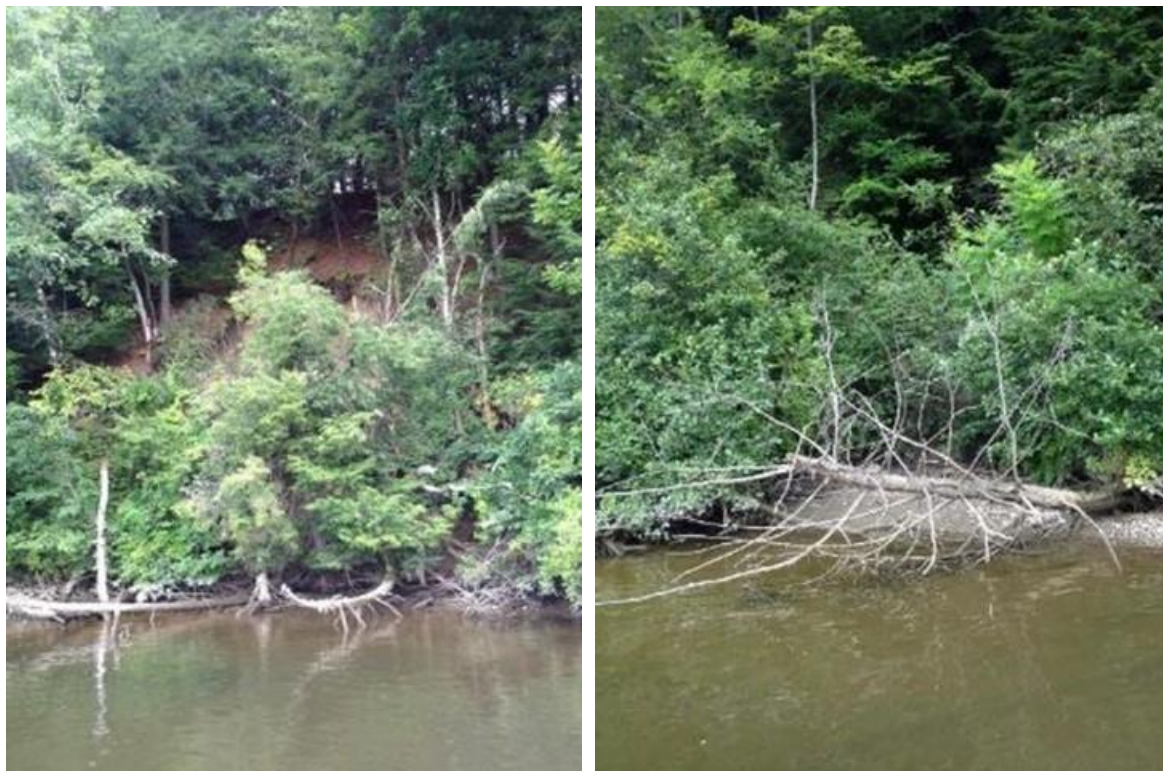
BSTEM runs at this site show that under the Baseline Condition, 55.0 ft³ of erosion occurred per foot of bank, during the 2000 to 2014 flow period, averaging 3.76 ft³/ft/y ([Table 5.4.3-1](#)). This results in the 8th highest erosion rate for the Baseline Condition, placing it between the 75th and 80th percentiles of erosion rates along the reach. The modeling also indicates that roughly 56% (2.10 ft³/y) of the erosion is due directly to hydraulic processes, whereas the other 44% (1.66 ft³/y) is the result of geotechnical processes and associated mass failures.

It should be noted that at this site, the Baseline Condition flows did not result in the greatest amount of erosion. One possible cause for this is that the peaking operations at Northfield Mountain are creating greater fluctuations in water surface elevations than would be created under a run-of-river scenario. By elimination of these fluctuations as seen in Scenario 1 this causes the shear stresses to be focused on a narrower band of the bank cross section, resulting in slightly higher hydraulic erosion which could cause an increase in the size of the individual bank failures.

Figure 5.4.3.26-1 Photos at site 75BL

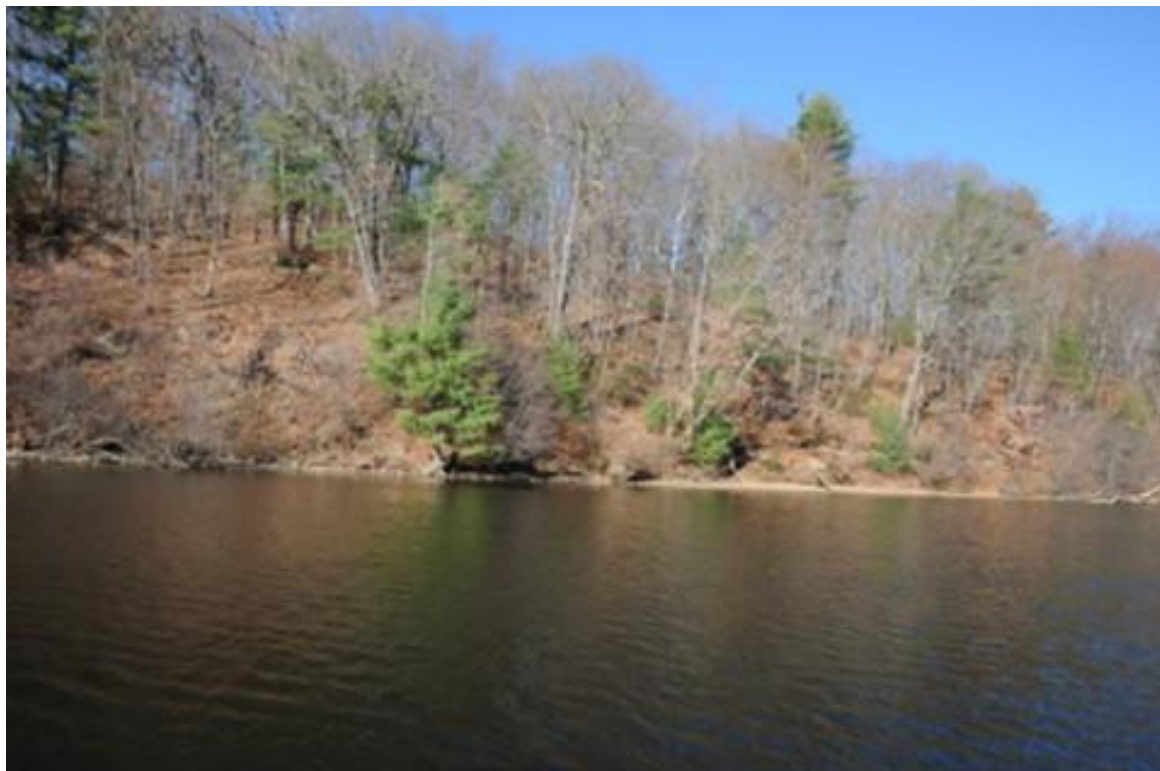
The river at site 9R (station 6,750) has moderately steep, sparsely vegetated banks and is located on the south side of the Barton Cove Campground. The bank is roughly 61 feet tall, with a sandy toe and a sandy-loam upper bank. The bank is thinly vegetated with Northern red oak, American basswood, and Green ash trees. There was a significant amount of bare soil noted on the bank face, likely due to the large trees and canopy cover ([Figure 5.4.3.27-1](#)).

Overall the difference between Baseline and S1 was found to be 4%; however, determining the causes of erosion at this site is not as simple as subtracting Baseline and S1, as was done at other sites. The difference in impact from boat waves between the Baseline Condition (82%) and S1 (85%) demonstrates how waves influence the erosion in this reach. When Northfield Mountain is set to idle (S1), erosion due to boat waves is 3% greater than if Northfield Mountain is online. In other words, it would appear that the effect of waves on the bank is reduced with Northfield Mountain operating. When taking boat waves into consideration, the actual percent reduction in erosion with the S1 Scenario is likely closer to 1%. This results in an S1 erosion amount of 0.075 ft³/ft/y, which is lower than the measurable/significant rate of 0.163 ft³/ft/y. Another factor compounding the S1 results in this area is the downstream boundary condition used to simulate the Turner Falls Dam. The historic dam operations were used as the boundary condition for S1 which resulted in potentially more TFI fluctuations than may have occurred had Northfield Mountain actually been idle. The increased water level fluctuations modeled in S1 may have actually led to less hydraulic erosion than would have occurred had the TFI been fluctuated less given that the location of the water surface on the bank varied more than it would have historically which would have prevented the repeated undercutting of the bank at the same location.

Figure 5.4.3.27-1 Photos at site 9R Pre Restoration (Photo from 2013 FRR)
