Relicensing Study 3.1.2

**Northfield Mountain / Turners Falls
Operations Impact on Existing Erosion and
Potential Bank Instability
Study Report**

**Northfield Mountain Pumped Storage Project (No. 2485) and
Turners Falls Hydroelectric Project (No. 1889)**

SEPTEMBER 2016

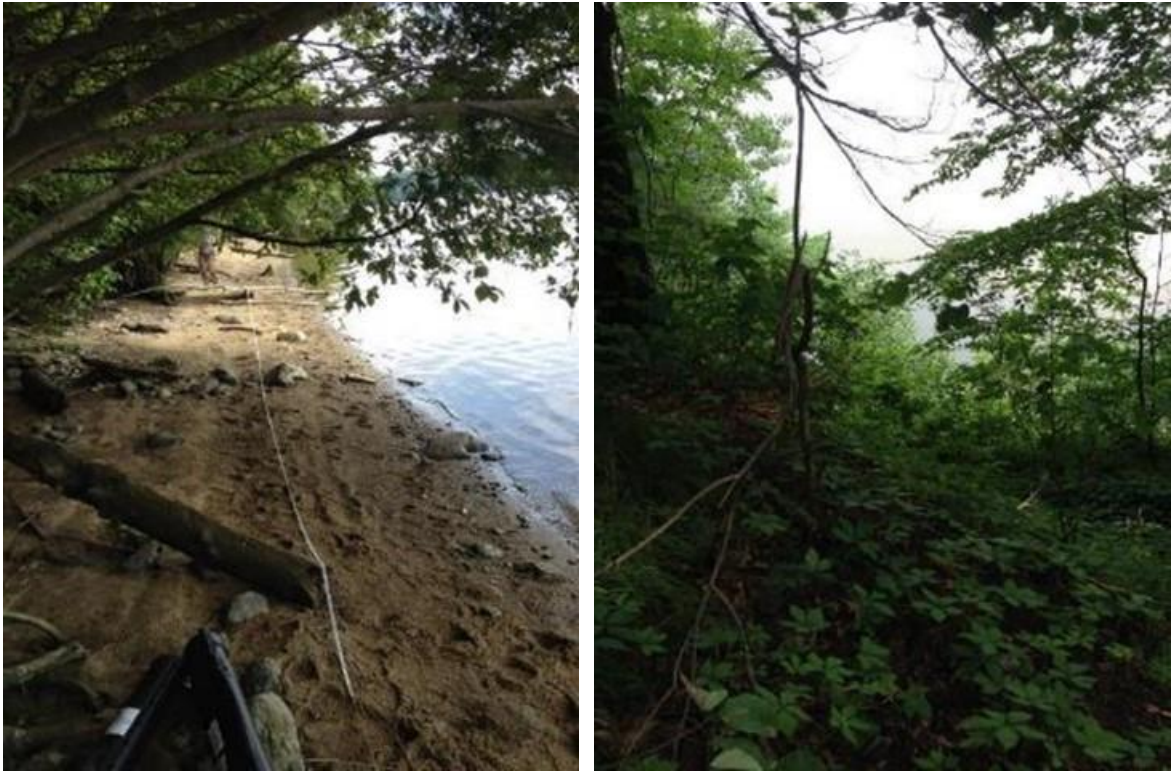
BSTEM runs at this site show that for Post-restoration under the Baseline Condition, 1.40 ft³ of erosion occurred per foot of bank, during the 2008 to 2014 flow period, averaging 0.227 ft³/ft/y ([Table 5.4.3-1](#)). This results in the 8th lowest erosion rate for the Baseline Condition, placing it between the 20th and 25th percentiles of erosion rates along the reach. The modeling also indicates that all of the erosion is due directly to hydraulic processes.

Scenario 1 had a resulting erosion amount of 0.224 ft³/ft/y ([Figure 5.4.3.28-2](#)). The Baseline Condition (Waves off) resulted in 0.002 ft³/ft/y, indicating a substantial reduction in bank-erosion rates with the removal of the impacts from boat-generated waves. As there was a large difference between the Baseline Condition (Waves on) and Baseline Condition (Waves off), Scenario 1 was investigated for the waves off condition as well. This resulted in 1.50 x10⁻³ ft³/ft/y of erosion for Scenario 1 (Note- while this site did show a small reduction in erosion between the BL and S1 Scenarios the total reduction in erosion is well below the measureable/significant rate of 0.163 ft³/ft/yr). The highest water surface elevation for this period occurred at 184.5 ft. Most of the measured erosion for this site appears to occur above 190 feet. This erosion does not appear to be a function of the TFI hydraulics. For erosion to be present above the high water line, toe erosion would need to occur and then a geotechnical failure would occur above. The toe for this site, based on survey data, has not eroded significantly since the restoration to the point where a geotechnical failure would occur.

Figure 5.4.3.28-1 Photos at site 9R Post Restoration

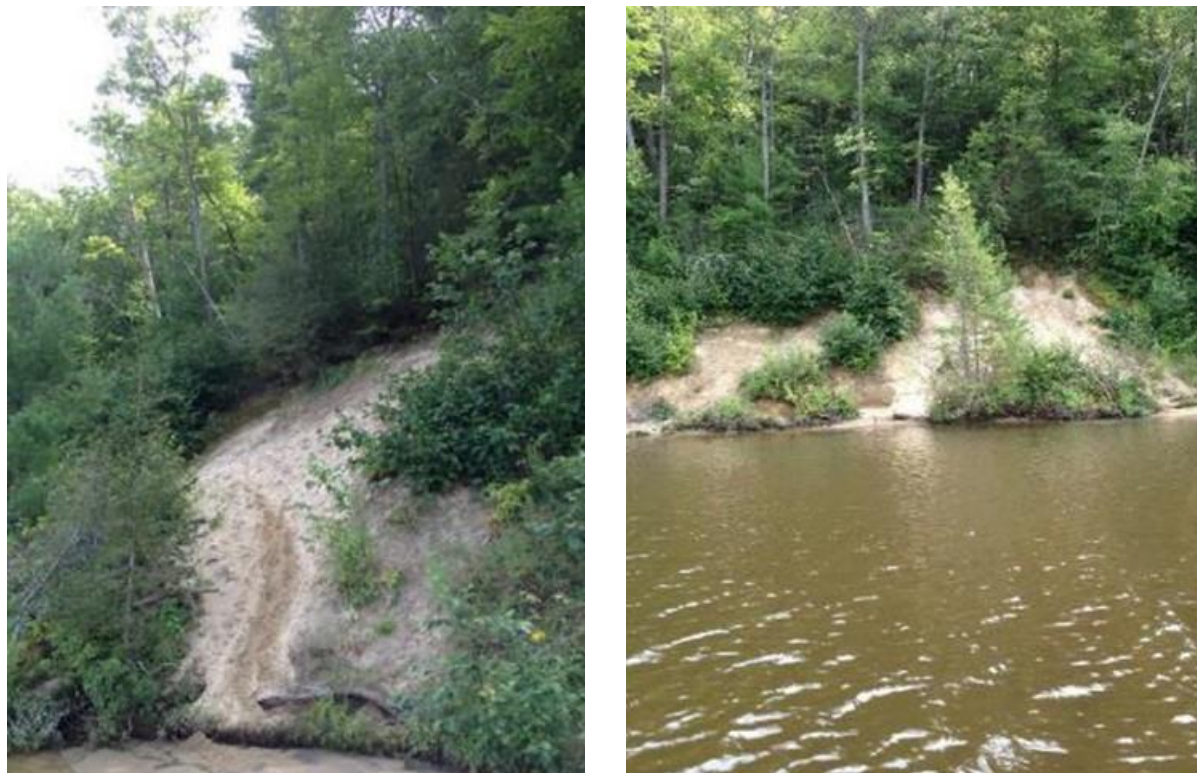
BSTEM runs at this site show that under the Baseline Condition, 32.6 ft³ of erosion occurred per foot of bank, during the 2000 to 2014 flow period, averaging 2.22 ft³/ft/y ([Table 5.4.3-1](#)). This results in the 12th highest erosion rate for the Baseline Condition, placing it between the 60th and 65th percentiles of erosion rates along the reach. The modeling also indicates that roughly 74% (1.65 ft³/y) of the erosion is due directly to hydraulic processes, whereas the other 26% (0.57 ft³/y) is the result of geotechnical processes and associated mass failures.

For Scenario 1, 2.15 ft³/ft/y of erosion occurred ([Figure 5.4.3.29-2](#) to [Figure 5.4.3.29-4](#)) resulting in about 3% of the total erosion (Note- while this site did show a small reduction in erosion between the BL and S1 Scenarios the total reduction in erosion is well below the measureable/significant rate of 0.163 ft³/ft/yr). With the lower variability in water surface fluctuations at this site we see a bigger wave influence. The Baseline Condition (Waves off) resulted in 0.239 ft³/ft/y representing about 89% of the total erosion, attesting to the important role of boat-generated waves in inducing erosion at this site. As Baseline Condition (Waves off) scenario illustrated a significant reduction in erosion, Scenario 1 was also run without the effects of boat waves. With waves off the model run for Scenario 1 resulted in 0.194 ft³/ft/y. Clearly, boat waves are significant for all Operational scenarios and, therefore, protection of the bank-toe region could limit further bank erosion at this site.

Figure 5.4.3.29-1 Photos at site 12BL

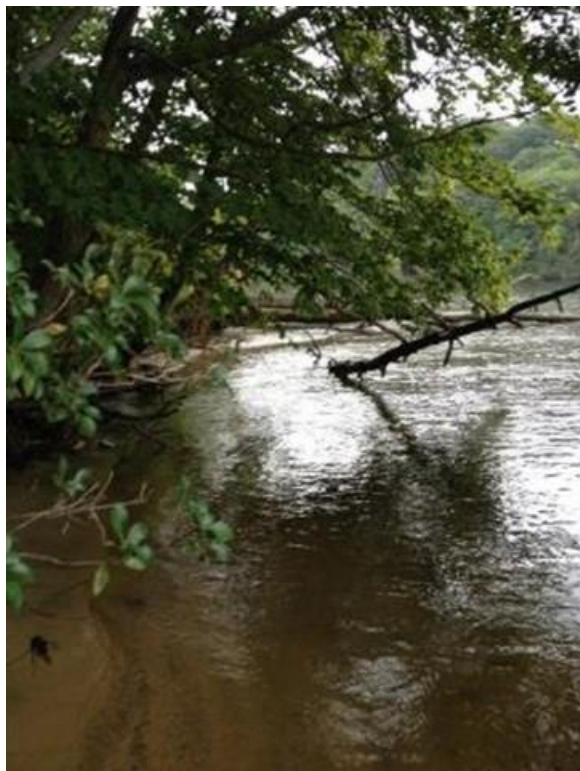
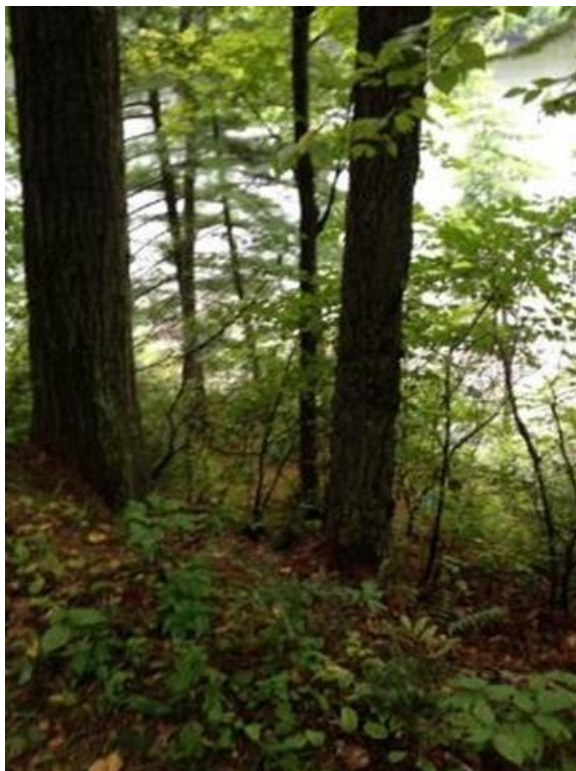
The river at site BC-1R (station 4,750) has moderately steep, heavily vegetated banks and is located on the north side of the Barton Cove Campground, immediately upstream of the Turners Falls Dam. The bank is roughly 20 feet tall, with a silty-loam toe and a sandy upper bank. The bank face and bank top are heavily vegetated with Black birch, Eastern hemlock, Eastern white pine, and Northern red oak trees. There was a significant amount of bare soil noted on the bank face, likely due to the large trees and canopy cover ([Figure 5.4.3.30-1](#)).

BSTEM runs at this site show that under the Baseline Condition, 2.70 ft³ of erosion occurred per foot of bank, during the 2000 to 2014 flow period, averaging 0.190 ft³/ft/y ([Table 5.4.3-1](#)). This results in the 6th lowest erosion rate for the Baseline Condition, placing it between the 15th and 20th percentiles of erosion rates along the reach. The modeling also indicates that 100% of the bank erosion is due directly to hydraulic processes, and none of the bank erosion is the result of mass failures.

Figure 5.4.3.30-1 Photos at site BC1R

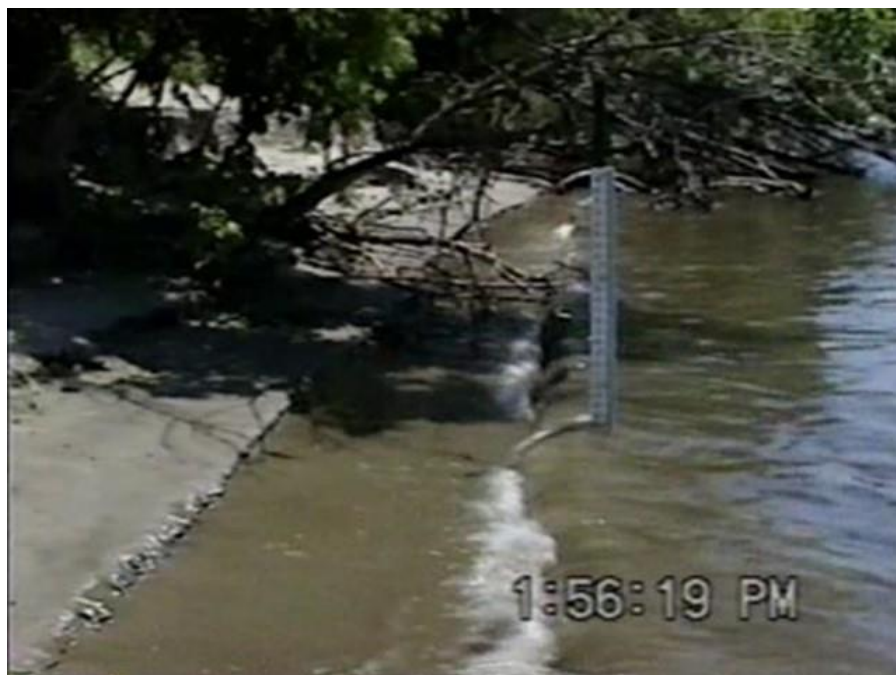
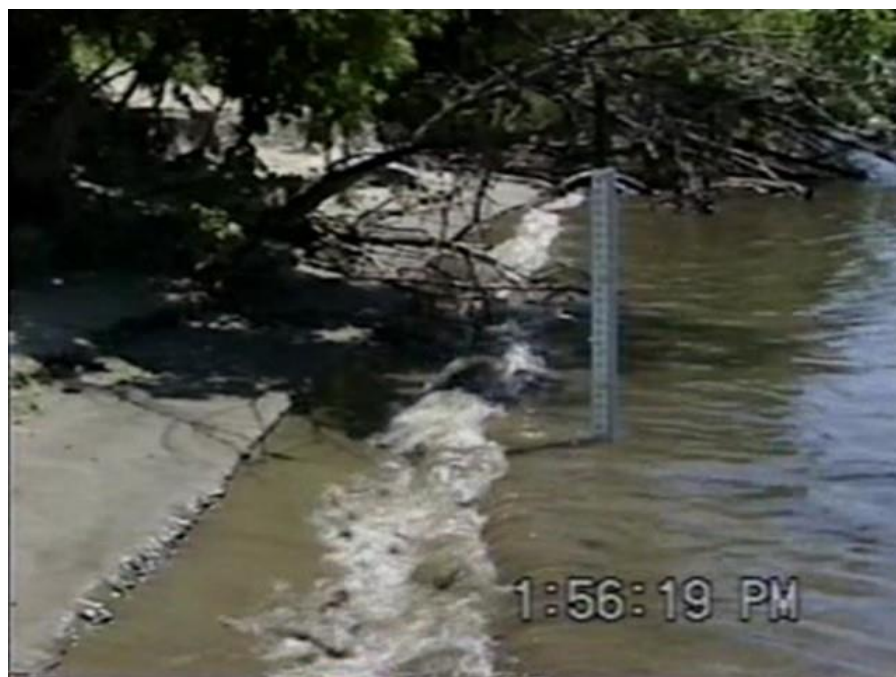
A series of six photos showing the sequence of a wave impacting the lower riverbank over a period of about 2 seconds is found in [Figure 5.5.3-2a](#) through [c](#). Given that the general water level that day was on the lower riverbank, as the waves moved towards the bank they would break on the lower bank and erode a short notch into the bank. As each progressive wave would impact this small notch, some of the vertical face would frequently break off and collapse onto the beach where the water would move sediment particles back down the beach where they would generally deposit. During these low flow conditions the downstream velocity of the flow was negligible so no significant downstream transport of the detached and mobile sediment occurred. Even during this period of relatively low flow and water surface elevation, there was evidence of larger notches cut by the waves in the transition area between the lower and upper riverbanks ([Figure 5.5.3-3](#)).

Figure 5.5.3-2a: Boat Wave Data Collection, July 1997

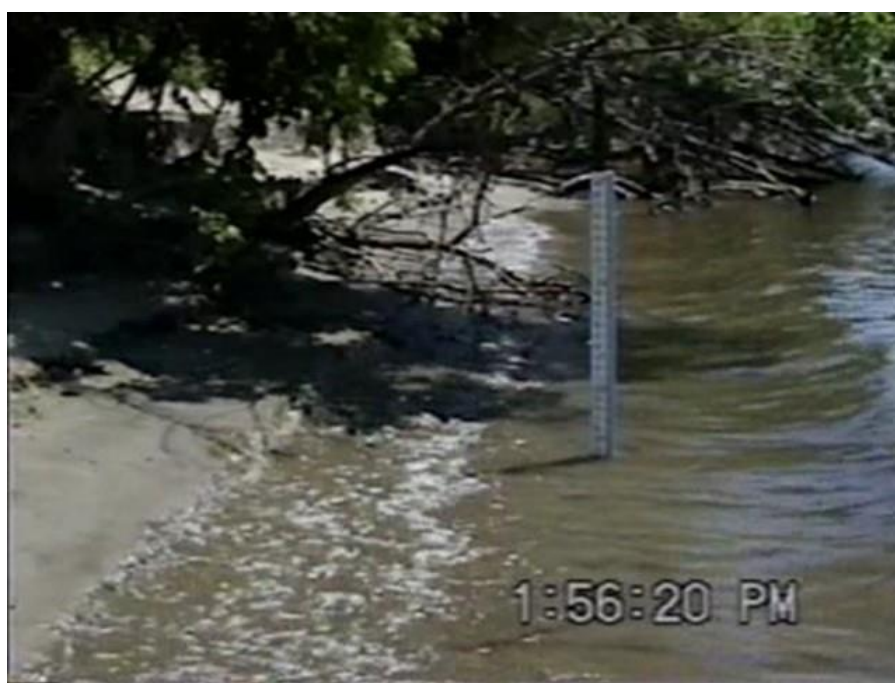
When the water level is on the lower bank (beach) and boat waves occur, erosion limited in size and damage to the overall riverbank occurs (as shown in [Figures 5.5.3-2 a](#) through [c](#)). Under conditions with waves breaking on the beach, erosion is typically on the order of an inch or two high and may move on the order of an inch up to a foot in an episode of erosion up the beach. The sediment movement, in this scenario; is from wherever on the beach the wave breaks, down to lower portions of the beach. Since the waves break on the beach, the upper riverbank is not undercut to any significant degree.

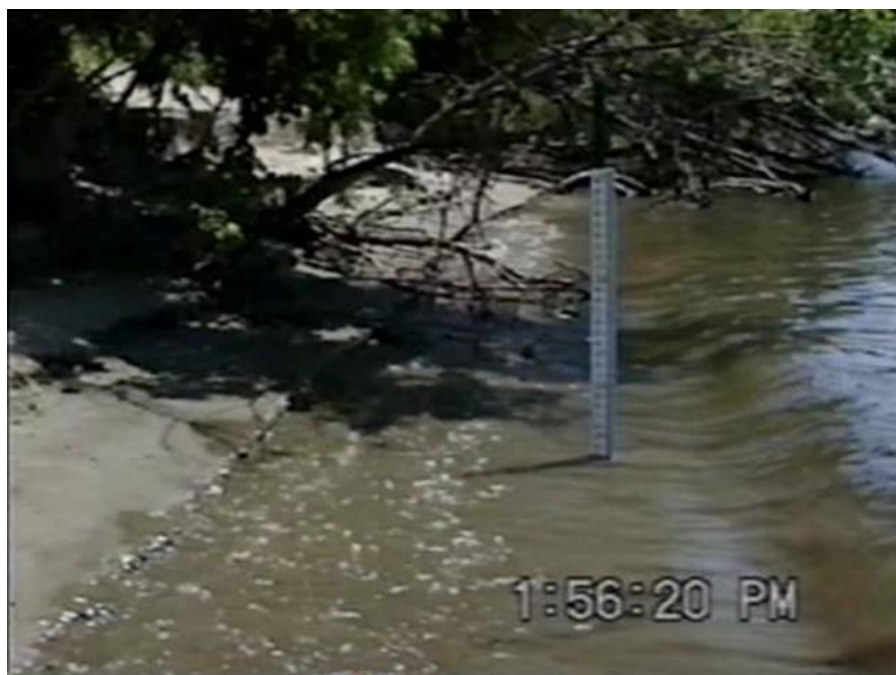
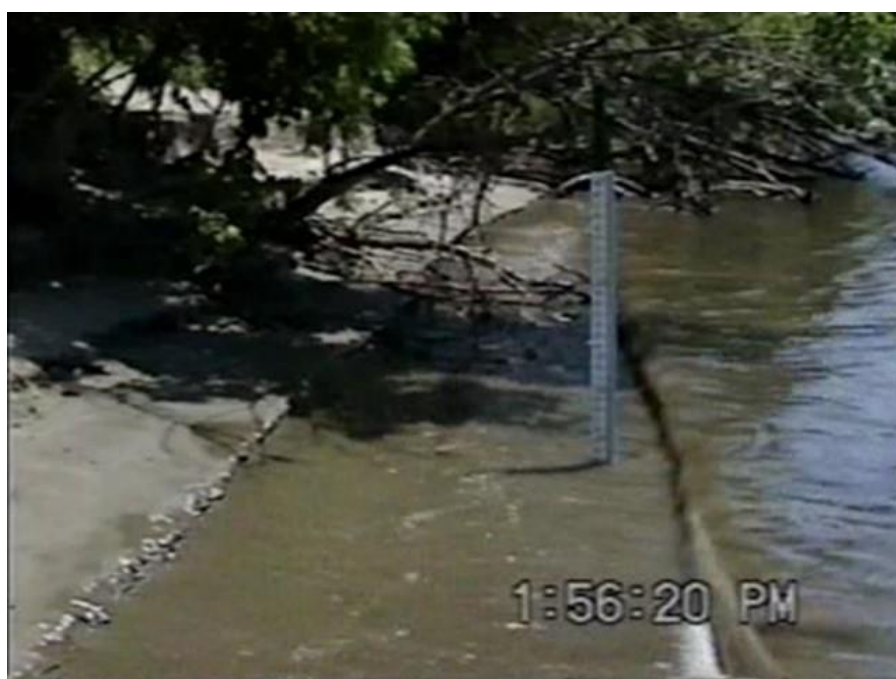
Figure 5.5.3-2b: Boat Wave Data Collection, July 1997

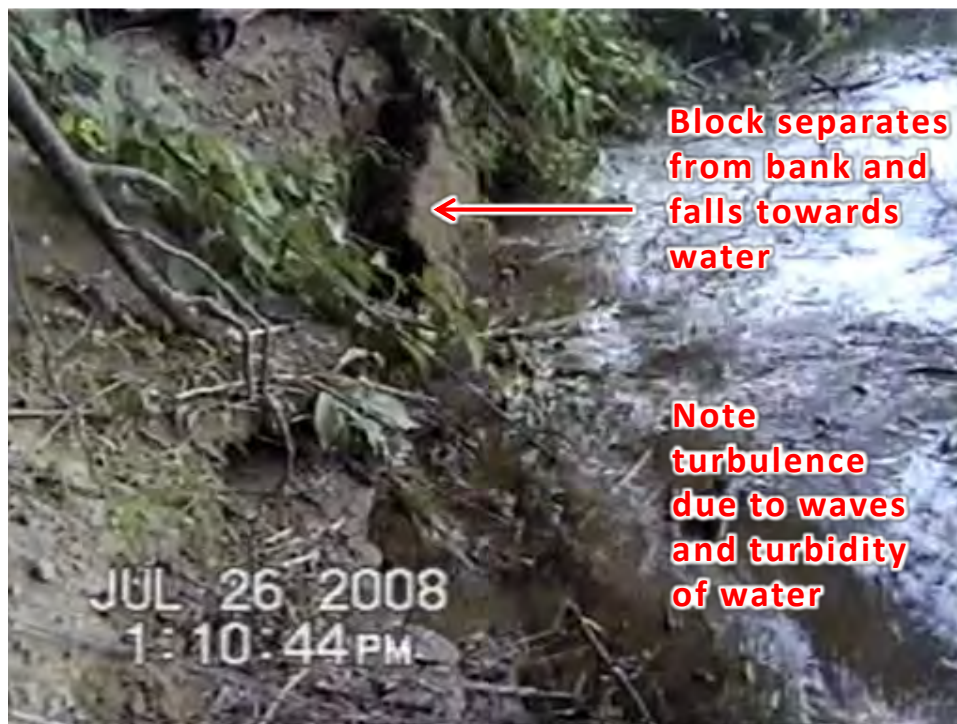
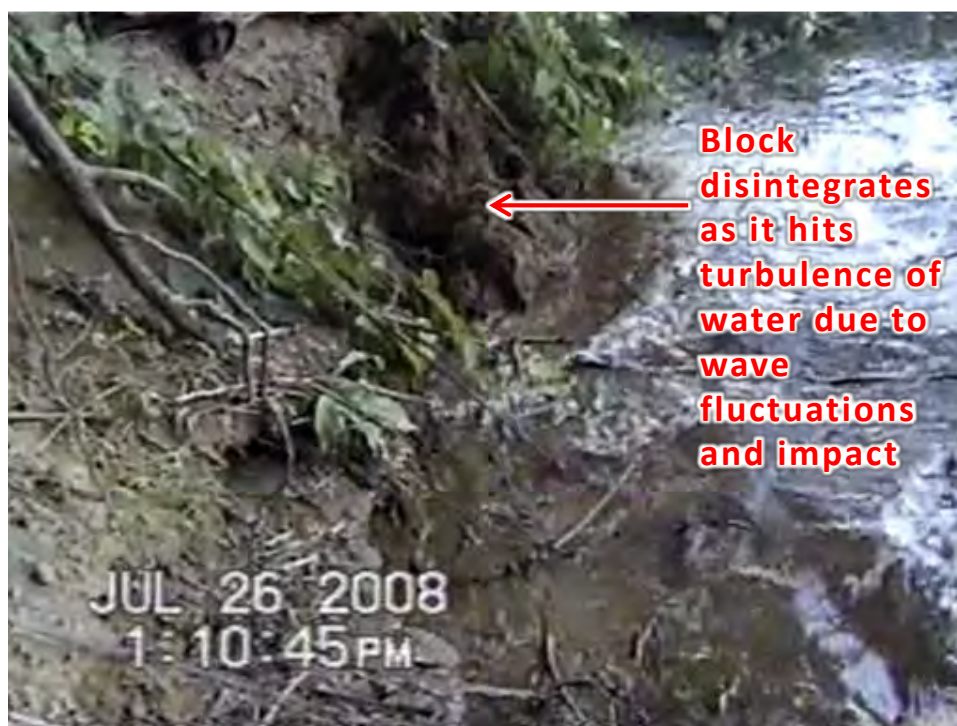
The boat traffic was relatively light for a weekend in July due to cool temperatures and occasional rain. Despite the light boat traffic, significant erosion was observed due to boat waves. [Figures 5.5.3-6a](#) and [5.5.3-6b](#)) show a sequence of boat wave impact and erosion photos captured from the video taken these two days. This sequence of photos covers a period of about 10 seconds. The first photo in the sequence shows that a piece of riverbank about 4 to 6 inches in thickness and about a foot or more in height was being undercut by waves at its base had begun to crack loose from the riverbank. As the waves continue to impact the base of this riverbank the crack widens and then the piece falls into the turbulent water. Because the water level was on the upper bank, boat waves undercut the bank and easily caused pieces of bank to fail. As a result, erosion was quite significant over this two day period at the observation site. Hours of video tape are available showing the significant and progressive erosion that resulted from boat waves that impacted the upper bank during a moderately high flow event in July 2008. During these two days, no significant erosion was observed due to the current or the slow rise and fall of the water surface. Significant erosion was observed consistently, however, whenever boat waves impacted and undercut the riverbank. This can be clearly seen in the DVD documenting the study.

Figure 5.5.3-6b: Boat Wave Erosion Sequence

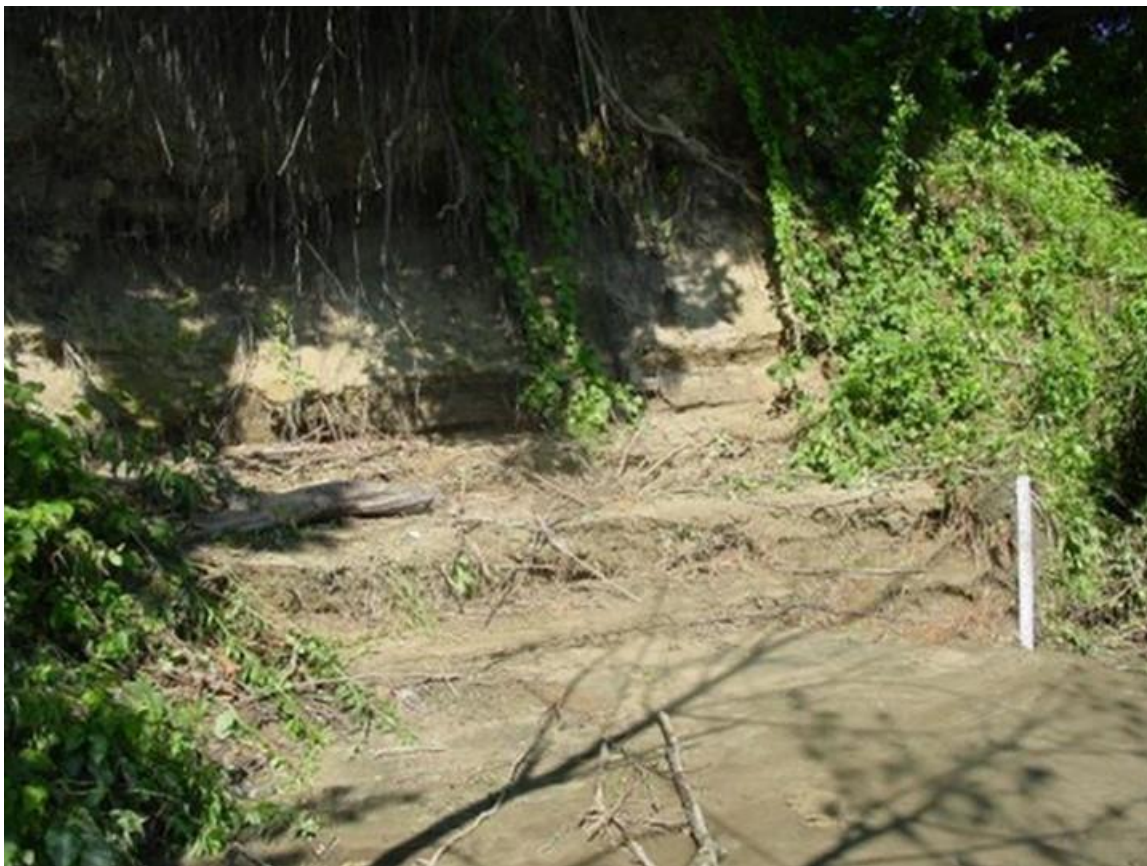
After the water had receded further, a photograph of this same area shows that about 4 vertical benches were eroded into the riverbank as waves impacted the bank at different levels as the water level varied with flow ([Figure 5.5.3-7](#)). Note that tree roots are observed dangling beneath the overhanging bank at the top of the photograph. It is apparent that other higher flow events have eroded this riverbank resulting in the overhanging bank. A view from a little farther out shows the notches cut into the riverbank by boat waves and the hanging roots from the undercut tree above the portion of the bank recently impacted by boat waves ([Figure 5.5.3-8](#)).

Figure 5.5.3-7: Example of Boat Wave Erosion

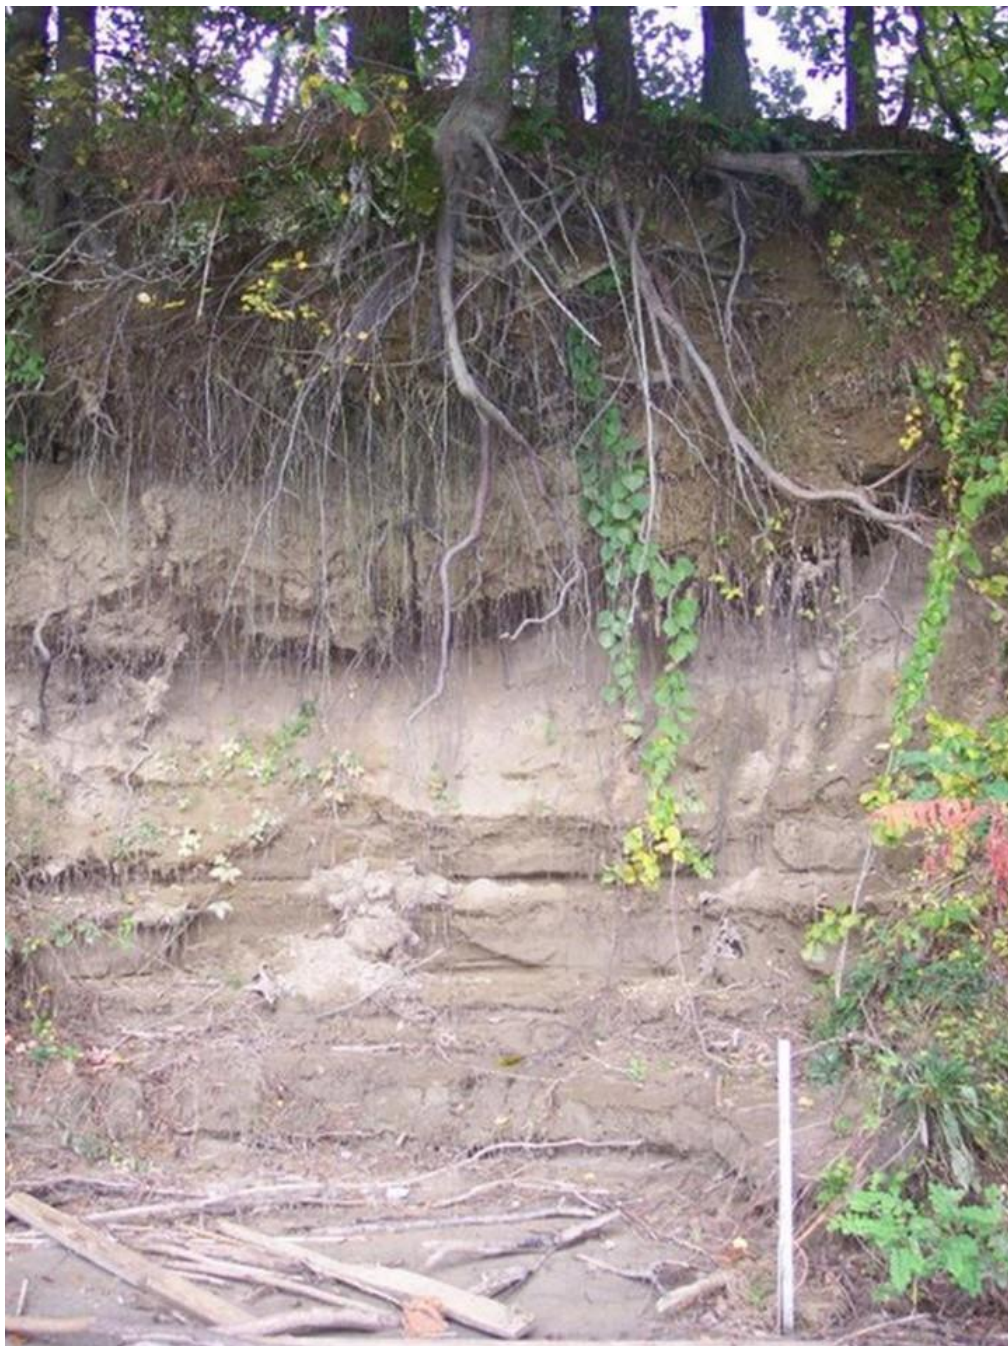
Figure 5.5.3-8: Example of Boat Wave Erosion

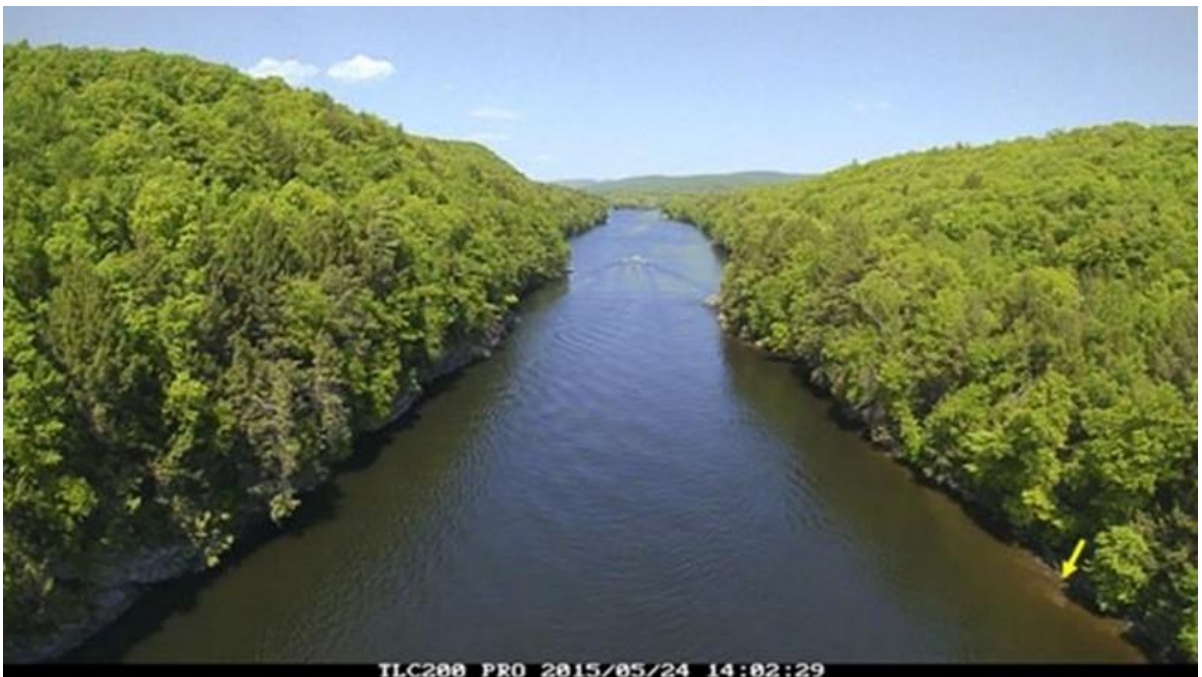
In 2015 detailed boat traffic and wave data were collected as discussed in [Section 4.2.8](#). As part of this data collection effort, cameras were placed on three bridges throughout the TFI to document boat traffic over time. Images from this effort provide further perspective into the fact that boat waves cause some erosion along the riverbanks of the TFI. [Figures 5.5.3-9](#) through [5.5.3-12](#), taken from the French King Bridge, provide evidence of the impact boat waves can have on erosion. As illustrated by the arrow in the figures, the waves breaking on the shore from the recently passed boat appear to result in a sediment plume emanating from the riverbank. As time progresses so too does the size of the plume.

Figure 5.5.3-10: Suspended Sediment Plume Expands

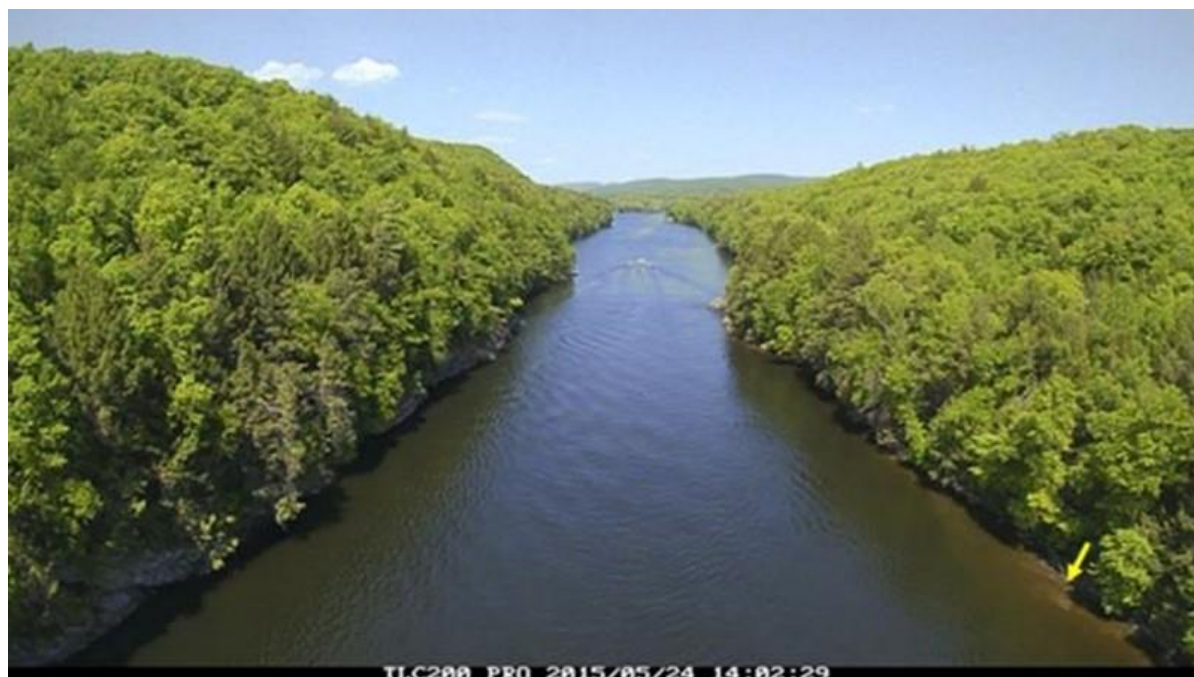
Figure 5.5.3-11: Further Expansion of Suspended Sediment Plume

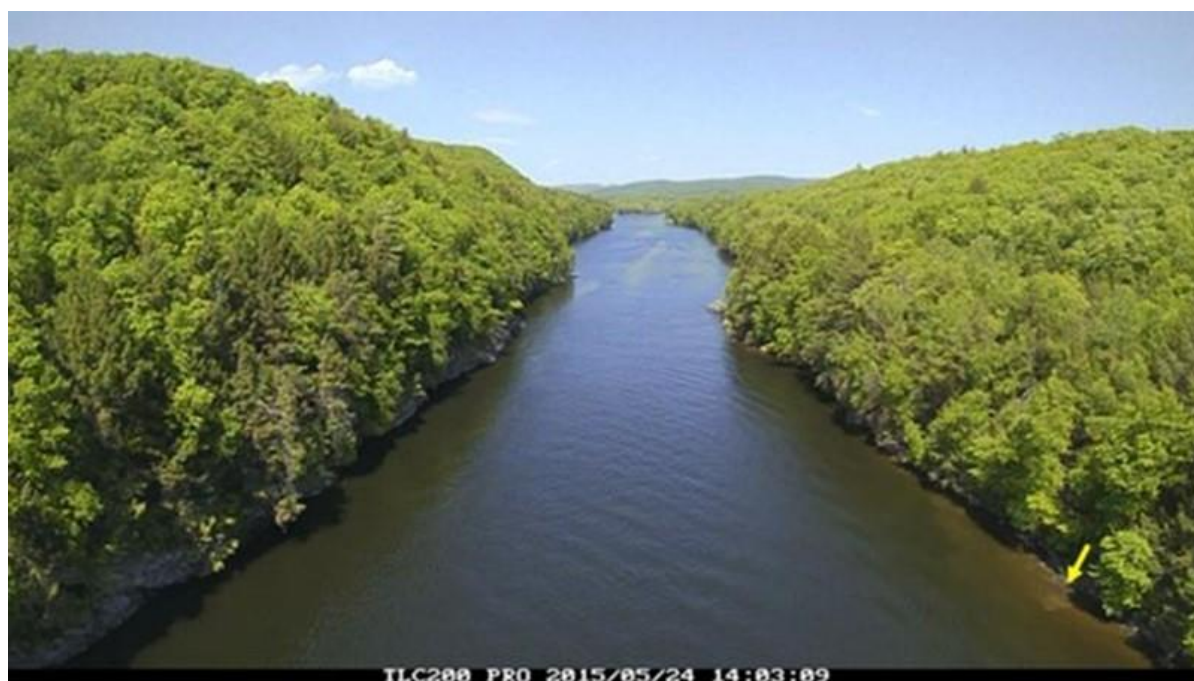
Figure 5.5.3-12: Suspended Sediment Plume Expands Farther Out From Banks

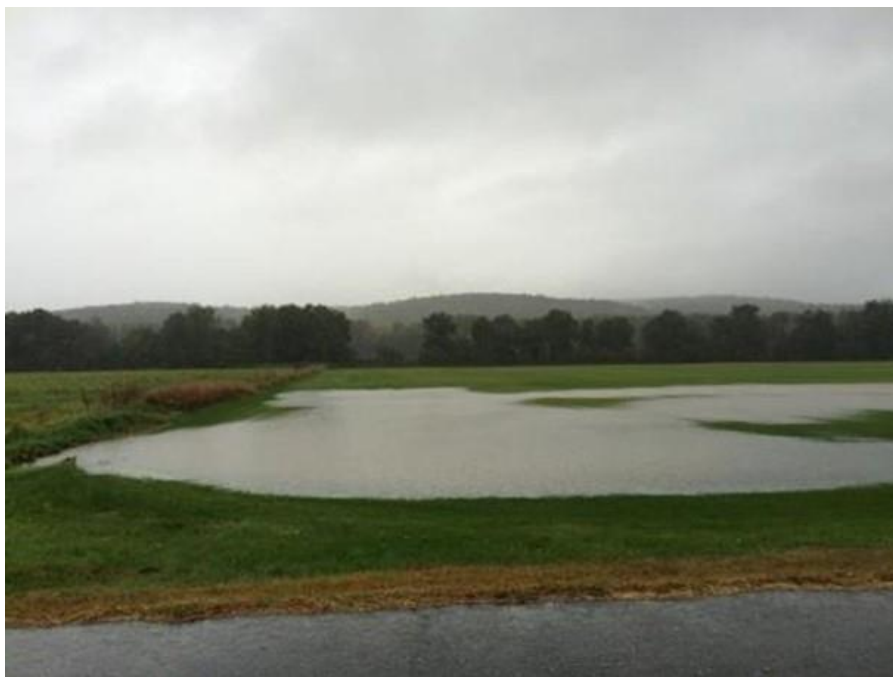
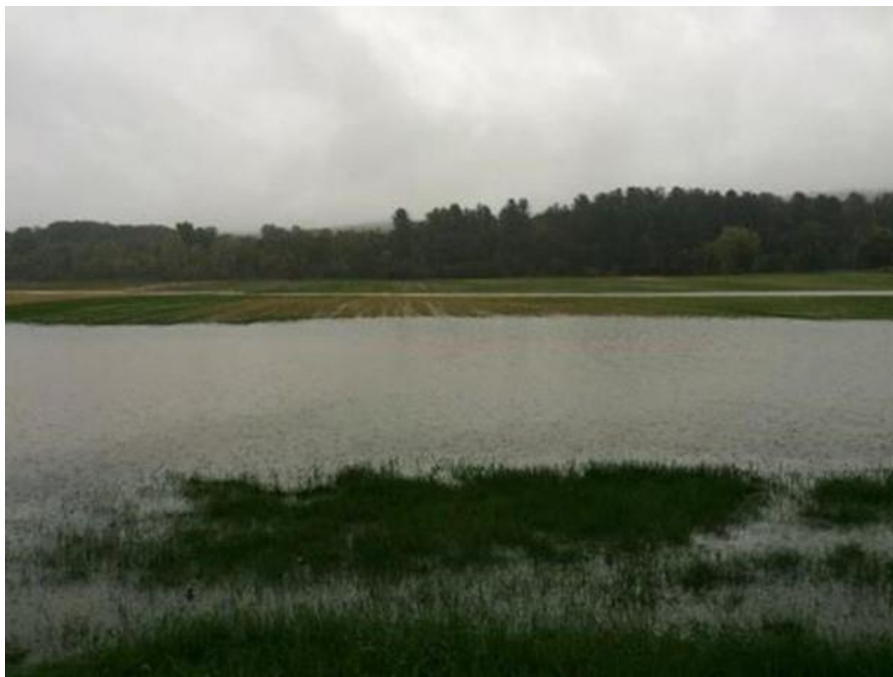
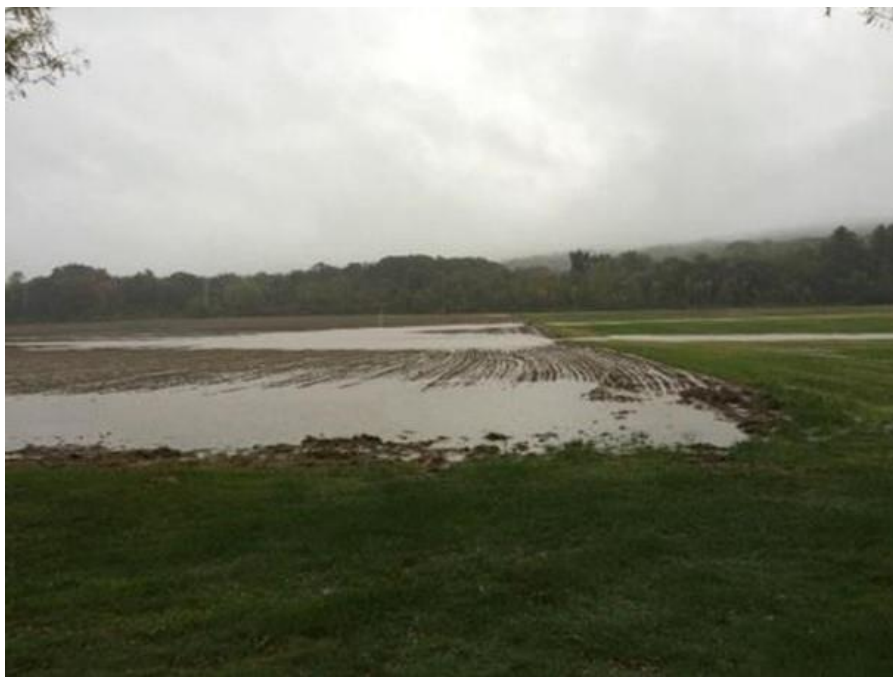
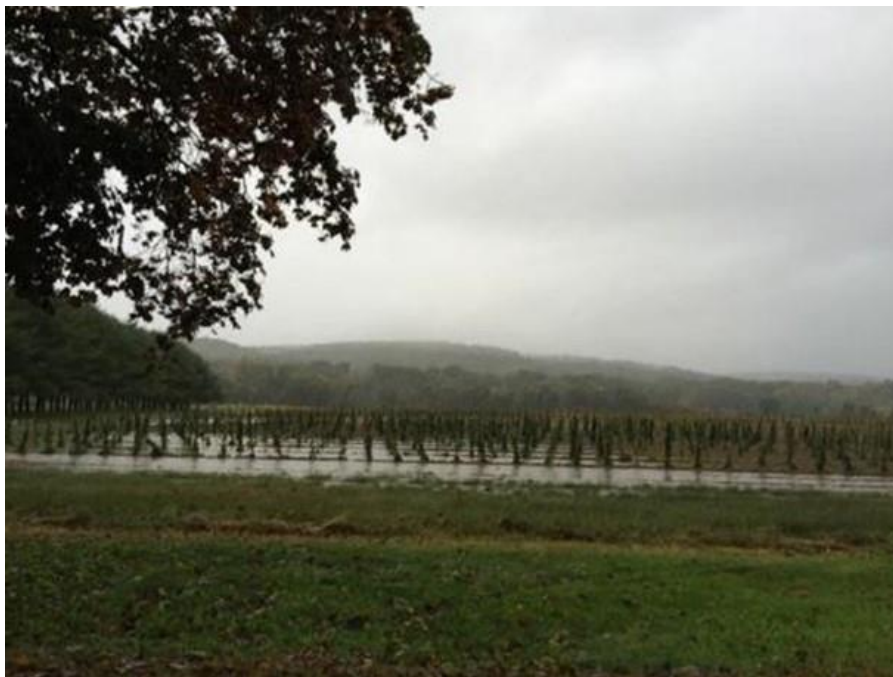
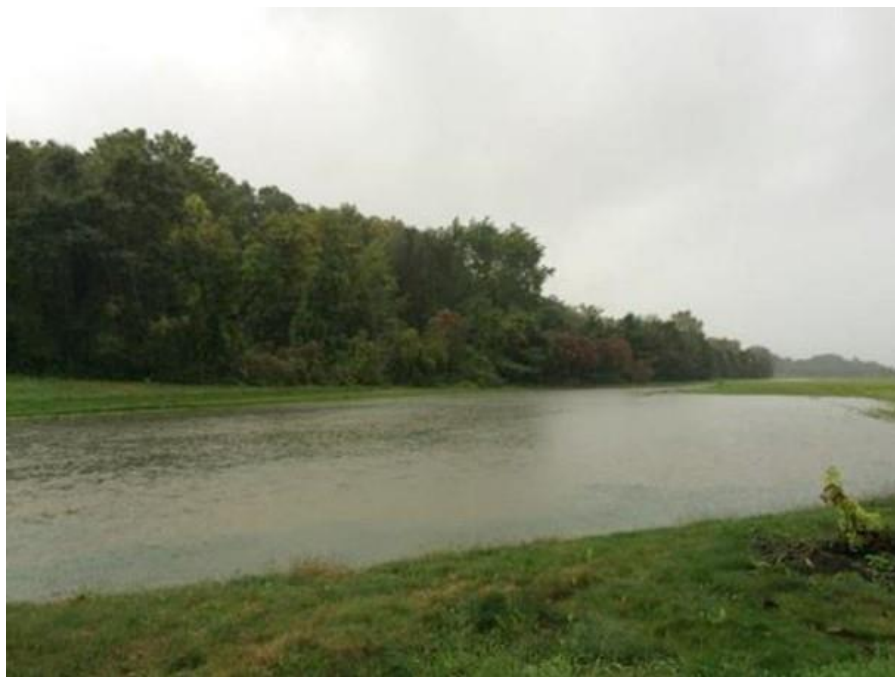
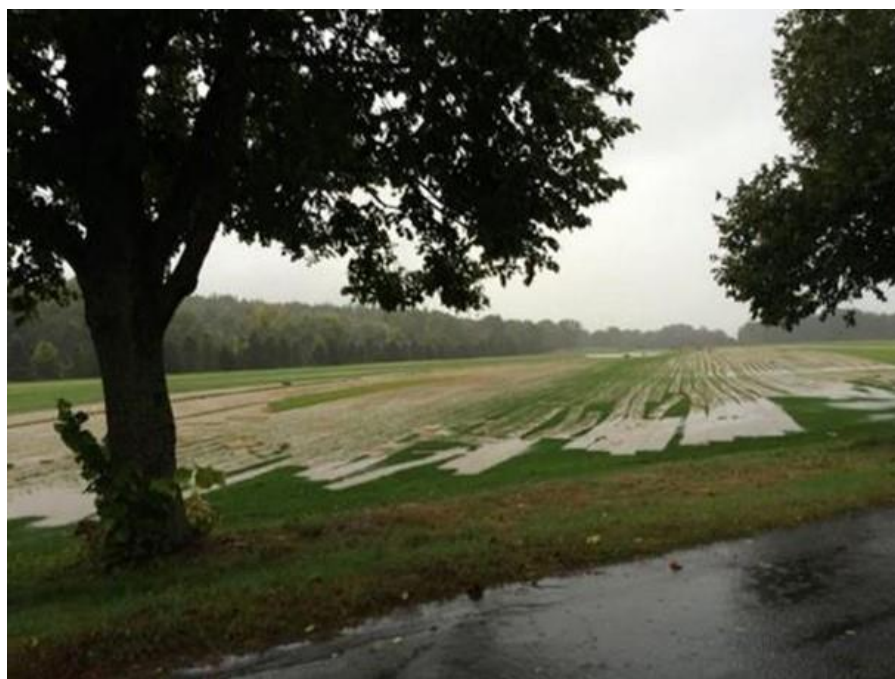
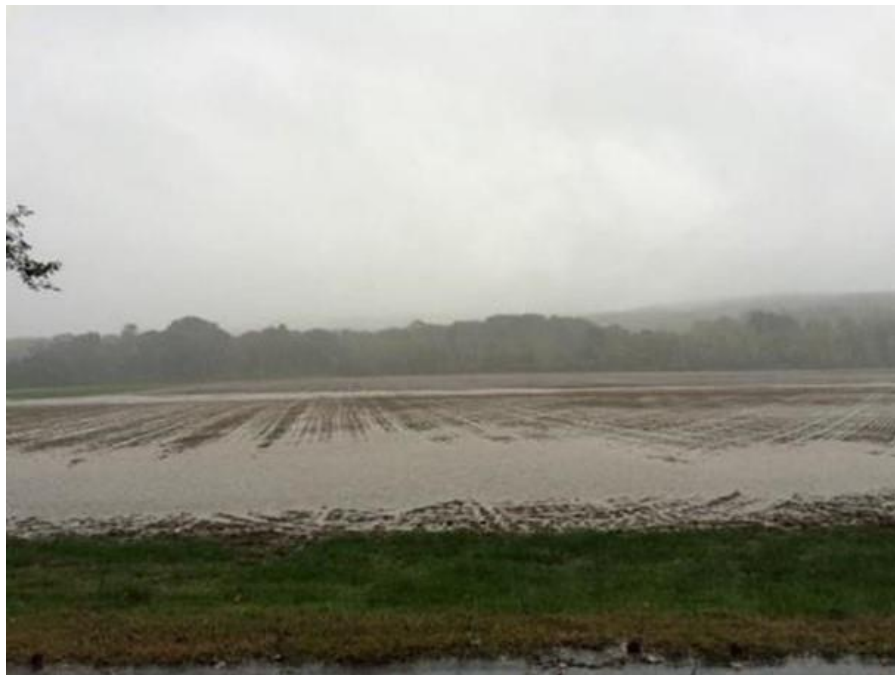
When significant rainfall occurs, water may pond on relatively flat agricultural fields and infiltrate into the ground ([Figures 5.5.4-7](#) through [5.5.4-13](#), 9/30/2015). This adds to soil saturation (compared to hillslopes where more rainfall tends to occur as runoff and less infiltration into the soil). A greater degree of saturation in these soils would then result in additional seepage through the riverbank and back to the river.

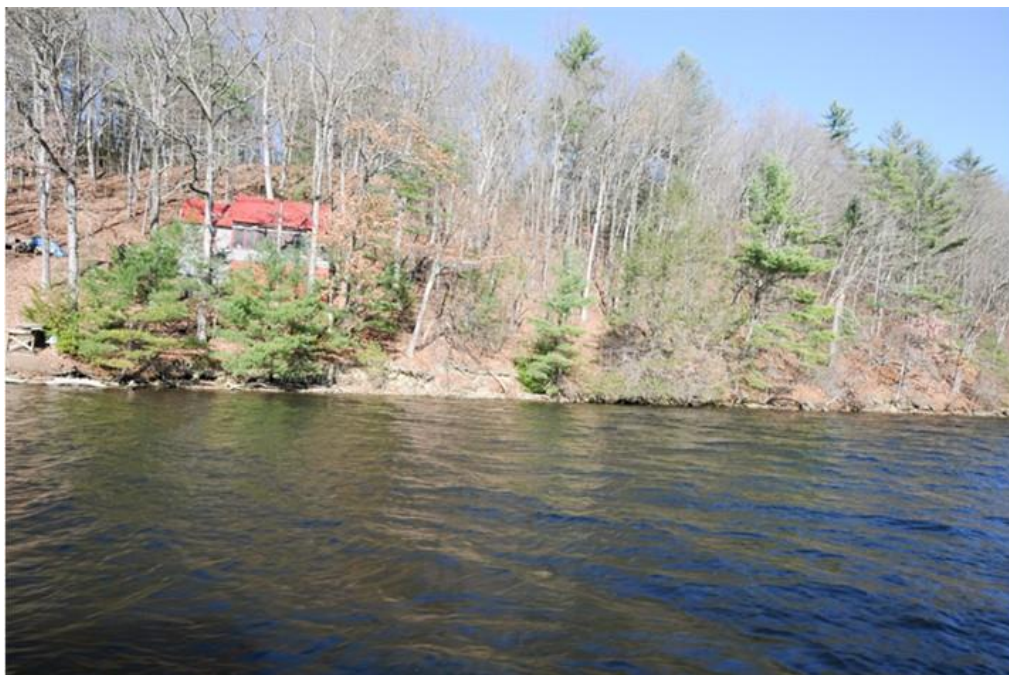
In addition to agriculture, erosion has also been observed in areas where houses and other associated development are located in close proximity to the river. An example of erosion in close proximity to a house is shown in [Figure 5.5.4-14](#). As shown in the figure undercutting, overhanging bank, and exposed roots were observed at this location in close proximity to the structure. In several instances where houses have been built close to the river, riparian vegetation has also been cleared which can adversely affect riverbank stability. An example of this is shown in [Figure 5.5.4-15](#).

Figure 5.5.4-14: Erosion adjacent to seasonal Camp 2-W

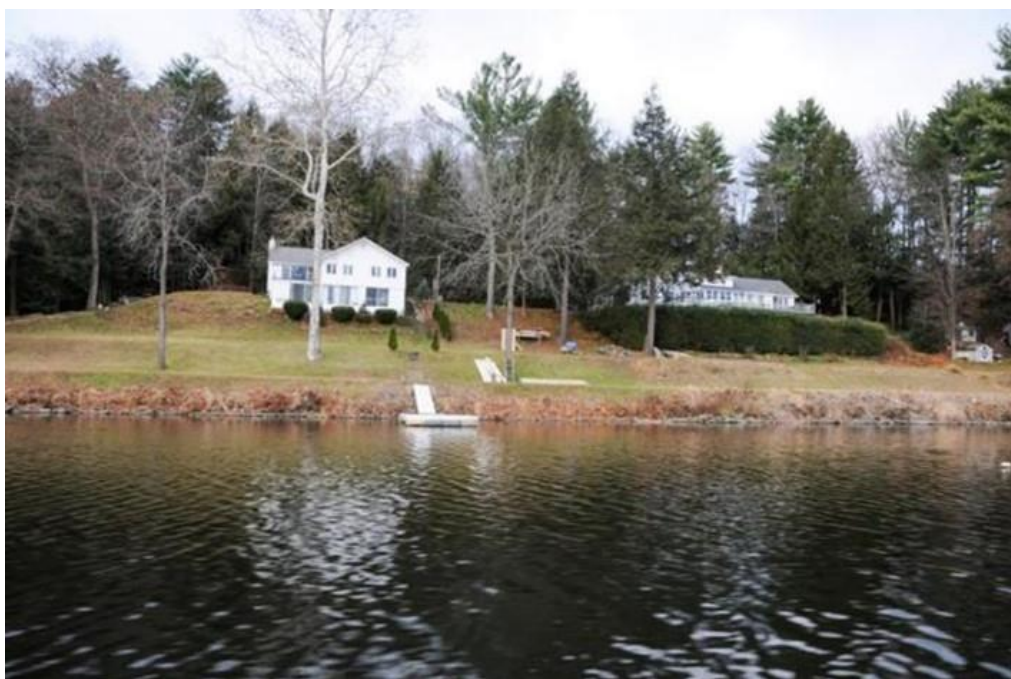
Figure 5.5.4-15: Development thinning or removing riparian vegetation

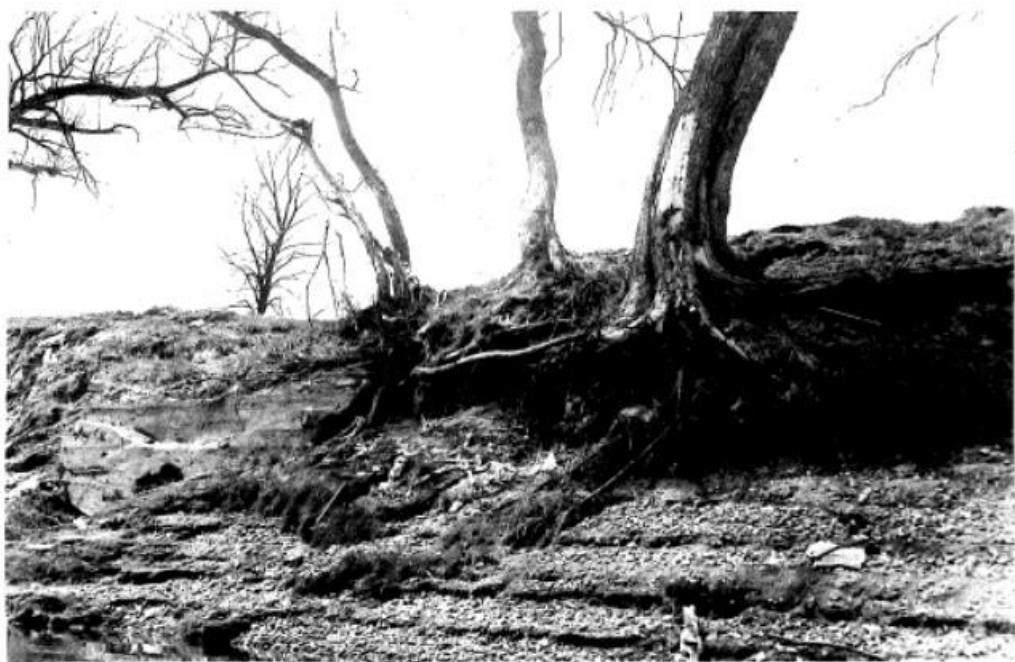
Figure 5.5.5.2-14 Connecticut River near Windsor, VT – April 24, 1946 (TransCanada)

Ice also has an adverse effect on riparian vegetation (as shown in previously referenced [Figure 5.5.5.2-14](#), [5.5.5.2-19](#), and [5.5.5.2-20](#)). As noted in R. Ettema, 2002:

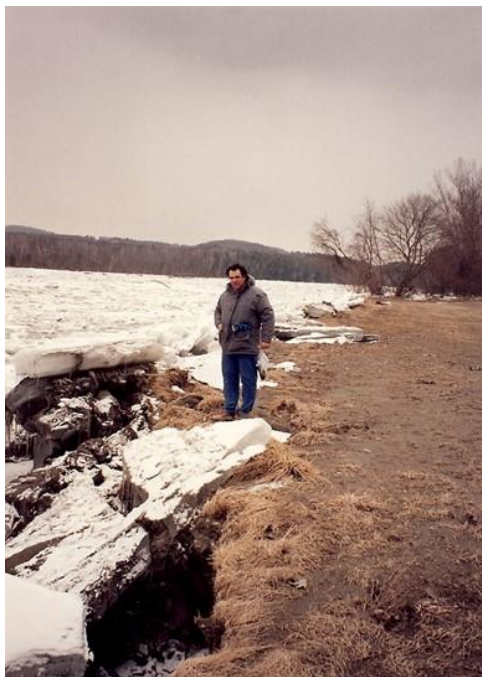
Damage to riverbanks near Cornish, NH in 1946 look very similar to what was observed farther downstream in the Bellows Falls Impoundment in the study conducted by Simons & Associates, [1992](#), "*Analysis of Bank Erosion at the Skitchwaug Site in the Bellows Falls Pool of the Connecticut River.*" The destruction of vegetation and the jagged nature of the top of bank in 1946 ([Figure 5.5.5.2-22](#)) following the ice event that year look similar to the lack of vegetation and ice pushed into the banks in 1992 ([Figure 5.5.5.2-23](#)). We believe the impacts at this location in 1992 were similar to that depicted in the 1946 photo.

Figure 5.5.5.2-23 Ice-Riverbank Interaction in Bellows Falls Impoundment – 1992 (TransCanada)

Another phenomenon discussed in R. Ettema, 2002 was that ice may cause erosion to riverbanks by abrasion or gouging. The review specifically noted that “*during heavy ice runs resulting from ice-cover breakup or ice-jam release, large pieces of ice potentially may gouge and abrade channel banks. There exists significant evidence showing that ice runs may substantially affect riverbank morphology* (Marusenko 1956; Hamelin 1979; Smith 1979; U.S. 1983; Doyle 1988; Wuebben 1995; Uunila 1997)” (R. Ettema, 2002). Ice flowing downstream, or being forced into the banks, was clearly seen in historic and recent photographs shown previously in this report (see [Figures 5.5.5.2-1](#) through [5.5.5.2-4](#), [5.5.5.2-9](#) through [5.5.5.2-11](#), and [5.5.5.2-23](#)). Damage associated with these ice events can be observed in previous figures ([Figure 5.5.5.2-13](#), [5.5.5.2-15](#) through [5.5.5.2-18](#), and [5.5.5.2-22](#) through [5.5.5.2-23](#)).

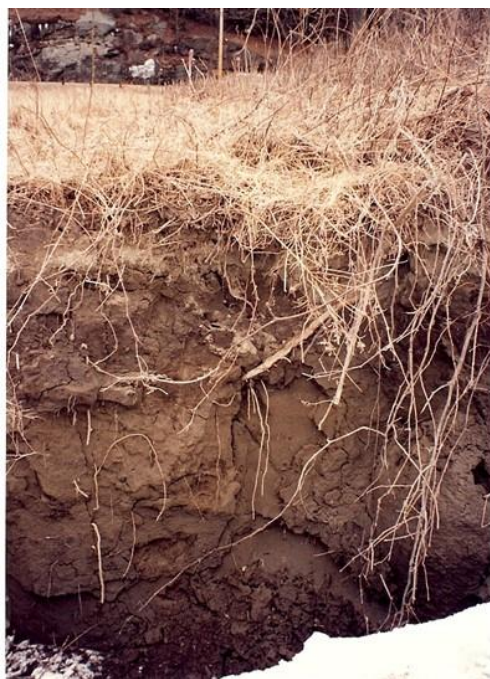
Inspection of riverbanks during winter conditions sometimes reveals cracks in the bank that may be related to freeze-thaw. Cracks that form as a result of this dynamic encourage more water to infiltrate into the crack because there is less resistance to flow than through the general soil matrix. As a result of subsequent freeze-thaw cycles, cracks in the soil may grow and eventually could lead to pieces of sediment breaking loose (spalling) and falling or sliding down the riverbank slope. [Figure 5.5.5.3-1](#) shows ice on the river as well as icicles hanging down the riverbank, which is indicative of water moving through the riverbank and freezing. [Figure 5.5.5.3-2](#) is an example of the small cracks forming in riverbanks that may be due to freeze-thaw. No actual data exist that allows quantification of the effect of freeze-thaw cycles on riverbank stability in the TFI. Freeze-thaw is a natural process that is primarily influenced by weather and climatic cycles and is not considered a primary factor in riverbank erosion processes in the TFI, nonetheless it is likely to contribute to riverbank instability to some lesser degree.

Figure 5.5.5.3-2 Cracks in a Riverbank Potentially Associated with Freeze-Thaw
