Relicensing Study 3.1.2

**Northfield Mountain / Turners Falls
Operations Impact on Existing Erosion and
Potential Bank Instability
Study Report**

**Northfield Mountain Pumped Storage Project (No. 2485) and
Turners Falls Hydroelectric Project (No. 1889)**

SEPTEMBER 2016

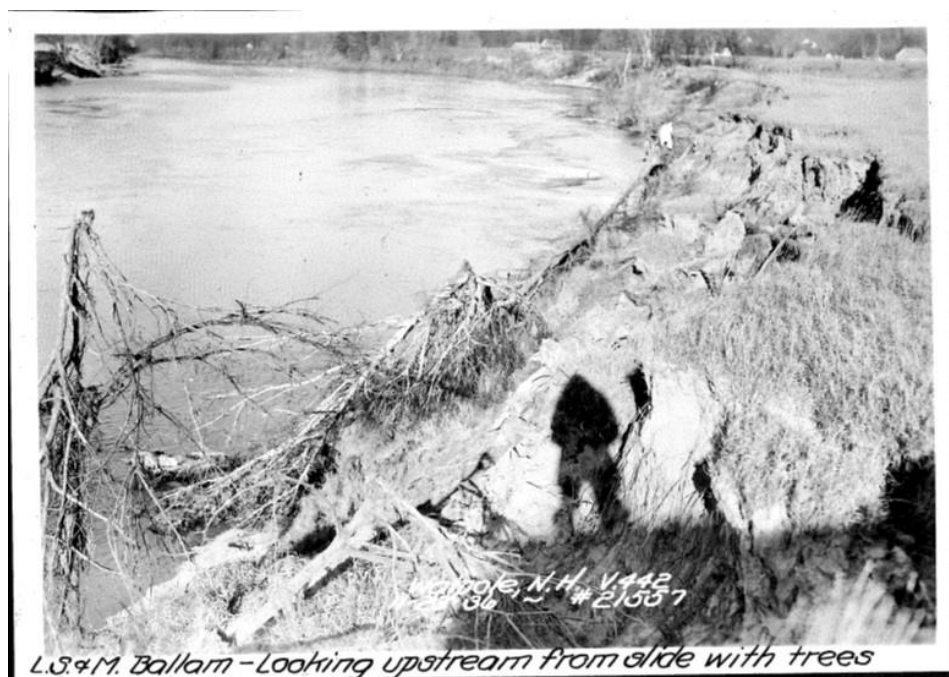
Figure 5.5.5-1 Erosion Damage – 1936 Flood

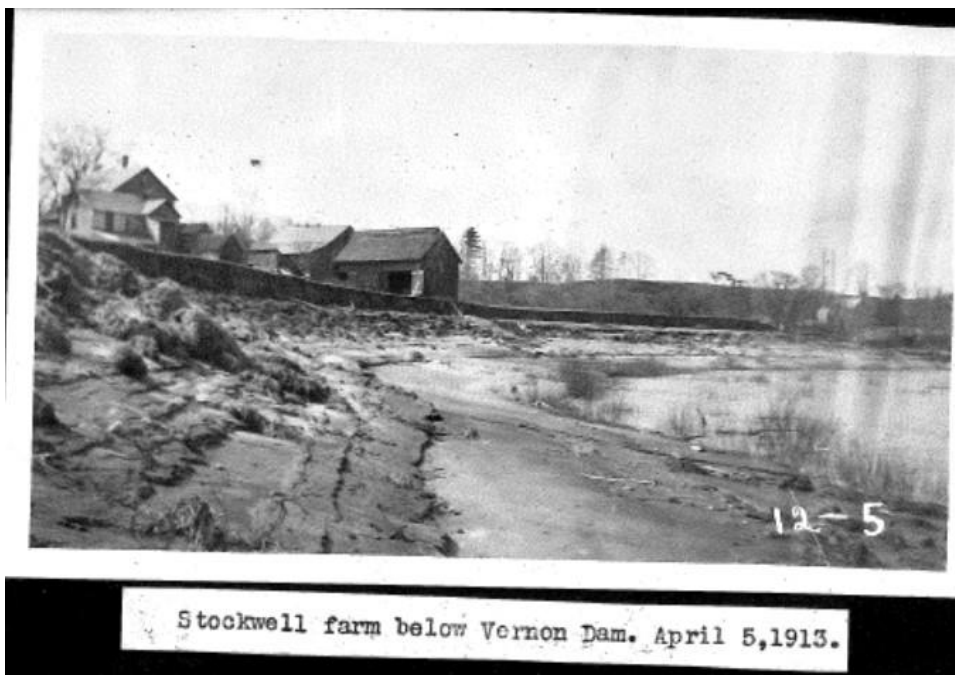
Figure 5.5.5.5 Eroded Bank in Turners Falls Impoundment Downstream of Vernon Dam – April 5, 1913 (TransCanada)

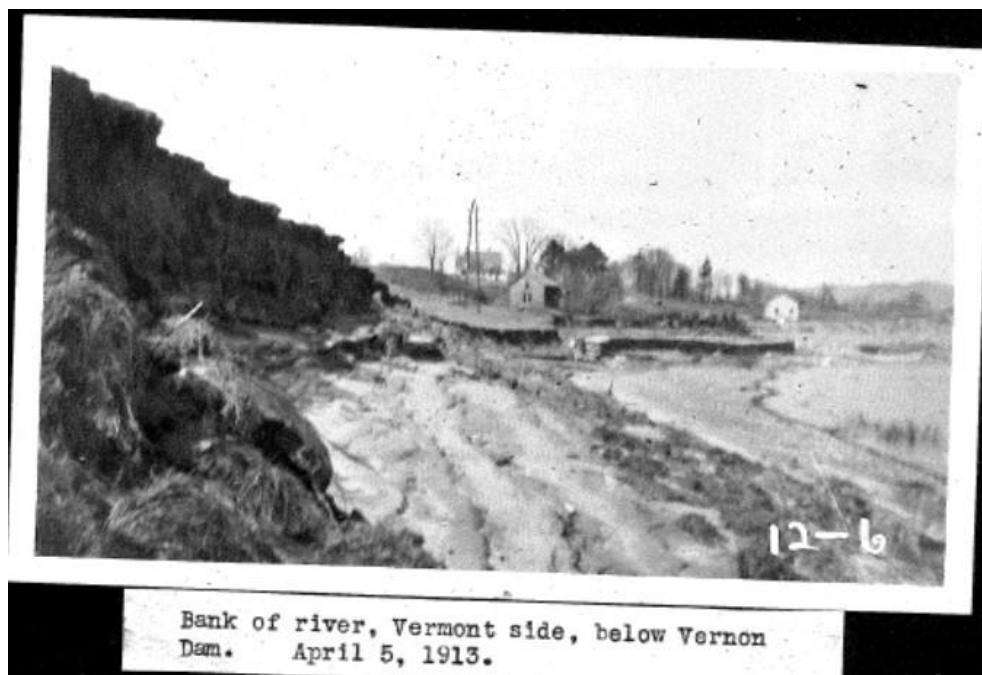
Figure 5.5.5.6 Eroded Bank in Turners Falls Impoundment Downstream of Vernon Dam – April 5, 1913 (TransCanada)

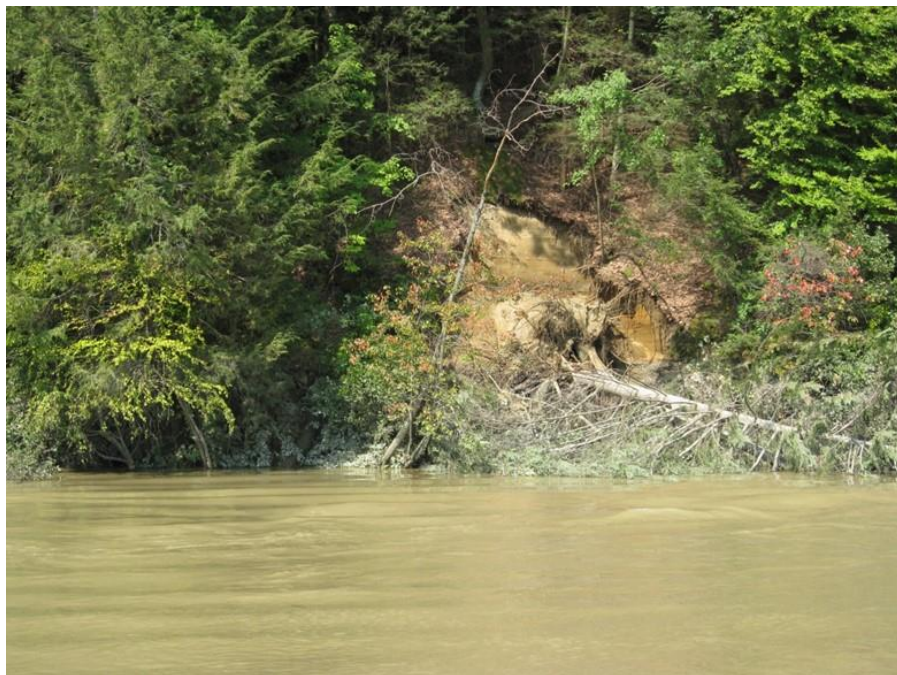
Figure 5.5.5.5-16 Erosion Due to High Flow in 2011

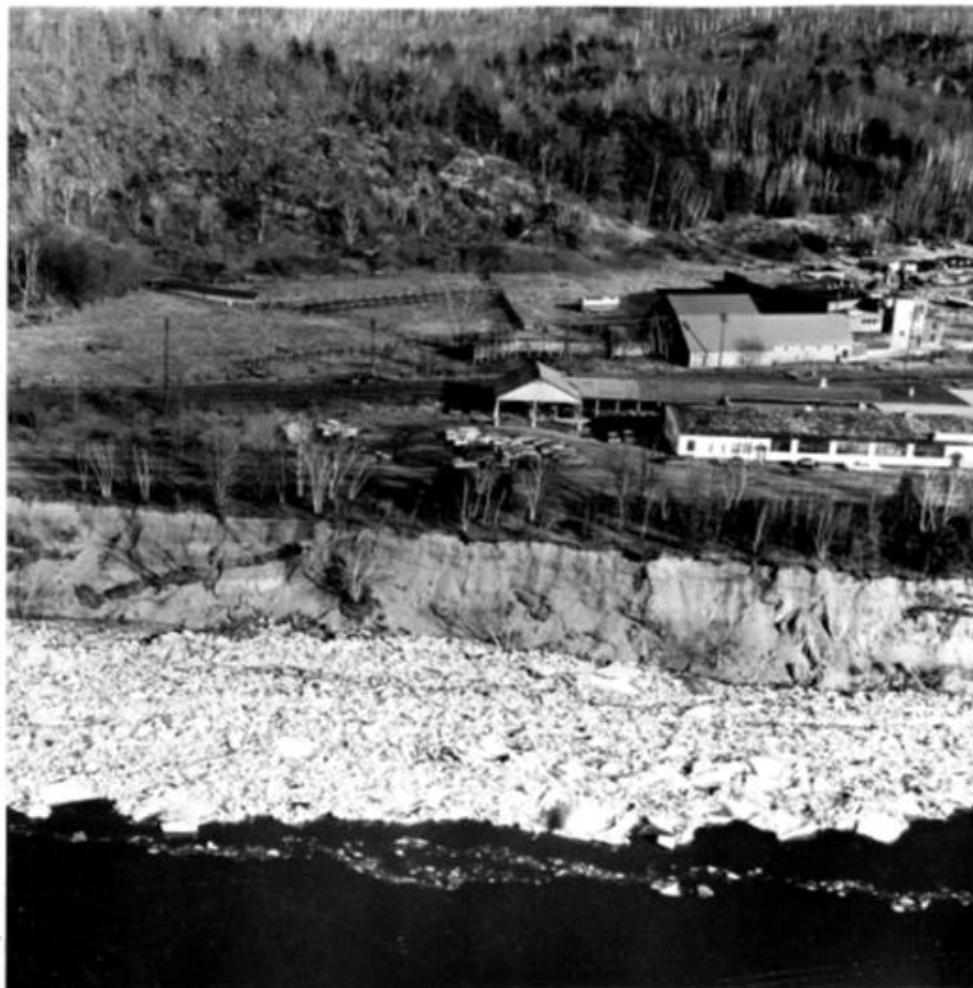
A - 3

March 25, 1968 - Eroded banks on N.E.P.
property just north of Gray banks.

Figure 5.5.5.23 Ice and erosion damage, 1968

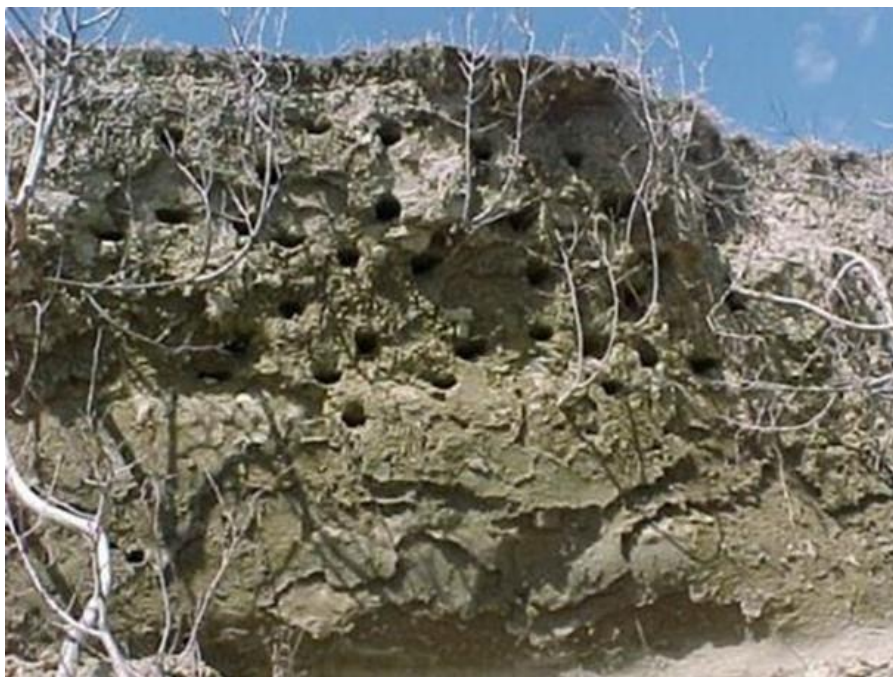
As part of the 2013 FRR, the locations of sensitive receptors found along or near the TFI riverbanks were mapped. A sensitive receptor was defined as important wildlife habitat located at or near the riverbank. Many wildlife features were observed during this survey including bank swallow and belted kingfisher nesting sites and bald eagle nest and perch sites. Of particular interest to this study were the bank swallow and belted kingfisher nesting sites since they are reliant on eroding banks for habitat. Belted kingfishers and bank swallows excavate cavities to use as nests in sheer banks lacking vegetation and containing appropriate soil conditions. [Figure 5.5.6-1](#) depicts the locations of the sensitive receptors identified during the 2013 FRR. An example of a bank swallow nesting site is found in [Figure 5.5.6-2](#).

Figure 5.5.6-2: Bank swallow nests – Flagg erosion site near Kidds Island, Turners Falls Impoundment

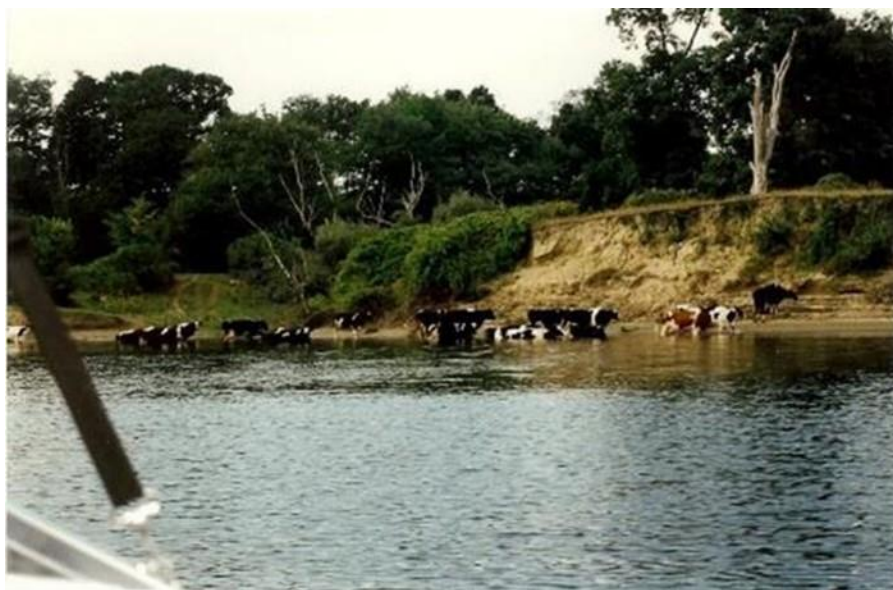
Along agricultural fields, paths are frequently created by animals traveling between fields and the river. Examples of this activity are shown in [Figure 5.5.6-3](#) and again in Figures [5.5.6-4](#) through [5.5.6-12](#). [Figure 5.5.6-13](#) shows the location where each of the photos in [Figures 5.5.6-4](#) through [5.5.6-12](#) were taken. At the agricultural field found in [Figures 5.5.6-4](#) through [5.5.6-12](#) it was observed that there were a number of animal paths over the length of the field. Based on the width of the riparian zone adjacent to this particular field, the animal paths were found where the riparian zone was narrow while no animal paths were observed where the riparian zone was wider.

Figure 5.5.6-3: Cattle using riverbank area along Connecticut River – Flagg erosion site near Kidds Island, Turners Falls Impoundment

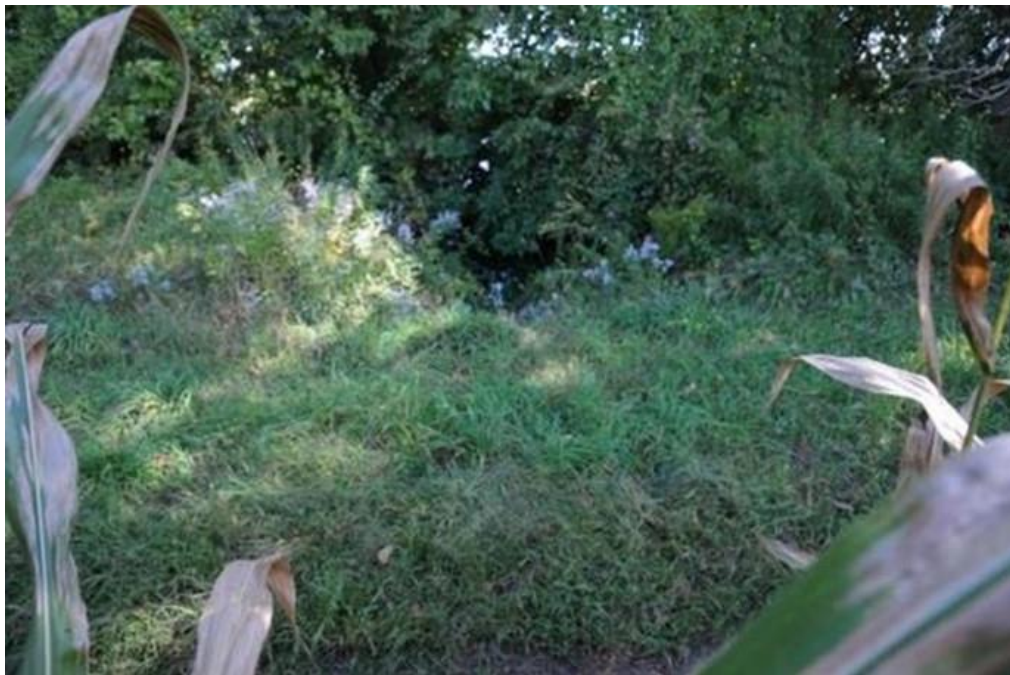
Figure 5.5.6-4: Animal path from river to field, Photo 101

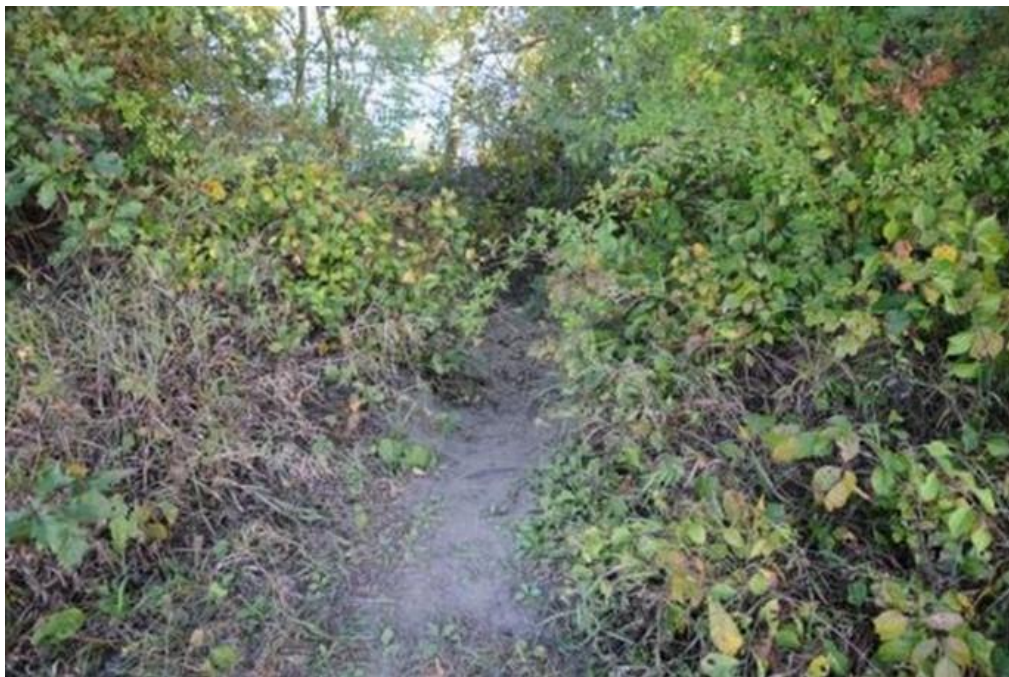
Figure 5.5.6-5: Animal path from river to field, Photo 109

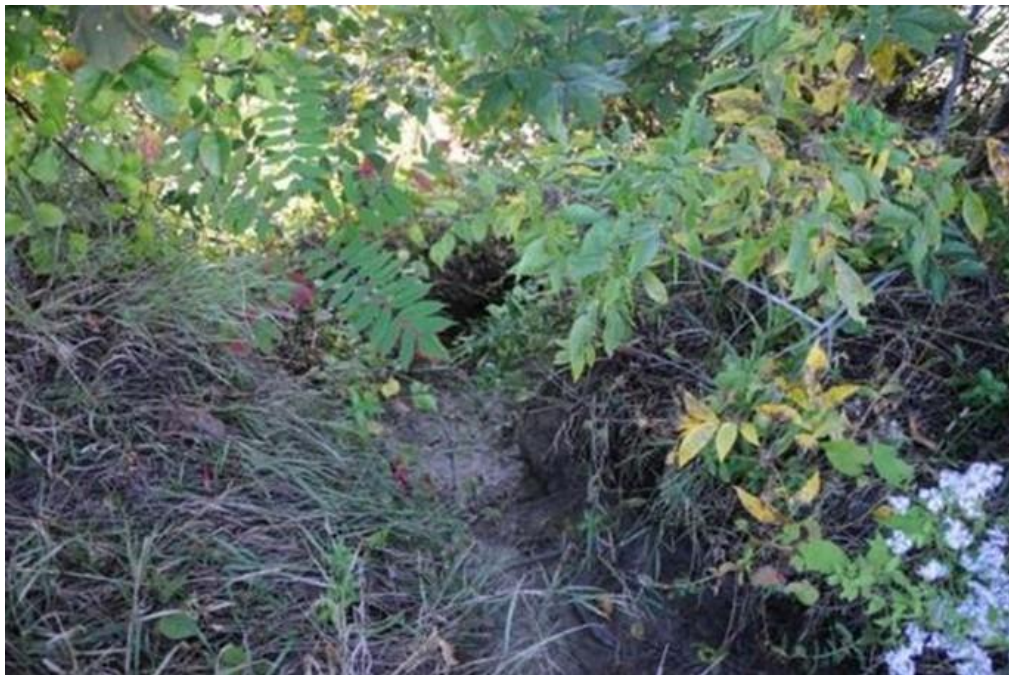
Figure 5.5.6-6: Animal path from river to field, Photo 117

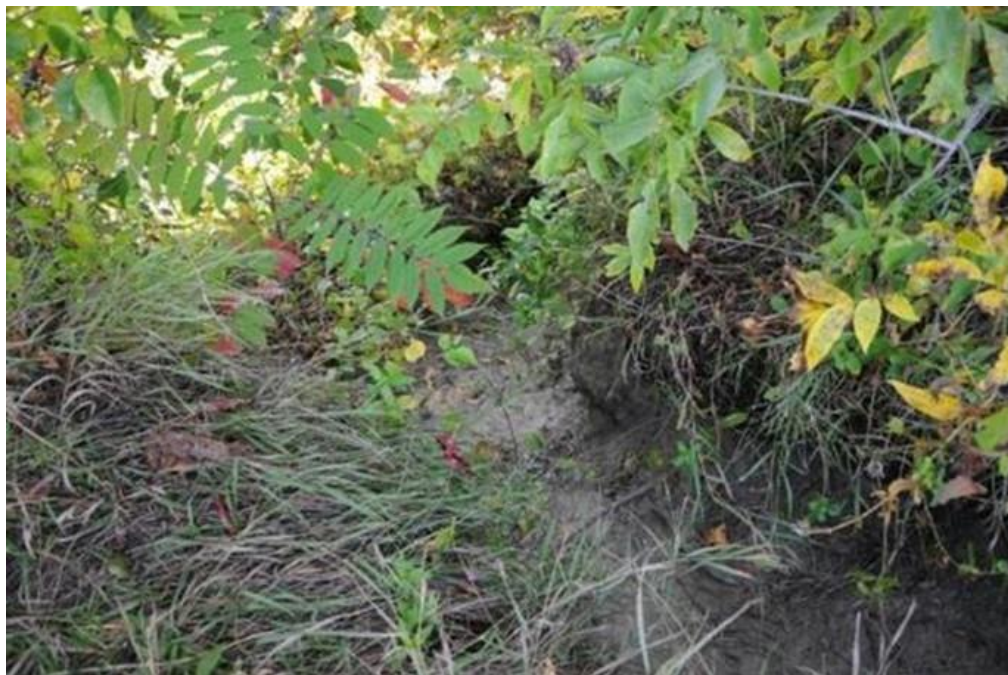
Figure 5.5.5-6-7: Animal path from river to field, Photo 119

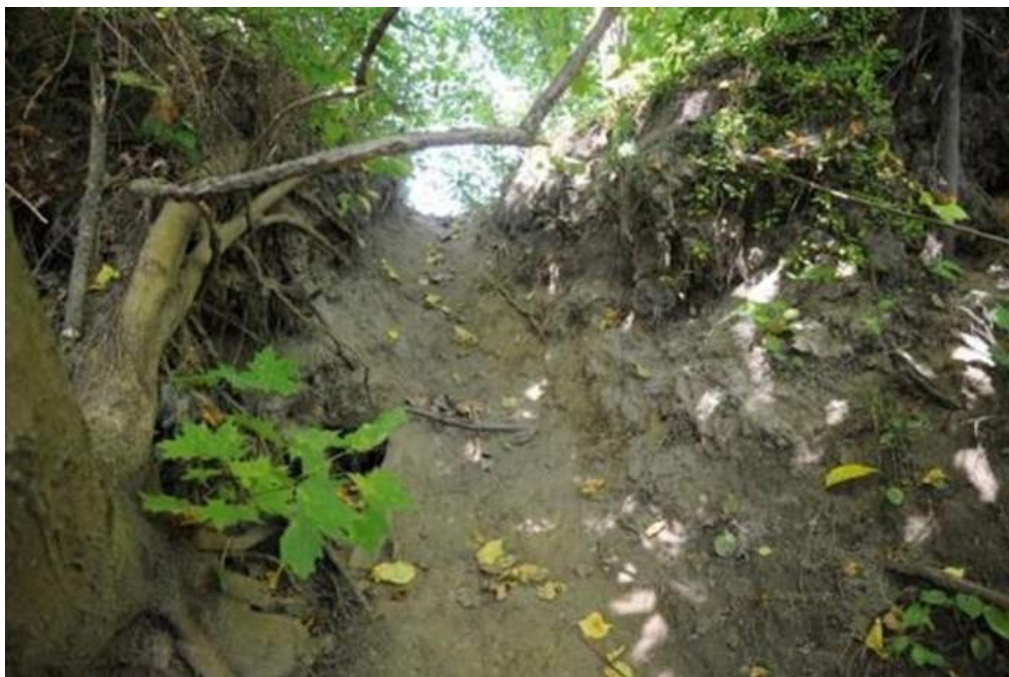
Figure 5.5.6-10: Animal path from river to field, Photo 128

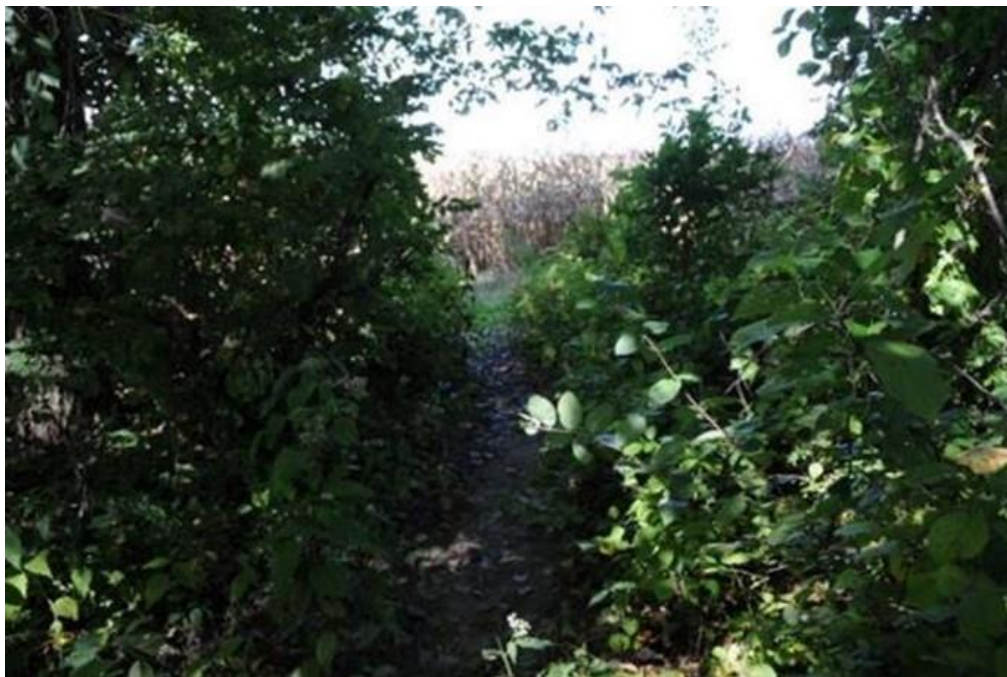
Figure 5.5.6-11: Animal path from river to field, Photo 130

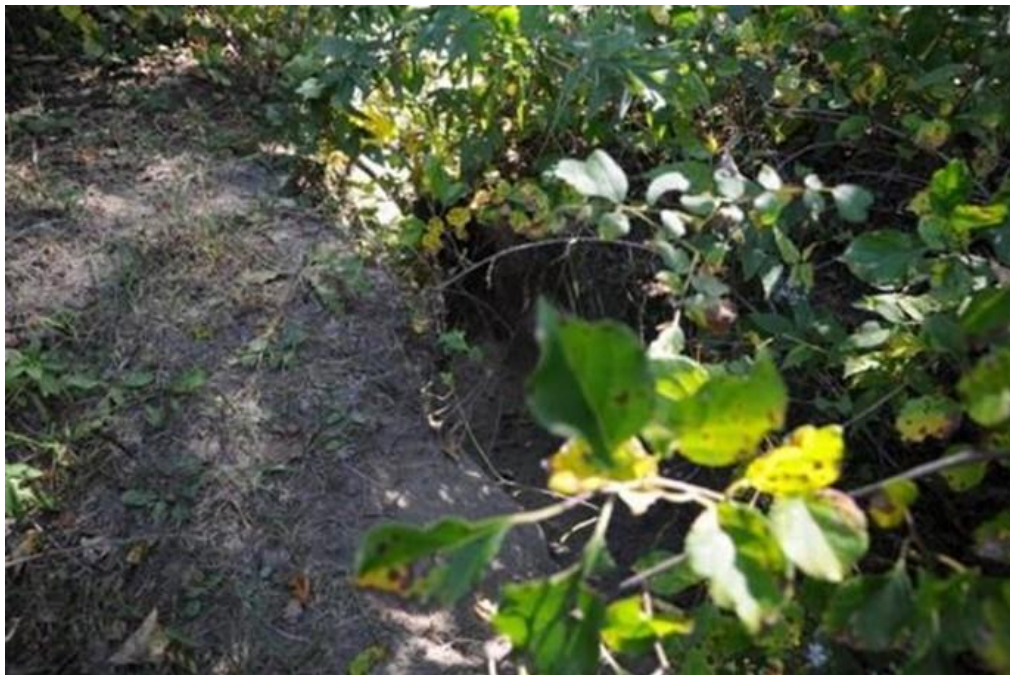
Figure 5.5.6-12: Animal path from river to field, Photo 135

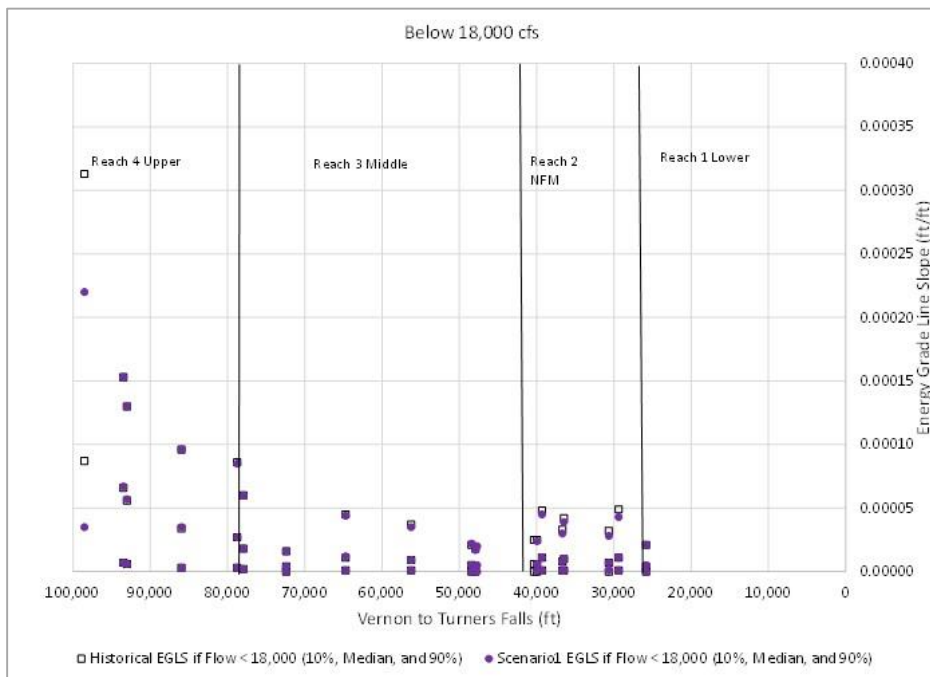
Figure 6.1.2.2-1: Energy slope trends through the Turners Falls Impoundment at flows less than 18,000 cfs

As observed in the figures, the energy grade line slopes for the supplemental run do not vary appreciably from the results of the Baseline Condition scenario, thus validating the four hydraulic reaches identified from the Baseline Condition HEC-RAS run. Given the clear delineation and characteristics of each hydraulic reach it is unlikely that a hydropower project can have an impact on erosion processes outside of the hydraulic reach in which it is located. While a hydropower project can impact water level fluctuations and flow outside of its hydraulic reach, the magnitude of those impacts are so minor that they do not affect the energy grade line slope outside of their given reach. For example, even though Northfield Mountain operations can impact the water surface elevation in reaches 3 and 4 at flows which exceed the erosion flow threshold at the detailed study sites, the impacts are so negligible that corresponding changes to the energy grade line slope do not occur. Thus, given the hydraulic characteristics of each reach it is unlikely that Northfield Mountain operations can impact erosion processes outside of reach 2. Conversely, it is also unlikely that Vernon operations can impact erosion processes outside of reach 4 or that Turners Falls operations can impact erosion processes outside of Reach 1.

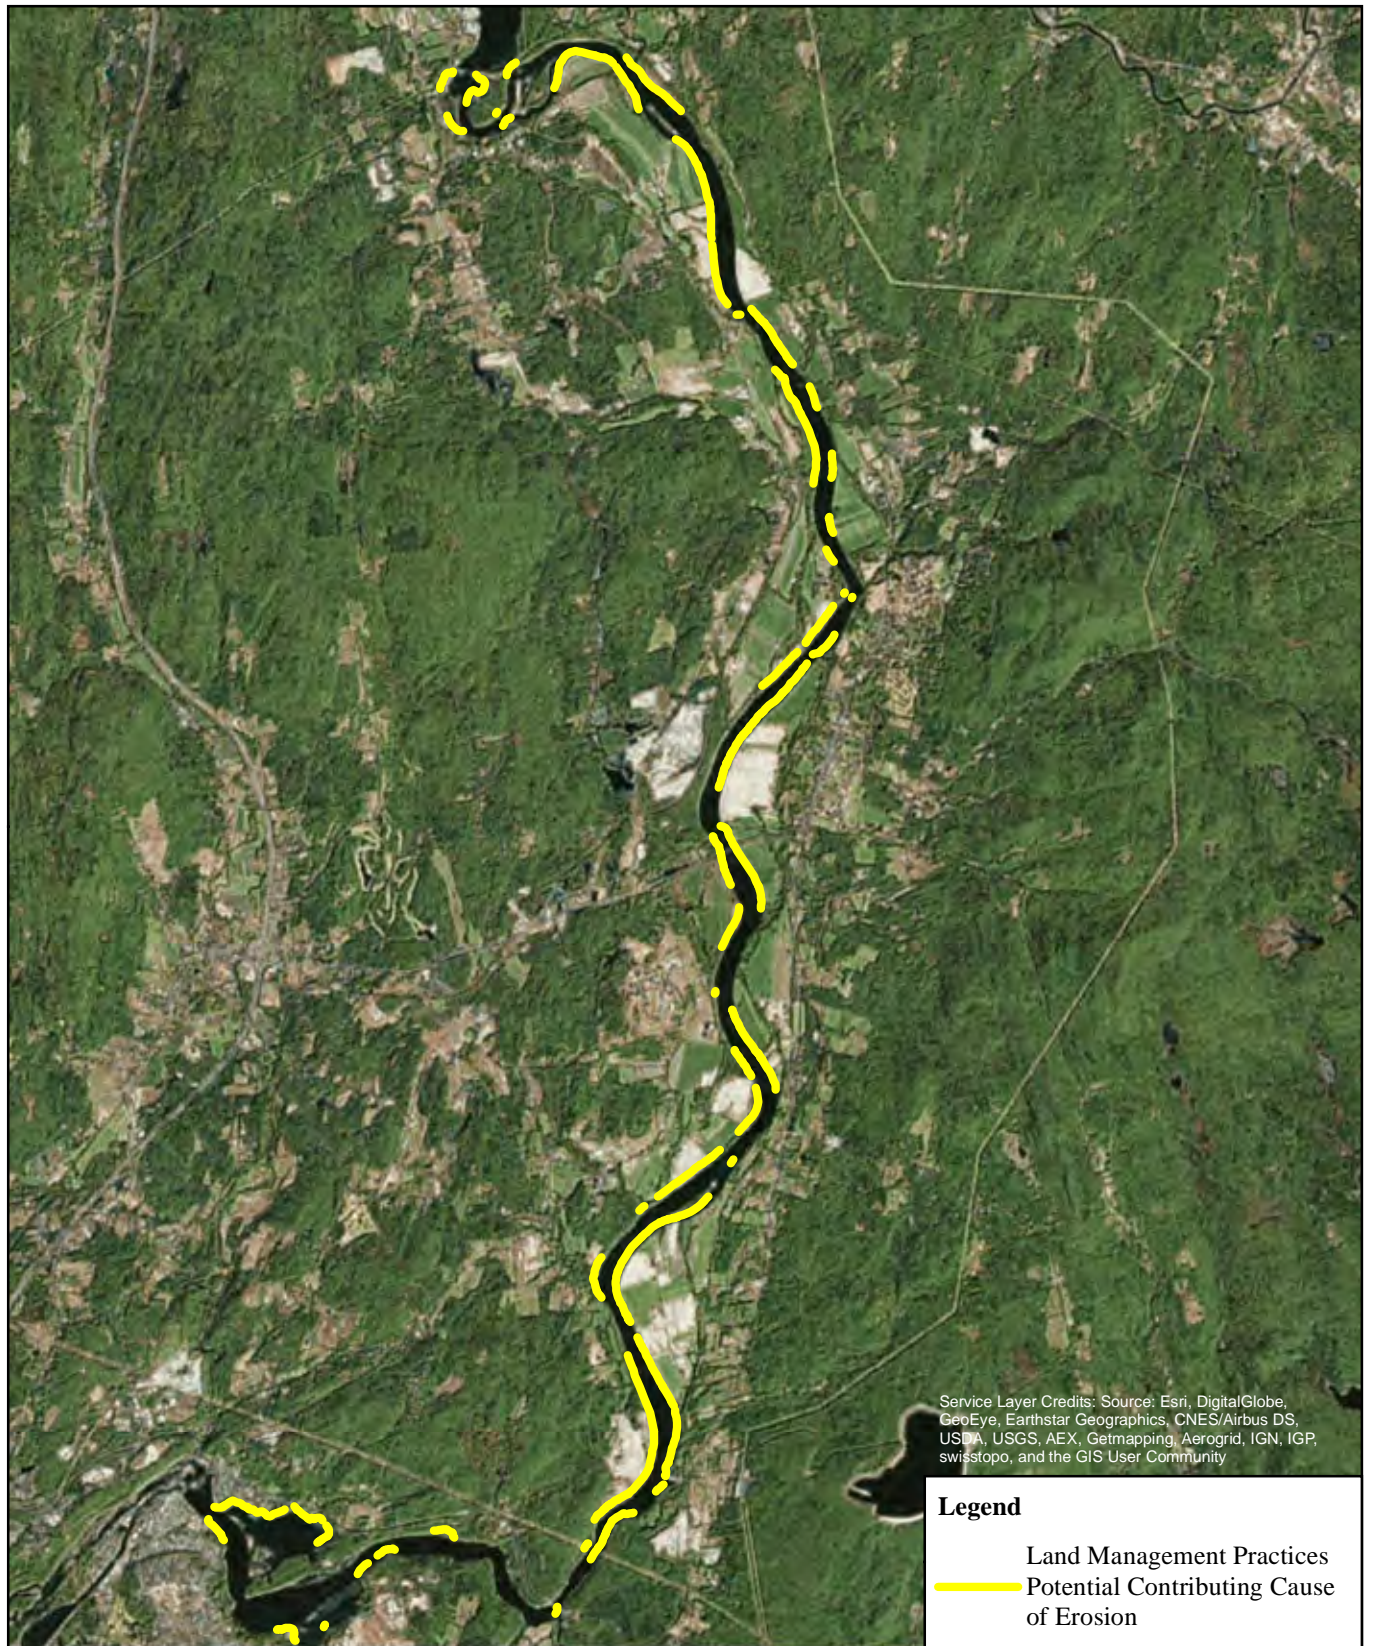
Figure 6.1.2.2-5:
Location of Turners Falls Impoundment
Riverbank Segments where Land Management
Practices are a Potential Contributing Cause of
Erosion

6. **Analyze land-use and width of riparian buffers:** Analyze the land-use and width of riparian buffers found adjacent to the riverbanks throughout the TFI in ArcGIS. Segments where the adjacent land-use is Agriculture or Developed and the riparian buffer width is less than 50 ft. were identified as segments where land management practices are a potential contributing cause of erosion;

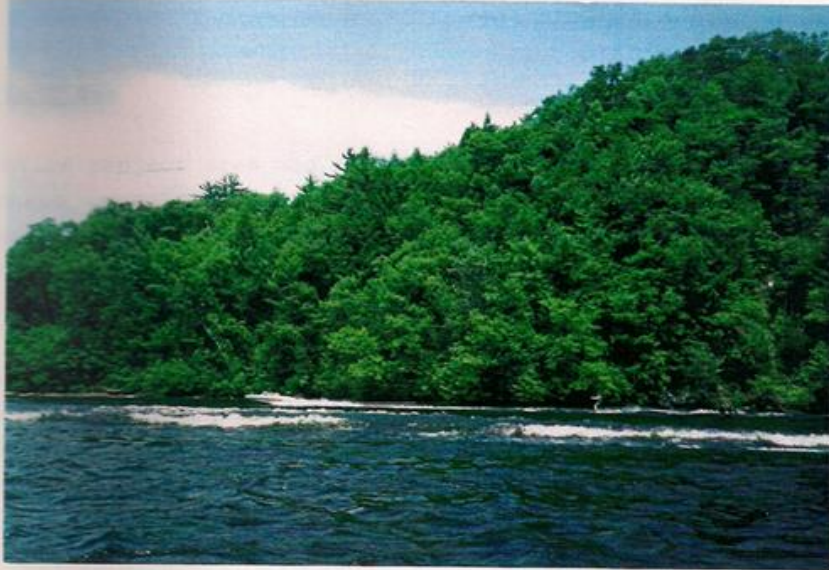
Power boating, including water skiing, is a growing recreational activity along the river - July 4, 1990.

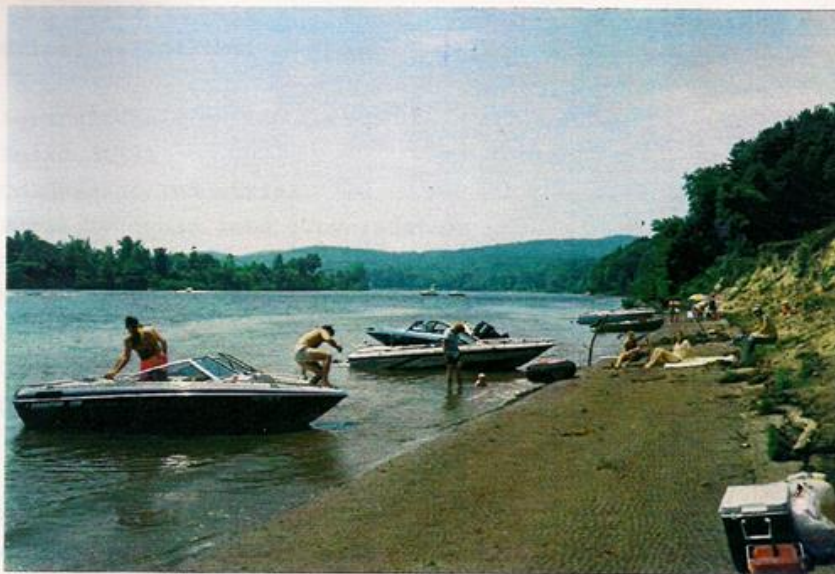
The long, exposed beach west of Kidds Island is a popular summer recreational spot for boaters - July 4, 1990.
