Relicensing Study 3.1.2

**Northfield Mountain / Turners Falls
Operations Impact on Existing Erosion and
Potential Bank Instability
Study Report**

Volume II – Main Report

**Northfield Mountain Pumped Storage Project (No. 2485) and
Turners Falls Hydroelectric Project (No. 1889)**

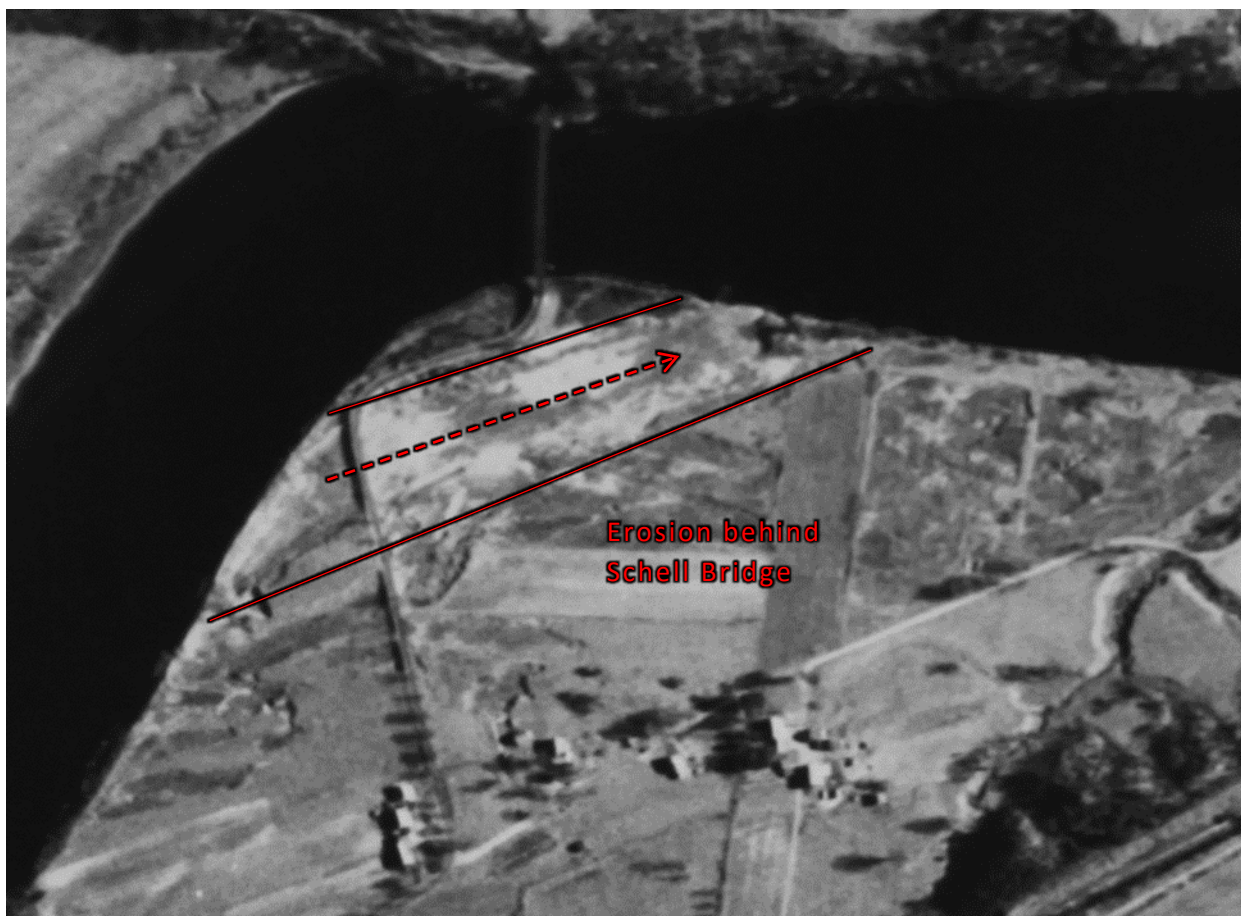
Figure 2.3.2-6 Erosion behind Schell Bridge, 1939 (c)

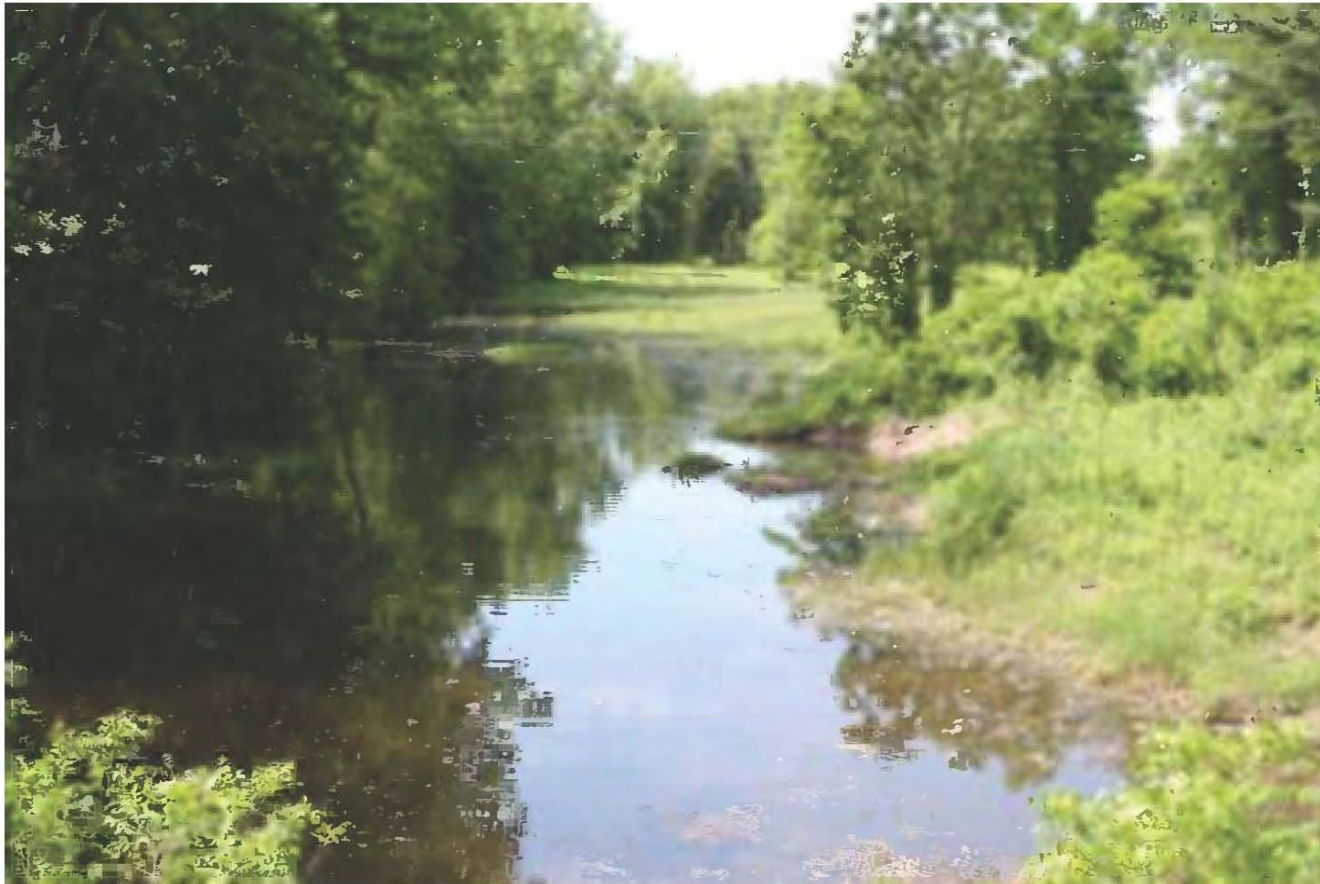
Figure 2.3.2-7 Abandoned avulsion channel behind Schell Bridge (d) (Field, 2007)

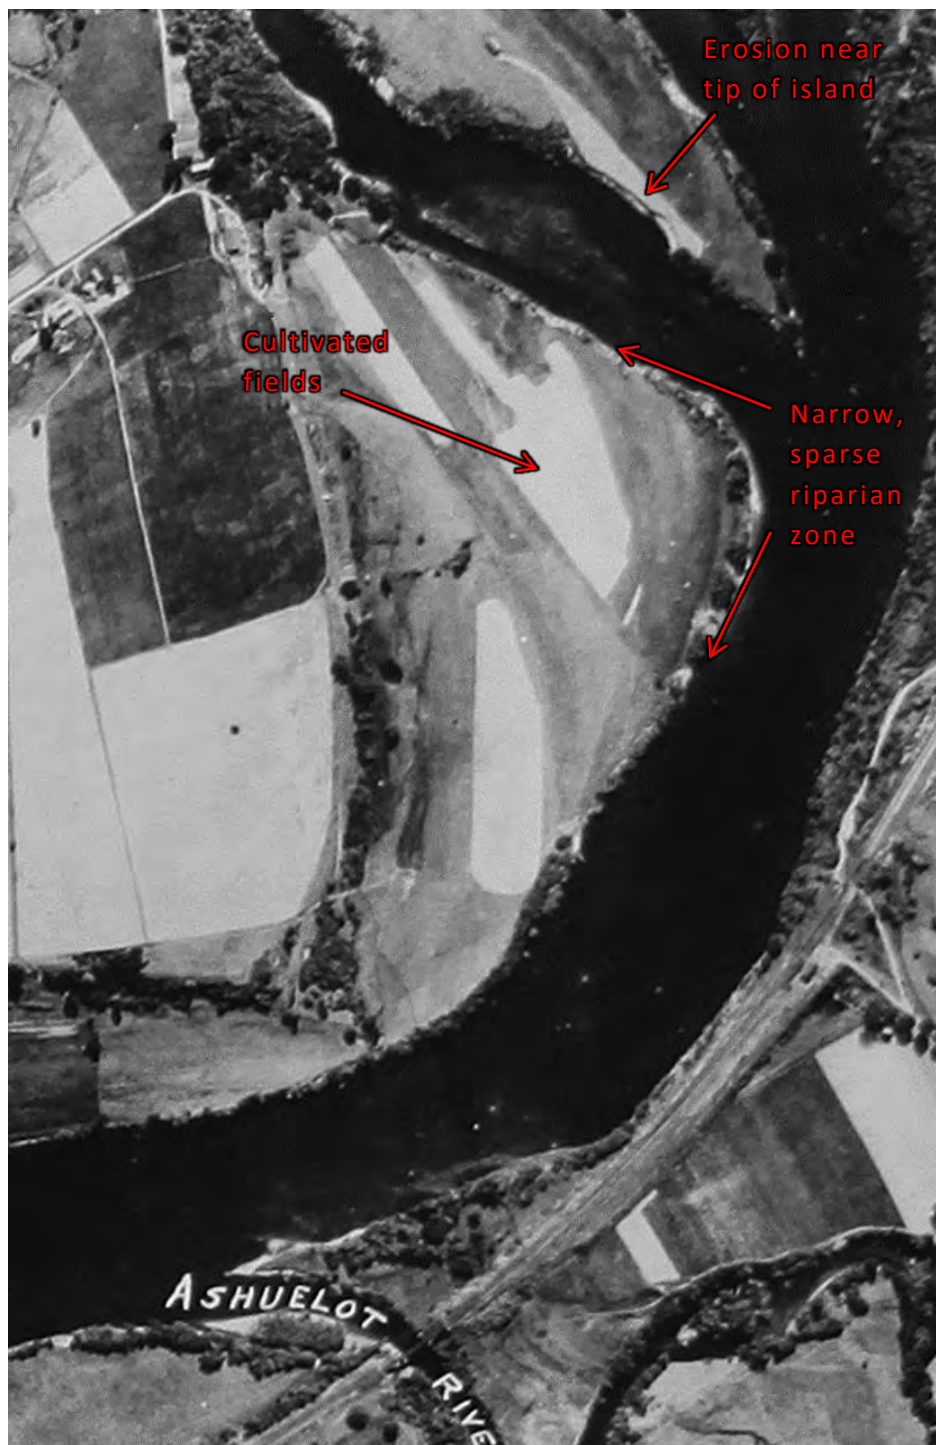
Figure 2.3.2-8 Stebbins Island – Ashuelot River, 1929 (a)

Site #	Site Name	Current Status (2014)	Pre-Northfield Mtn. Status
15	Stebbins Island	Not selected for stabilization	Eroded: Downstream end of island has narrowed through erosion from 1952 to 2008-2010.
16	Kaufhold	Upper Split River stabilized 2010, Bathory-Gallagher stabilized 2012-2013	Eroded: Bathory-Gallagher – Upstream of the tailrace along both banks there was a band of riparian vegetation in the 1952 photograph. By the 1961 photograph the riparian zone appear to have decreased and erosion is evident. Eroded: Upper Split River – 1952 and 1961 photographs show erosion and lack of riparian vegetation.
17	Montague	Stabilized by preventative maintenance in 2008	Eroded: Erosion evident in 1961 photograph.
18	Campground Point	Stabilized by preventative maintenance in 2008	Eroded: Some erosion is evident in the earlier photographs such as 1952 continuing through the 2008 aerial photo
19	Davenport or Upper Island	Not selected for stabilization	Condition unknown based on aerial photos (incomplete imagery available).

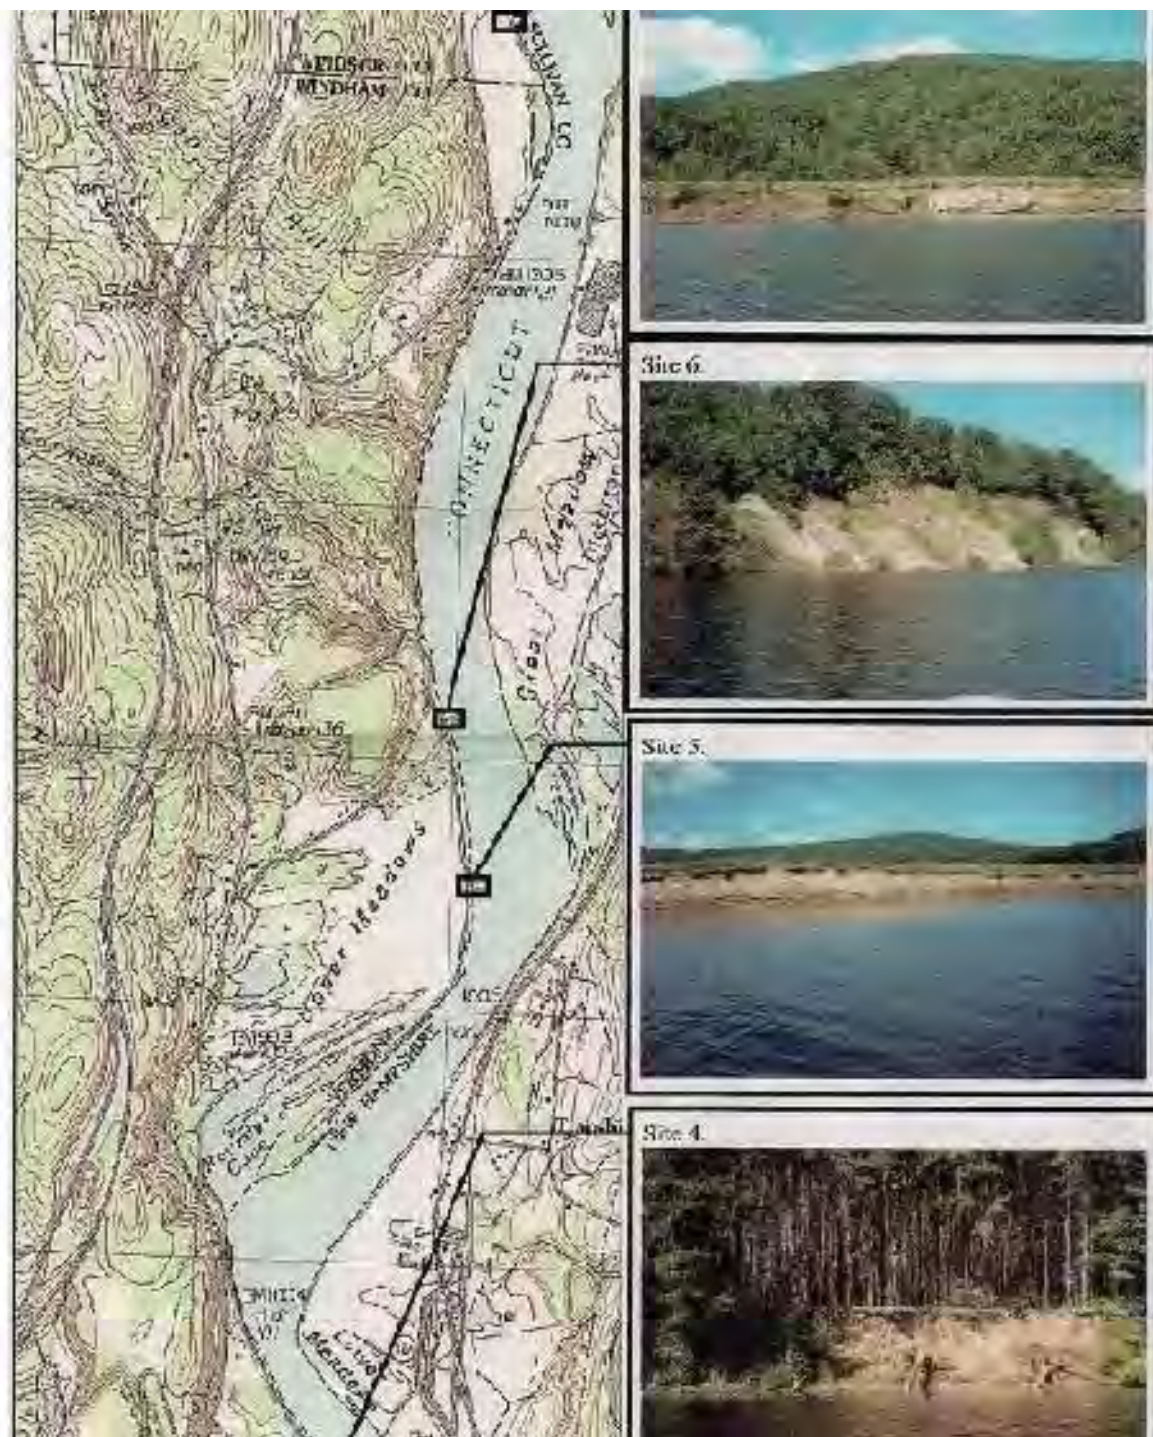
Figure 2.5-2: Erosion sites 4-7, Bellows Falls Impoundment (1997)

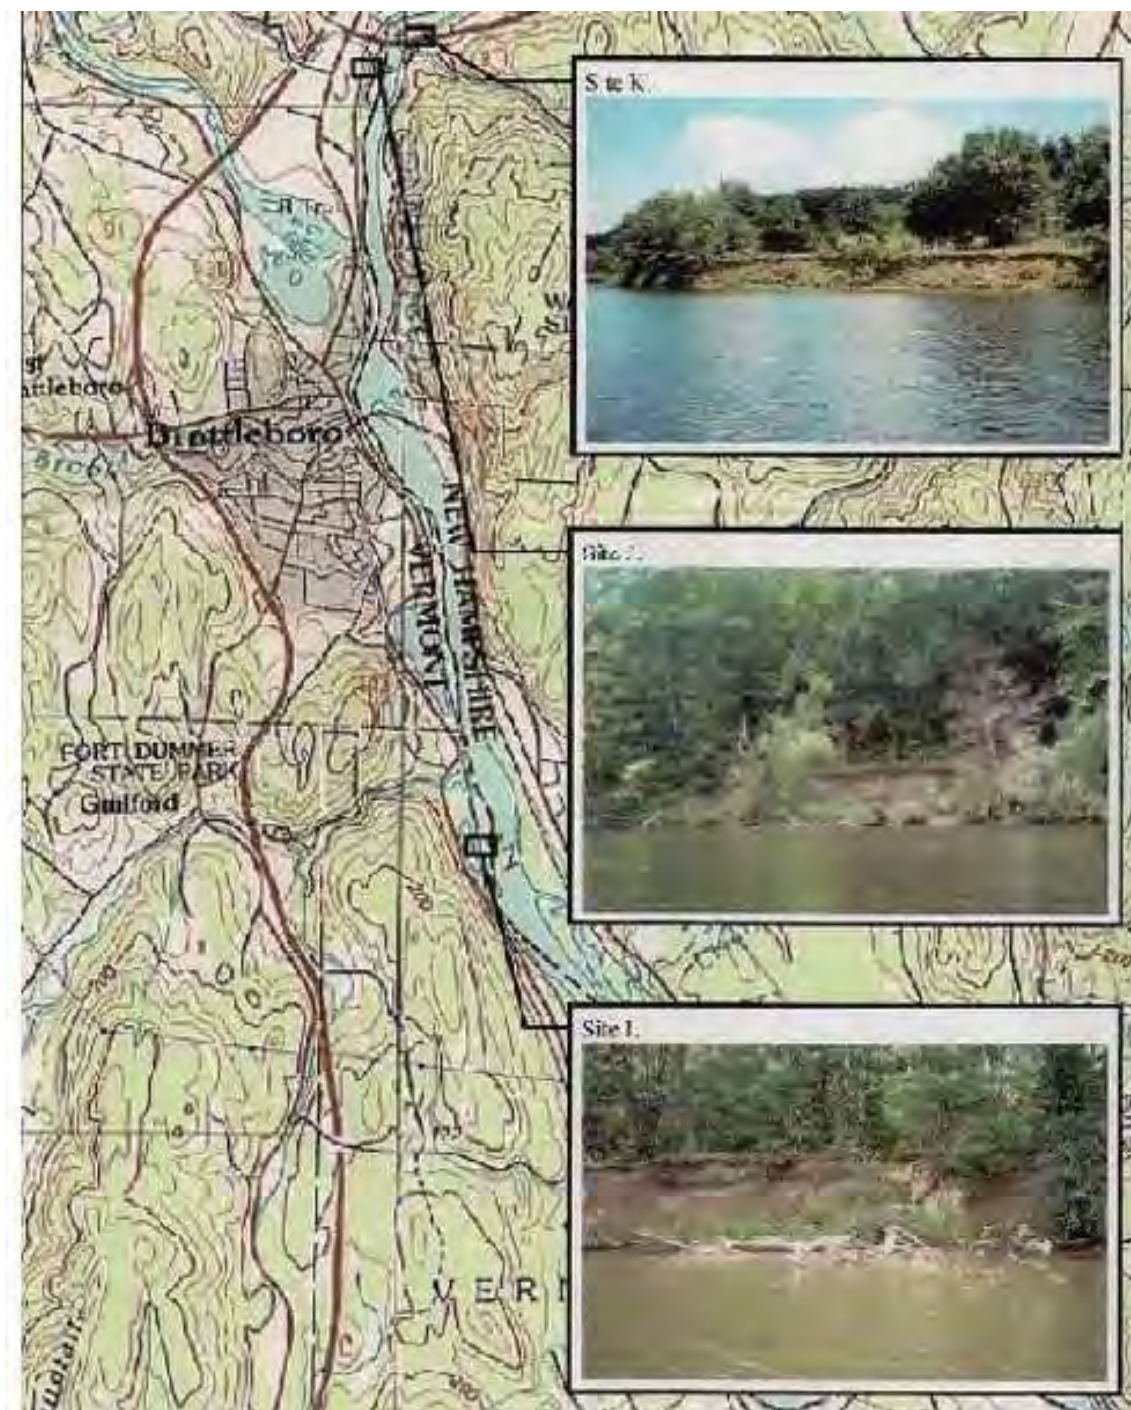
Figure 2.5-3: Erosion sites I-K, Vernon Impoundment (1997)

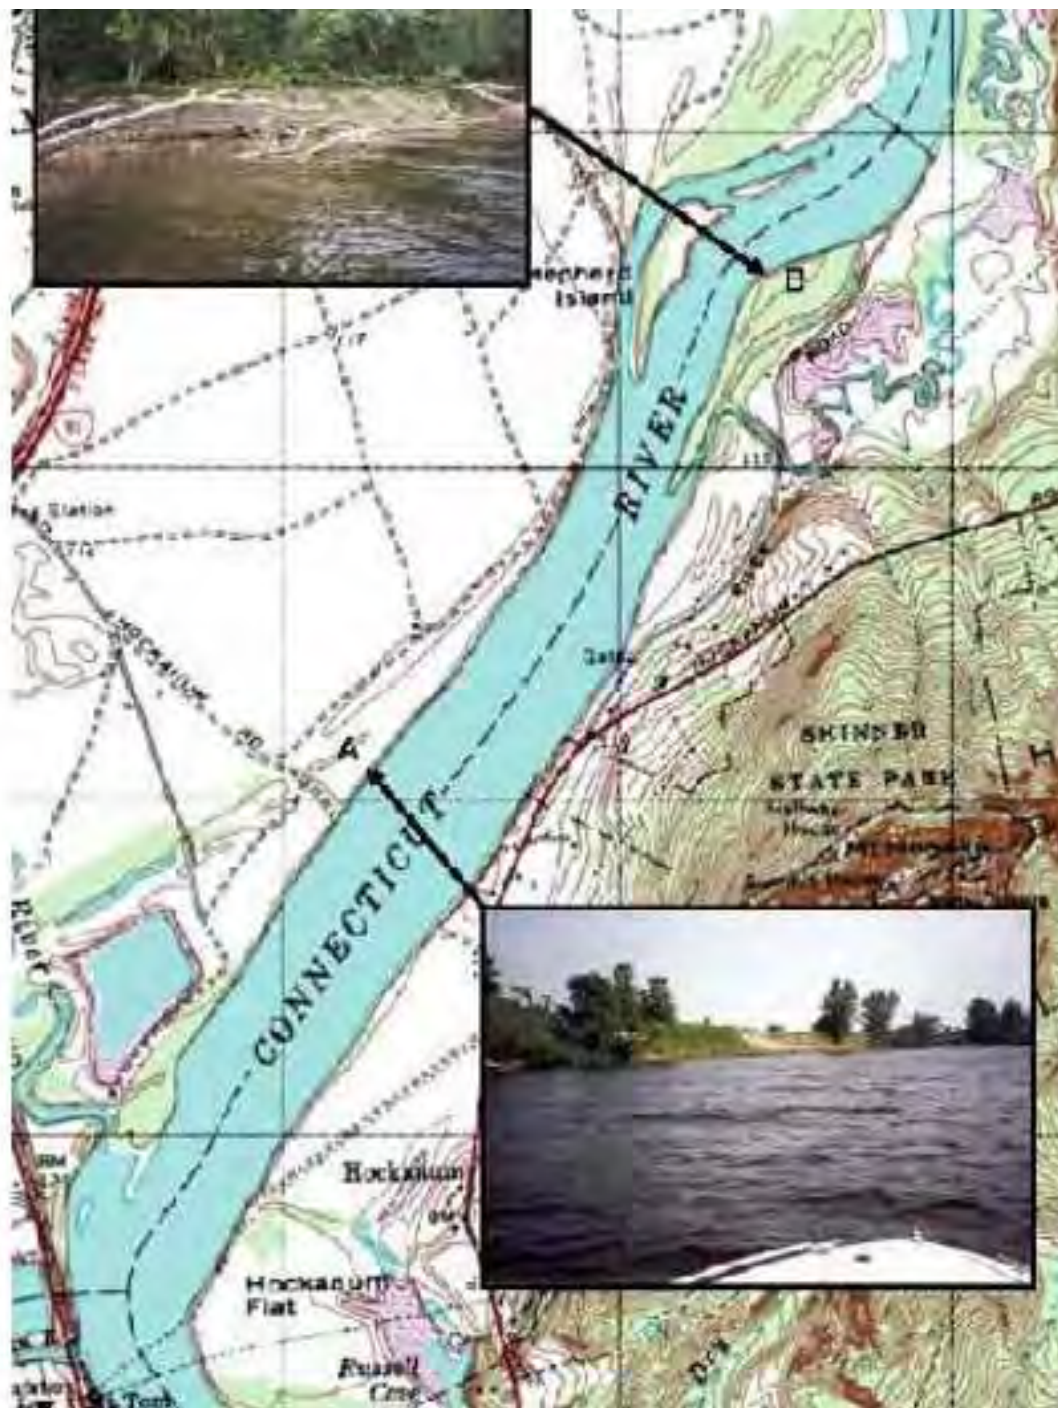
Figure 2.5-4 Erosion sites A and B, Holyoke Impoundment (1997)

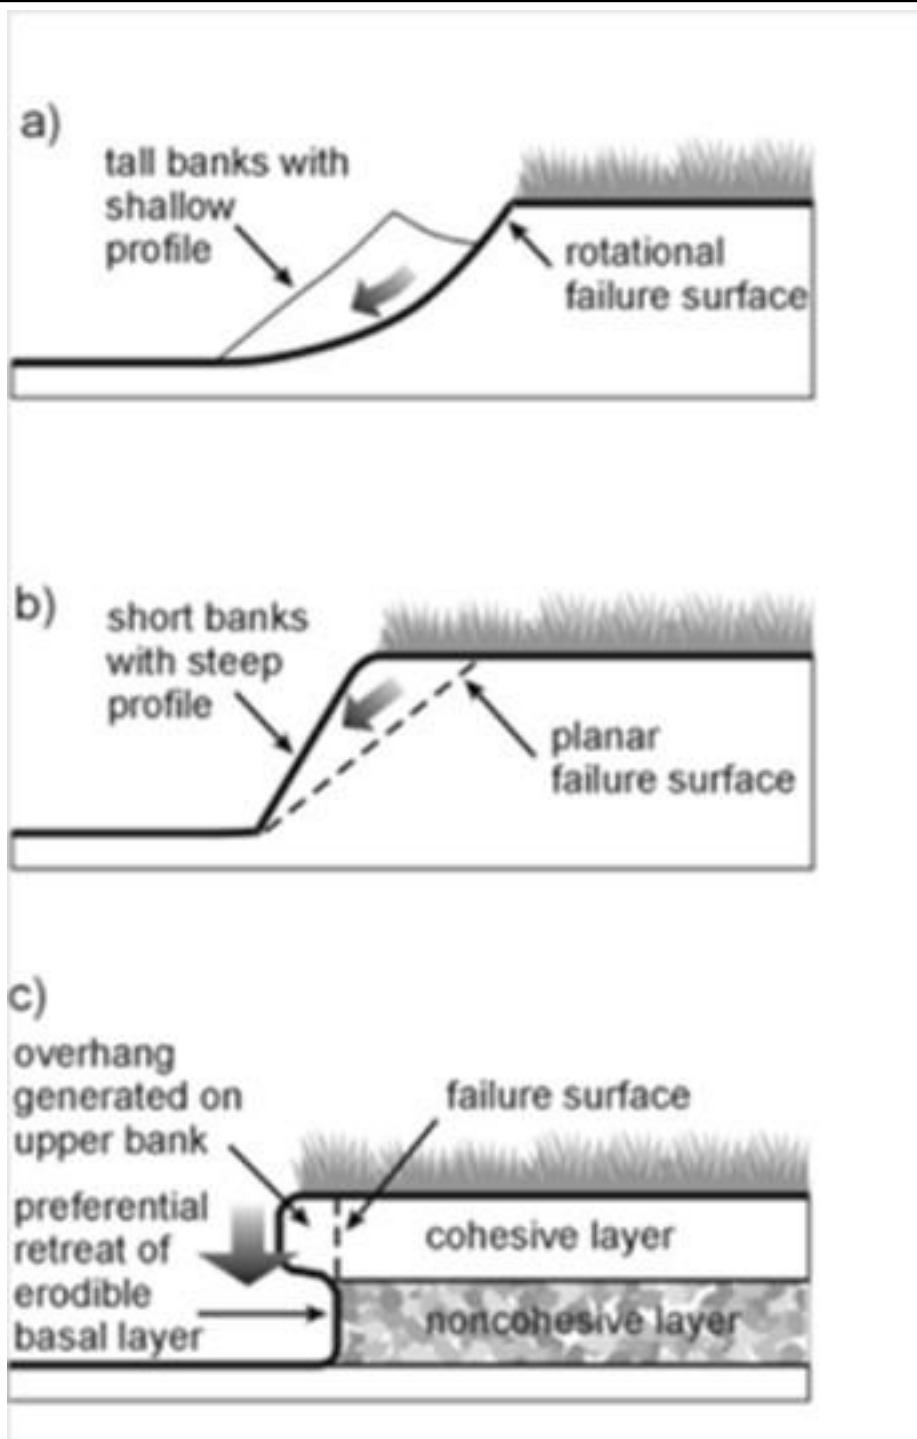
Figure 4.2.5.3-1: Streambank Failure Mechanisms

The bank stability sub-model simulates planar failure types in steep banks, and shear failure in banks that have been undercut by preferential erosion of an erodible basal layer ([Figure 4.2.5.3-1](#)). These are shear-type failures that occur when the driving force (stress) exceeds the resisting force (strength). The model combines two limit-equilibrium methods that estimate the Factor of Safety (F_s) of multi-layer streambanks. F_s is the ratio between the resisting and driving forces acting on a potential failure block. A value of unity indicates that the driving forces are equal to the resisting forces and that failure is imminent ($F_s = 1$). Instability exists under any condition where the driving forces exceed the resisting forces ($F_s < 1$), conditional stability is indicated by F_s values between 1 and 1.3, with stable bank conditions having a $F_s > 1.3$.

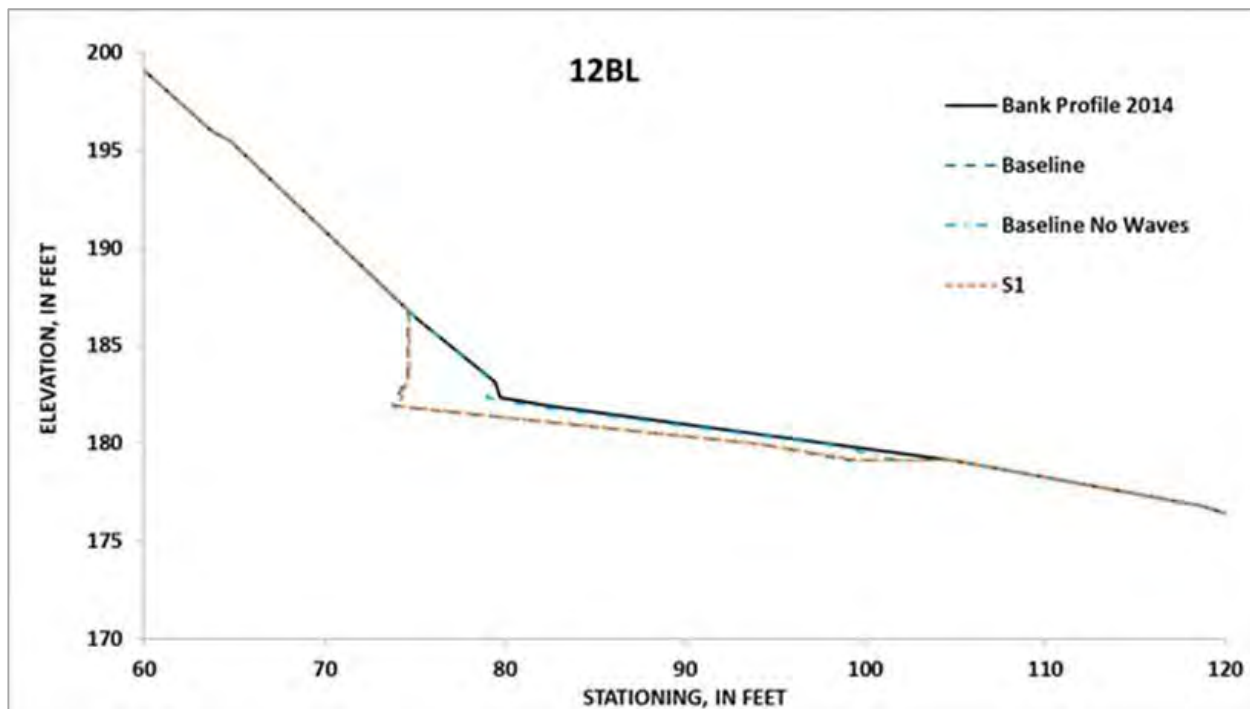
- Third, the role of boat waves has a small impact starting in the lower TFI (Reach 1) in the vicinity of station 27,000 (site 75BL) and generally increases downstream. This is related to the general lake-like conditions in the lower TFI where water-surface elevations vary across a narrow range (See [Figure 5.4.1.1-4](#); Top from previous section), focusing wave impacts in the zone where the beach/toe intersect the lower-most part of the upper bank. A close up of the erosion at site 12BL (station 6,500) shows the increase in basal undercutting that took place with the “waves on” version of the Baseline Condition in comparison to the simulation without waves ([Figure 5.4.2.2-2](#)).

Figure 5.4.2.2-2: Example of the Important Effect of Boat Waves in the Lower TFI (Reach 1) showing the Greater amount of Hydraulic Erosion (Undercutting) between the Baseline Condition with Waves as Compared to the Baseline Condition Without Waves at Site 12BL

The role of boat-generated waves for the Baseline Condition was briefly discussed in an earlier section. A plot from site 12BL ([Figure 5.4.2.2-2](#), previous section) was used as an example of the much greater amounts of basal undercutting that can occur in the lower TFI as a result of boat-generated waves. This is related to the fact that water-surface elevations do not vary significantly in the lower TFI, thereby focusing all of the wave energy along a narrow band of elevations along the bank. Because the resulting basal erosion rate is the product of the magnitude of the excess shear stress and the duration of that excess stress at a given bank node, the greater durations provided along this narrow band makes boat-generated waves an important factor in bank erosion at these locations. This helps to explain why boat-generated wave action is not as important a factor in bank erosion rates in other parts of the TFI. As described in a previous chapter on wave characteristics, wind-generated waves in the study reach do not have sufficient energy to cause basal erosion, likely due to short fetches.

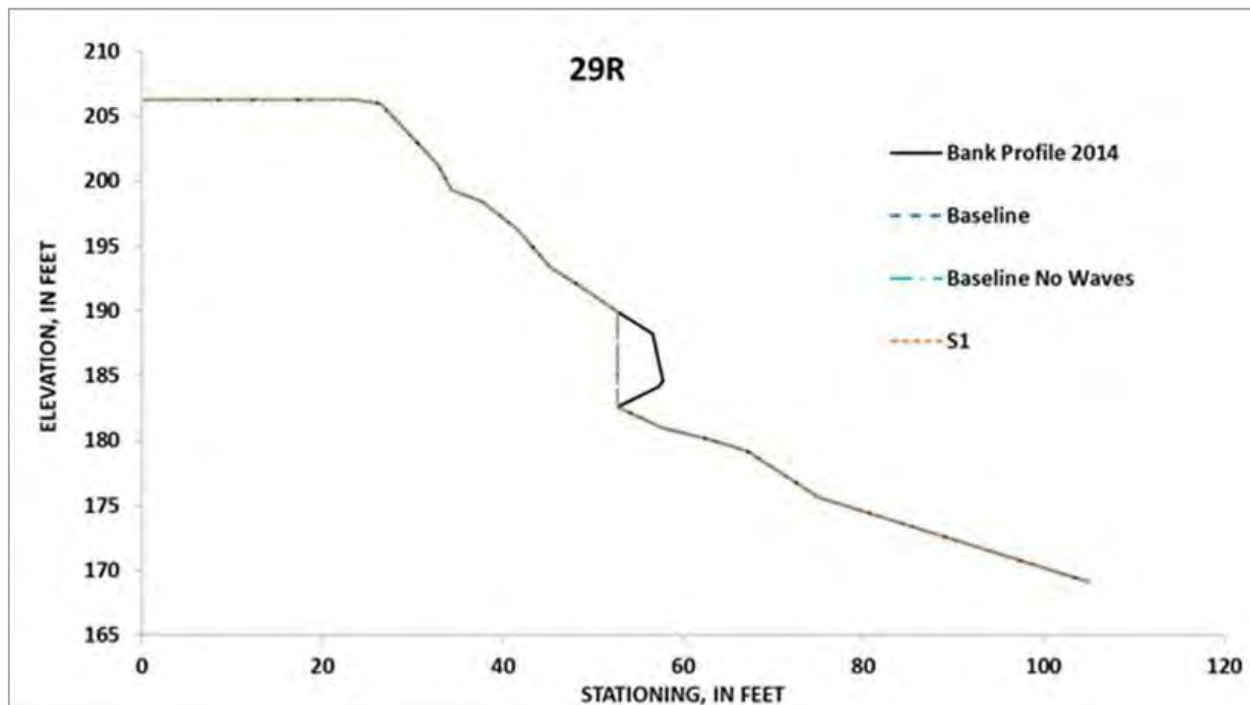
Figure 5.4.2.2-6: Bank profile for site 29R at Station 66,000 Showing Pronounced Undercut at the Start of the Simulations

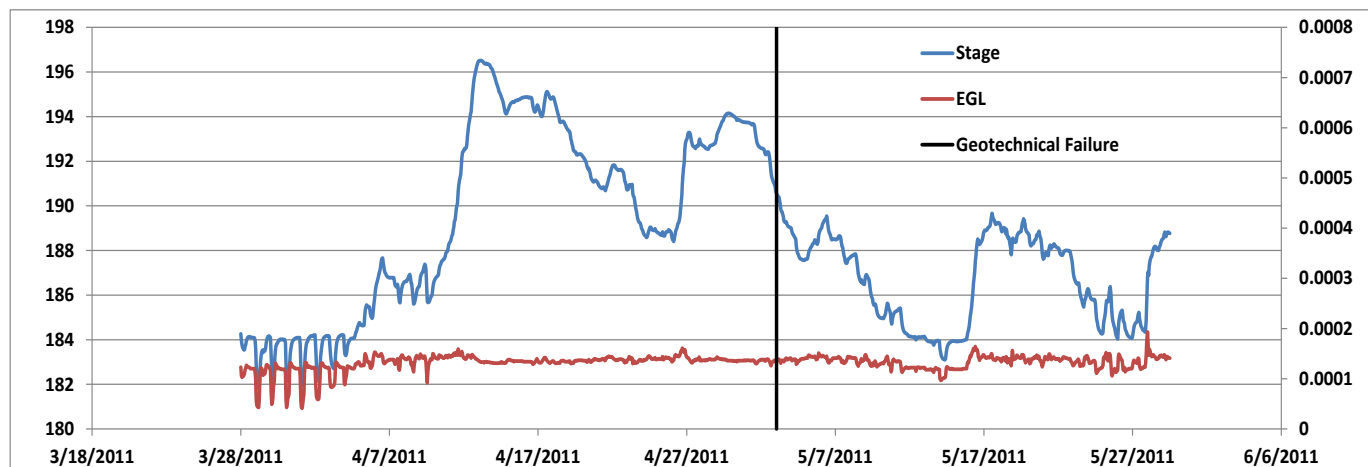
Figure 5.4.3.4-5: Stage and Energy Grade Line (EGL) of flows at Site 303BL under Scenario 1 around the time of the geotechnical failure on 05/03/2011 at 1:00AM (denoted by vertical black line).

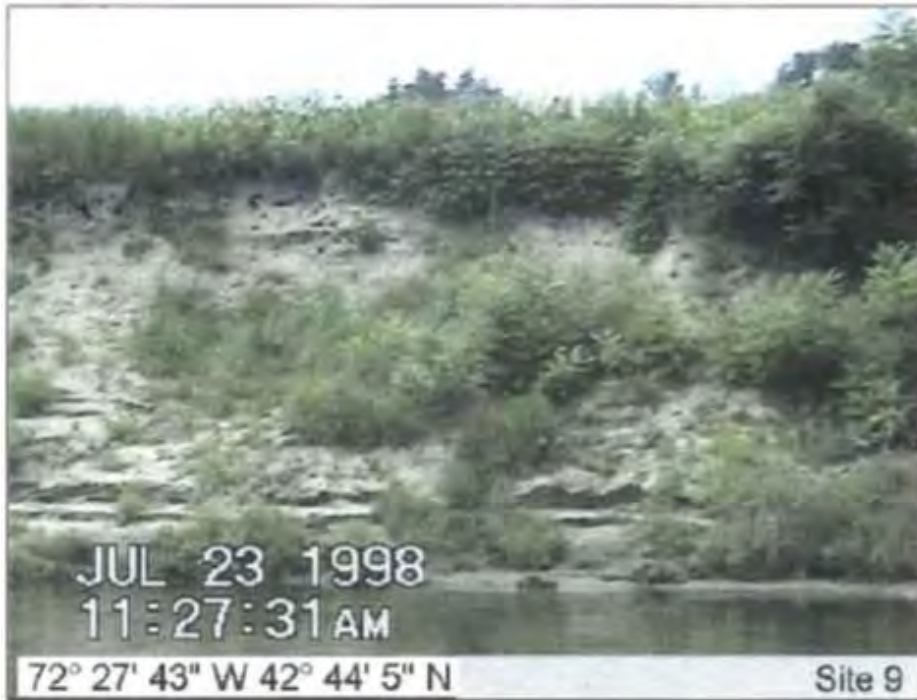
Figure 5.4.3.7-1 Photos from 1998 at site 3R Pre Restoration (Labeled as 1998 FRR/ECP-Site 9)

Right bank, 1998

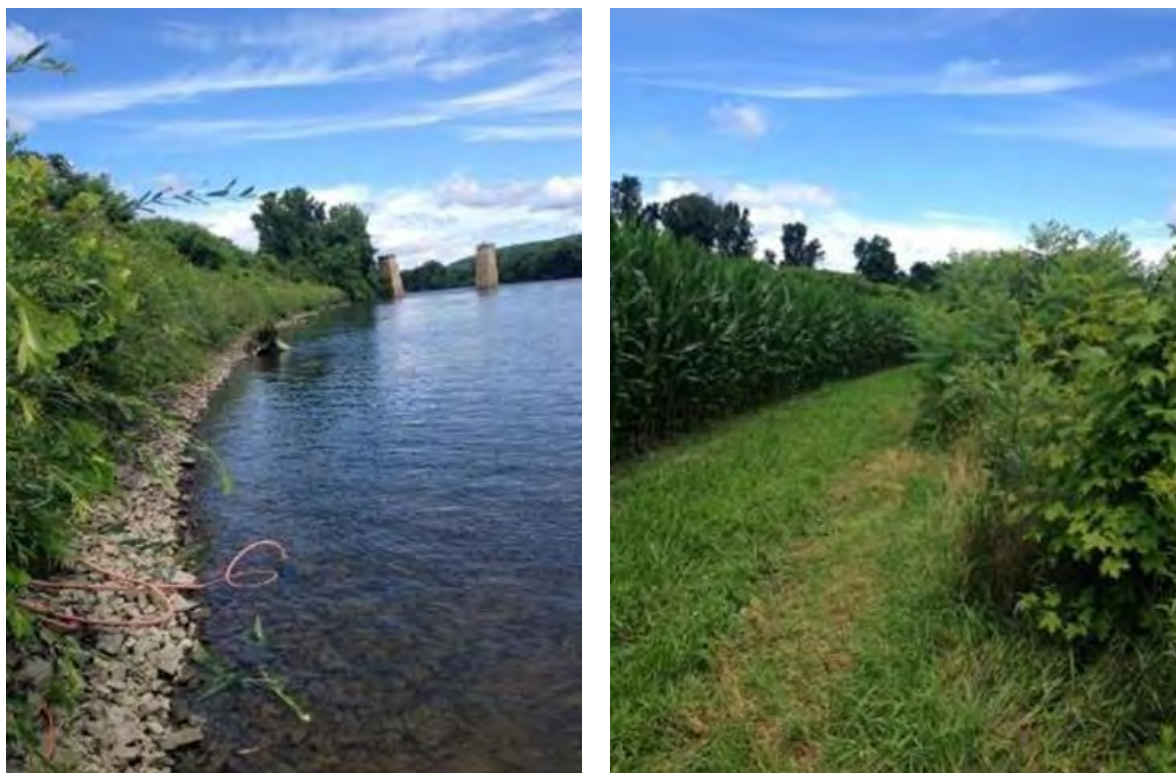
Figure 5.4.3.8-1 Photos at site 3R Post Restoration

BSTEM runs at this site show that under the Baseline Condition, 1.75 ft^3 of erosion occurred per foot of bank, during the 2006 to 2014 flow period after restoration activities, averaging $0.285 \text{ ft}^3/\text{ft}/\text{y}$ ([Table 5.4.3-1](#)). This results in the 9th lowest erosion rate for the Baseline Condition, placing it between the 20th and 25th percentiles of erosion rates along the reach. The modeling also indicates that all 100% ($0.285 \text{ ft}^3/\text{ft}/\text{y}$) of the erosion is due directly to hydraulic processes, and none of the bank erosion is the result of larger geotechnical failures. The minimal amount of hydraulic erosion that is occurring is within the level of the placed rock at the toe, indicating that the rock may be slightly undersized for the flows.

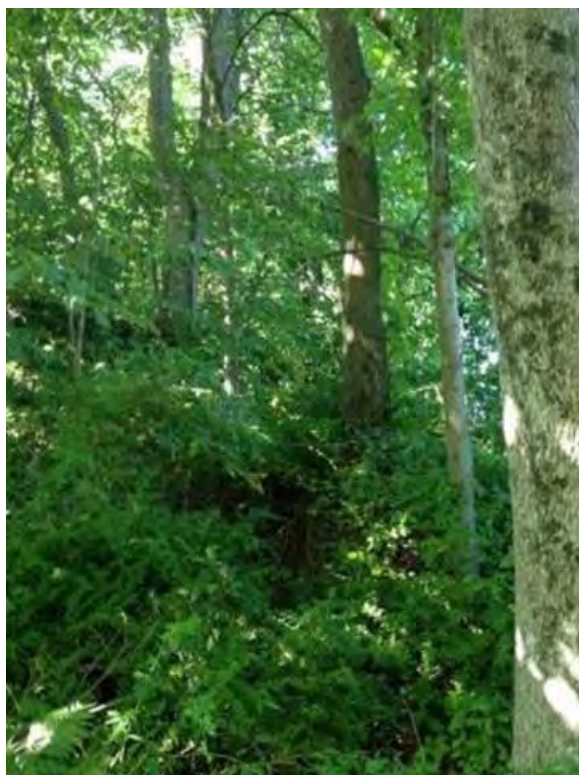
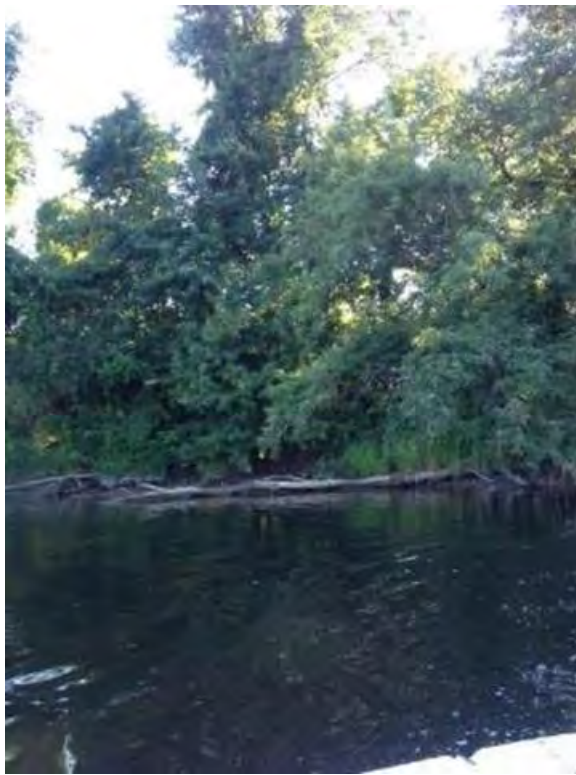
Figure 5.4.3.9-1: Photos at site 21R

The river at site 21R has a steep bank face, sparsely vegetated banks, and is located at station 79,250, just north of the Massachusetts-Vermont Border. The bank is roughly 27 feet tall, with a sandy-loam bank toe and upper bank. The bank is vegetated mostly with grasses and small shrubs, but contains a few American basswood, Green ash, and Northern red oak trees. A significant amount of bare soil was noted on the bank face. No historical cross sections existed for this site. A survey conducted in 2014 was used as the initial bank geometry for the model runs ([Figure 5.4.3.9-1](#)).

BSTEM runs at this site show that under the Baseline Condition, 34.6 ft³ of erosion occurred per foot of bank, during the 2000-2014 flow period, averaging 2.36 ft³/ft/y ([Table 5.4.3-1](#)). This results in the 11th highest erosion rate for the Baseline Condition, placing it between the 65th and 70th percentiles of erosion rates along the reach. The modeling also indicates that all 100% (2.36 ft³/ft/y) of the erosion is due directly to hydraulic processes, and that none of the bank erosion is the result of larger geotechnical failures.

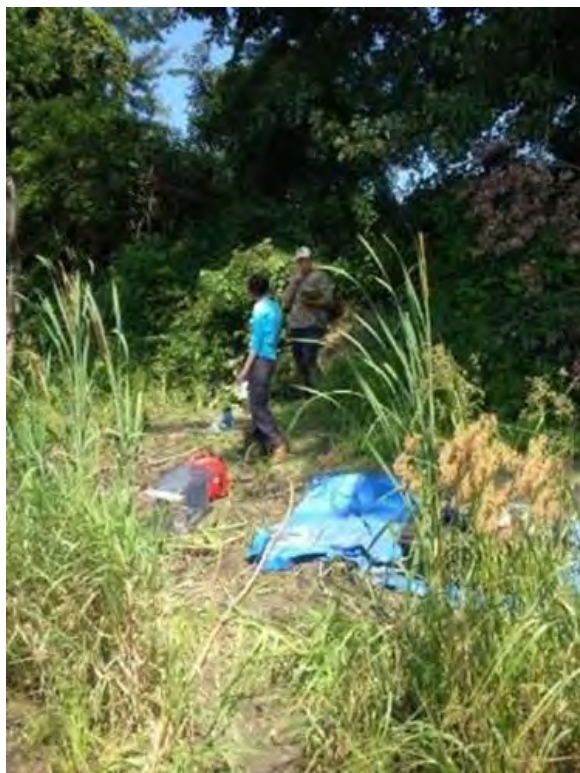
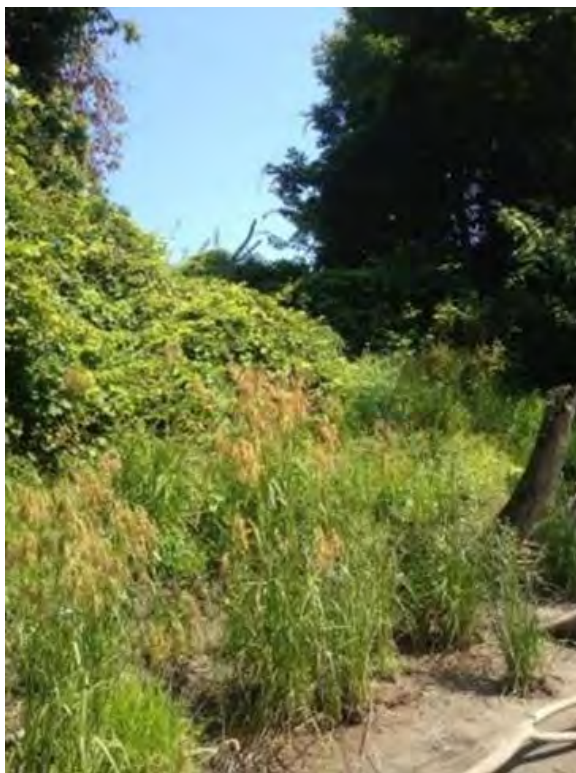
Figure 5.4.3.10-1 Photos at site 4L

BSTEM runs at this site show that under the Baseline Condition, 0.25 ft³ of erosion occurred per foot of bank, during the 2000-2014 flow period, averaging 0.017 ft³/ft/y ([Table 5.4.3-1](#)). This results in the 3rd lowest erosion rate for the Baseline Condition, placing it between the 5th and 10th percentiles of erosion rates along the reach. The modeling also indicates that all 100% (0.0173 ft³/ft/y) of the erosion is due directly to hydraulic processes, and that none of the bank erosion is the result of geotechnical failures.

The erosion modeled at this site does not account for the depositional material that has been placed at the toe. The model does not recognize depositional material, and the slight erosion that is happening under the Baseline Condition, is happening at the toe. As material from the bank toe is being eroded, the river is re-depositing additional sediment to compensate. In general though, very little erosion is occurring at this site.

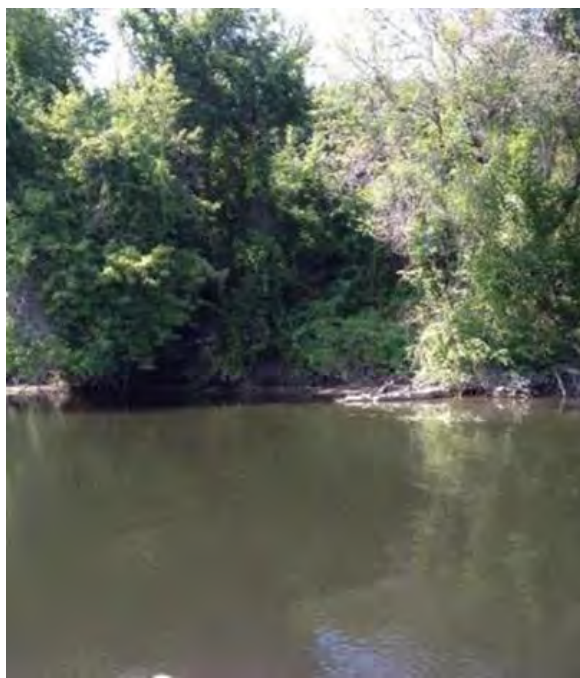
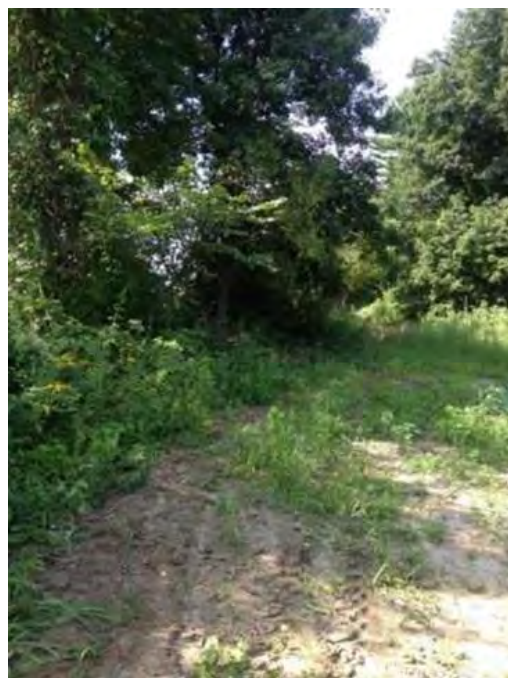
Figure 5.4.3.11-1 Photos at site 29R

The river at site 29R (at station 66,000) has a steep bank face, sparsely vegetated banks, and is located between Mallory Brook and the Pauchaug Boat Ramp. The bank is roughly 26 feet tall, with a sandy loam toe and upper bank slope. The bank contains only patchy vegetation with Green ash and Silver maple trees. A significant amount of bare soil was noted on the bank face. No historical cross sections exist for this site, however this site was surveyed in 2014 and this was used as the initial geometry for the model runs ([Figure 5.4.3.11-1](#)).

BSTEM runs at this site show that under the Baseline Condition, 25.2 ft³ of erosion occurred per foot of bank during the 2000-2014 flow period, averaging 1.72 ft³/ft/y ([Table 5.4.3-1](#)). This results in the 14th highest erosion rate for the Baseline Condition, placing it between the 55th and 60th percentiles of erosion rates along the reach. The modeling also indicates that only 1% (about 0.009 ft³/ft/y) of the erosion is due directly to hydraulic processes, whereas the other 99% (1.71 ft³/ft/y) is the result of geotechnical processes and associated mass failures. Looking at the starting cross section, with the existing undercut, it becomes obvious that a large geotechnical failure is imminent ([Figure 5.4.3.11-2](#)). In fact, failure of the upper bank here represents the single, significant erosion event at this site that occurred early on in the simulation period.

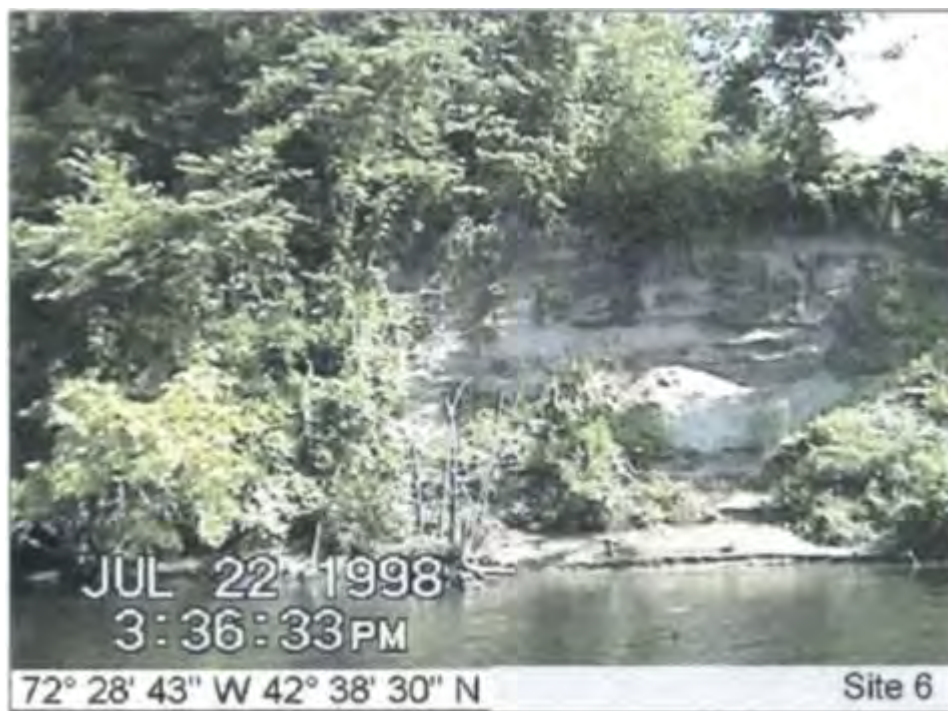
Figure 5.4.3.16-1 Photos at site 6AL Pre Restoration (Labeled as 1998 FRR/ECP-Site 6)

Left bank, 1998

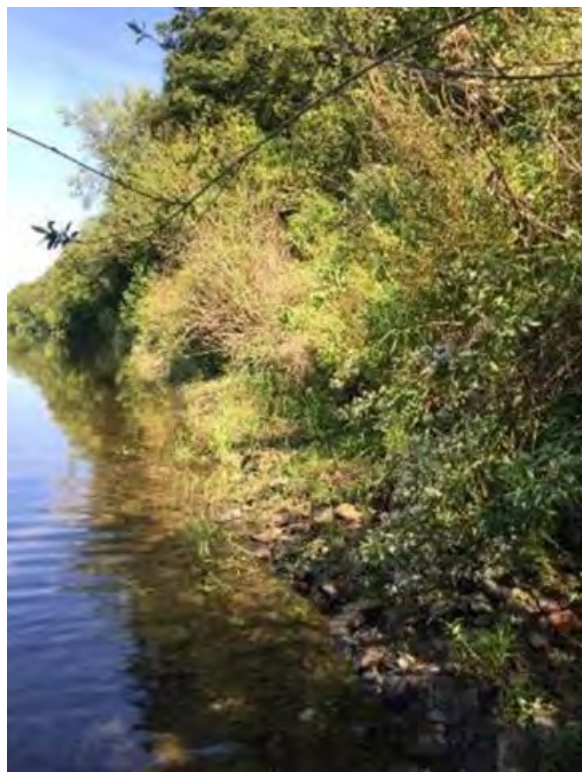
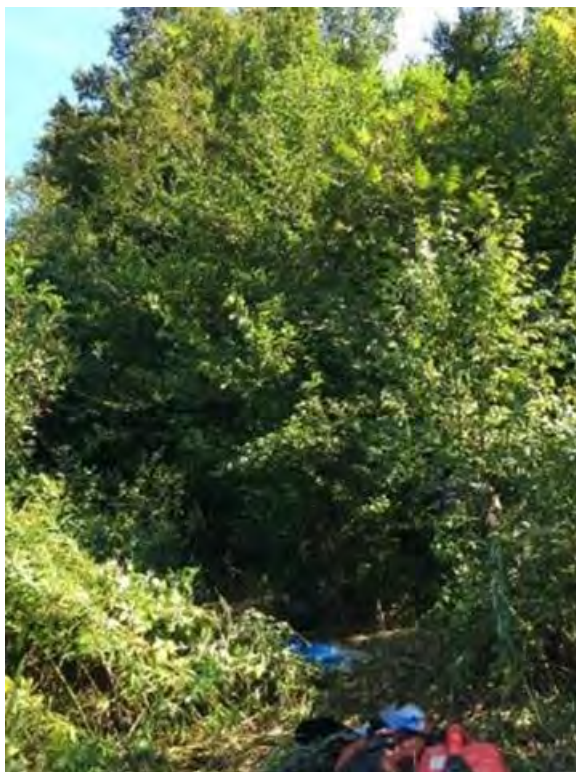
Figure 5.4.3.17-1 Photos at site 6AL Post Restoration

The Post Restoration condition at site 6AL is characterized by steep, heavily vegetated banks. The bank is roughly 37 feet tall, with a rock toe ($d_{50}=55$ mm) and a silt loam bank. The replanted bank is heavily vegetated with large shrubs, Northern red oak, and Sugar maple ([Figure 5.4.3.17-1](#)).

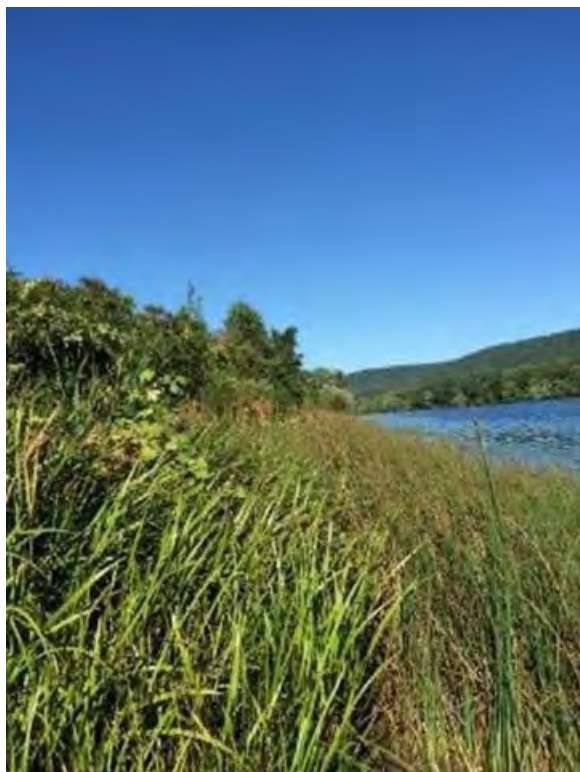
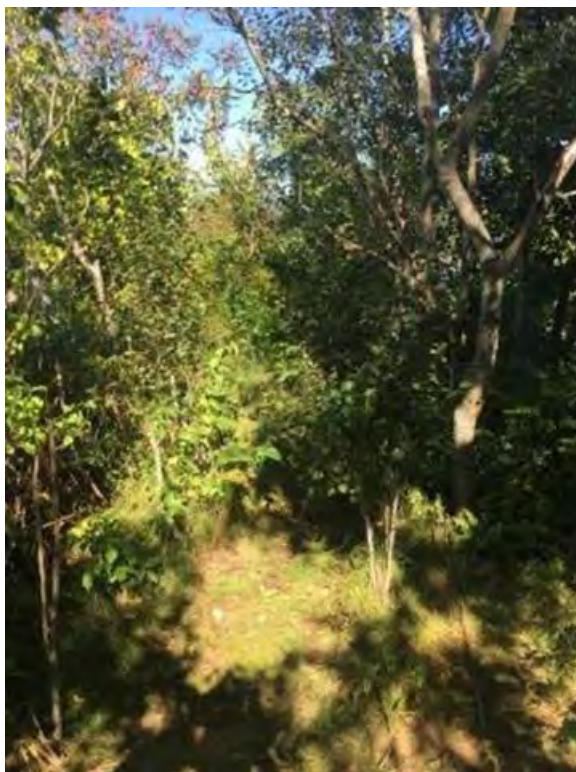
Figure 5.4.3.18-1 Photos at site 6AR Post Restoration

BSTEM runs for the Post Restoration Condition at this site show that under the Baseline Condition, 0.295 ft^3 of erosion occurred per foot of bank, during the 2000 to 2014 flow period after restoration, averaging 0.0209 $\text{ft}^3/\text{ft}/\text{y}$ ([Table 5.4.3-1](#)). This results in the 4th lowest erosion rate for the Baseline Condition, placing it between the 10th and 15th percentiles of erosion rates along the reach. The modeling also indicates that all 100% (0.021 $\text{ft}^3/\text{ft}/\text{y}$) of the erosion is due directly to hydraulic processes, and none of the bank erosion is the result of larger, geotechnical failures.

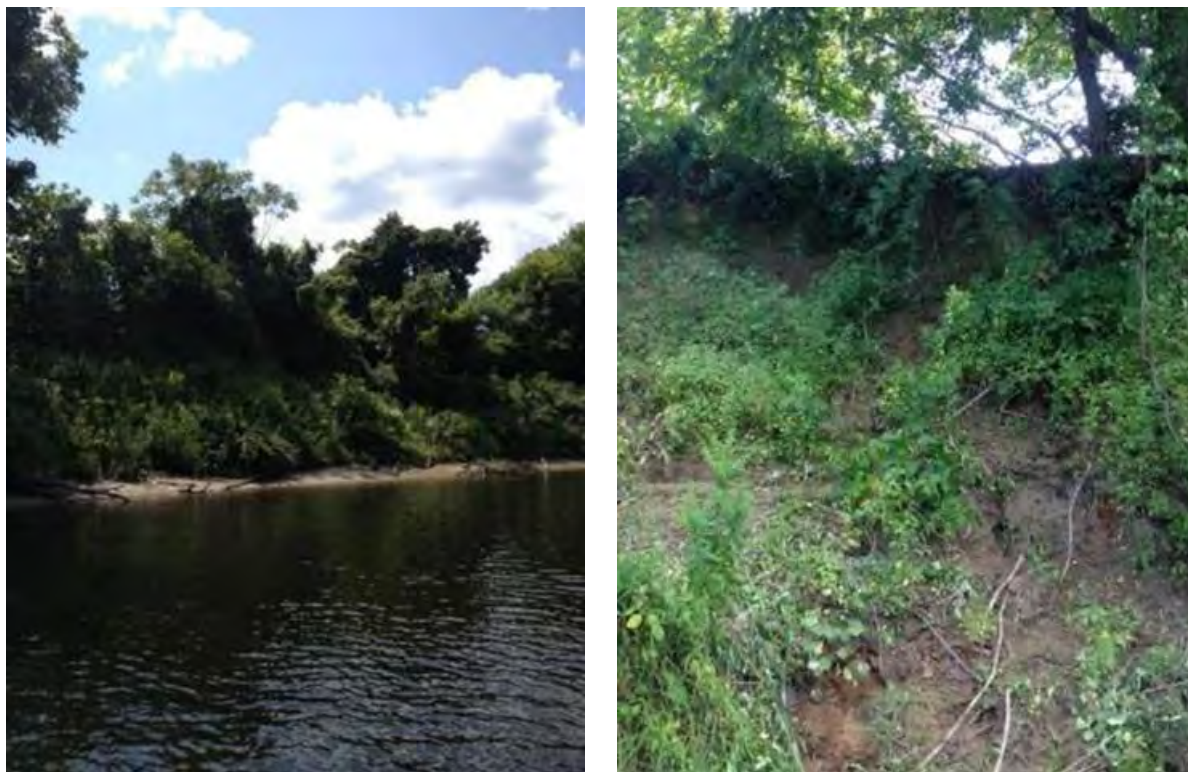
Figure 5.4.3.19-1 Photos at site 119BL

BSTEM runs at this site show that under the Baseline Condition 86.1 ft^3 of erosion occurred per feet of bank, during the 2000 to 2014 flow period modeled, averaging 5.88 $\text{ft}^3/\text{ft}/\text{y}$ ([Table 5.4.3-1](#)). This results in the 5th highest erosion amongst the model sites, placing it between the 85th and 90th percentiles of erosion rates along the reach. The modeling also indicates that roughly 73% (4.26 $\text{ft}^3/\text{ft}/\text{y}$) of erosion is due to hydraulic processes, whereas the other 27% (1.62 $\text{ft}^3/\text{ft}/\text{y}$) is due to geotechnical processes and mass failures. This is also shown in the Percent Contribution of Total Erosion by Discharge plot for Site 119BL ([Figure 5.4.3.19-4](#)), as the graph has a very gradual smooth shape, with few large spikes indicating mass wasting.
