Relicensing Study 3.1.2

**Northfield Mountain / Turners Falls
Operations Impact on Existing Erosion and
Potential Bank Instability
Study Report**

Volume II – Main Report

**Northfield Mountain Pumped Storage Project (No. 2485) and
Turners Falls Hydroelectric Project (No. 1889)**

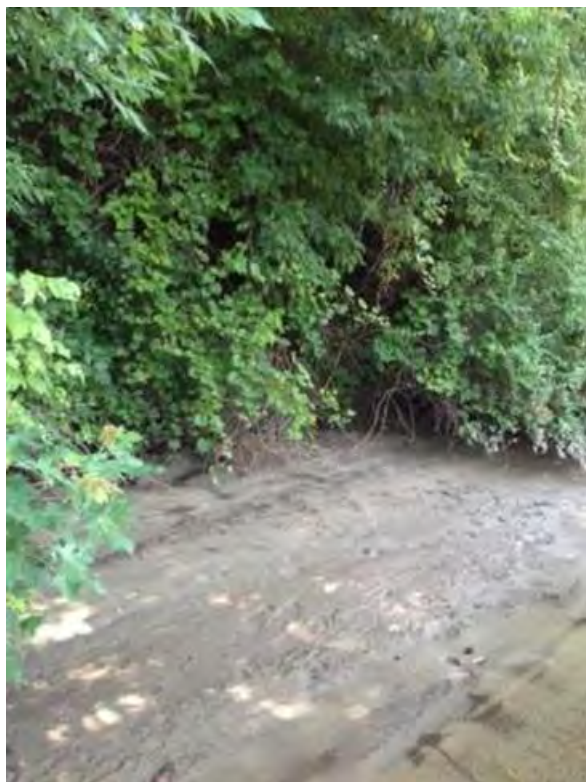
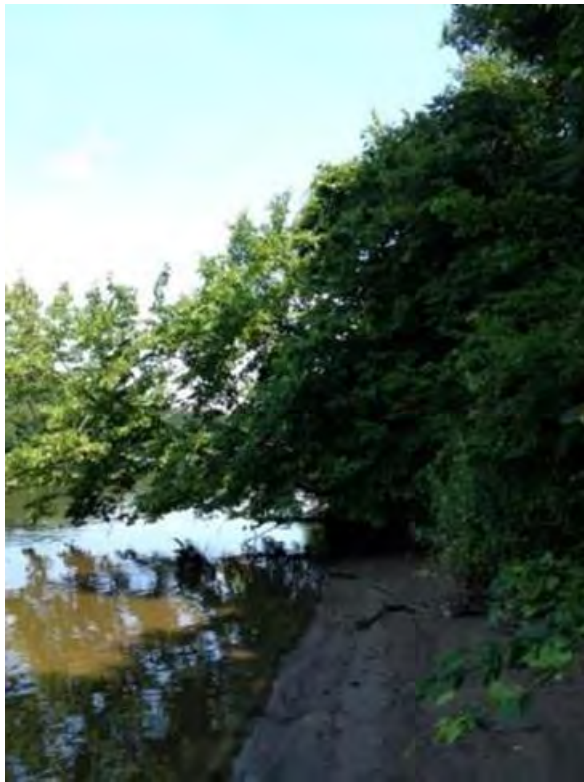
Figure 5.4.3.20-1 Photos at site 7L

BSTEM runs at this site show that under the Baseline Condition, 62.9 ft³ of erosion occurred per foot of bank, during the 2000 to 2014 flow period, averaging 4.29 ft³/ft/y ([Table 5.4.3-1](#)). This results in the 7th highest erosion rate for the Baseline Condition, placing it between the 75th and 80th percentiles of erosion rates along the reach. The modeling also indicates that roughly 81% (3.48 ft³/ft/y) of the erosion is due directly to hydraulic processes, whereas the other 19% (0.81 ft³/ft/y) is the result of geotechnical processes and associated mass failures.

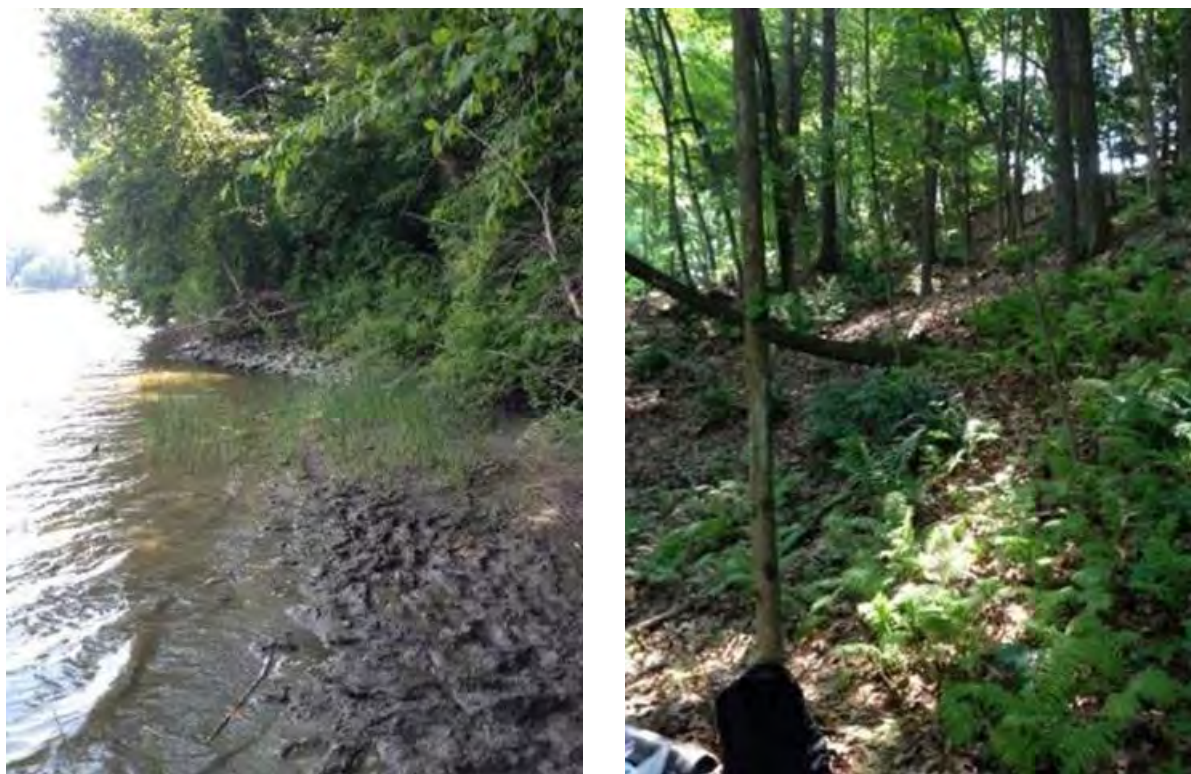
Figure 5.4.3.21-1 Photos at site 7R

Site 7R (station 37,500) is located between Kidds Island and the Northfield Mountain Tailrace, just upstream of Dry Brook. The site has steep, partially vegetated banks that are roughly 24 feet tall, with a sandy toe and a sandy-loam upper bank. The bank is vegetated with 20 to 50 year-old Hemlock, Pine, and Silver maple. There was a significant amount of bare soil noted on the upper bank, likely due to the dense tree canopy ([Figure 5.4.3.21-1](#)).

BSTEM runs at this site show that under the Baseline Condition, 30.1 ft³ of erosion occurred per foot of bank, during the 2000 to 2014 flow period, averaging 2.06 ft³/ft/y ([Table 5.4.3-1](#)). This results in the 13th highest erosion rate for the Baseline Condition, placing it between the 55th and 60th percentiles of erosion rates along the reach. The modeling also indicates that all 100% (2.06 ft³/ft/y) of the erosion is due directly to hydraulic processes, and none of the bank erosion is the result of larger, geotechnical failures.

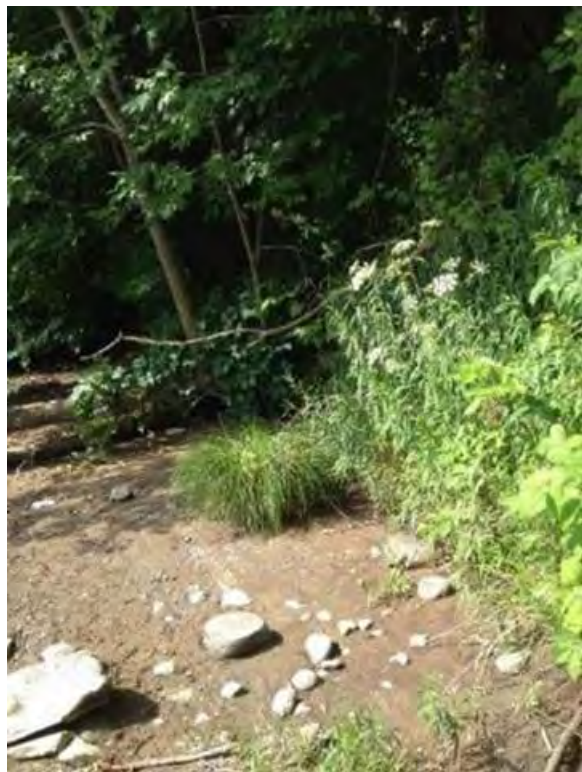
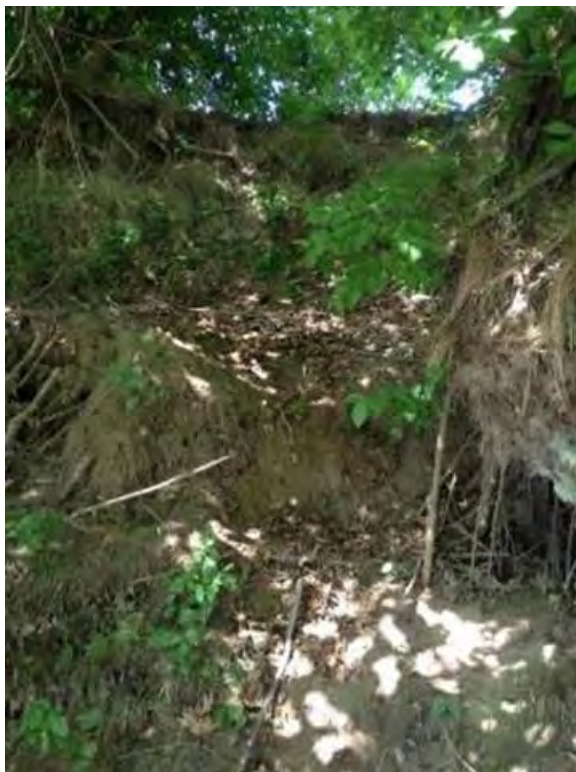
Figure 5.4.3.22-1 Photos at site 8BL

The river at site 8BL (station 32,750) has steep, vegetated banks and is located between Kidds Island and the Northfield Mountain Tailrace, just upstream of Pine Meadow Brook. The bank is roughly 24 feet tall, with a sandy toe and a sandy-loam upper bank. The bank is highly vegetated with 20 to 50 year old Hemlock, Pine, and Silver maple. There was a significant amount of bare soil noted, likely due to the dense tree canopy ([Figure 5.4.3.22-1](#)).

BSTEM runs at this site show that under the Baseline Condition, 6.09 ft³ of erosion occurred per foot of bank, during the 2000 to 2014 flow period, averaging 0.43 ft³/ft/y ([Table 5.4.3-1](#)). This results in the 19th highest erosion rate for the Baseline Condition, placing it between the 35th and 40th percentiles of erosion rates along the reach. The modeling also indicates that all 100% (0.428 ft³/ft/y) of the erosion is due directly to hydraulic processes, and none of the bank erosion is the result of geotechnical processes and associated mass failures.

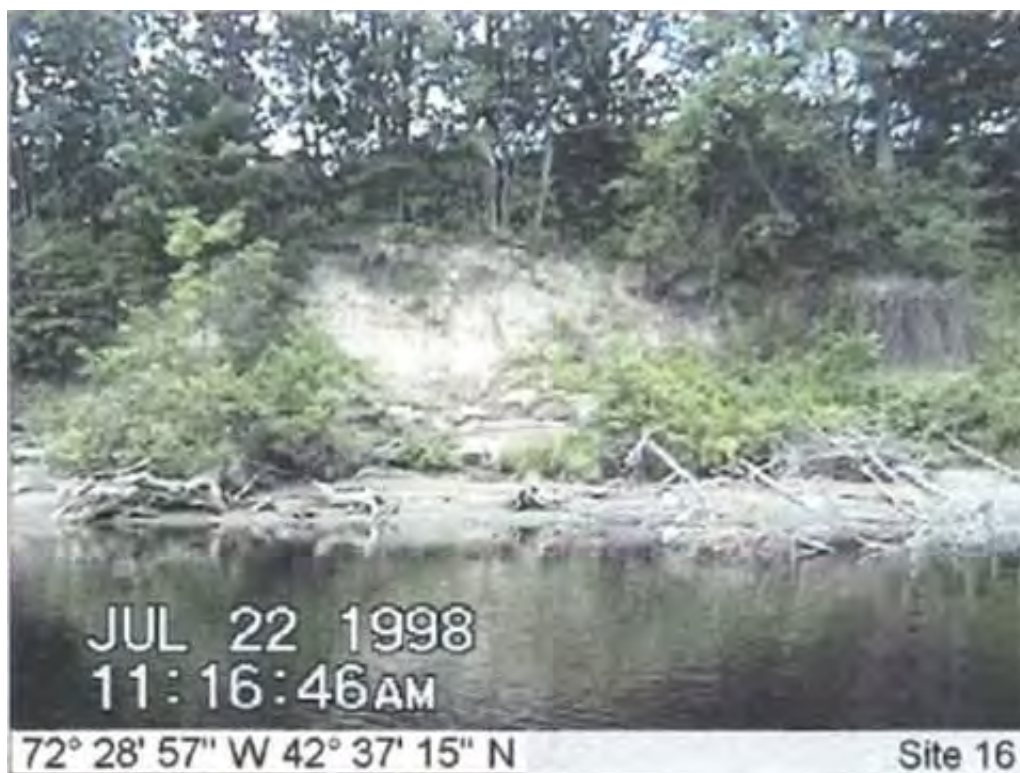
Figure 5.4.3.23-1 Photos at site 8BR Pre Restoration (Labeled as 1998 FRR/ECP-Site 16)

The river at site 8BR (station 32,750) has steep, sparsely vegetated banks and is located between Kidds Island and Northfield Mountain Tailrace, just upstream of Pine Meadow Brook. The bank is roughly 19 feet tall, with a sandy toe and a sandy-loam upper bank. The bank is thinly vegetated with Northern red oak and Green ash. There was also significant amount of bare soil noted ([Figure 5.4.3.23-1](#)).

BSTEM runs for the Pre-Restoration Condition at this site show that under the Baseline Condition, 89.6 ft³ of erosion occurred per foot of bank, during the 2000 to 2012 flow period prior to restoration, averaging 7.42 ft³/ft/y ([Table 5.4.3-1](#)). This results in the 3rd highest erosion rate for the Baseline Condition, placing it between the 90th and 95th percentiles of erosion rates along the reach. The modeling also indicates that roughly 30% (2.23 ft³/y) of the erosion is due to hydraulic processes, whereas the other 70% (5.19 ft³/y) is the result of geotechnical processes and associated mass failures.

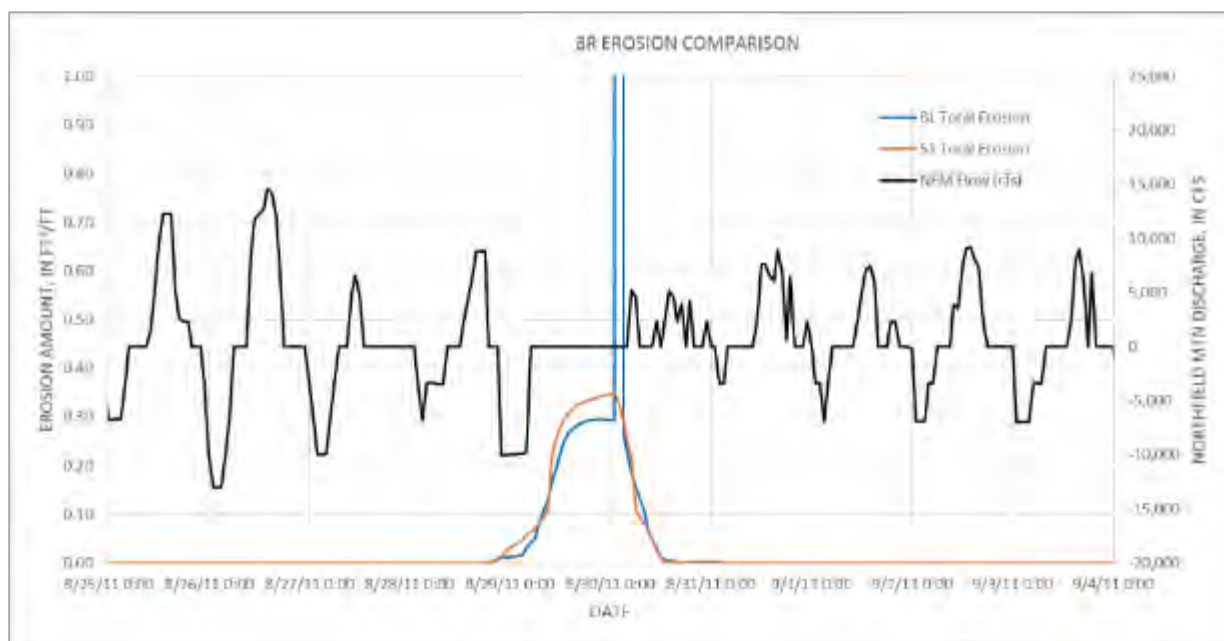
Figure 5.7.23-4 – Timing of large, geotechnical failure during Hurricane Irene for the Baseline Condition but not during Scenario 1 when NFM is idle.

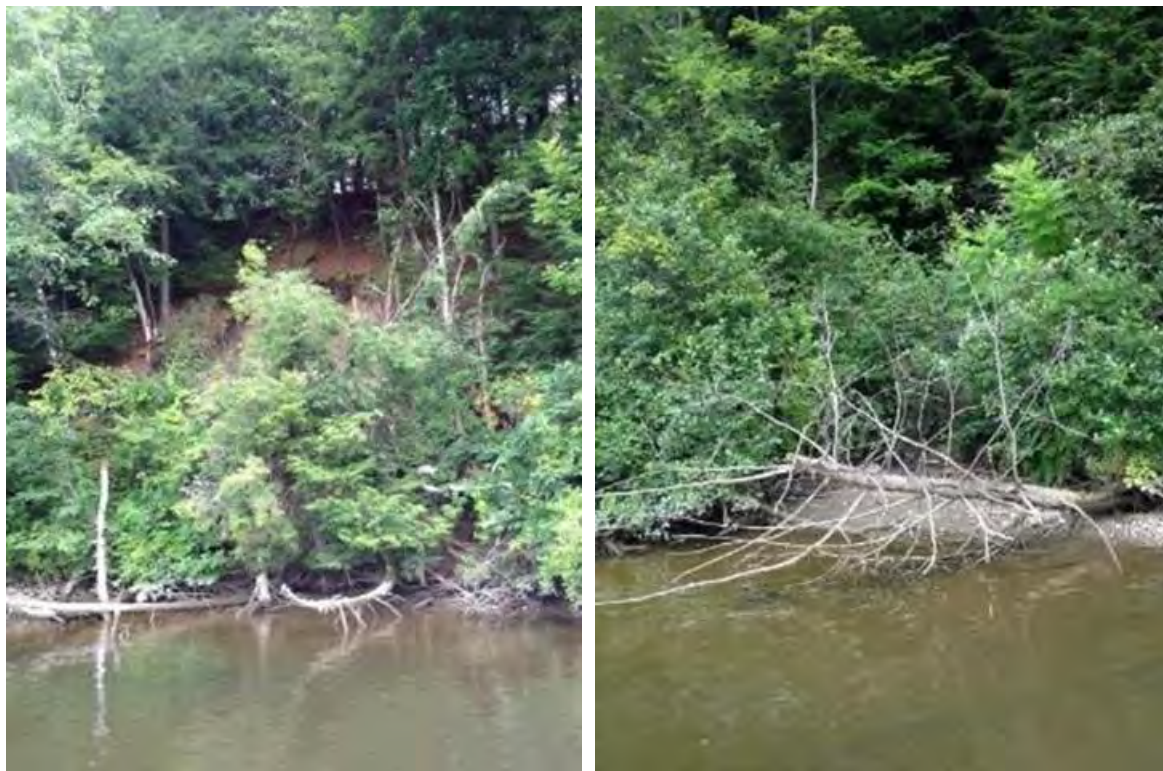
Figure 5.4.3.26-1 Photos at site 75BL

BSTEM runs at this site show that under the Baseline Condition, 55.0 ft³ of erosion occurred per foot of bank, during the 2000 to 2014 flow period, averaging 3.76 ft³/ft/y ([Table 5.4.3-1](#)). This results in the 8th highest erosion rate for the Baseline Condition, placing it between the 75th and 80th percentiles of erosion rates along the reach. The modeling also indicates that roughly 56% (2.10 ft³/y) of the erosion is due directly to hydraulic processes, whereas the other 44% (1.66 ft³/y) is the result of geotechnical processes and associated mass failures.

It should be noted that at this site, the Baseline Condition flows did not result in the greatest amount of erosion. One possible cause for this is that the peaking operations at Northfield Mountain are creating greater fluctuations in water surface elevations than would be created under a run-of-river scenario. By elimination of these fluctuations as seen in Scenario 1 this causes the shear stresses to be focused on a narrower band of the bank cross section, resulting in slightly higher hydraulic erosion which could cause an increase in the size of the individual bank failures.

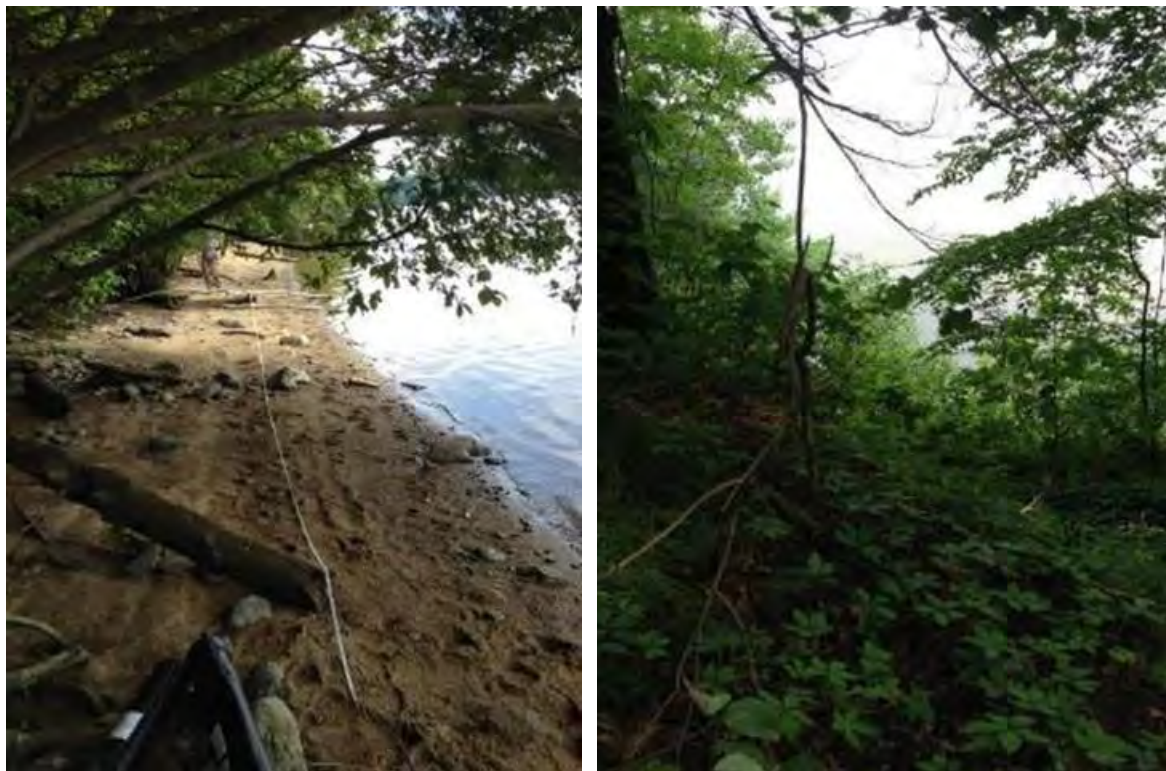
Figure 5.4.3.28-1 Photos at site 9R Post Restoration

BSTEM runs at this site show that for Post-restoration under the Baseline Condition, 1.40 ft³ of erosion occurred per foot of bank, during the 2008 to 2014 flow period, averaging 0.227 ft³/ft/y ([Table 5.4.3-1](#)). This results in the 8th lowest erosion rate for the Baseline Condition, placing it between the 20th and 25th percentiles of erosion rates along the reach. The modeling also indicates that all of the erosion is due directly to hydraulic processes.

Scenario 1 had a resulting erosion amount of 0.224 ft³/ft/y ([Figure 5.4.3.28-2](#)). The Baseline Condition (Waves off) resulted in 0.002 ft³/ft/y, indicating a substantial reduction in bank-erosion rates with the removal of the impacts from boat-generated waves. As there was a large difference between the Baseline Condition (Waves on) and Baseline Condition (Waves off), Scenario 1 was investigated for the waves off condition as well. This resulted in 1.50 x10⁻³ ft³/ft/y of erosion for Scenario 1 (Note- while this site did show a small reduction in erosion between the BL and S1 Scenarios the total reduction in erosion is well below the measureable/significant rate of 0.163 ft³/ft/yr). The highest water surface elevation for this period occurred at 184.5 ft. Most of the measured erosion for this site appears to occur above 190 feet. This erosion does not appear to be a function of the TFI hydraulics. For erosion to be present above the high water line, toe erosion would need to occur and then a geotechnical failure would occur above. The toe for this site, based on survey data, has not eroded significantly since the restoration to the point where a geotechnical failure would occur.

As a stage-discharge relation could not be developed for site 9R the high flow analysis is presented according to stage data only ([Figure 5.4.3.28-3](#)). Boat-generated waves are a dominant factor in erosion rates at this site producing 99% of the erosion.

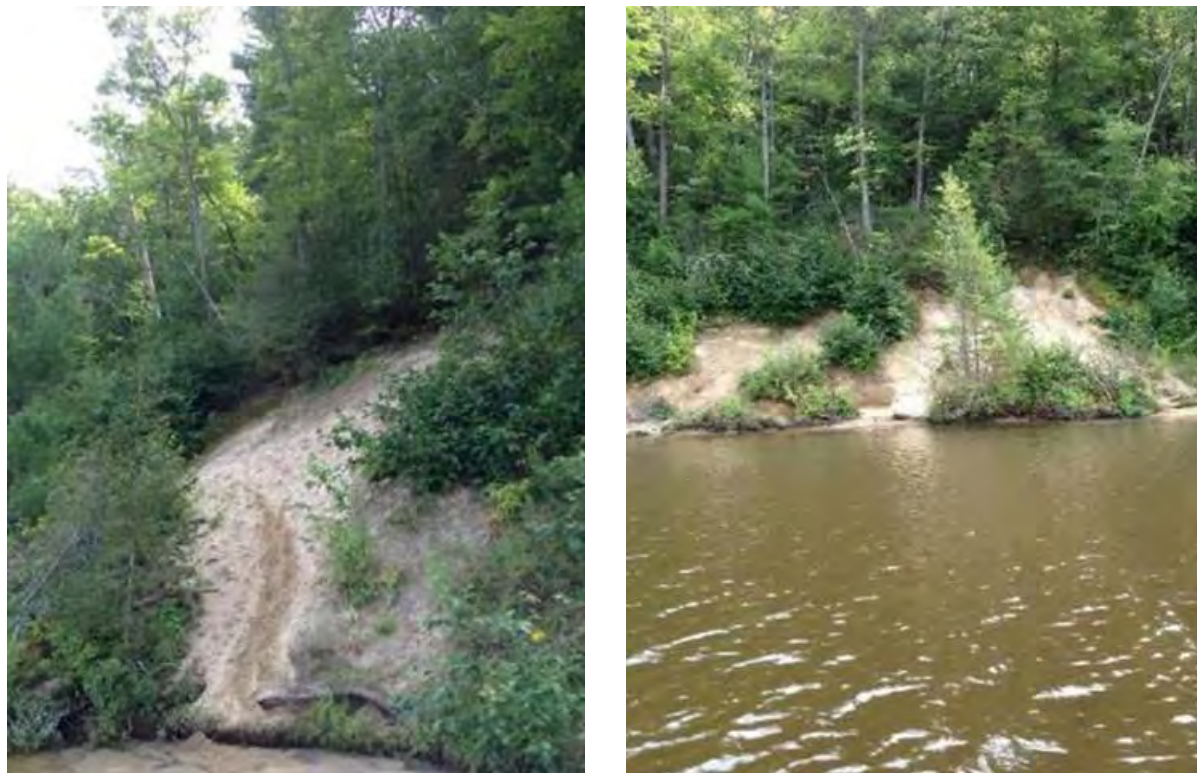
Figure 5.4.3.29-1 Photos at site 12BL

BSTEM runs at this site show that under the Baseline Condition, 32.6 ft³ of erosion occurred per foot of bank, during the 2000 to 2014 flow period, averaging 2.22 ft³/ft/y ([Table 5.4.3-1](#)). This results in the 12th highest erosion rate for the Baseline Condition, placing it between the 60th and 65th percentiles of erosion rates along the reach. The modeling also indicates that roughly 74% (1.65 ft³/y) of the erosion is due directly to hydraulic processes, whereas the other 26% (0.57 ft³/y) is the result of geotechnical processes and associated mass failures.

For Scenario 1, 2.15 ft³/ft/y of erosion occurred ([Figure 5.4.3.29-2](#) to [Figure 5.4.3.29-4](#)) resulting in about 3% of the total erosion (Note- while this site did show a small reduction in erosion between the BL and S1 Scenarios the total reduction in erosion is well below the measureable/significant rate of 0.163 ft³/ft/yr). With the lower variability in water surface fluctuations at this site we see a bigger wave influence. The Baseline Condition (Waves off) resulted in 0.239 ft³/ft/y representing about 89% of the total erosion, attesting to the important role of boat-generated waves in inducing erosion at this site. As Baseline Condition (Waves off) scenario illustrated a significant reduction in erosion, Scenario 1 was also run without the effects of boat waves. With waves off the model run for Scenario 1 resulted in 0.194 ft³/ft/y. Clearly, boat waves are significant for all Operational scenarios and, therefore, protection of the bank-toe region could limit further bank erosion at this site.

As a stage-discharge relation could not be developed for site 12BL, the high flow analysis is presented according to stage data only ([Figure 5.4.3.29-5](#)). Boat-generated waves are a dominant factor in erosion rates at this site producing 89% of the erosion. While moderate to high flow erosion rates could not be determined for this site, based on the trend throughout the impoundment in reaches 2, 3, and 4 it is likely that moderate to high flows still play a contributing role in total erosion.

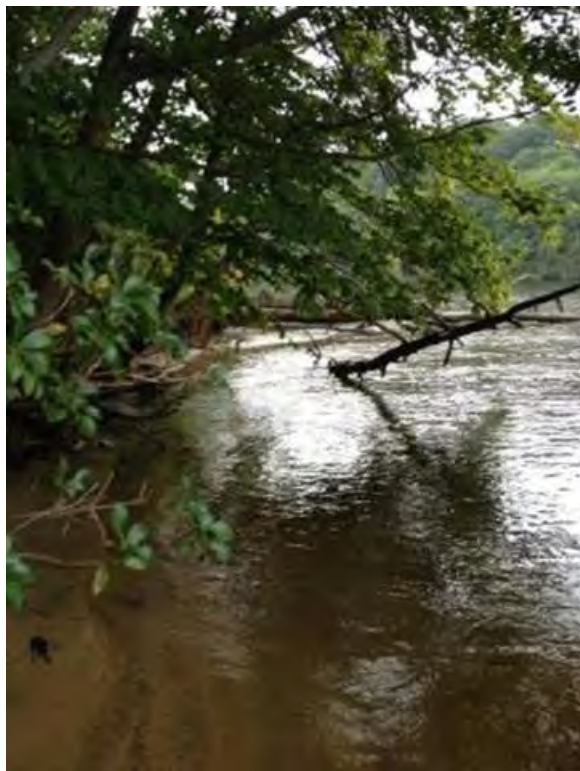
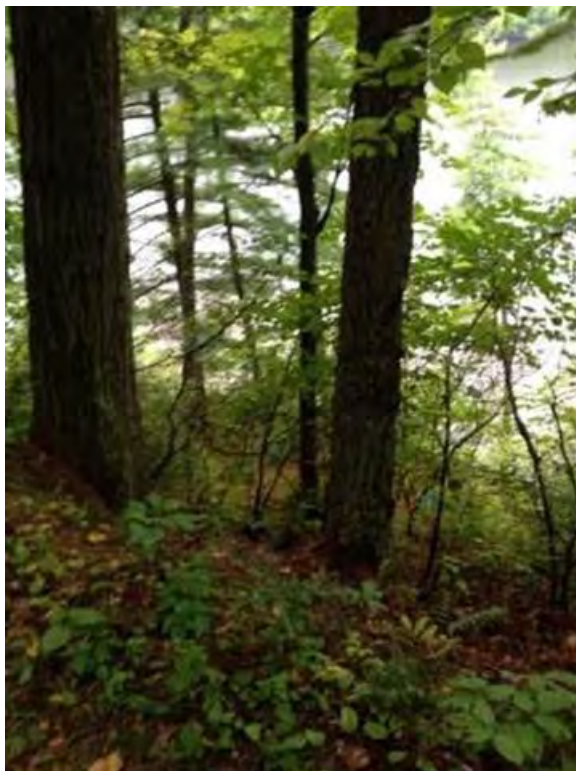
Figure 5.4.3.30-1 Photos at site BC1R

The river at site BC-1R (station 4,750) has moderately steep, heavily vegetated banks and is located on the north side of the Barton Cove Campground, immediately upstream of the Turners Falls Dam. The bank is roughly 20 feet tall, with a silty-loam toe and a sandy upper bank. The bank face and bank top are heavily vegetated with Black birch, Eastern hemlock, Eastern white pine, and Northern red oak trees. There was a significant amount of bare soil noted on the bank face, likely due to the large trees and canopy cover ([Figure 5.4.3.30-1](#)).

BSTEM runs at this site show that under the Baseline Condition, 2.70 ft³ of erosion occurred per foot of bank, during the 2000 to 2014 flow period, averaging 0.190 ft³/ft/y ([Table 5.4.3-1](#)). This results in the 6th lowest erosion rate for the Baseline Condition, placing it between the 15th and 20th percentiles of erosion rates along the reach. The modeling also indicates that 100% of the bank erosion is due directly to hydraulic processes, and none of the bank erosion is the result of mass failures.

For Scenario 1, 0.189 ft³/ft/y, of erosion occurred ([Figure 5.4.3.30-2](#) to [Figure 5.4.3.30-3](#)) resulting in the percent reduction in erosion rates of 0.237%. With the lower variability in water surface fluctuations at this site we see a bigger wave influence. As there was a large difference between the Baseline Condition (Waves on) and Baseline Condition (Waves off), Scenario 1 was investigated for the waves-off condition as well. This resulted in virtually no erosion with 8.42x10⁻⁹ ft³/ft/y. Thus, boat-generated waves are the dominant cause (almost 100%) for the small amount of bank erosion at this site.

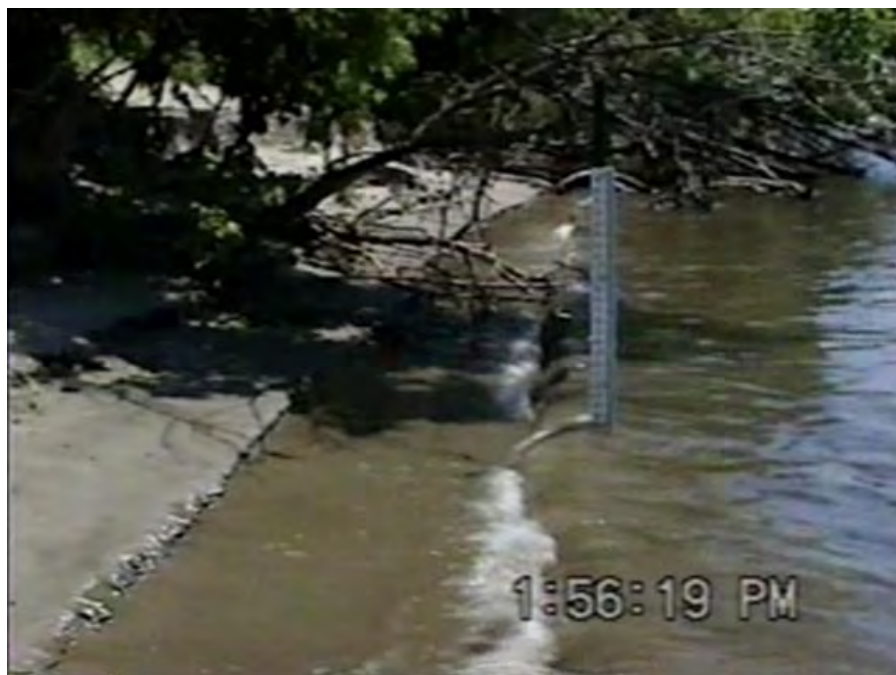
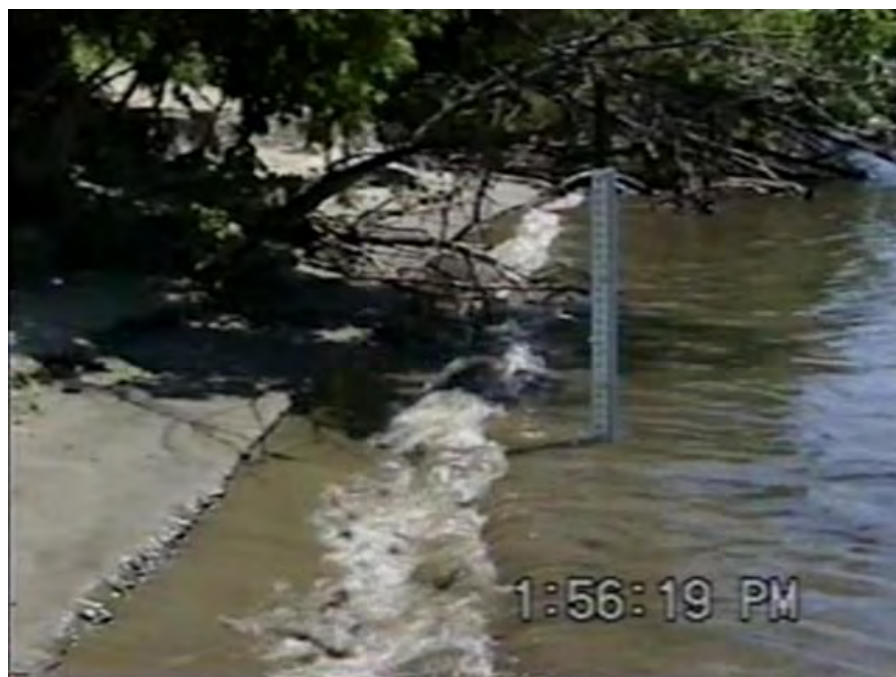
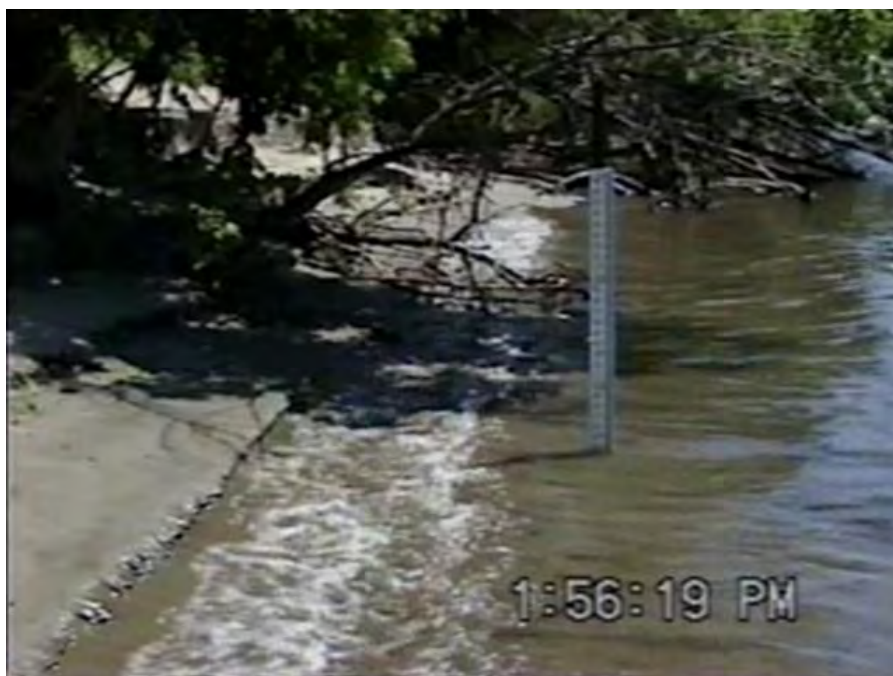
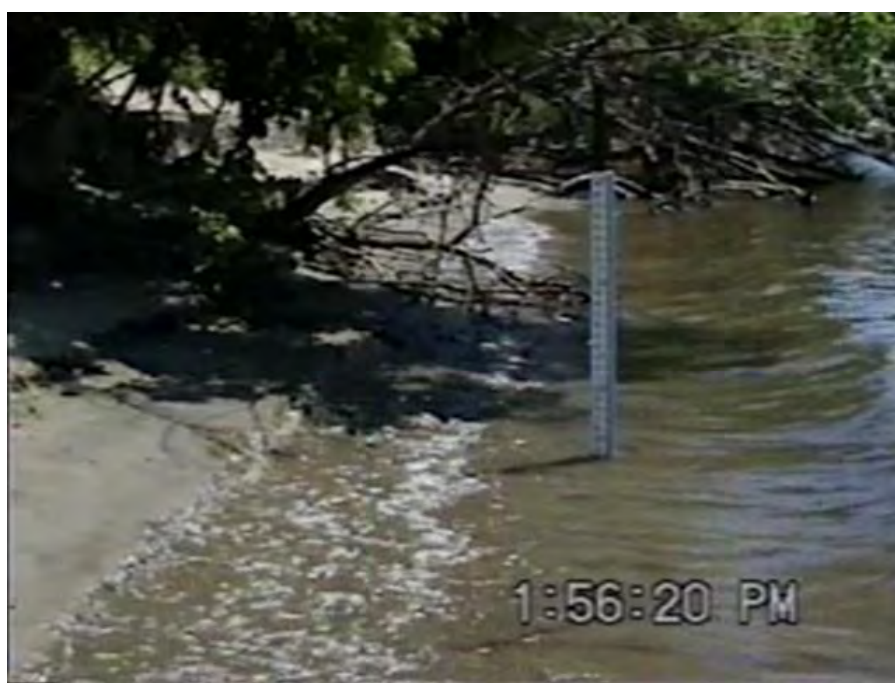
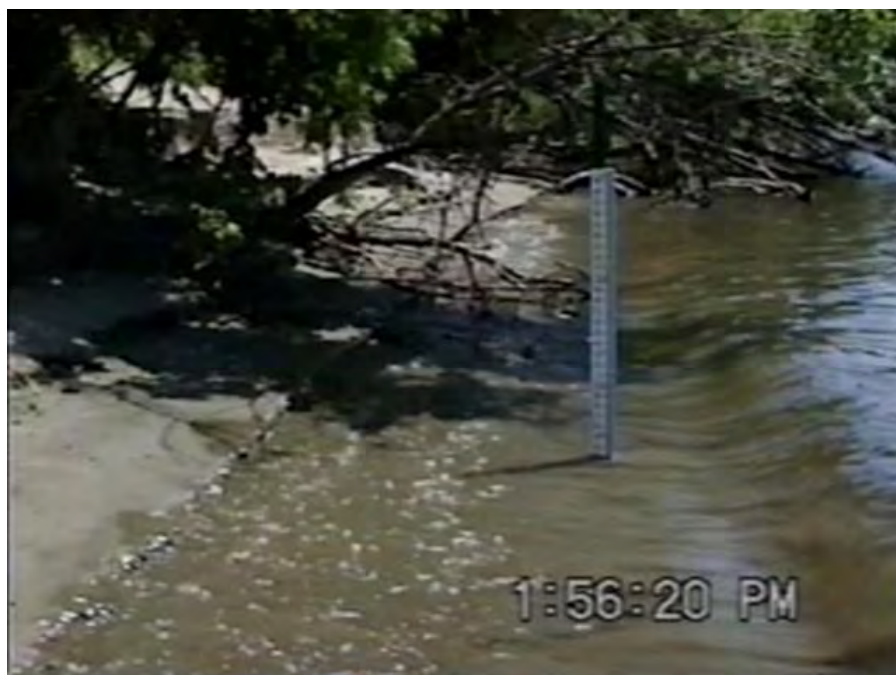
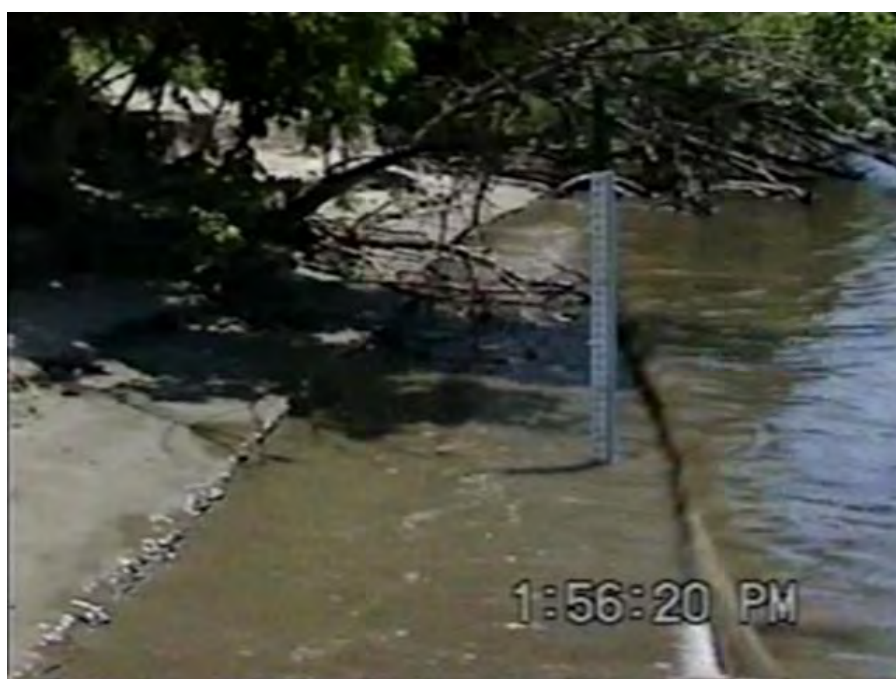
Figure 5.5.3-2a: Boat Wave Data Collection, July 1997

A series of six photos showing the sequence of a wave impacting the lower riverbank over a period of about 2 seconds is found in [Figure 5.5.3-2a](#) through [c](#). Given that the general water level that day was on the lower riverbank, as the waves moved towards the bank they would break on the lower bank and erode a short notch into the bank. As each progressive wave would impact this small notch, some of the vertical face would frequently break off and collapse onto the beach where the water would move sediment particles back down the beach where they would generally deposit. During these low flow conditions the downstream velocity of the flow was negligible so no significant downstream transport of the detached and mobile sediment occurred. Even during this period of relatively low flow and water surface elevation, there was evidence of larger notches cut by the waves in the transition area between the lower and upper riverbanks ([Figure 5.5.3-3](#)).

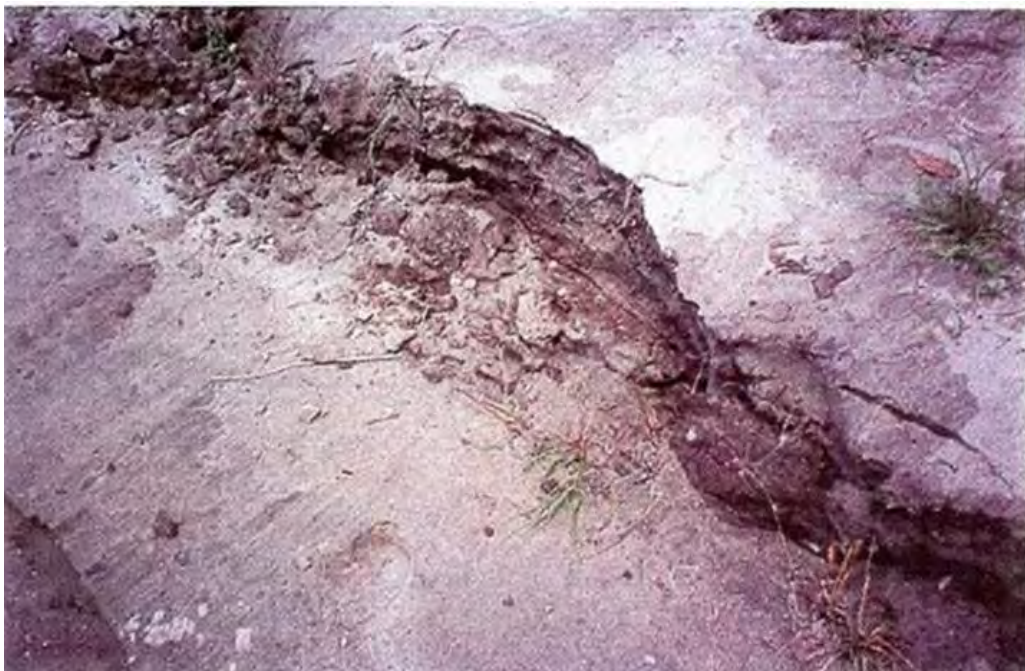
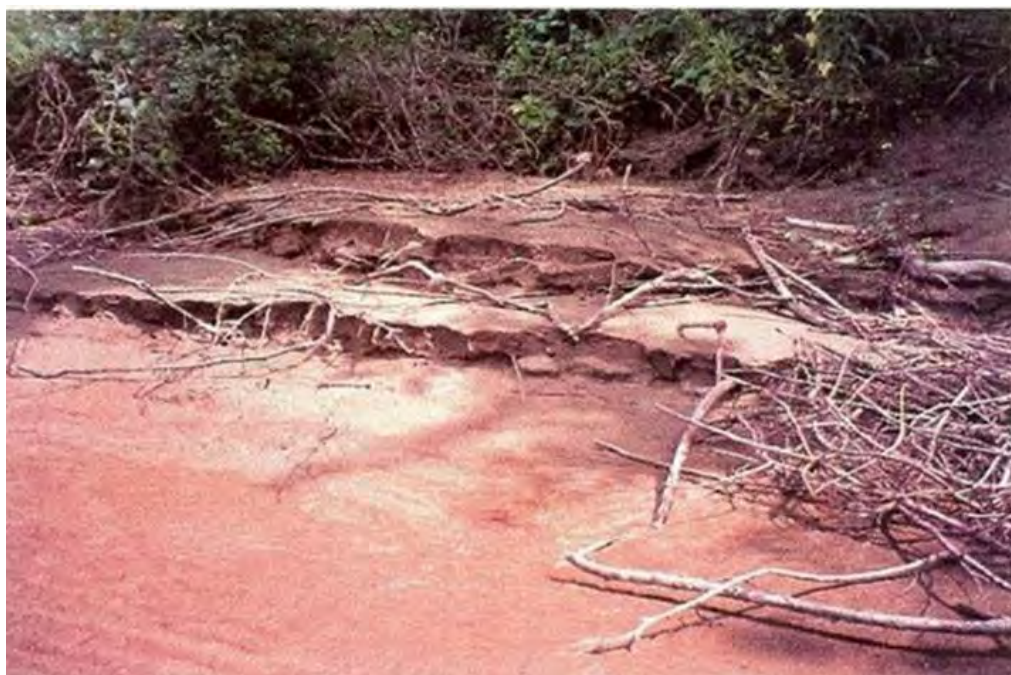
Figure 5.5.3-3: Notching Due to Boat Waves

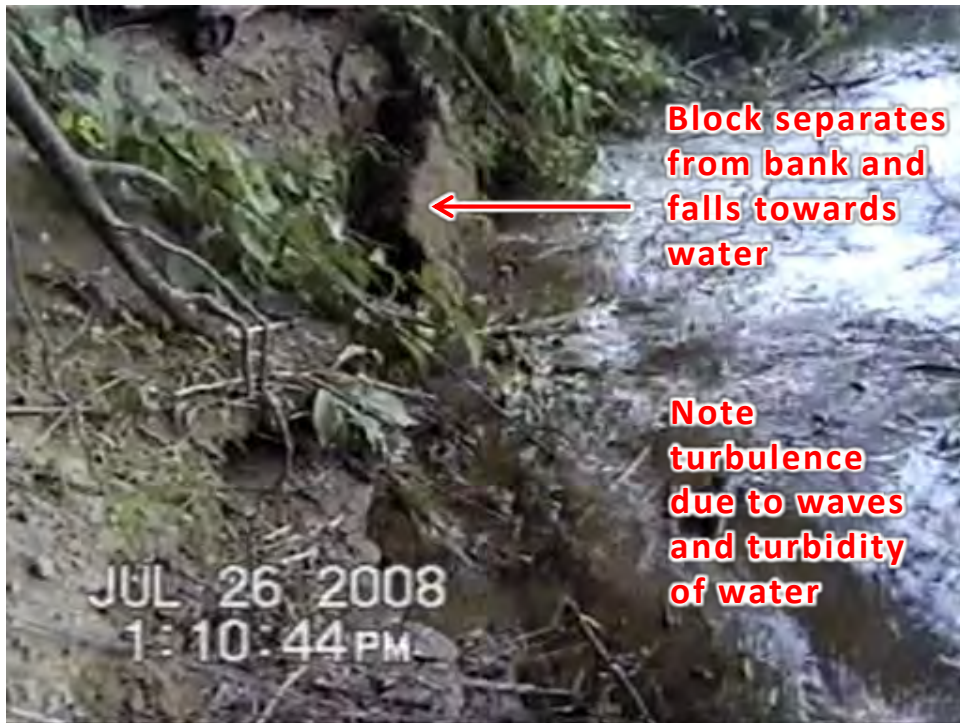
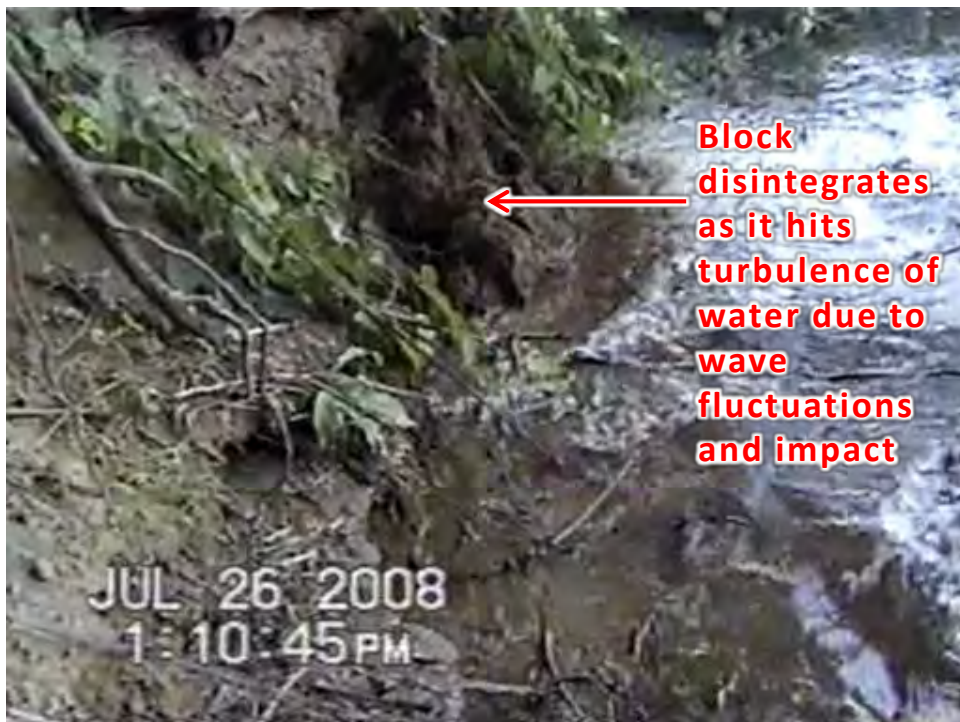
The boat traffic was relatively light for a weekend in July due to cool temperatures and occasional rain. Despite the light boat traffic, significant erosion was observed due to boat waves. [Figures 5.5.3-6a](#) and [5.5.3-6b](#)) show a sequence of boat wave impact and erosion photos captured from the video taken these two days. This sequence of photos covers a period of about 10 seconds. The first photo in the sequence shows that a piece of riverbank about 4 to 6 inches in thickness and about a foot or more in height was being undercut by waves at its base had begun to crack loose from the riverbank. As the waves continue to impact the base of this riverbank the crack widens and then the piece falls into the turbulent water. Because the water level was on the upper bank, boat waves undercut the bank and easily caused pieces of bank to fail. As a result, erosion was quite significant over this two day period at the observation site. Hours of video tape are available showing the significant and progressive erosion that resulted from boat waves that impacted the upper bank during a moderately high flow event in July 2008. During these two days, no significant erosion was observed due to the current or the slow rise and fall of the water surface. Significant erosion was observed consistently, however, whenever boat waves impacted and undercut the riverbank. This can be clearly seen in the DVD documenting the study.

Figure 5.5.3-6b: Boat Wave Erosion Sequence

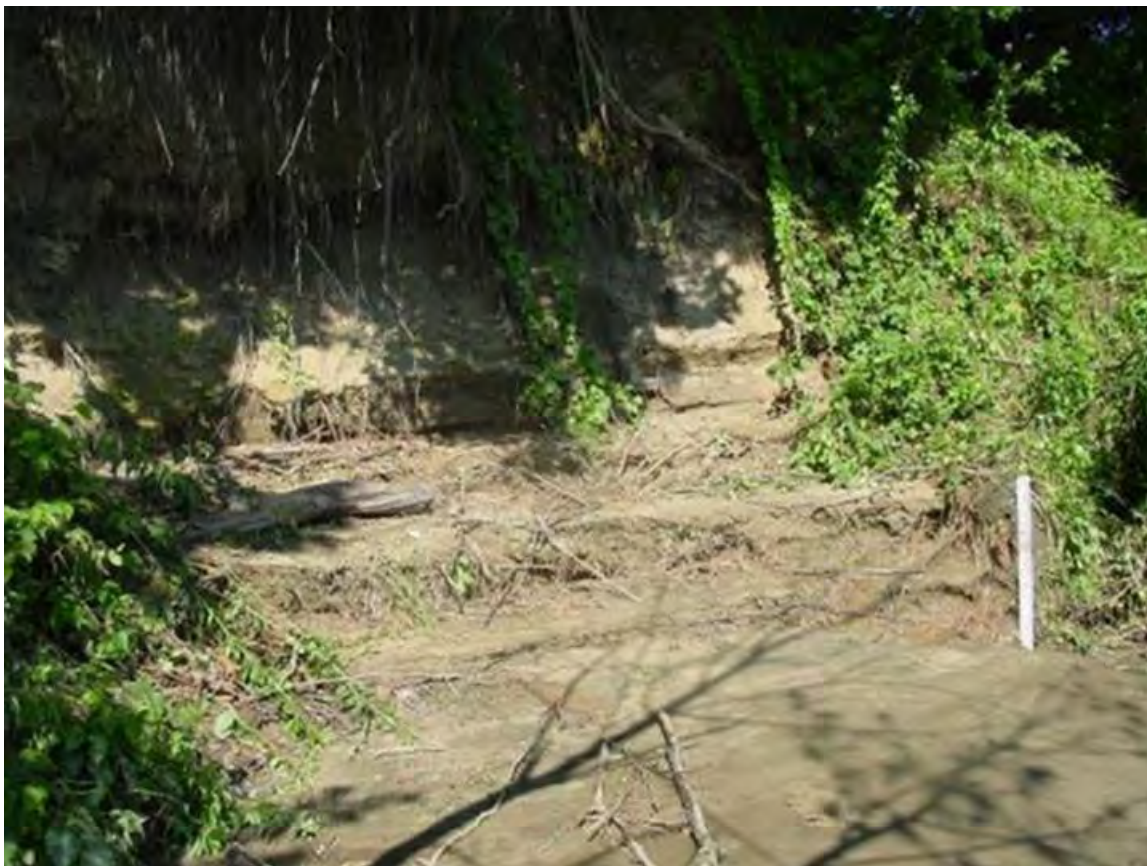
After the water had receded further, a photograph of this same area shows that about 4 vertical benches were eroded into the riverbank as waves impacted the bank at different levels as the water level varied with flow ([Figure 5.5.3-7](#)). Note that tree roots are observed dangling beneath the overhanging bank at the top of the photograph. It is apparent that other higher flow events have eroded this riverbank resulting in the overhanging bank. A view from a little farther out shows the notches cut into the riverbank by boat waves and the hanging roots from the undercut tree above the portion of the bank recently impacted by boat waves ([Figure 5.5.3-8](#)).

Figure 5.5.3-7: Example of Boat Wave Erosion

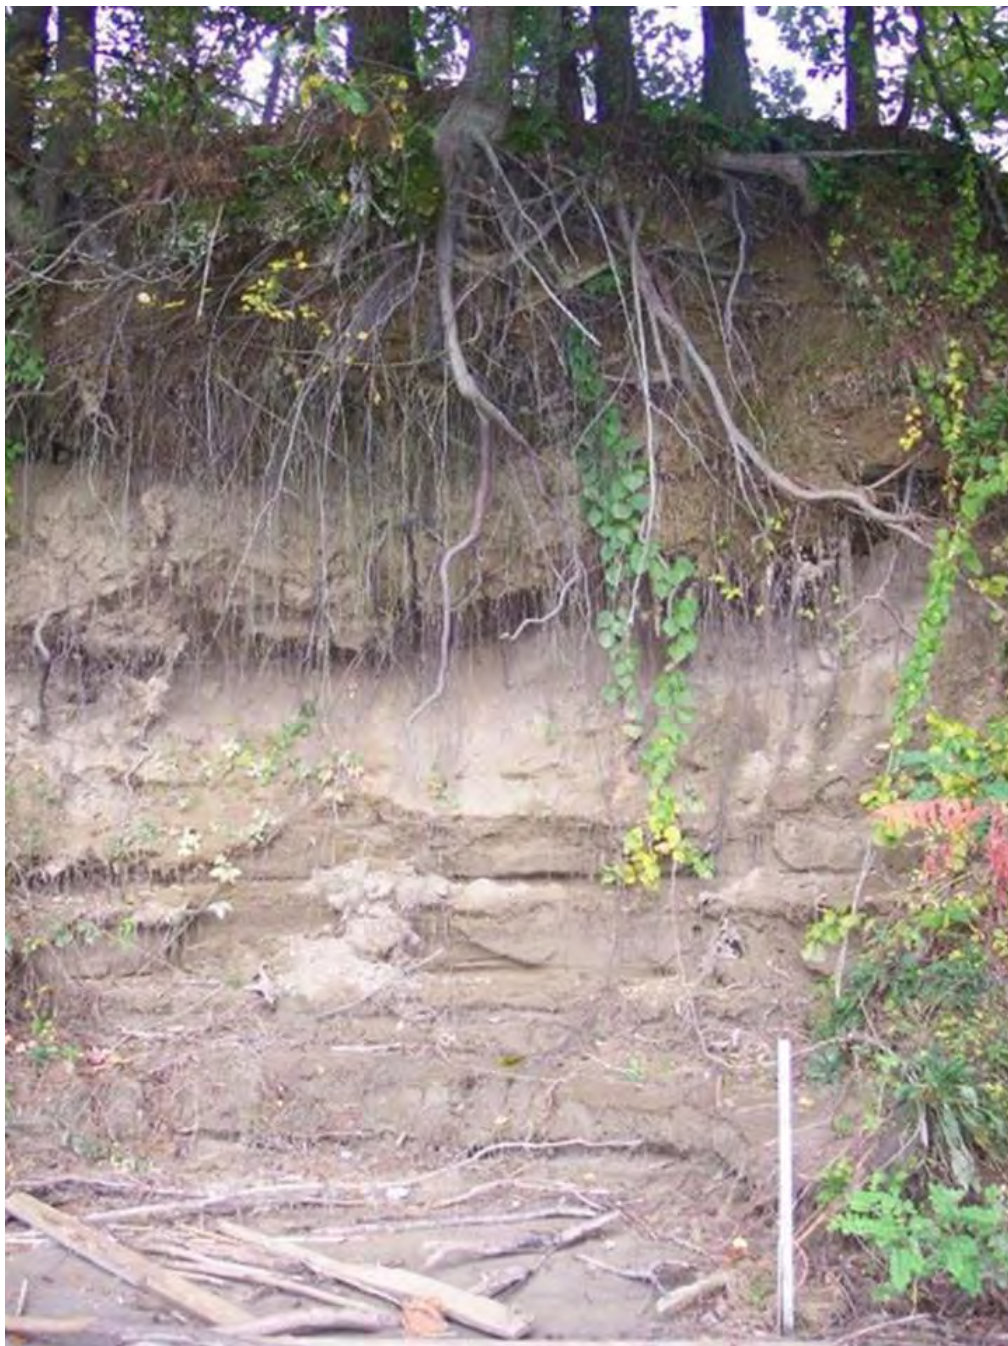
Figure 5.5.3-8: Example of Boat Wave Erosion

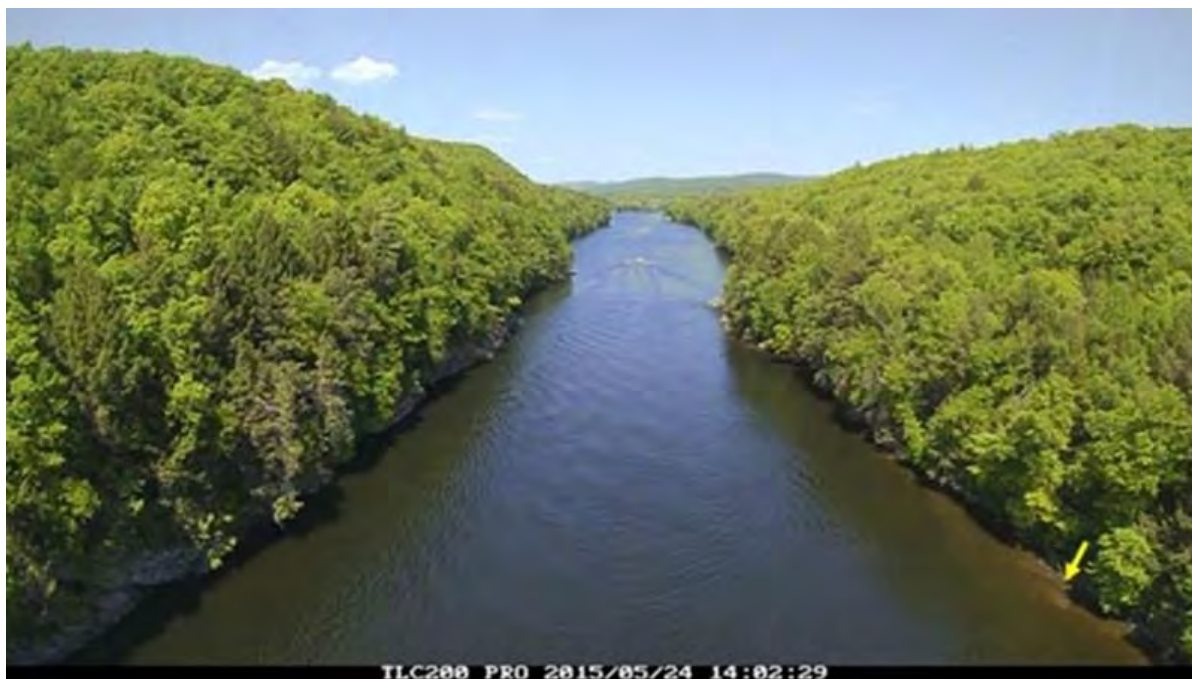
Figure 5.5.3-10: Suspended Sediment Plume Expands

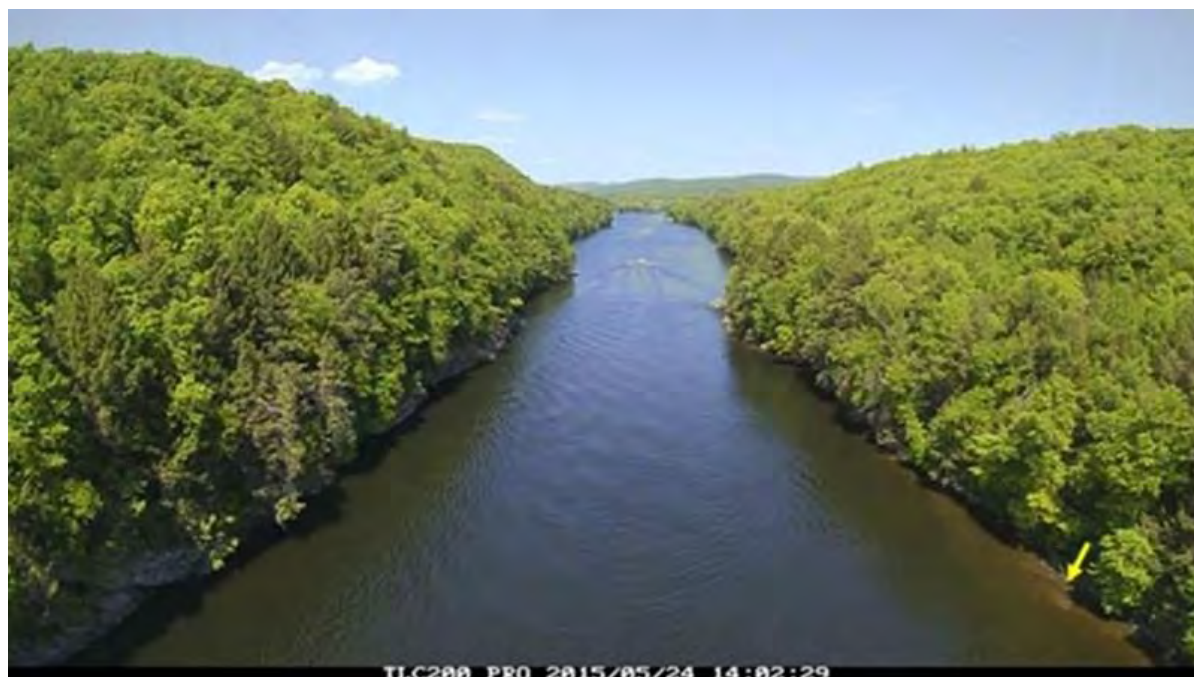
Figure 5.5.3-11: Further Expansion of Suspended Sediment Plume
