Relicensing Study 3.1.2

**Northfield Mountain / Turners Falls
Operations Impact on Existing Erosion and
Potential Bank Instability
Study Report**

Volume II – Main Report

**Northfield Mountain Pumped Storage Project (No. 2485) and
Turners Falls Hydroelectric Project (No. 1889)**

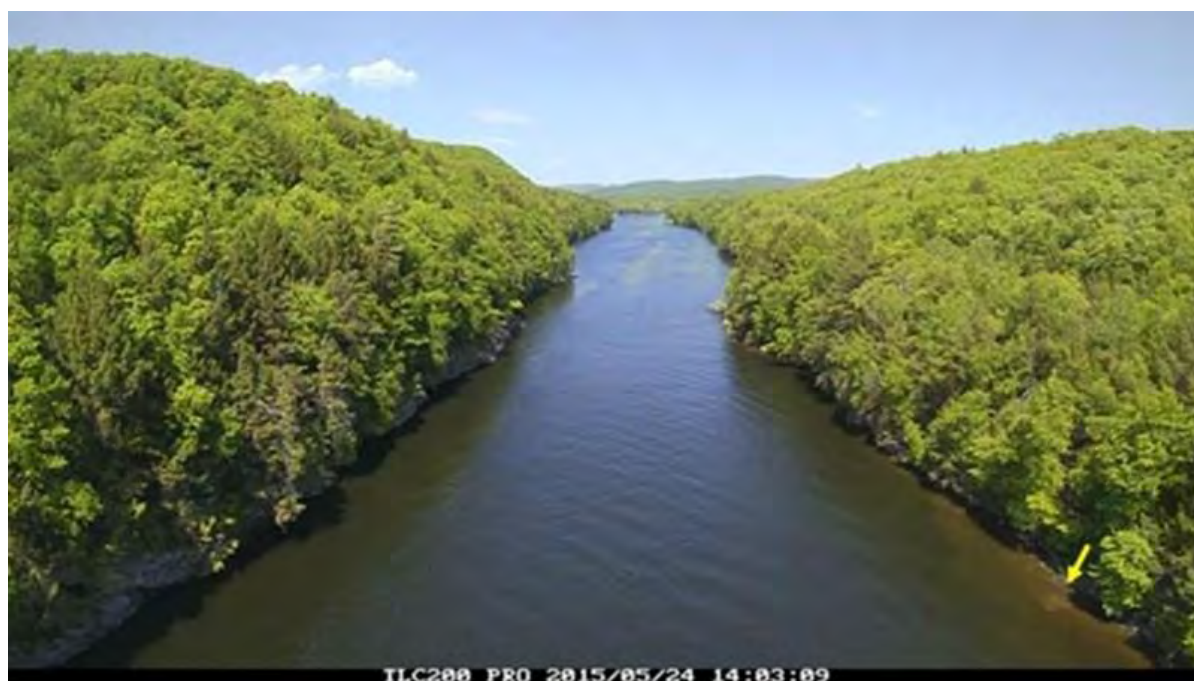
Figure 5.5.3-12: Suspended Sediment Plume Expands Farther Out From Banks

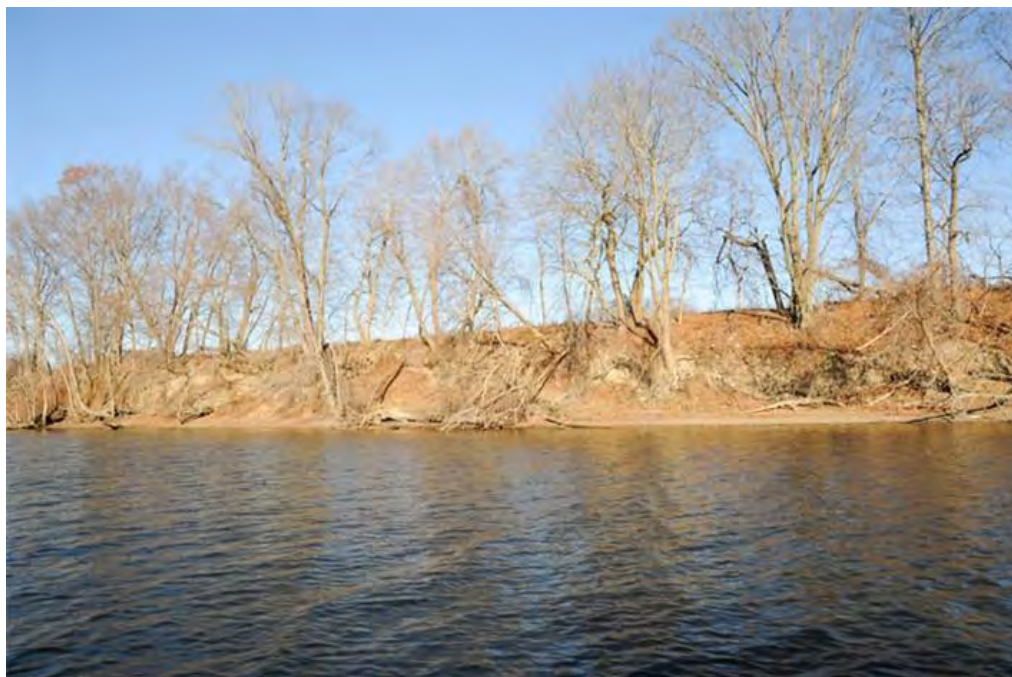
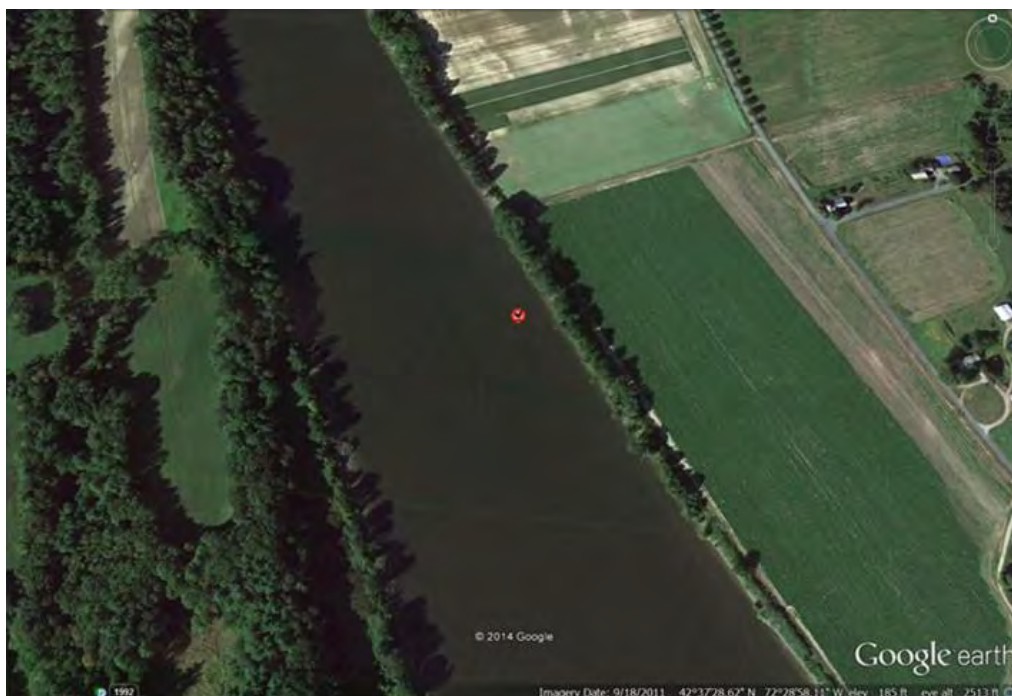
As observed in [Tables 5.5.4-1](#) and [5.5.4-2](#), 27.5% of TFI riverbanks were classified as either cropland or pasture with 38% of riverbanks exhibiting a riparian buffer less than 50 ft. Frequently riverbanks in areas with narrow or non-existent riparian buffers consist of steep to overhanging banks consisting of silty/sandy soils that are easily erodible unless sufficient vegetation is present to reinforce the soil and provide some buffering of hydraulic forces. An example of erosion that has occurred where the agricultural land-use exists can be seen in [Figure 5.5.4-3](#).

Figure 5.5.4-3: Erosion Adjacent to Agricultural Land-use

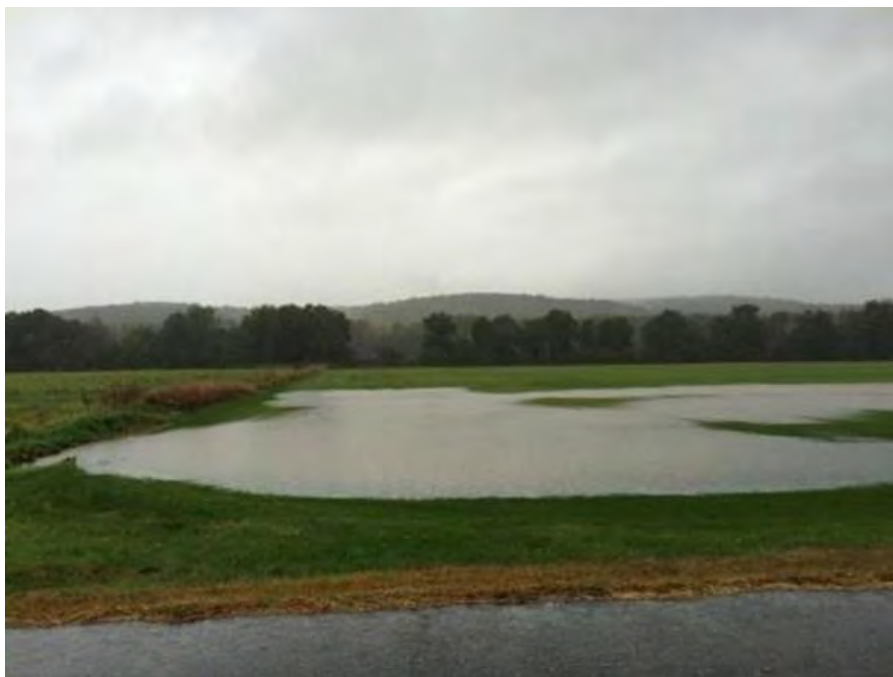
When significant rainfall occurs, water may pond on relatively flat agricultural fields and infiltrate into the ground ([Figures 5.5.4-7](#) through [5.5.4-13](#), 9/30/2015). This adds to soil saturation (compared to hillslopes where more rainfall tends to occur as runoff and less infiltration into the soil). A greater degree of saturation in these soils would then result in additional seepage through the riverbank and back to the river.

Figure 5.5.4-7: Ponding on agricultural fields from rainfall event, September 30, 2015 (a)

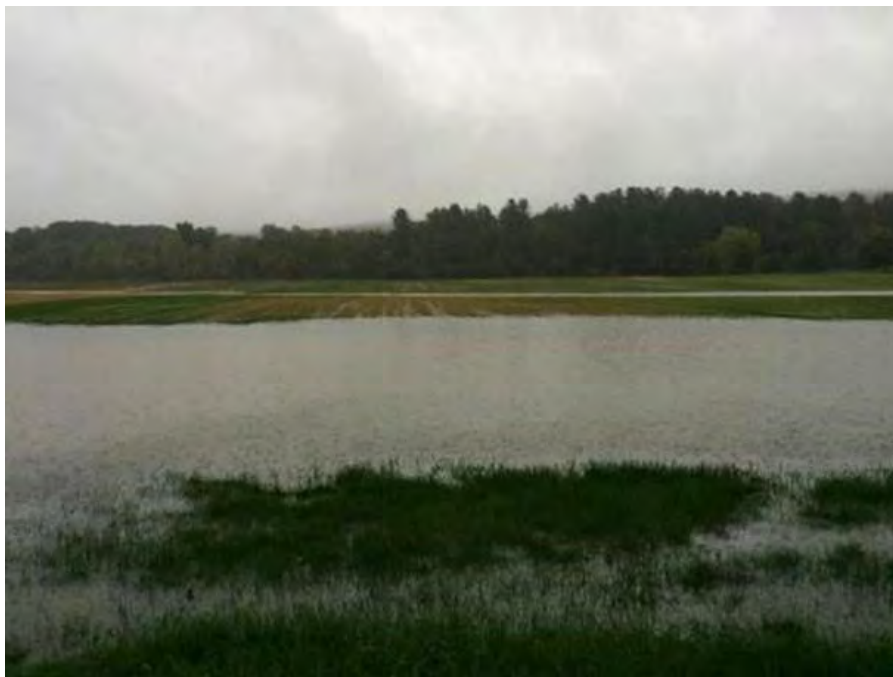
Figure 5.5.4-8: Ponding on agricultural fields from rainfall event, September 30, 2015 (b)

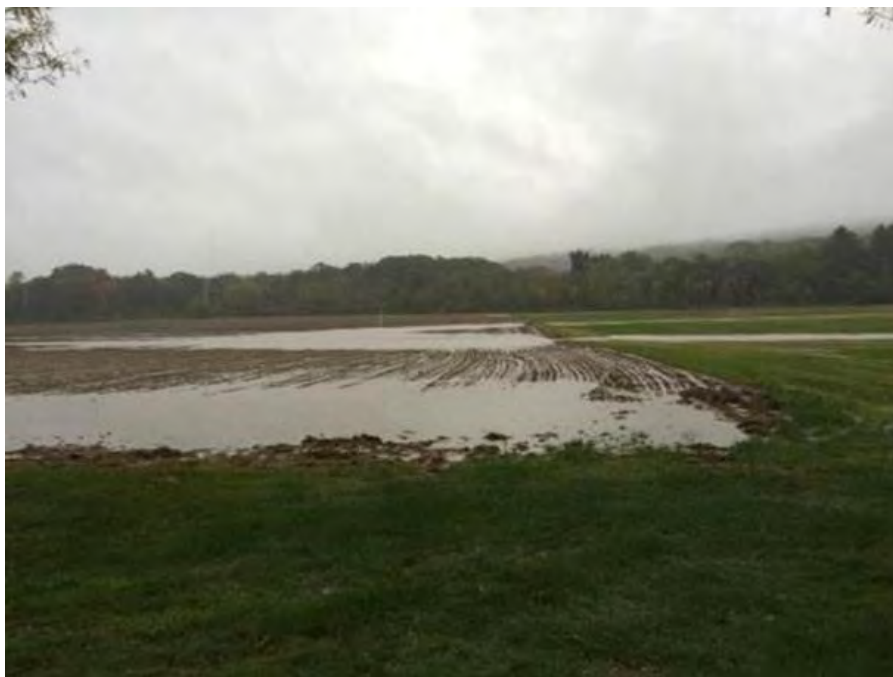
Figure 5.5.4-9: Ponding on agricultural fields from rainfall event, September 30, 2015 (c)

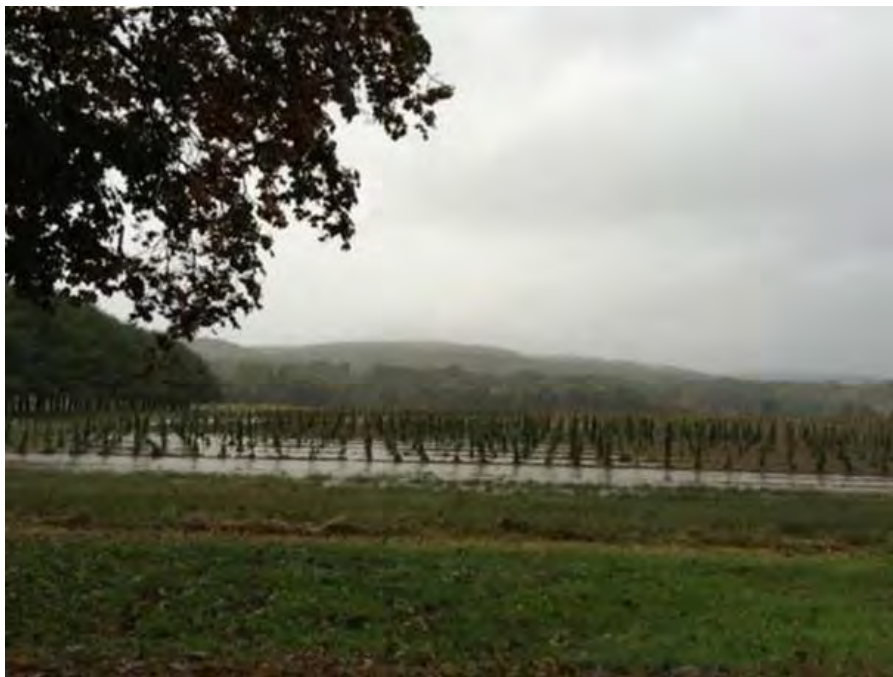
Figure 5.5.4-10: Ponding on agricultural fields from rainfall event, September 30, 2015 (d)

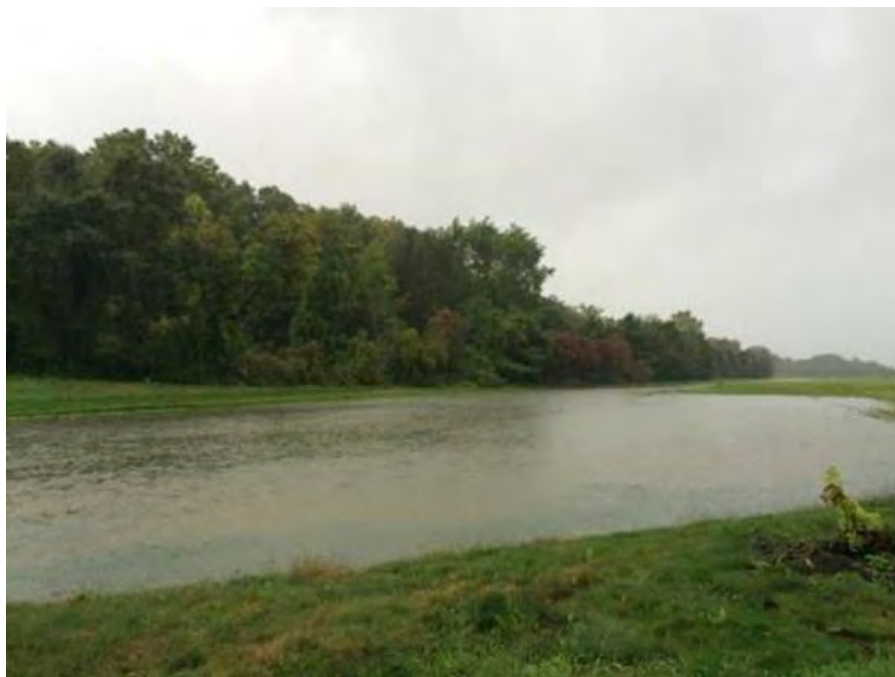
Figure 5.5.4-11: Ponding on agricultural fields from rainfall event, September 30, 2015 (e)

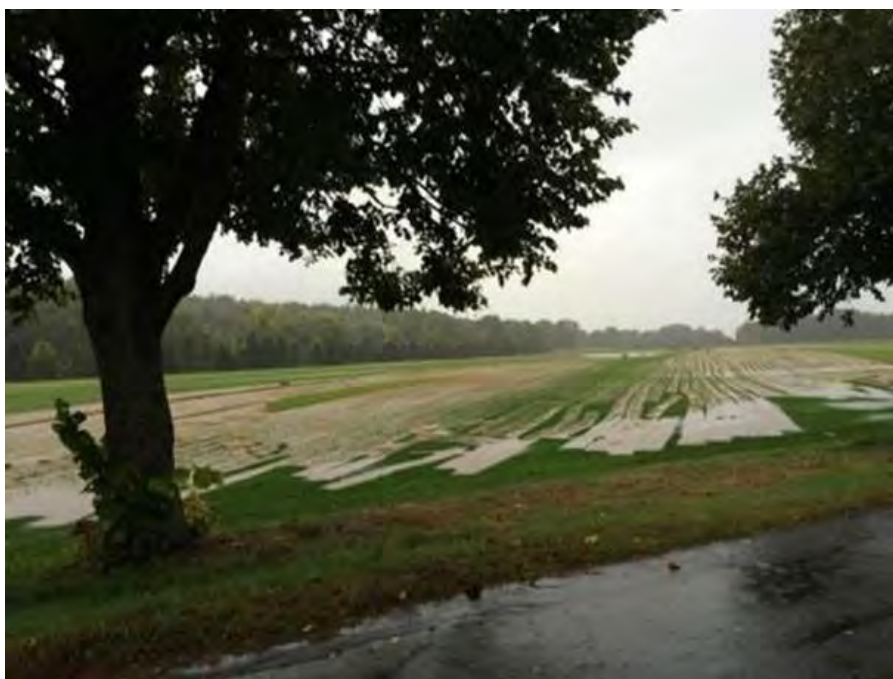
Figure 5.5.4-12: Ponding on agricultural fields from rainfall event, September 30, 2015 (f)

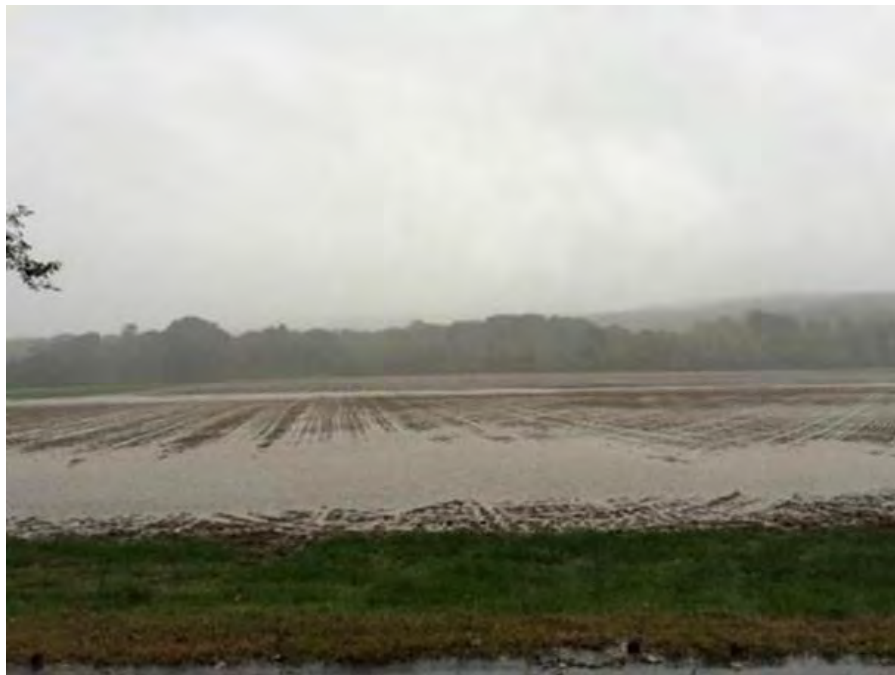
Figure 5.5.4-13: Ponding on Agricultural Fields from Rainfall Event, September 30, 2015 (g)

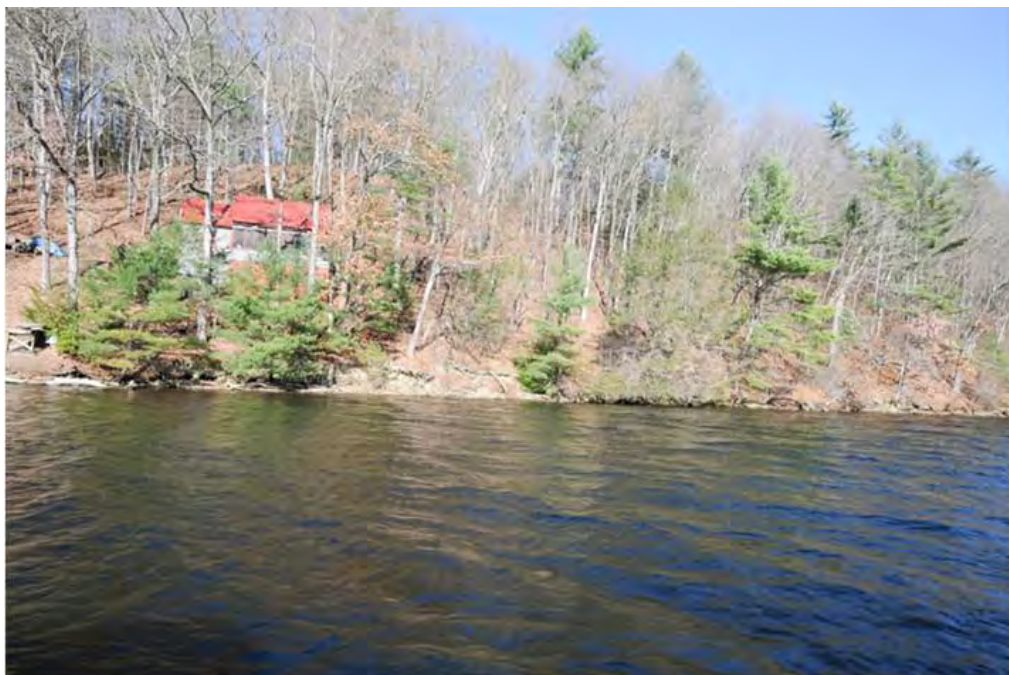
In addition to agriculture, erosion has also been observed in areas where houses and other associated development are located in close proximity to the river. An example of erosion in close proximity to a house is shown in [Figure 5.5.4-14](#). As shown in the figure undercutting, overhanging bank, and exposed roots were observed at this location in close proximity to the structure. In several instances where houses have been built close to the river, riparian vegetation has also been cleared which can adversely affect riverbank stability. An example of this is shown in [Figure 5.5.4-15](#).

Figure 5.5.4-14: Erosion adjacent to seasonal Camp 2-W

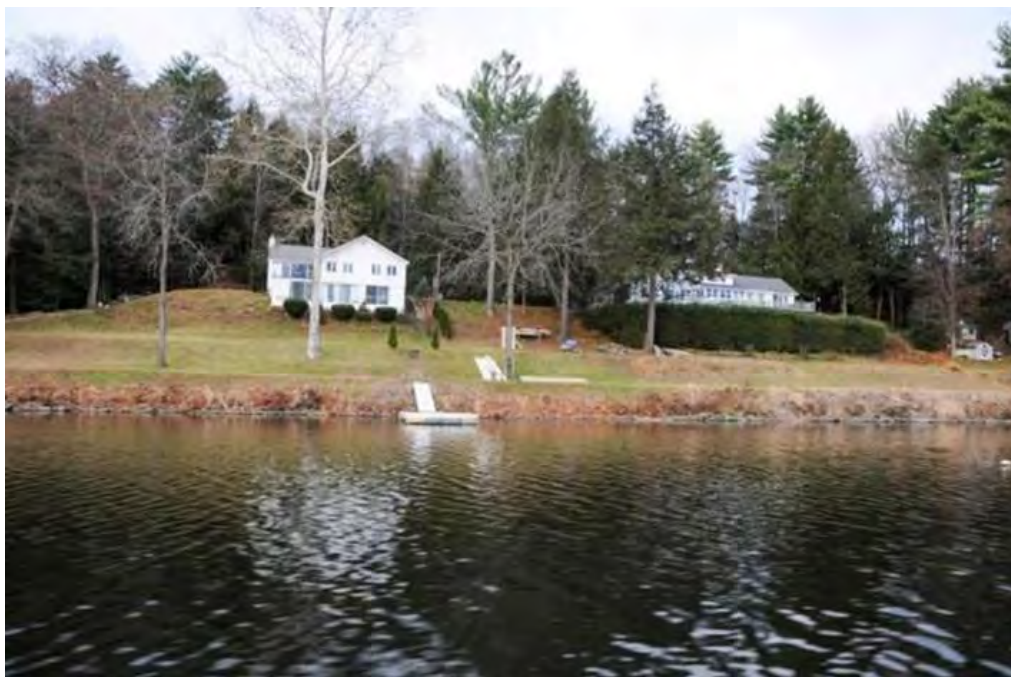
Figure 5.5.4-15: Development thinning or removing riparian vegetation

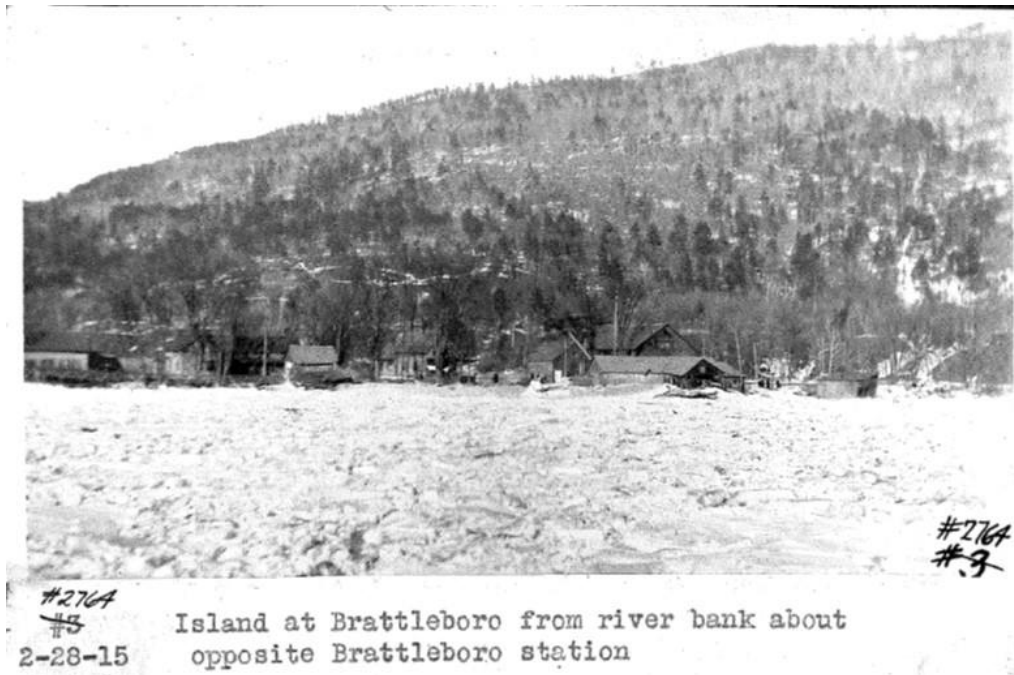
Figure 5.5.5.2-1 Ice on the Connecticut River at Brattleboro, VT – 1915 (TransCanada)

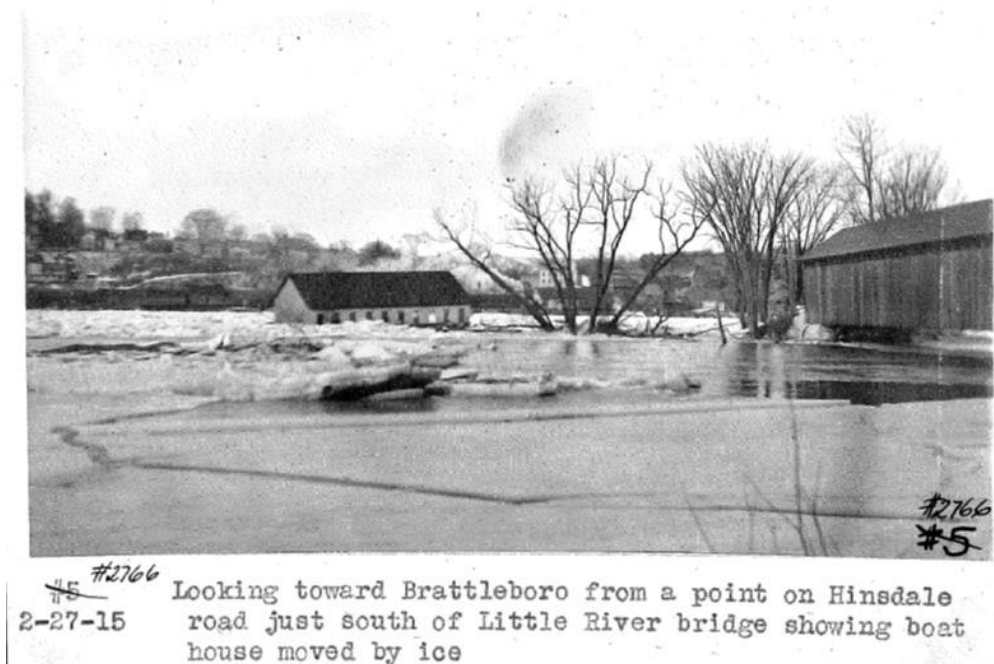
Much of the information contained in the TransCanada files consisted of photographs of ice jams, ice damage and erosion that occurred as a result of ice. One of the earliest set of photos from TransCanada showing ice was taken in 1915 at Brattleboro, VT ([Figure 5.5.5.2-1](#)), which is located in the Vernon Impoundment and just downstream of the West River confluence. Ice had moved a boat house adjacent to the river and ice had been forced over the riverbanks causing damage to trees as shown in [Figures 5.5.5.2-2](#) and [5.5.5.2-3](#).

Figure 5.5.5.2-2 Connecticut River Boat House Moved by Ice – 1915 (TransCanada)

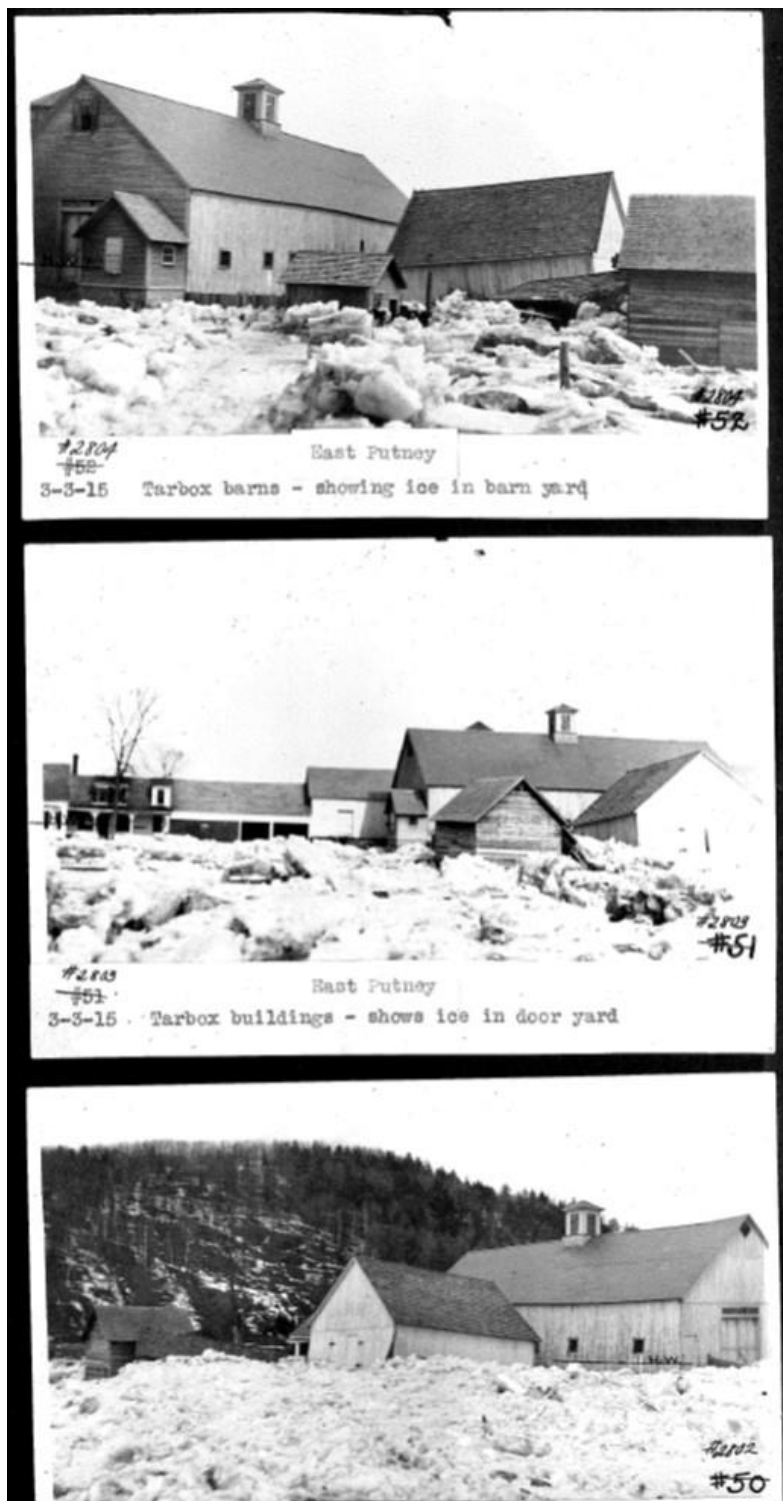
Sets of photographs showing ice found in the TransCanada files include the following years: 1915, 1935, 1940, 1941, 1942, 1943, 1945, 1946, 1959, 1968, 1989, 1992, and 1994. [Figure 5.5.5.2-4](#) provides an example of historic ice photos taken in 1915. In addition to a number of sets of photographs of ice, some data was also available in the TransCanada files including ice thickness at several locations along the river. An example of such data is shown in [Figure 5.5.5.2-5](#). Another example of the type of ice data that are available is found in [Figure 5.5.5.2-6](#). Similar types of data were found in the TransCanada files for the following years: 1940, 1944, 1945, 1946, 1948, 1951, 1952, 1953, 1955, 1956, 1957, and 1958. While some observations, are available before and after these years, actual measurements of ice in the available files were concentrated in the 1940s and 1950s. In addition, maps of the extent of ice were occasionally developed based on observations along the river ([Figure 5.5.5.2-7](#)). A review of the files also found that tributaries to the Connecticut River are a significant contributor of ice. When ice jams occur, they form as a result of constrictions or shallow areas associated with tributaries.

Figure 5.5.5.2-4 Ice at East Putney – 1915 (TransCanada)

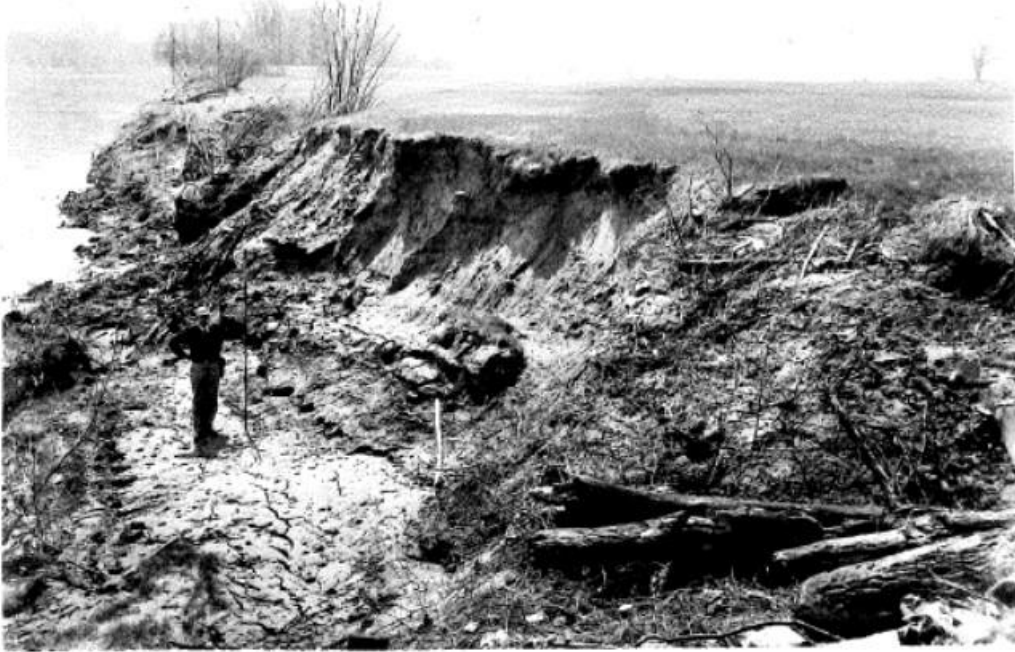
Figure 5.5.5.2-13 Connecticut River near Windsor, VT – April 24, 1946 (TransCanada)

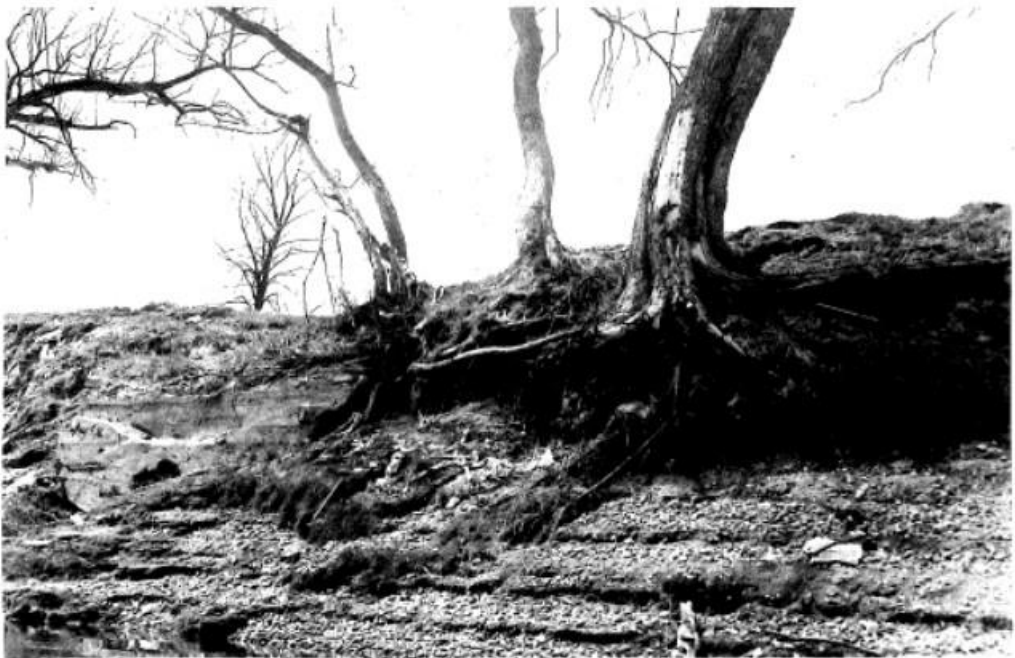
Figure 5.5.5.2-14 Connecticut River near Windsor, VT – April 24, 1946 (TransCanada)

Ice also has an adverse effect on riparian vegetation (as shown in previously referenced [Figure 5.5.5.2-14](#), [5.5.5.2-19](#), and [5.5.5.2-20](#)). As noted in R. Ettema, 2002:

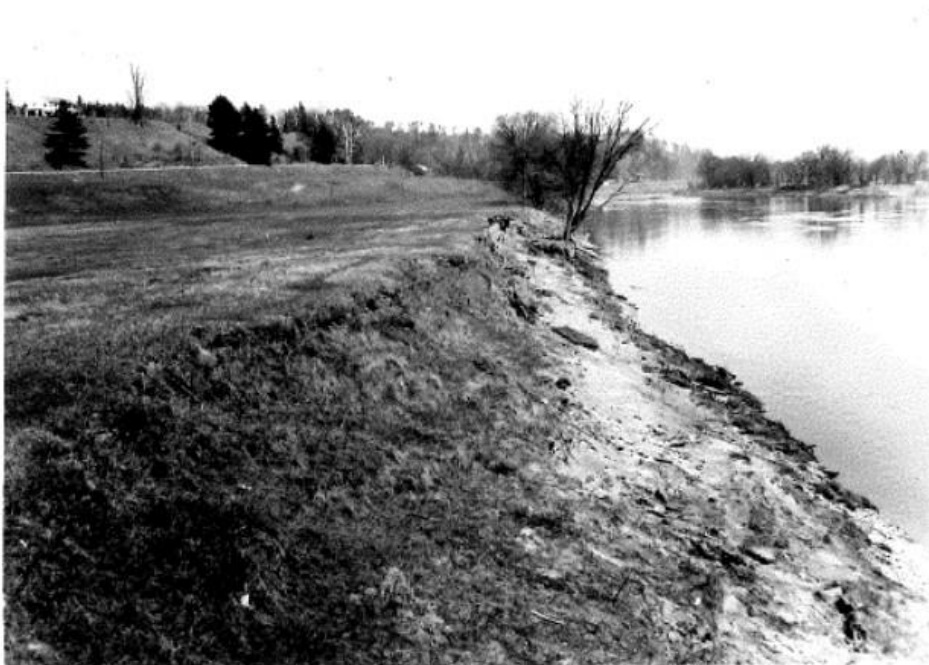
Figure 5.5.5.2-15 Connecticut River near Windsor, VT – April 24, 1946 (TransCanada)

Another phenomenon discussed in R. Ettema, 2002 was that ice may cause erosion to riverbanks by abrasion or gouging. The review specifically noted that “*during heavy ice runs resulting from ice-cover breakup or ice-jam release, large pieces of ice potentially may gouge and abrade channel banks. There exists significant evidence showing that ice runs may substantially affect riverbank morphology* (Marusenko 1956; Hamelin 1979; Smith 1979; U.S. 1983; Doyle 1988; Wuebben 1995; Uunila 1997)” (R. Ettema, 2002). Ice flowing downstream, or being forced into the banks, was clearly seen in historic and recent photographs shown previously in this report (see [Figures 5.5.5.2-1](#) through [5.5.5.2-4](#), [5.5.5.2-9](#) through [5.5.5.2-11](#), and [5.5.5.2-23](#)). Damage associated with these ice events can be observed in previous figures ([Figure 5.5.5.2-13](#), [5.5.5.2-15](#) through [5.5.5.2-18](#), and [5.5.5.2-22](#) through [5.5.5.2-23](#)).

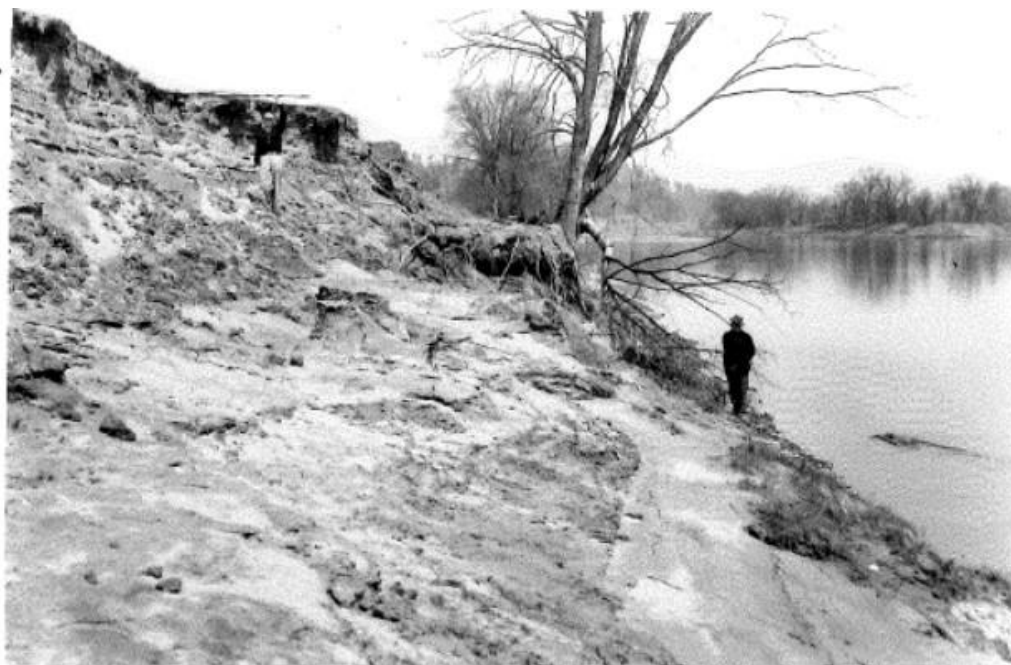
Figure 5.5.5.2-16 Connecticut River near Windsor, VT – April 24, 1946 (TransCanada)

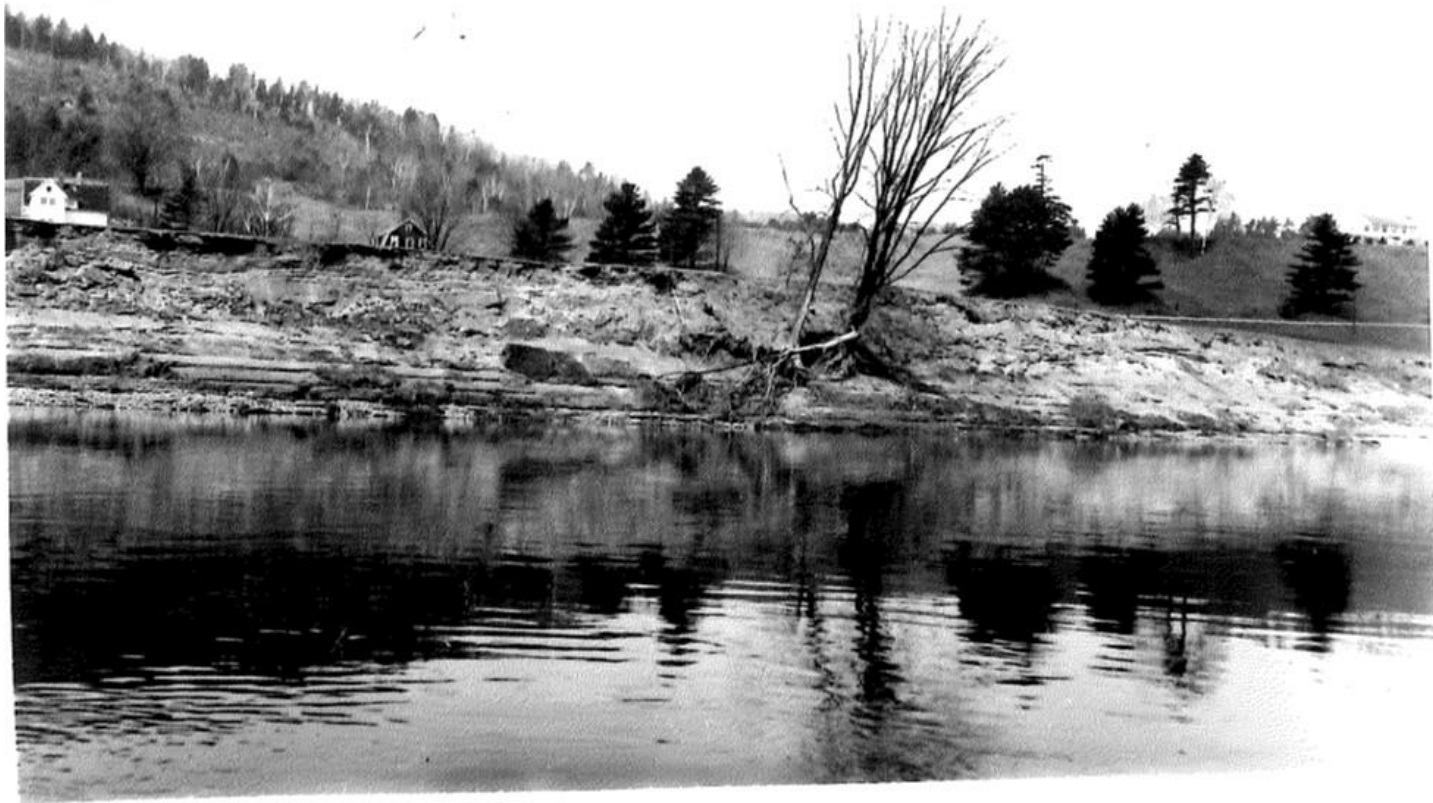
Figure 5.5.5.2-17 Connecticut River near Windsor, VT – April 24, 1946 (TransCanada)

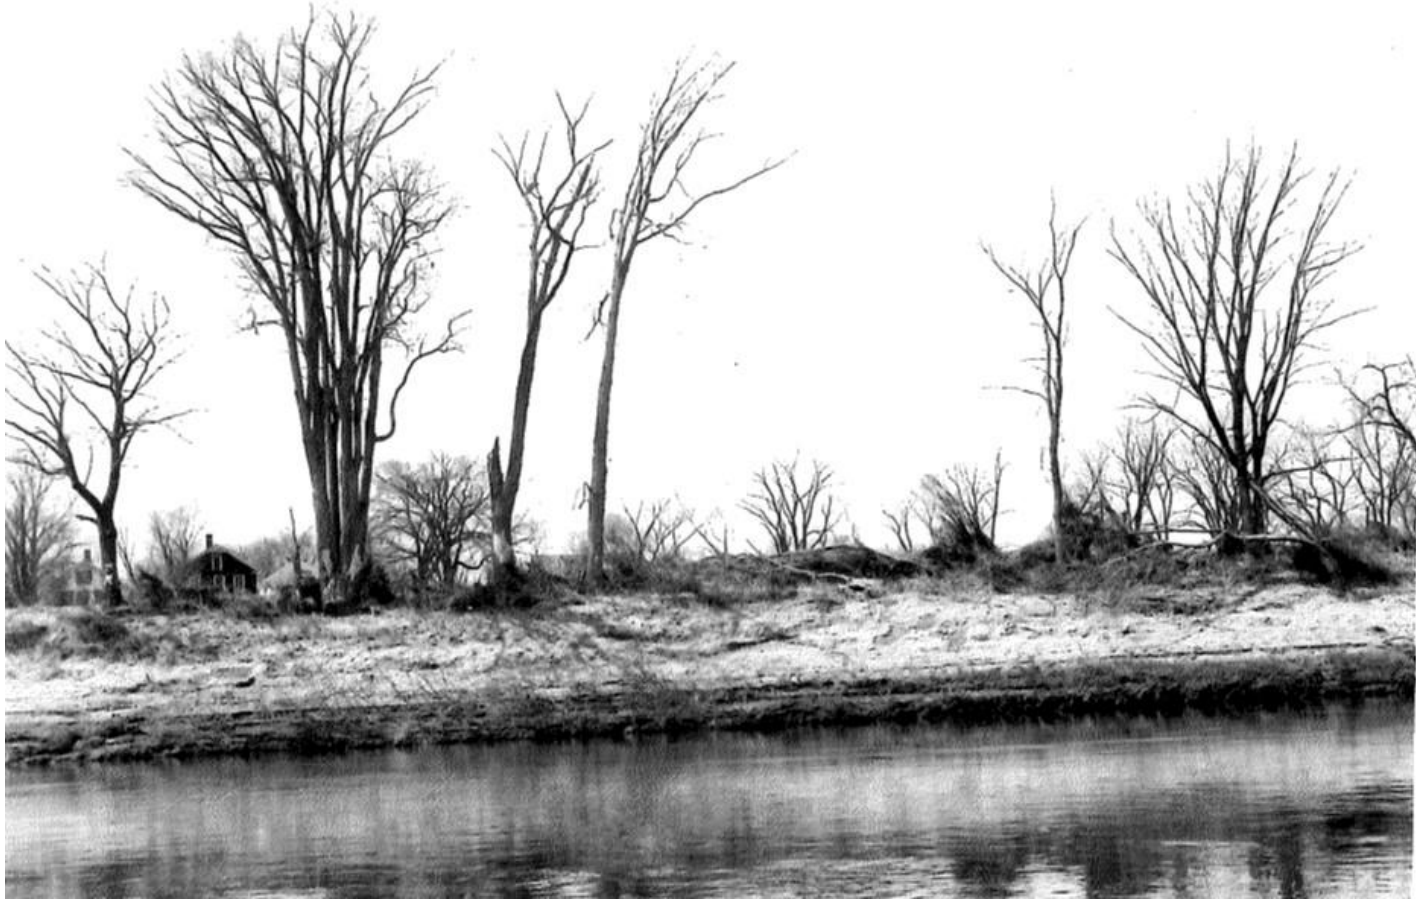
Figure 5.5.5.2-18 Connecticut River near Windsor, VT – April 24, 1946 (TransCanada)

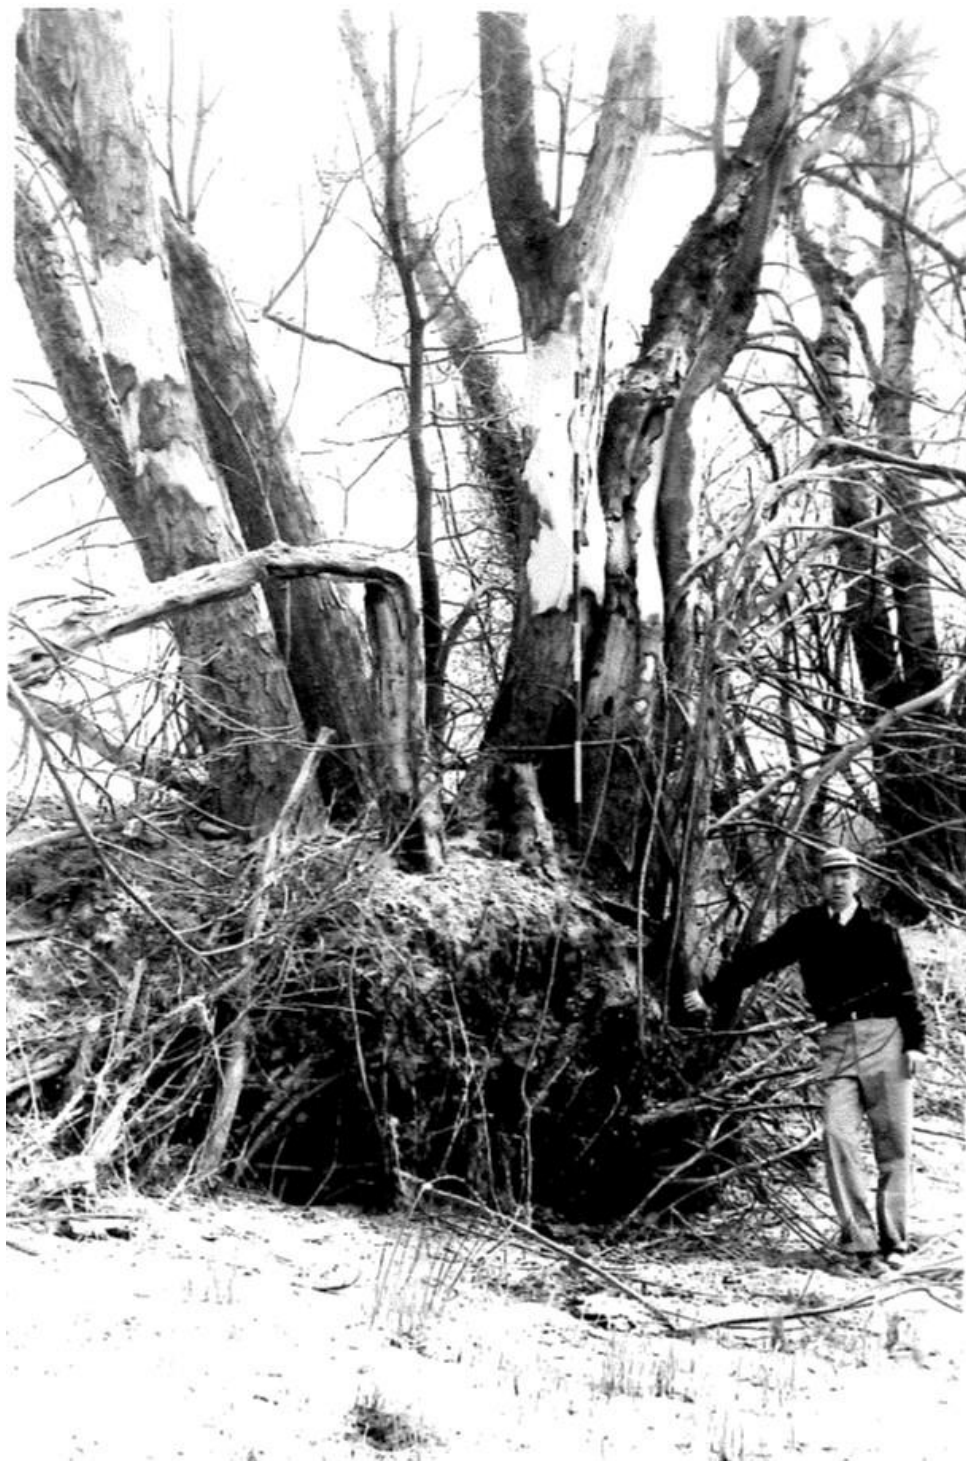
Figure 5.5.5.2-19 Connecticut River near Cornish, NH – April 23, 1946 (TransCanada)

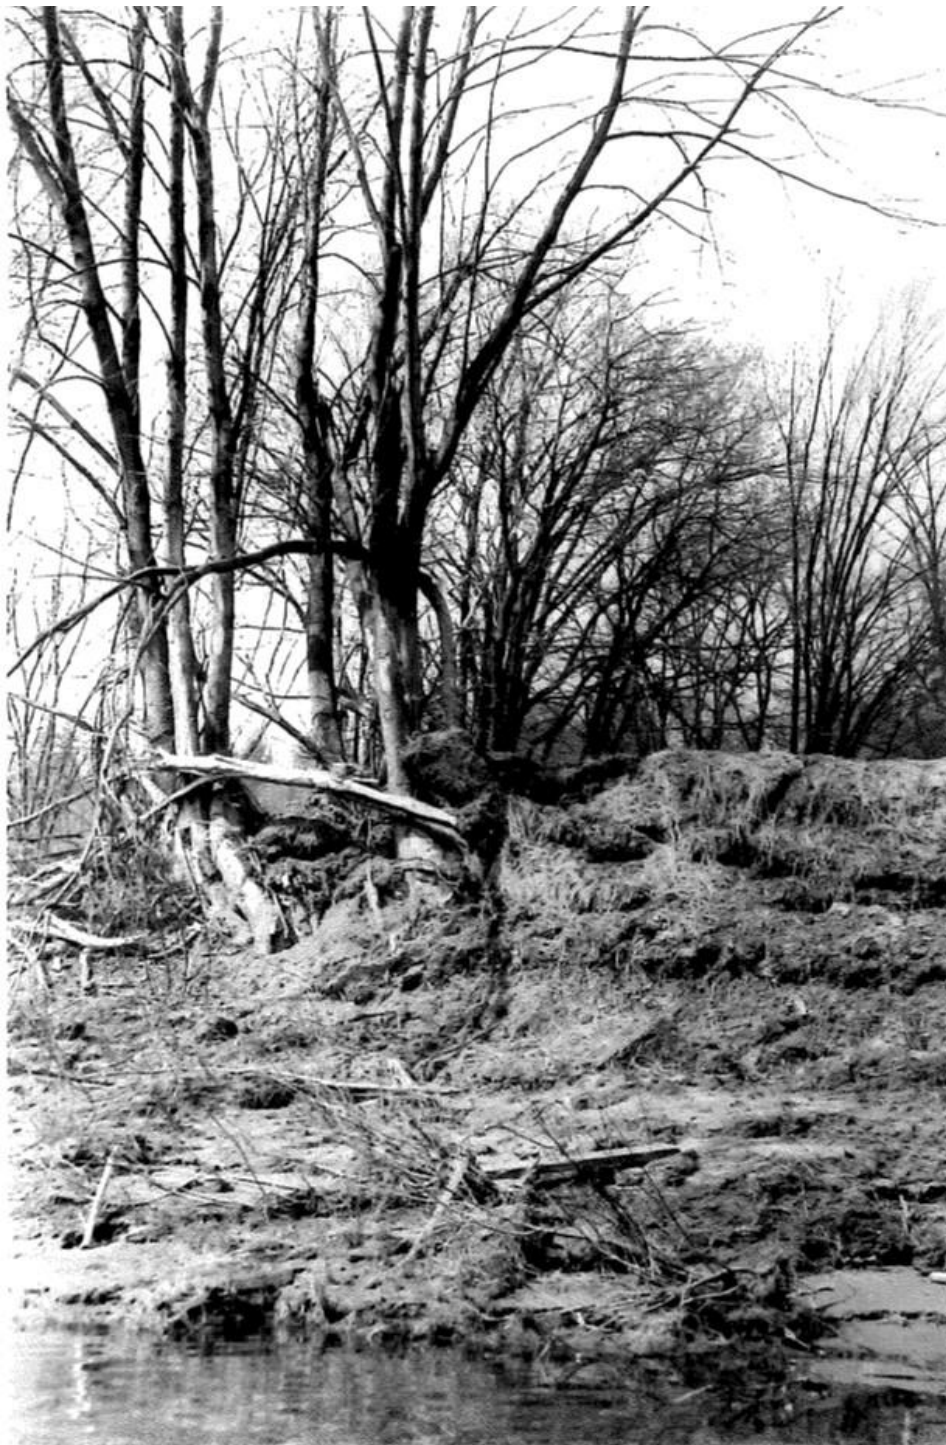
Figure 5.5.2-20 Connecticut River near Windsor, VT – April 23, 1946 (TransCanada)

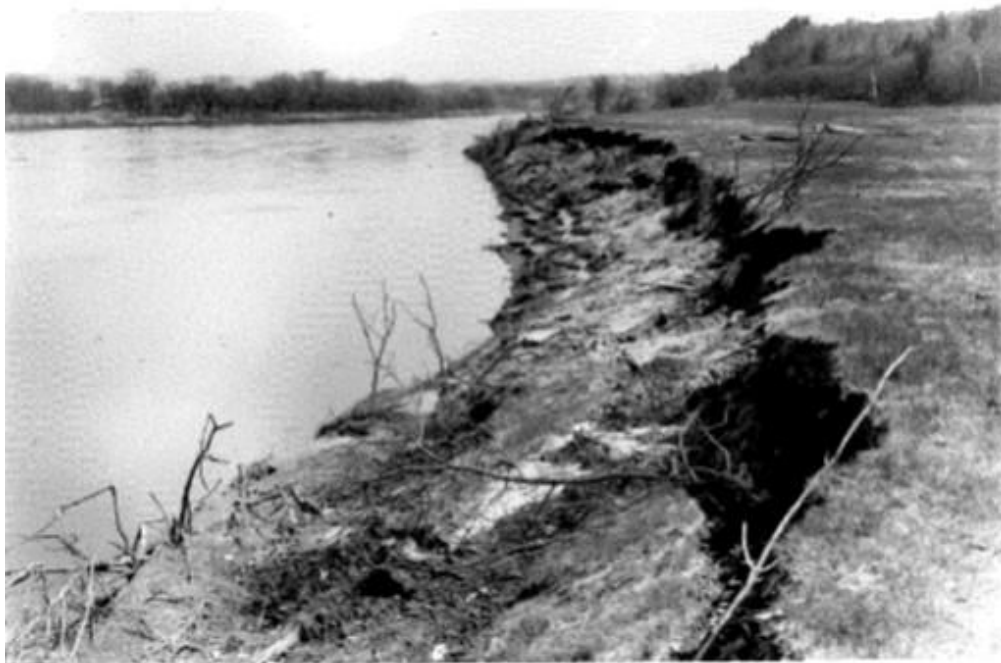
Damage to riverbanks near Cornish, NH in 1946 look very similar to what was observed farther downstream in the Bellows Falls Impoundment in the study conducted by Simons & Associates, [1992](#), "*Analysis of Bank Erosion at the Skitchaug Site in the Bellows Falls Pool of the Connecticut River.*" The destruction of vegetation and the jagged nature of the top of bank in 1946 ([Figure 5.5.5.2-22](#)) following the ice event that year look similar to the lack of vegetation and ice pushed into the banks in 1992 ([Figure 5.5.5.2-23](#)). We believe the impacts at this location in 1992 were similar to that depicted in the 1946 photo.

Figure 5.5.5.2-22 Connecticut River near Cornish, NH – April 25, 1946 (TransCanada)

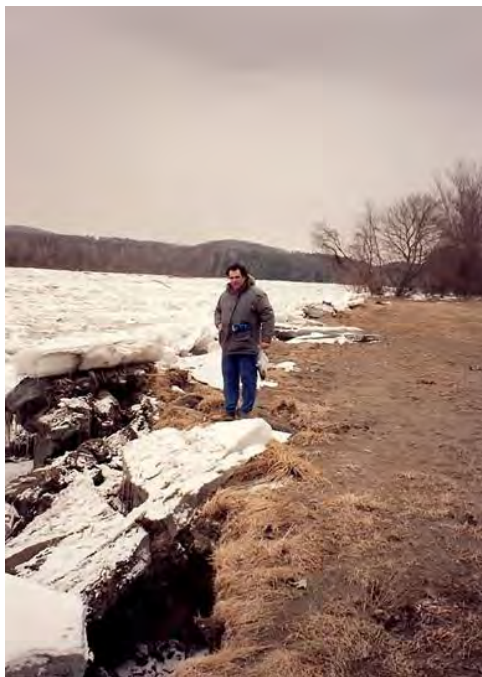
Figure 5.5.5.2-23 Ice-Riverbank Interaction in Bellows Falls Impoundment – 1992 (TransCanada)

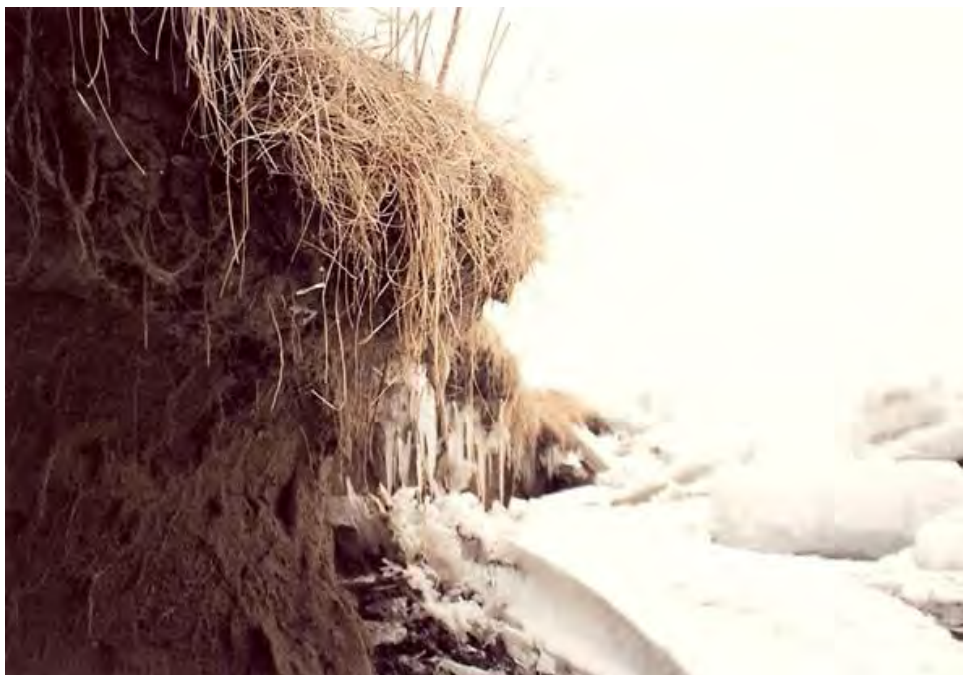
Figure 5.5.5.3-1 Icicles Hanging from Upper Bank

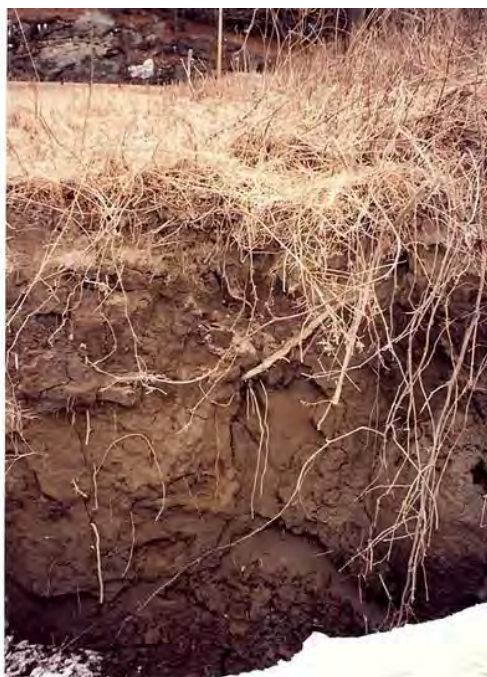
Inspection of riverbanks during winter conditions sometimes reveals cracks in the bank that may be related to freeze-thaw. Cracks that form as a result of this dynamic encourage more water to infiltrate into the crack because there is less resistance to flow than through the general soil matrix. As a result of subsequent freeze-thaw cycles, cracks in the soil may grow and eventually could lead to pieces of sediment breaking loose (spalling) and falling or sliding down the riverbank slope. [Figure 5.5.5.3-1](#) shows ice on the river as well as icicles hanging down the riverbank, which is indicative of water moving through the riverbank and freezing. [Figure 5.5.5.3-2](#) is an example of the small cracks forming in riverbanks that may be due to freeze-thaw. No actual data exist that allows quantification of the effect of freeze-thaw cycles on riverbank stability in the TFI. Freeze-thaw is a natural process that is primarily influenced by weather and climatic cycles and is not considered a primary factor in riverbank erosion processes in the TFI, nonetheless it is likely to contribute to riverbank instability to some lesser degree.

Figure 5.5.5.3-2 Cracks in a Riverbank Potentially Associated with Freeze-Thaw
