Relicensing Study 3.1.2

**Northfield Mountain / Turners Falls
Operations Impact on Existing Erosion and
Potential Bank Instability
Study Report**

Volume II – Main Report

**Northfield Mountain Pumped Storage Project (No. 2485) and
Turners Falls Hydroelectric Project (No. 1889)**

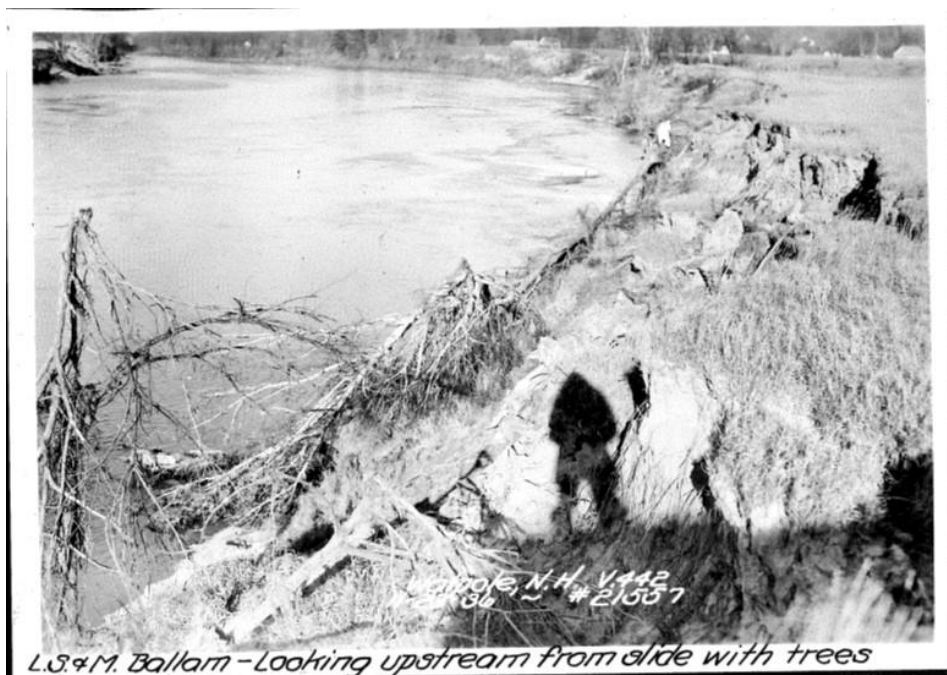
Figure 5.5.5.5-1 Erosion Damage – 1936 Flood

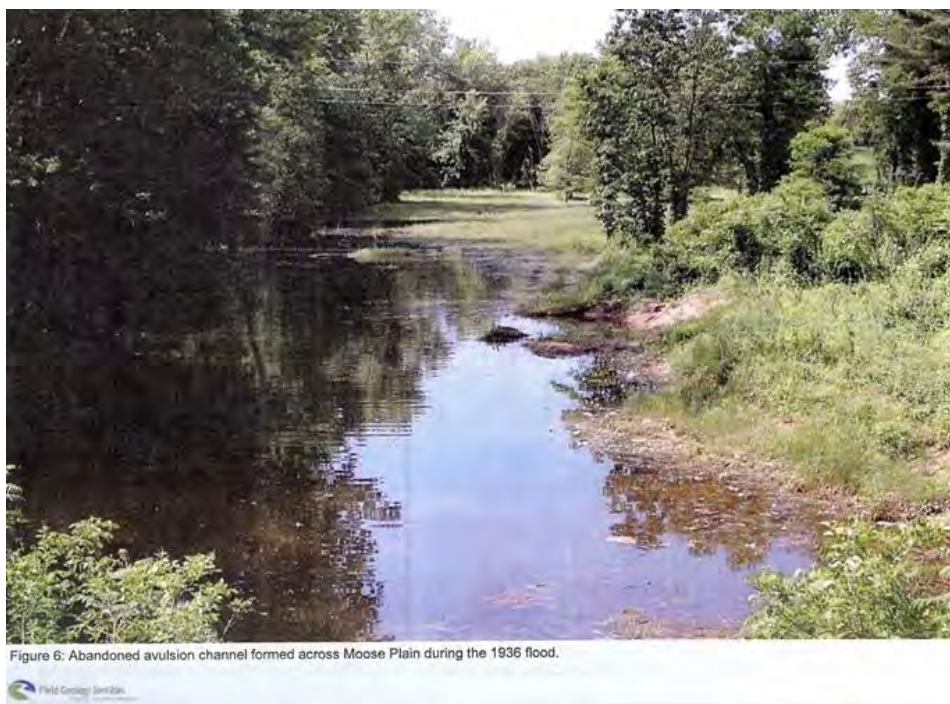
Figure 6: Abandoned avulsion channel formed across Moose Plain during the 1936 flood.

Figure 5.5.5.5-2 Abandoned Avulsion Channel – 1936 Flood (Field, 2007)

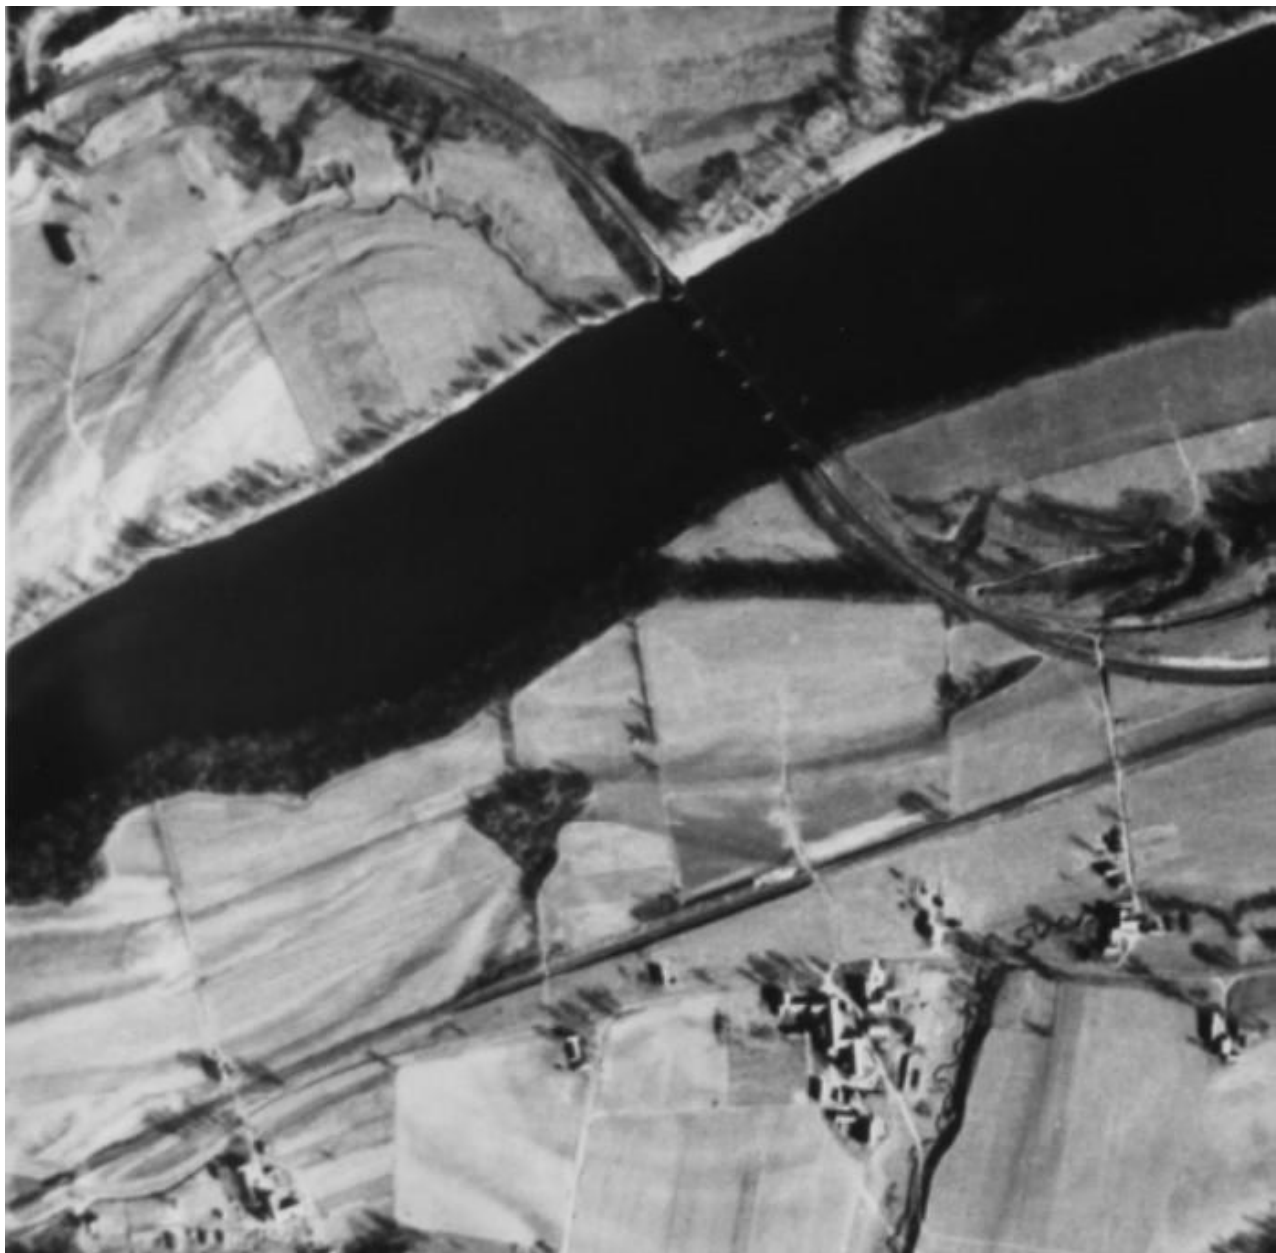
Figure 5.5.5.5-3 Aerial Photo Showing Erosion Scars on Floodplain - 1939

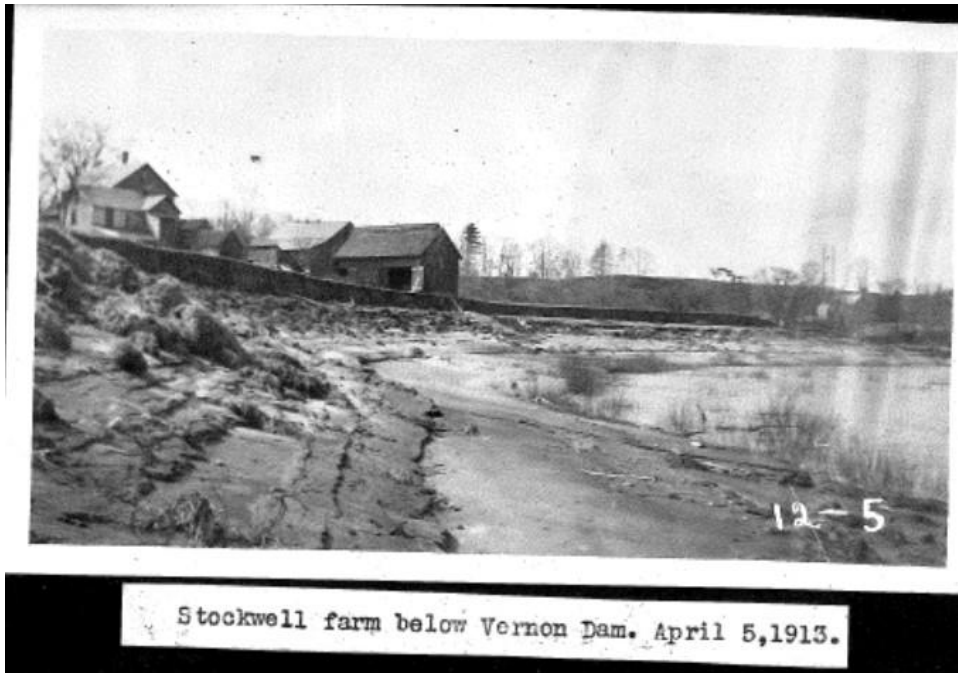
Figure 5.5.5.5 Eroded Bank in Turners Falls Impoundment Downstream of Vernon Dam – April 5, 1913 (TransCanada)

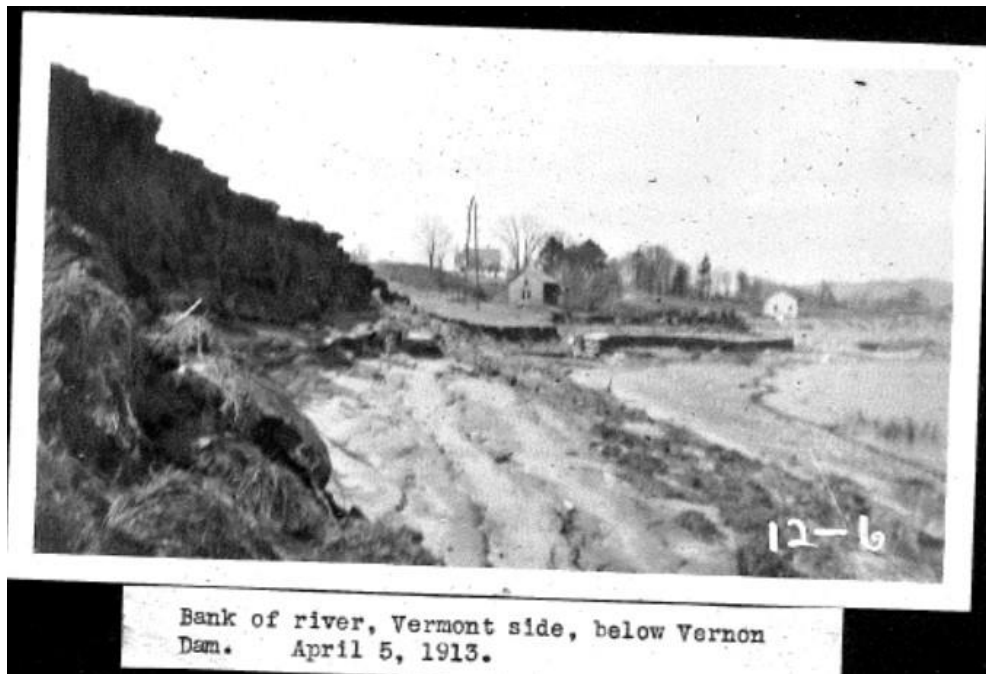
Figure 5.5.5.6 Eroded Bank in Turners Falls Impoundment Downstream of Vernon Dam – April 5, 1913 (TransCanada)

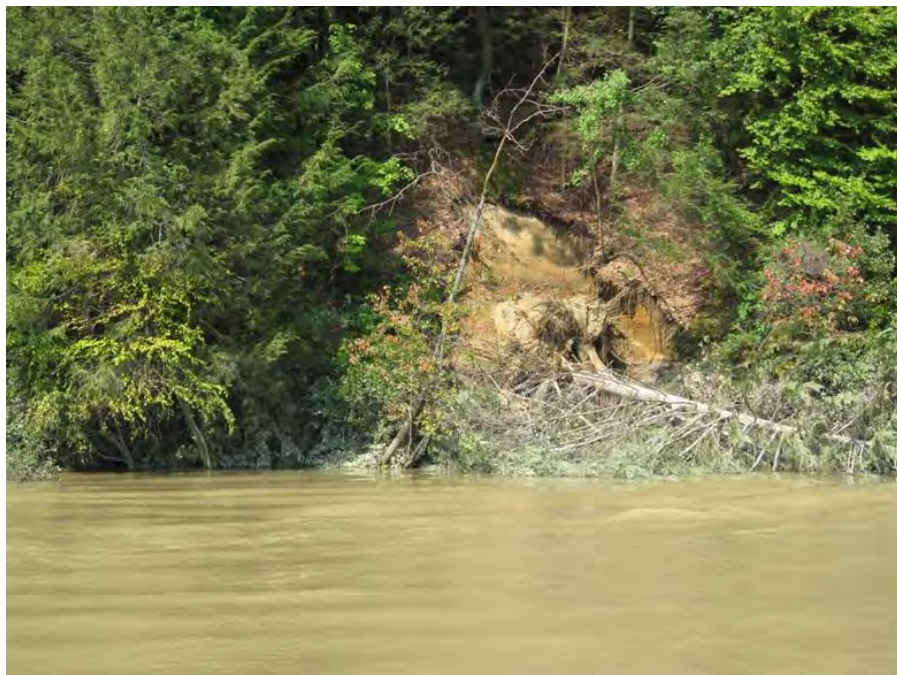
Figure 5.5.5.5-16 Erosion Due to High Flow in 2011

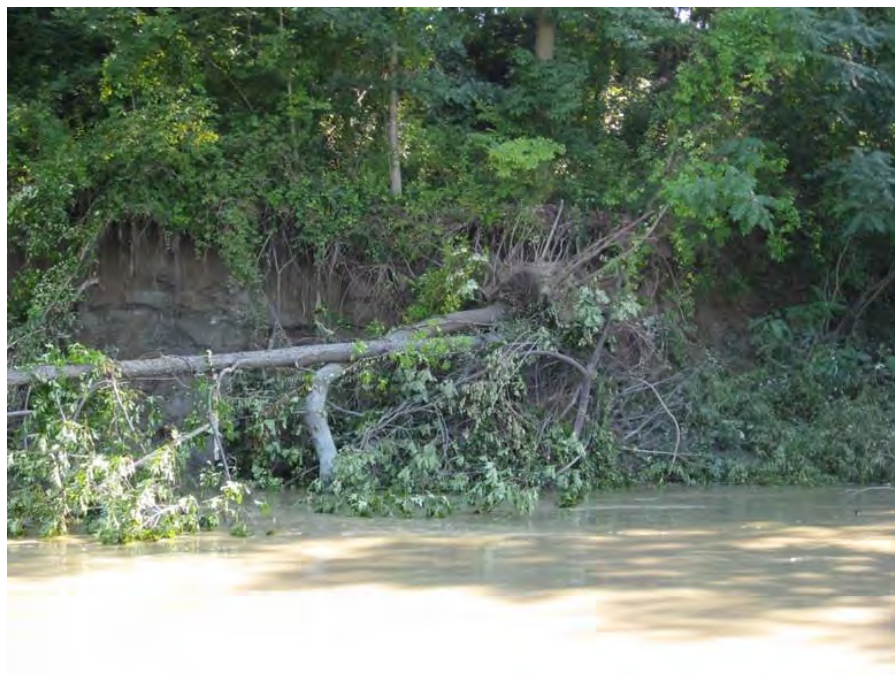
Figure 5.5.5.5-17 Erosion Due to High Flow in 2011

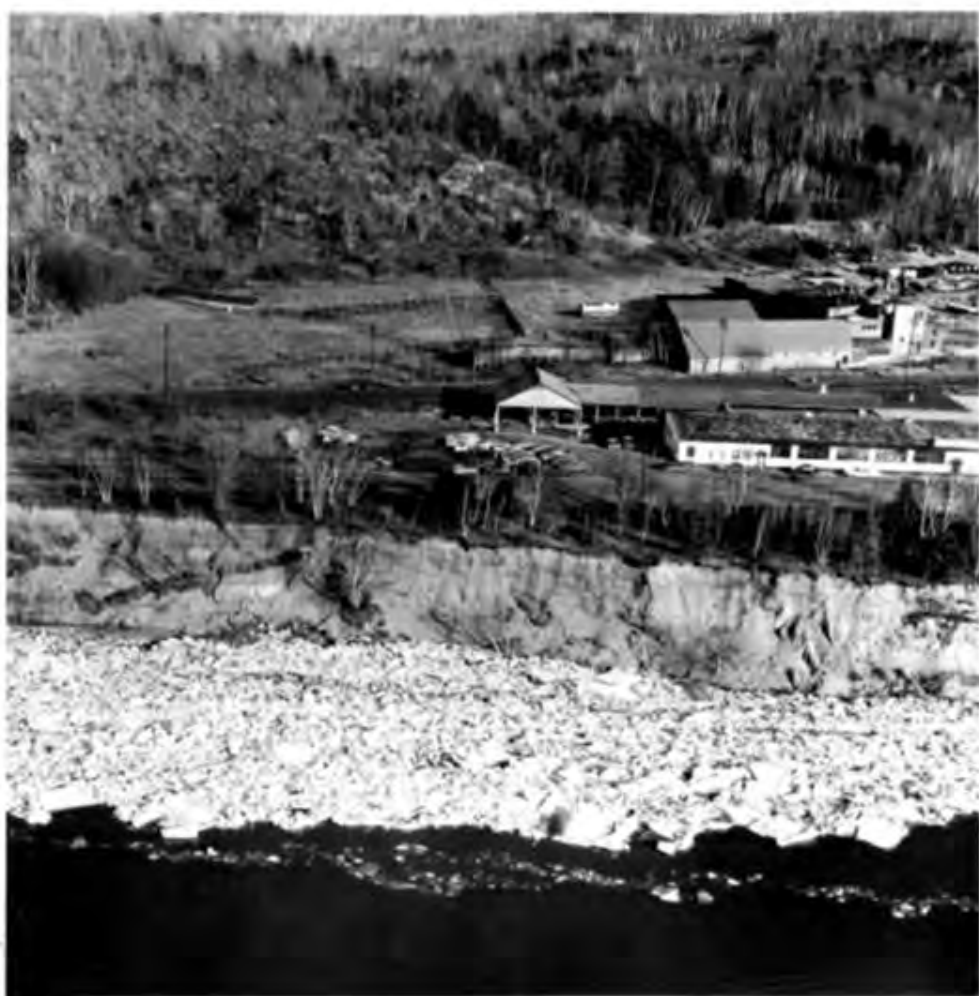
A - 3

March 25, 1968 - Eroded banks on H.E.P.
property just north of Gray banks.

Figure 5.5.5.5-23 Ice and erosion damage, 1968

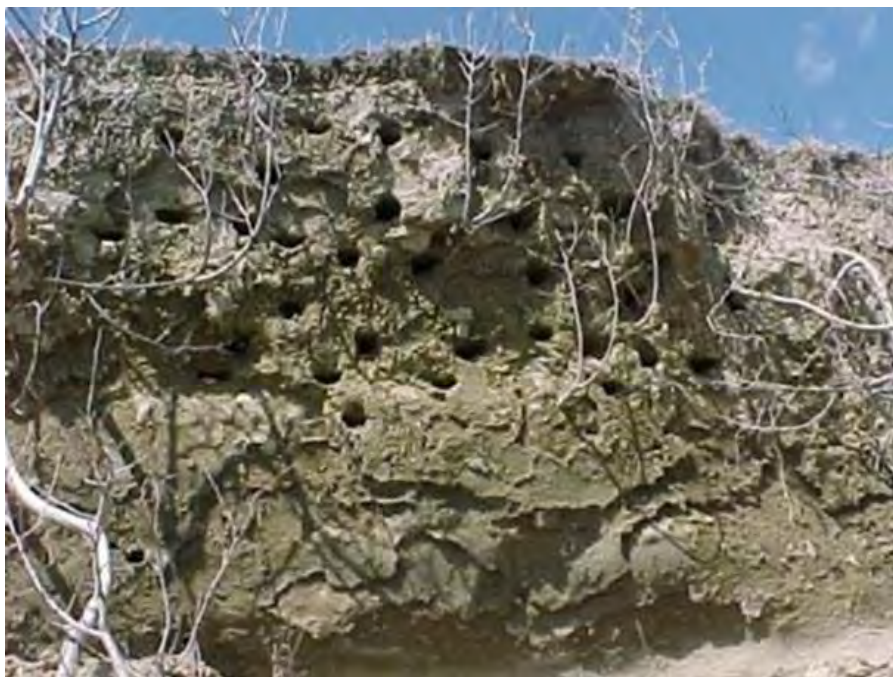
As part of the 2013 FRR, the locations of sensitive receptors found along or near the TFI riverbanks were mapped. A sensitive receptor was defined as important wildlife habitat located at or near the riverbank. Many wildlife features were observed during this survey including bank swallow and belted kingfisher nesting sites and bald eagle nest and perch sites. Of particular interest to this study were the bank swallow and belted kingfisher nesting sites since they are reliant on eroding banks for habitat. Belted kingfishers and bank swallows excavate cavities to use as nests in sheer banks lacking vegetation and containing appropriate soil conditions. [Figure 5.5.6-1](#) depicts the locations of the sensitive receptors identified during the 2013 FRR. An example of a bank swallow nesting site is found in [Figure 5.5.6-2](#).

Figure 5.5.6-2: Bank swallow nests – Flagg erosion site near Kidds Island, Turners Falls Impoundment

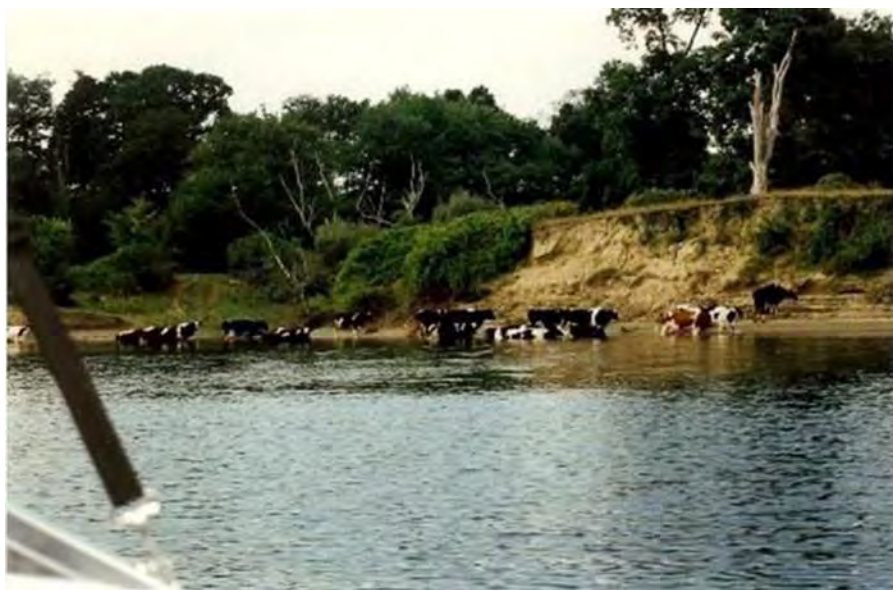
Along agricultural fields, paths are frequently created by animals traveling between fields and the river. Examples of this activity are shown in [Figure 5.5.6-3](#) and again in [Figures 5.5.6-4](#) through [5.5.6-12](#). [Figure 5.5.6-13](#) shows the location where each of the photos in [Figures 5.5.6-4](#) through [5.5.6-12](#) were taken. At the agricultural field found in [Figures 5.5.6-4](#) through [5.5.6-12](#) it was observed that there were a number of animal paths over the length of the field. Based on the width of the riparian zone adjacent to this particular field, the animal paths were found where the riparian zone was narrow while no animal paths were observed where the riparian zone was wider.

Figure 5.5.6-3: Cattle using riverbank area along Connecticut River – Flagg erosion site near Kidds Island, Turners Falls Impoundment

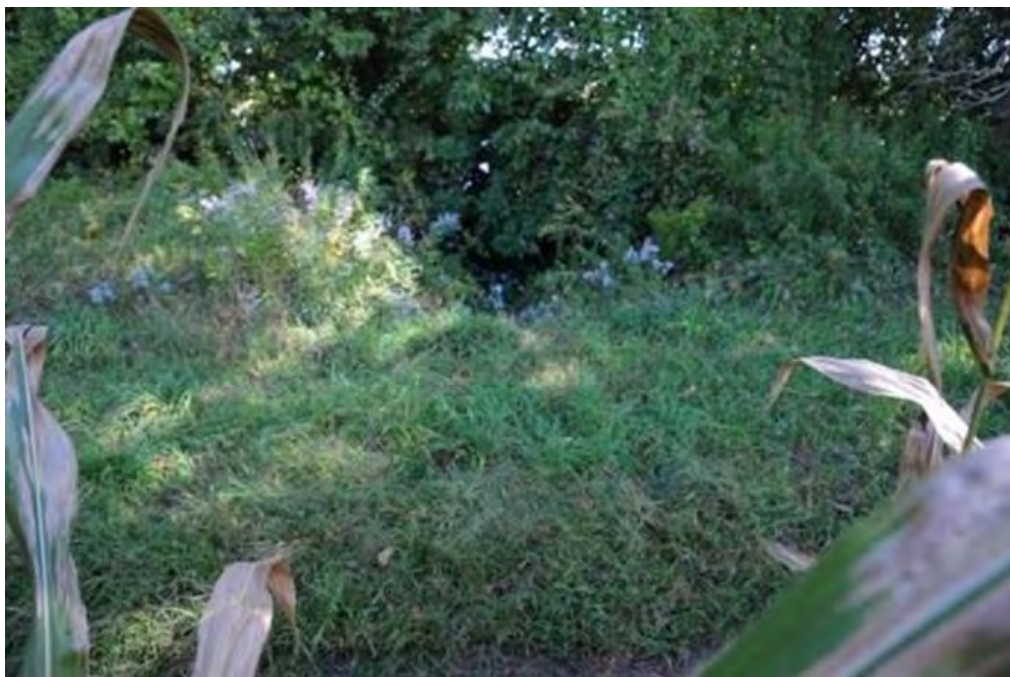
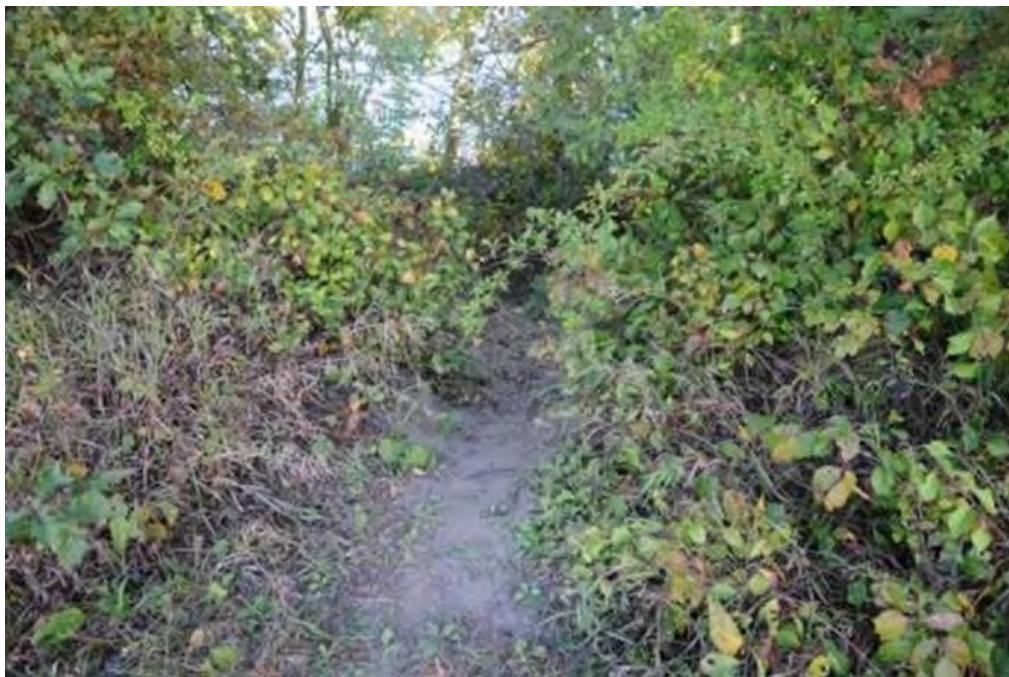
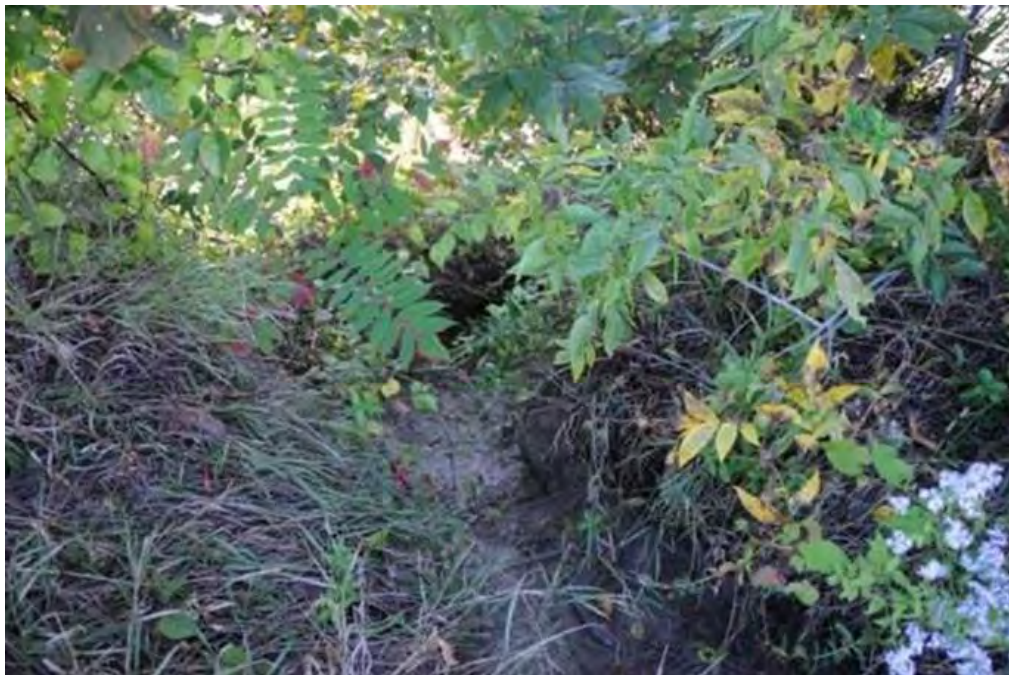
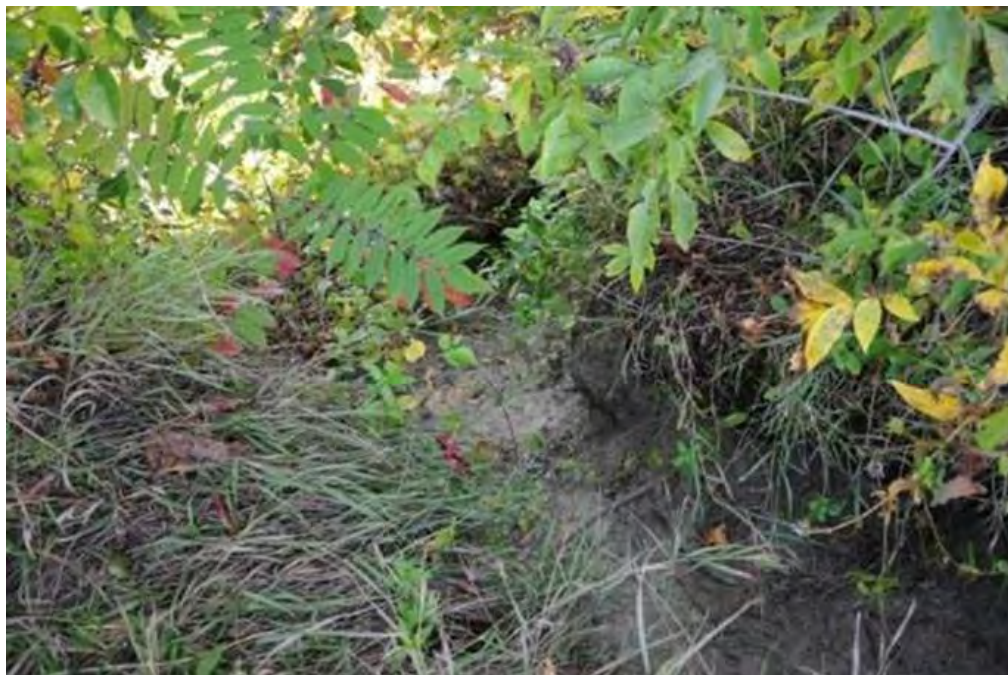
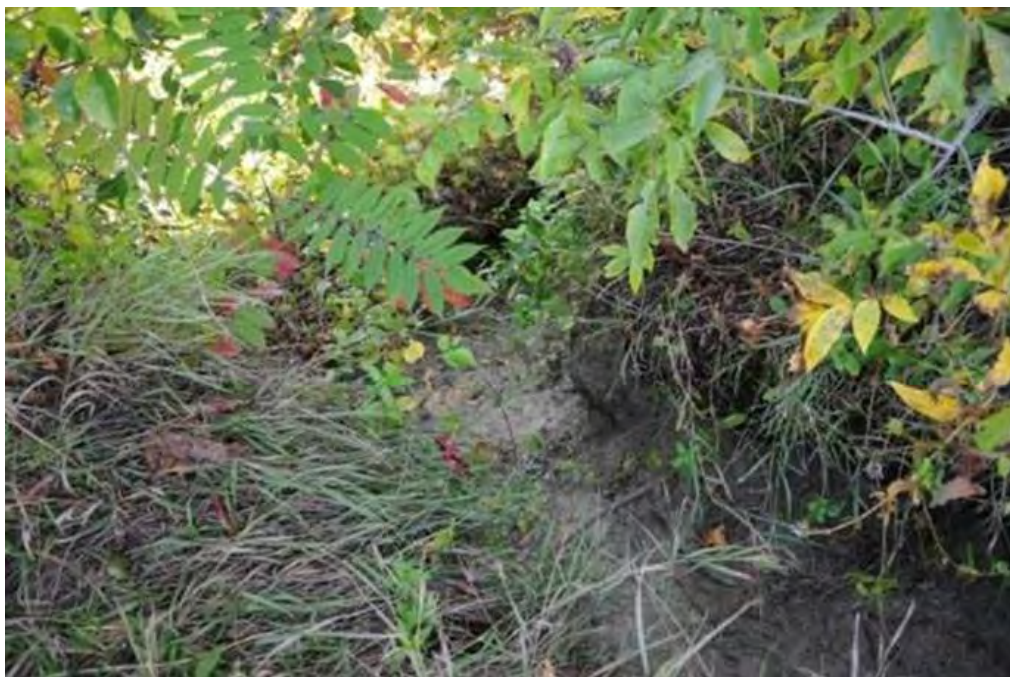
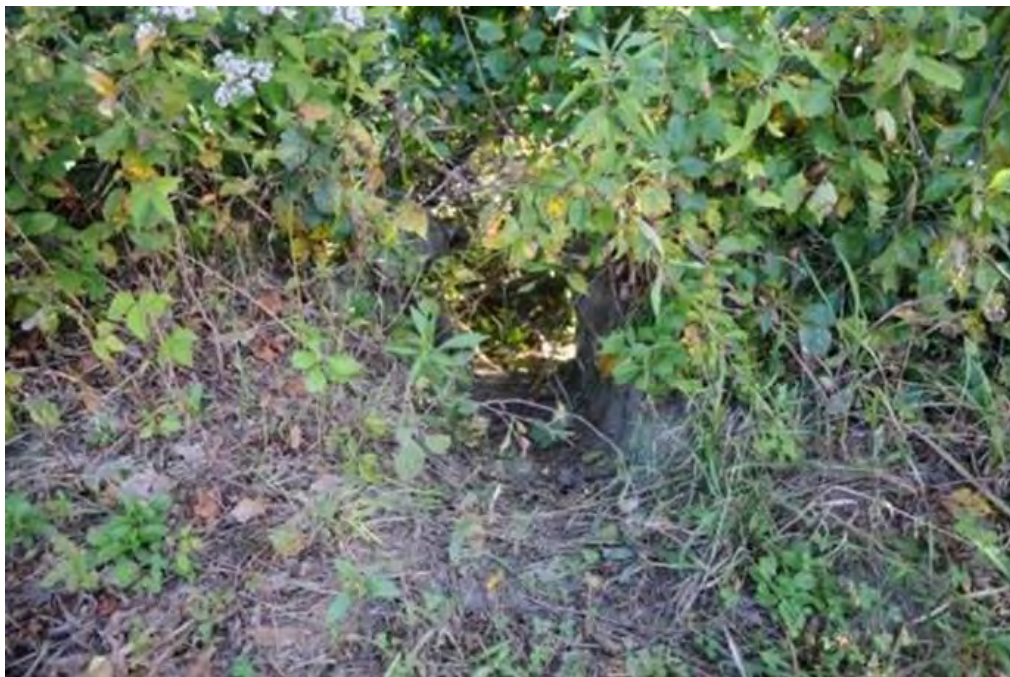
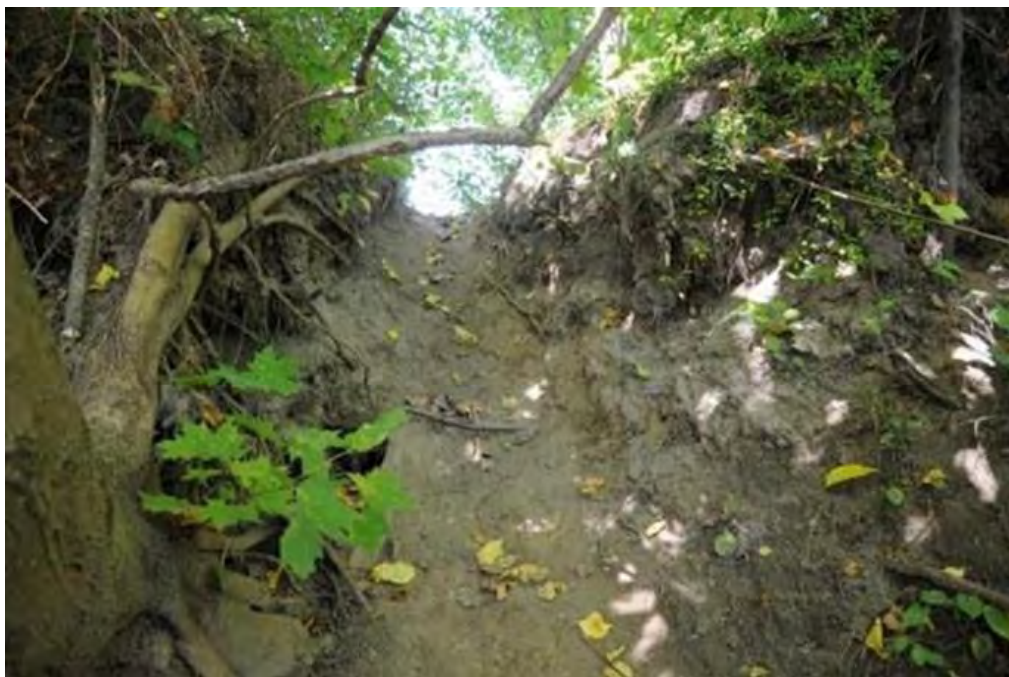
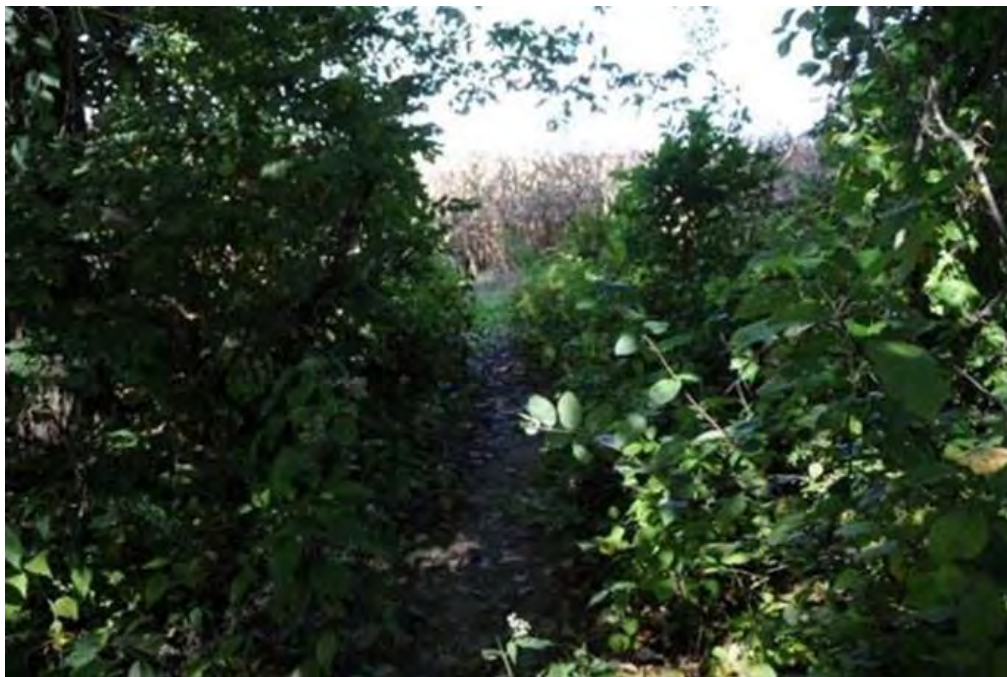
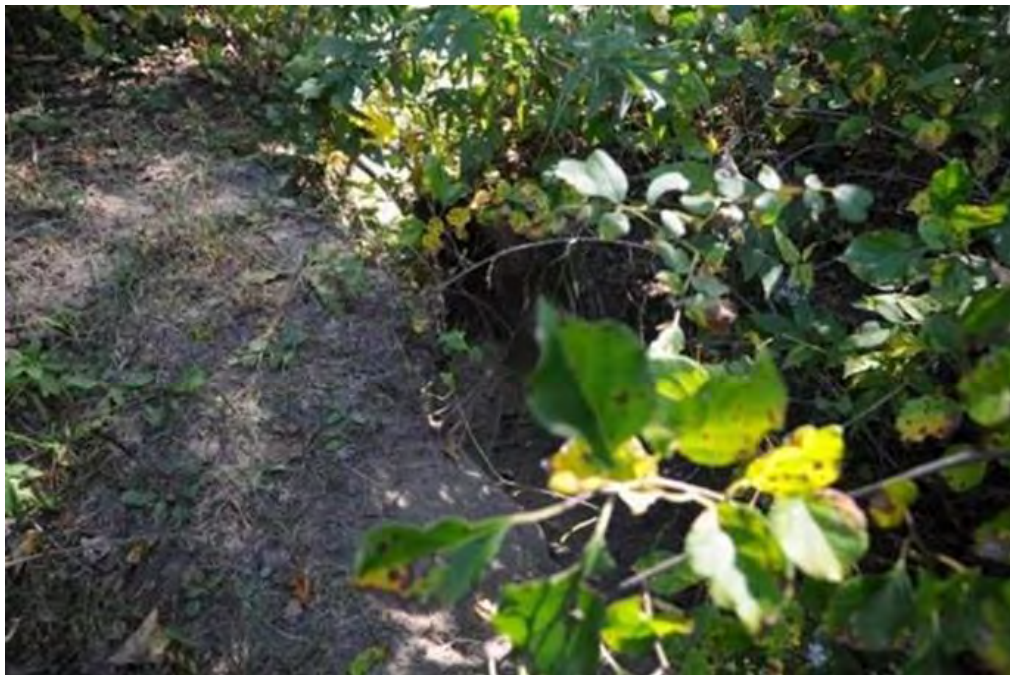
Figure 5.5.6-4: Animal path from river to field, Photo 101

Figure 5.5.6-5: Animal path from river to field, Photo 109

Figure 5.5.6-6: Animal path from river to field, Photo 117

Figure 5.5.5-6-7: Animal path from river to field, Photo 119

Figure 5.5.6-8: Animal path from river to field, Photo 120

Figure 5.5.6-9: Animal path from river to field, Photo 124

Figure 5.5.6-10: Animal path from river to field, Photo 128

Figure 5.5.6-11: Animal path from river to field, Photo 130

Figure 5.5.6-12: Animal path from river to field, Photo 135

- The impacts of animal activity, both from an anthropogenic and natural perspective, in reducing riparian vegetation are typically limited to a number of localized areas throughout the TFI. Observed animal pathways are typically on the order of a couple feet wide or narrower and may exist at a spacing of every few hundred feet along agricultural fields. The contributions of anthropogenic influences were taken into consideration in the analysis of land-use and land management practices. Sensitive receptors, such as burrows, were identified during the 2013 FRR and were found to be scattered throughout the TFI at a number of localized areas. While animal activity, both anthropogenic and naturally occurring, may potentially contribute to erosion processes at limited, localized areas (e.g., riverbanks adjacent to agricultural fields with narrow riparian buffers) it was not found to be a significant factor in erosion processes throughout the TFI.

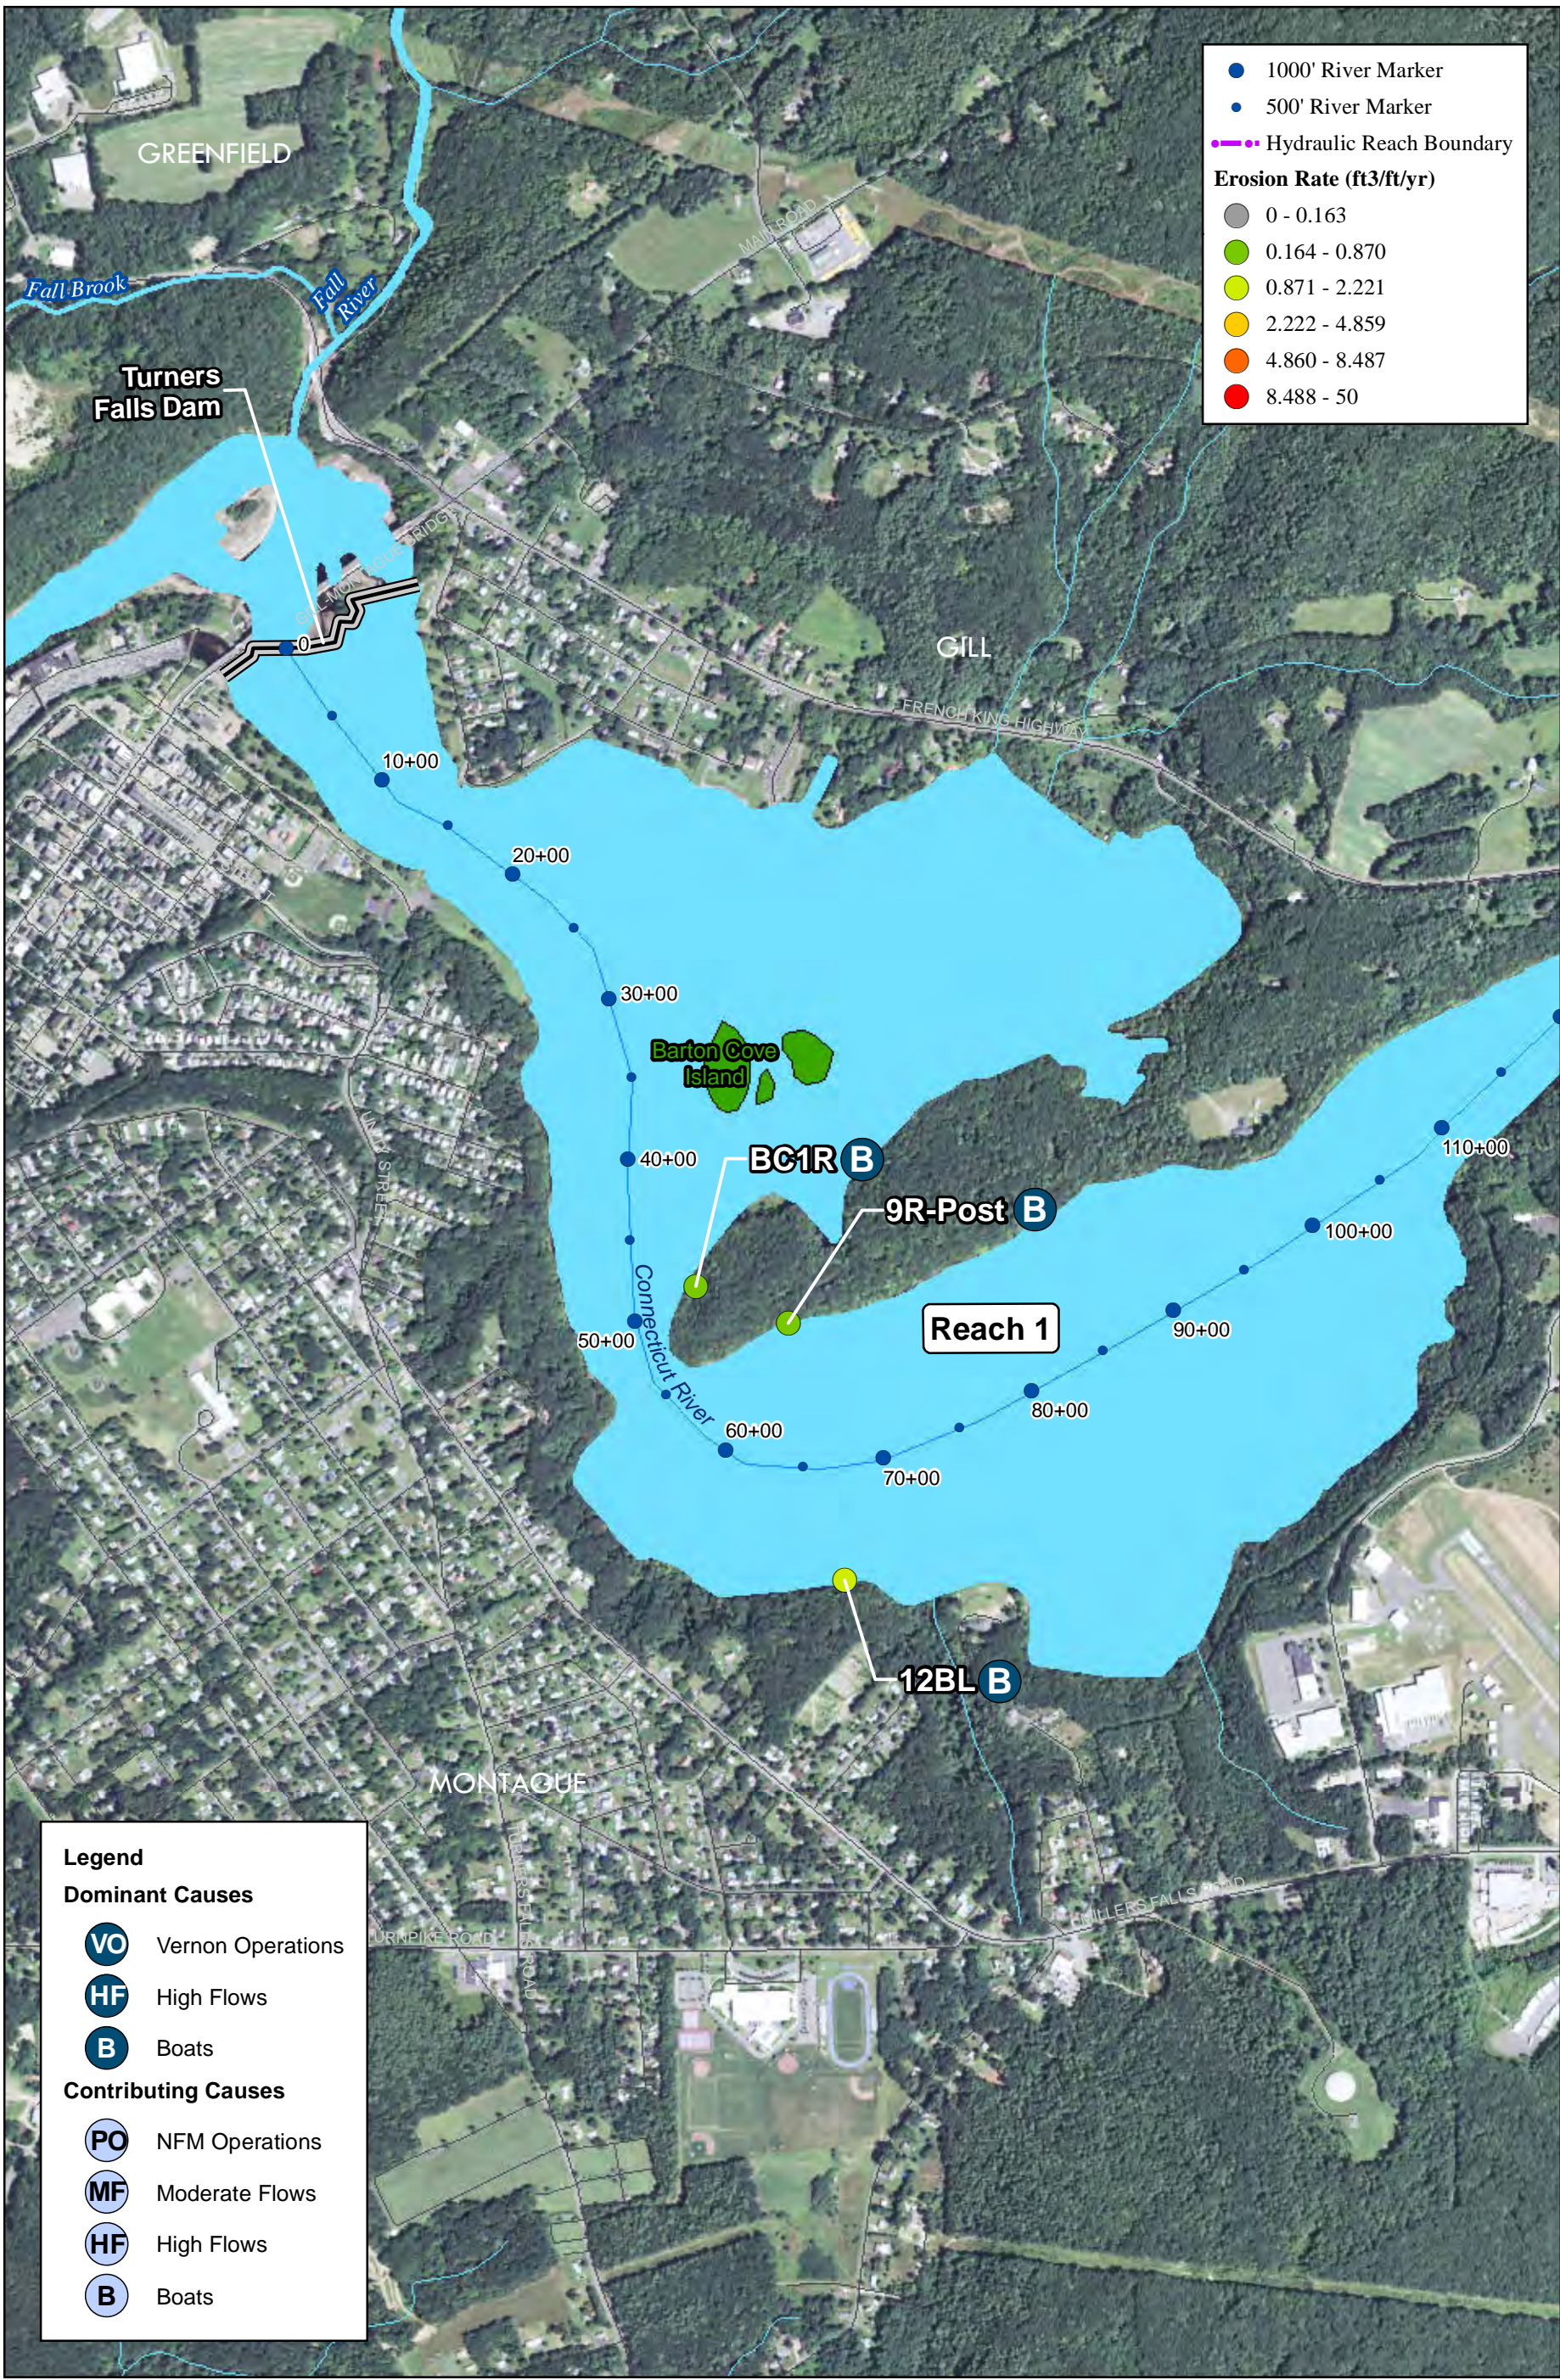
Figure 6.1.1-1:
Dominant and Contributing Causes
of Erosion at each Detailed Study Site
Reach 1

The results of the various analyses found that naturally occurring high flows were the dominant primary cause of erosion in the TFI, followed by boat waves, and Vernon operations. Northfield Mountain or Turners Falls Project operations were not found to be a dominant primary cause of erosion at any riverbank segment in the TFI. The dominant primary causes of erosion followed a clear spatial pattern with Vernon Project operations being the dominant cause from Vernon Dam to downstream of detailed study site 11L, natural high flows from downstream of detailed study site 11L to upstream of Barton Cove, and boat waves from upstream of Barton Cove to Turners Falls Dam. The findings of this analysis are summarized below based on relative percentage of total TFI riverbank length:

Analysis of contributing primary causes of erosion (i.e., >5% but <50% of erosion at a given site), found that the majority of riverbank segments in the TFI did not have a contributing primary cause. Natural high flows were such a dominant factor in erosion processes that no other contributing primary causes were identified at the majority of riverbank segments. At riverbanks segments that did have contributing primary causes of erosion, boat waves were found to be the most common followed by naturally occurring moderate flows, natural high flows, and Northfield Mountain operations. Turners Falls or Vernon operations were not found to be a contributing primary cause of erosion at any riverbank segment in the TFI. Riverbank segments that exhibited contributing causes of erosion were limited to the Upper (high flows); Northfield Mountain (moderate flows), Northfield Mountain operations, and boats); and Lower (moderate flows and boats) hydraulic reaches. The findings of this analysis are summarized below based on relative percentage of total TFI riverbank length:

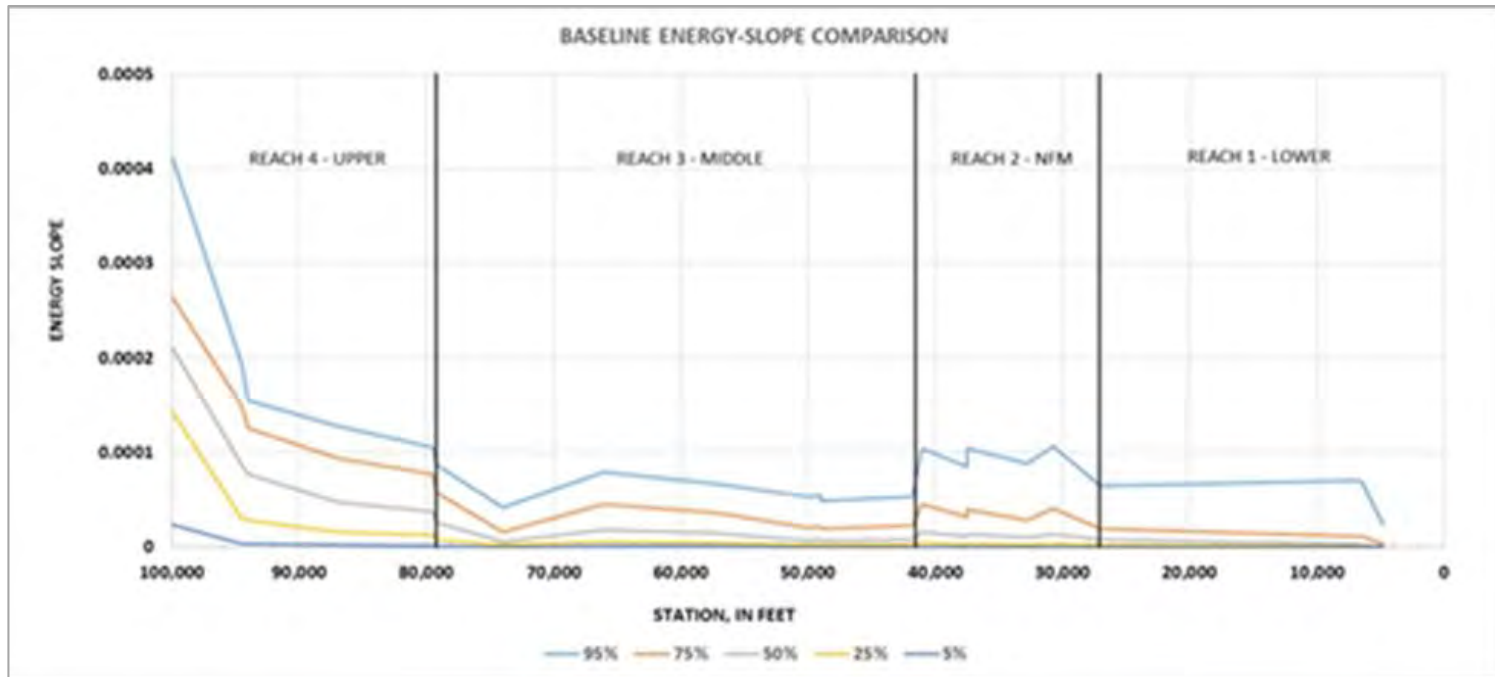
Figure 6.1.2.1-1: Energy slope trends through the Turners Falls Impoundment

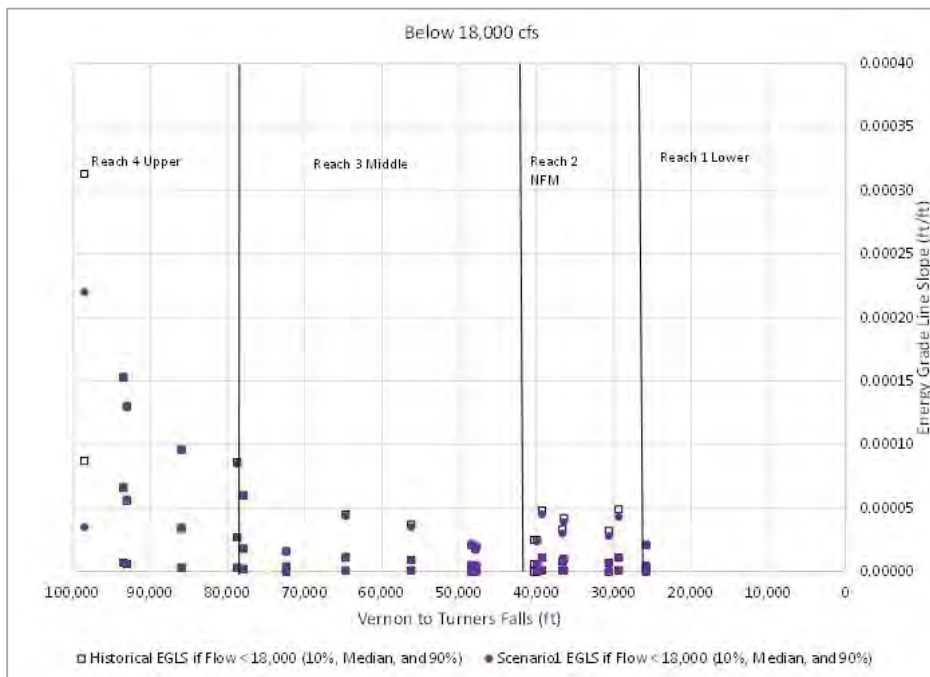
As observed in the figures, the energy grade line slopes for the supplemental run do not vary appreciably from the results of the Baseline Condition scenario, thus validating the four hydraulic reaches identified from the Baseline Condition HEC-RAS run. Given the clear delineation and characteristics of each hydraulic reach it is unlikely that a hydropower project can have an impact on erosion processes outside of the hydraulic reach in which it is located. While a hydropower project can impact water level fluctuations and flow outside of its hydraulic reach, the magnitude of those impacts are so minor that they do not affect the energy grade line slope outside of their given reach. For example, even though Northfield Mountain operations can impact the water surface elevation in reaches 3 and 4 at flows which exceed the erosion flow threshold at the detailed study sites, the impacts are so negligible that corresponding changes to the energy grade line slope do not occur. Thus, given the hydraulic characteristics of each reach it is unlikely that Northfield Mountain operations can impact erosion processes outside of reach 2. Conversely, it is also unlikely that Vernon operations can impact erosion processes outside of reach 4 or that Turners Falls operations can impact erosion processes outside of Reach 1.

Figure 6.1.2.2-1: Energy slope trends through the Turners Falls Impoundment at flows less than 18,000 cfs

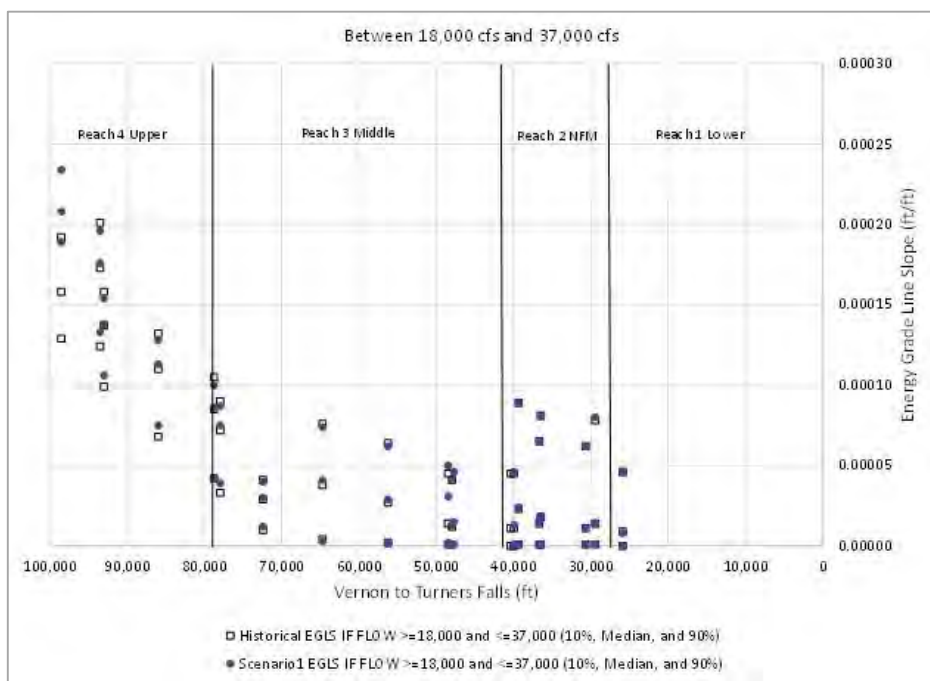
Figure 6.1.2.2-2: Energy slope trends through the Turners Falls Impoundment at flows between 18,000 and 37,000 cfs

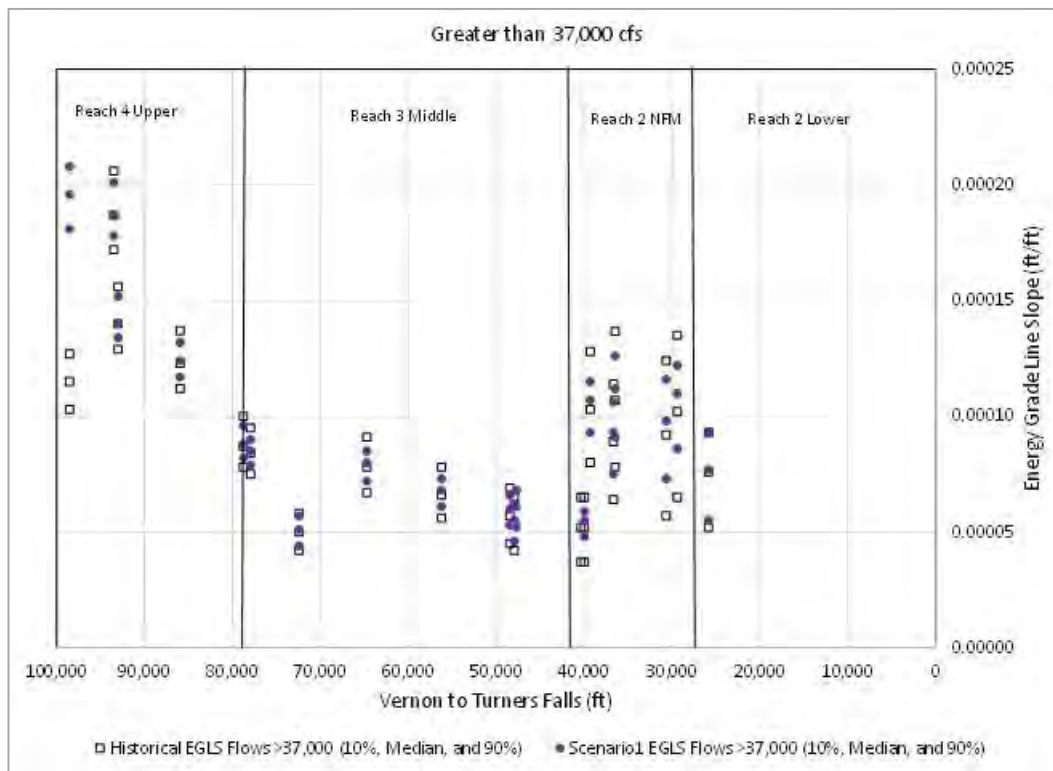
Figure 6.1.2.2-3: Energy slope trends through the Turners Falls Impoundment at flows over 37,000 cfs
