Relicensing Study 3.1.2

**Northfield Mountain / Turners Falls
Operations Impact on Existing Erosion and
Potential Bank Instability
Study Report**

Volume II – Main Report

**Northfield Mountain Pumped Storage Project (No. 2485) and
Turners Falls Hydroelectric Project (No. 1889)**

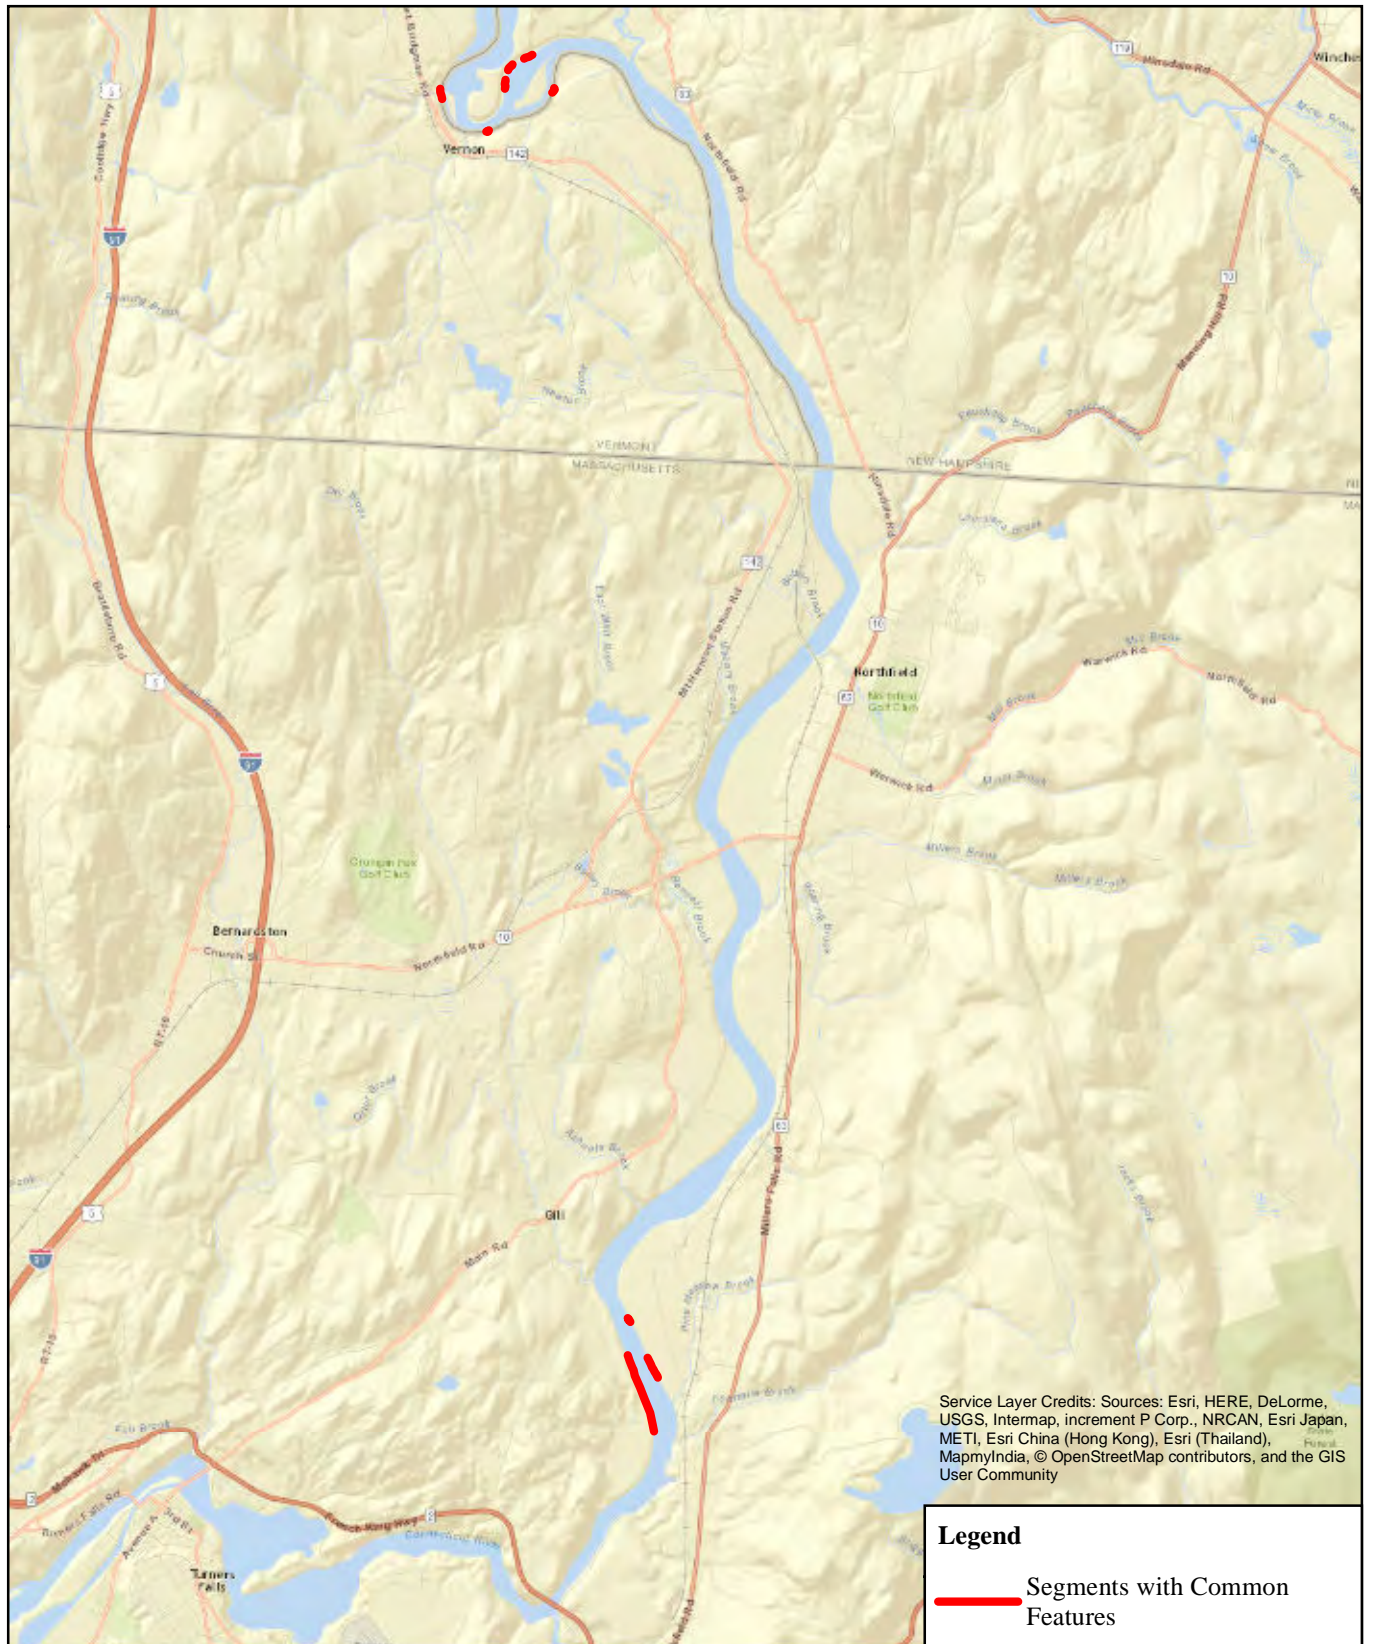
Figure 6.1.2.2-4:
Locations of Riverbank Segments with
Features and Characteristics similar to those
Detailed Study Sites where Hydropower
Project Operations are a Cause of Erosion

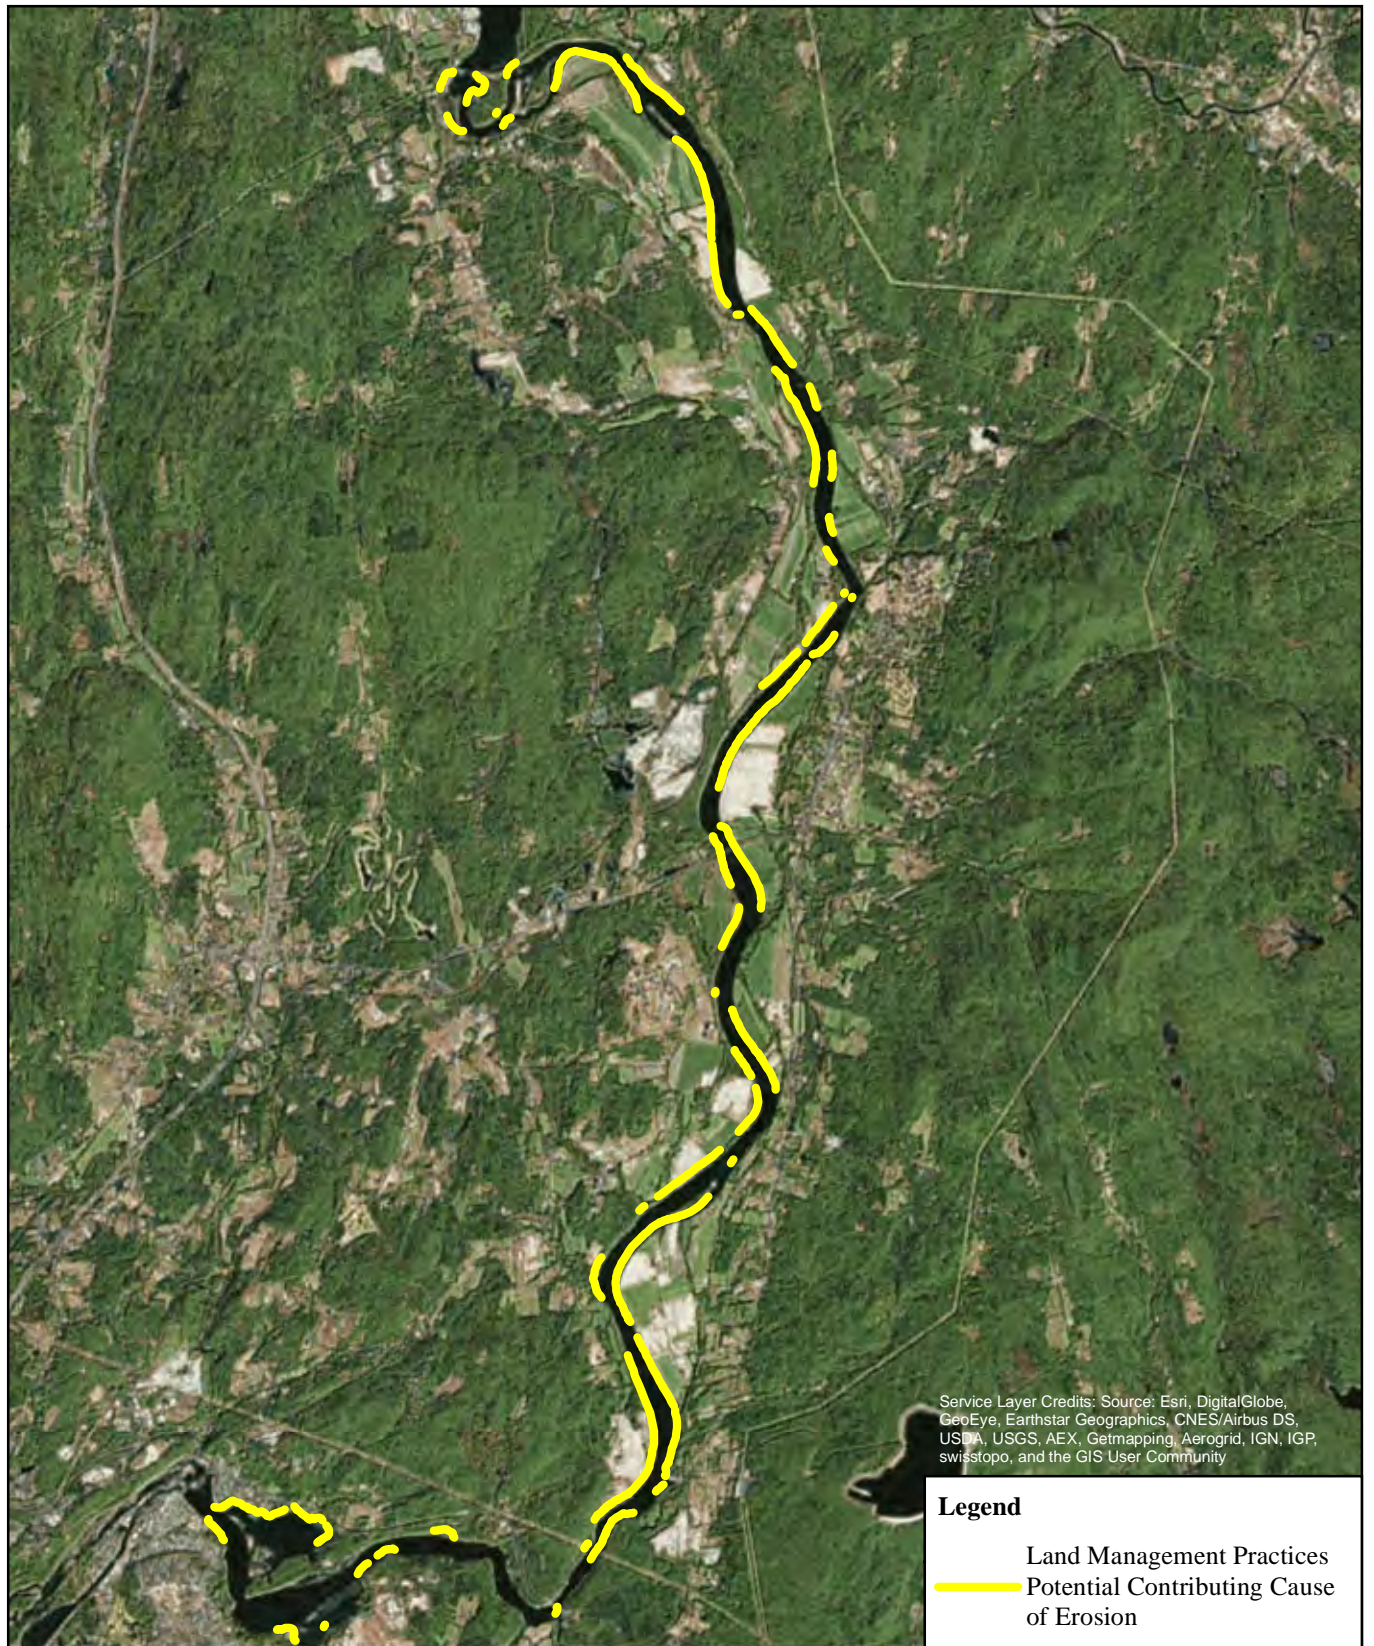
Figure 6.1.2.2-5:
Location of Turners Falls Impoundment
Riverbank Segments where Land Management
Practices are a Potential Contributing Cause of
Erosion

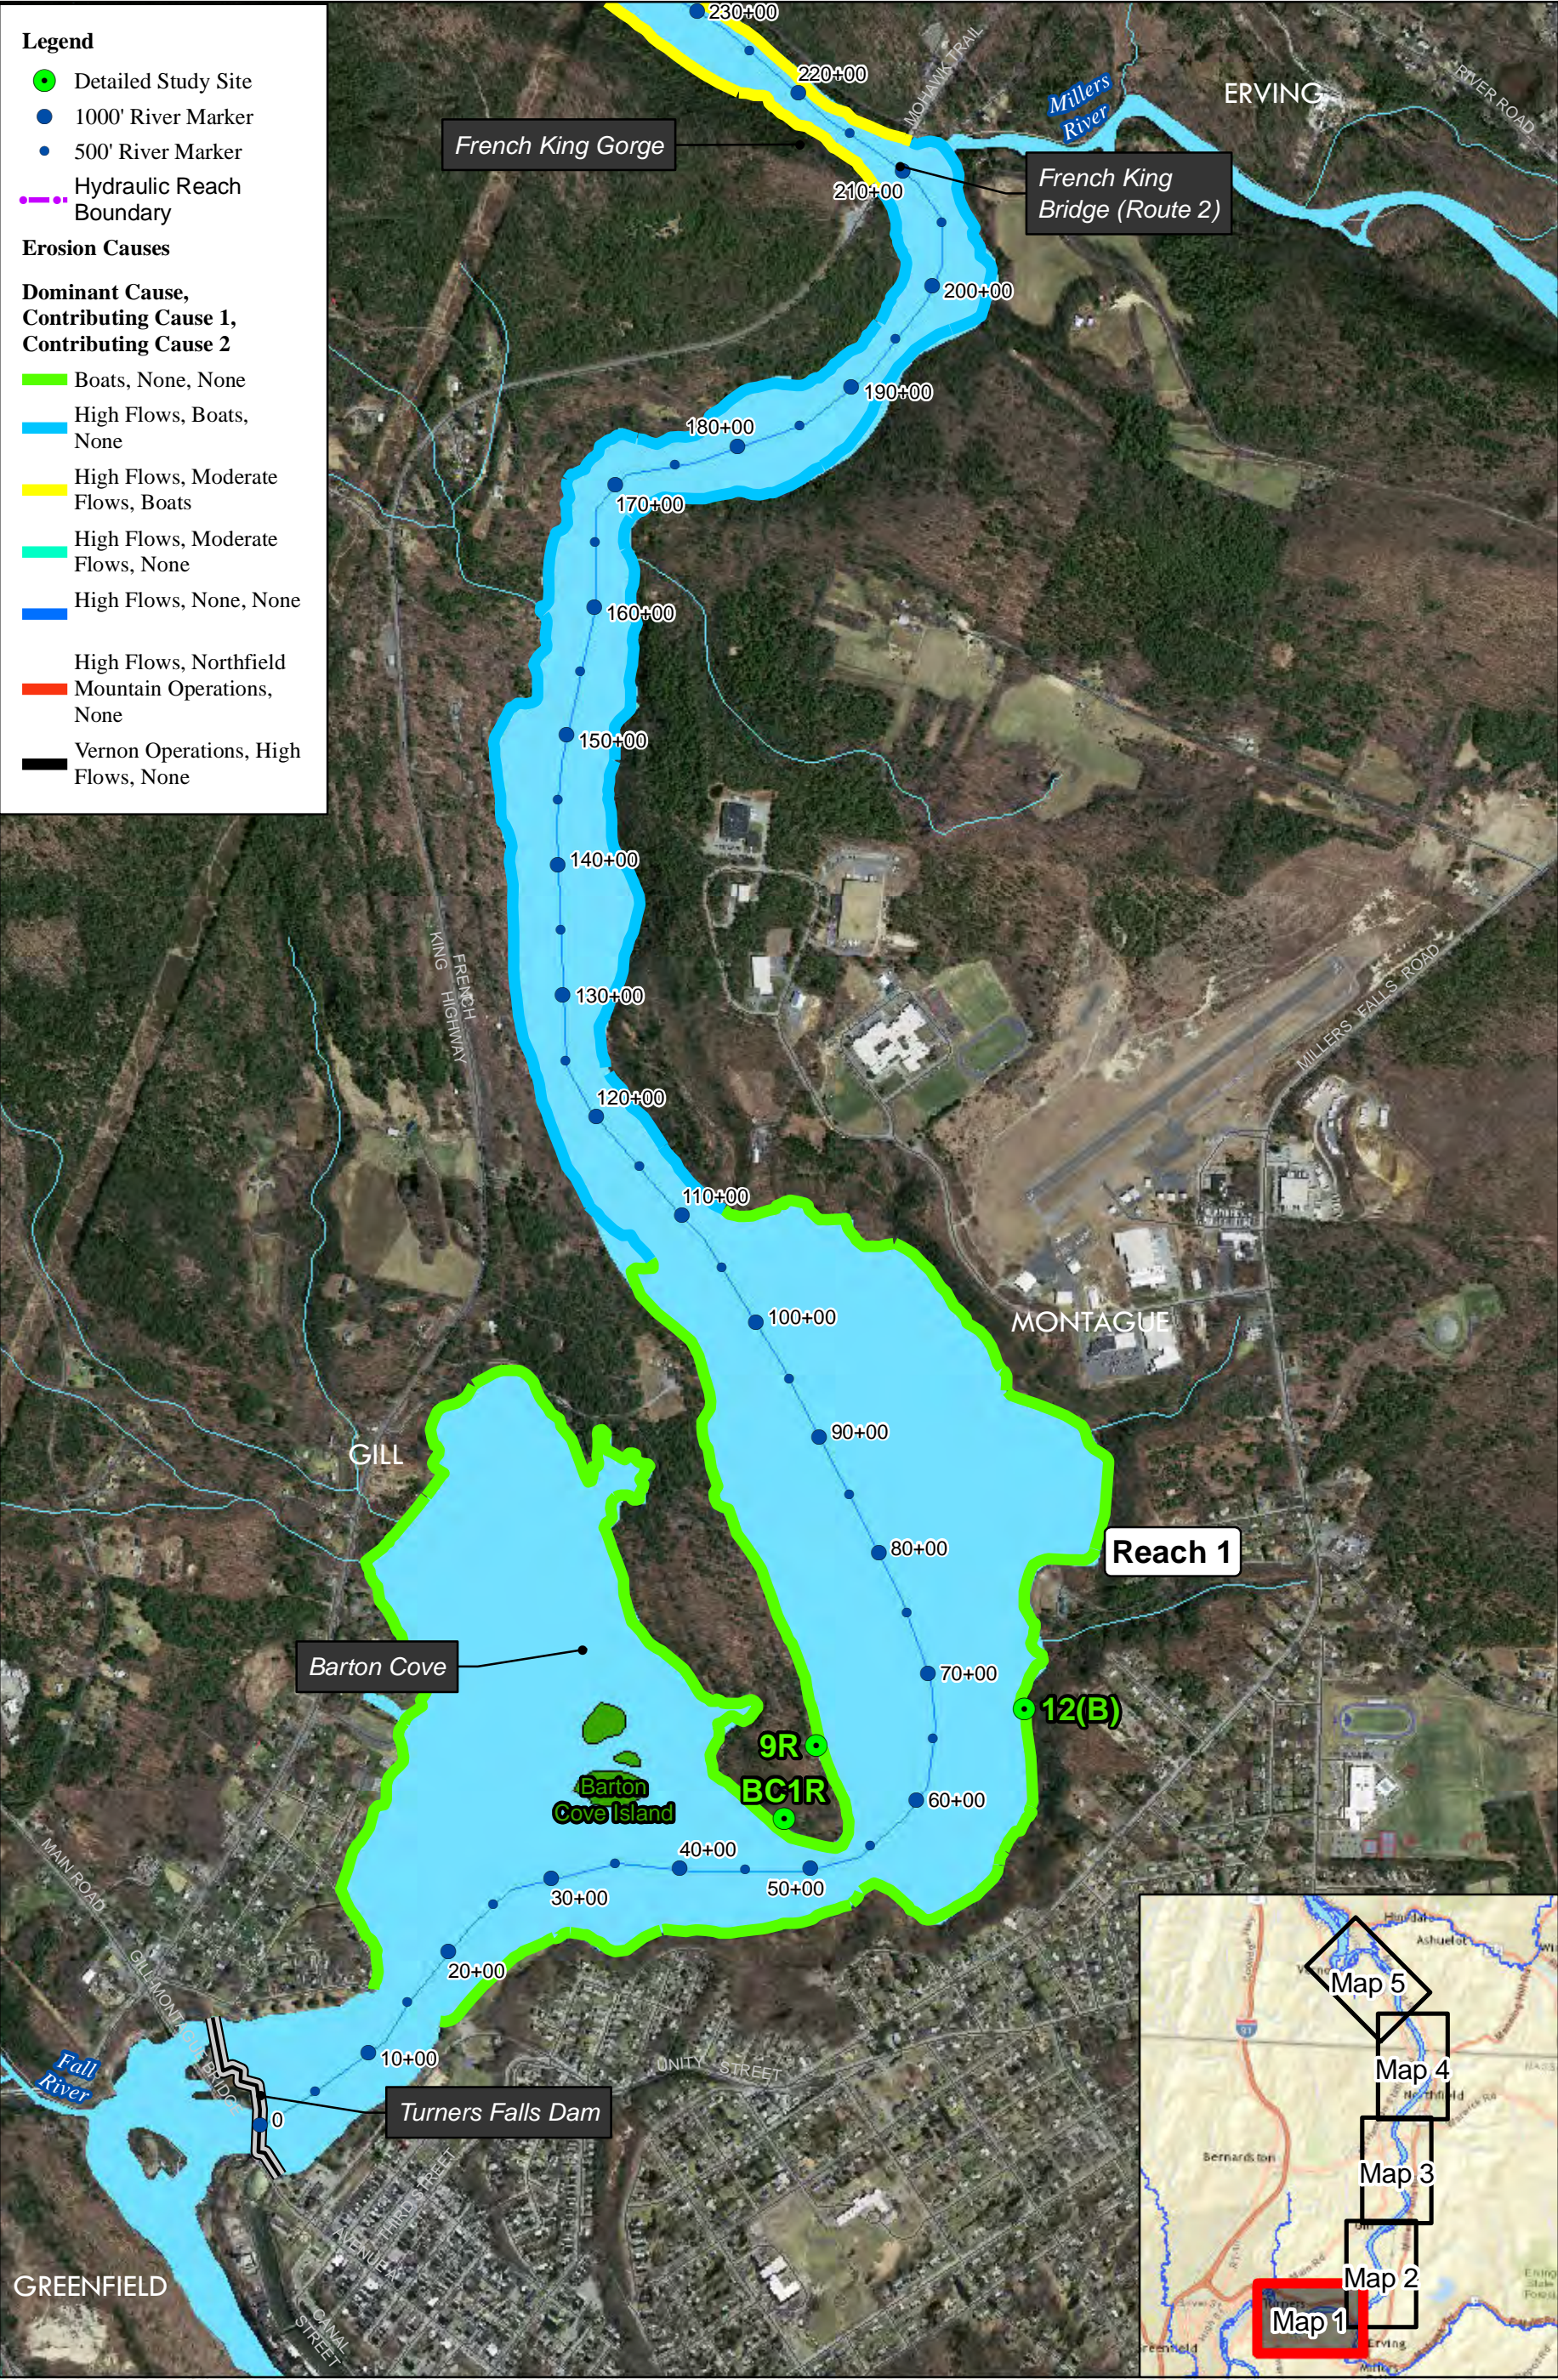
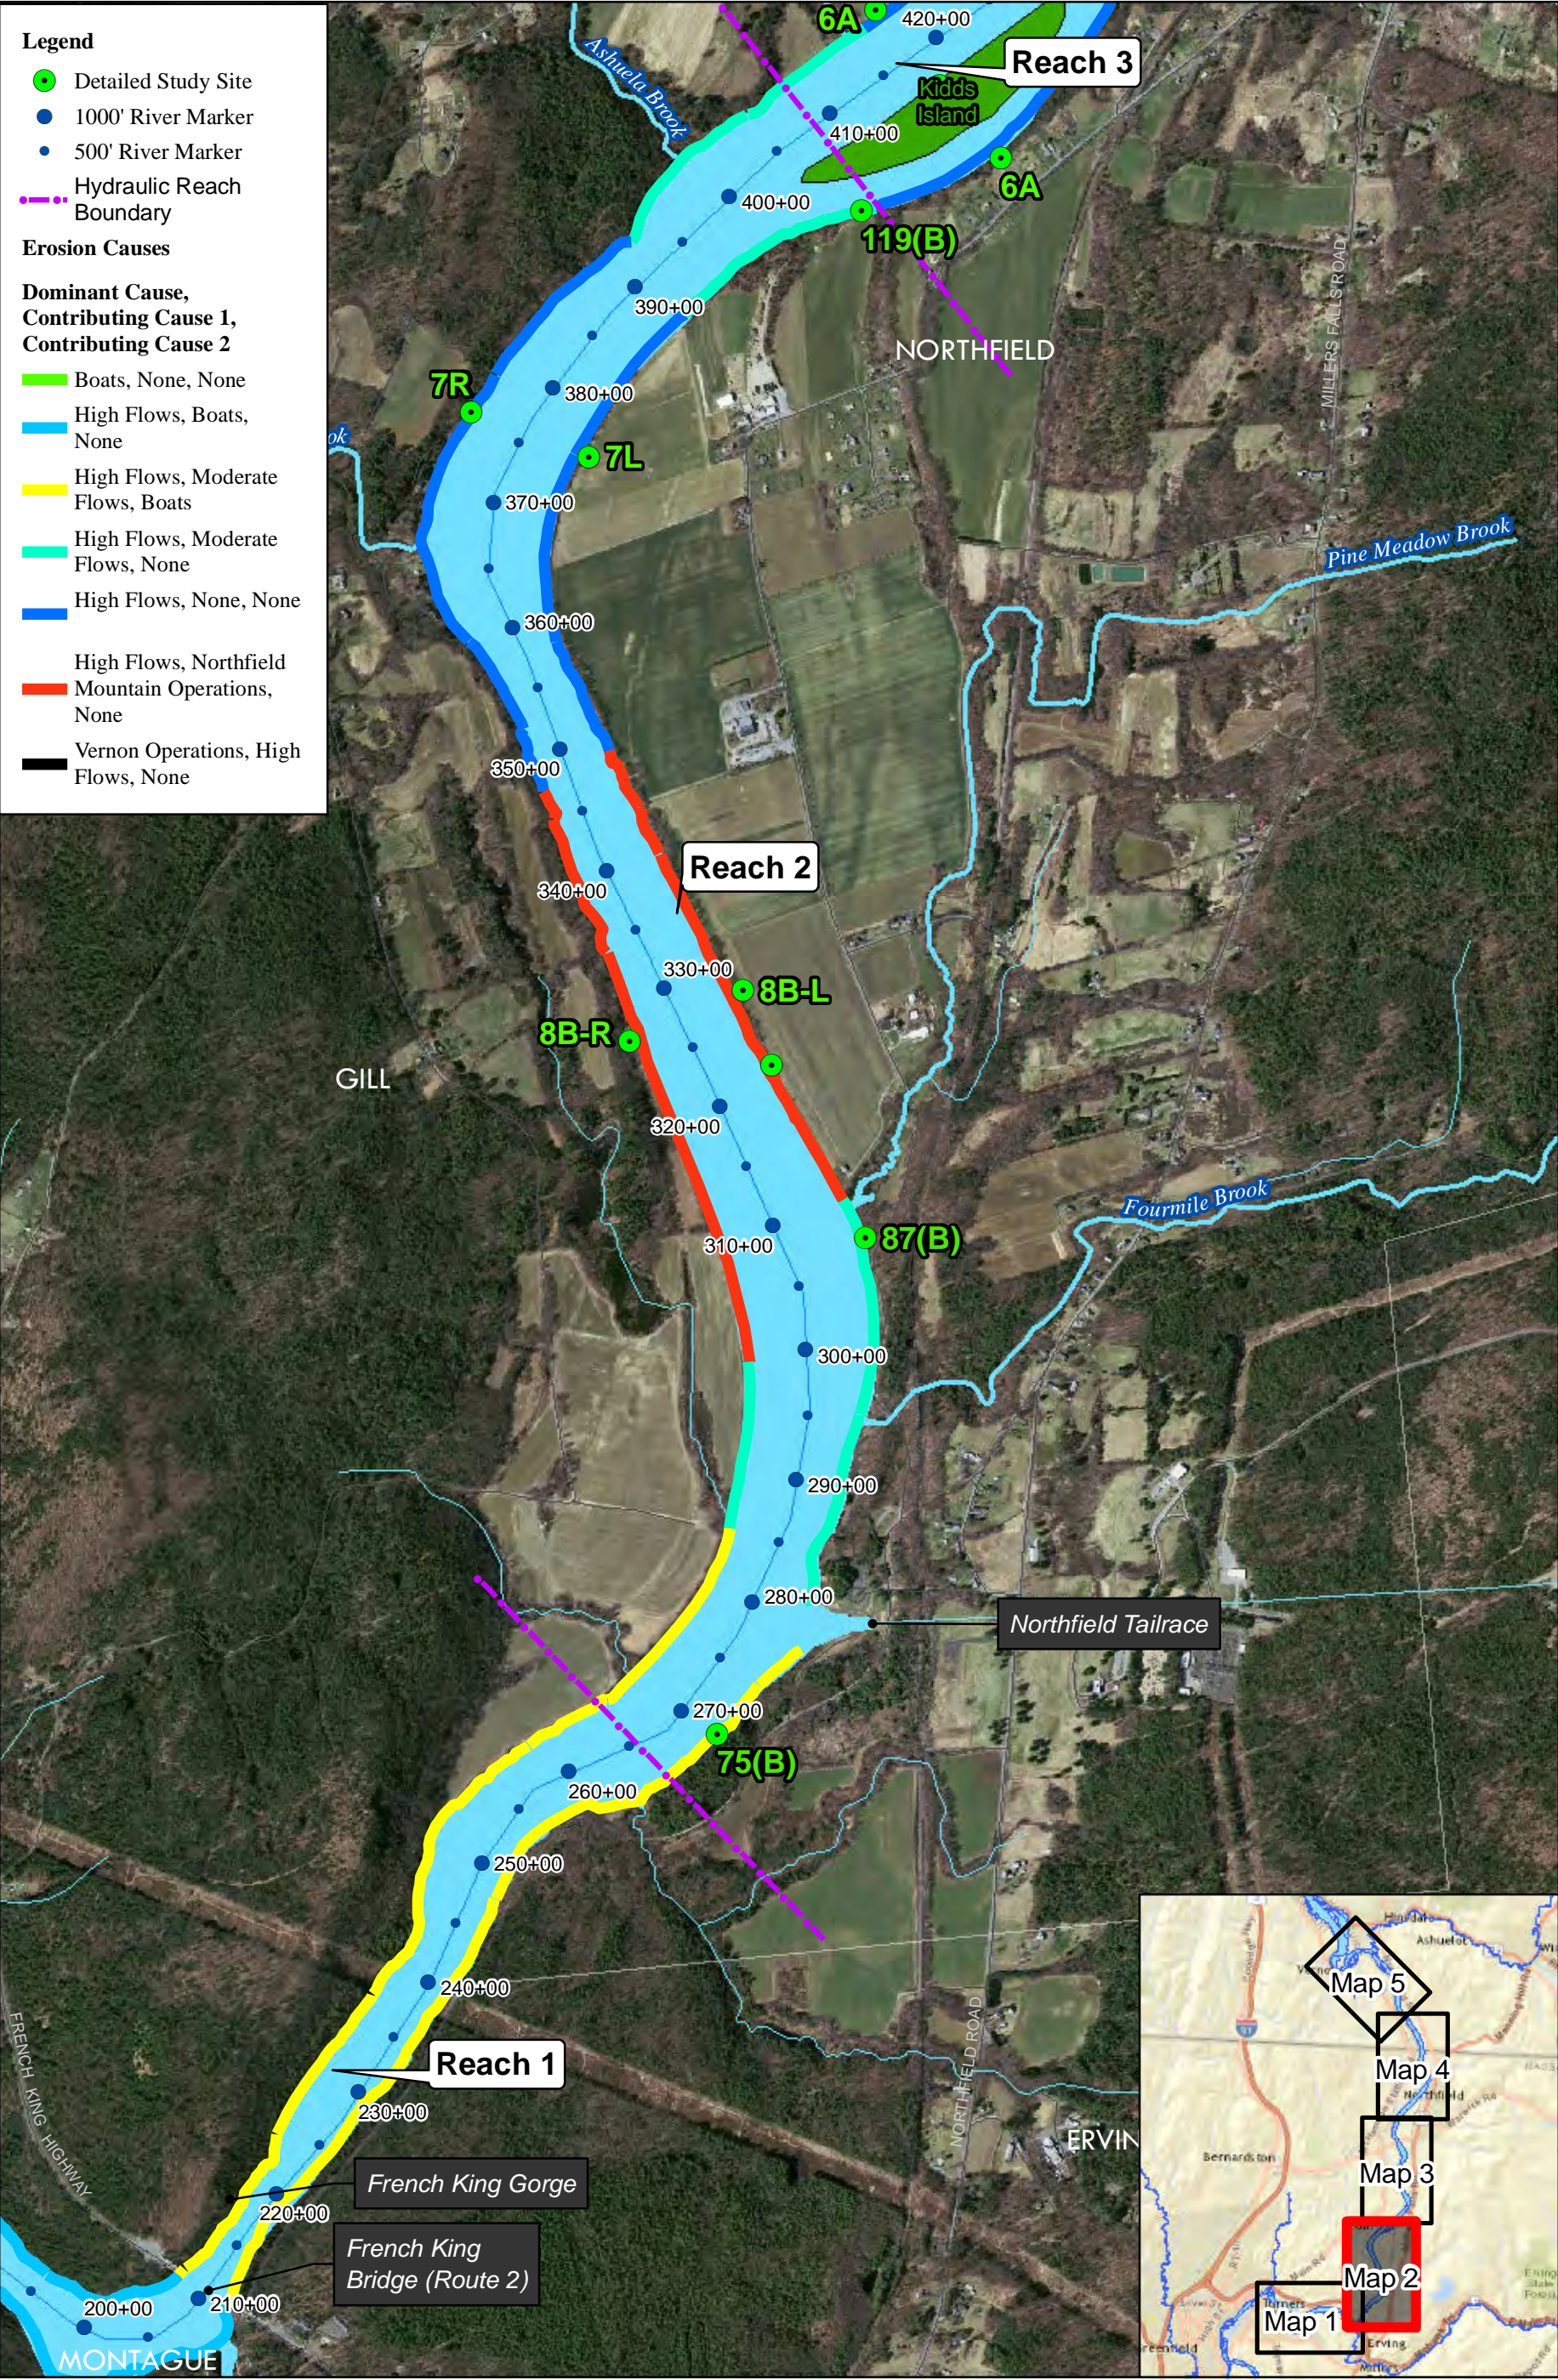
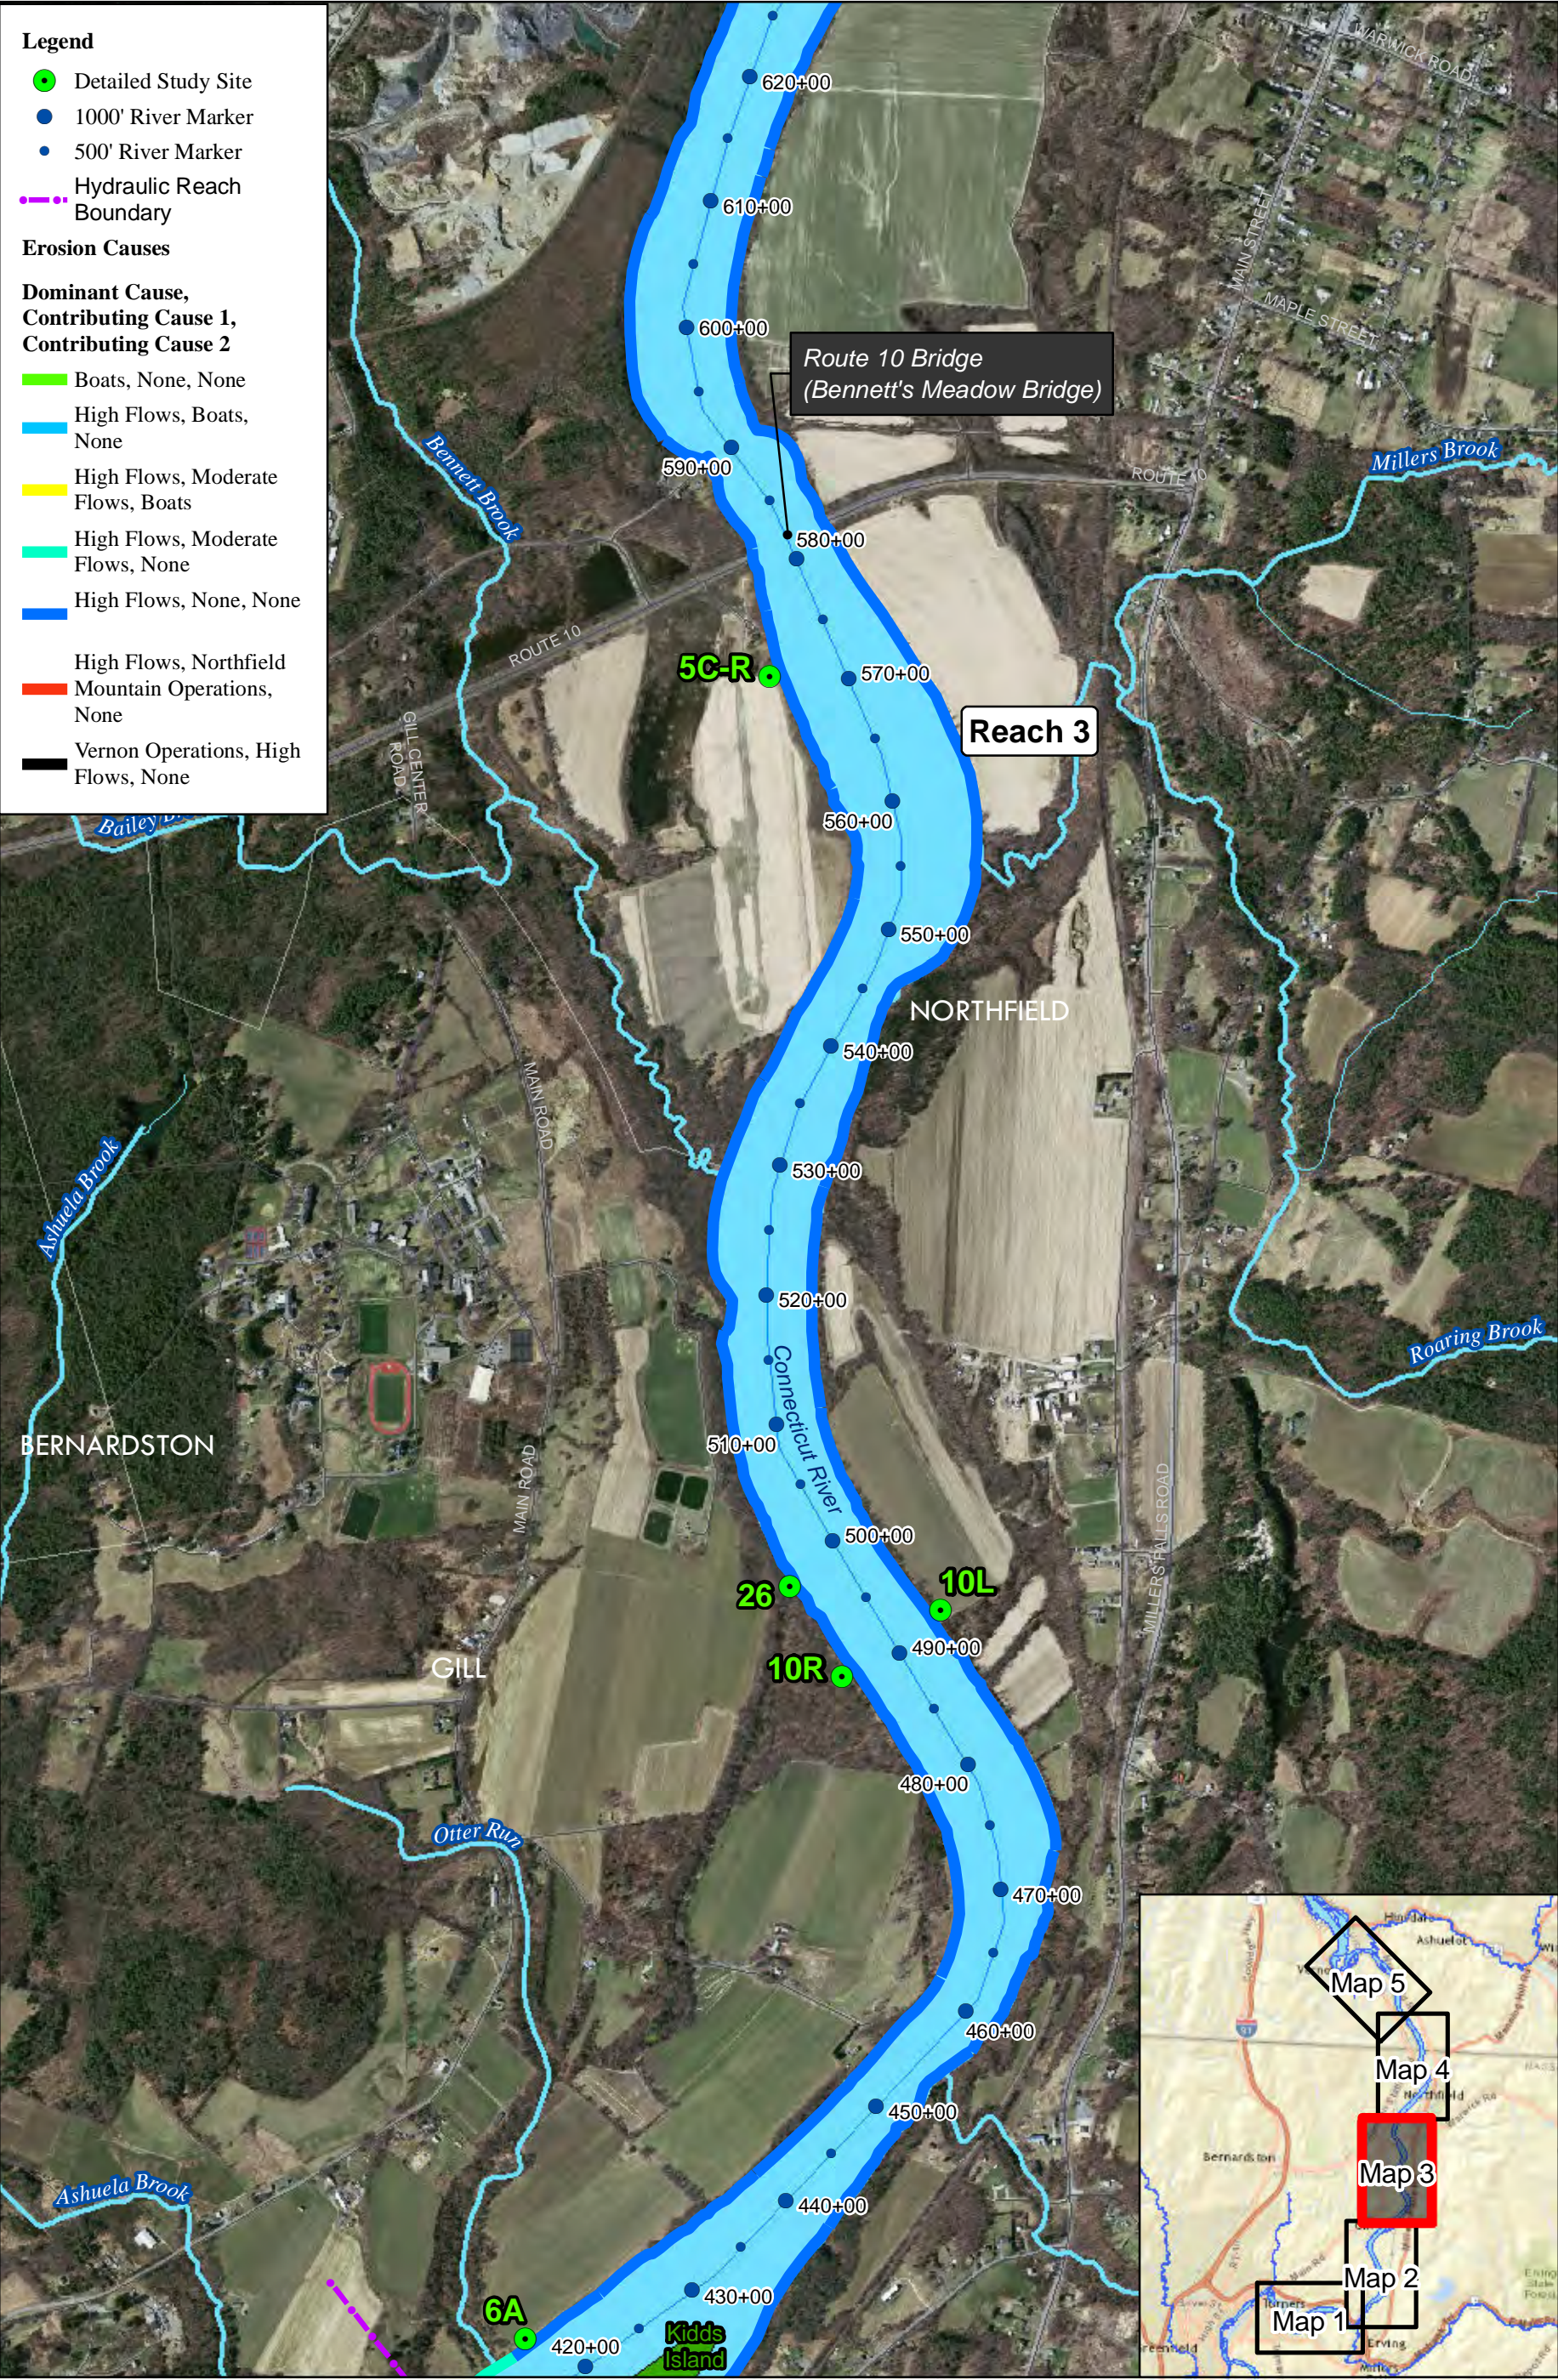
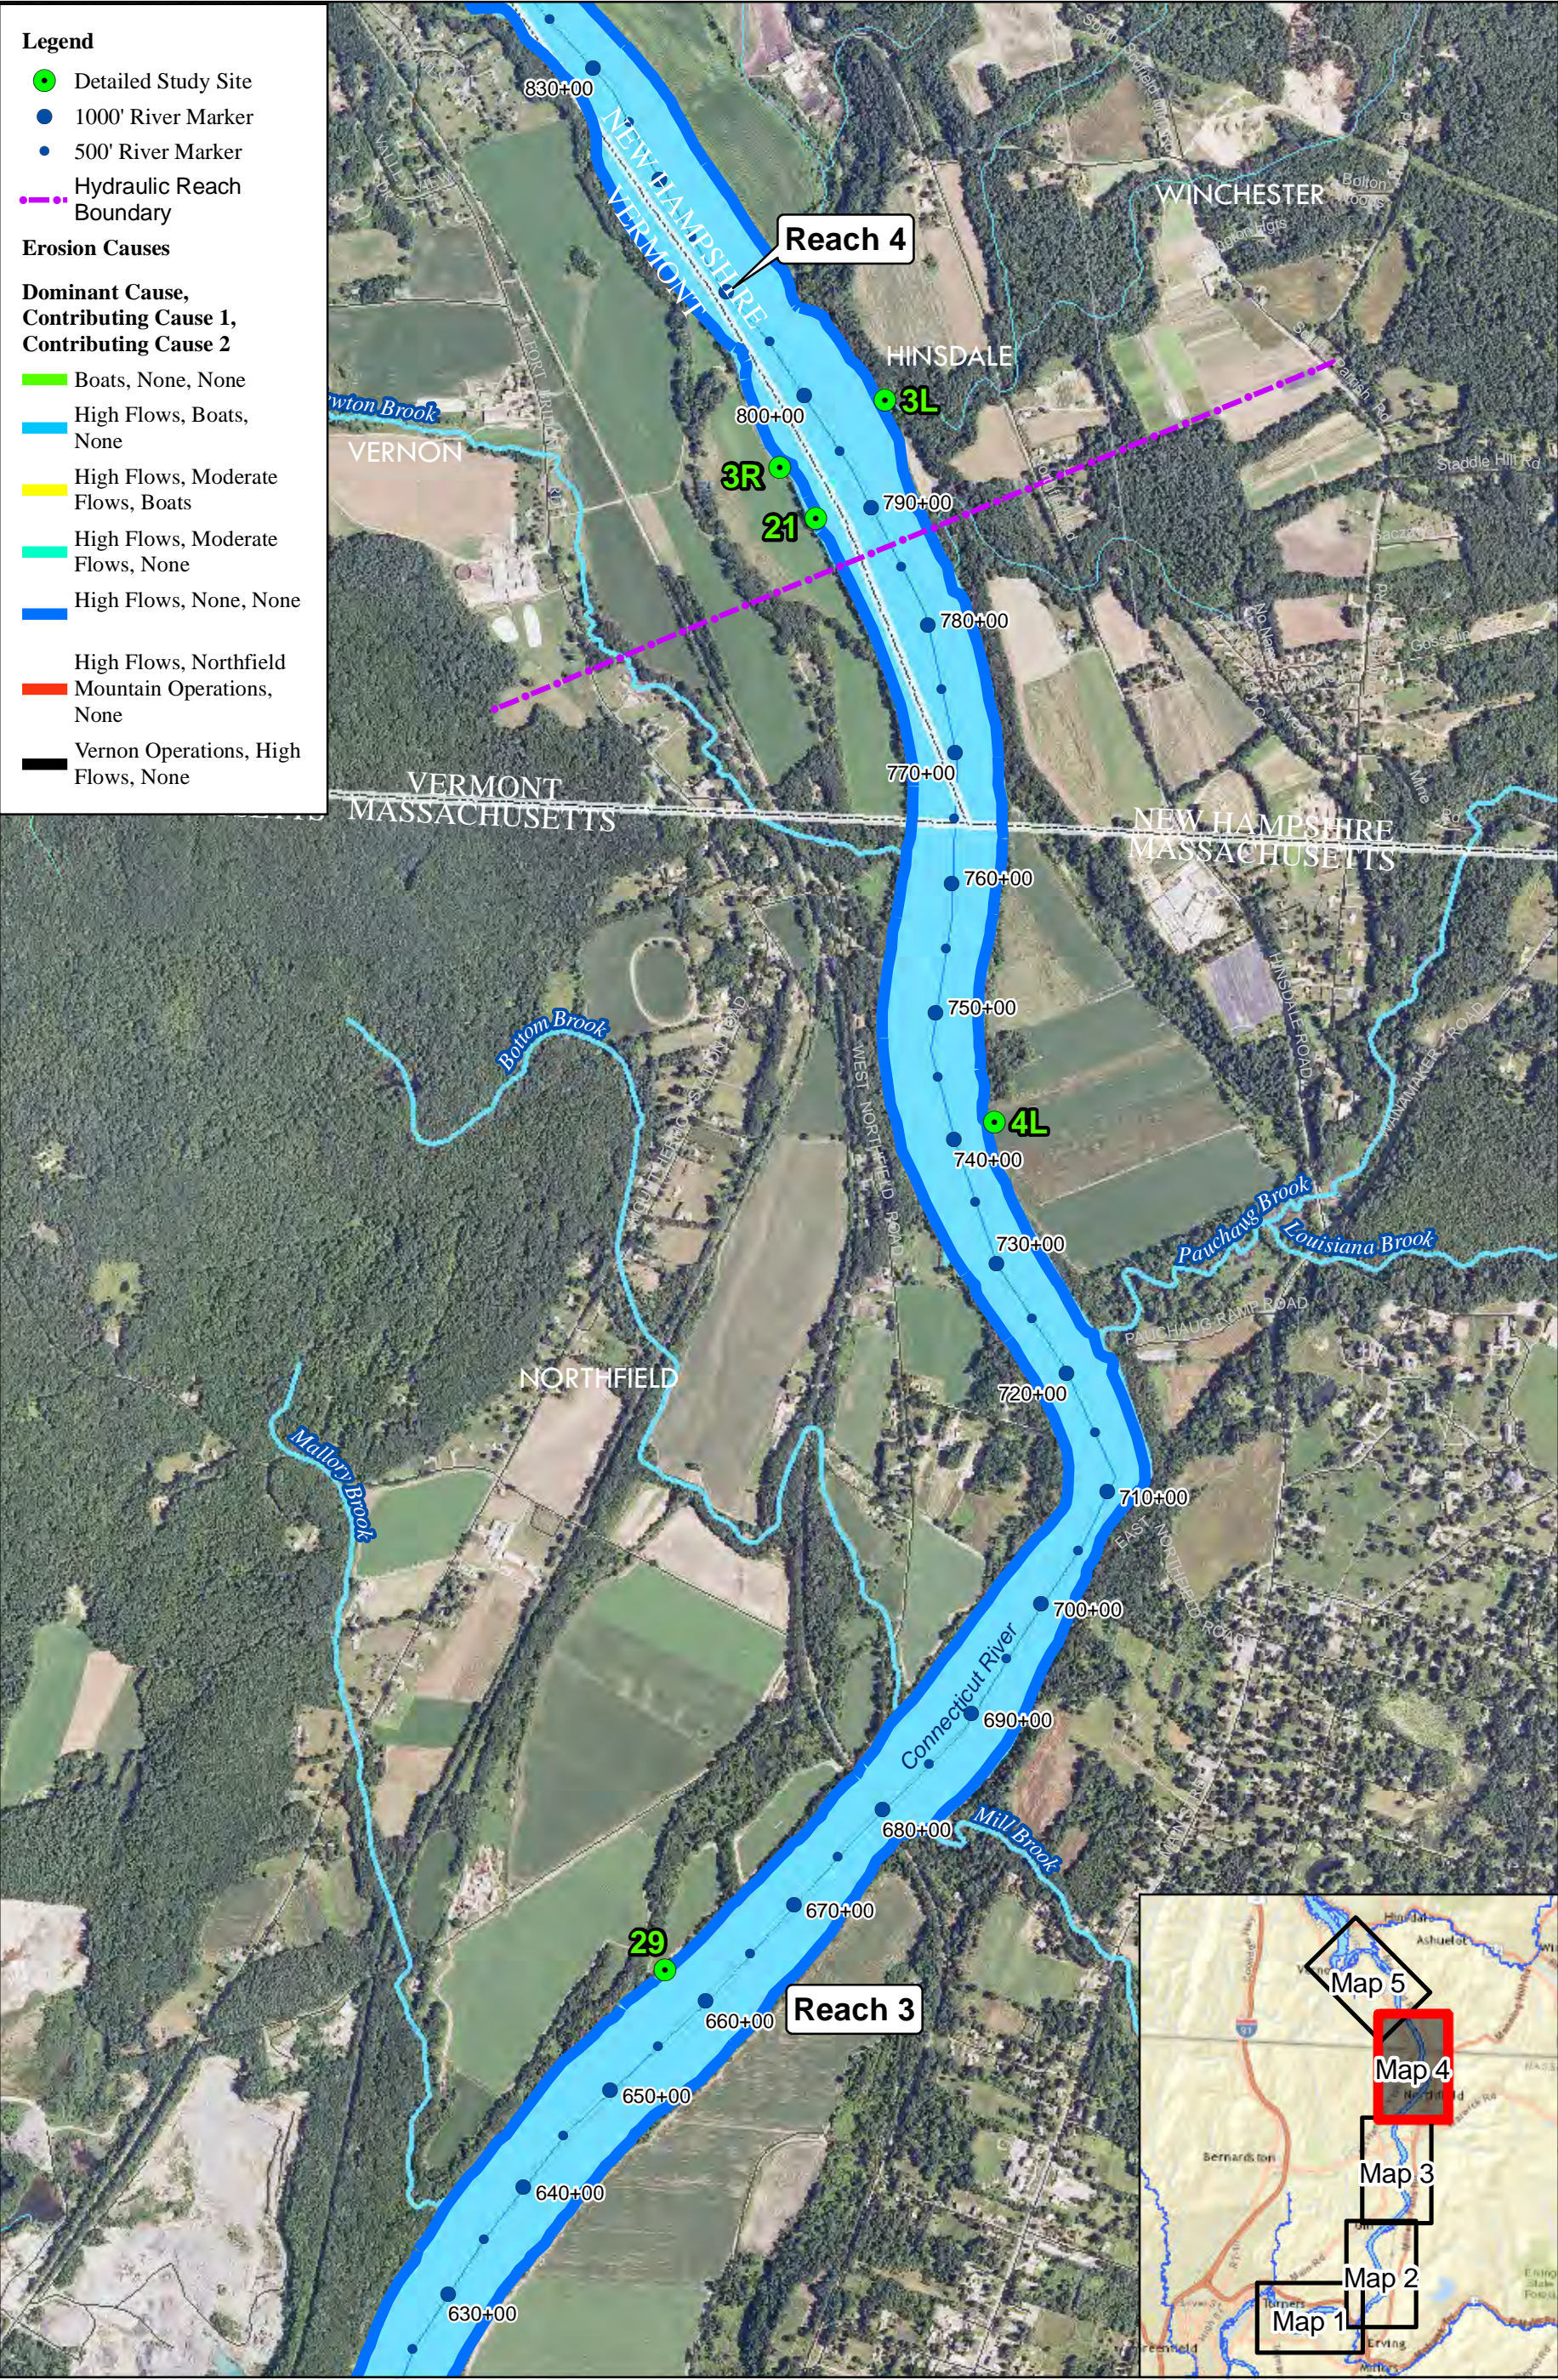
Figure 6.1.2.2-6:
Final Extrapolation of the Causes of Erosion
for each Riverbank Segment in
Turners Falls Impoundment

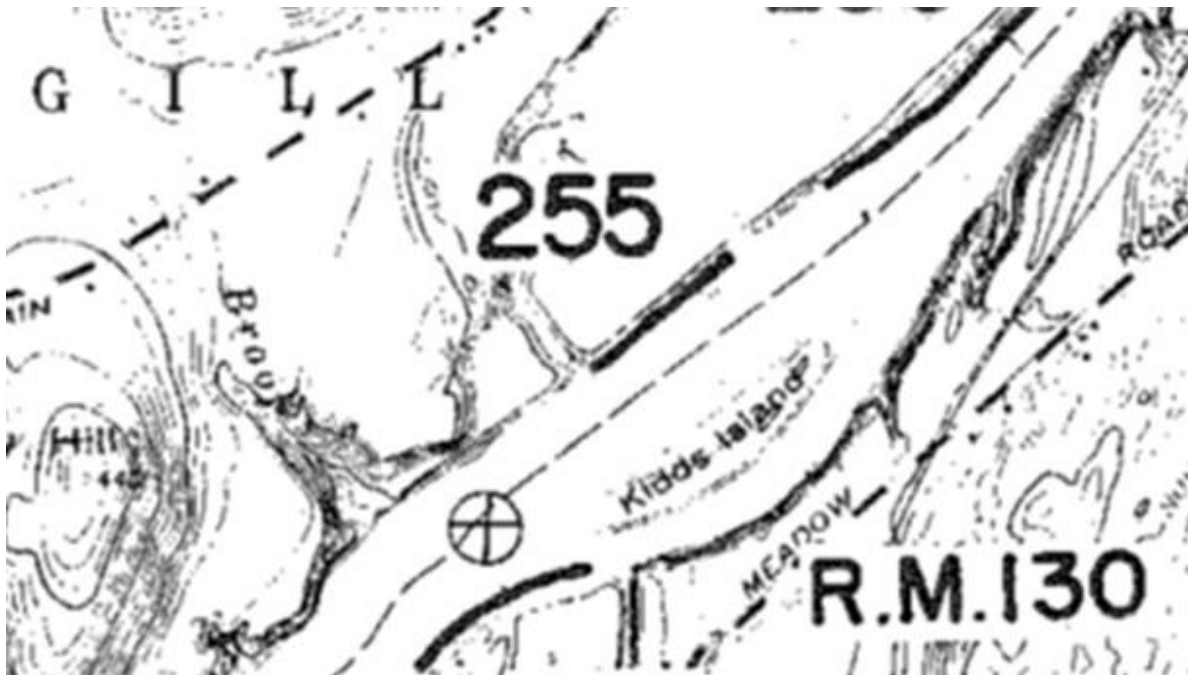
Figure 6.1.4.1-2 TFI USACE Index Site 255 (USACE, 1979)

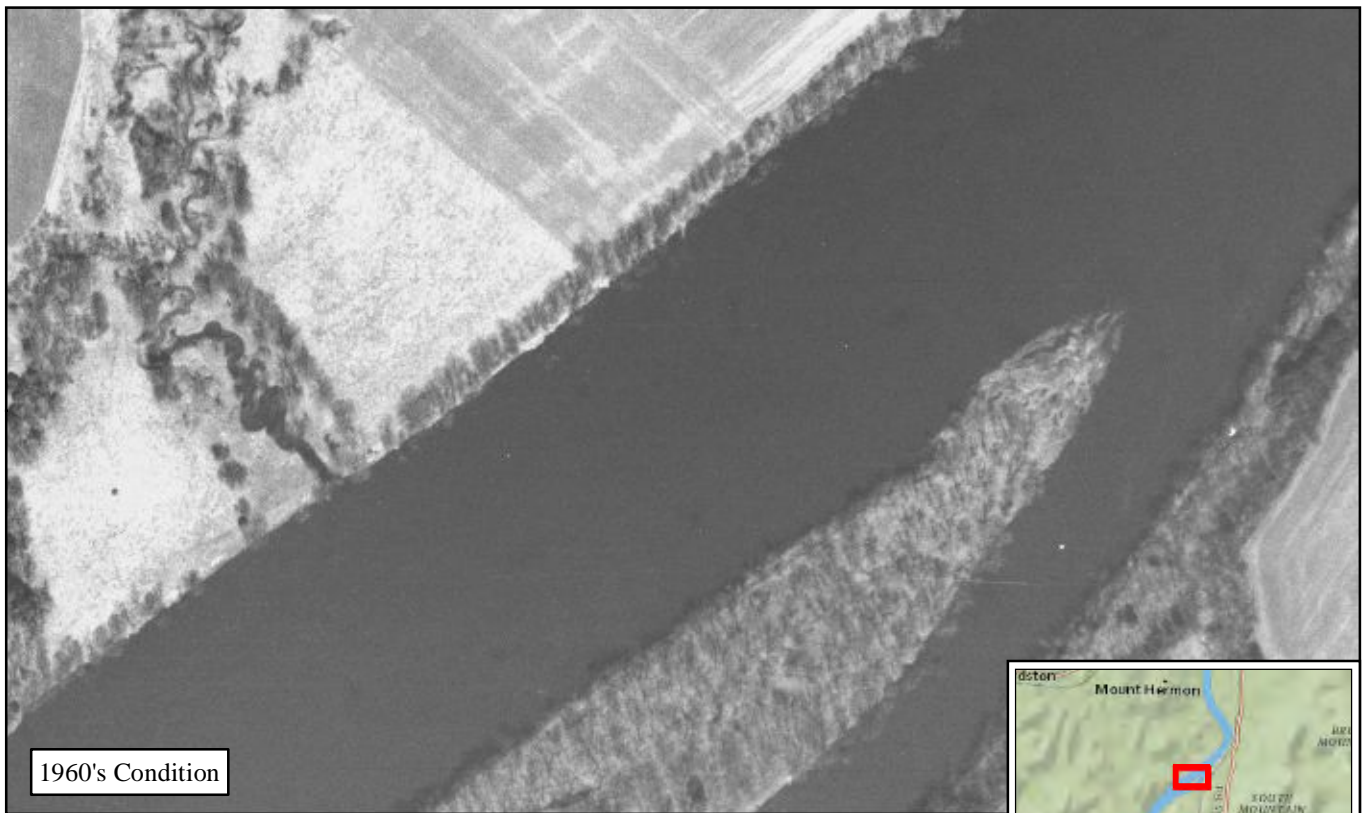
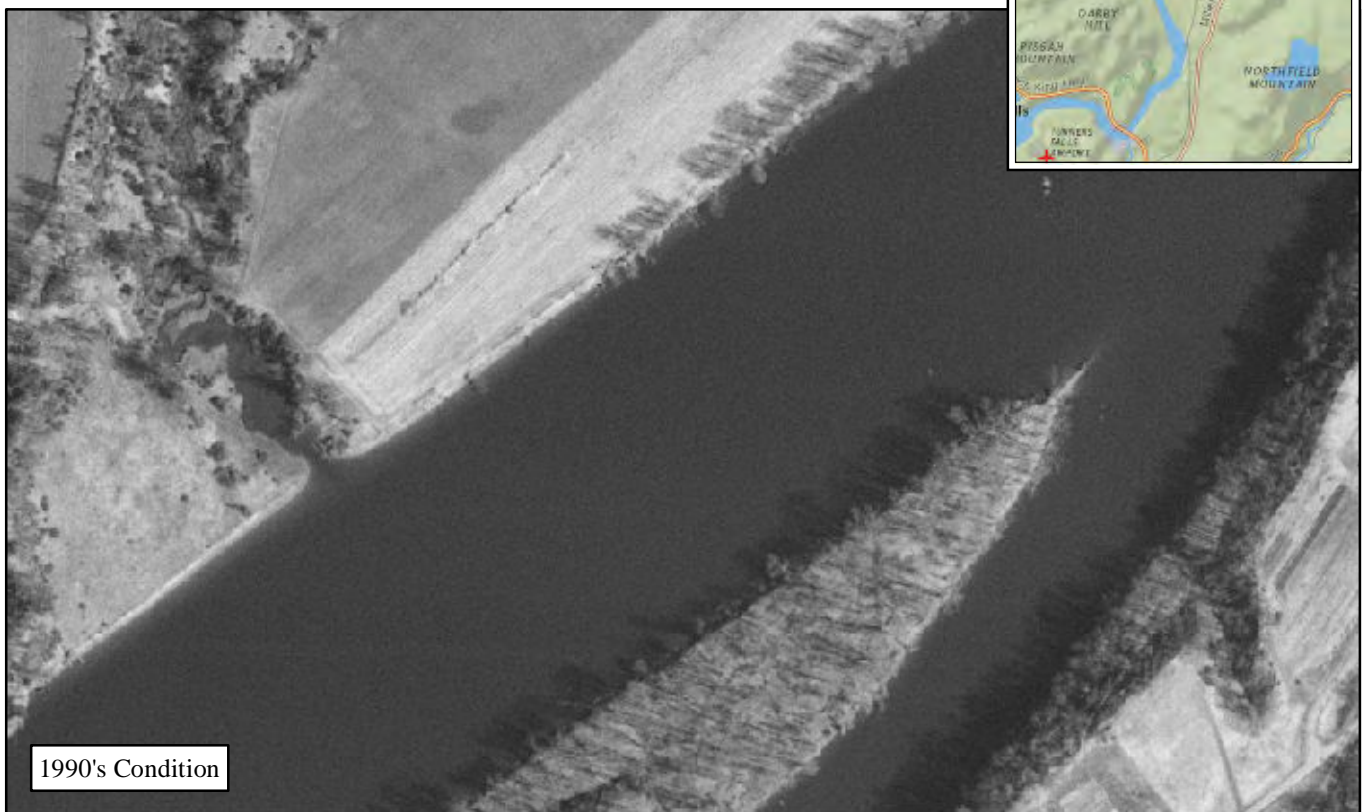
Figure 6.1.4.1-3:
TFI USACE Index Site 255
1960's and 1990's Condition

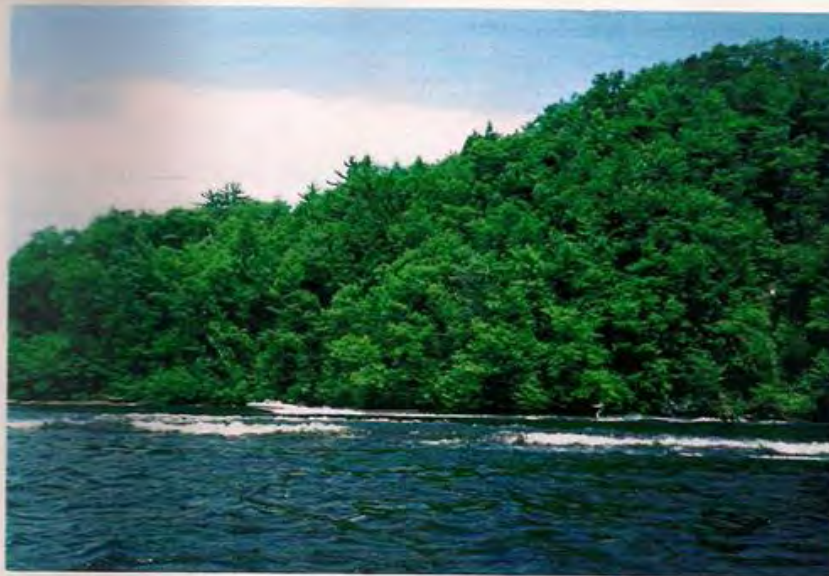
Power boating, including water skiing, is a growing recreational activity along the river - July 4, 1990.

Figure 6.1.4.1-4: Example of Past Boat Activity in the Vicinity of USACE Site 255 (July 4, 1990)
(Top)
