Relicensing Study 3.1.2

**Northfield Mountain / Turners Falls
Operations Impact on Existing Erosion and
Potential Bank Instability
Study Report**

Volume II – Main Report

**Northfield Mountain Pumped Storage Project (No. 2485) and
Turners Falls Hydroelectric Project (No. 1889)**

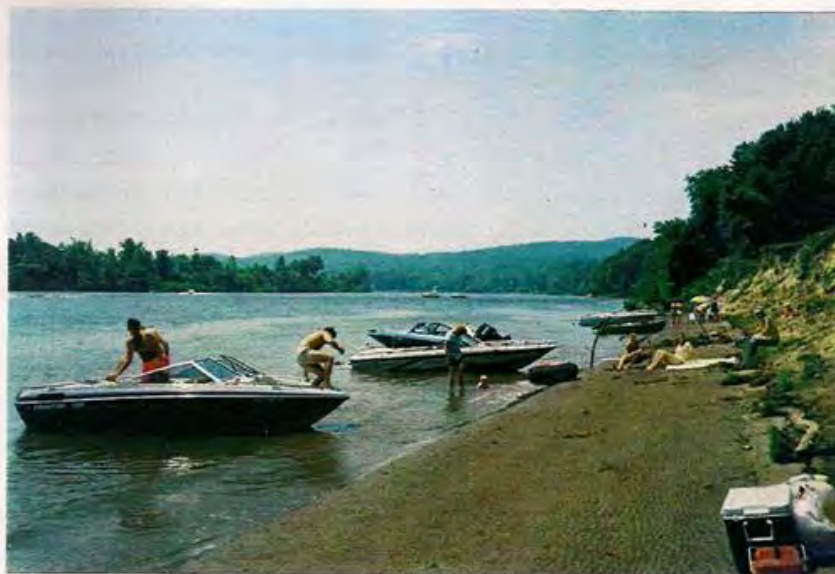
The long, exposed beach west of Kidds Island is a popular summer recreational spot for boaters - July 4, 1990.

Figure 6.1.4.1-4: Example of Past Boat Activity in the Vicinity of USACE Site 255 (July 4, 1990)
(Top)
