Riverbank Erosion Comparison along the Connecticut River

October 2012

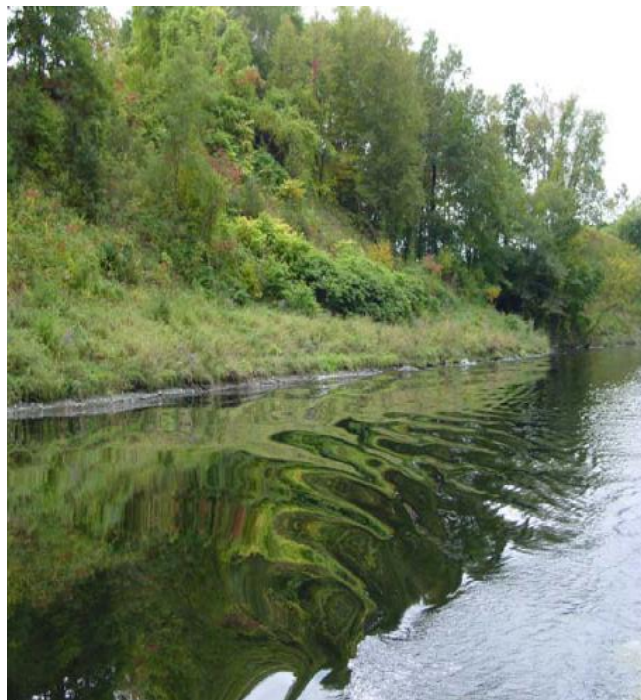
Figure 17. Comparison of Skalski Site pre 2004 to 2008

Photographs are available at several erosion sites in the Turners Falls Impoundment taken before and after riverbank stabilization projects that have occurred with implementation of the ECP. Many of the erosion sites identified in the ECP have been stabilized by a range of measures including placement of rock at the toe of the slope, coir logs, placement of large woody debris, various fabrics, and planting of vegetation including riparian and aquatic. Some re-shaping of riverbanks has also been conducted at some sites. An example of the transformation from an unstable, eroding riverbank to a stabilized riverbank is shown in Figure 17. As shown by this comparison of photos from before 2004 to 2008, the eroding bank has been stabilized by placing relatively small rock at the toe of the slope and planting vegetation above the rock on the formerly eroded bank. The 2008 photo shows the transformation from erosion to stability accomplished by this effort. Appendix H provides other examples of riverbank stabilization efforts in the Turners Falls Impoundment. From the commencement of implementation of the ECP to the present, approximately 14,000 feet of riverbank have been stabilized in the Turners Falls Impoundment.

Site 6 – Skalski, 2008 (from Maintenance Inspection Report)

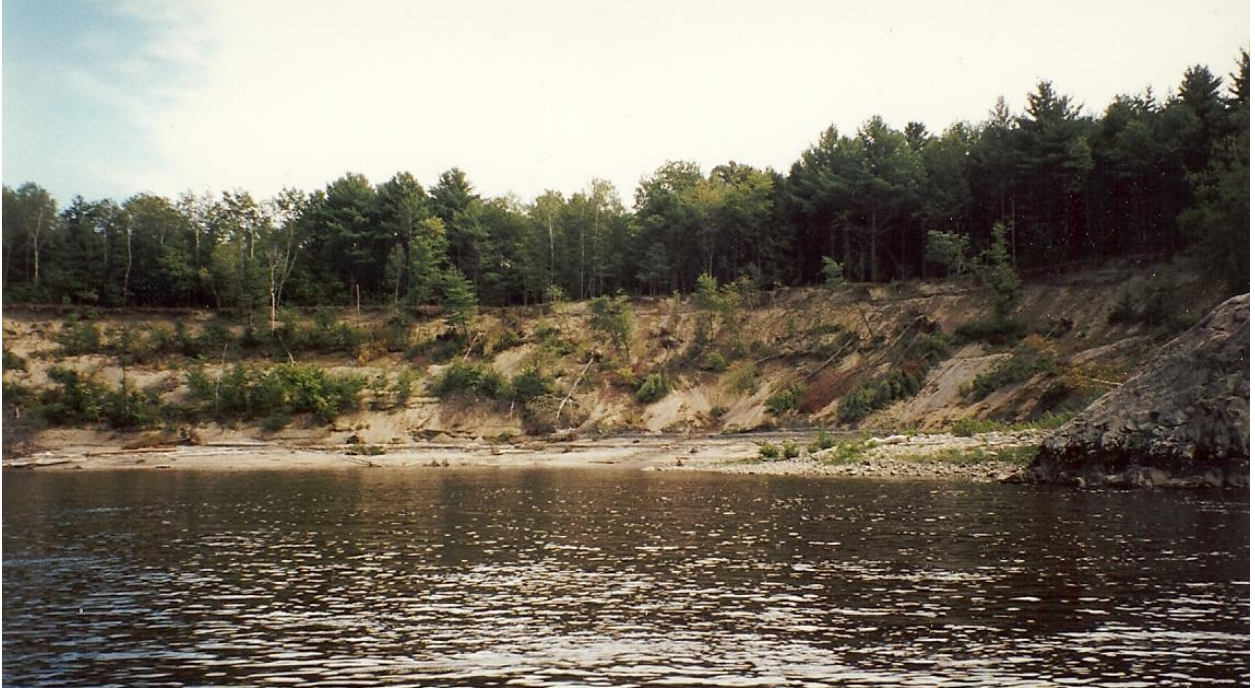
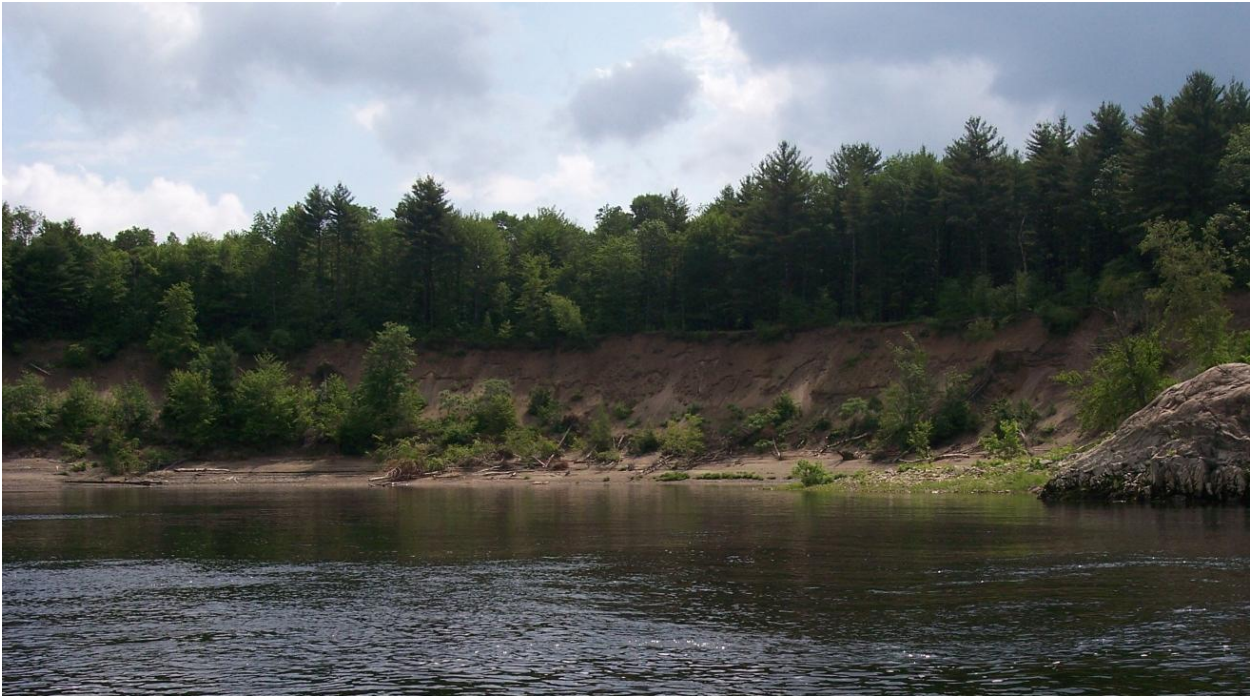
Figure 18. Natural stabilization processes 1996-2008 downstream of Vernon Dam

In addition to stabilization of erosion sites, natural stabilization processes as a result of increasing expansion of vegetation has been observed over the period from 1998 to 2008. Areas of increased vegetation on upper riverbanks – both relative to density as well as height have been observed over this time period. Some areas of dense aquatic vegetation on lower riverbanks have also been observed. An example of natural stabilization processes is shown in Figure 18 where ongoing erosion processes are evident in 1996 with numerous trees that have fallen down, other trees tipping and on the verge of falling along with fresh erosion scars. This area of erosion is located immediately downstream of Vernon Dam on the east side of the Connecticut River. In 2008, there are no recently fallen trees, very few tipping trees, and an increased band of trees and other vegetation is growing in the transition area between the steep upper bank and the flatter lower bank where beach formation is evident. Less fresh erosion scarring can be seen. Other examples of these natural stabilization processes through increasing vegetation expansion in the Turners Falls Impoundment are shown in Appendix I. Additional expansion of vegetation was also noted during a field trip observing riverbank conditions taken in the fall of 2009.

1996 – Eddy-induced erosion downstream of Vernon Dam

2008 – Eddy-induced erosion downstream of Vernon Dam

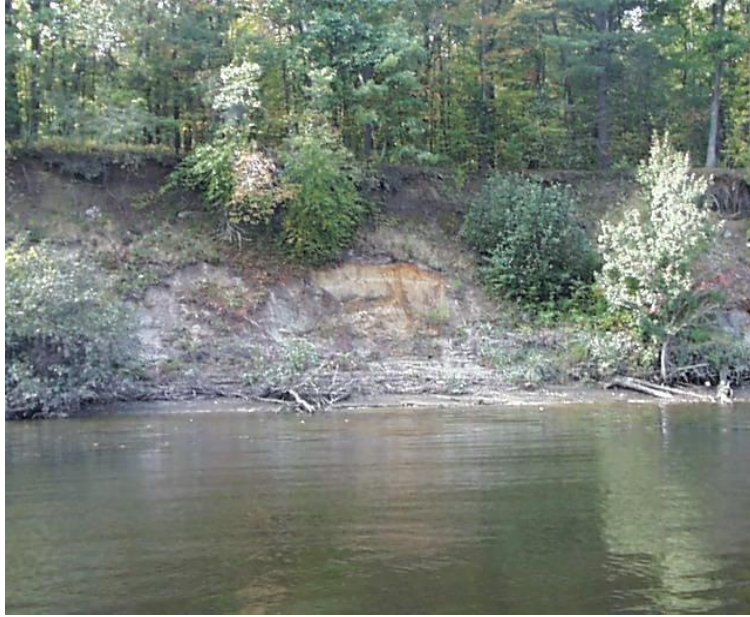
Site 4 – Urgiel (upstream), before 2001

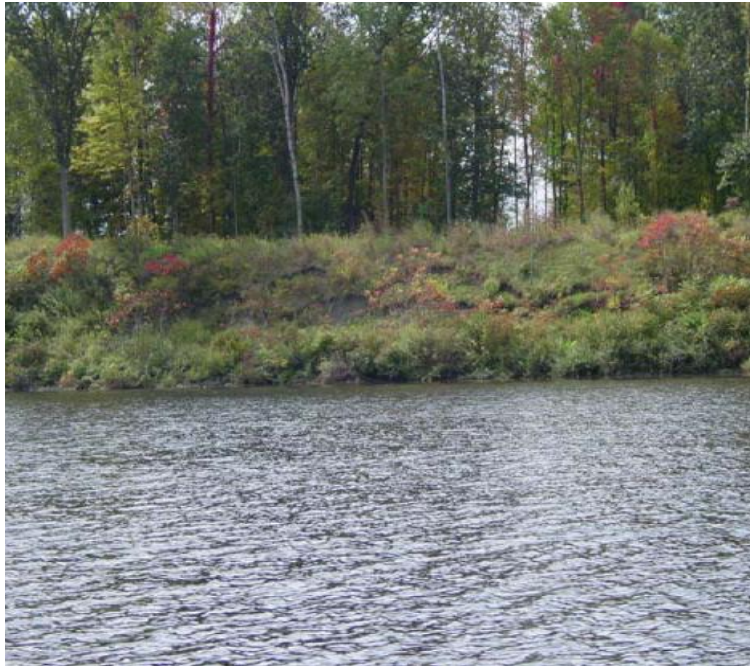
Site 4 – Urgiel (upstream), 2008 (from Maintenance Inspection Report)

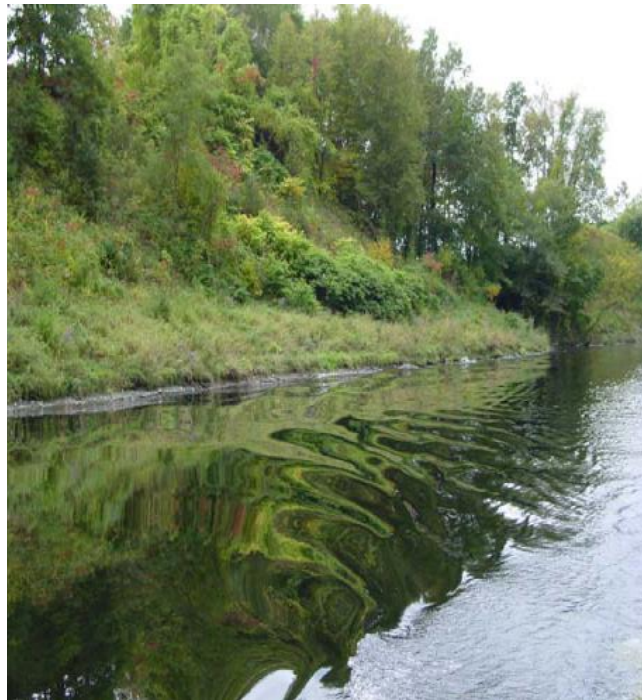
Site 6 – Skalski, 2008 (from Maintenance Inspection Report)

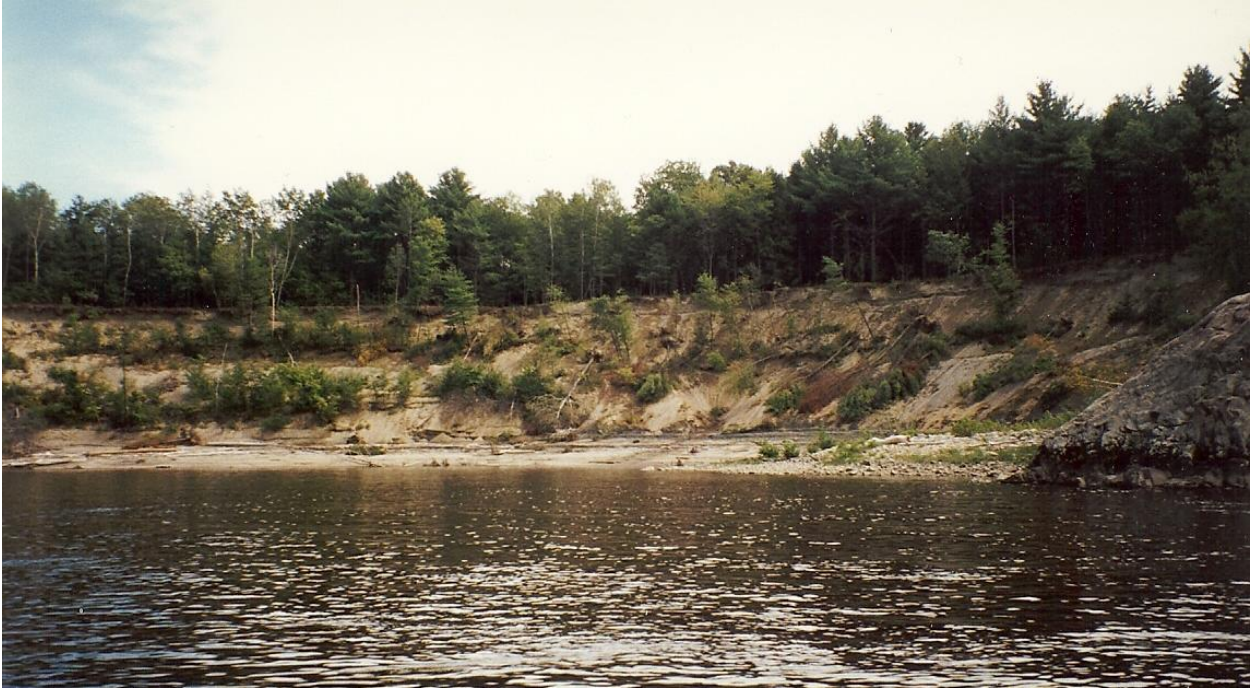
1996 – Eddy-induced erosion downstream of Vernon Dam

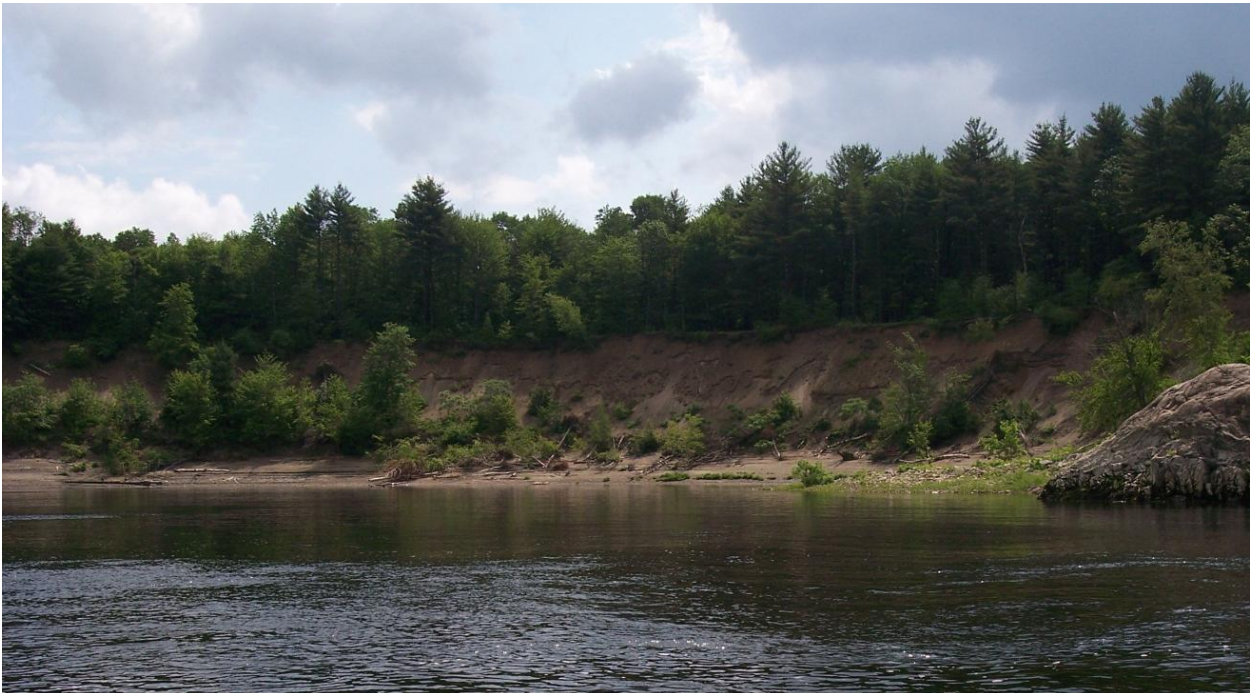
2008 – Eddy-induced erosion downstream of Vernon Dam

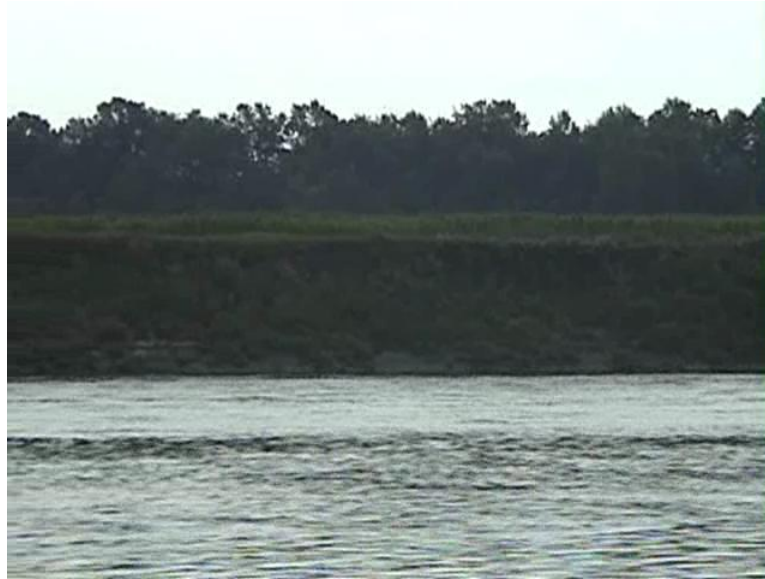
Right Bank near downstream end of Stebbin's Island - 1998

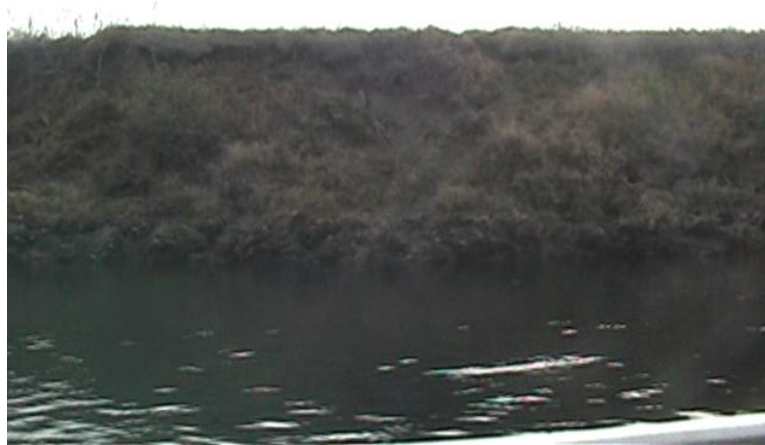
Right Bank near downstream end of Stebbin's Island - 2008
