Re: Filing of Addendum to Study No. 3.1.1- 2013 Full River Reconnaissance  
Turners Falls Hydroelectric Project (FERC No. 1889) and Northfield Mountain Pumped Storage  
Project (FERC No. 2485)

## **ATTACHMENT A: 2013 Full River Reconnaissance – 2015 Addendum: Riverbank Segment QA Comparison**

2015 FRR Addendum  
 Selected Riverbank Segments for QA  
 Map 1

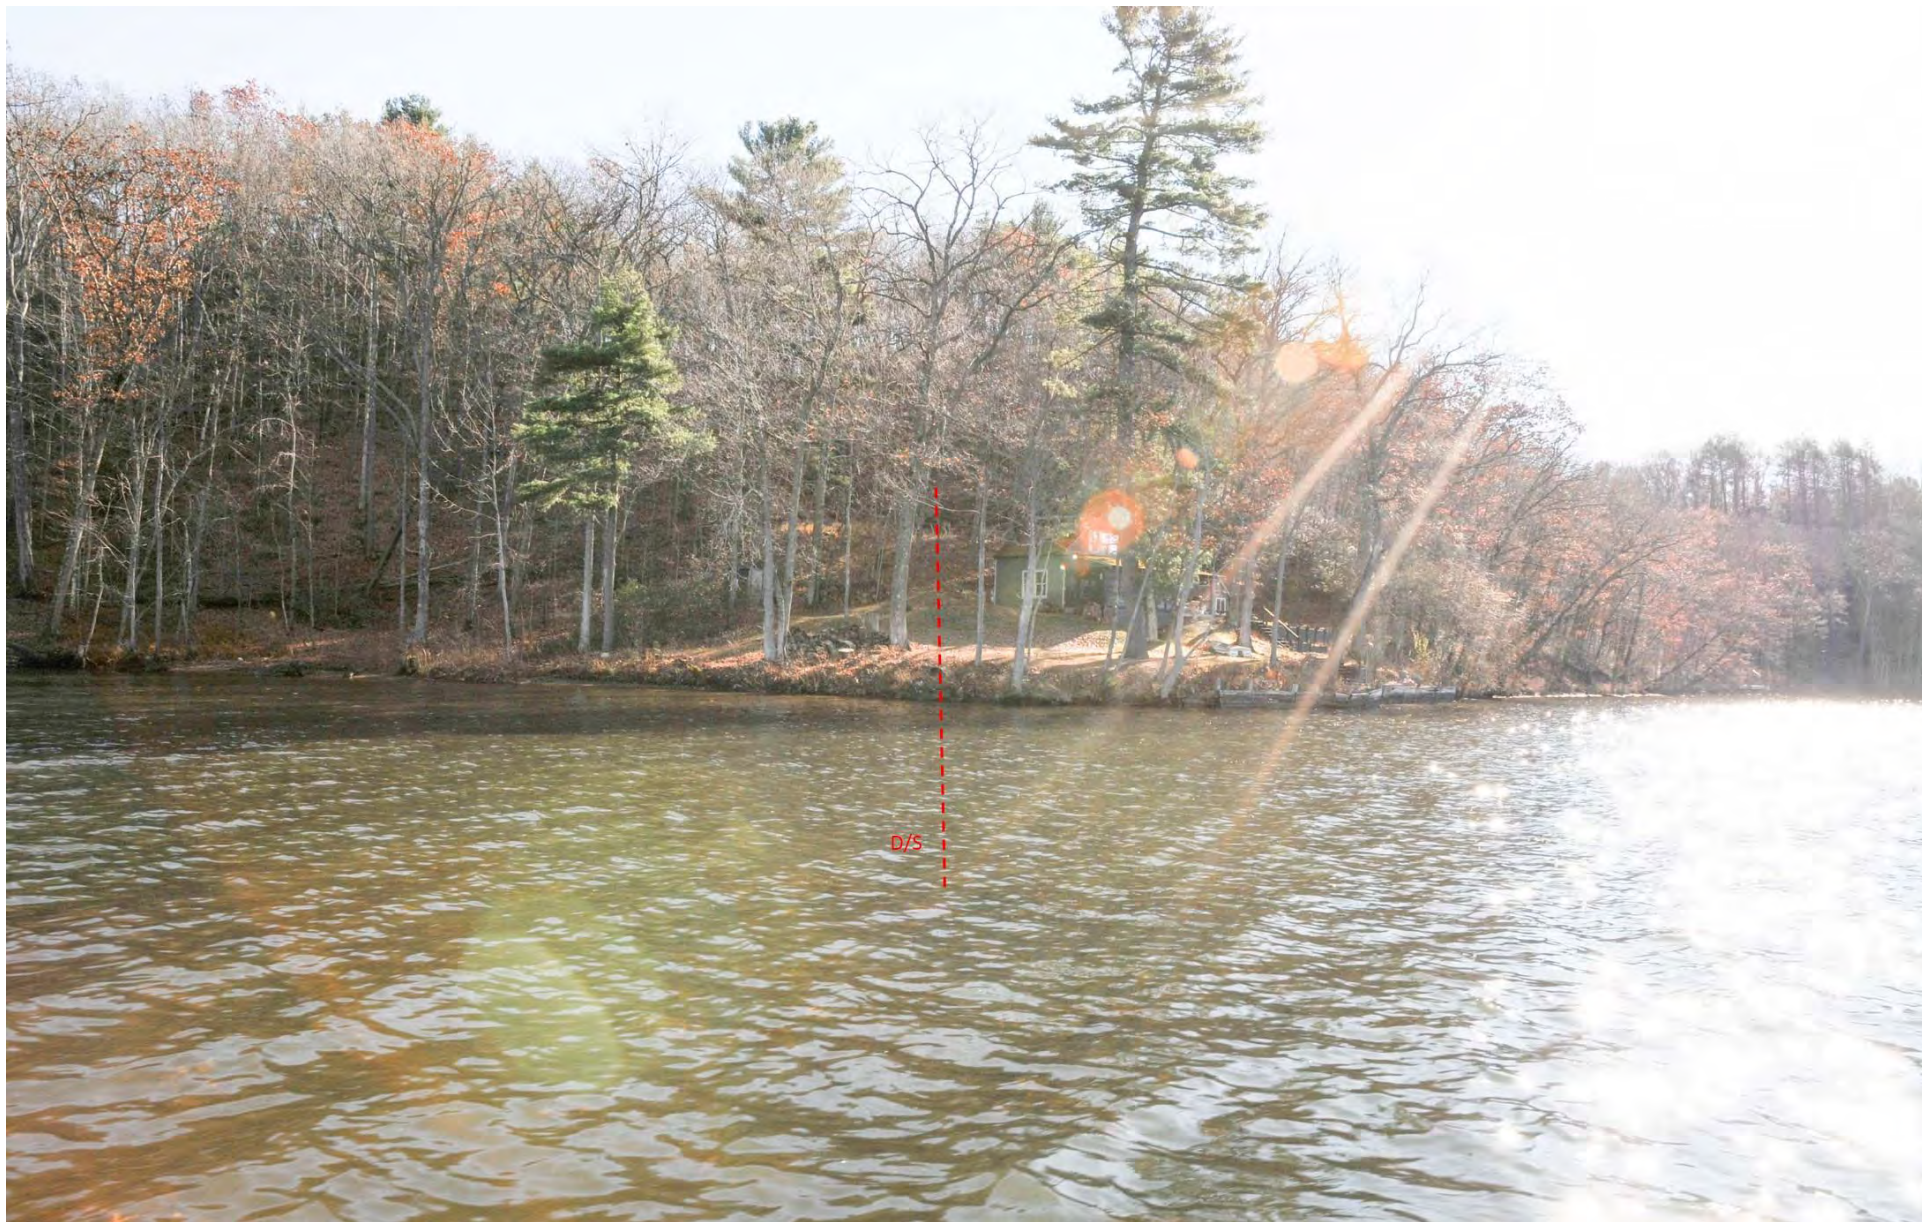
Photo ID 232 (D/S, left of line)

Riverbank Features	Characteristics
Upper Riverbank Slope	Moderate
Upper Riverbank Height	Low
Upper Riverbank Sediment	Silt/Sand
Upper Riverbank Vegetation	Heavy
Lower Riverbank Slope	Flat/Beach
Lower Riverbank Sediment	Silt/Sand
Lower Riverbank Vegetation	None to very sparse
Type of Erosion	Undercut
Potential Erosion Indicators	None
Stage of Erosion	Stable
Extent of Erosion	None/Little

**QA Observations:** Upon review of the photos for this segment, classification made in the field was confirmed.

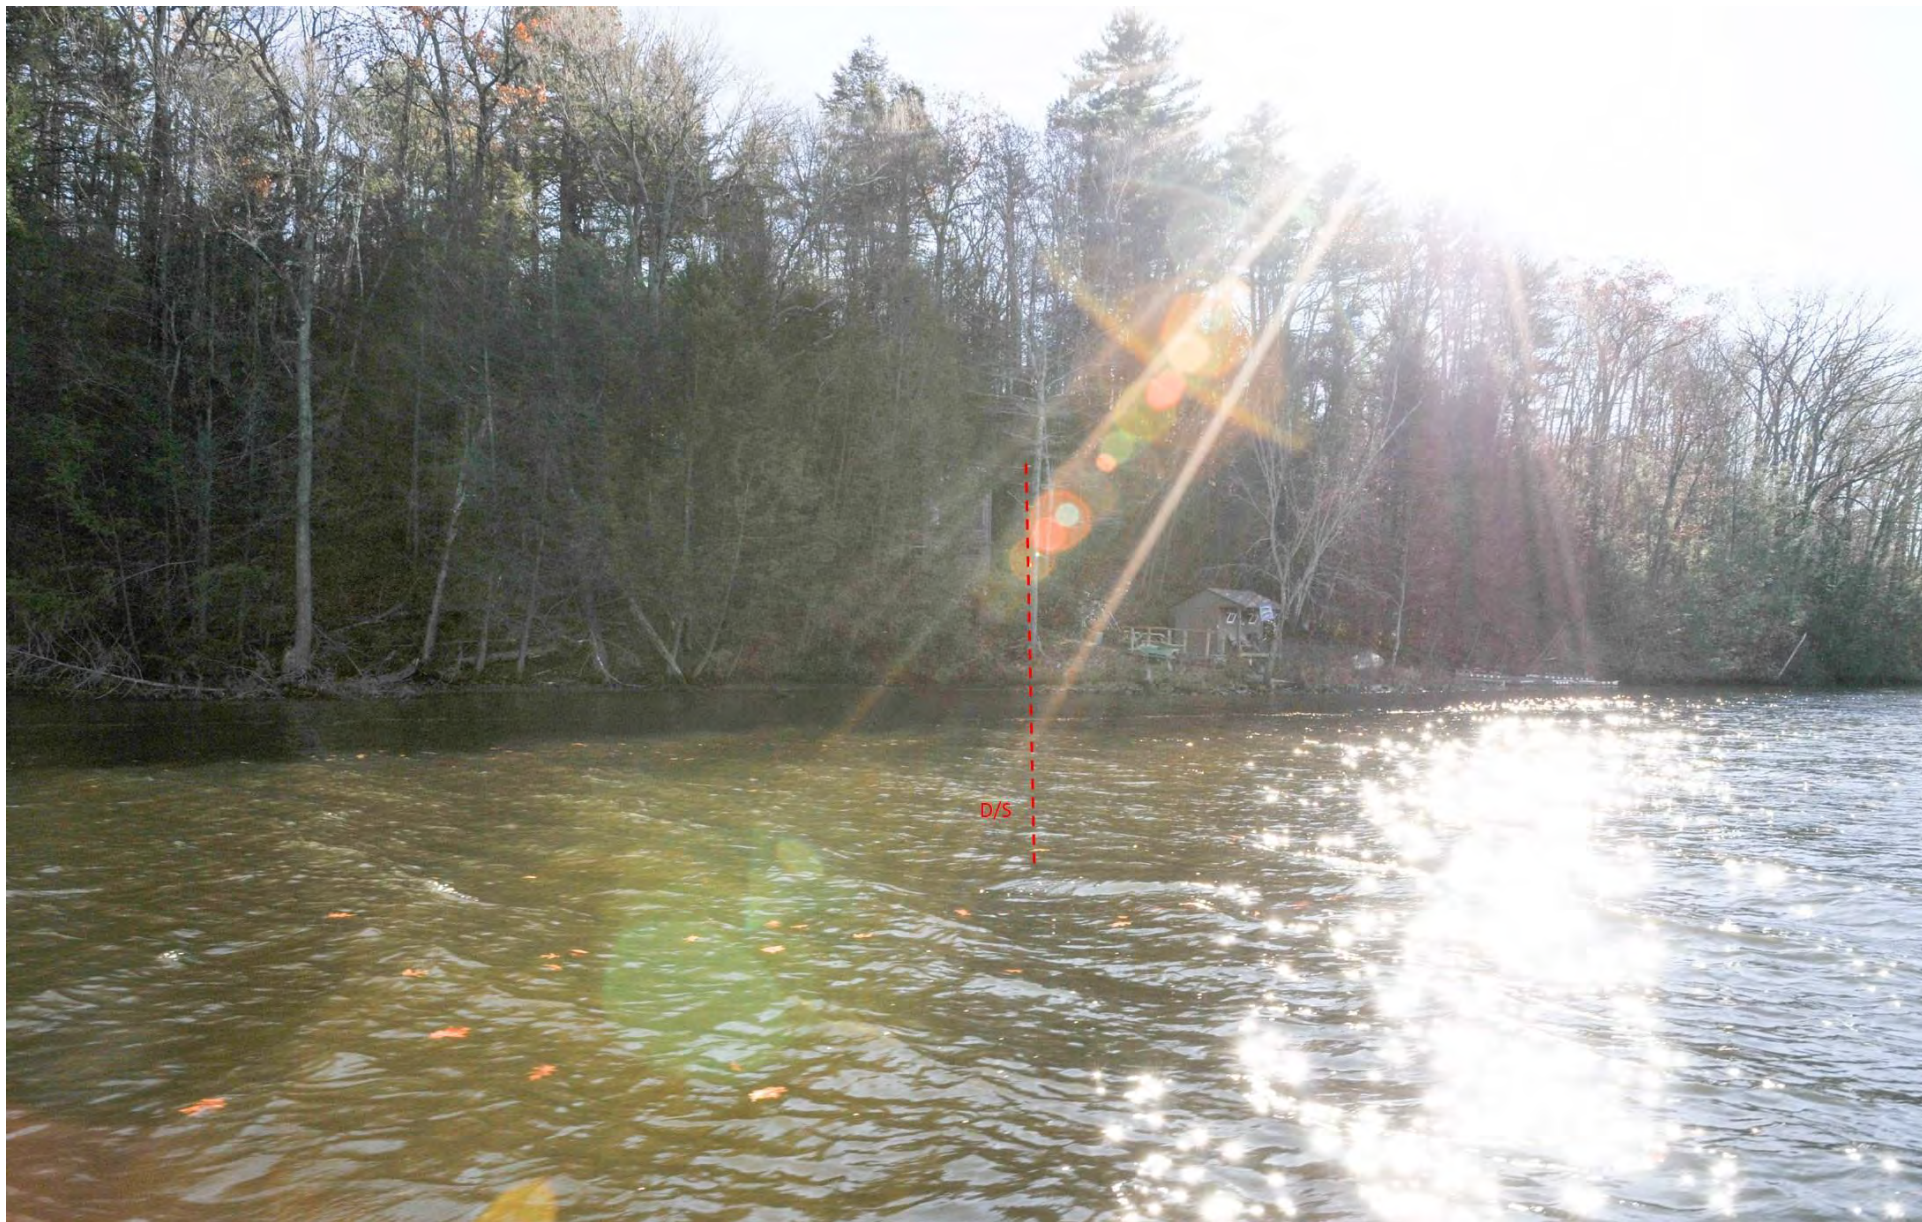
Photo ID 209 (D/S, left of line)

Riverbank Features	Characteristics
Upper Riverbank Slope	Moderate
Upper Riverbank Height	High
Upper Riverbank Sediment	Silt/Sand
Upper Riverbank Vegetation	Heavy
Lower Riverbank Slope	Flat/Beach
Lower Riverbank Sediment	Silt/Sand
Lower Riverbank Vegetation	None to very sparse
Type of Erosion	Undercut
Potential Erosion Indicators	Creep/leaning trees
Stage of Erosion	Stable
Extent of Erosion	None/Little

**QA Observations:** Upon review of the photos for this segment, classification made in the field was confirmed.

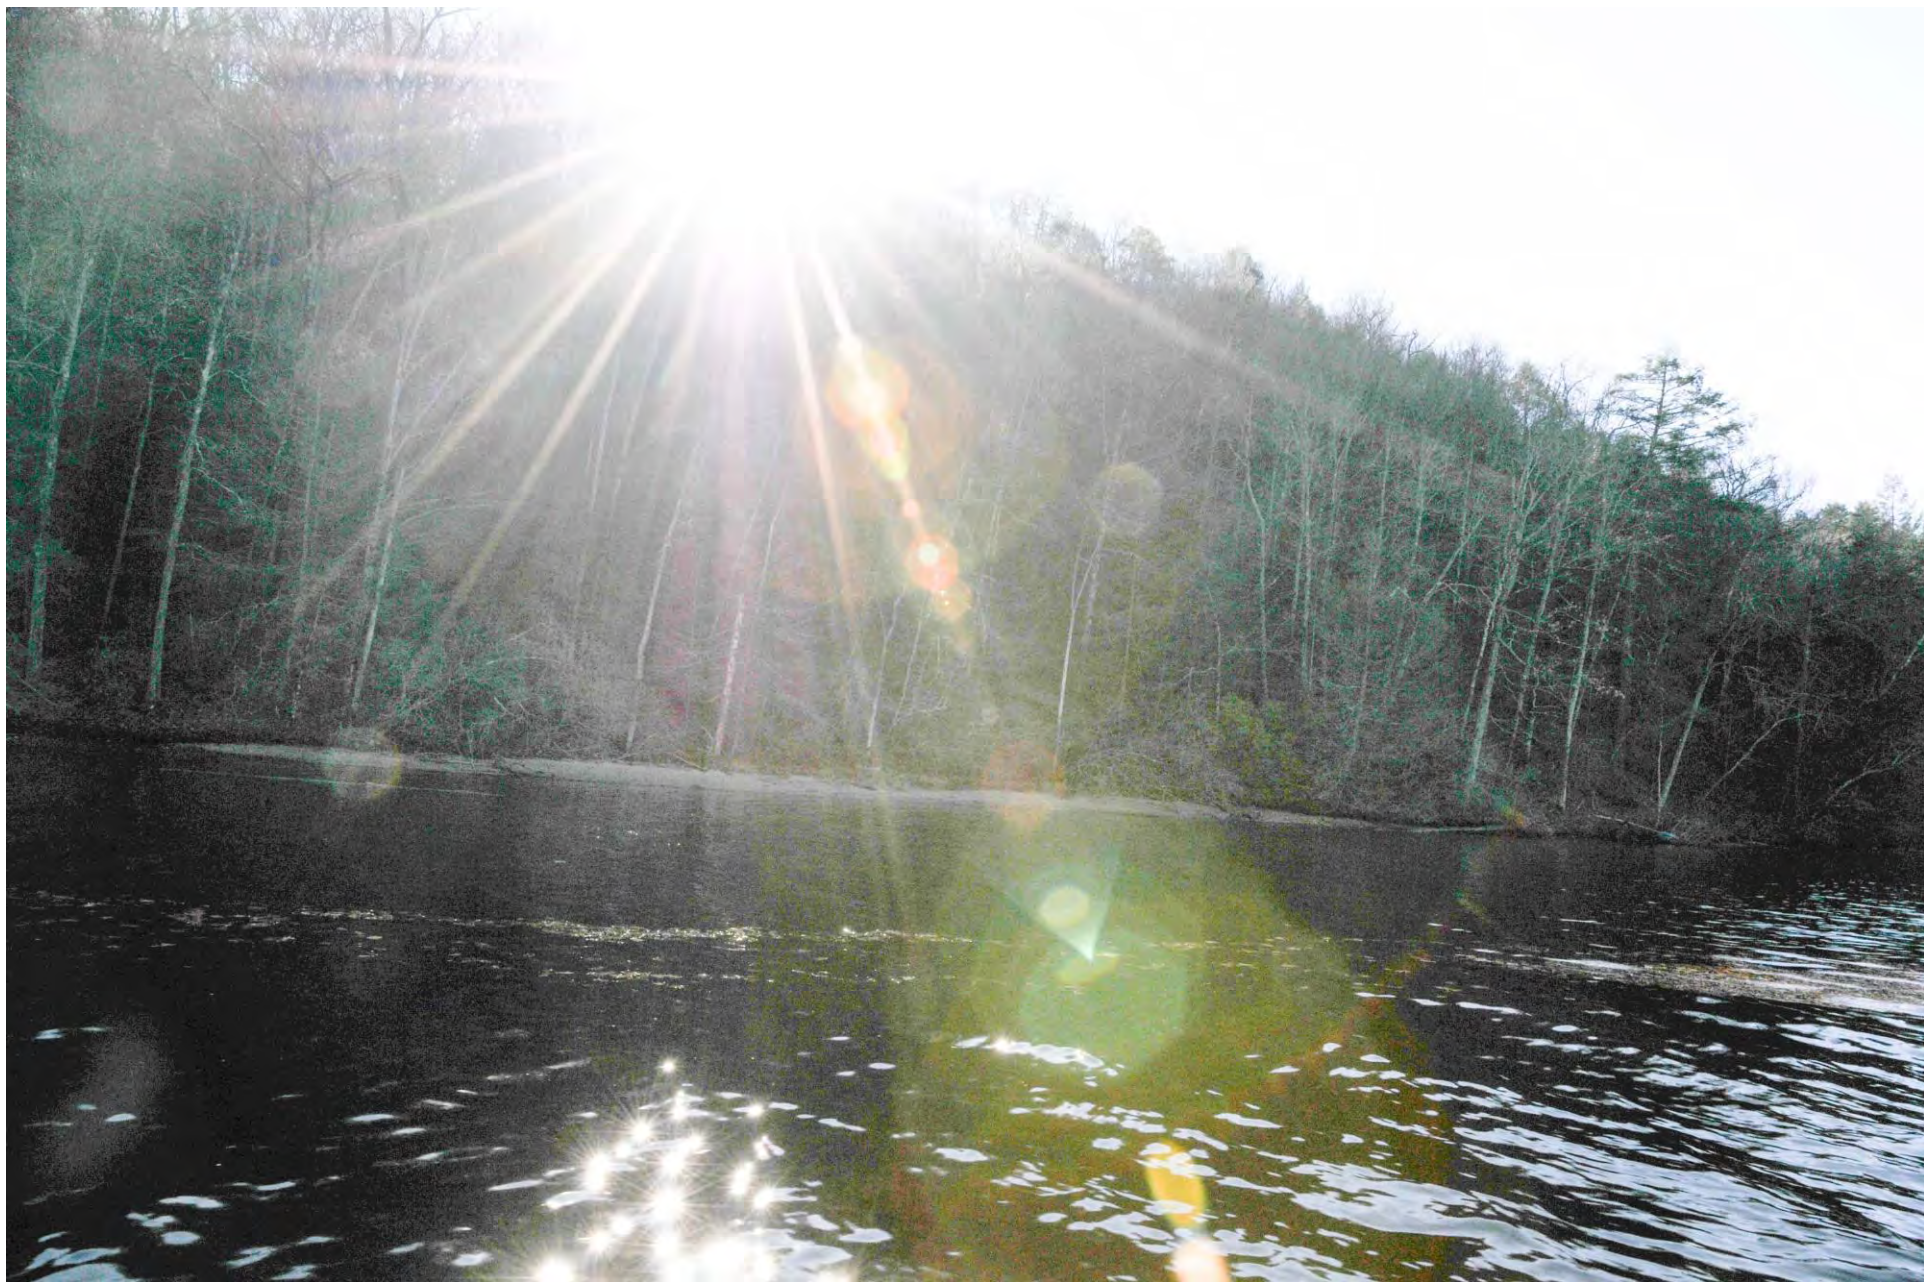
Photo ID 192 (middle)

Riverbank Features	Characteristics
Upper Riverbank Slope	Moderate
Upper Riverbank Height	High
Upper Riverbank Sediment	Silt/Sand
Upper Riverbank Vegetation	Heavy
Lower Riverbank Slope	Flat/Beach
Lower Riverbank Sediment	Silt/Sand
Lower Riverbank Vegetation	None to very sparse
Type of Erosion	Undercut
Potential Erosion Indicators	None
Stage of Erosion	Stable
Extent of Erosion	None/Little

**QA Observations:** Upon review of the photos for this segment, classification made in the field was confirmed.

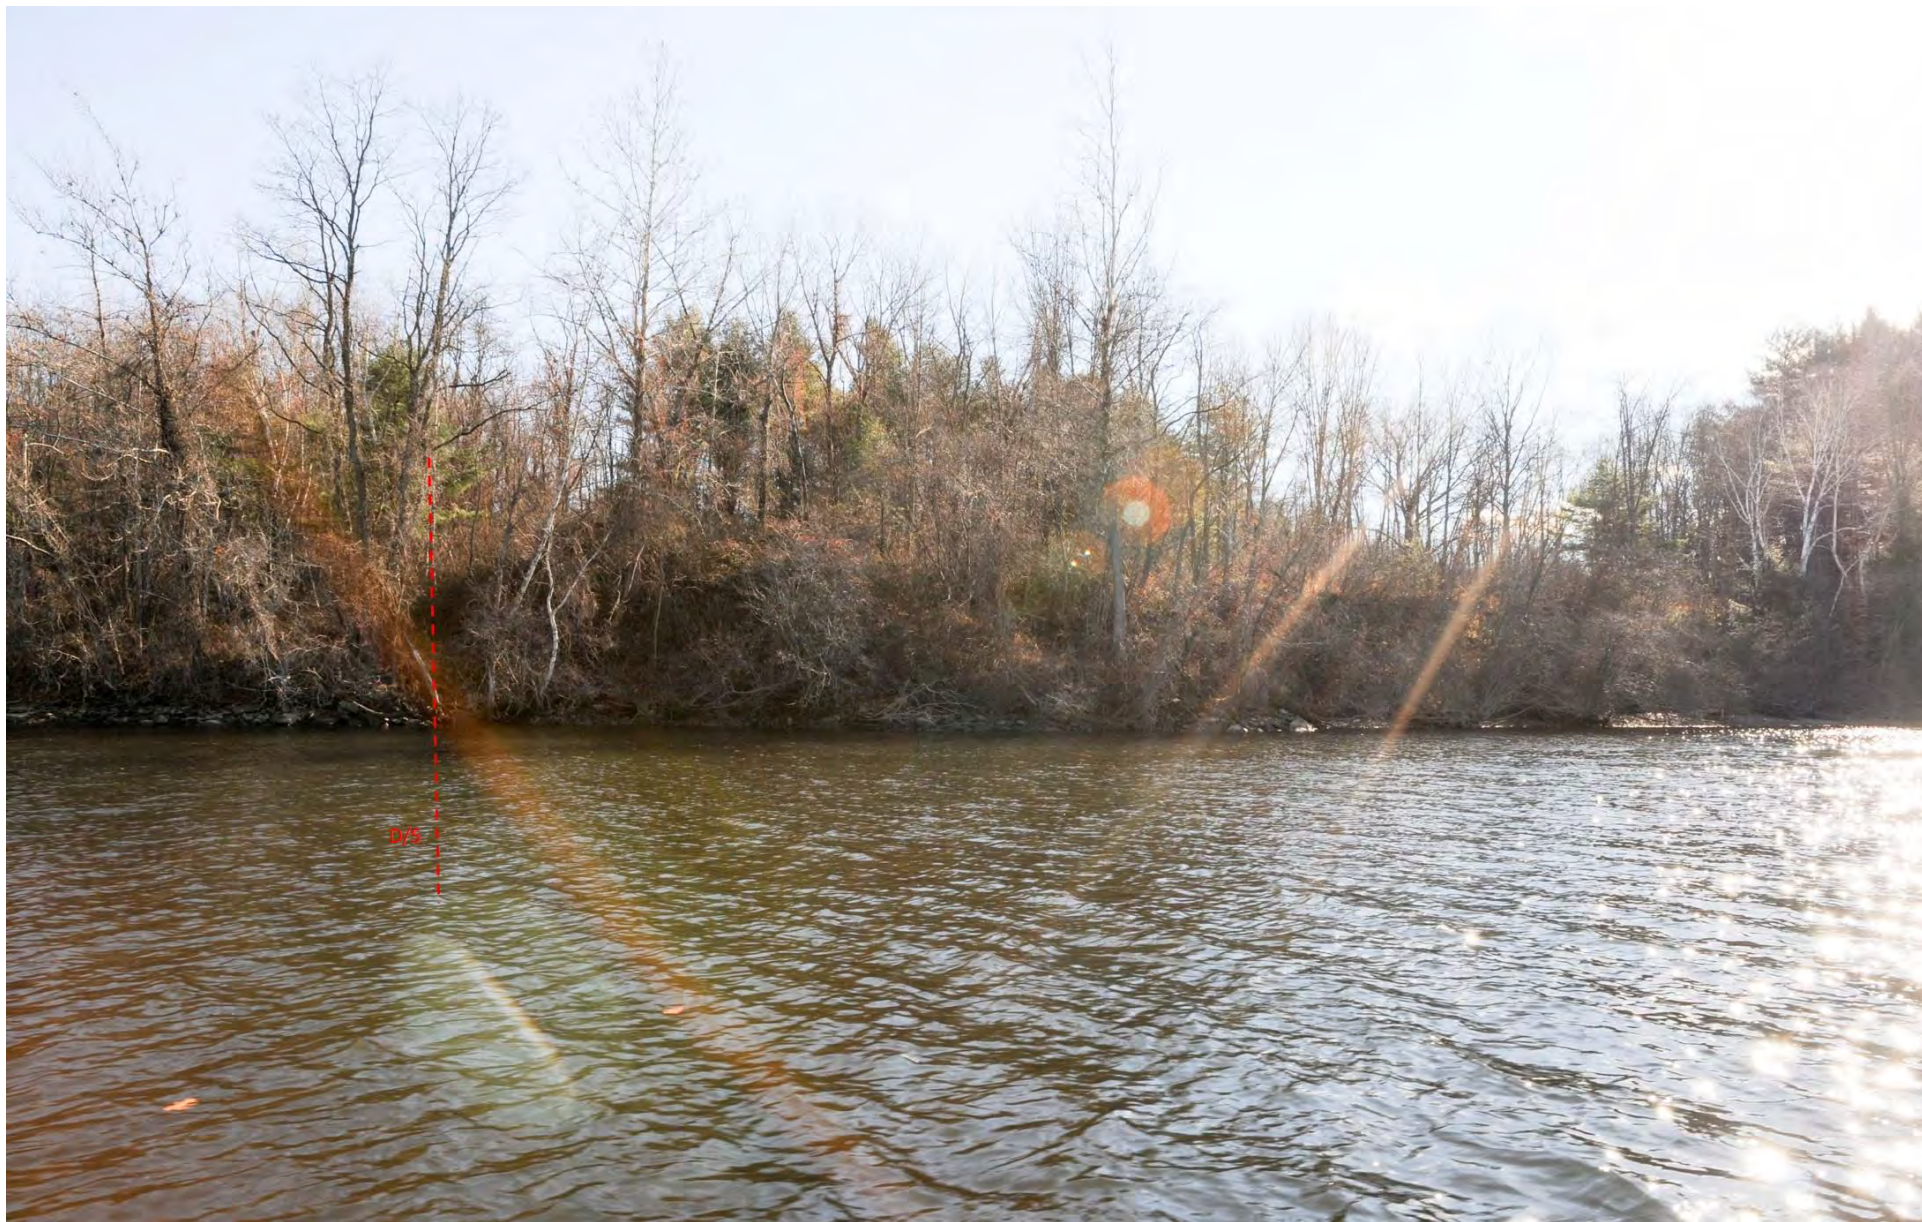
**Photo ID 115** (D/S, left of line)

Riverbank Features	Characteristics
Upper Riverbank Slope	Moderate
Upper Riverbank Height	High
Upper Riverbank Sediment	Silt/Sand
Upper Riverbank Vegetation	Heavy
Lower Riverbank Slope	Moderate
Lower Riverbank Sediment	Boulders
Lower Riverbank Vegetation	None to very sparse
Type of Erosion	
Potential Erosion Indicators	None
Stage of Erosion	Stable
Extent of Erosion	None/Little

**QA Observations:** Upon review of the photos for this segment, classification made in the field was confirmed.

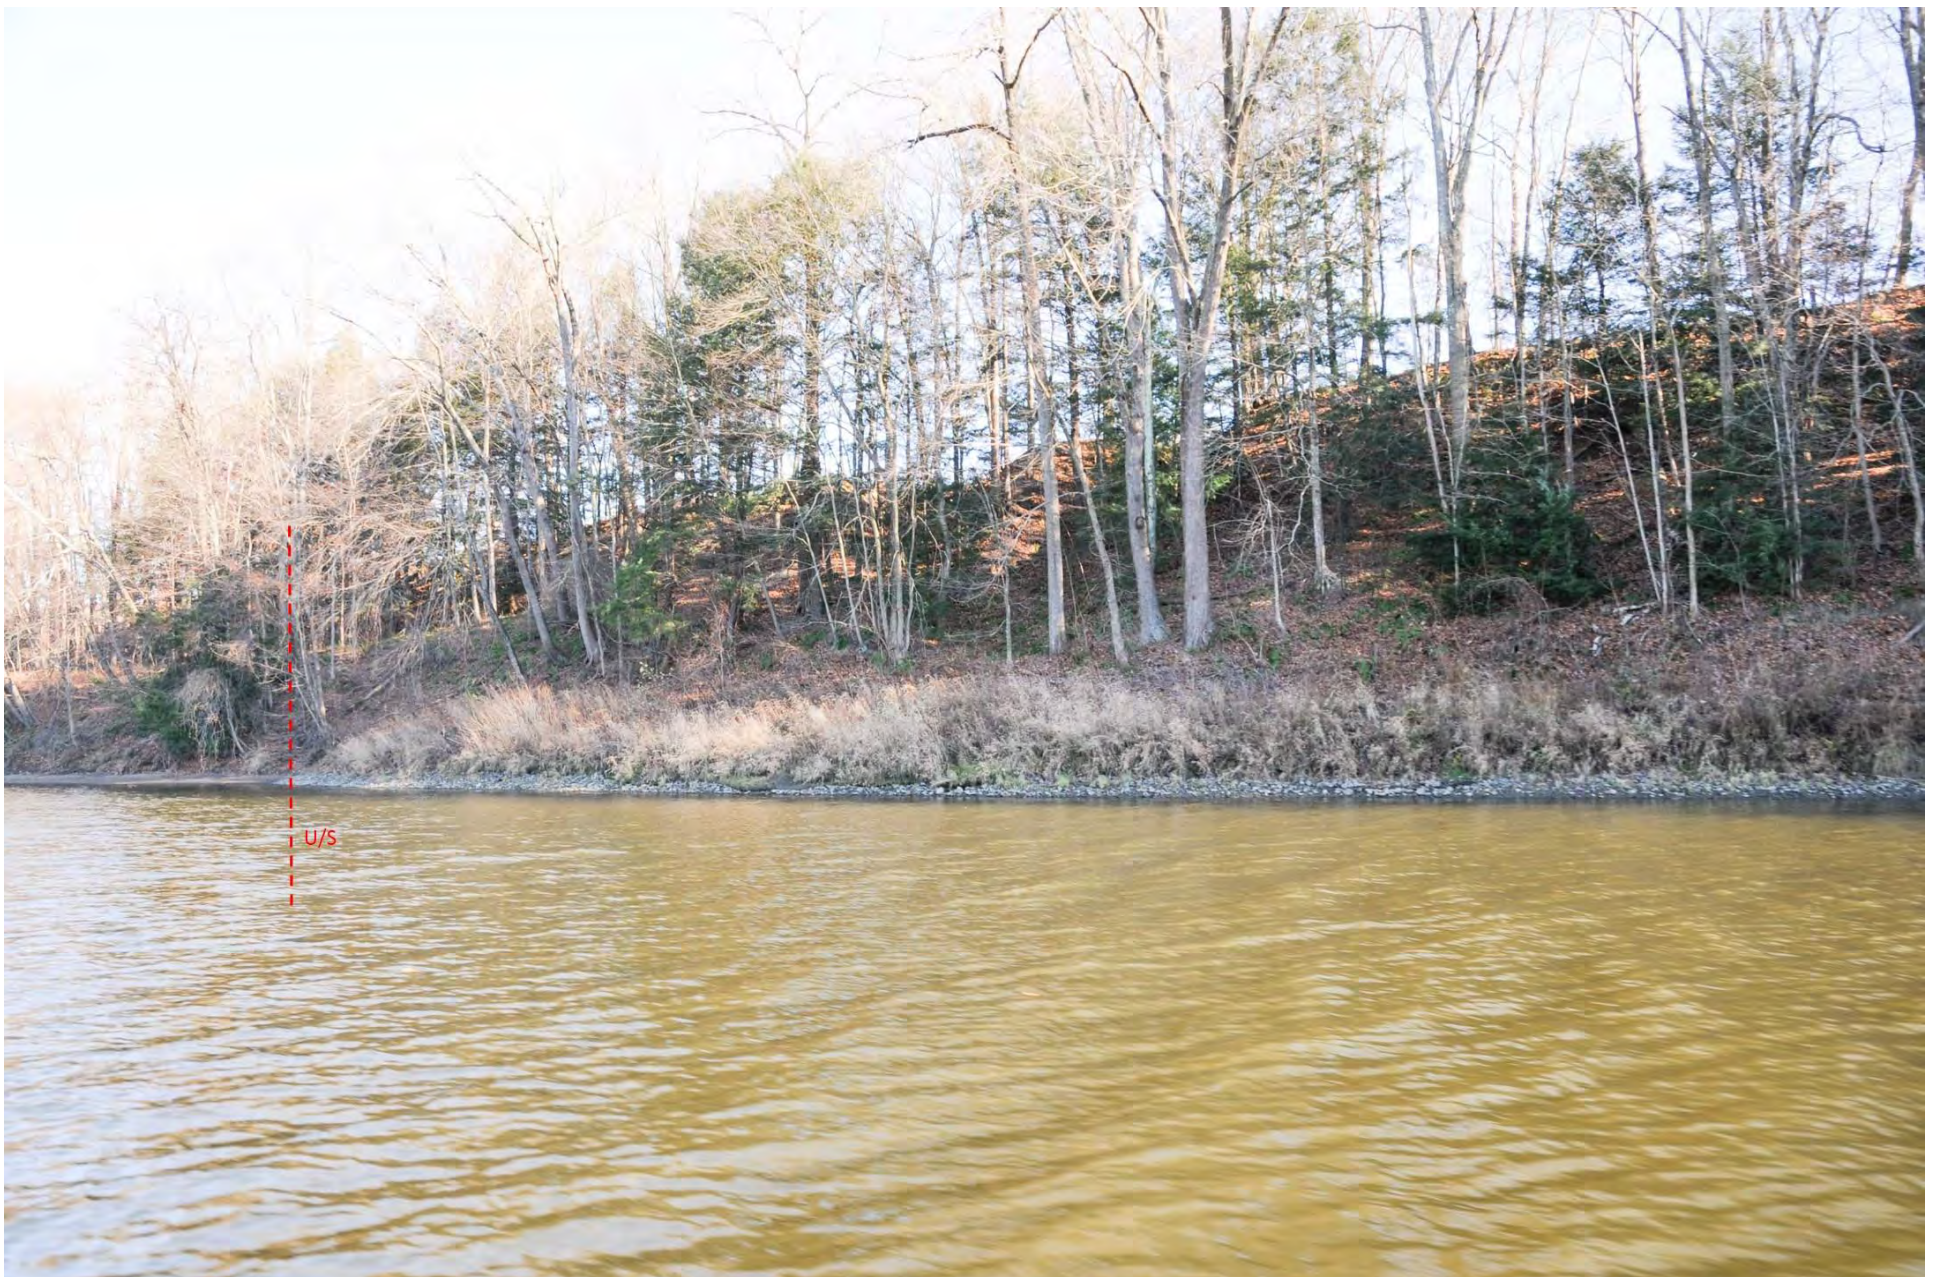
**Photo ID 685 (U/S, right of line)**

Riverbank Features	Characteristics
Upper Riverbank Slope	Moderate
Upper Riverbank Height	High
Upper Riverbank Sediment	Silt/Sand
Upper Riverbank Vegetation	Heavy
Lower Riverbank Slope	Moderate
Lower Riverbank Sediment	Cobbles
Lower Riverbank Vegetation	None to very sparse
Type of Erosion	
Potential Erosion Indicators	None
Stage of Erosion	Stable
Extent of Erosion	None/Little

**QA Observations:** Upon review of the photos for this segment, classification made in the field was confirmed.

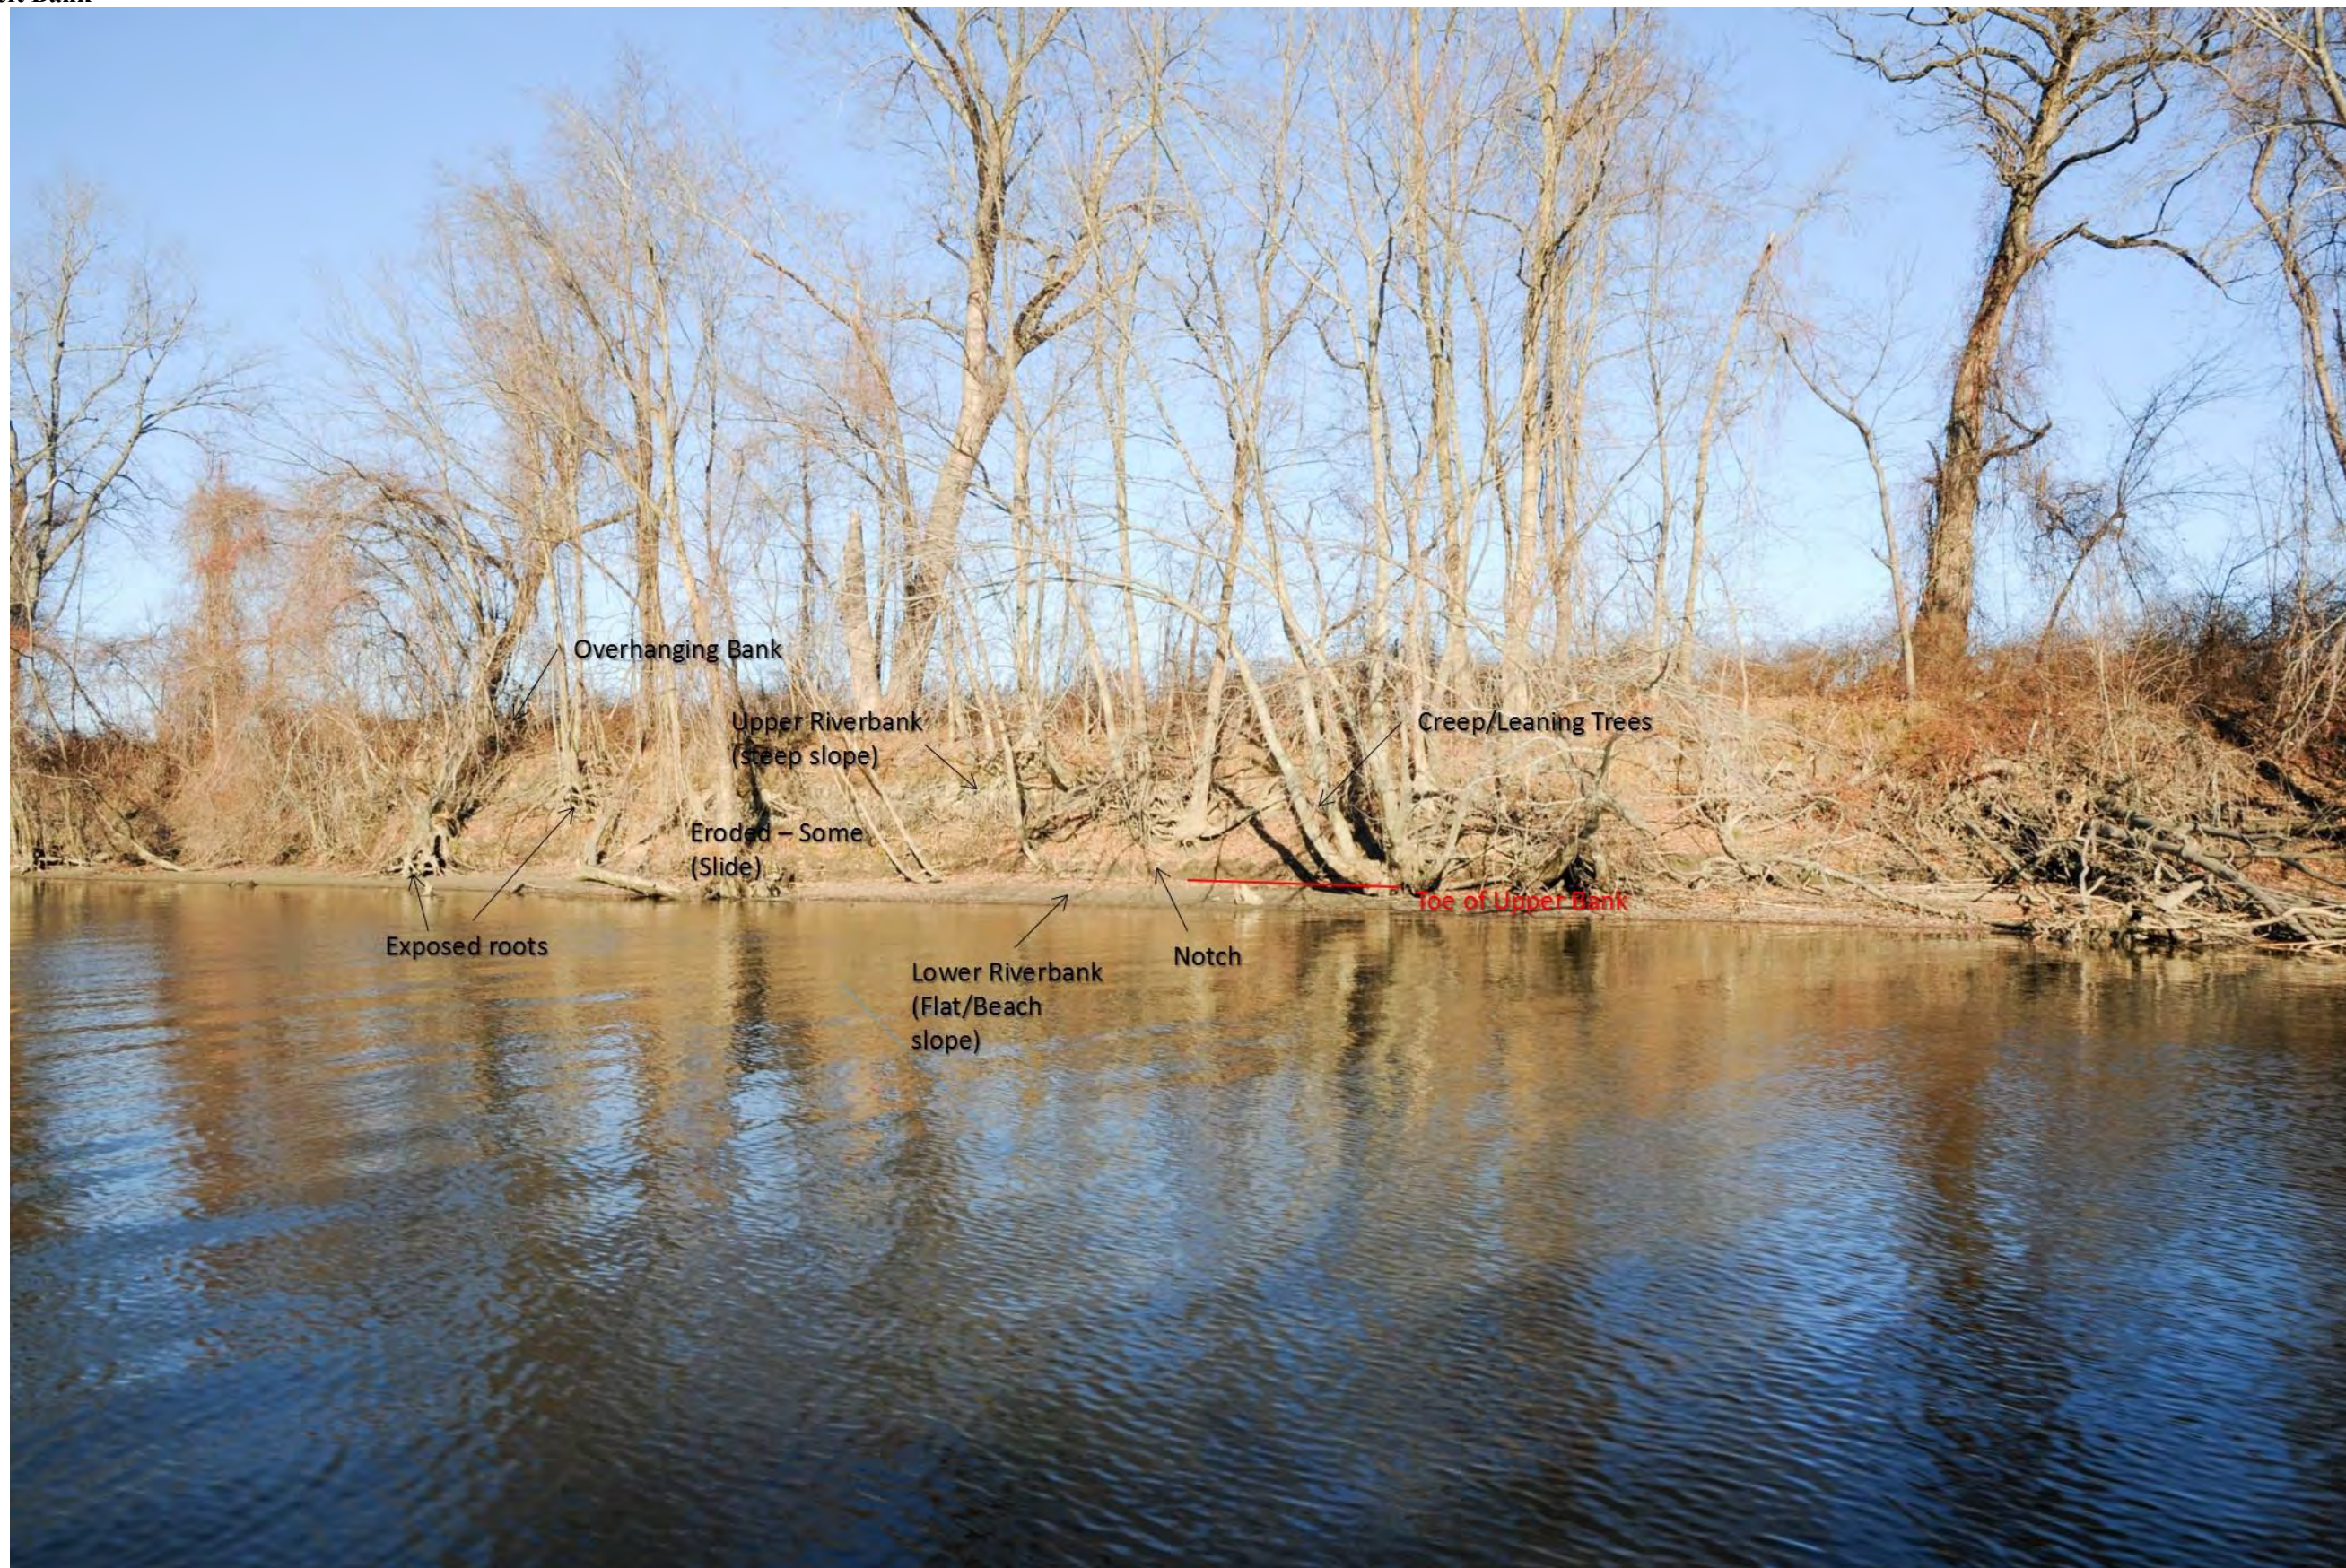
Photo ID 745 (middle)

Riverbank Features	Characteristics
Upper Riverbank Slope	Steep
Upper Riverbank Height	High
Upper Riverbank Sediment	Silt/Sand
Upper Riverbank Vegetation	Heavy
Lower Riverbank Slope	Flat/Beach
Lower Riverbank Sediment	Silt/Sand
Lower Riverbank Vegetation	None to very sparse
Type of Erosion	Slide
Potential Erosion Indicators	Exposed roots, Creep/leaning trees, Overhanging bank, Notch
Stage of Erosion	Eroded
Extent of Erosion	Some

**QA Observations:** Upon review of the photos for this segment, classification made in the field was confirmed and additional indicators of potential future erosion were included.

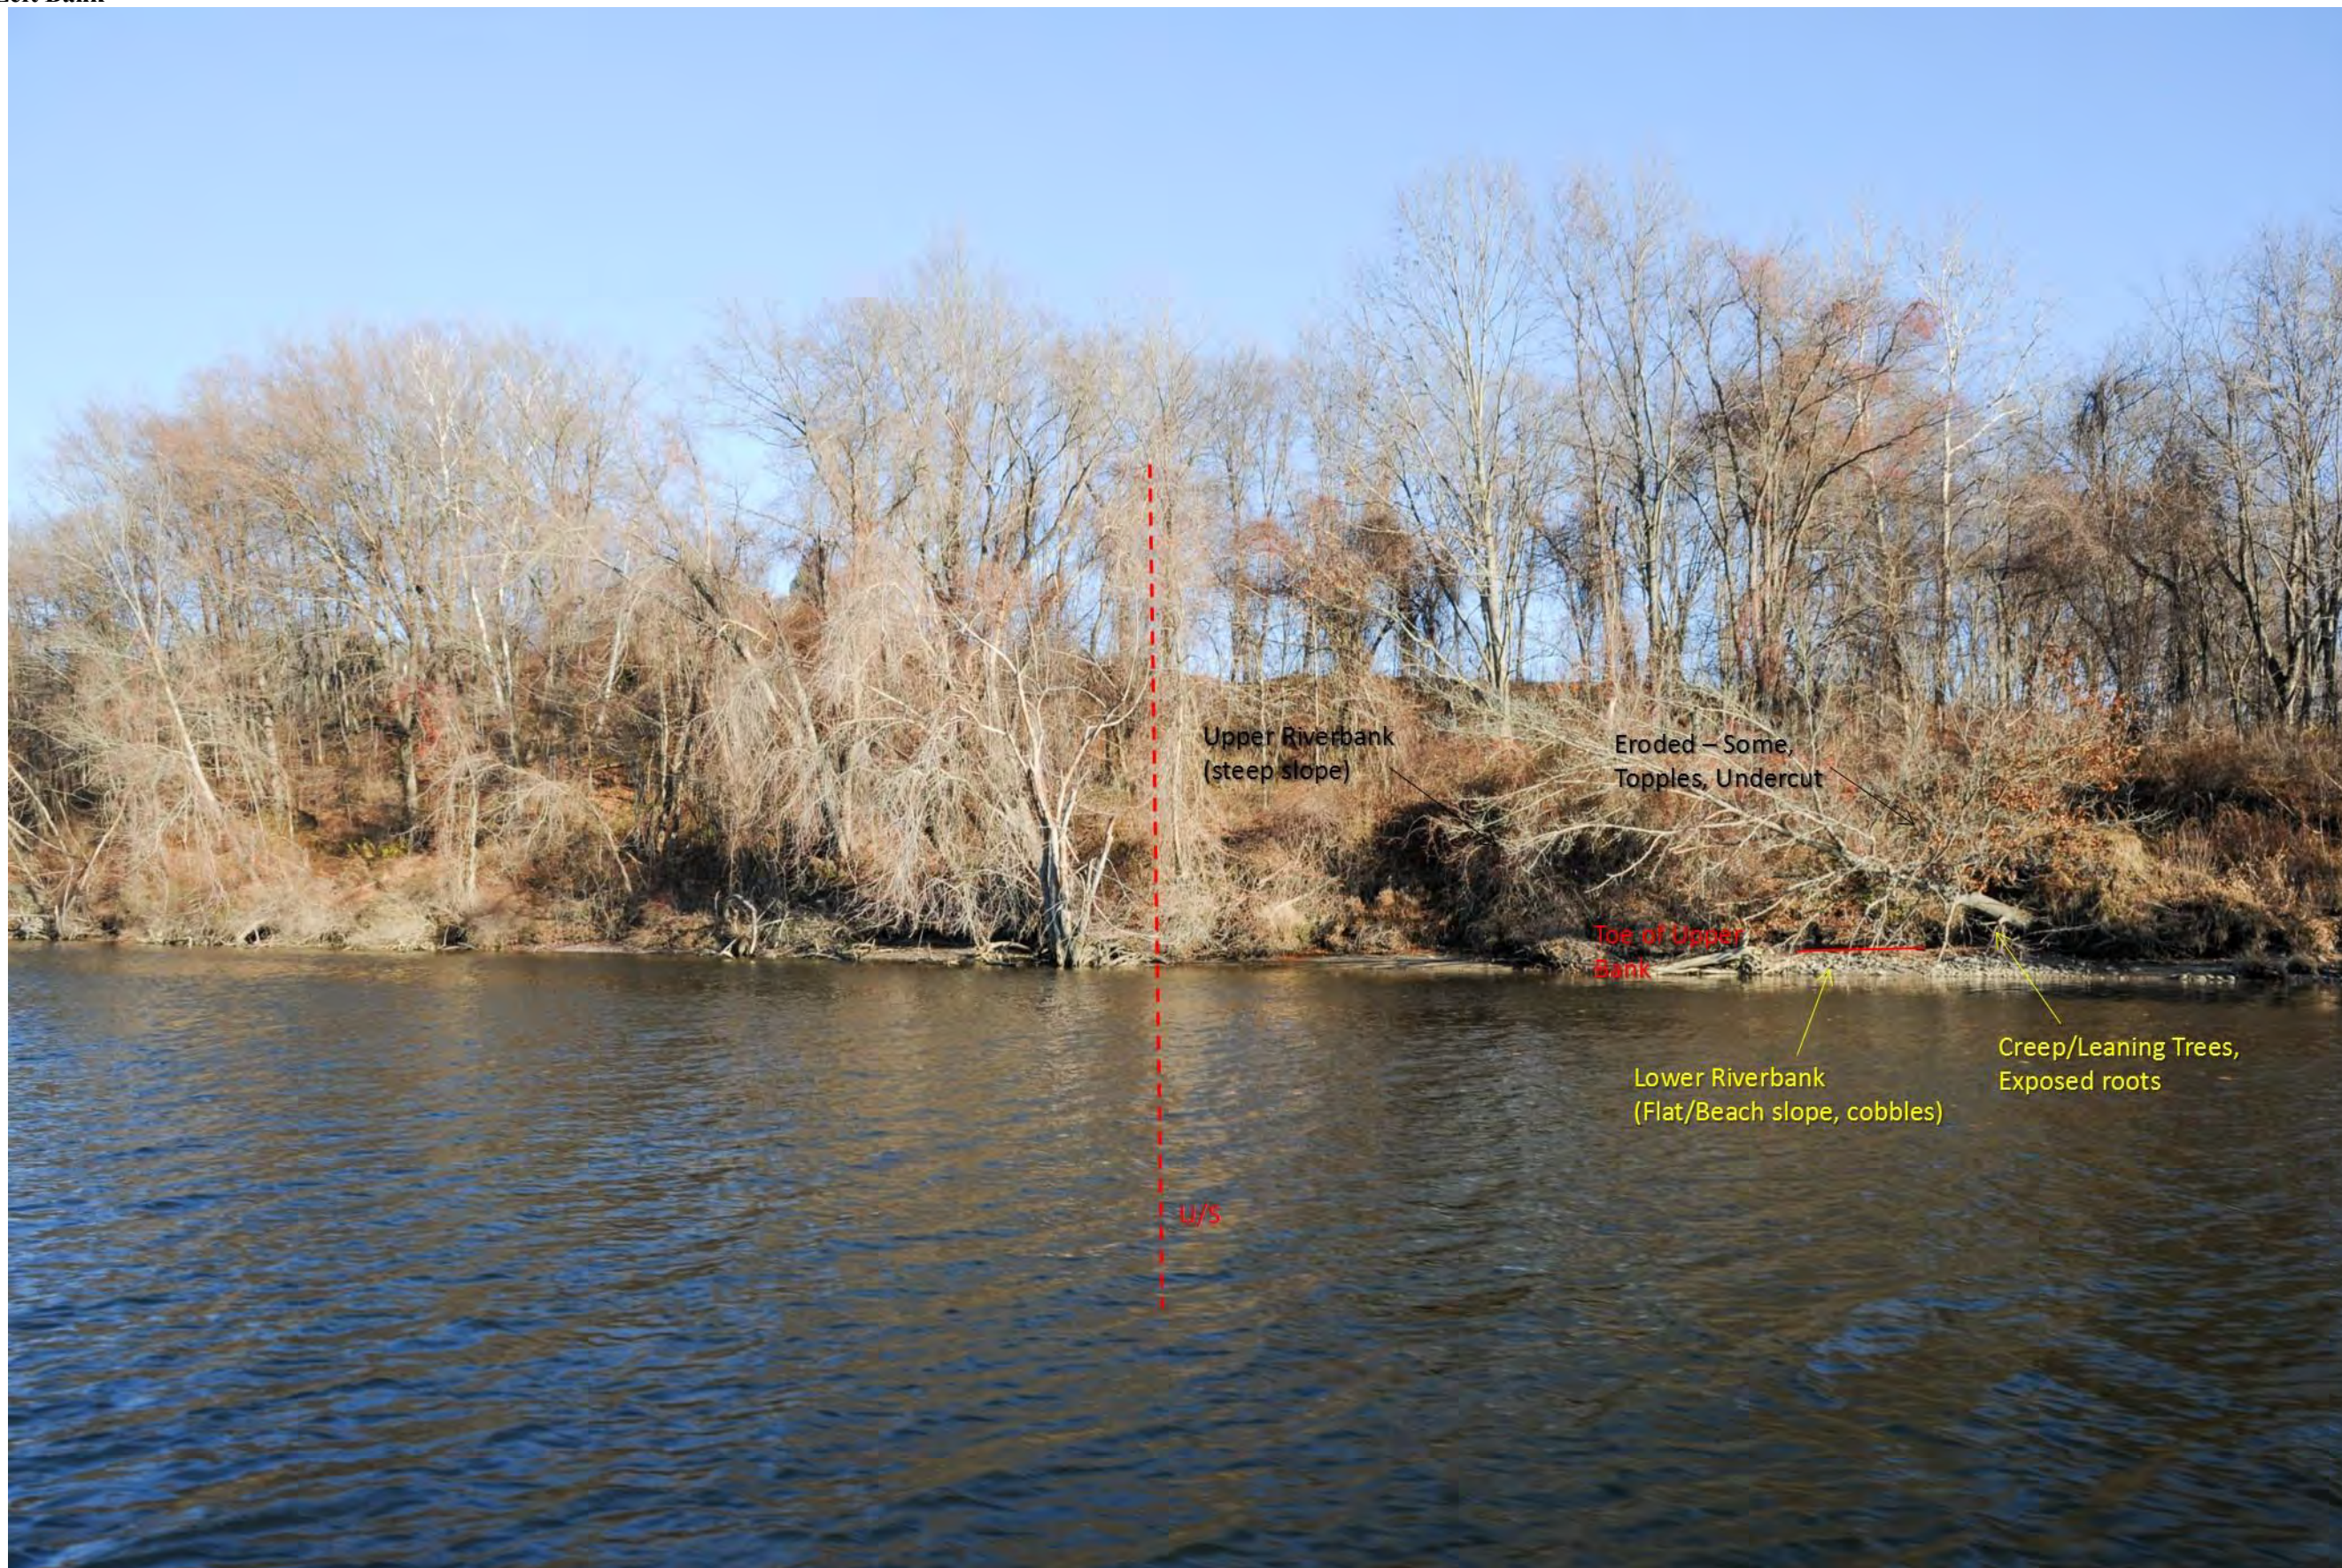
Photo ID 765 (U/S)

Riverbank Features	Characteristics
Upper Riverbank Slope	Steep
Upper Riverbank Height	High
Upper Riverbank Sediment	Silt/Sand
Upper Riverbank Vegetation	Heavy
Lower Riverbank Slope	Flat/Beach
Lower Riverbank Sediment	Cobbles
Lower Riverbank Vegetation	None to very sparse
Type of Erosion	Topples, Undercut
Potential Erosion Indicators	Creep/leaning trees, Exposed roots
Stage of Erosion	Eroded
Extent of Erosion	Some

**QA Observations:** Upon review of the photos for this segment, classification made in the field was confirmed and additional indicators of potential future erosion were included.
