Re: Filing of Addendum to Study No. 3.1.1- 2013 Full River Reconnaissance  
Turners Falls Hydroelectric Project (FERC No. 1889) and Northfield Mountain Pumped Storage  
Project (FERC No. 2485)

## **ATTACHMENT A: 2013 Full River Reconnaissance – 2015 Addendum: Riverbank Segment QA Comparison**

2015 FRR Addendum  
 Selected Riverbank Segments for QA  
 Map 1

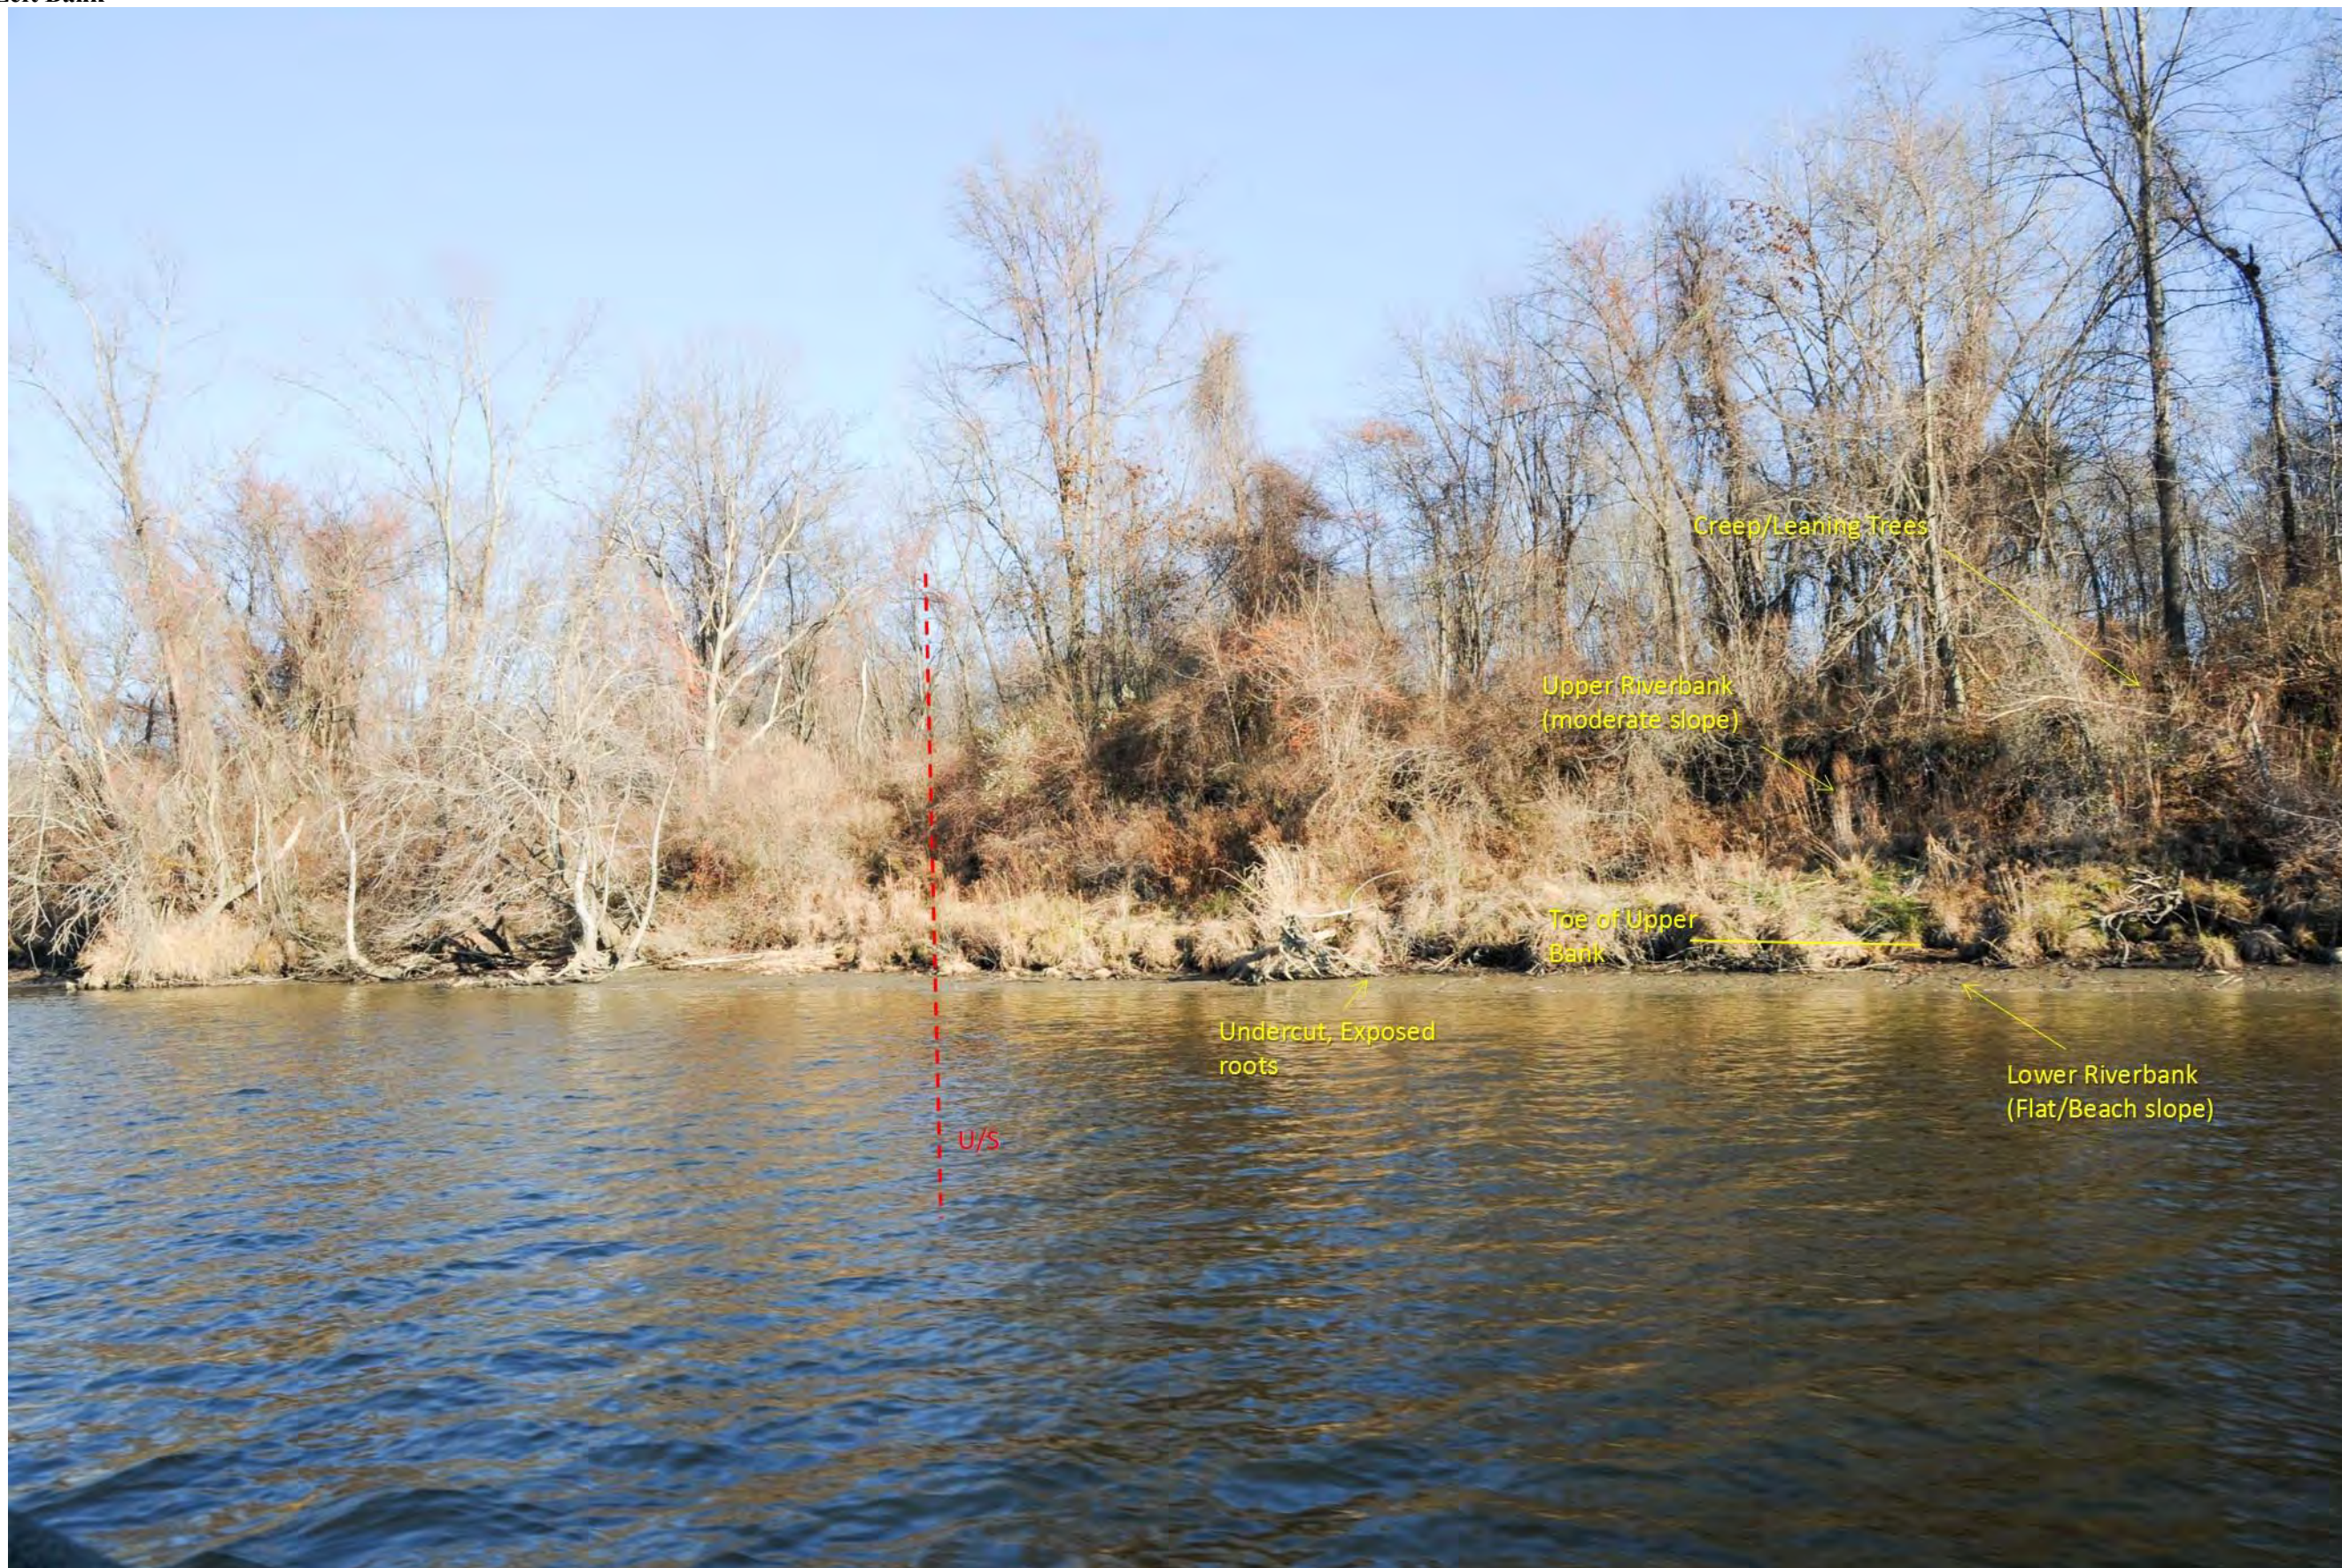
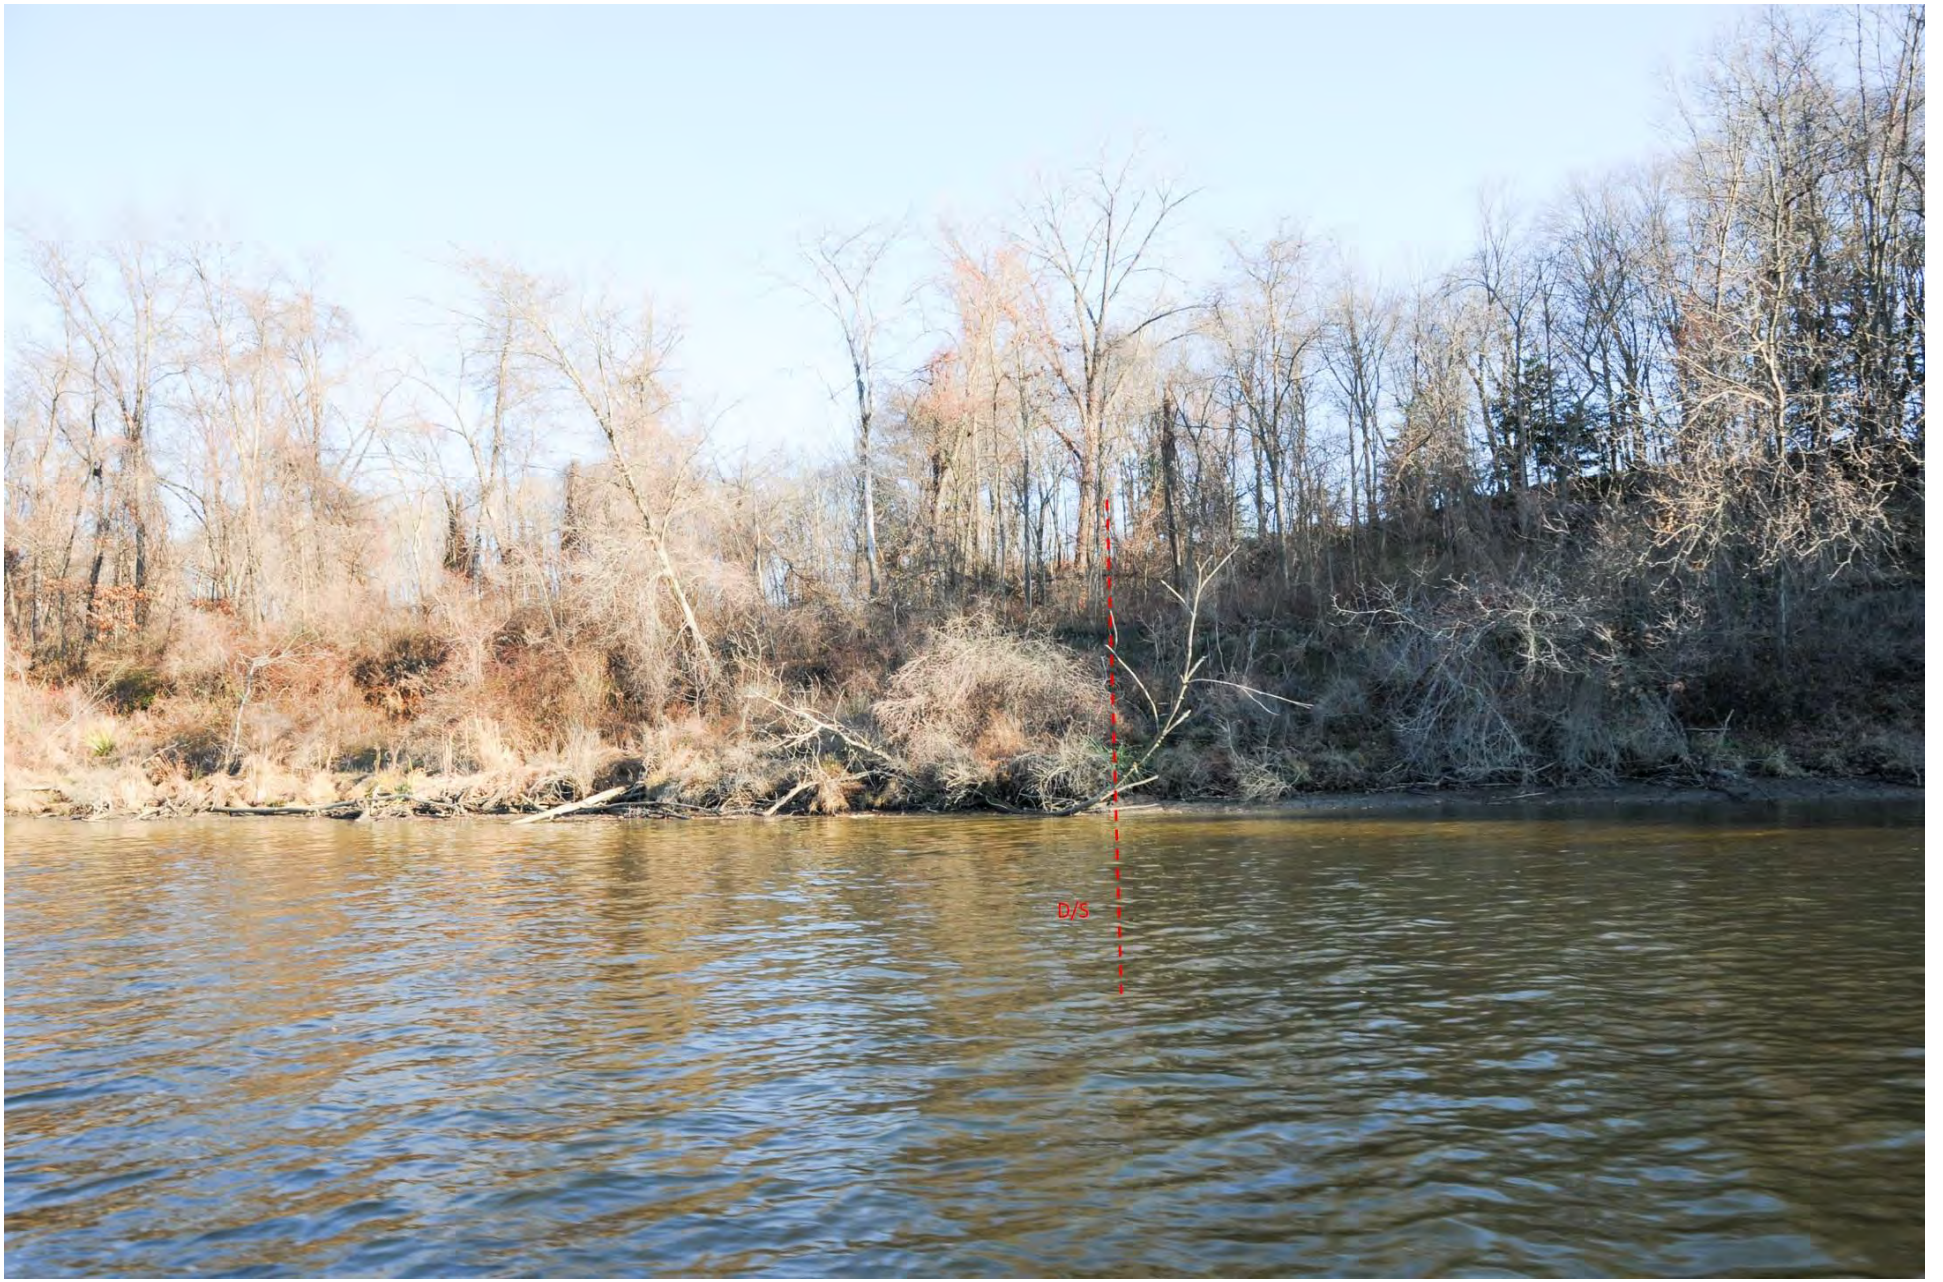
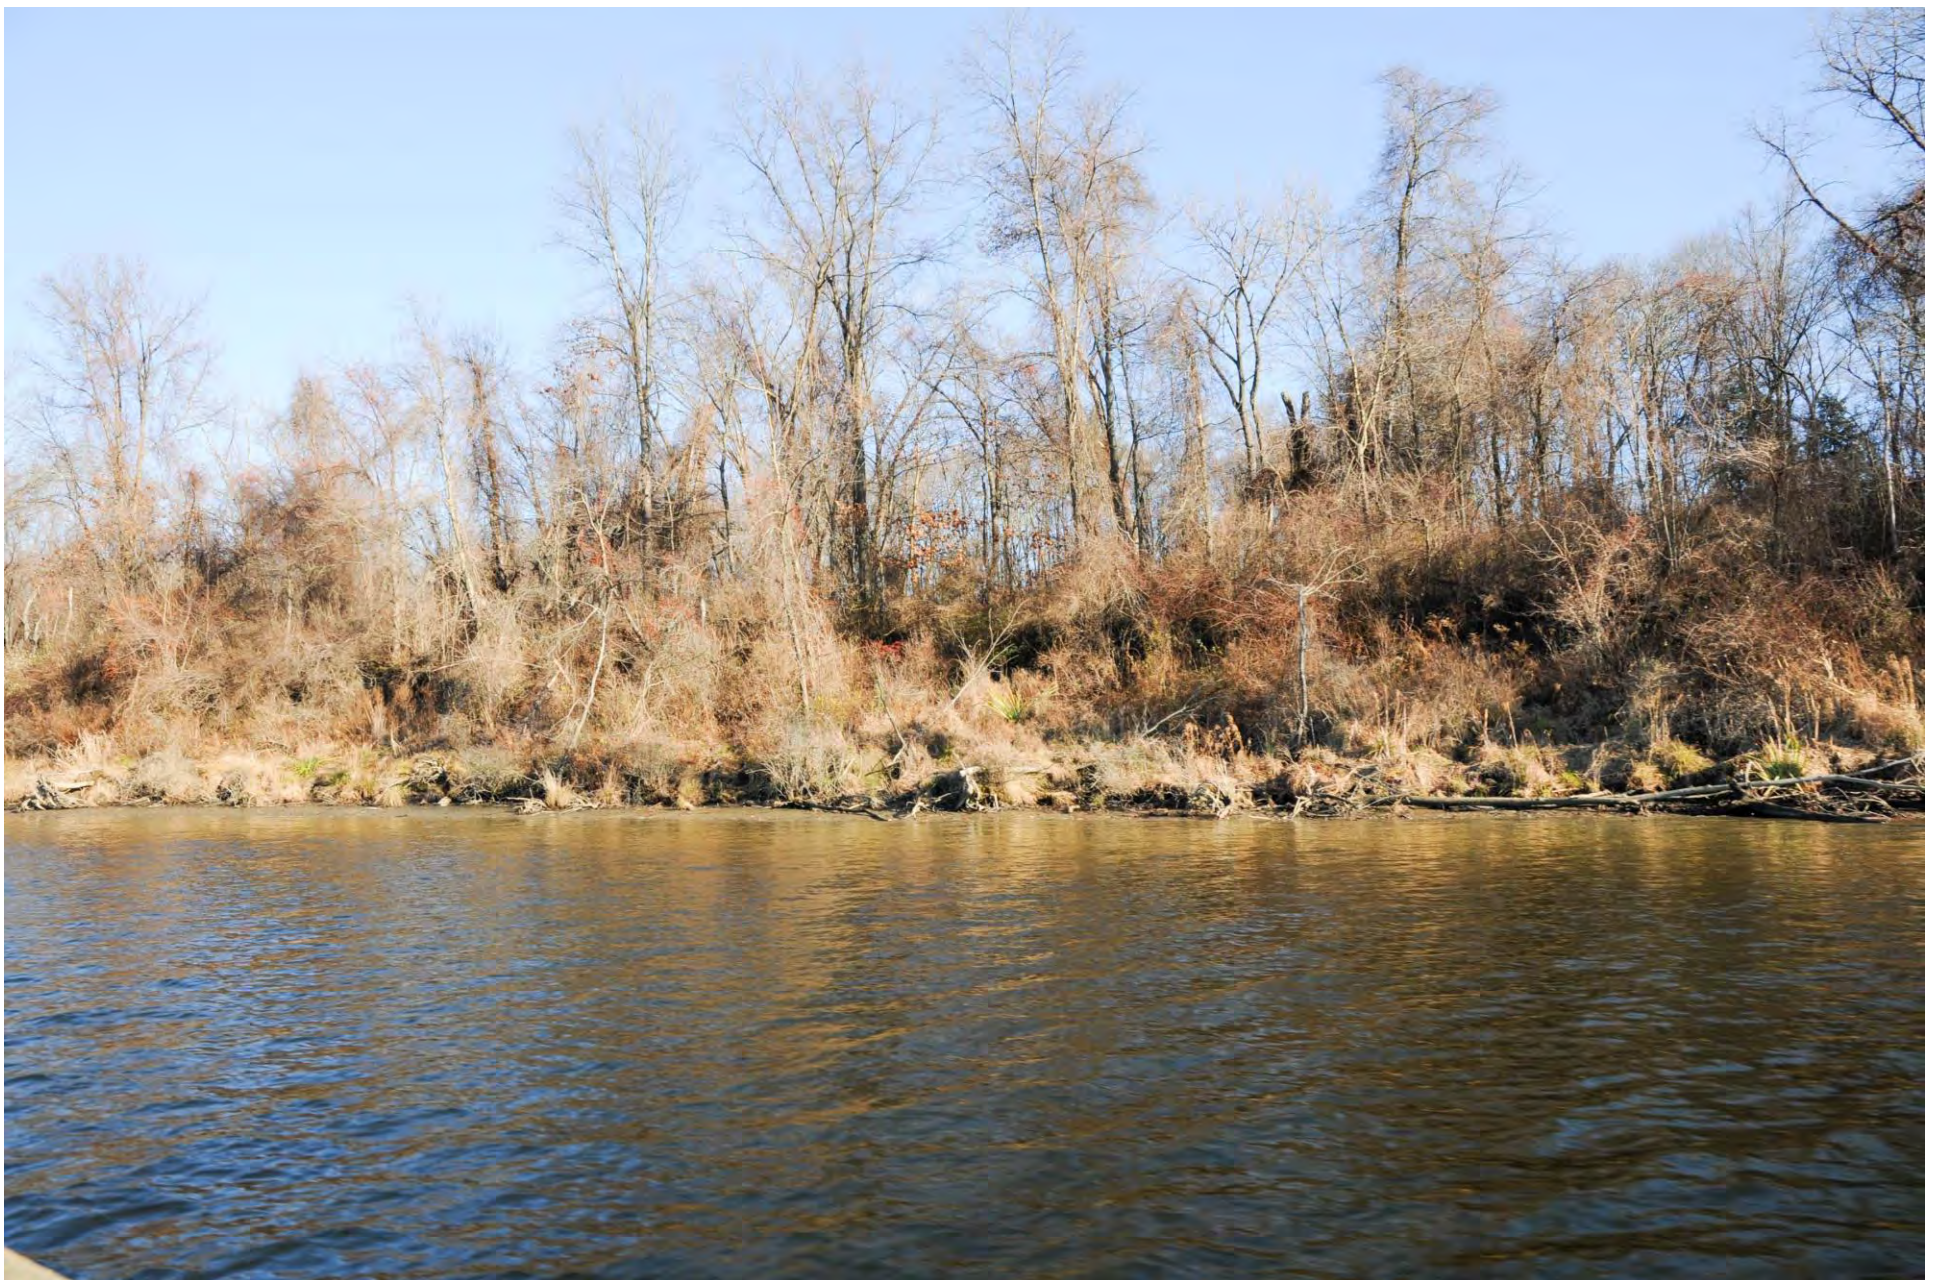
Approximate Photo Location

Riverbank Features	Characteristics
Upper Riverbank Slope	Moderate
Upper Riverbank Height	High
Upper Riverbank Sediment	Silt/Sand
Upper Riverbank Vegetation	Heavy
Lower Riverbank Slope	Flat/Beach
Lower Riverbank Sediment	Silt/Sand
Lower Riverbank Vegetation	None to very sparse
Type of Erosion	Undercut
Potential Erosion Indicators	Exposed roots, Creep/leaning trees
Stage of Erosion	Stable
Extent of Erosion	None/Little

**QA Observations:** Upon review of the photos for this segment, classification made in the field was confirmed and additional indicators of potential future erosion were included.

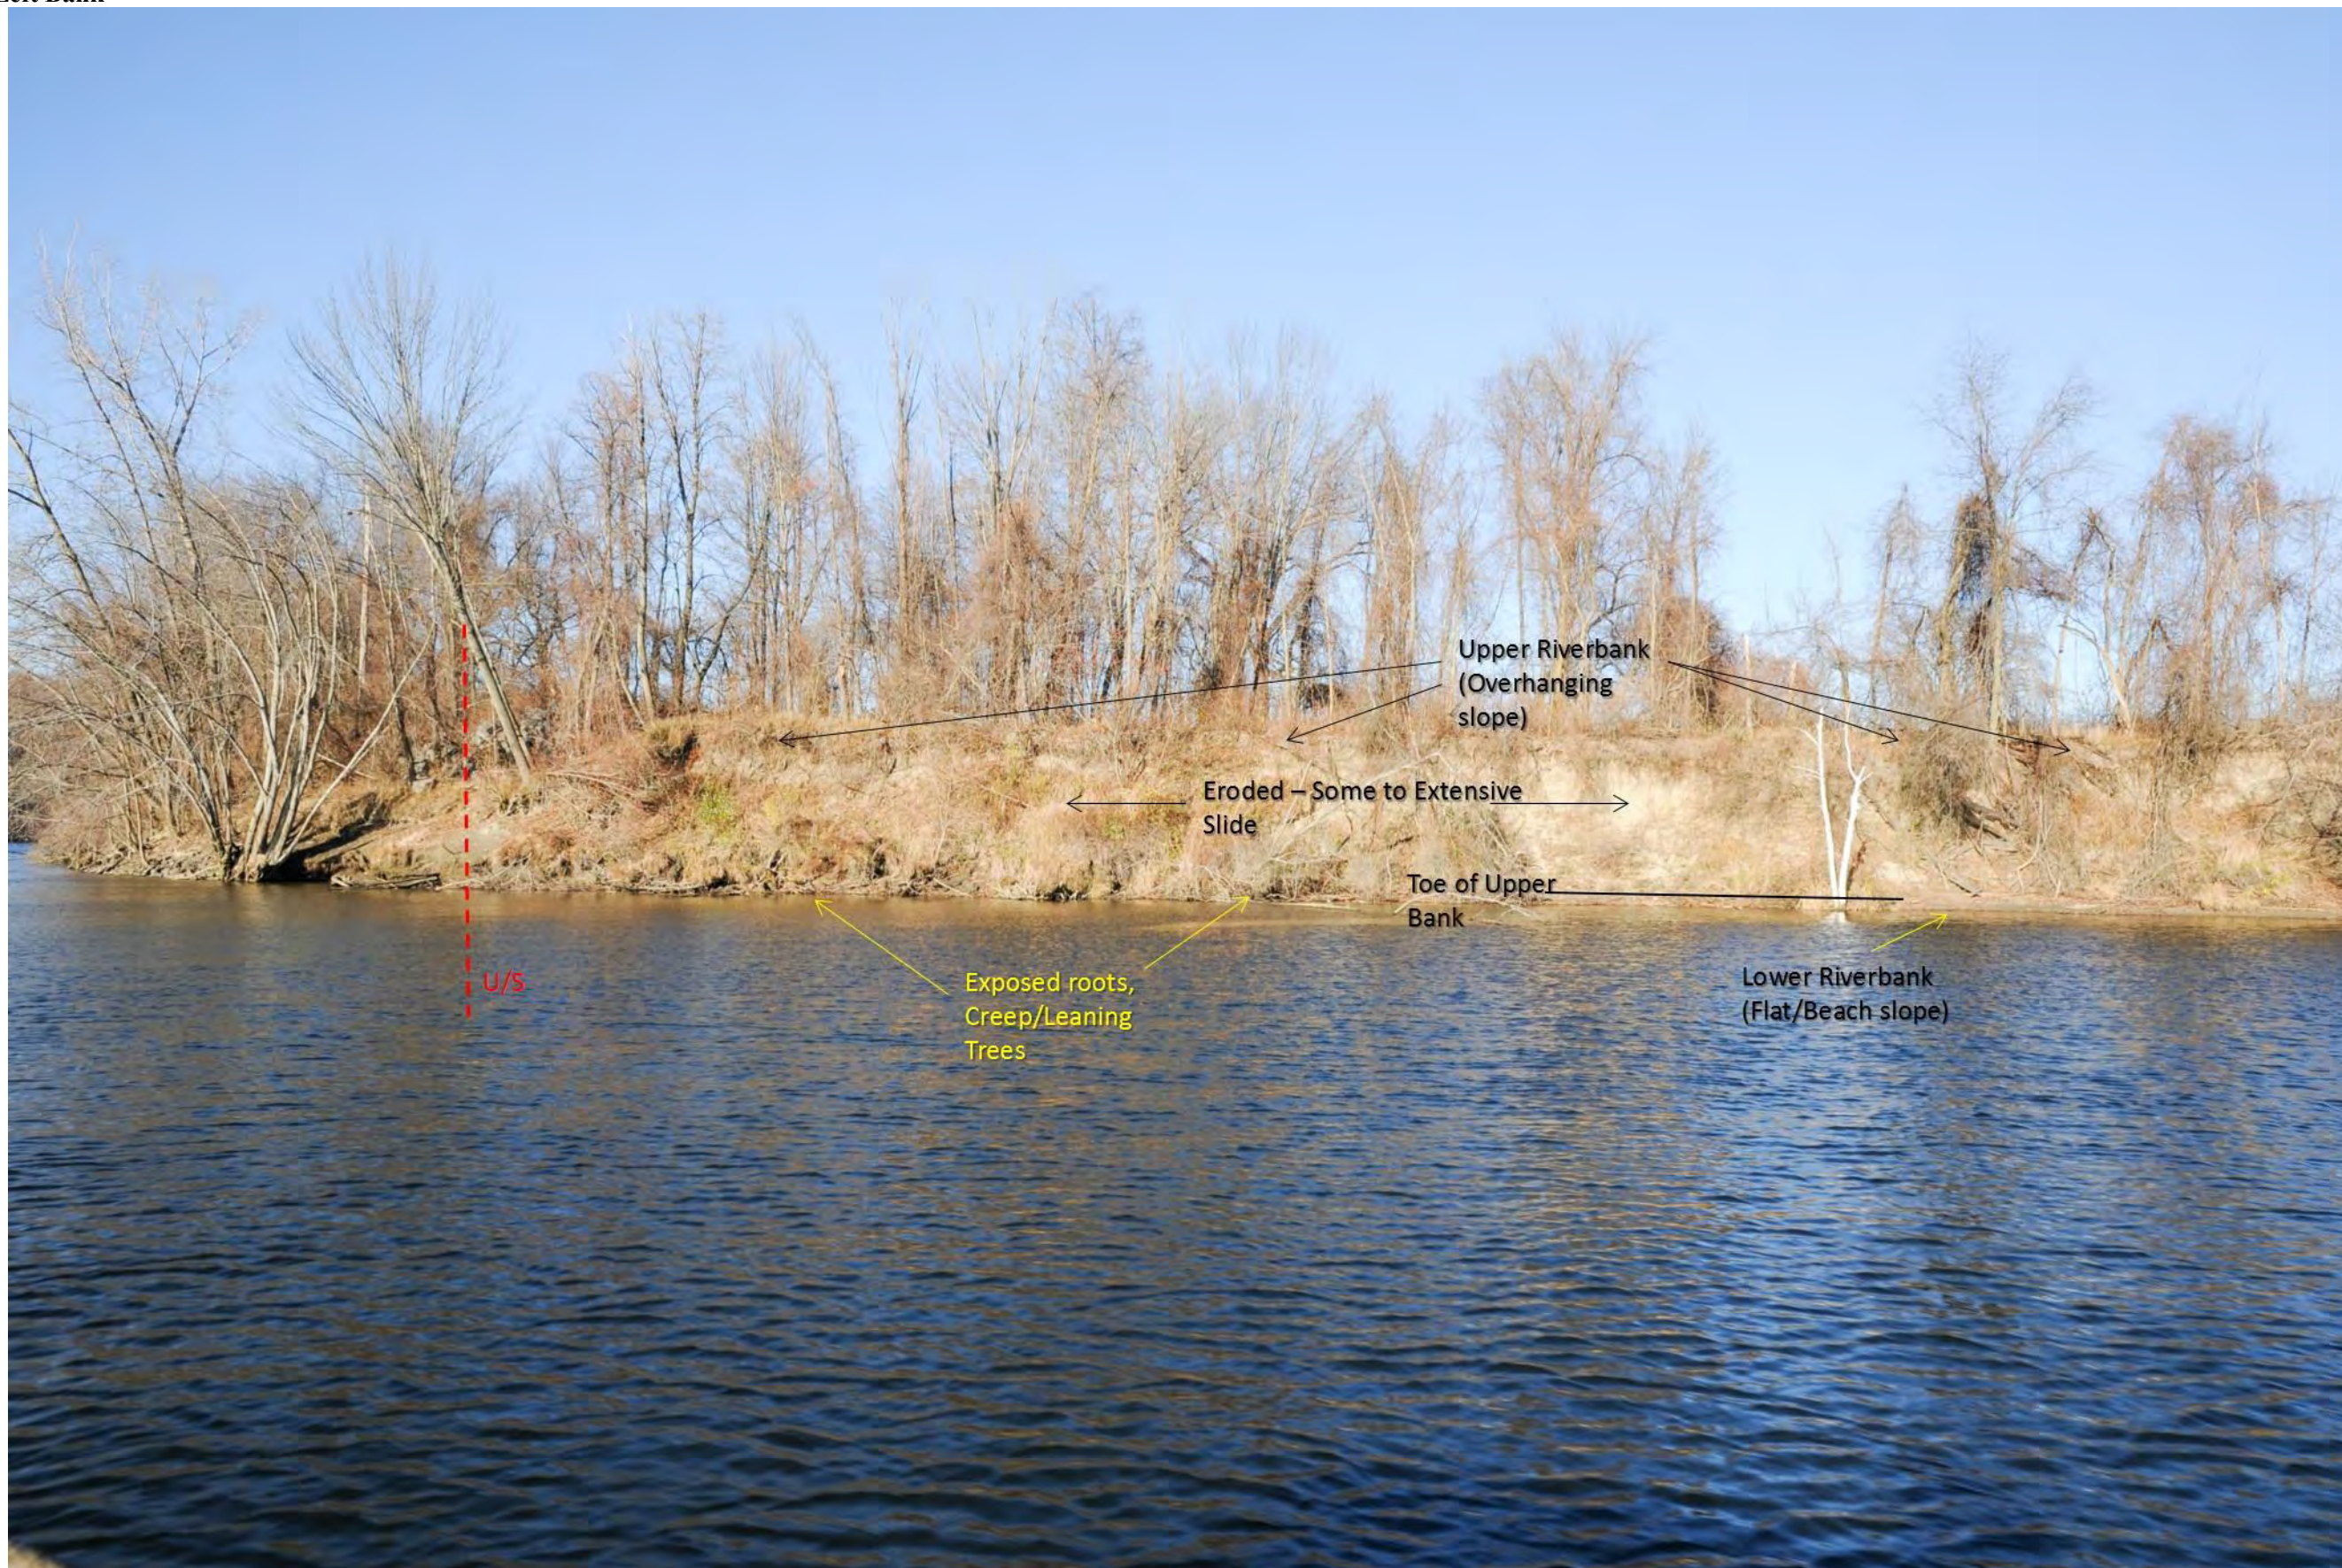
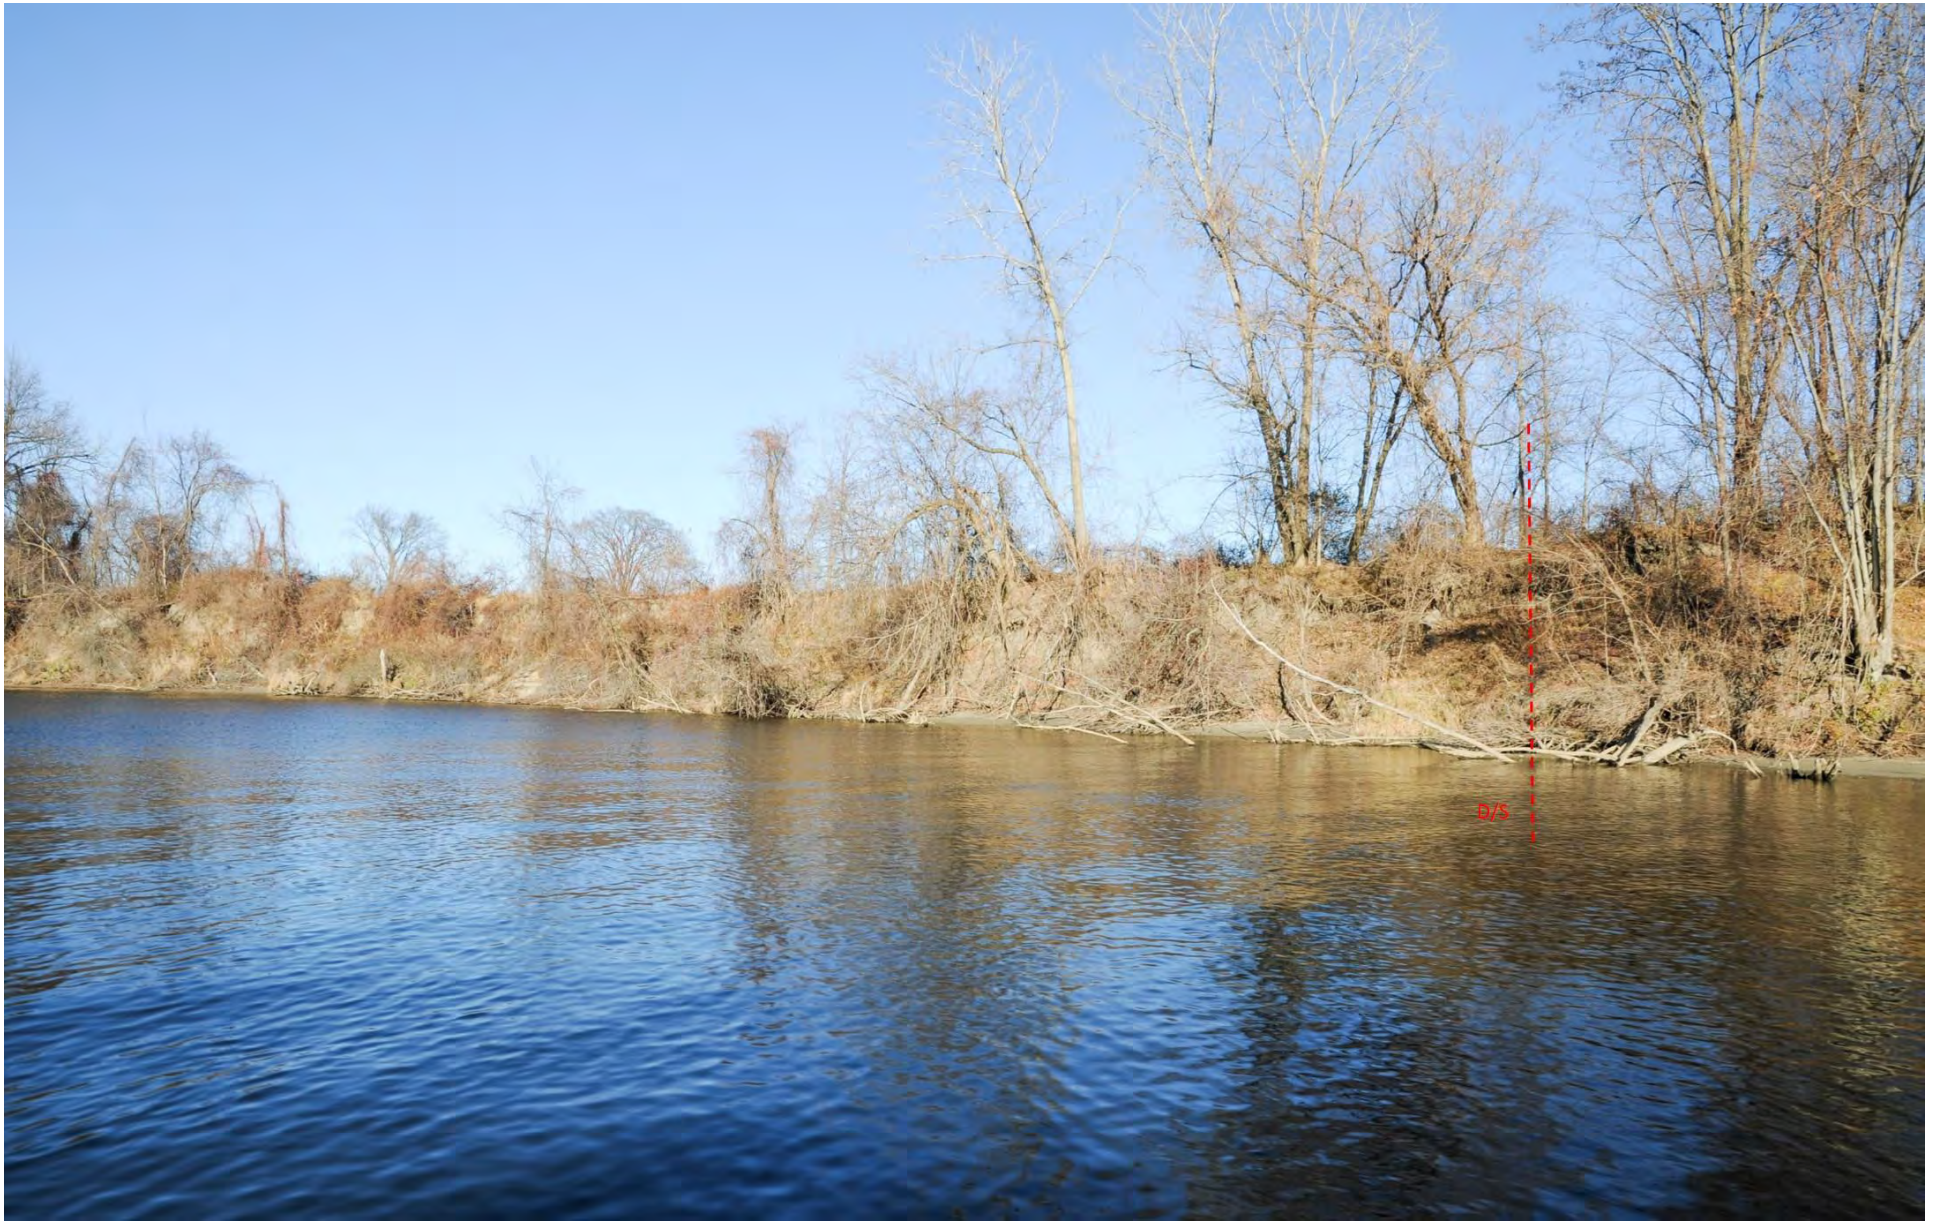
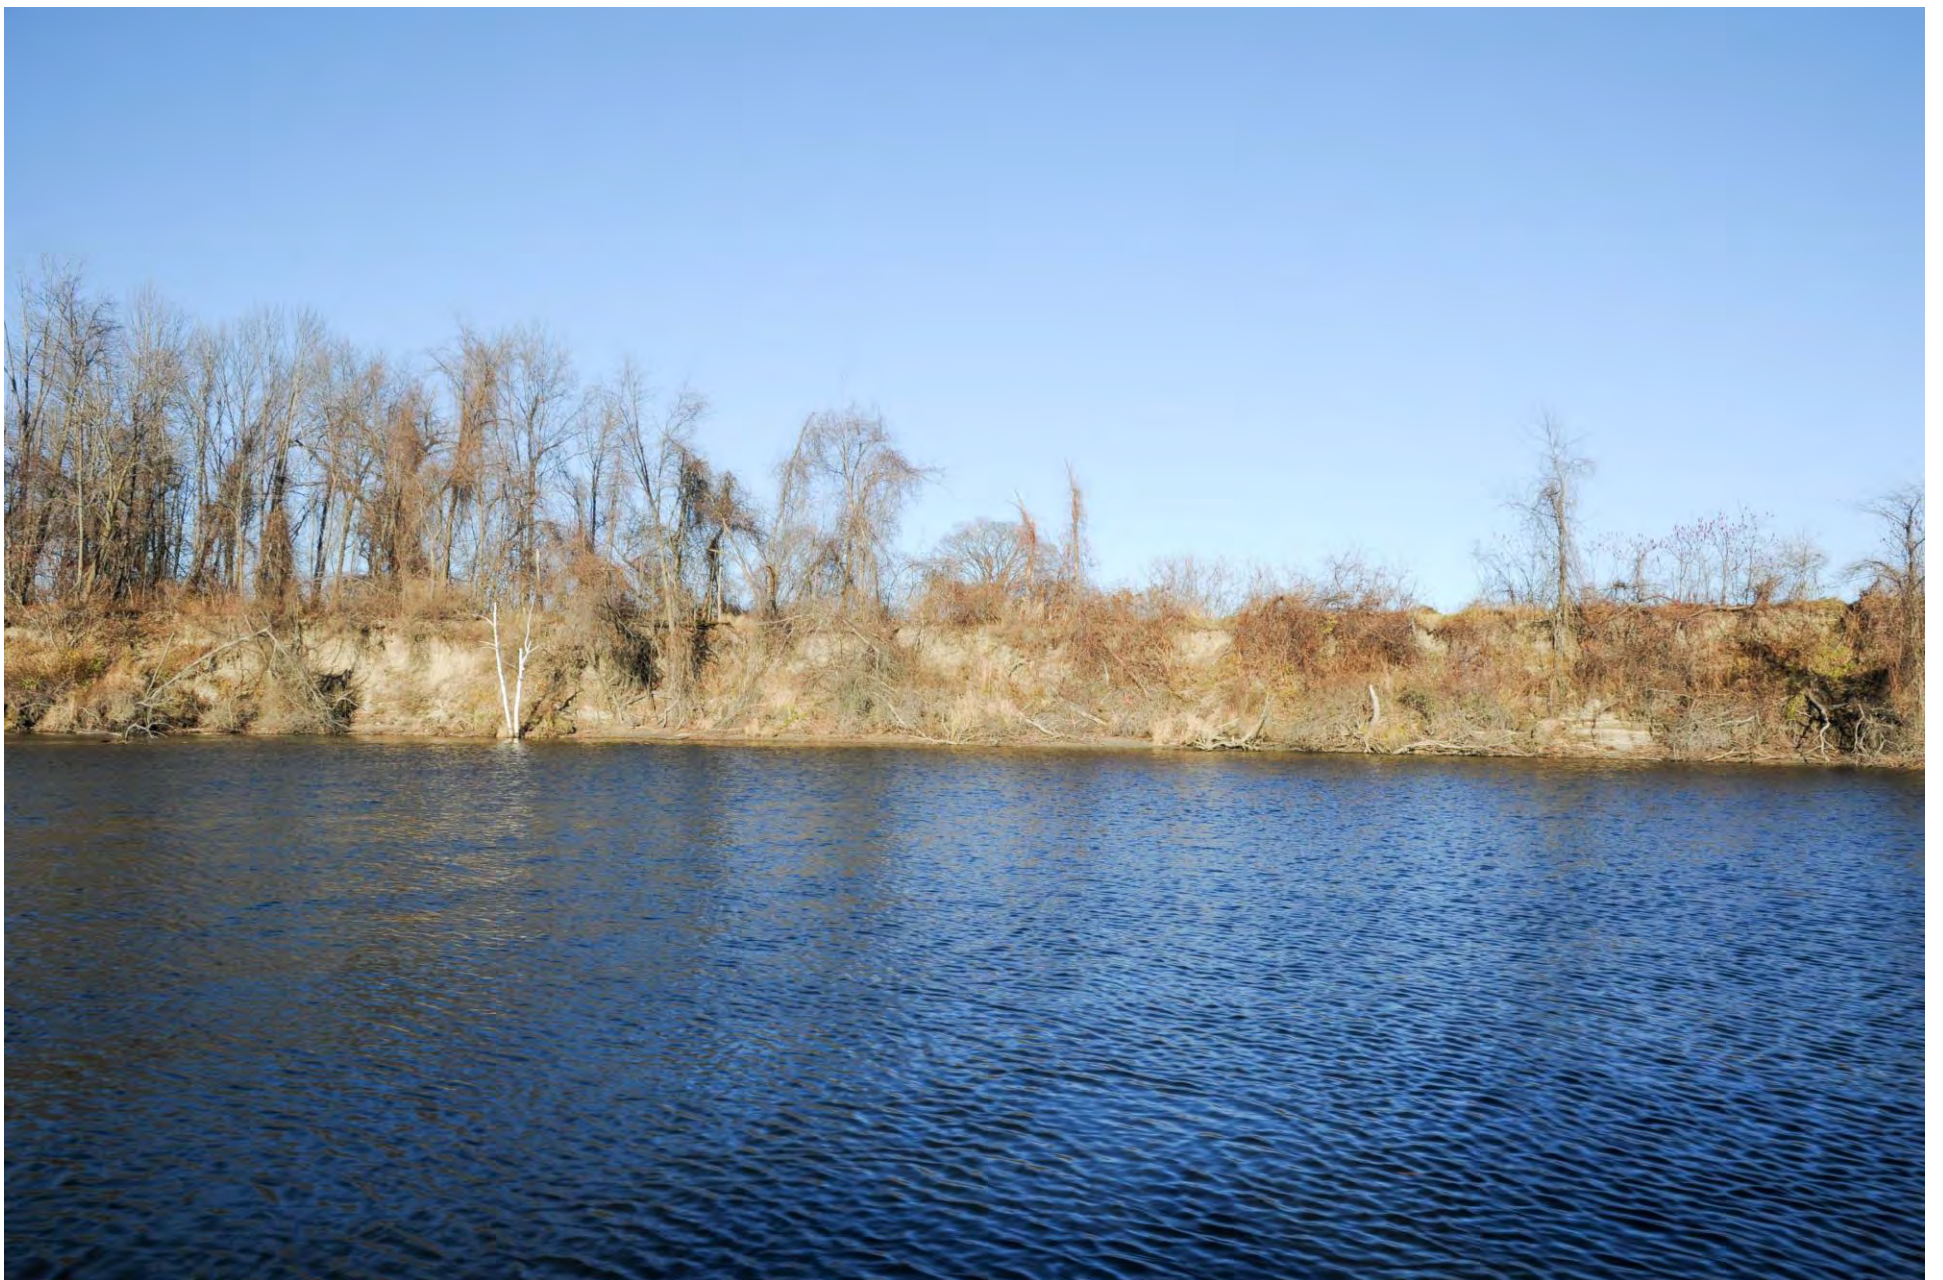
Approximate Photo Location

Riverbank Features	Characteristics
Upper Riverbank Slope	Overhanging
Upper Riverbank Height	High
Upper Riverbank Sediment	Silt/Sand
Upper Riverbank Vegetation	Moderate
Lower Riverbank Slope	Flat/Beach
Lower Riverbank Sediment	Silt/Sand
Lower Riverbank Vegetation	None to very sparse
Type of Erosion	Slide
Potential Erosion Indicators	Overhanging bank, Exposed roots, Creep/leaning trees
Stage of Erosion	Eroded
Extent of Erosion	Some to Extensive

**QA Observations:** Upon review of the photos for this segment, classification made in the field was confirmed and additional indicators of potential future erosion were included.
