Re: Filing of Addendum to Study No. 3.1.1- 2013 Full River Reconnaissance  
Turners Falls Hydroelectric Project (FERC No. 1889) and Northfield Mountain Pumped Storage  
Project (FERC No. 2485)

## **ATTACHMENT A: 2013 Full River Reconnaissance – 2015 Addendum: Riverbank Segment QA Comparison**

2015 FRR Addendum  
 Selected Riverbank Segments for QA  
 Map 1

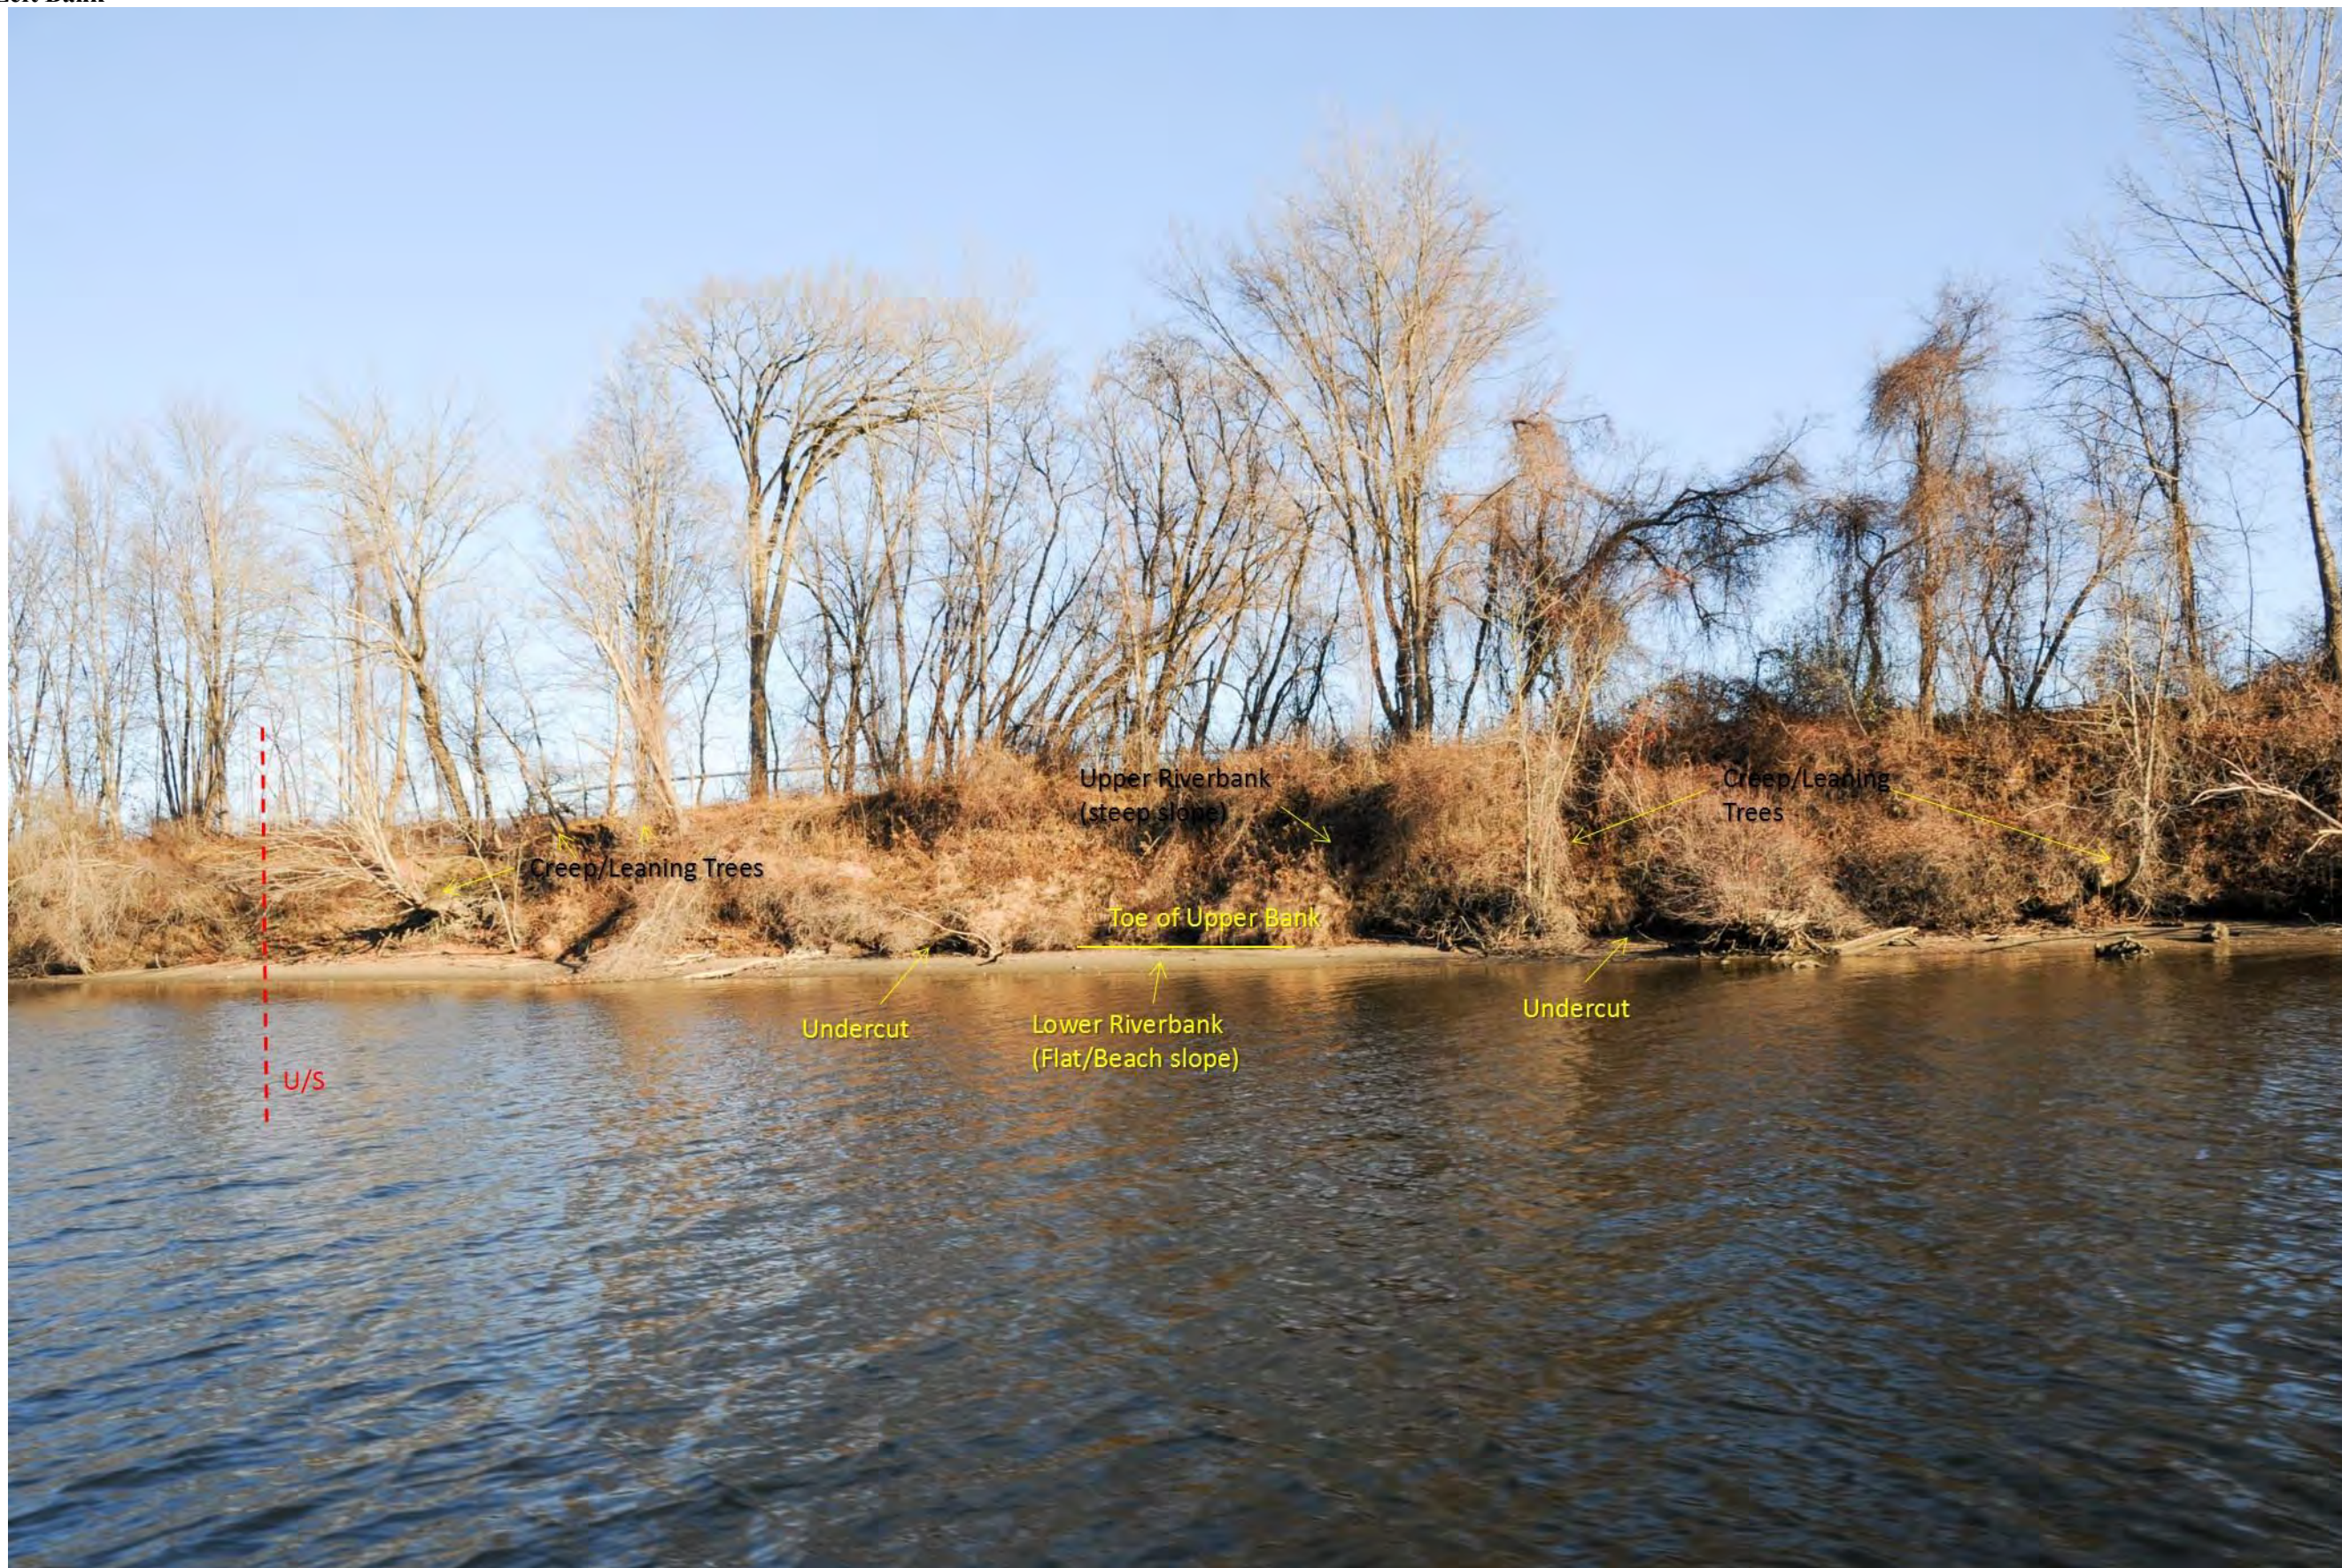
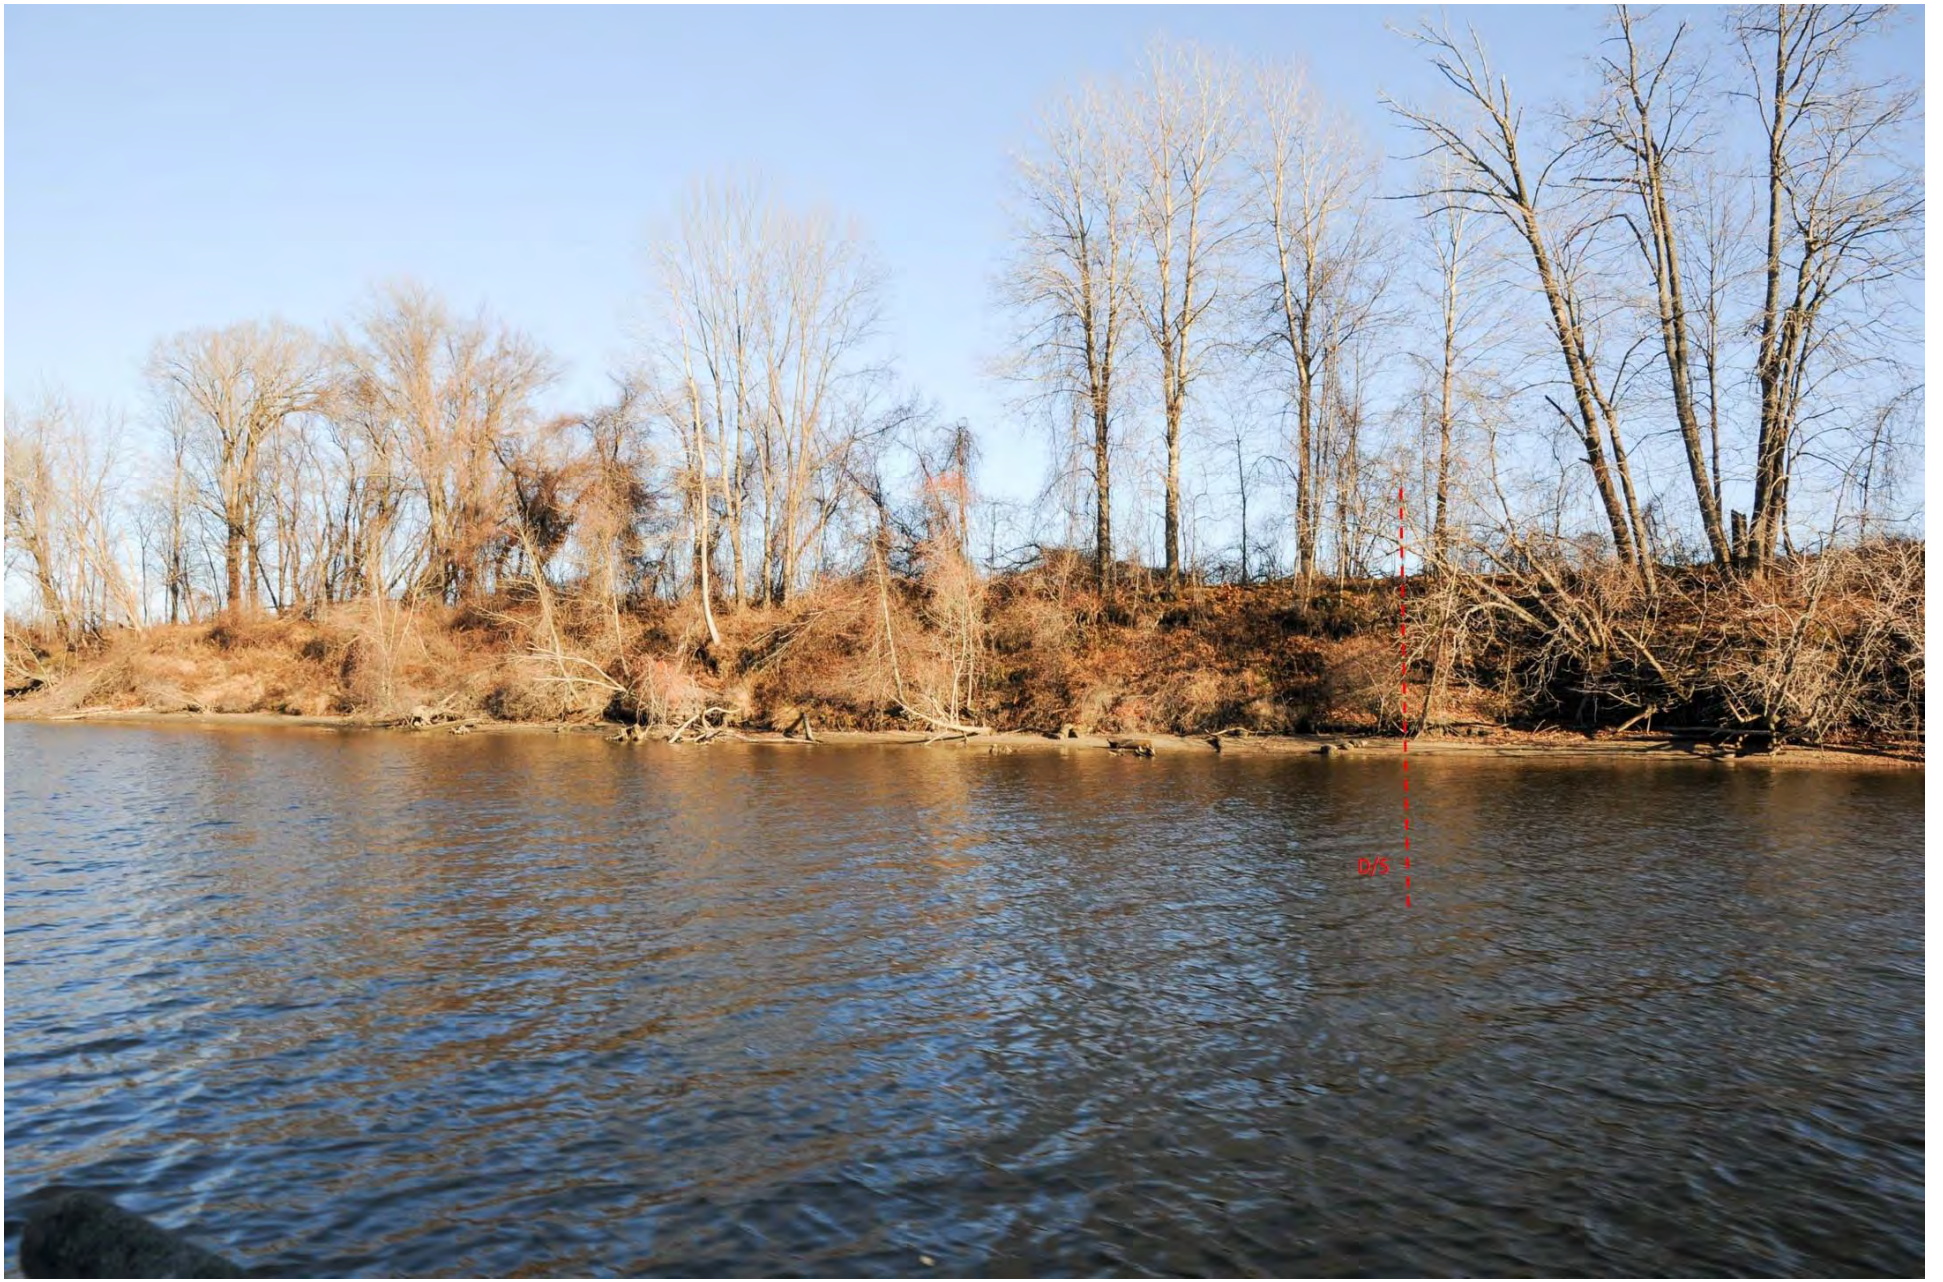
Approximate Photo Location

Riverbank Features	Characteristics
Upper Riverbank Slope	Steep
Upper Riverbank Height	High
Upper Riverbank Sediment	Silt/Sand
Upper Riverbank Vegetation	Heavy
Lower Riverbank Slope	Flat/Beach
Lower Riverbank Sediment	Silt/Sand
Lower Riverbank Vegetation	None to very sparse
Type of Erosion	Undercut
Potential Erosion Indicators	Creep/leaning trees, Exposed roots
Stage of Erosion	Stable
Extent of Erosion	None/Little

**QA Observations:** Upon review of the photos for this segment, classification made in the field was confirmed and additional indicators of potential future erosion were included.

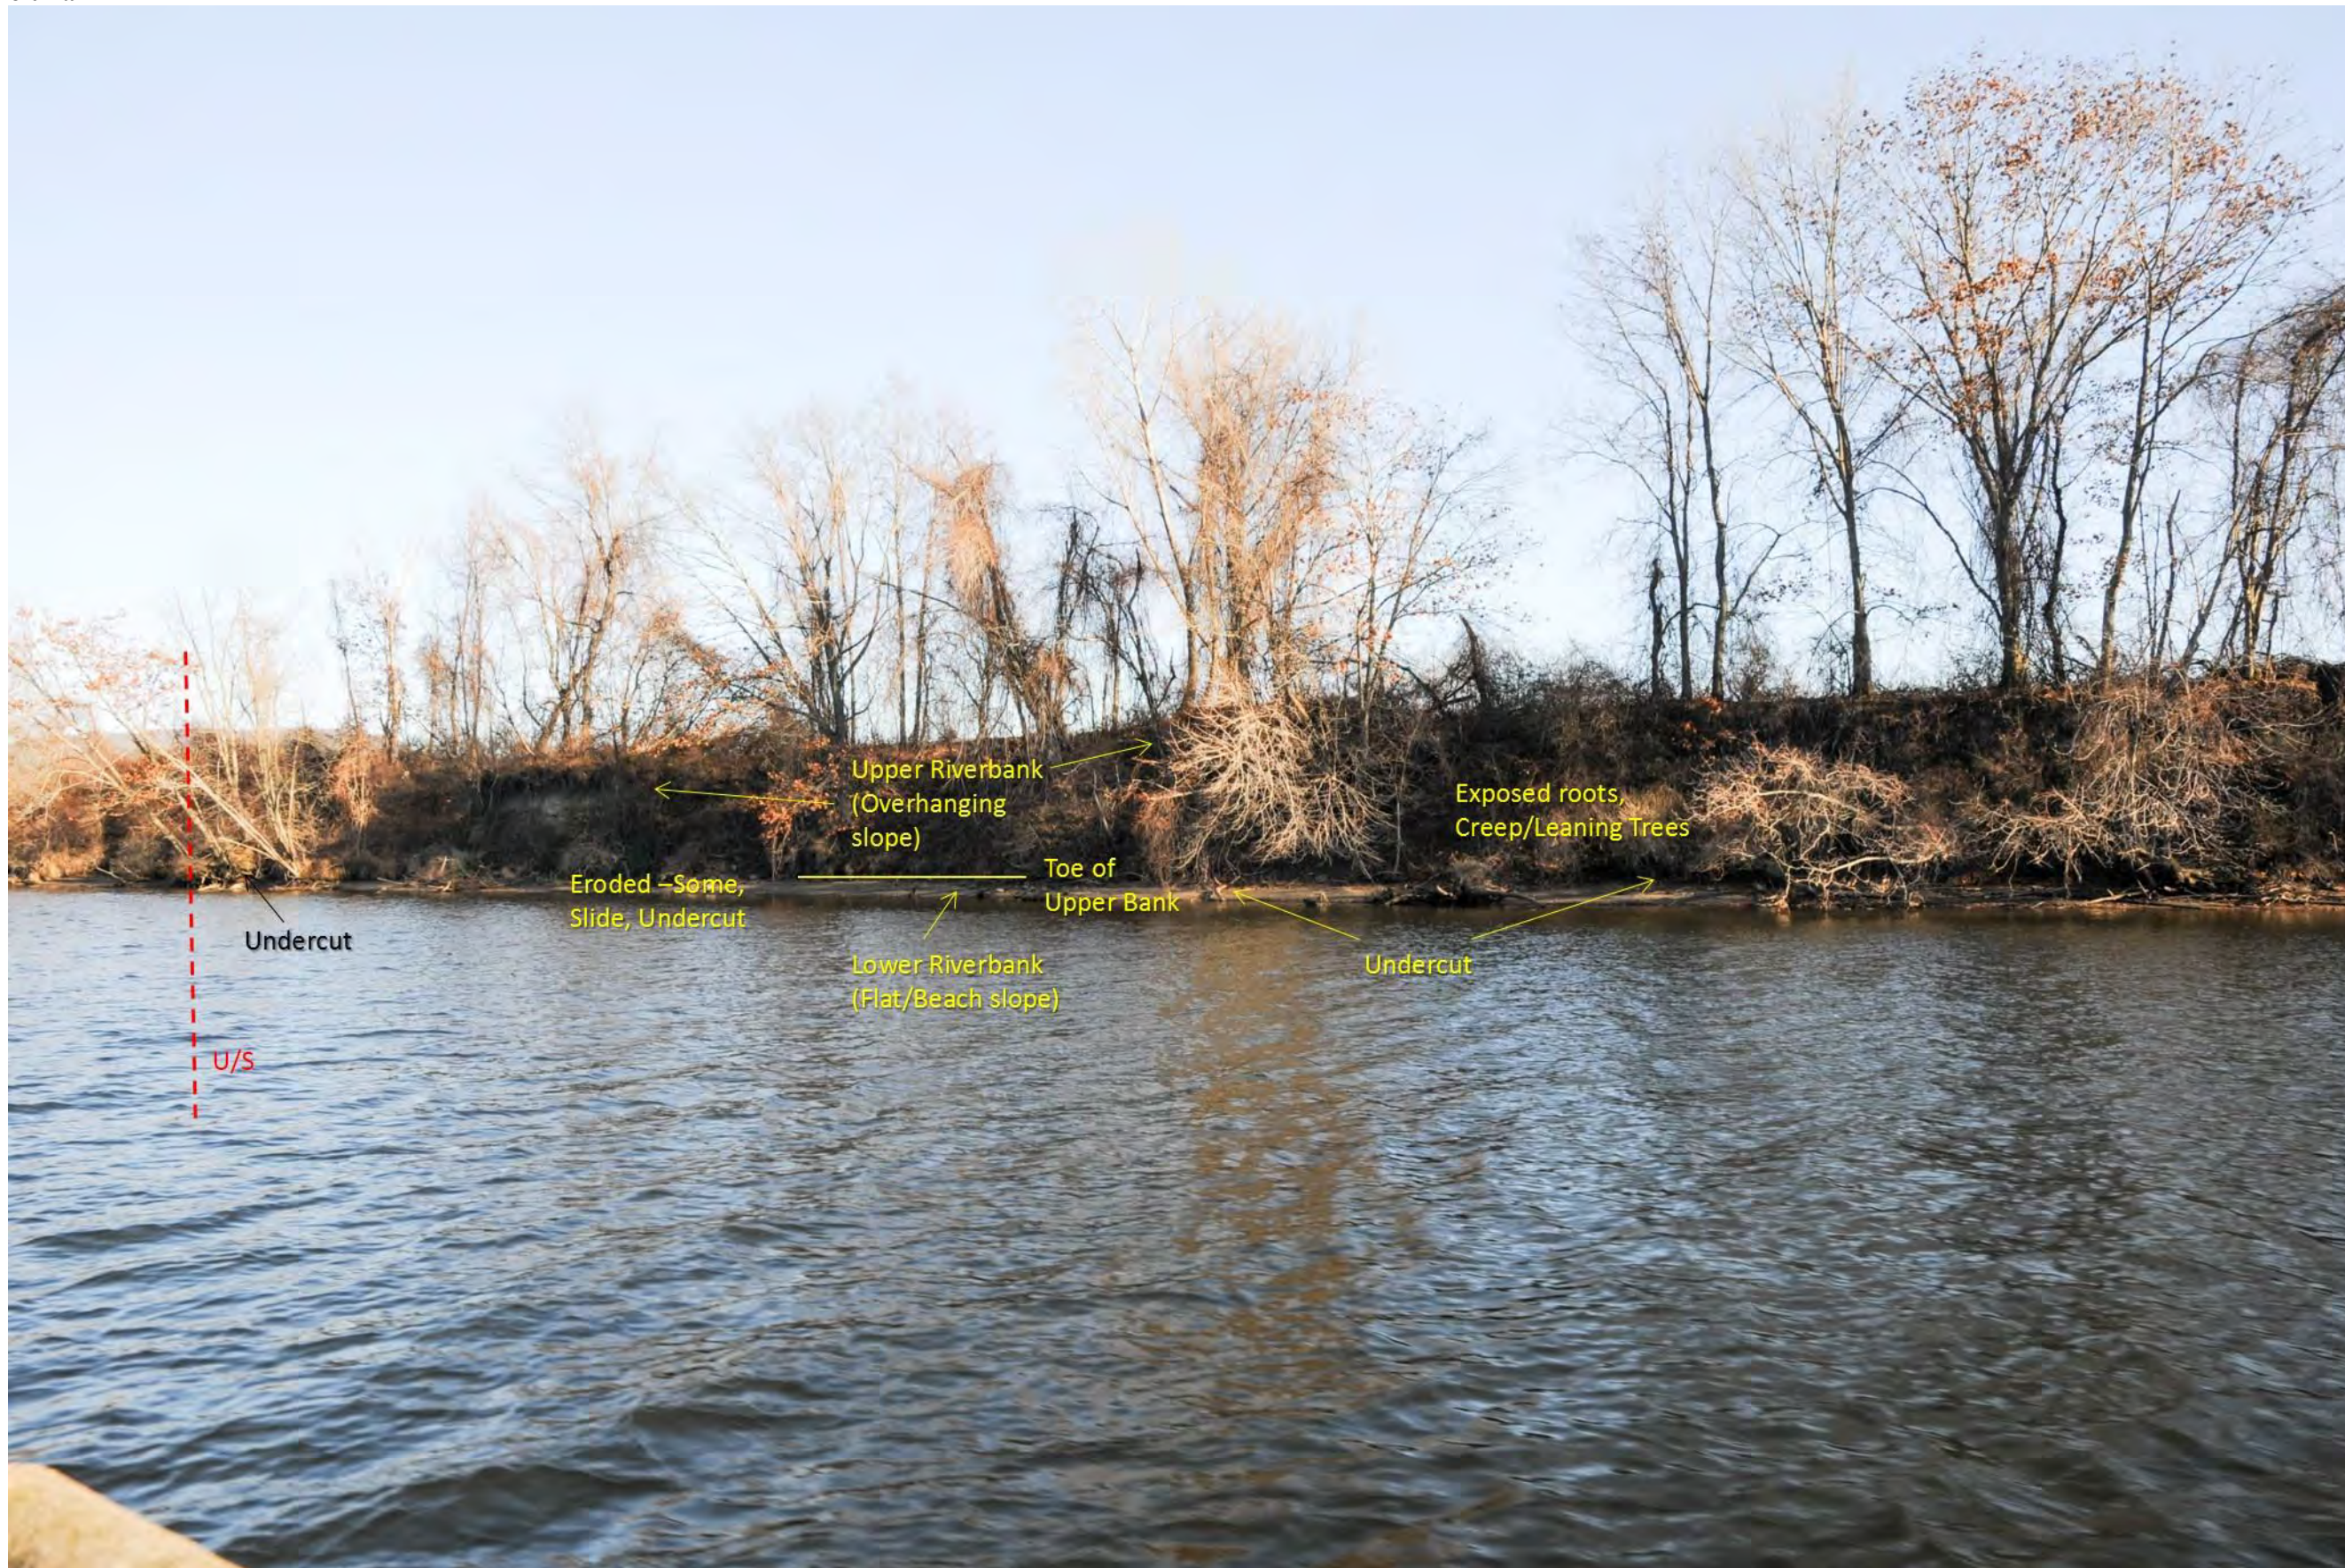
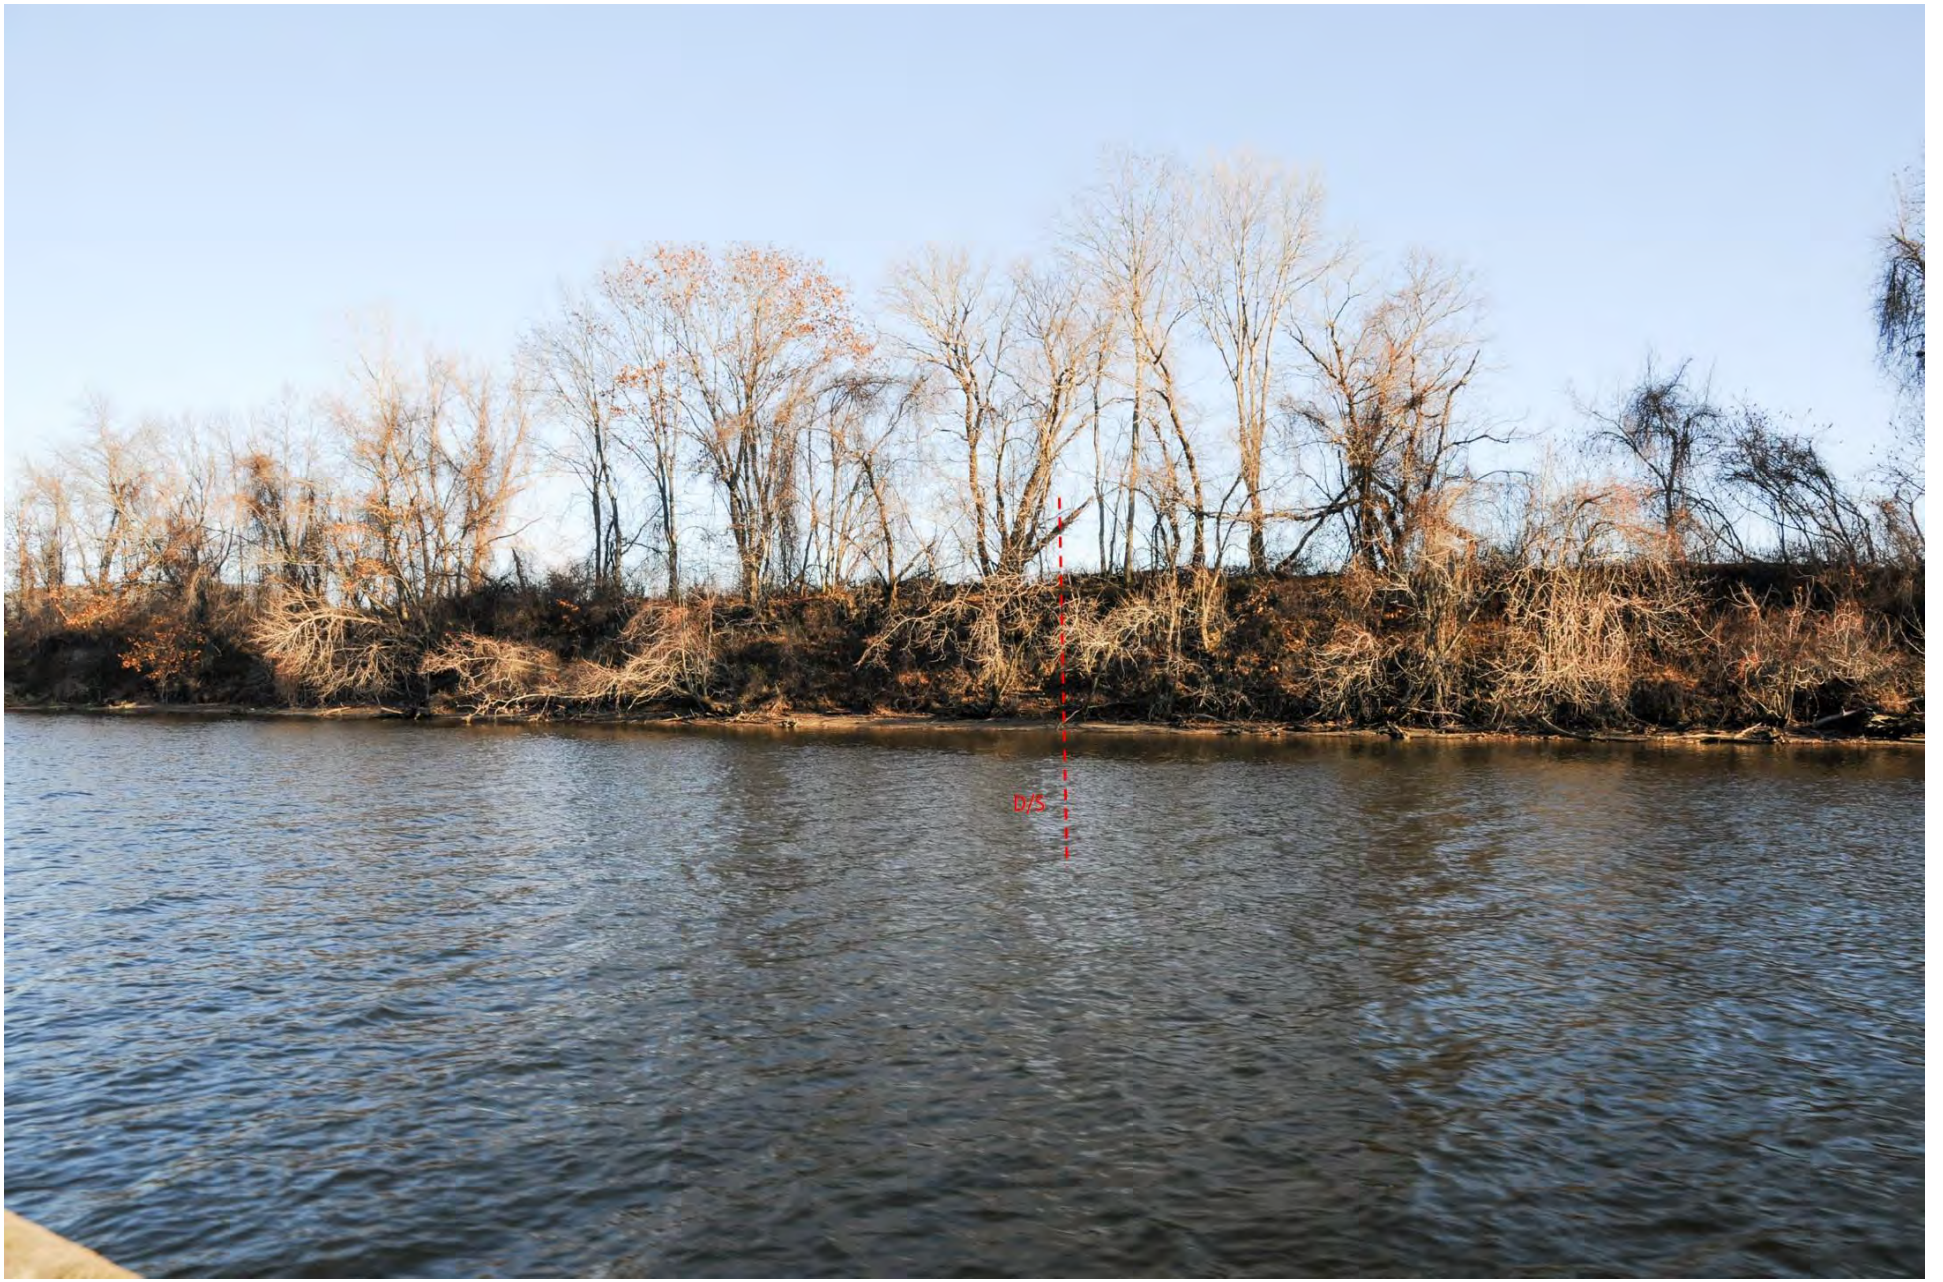
Approximate Photo Location

Riverbank Features	Characteristics
Upper Riverbank Slope	Overhanging
Upper Riverbank Height	High
Upper Riverbank Sediment	Silt/Sand
Upper Riverbank Vegetation	Moderate
Lower Riverbank Slope	Flat/Beach
Lower Riverbank Sediment	Silt/Sand
Lower Riverbank Vegetation	None to very sparse
Type of Erosion	Slide, undercut
Potential Erosion Indicators	Exposed roots, Overhanging bank, Creep/leaning trees
Stage of Erosion	Eroded
Extent of Erosion	Some

**QA Observations:** Upon review of the photos for this segment, classification made in the field was confirmed and additional indicators of potential future erosion were included.

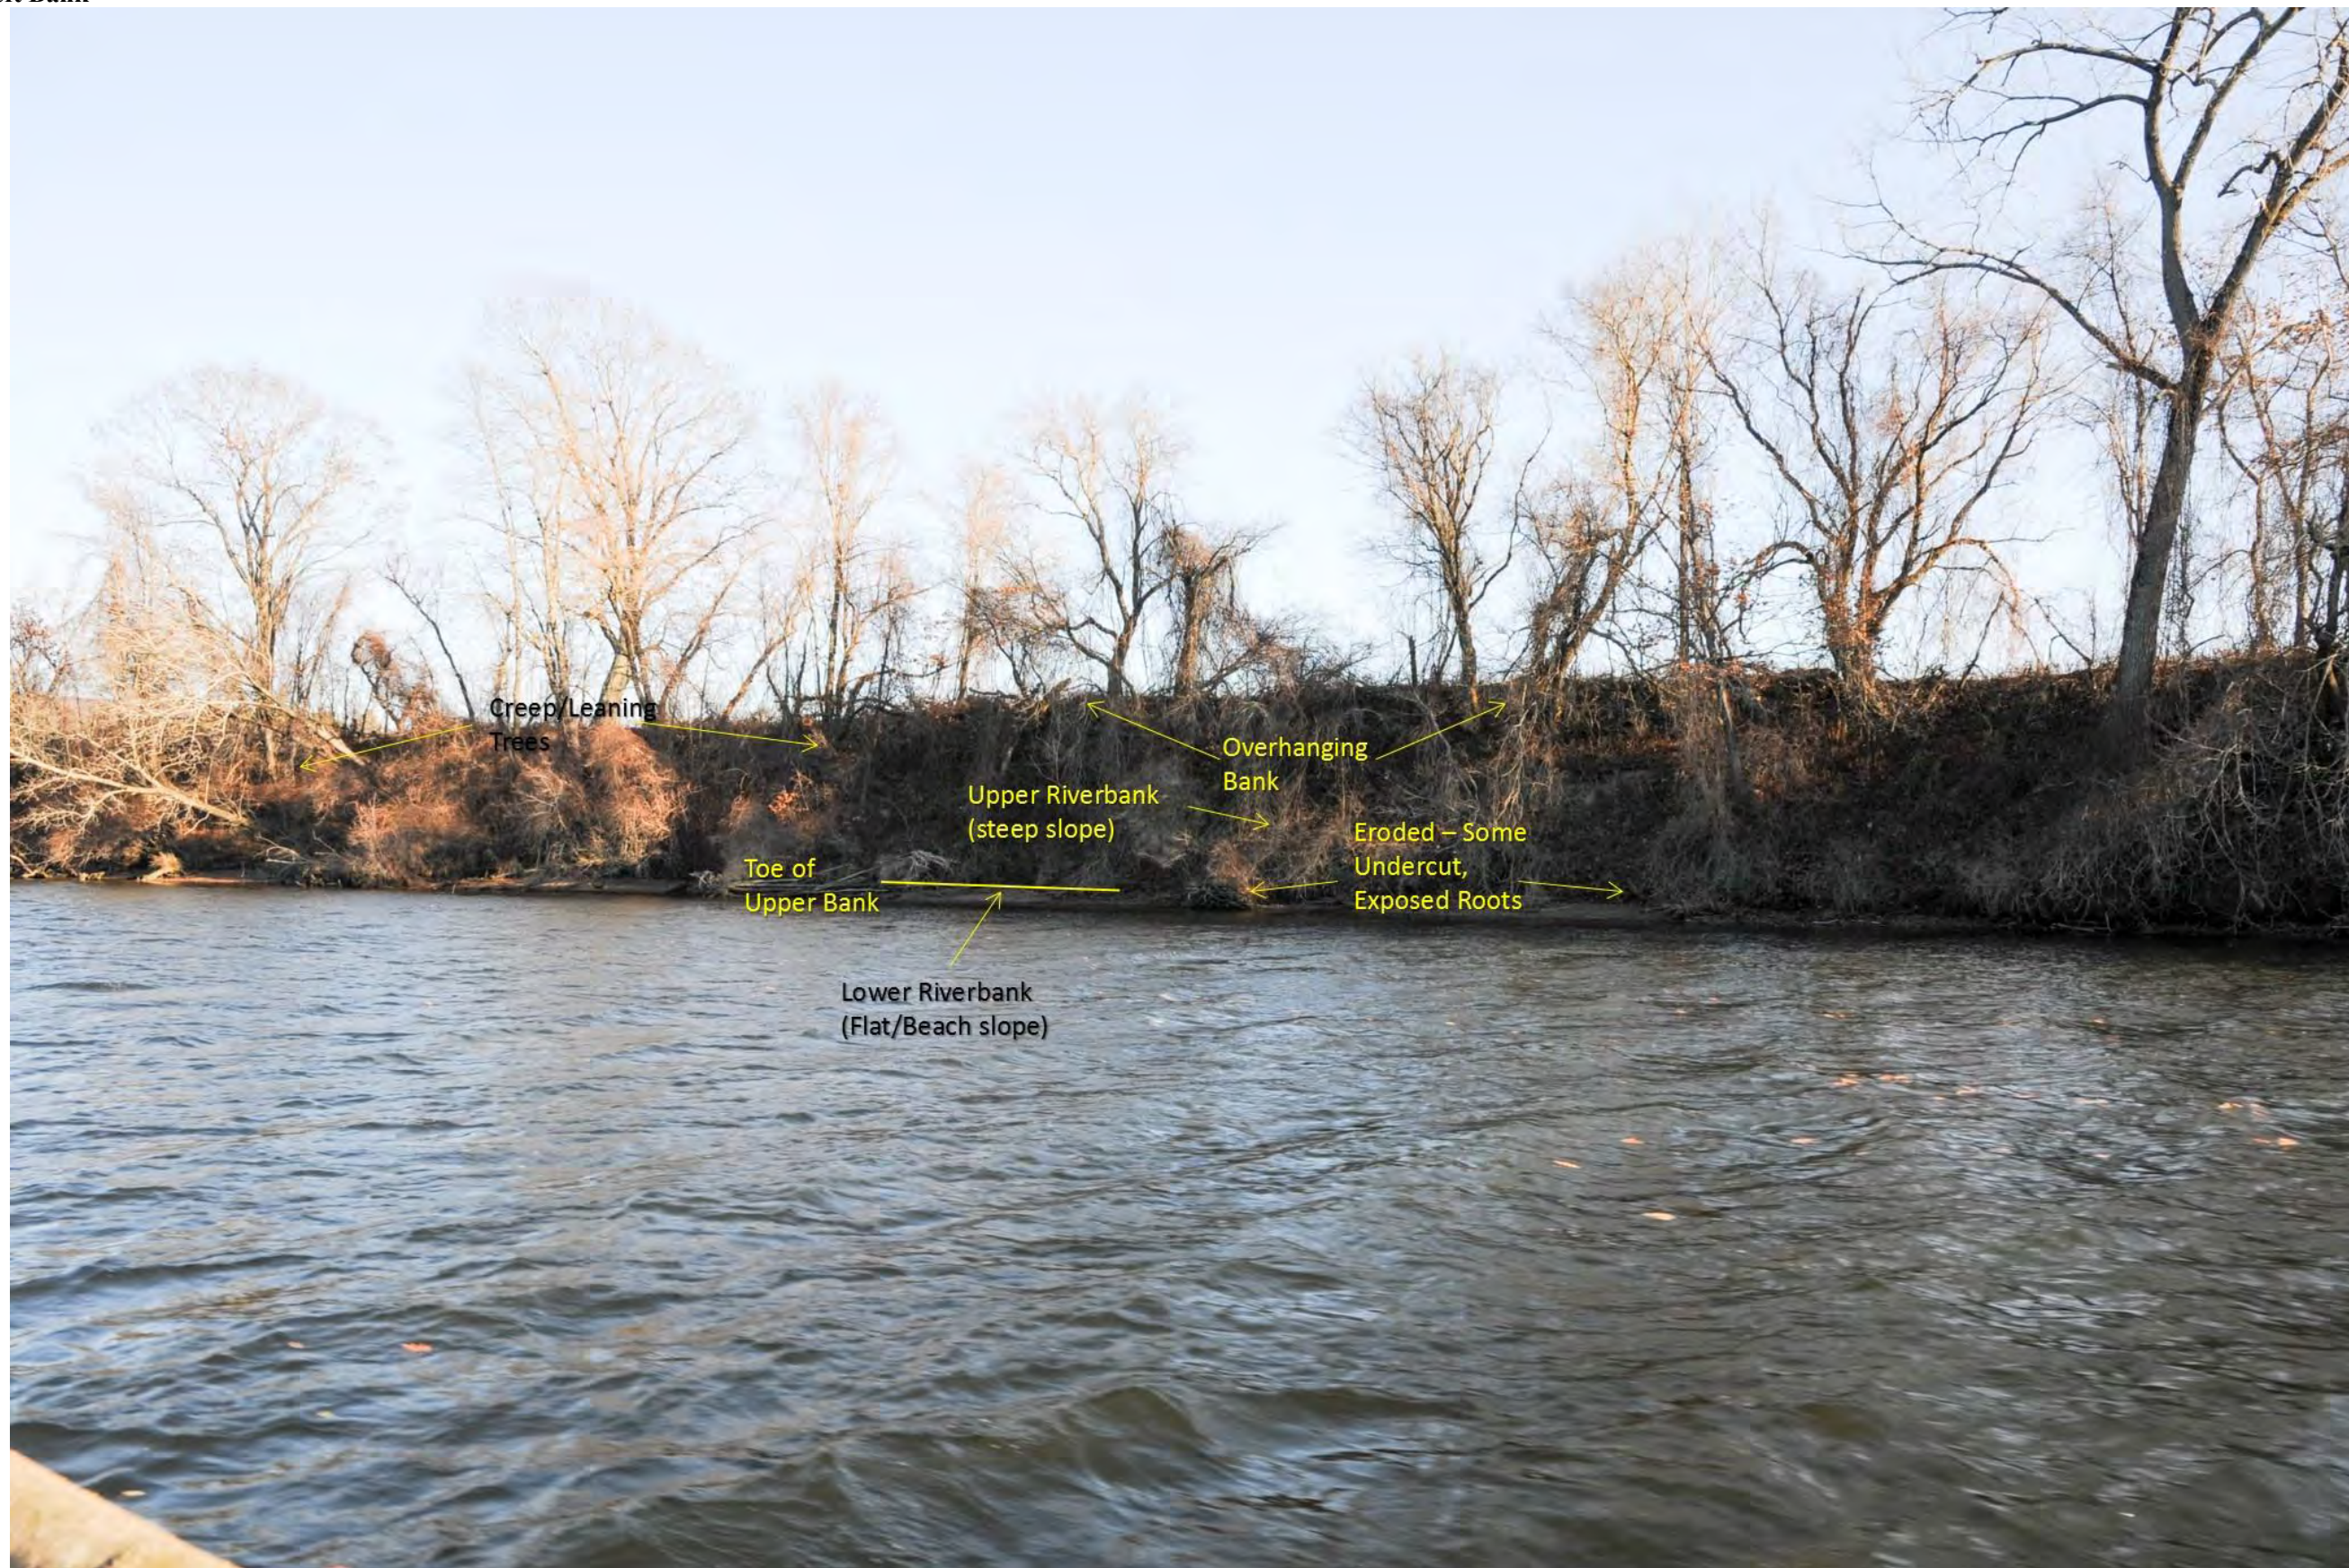
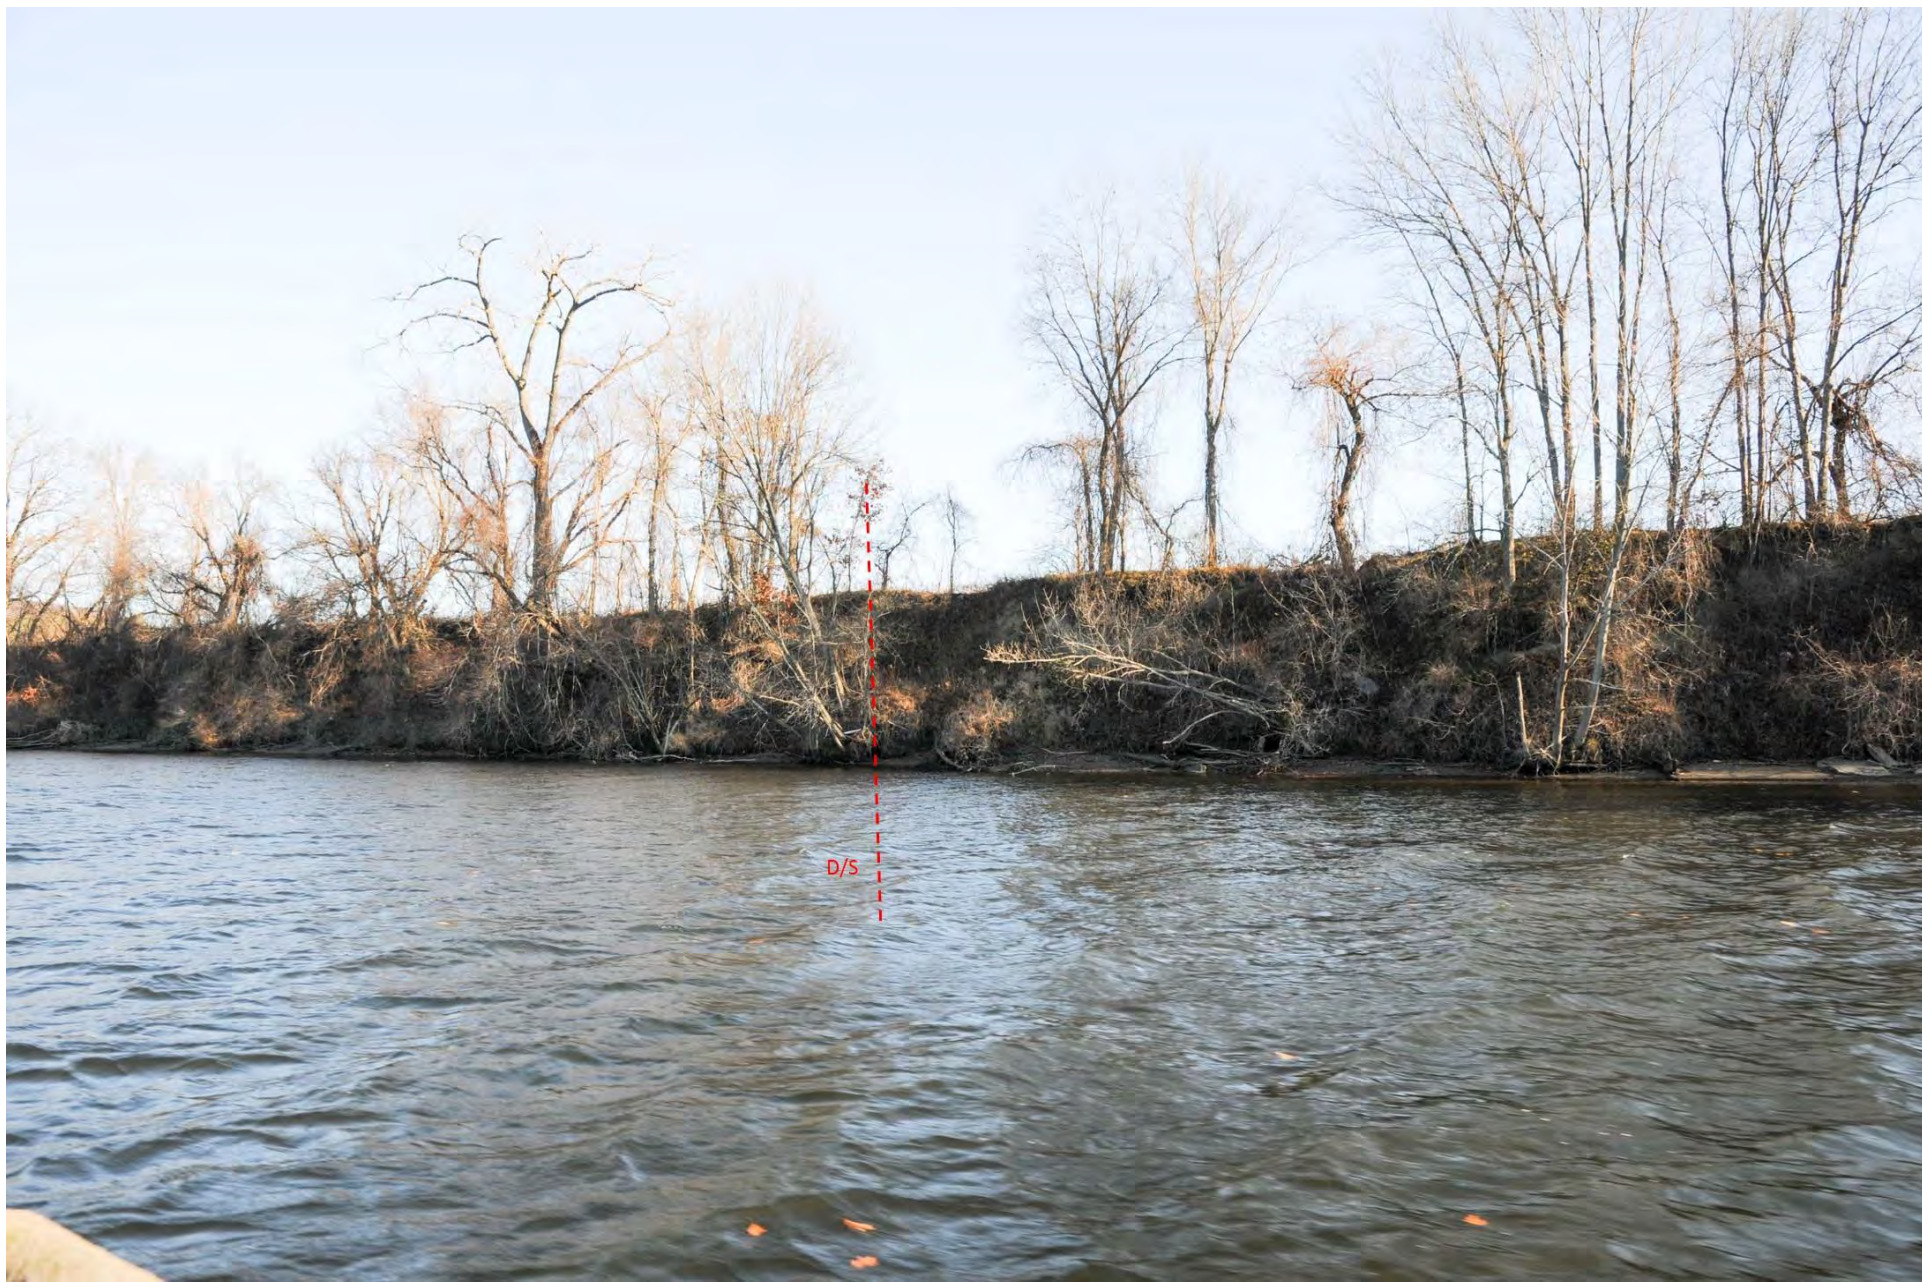
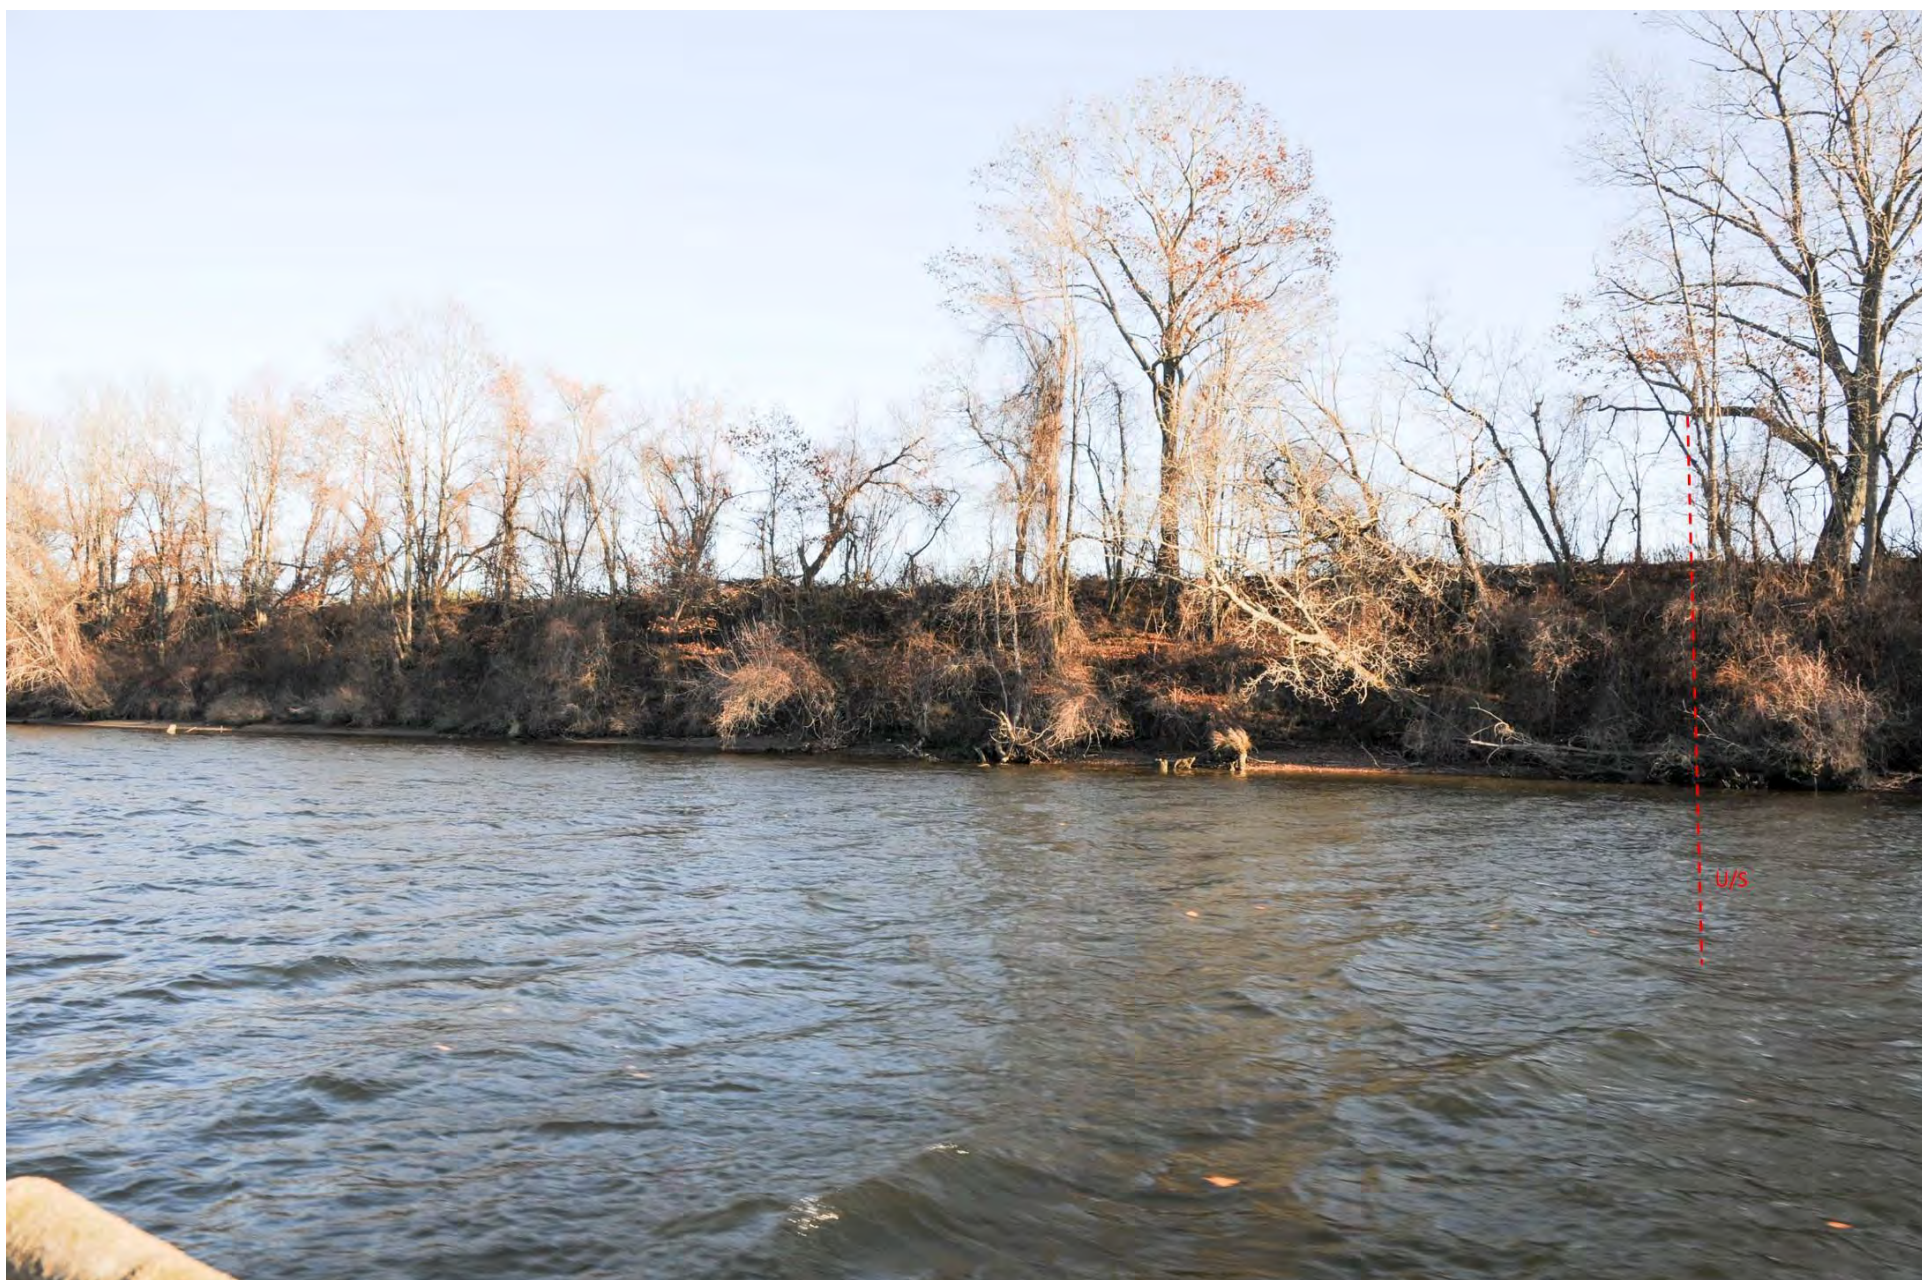
Approximate Photo Location

Riverbank Features	Characteristics
Upper Riverbank Slope	Steep
Upper Riverbank Height	High
Upper Riverbank Sediment	Silt/Sand
Upper Riverbank Vegetation	Heavy
Lower Riverbank Slope	Flat/Beach
Lower Riverbank Sediment	Silt/Sand
Lower Riverbank Vegetation	None to very sparse
Type of Erosion	Undercut
Potential Erosion Indicators	Creep/leaning trees, Exposed roots, Overhanging bank
Stage of Erosion	Eroded
Extent of Erosion	Some

**QA Observations:** Upon review of the photos for this segment, classification made in the field was confirmed and additional indicators of potential future erosion were included.
