Re: Filing of Addendum to Study No. 3.1.1- 2013 Full River Reconnaissance  
Turners Falls Hydroelectric Project (FERC No. 1889) and Northfield Mountain Pumped Storage  
Project (FERC No. 2485)

## **ATTACHMENT A: 2013 Full River Reconnaissance – 2015 Addendum: Riverbank Segment QA Comparison**

2015 FRR Addendum  
 Selected Riverbank Segments for QA  
 Map 1

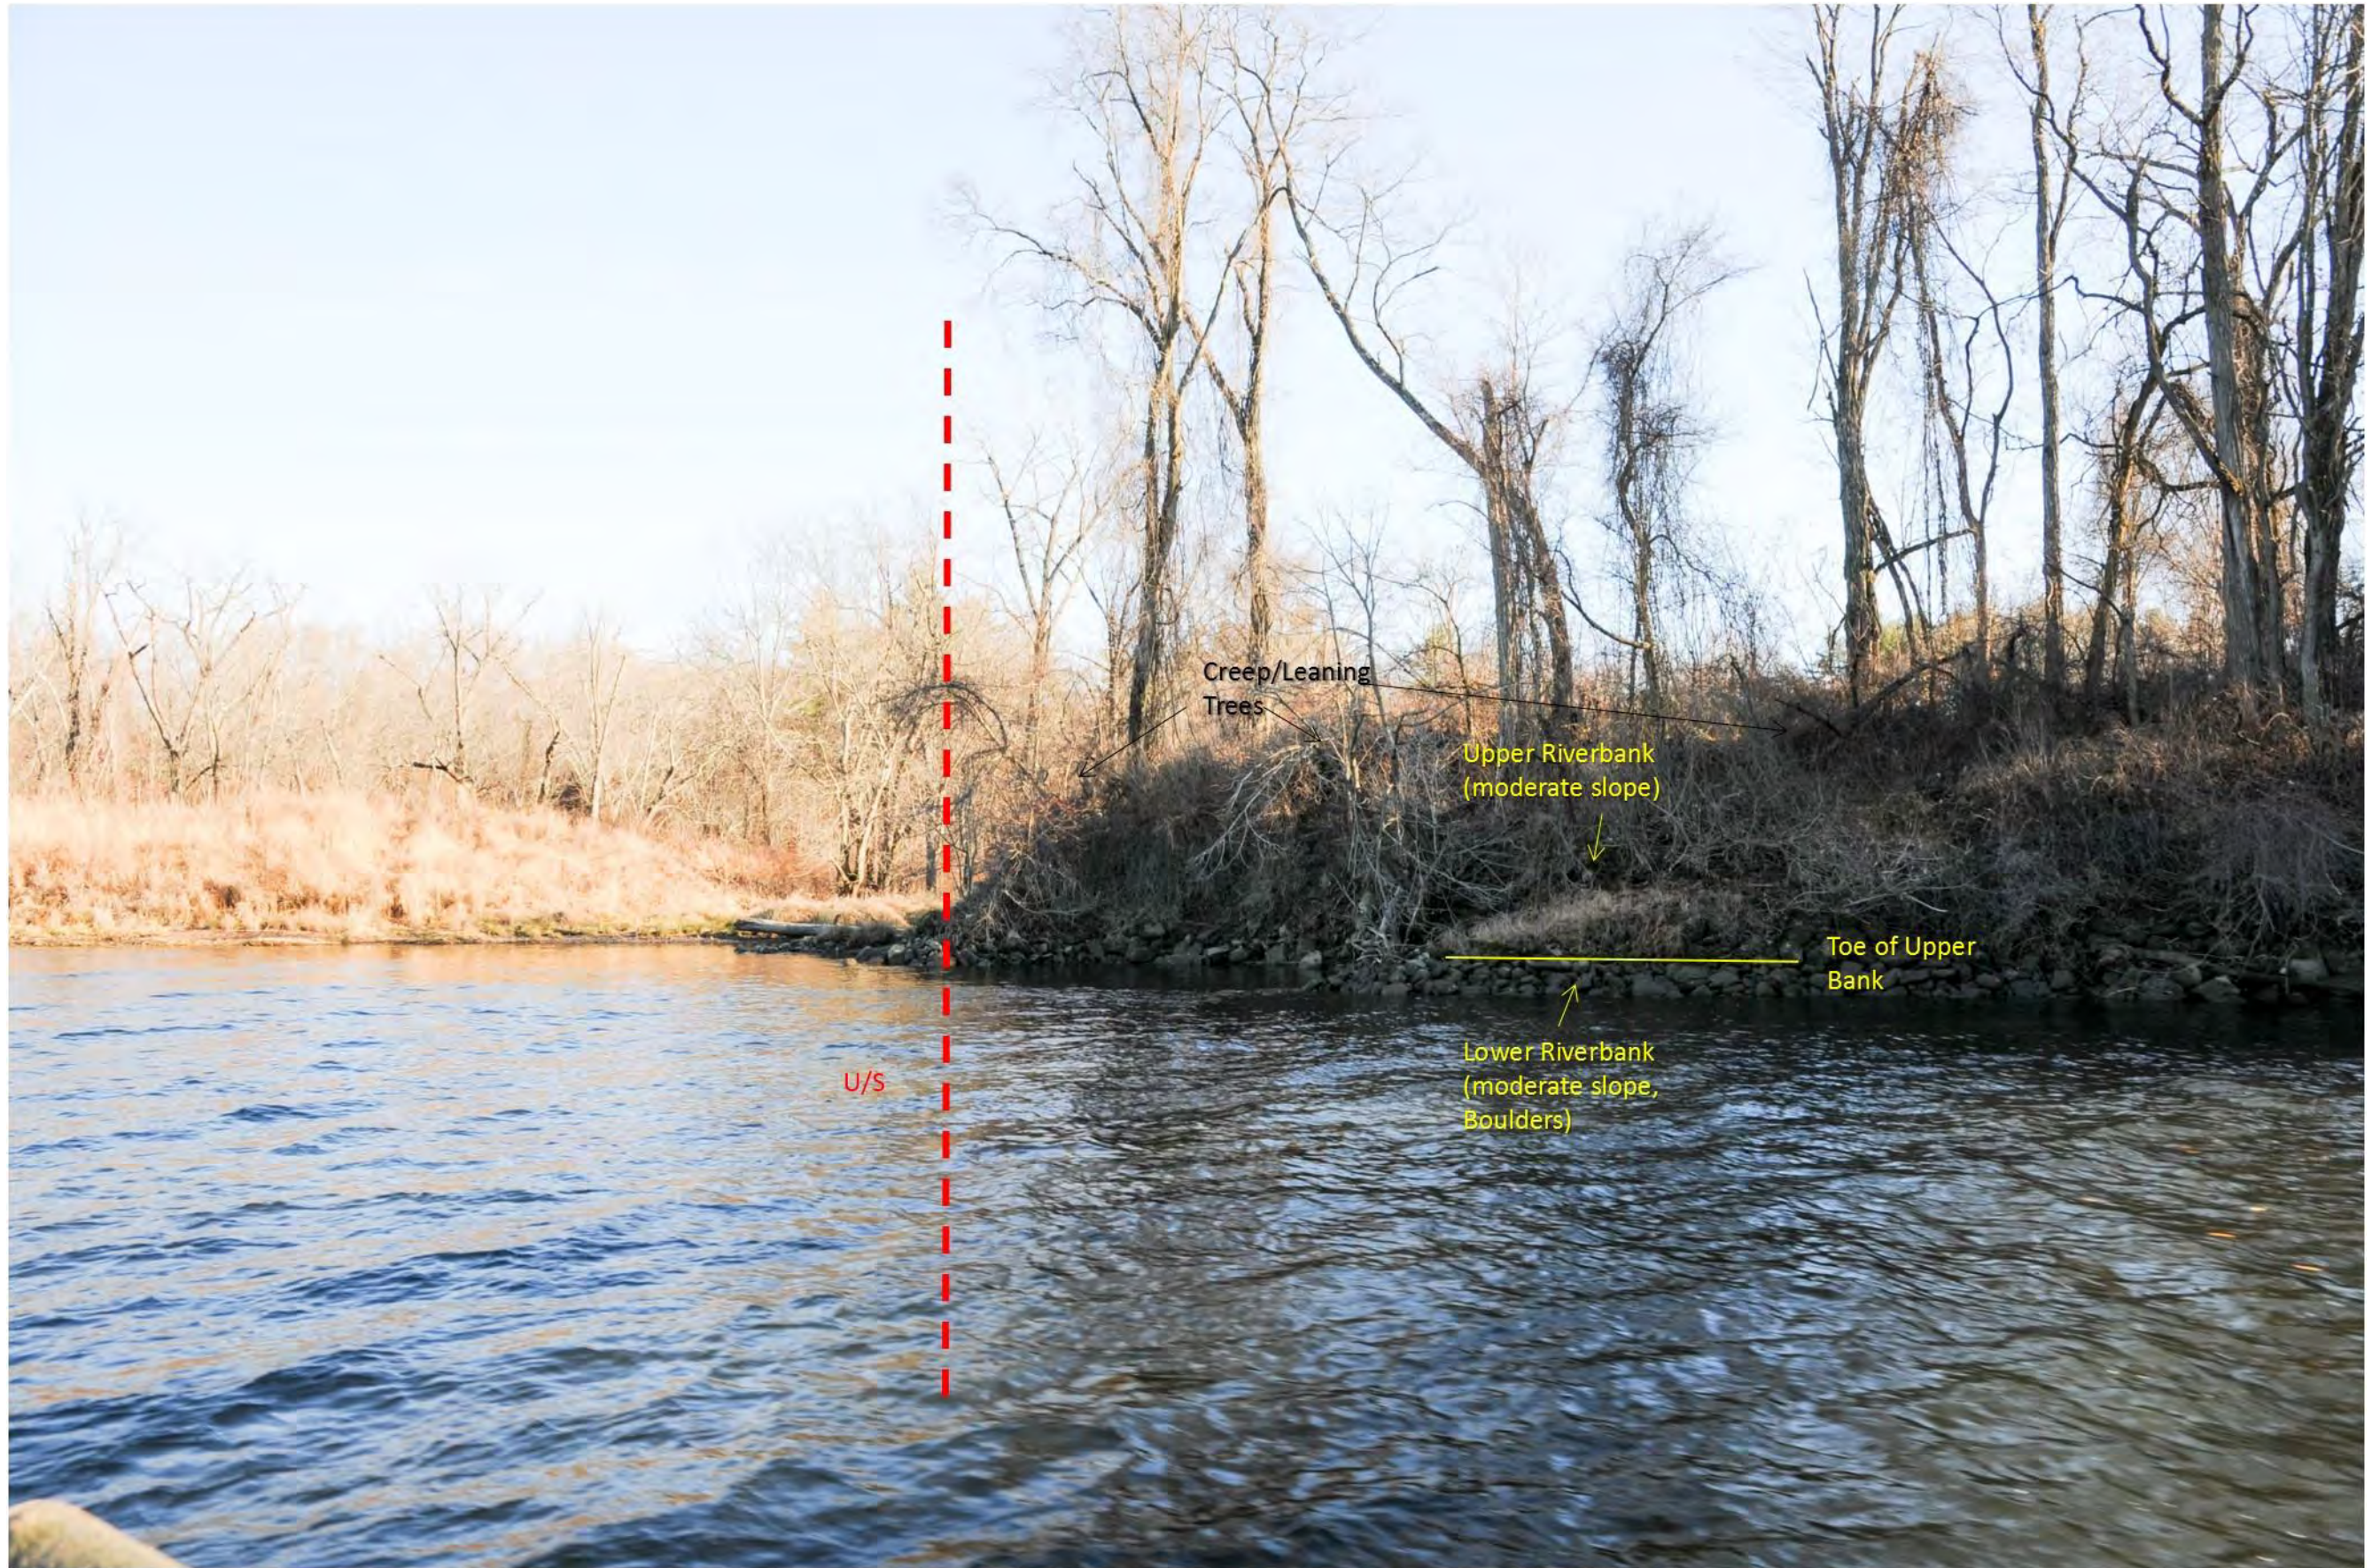
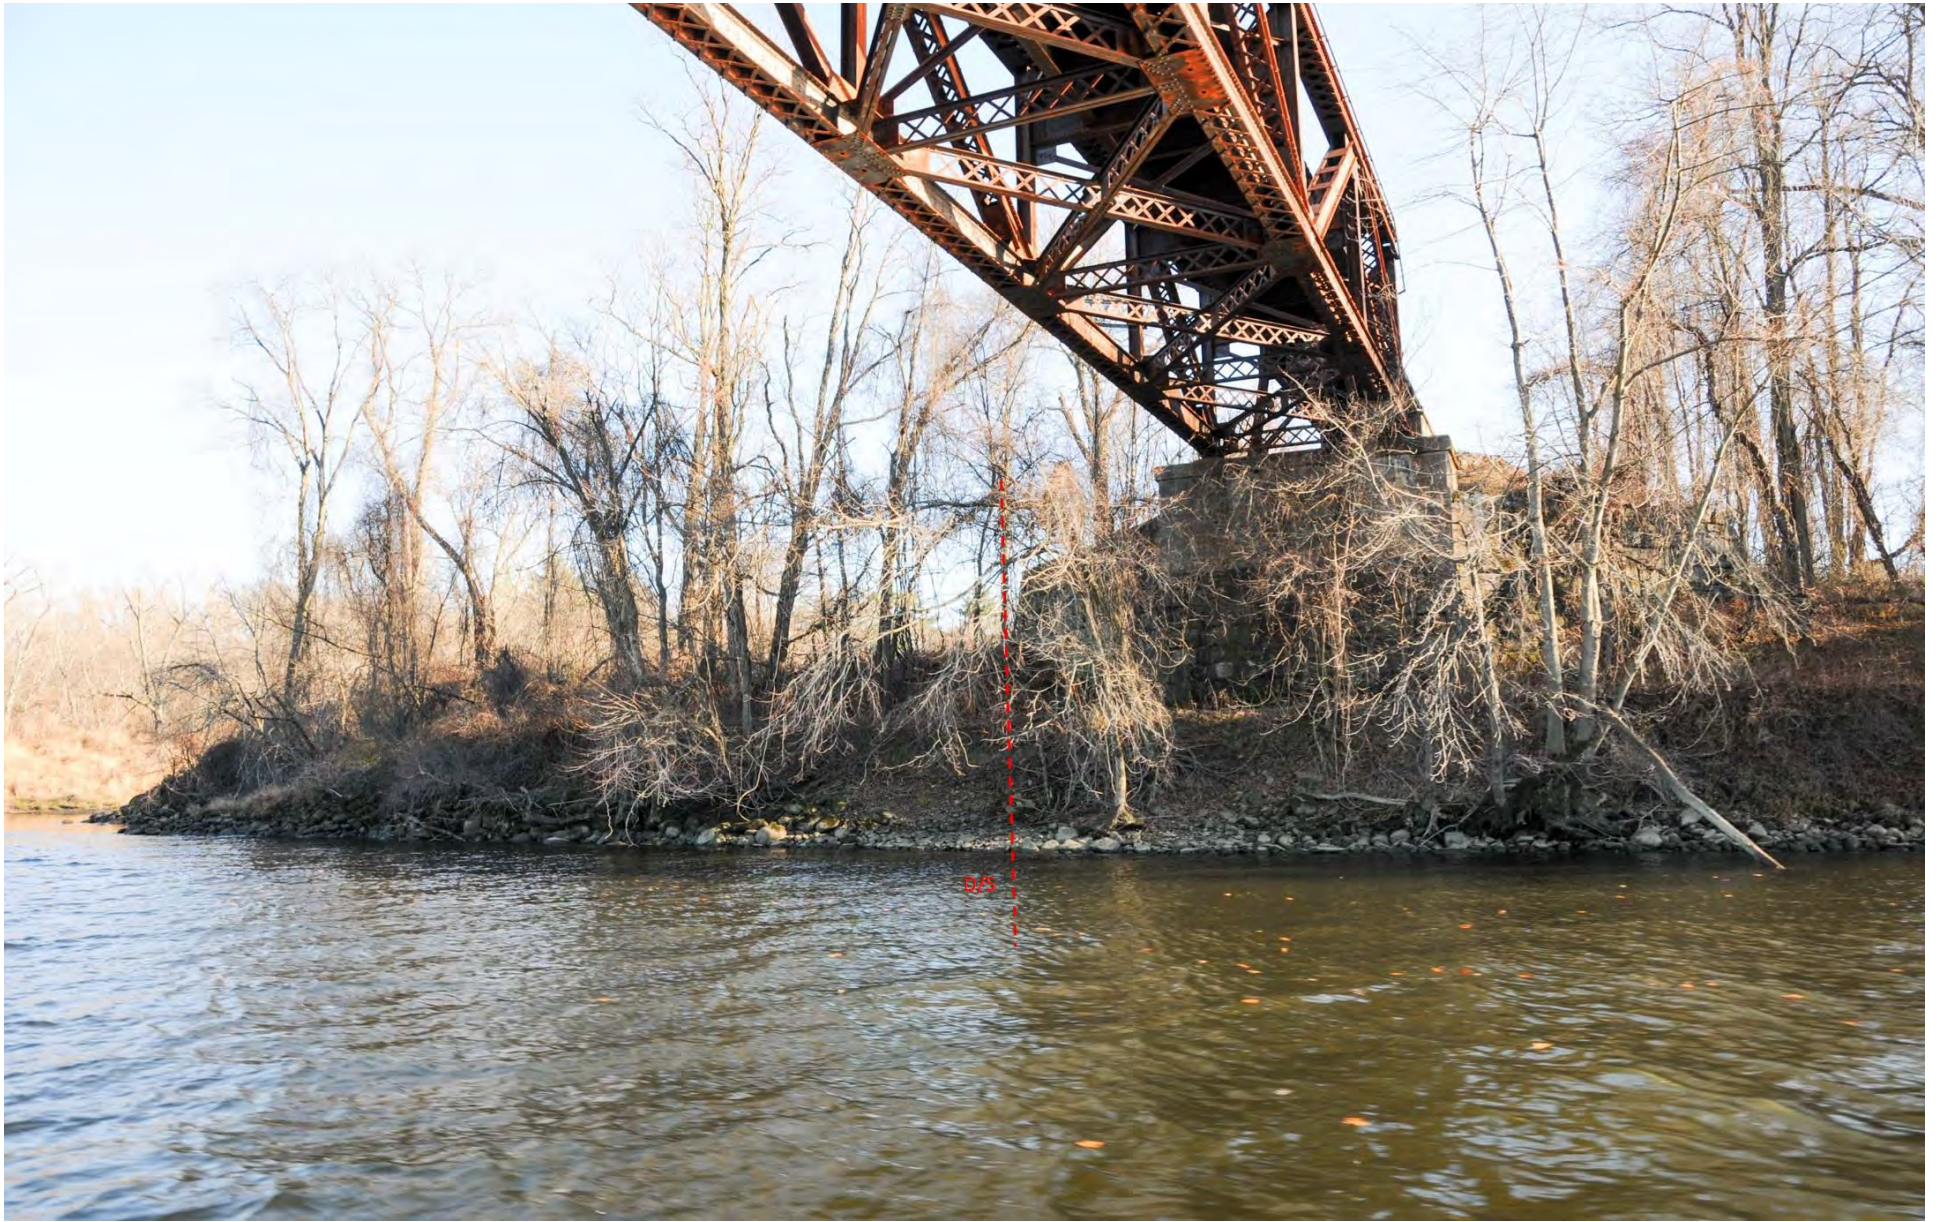
Approximate Photo Location

Riverbank Features	Characteristics
Upper Riverbank Slope	Moderate
Upper Riverbank Height	Low
Upper Riverbank Sediment	Silt/Sand
Upper Riverbank Vegetation	Heavy
Lower Riverbank Slope	Moderate
Lower Riverbank Sediment	Boulders
Lower Riverbank Vegetation	None to very sparse
Type of Erosion	
Potential Erosion Indicators	Creep/leaning trees
Stage of Erosion	Stable
Extent of Erosion	None/Little

**QA Observations:** Upon review of the photos for this segment, classification made in the field was confirmed.

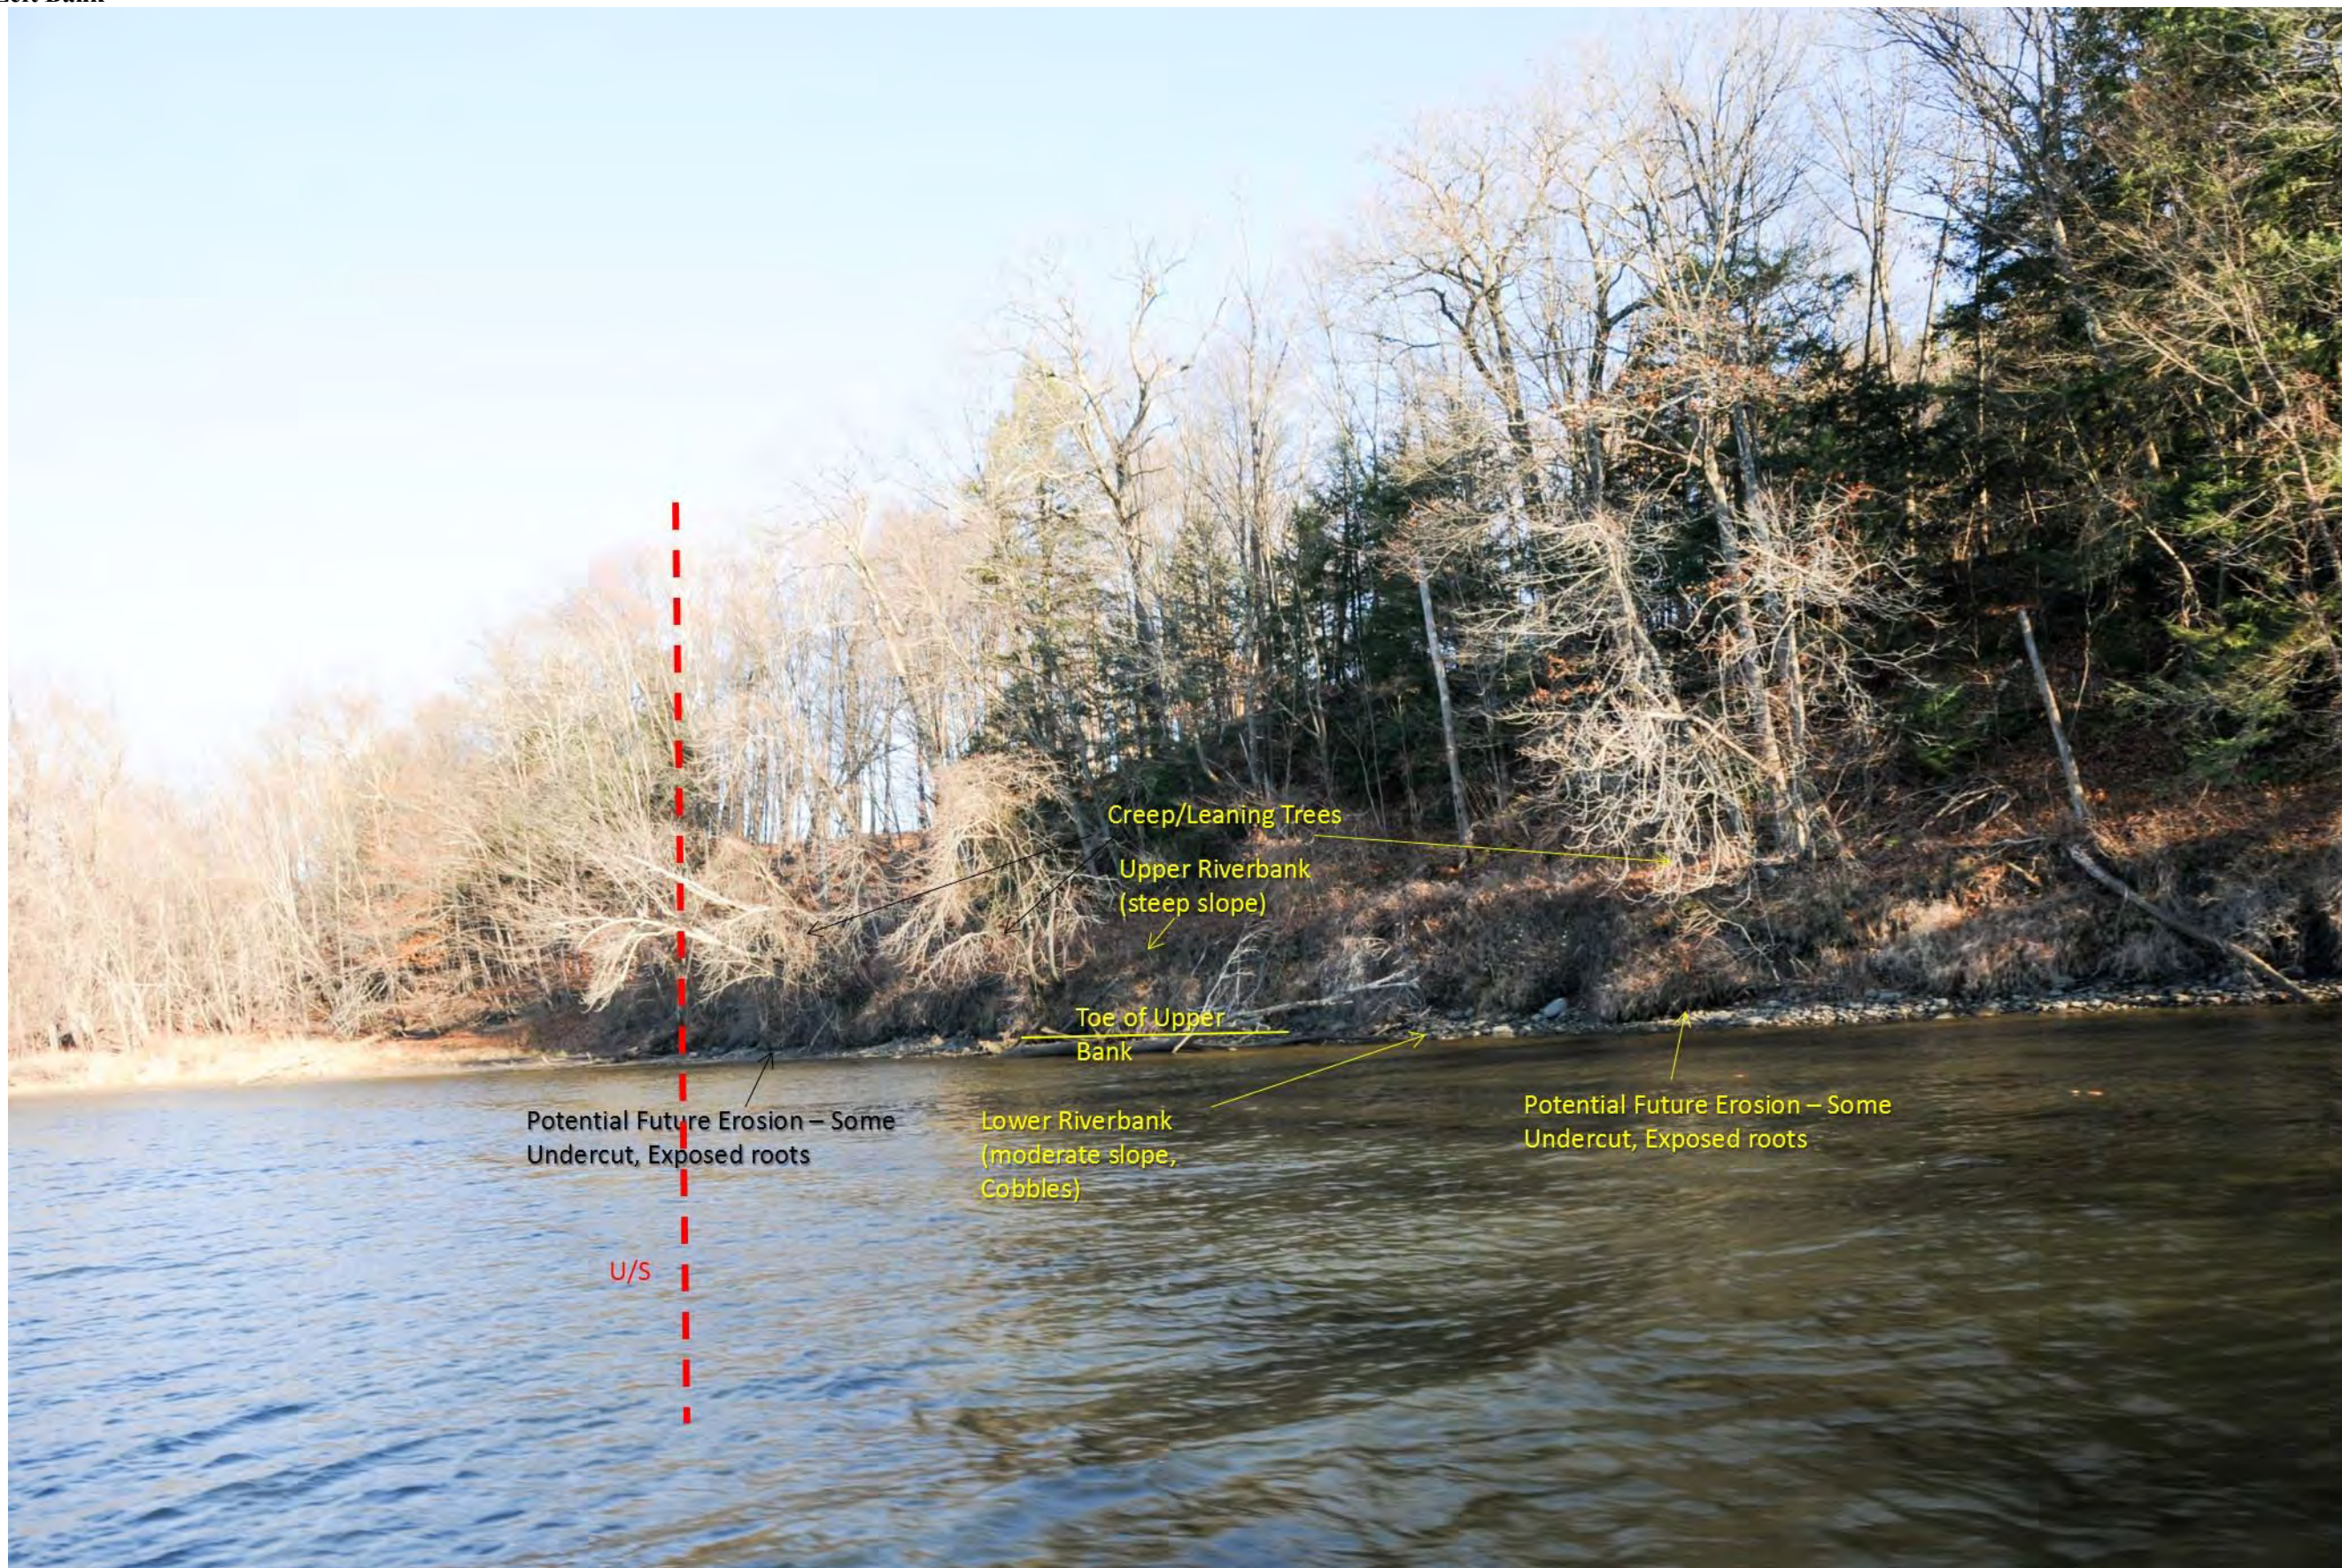
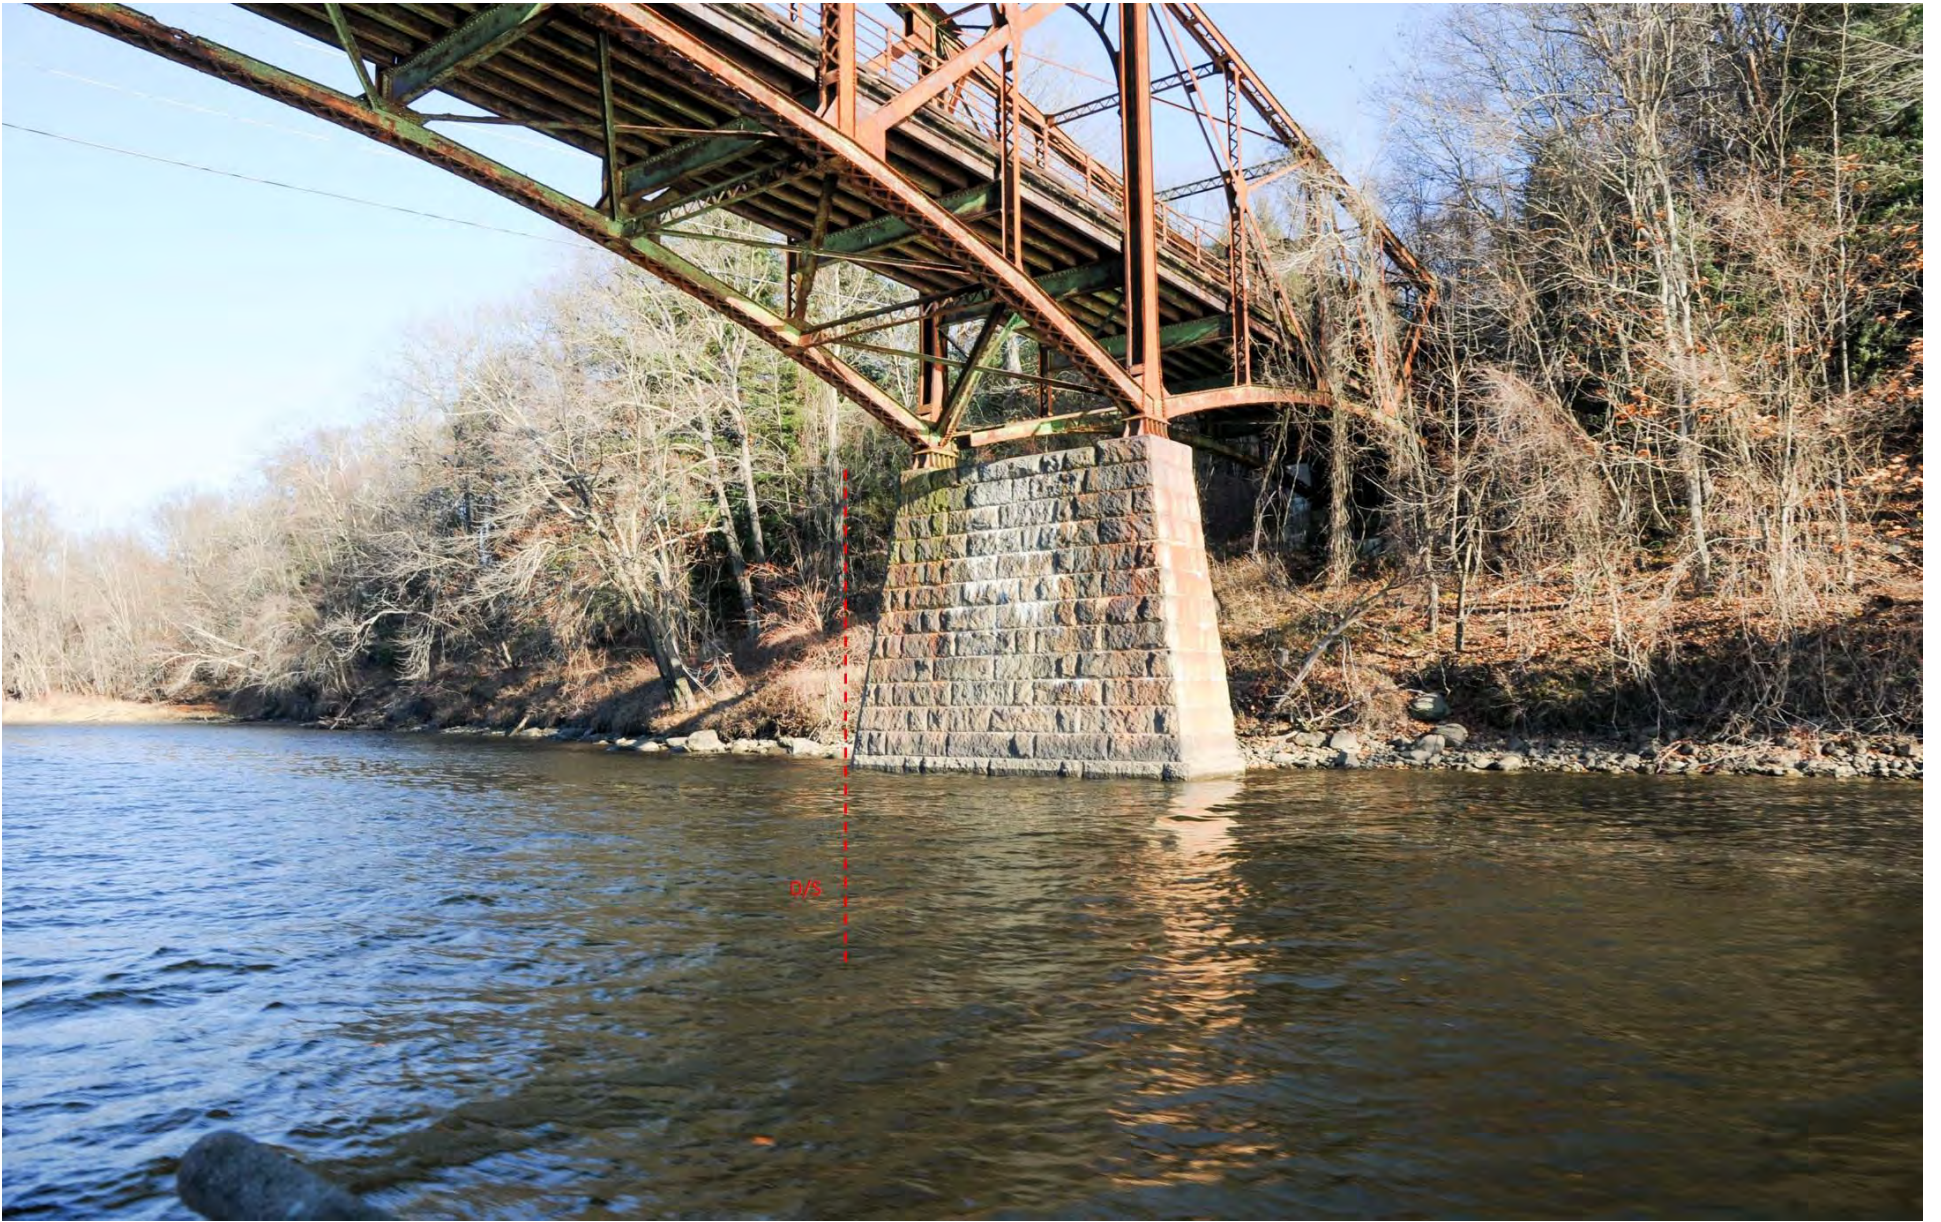
Approximate Photo Location

Riverbank Features	Characteristics
Upper Riverbank Slope	Steep
Upper Riverbank Height	High
Upper Riverbank Sediment	Silt/Sand
Upper Riverbank Vegetation	Heavy
Lower Riverbank Slope	Moderate
Lower Riverbank Sediment	Cobbles
Lower Riverbank Vegetation	None to very sparse
Type of Erosion	Undercut
Potential Erosion Indicators	Creep/leaning trees, Exposed roots
Stage of Erosion	Potential Future Erosion
Extent of Erosion	Some

**QA Observations:** Upon review of the photos for this segment, classification made in the field was confirmed and additional indicators of potential future erosion were included.

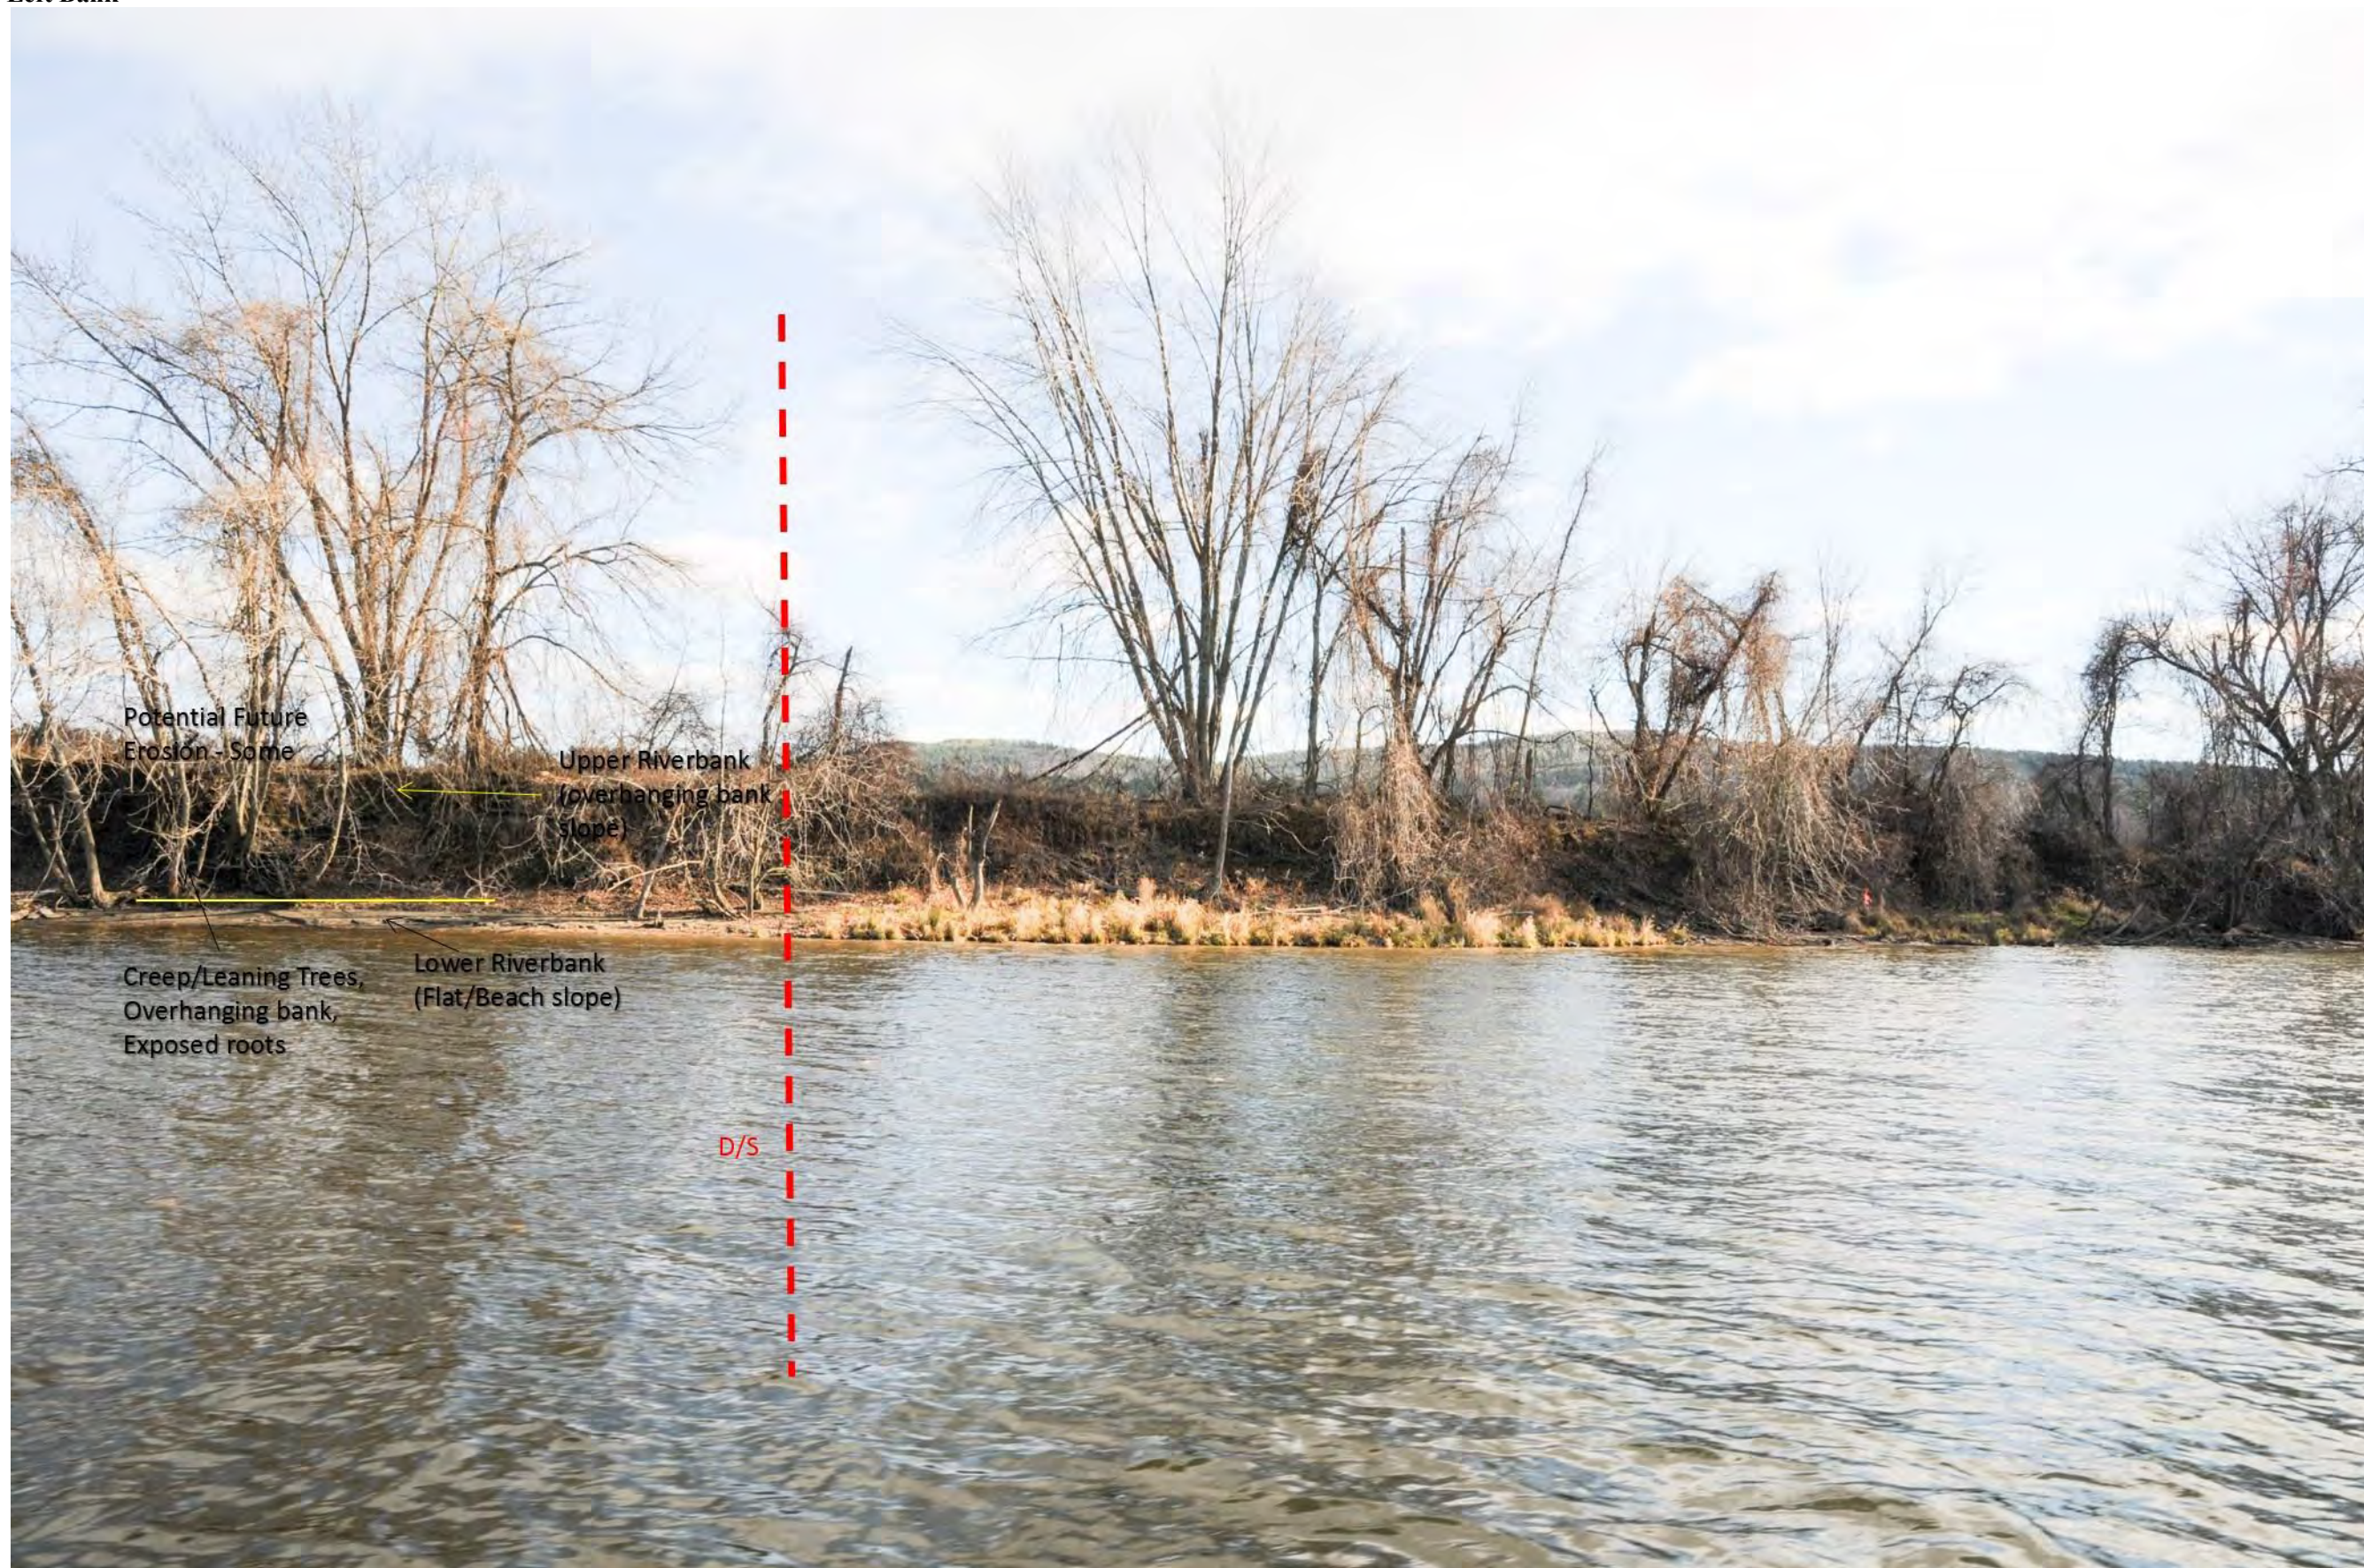
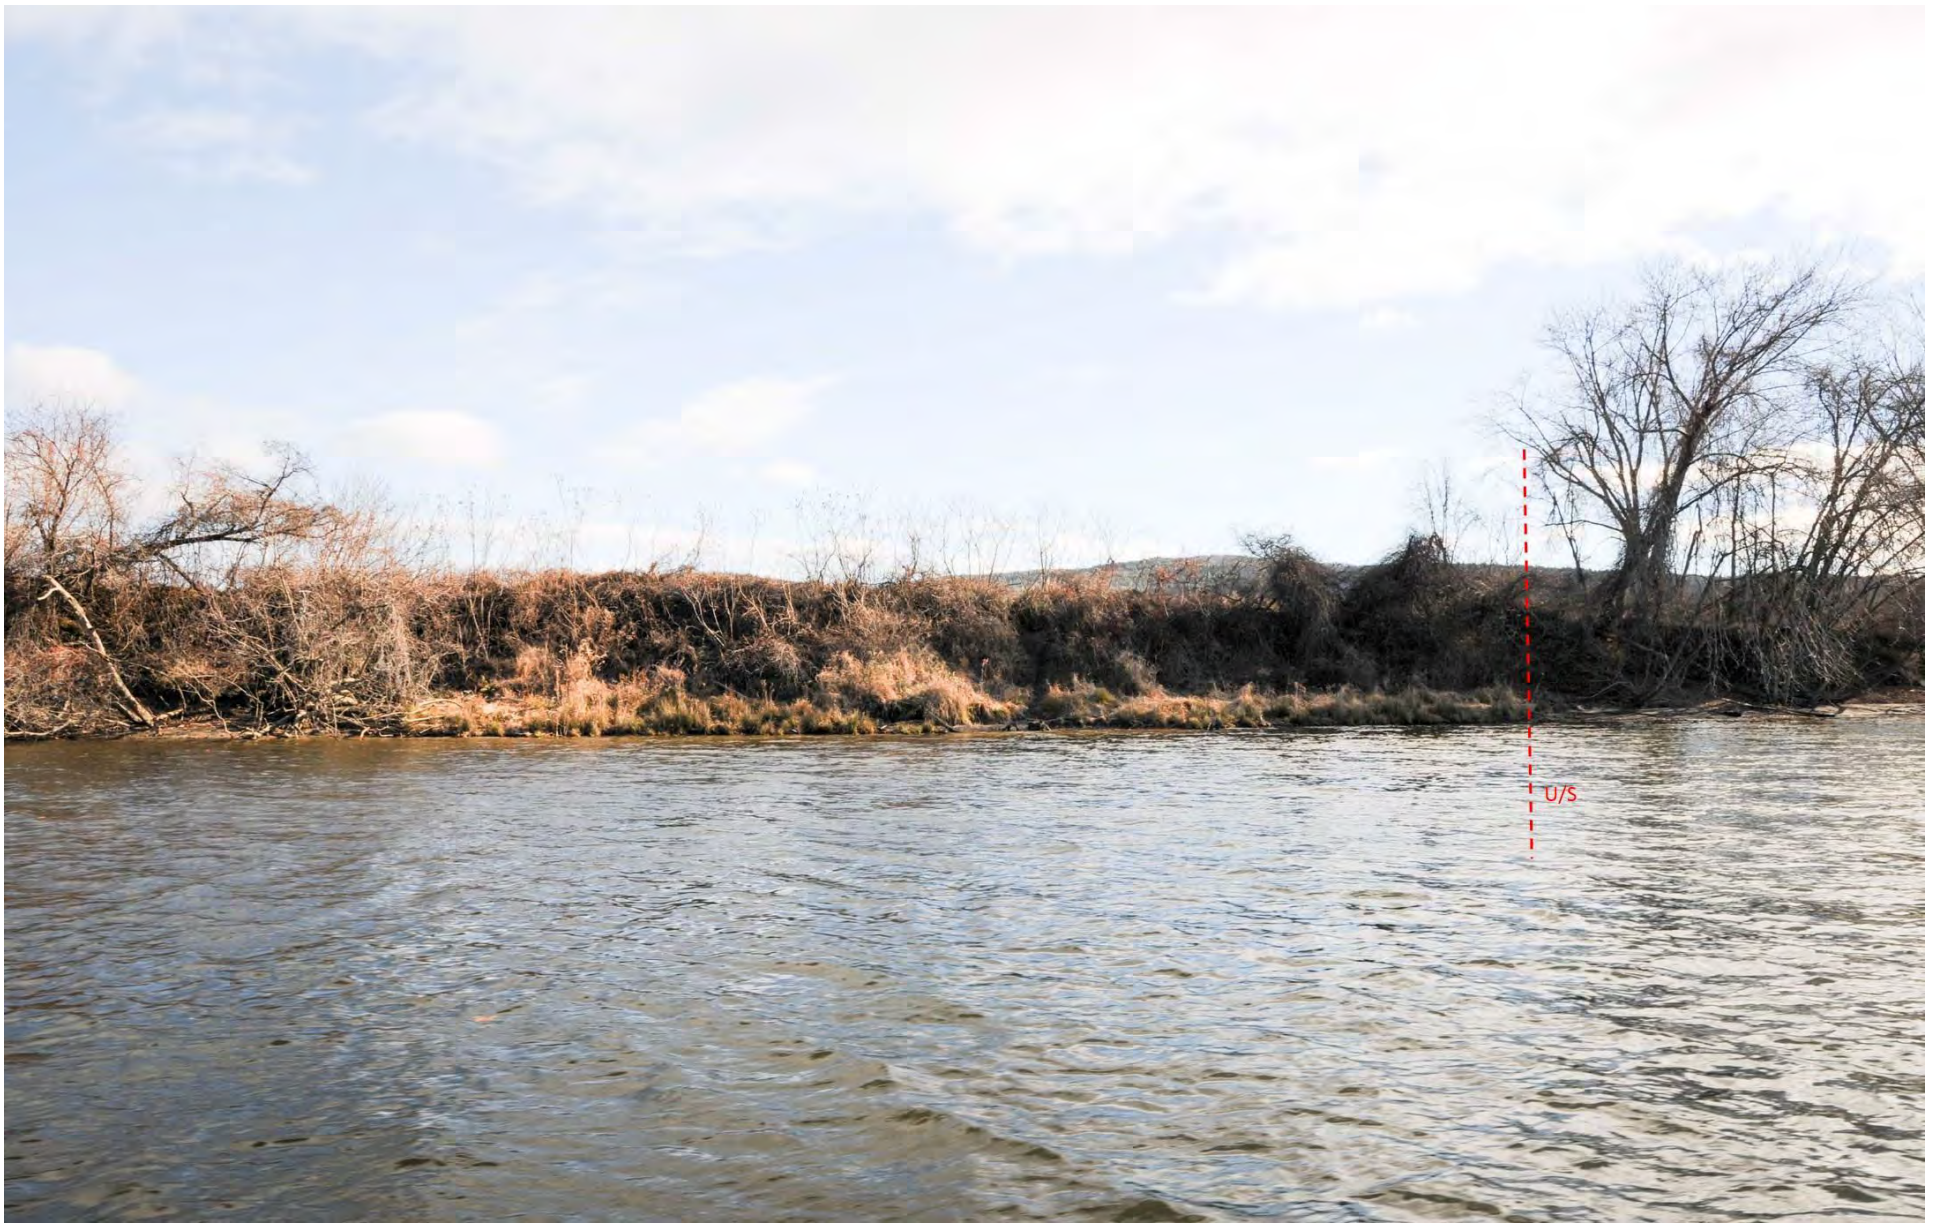
Approximate Photo Location

Riverbank Features	Characteristics
Upper Riverbank Slope	Overhanging
Upper Riverbank Height	Medium
Upper Riverbank Sediment	Silt/Sand
Upper Riverbank Vegetation	Moderate
Lower Riverbank Slope	Flat/Beach
Lower Riverbank Sediment	Silt/Sand
Lower Riverbank Vegetation	None to very sparse
Type of Erosion	
Potential Erosion Indicators	Creep/leaning trees, Overhanging bank, Exposed roots
Stage of Erosion	Potential Future Erosion
Extent of Erosion	Some

**QA Observations:** Upon review of the photos for this segment, classification made in the field was confirmed and additional indicators of potential future erosion were included.
