Re: Filing of Addendum to Study No. 3.1.1- 2013 Full River Reconnaissance  
Turners Falls Hydroelectric Project (FERC No. 1889) and Northfield Mountain Pumped Storage  
Project (FERC No. 2485)

## **ATTACHMENT A: 2013 Full River Reconnaissance – 2015 Addendum: Riverbank Segment QA Comparison**

2015 FRR Addendum  
 Selected Riverbank Segments for QA  
 Map 1

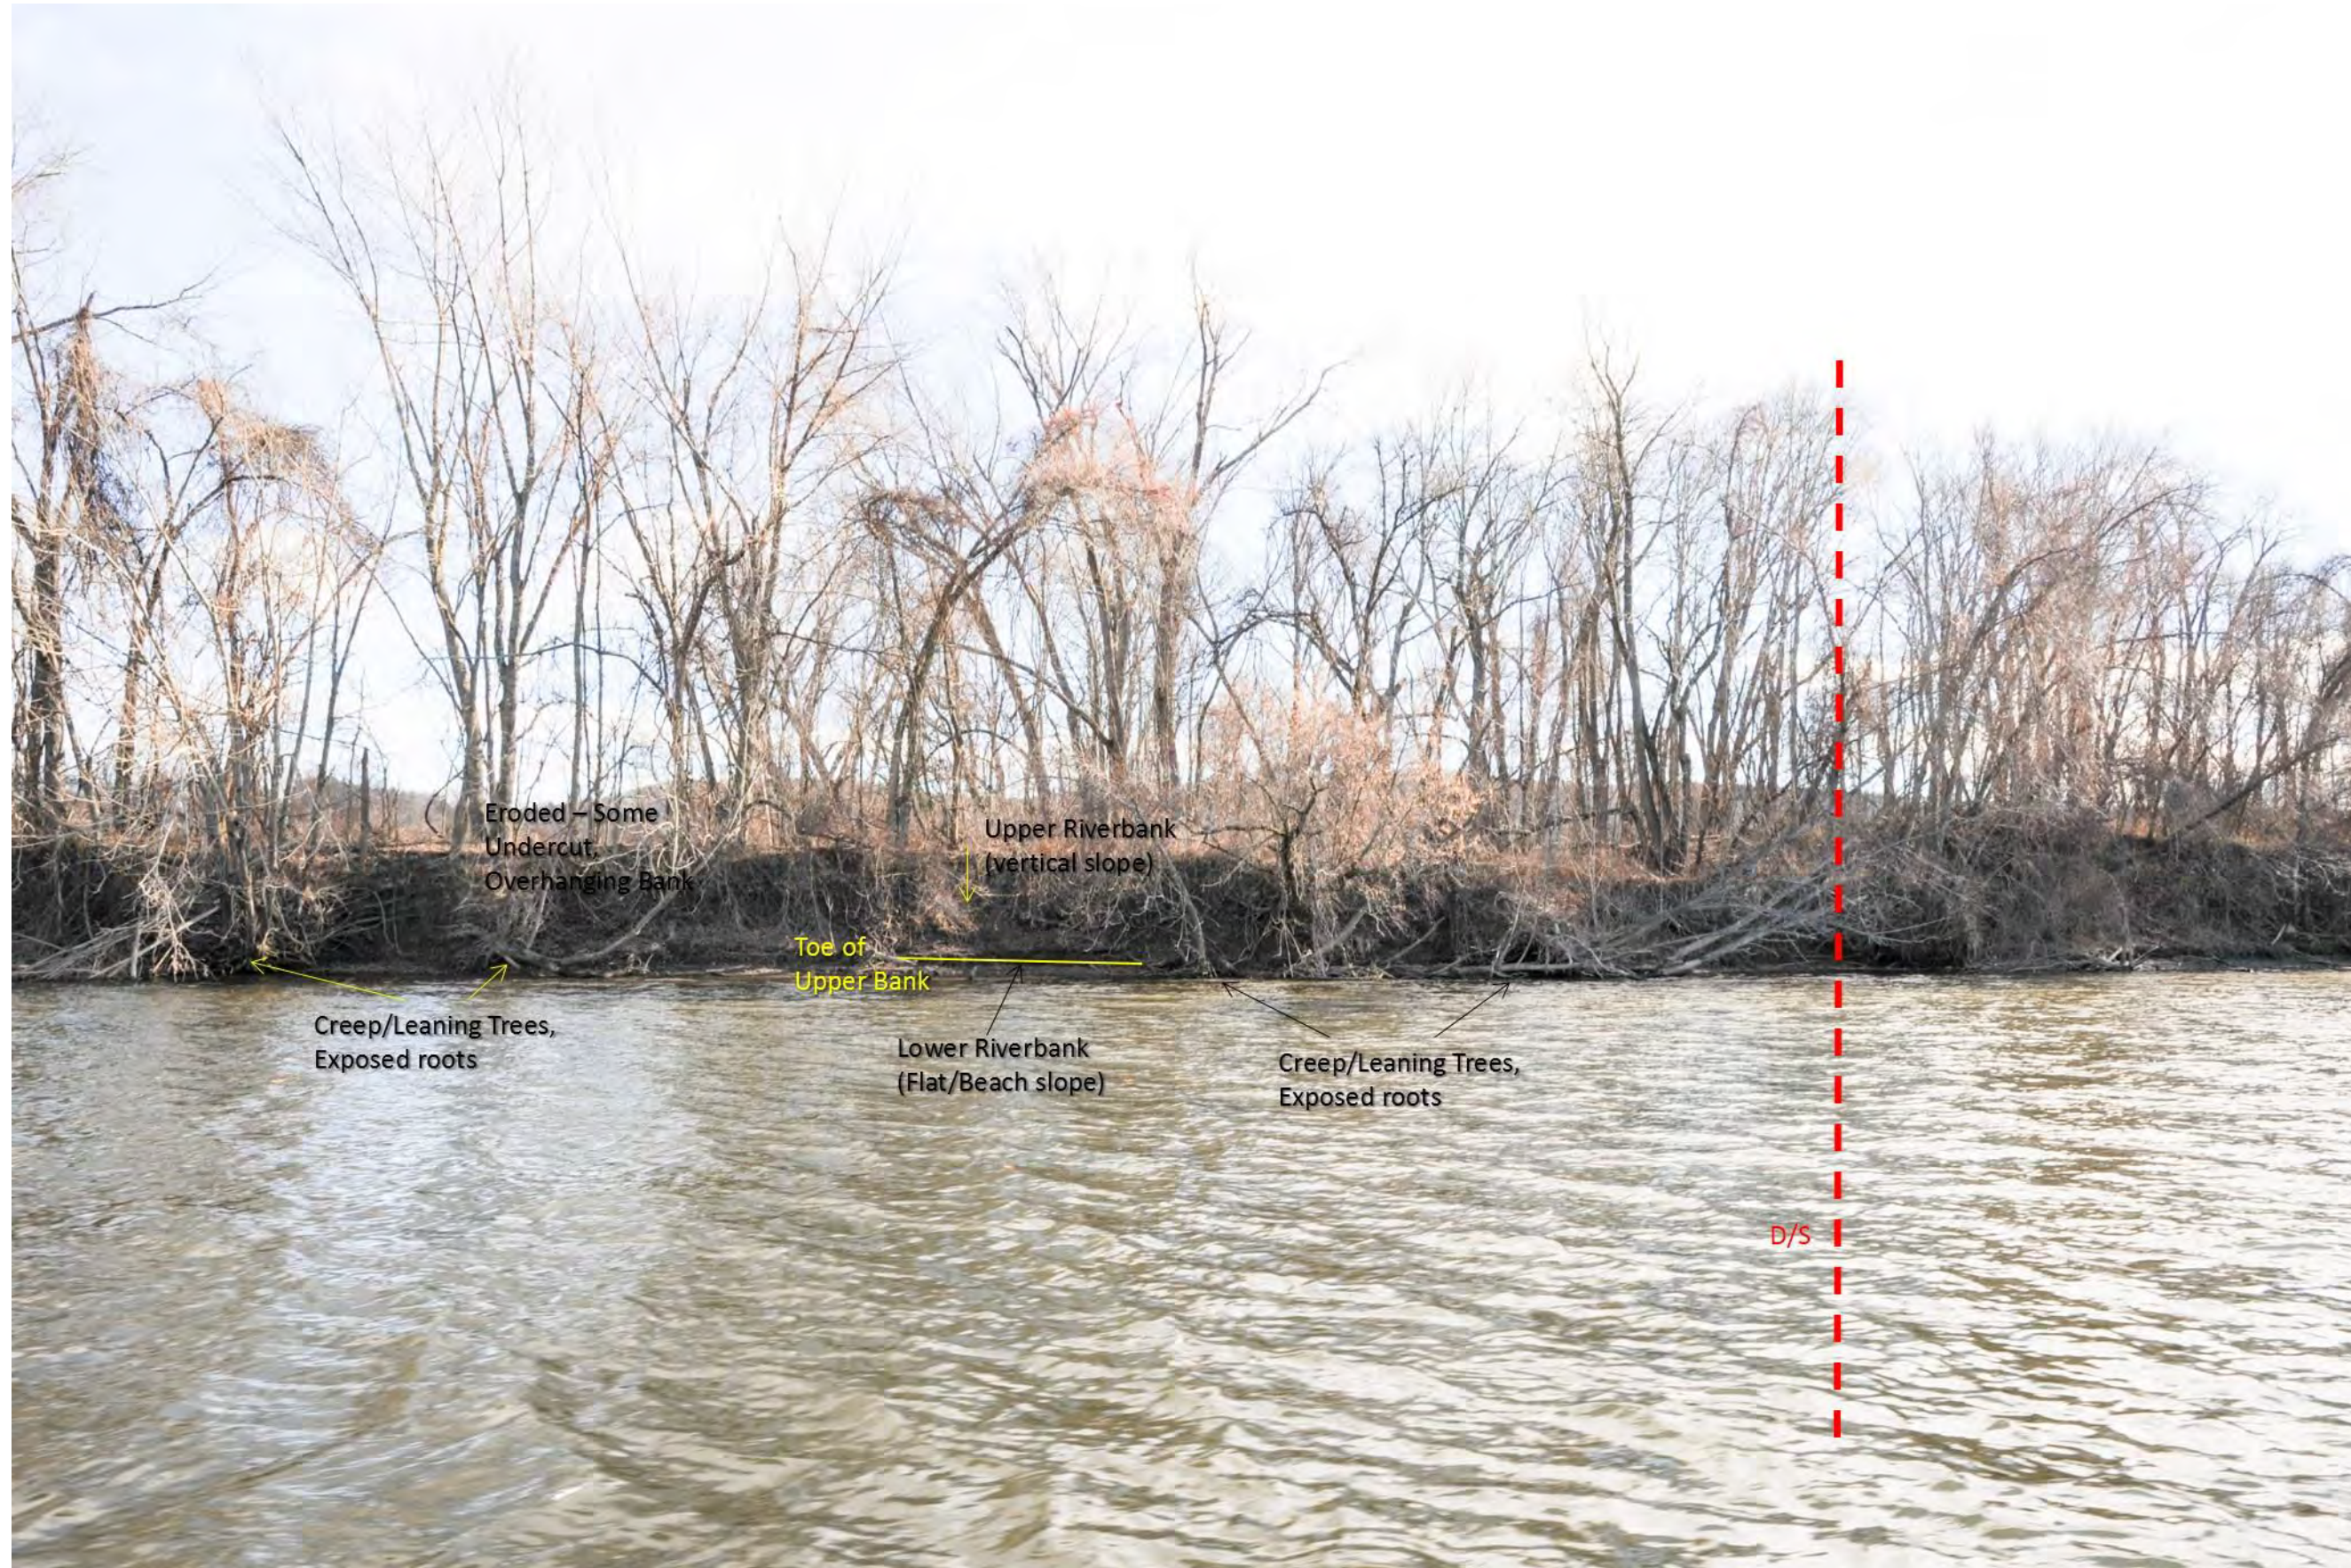
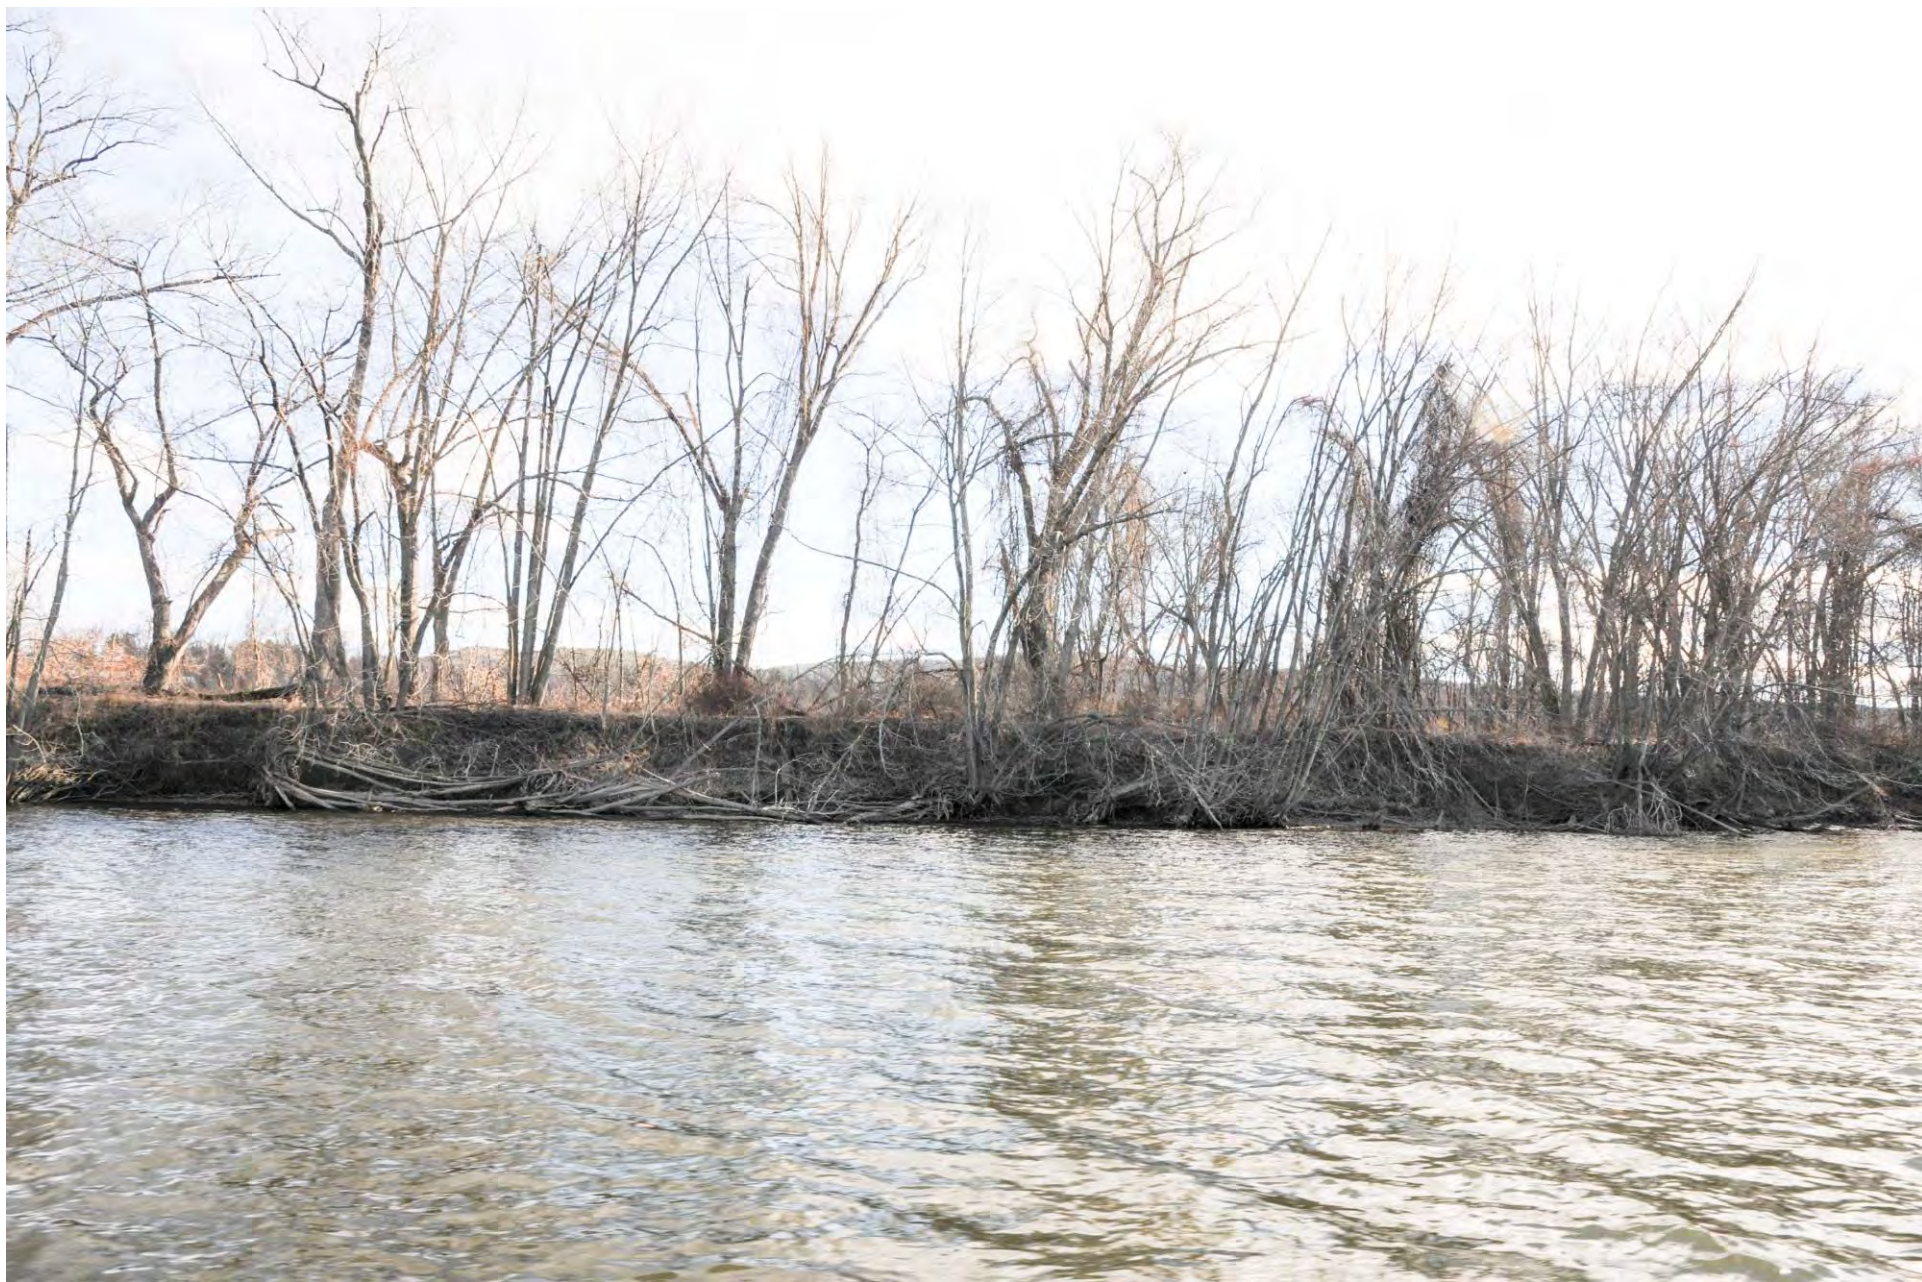
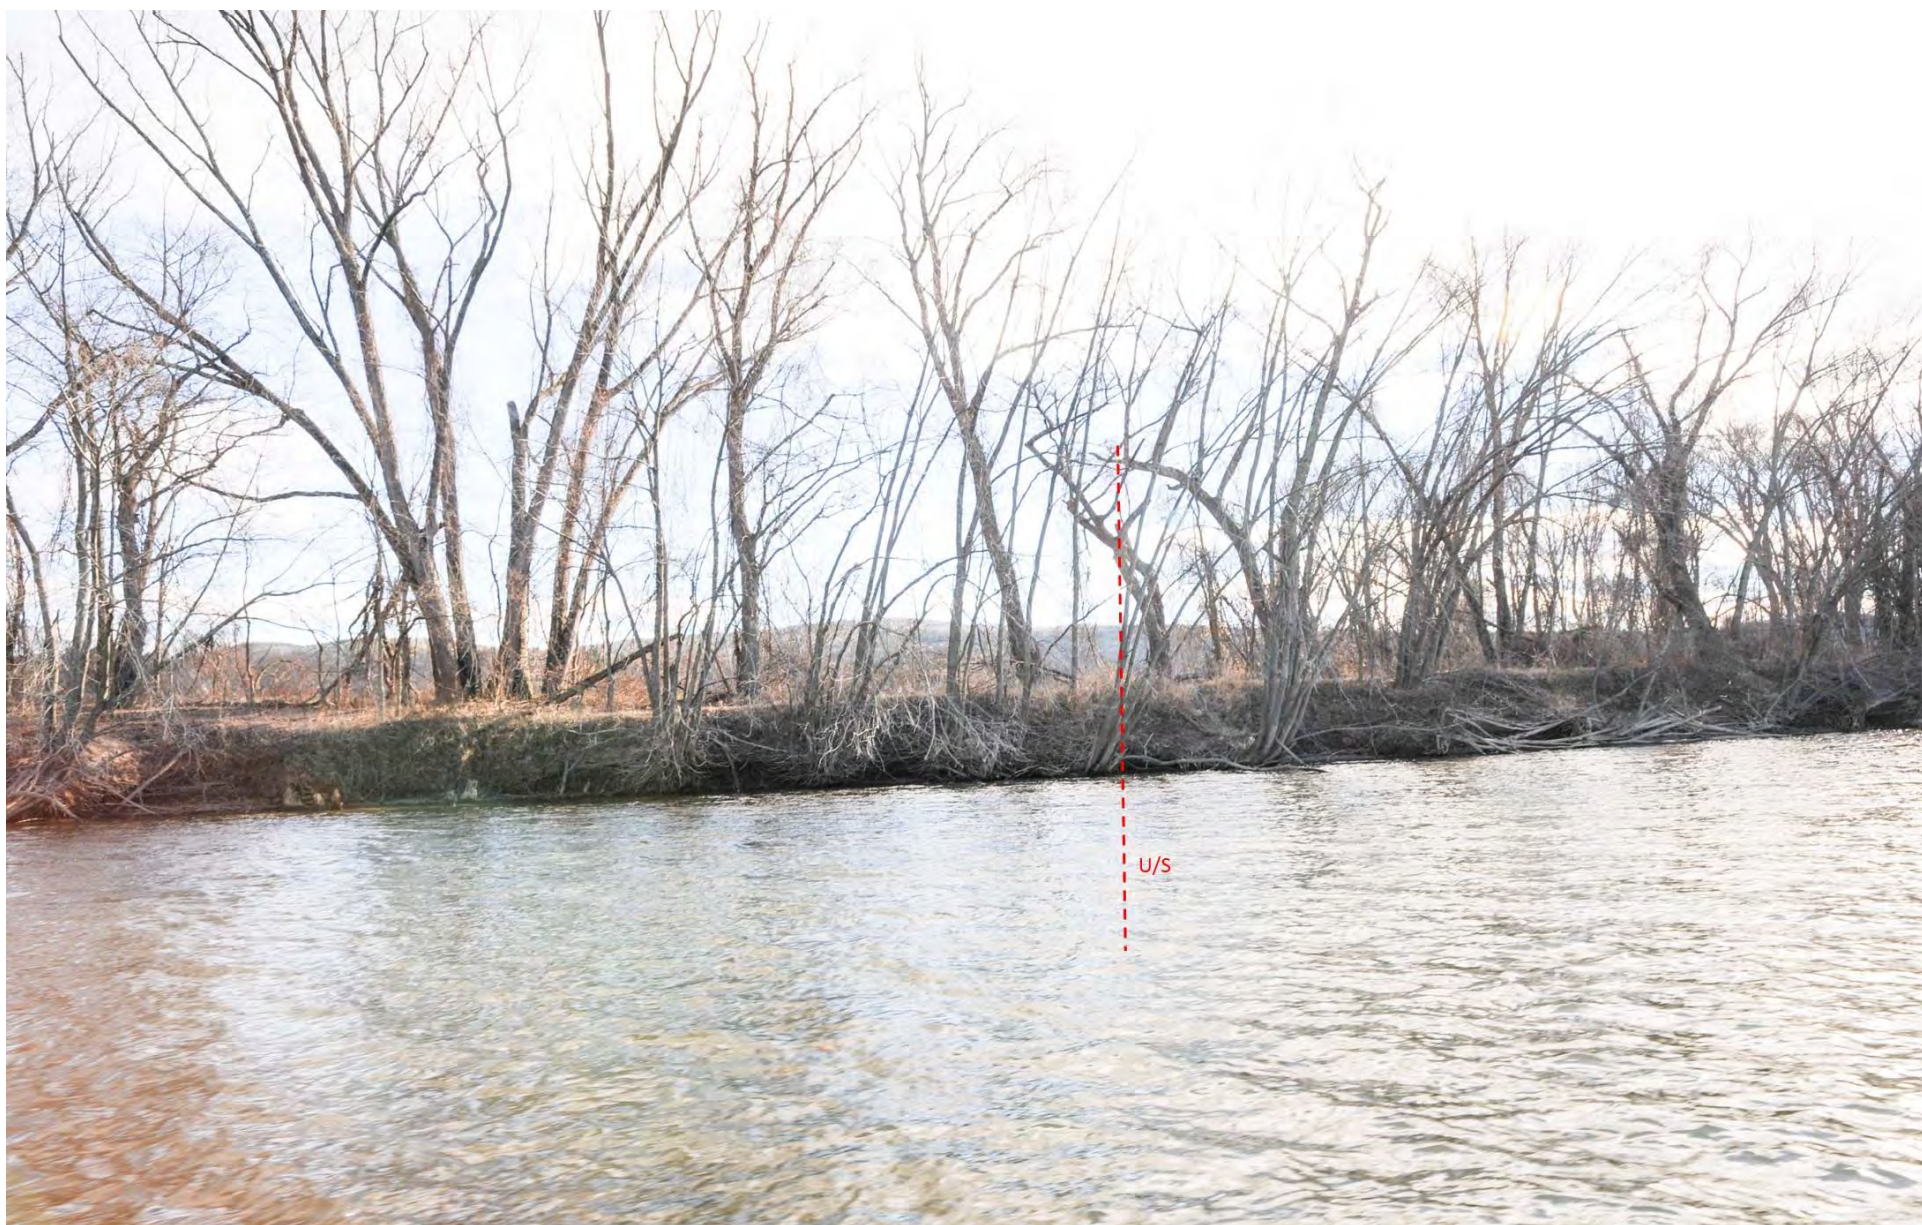
Approximate Photo Location

Riverbank Features	Characteristics
Upper Riverbank Slope	Vertical
Upper Riverbank Height	Low
Upper Riverbank Sediment	Silt/Sand
Upper Riverbank Vegetation	Moderate
Lower Riverbank Slope	Flat/Beach
Lower Riverbank Sediment	Silt/Sand
Lower Riverbank Vegetation	None to very sparse
Type of Erosion	Undercut
Potential Erosion Indicators	Creep/leaning trees, Exposed roots, Overhanging bank
Stage of Erosion	Eroded
Extent of Erosion	Some

**QA Observations:** Upon review of the photos for this segment, classification made in the field was confirmed and additional indicators of potential future erosion were included.

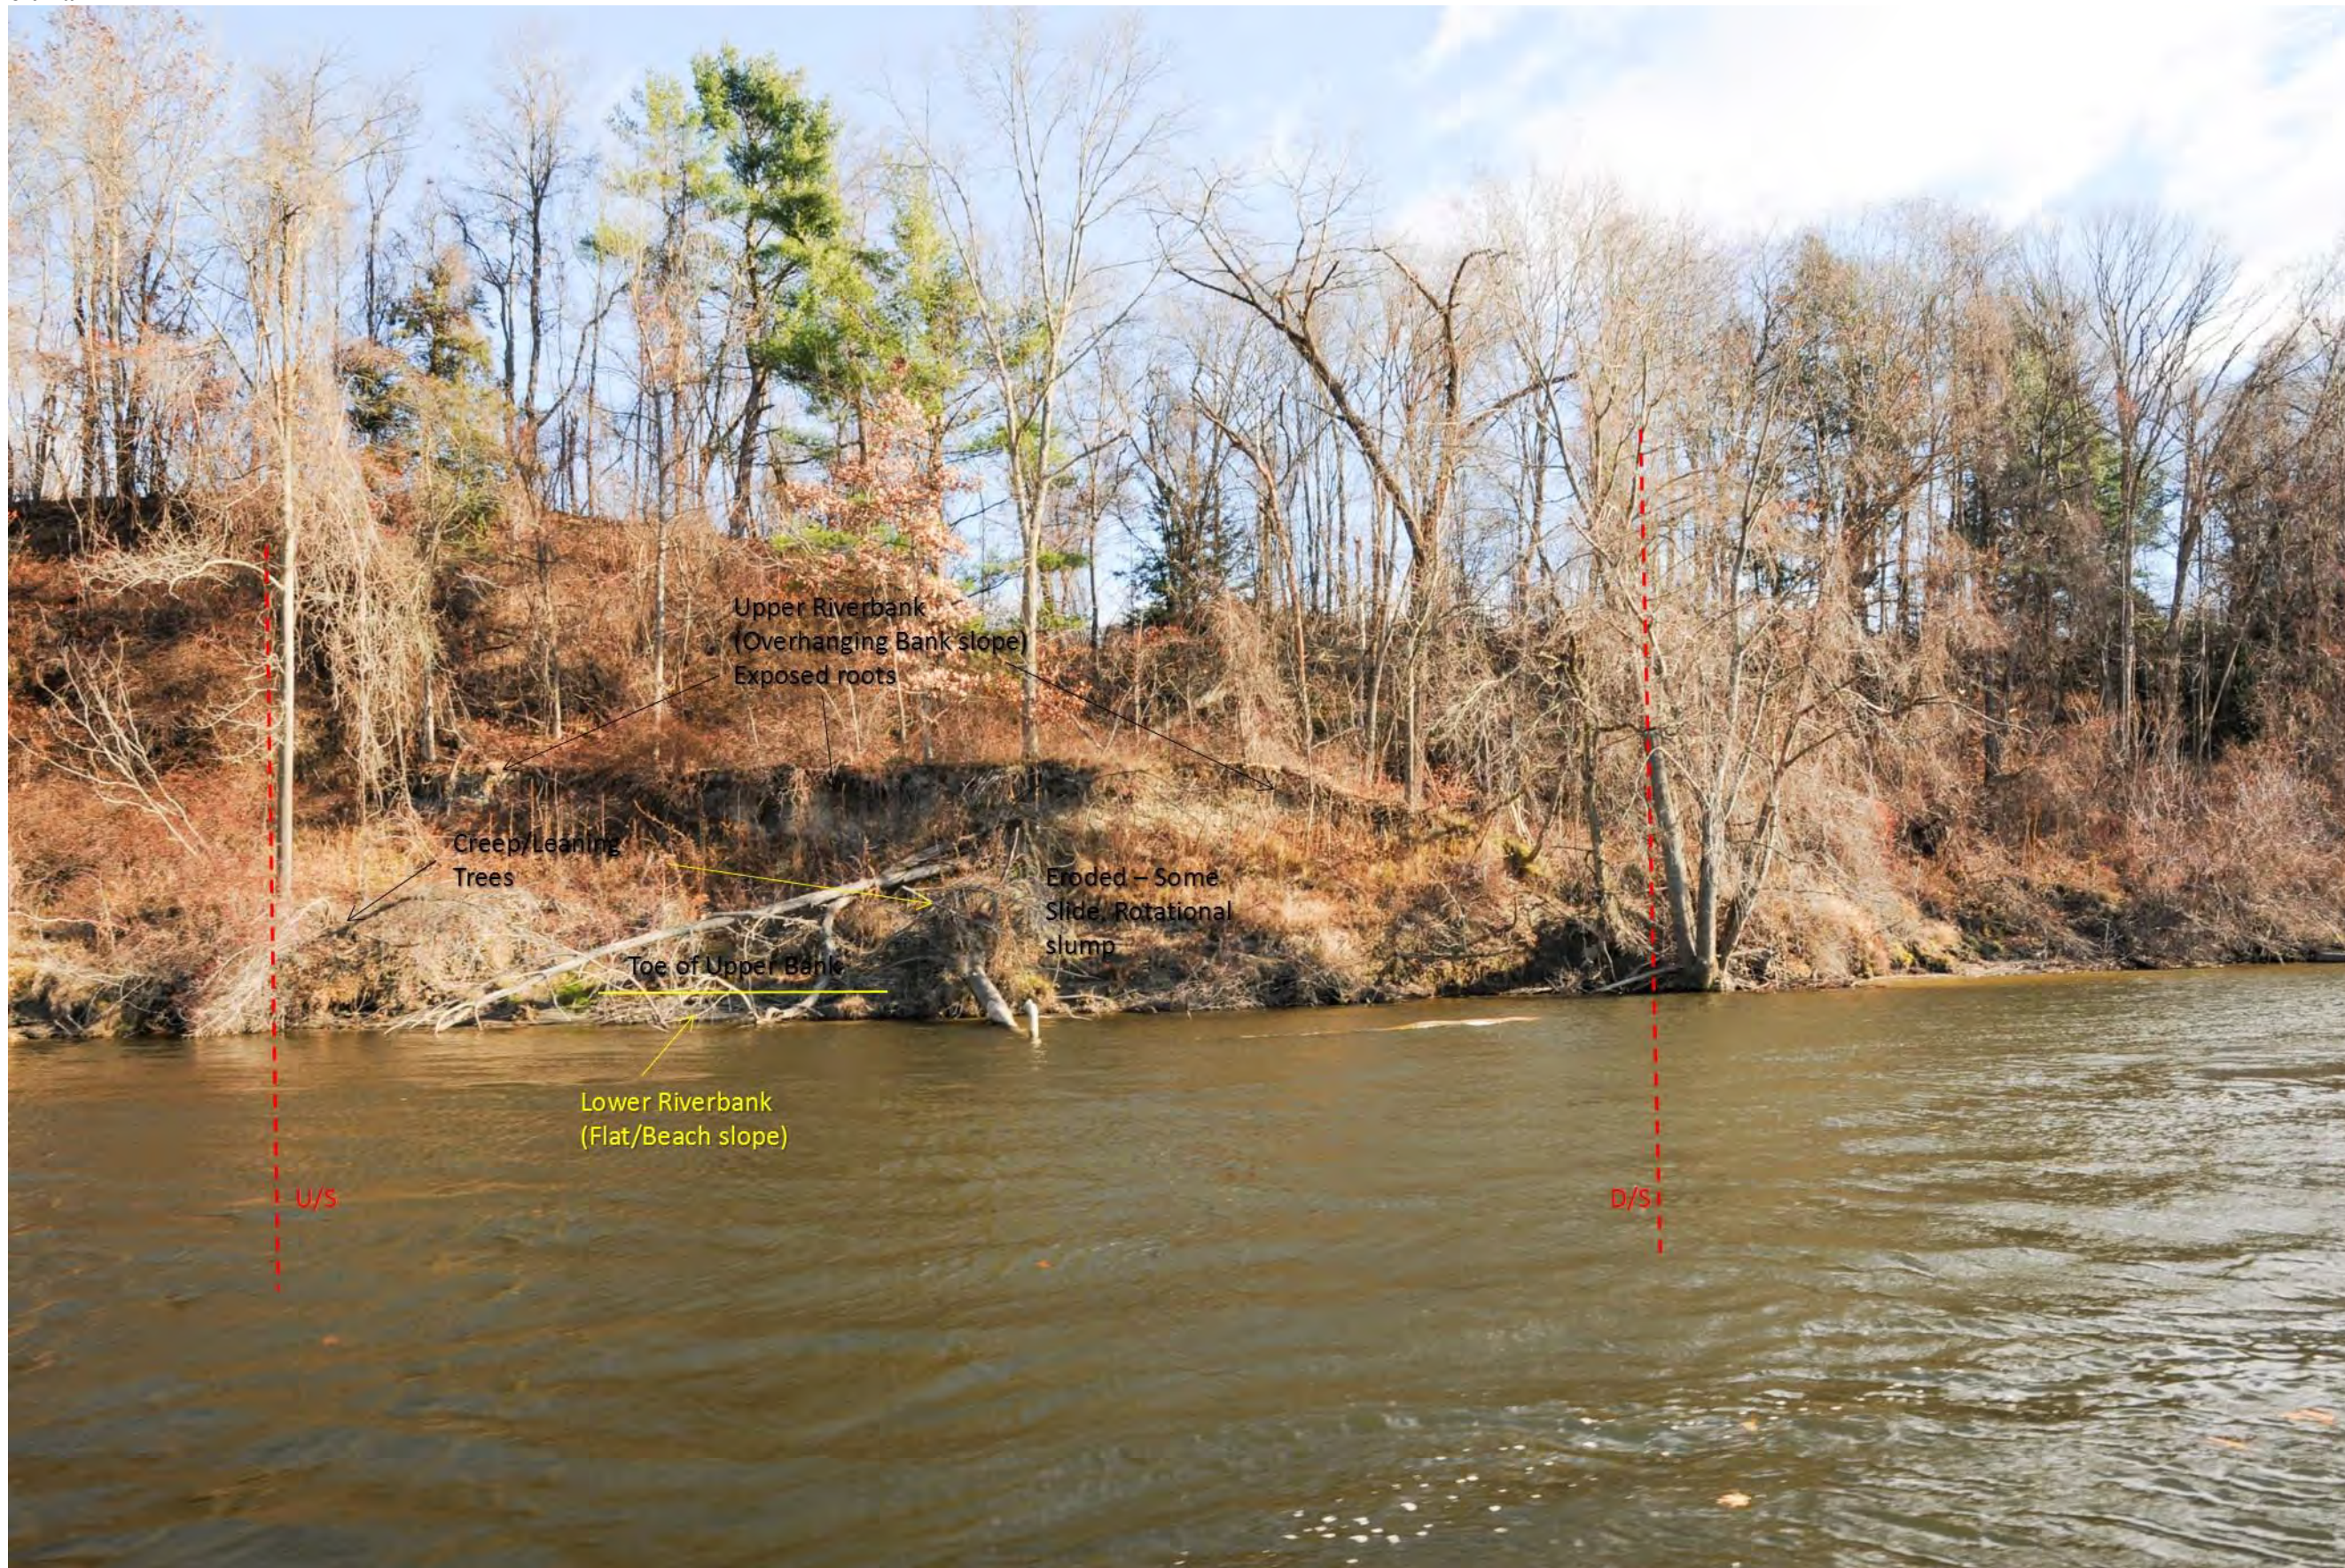
Approximate Photo Location

Riverbank Features	Characteristics
Upper Riverbank Slope	Overhanging
Upper Riverbank Height	High
Upper Riverbank Sediment	Silt/Sand
Upper Riverbank Vegetation	Moderate
Lower Riverbank Slope	Flat/Beach
Lower Riverbank Sediment	Silt/Sand
Lower Riverbank Vegetation	None to very sparse
Type of Erosion	Slide, Rotational Slump
Potential Erosion Indicators	Overhanging bank, Creep/leaning trees, Exposed roots,
Stage of Erosion	Eroded
Extent of Erosion	Some

**QA Observations:** Upon review of the photos for this segment, classification made in the field was confirmed and additional indicators of potential future erosion were included.

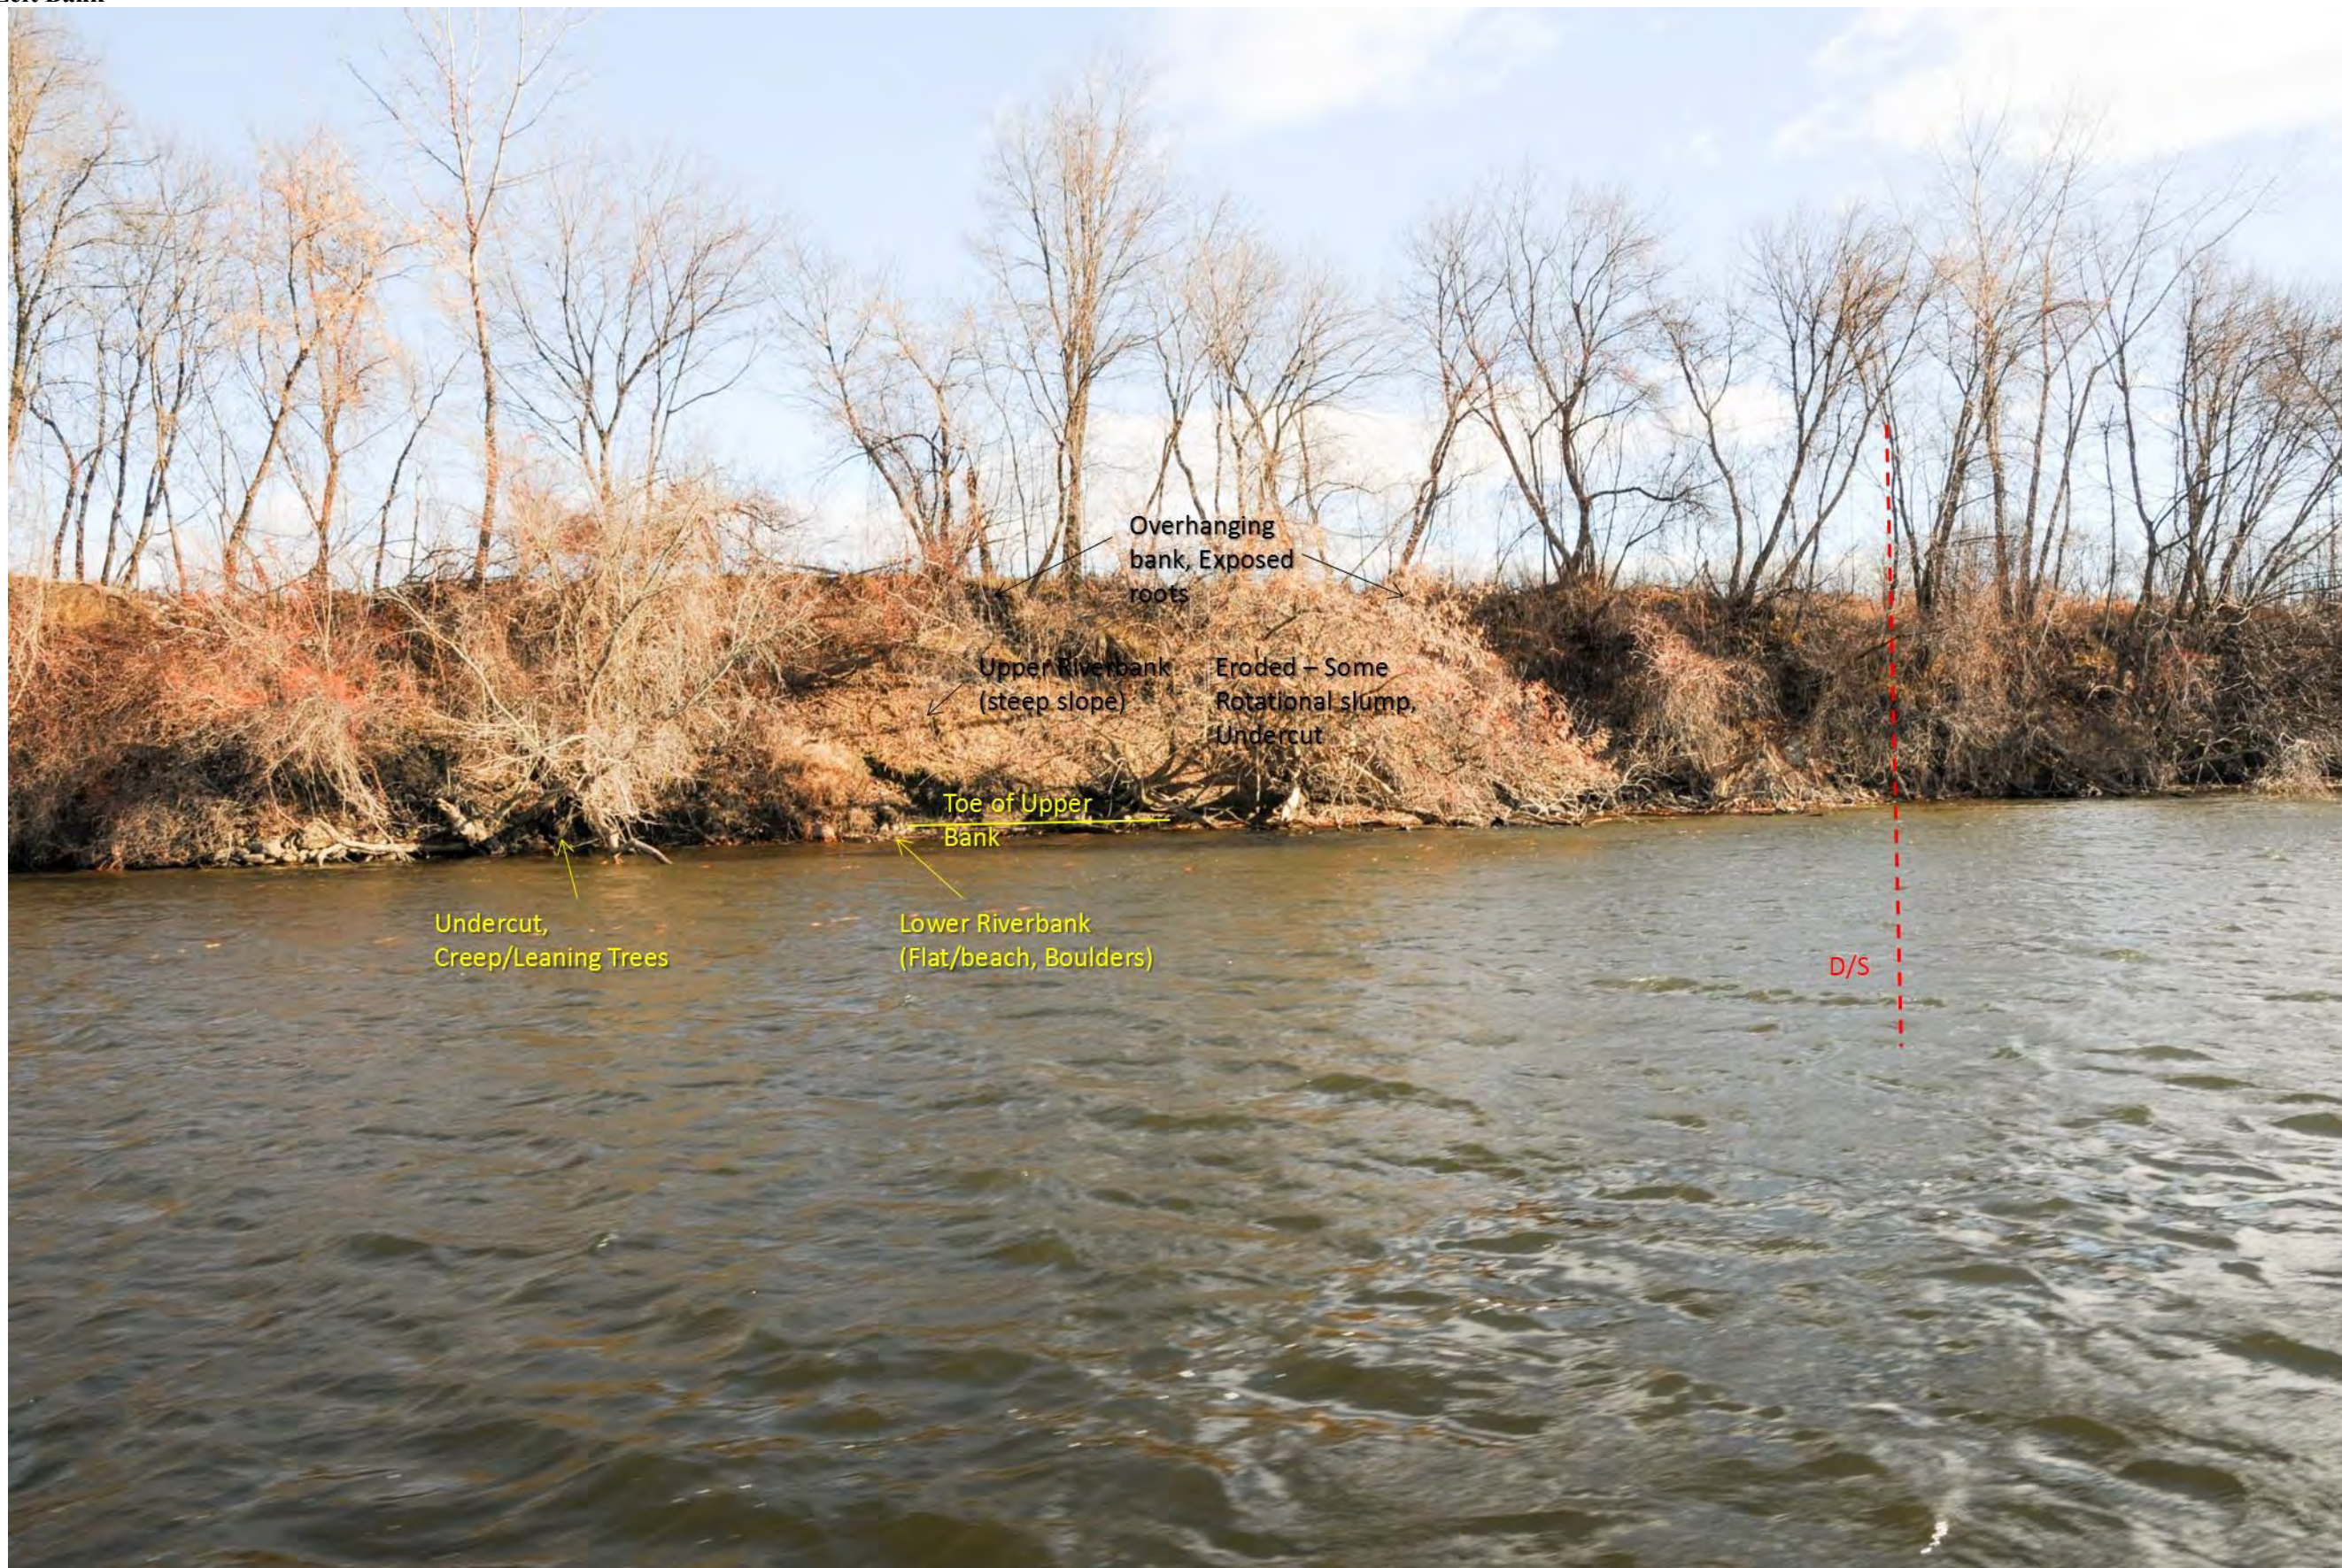
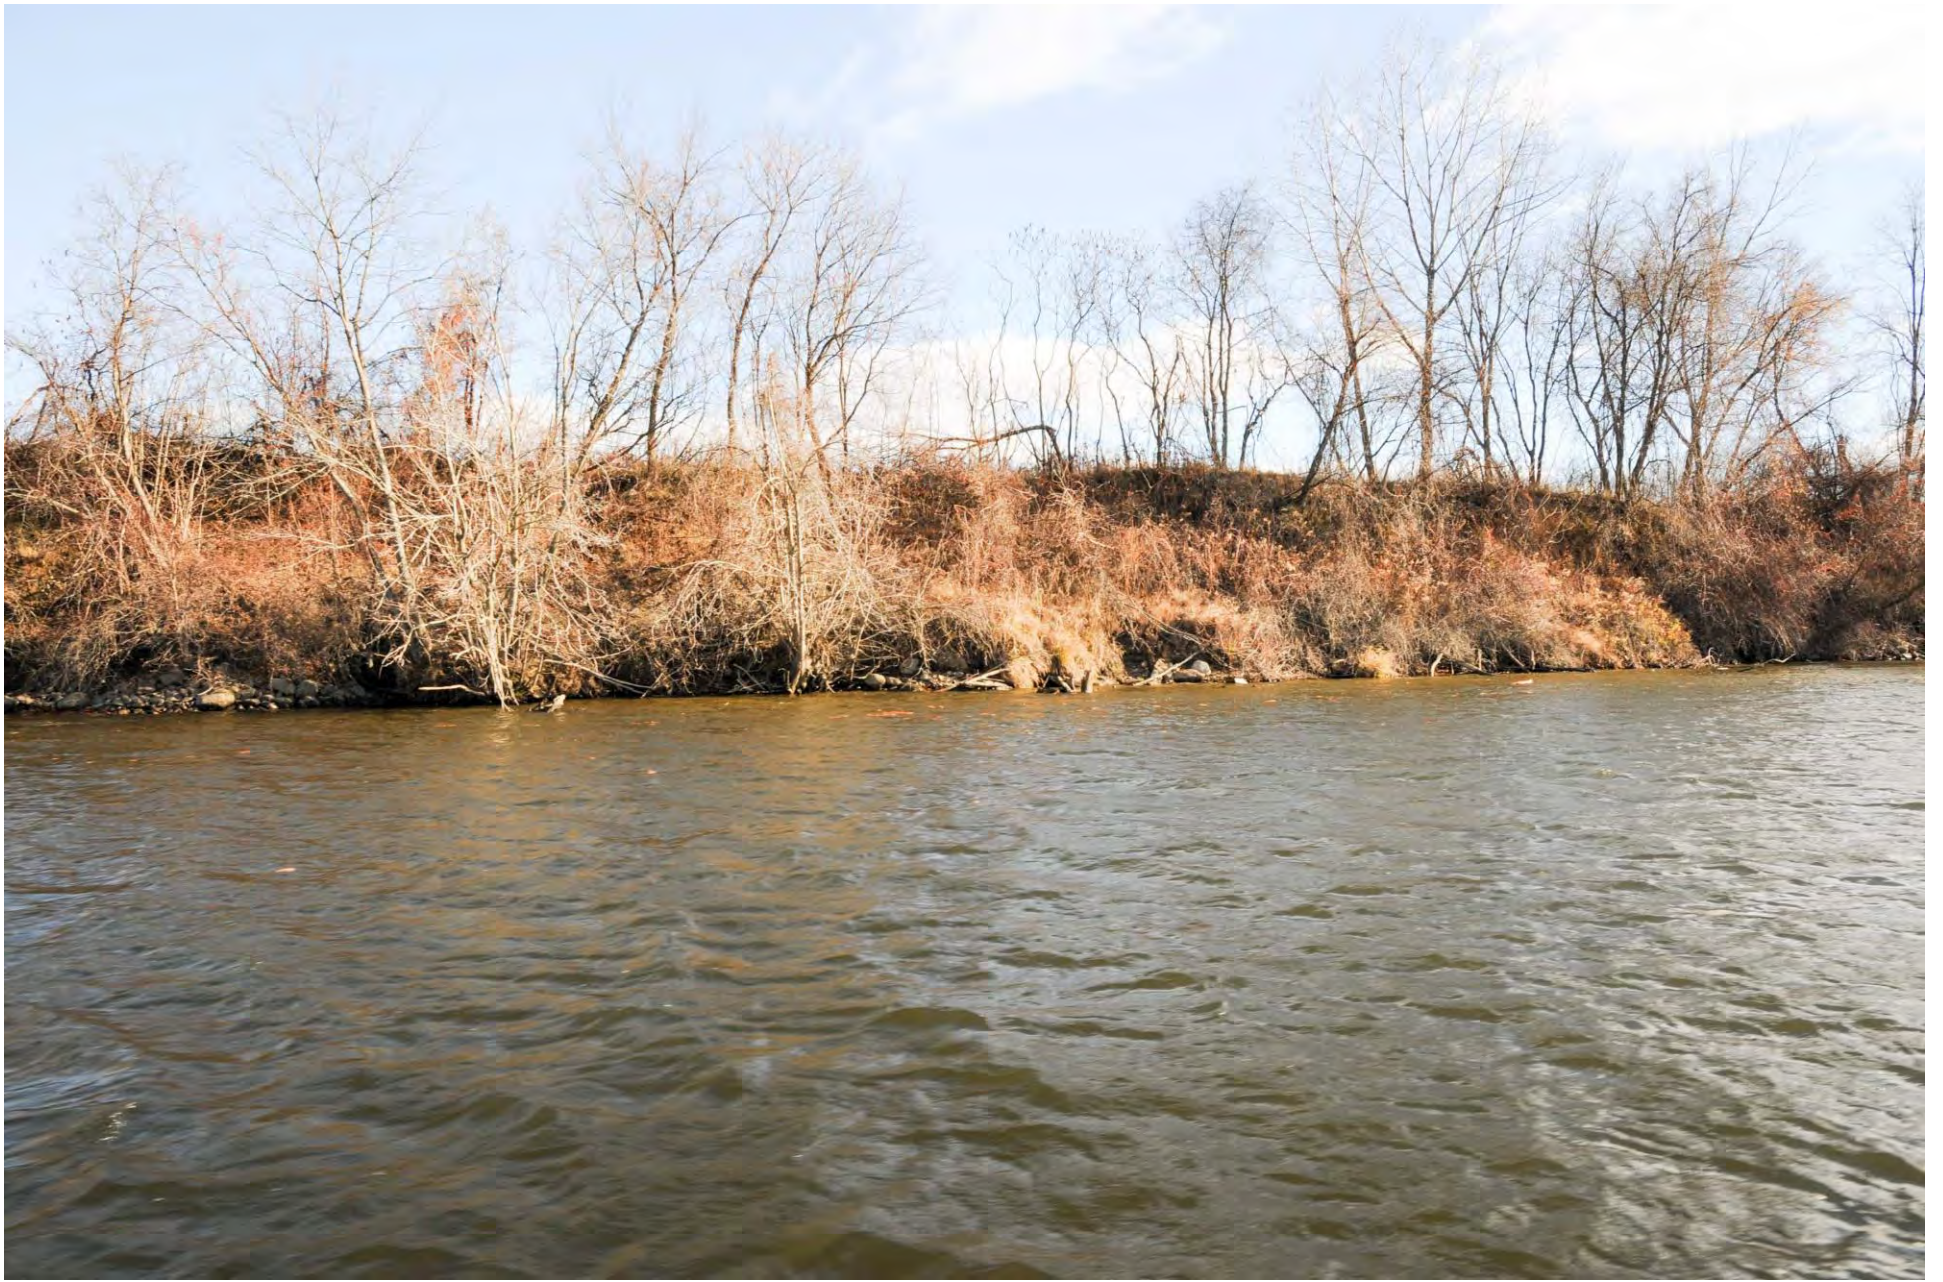
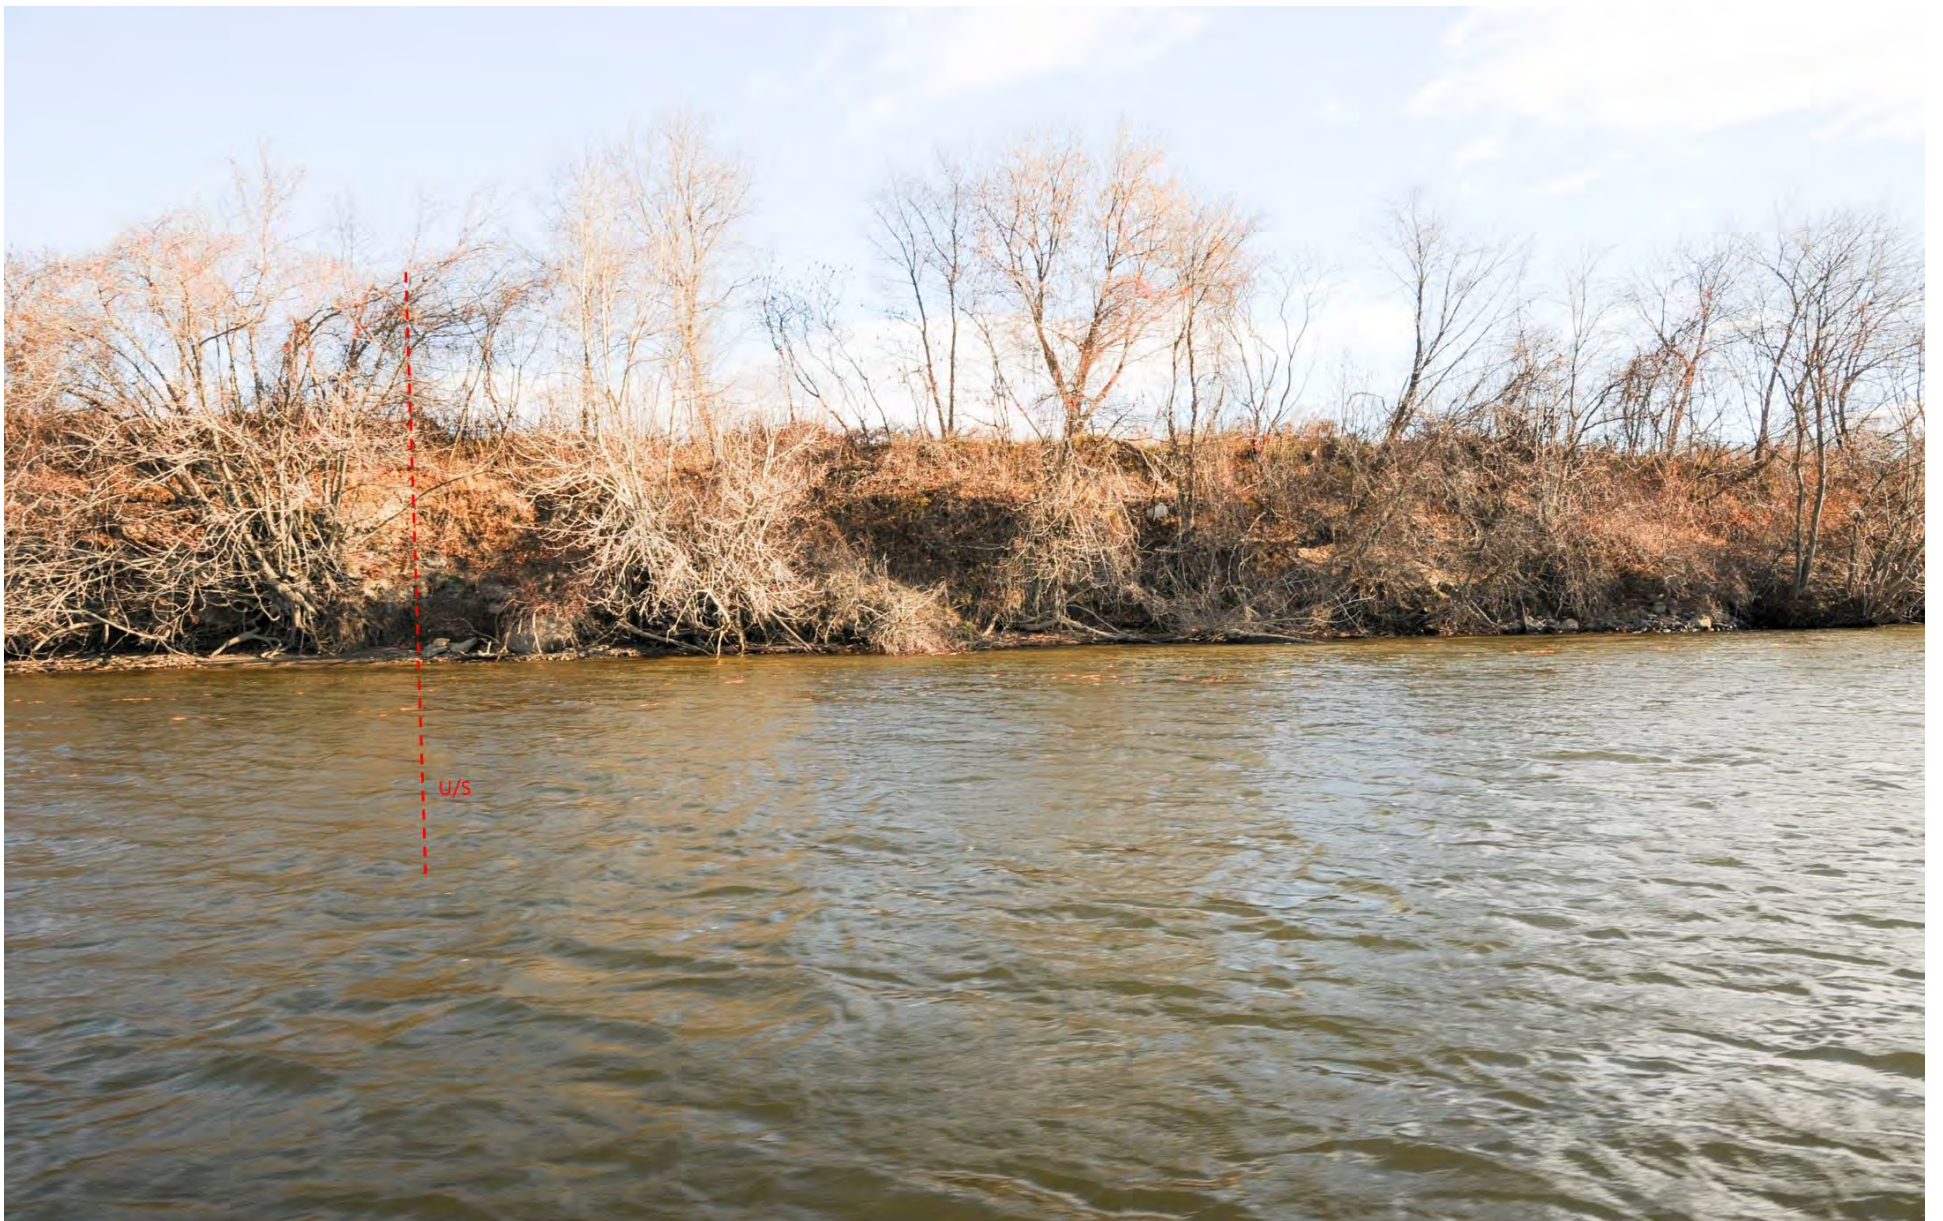
Approximate Photo Location

Riverbank Features	Characteristics
Upper Riverbank Slope	Steep
Upper Riverbank Height	High
Upper Riverbank Sediment	Silt/Sand
Upper Riverbank Vegetation	Moderate
Lower Riverbank Slope	Flat/Beach
Lower Riverbank Sediment	Boulders
Lower Riverbank Vegetation	None to very sparse
Type of Erosion	Rotational Slump, Undercut
Potential Erosion Indicators	Creep/leaning trees, Overhanging bank, Exposed roots
Stage of Erosion	Eroded
Extent of Erosion	Some

**QA Observations:** Upon review of the photos for this segment, classification made in the field was confirmed and additional indicators of potential future erosion were included.
