Re: Filing of Addendum to Study No. 3.1.1- 2013 Full River Reconnaissance  
Turners Falls Hydroelectric Project (FERC No. 1889) and Northfield Mountain Pumped Storage  
Project (FERC No. 2485)

## **ATTACHMENT A: 2013 Full River Reconnaissance – 2015 Addendum: Riverbank Segment QA Comparison**

2015 FRR Addendum  
 Selected Riverbank Segments for QA  
 Map 1

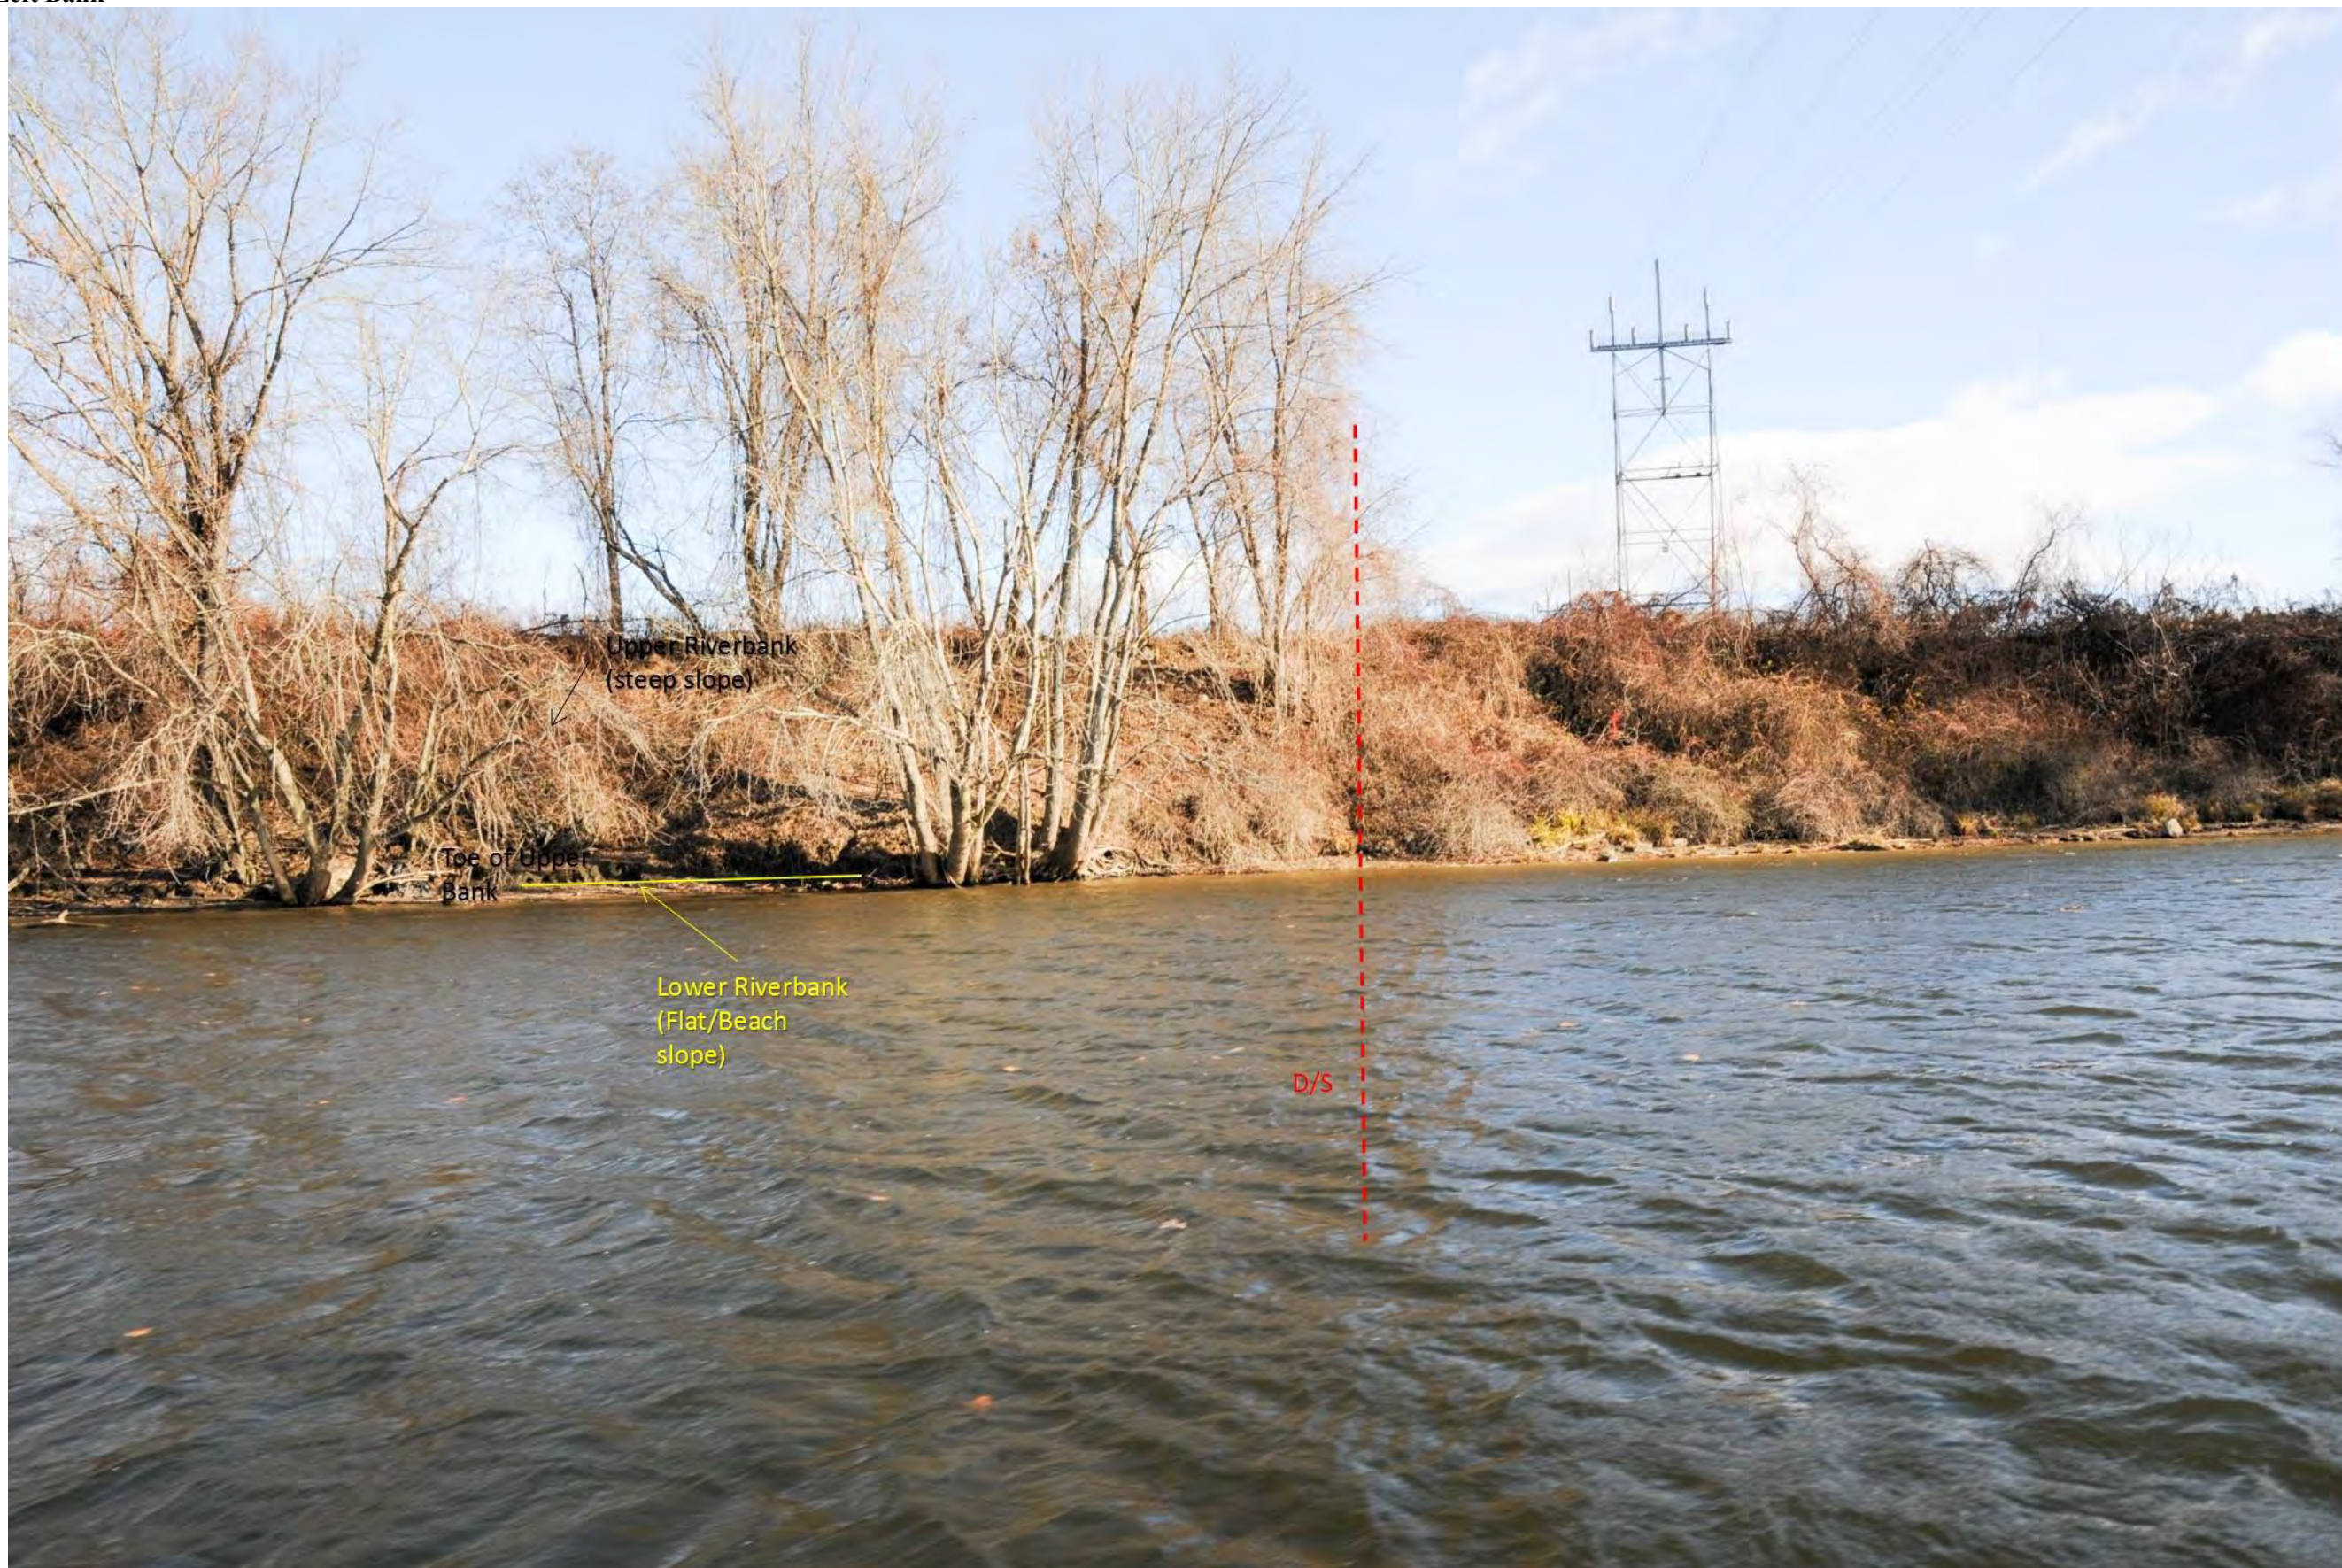
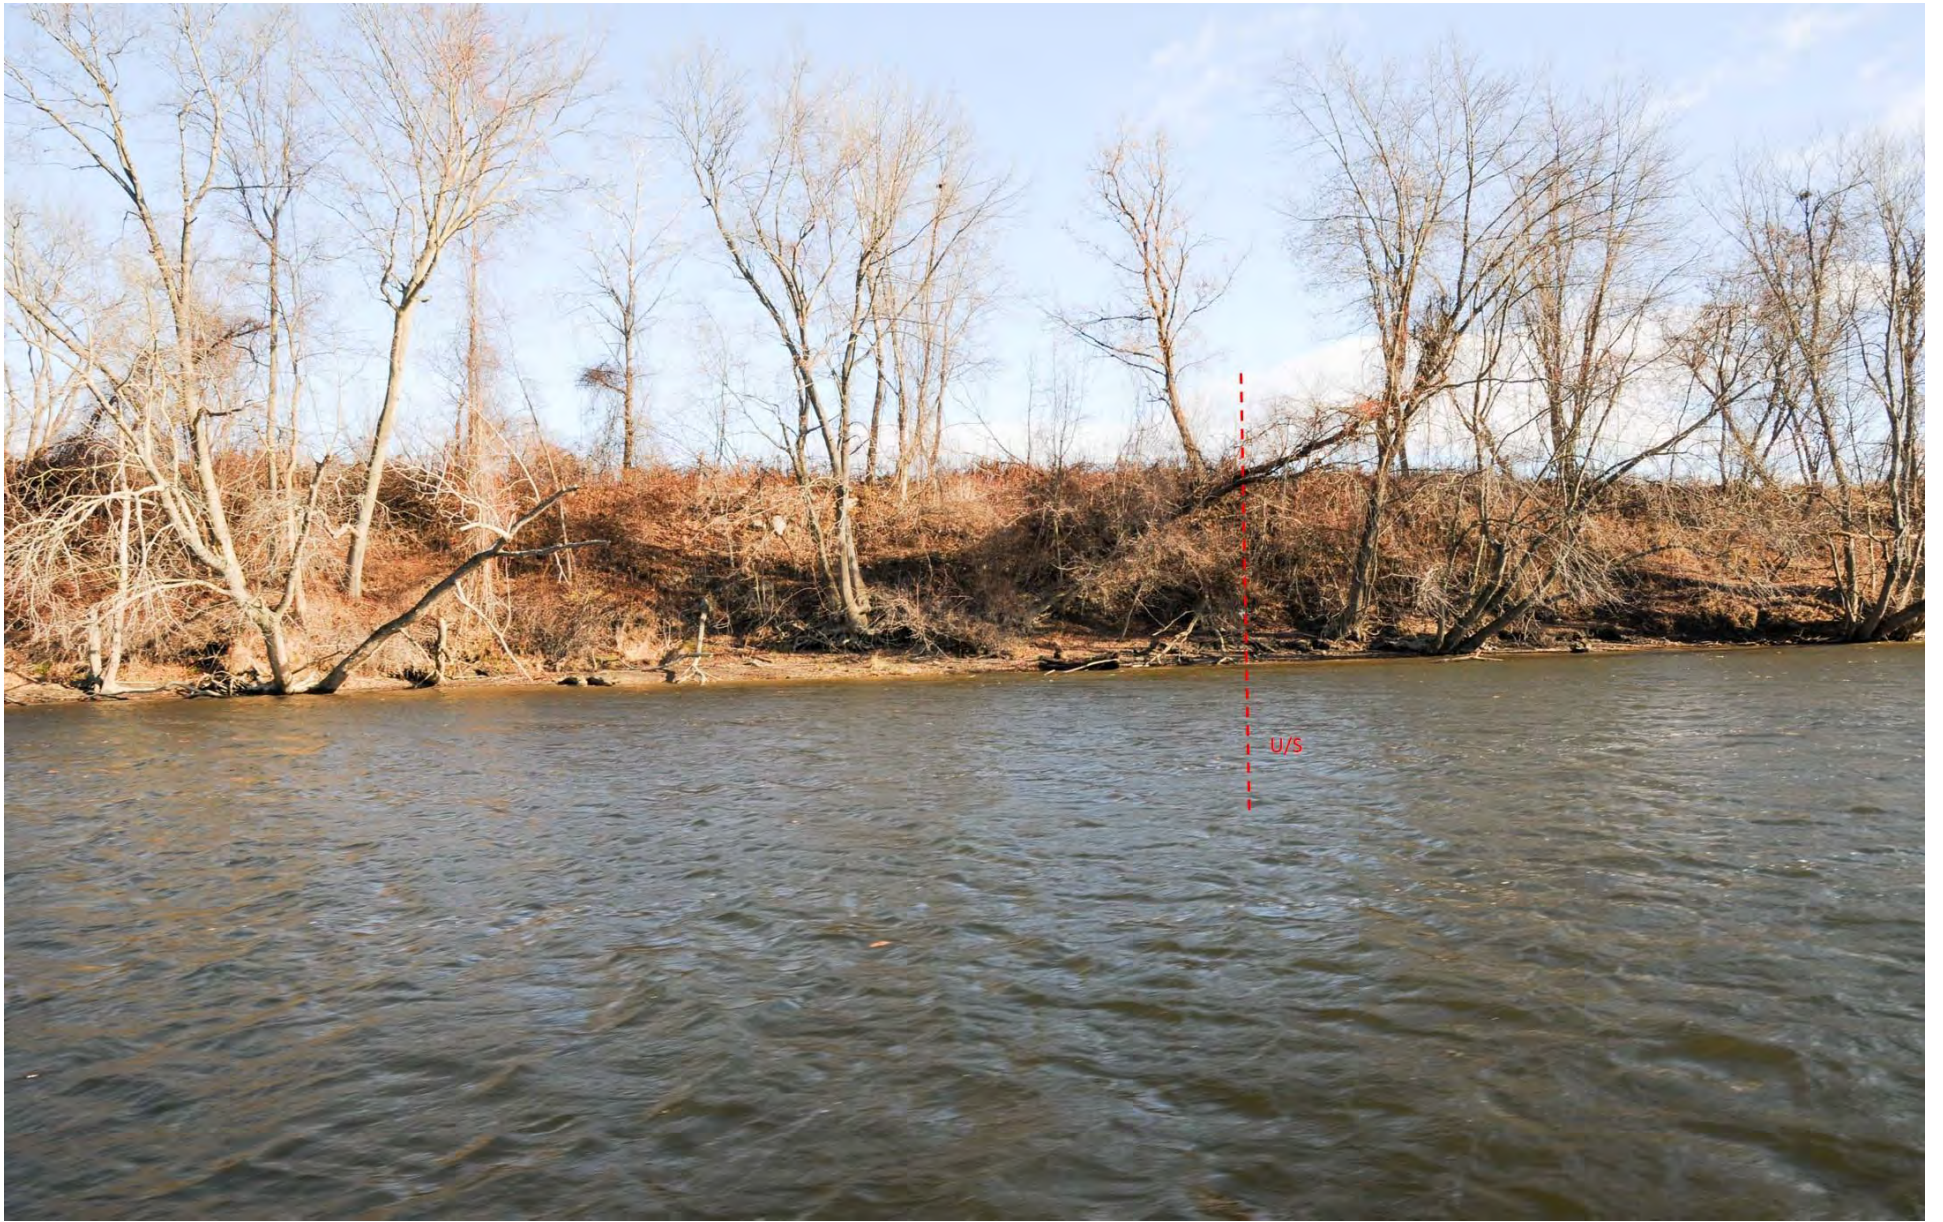
Approximate Photo Location

Riverbank Features	Characteristics
Upper Riverbank Slope	Steep
Upper Riverbank Height	High
Upper Riverbank Sediment	Silt/Sand
Upper Riverbank Vegetation	Heavy
Lower Riverbank Slope	Flat/Beach
Lower Riverbank Sediment	Silt/Sand
Lower Riverbank Vegetation	None to very sparse
Type of Erosion	
Potential Erosion Indicators	None
Stage of Erosion	Stable
Extent of Erosion	None/Little

**QA Observations:** Upon review of the photos for this segment, classification made in the field was confirmed.

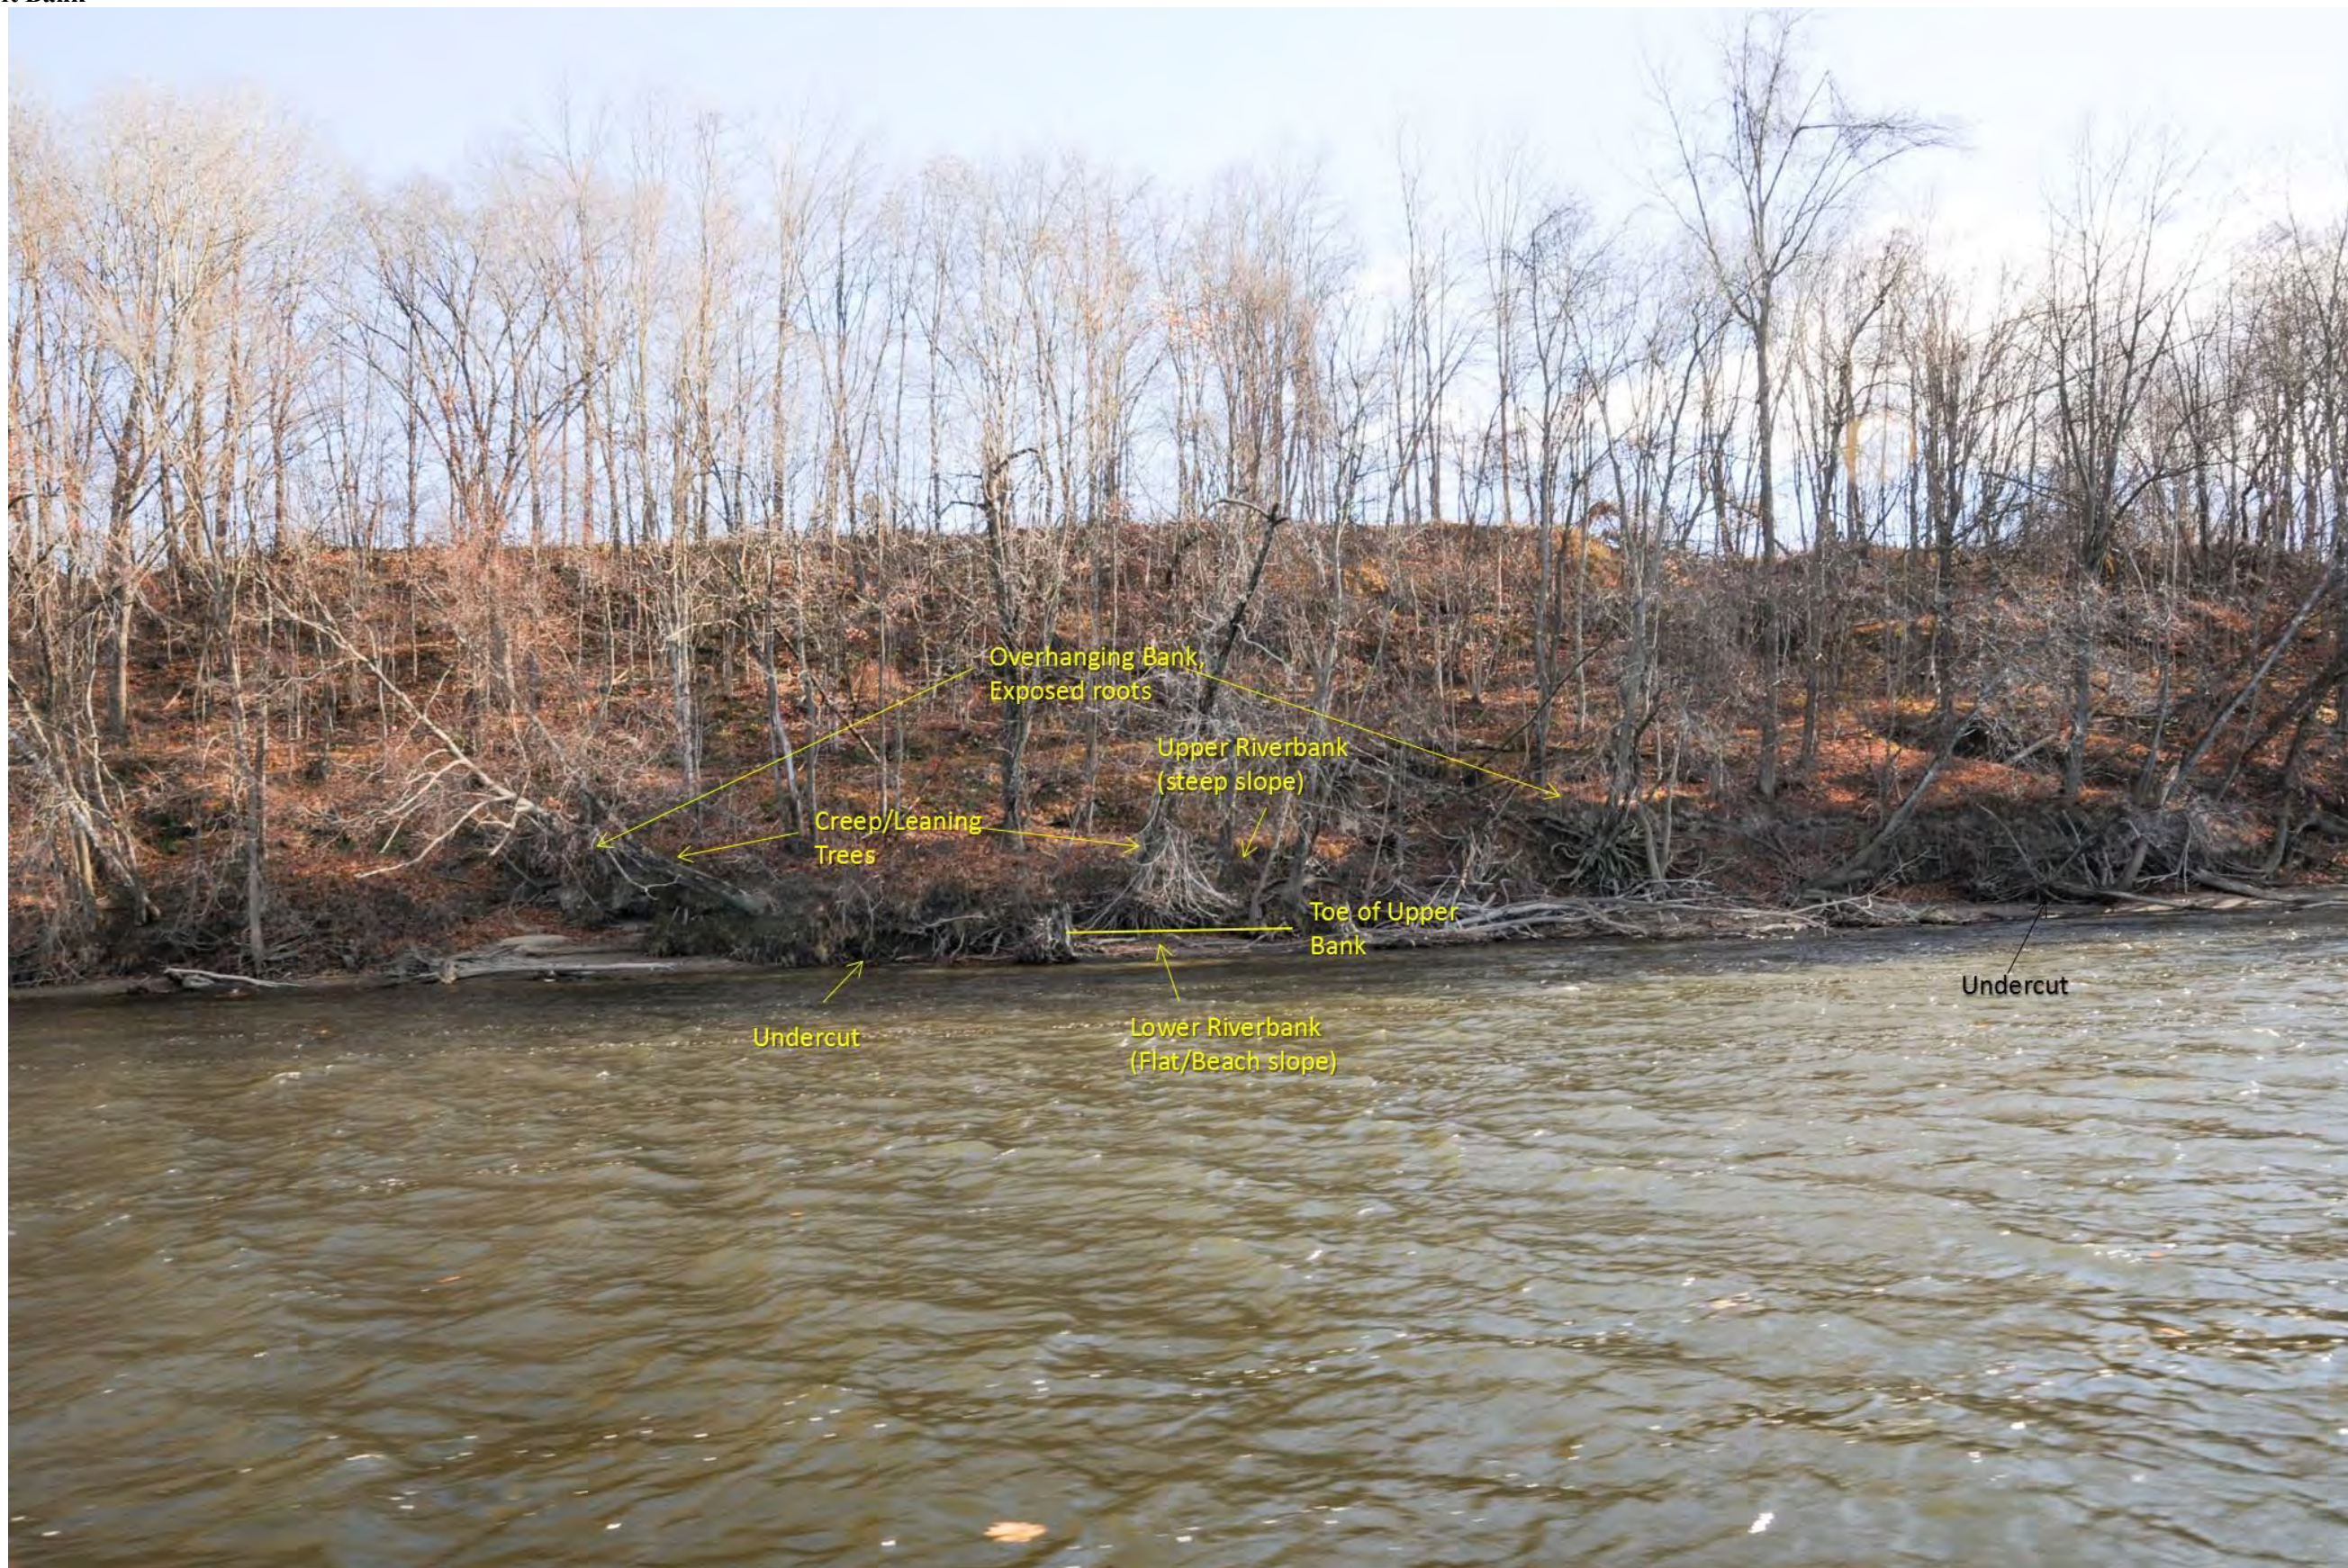
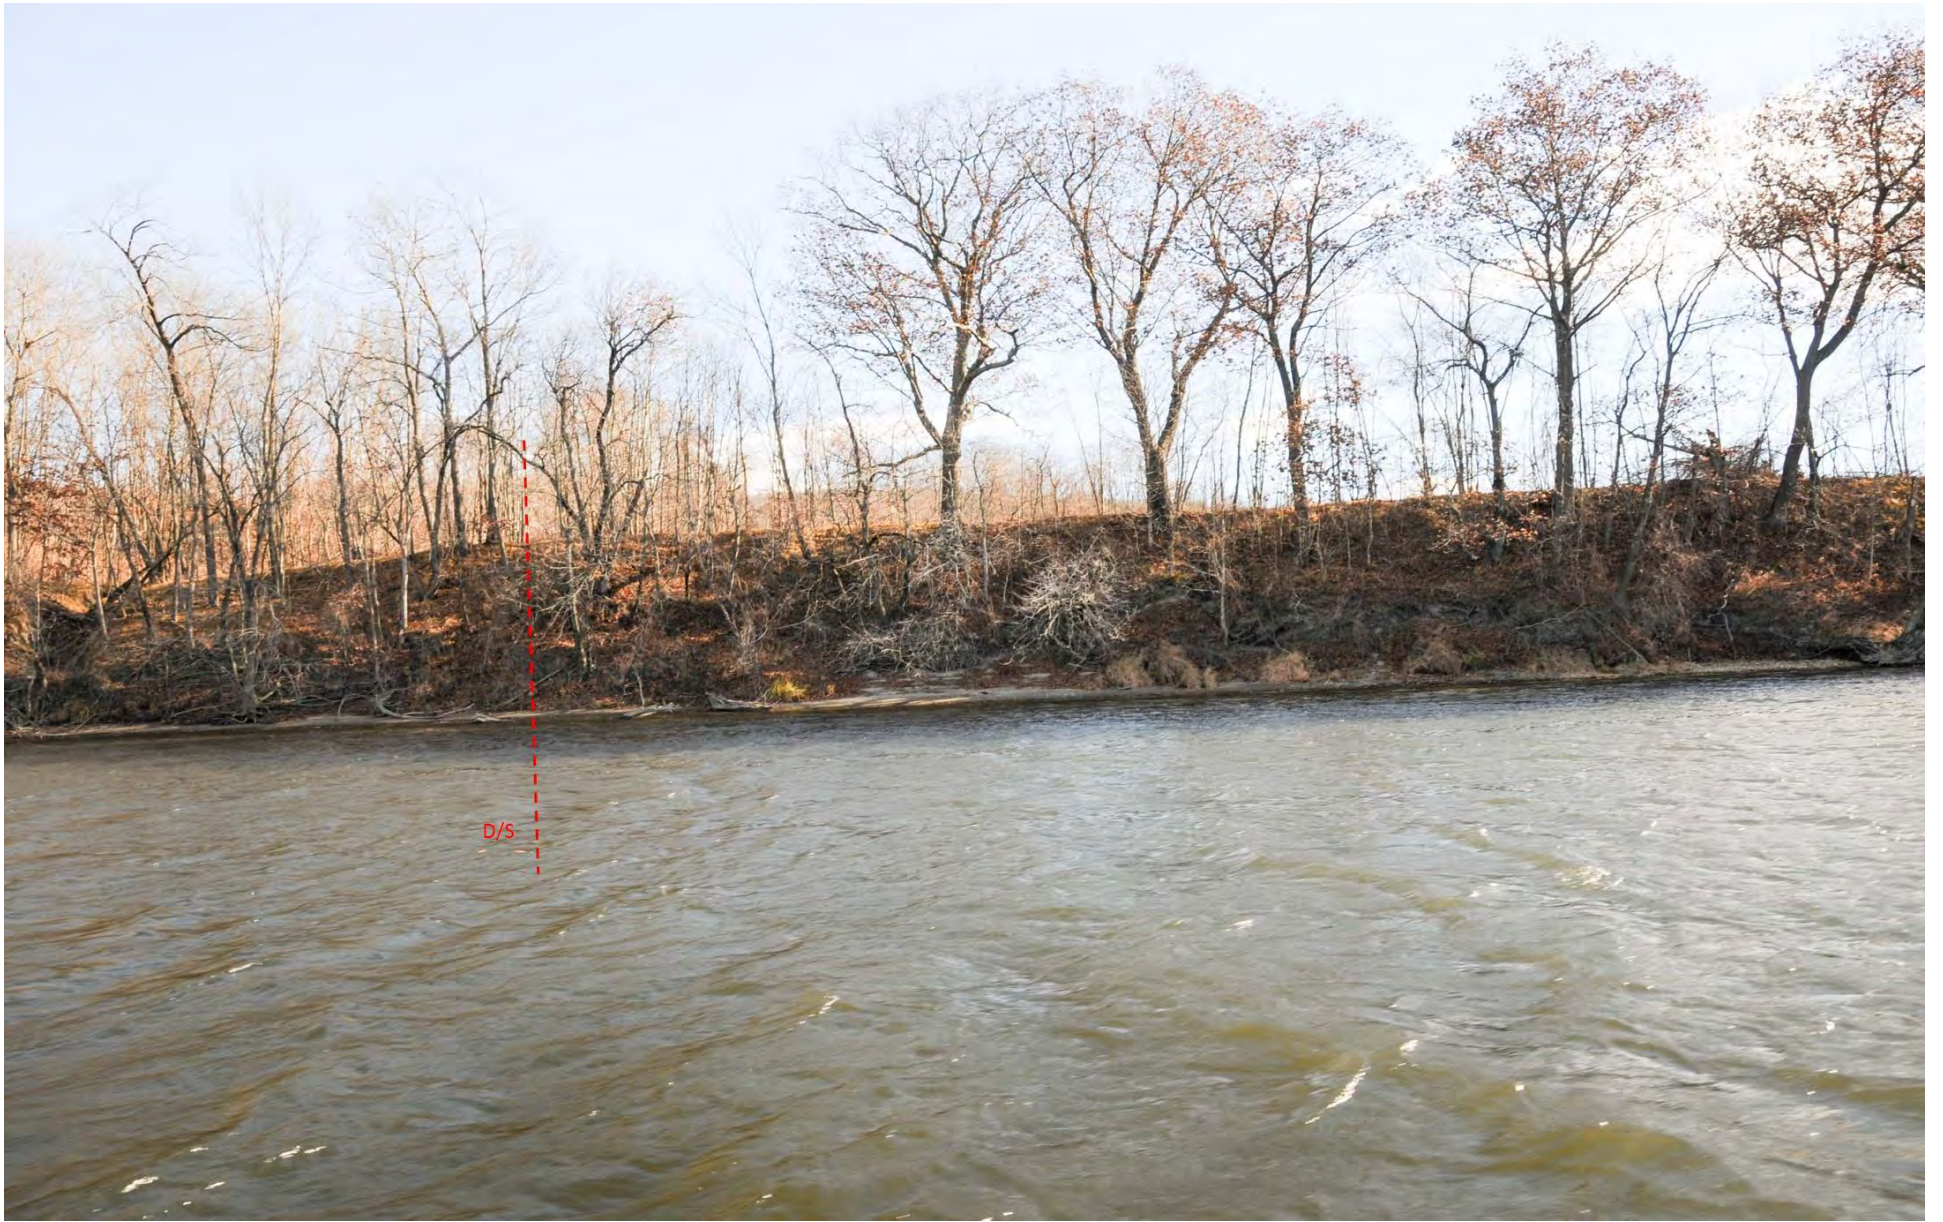
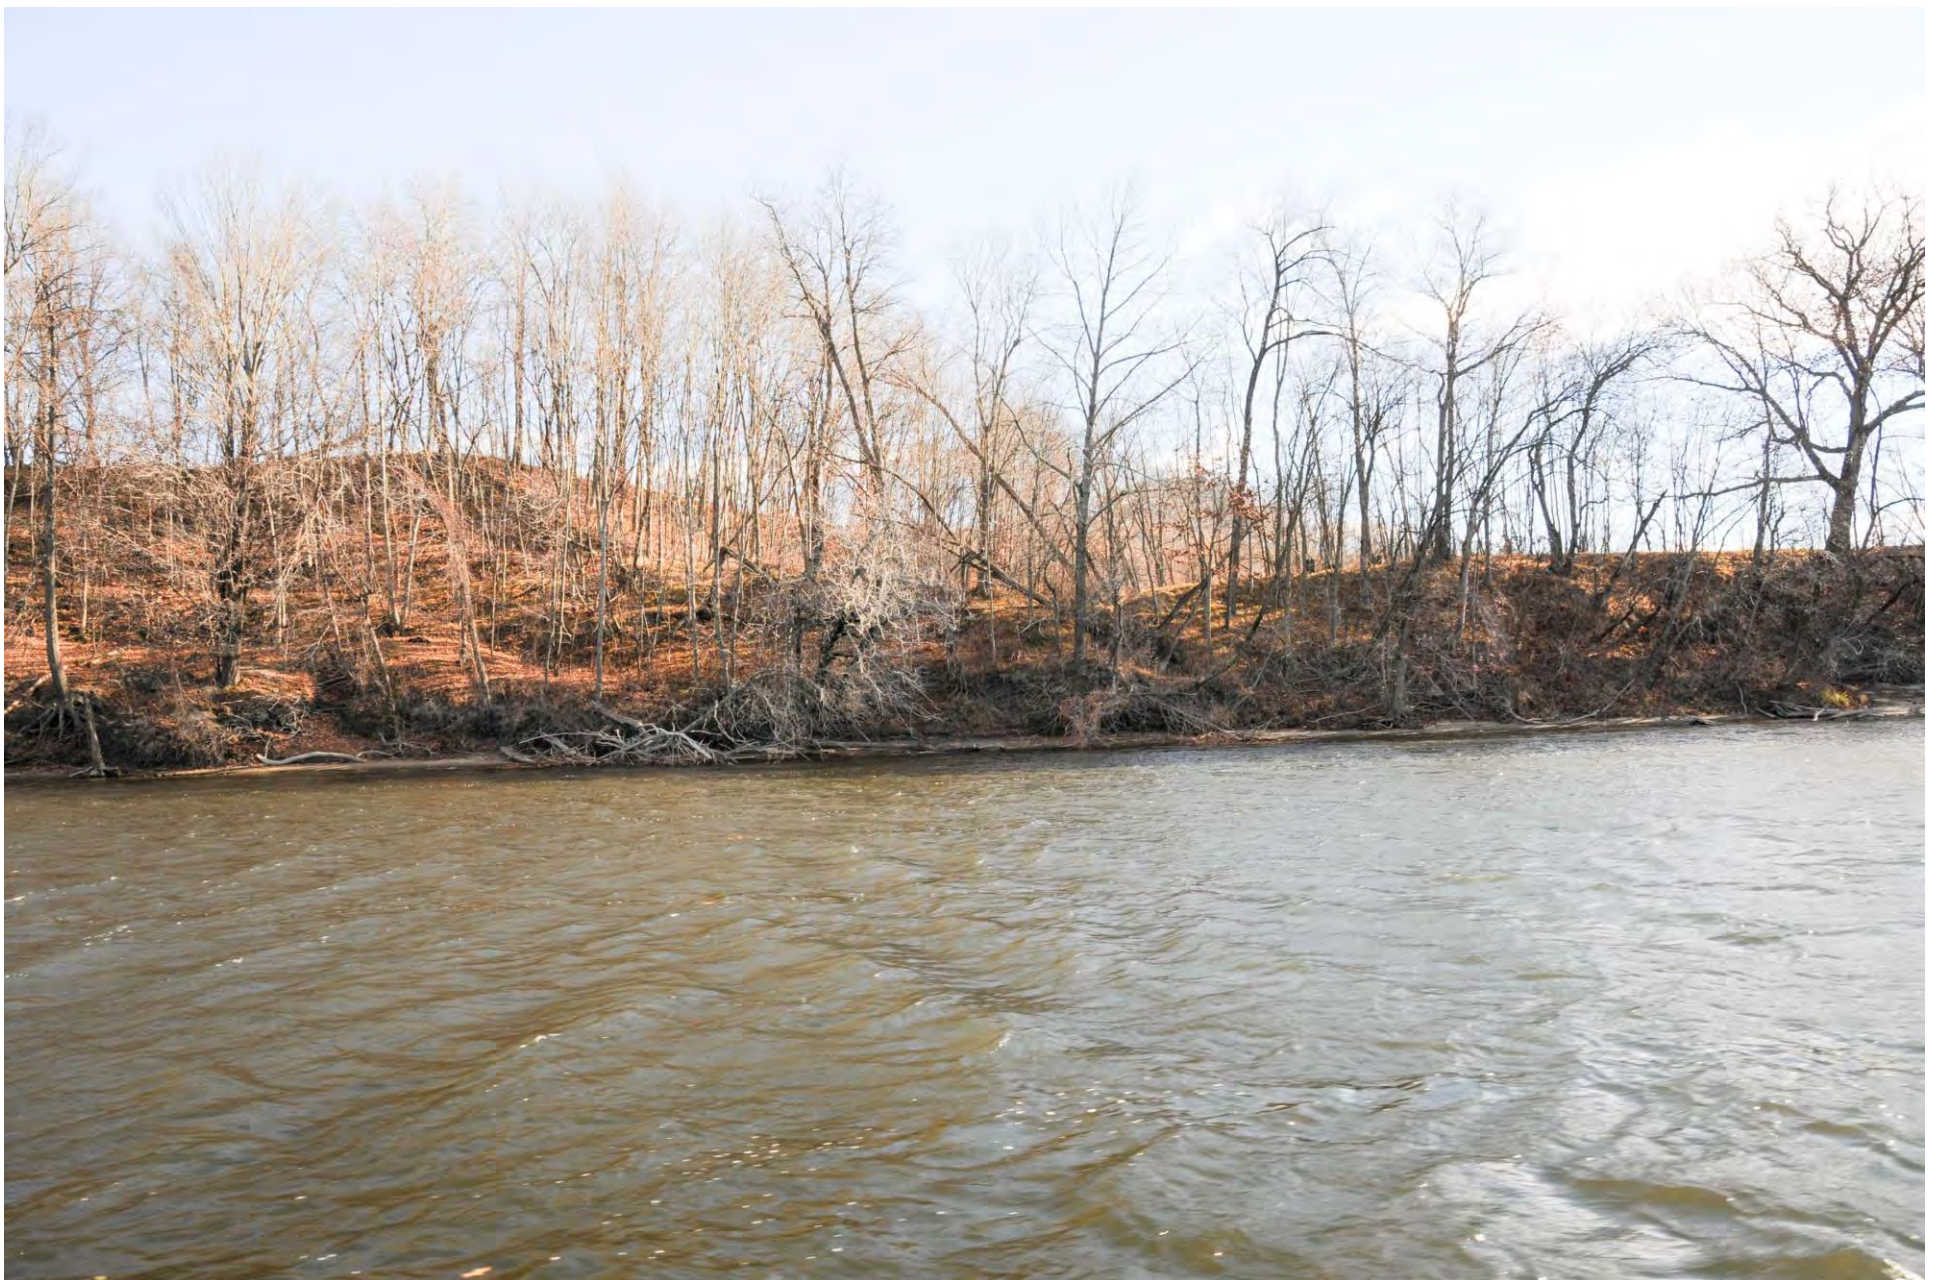
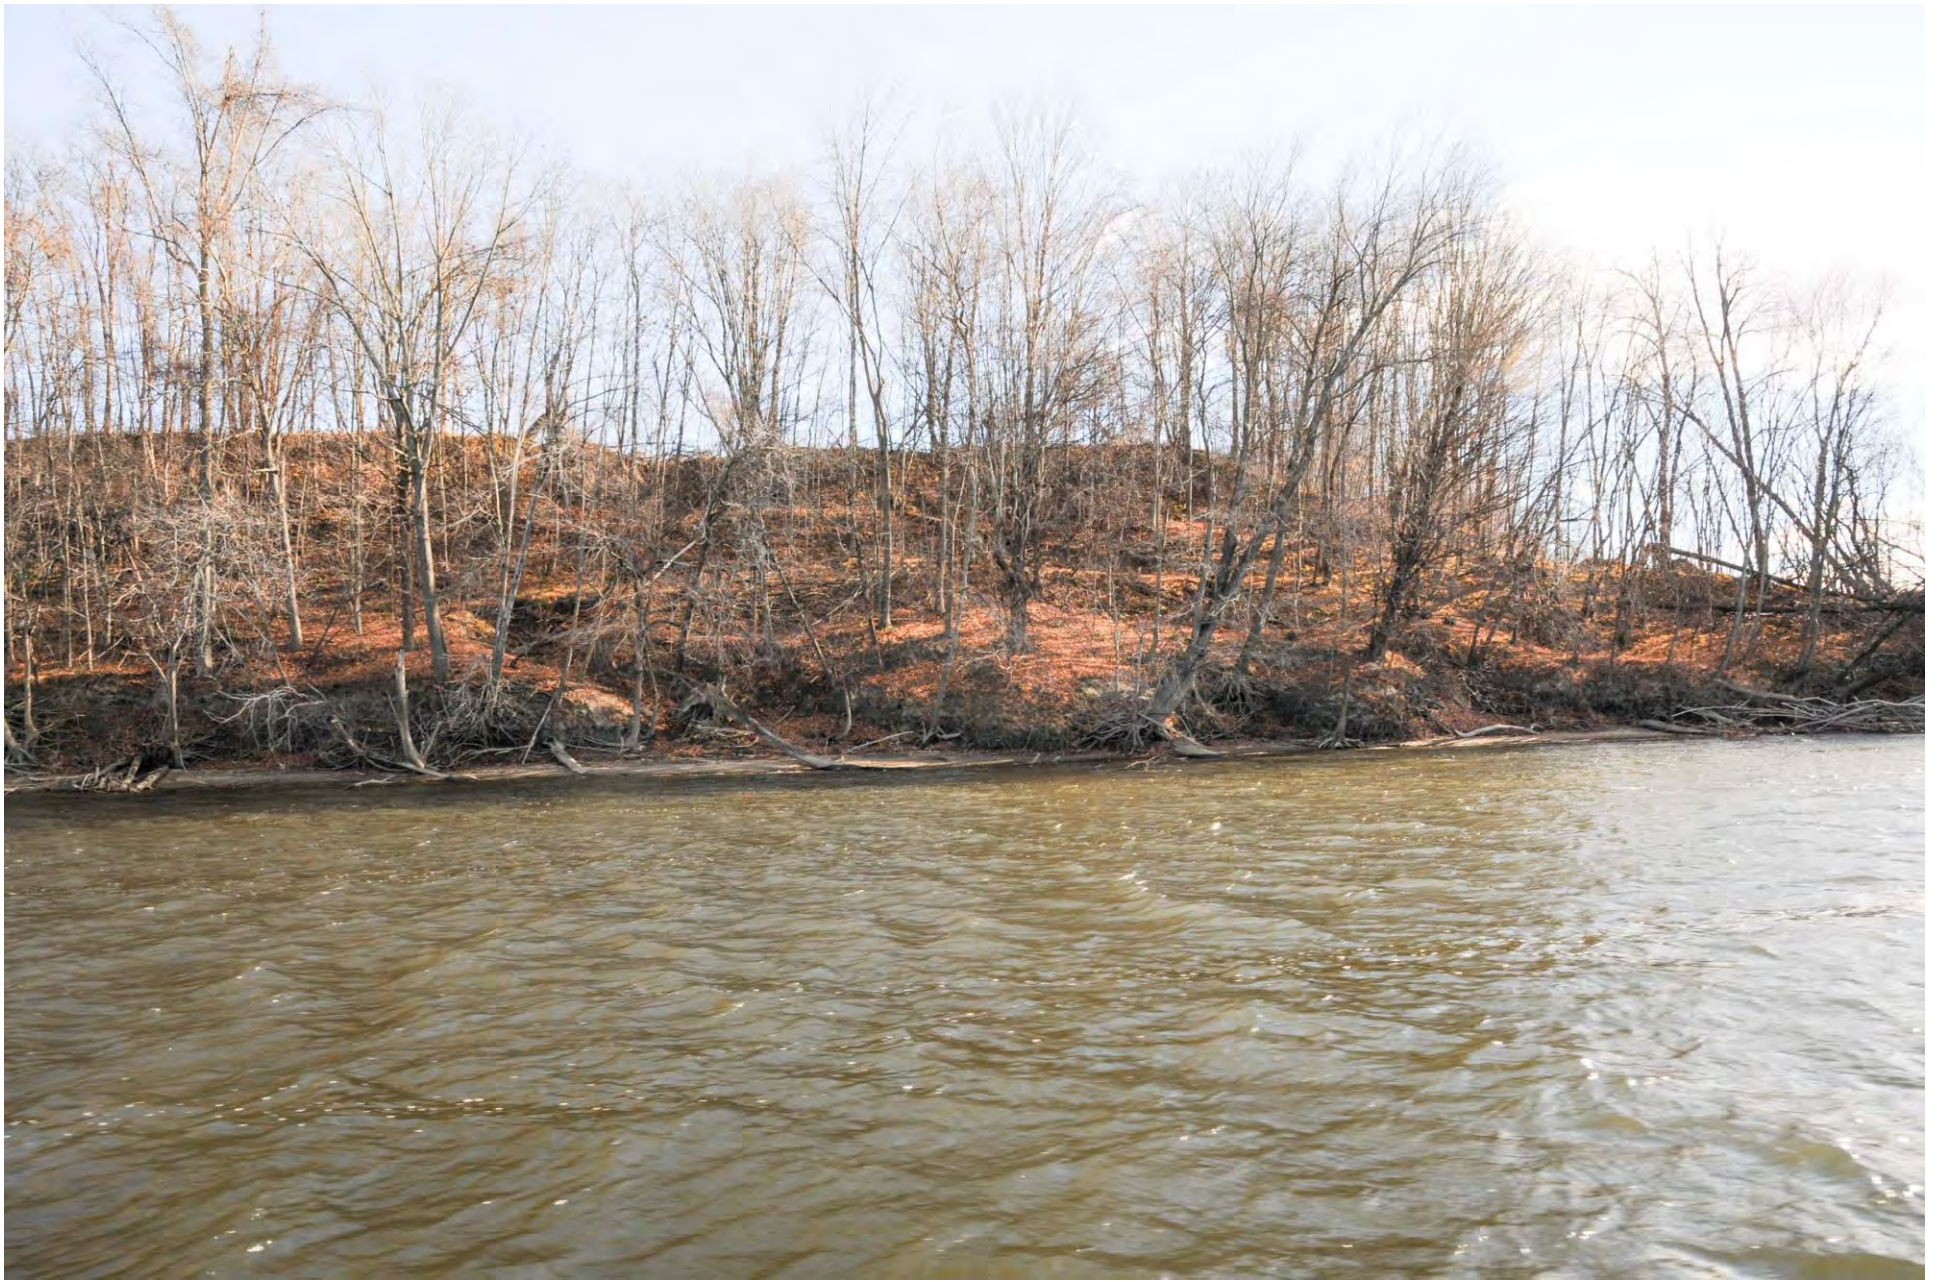
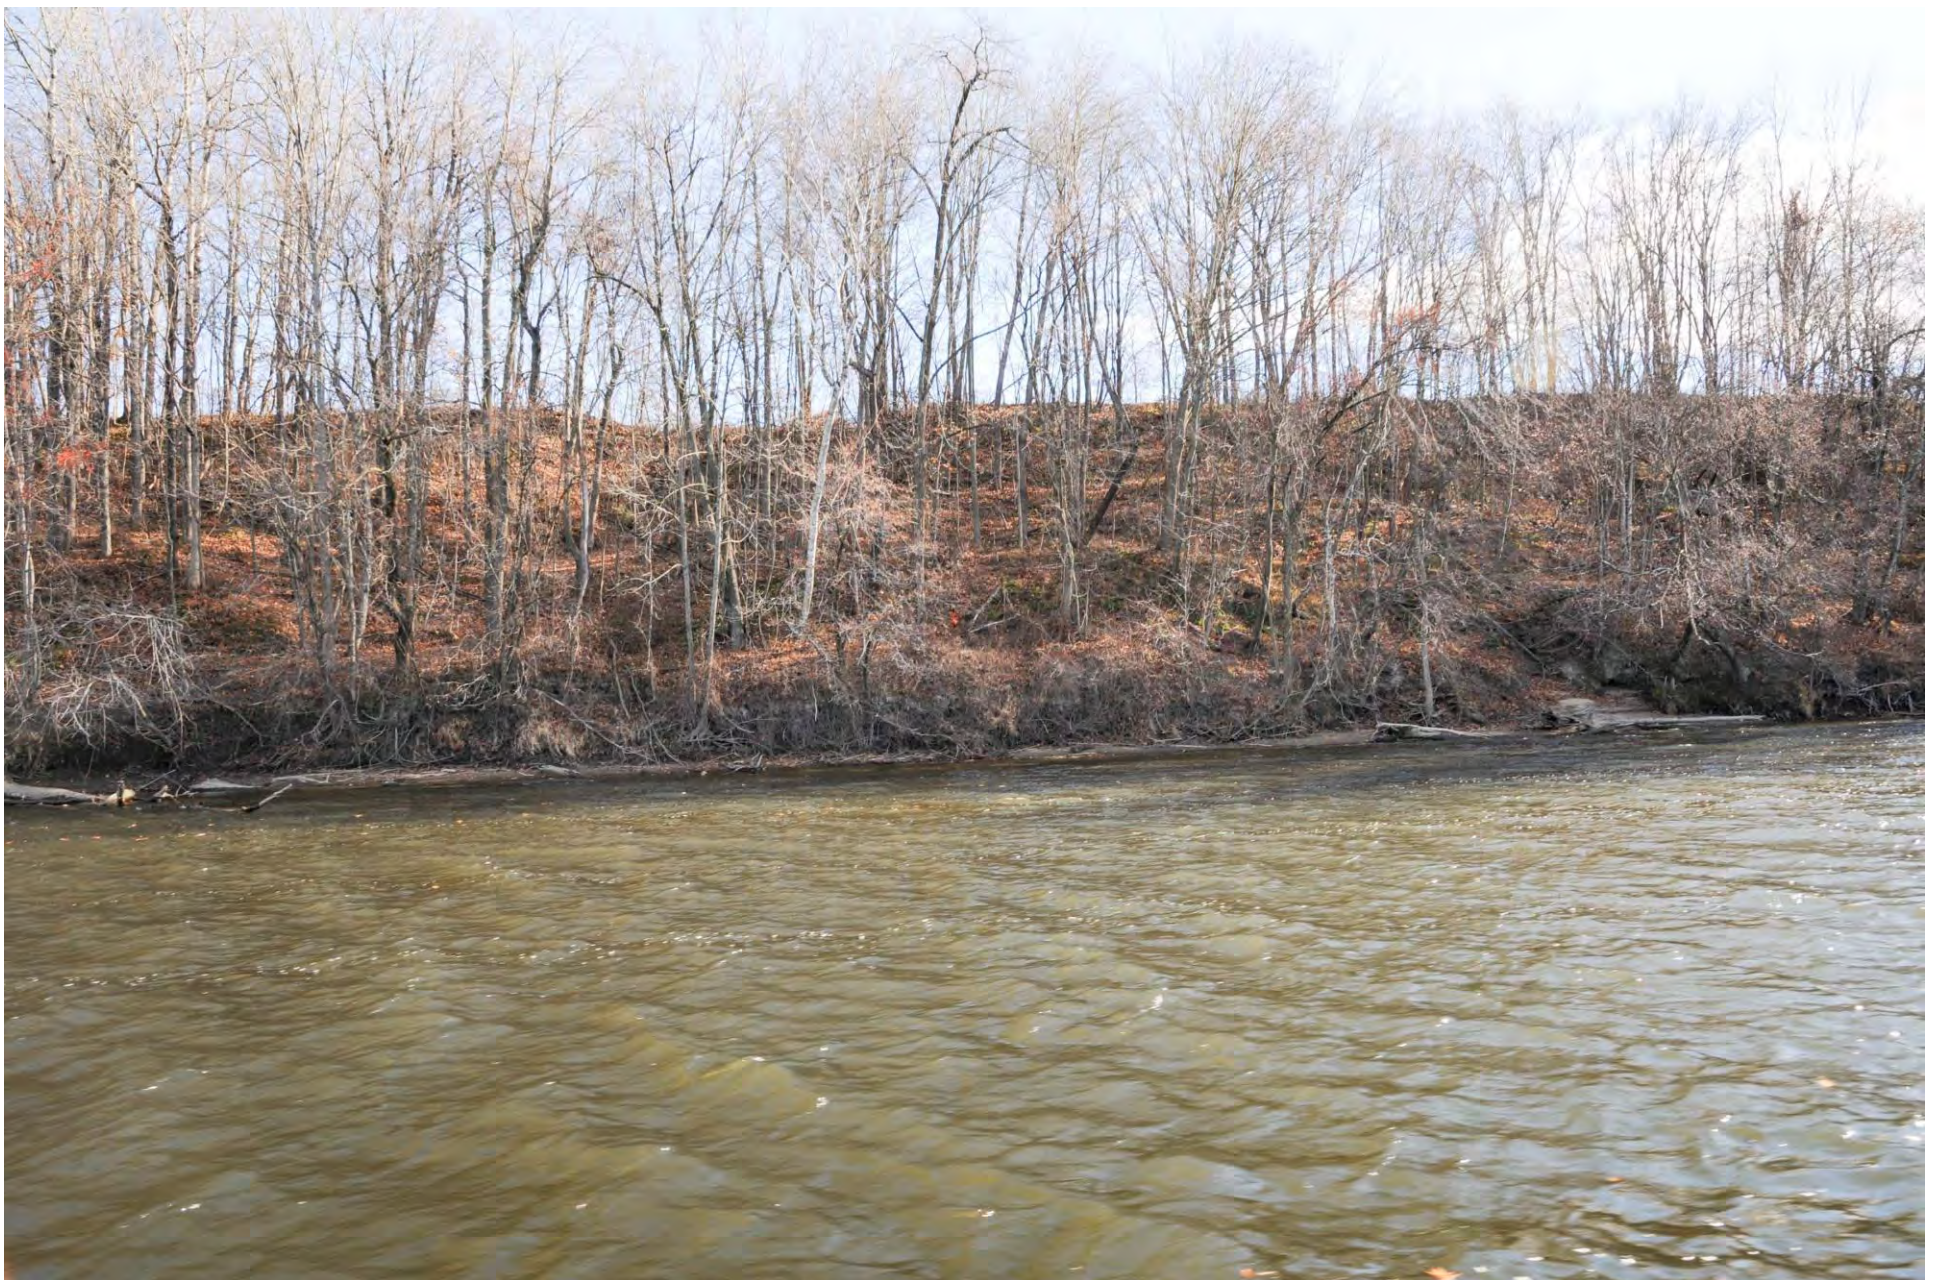
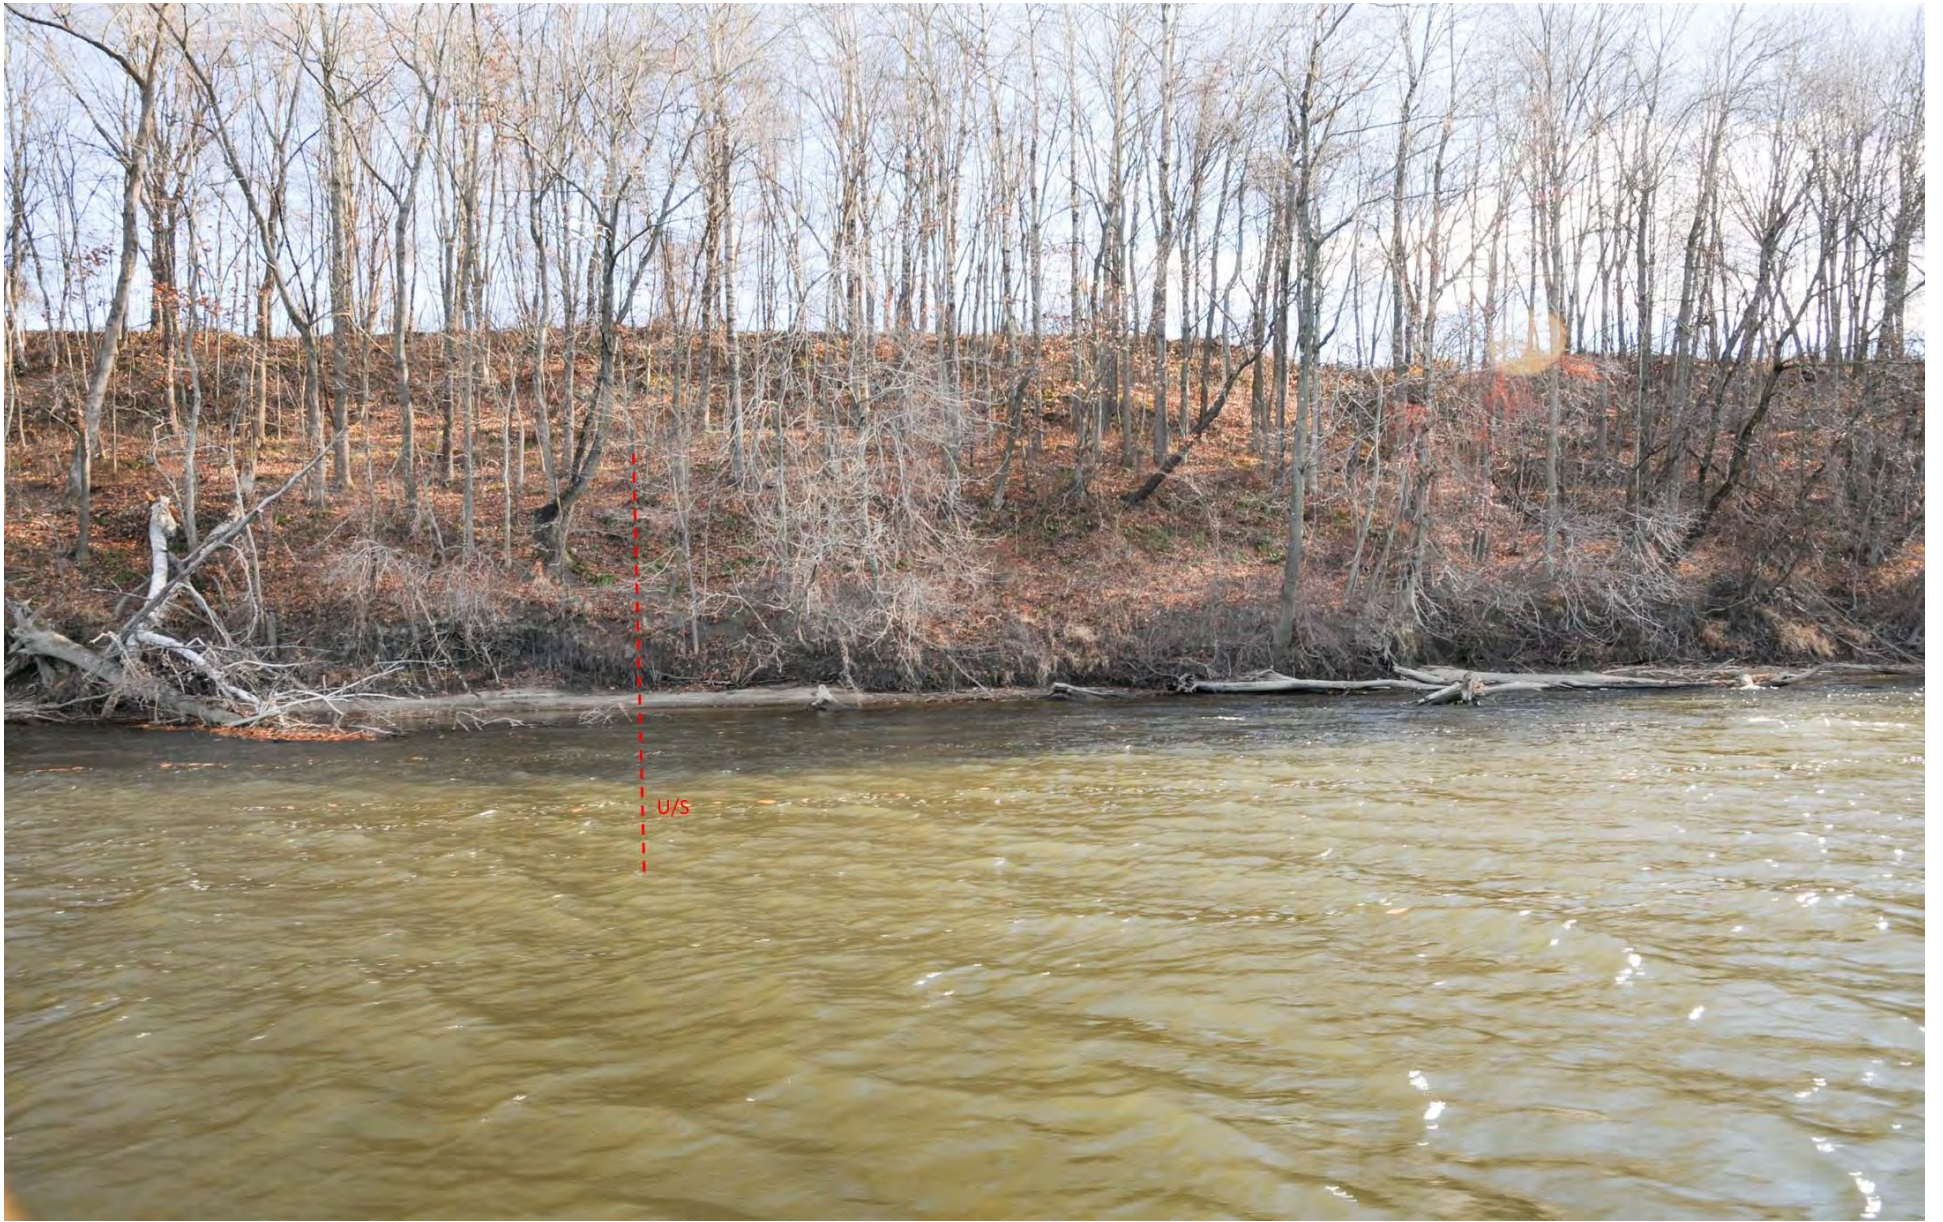
Segment 280 – Left Bank

Riverbank Features	Characteristics
Upper Riverbank Slope	Steep
Upper Riverbank Height	High
Upper Riverbank Sediment	Silt/Sand
Upper Riverbank Vegetation	Heavy
Lower Riverbank Slope	Flat/Beach
Lower Riverbank Sediment	Silt/Sand
Lower Riverbank Vegetation	None to very sparse
Type of Erosion	Undercut
Potential Erosion Indicators	Creep/leaning trees, Exposed roots, Overhanging bank
Stage of Erosion	Stable
Extent of Erosion	None/Little

**QA Observations:** Upon review of the photos for this segment, classification made in the field was confirmed and additional indicators of potential future erosion were included.
