Re: Filing of Addendum to Study No. 3.1.1- 2013 Full River Reconnaissance  
Turners Falls Hydroelectric Project (FERC No. 1889) and Northfield Mountain Pumped Storage  
Project (FERC No. 2485)

## **ATTACHMENT A: 2013 Full River Reconnaissance – 2015 Addendum: Riverbank Segment QA Comparison**

2015 FRR Addendum  
 Selected Riverbank Segments for QA  
 Map 1

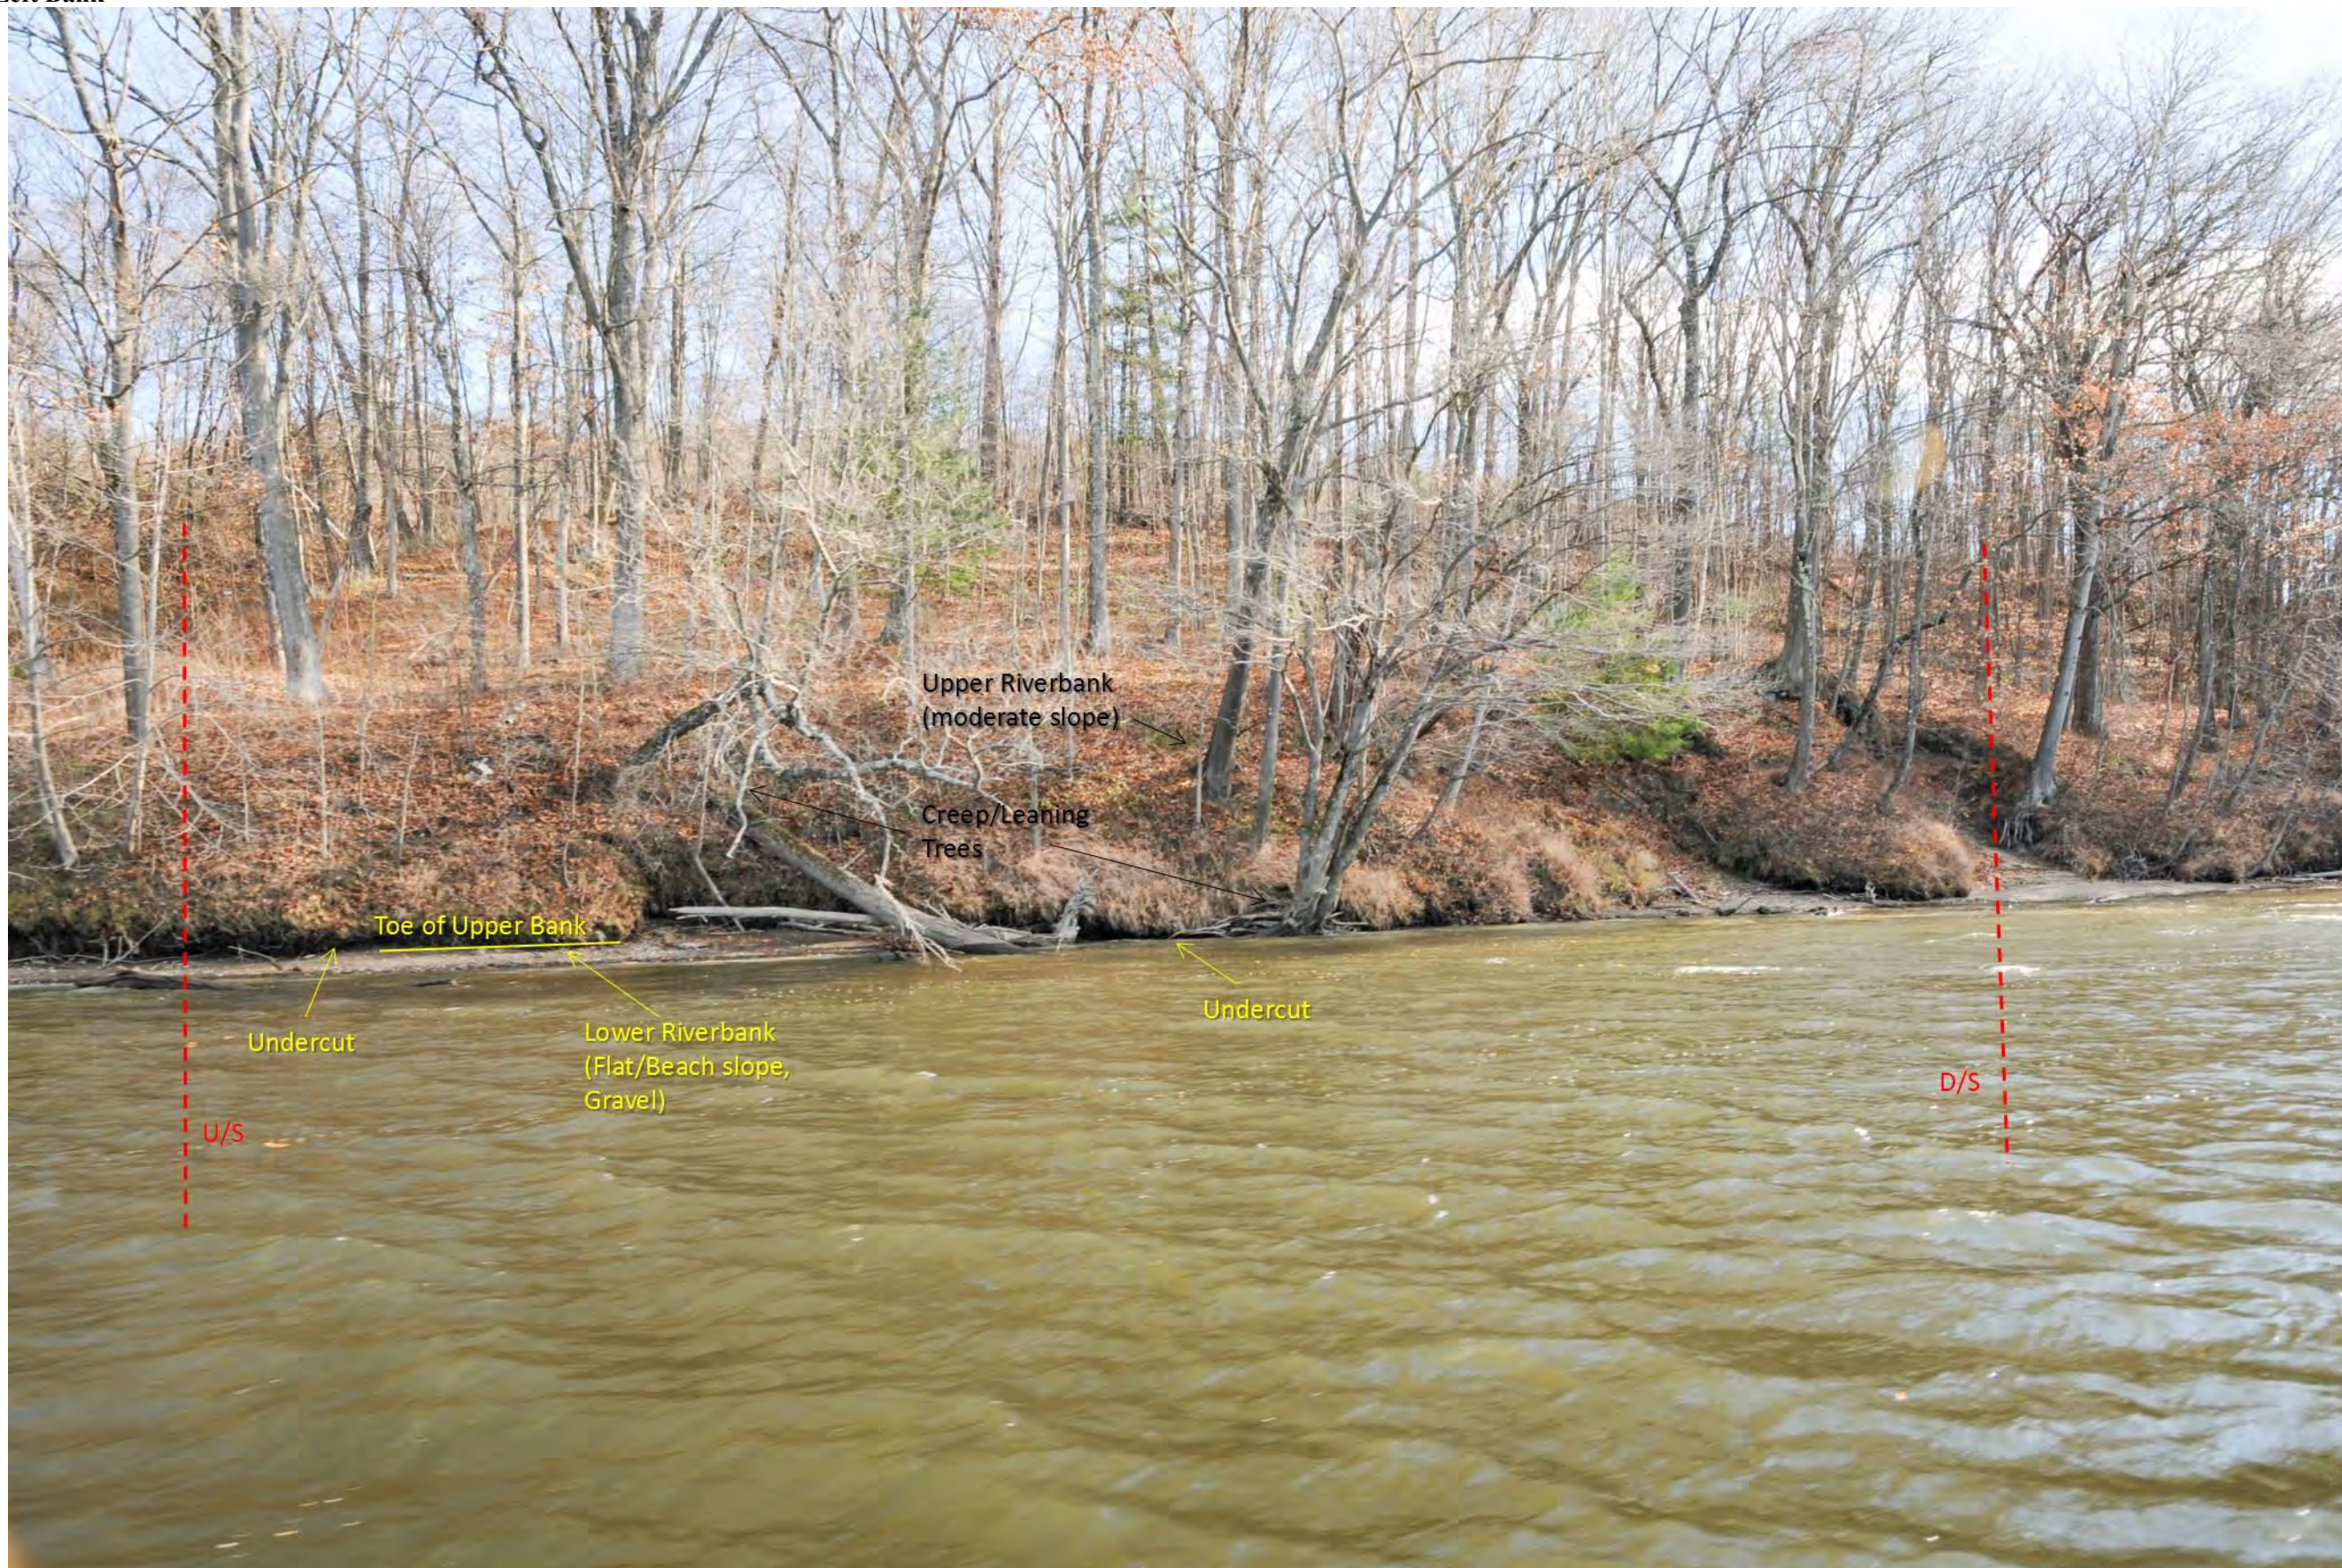
Segment 290 – Left Bank

Riverbank Features	Characteristics
Upper Riverbank Slope	Moderate
Upper Riverbank Height	High
Upper Riverbank Sediment	Silt/Sand
Upper Riverbank Vegetation	Heavy
Lower Riverbank Slope	Flat/Beach
Lower Riverbank Sediment	gravel
Lower Riverbank Vegetation	None to very sparse
Type of Erosion	Undercut
Potential Erosion Indicators	Creep/leaning trees
Stage of Erosion	Stable
Extent of Erosion	None/Little

**QA Observations:** Upon review of the photos for this segment, classification made in the field was confirmed.

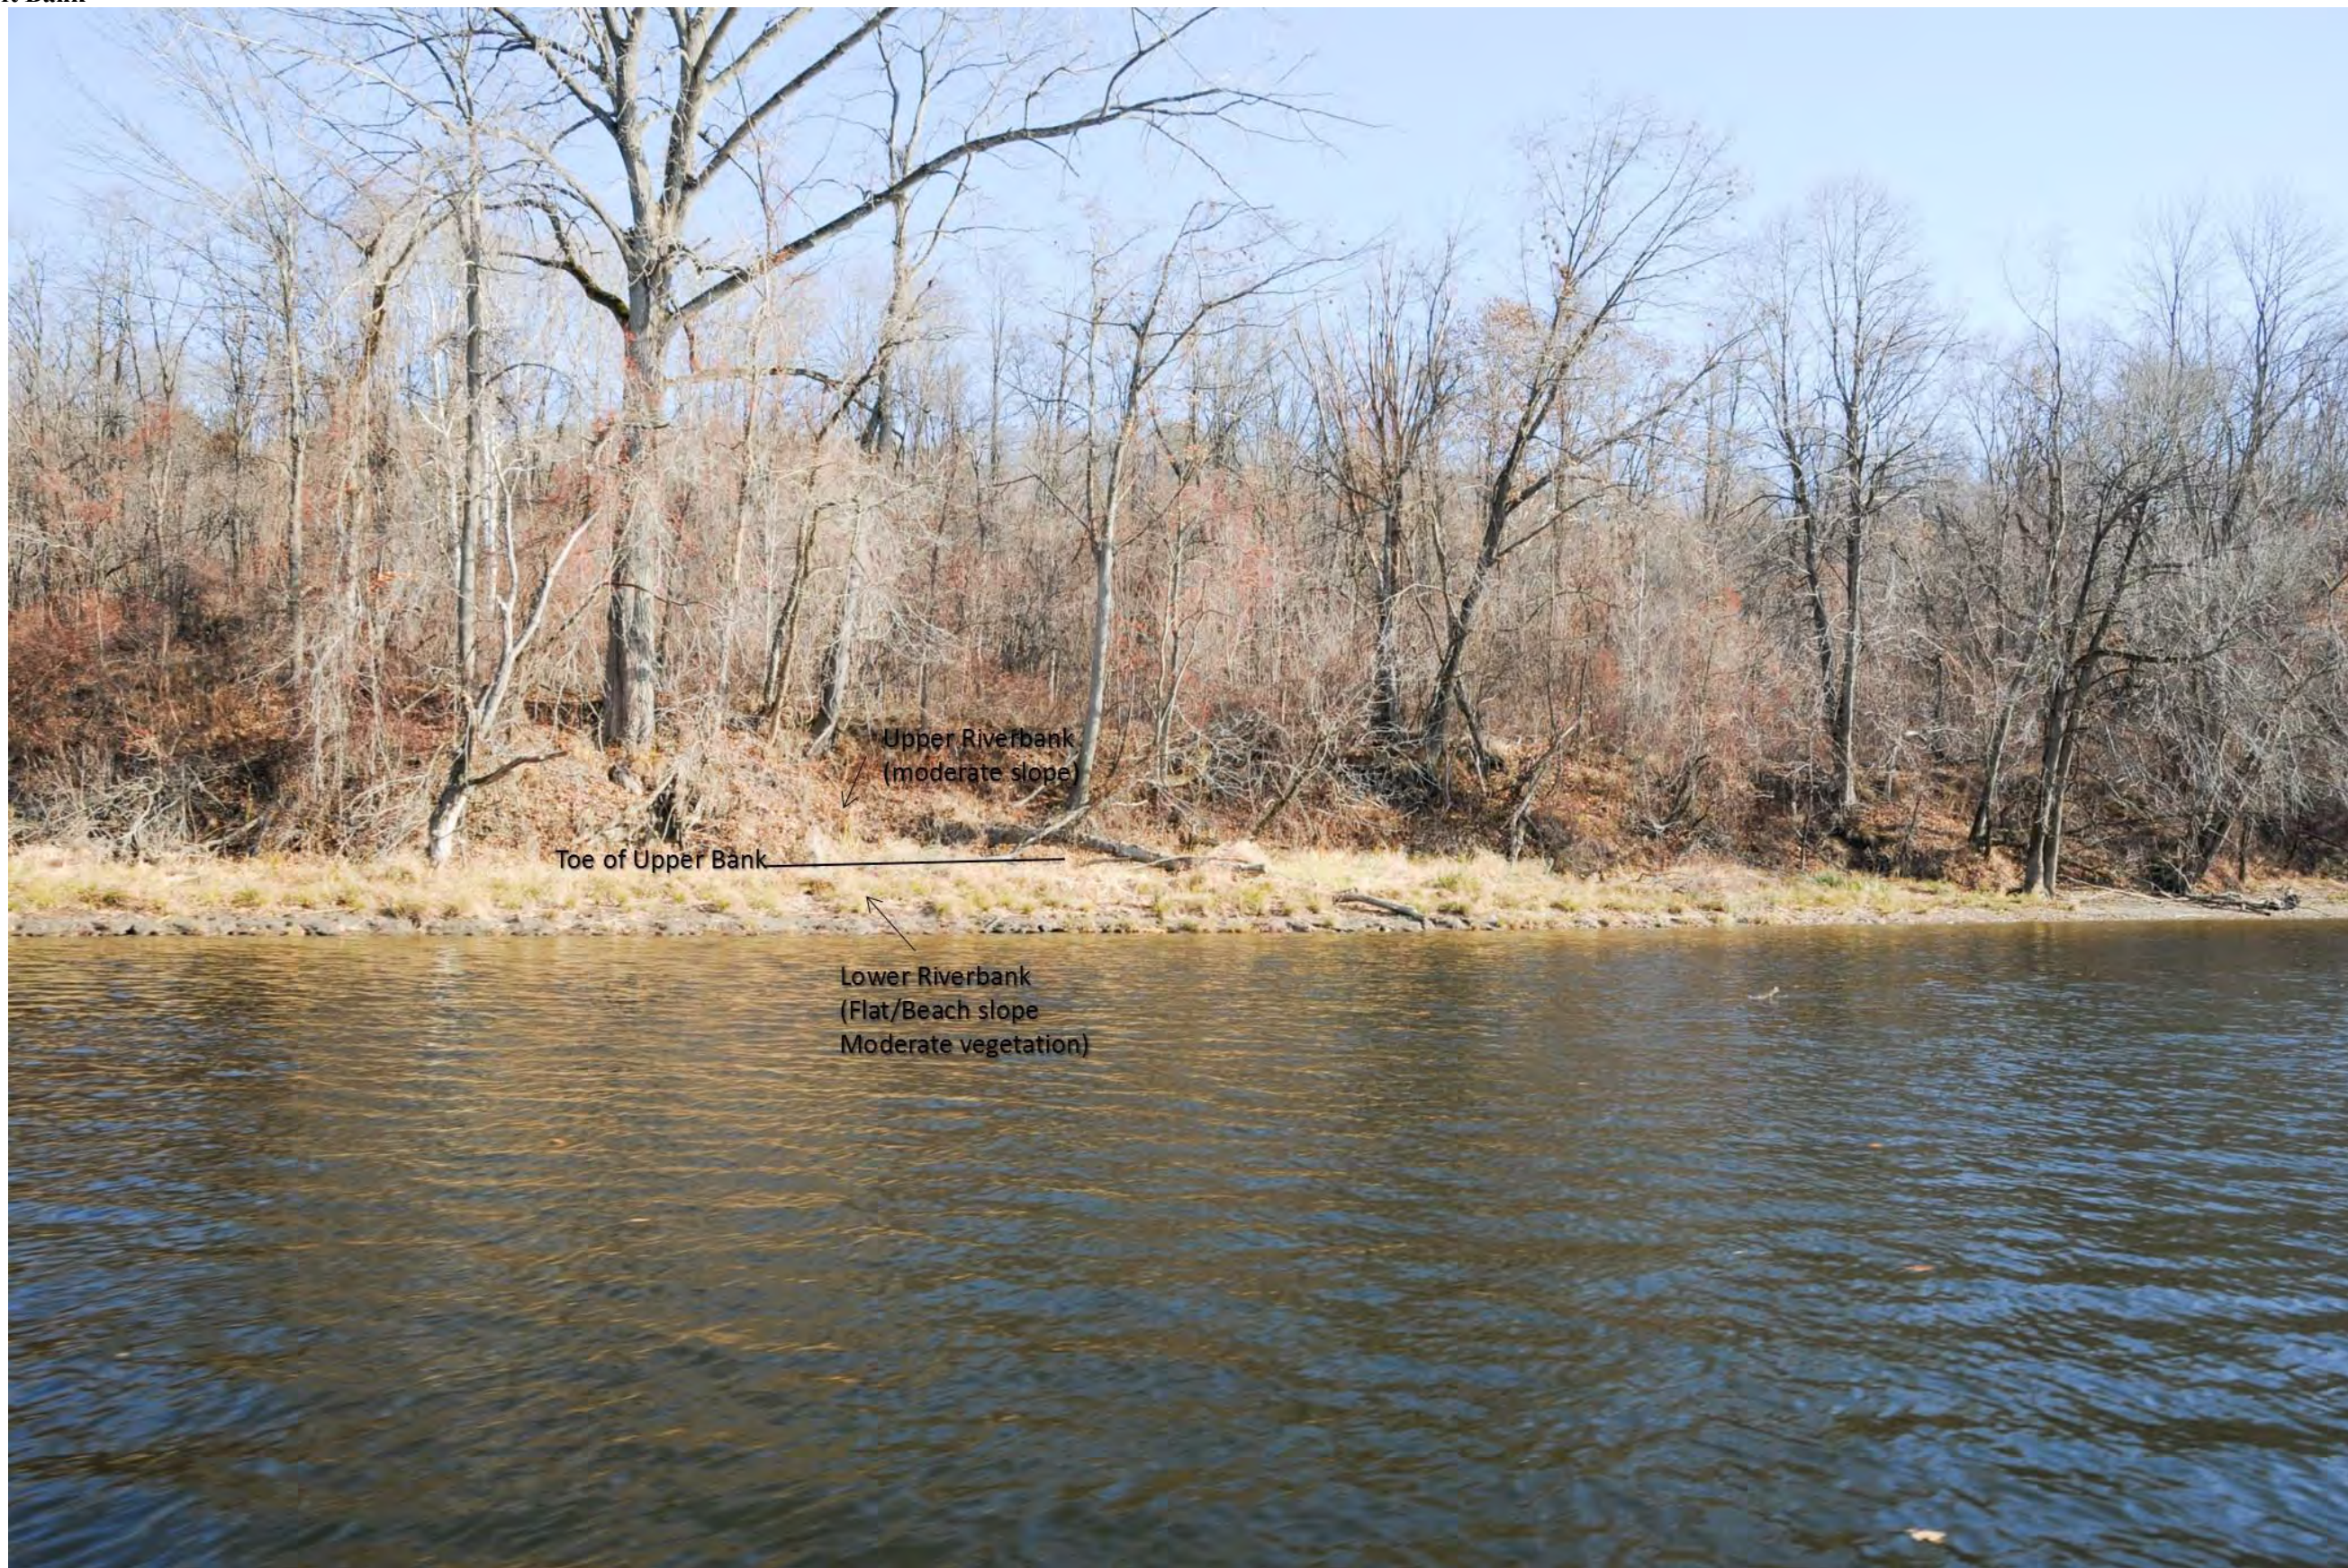
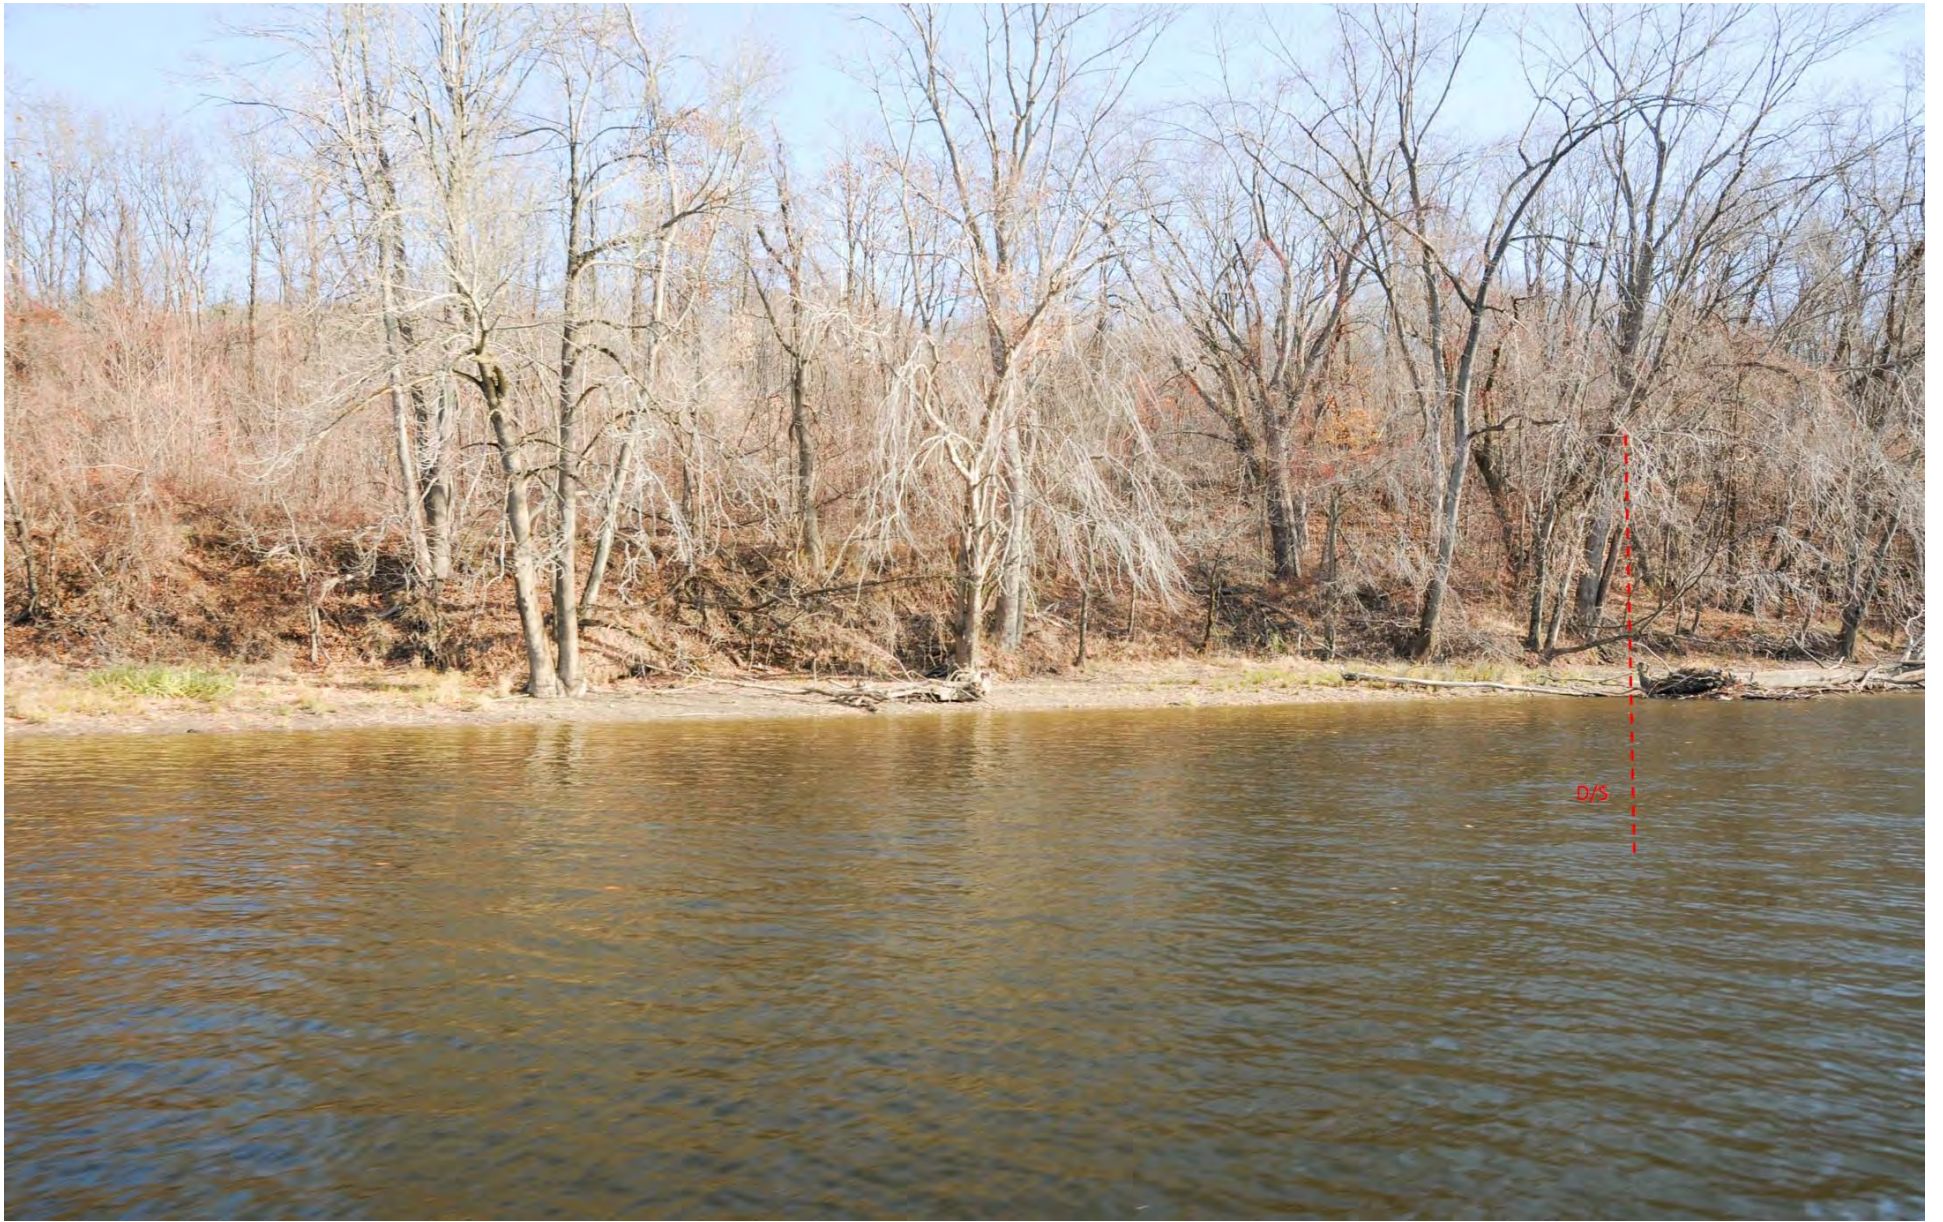
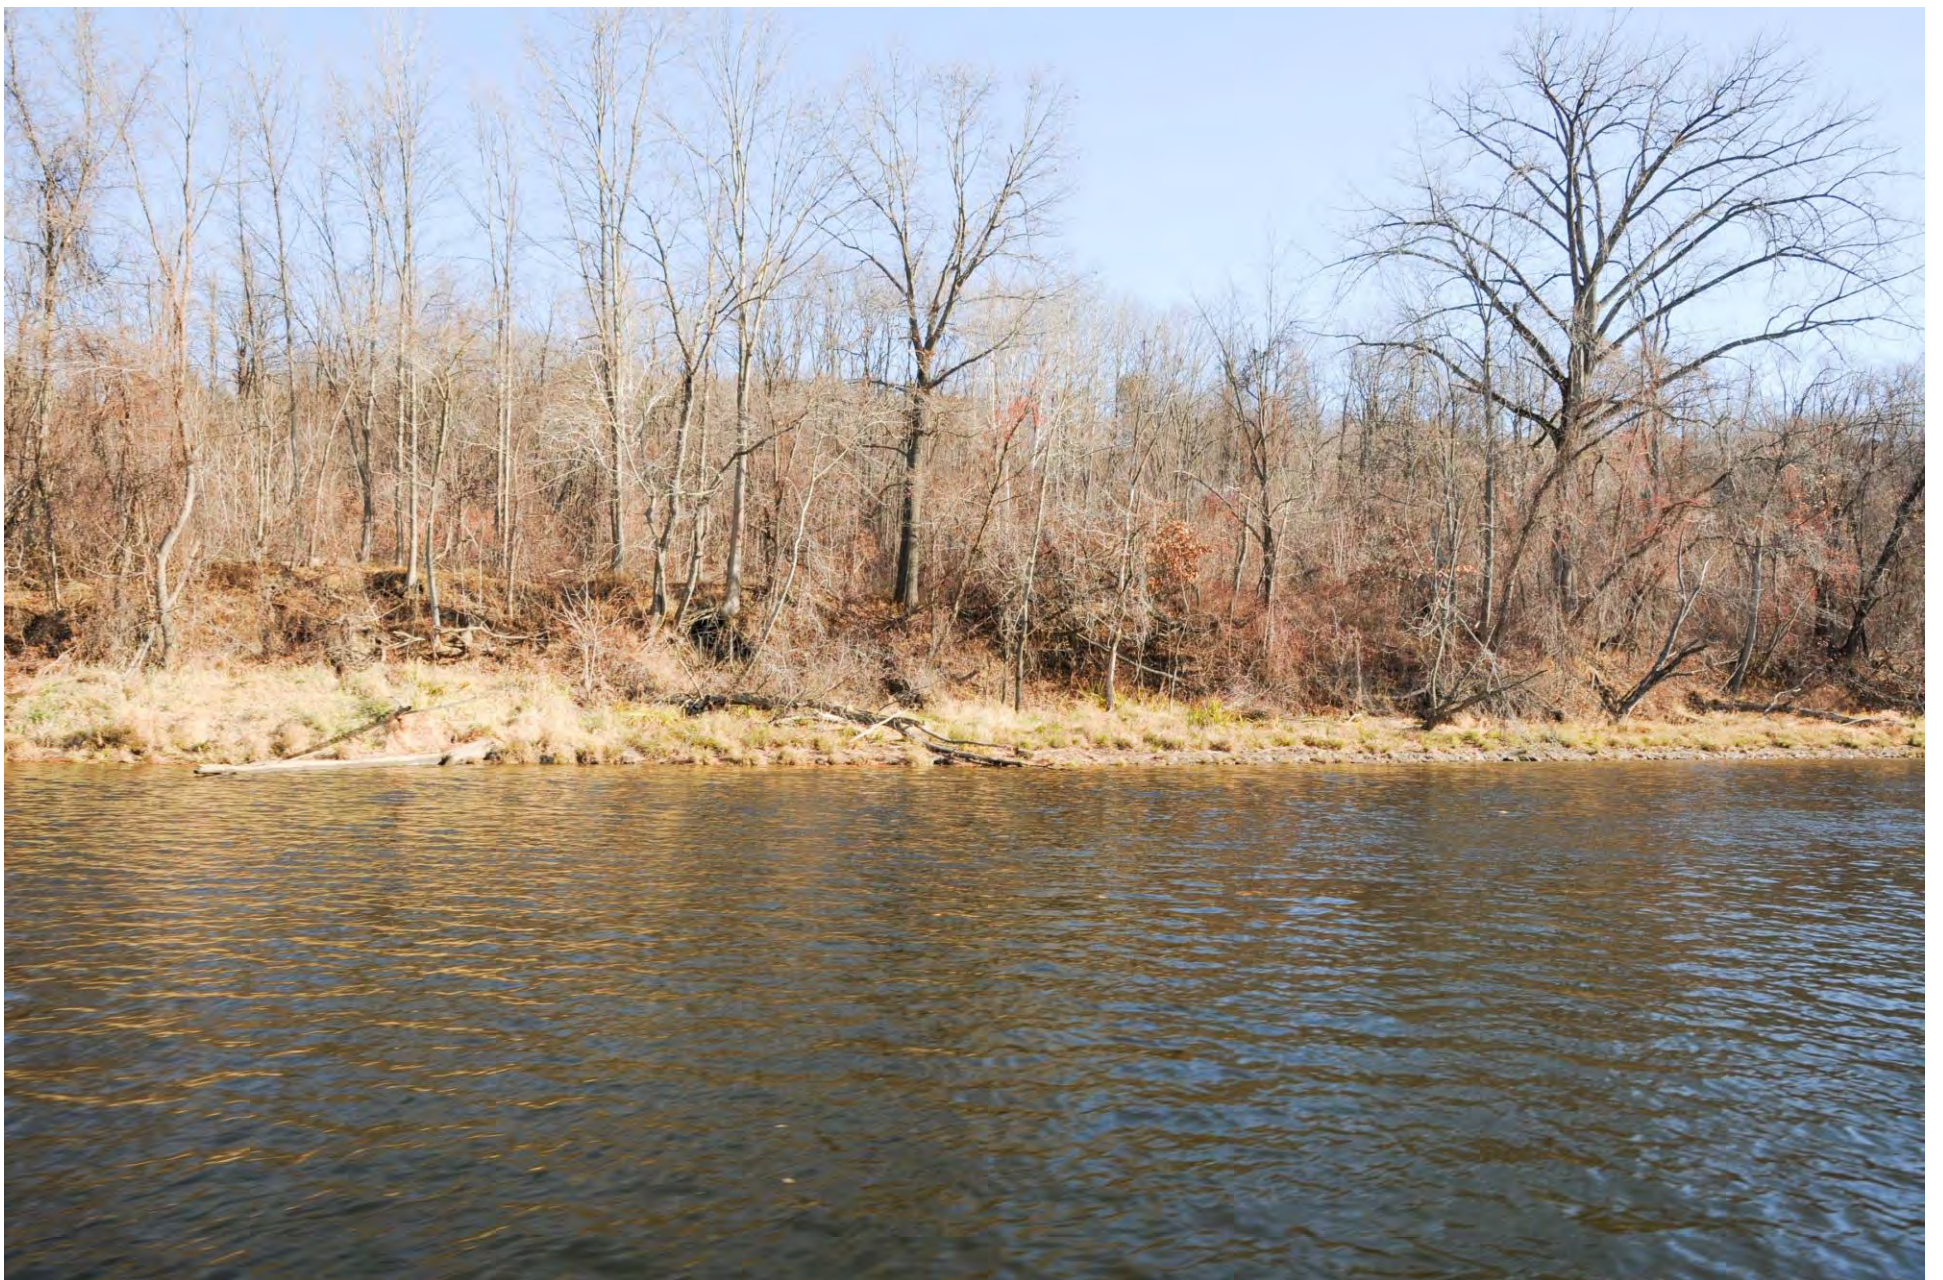
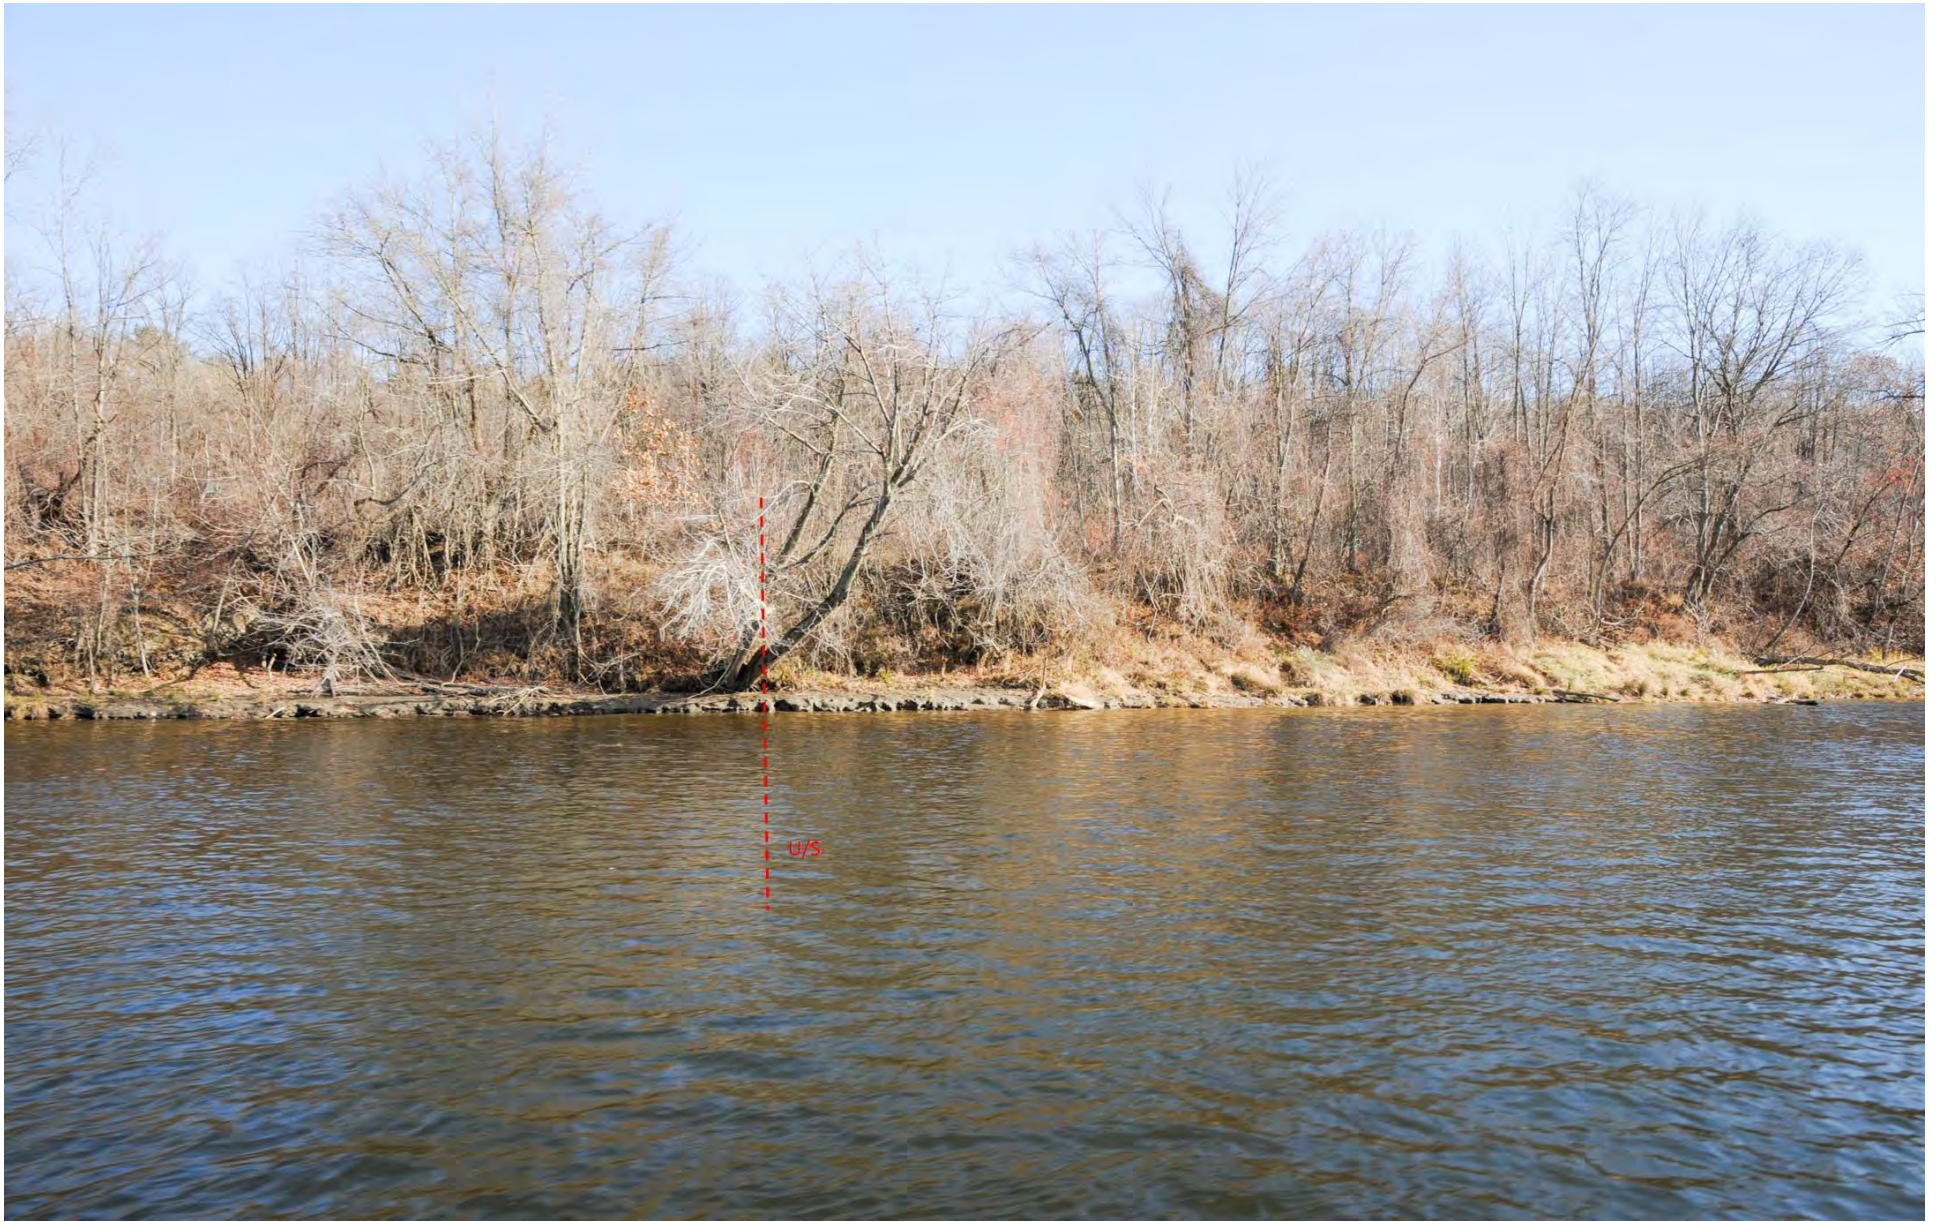
Segment 300 – Left Bank

Riverbank Features	Characteristics
Upper Riverbank Slope	Moderate
Upper Riverbank Height	High
Upper Riverbank Sediment	Silt/Sand
Upper Riverbank Vegetation	Heavy
Lower Riverbank Slope	Flat/Beach
Lower Riverbank Sediment	Silt/Sand
Lower Riverbank Vegetation	Moderate
Type of Erosion	
Potential Erosion Indicators	None
Stage of Erosion	Stable
Extent of Erosion	None/Little

**QA Observations:** Upon review of the photos for this segment, classification made in the field was confirmed.

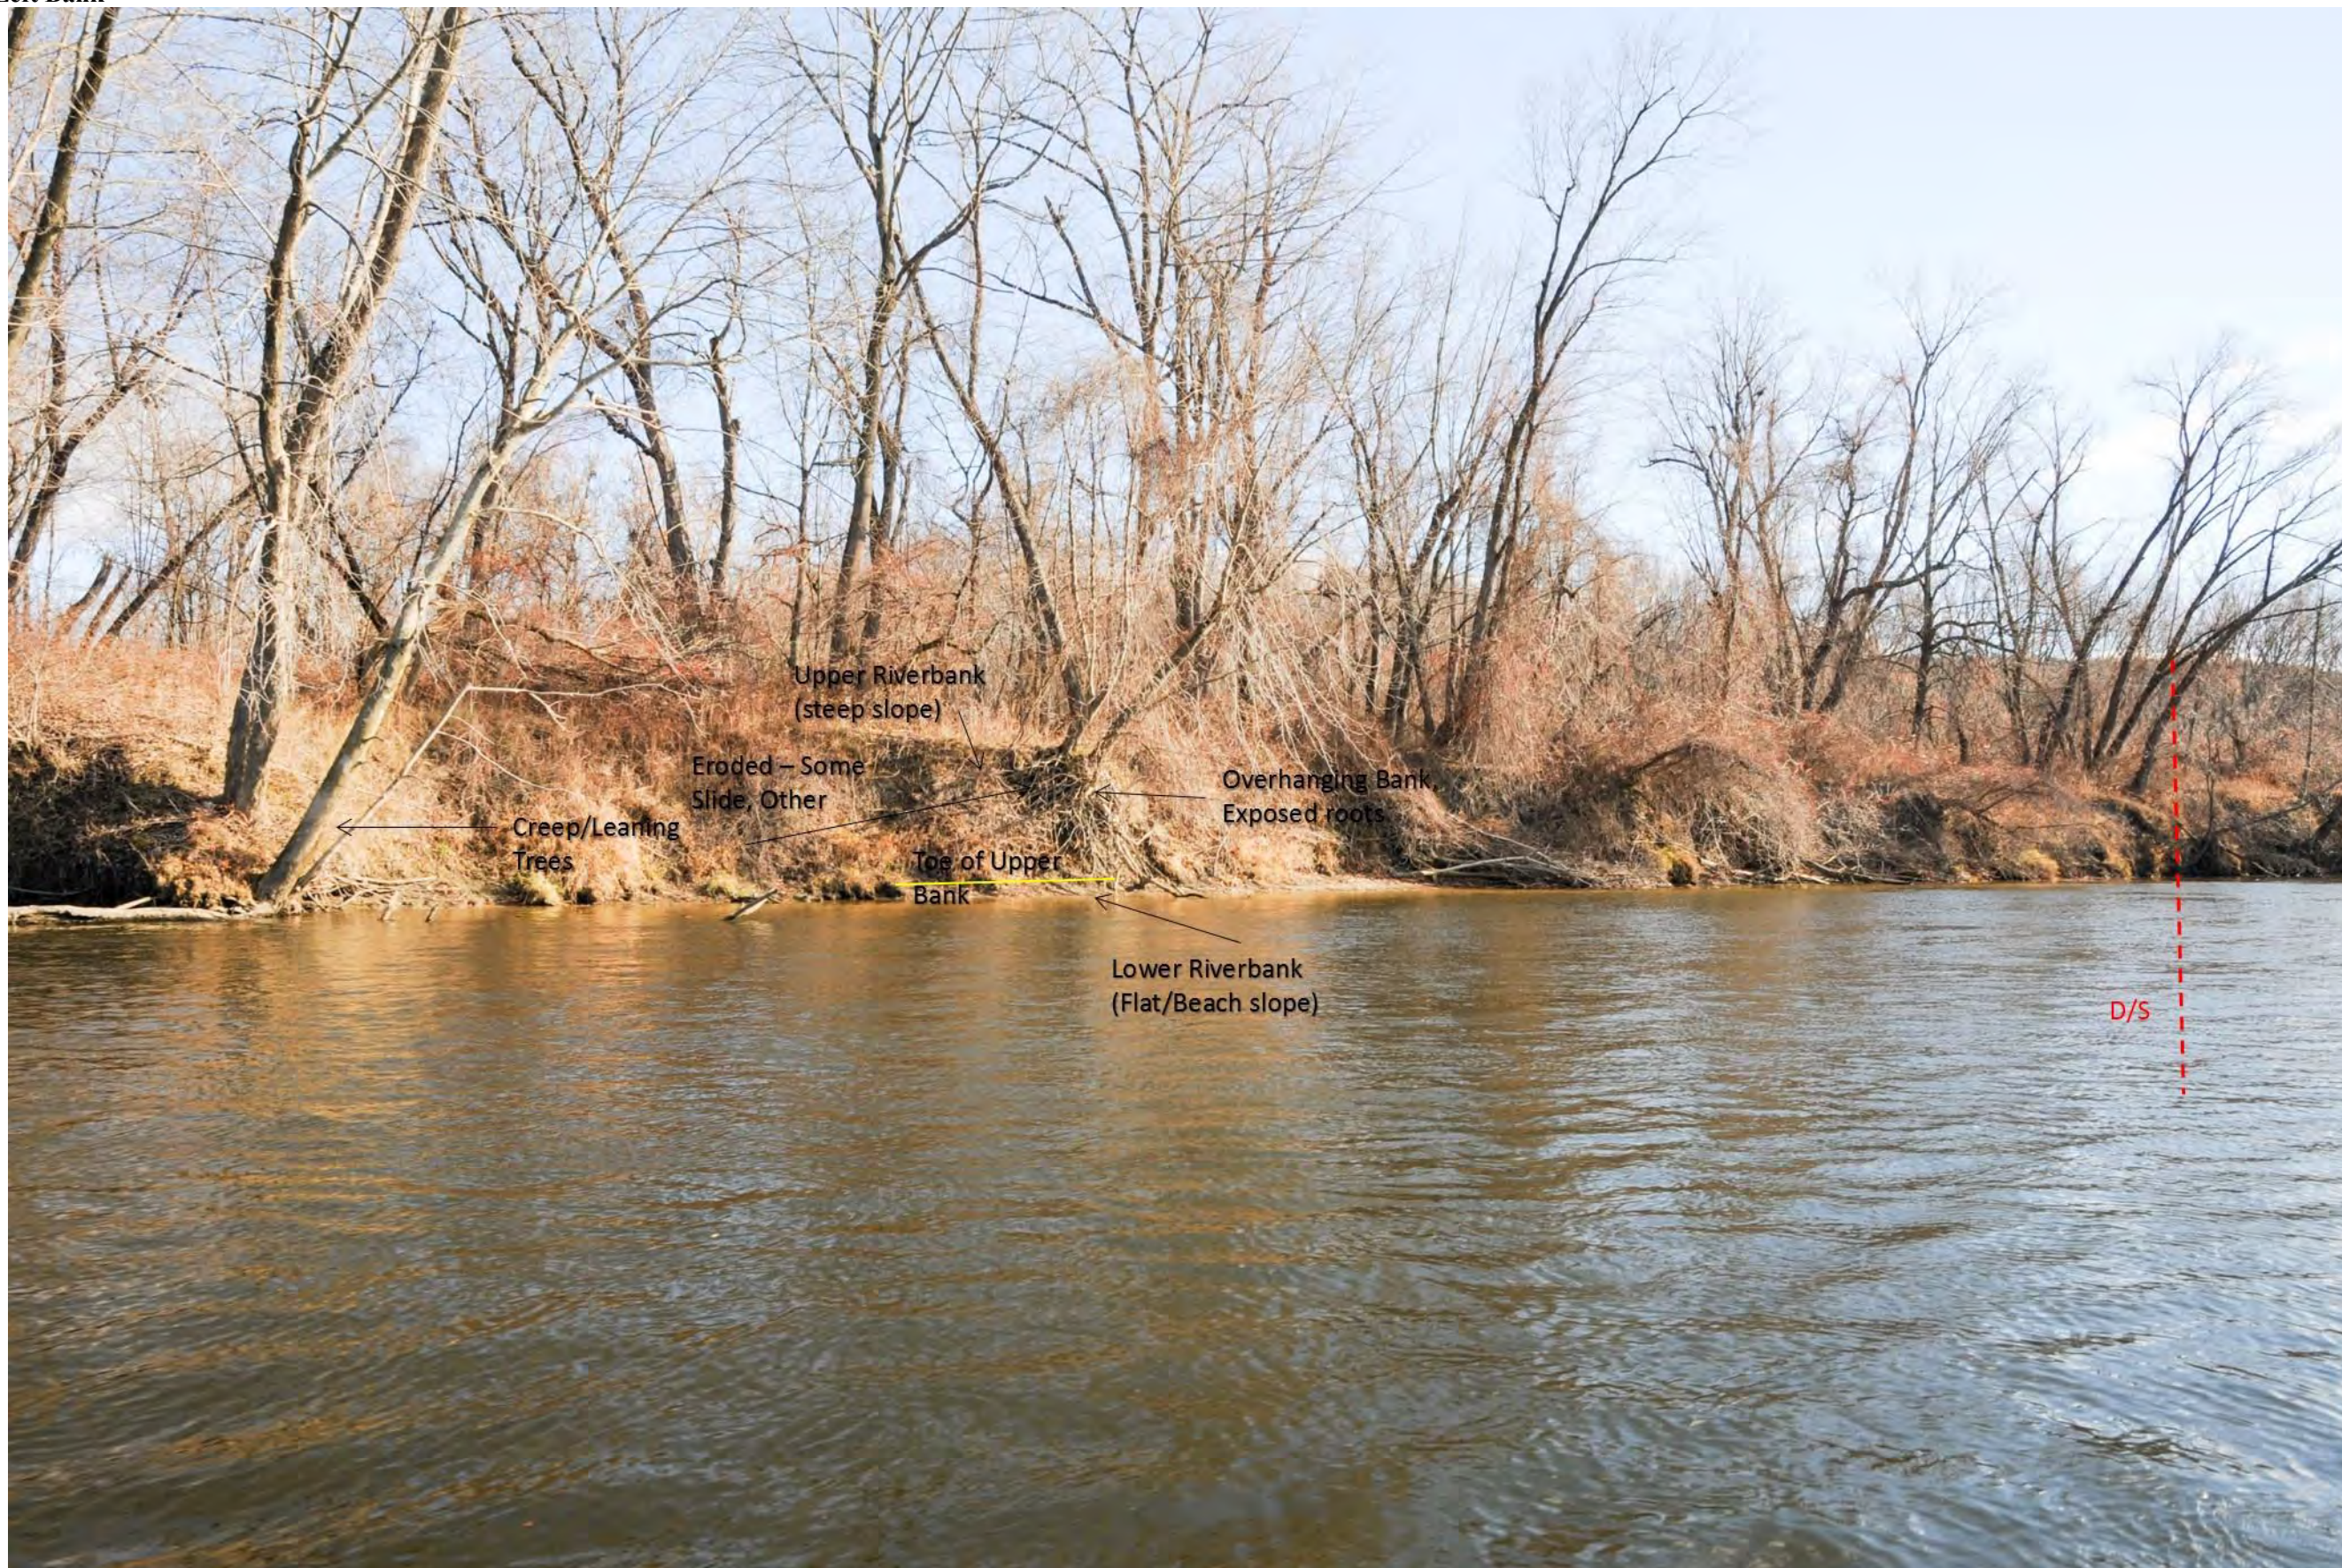
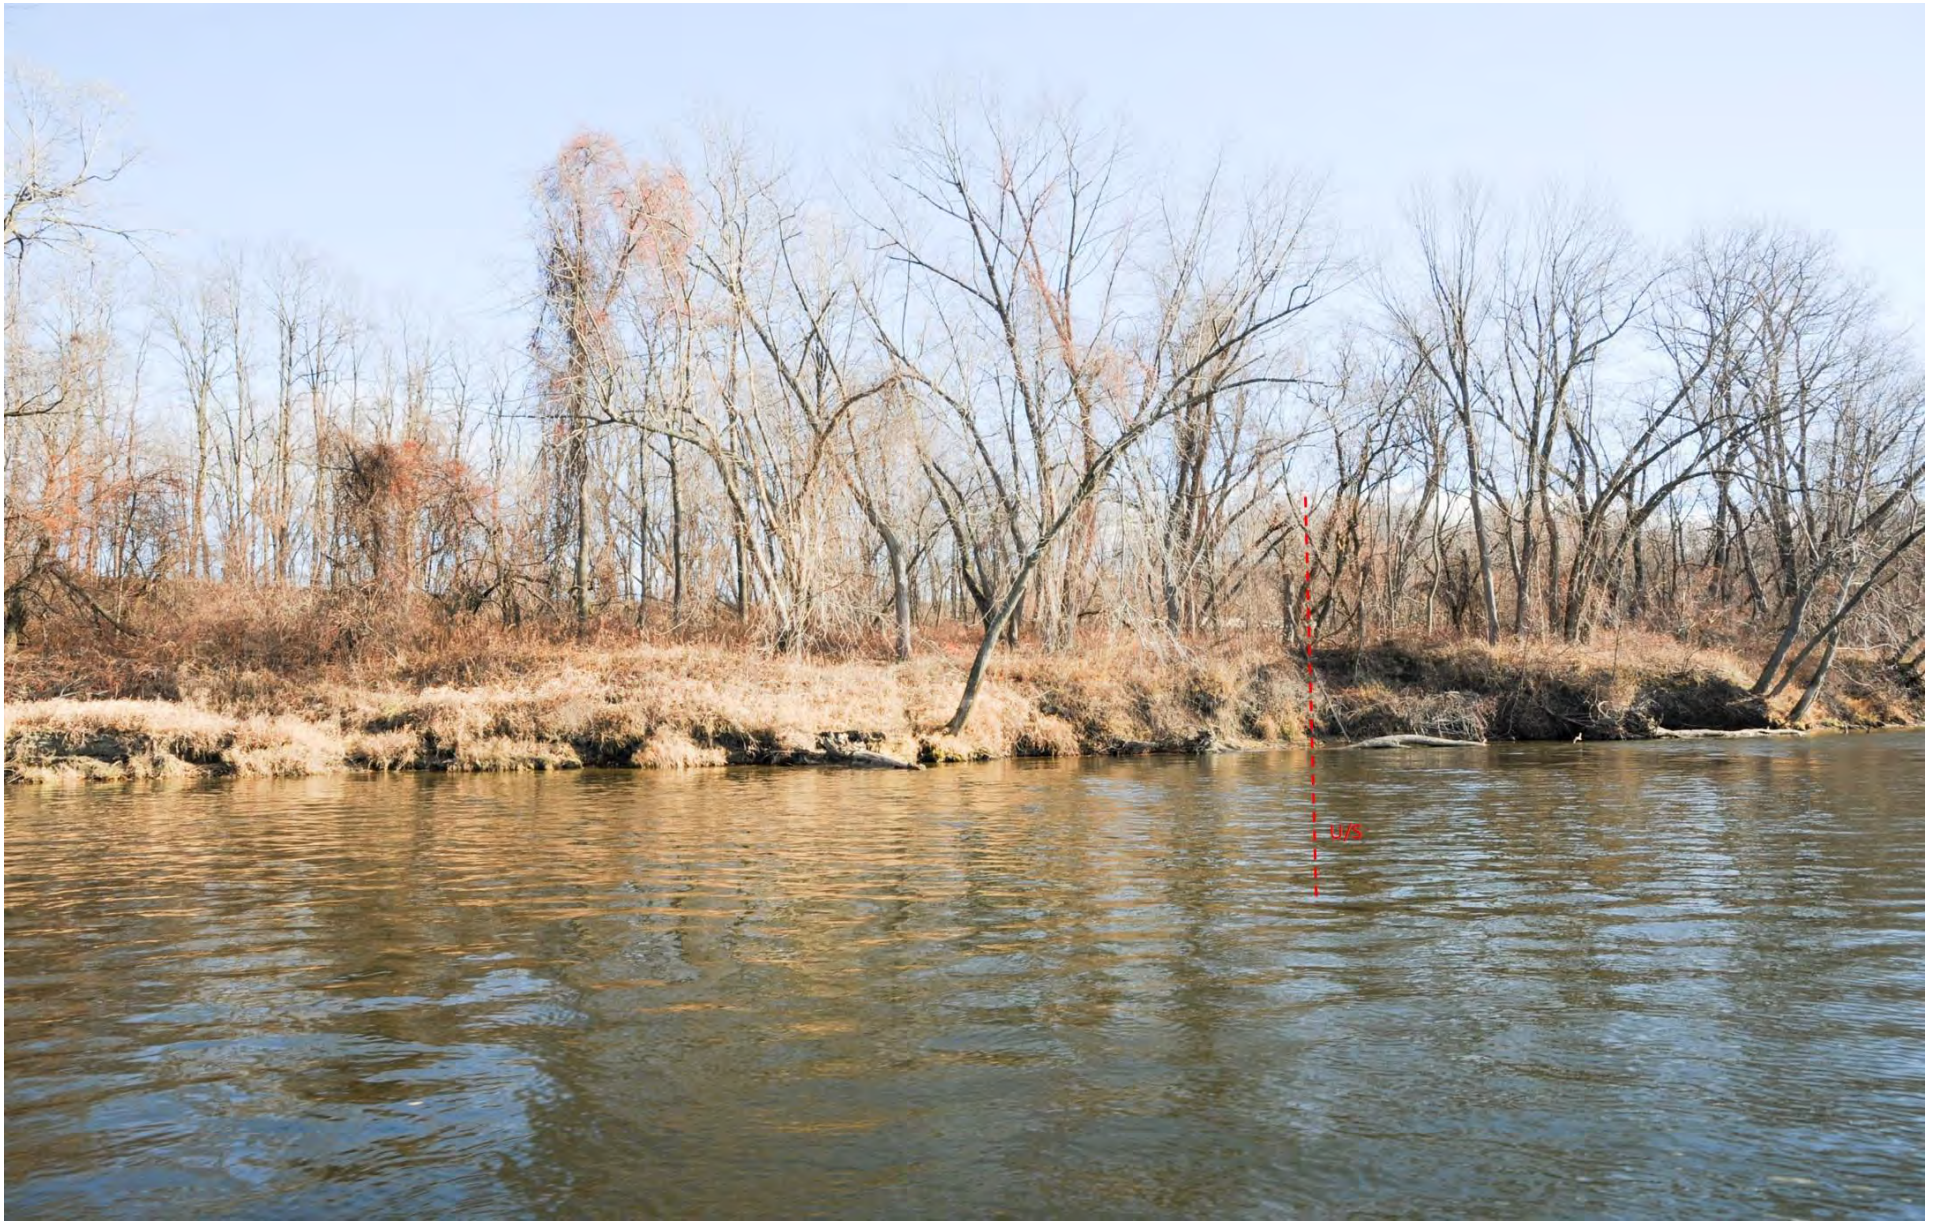
Segment 310 – Left Bank

Riverbank Features	Characteristics
Upper Riverbank Slope	Steep
Upper Riverbank Height	Medium
Upper Riverbank Sediment	Silt/Sand
Upper Riverbank Vegetation	Moderate
Lower Riverbank Slope	Flat/Beach
Lower Riverbank Sediment	Silt/Sand
Lower Riverbank Vegetation	None to very sparse
Type of Erosion	Slide
Potential Erosion Indicators	Other, Creep/leaning trees, Exposed roots, Overhanging bank
Stage of Erosion	Eroded
Extent of Erosion	Some

**QA Observations:** Upon review of the photos for this segment, classification made in the field was confirmed and additional indicators of potential future erosion were included.
