Re: Filing of Addendum to Study No. 3.1.1- 2013 Full River Reconnaissance  
Turners Falls Hydroelectric Project (FERC No. 1889) and Northfield Mountain Pumped Storage  
Project (FERC No. 2485)

## **ATTACHMENT A: 2013 Full River Reconnaissance – 2015 Addendum: Riverbank Segment QA Comparison**

2015 FRR Addendum  
 Selected Riverbank Segments for QA  
 Map 1

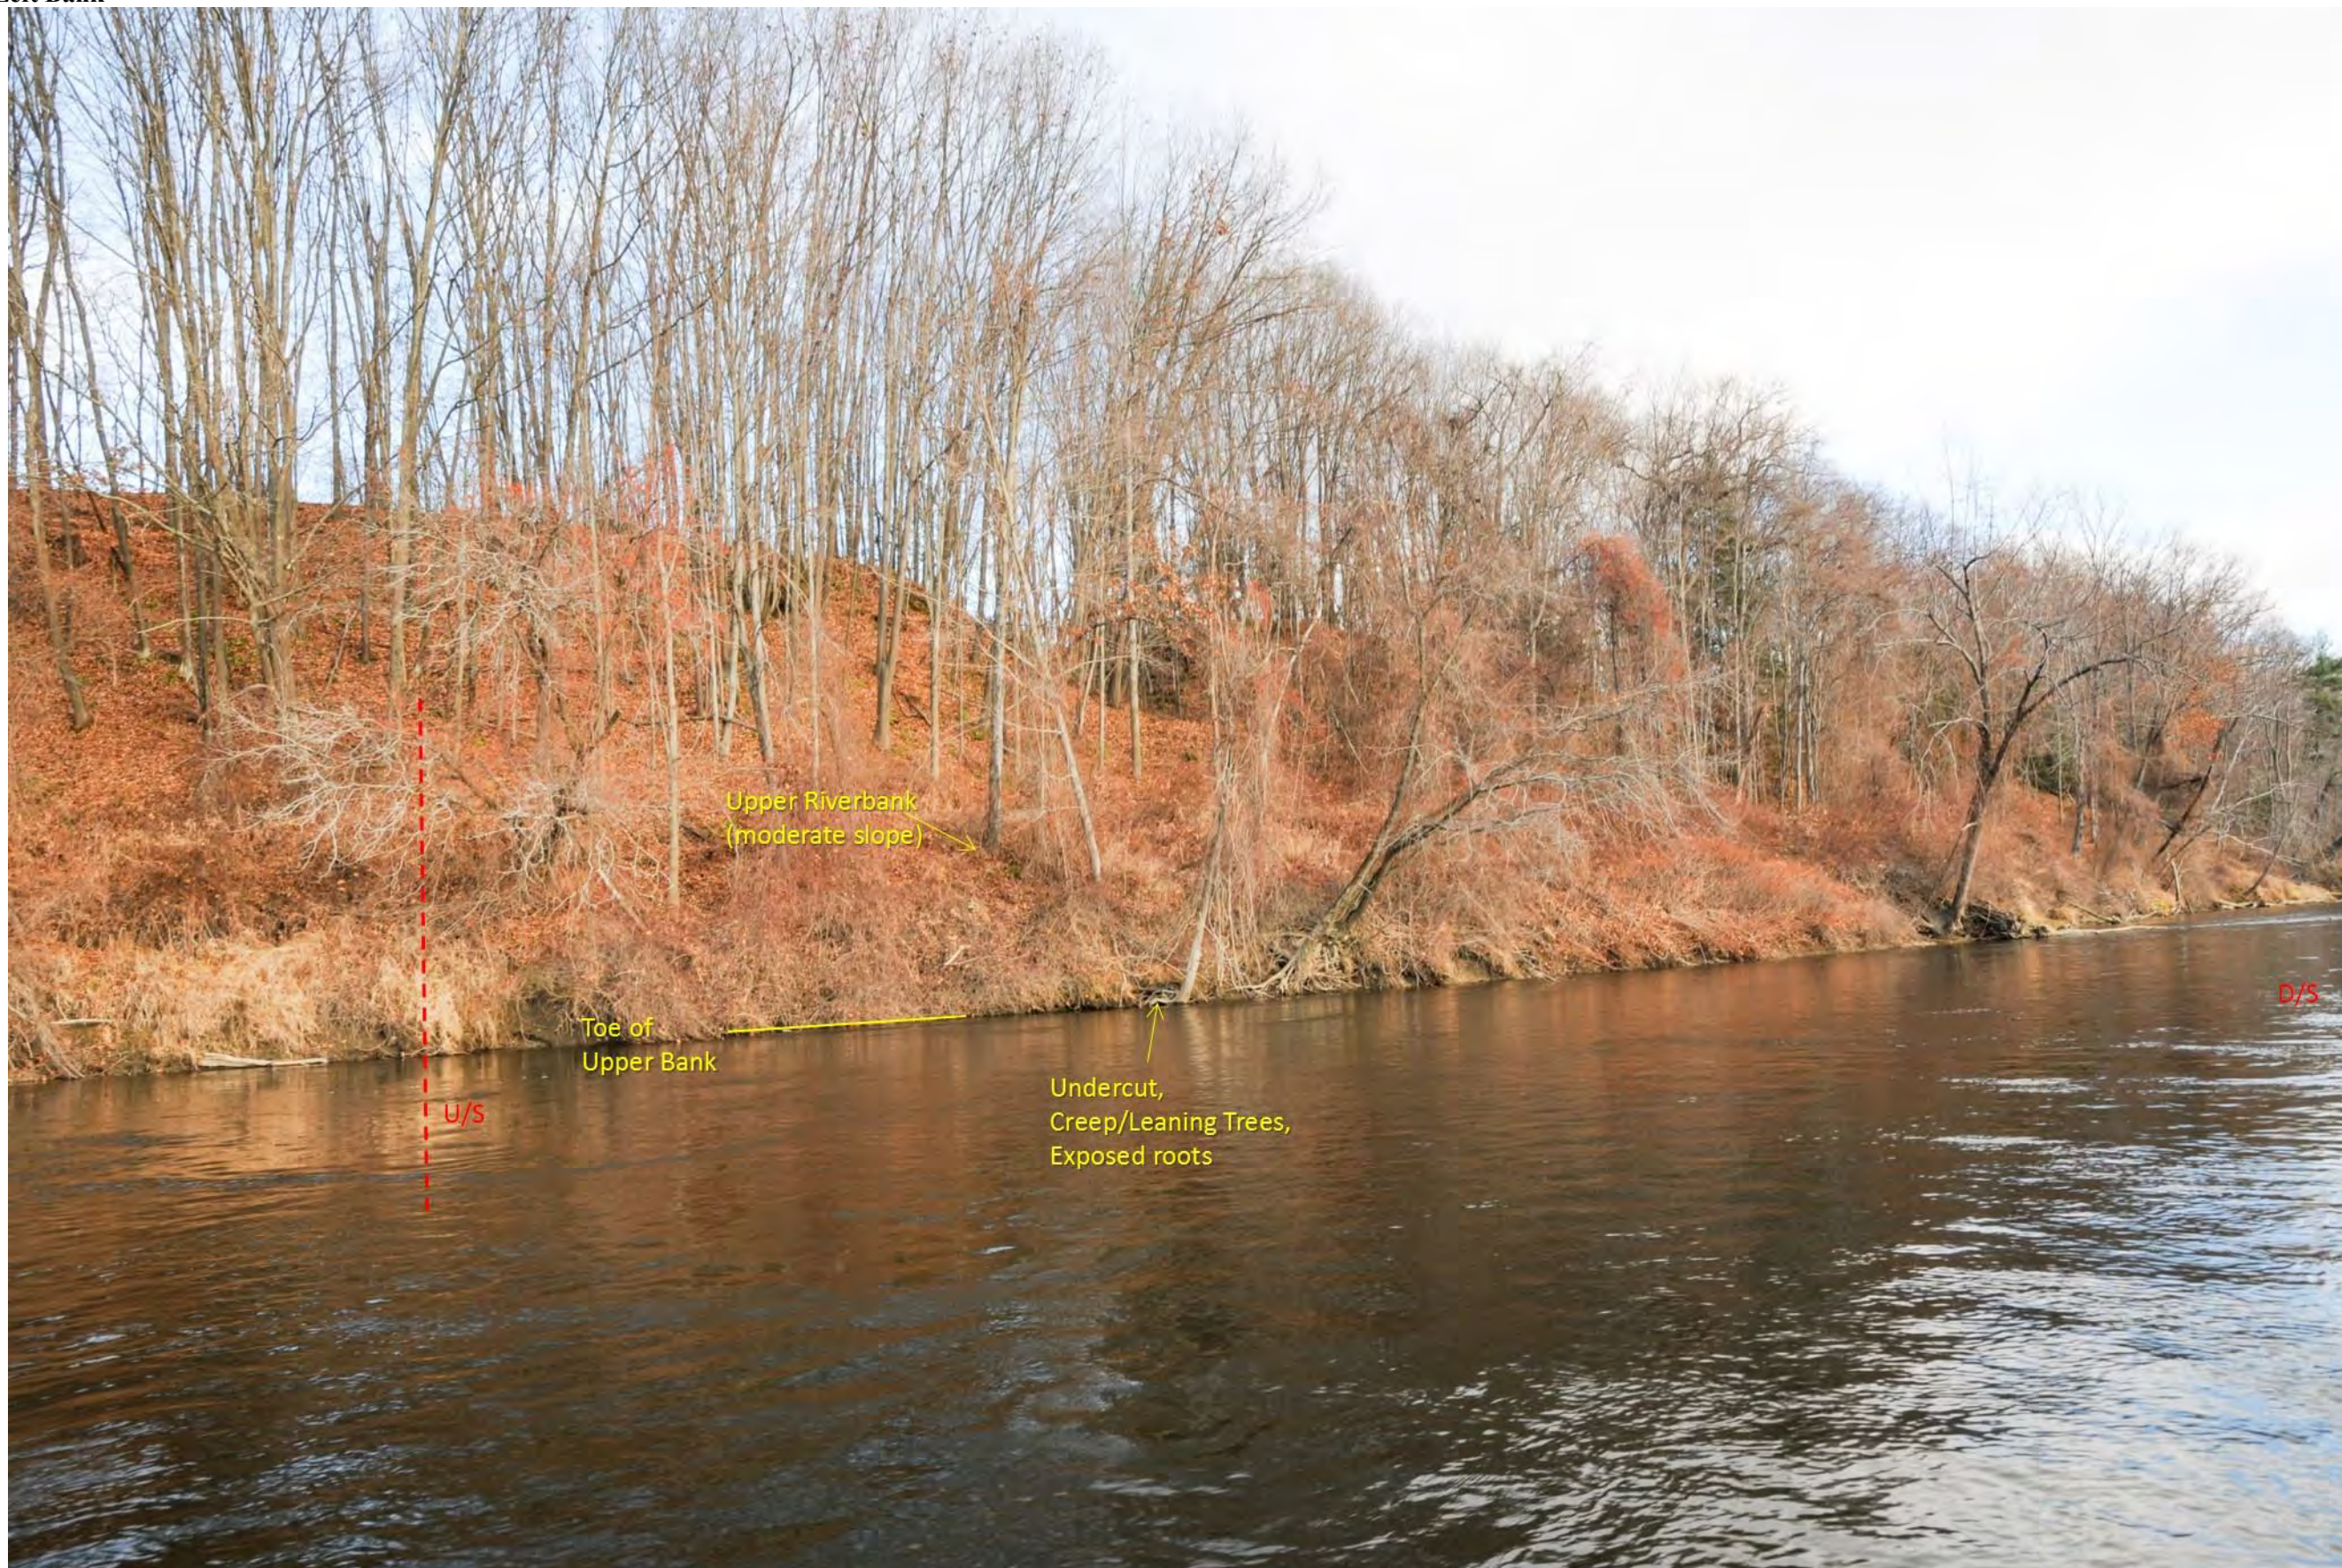
Segment 320 – Left Bank

<b>Riverbank Features</b>	<b>Characteristics</b>
<b>Upper Riverbank Slope</b>	Moderate
<b>Upper Riverbank Height</b>	High
<b>Upper Riverbank Sediment</b>	Silt/Sand
<b>Upper Riverbank Vegetation</b>	Heavy
<b>Lower Riverbank Slope</b>	Flat/Beach
<b>Lower Riverbank Sediment</b>	Silt/Sand
<b>Lower Riverbank Vegetation</b>	None to very sparse
<b>Type of Erosion</b>	Undercut
<b>Potential Erosion Indicators</b>	Creep/Leaning trees, Exposed Roots
<b>Stage of Erosion</b>	Stable
<b>Extent of Erosion</b>	None/Little

**QA Observations:** Upon review of the photos for this segment, classification made in the field was confirmed and additional indicators of potential future erosion were included.

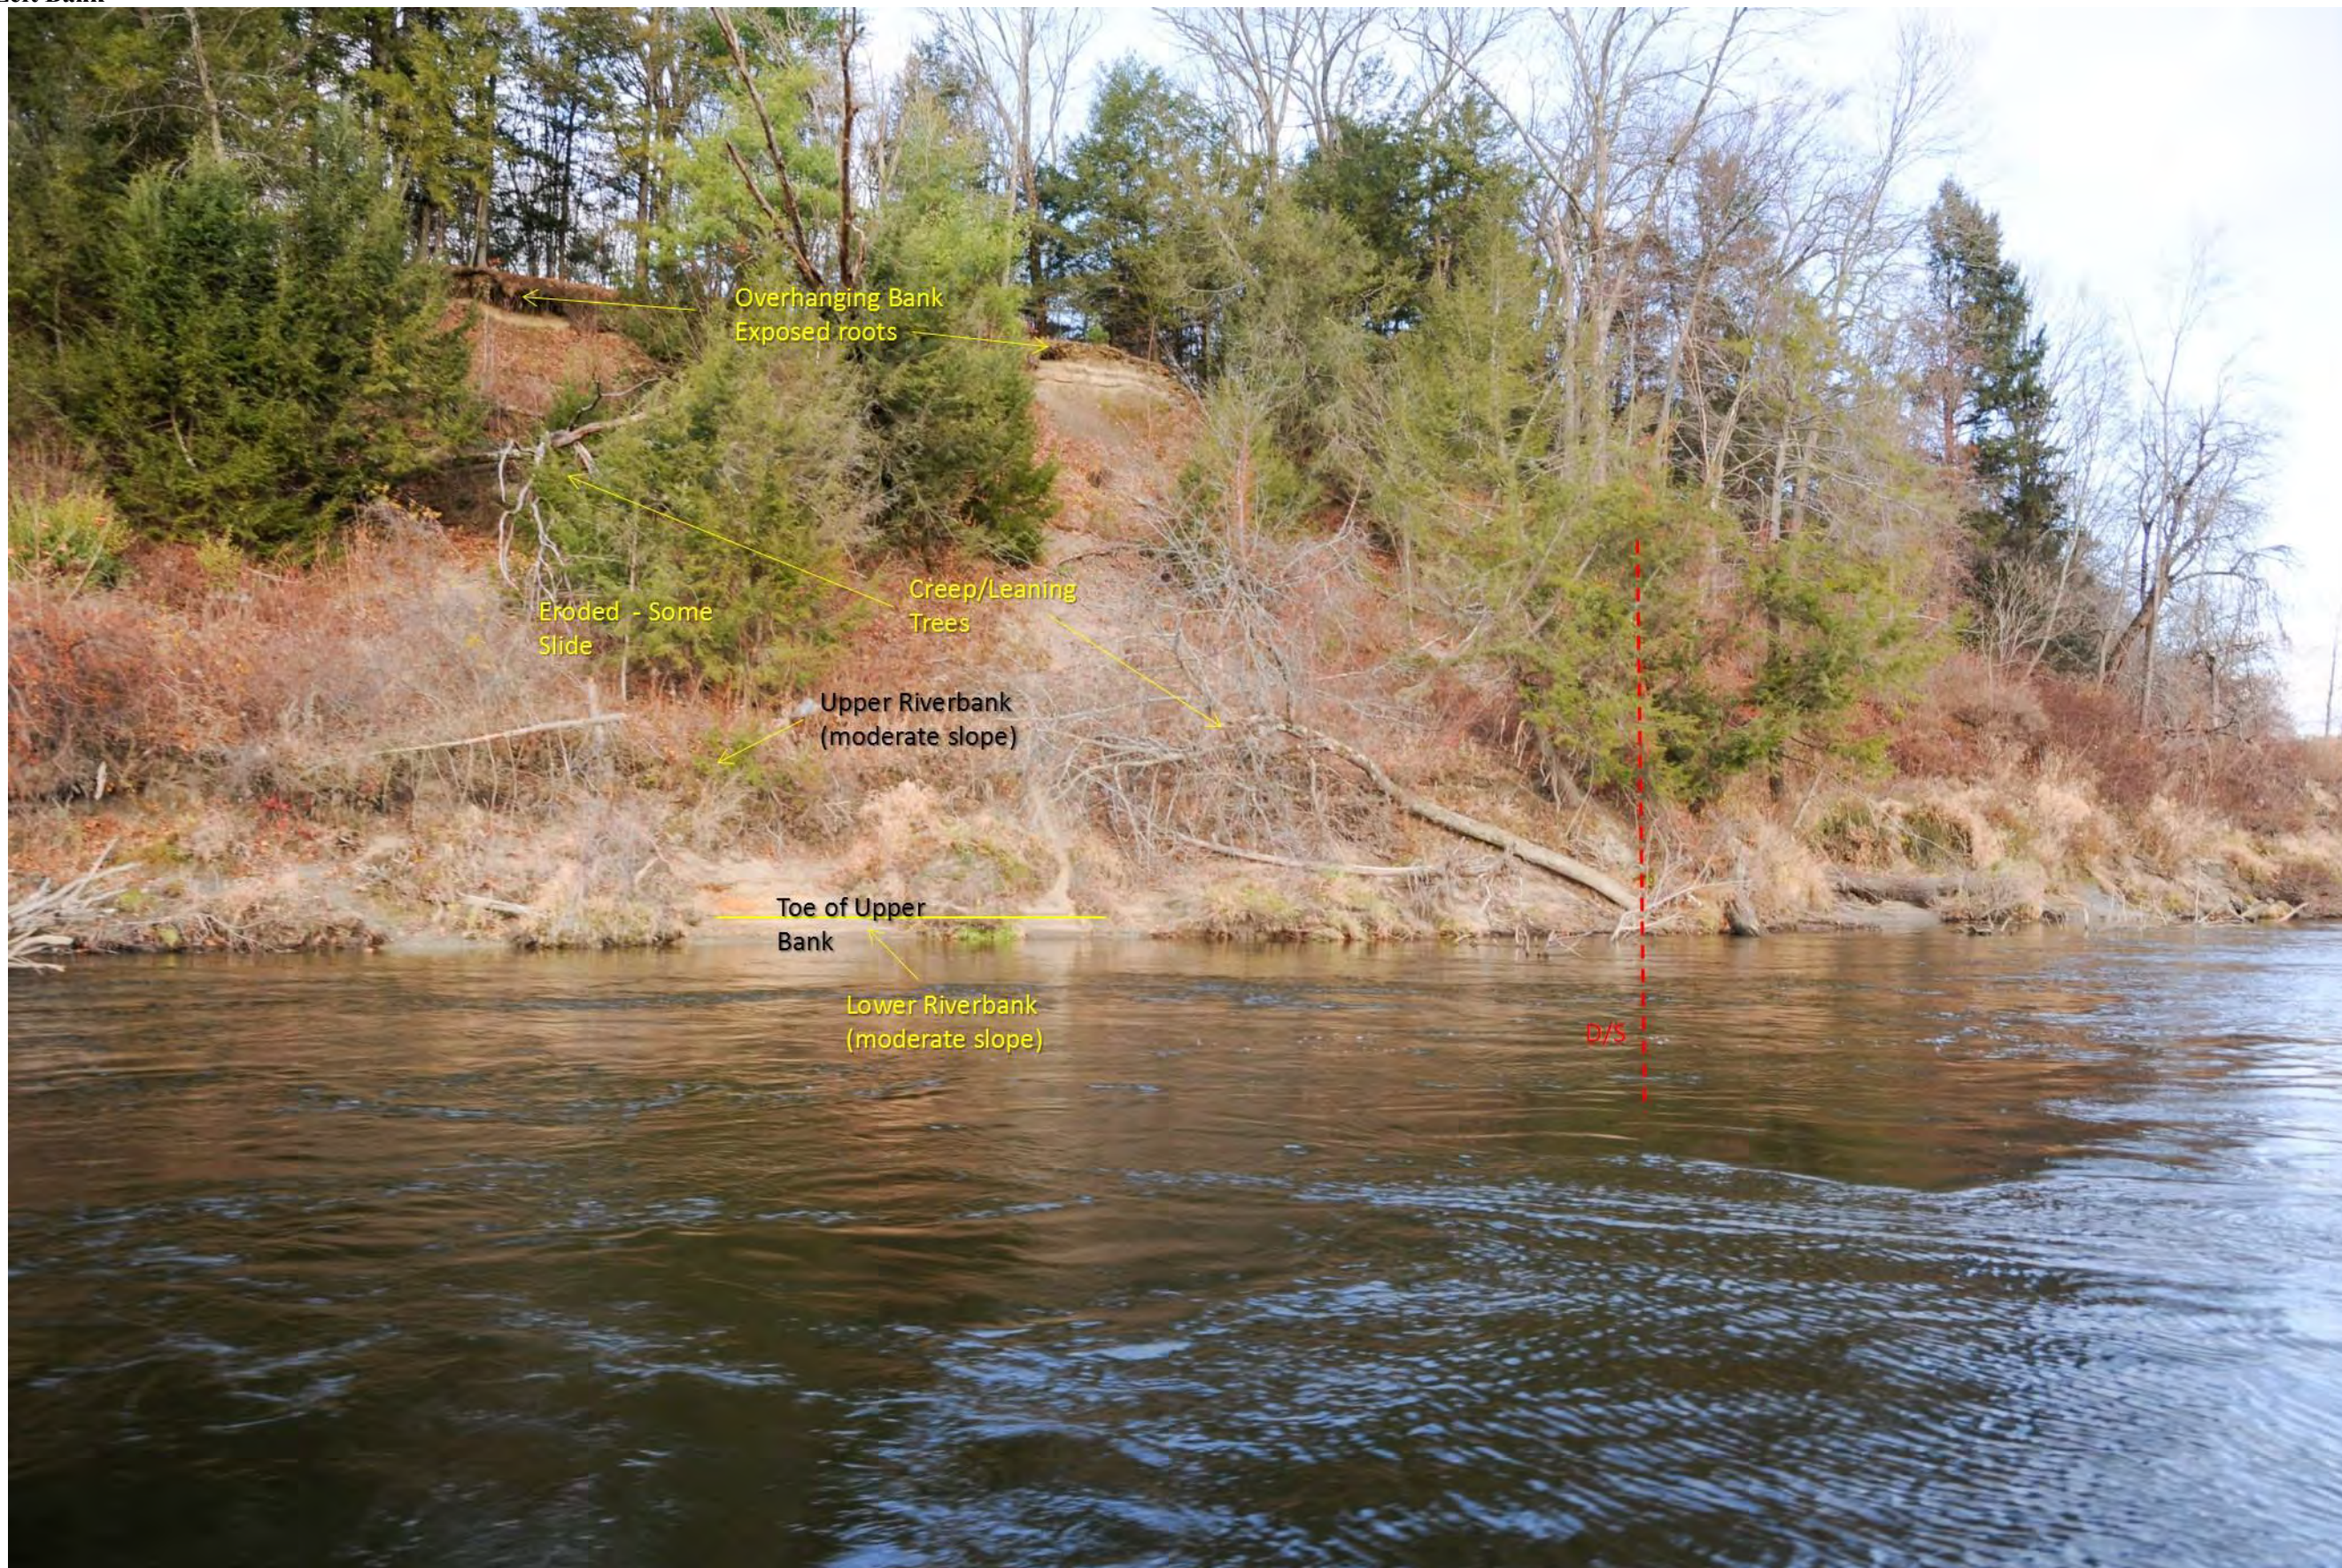
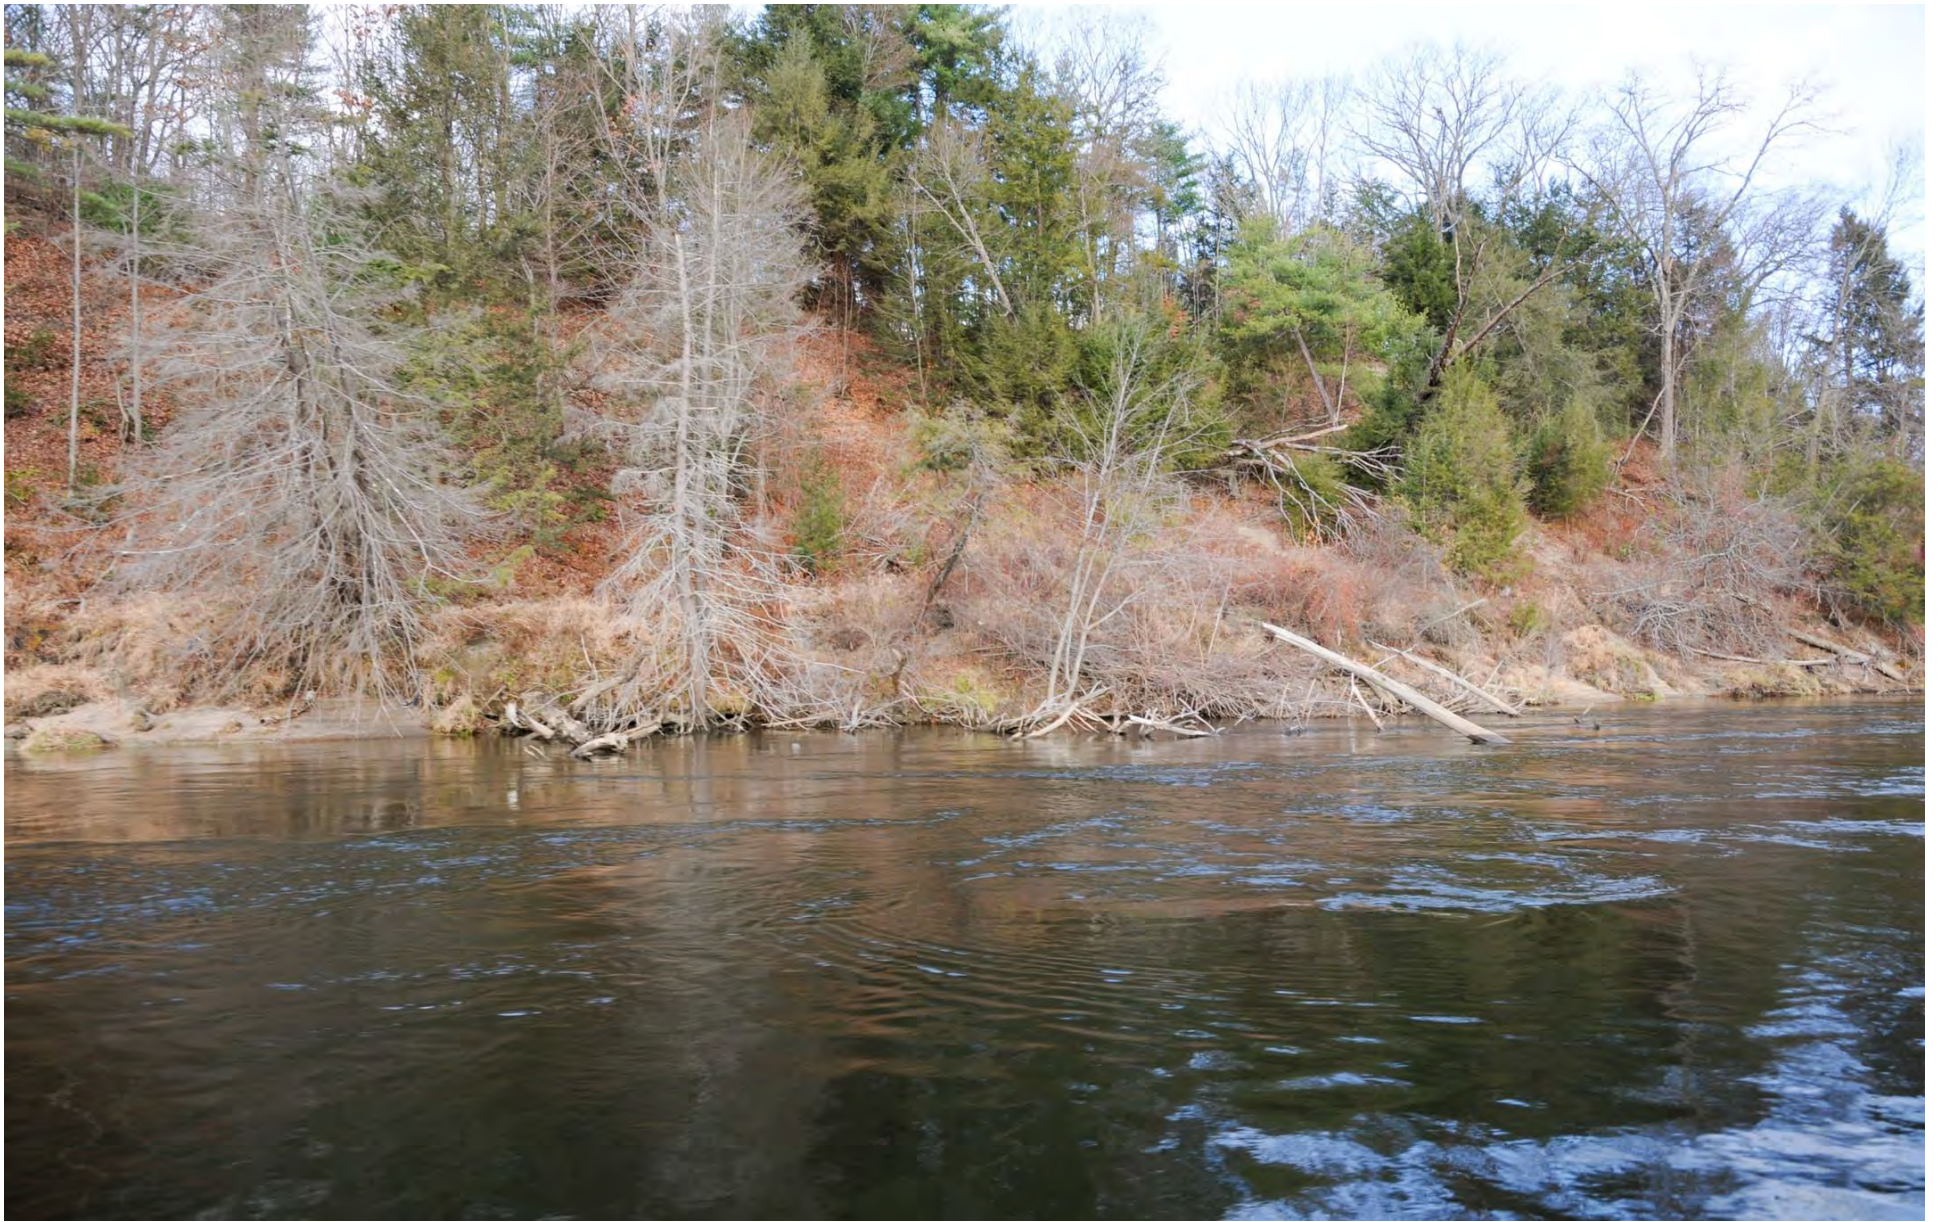
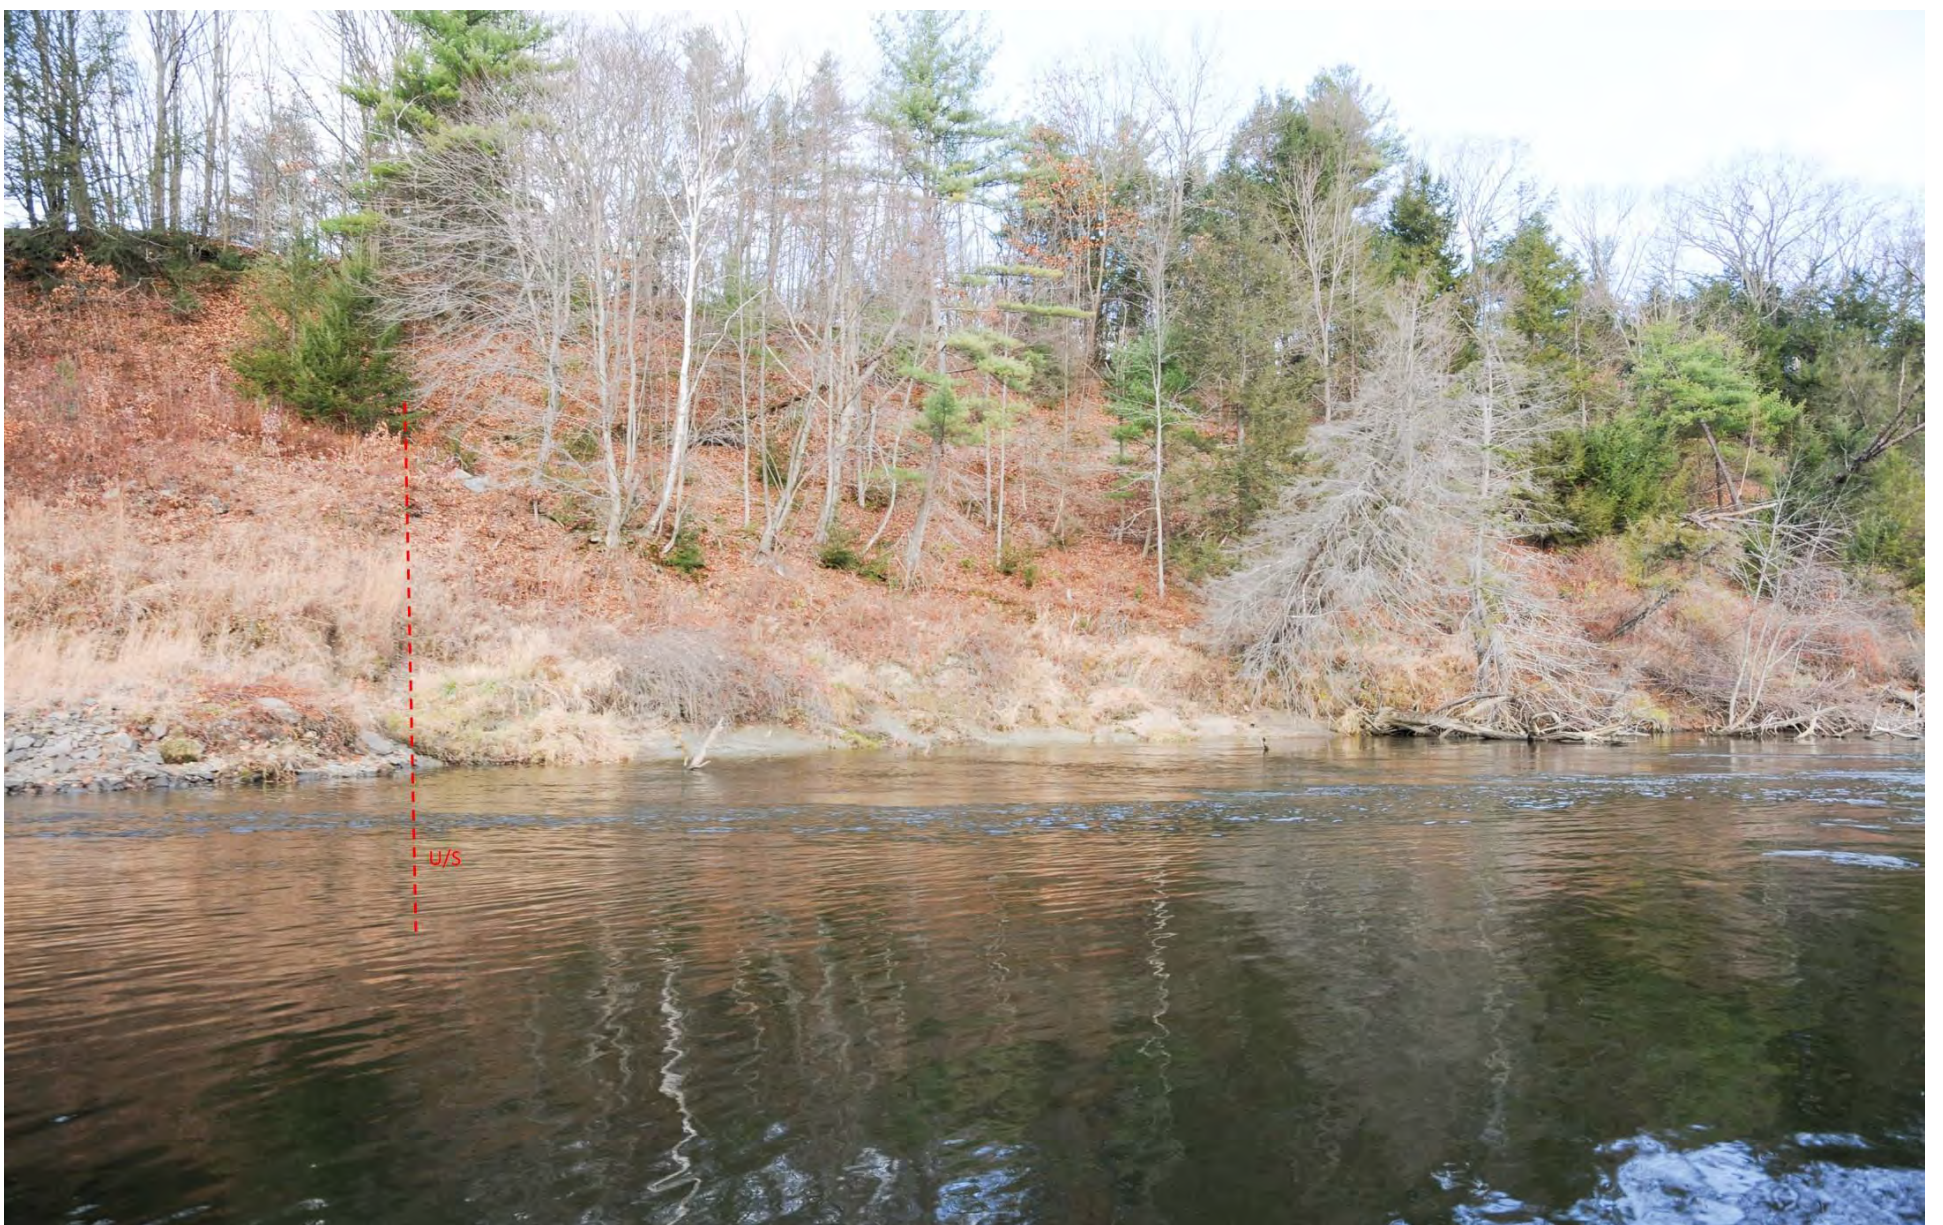
Segment 330 – Left Bank

Riverbank Features	Characteristics
Upper Riverbank Slope	Moderate
Upper Riverbank Height	High
Upper Riverbank Sediment	Silt/Sand
Upper Riverbank Vegetation	Heavy
Lower Riverbank Slope	Moderate
Lower Riverbank Sediment	Silt/Sand
Lower Riverbank Vegetation	None to very sparse
Type of Erosion	Slide
Potential Erosion Indicators	Creep/leaning trees, Overhanging bank, Exposed roots
Stage of Erosion	Eroded
Extent of Erosion	Some

**QA Observations:** Upon review of the photos for this segment, classification made in the field was confirmed and additional indicators of potential future erosion were included.
