Re: Filing of Addendum to Study No. 3.1.1- 2013 Full River Reconnaissance  
Turners Falls Hydroelectric Project (FERC No. 1889) and Northfield Mountain Pumped Storage  
Project (FERC No. 2485)

## **ATTACHMENT A: 2013 Full River Reconnaissance – 2015 Addendum: Riverbank Segment QA Comparison**

2015 FRR Addendum  
 Selected Riverbank Segments for QA  
 Map 1

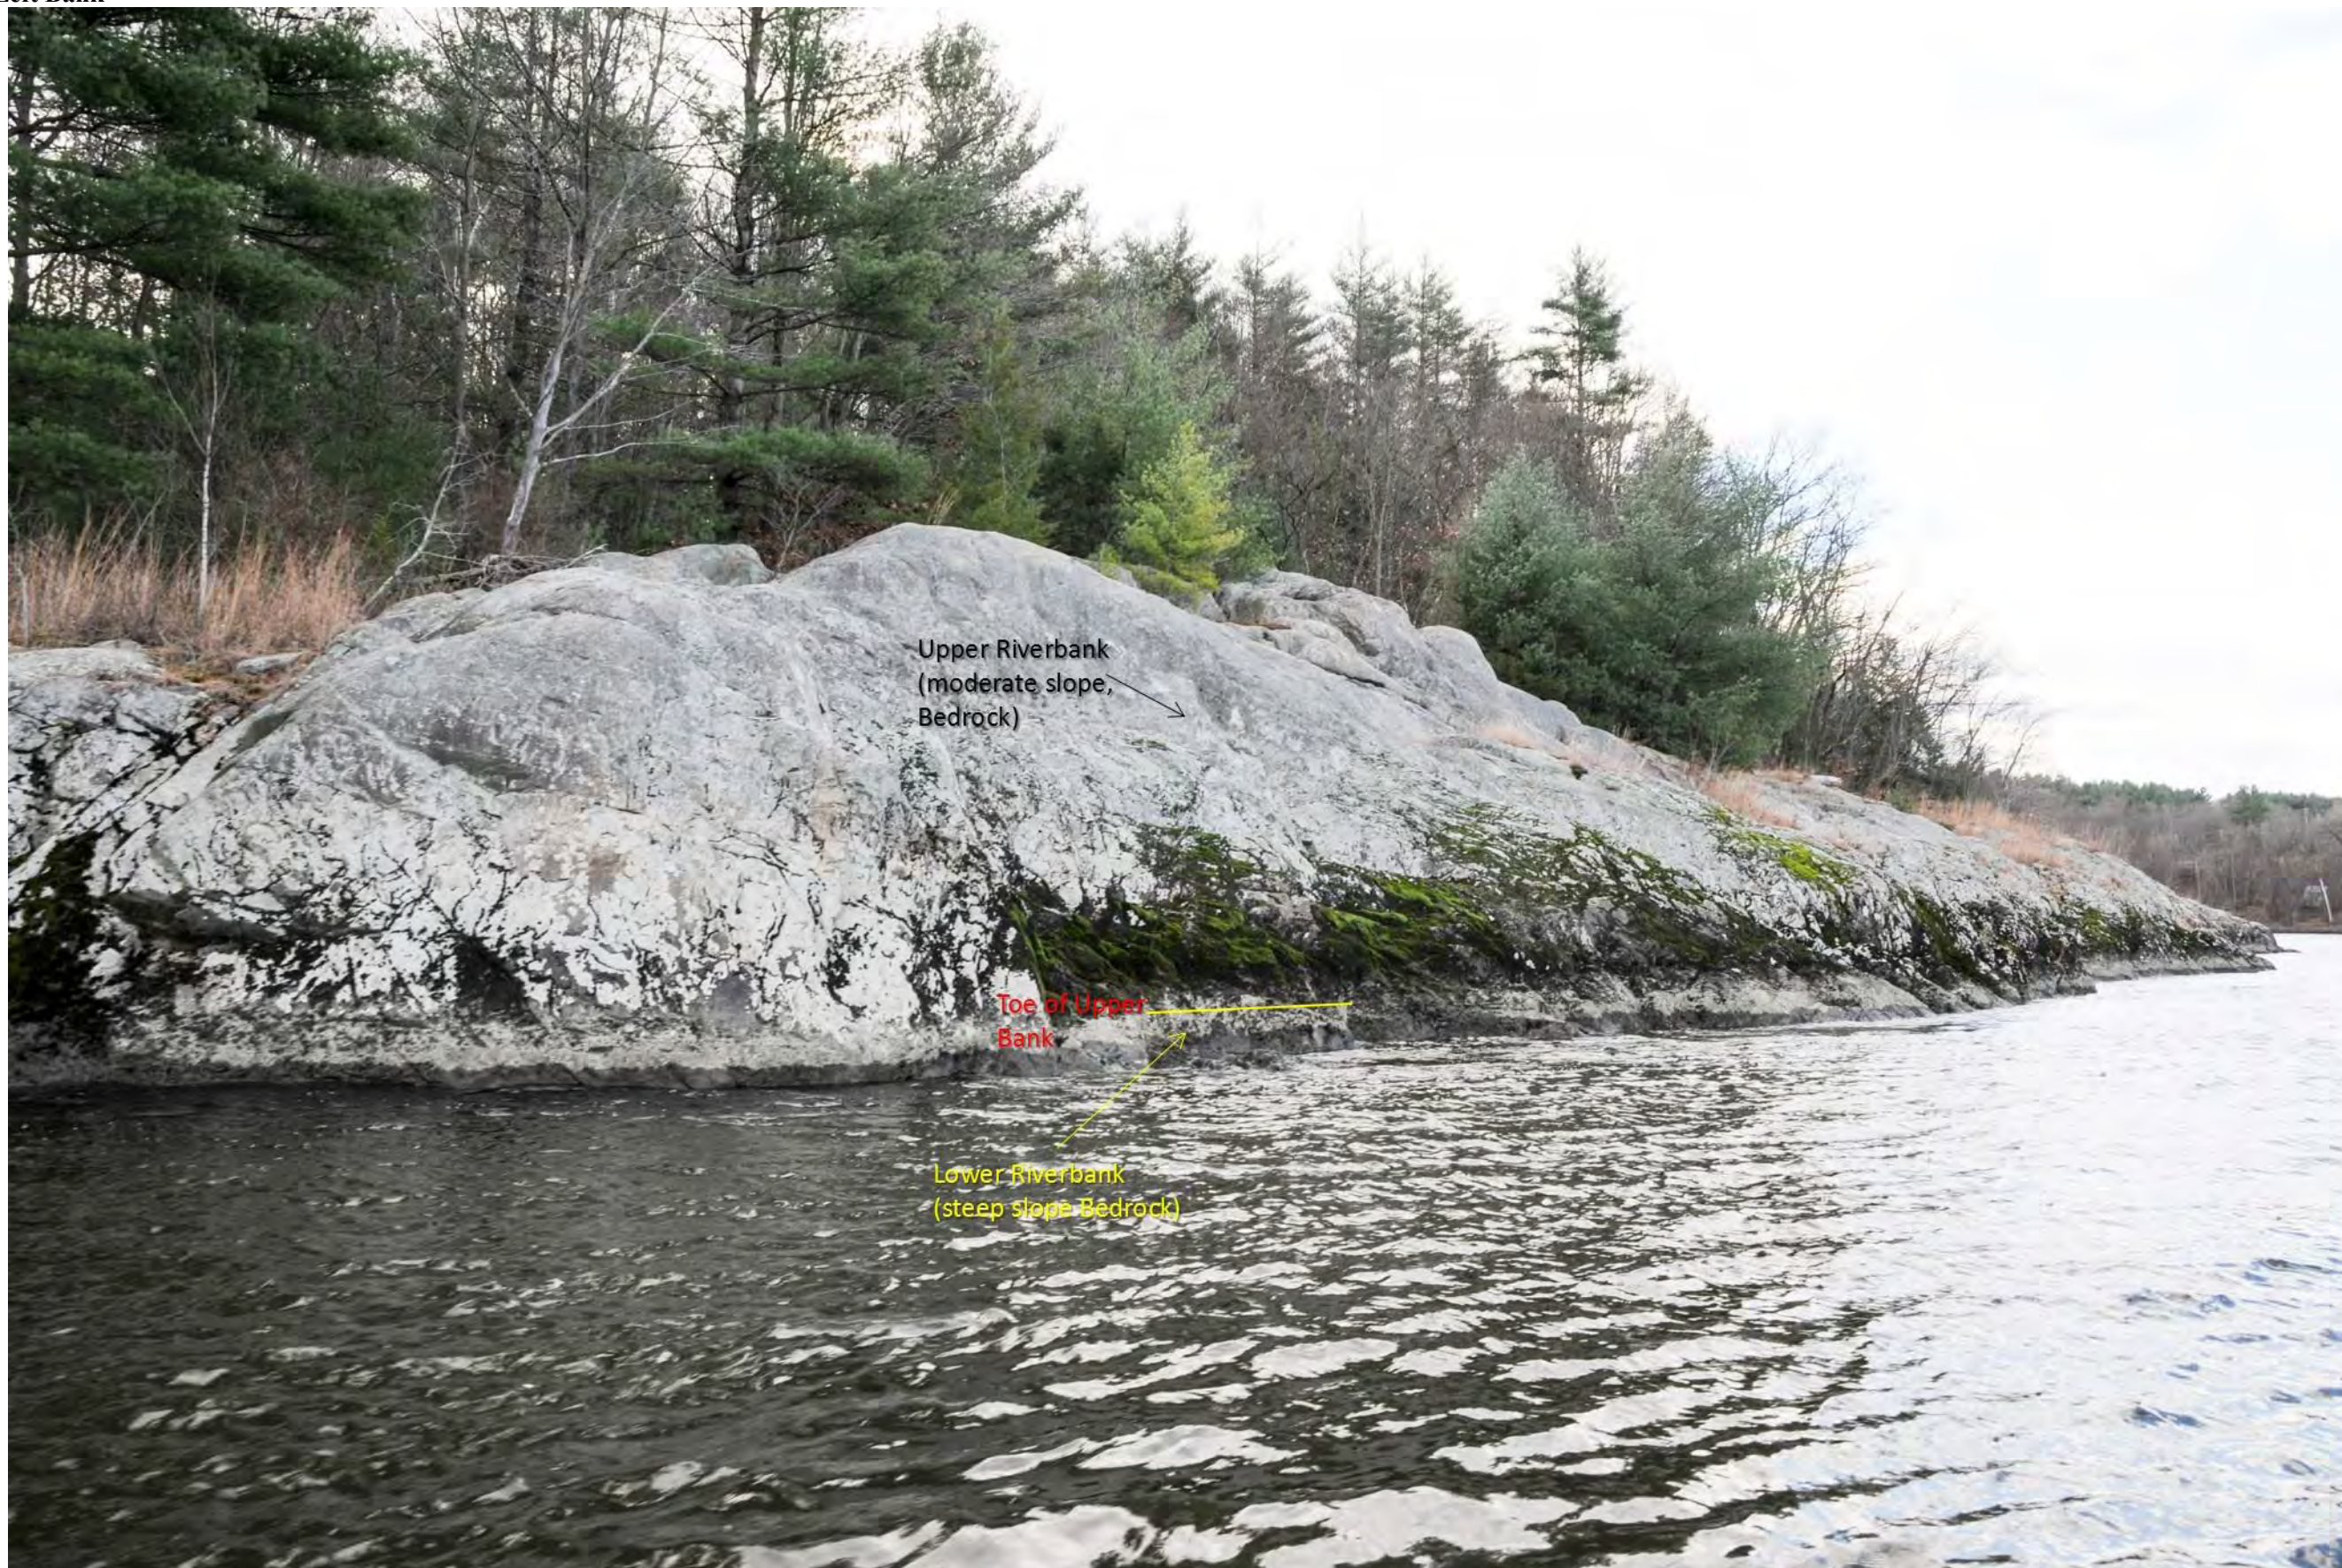
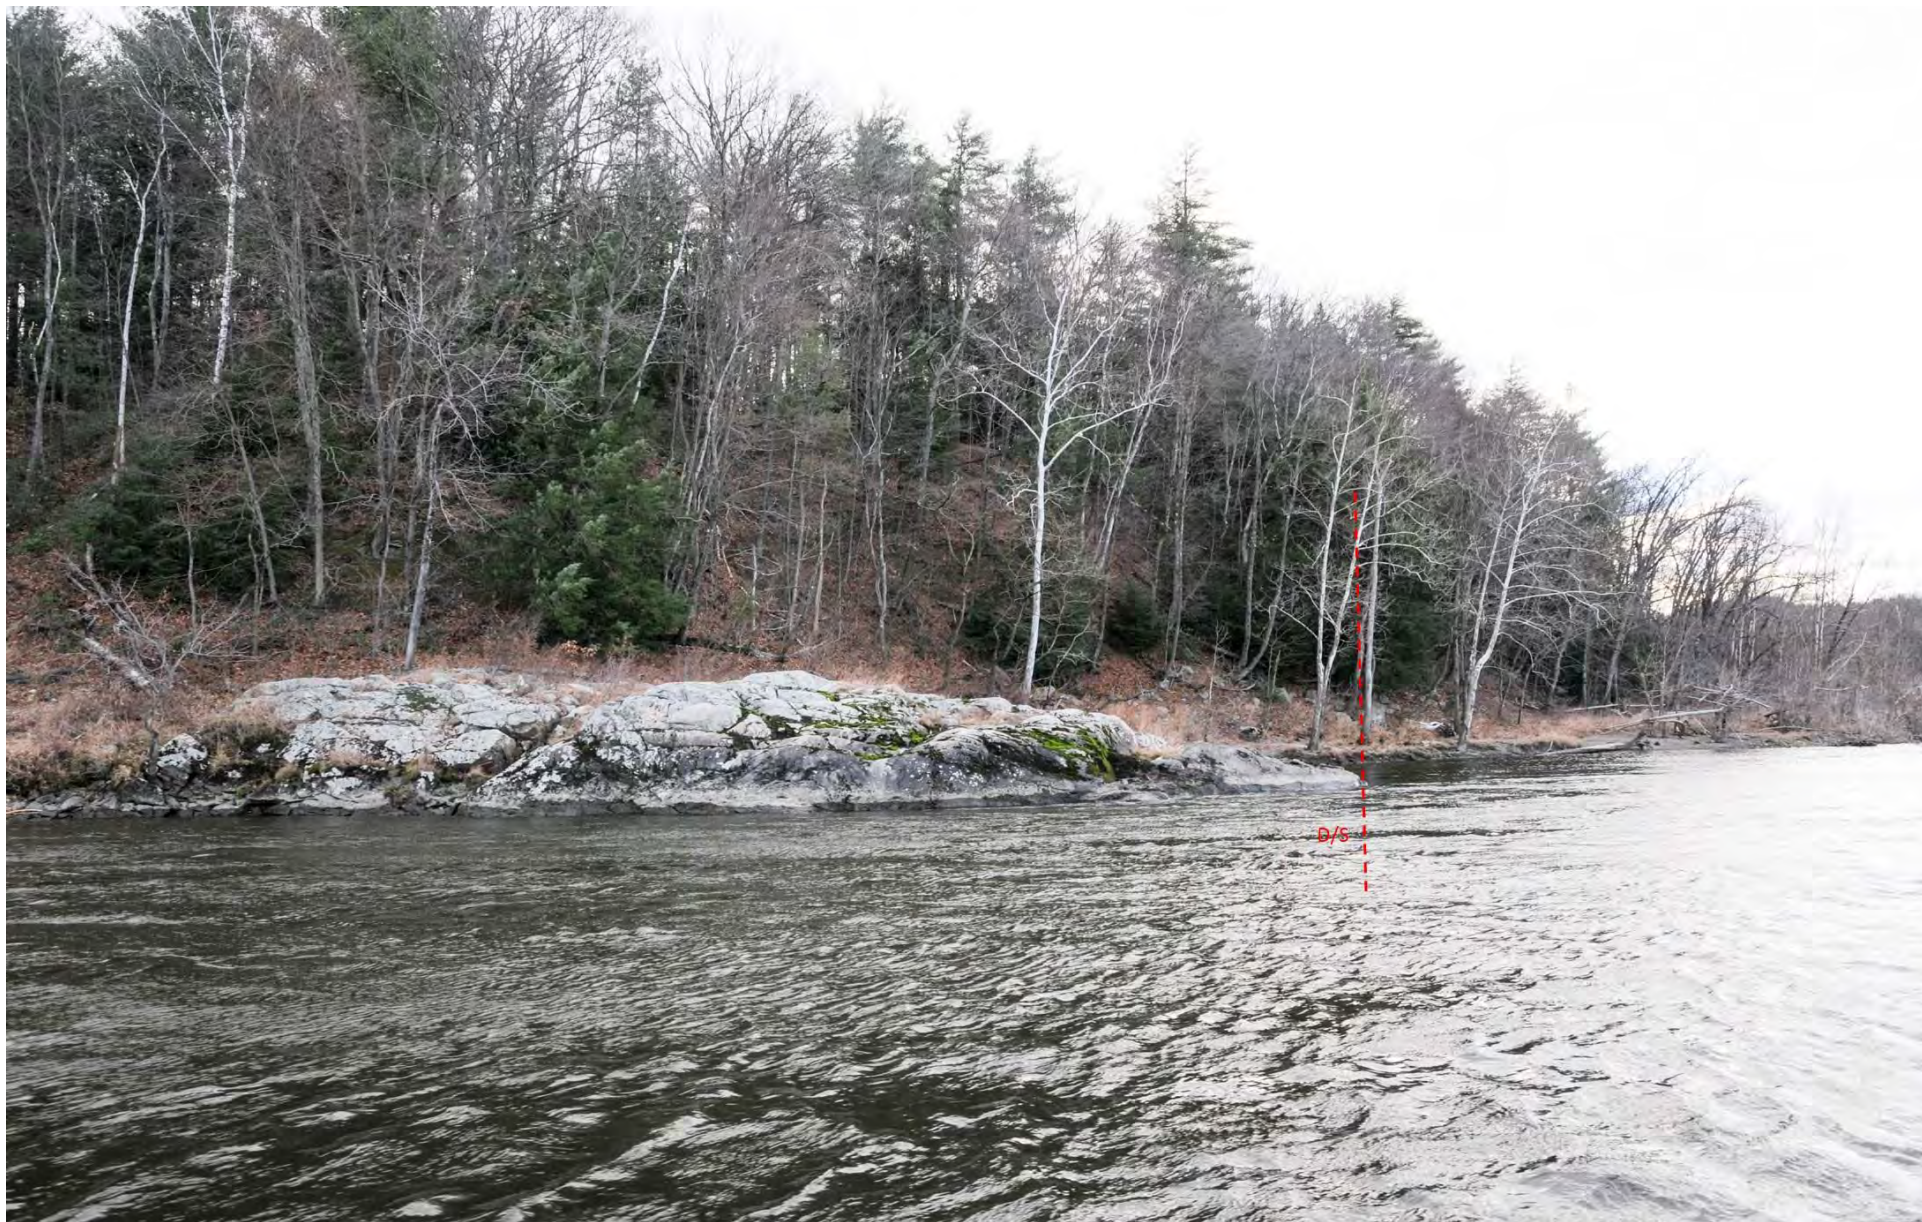
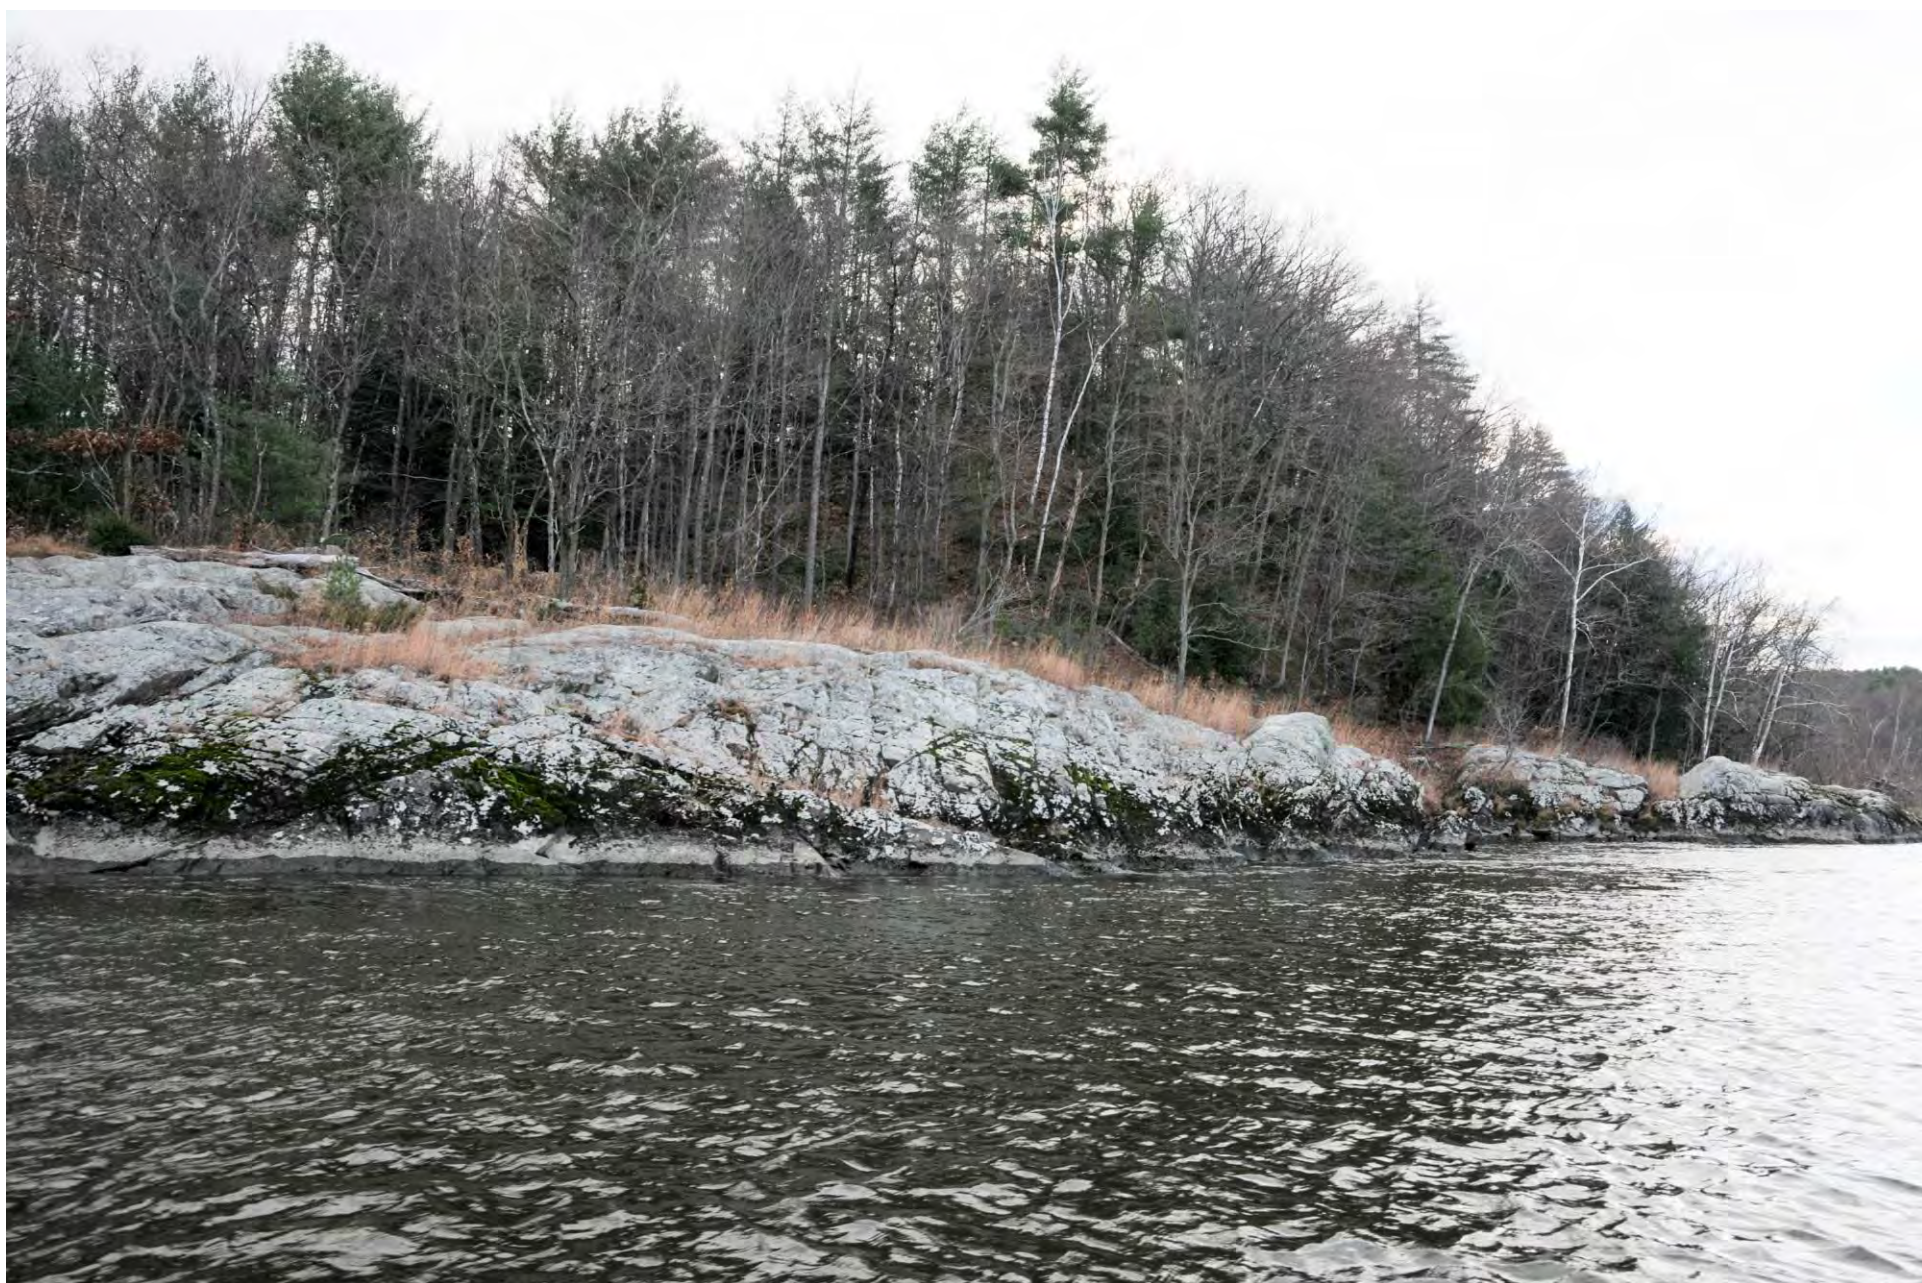
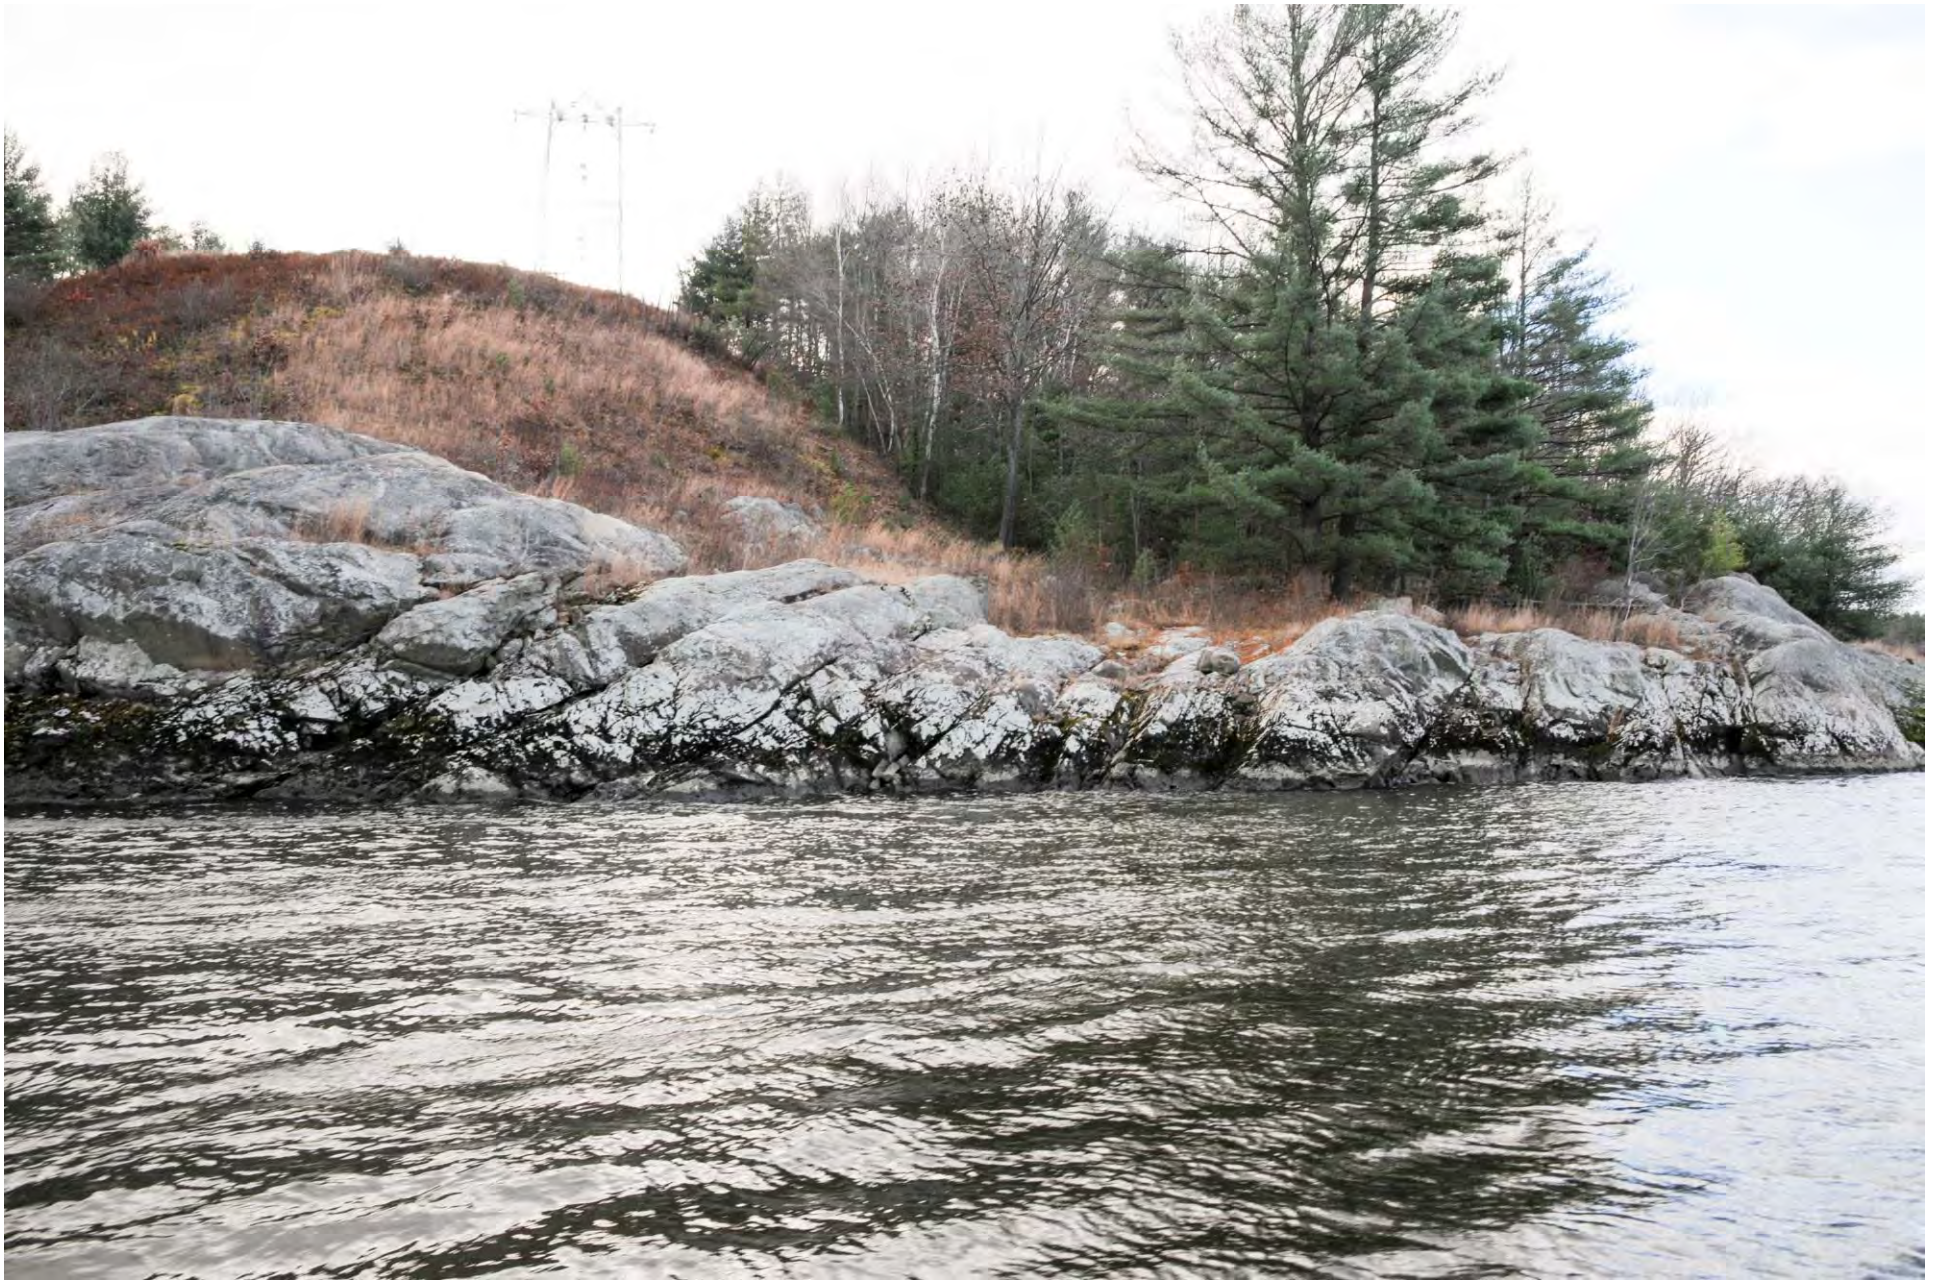
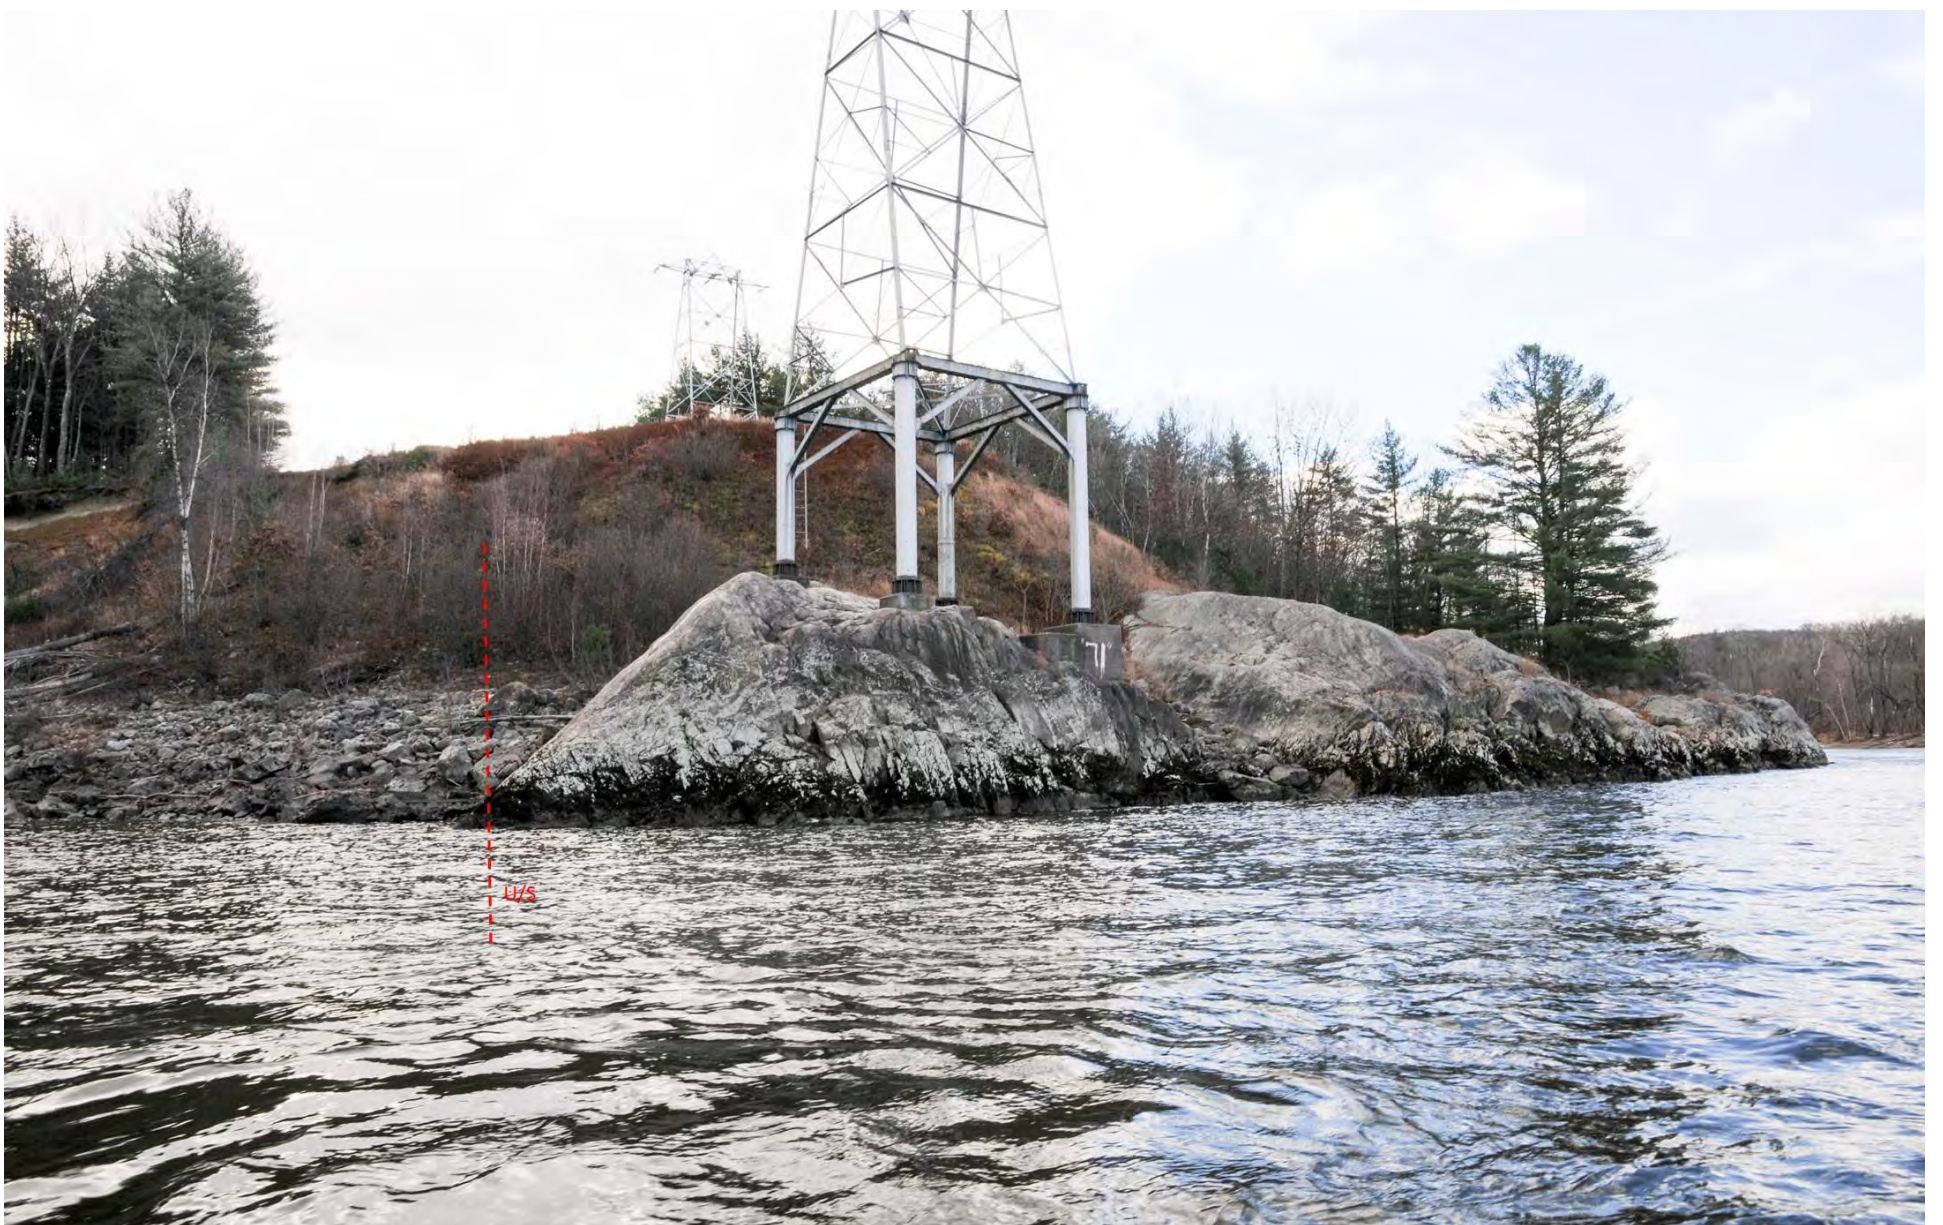
Segment 340 – Left Bank

<b>Riverbank Features</b>	<b>Characteristics</b>
<b>Upper Riverbank Slope</b>	Moderate
<b>Upper Riverbank Height</b>	High
<b>Upper Riverbank Sediment</b>	Bedrock
<b>Upper Riverbank Vegetation</b>	None to very sparse
<b>Lower Riverbank Slope</b>	Steep
<b>Lower Riverbank Sediment</b>	Bedrock
<b>Lower Riverbank Vegetation</b>	None to very sparse
<b>Type of Erosion</b>	
<b>Potential Erosion Indicators</b>	None
<b>Stage of Erosion</b>	Stable
<b>Extent of Erosion</b>	None/Little

**QA Observations:** Upon review of the photos for this segment, classification made in the field was confirmed.

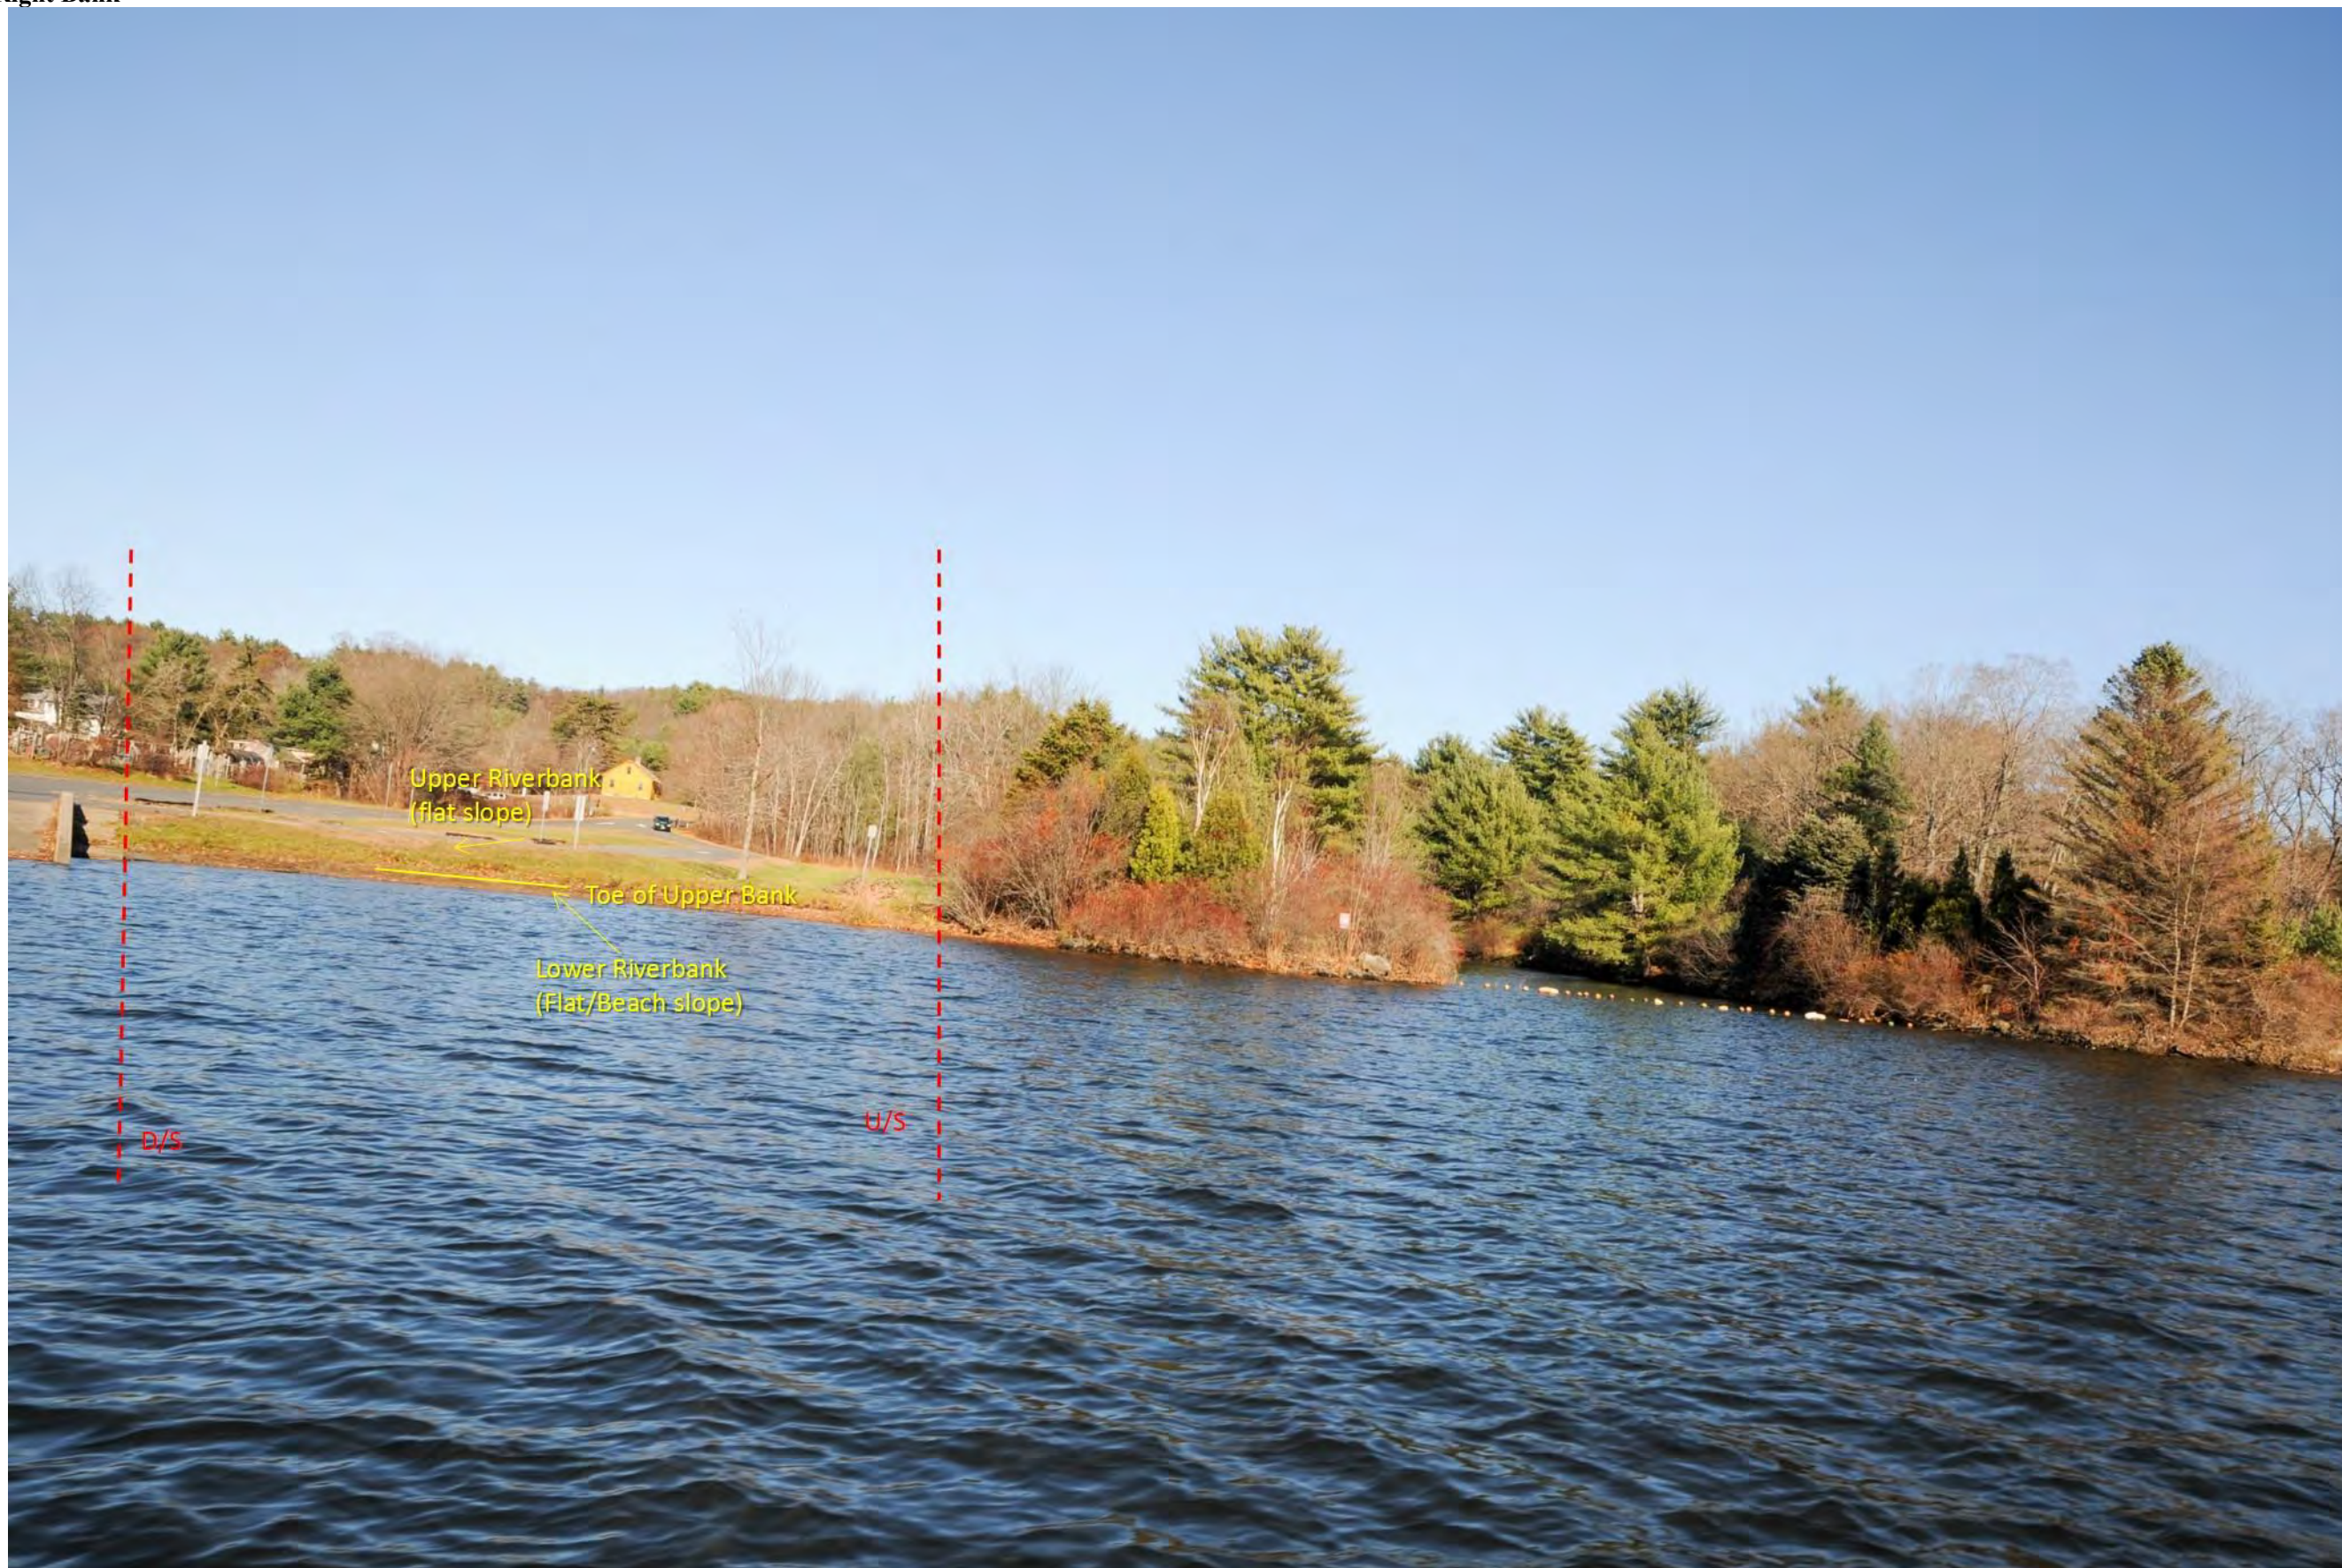
Segment 350 – Right Bank

Riverbank Features	Characteristics
Upper Riverbank Slope	Flat
Upper Riverbank Height	Low
Upper Riverbank Sediment	Silt/Sand
Upper Riverbank Vegetation	Heavy
Lower Riverbank Slope	Flat/Beach
Lower Riverbank Sediment	Silt/Sand
Lower Riverbank Vegetation	None to very sparse
Type of Erosion	
Potential Erosion Indicators	None
Stage of Erosion	Stable
Extent of Erosion	None/Little

**QA Observations:** Upon review of the photos for this segment, classification made in the field was confirmed.
