Re: Filing of Addendum to Study No. 3.1.1- 2013 Full River Reconnaissance  
Turners Falls Hydroelectric Project (FERC No. 1889) and Northfield Mountain Pumped Storage  
Project (FERC No. 2485)

## **ATTACHMENT A: 2013 Full River Reconnaissance – 2015 Addendum: Riverbank Segment QA Comparison**

2015 FRR Addendum  
 Selected Riverbank Segments for QA  
 Map 1

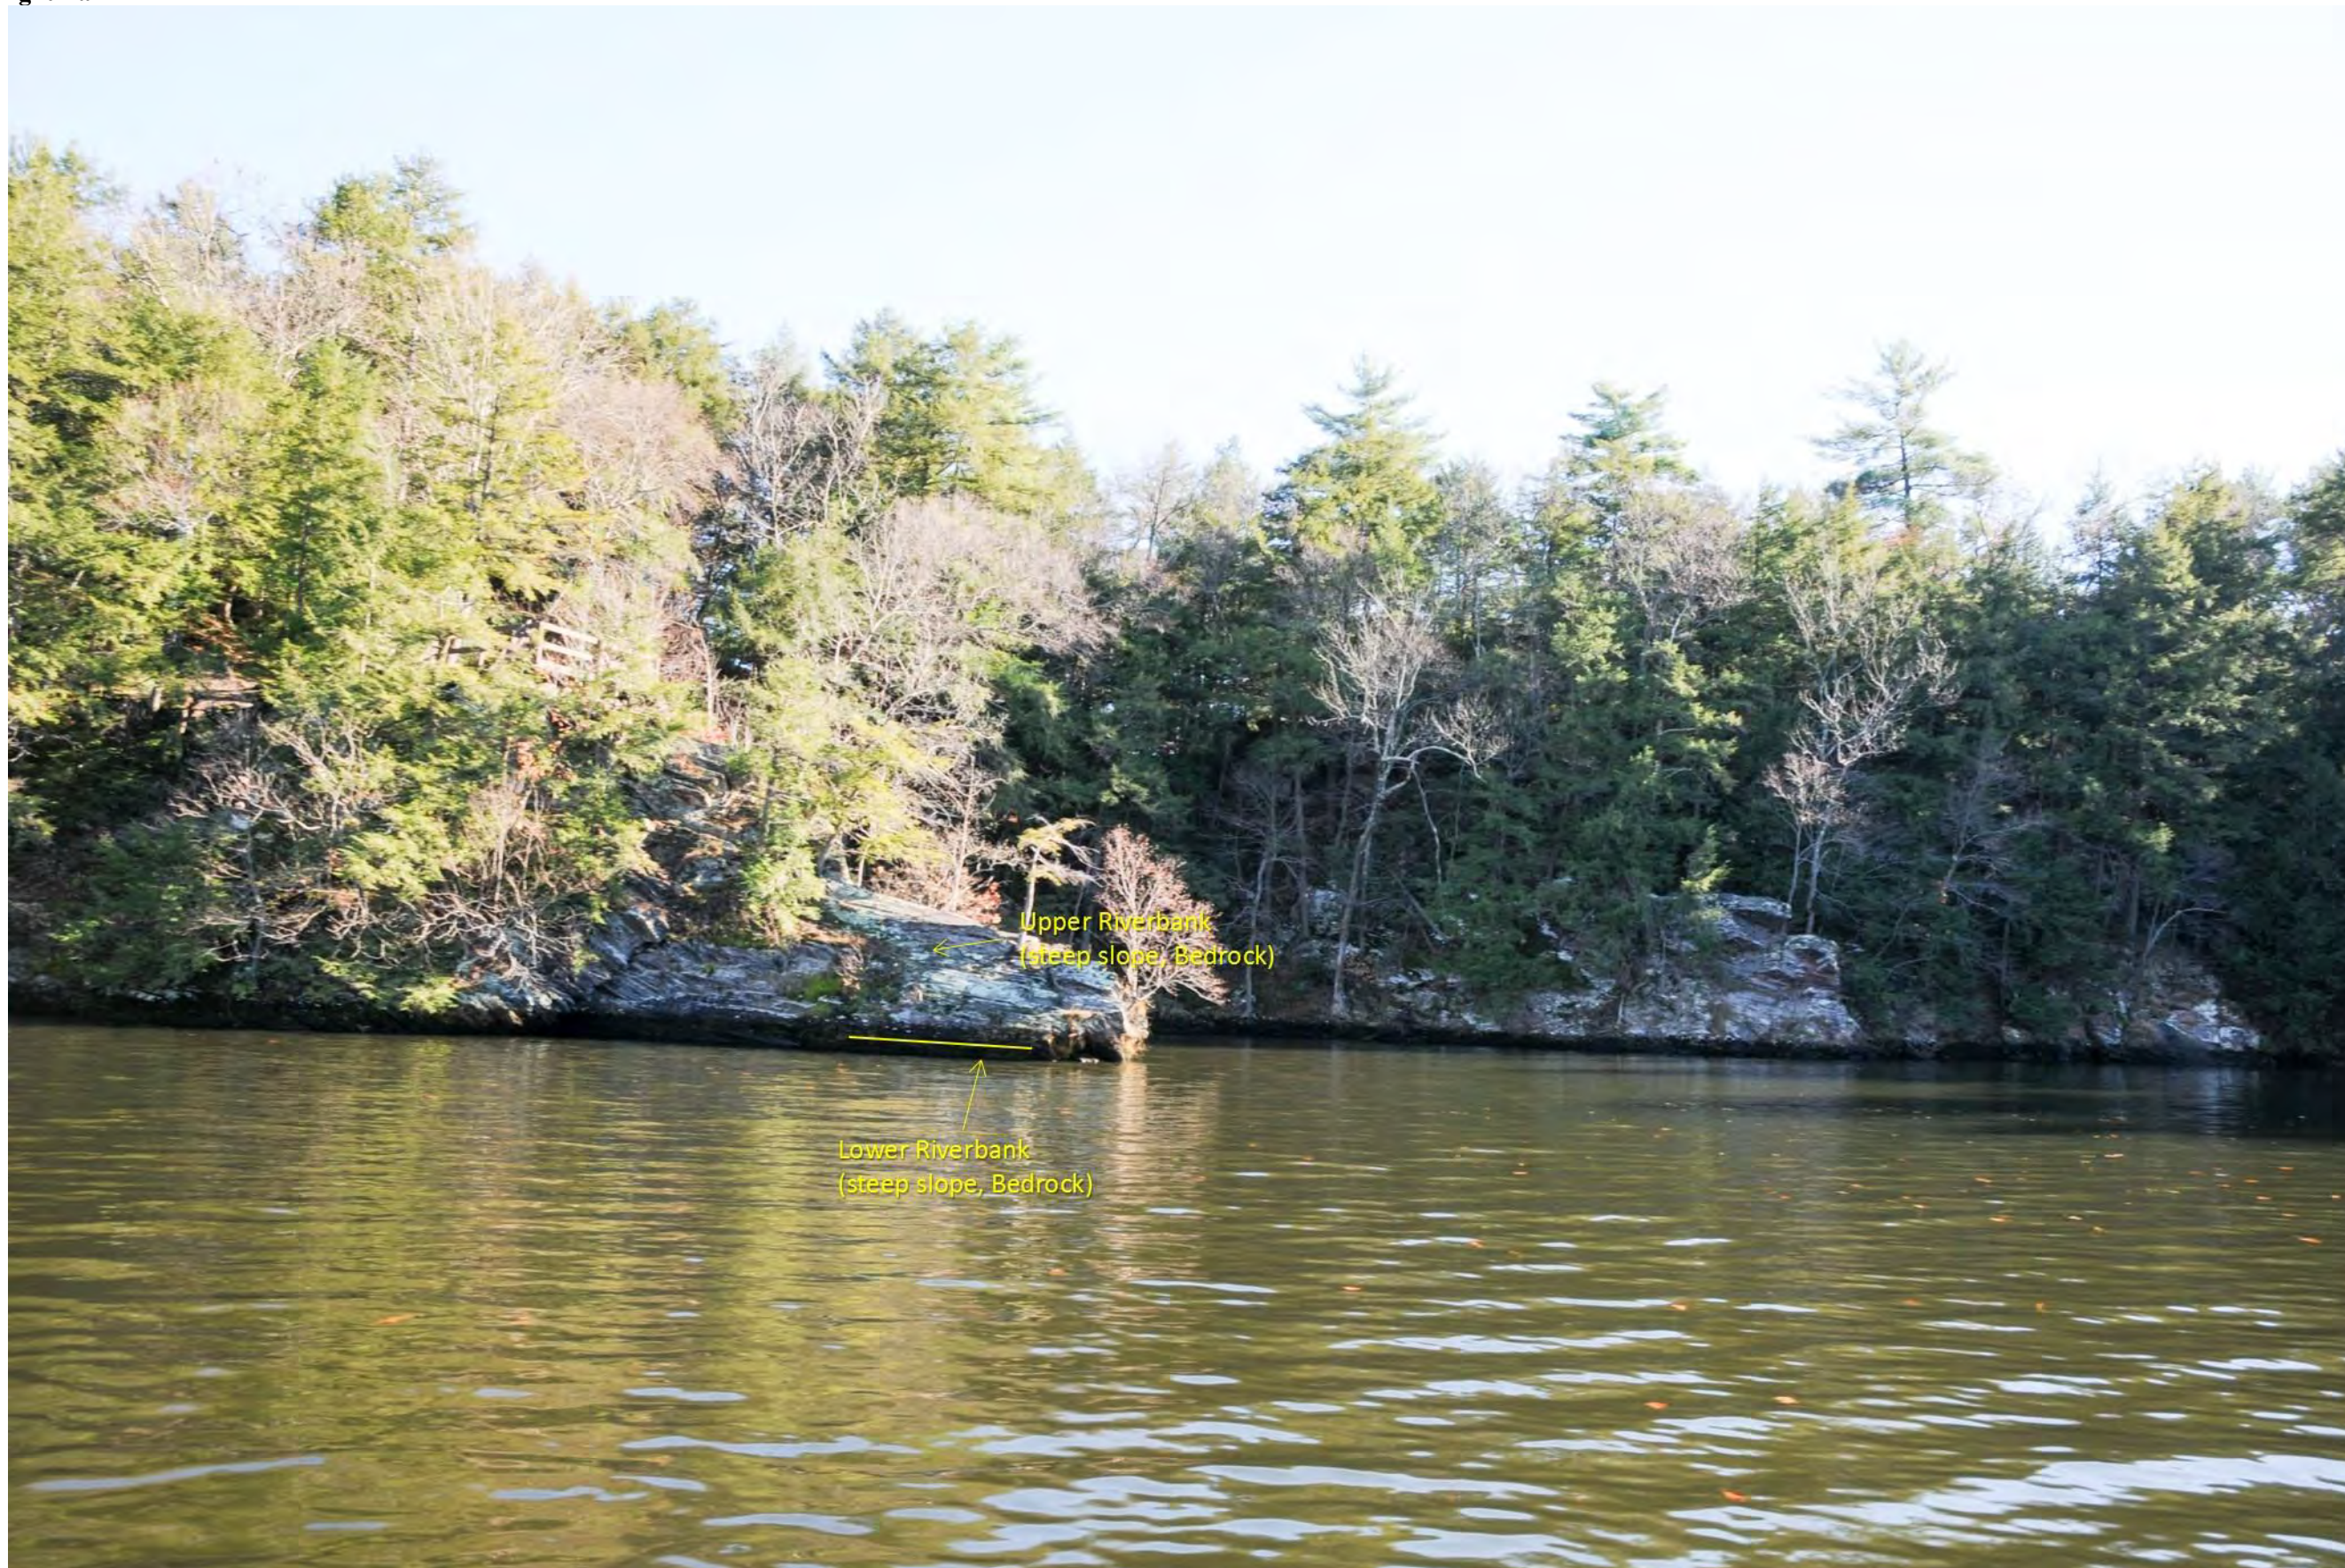
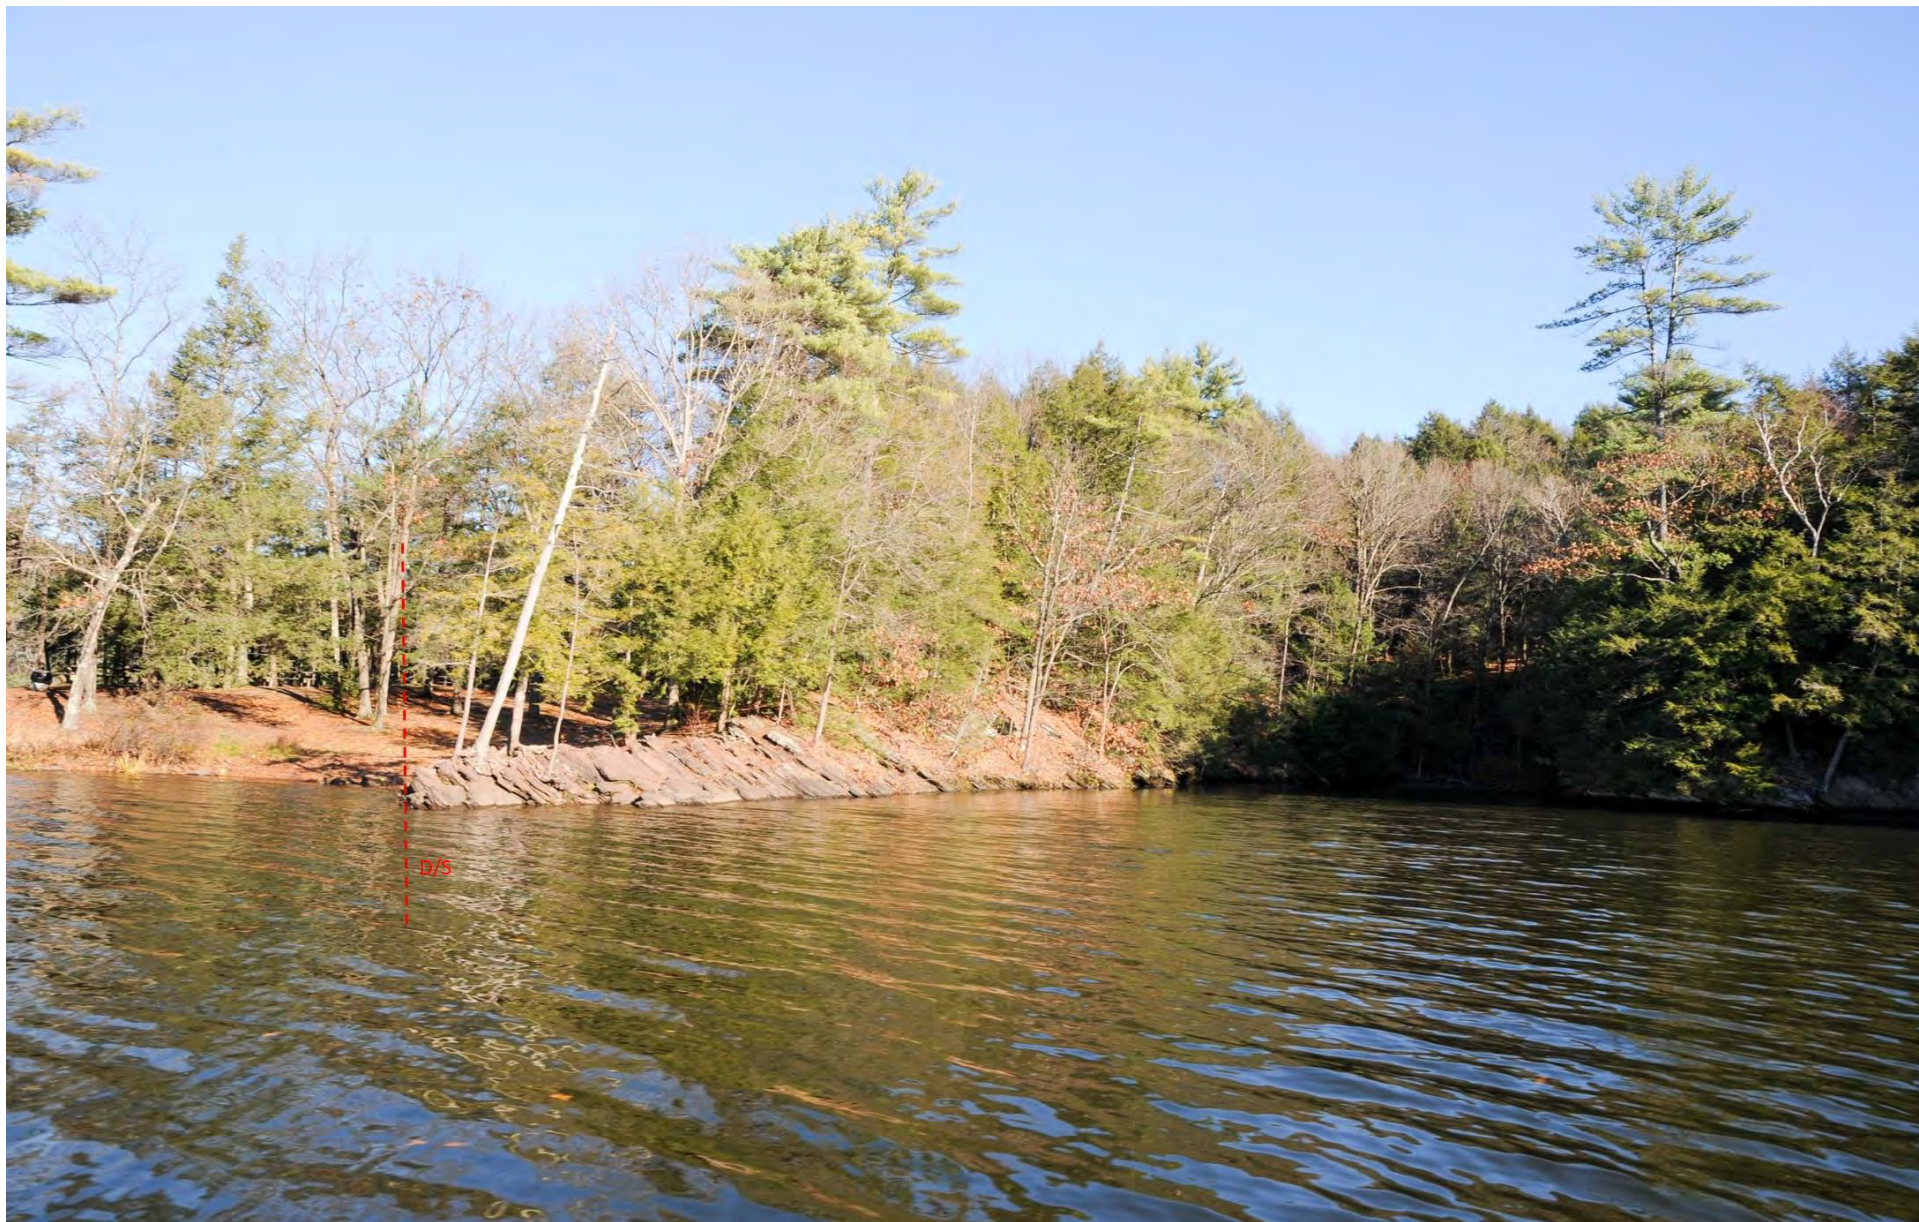
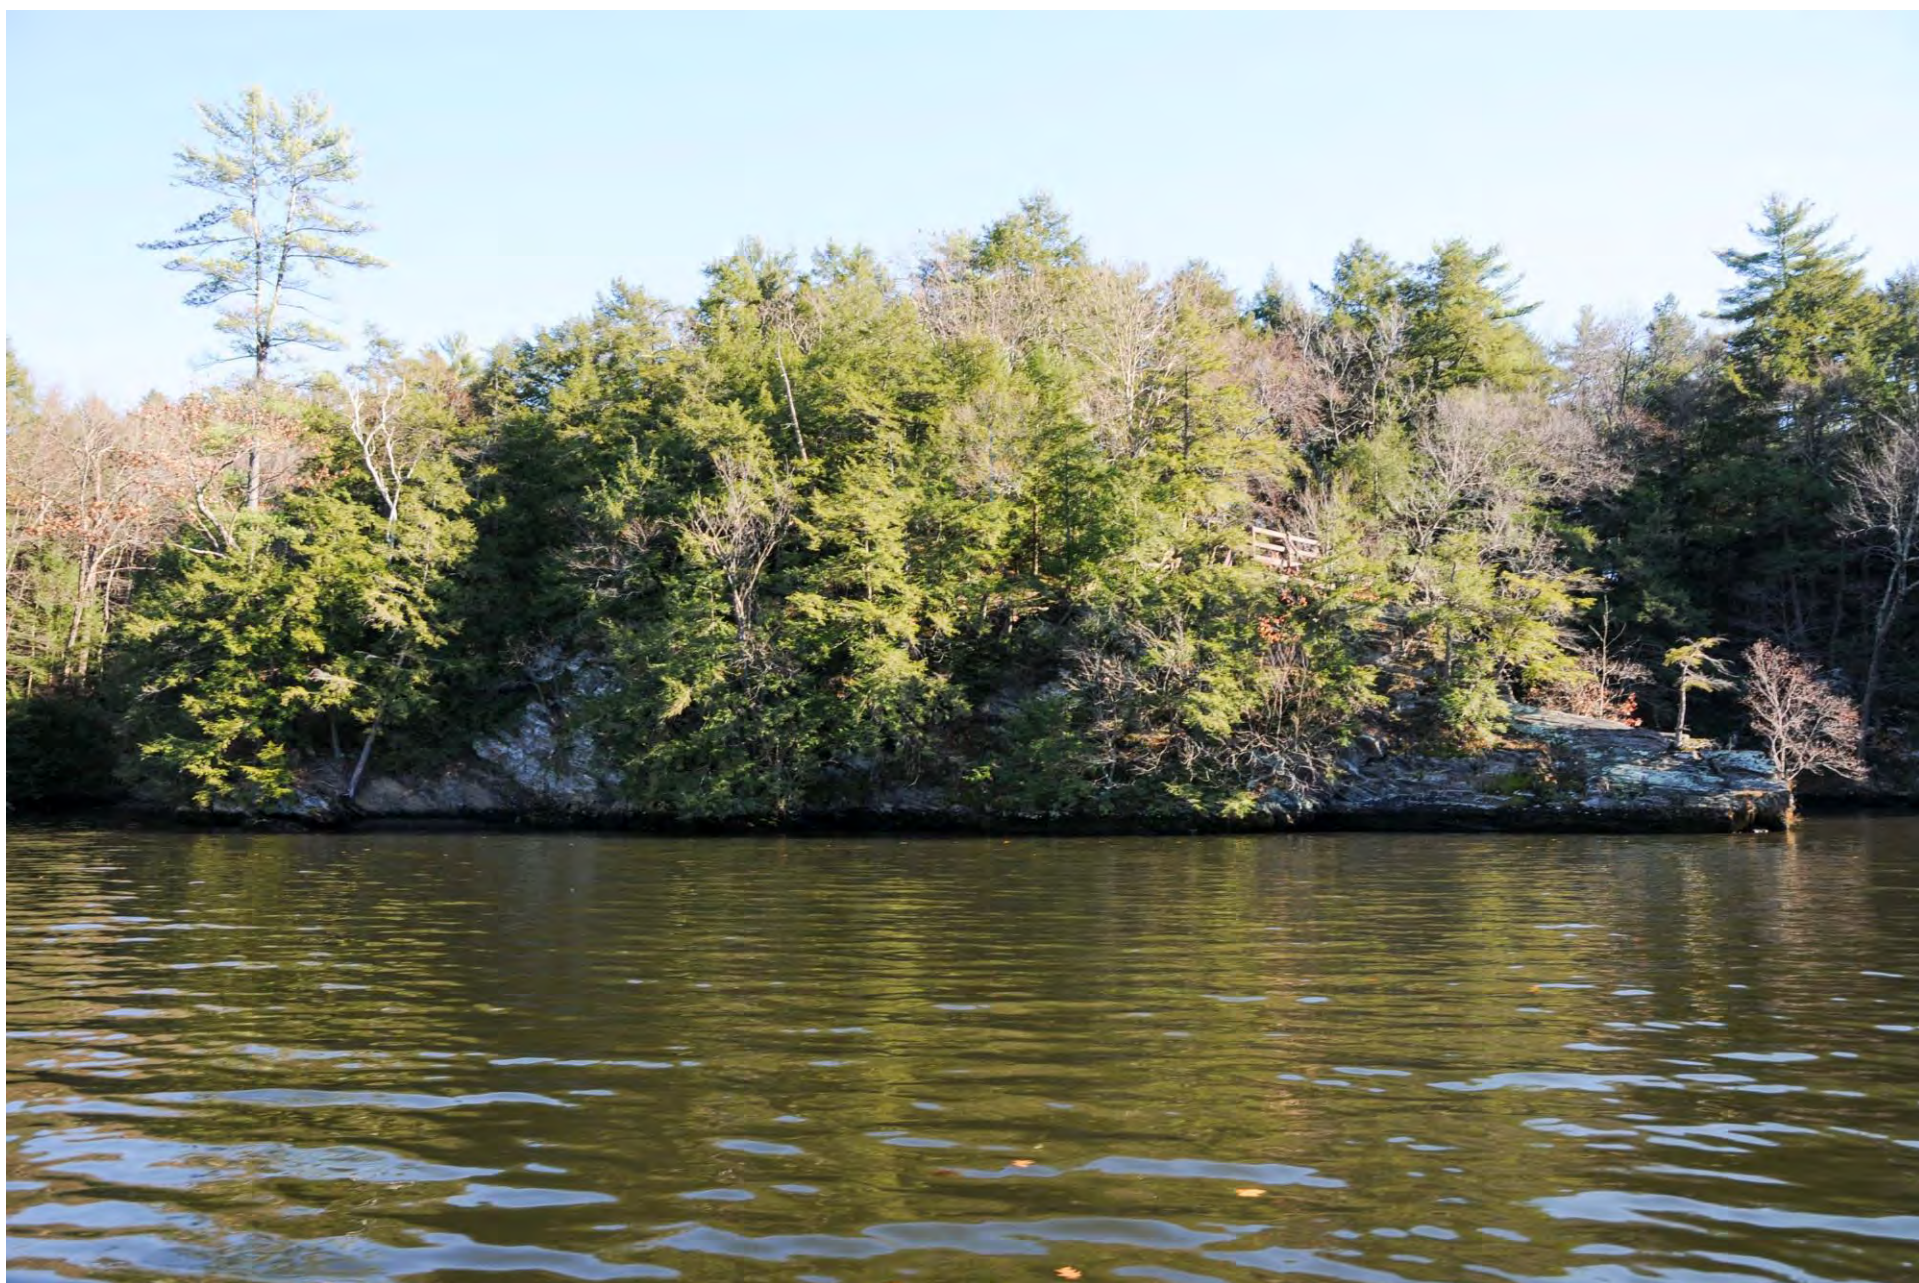
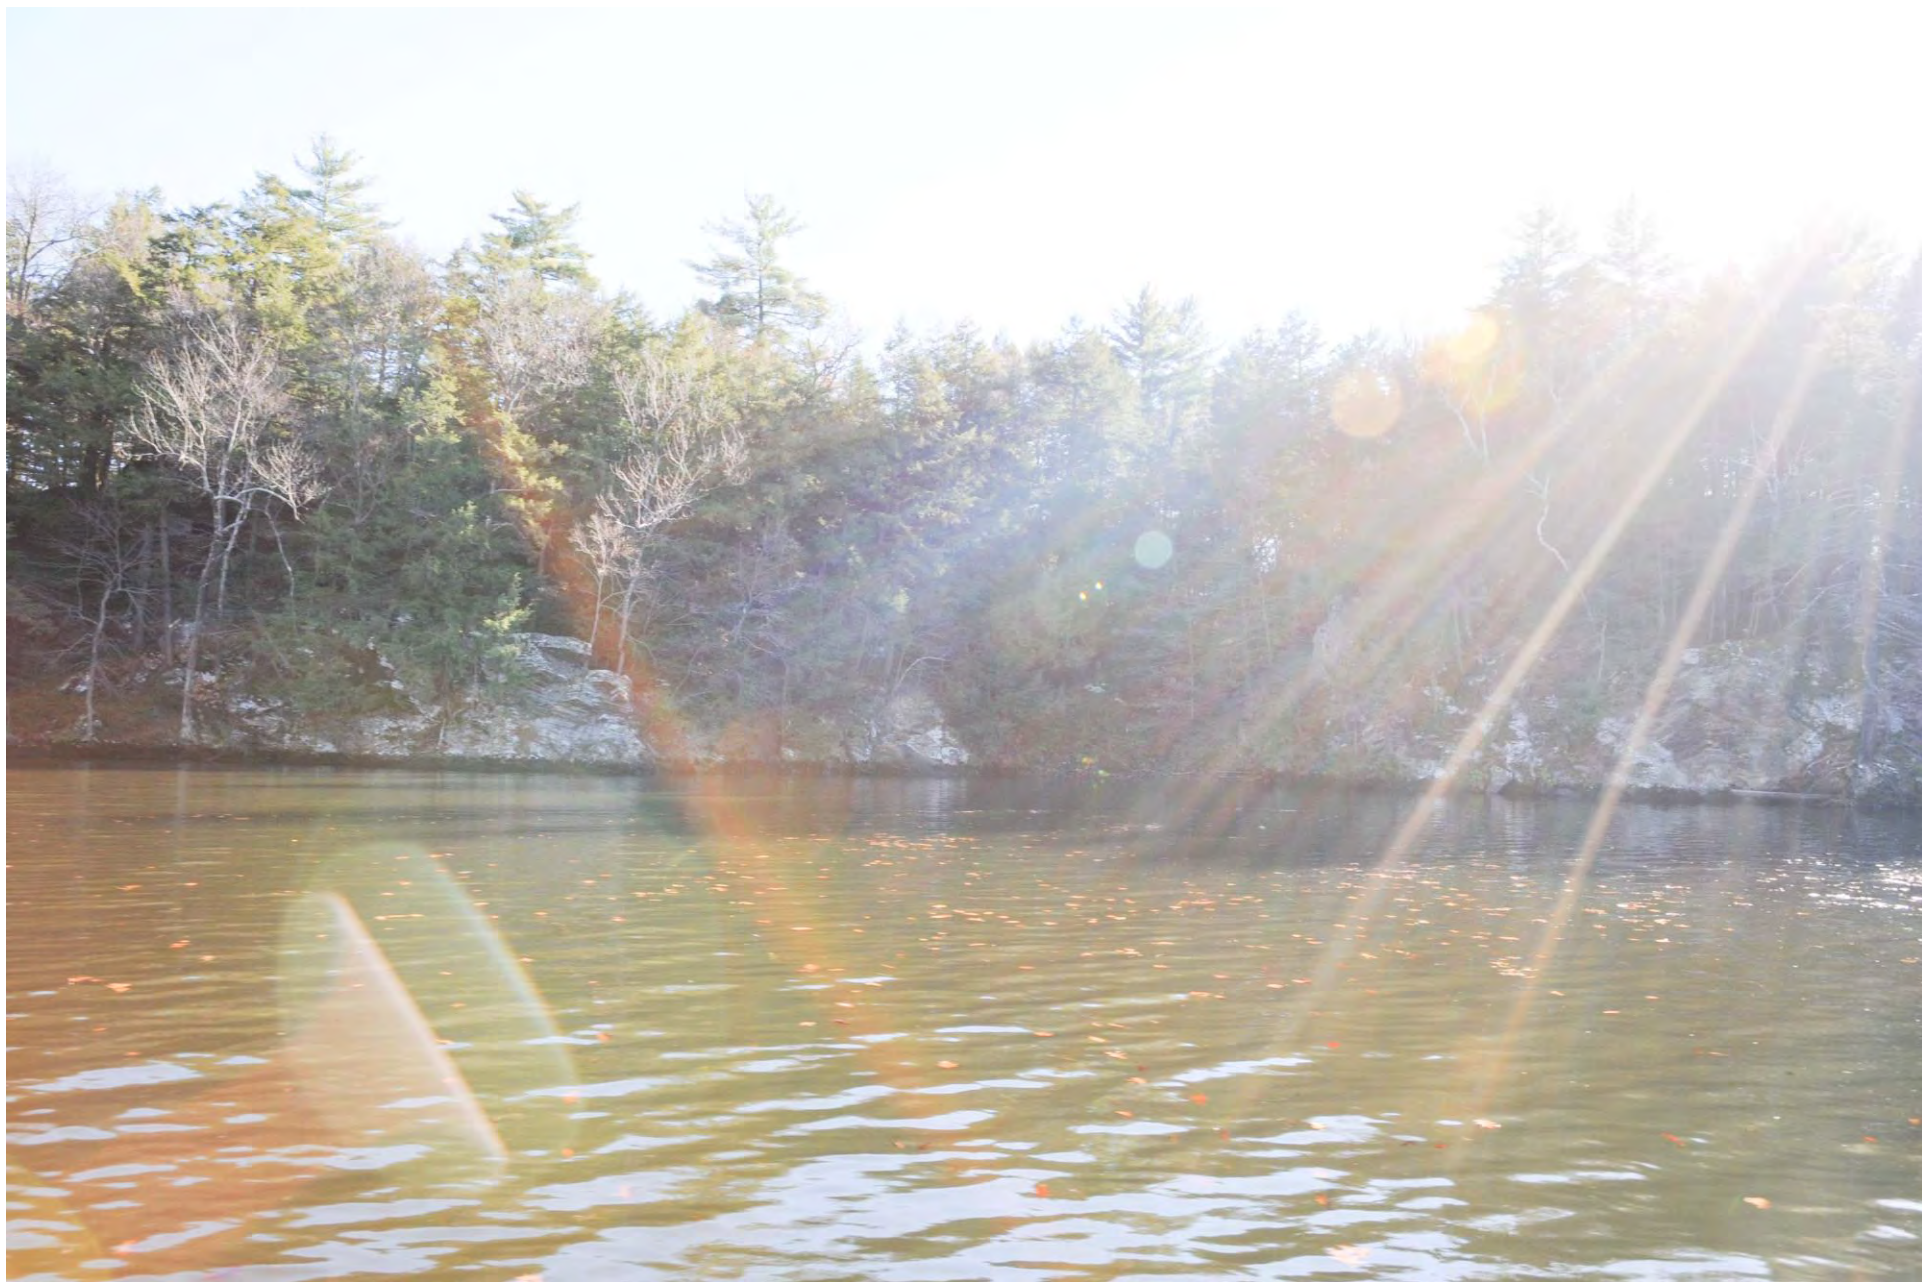
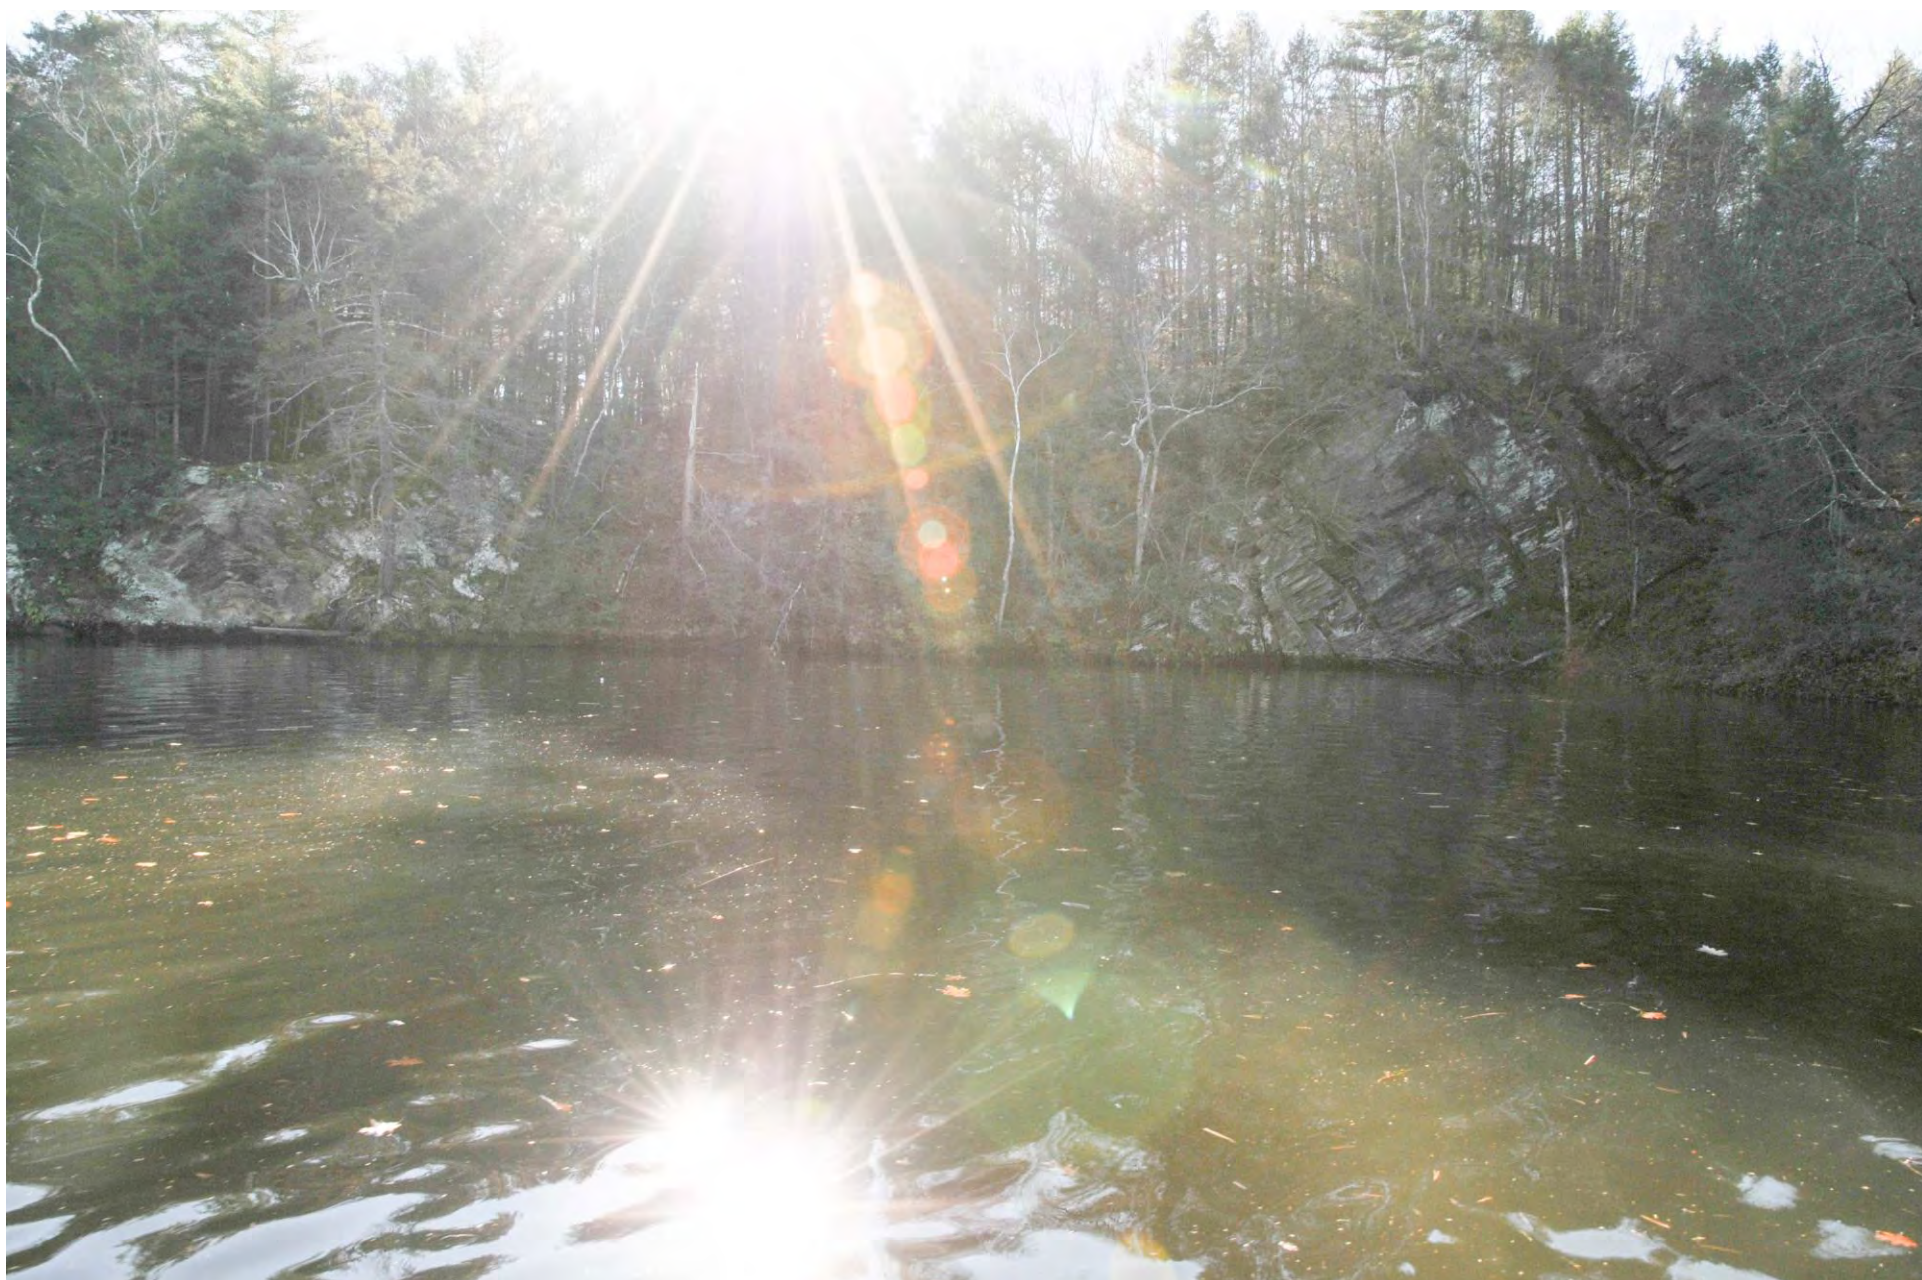
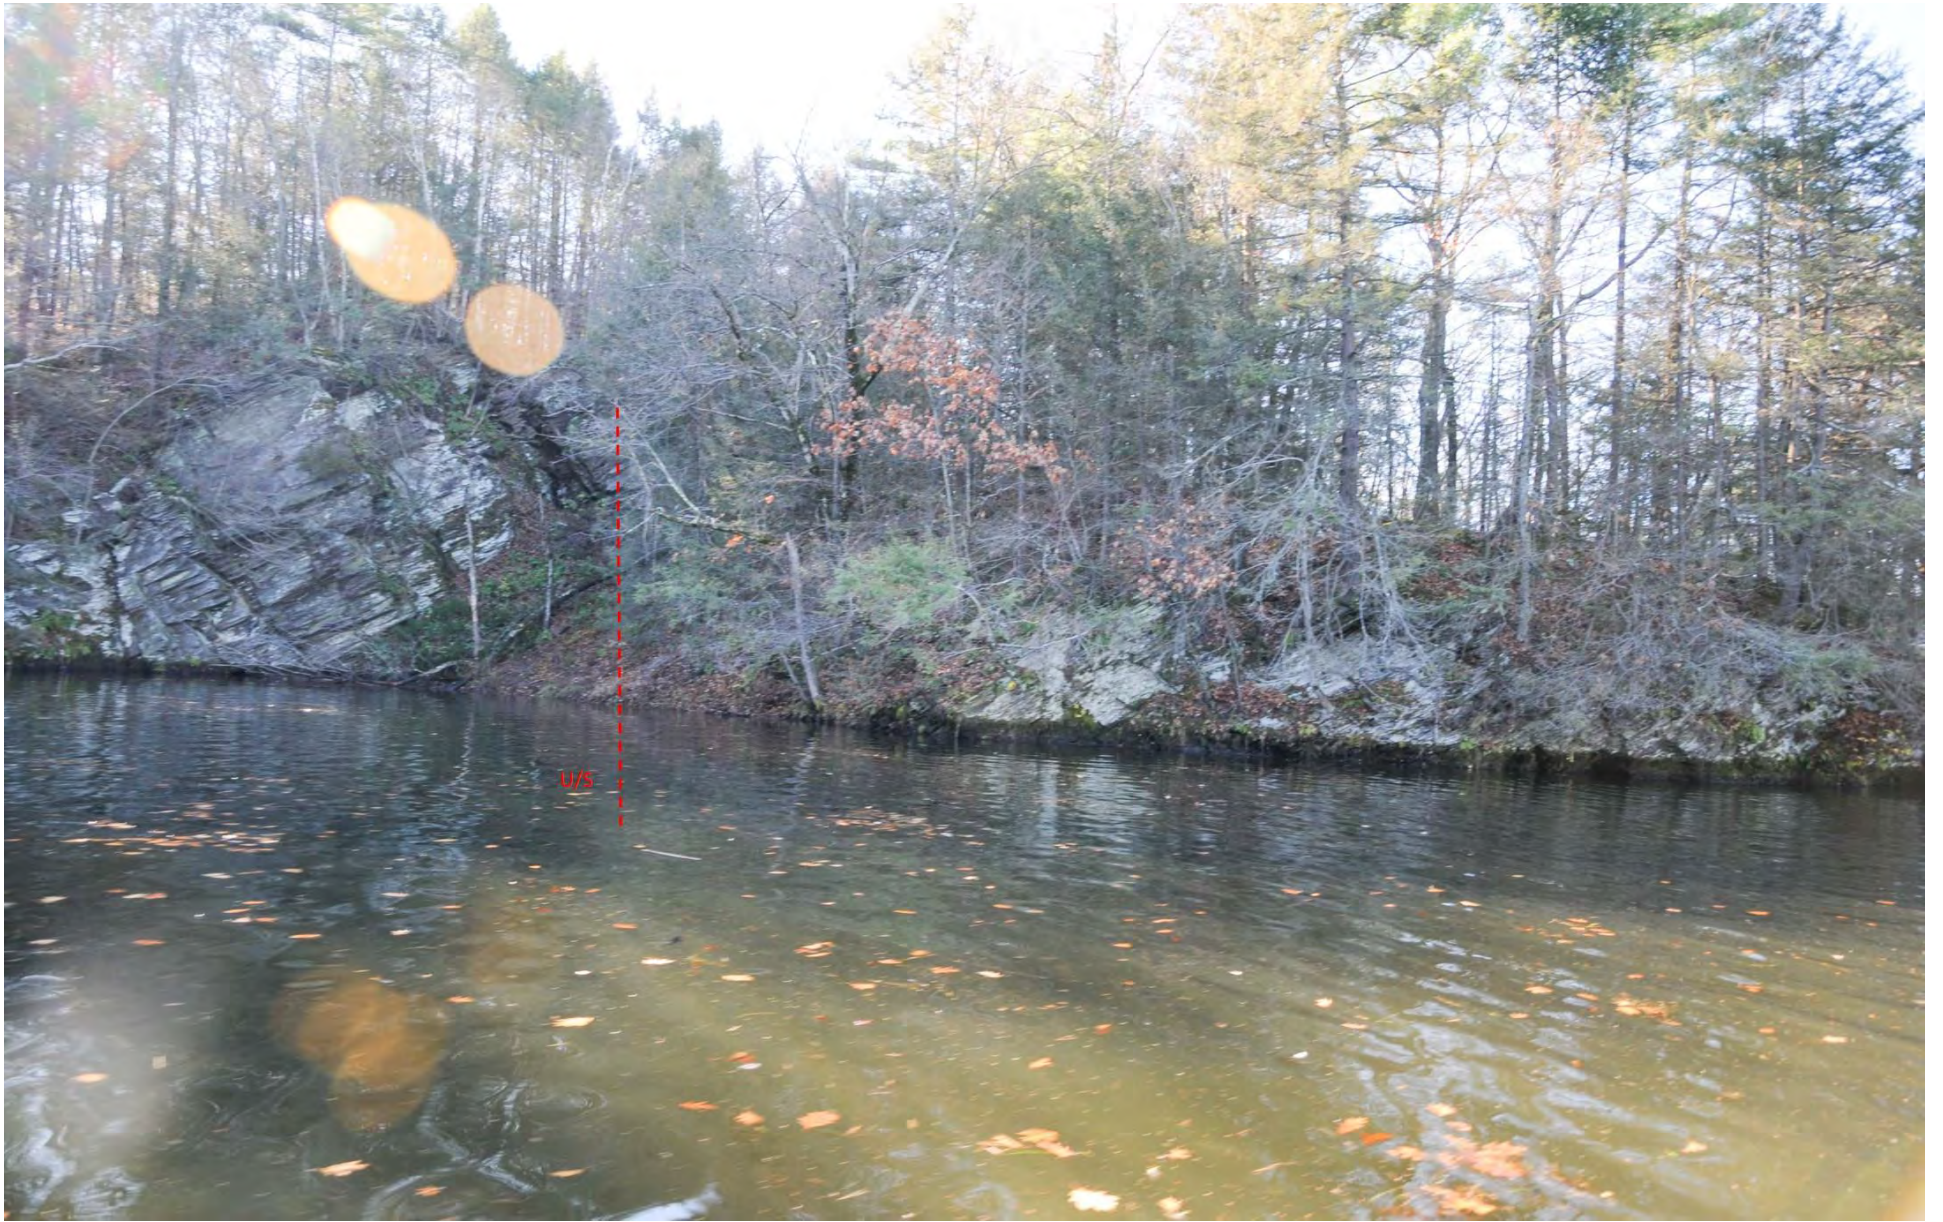
Segment 360 – Right Bank

Riverbank Features	Characteristics
Upper Riverbank Slope	Steep
Upper Riverbank Height	High
Upper Riverbank Sediment	Bedrock
Upper Riverbank Vegetation	Moderate
Lower Riverbank Slope	Steep
Lower Riverbank Sediment	Bedrock
Lower Riverbank Vegetation	None to very sparse
Type of Erosion	
Potential Erosion Indicators	None
Stage of Erosion	Stable
Extent of Erosion	None/Little

**QA Observations:** Upon review of the photos for this segment, classification made in the field was confirmed.

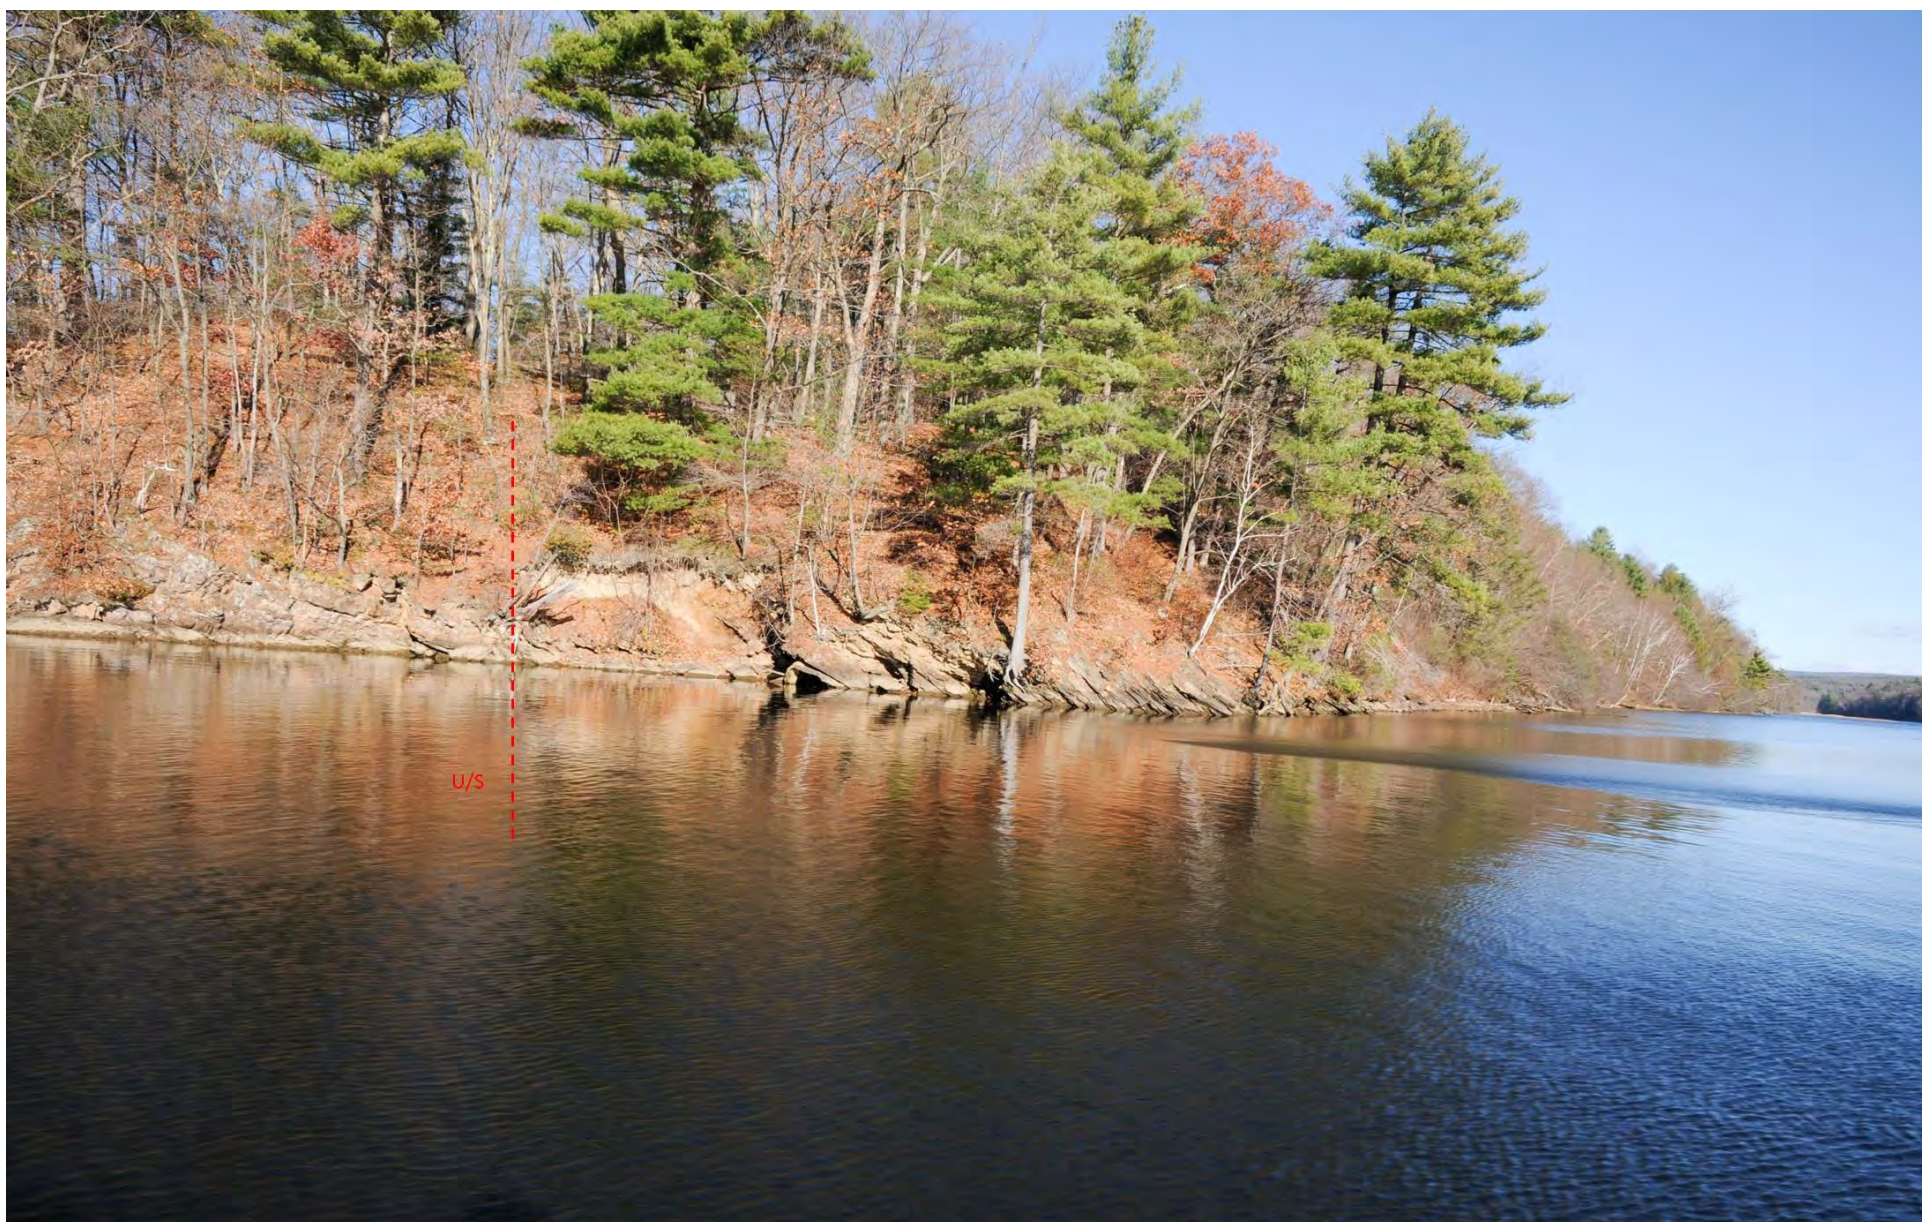
Photo ID 384 (U/S, left of line)

Riverbank Features	Characteristics
Upper Riverbank Slope	Steep
Upper Riverbank Height	High
Upper Riverbank Sediment	Bedrock
Upper Riverbank Vegetation	Moderate
Lower Riverbank Slope	Steep
Lower Riverbank Sediment	Bedrock
Lower Riverbank Vegetation	None to very sparse
Type of Erosion	
Potential Erosion Indicators	None
Stage of Erosion	Stable
Extent of Erosion	None/Little

**QA Observations:** Upon review of the photos for this segment, classification made in the field was confirmed.

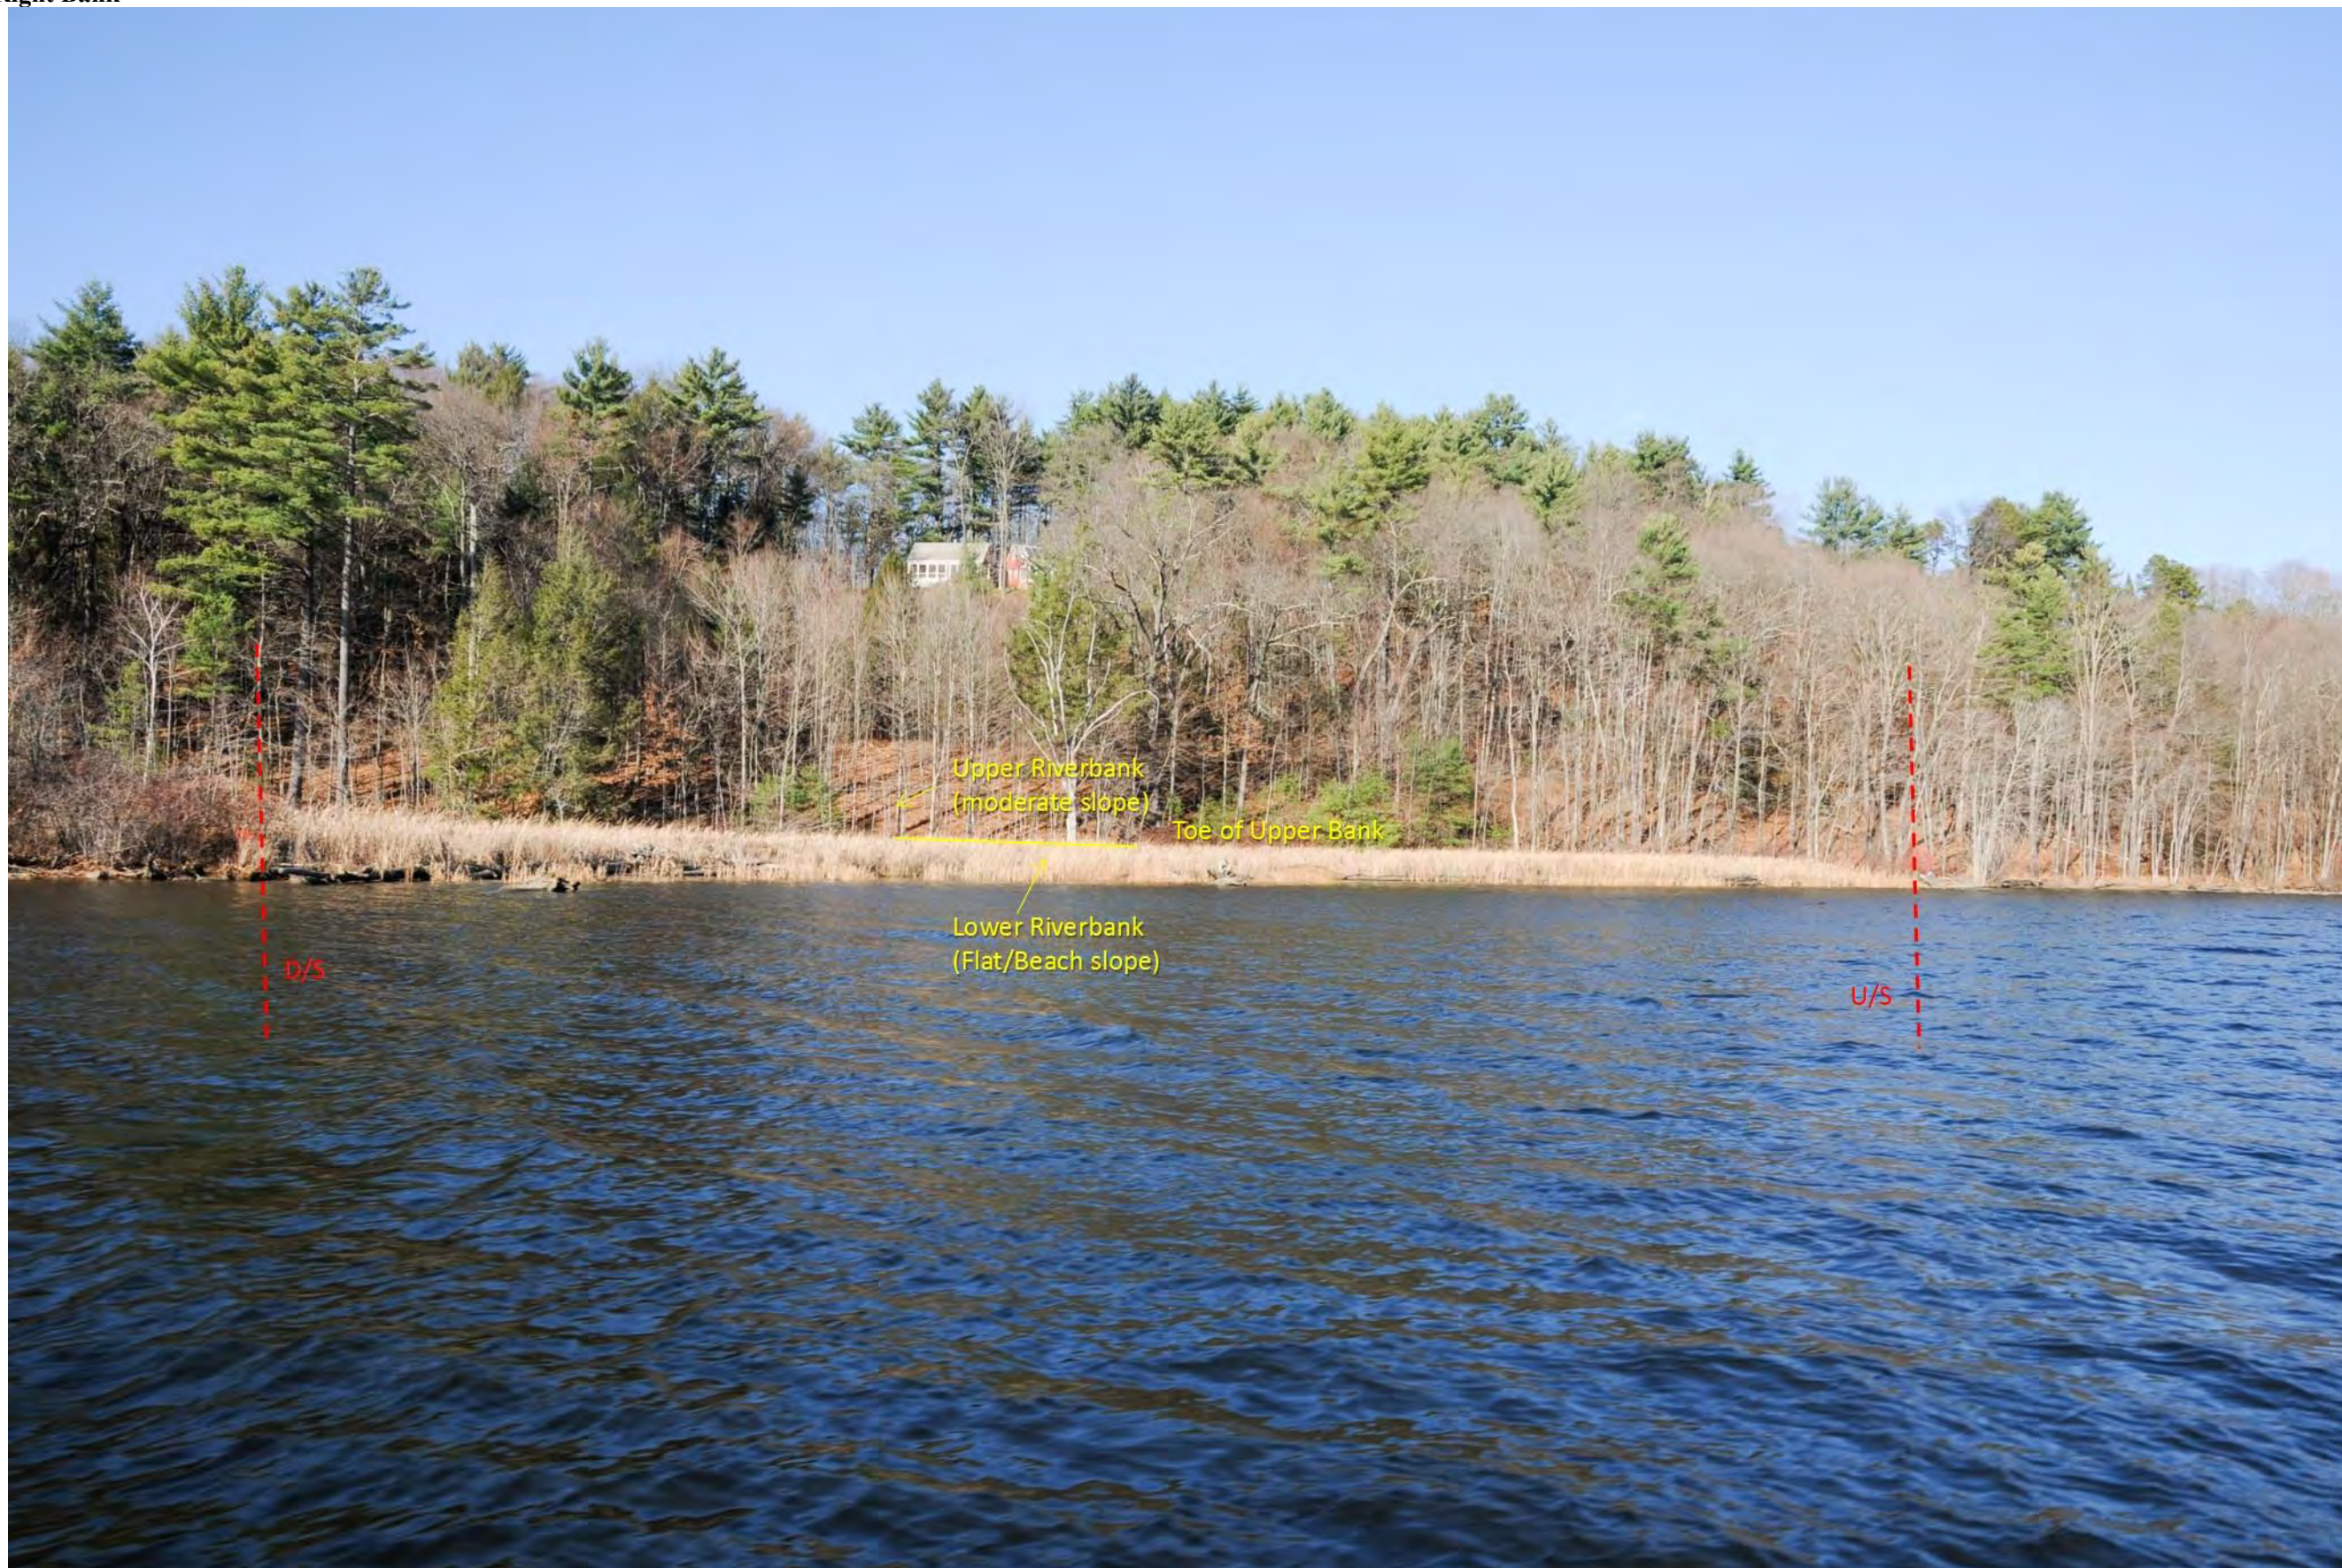
Photo ID 424 (photo covers segment)

Riverbank Features	Characteristics
Upper Riverbank Slope	Moderate
Upper Riverbank Height	High
Upper Riverbank Sediment	Silt/Sand
Upper Riverbank Vegetation	Heavy
Lower Riverbank Slope	Flat/Beach
Lower Riverbank Sediment	Silt/Sand
Lower Riverbank Vegetation	Heavy
Type of Erosion	
Potential Erosion Indicators	None
Stage of Erosion	Stable
Extent of Erosion	None/Little

**QA Observations:** Upon review of the photos for this segment, classification made in the field was confirmed.
