Re: Filing of Addendum to Study No. 3.1.1- 2013 Full River Reconnaissance  
Turners Falls Hydroelectric Project (FERC No. 1889) and Northfield Mountain Pumped Storage  
Project (FERC No. 2485)

## **ATTACHMENT A: 2013 Full River Reconnaissance – 2015 Addendum: Riverbank Segment QA Comparison**

2015 FRR Addendum  
 Selected Riverbank Segments for QA  
 Map 1

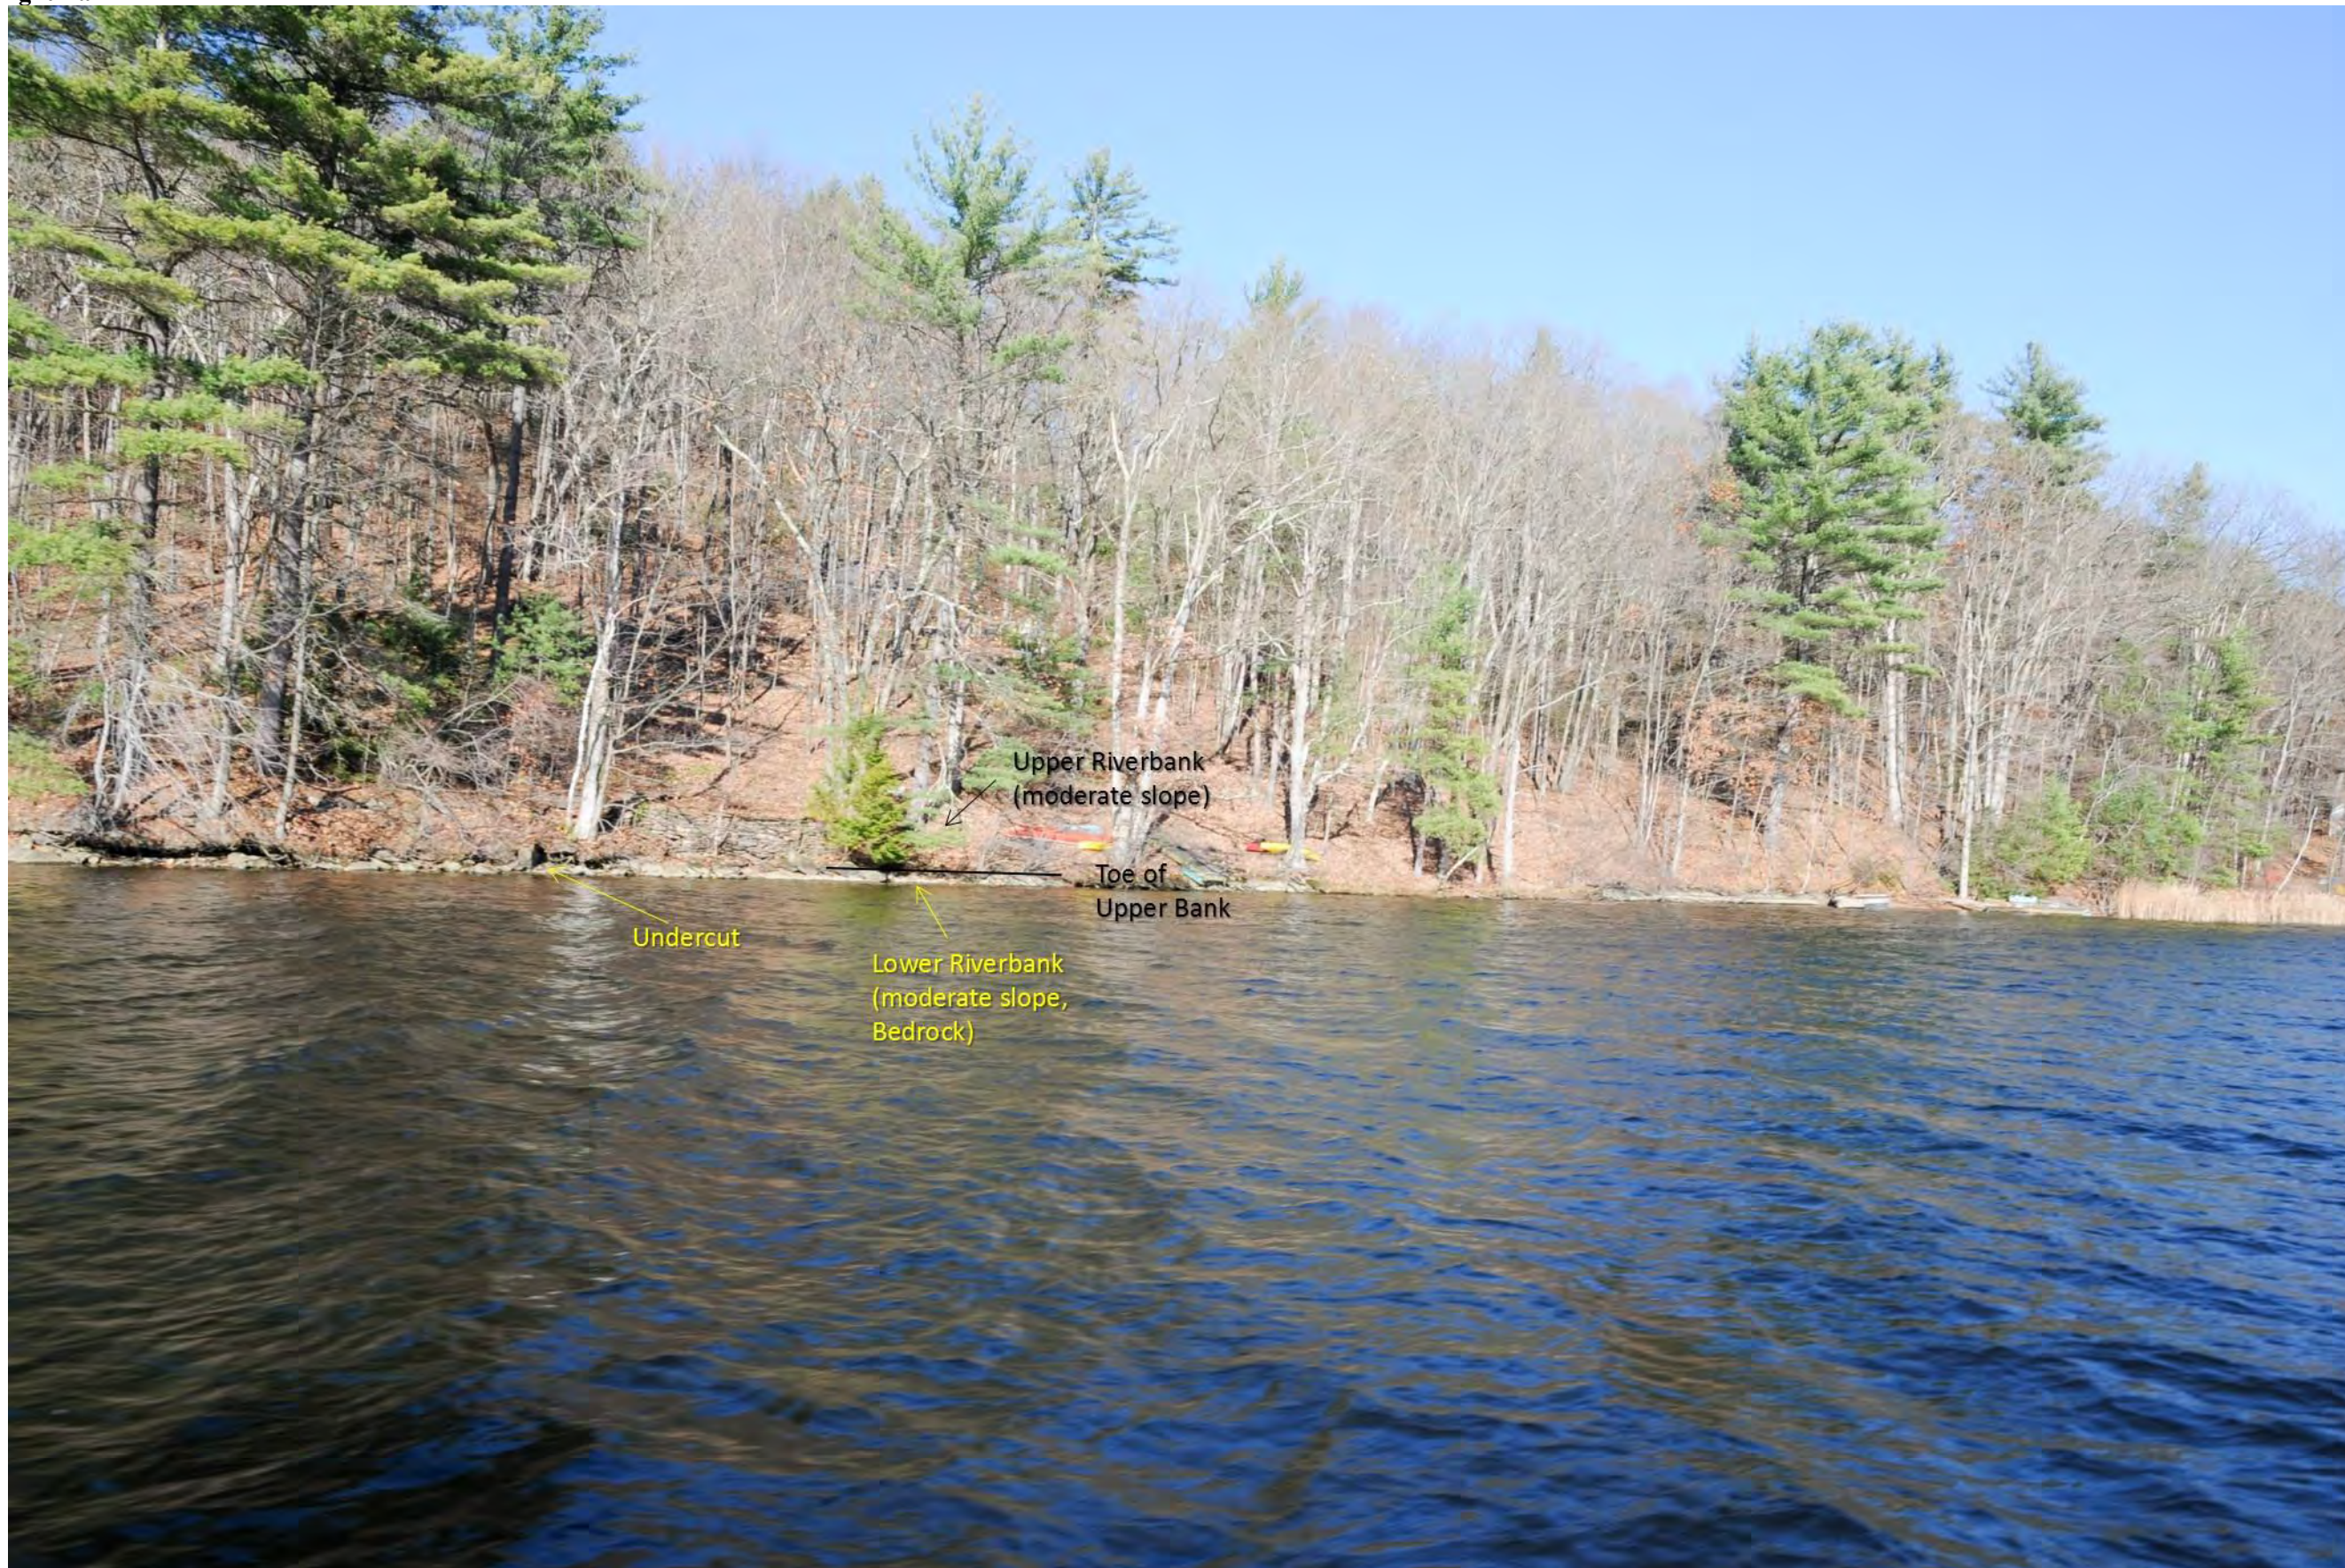
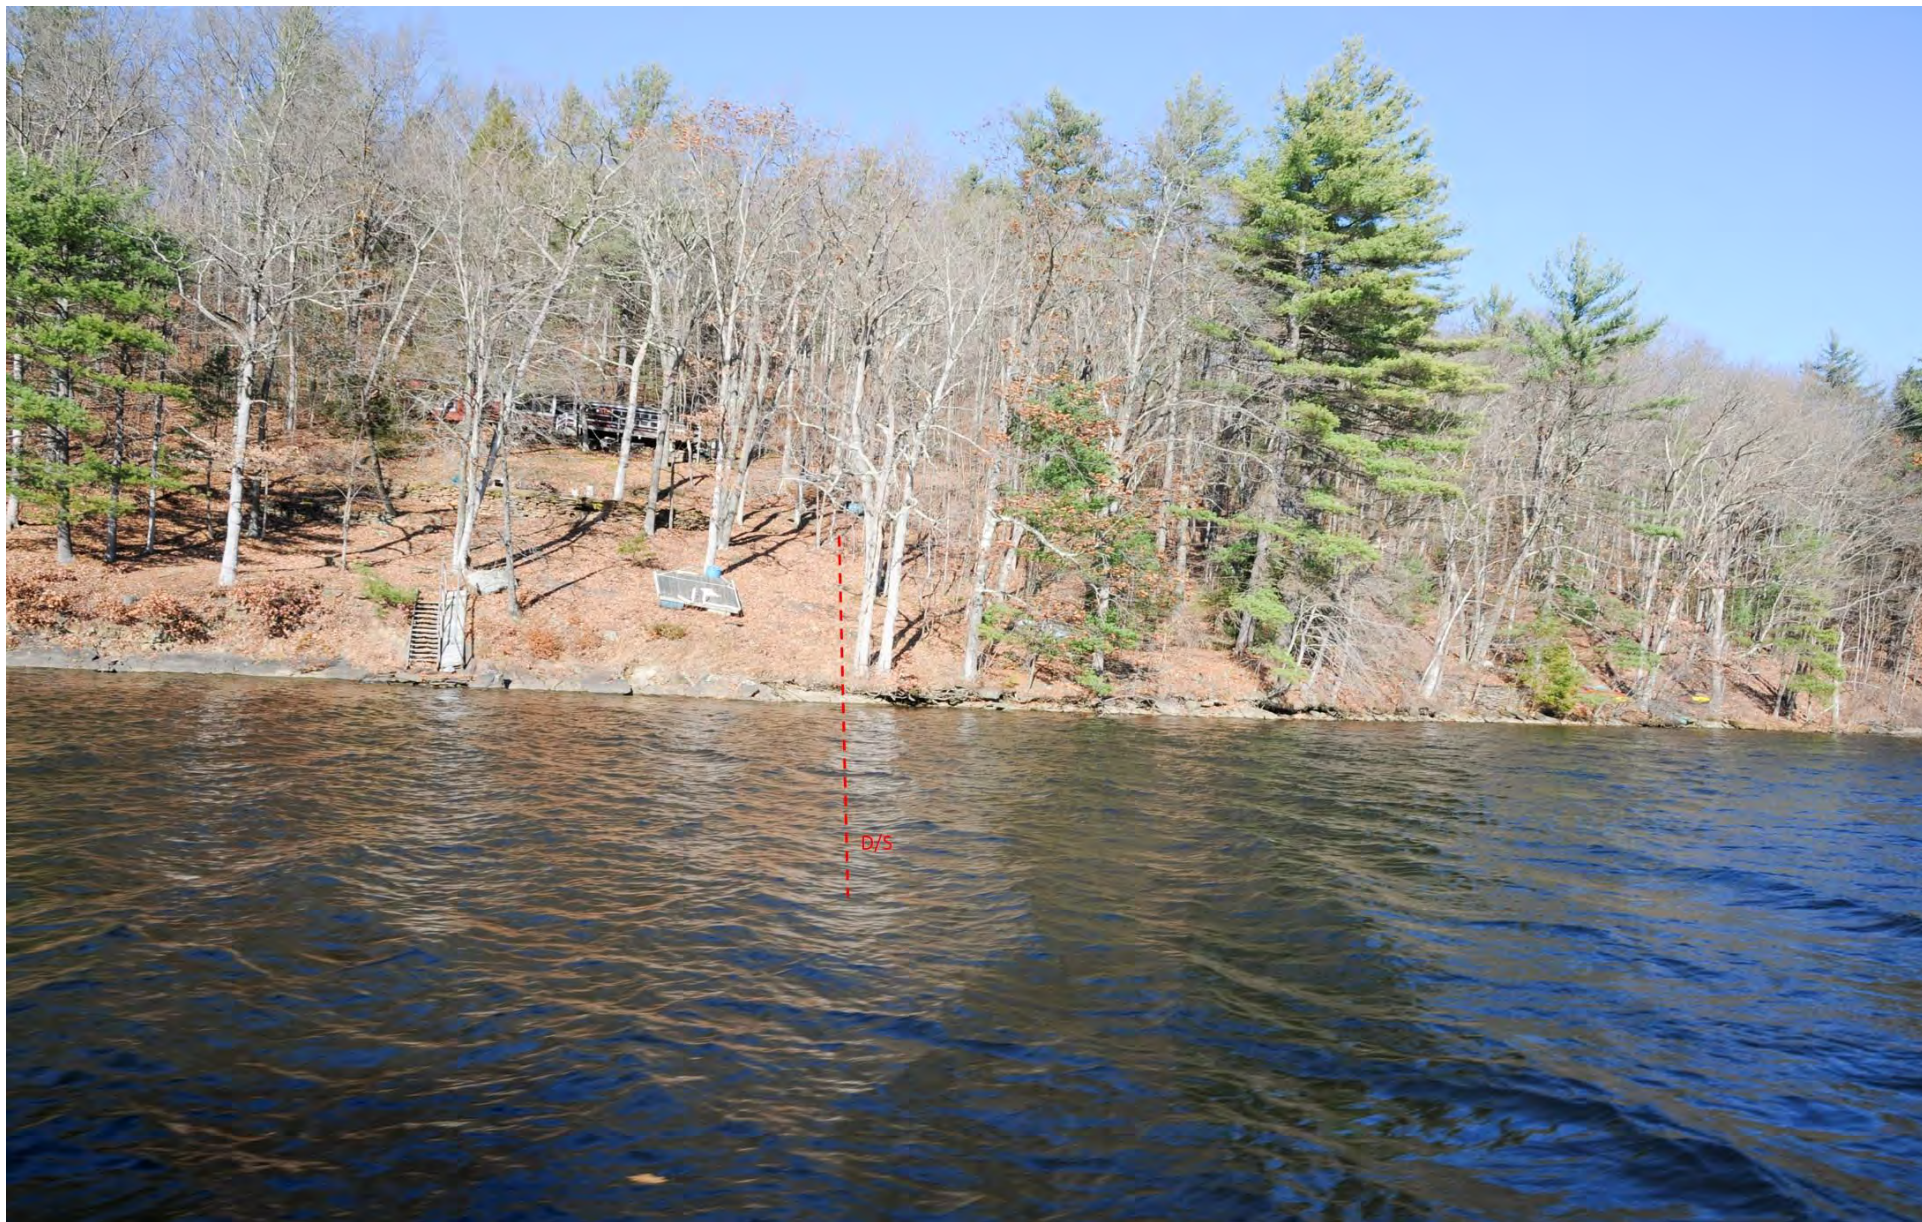
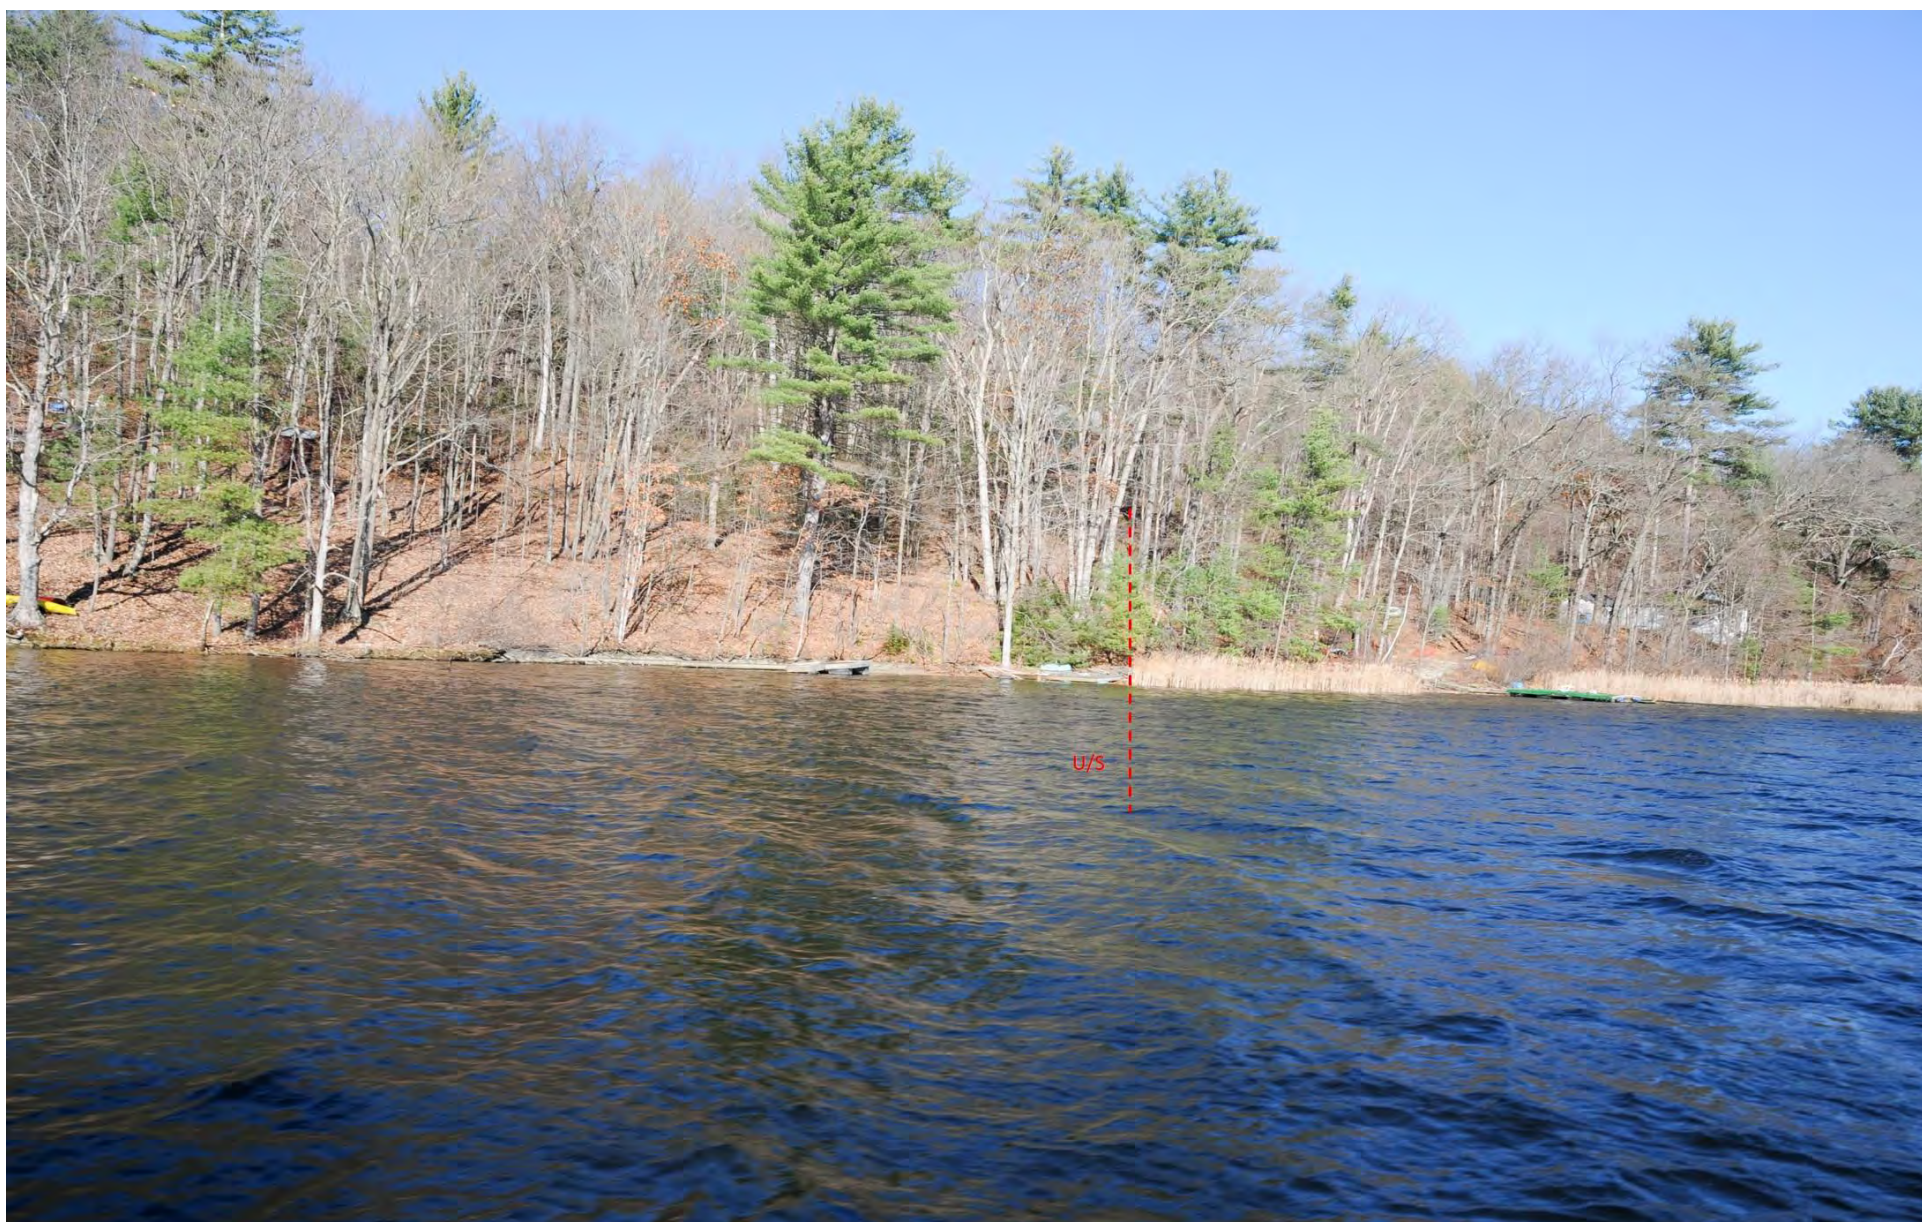
Segment 390 – Right Bank

Riverbank Features	Characteristics
Upper Riverbank Slope	Moderate
Upper Riverbank Height	High
Upper Riverbank Sediment	Silt/Sand
Upper Riverbank Vegetation	Heavy
Lower Riverbank Slope	Moderate
Lower Riverbank Sediment	Bedrock
Lower Riverbank Vegetation	None to very sparse
Type of Erosion	Undercut
Potential Erosion Indicators	None
Stage of Erosion	Stable
Extent of Erosion	None/Little

**QA Observations:** Upon review of the photos for this segment, classification made in the field was confirmed.

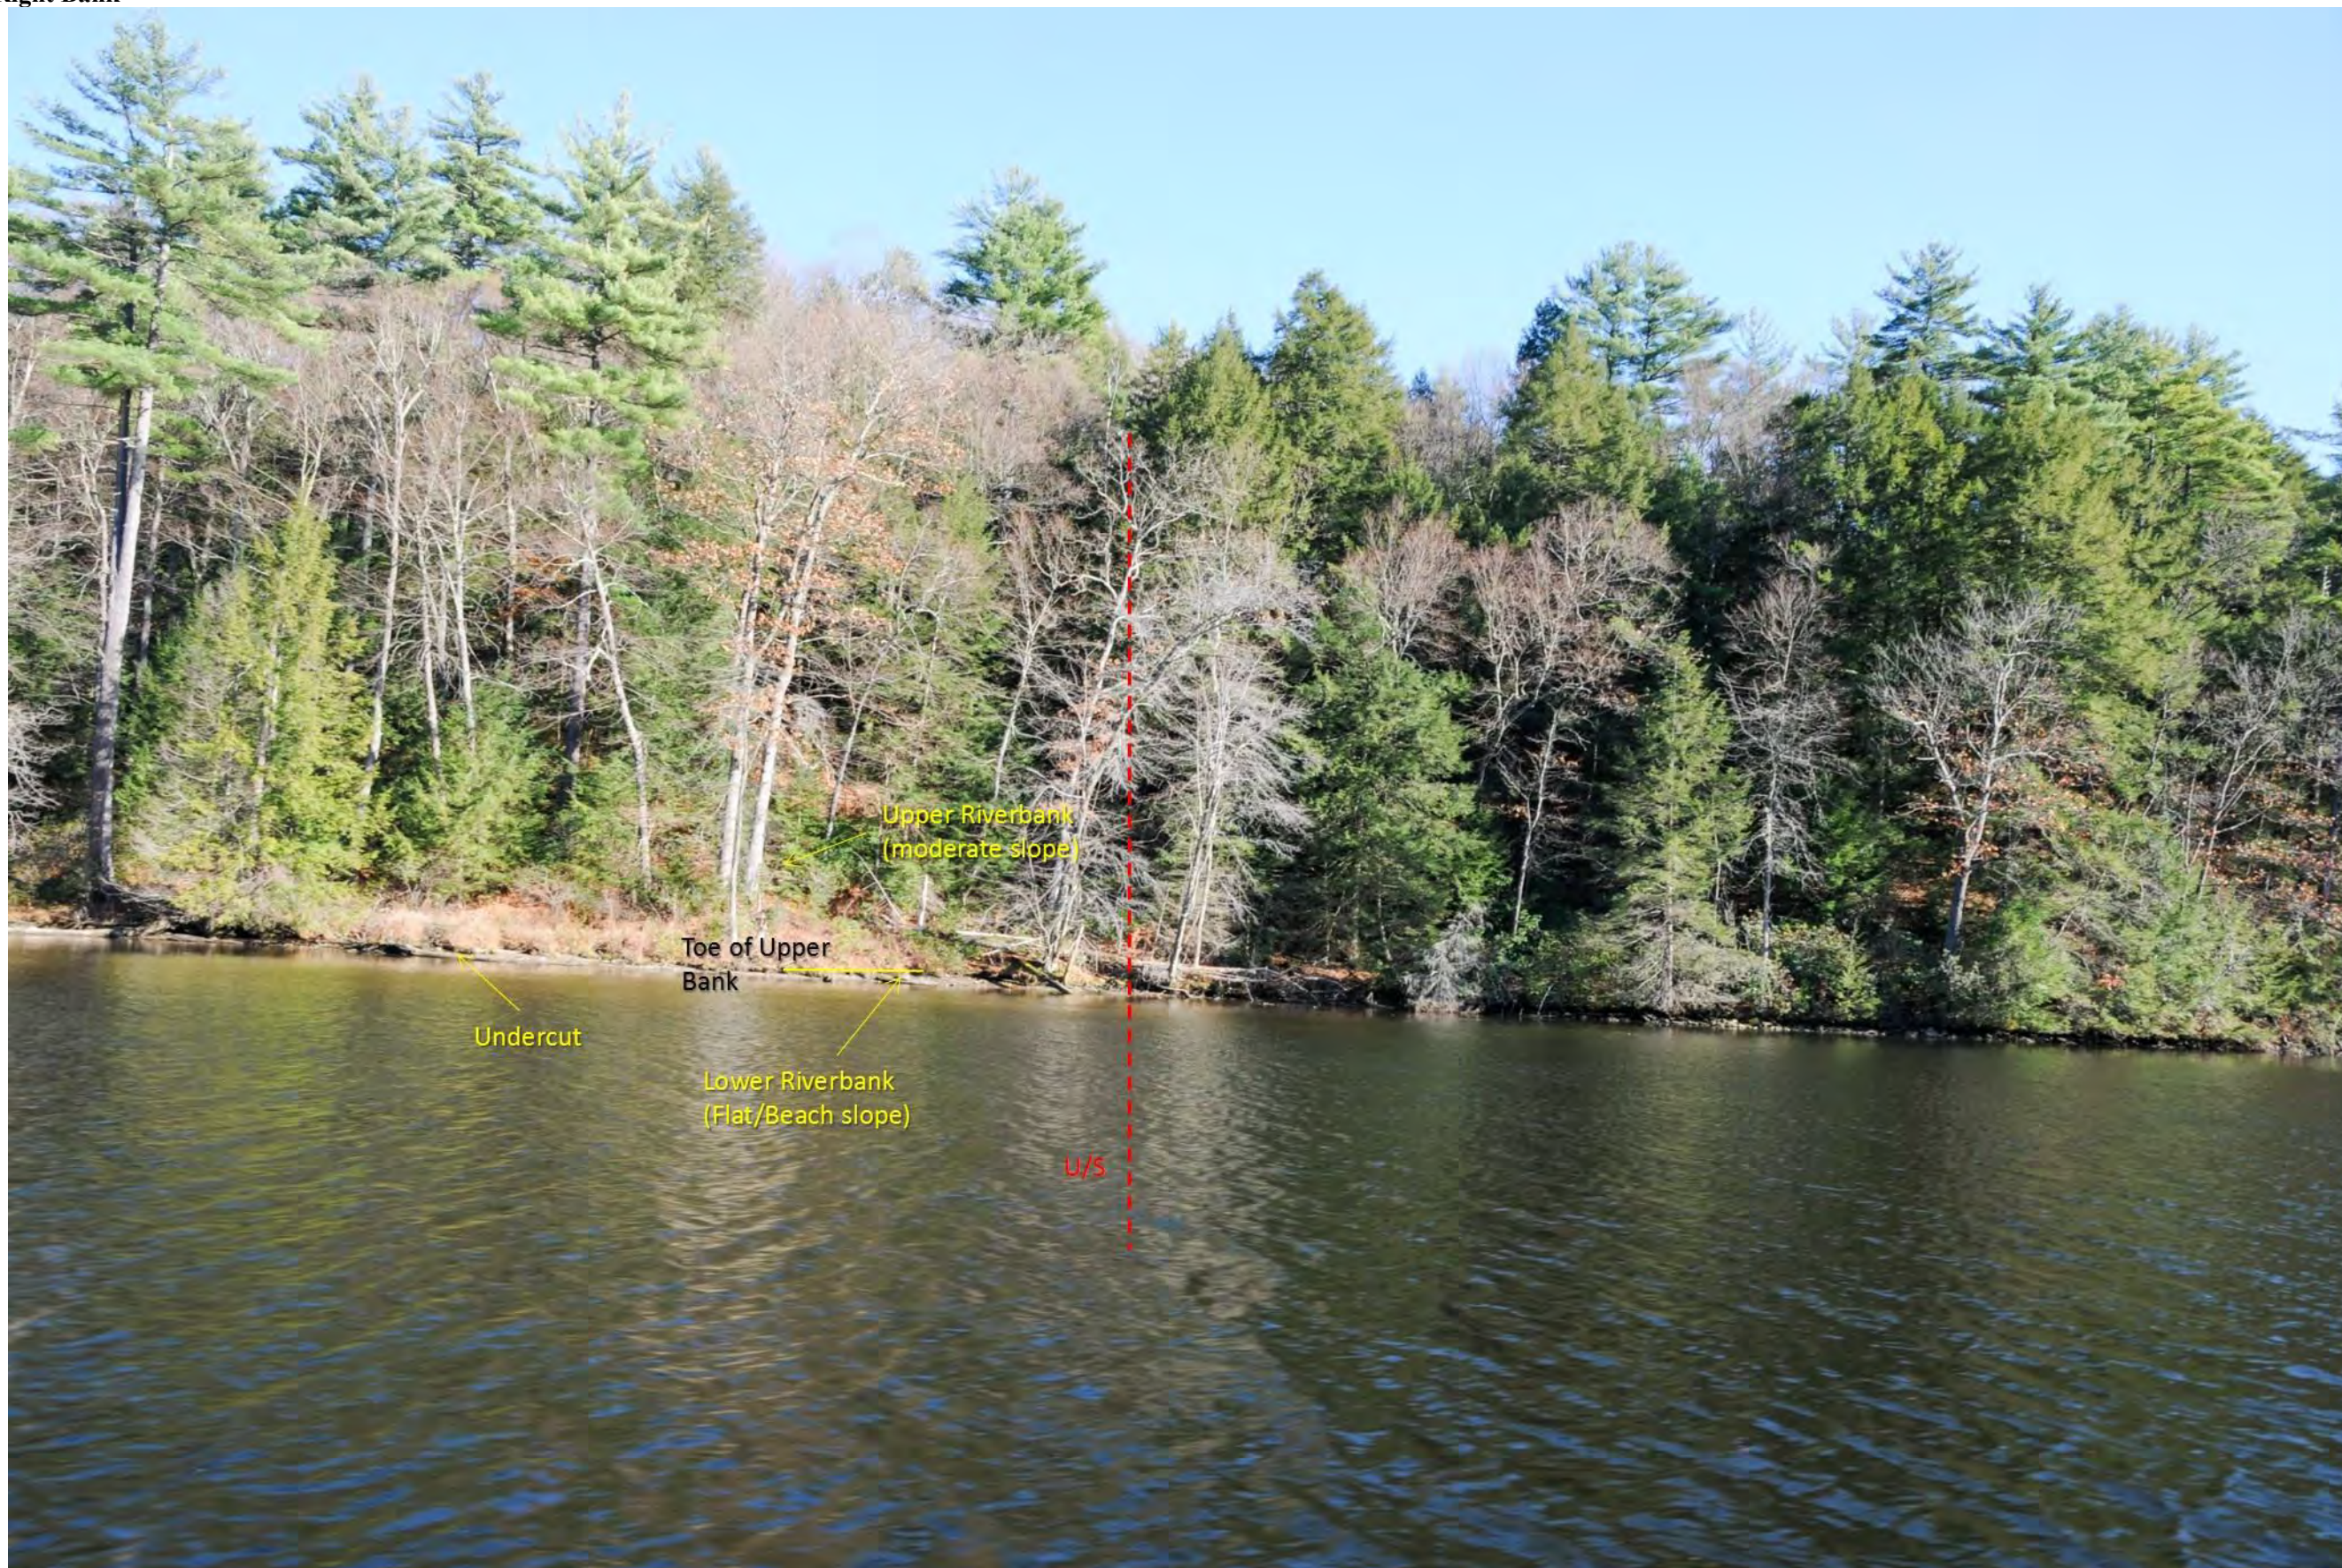
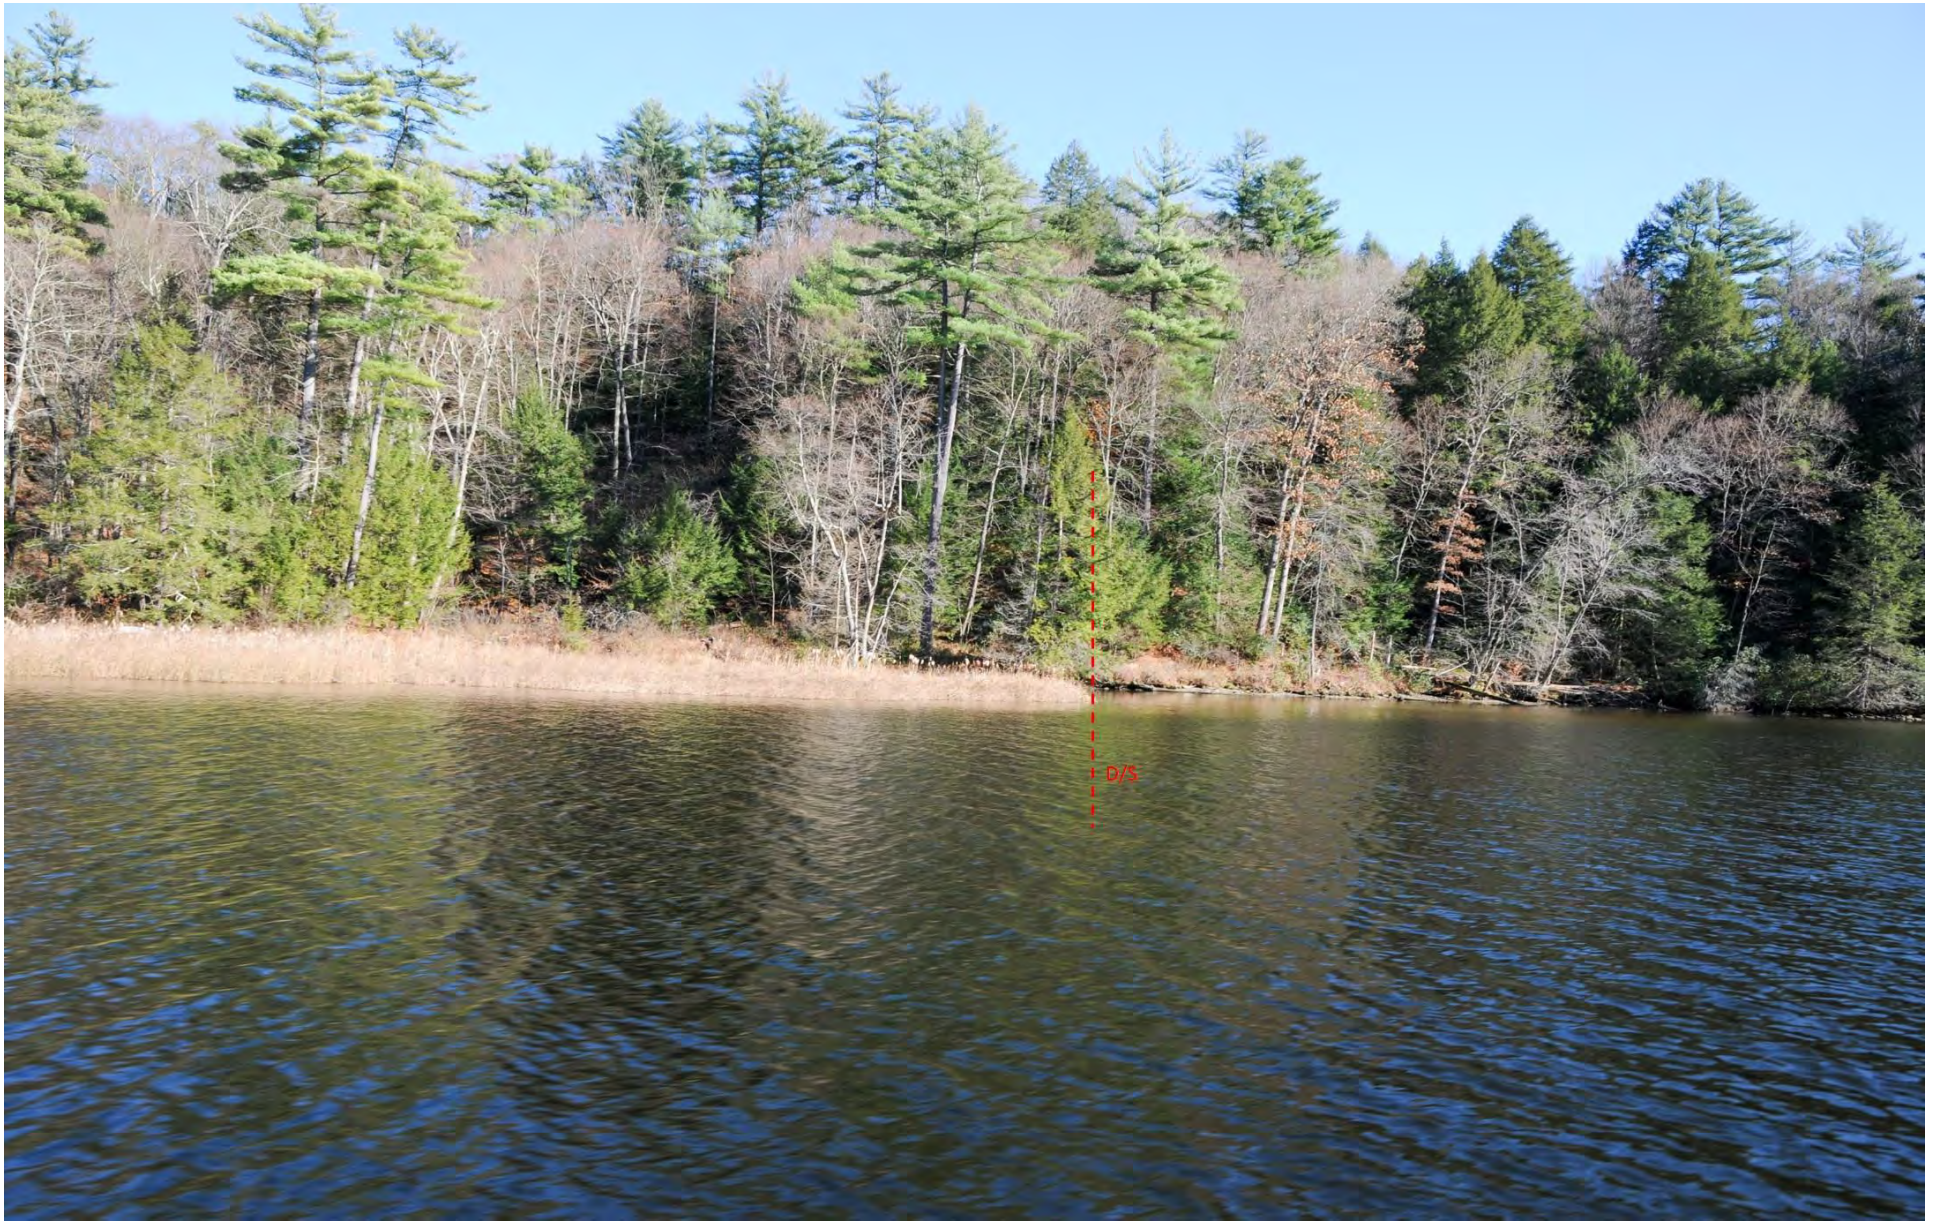
Segment 400 – Right Bank

Riverbank Features	Characteristics
Upper Riverbank Slope	Moderate
Upper Riverbank Height	High
Upper Riverbank Sediment	Silt/Sand
Upper Riverbank Vegetation	Heavy
Lower Riverbank Slope	Flat/Beach
Lower Riverbank Sediment	Silt/Sand
Lower Riverbank Vegetation	None to very sparse
Type of Erosion	Undercut
Potential Erosion Indicators	Creep/leaning trees
Stage of Erosion	Stable
Extent of Erosion	None/Little

**QA Observations:** Upon review of the photos for this segment, classification made in the field was confirmed.
