Re: Filing of Addendum to Study No. 3.1.1- 2013 Full River Reconnaissance  
Turners Falls Hydroelectric Project (FERC No. 1889) and Northfield Mountain Pumped Storage  
Project (FERC No. 2485)

## **ATTACHMENT A: 2013 Full River Reconnaissance – 2015 Addendum: Riverbank Segment QA Comparison**

2015 FRR Addendum  
 Selected Riverbank Segments for QA  
 Map 1

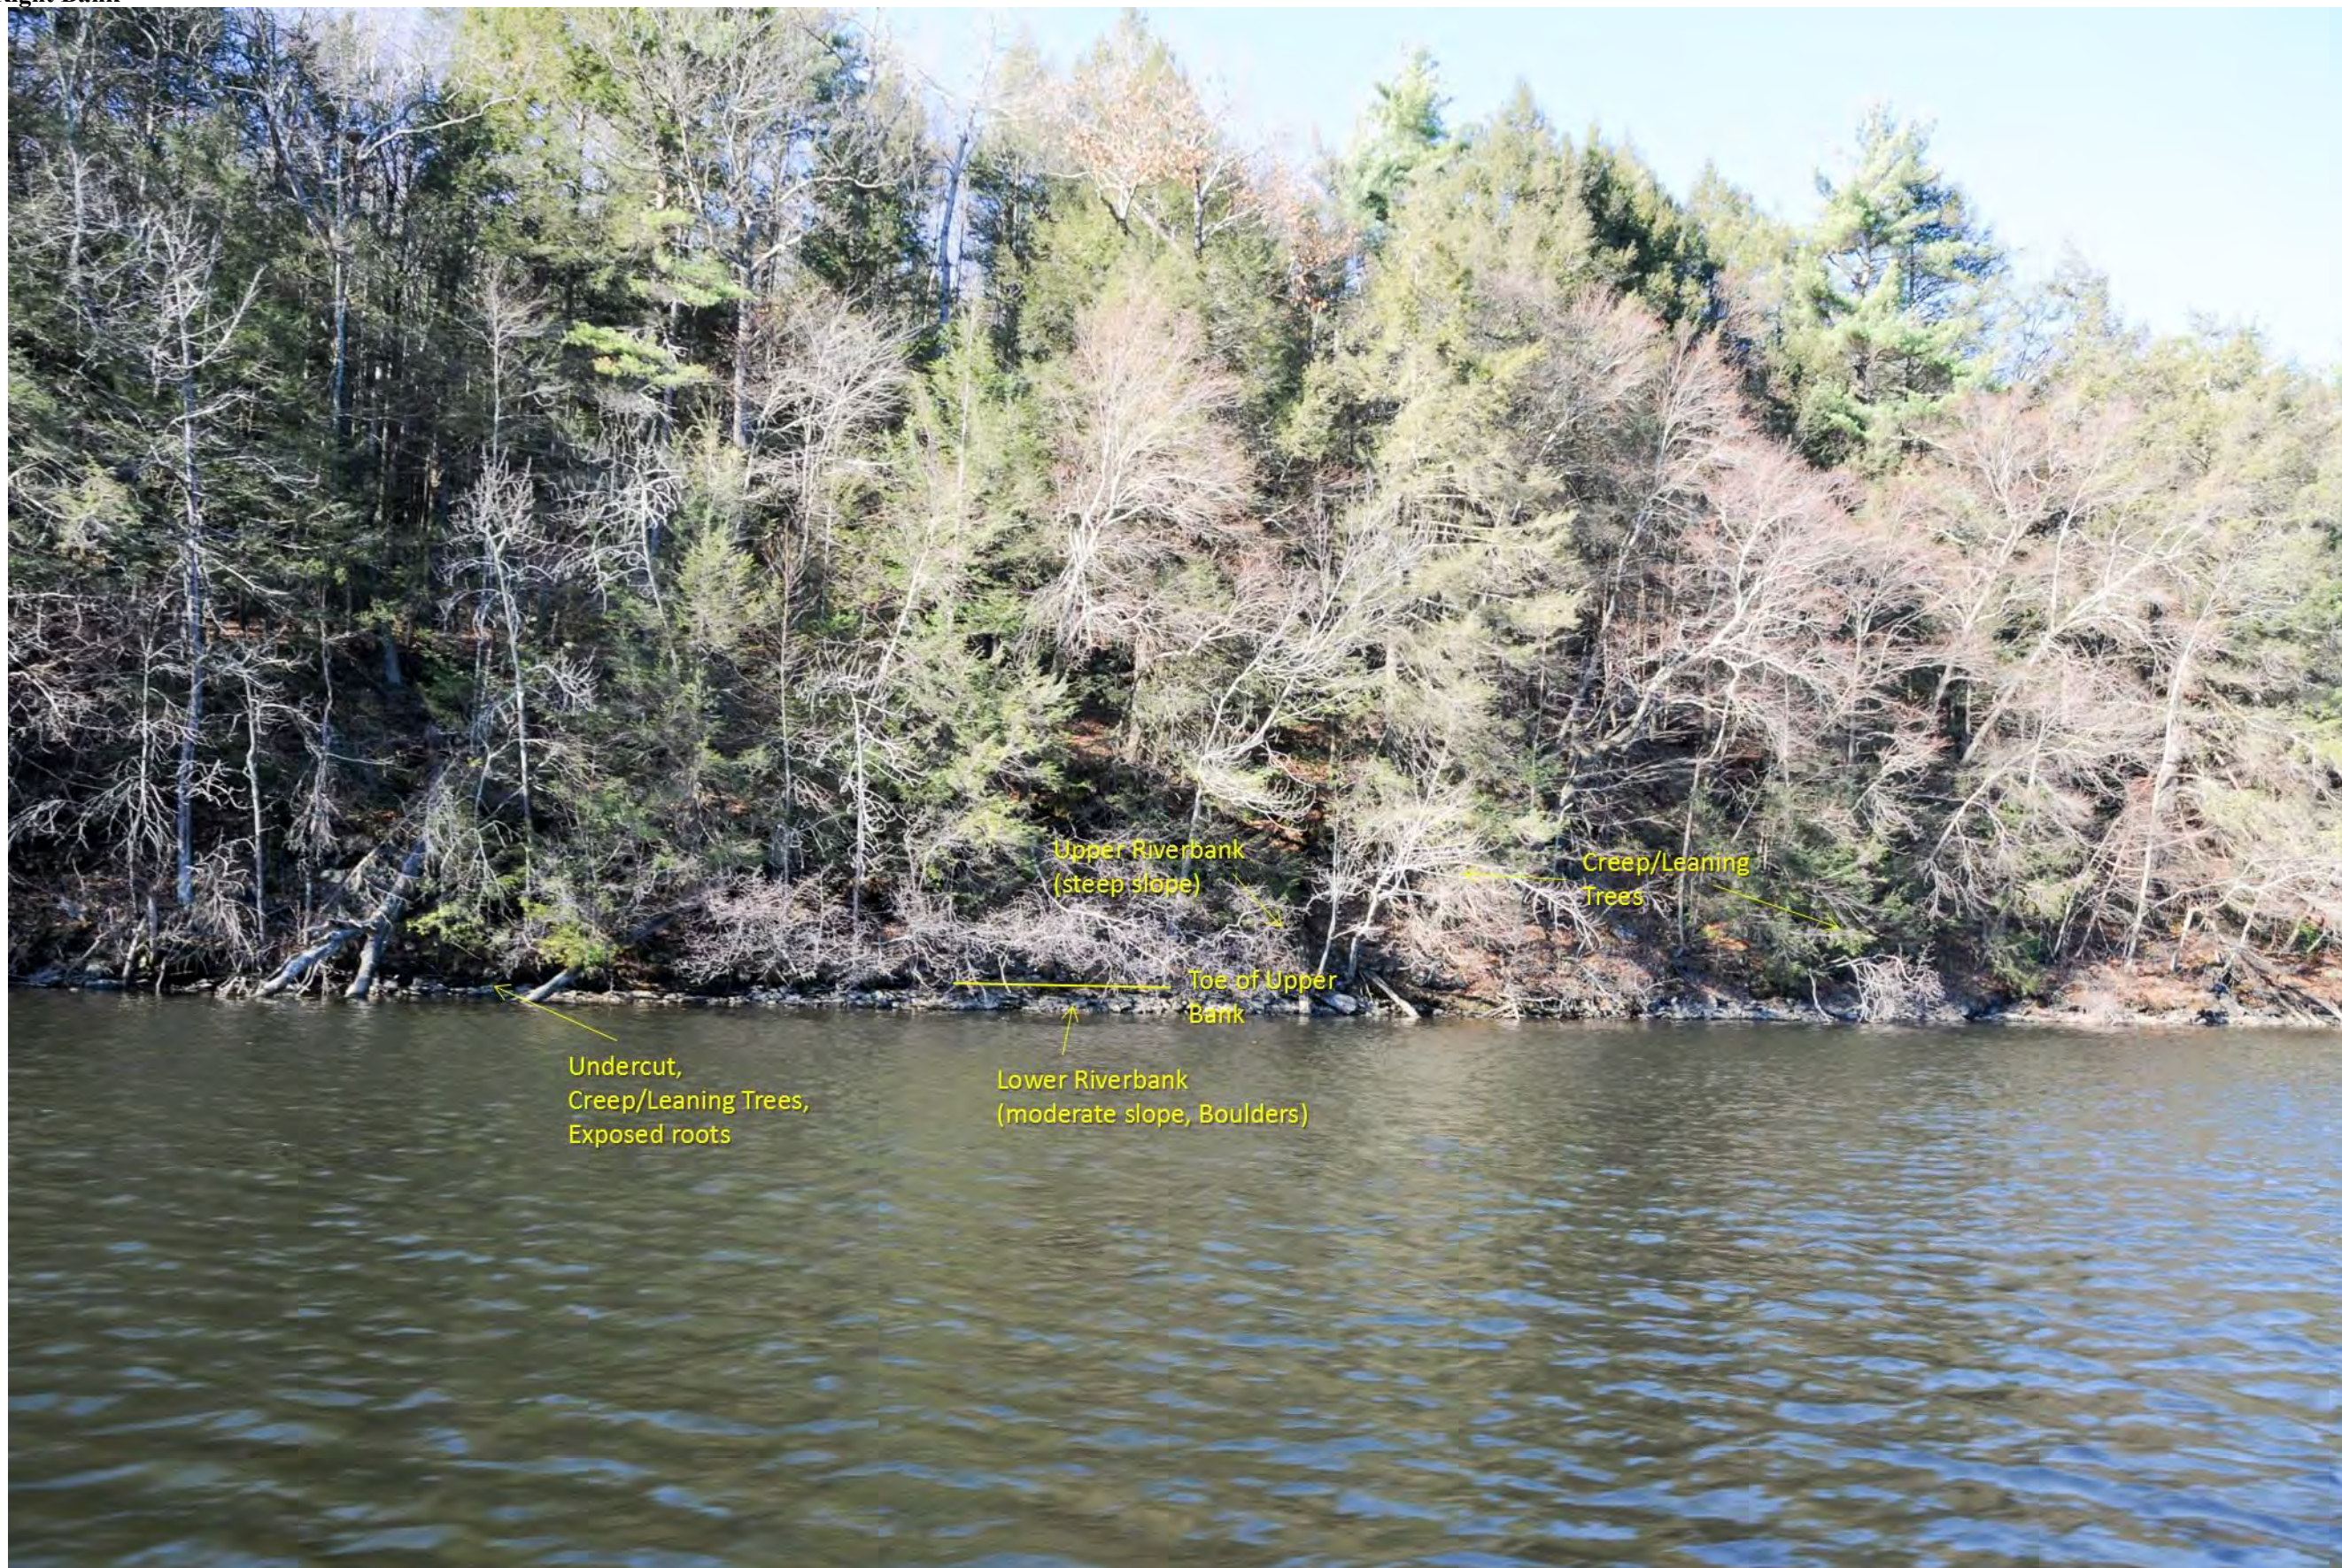
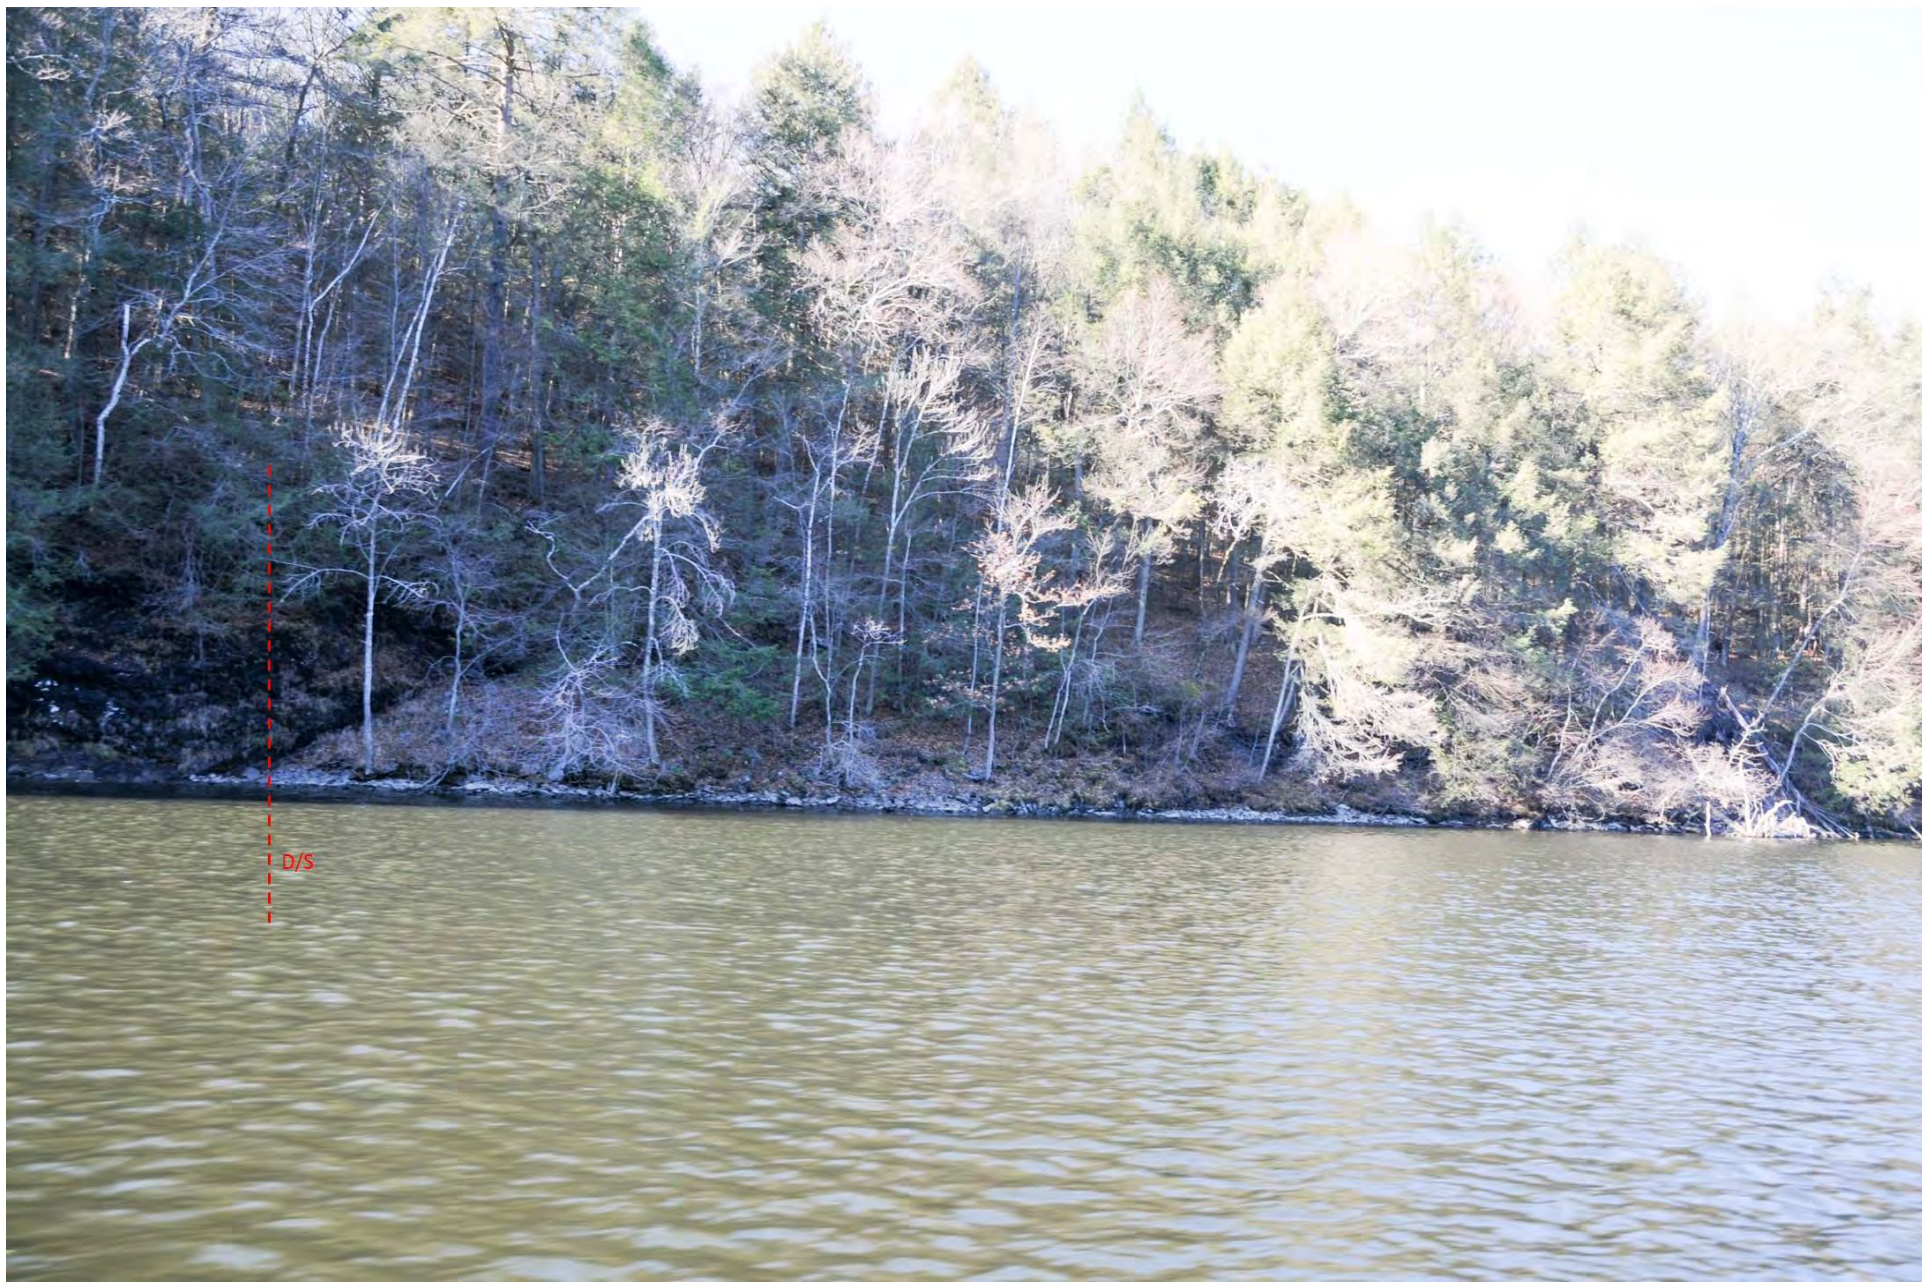
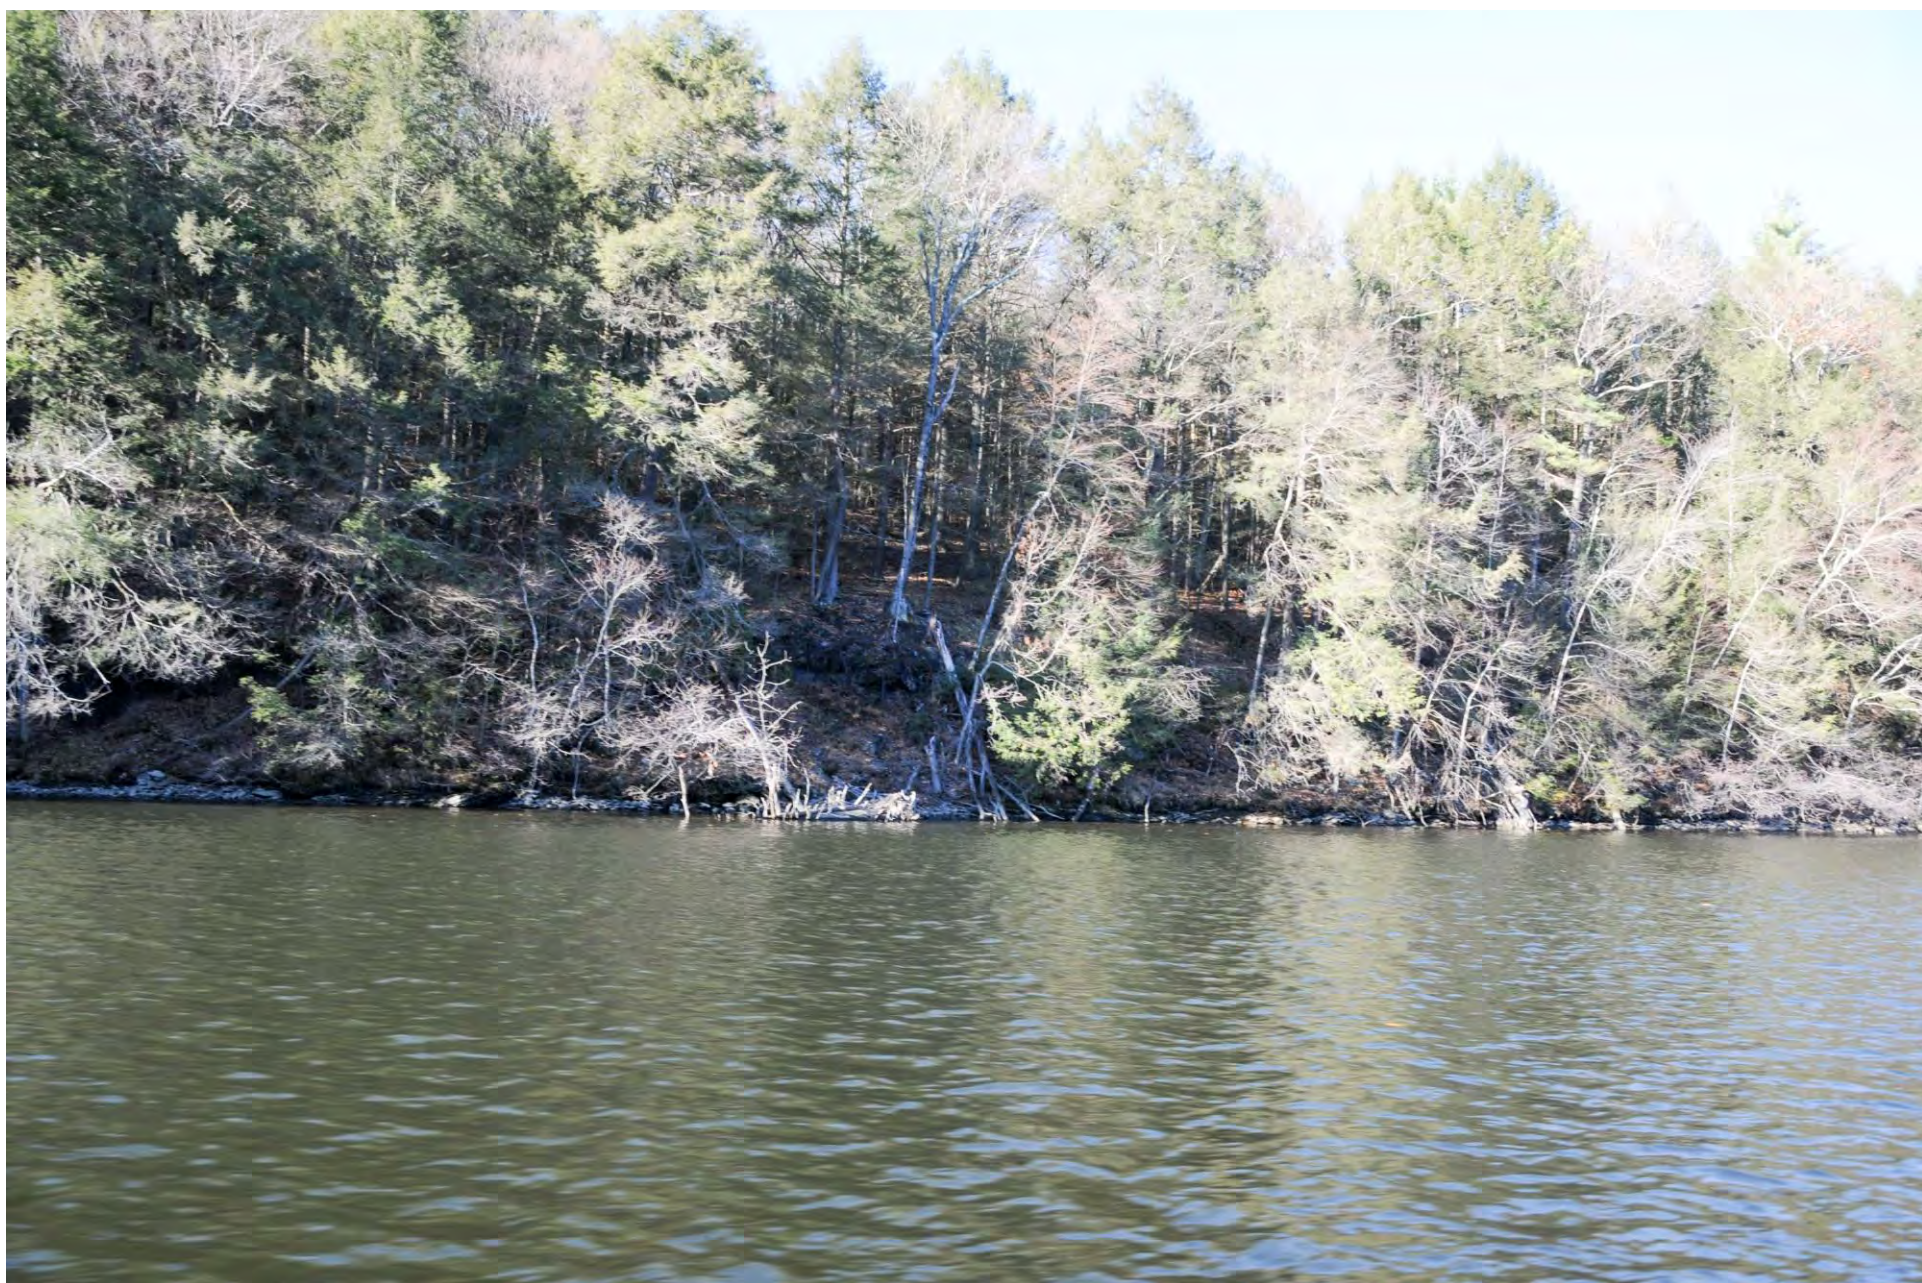
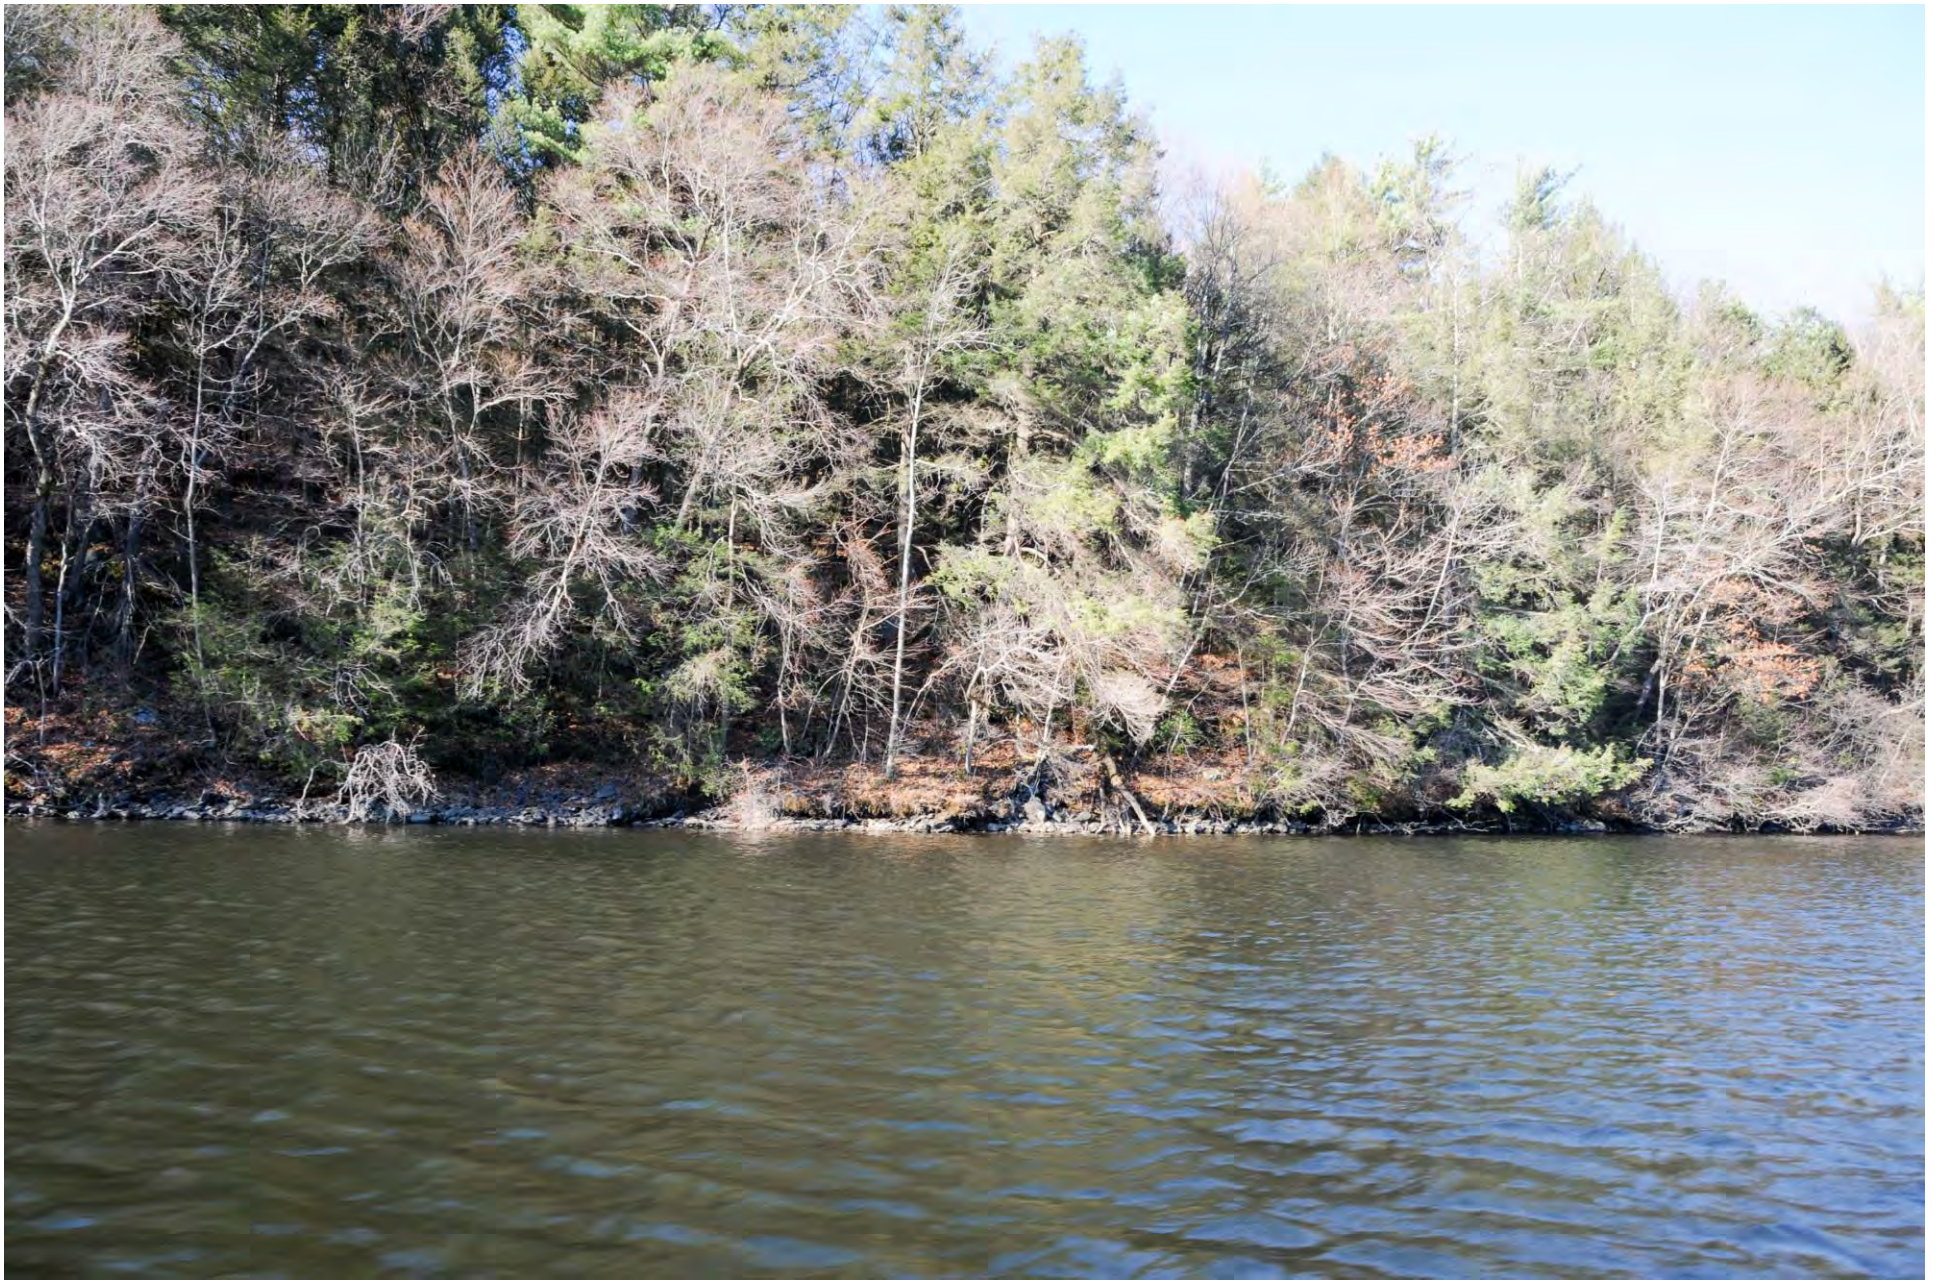
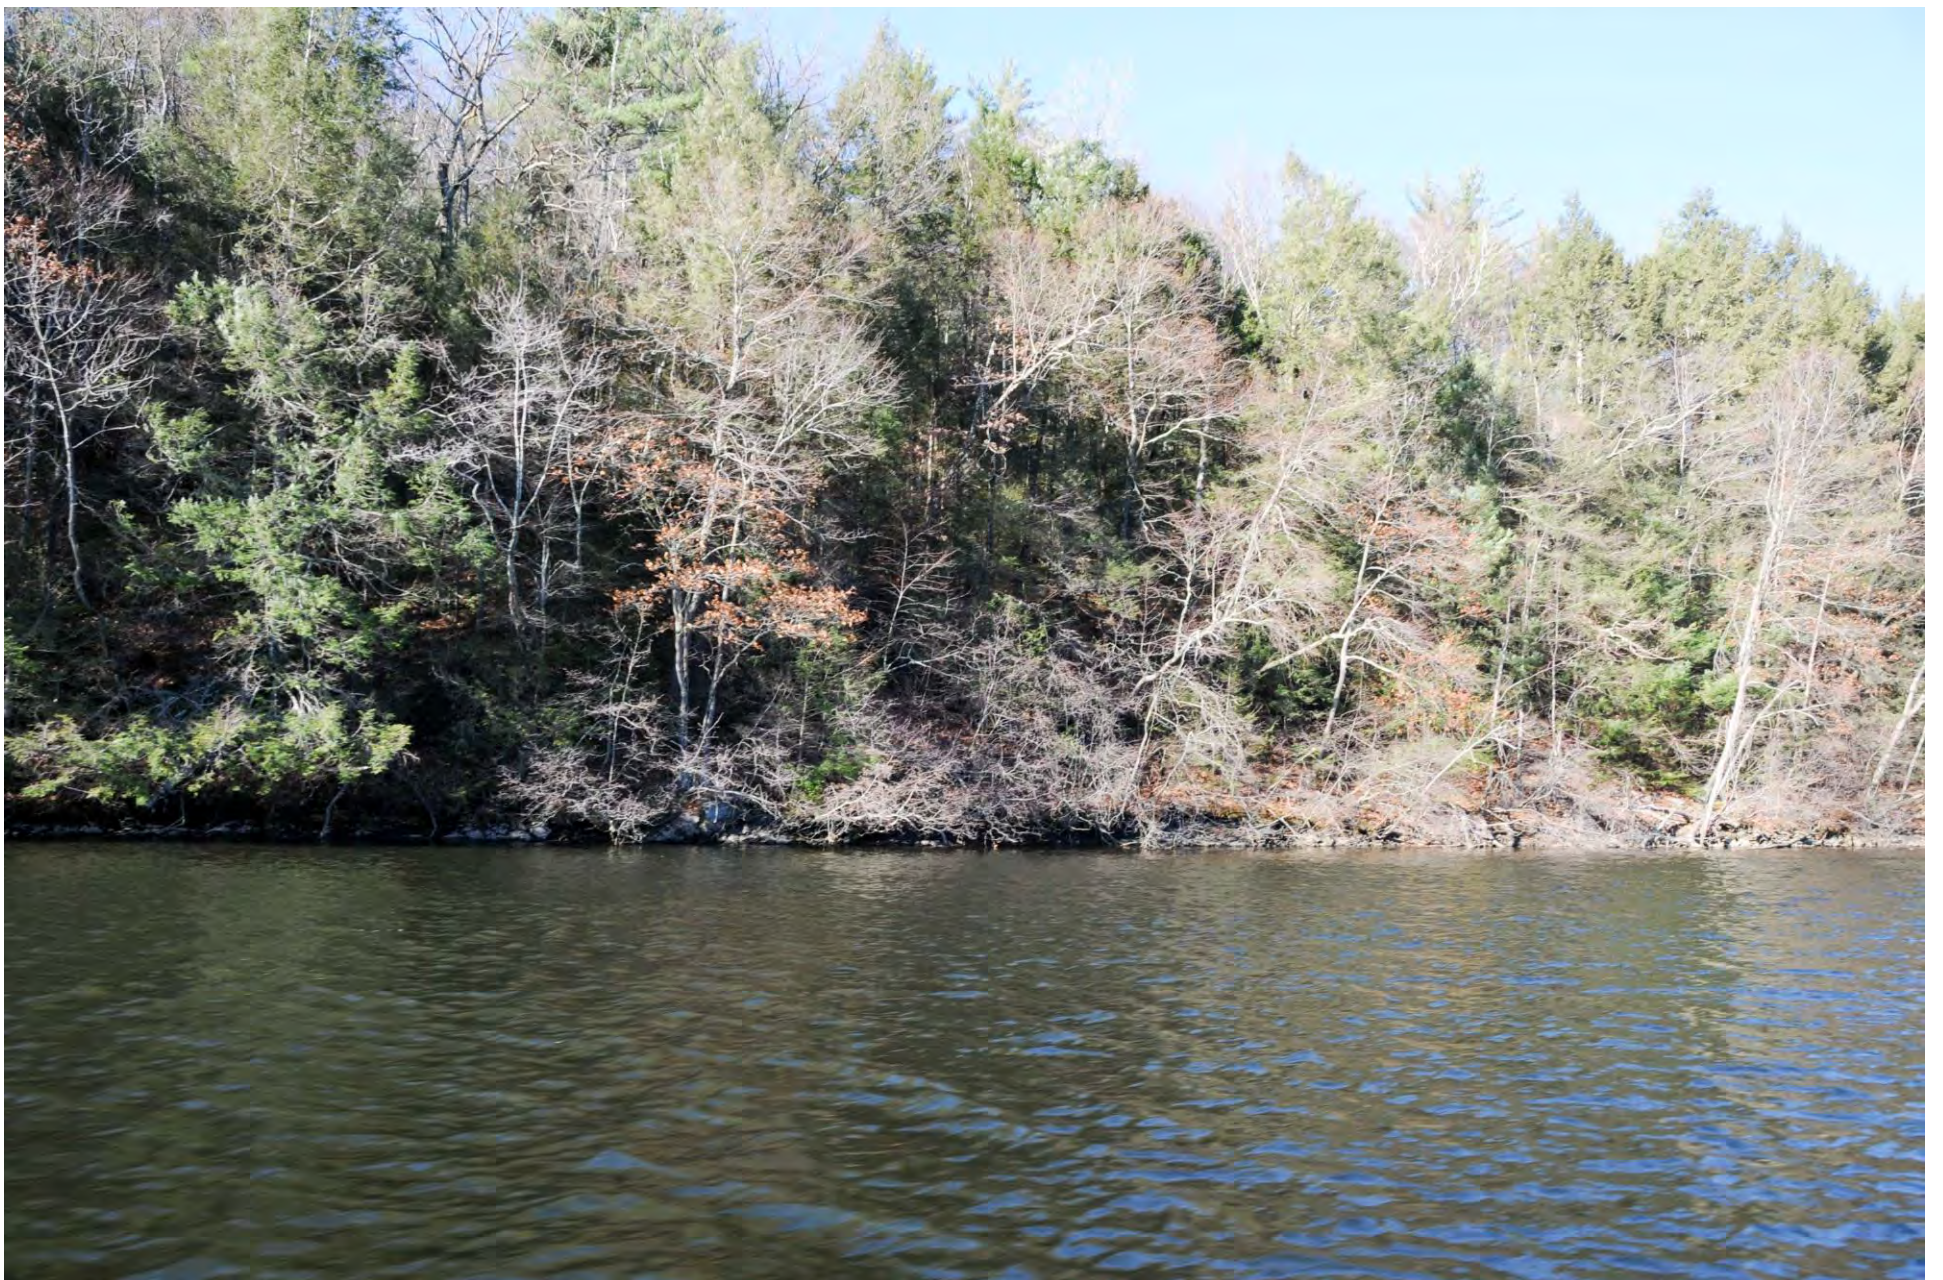
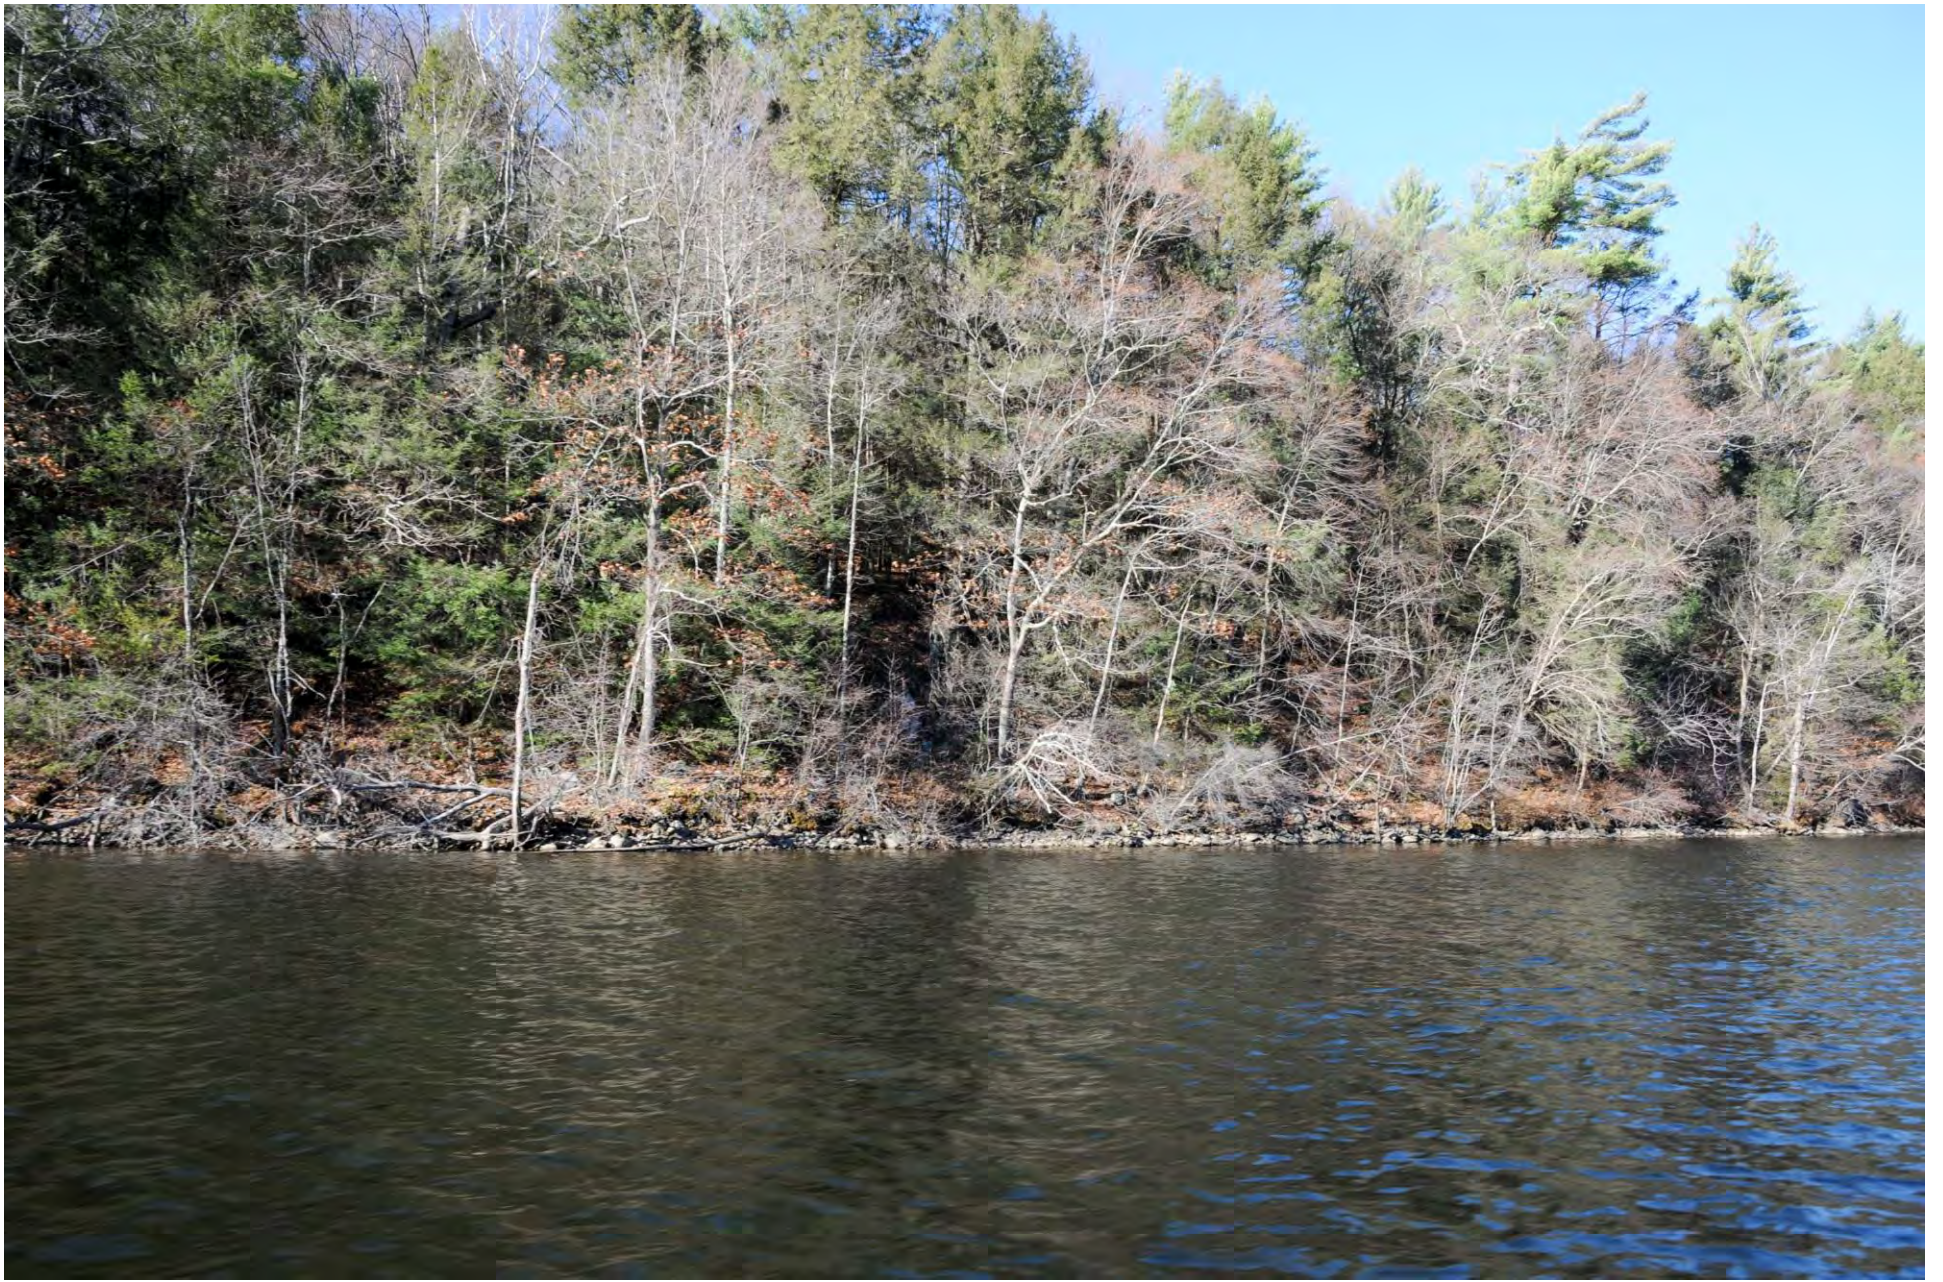
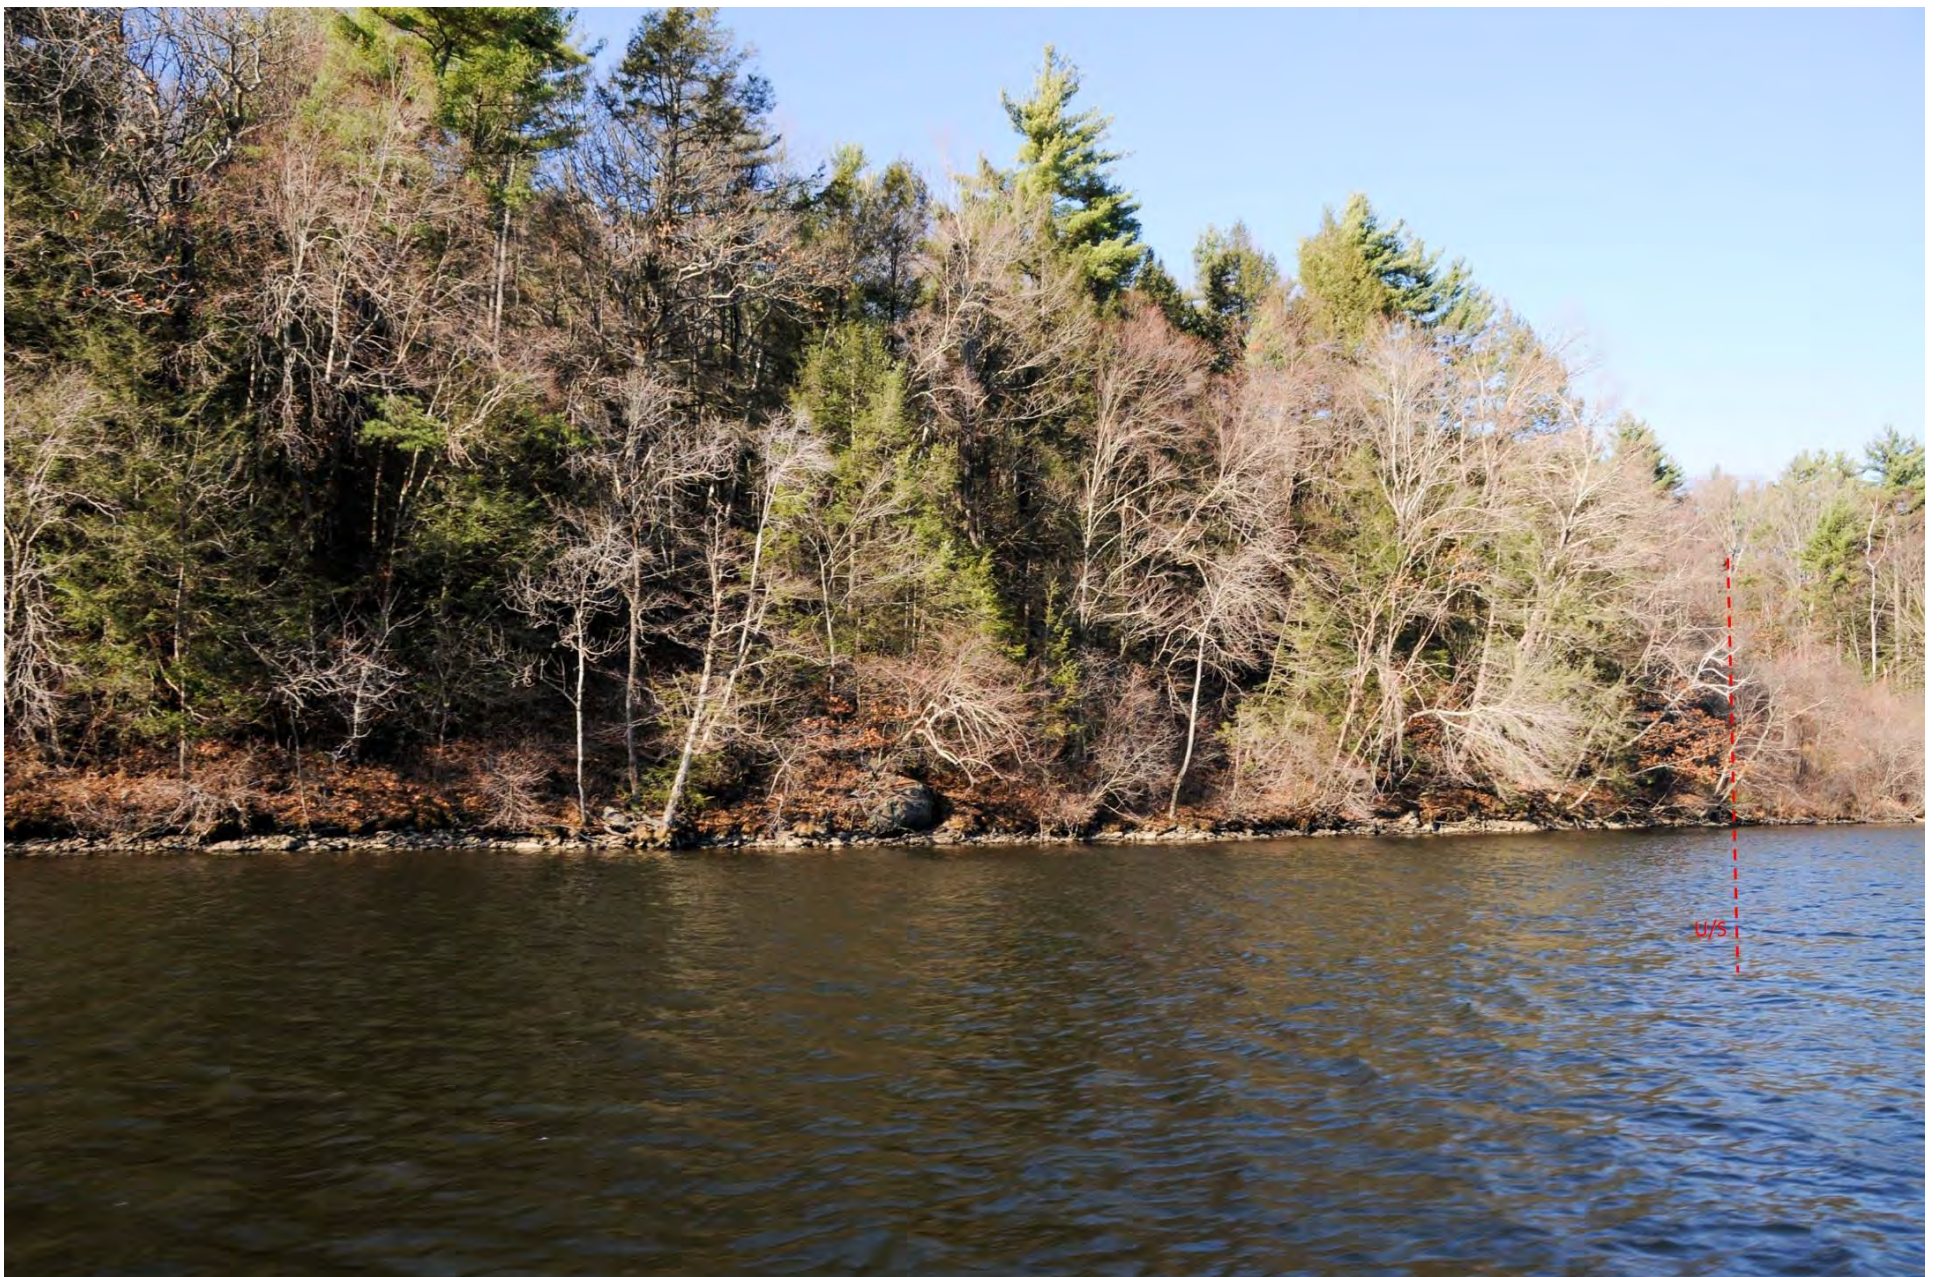
Segment 410 – Right Bank

Riverbank Features	Characteristics
Upper Riverbank Slope	Steep
Upper Riverbank Height	High
Upper Riverbank Sediment	Silt/Sand
Upper Riverbank Vegetation	Heavy
Lower Riverbank Slope	Moderate
Lower Riverbank Sediment	Boulders
Lower Riverbank Vegetation	None to very sparse
Type of Erosion	Undercut
Potential Erosion Indicators	Creep/leaning trees, Exposed roots
Stage of Erosion	Stable
Extent of Erosion	None/Little

**QA Observations:** Upon review of the photos for this segment, classification made in the field was confirmed and additional indicators of potential future erosion were included.
