**FIRSTLIGHT POWER RESOURCES**  
 RELICENSING STUDY 3.1.1  
 2013 FULL RIVER RECONNAISSANCE  
 TURNERS FALLS IMPOUNDMENT

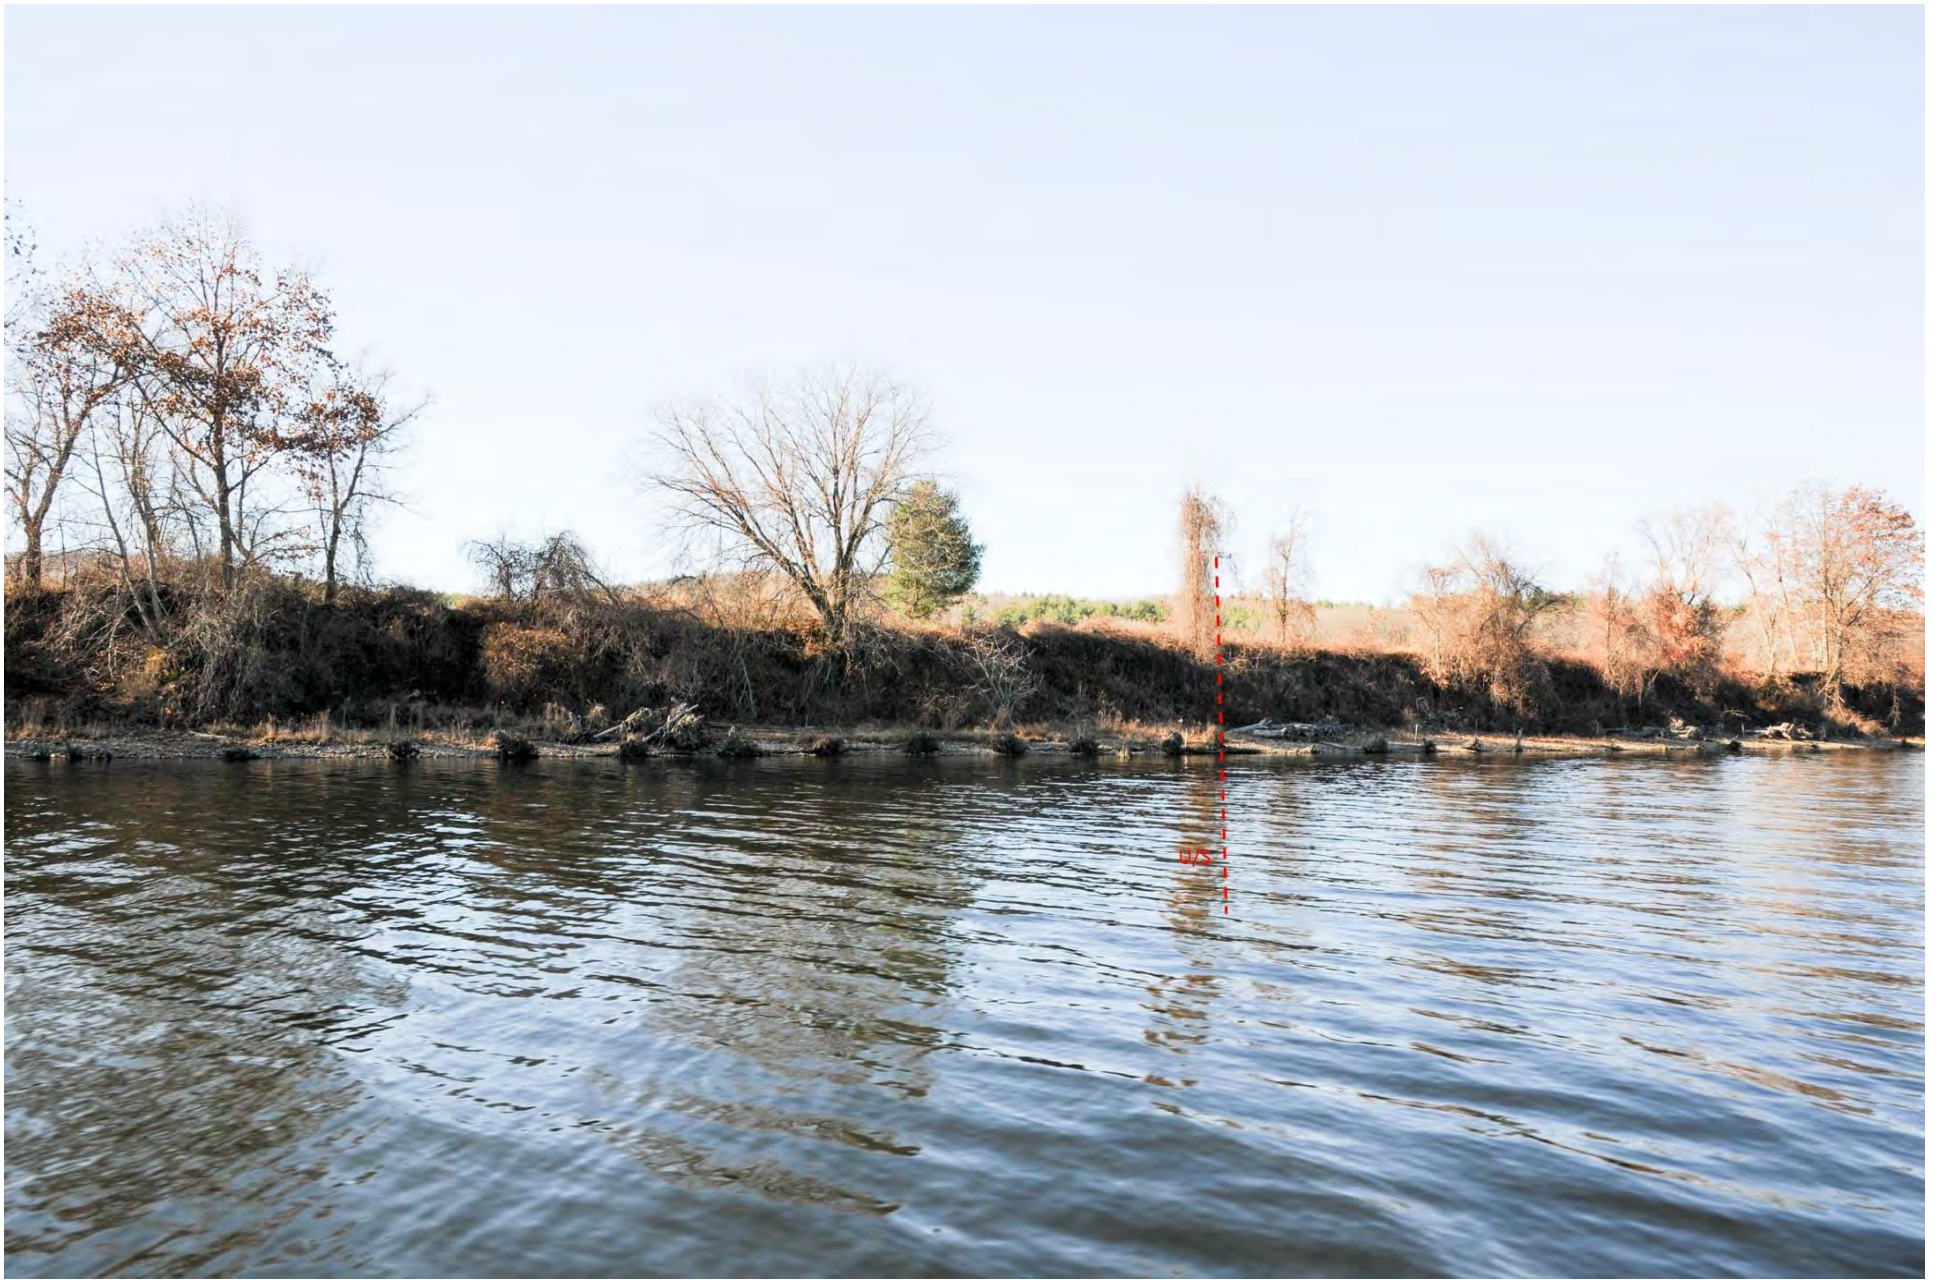
**Photo ID 551** (U/S, left of line)

Riverbank Features	Characteristics
Upper Riverbank Slope	Steep
Upper Riverbank Height	High
Upper Riverbank Sediment	Silt/Sand
Upper Riverbank Vegetation	Heavy
Lower Riverbank Slope	Flat/Beach
Lower Riverbank Sediment	Gravel
Lower Riverbank Vegetation	Moderate
Type of Erosion	
Potential Erosion Indicators	Overhanging bank, Exposed roots
Stage of Erosion	Stable
Extent of Erosion	None/Little

**QA Observations:** Upon review of the photos for this segment, classification made in the field was confirmed and additional indicators of potential future erosion were included.

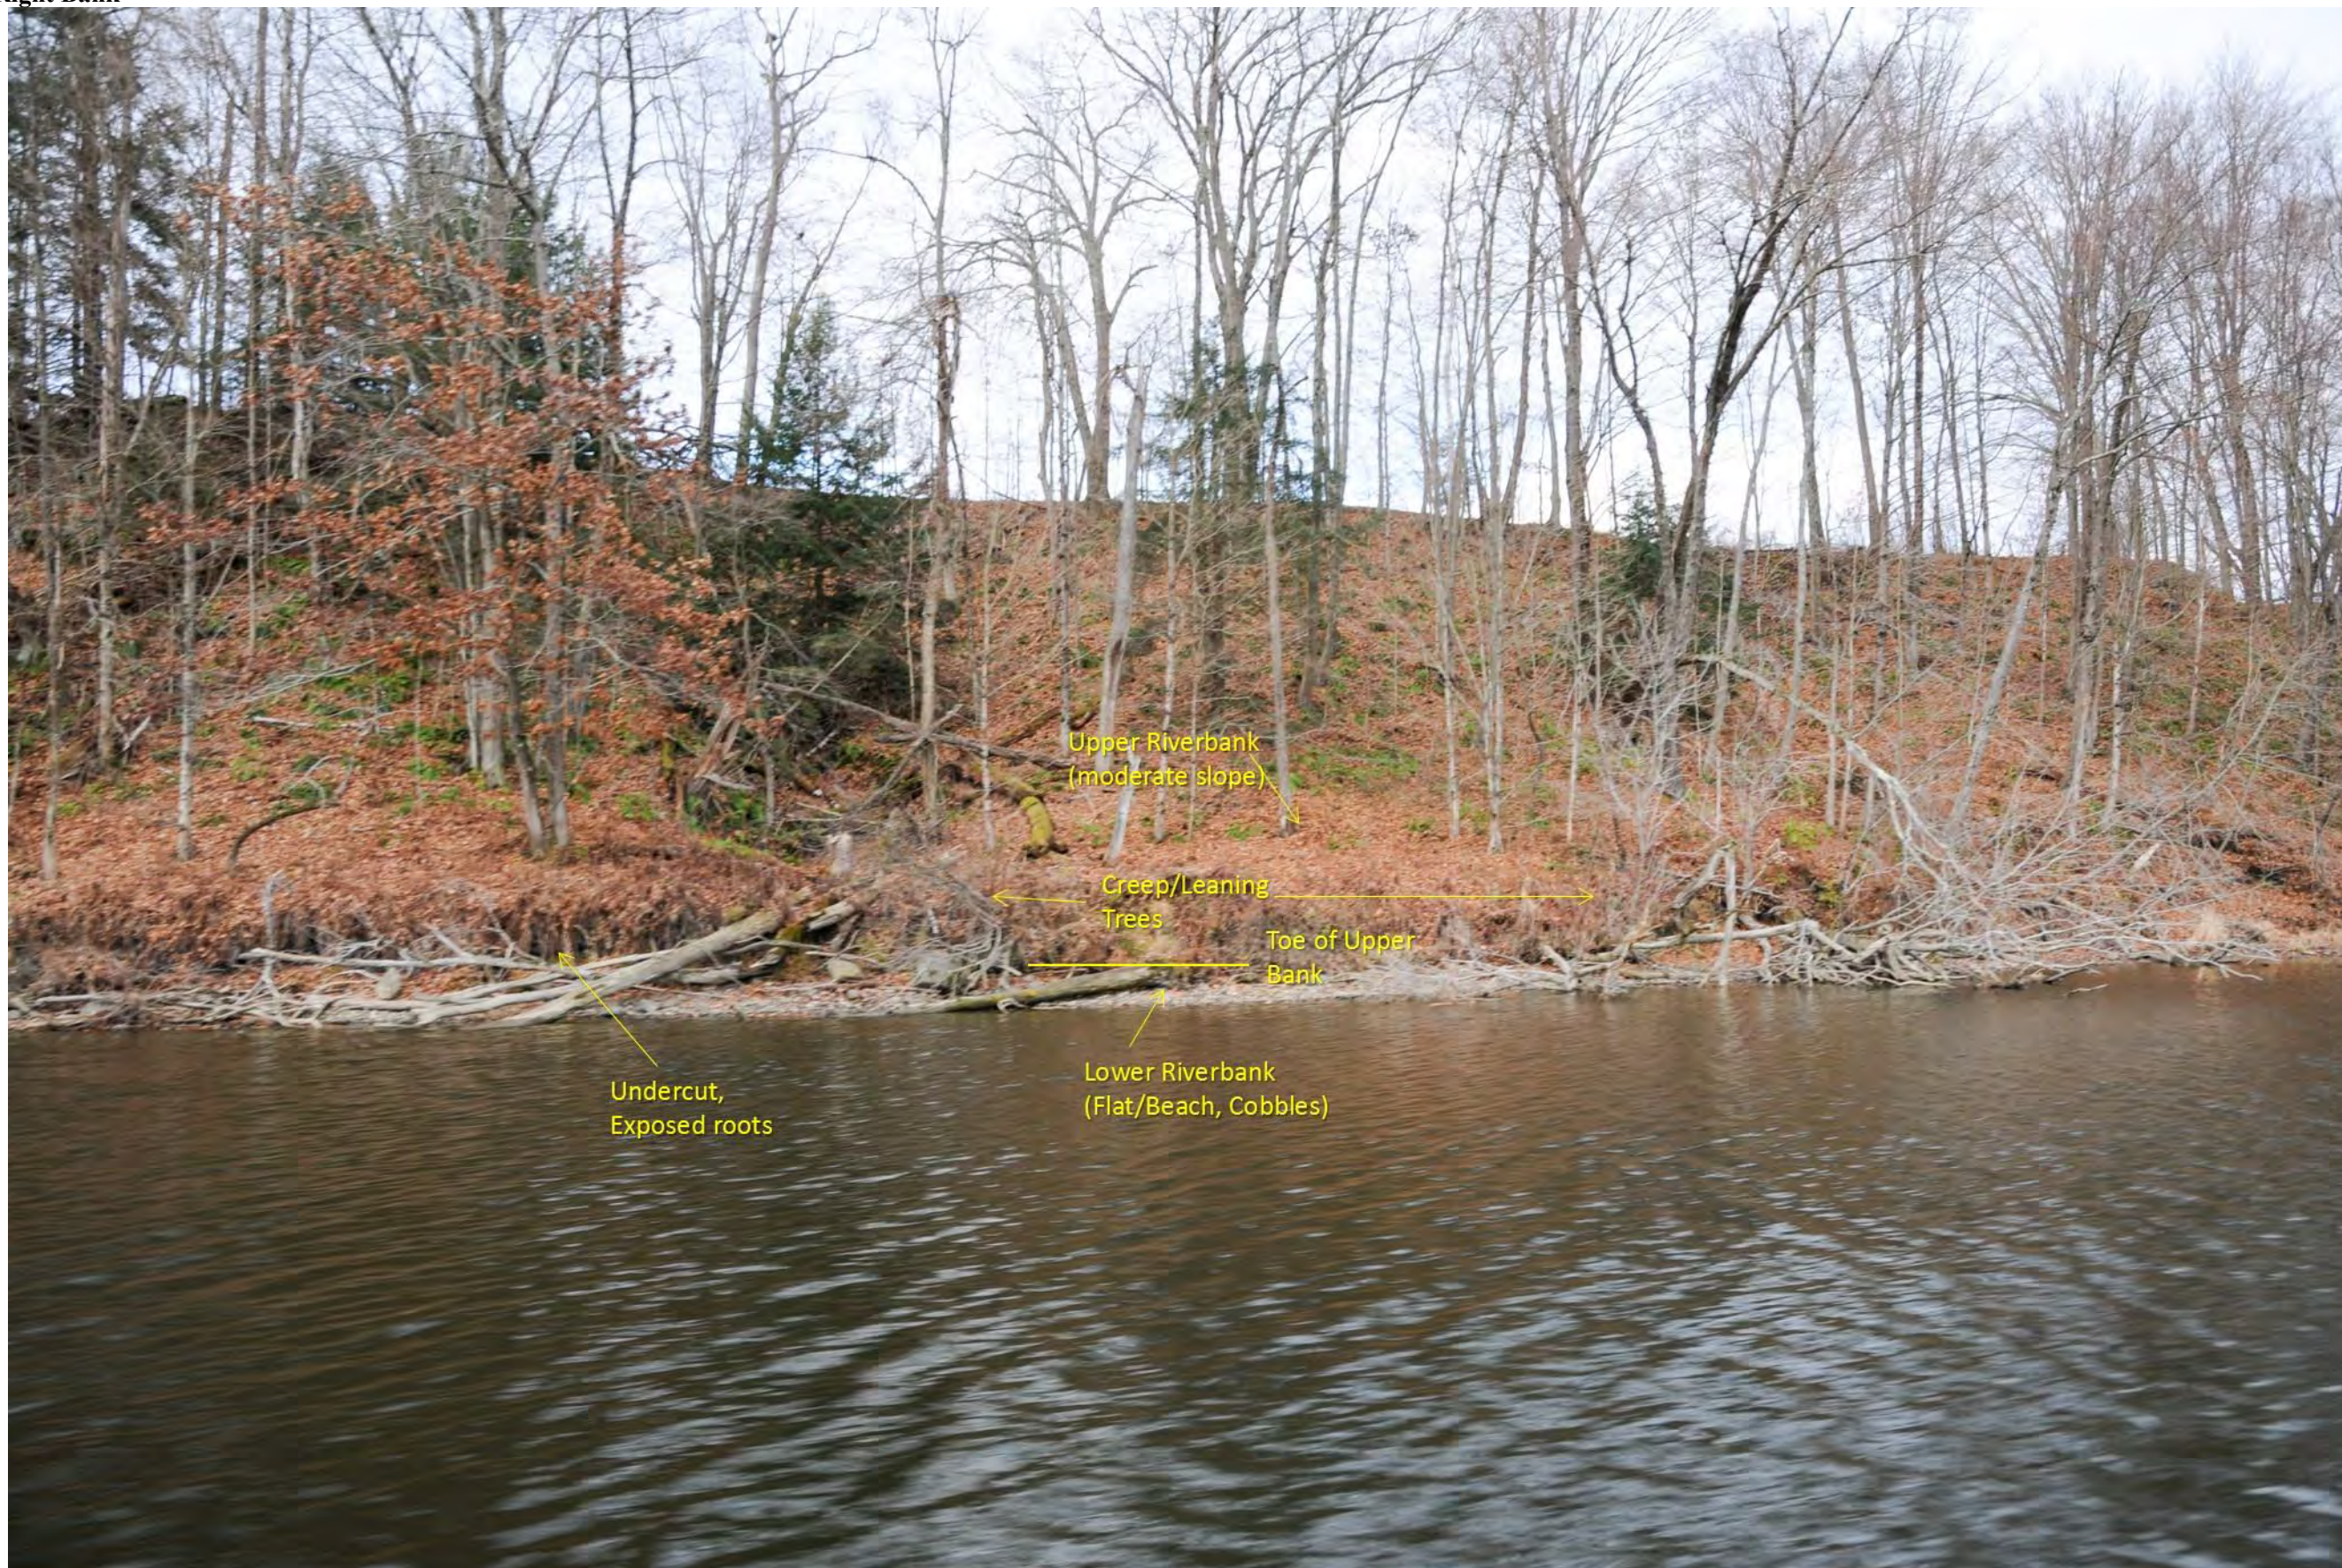
Photo ID 966 (mid-segment)

<b>Riverbank Features</b>	<b>Characteristics</b>
<b>Upper Riverbank Slope</b>	Moderate
<b>Upper Riverbank Height</b>	High
<b>Upper Riverbank Sediment</b>	Silt/Sand
<b>Upper Riverbank Vegetation</b>	Heavy
<b>Lower Riverbank Slope</b>	Flat/Beach
<b>Lower Riverbank Sediment</b>	Cobbles
<b>Lower Riverbank Vegetation</b>	None to very sparse
<b>Type of Erosion</b>	Undercut
<b>Potential Erosion Indicators</b>	Creep/Leaning trees, Exposed roots
<b>Stage of Erosion</b>	Stable
<b>Extent of Erosion</b>	None/Little

**QA Observations:** Upon review of the photos for this segment, classification made in the field was confirmed and additional indicators of potential future erosion were included.

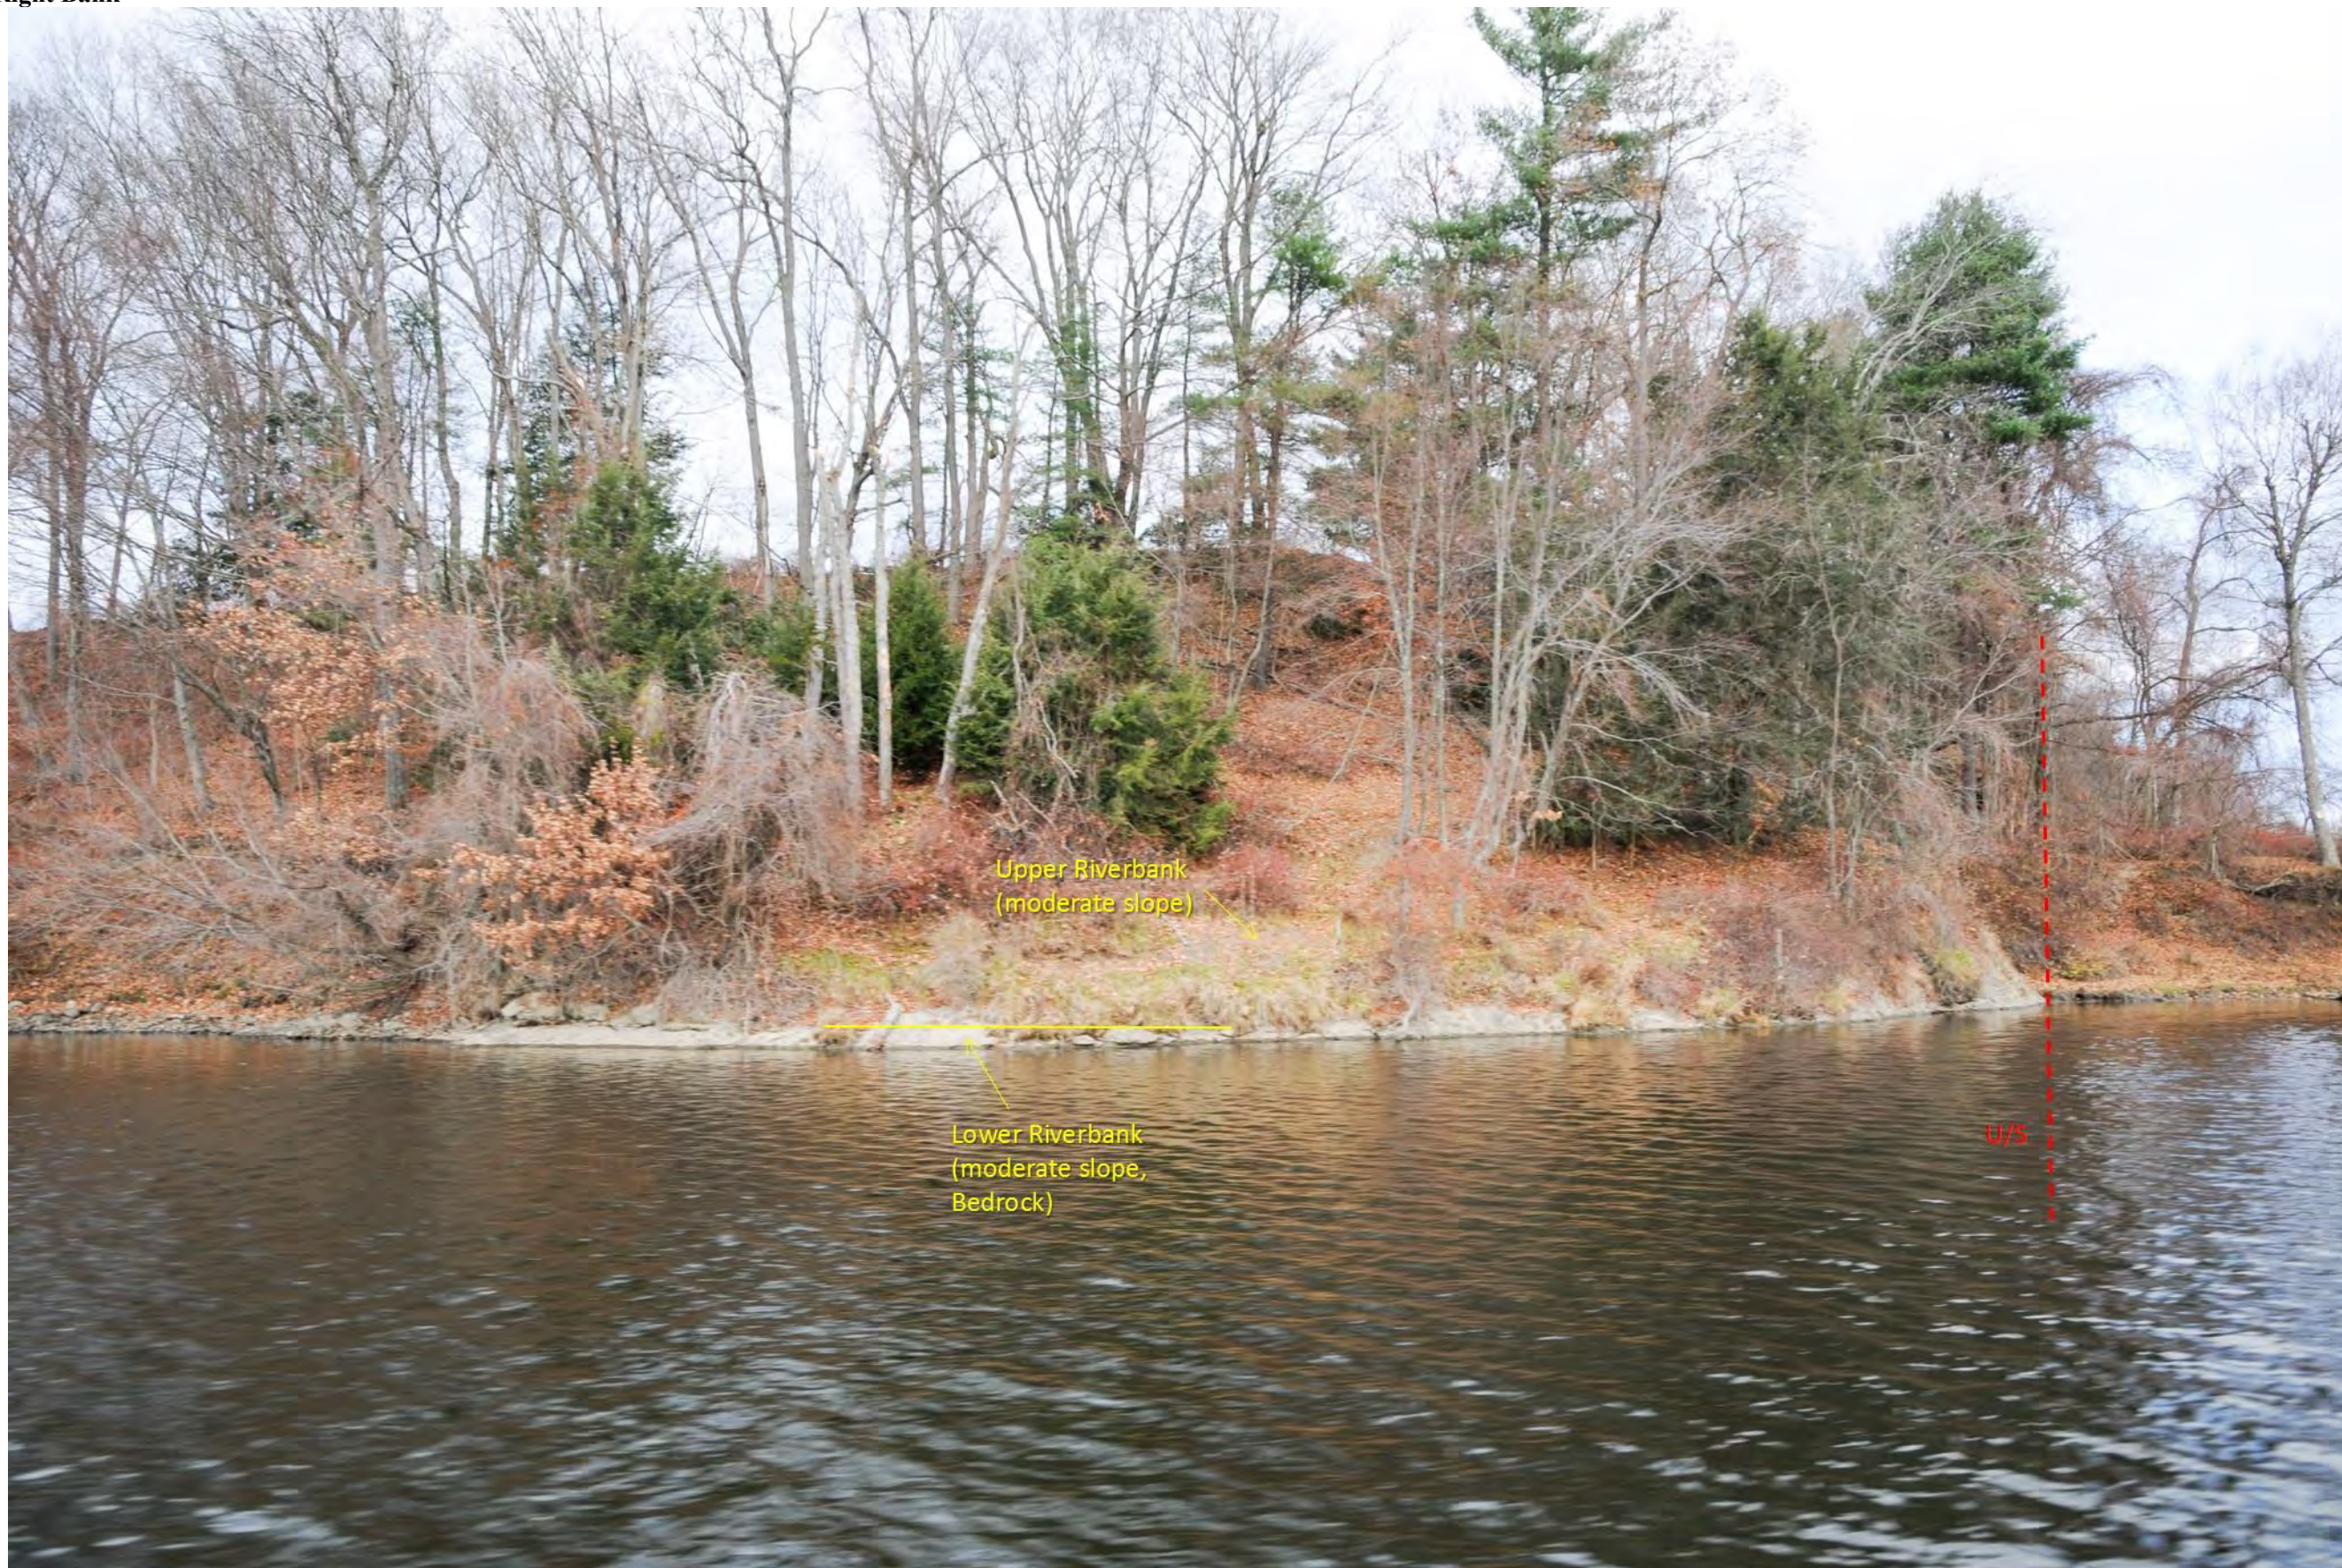
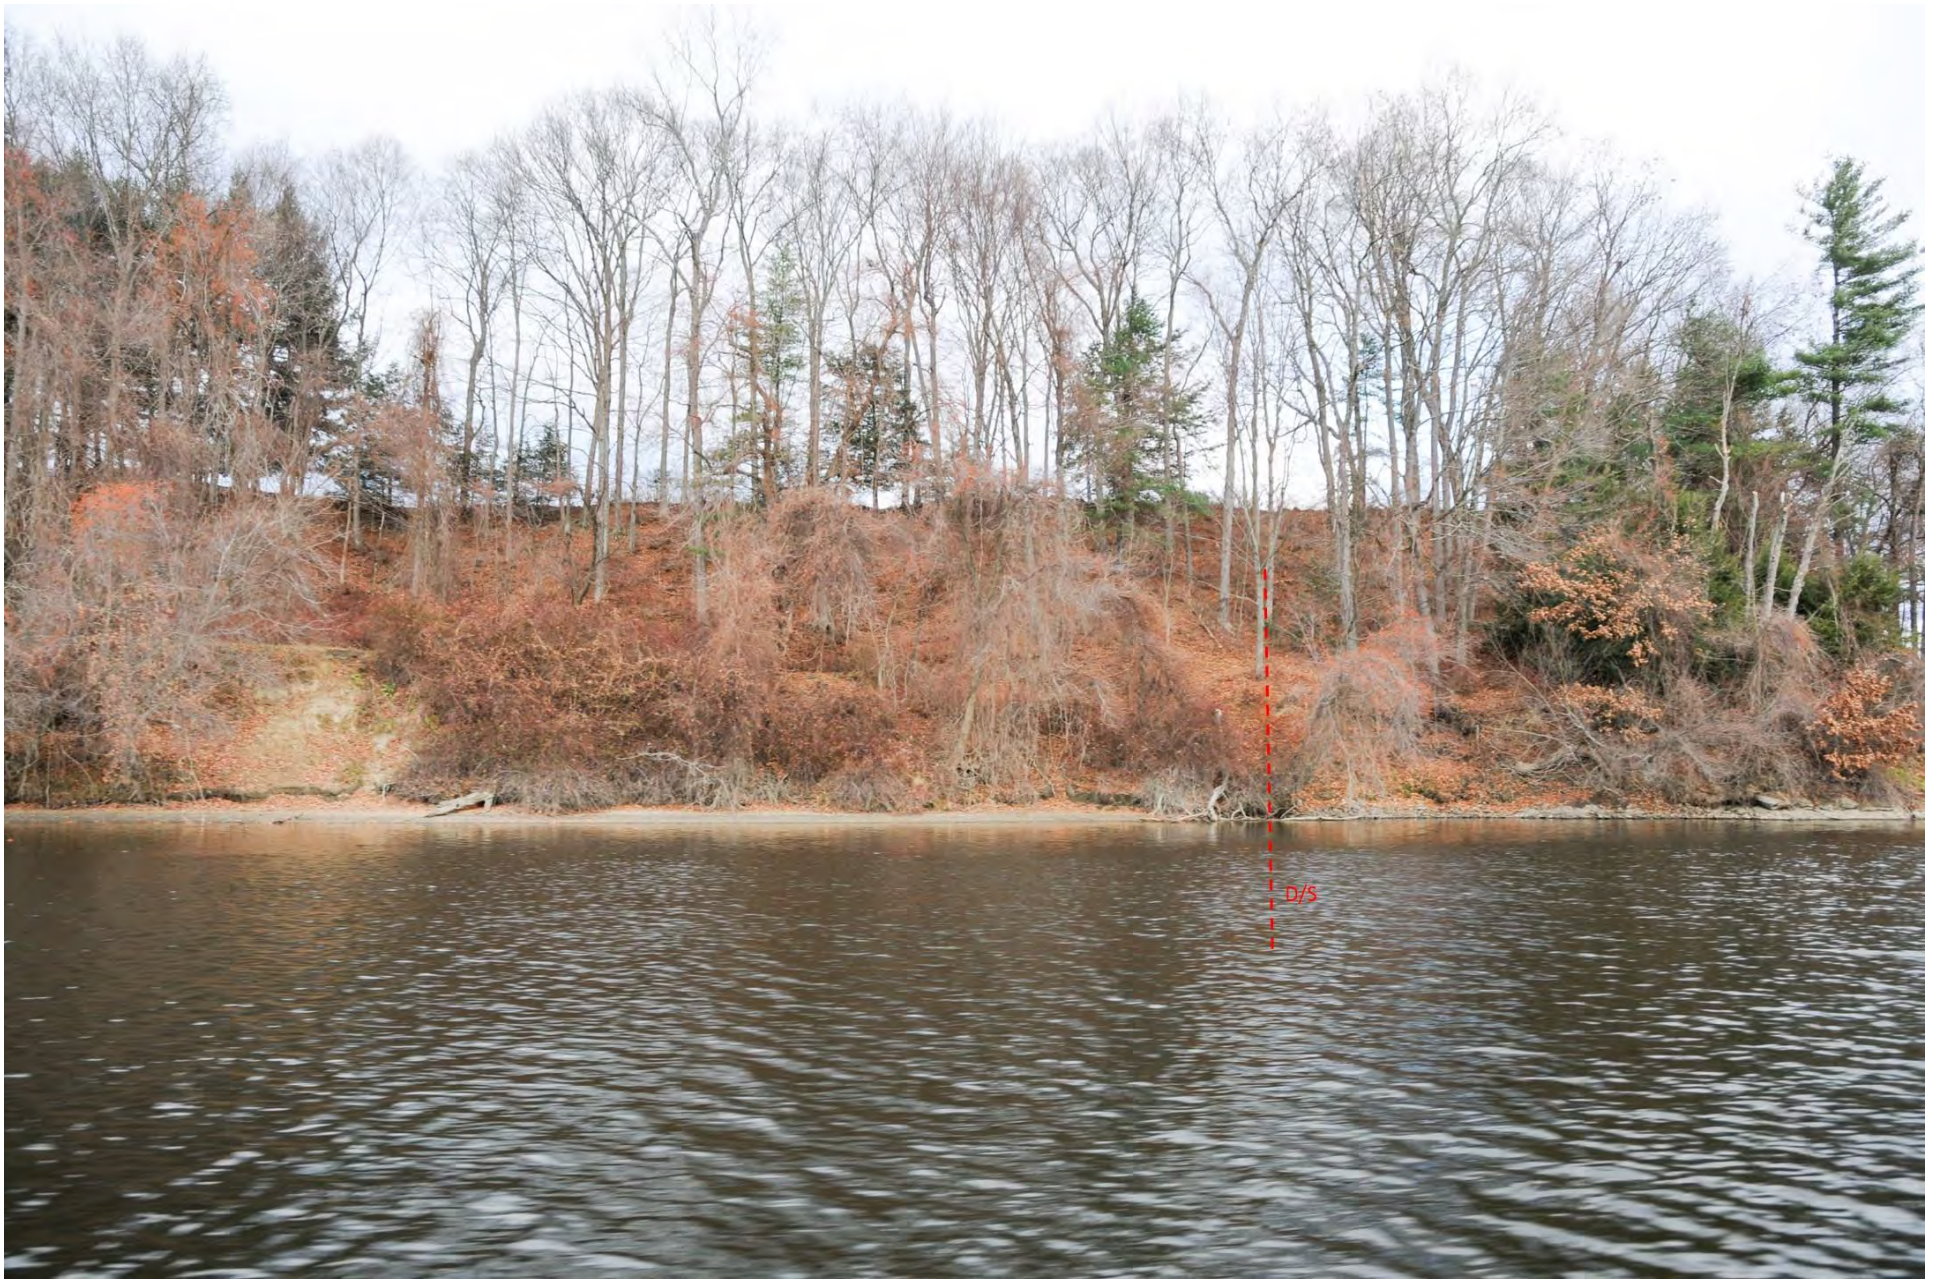
Riverbank Features	Characteristics
Upper Riverbank Slope	Moderate
Upper Riverbank Height	High
Upper Riverbank Sediment	Silt/Sand
Upper Riverbank Vegetation	Heavy
Lower Riverbank Slope	Moderate
Lower Riverbank Sediment	Bedrock
Lower Riverbank Vegetation	None to very sparse
Type of Erosion	
Potential Erosion Indicators	None
Stage of Erosion	Stable
Extent of Erosion	None/Little

**QA Observations:** Upon review of the photos for this segment, classification made in the field was confirmed.

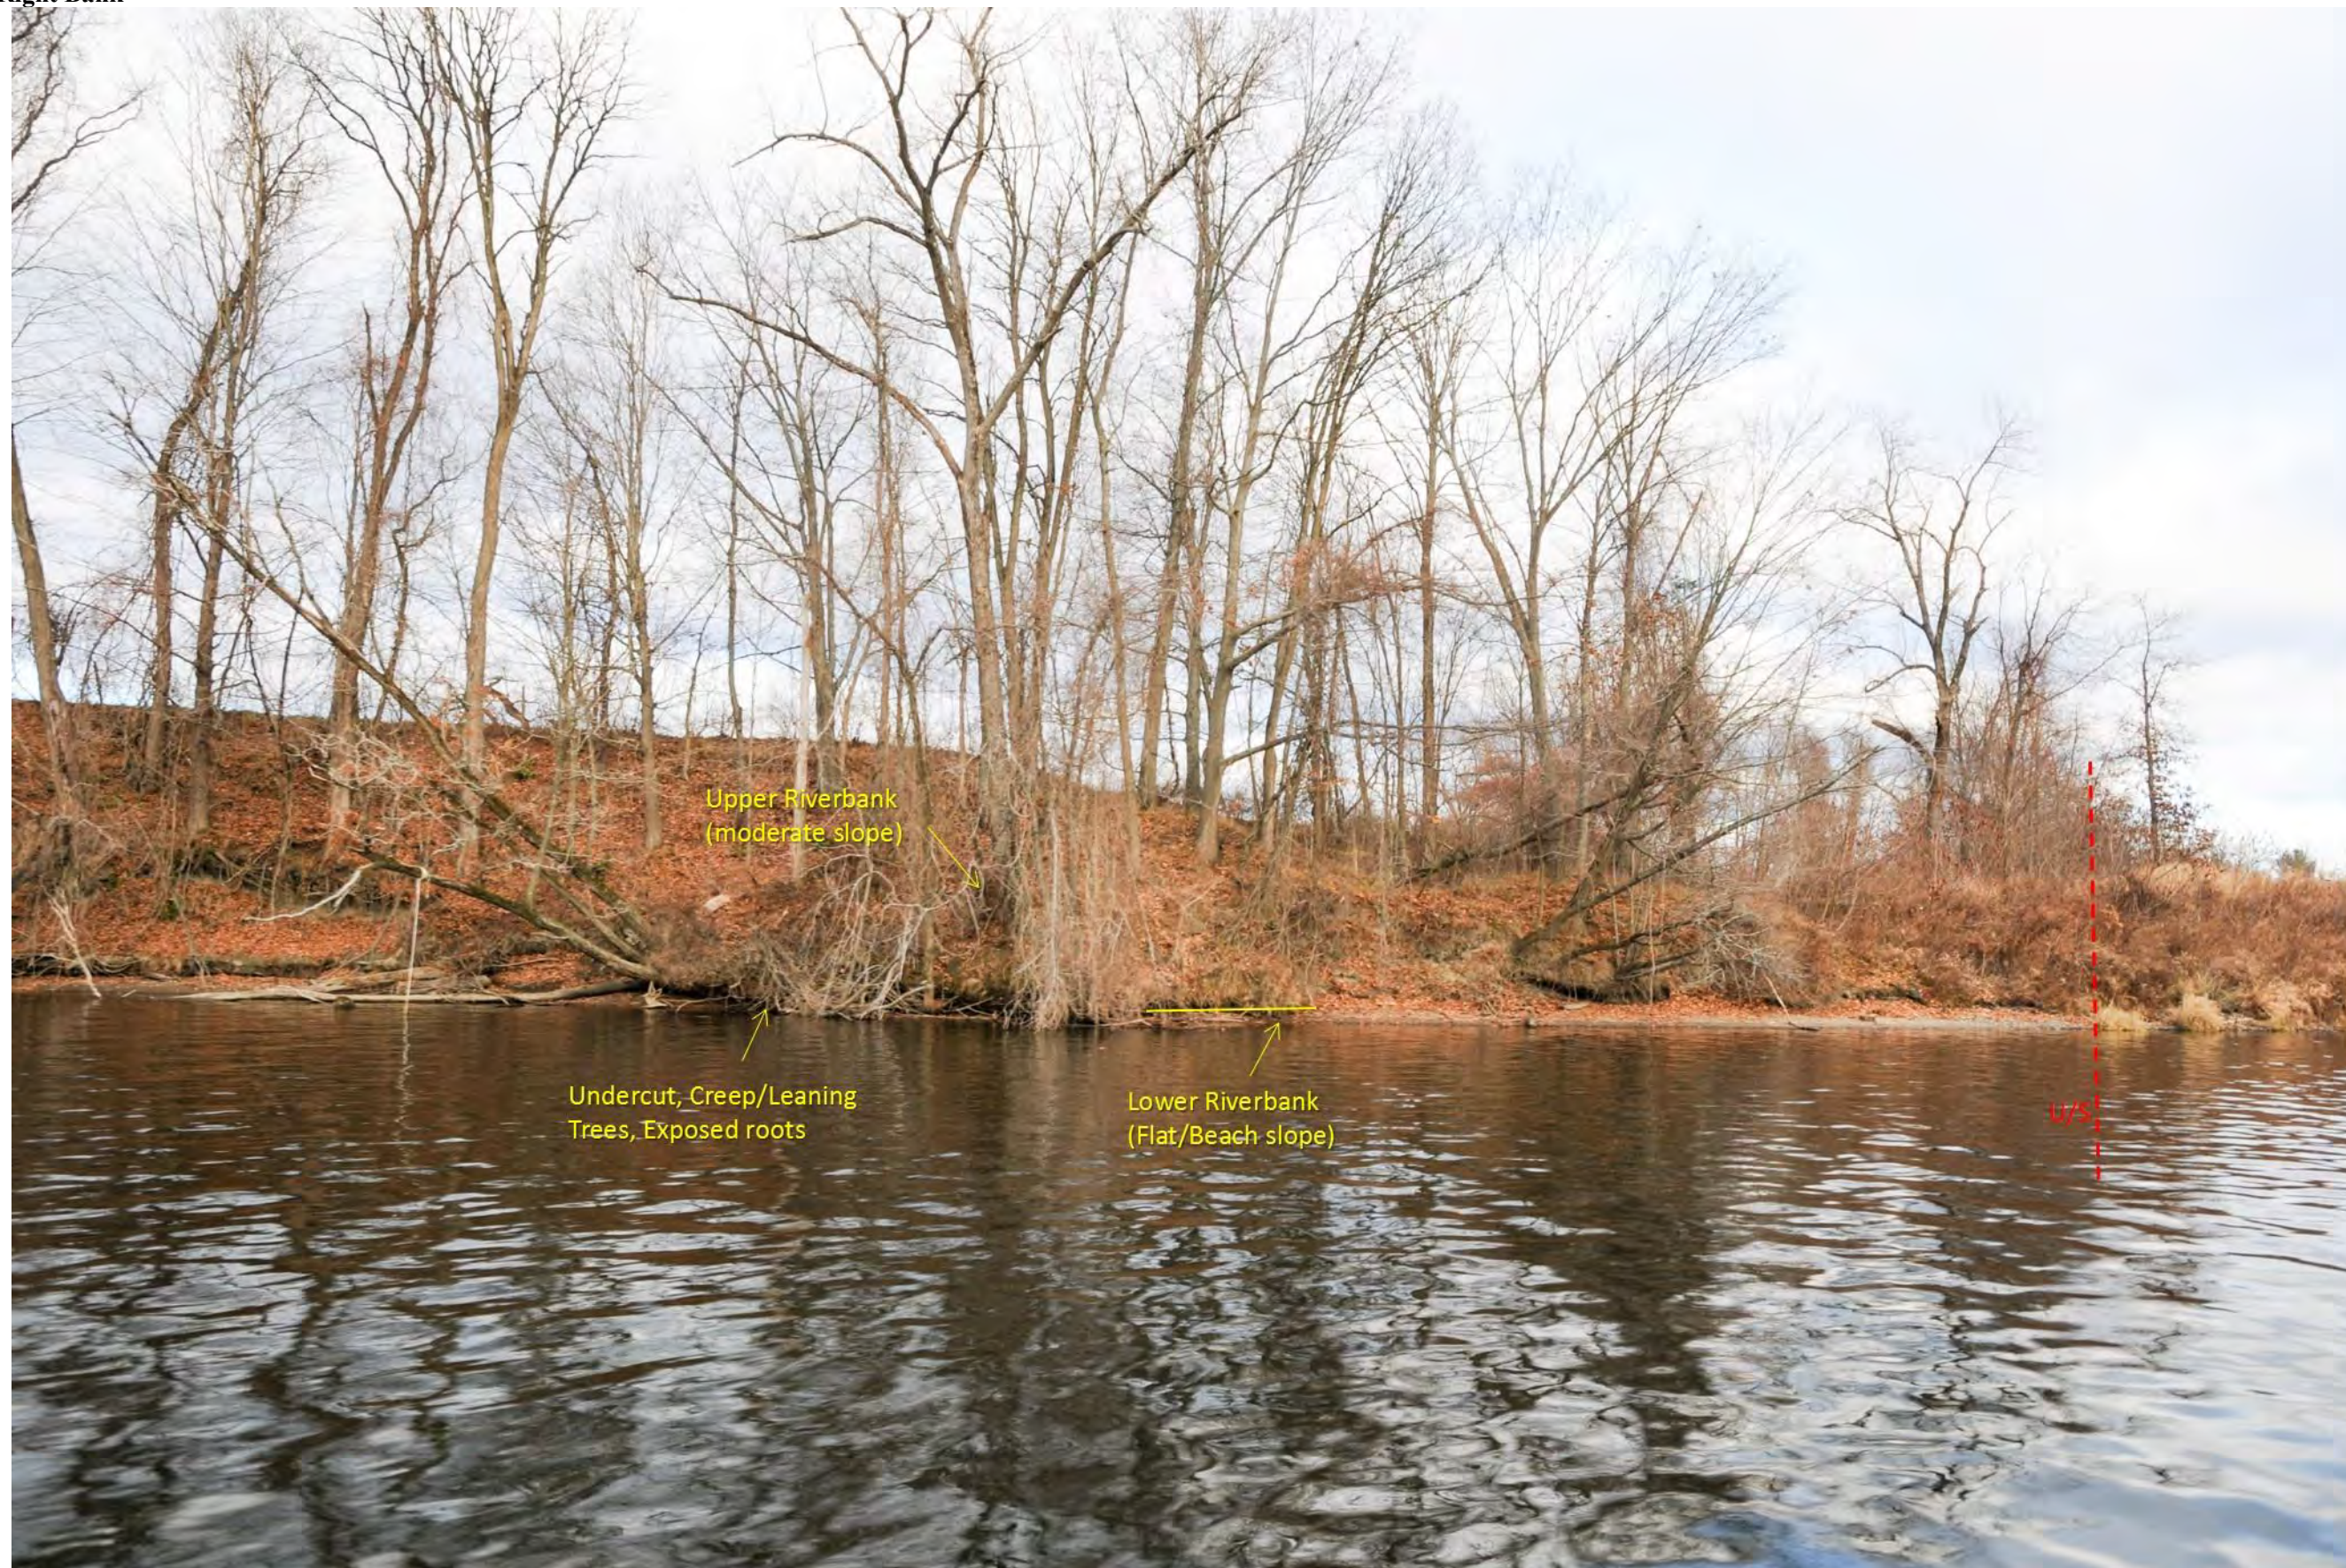
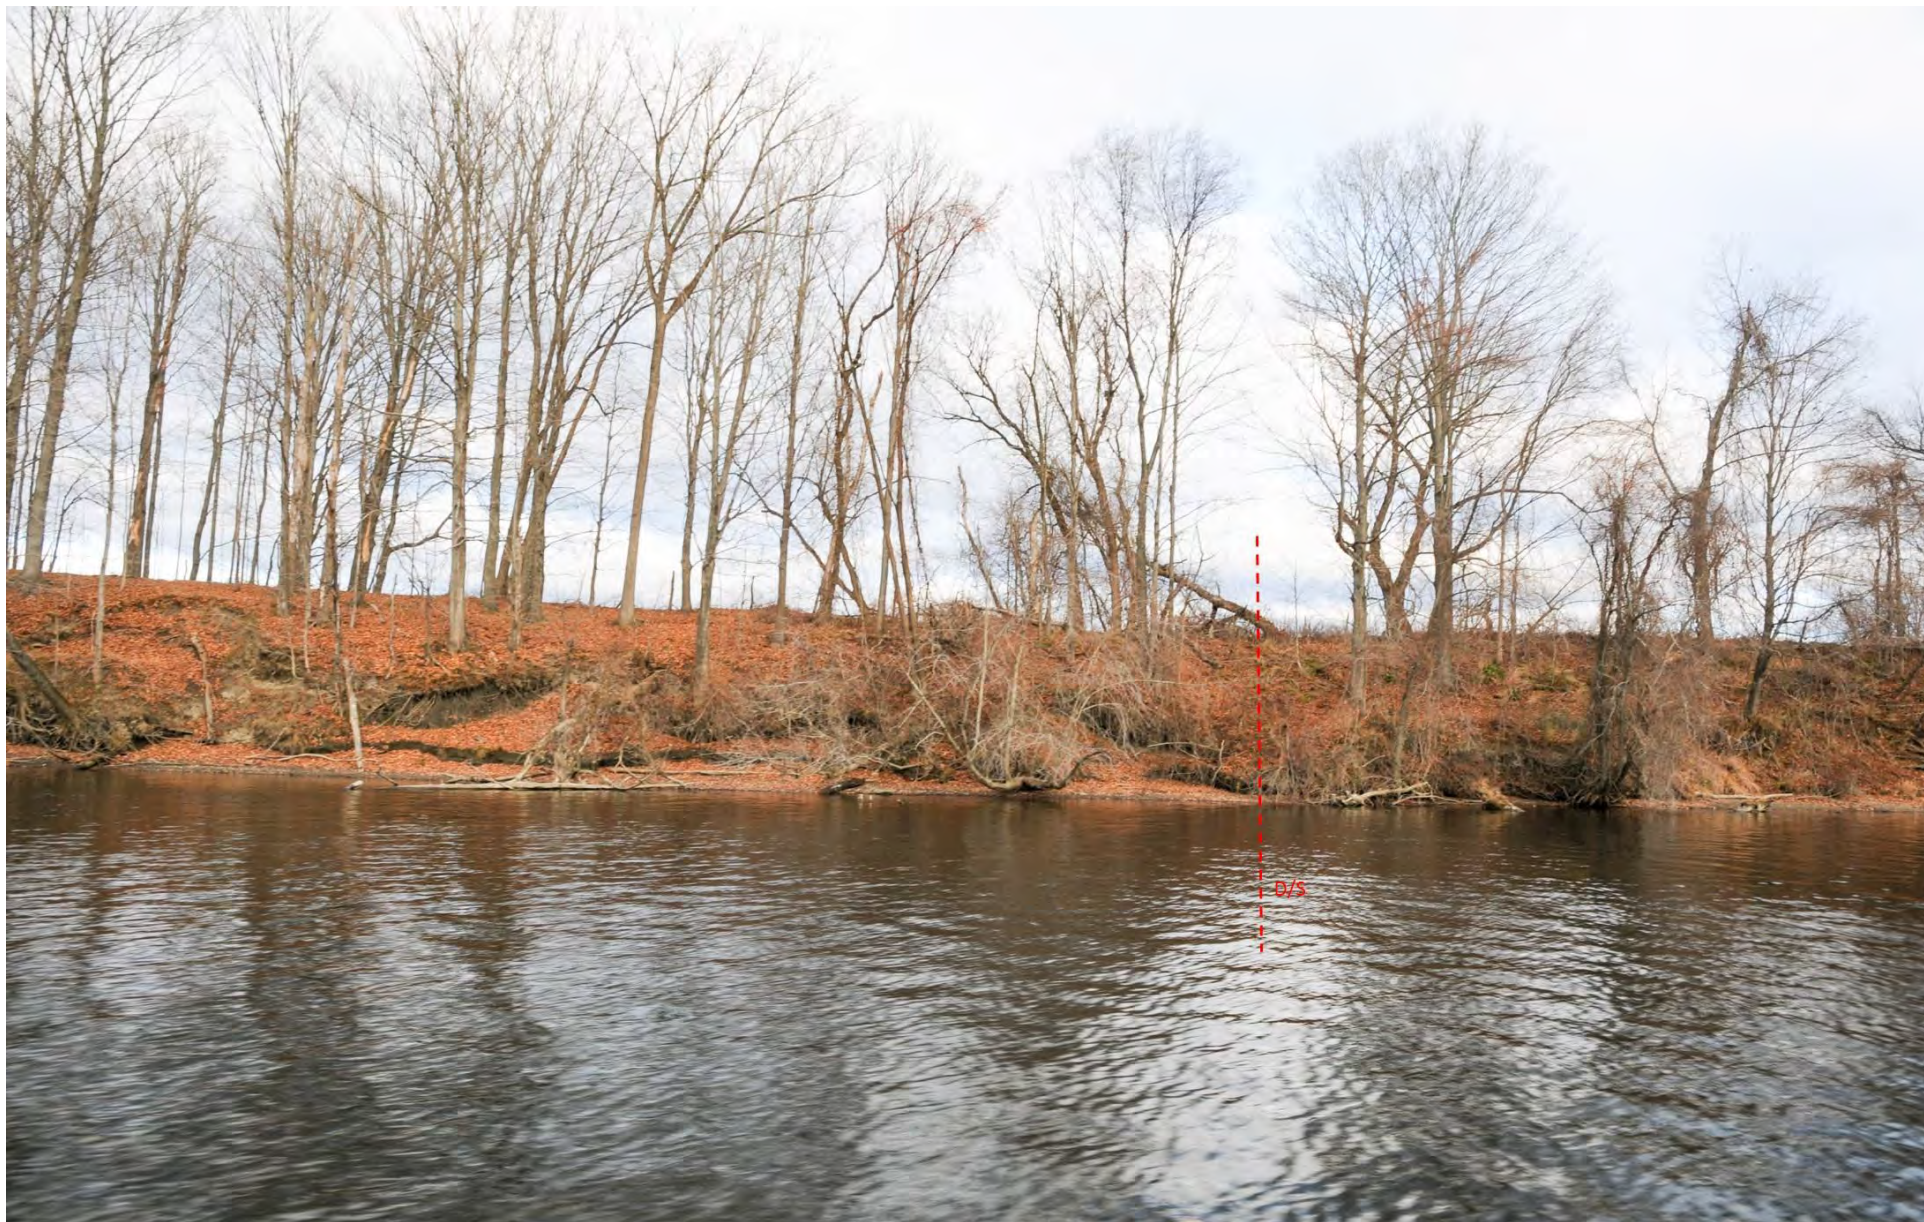
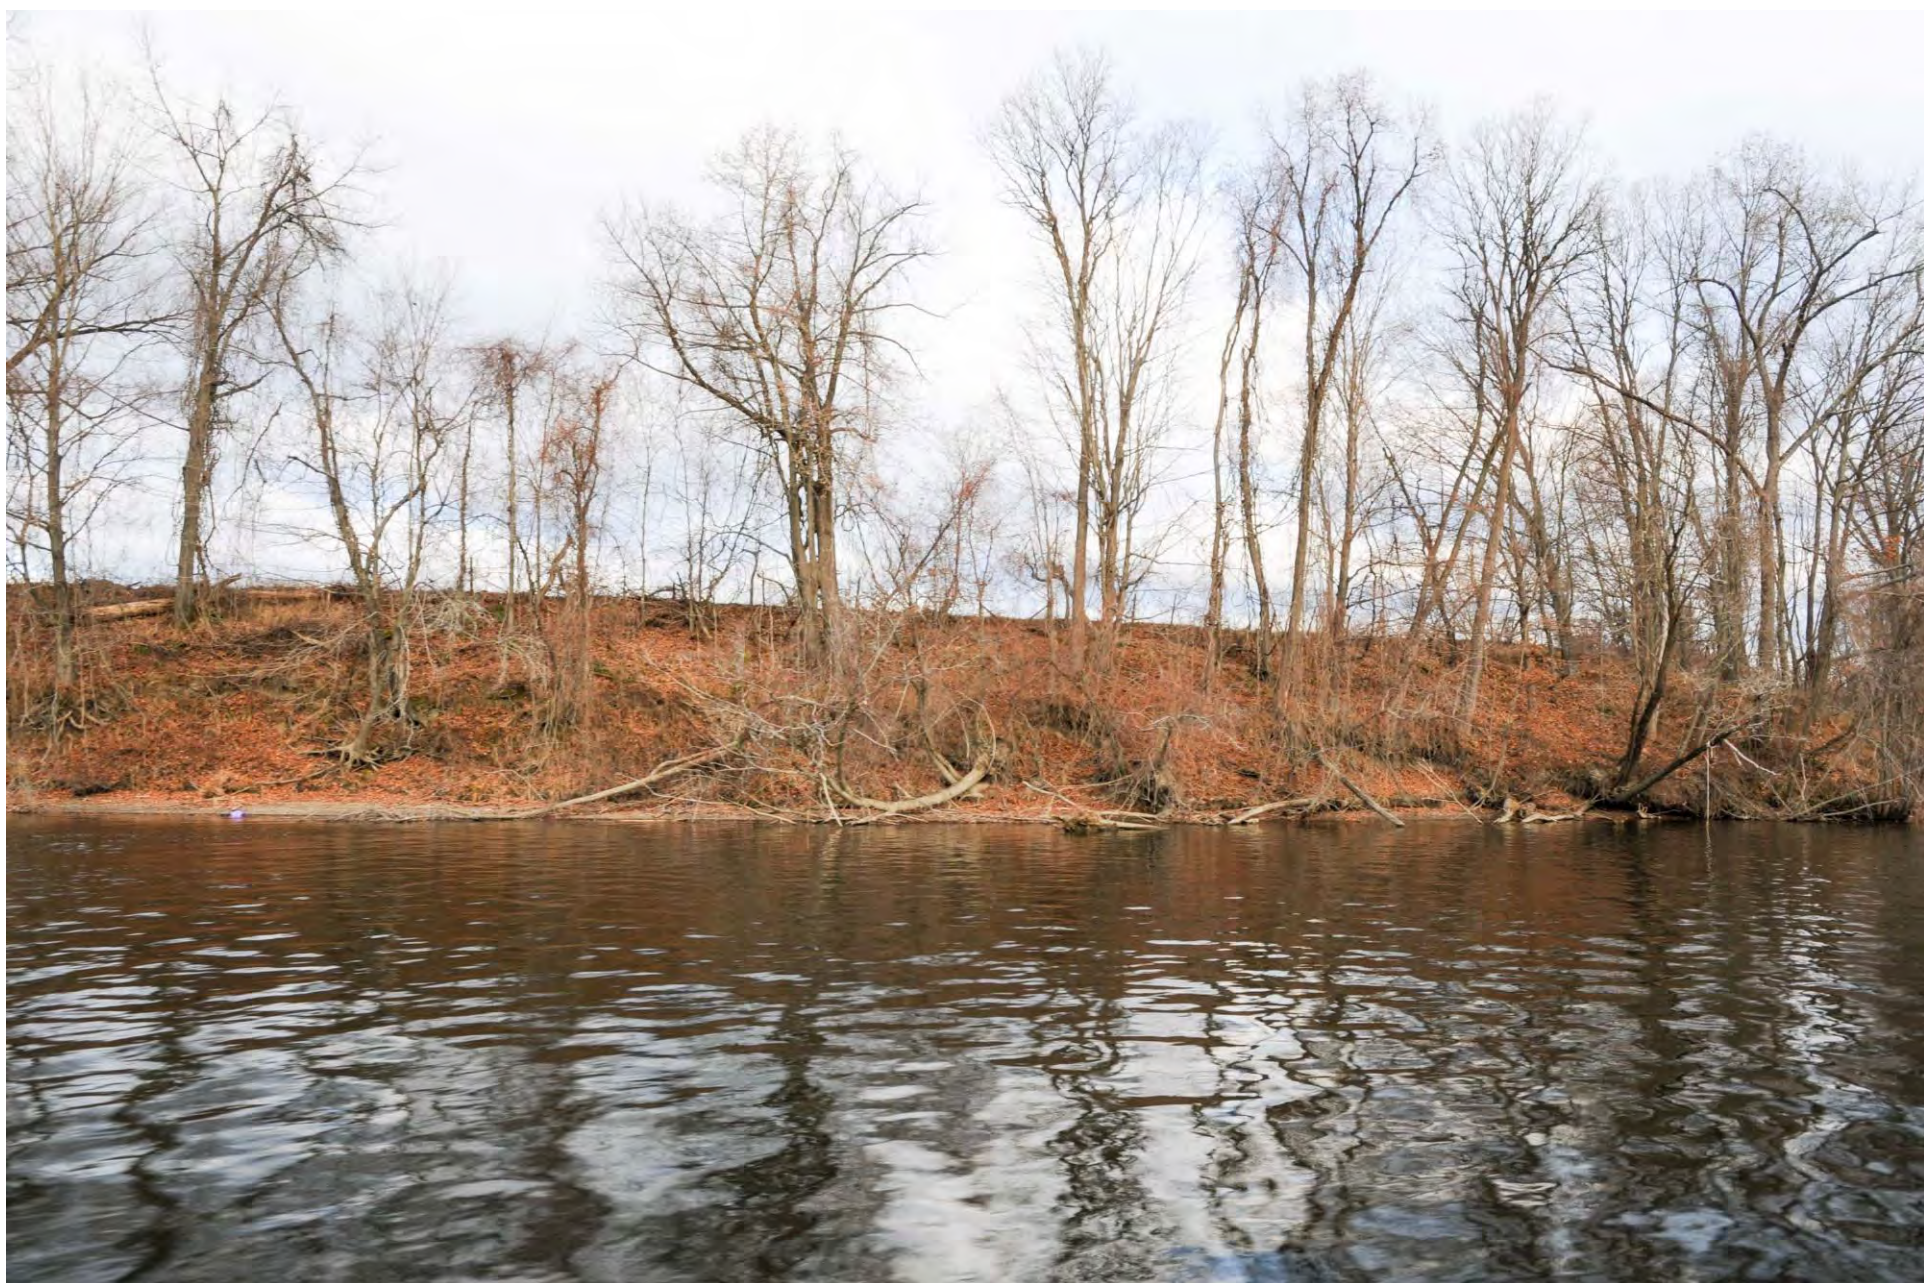
Riverbank Features	Characteristics
Upper Riverbank Slope	Moderate
Upper Riverbank Height	High
Upper Riverbank Sediment	Silt/Sand
Upper Riverbank Vegetation	Heavy
Lower Riverbank Slope	Flat/Beach
Lower Riverbank Sediment	Silt/Sand
Lower Riverbank Vegetation	None to very sparse
Type of Erosion	Undercut
Potential Erosion Indicators	Creep/Leaning trees, Exposed roots
Stage of Erosion	Stable
Extent of Erosion	None/Little

**QA Observations:** Upon review of the photos for this segment, classification made in the field was confirmed and additional indicators of potential future erosion were included.
