**FIRSTLIGHT POWER RESOURCES**  
 RELICENSING STUDY 3.1.1  
 2013 FULL RIVER RECONNAISSANCE  
 TURNERS FALLS IMPOUNDMENT

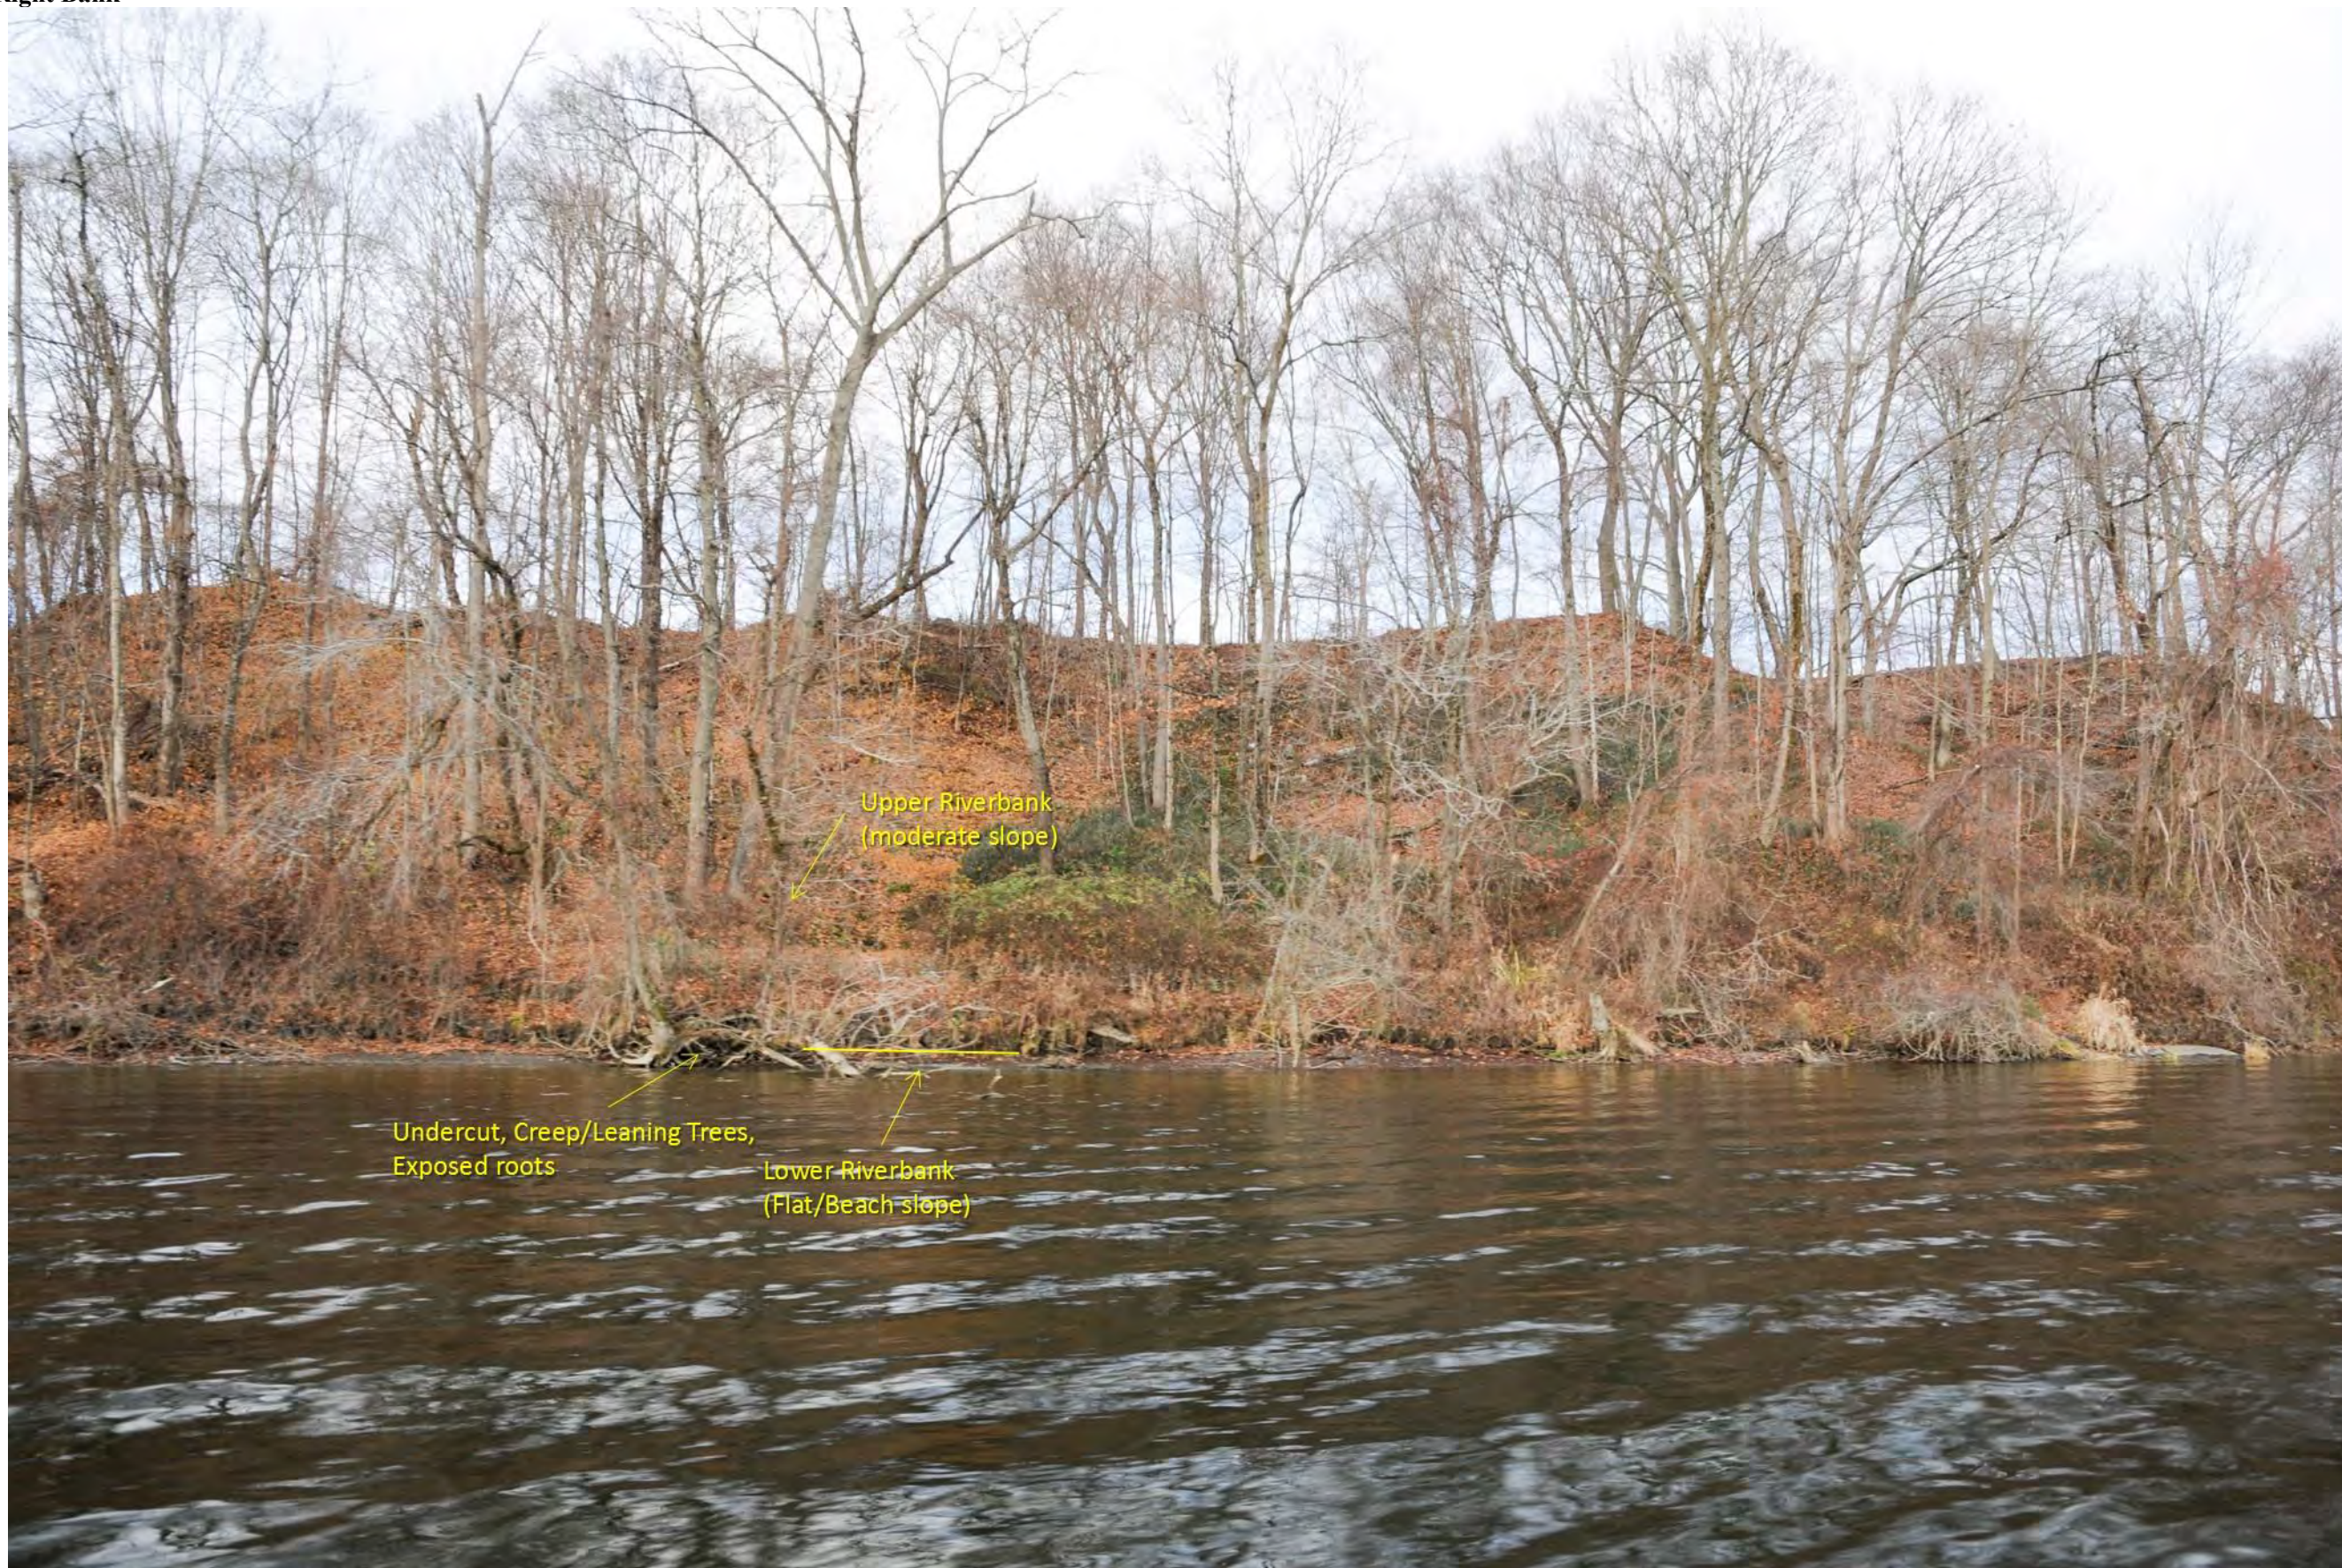
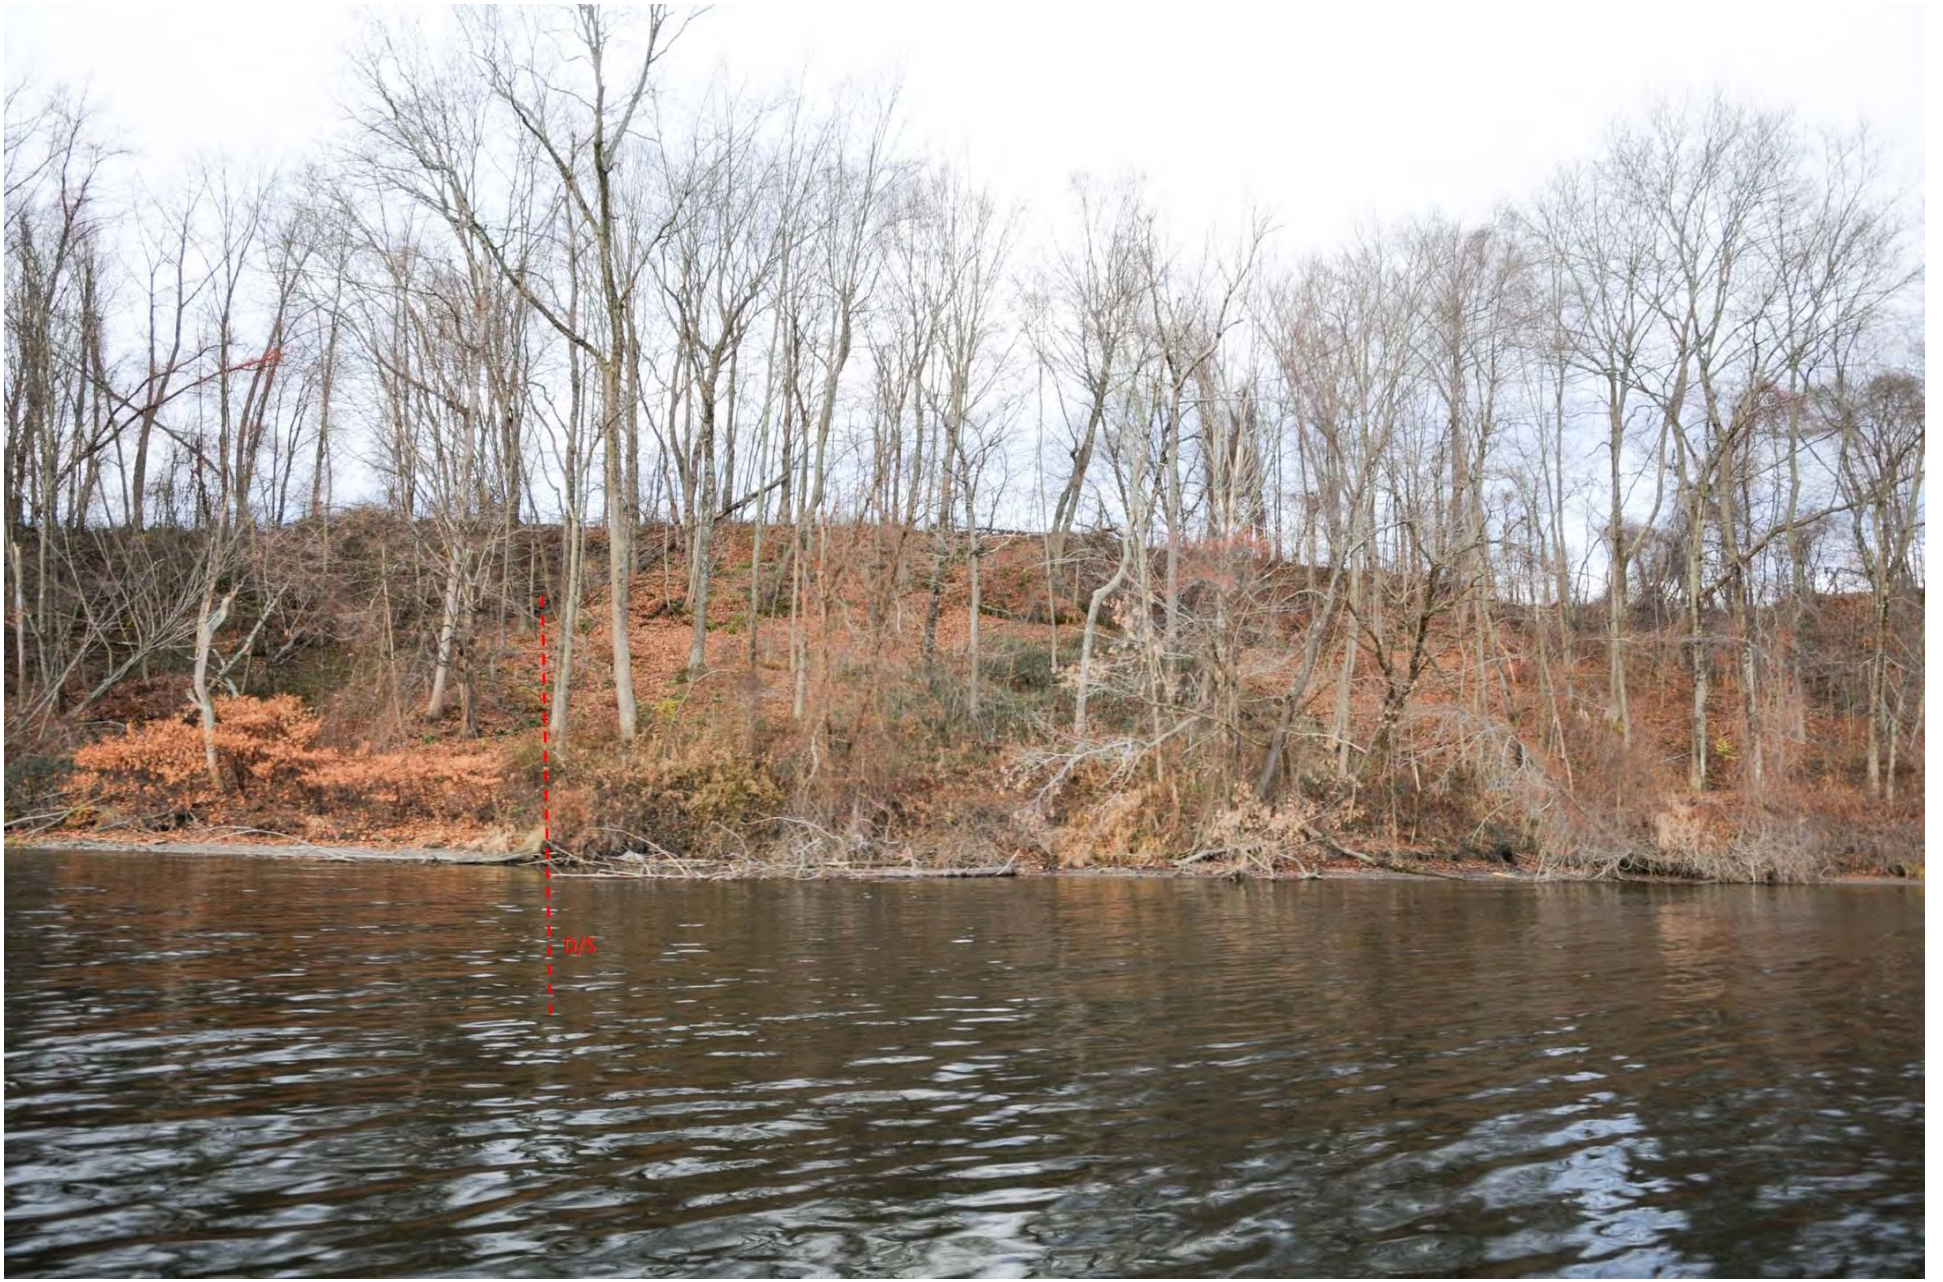
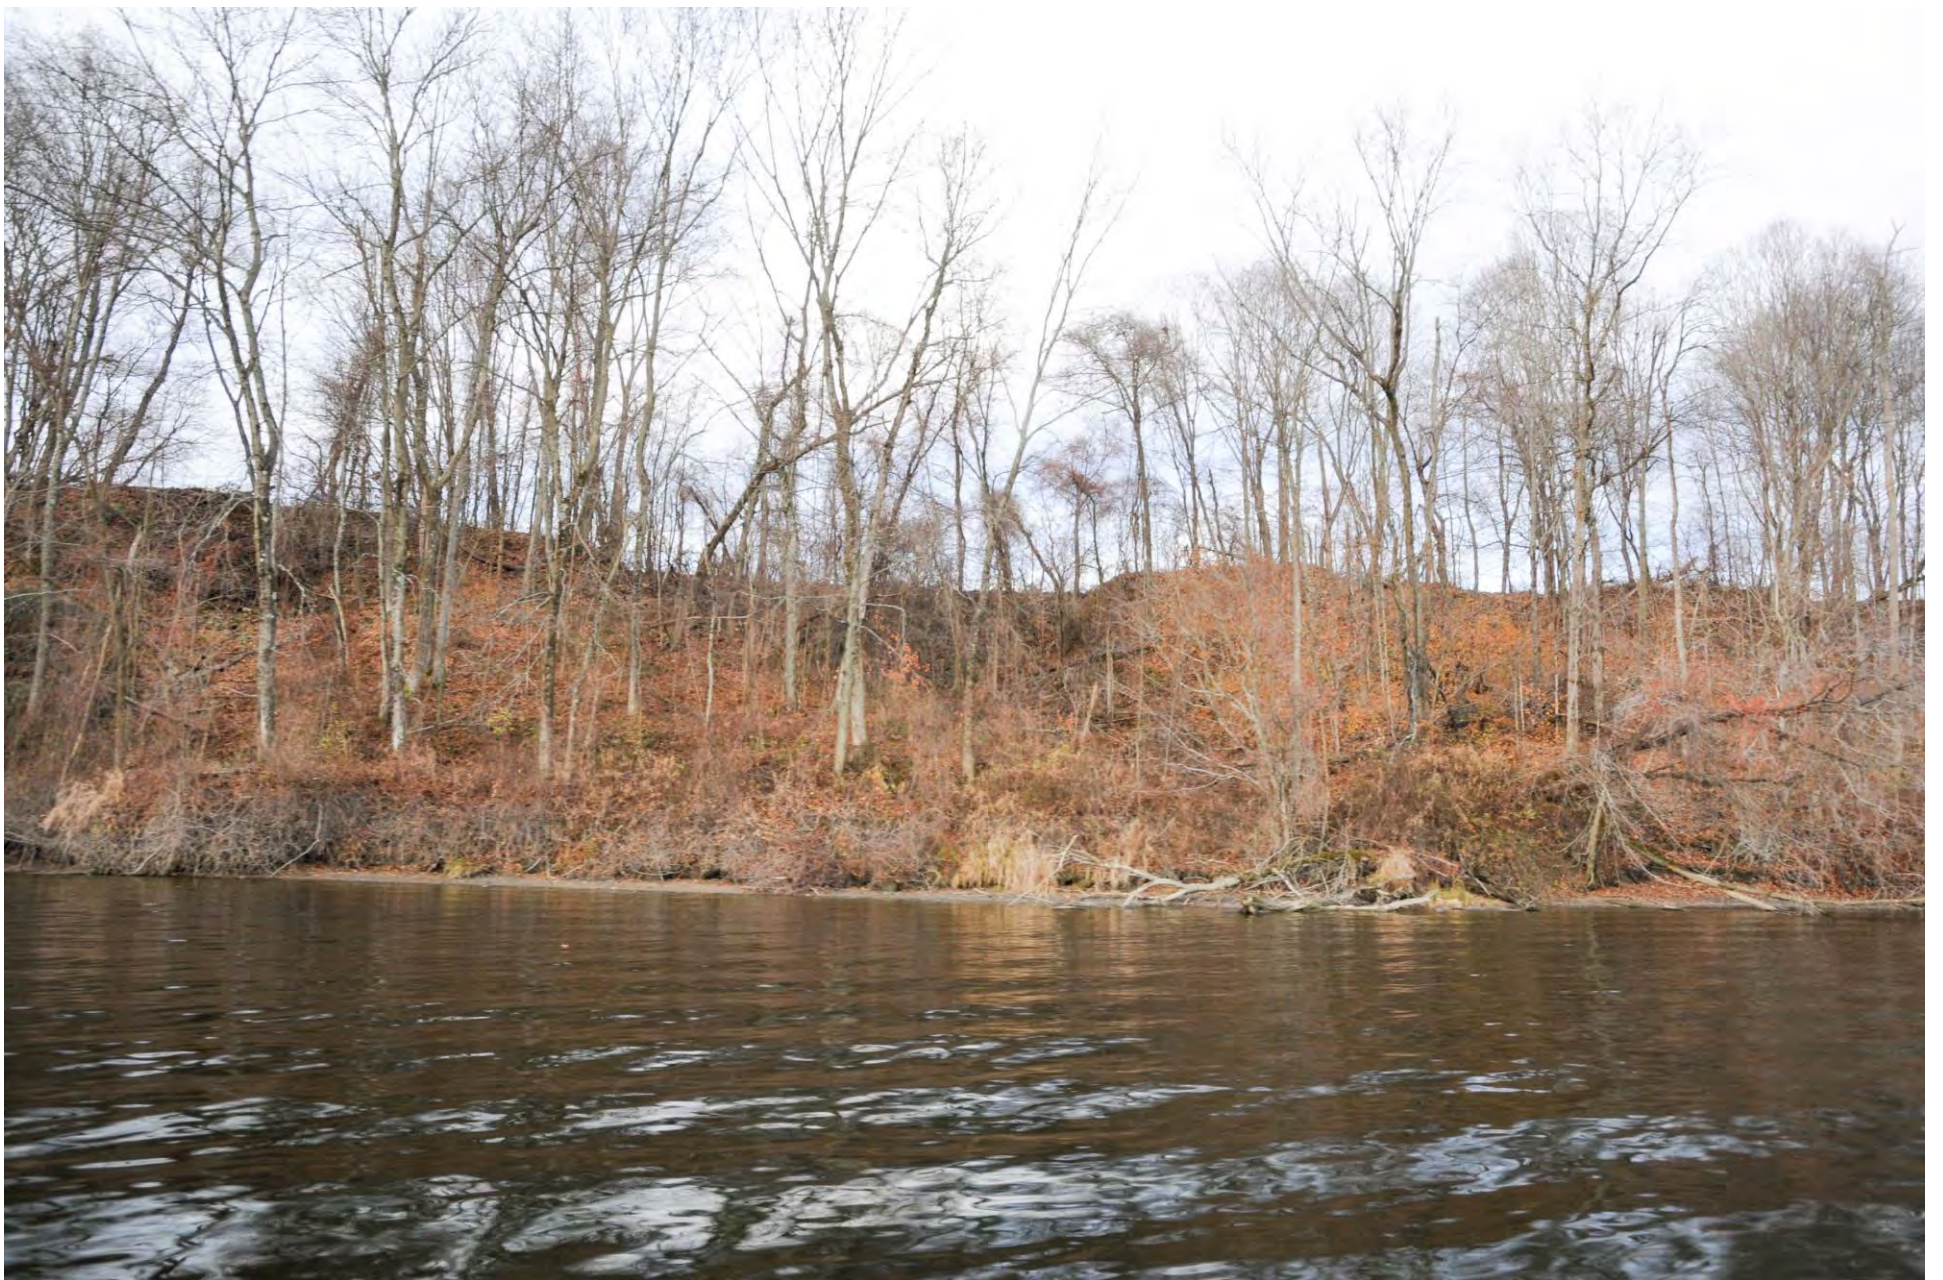
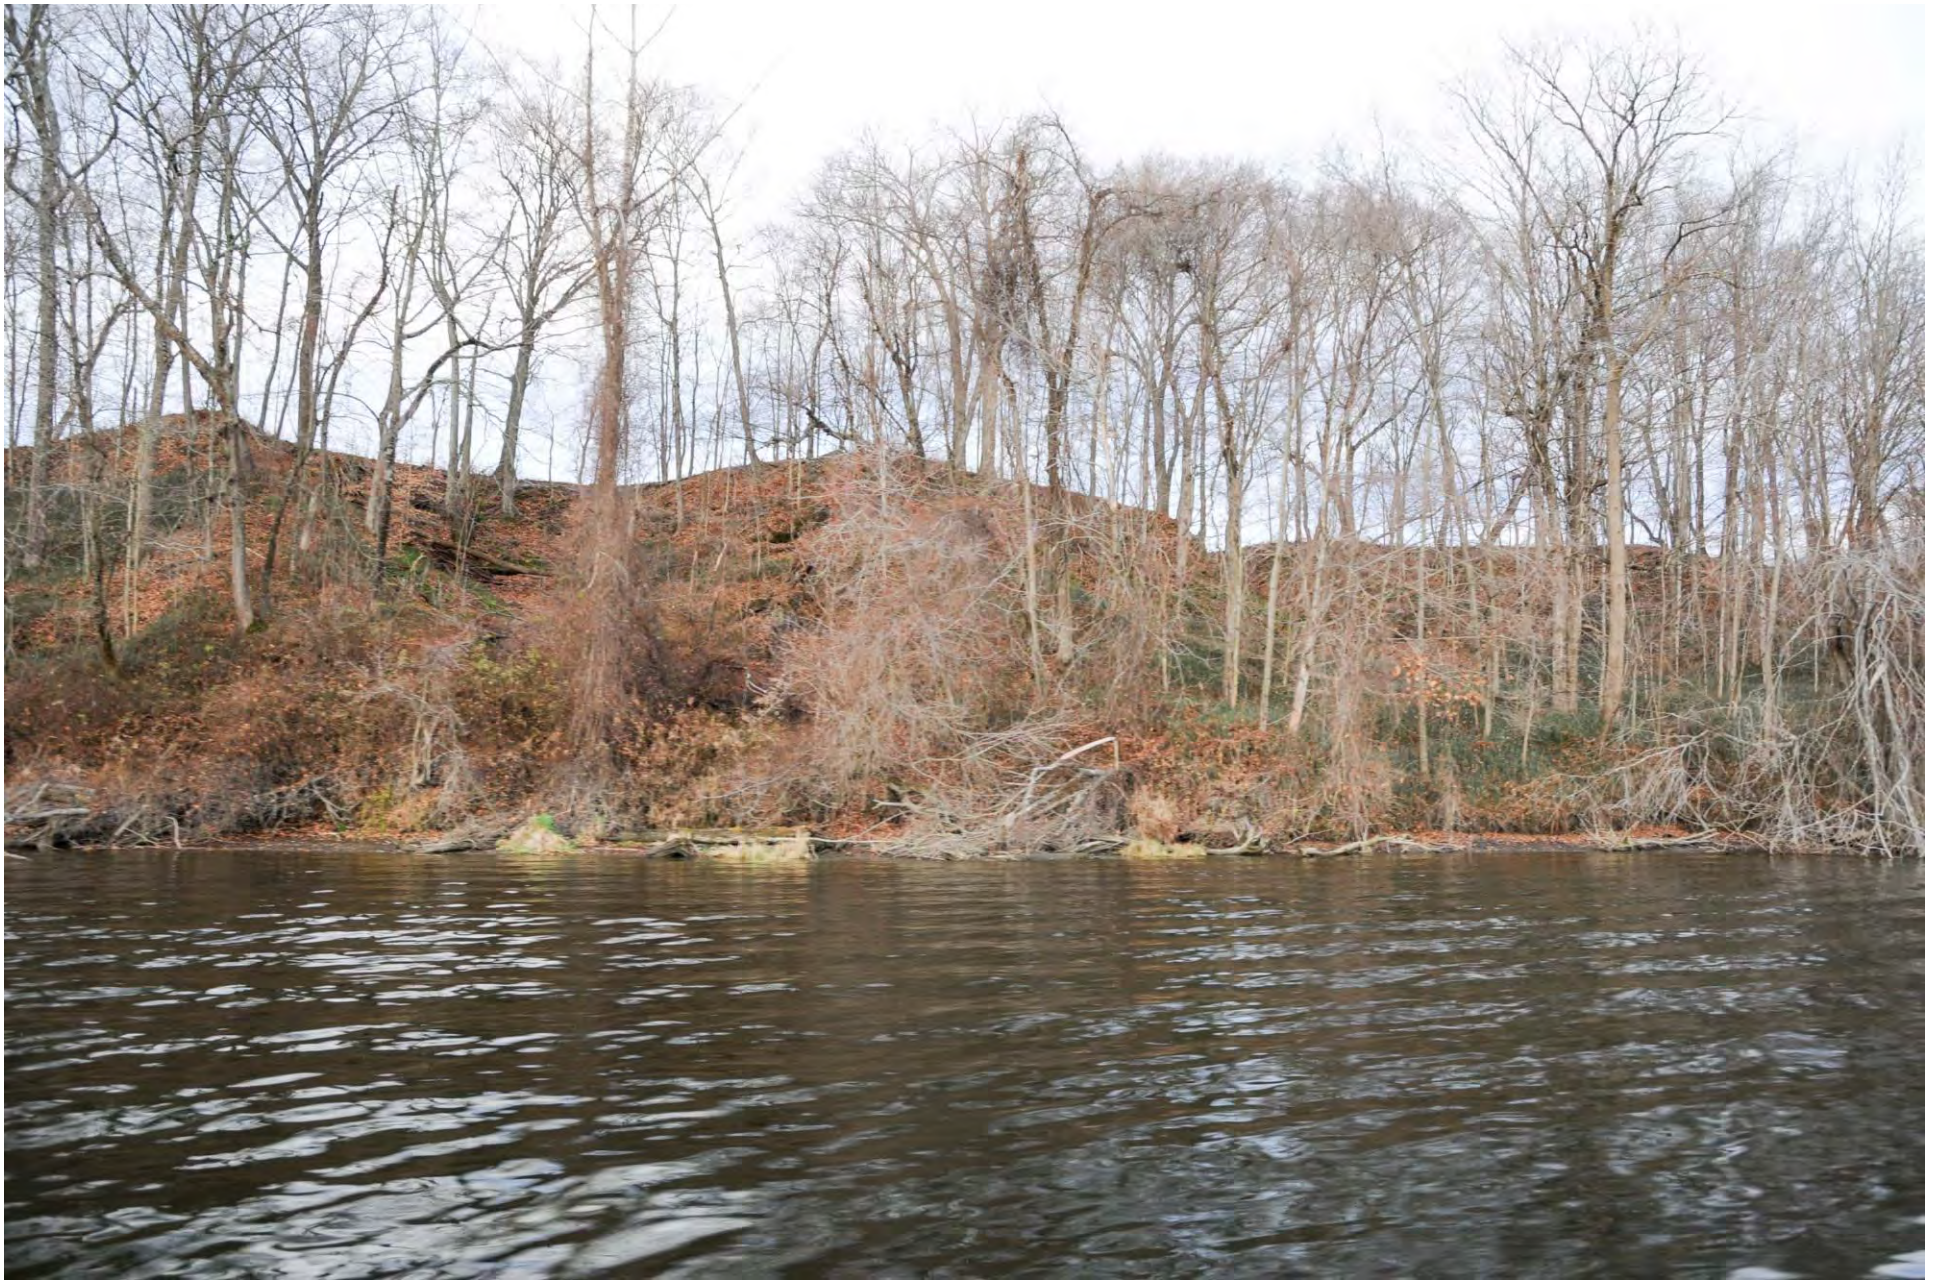
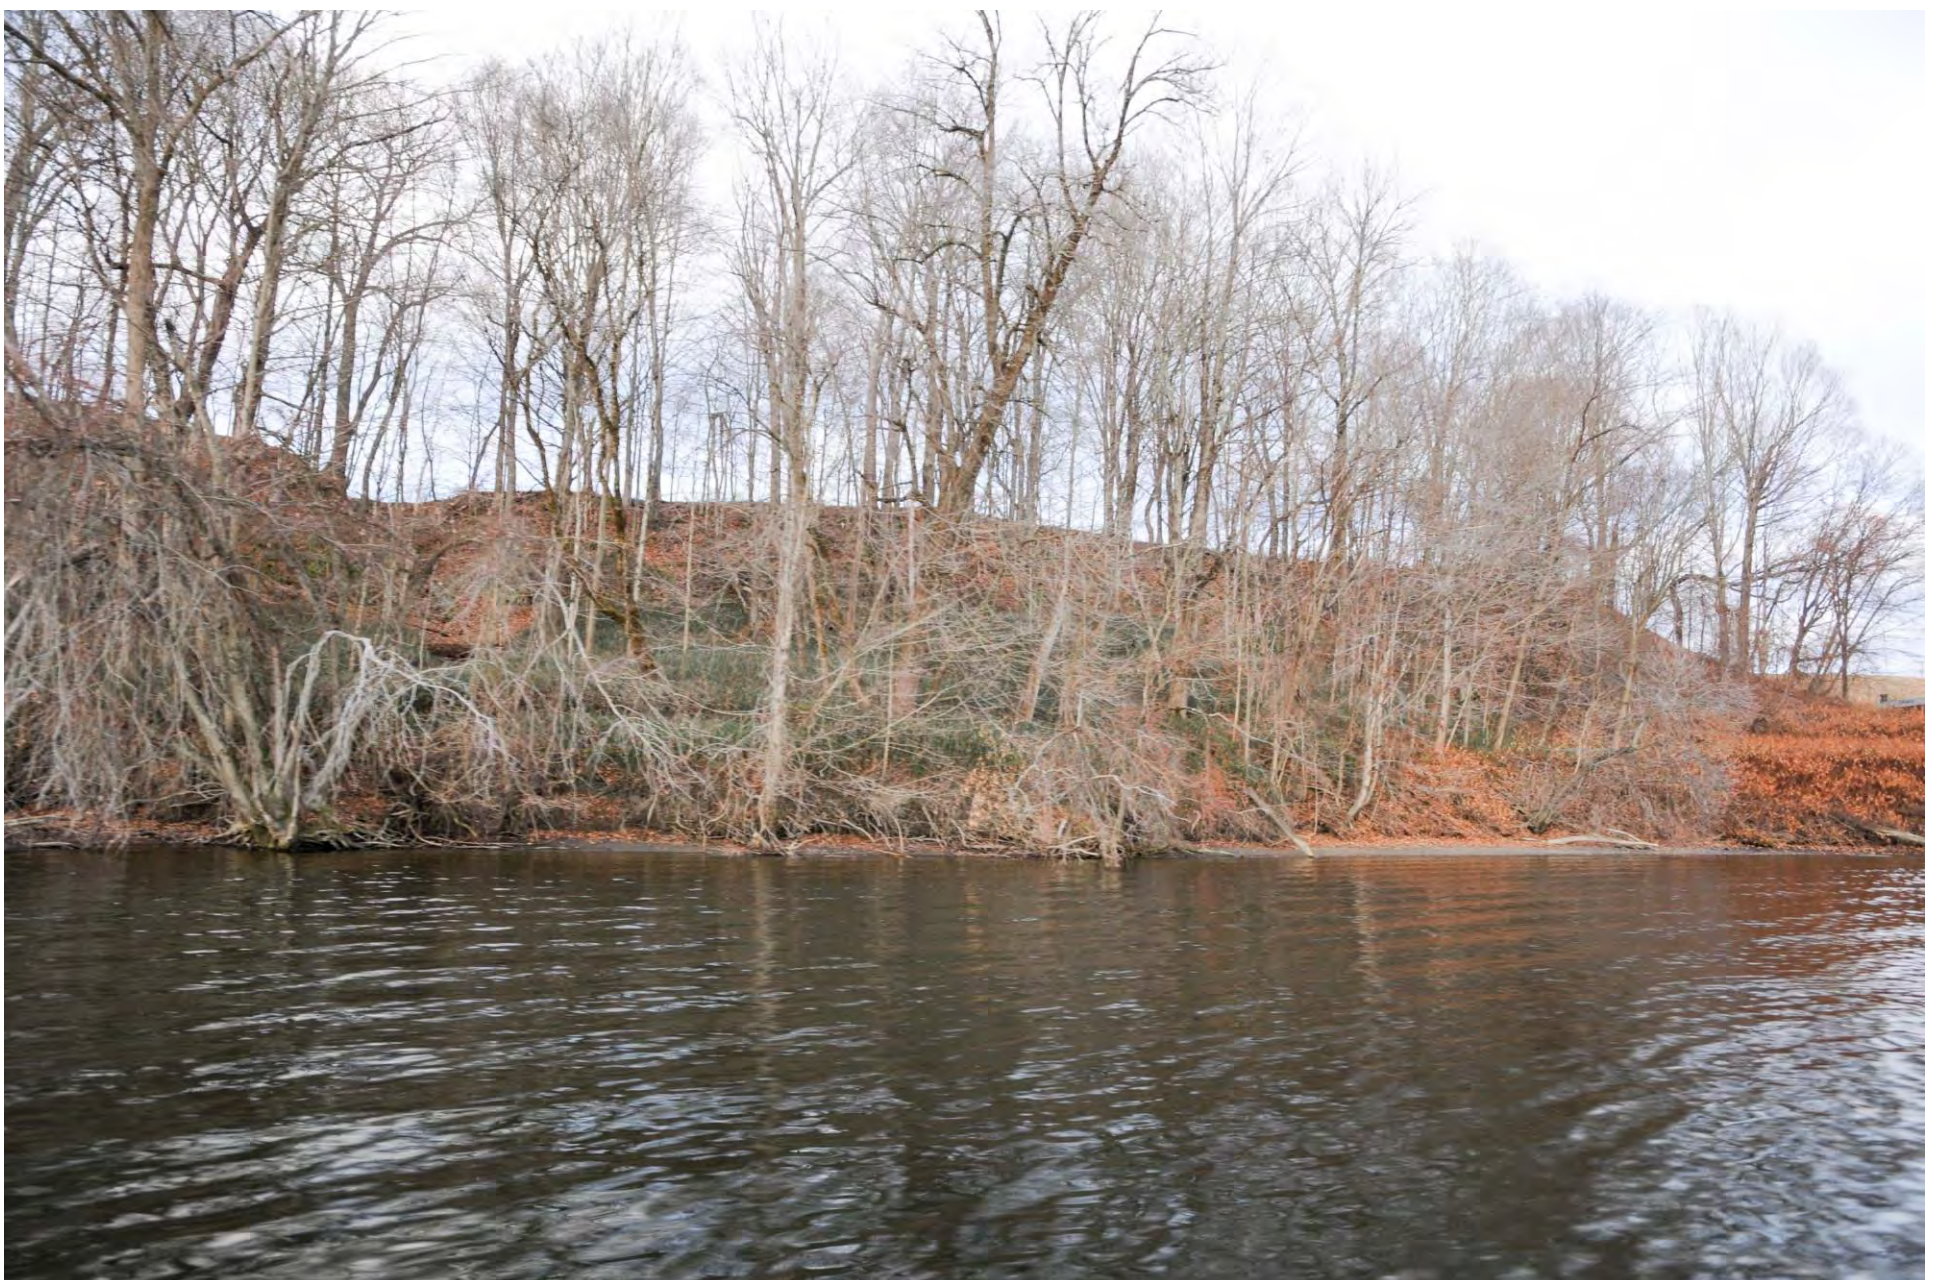
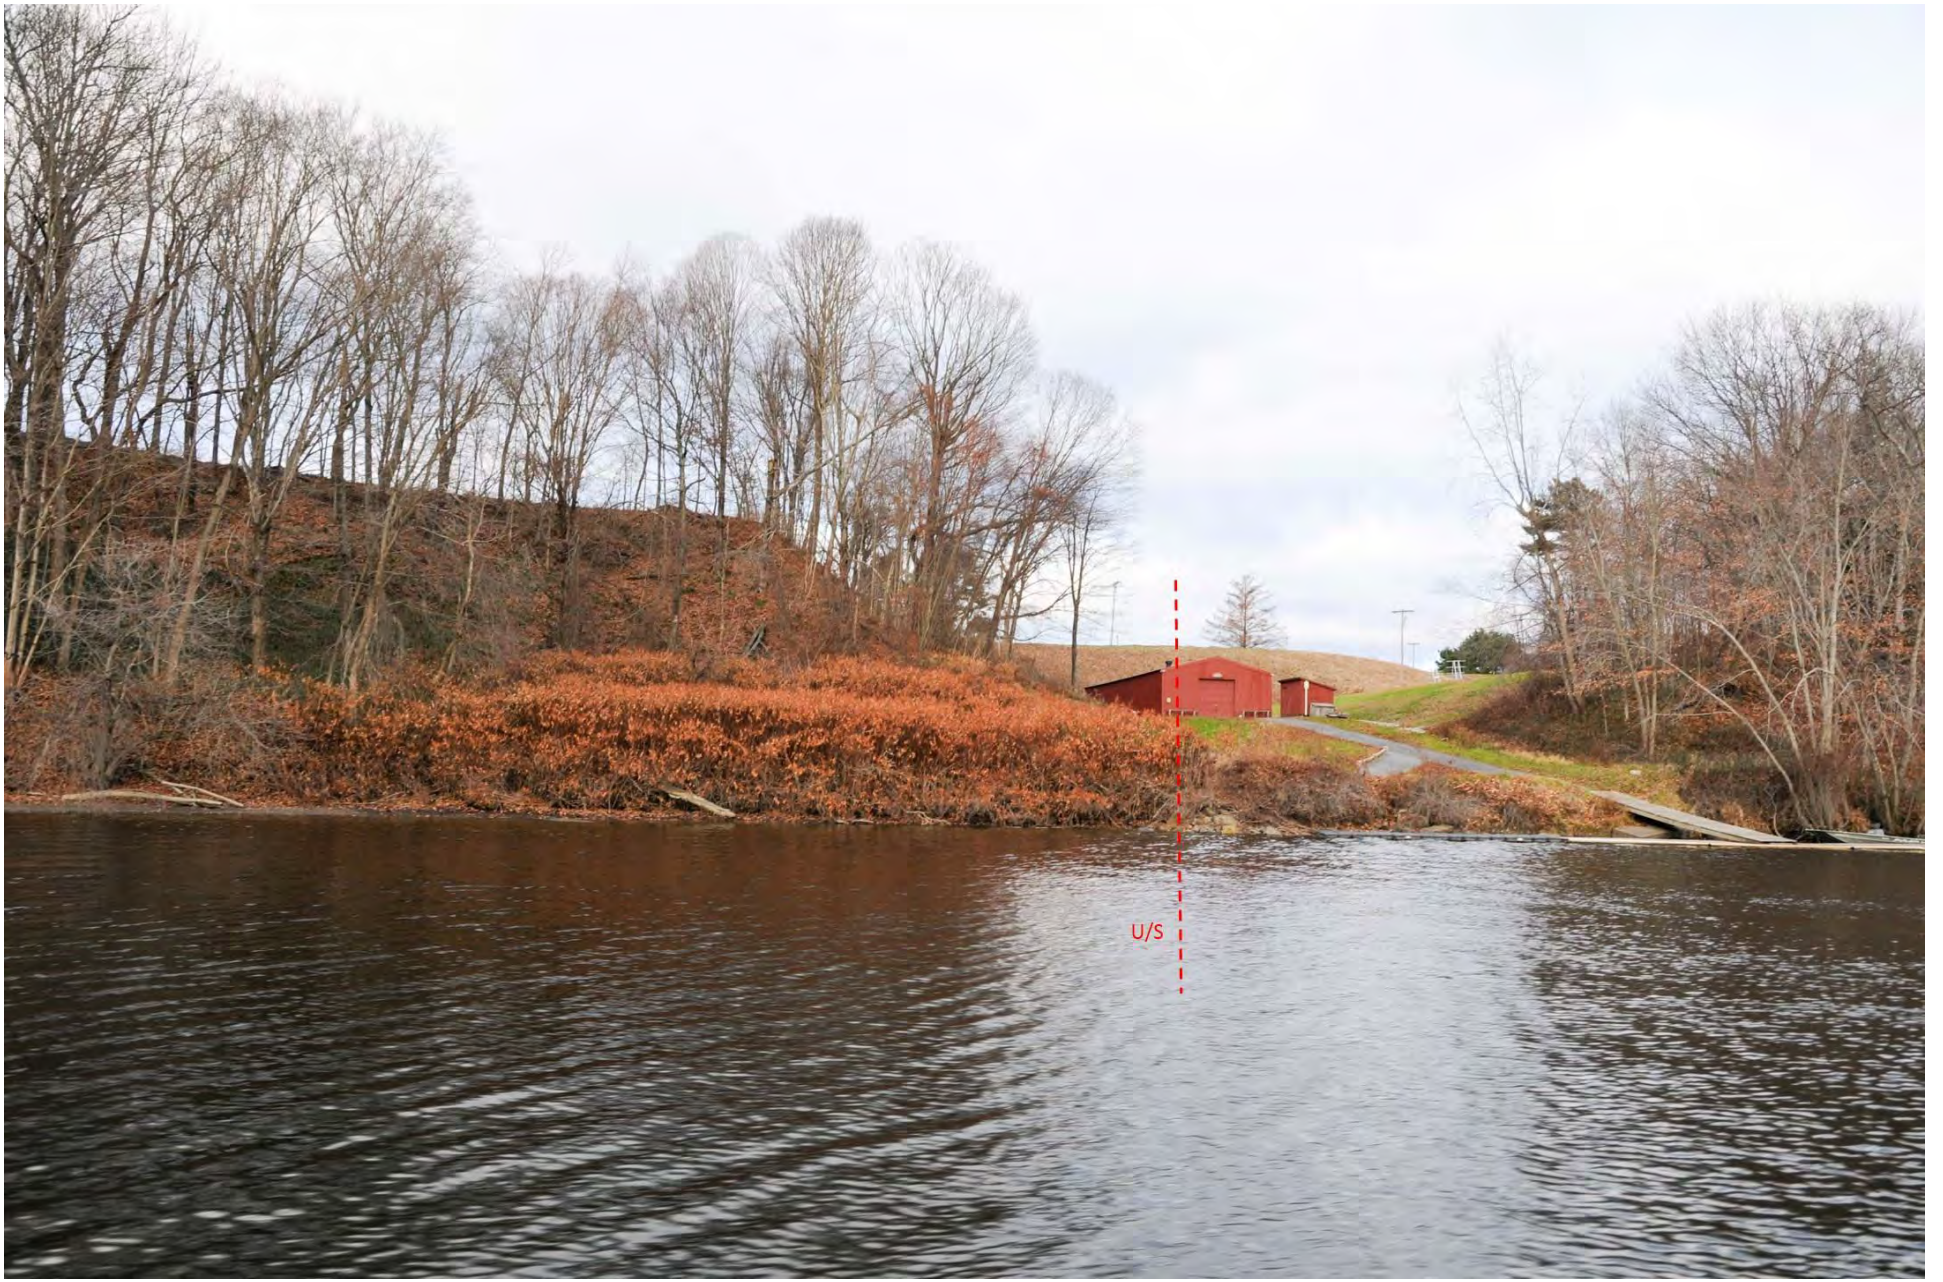
<b>Riverbank Features</b>	<b>Characteristics</b>
<b>Upper Riverbank Slope</b>	Moderate
<b>Upper Riverbank Height</b>	High
<b>Upper Riverbank Sediment</b>	Silt/Sand
<b>Upper Riverbank Vegetation</b>	Heavy
<b>Lower Riverbank Slope</b>	Flat/Beach
<b>Lower Riverbank Sediment</b>	Silt/Sand
<b>Lower Riverbank Vegetation</b>	None to very sparse
<b>Type of Erosion</b>	Undercut
<b>Potential Erosion Indicators</b>	Creep/Leaning trees, Exposed roots
<b>Stage of Erosion</b>	Stable
<b>Extent of Erosion</b>	None/Little

**QA Observations:** Upon review of the photos for this segment, classification made in the field was confirmed and additional indicators of potential future erosion were included.

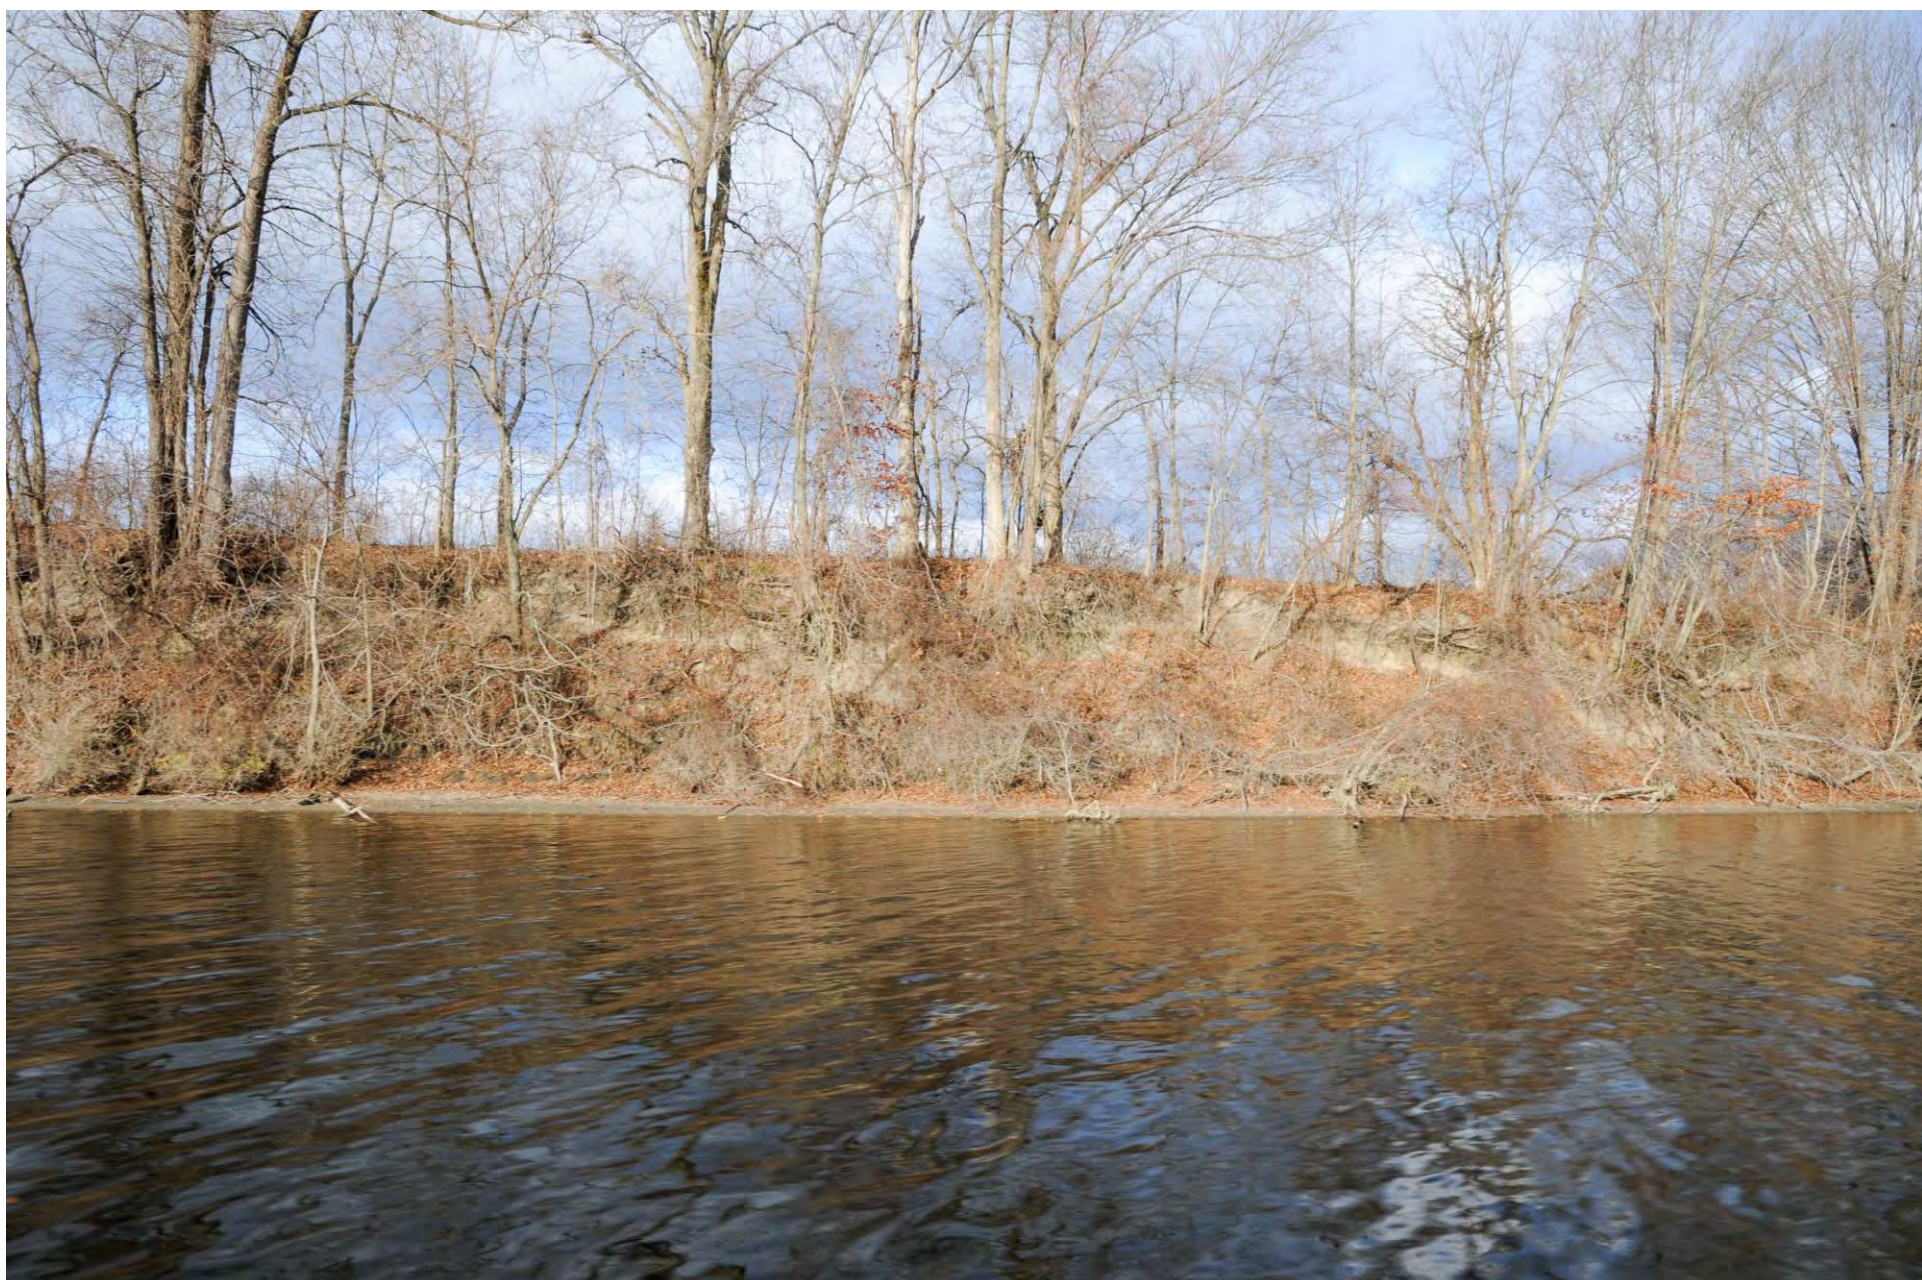
Photo ID 1091 (middle)

Riverbank Features	Characteristics
Upper Riverbank Slope	Overhanging
Upper Riverbank Height	High
Upper Riverbank Sediment	Silt/Sand
Upper Riverbank Vegetation	Heavy
Lower Riverbank Slope	Flat/Beach
Lower Riverbank Sediment	Silt/Sand
Lower Riverbank Vegetation	None to very sparse
Type of Erosion	Slide
Potential Erosion Indicators	Overhanging bank, Exposed roots, Creep/leaning trees
Stage of Erosion	Eroded
Extent of Erosion	Some

**QA Observations:** Upon review of the photos for this segment, classification made in the field was confirmed and additional indicators of potential future erosion were included.

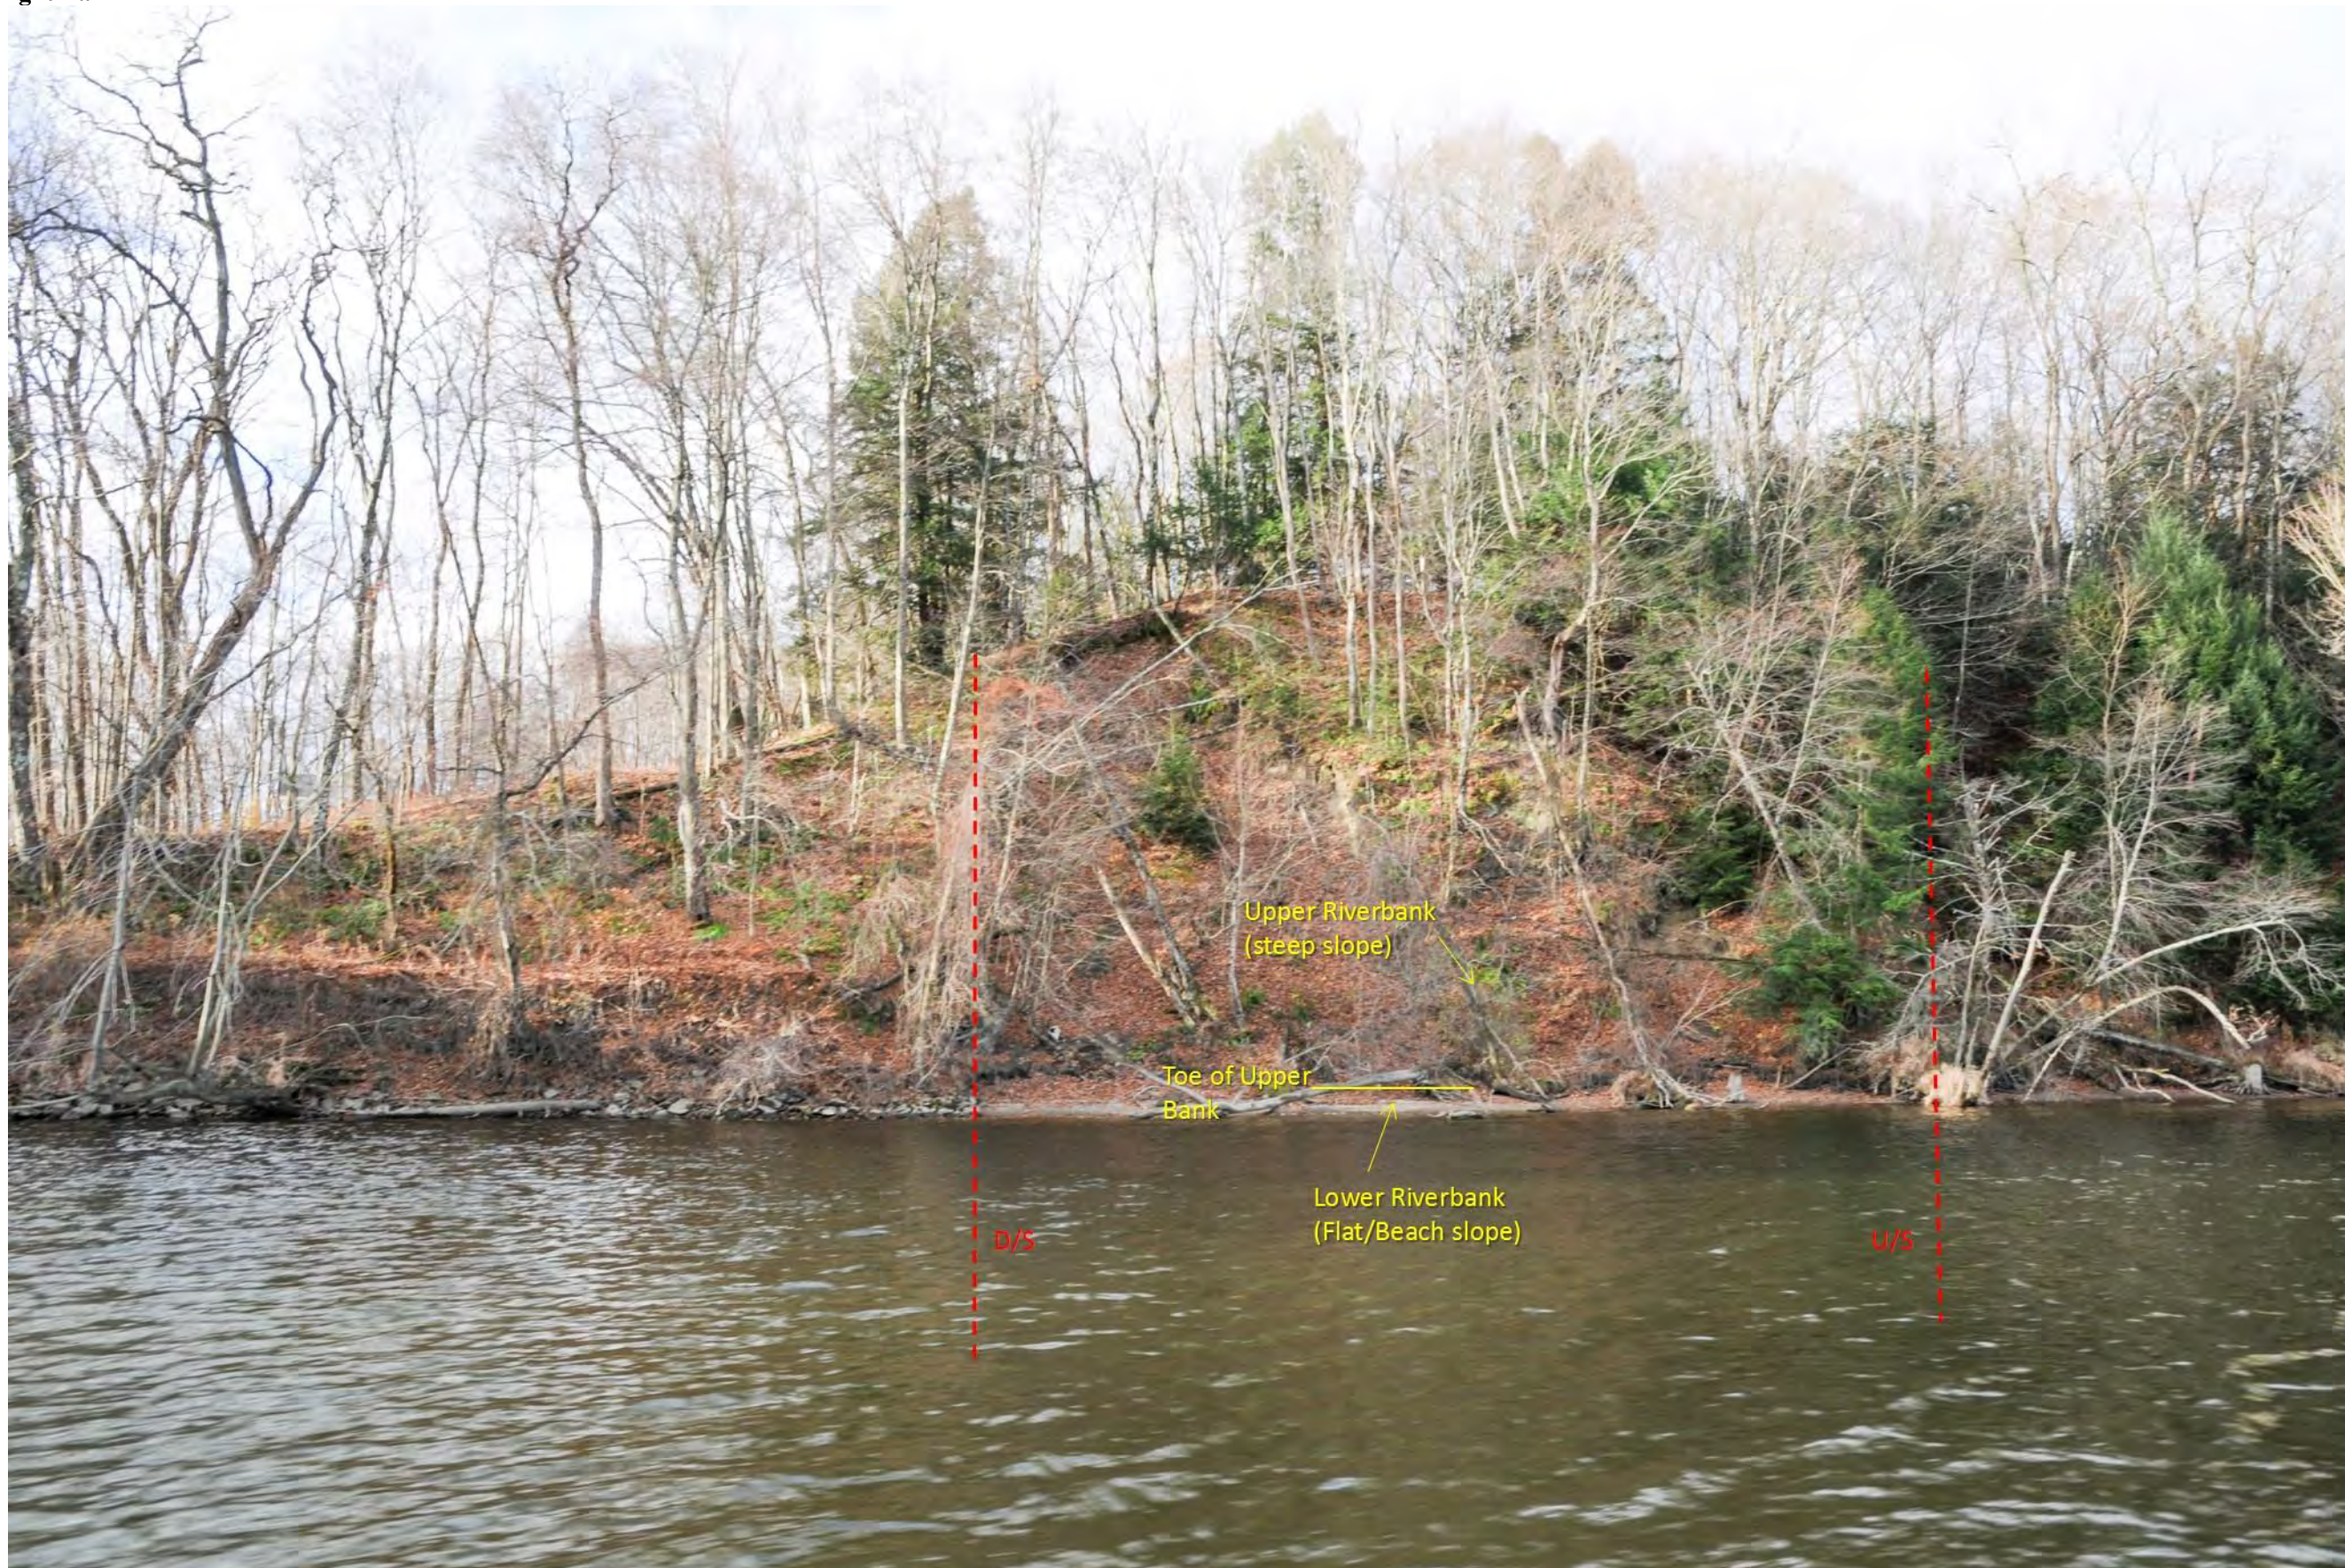
Photo ID 1114 (photo covers segment)

Riverbank Features	Characteristics
Upper Riverbank Slope	Steep
Upper Riverbank Height	High
Upper Riverbank Sediment	Silt/Sand
Upper Riverbank Vegetation	Moderate
Lower Riverbank Slope	Flat/Beach
Lower Riverbank Sediment	Silt/Sand
Lower Riverbank Vegetation	None to very sparse
Type of Erosion	
Potential Erosion Indicators	None
Stage of Erosion	Stable
Extent of Erosion	None/Little

**QA Observations:** Upon review of the photos for this segment, classification made in the field was confirmed.
