**FIRSTLIGHT POWER RESOURCES**  
 RELICENSING STUDY 3.1.1  
 2013 FULL RIVER RECONNAISSANCE  
 TURNERS FALLS IMPOUNDMENT

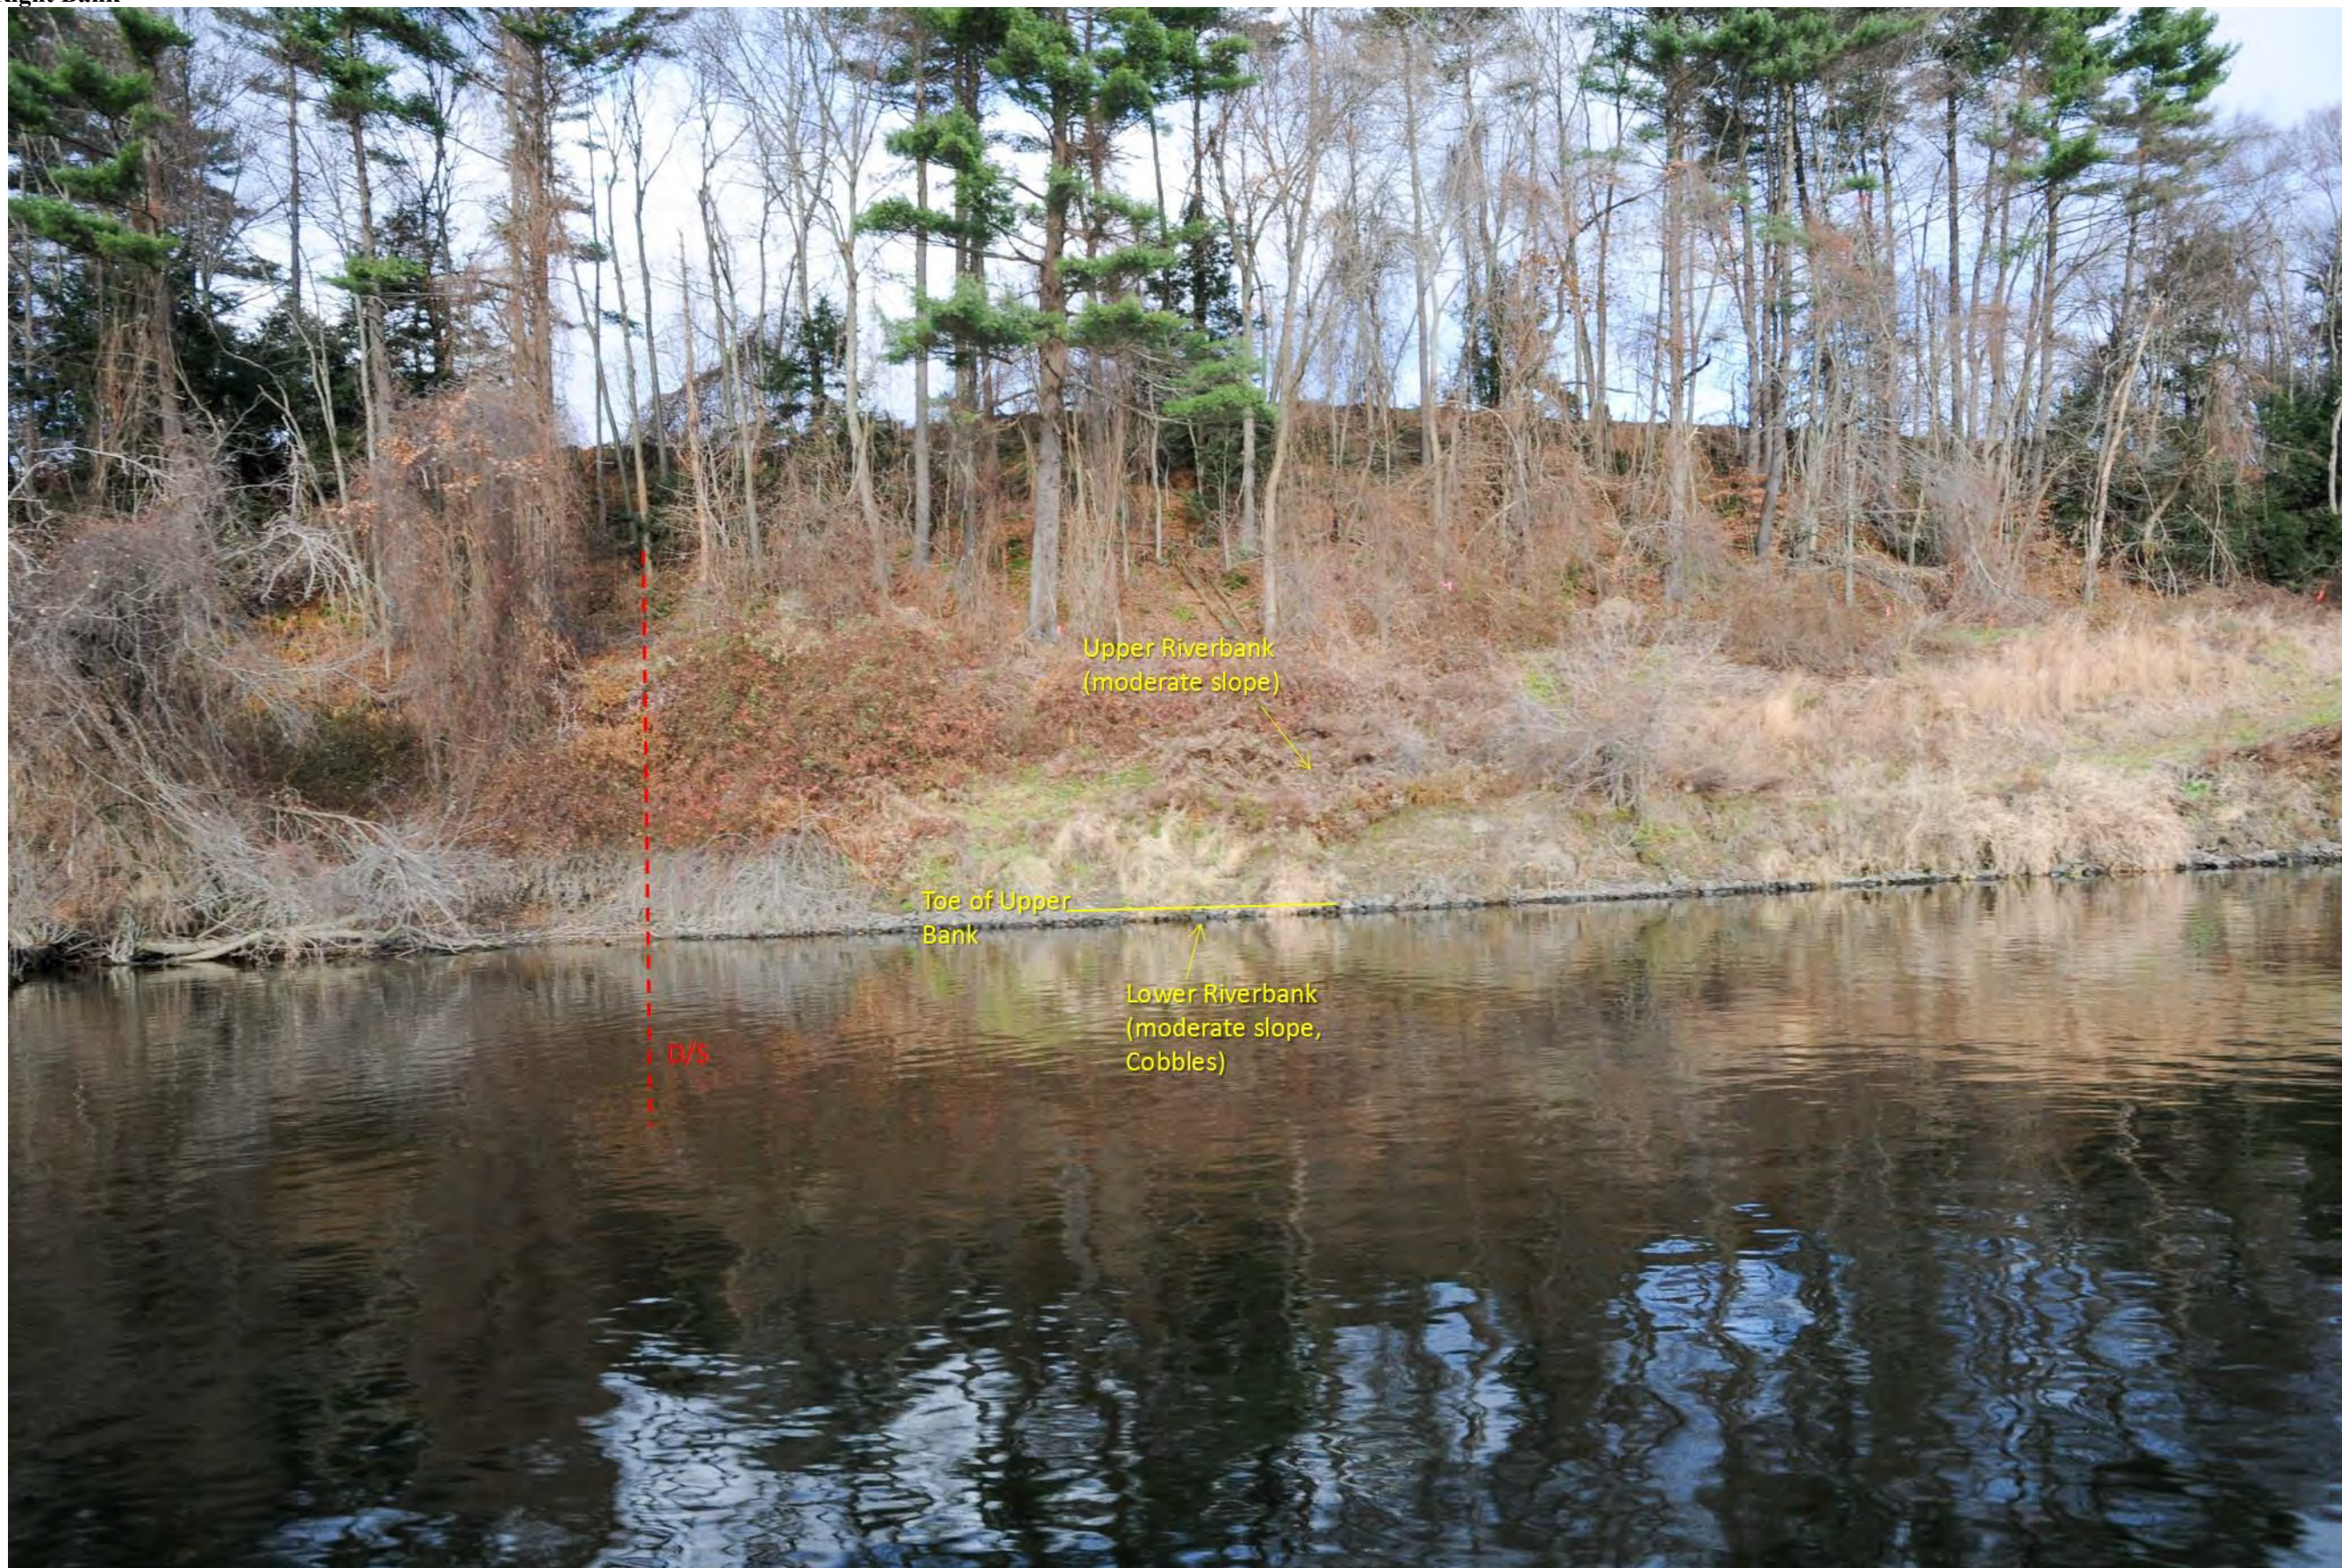
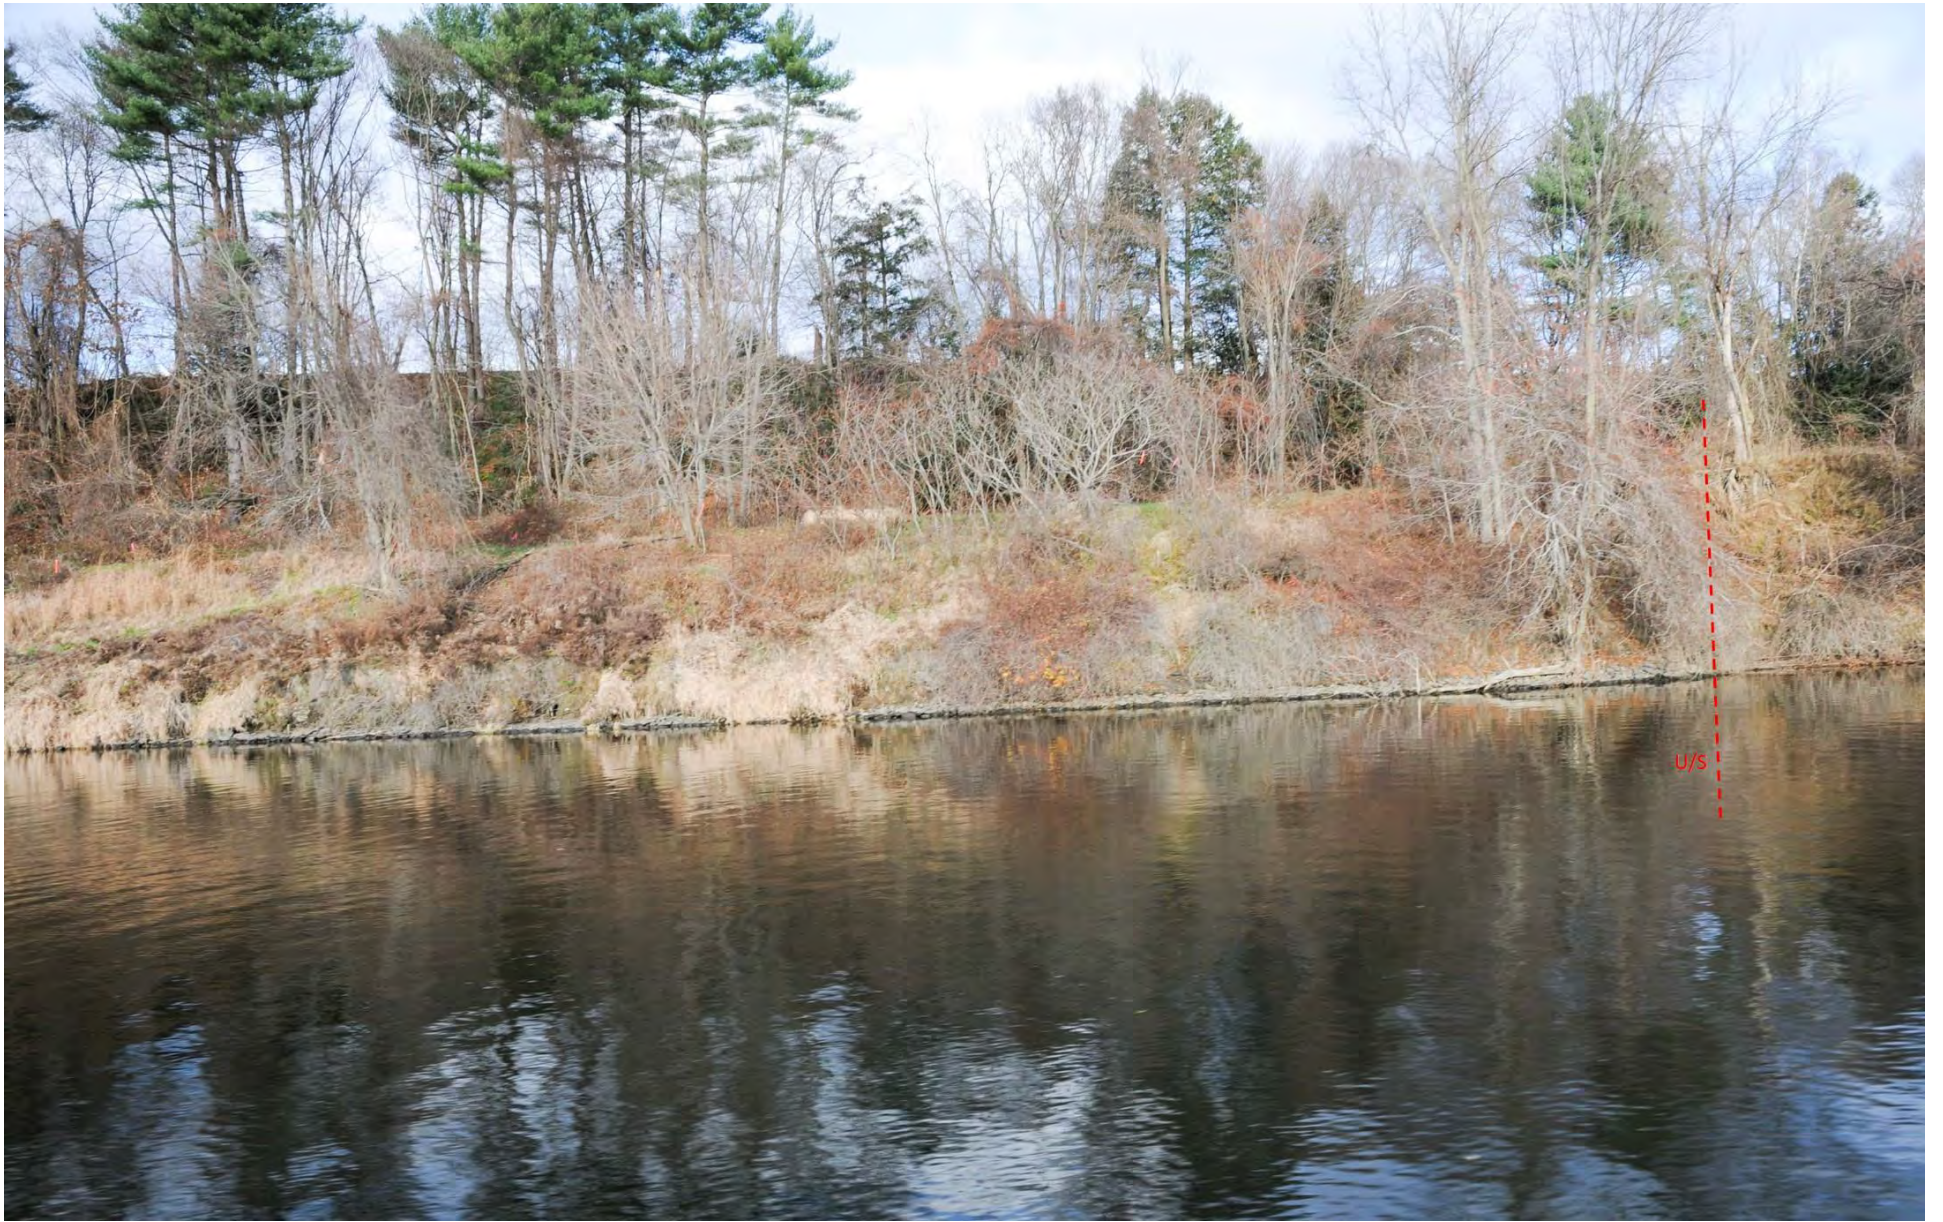
Riverbank Features	Characteristics
Upper Riverbank Slope	Moderate
Upper Riverbank Height	High
Upper Riverbank Sediment	Silt/Sand
Upper Riverbank Vegetation	Heavy
Lower Riverbank Slope	Moderate
Lower Riverbank Sediment	Cobbles
Lower Riverbank Vegetation	None to very sparse
Type of Erosion	
Potential Erosion Indicators	None
Stage of Erosion	Stable
Extent of Erosion	None/Little

**QA Observations:** Upon review of the photos for this segment, classification made in the field was confirmed.

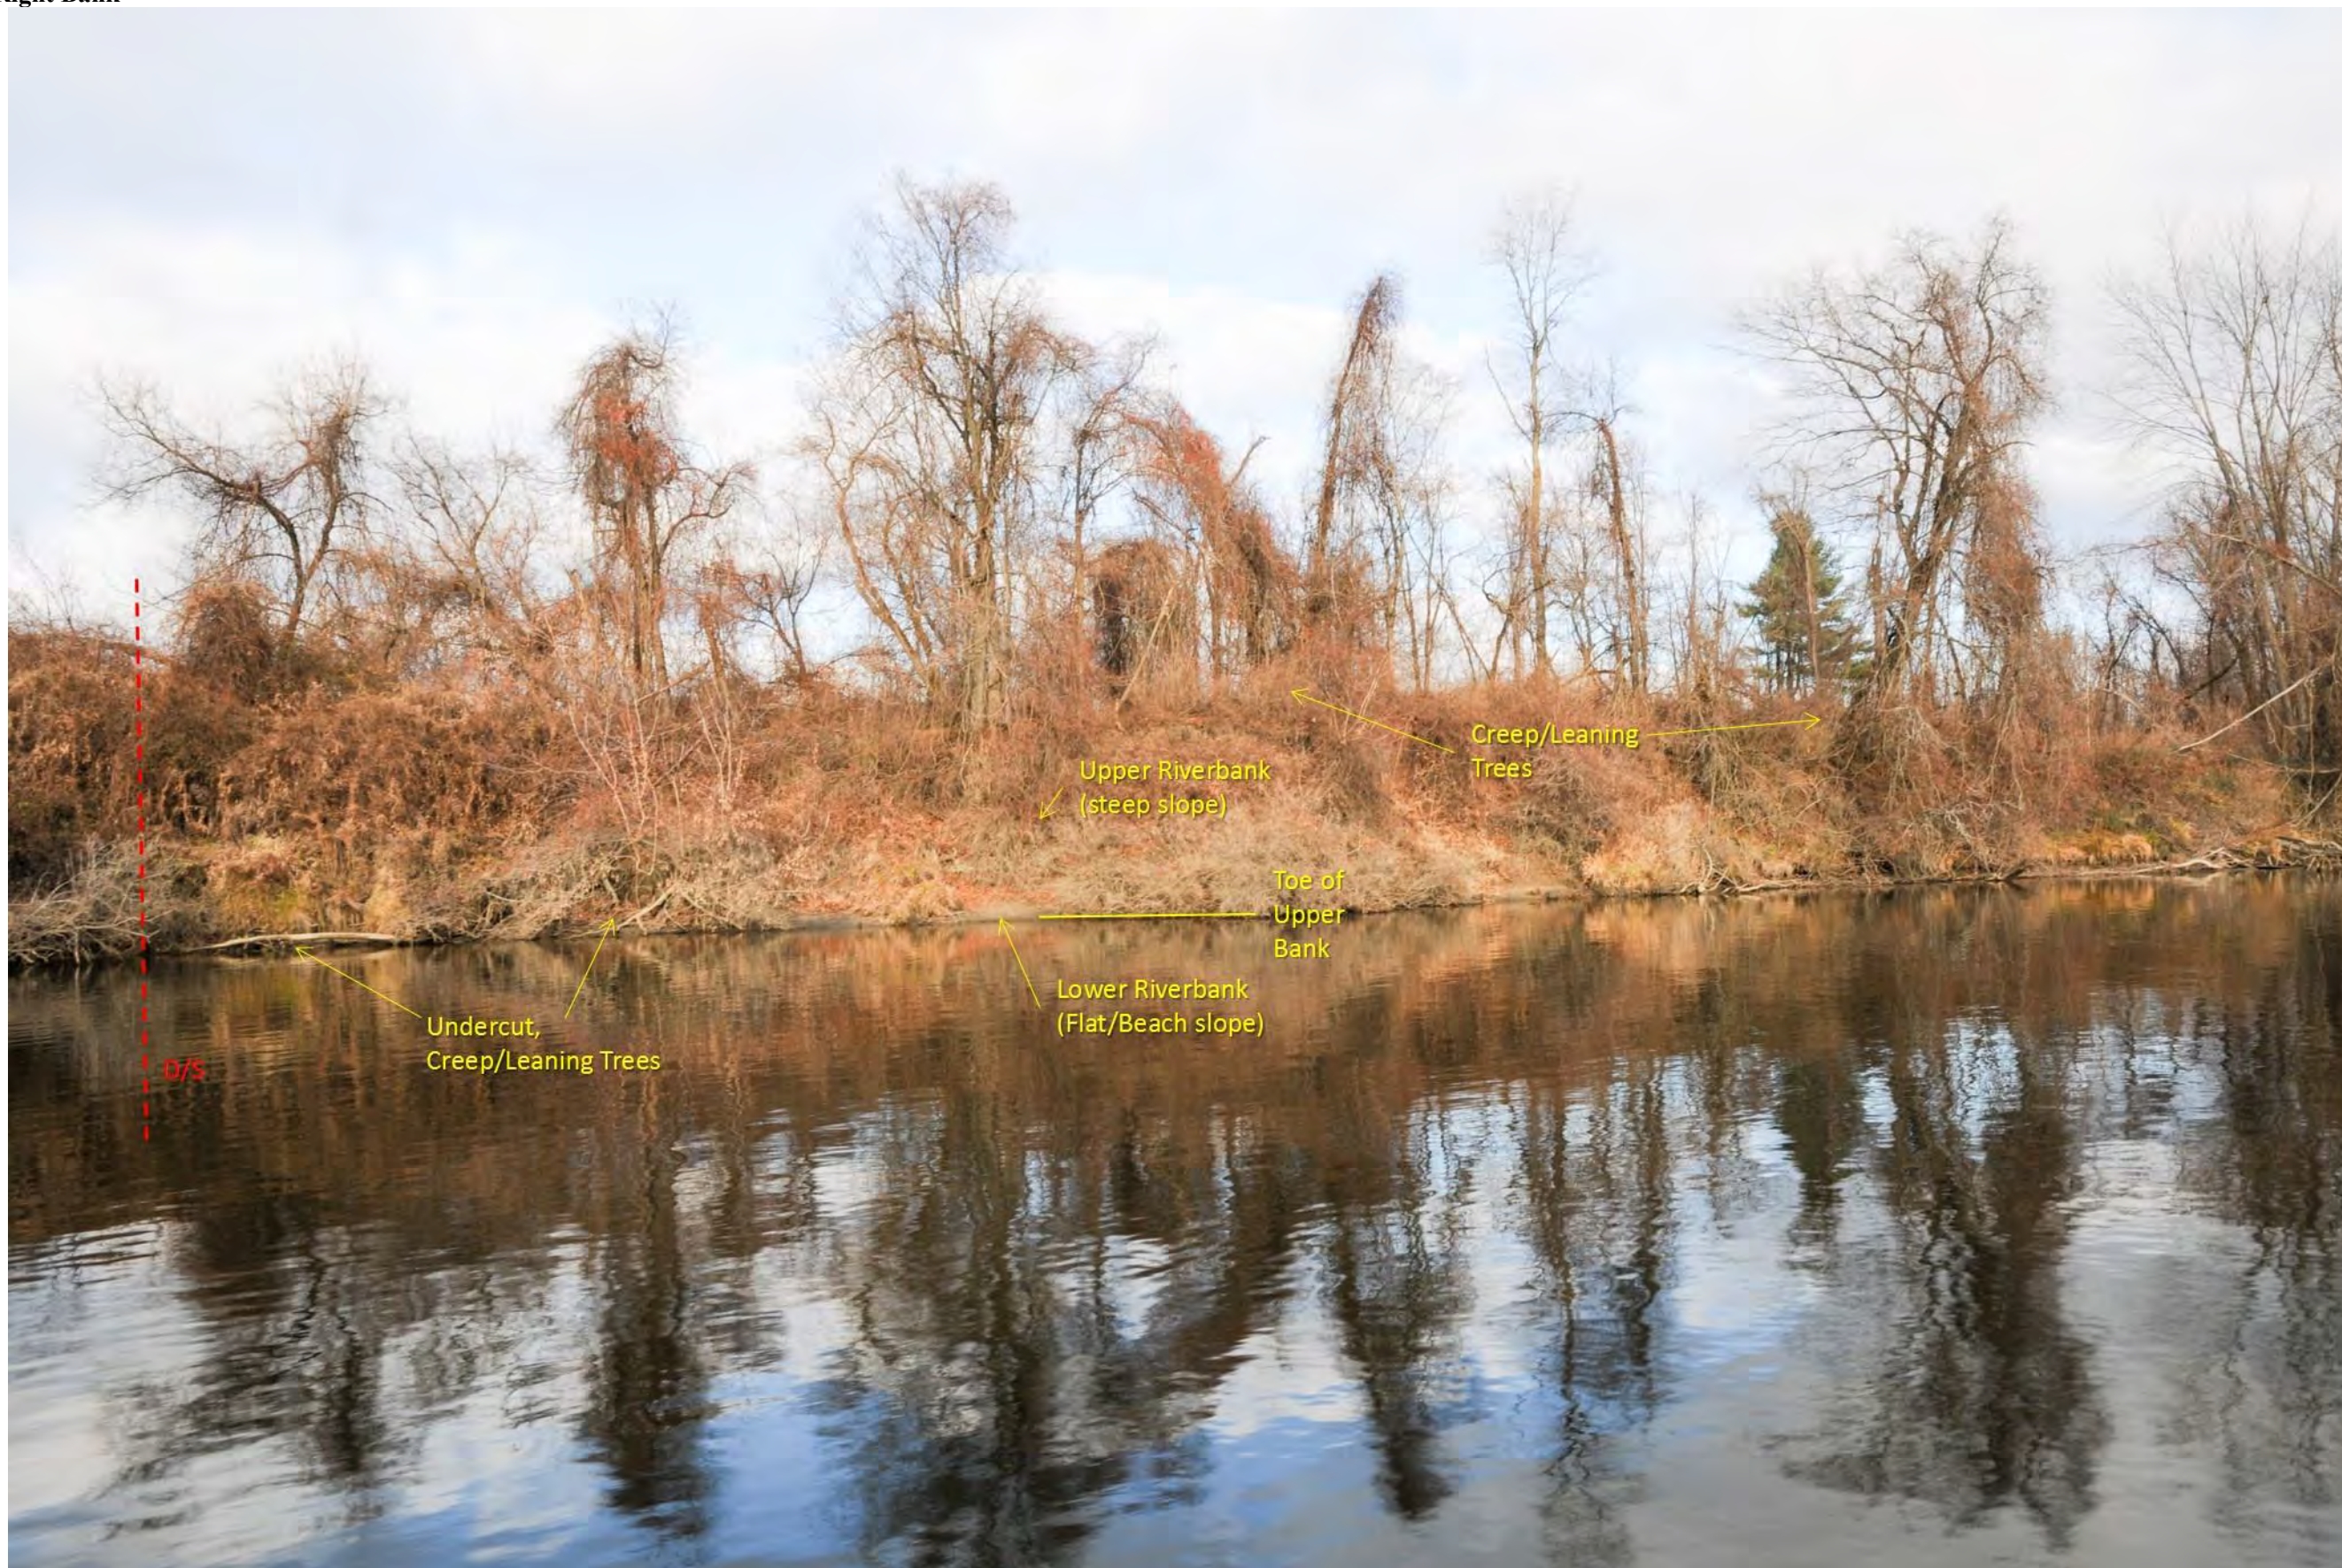
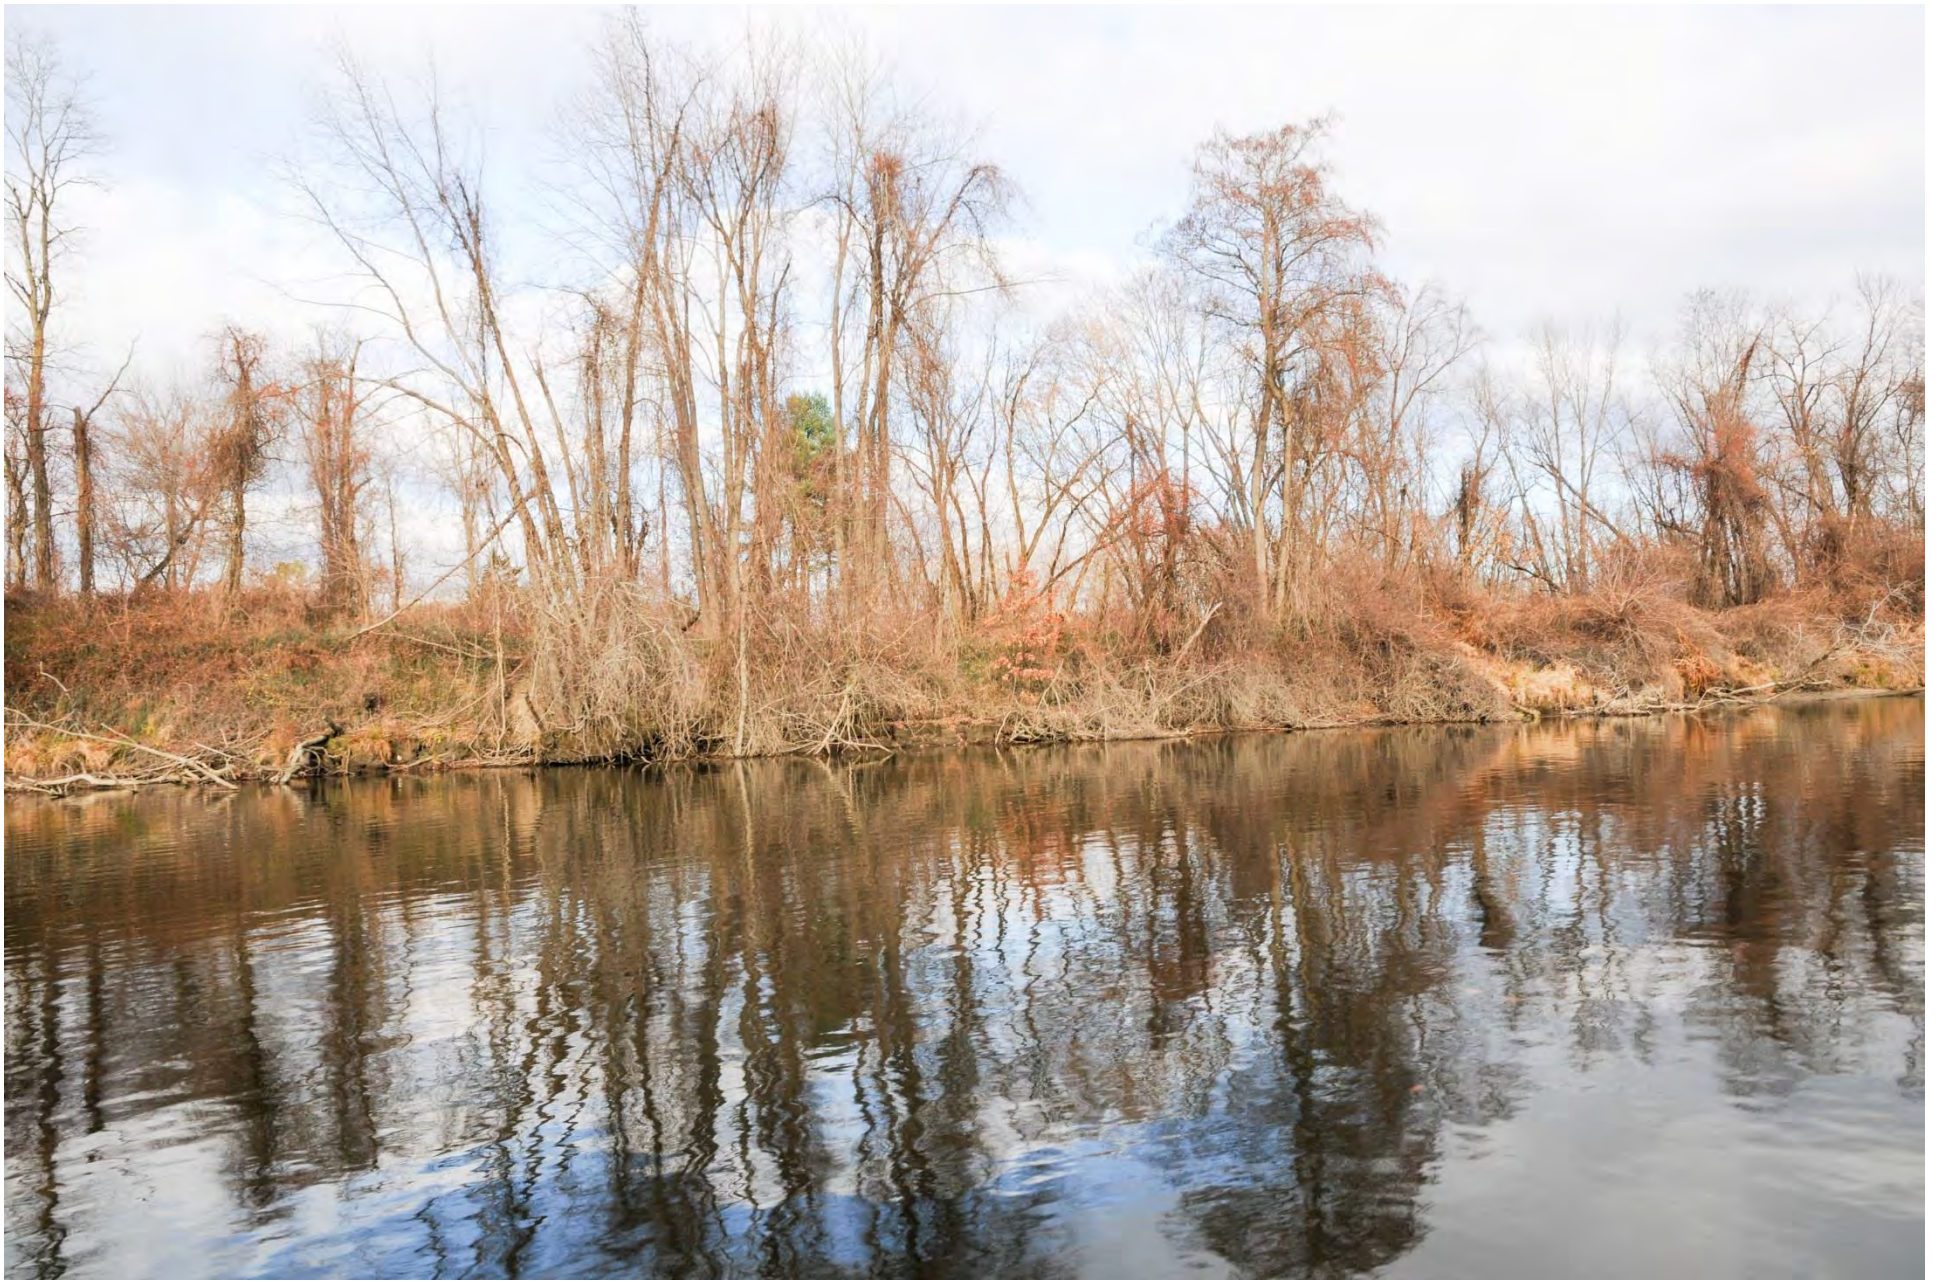
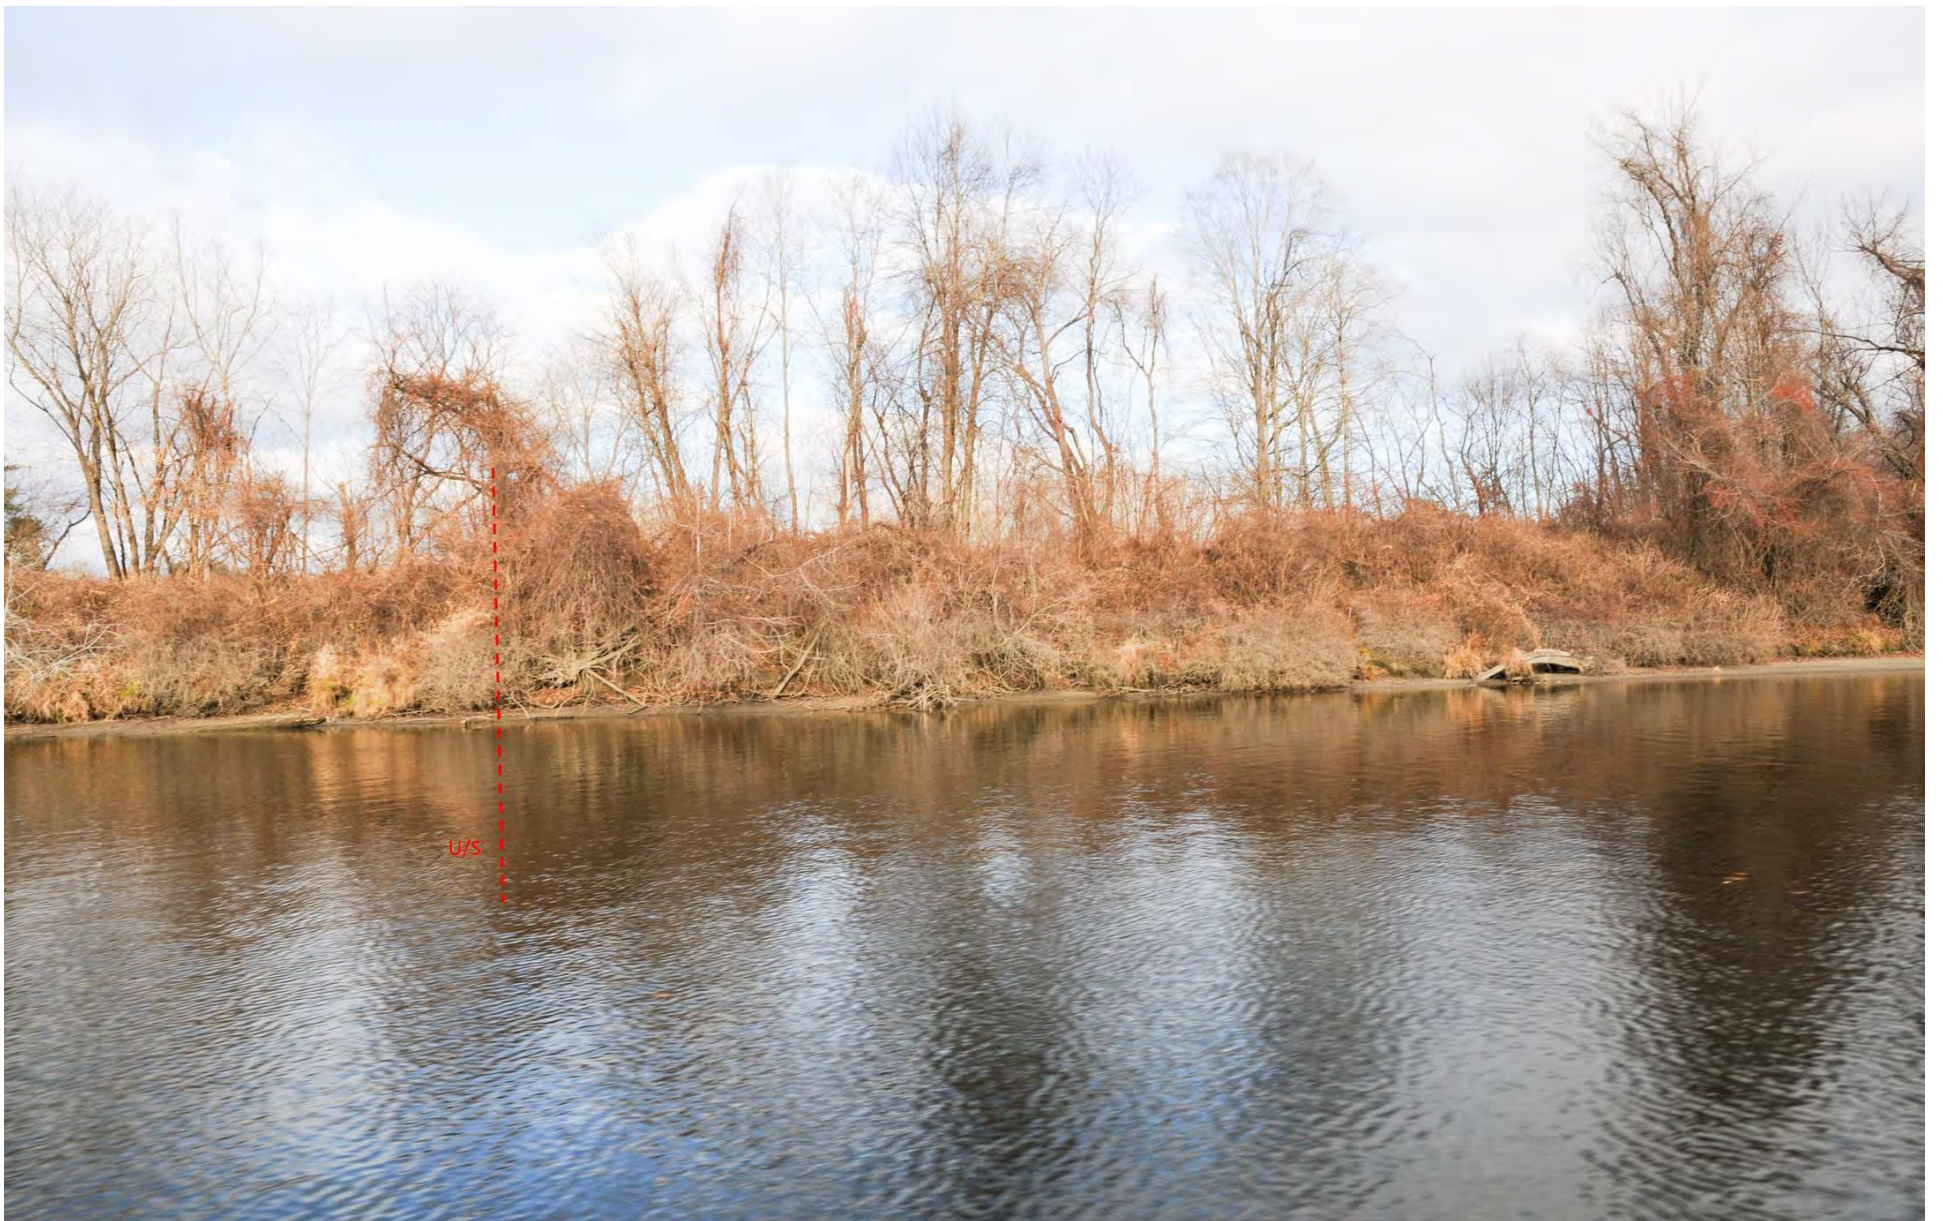
Riverbank Features	Characteristics
Upper Riverbank Slope	Steep
Upper Riverbank Height	Low
Upper Riverbank Sediment	Silt/Sand
Upper Riverbank Vegetation	Heavy
Lower Riverbank Slope	Flat/Beach
Lower Riverbank Sediment	Silt/Sand
Lower Riverbank Vegetation	None to very sparse
Type of Erosion	Undercut
Potential Erosion Indicators	Creep/leaning trees
Stage of Erosion	Stable
Extent of Erosion	None/Little

**QA Observations:** Upon review of the photos for this segment, classification made in the field was confirmed.
