**FIRSTLIGHT POWER RESOURCES**  
 RELICENSING STUDY 3.1.1  
 2013 FULL RIVER RECONNAISSANCE  
 TURNERS FALLS IMPOUNDMENT

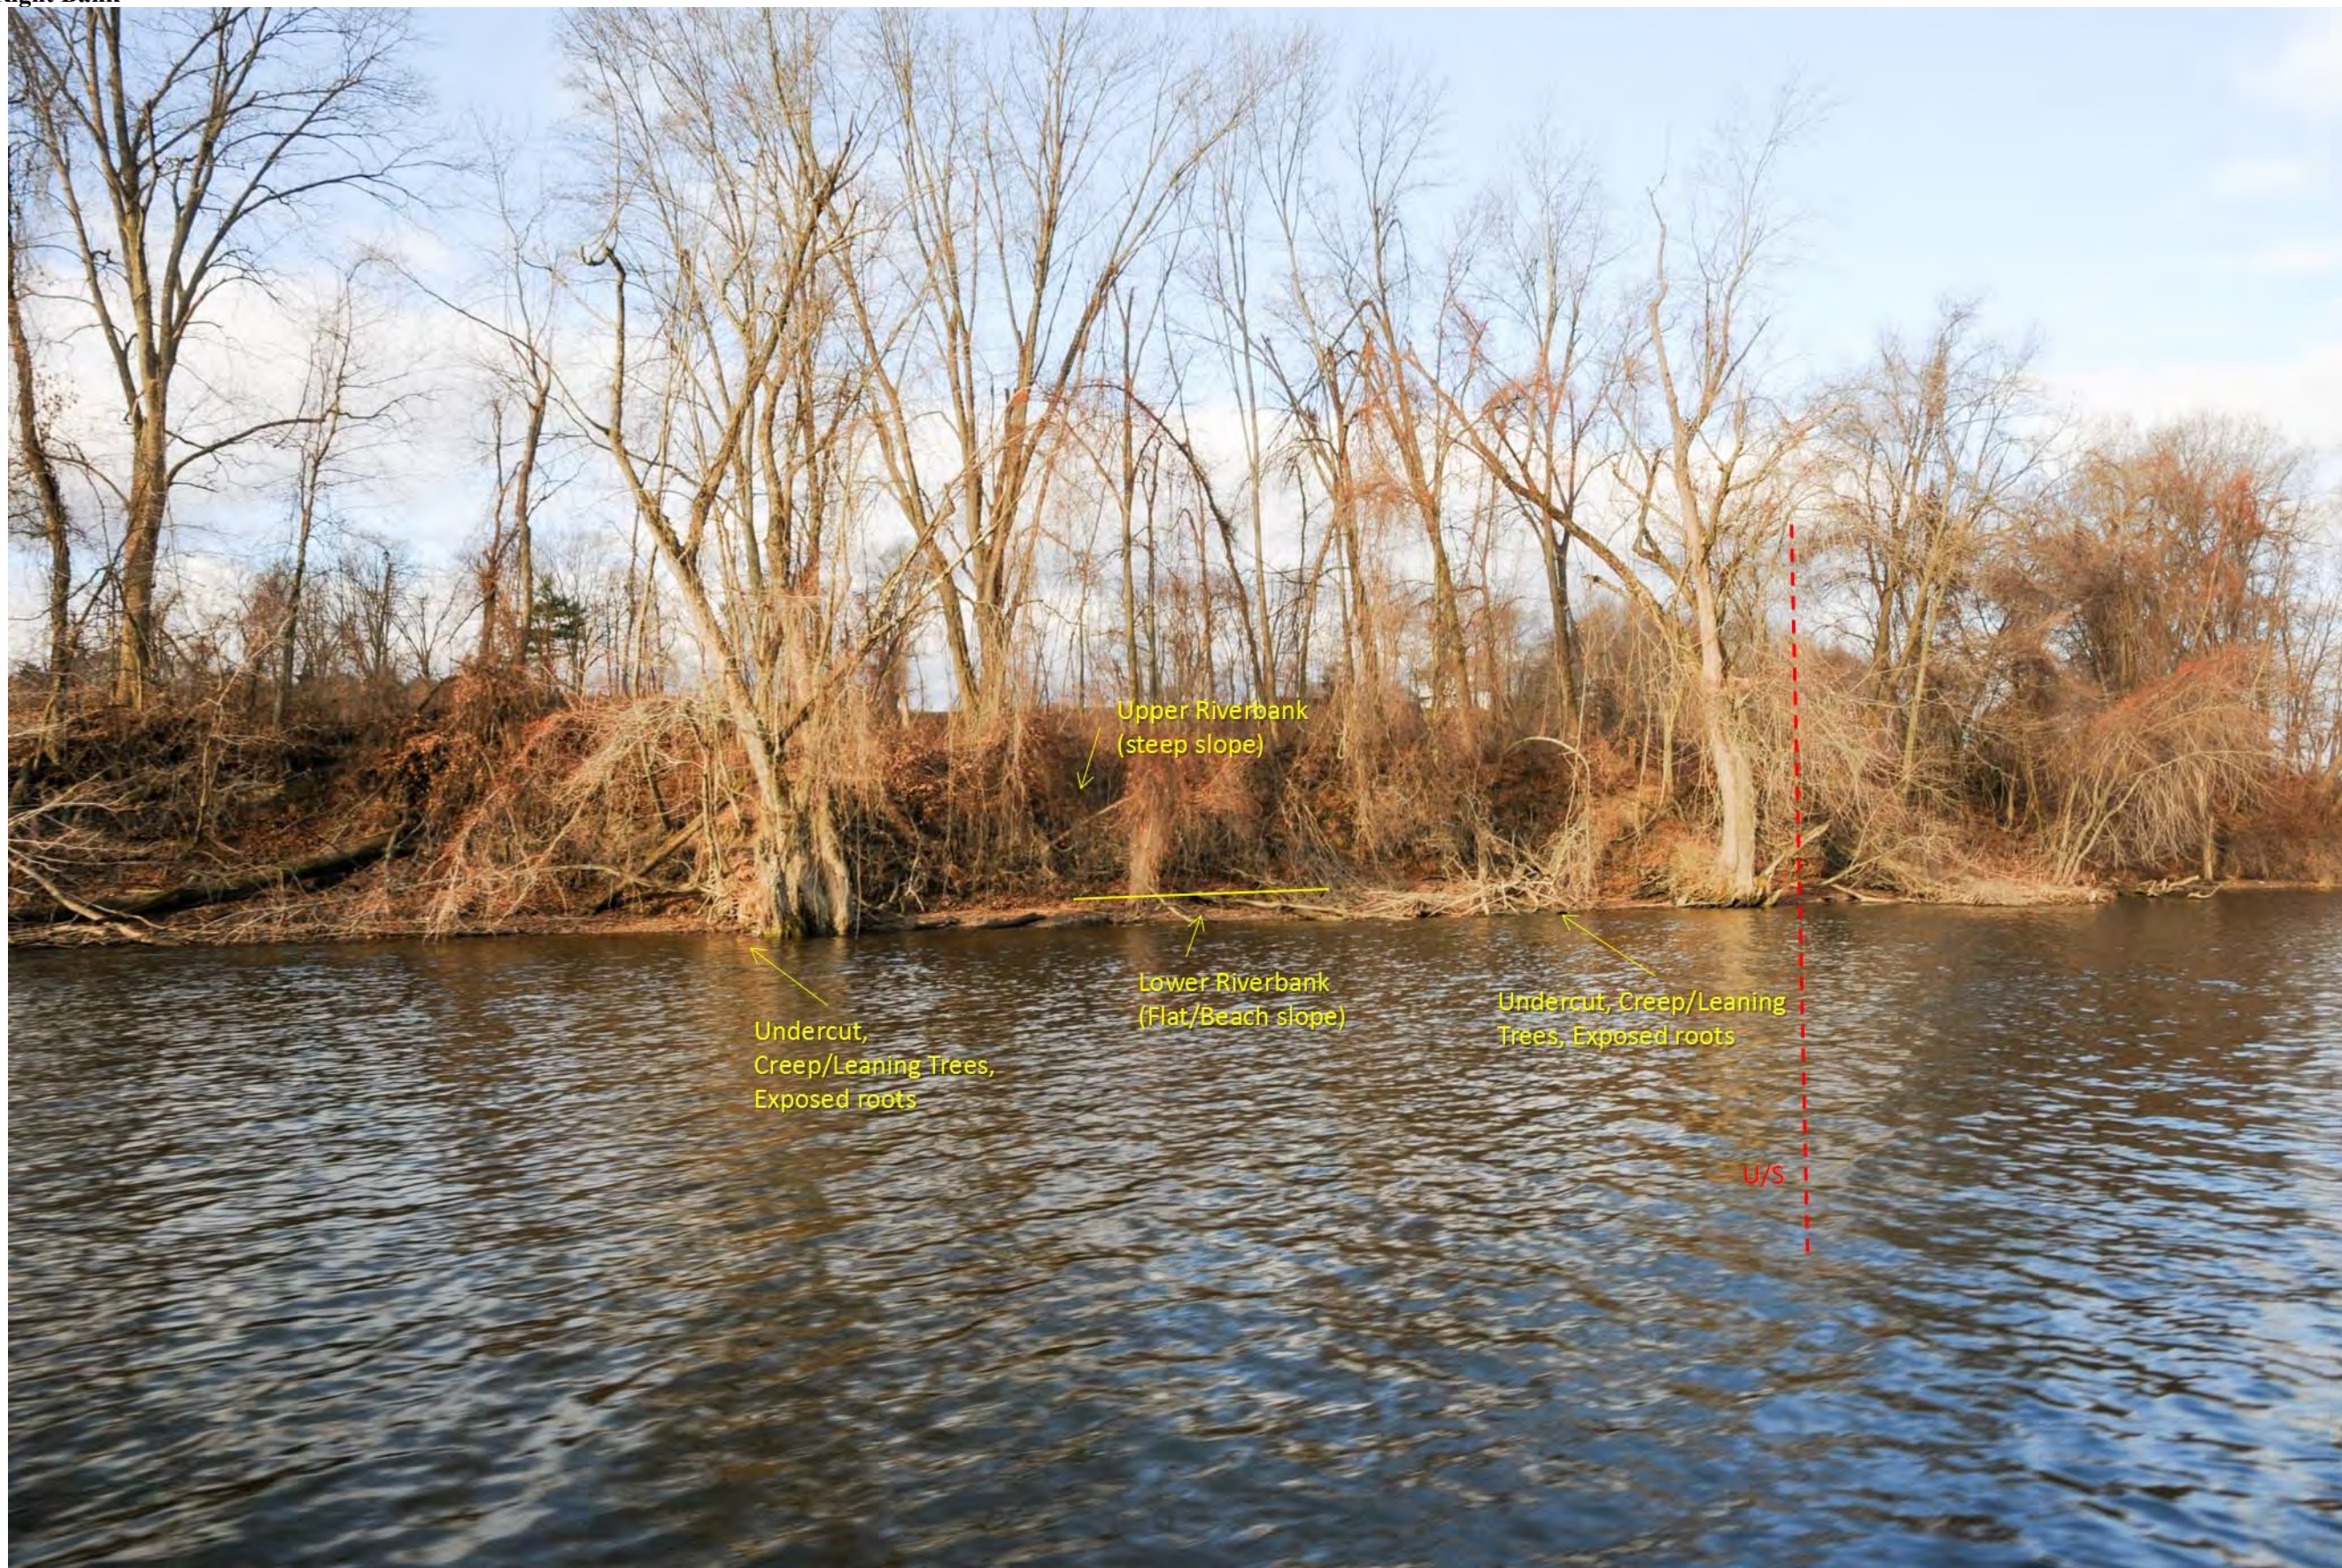
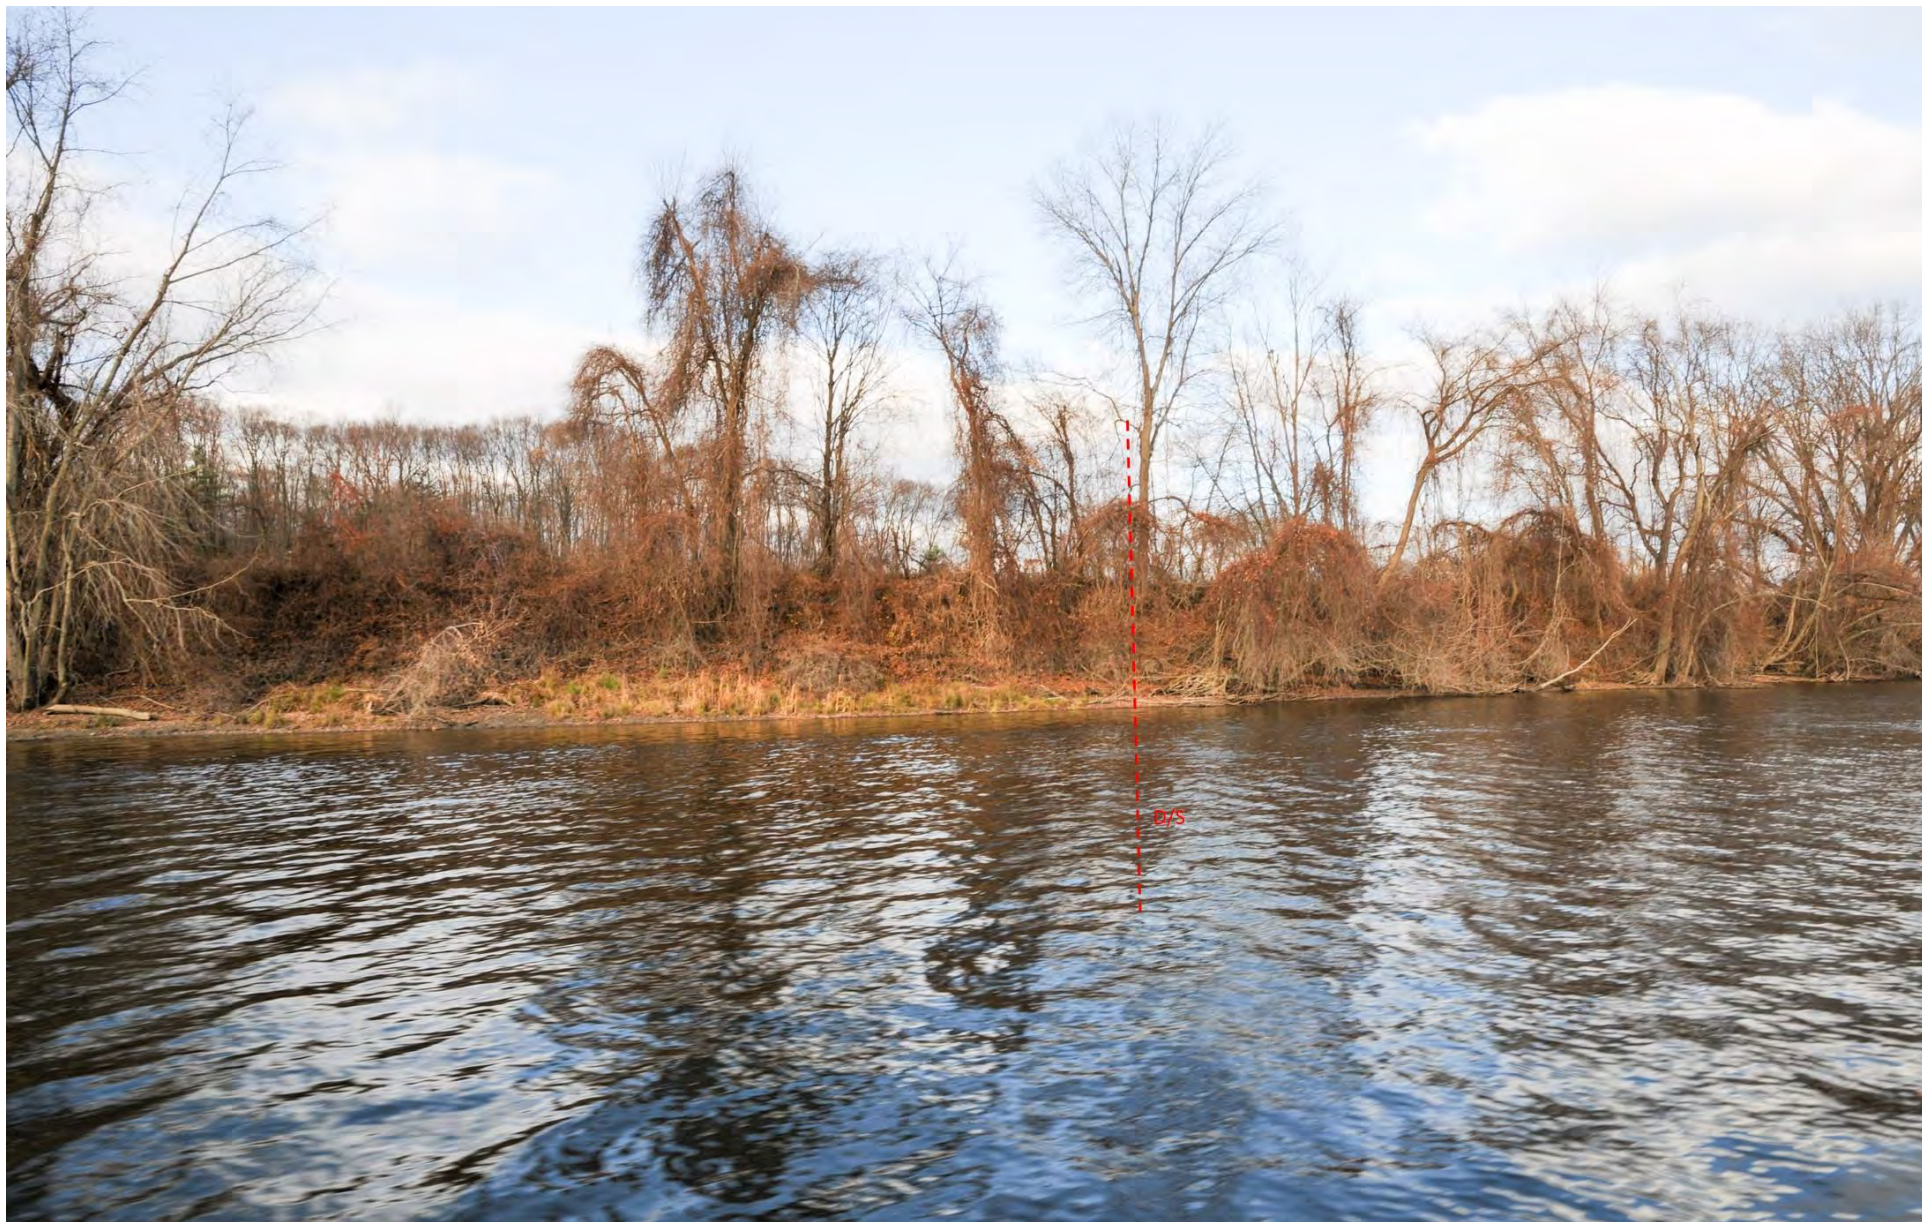
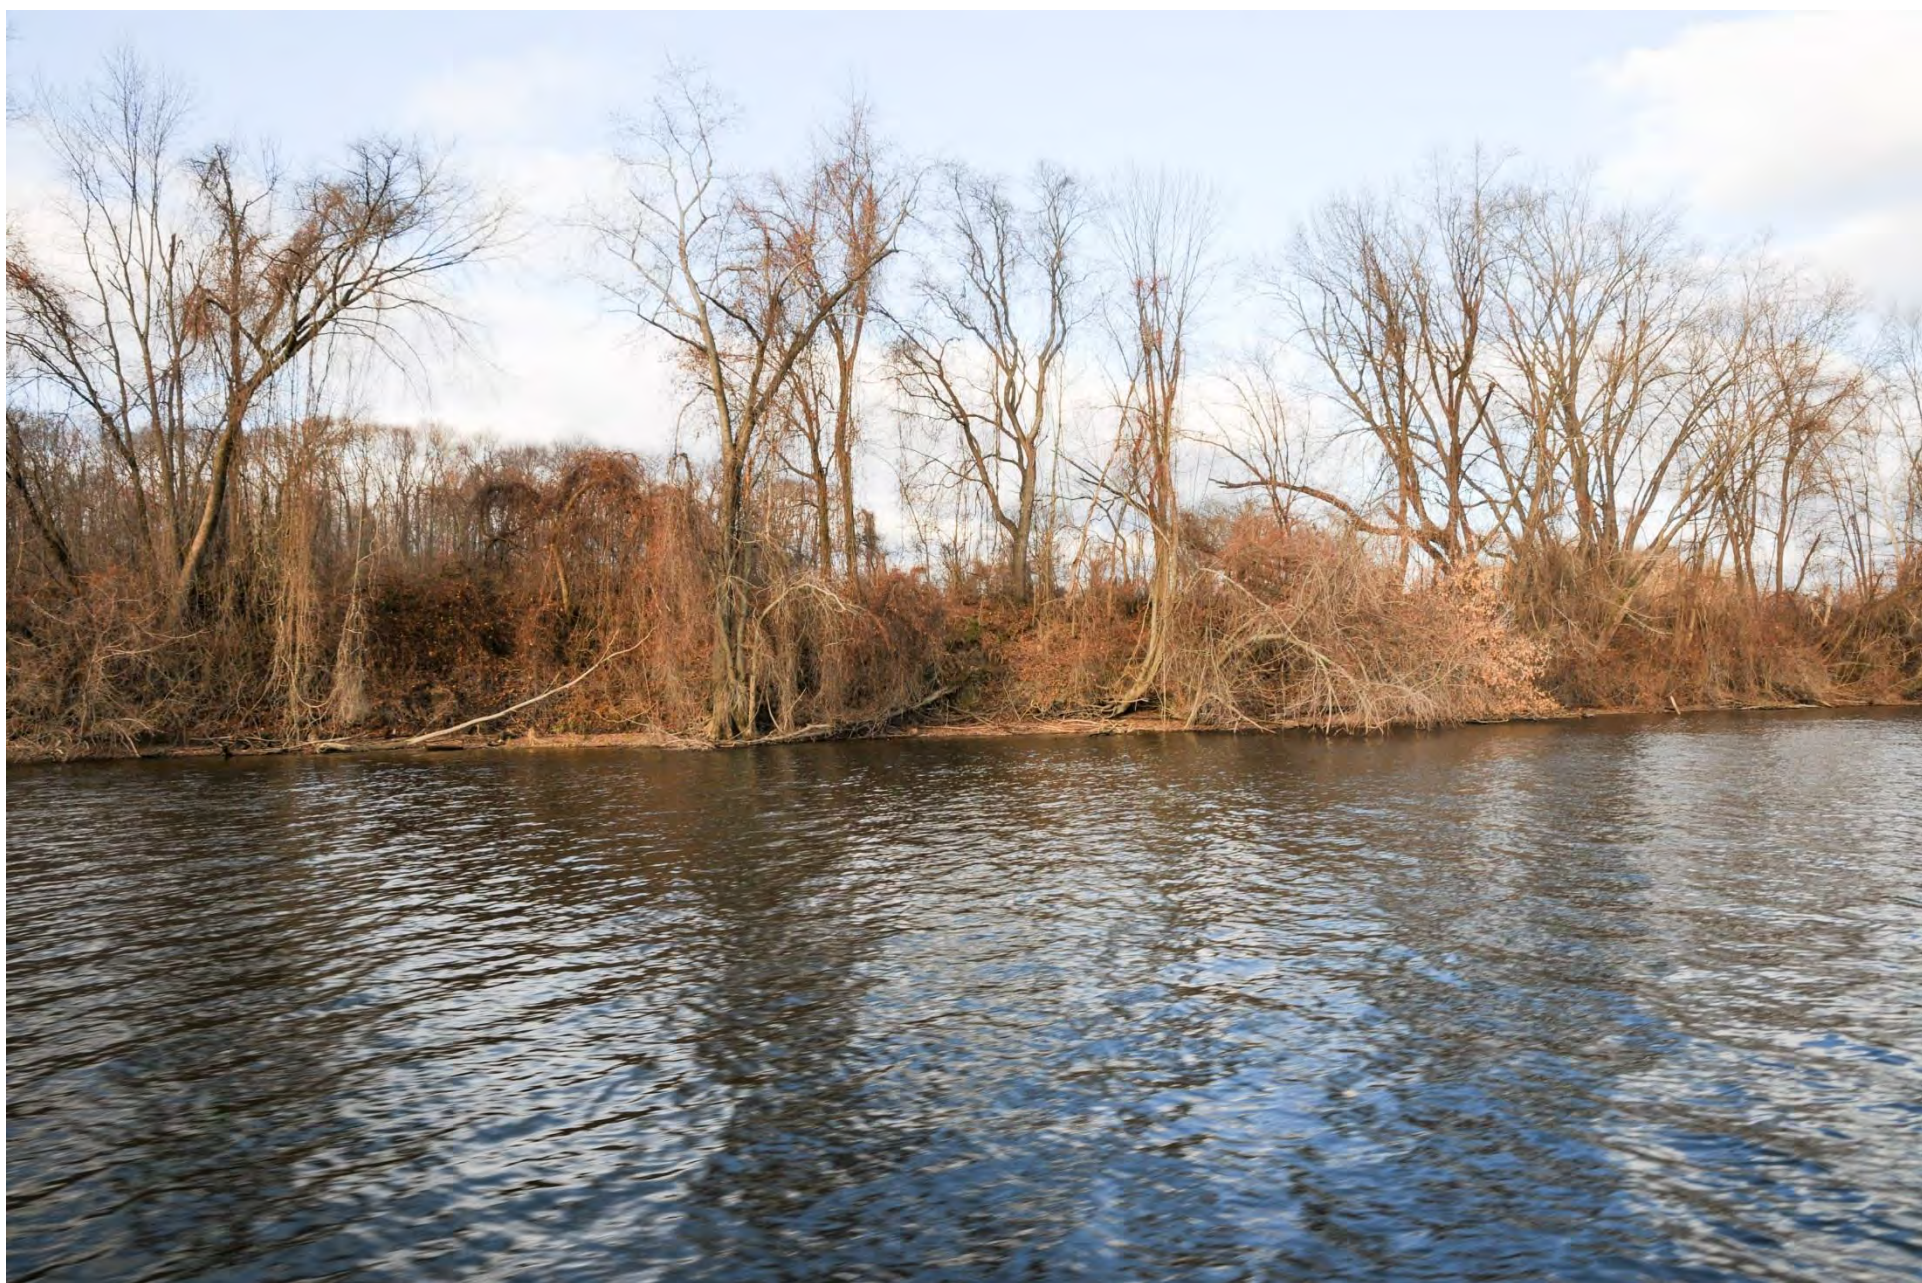
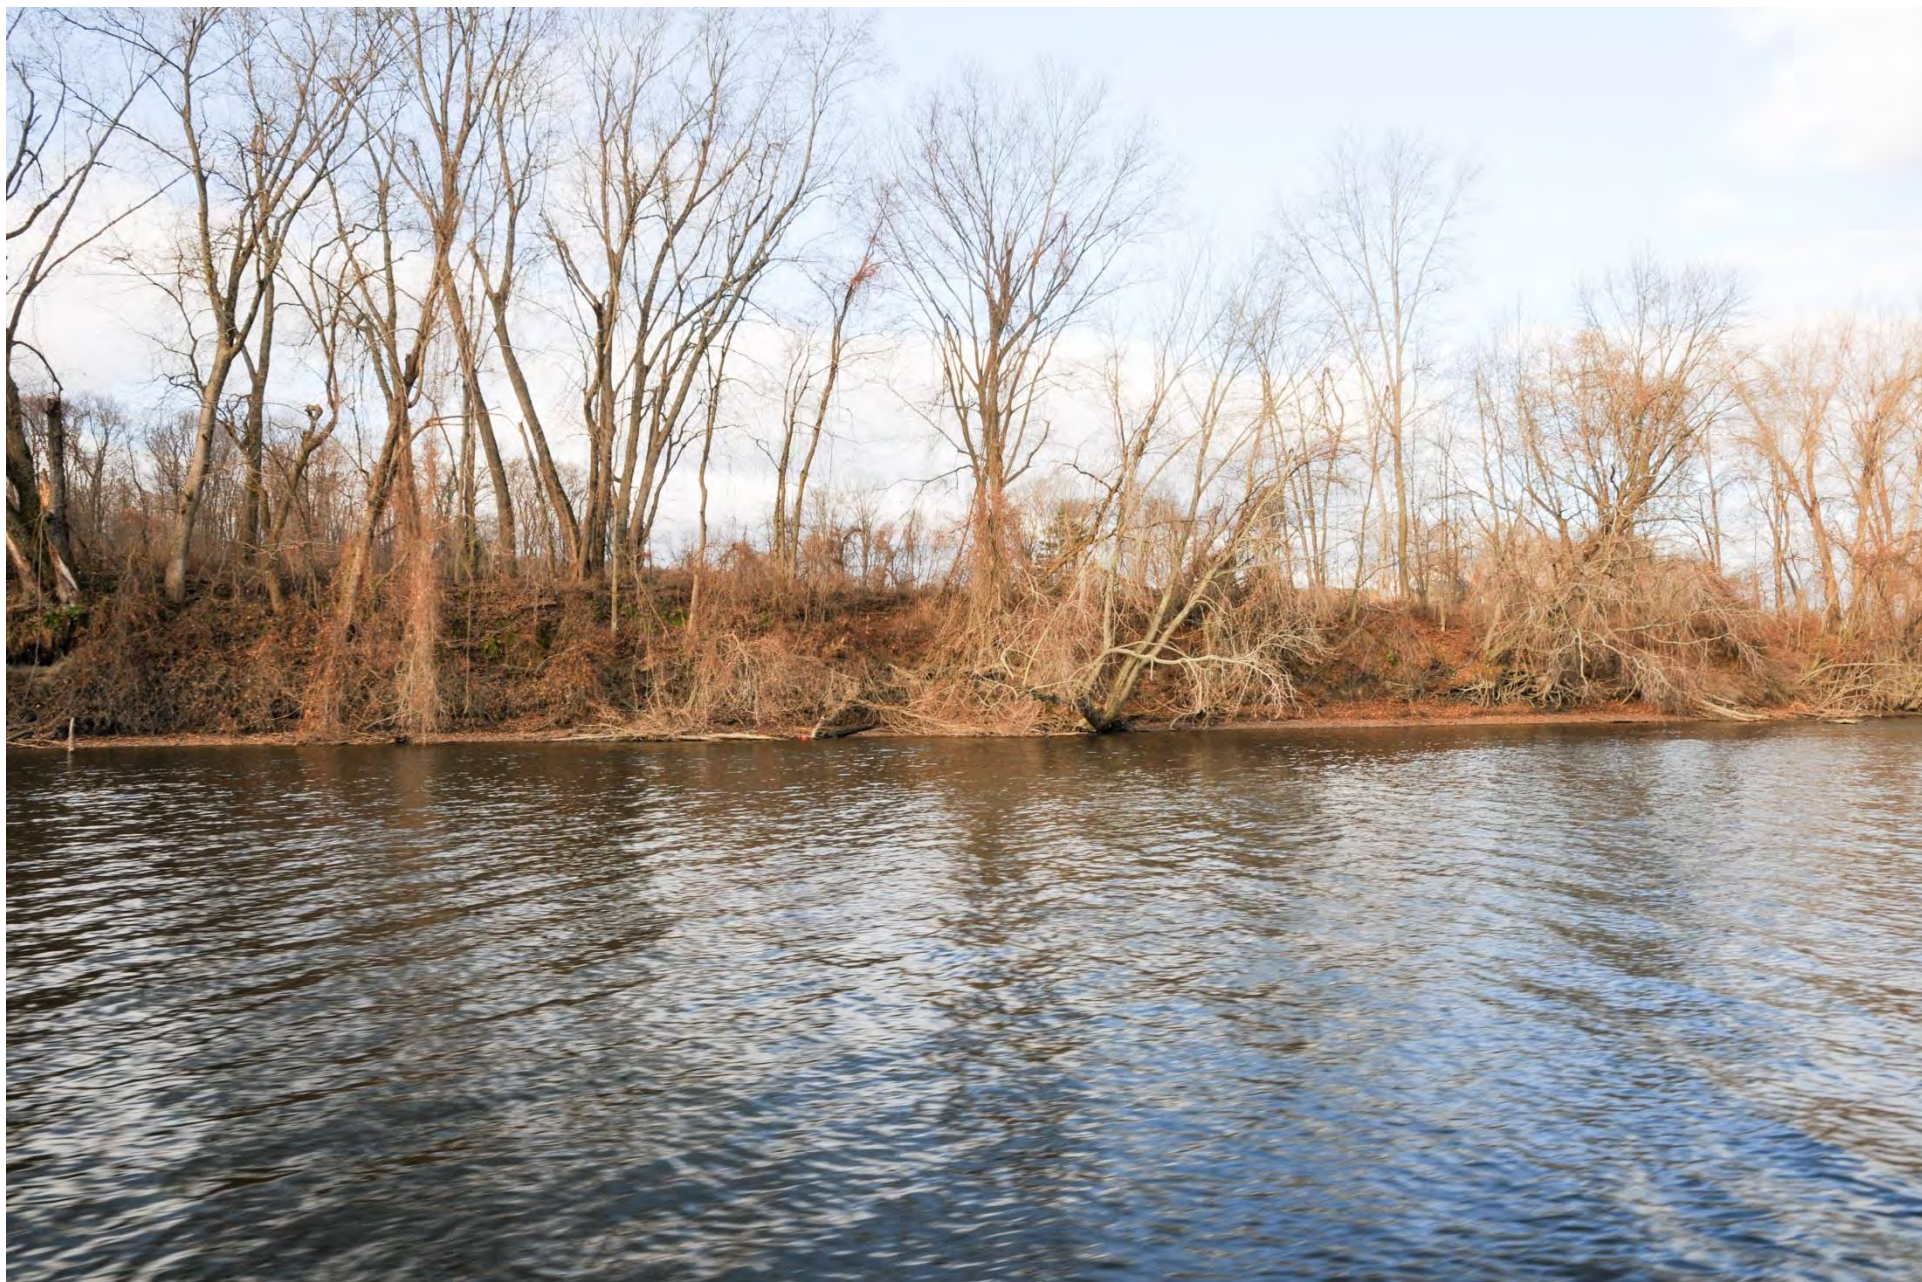
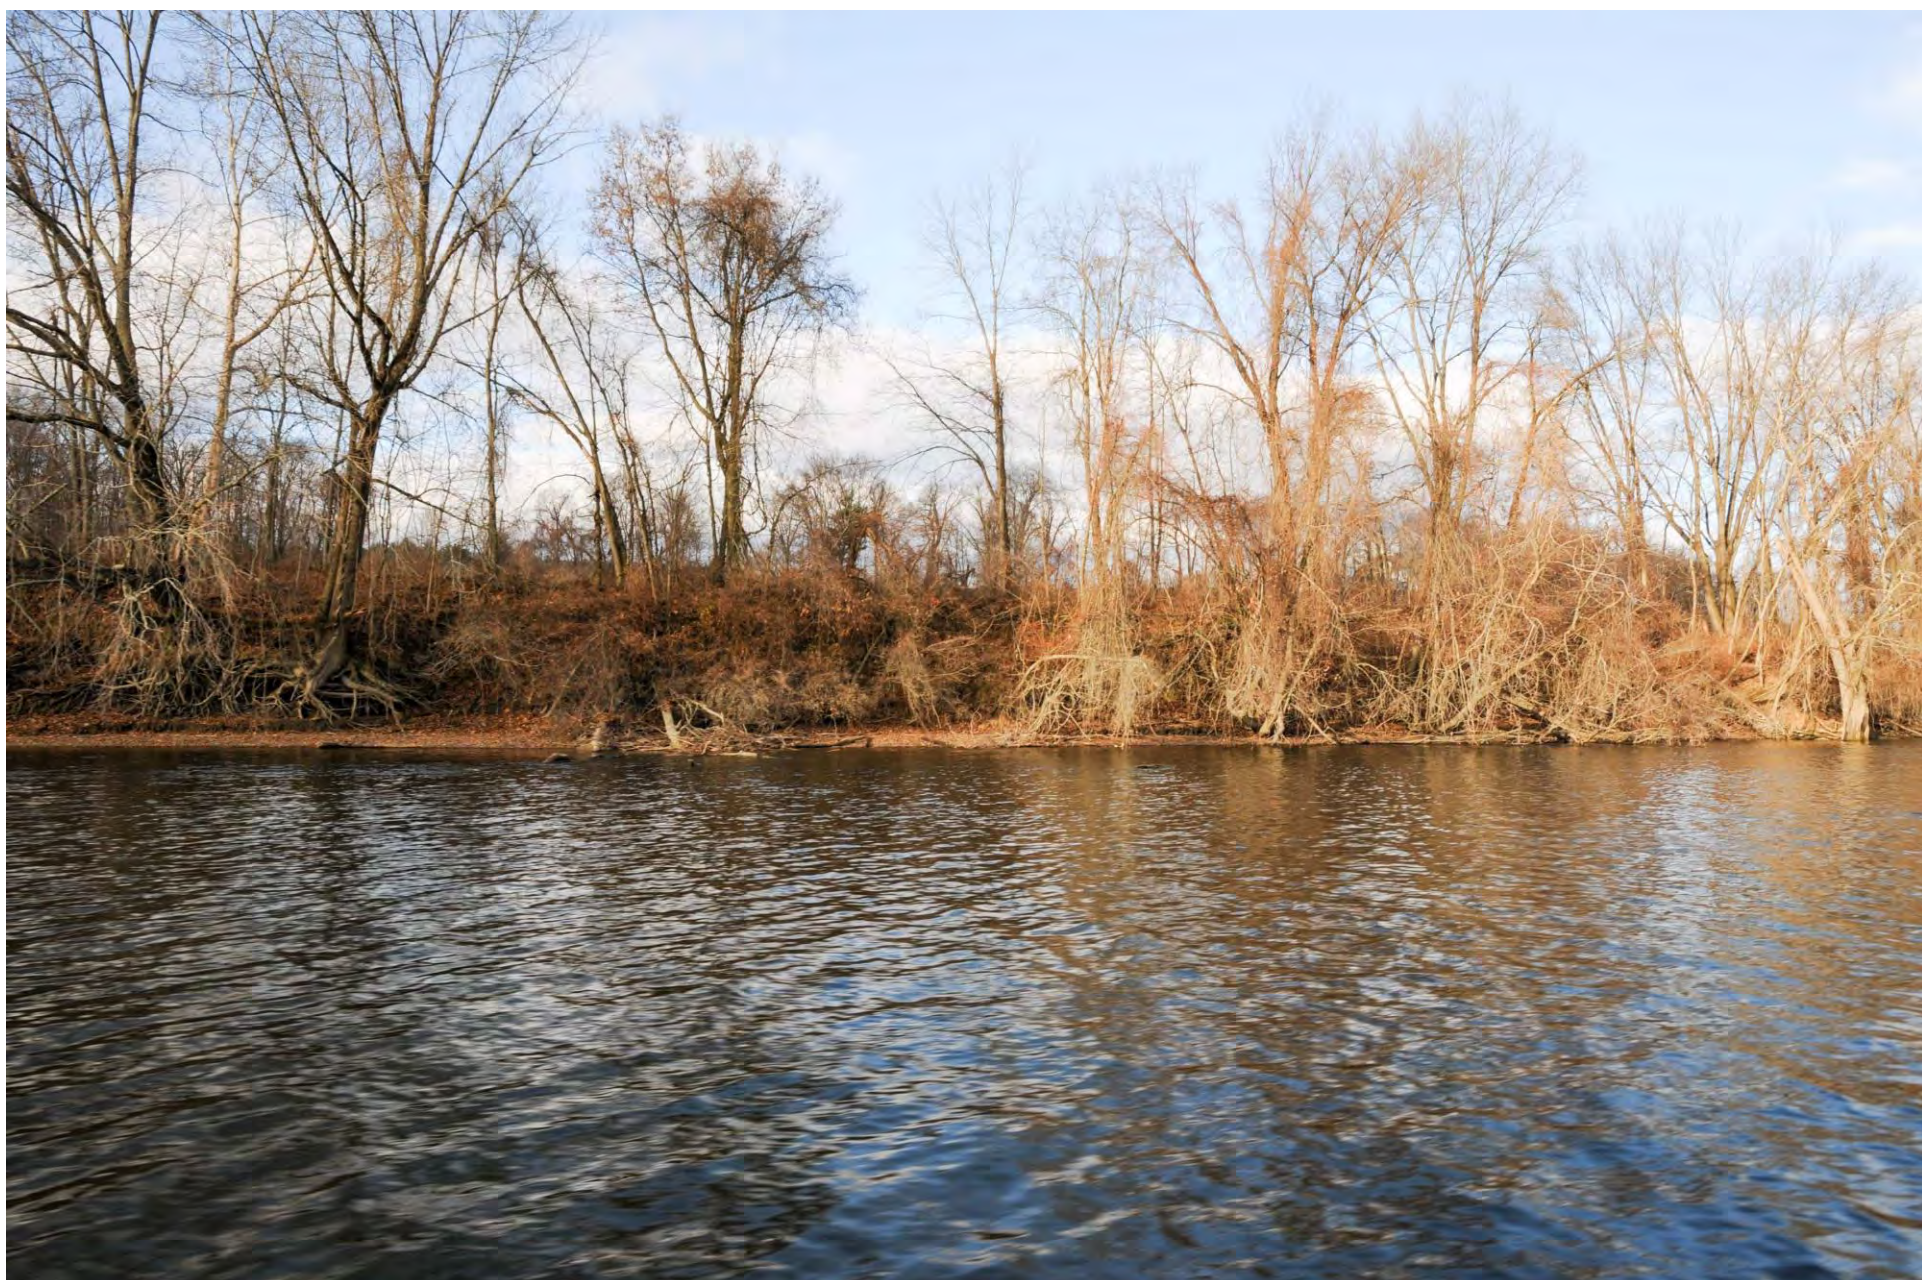
**Segment 520 – Right Bank**

Riverbank Features	Characteristics
Upper Riverbank Slope	Steep
Upper Riverbank Height	High
Upper Riverbank Sediment	Silt/Sand
Upper Riverbank Vegetation	Heavy
Lower Riverbank Slope	Flat/Beach
Lower Riverbank Sediment	Silt/Sand
Lower Riverbank Vegetation	None to very sparse
Type of Erosion	Undercut
Potential Erosion Indicators	Creep/leaning trees, Exposed roots
Stage of Erosion	Stable
Extent of Erosion	None/Little

**QA Observations:** Upon review of the photos for this segment, classification made in the field was confirmed and additional indicators of potential future erosion were included.

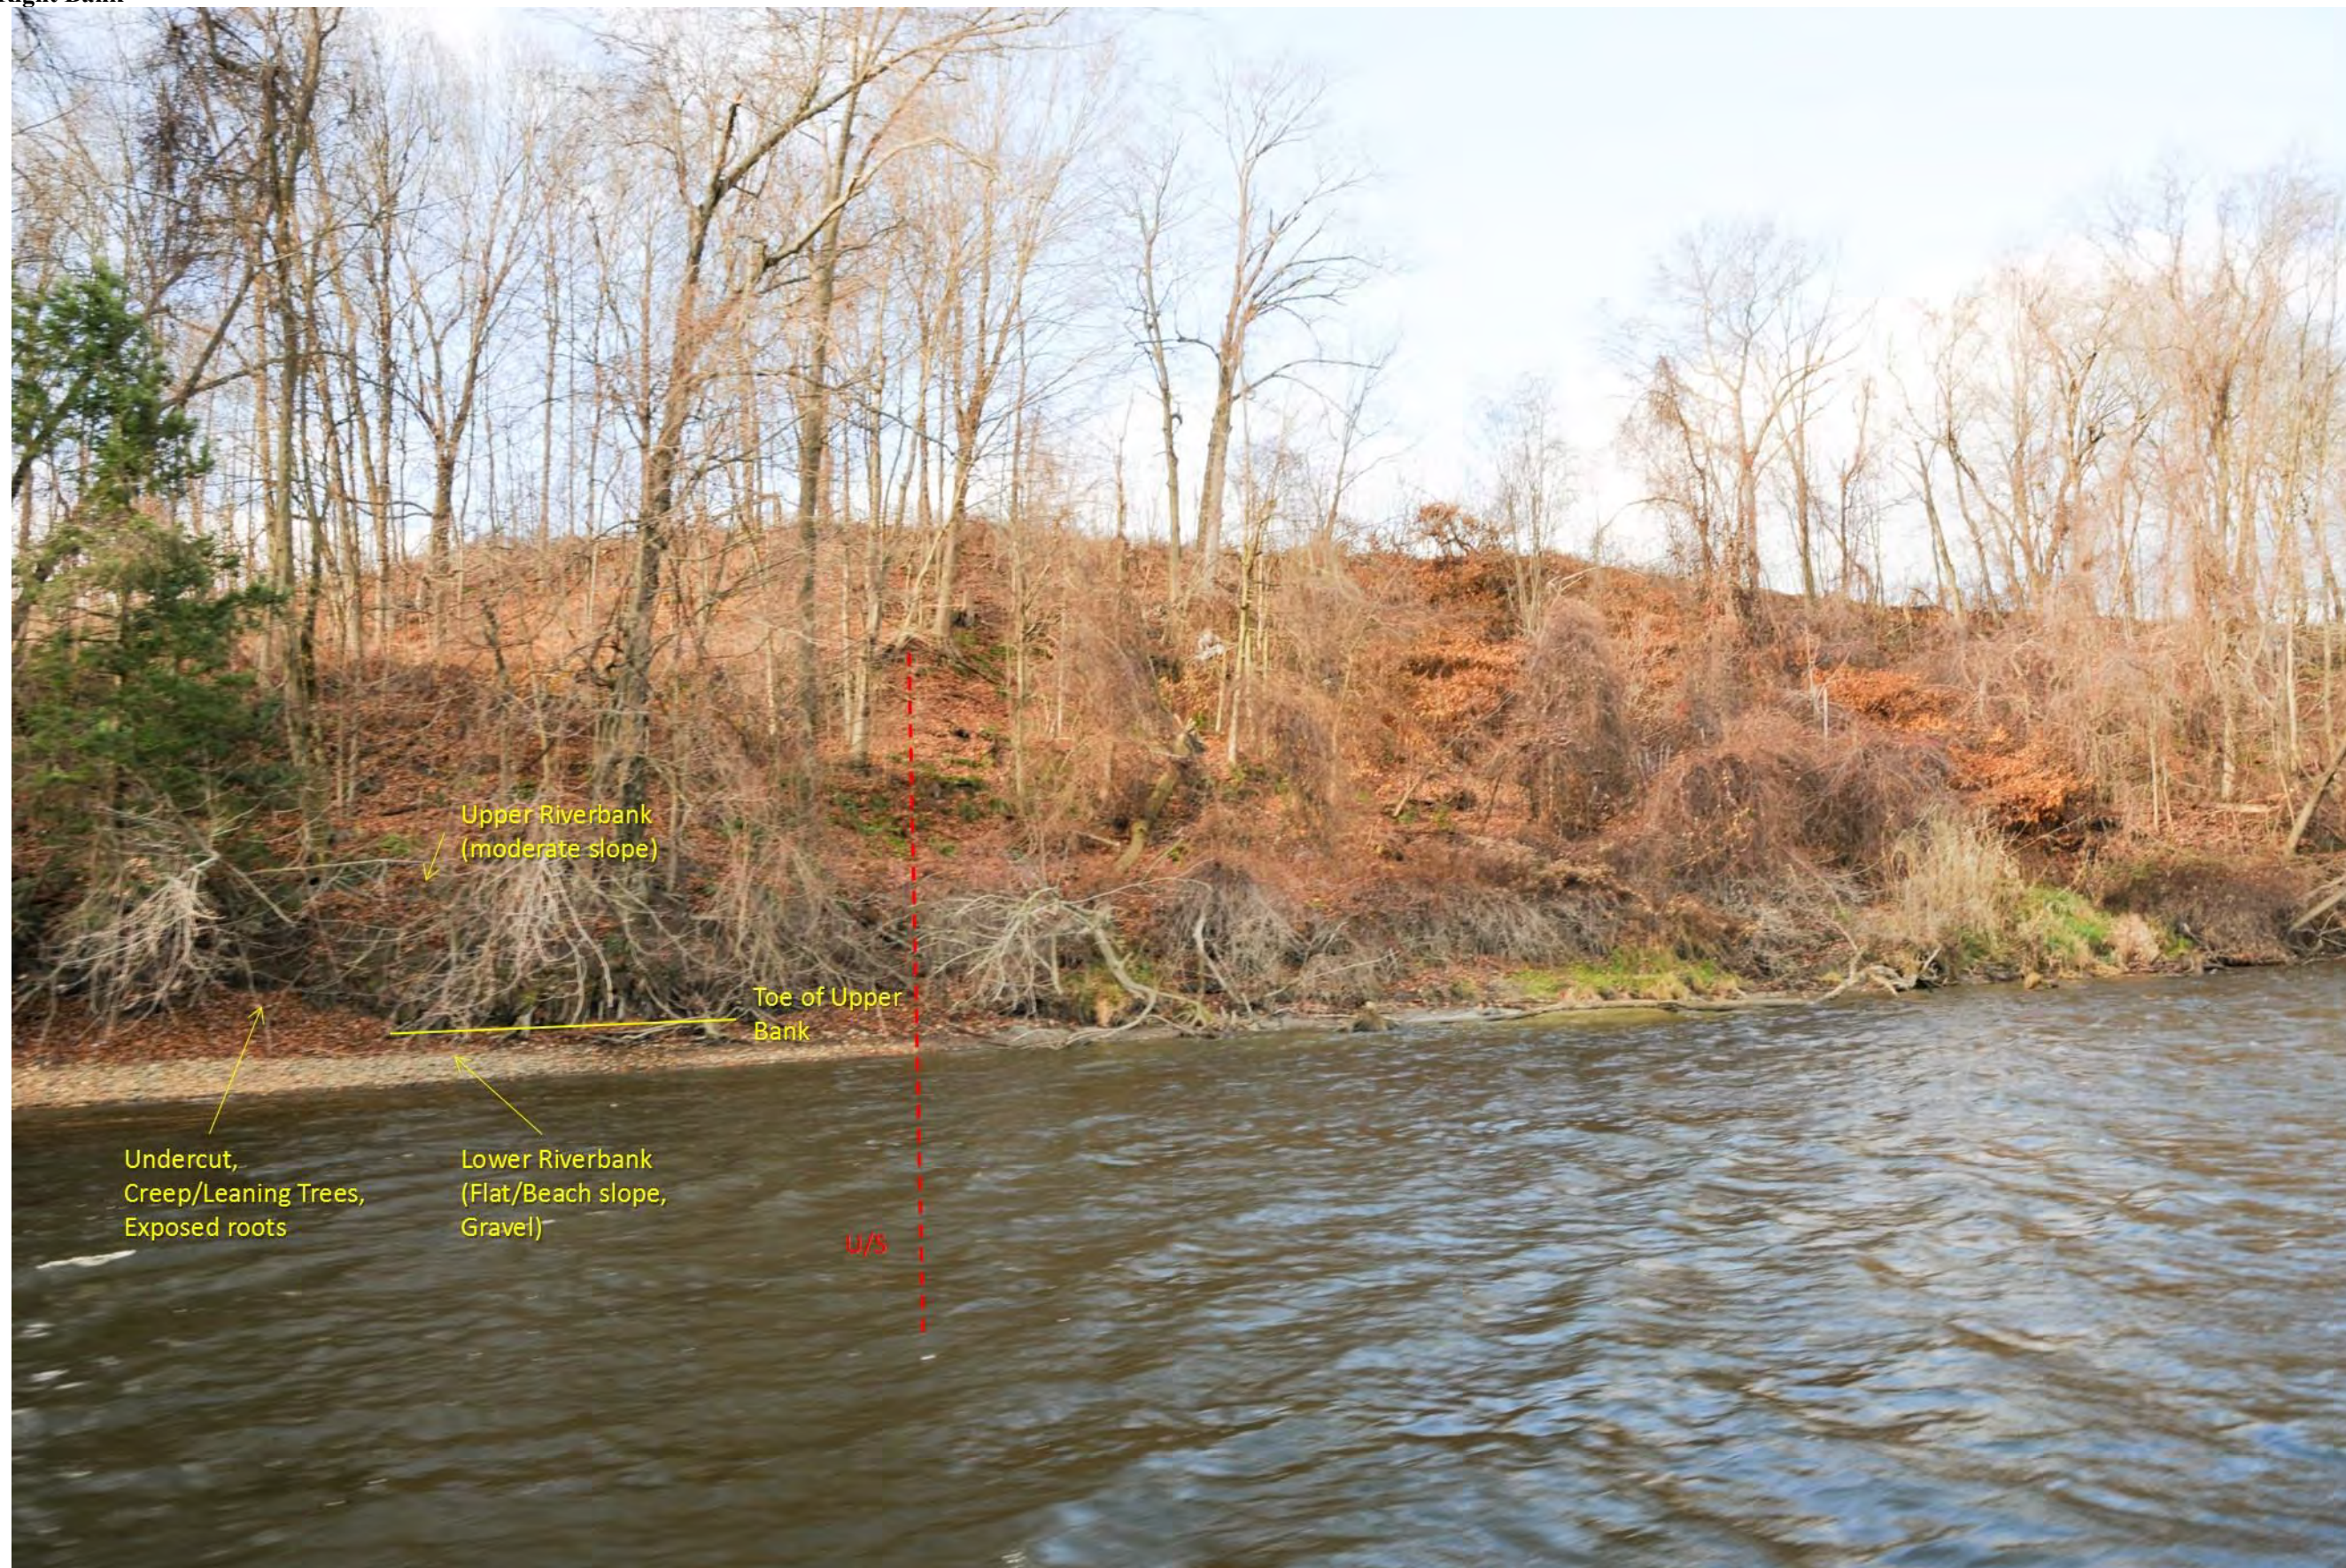
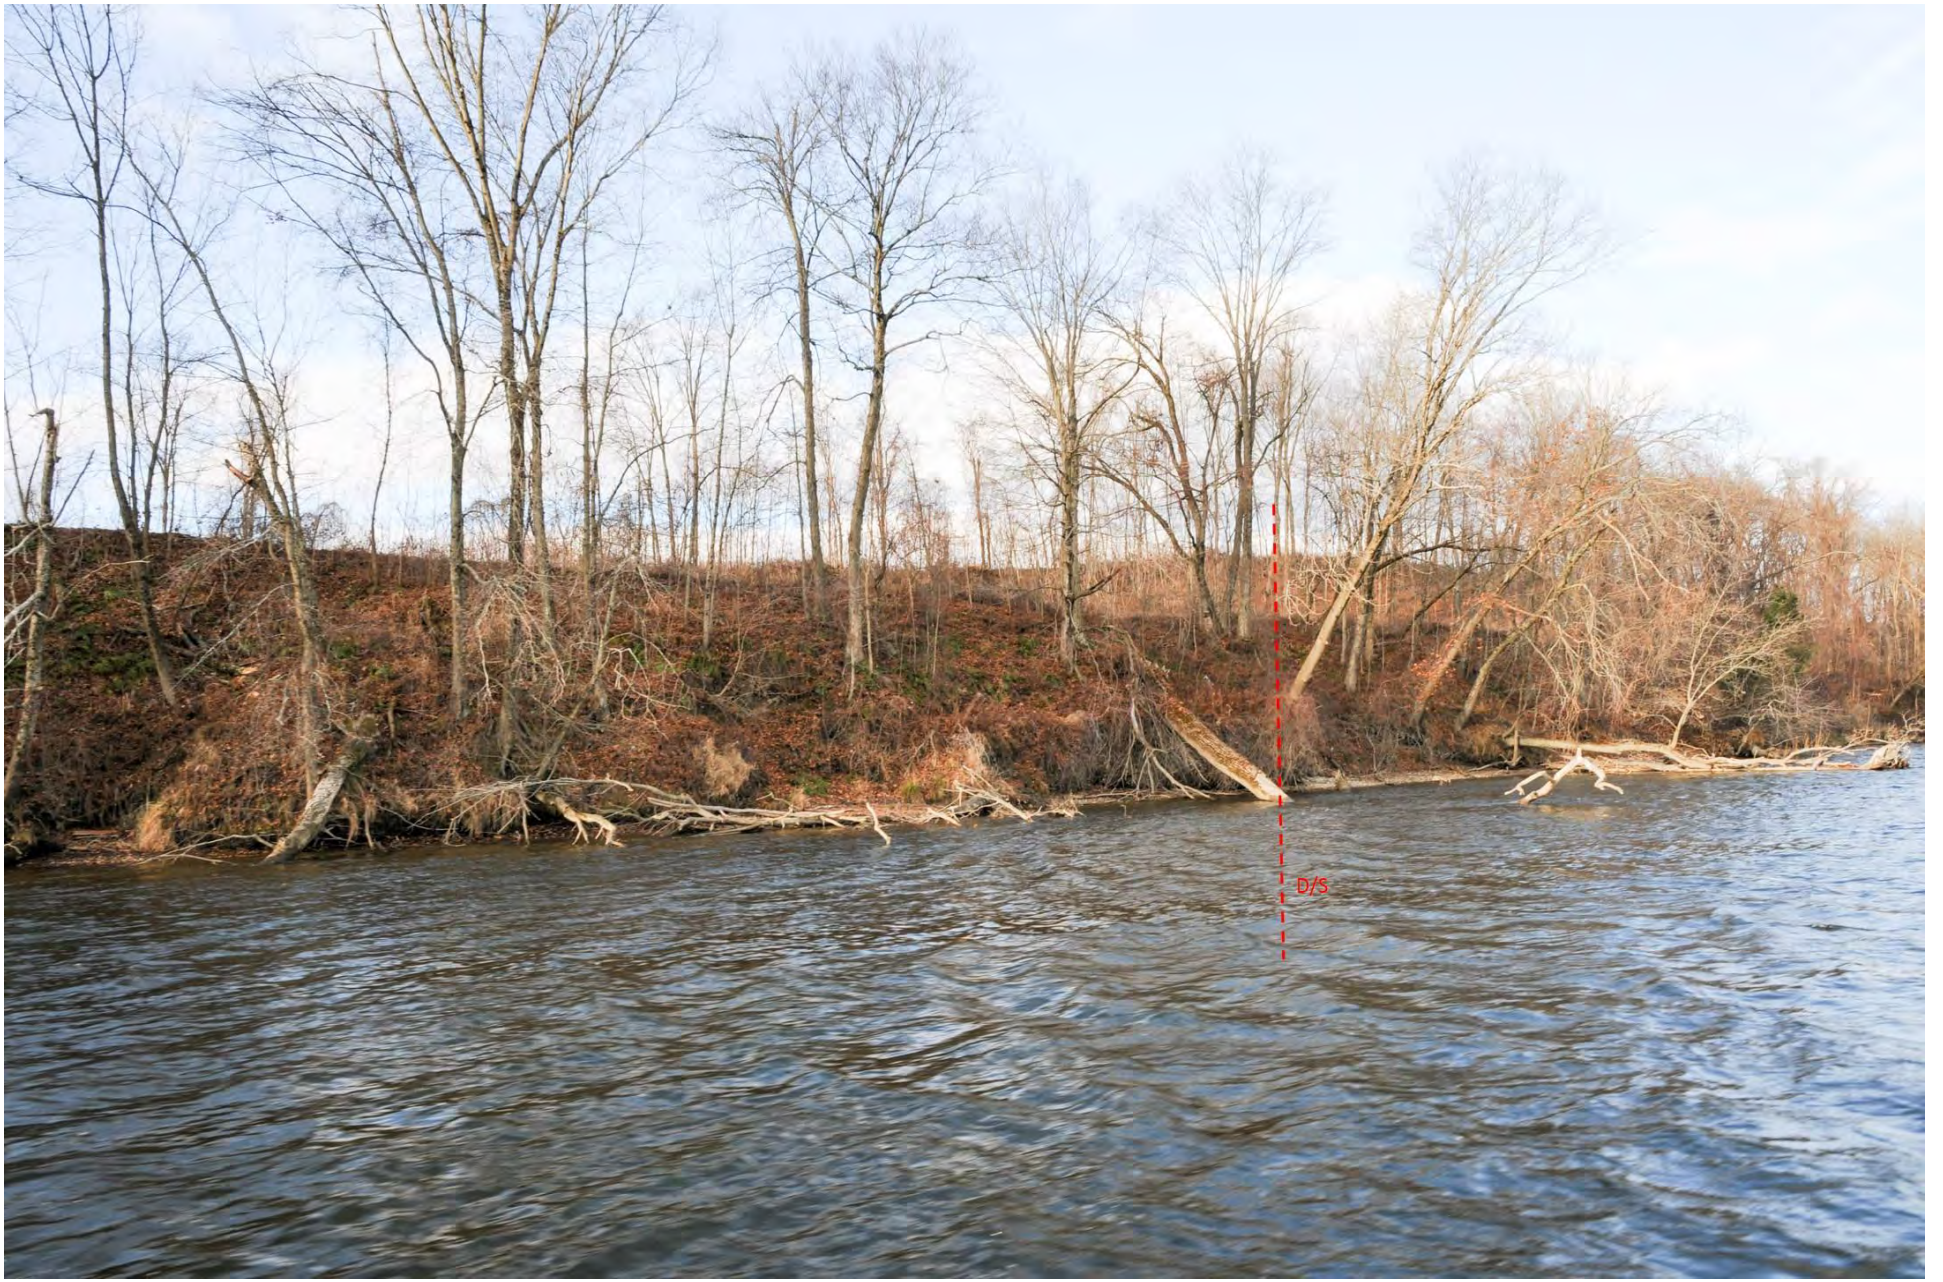
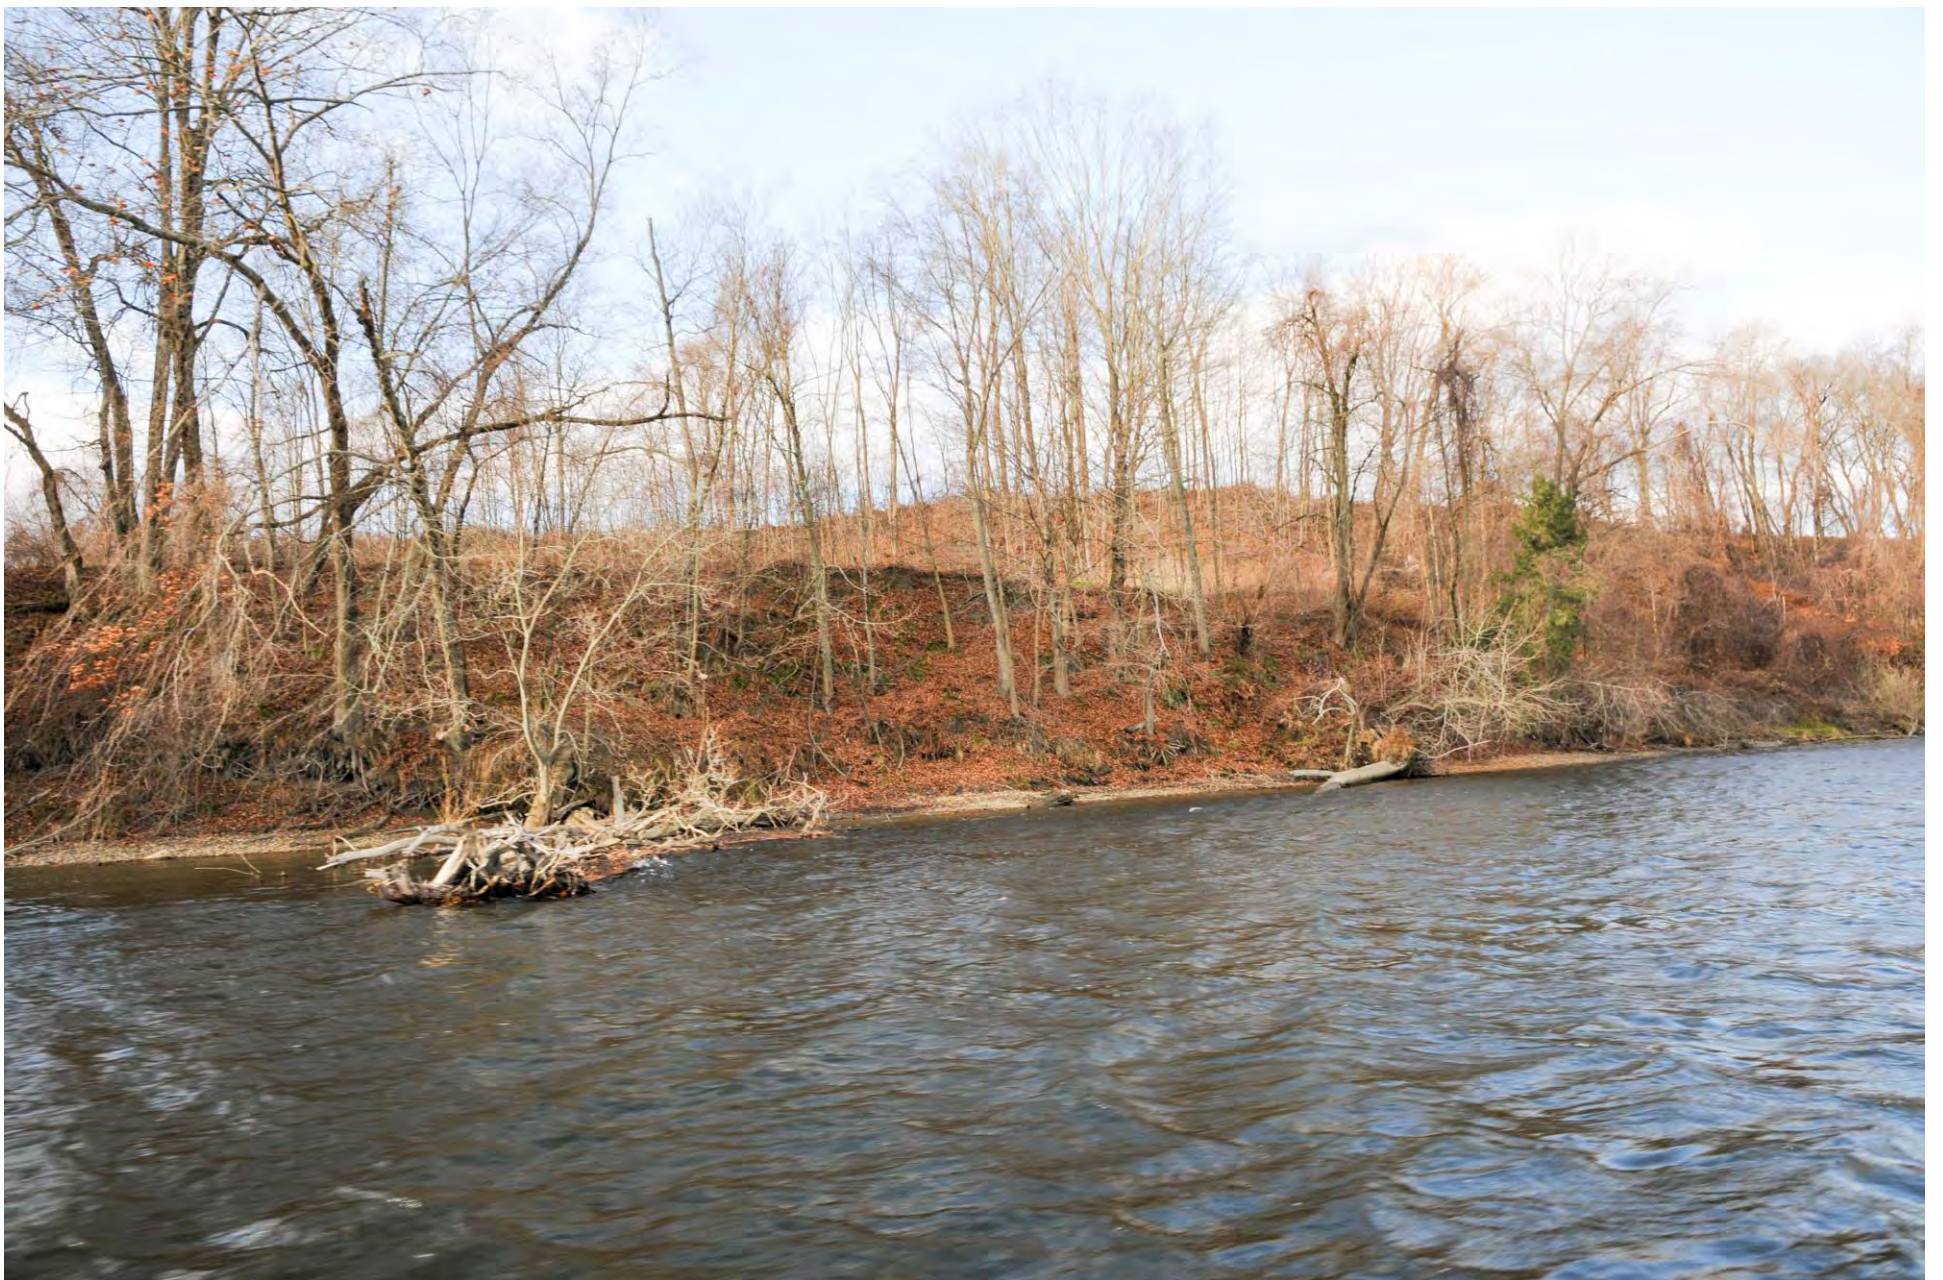
**Segment 530 – Right Bank**

Riverbank Features	Characteristics
Upper Riverbank Slope	Moderate
Upper Riverbank Height	High
Upper Riverbank Sediment	Silt/Sand
Upper Riverbank Vegetation	Heavy
Lower Riverbank Slope	Flat/Beach
Lower Riverbank Sediment	Gravel
Lower Riverbank Vegetation	None to very sparse
Type of Erosion	Undercut
Potential Erosion Indicators	Creep/leaning trees, Exposed roots
Stage of Erosion	Stable
Extent of Erosion	None/Little

**QA Observations:** Upon review of the photos for this segment, classification made in the field was confirmed and additional indicators of potential future erosion were included.
