**FIRSTLIGHT POWER RESOURCES**  
 RELICENSING STUDY 3.1.1  
 2013 FULL RIVER RECONNAISSANCE  
 TURNERS FALLS IMPOUNDMENT

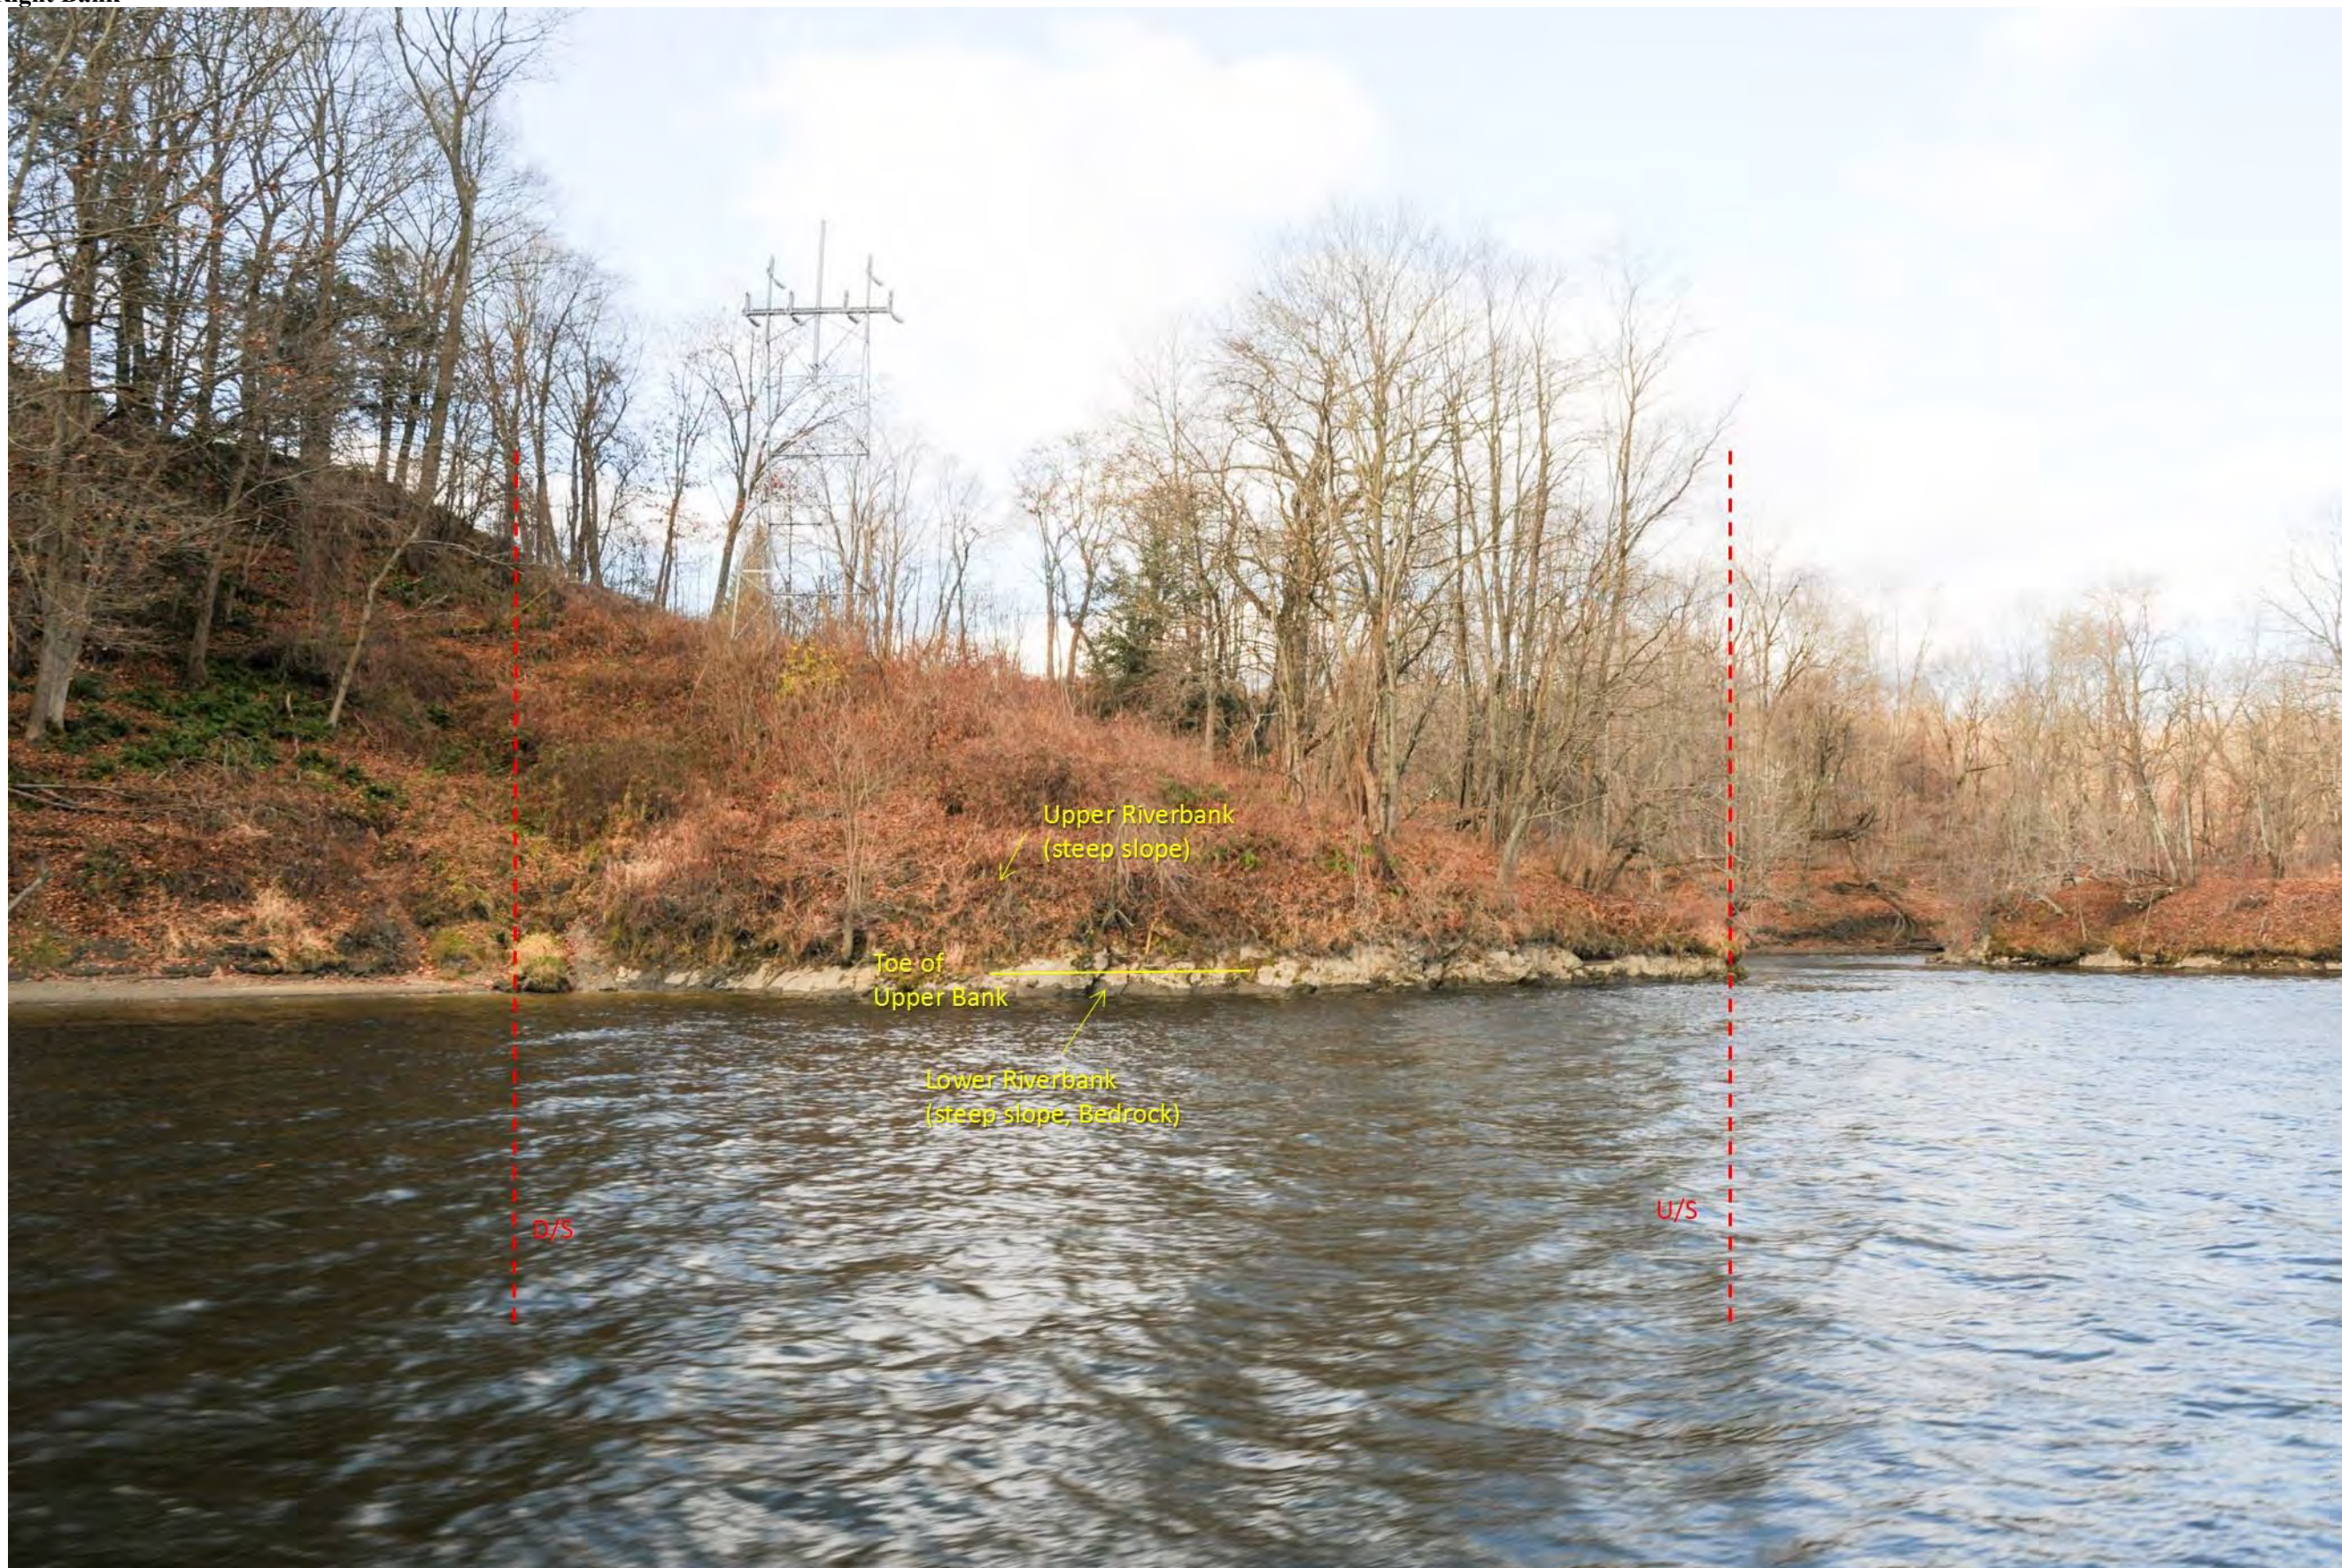
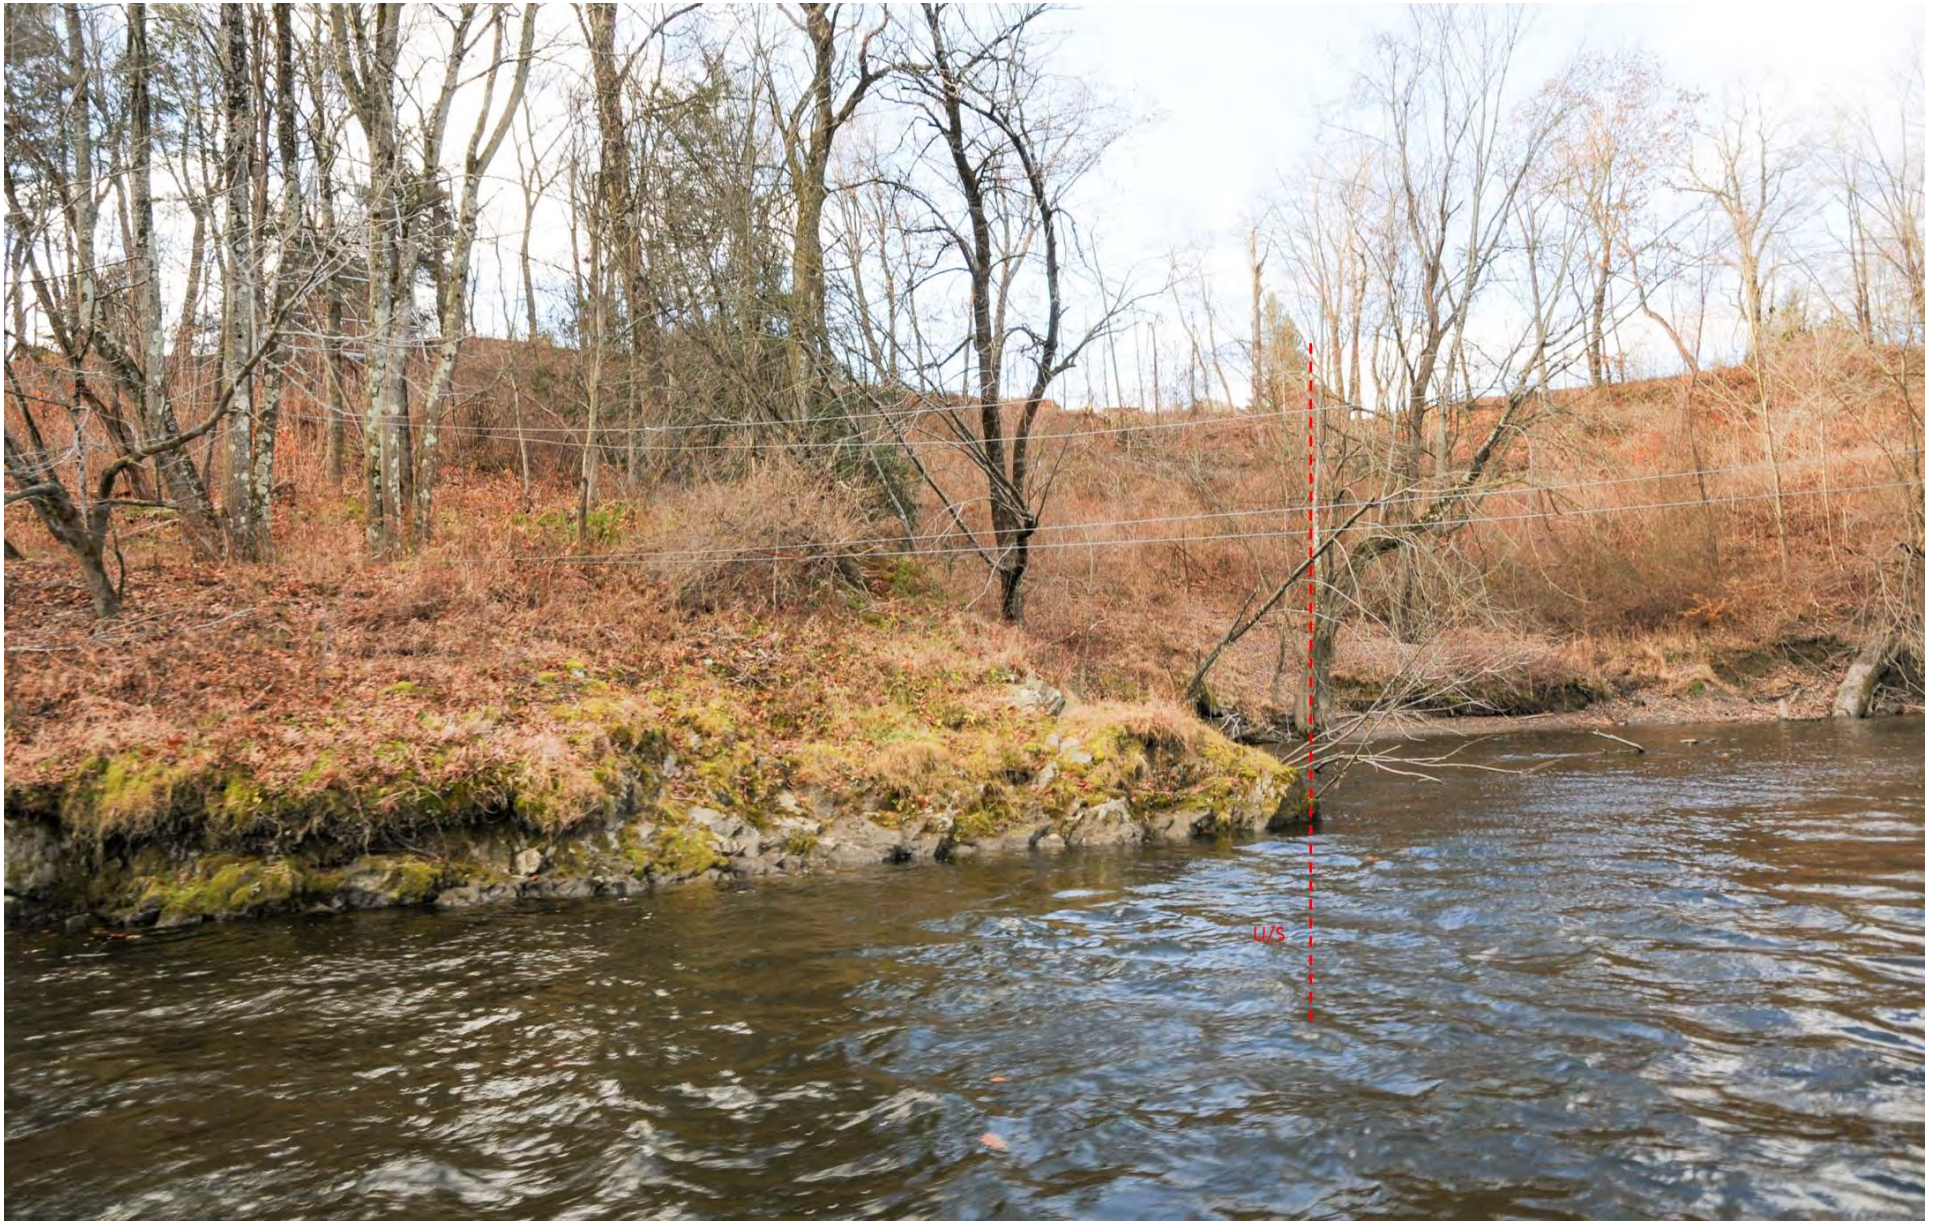
**Segment 540 – Right Bank**

Riverbank Features	Characteristics
Upper Riverbank Slope	Steep
Upper Riverbank Height	High
Upper Riverbank Sediment	Bedrock
Upper Riverbank Vegetation	Moderate
Lower Riverbank Slope	Steep
Lower Riverbank Sediment	Bedrock
Lower Riverbank Vegetation	None to very sparse
Type of Erosion	
Potential Erosion Indicators	None
Stage of Erosion	Stable
Extent of Erosion	None/Little

**QA Observations:** Upon review of the photos for this segment, classification made in the field was confirmed.

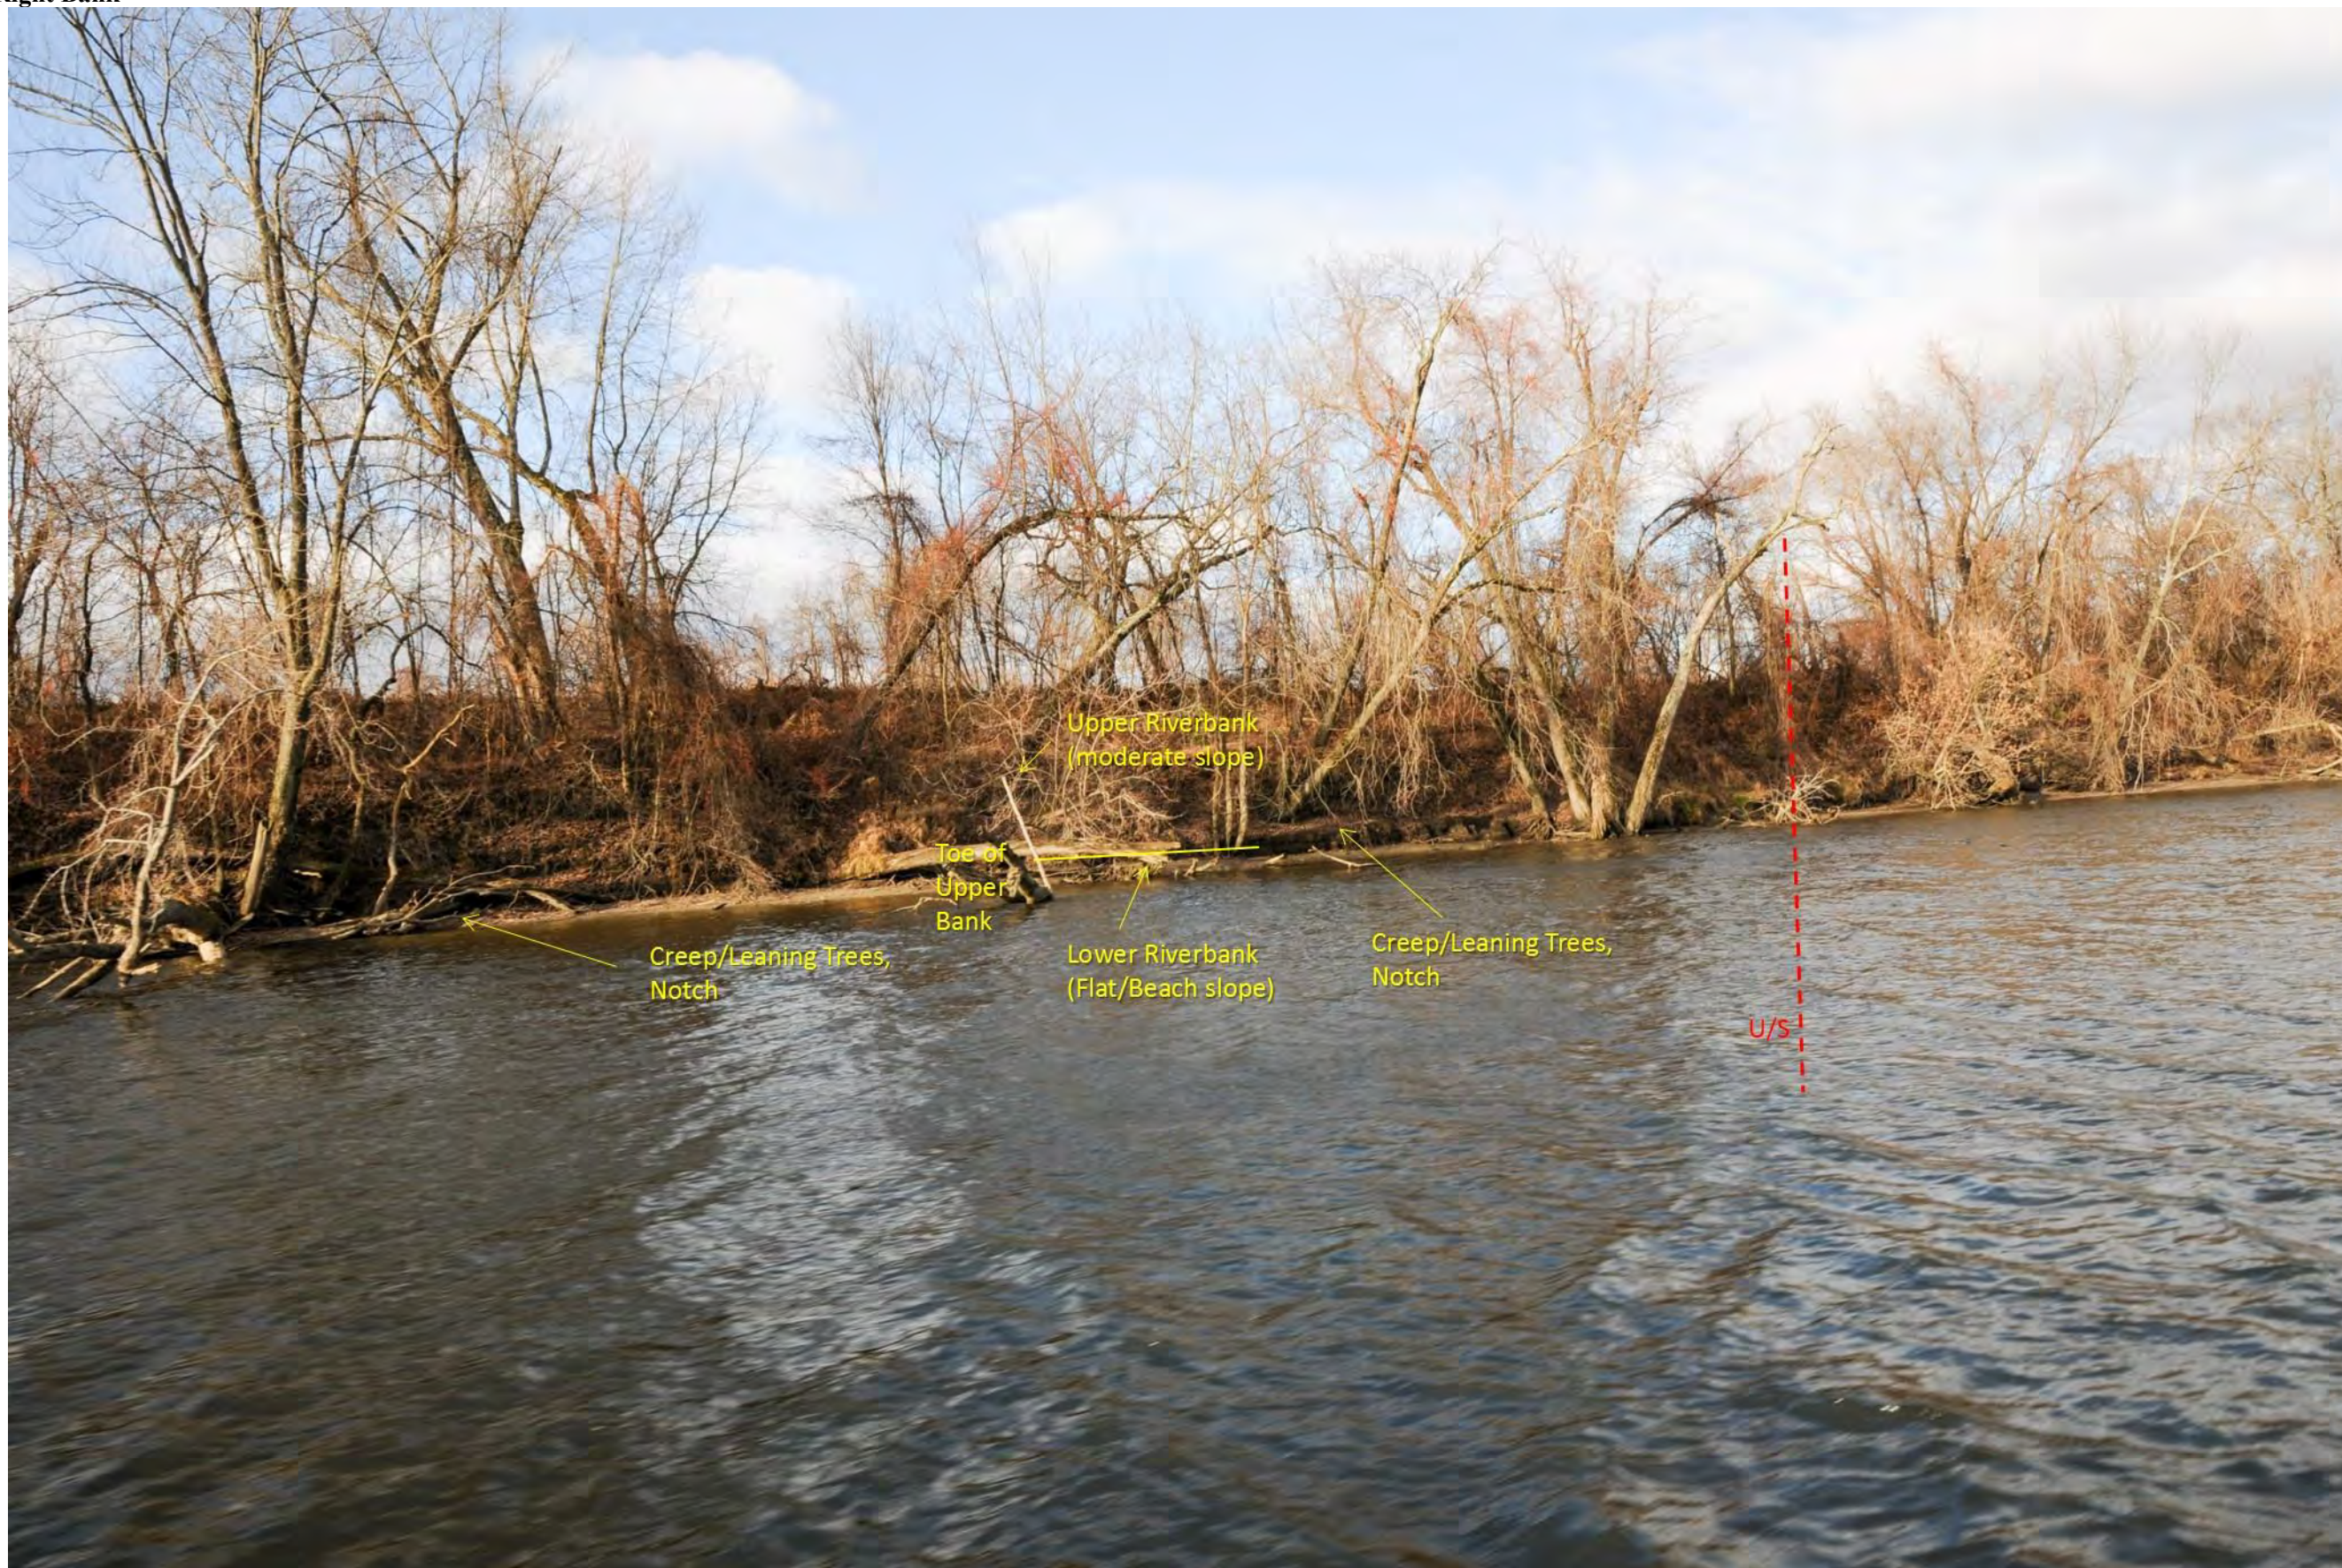
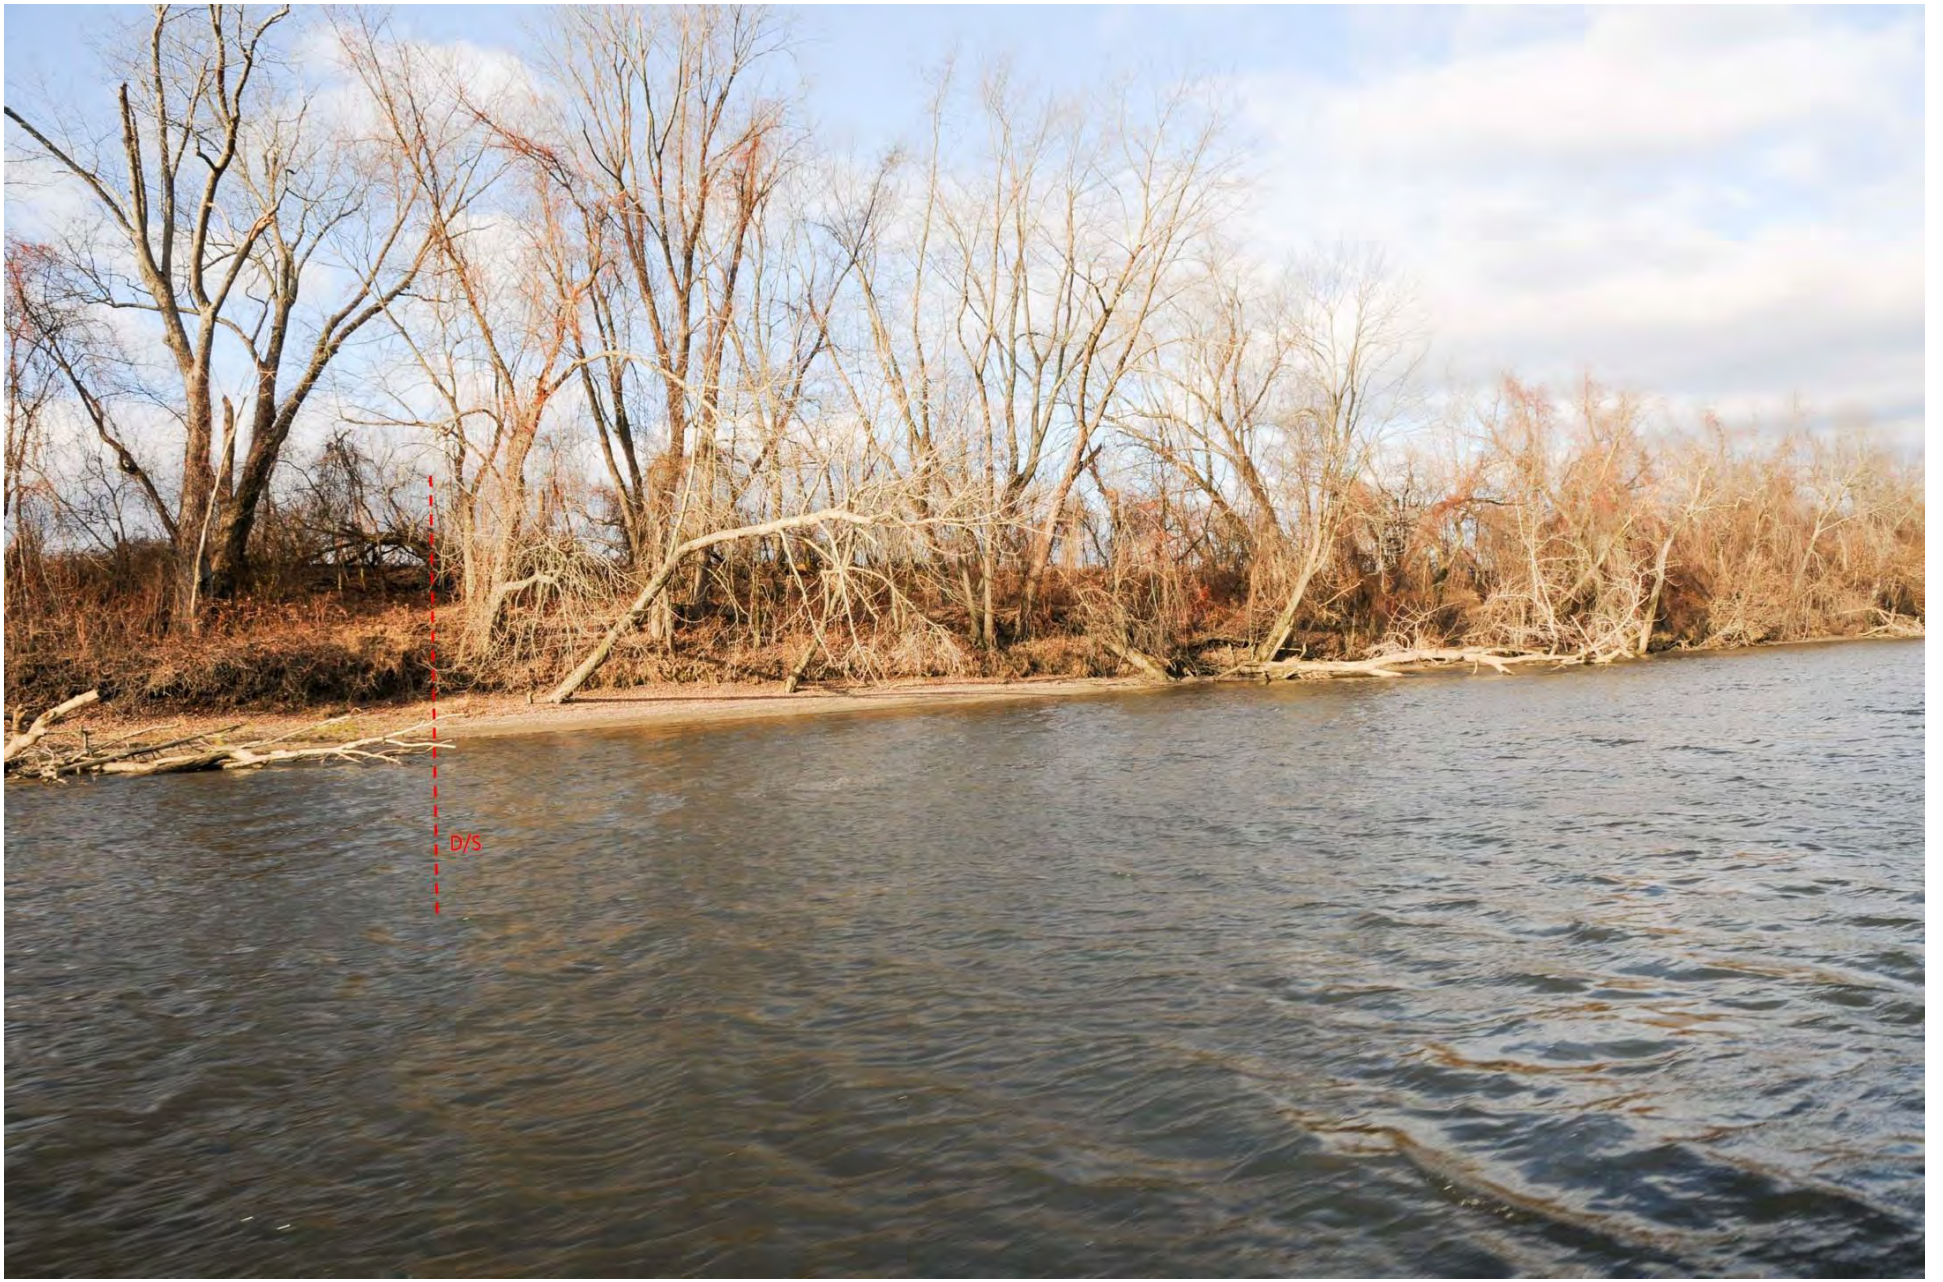
**Segment 550 – Right Bank**

Riverbank Features	Characteristics
Upper Riverbank Slope	Moderate
Upper Riverbank Height	High
Upper Riverbank Sediment	Silt/Sand
Upper Riverbank Vegetation	Heavy
Lower Riverbank Slope	Flat/Beach
Lower Riverbank Sediment	Silt/Sand
Lower Riverbank Vegetation	None to very sparse
Type of Erosion	
Potential Erosion Indicators	Creep/leaning trees, Notch
Stage of Erosion	Stable
Extent of Erosion	None/Little

**QA Observations:** Upon review of the photos for this segment, classification made in the field was confirmed and additional indicators of potential future erosion were included.

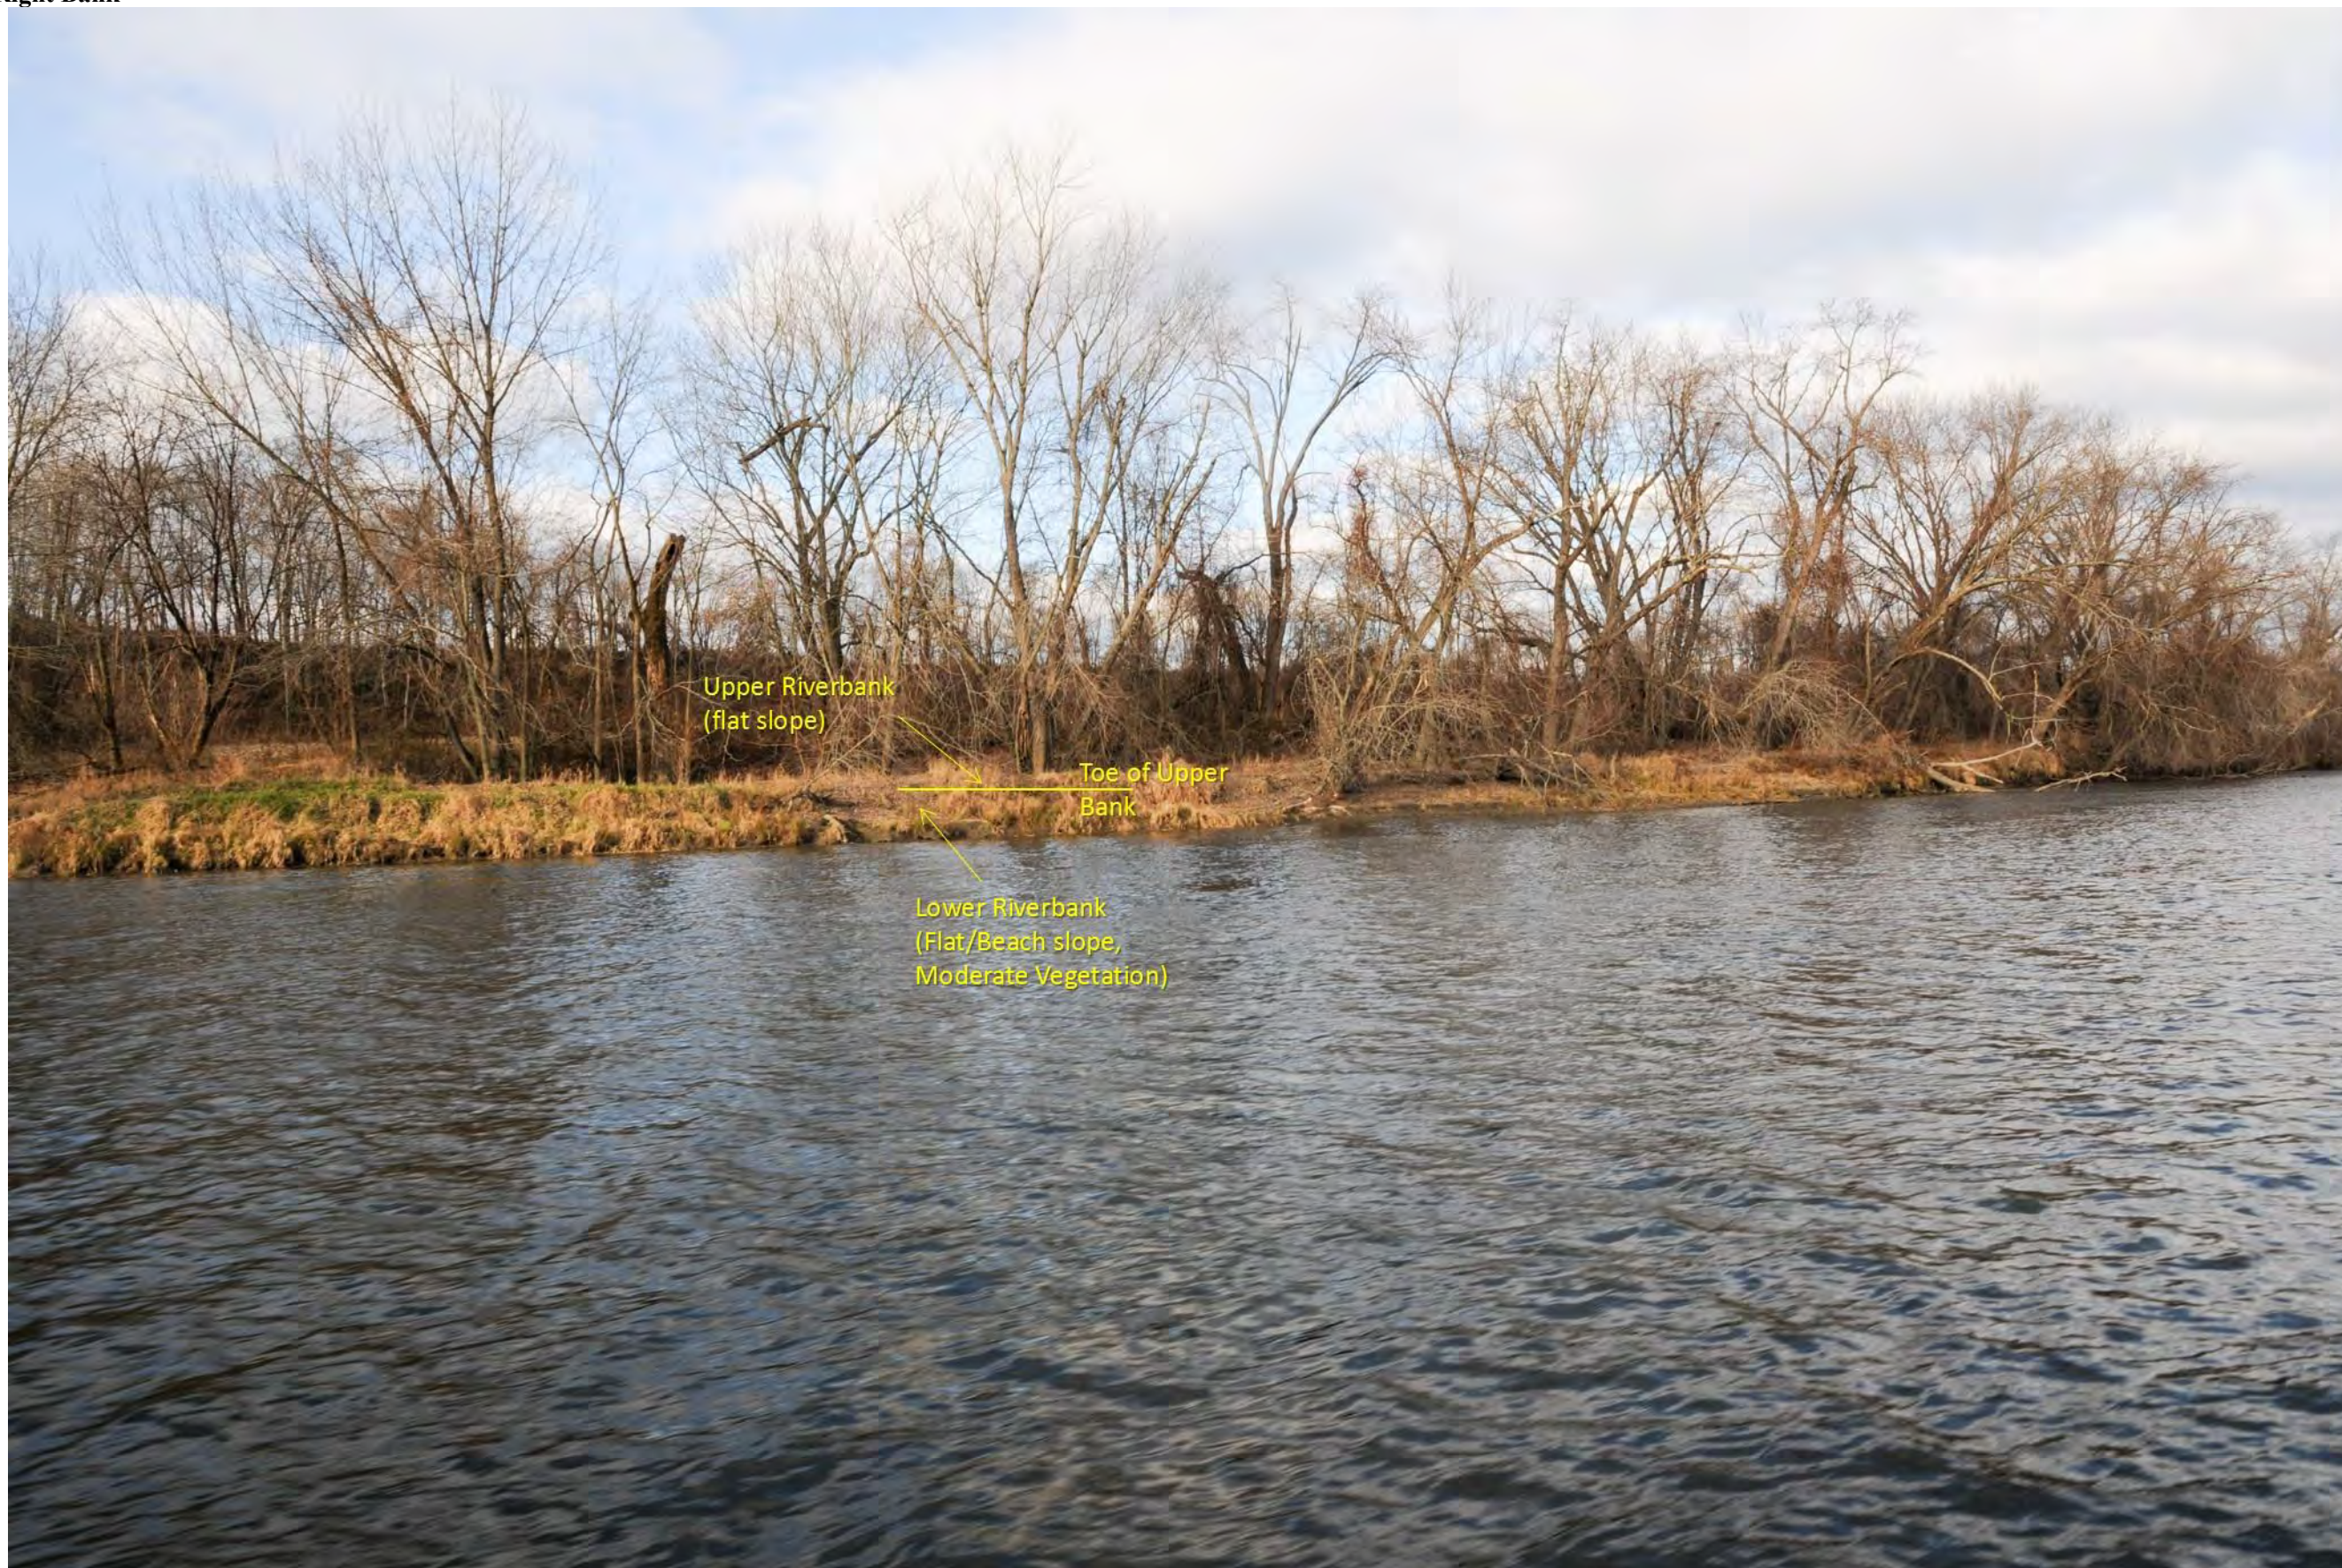
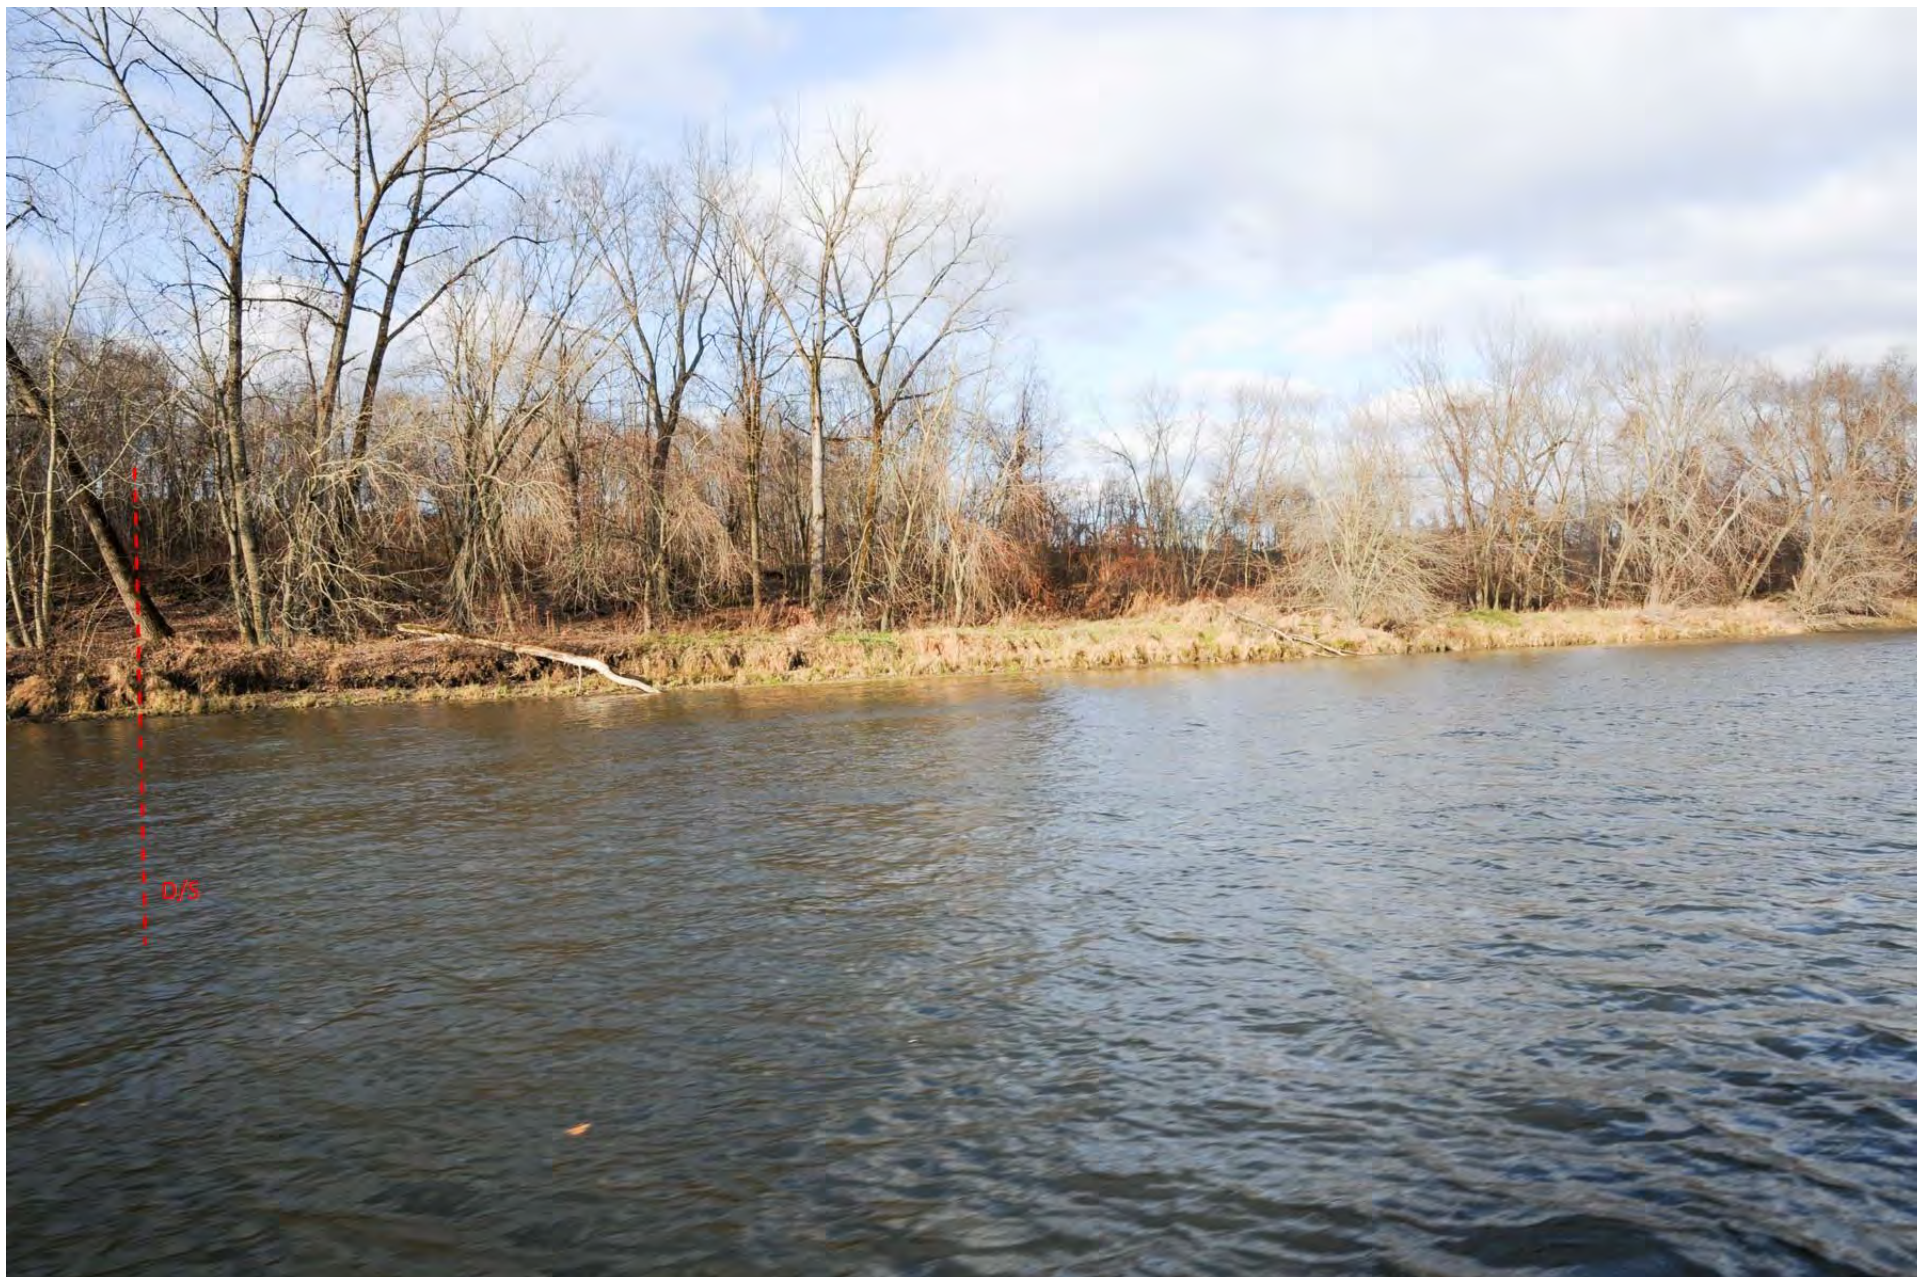
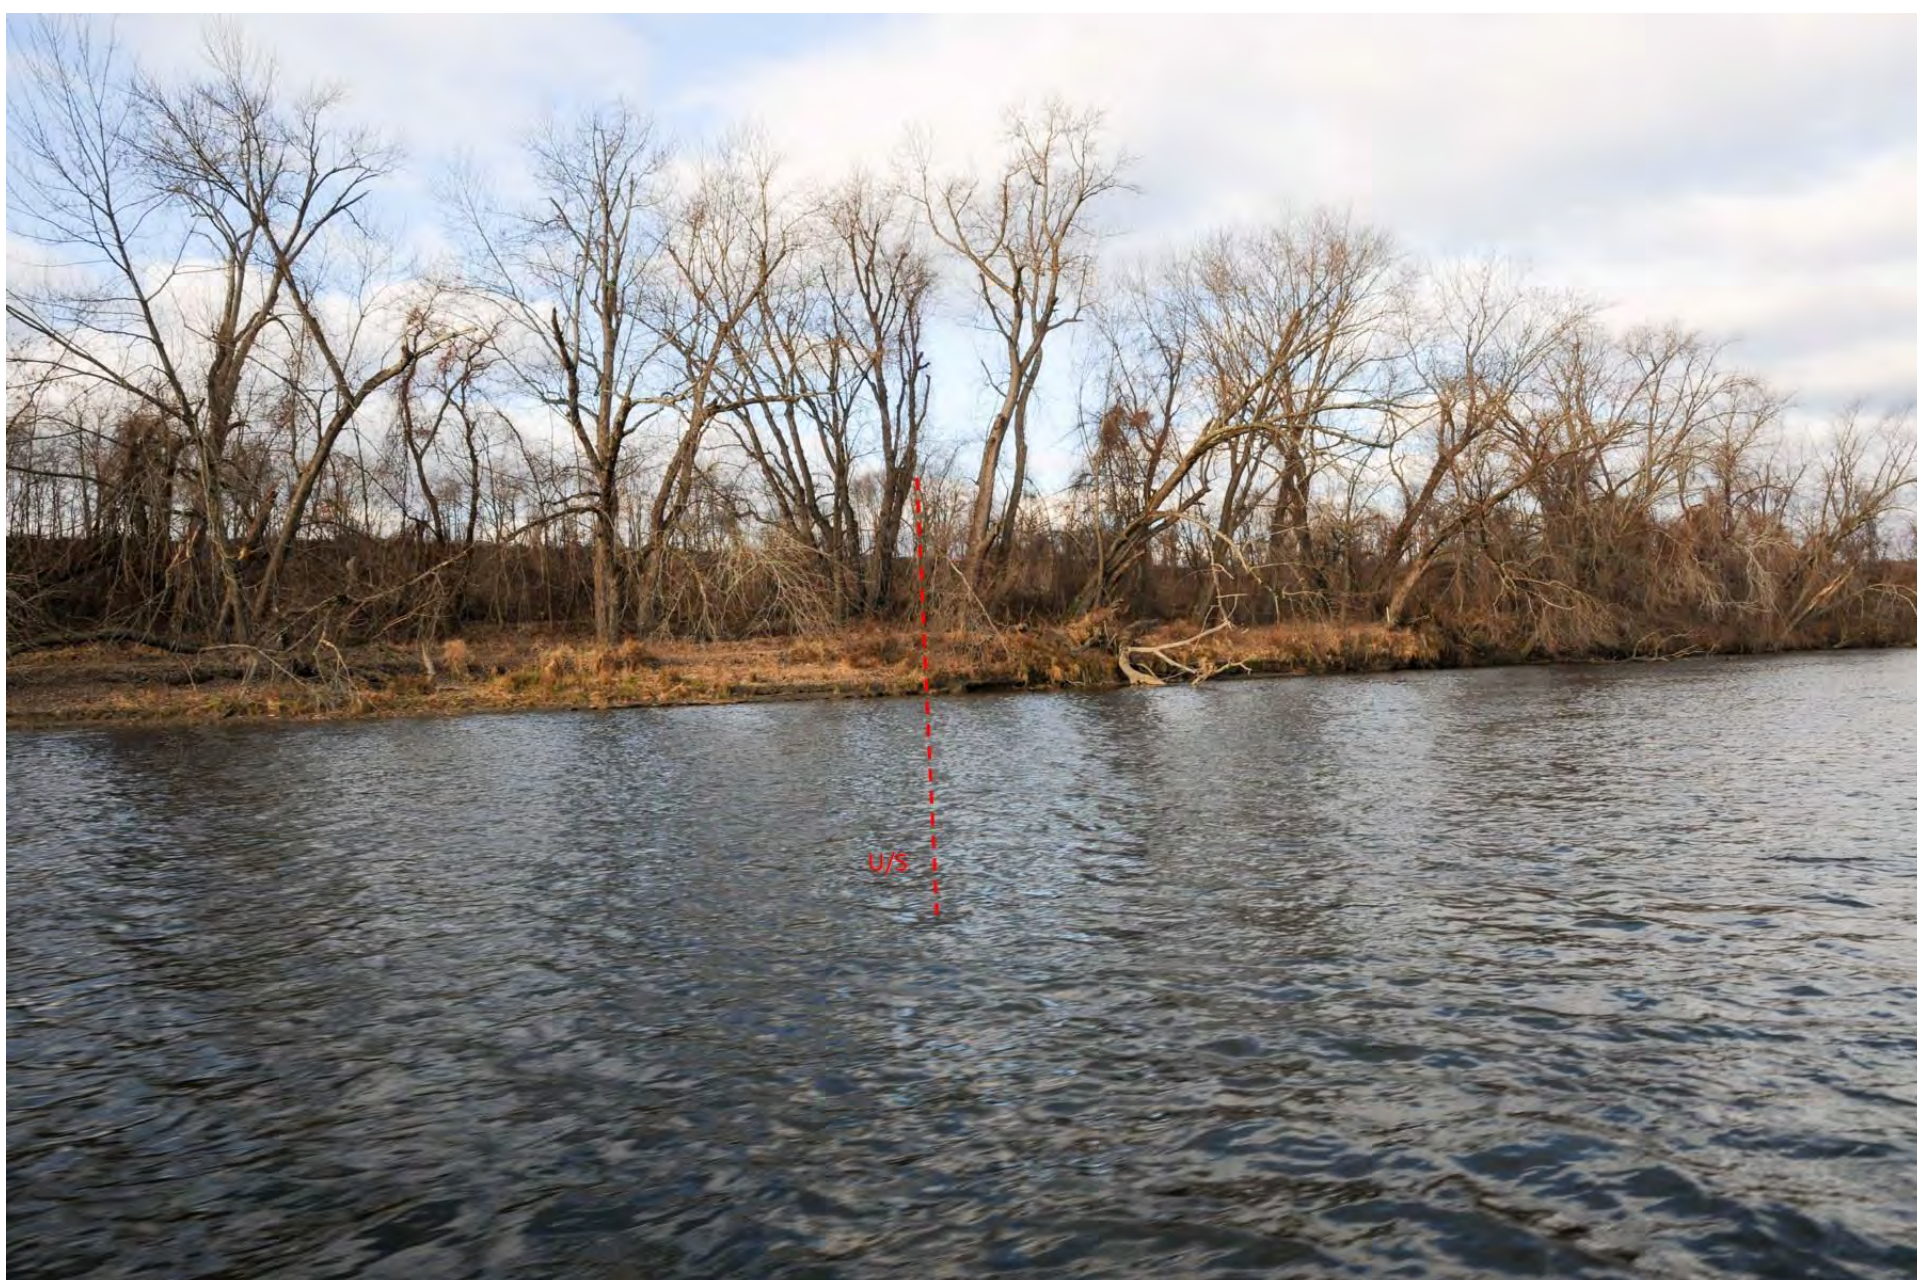
**Segment 560 – Right Bank**

Riverbank Features	Characteristics
Upper Riverbank Slope	Flat
Upper Riverbank Height	Low
Upper Riverbank Sediment	Silt/Sand
Upper Riverbank Vegetation	Moderate
Lower Riverbank Slope	Flat/Beach
Lower Riverbank Sediment	Silt/Sand
Lower Riverbank Vegetation	Moderate
Type of Erosion	
Potential Erosion Indicators	None
Stage of Erosion	Stable
Extent of Erosion	None/Little

**QA Observations:** Upon review of the photos for this segment, classification made in the field was confirmed.
