**FIRSTLIGHT POWER RESOURCES**  
 RELICENSING STUDY 3.1.1  
 2013 FULL RIVER RECONNAISSANCE  
 TURNERS FALLS IMPOUNDMENT

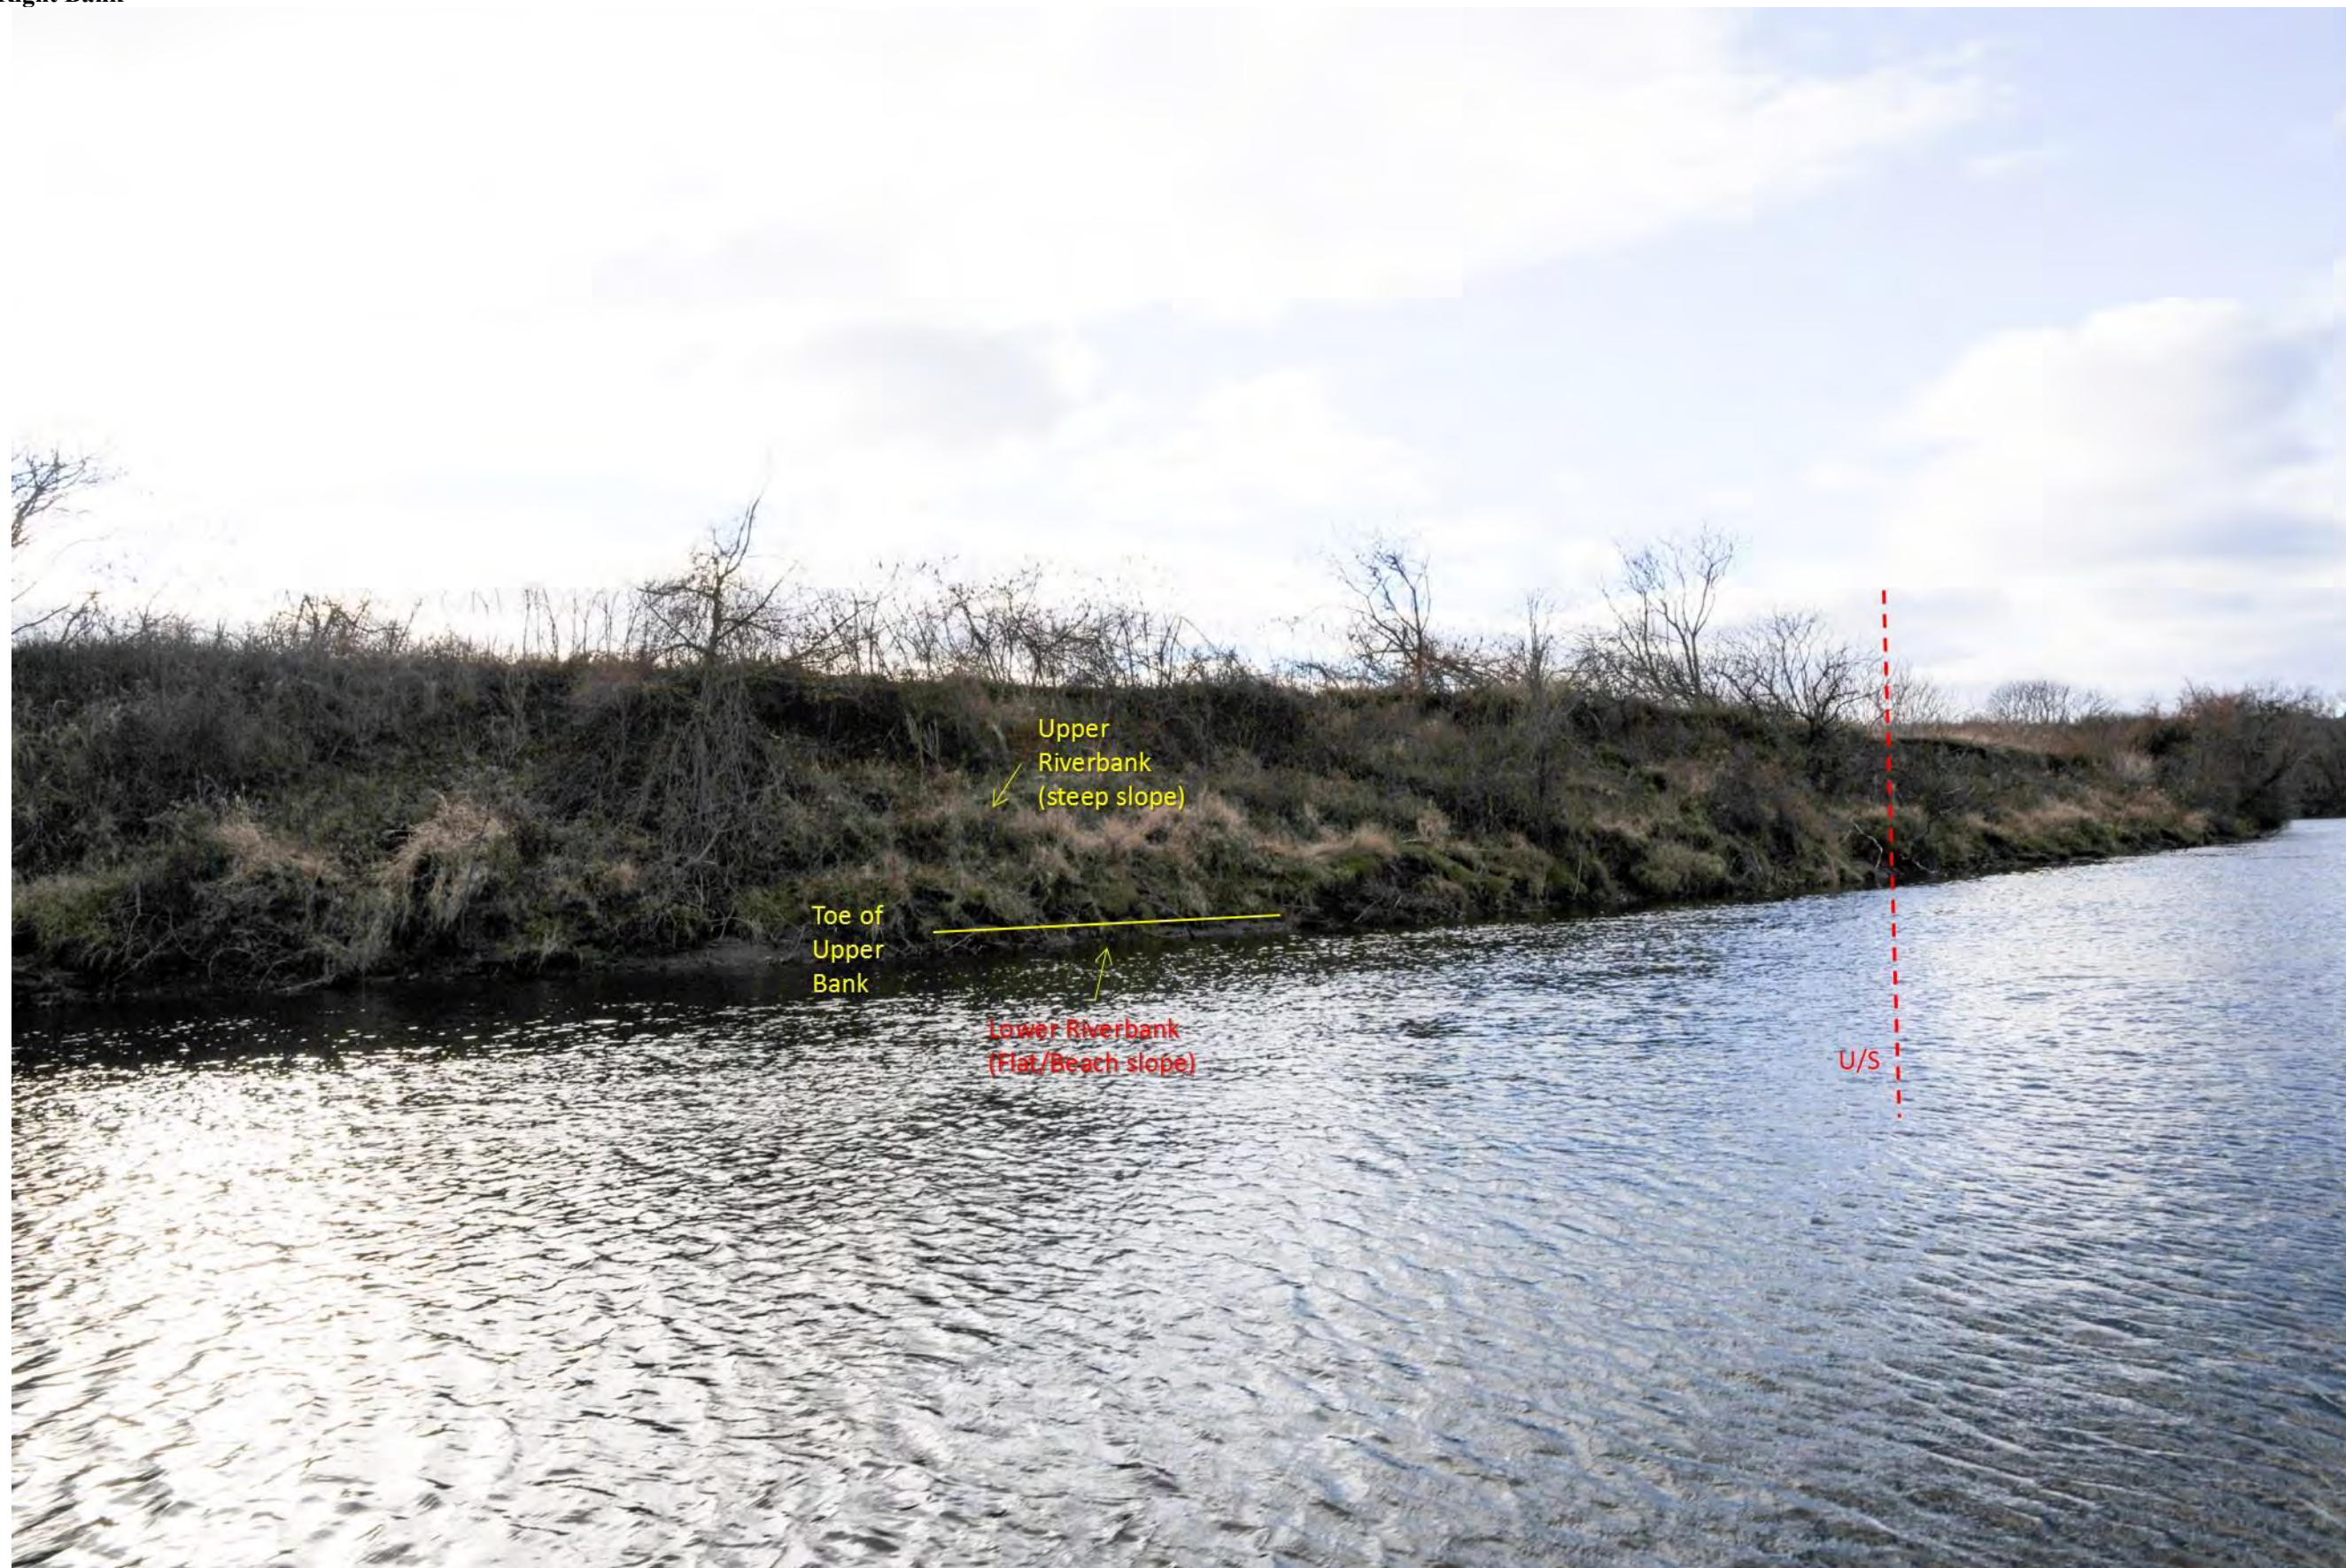
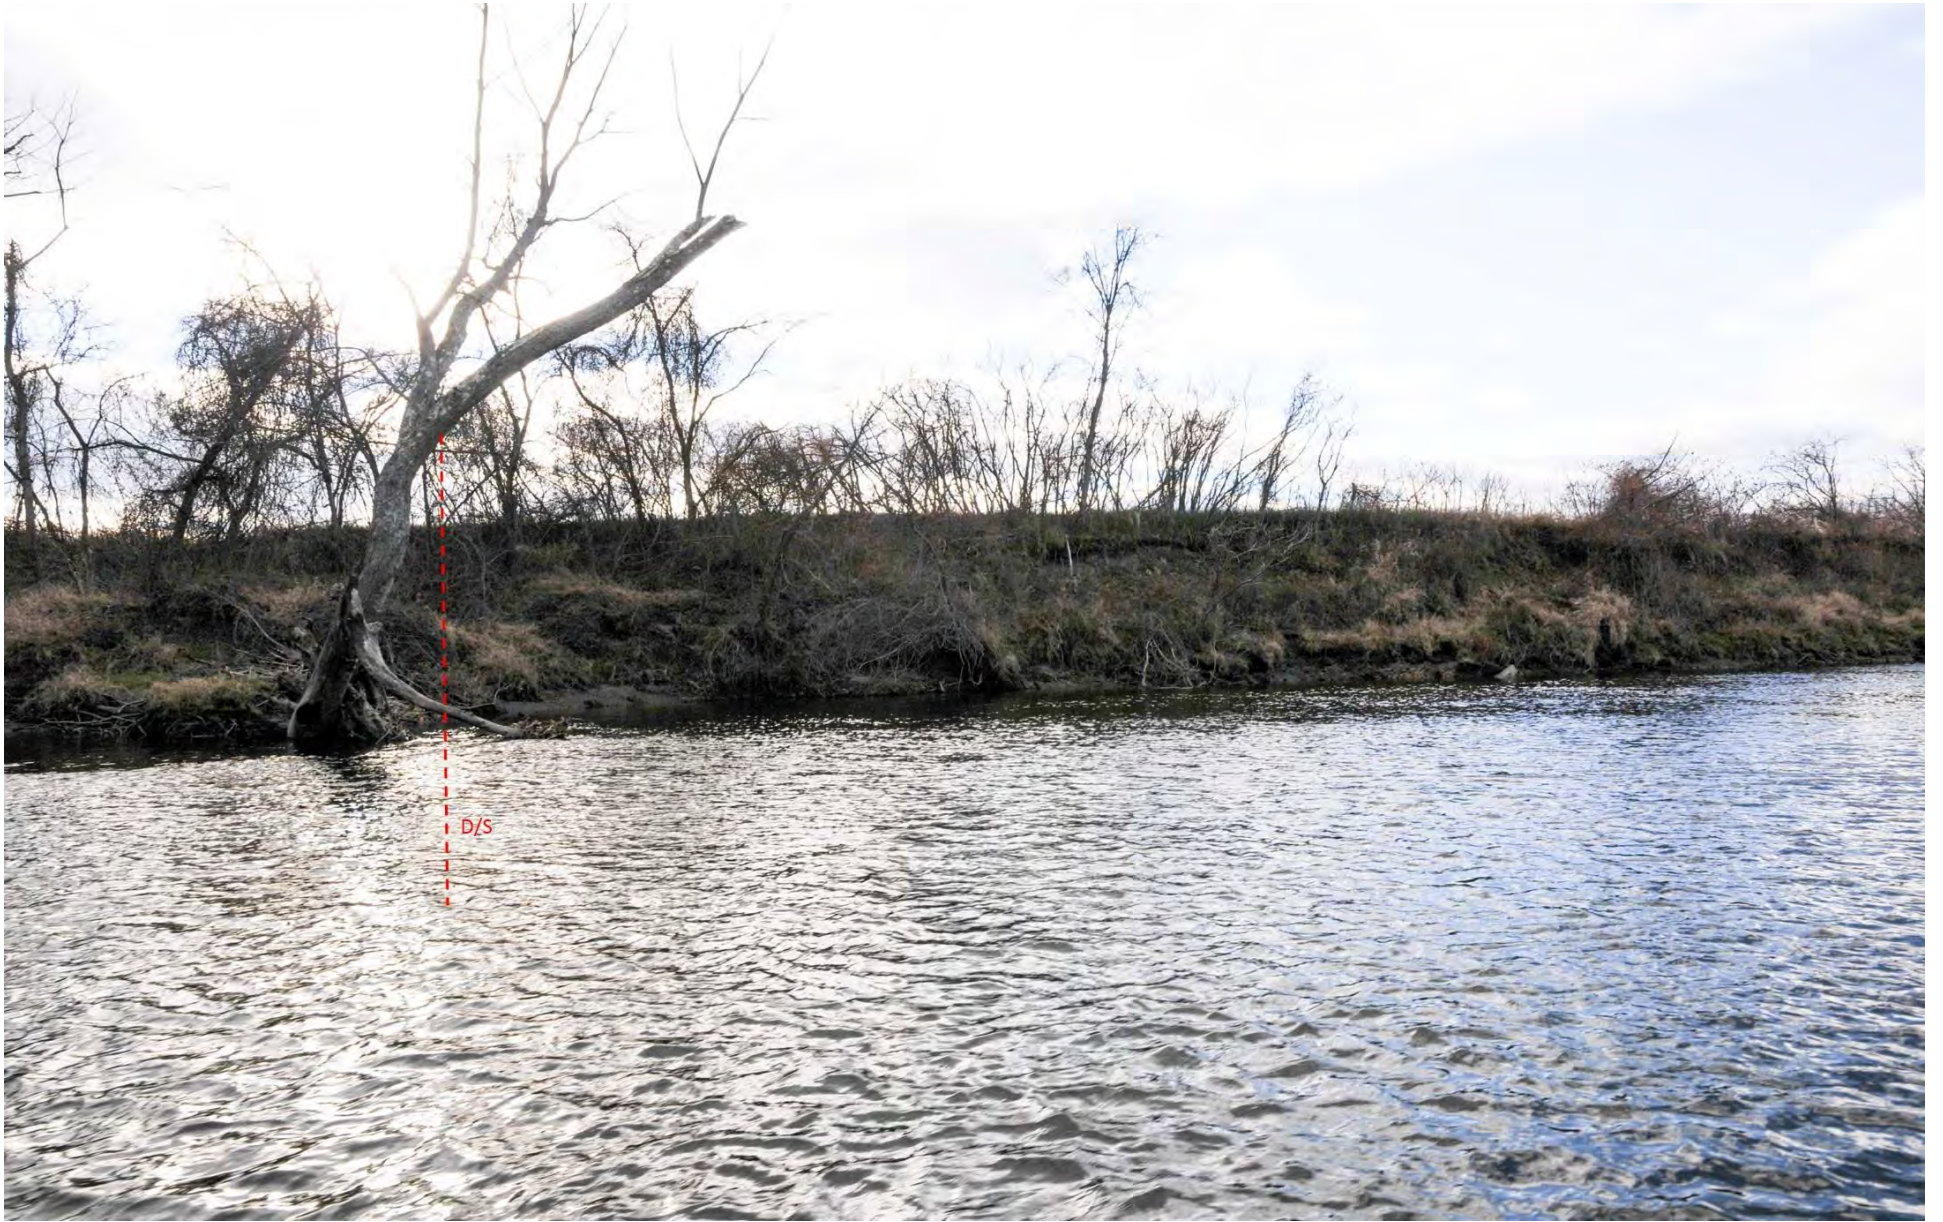
**Segment 570 – Right Bank**

Riverbank Features	Characteristics
Upper Riverbank Slope	Steep
Upper Riverbank Height	High
Upper Riverbank Sediment	Silt/Sand
Upper Riverbank Vegetation	Heavy
Lower Riverbank Slope	Flat/Beach
Lower Riverbank Sediment	Silt/Sand
Lower Riverbank Vegetation	None to very sparse
Type of Erosion	
Potential Erosion Indicators	None
Stage of Erosion	Stable
Extent of Erosion	None/Little

**QA Observations:** Upon review of the photos for this segment, classification made in the field was confirmed.

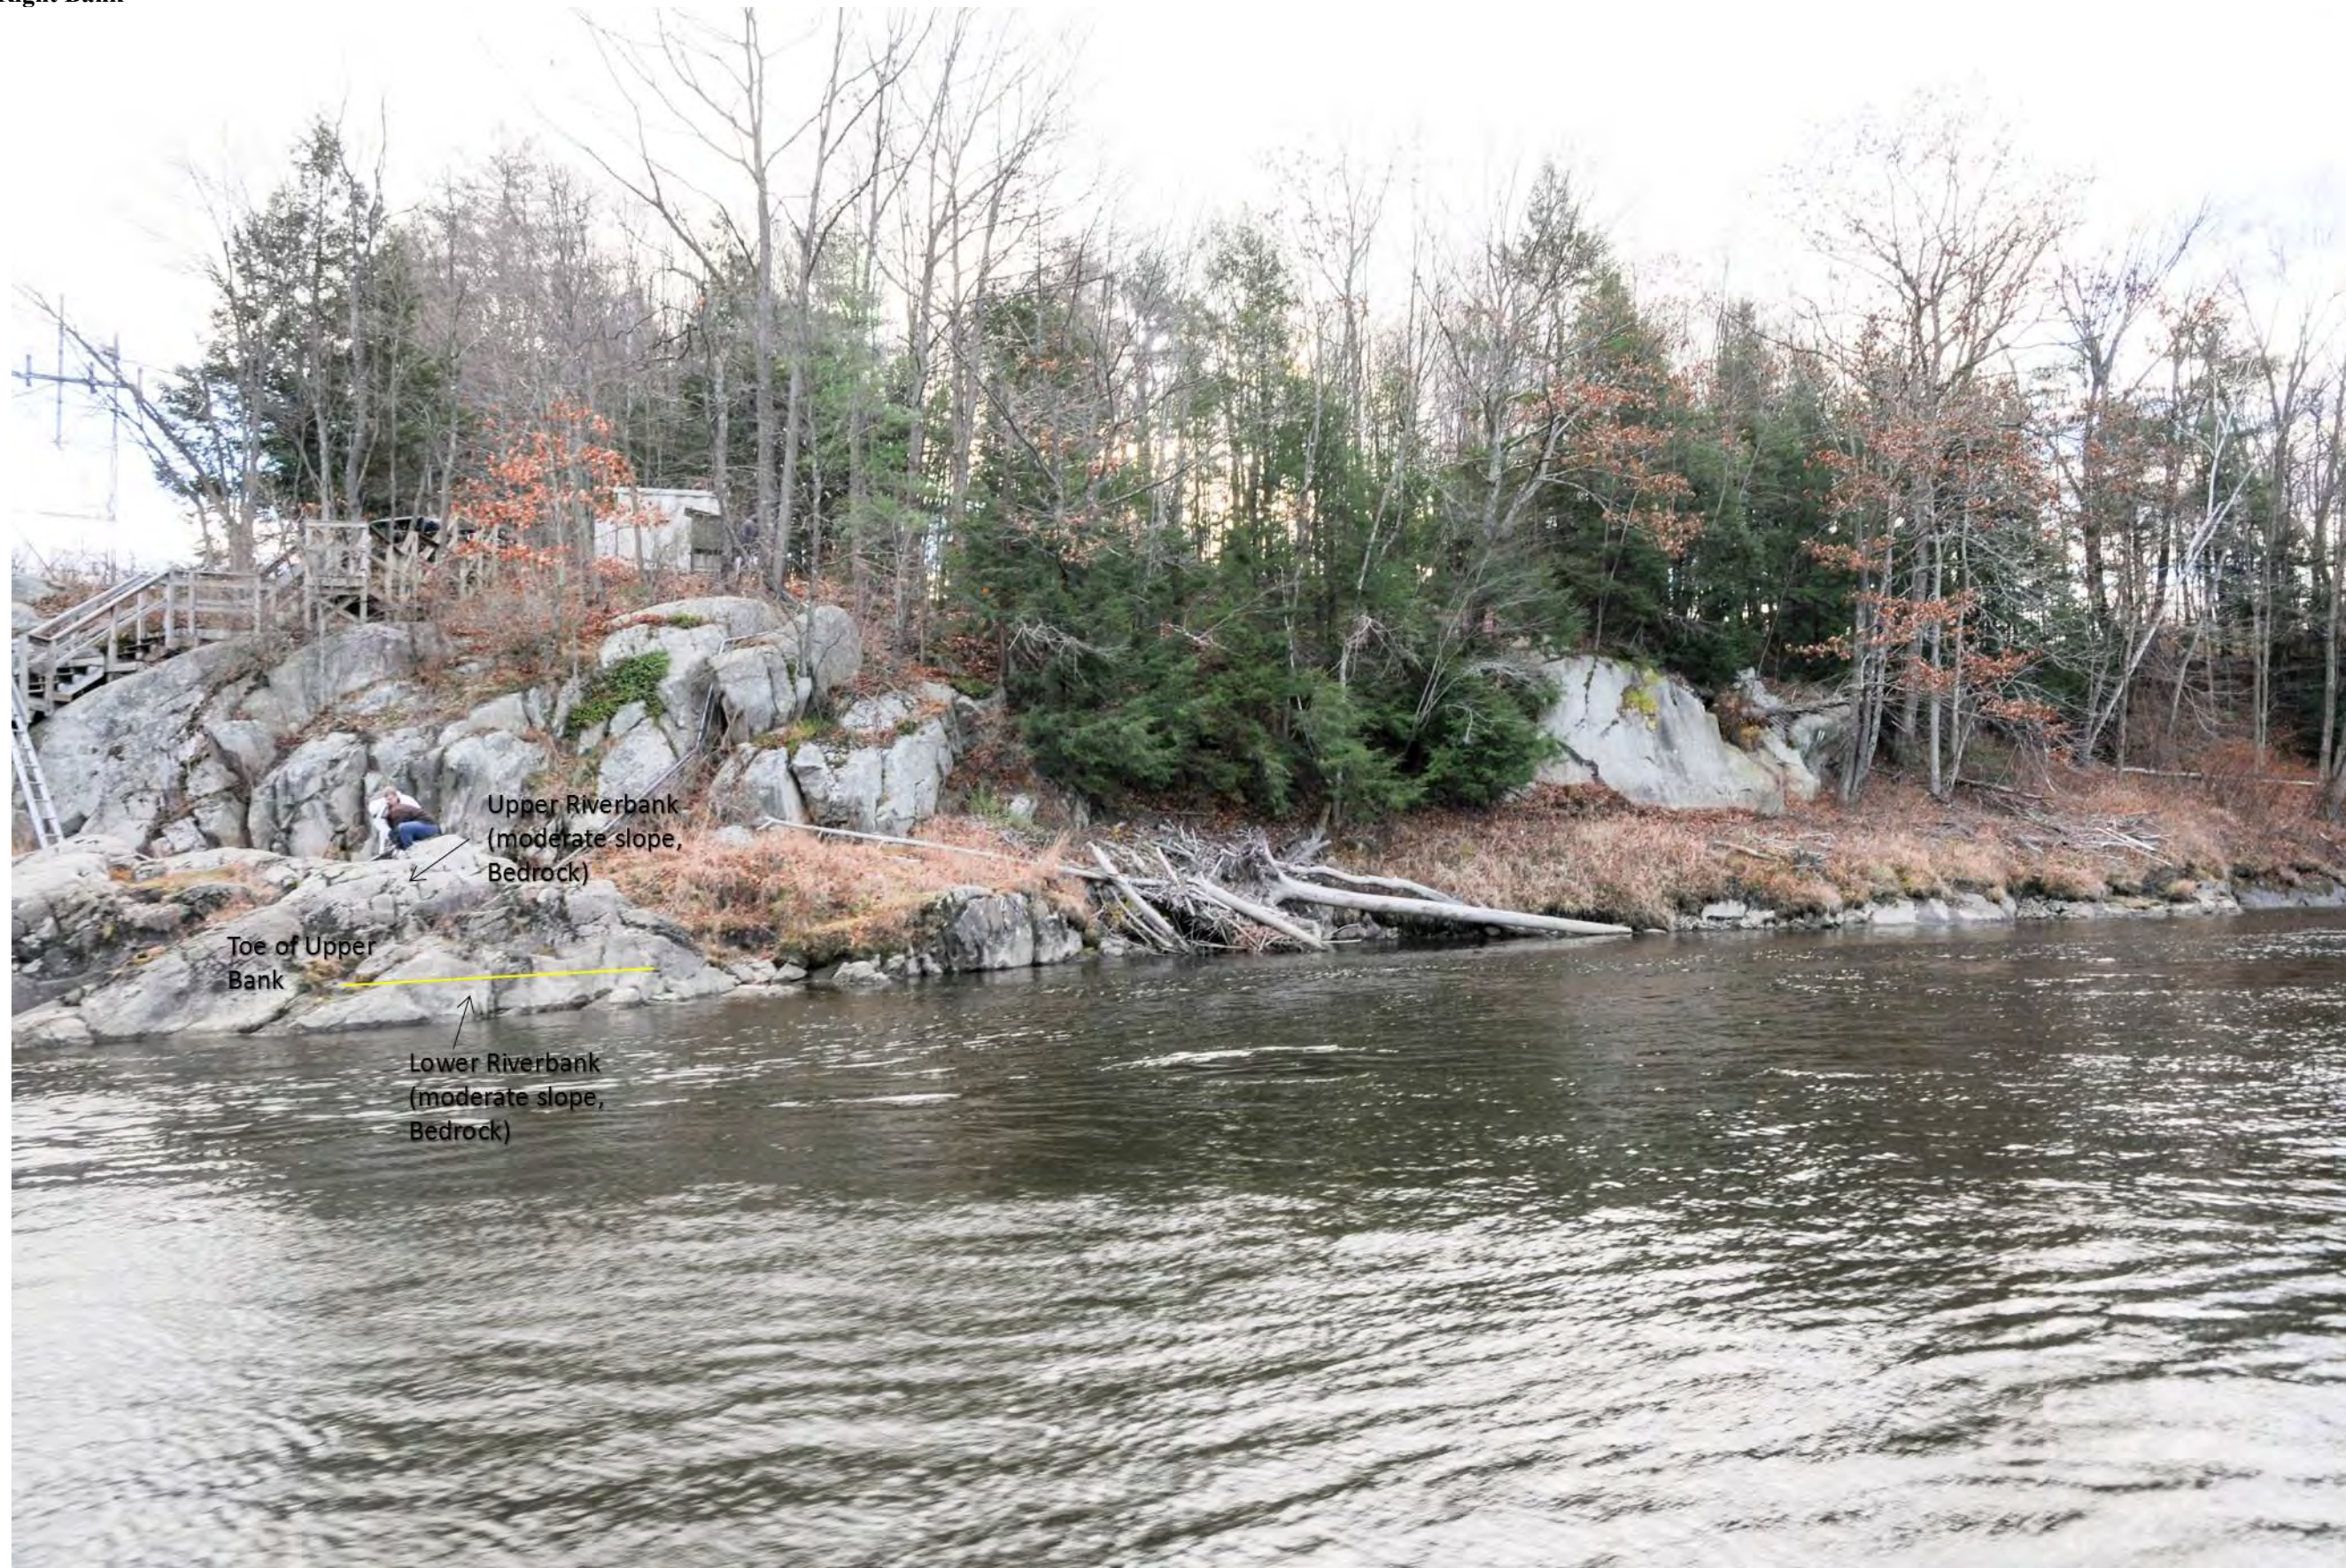
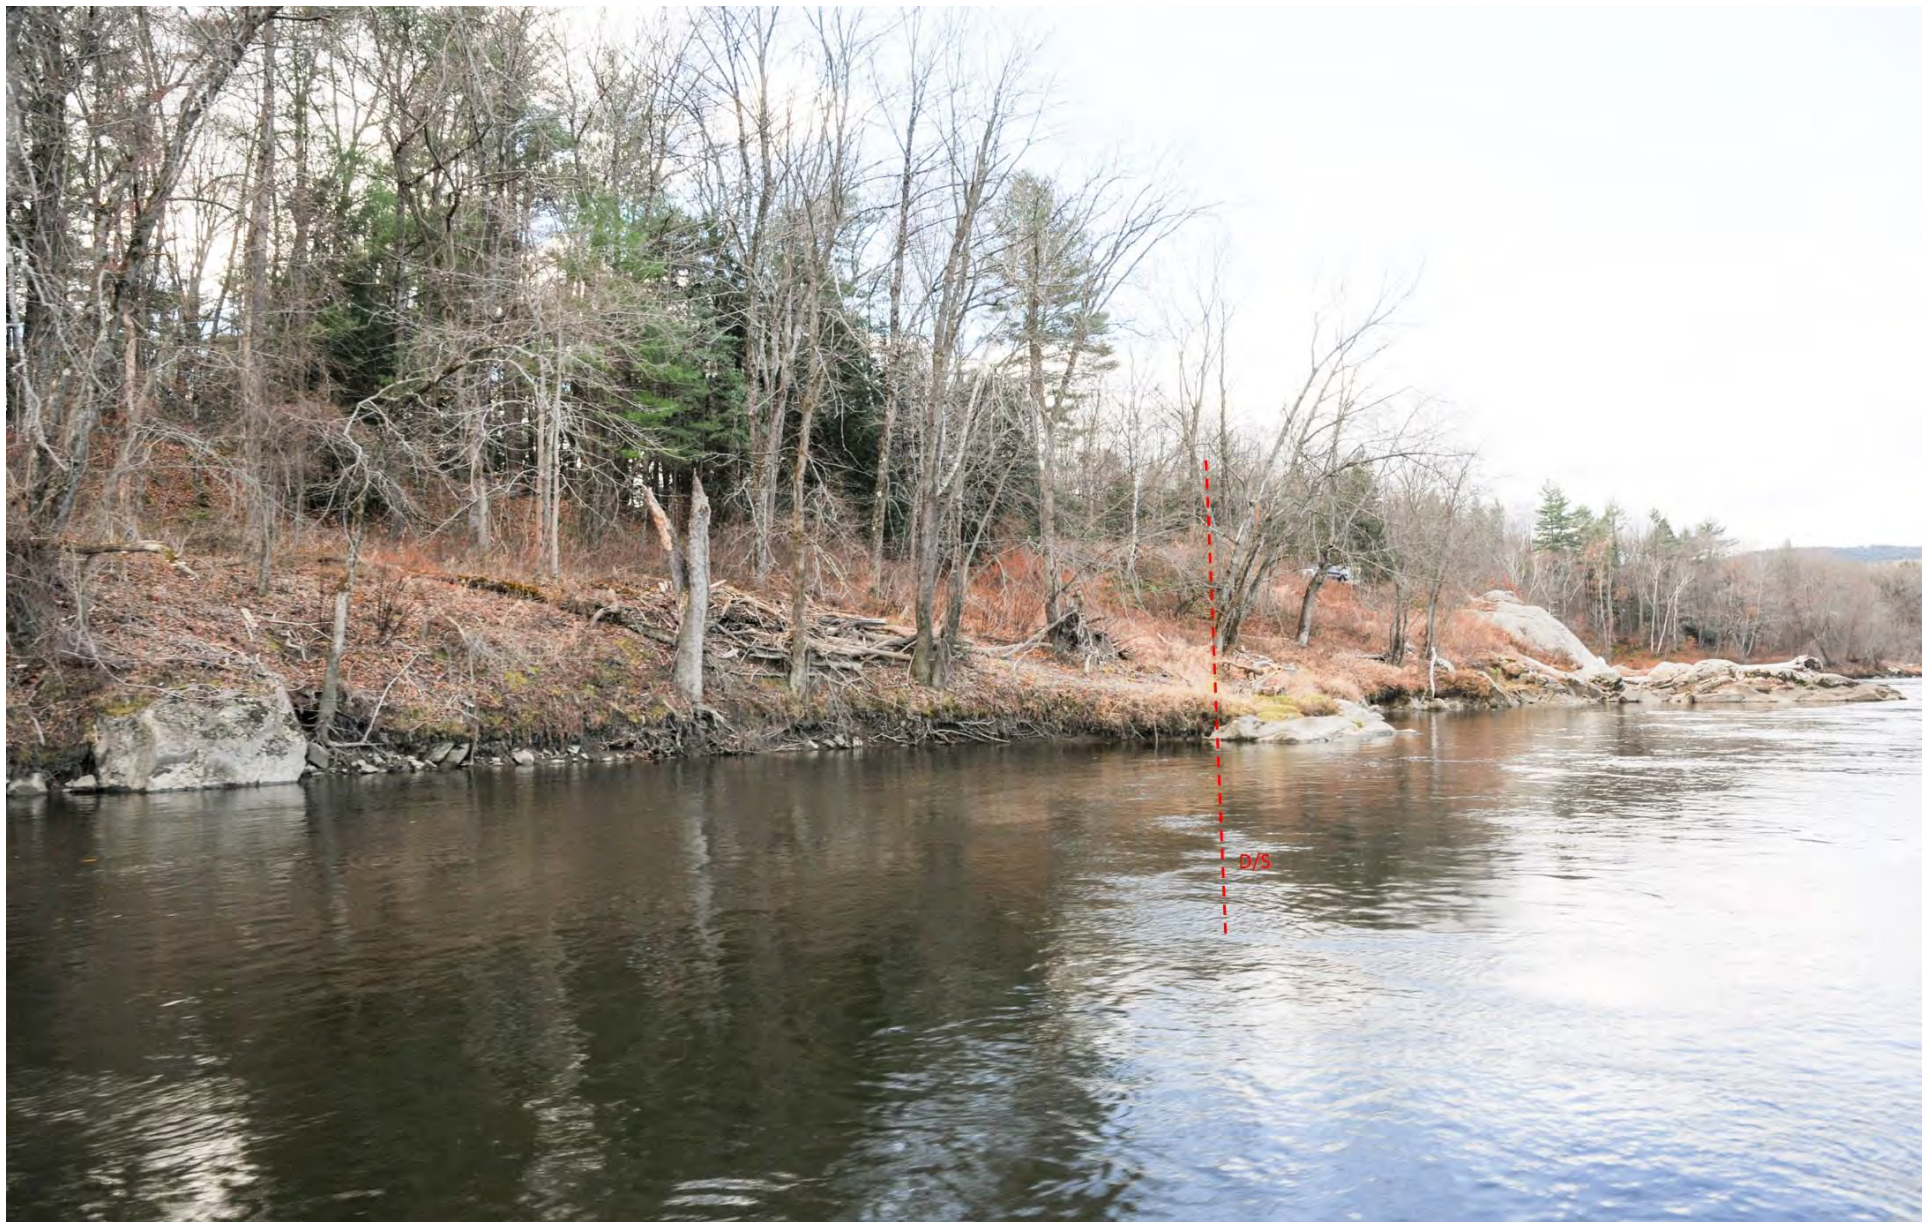
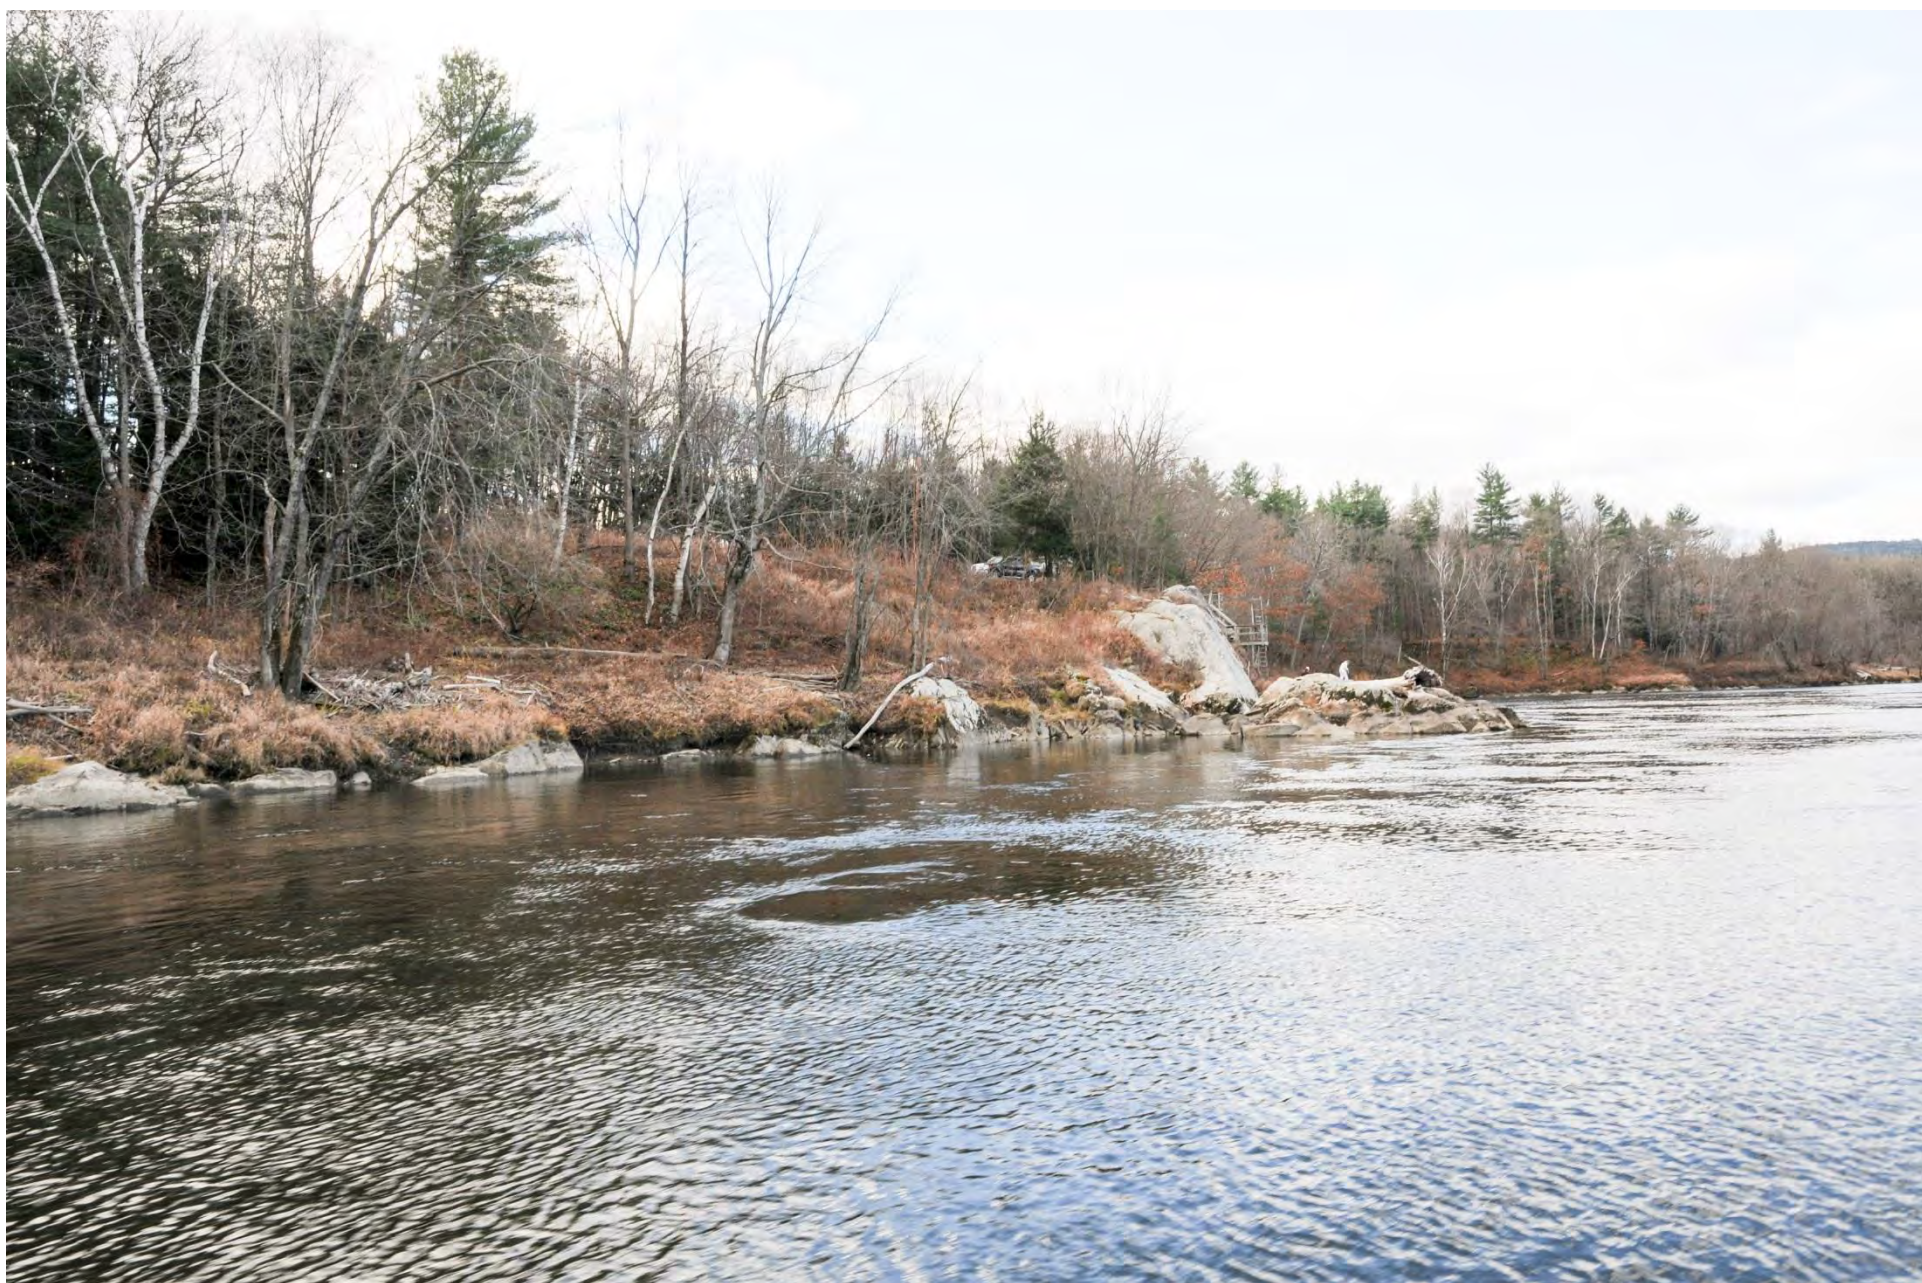
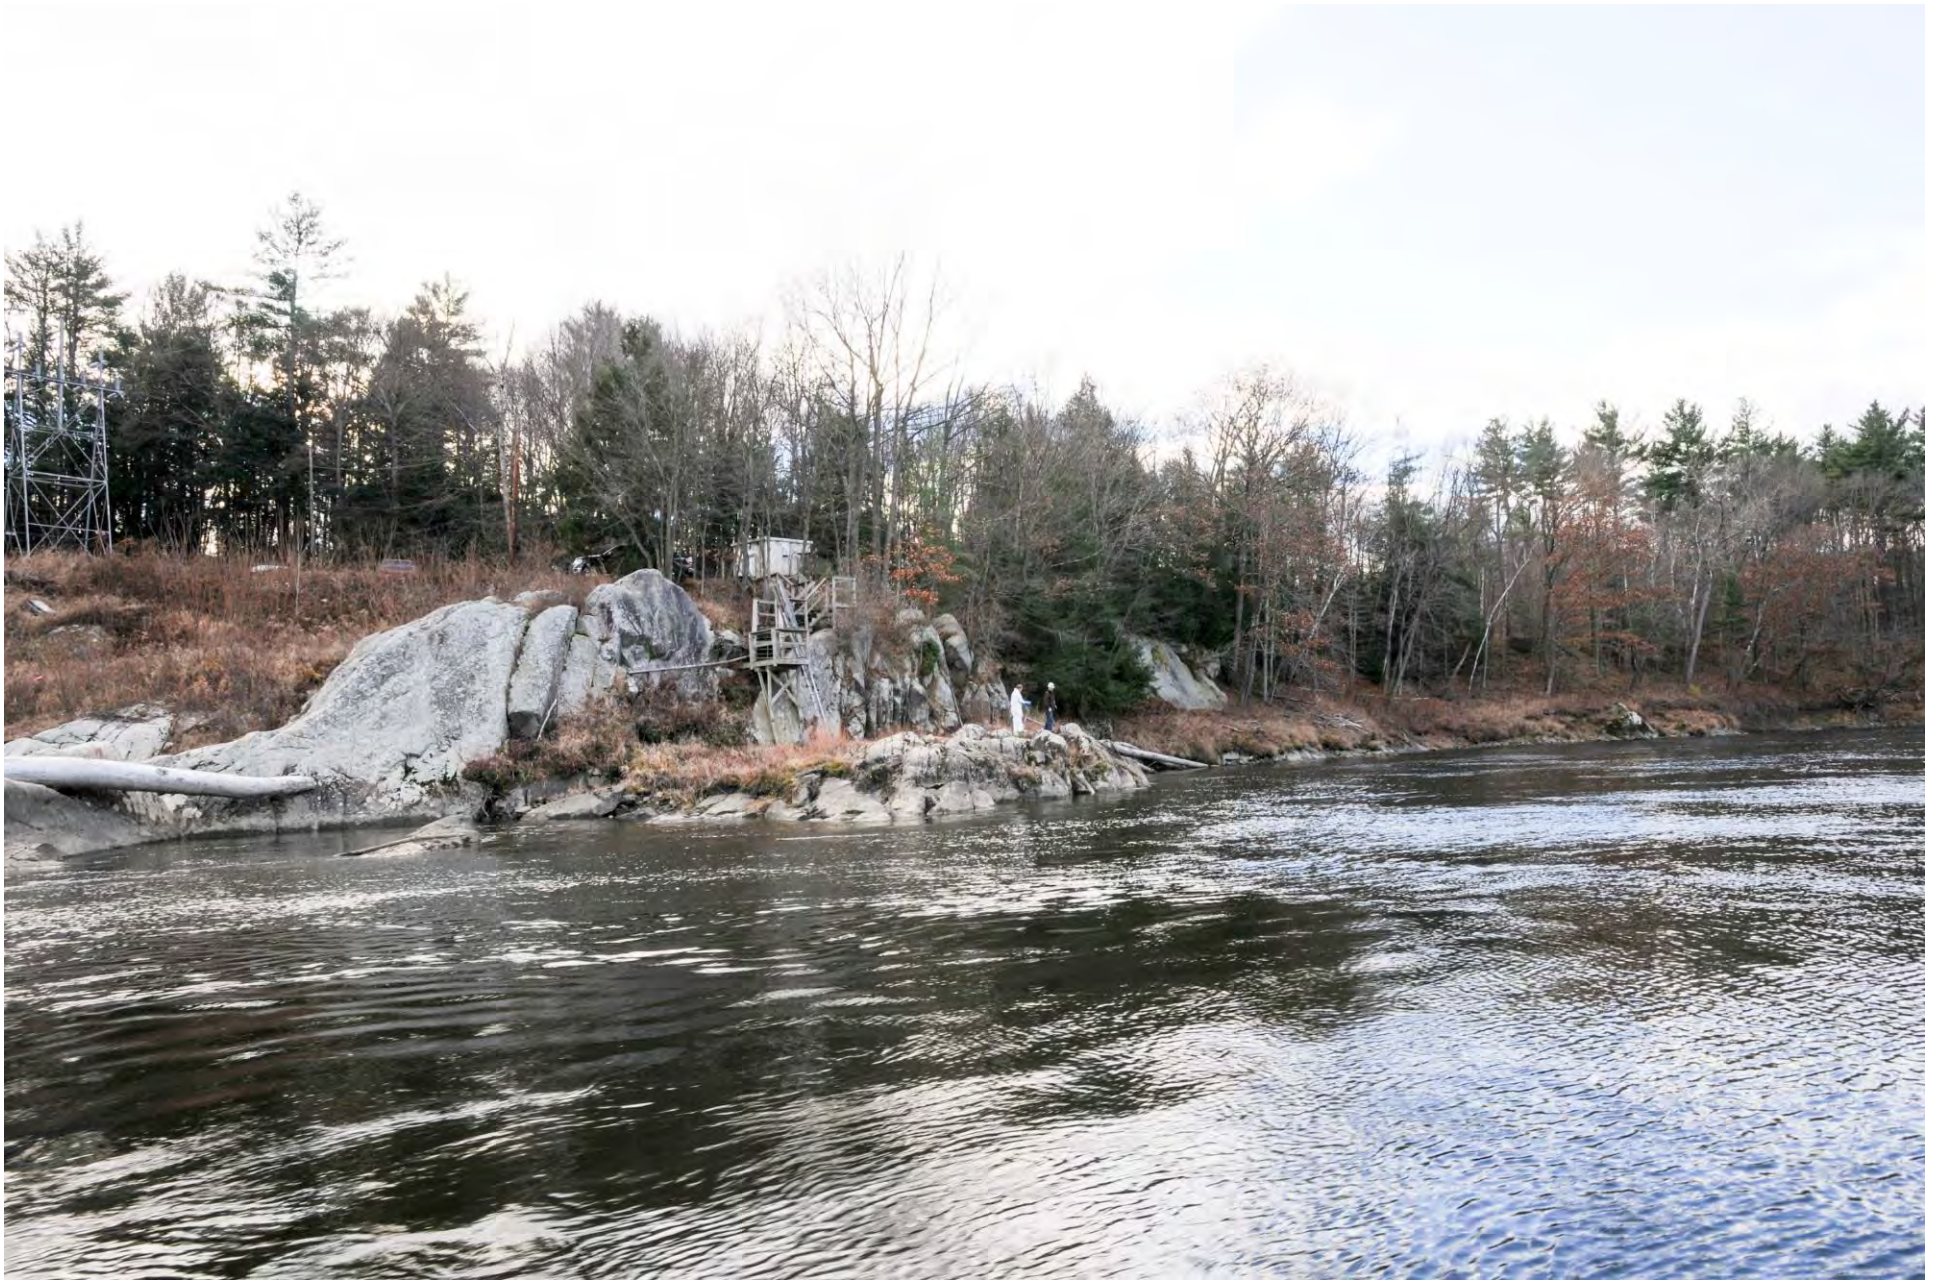
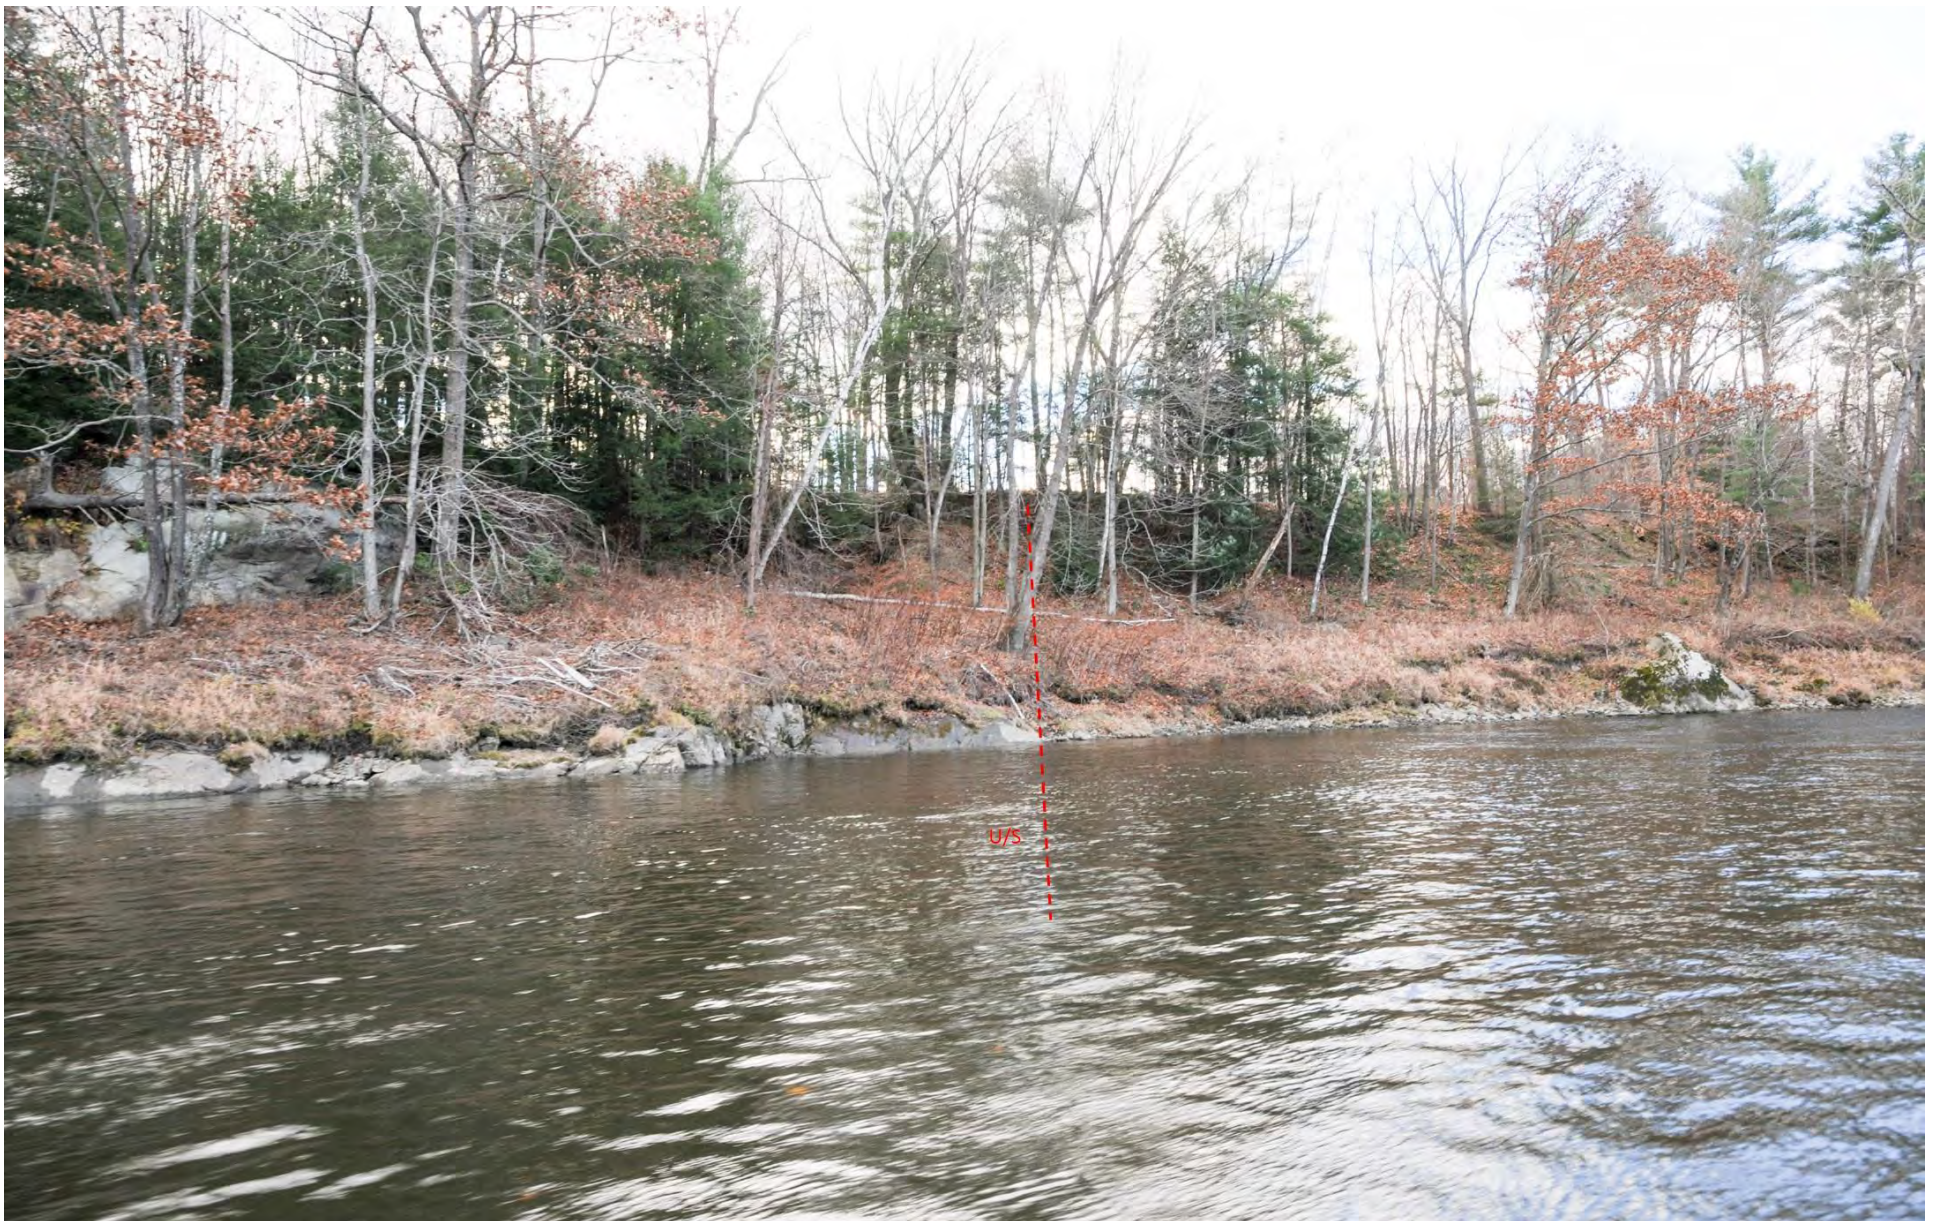
**Segment 580 – Right Bank**

Riverbank Features	Characteristics
Upper Riverbank Slope	Moderate
Upper Riverbank Height	High
Upper Riverbank Sediment	Bedrock
Upper Riverbank Vegetation	Moderate
Lower Riverbank Slope	Moderate
Lower Riverbank Sediment	Bedrock
Lower Riverbank Vegetation	None to very sparse
Type of Erosion	
Potential Erosion Indicators	None
Stage of Erosion	Stable
Extent of Erosion	None/Little

**QA Observations:** Upon review of the photos for this segment, classification made in the field was confirmed.
