**FIRSTLIGHT POWER RESOURCES**  
 RELICENSING STUDY 3.1.1  
 2013 FULL RIVER RECONNAISSANCE  
 TURNERS FALLS IMPOUNDMENT

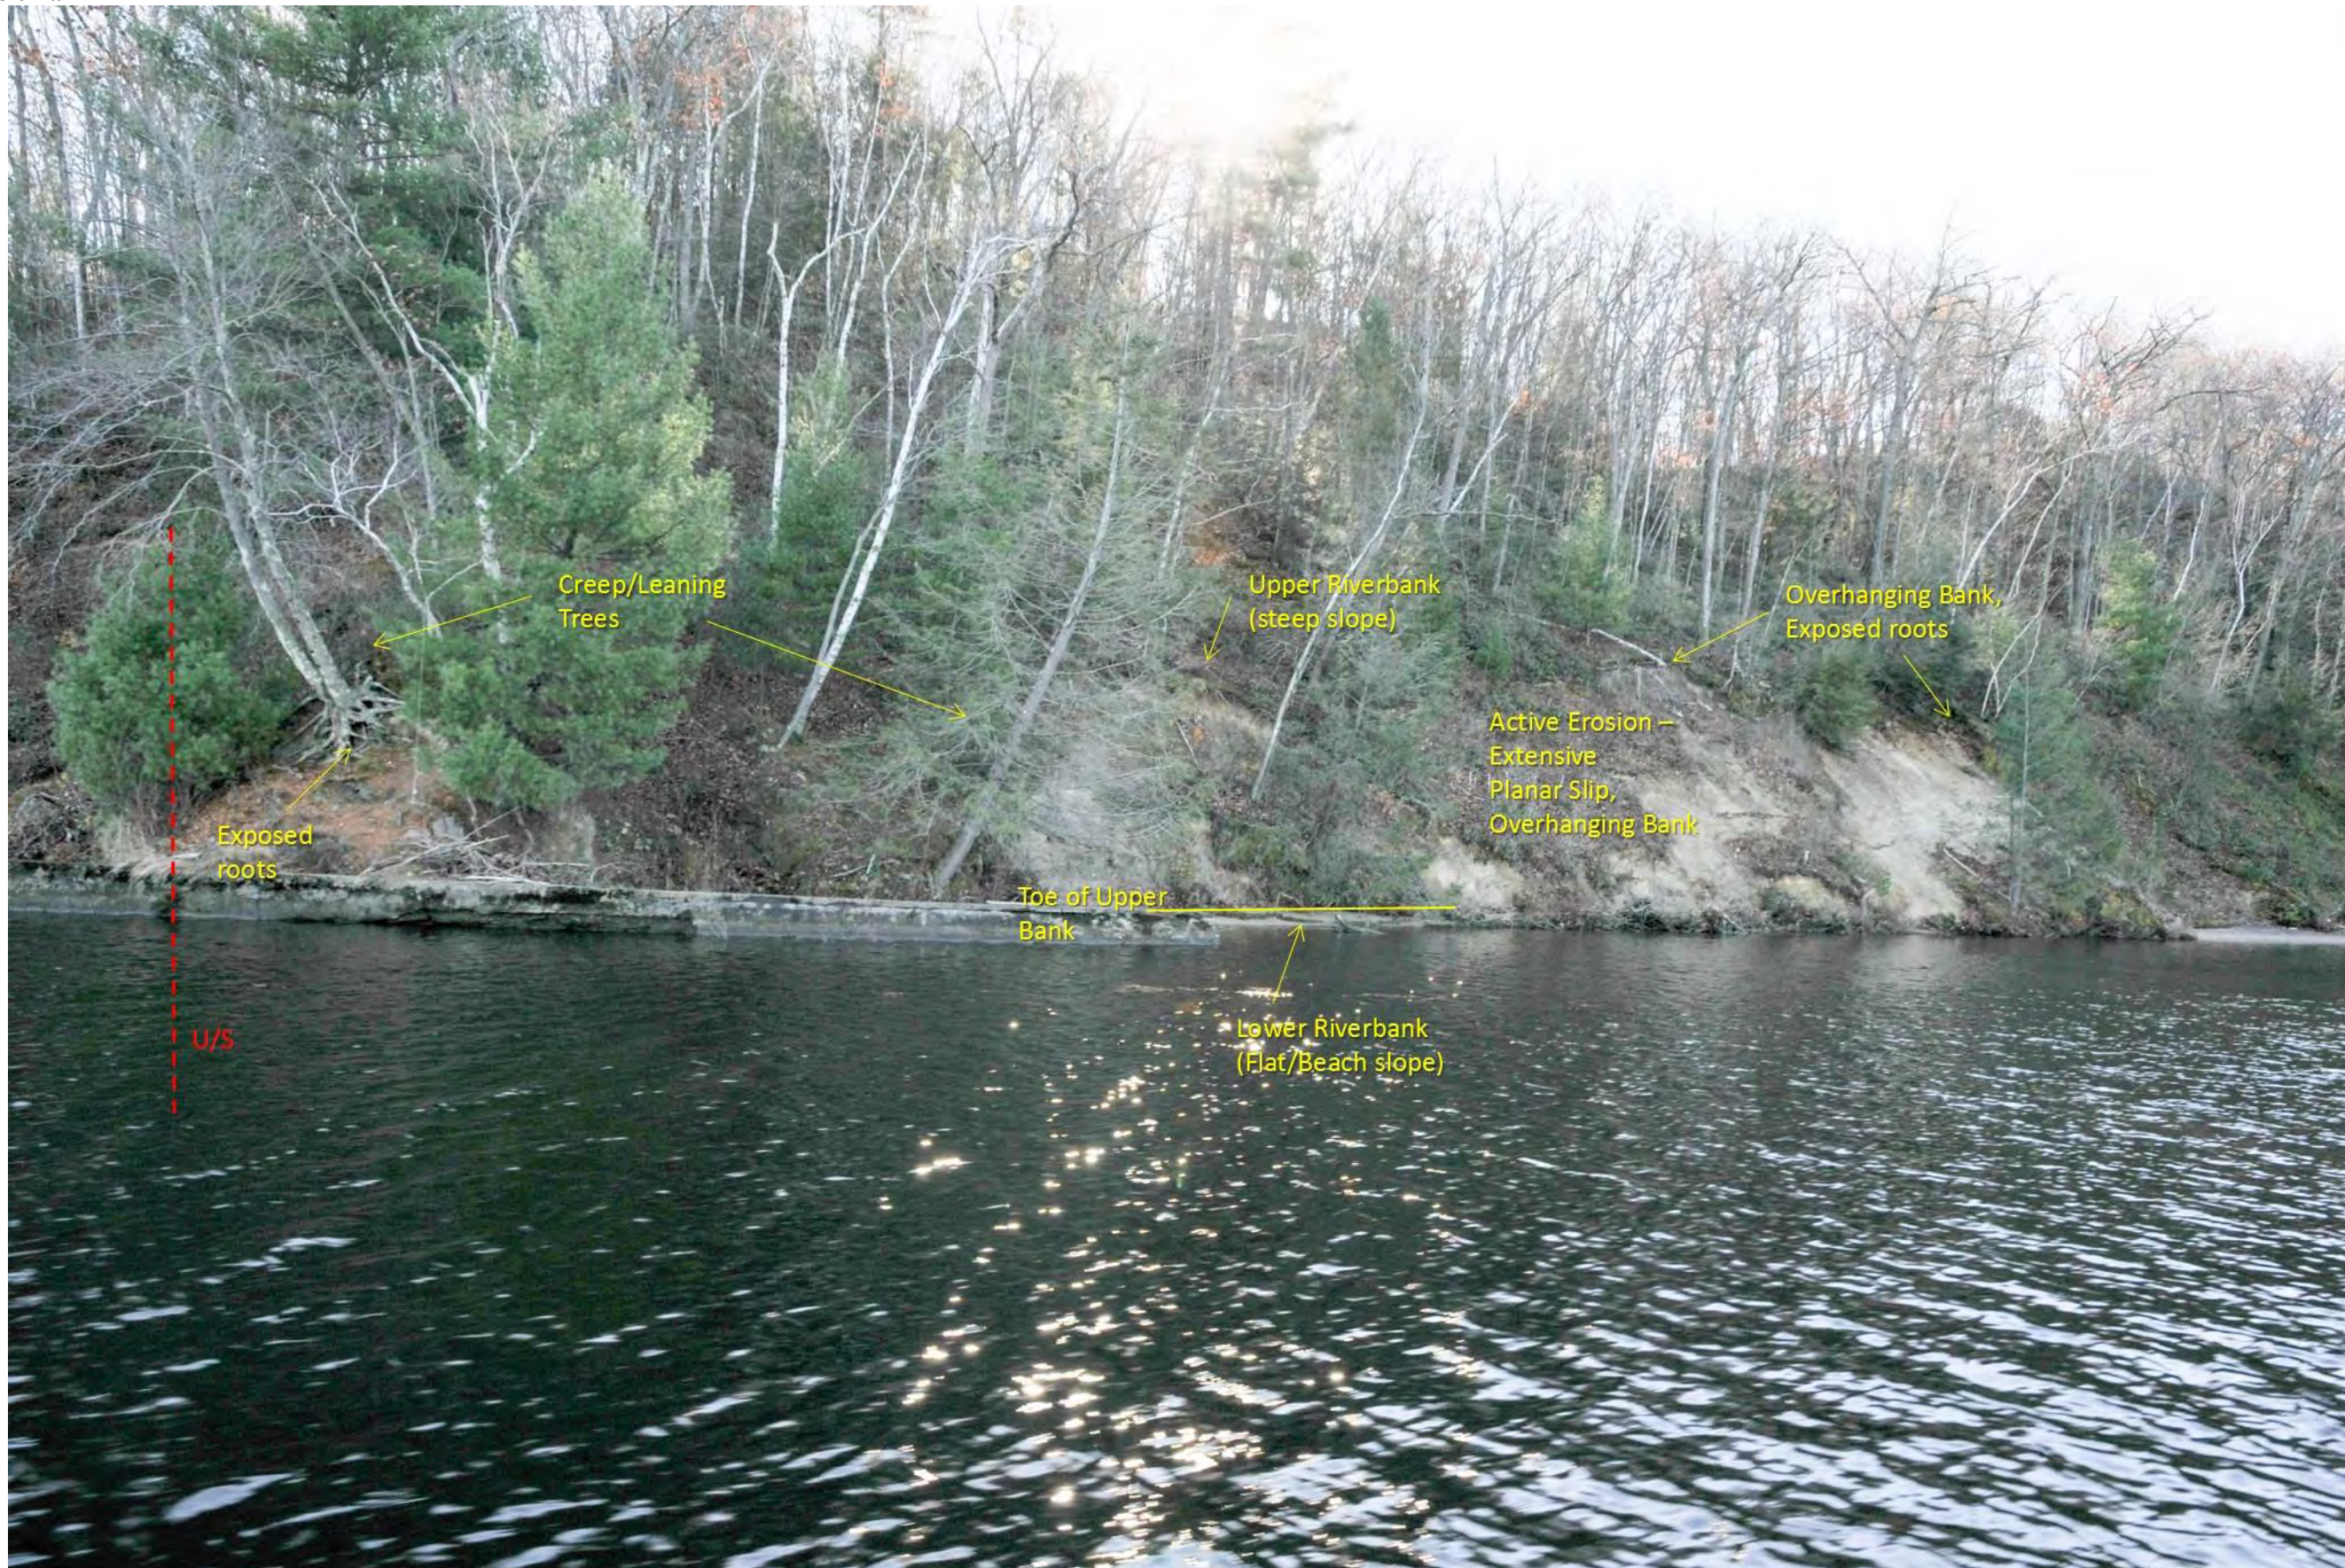
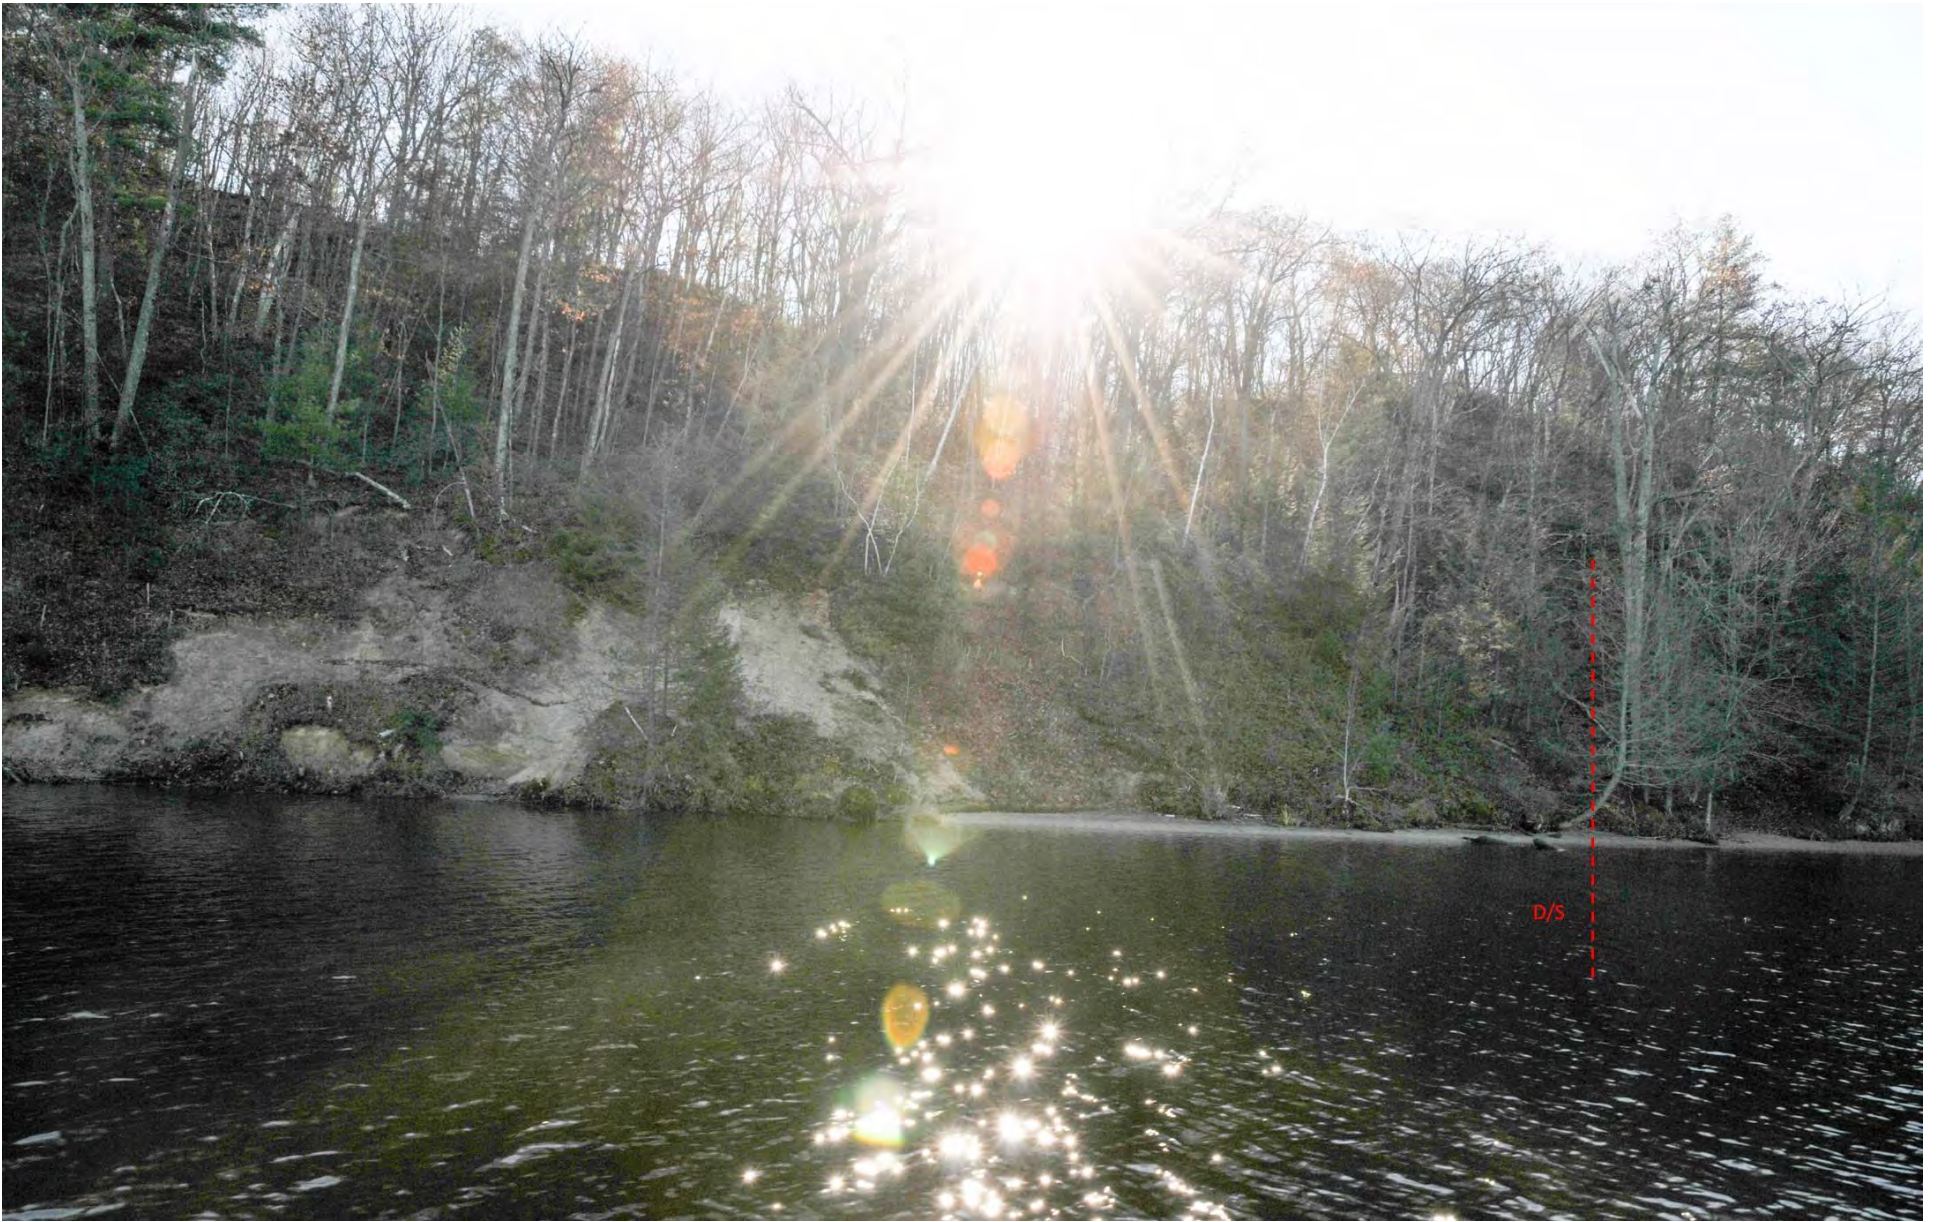
**Segment 12 – Left Bank**

Riverbank Features	Characteristics
Upper Riverbank Slope	Steep
Upper Riverbank Height	High
Upper Riverbank Sediment	Silt/Sand
Upper Riverbank Vegetation	Sparse
Lower Riverbank Slope	Flat/Beach
Lower Riverbank Sediment	Silt/Sand
Lower Riverbank Vegetation	None to very sparse
Type of Erosion	Planar Slip, Overhanging Bank
Potential Erosion Indicators	Overhanging Bank, Creep/leaning trees, Exposed roots, Other
Stage of Erosion	Active Erosion
Extent of Erosion	Extensive

**QA Observations:** Upon review of the photos for this segment, classification made in the field was confirmed and additional indicators of potential future erosion were included.

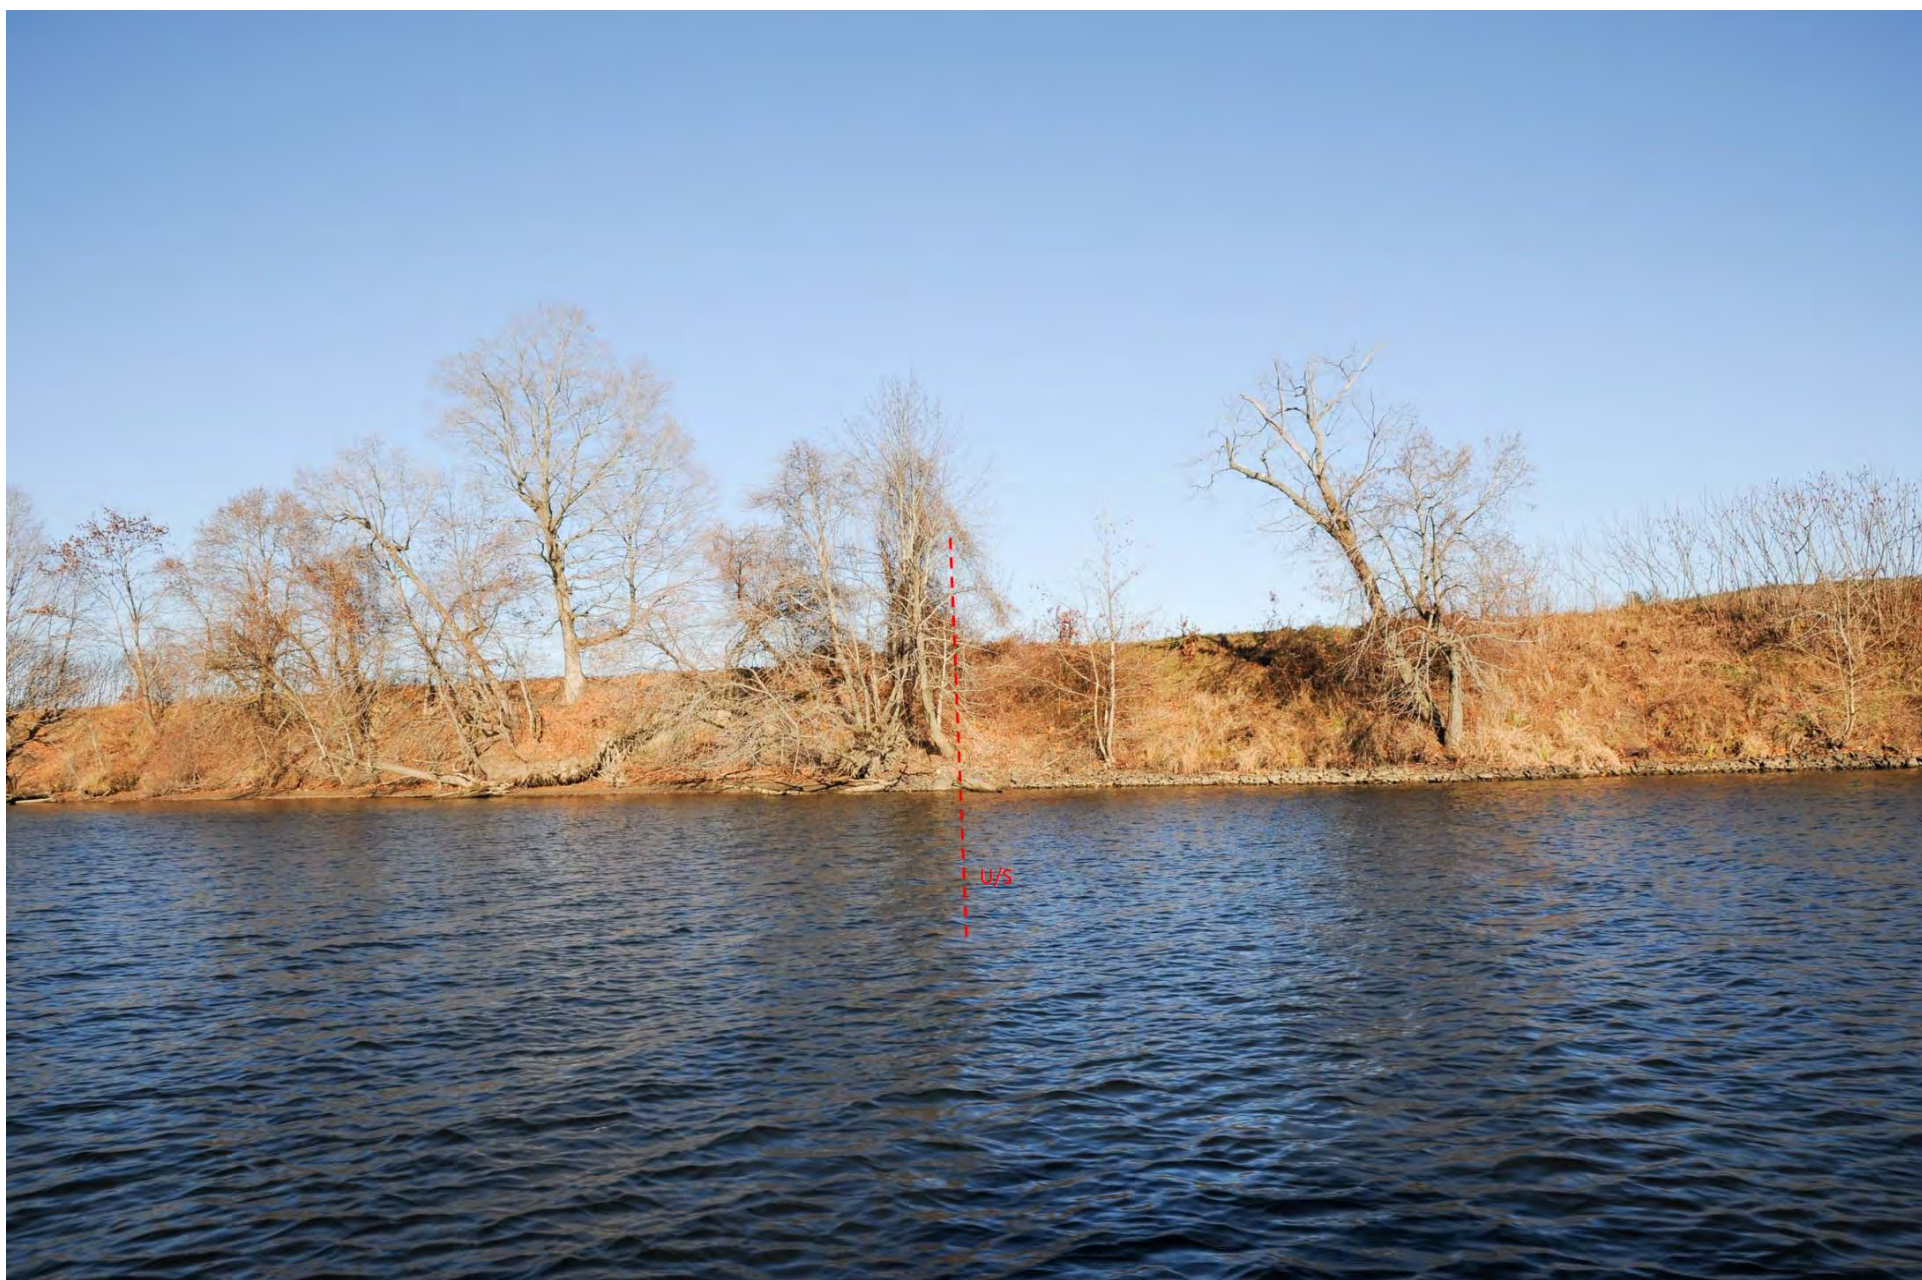
**Segment 89 – Left Bank**

<b>Riverbank Features</b>	<b>Characteristics</b>
<b>Upper Riverbank Slope</b>	Moderate
<b>Upper Riverbank Height</b>	High
<b>Upper Riverbank Sediment</b>	Silt/Sand
<b>Upper Riverbank Vegetation</b>	Heavy
<b>Lower Riverbank Slope</b>	Moderate
<b>Lower Riverbank Sediment</b>	Cobbles
<b>Lower Riverbank Vegetation</b>	None to very sparse
<b>Type of Erosion</b>	Undercut
<b>Potential Erosion Indicators</b>	Exposed roots
<b>Stage of Erosion</b>	Stable
<b>Extent of Erosion</b>	None/Little

**QA Observations:** Upon review of the photos for this segment, classification made in the field was confirmed. Segment added as a site of interest due to planned repair to existing restoration to deal with undercut and exposed roots.

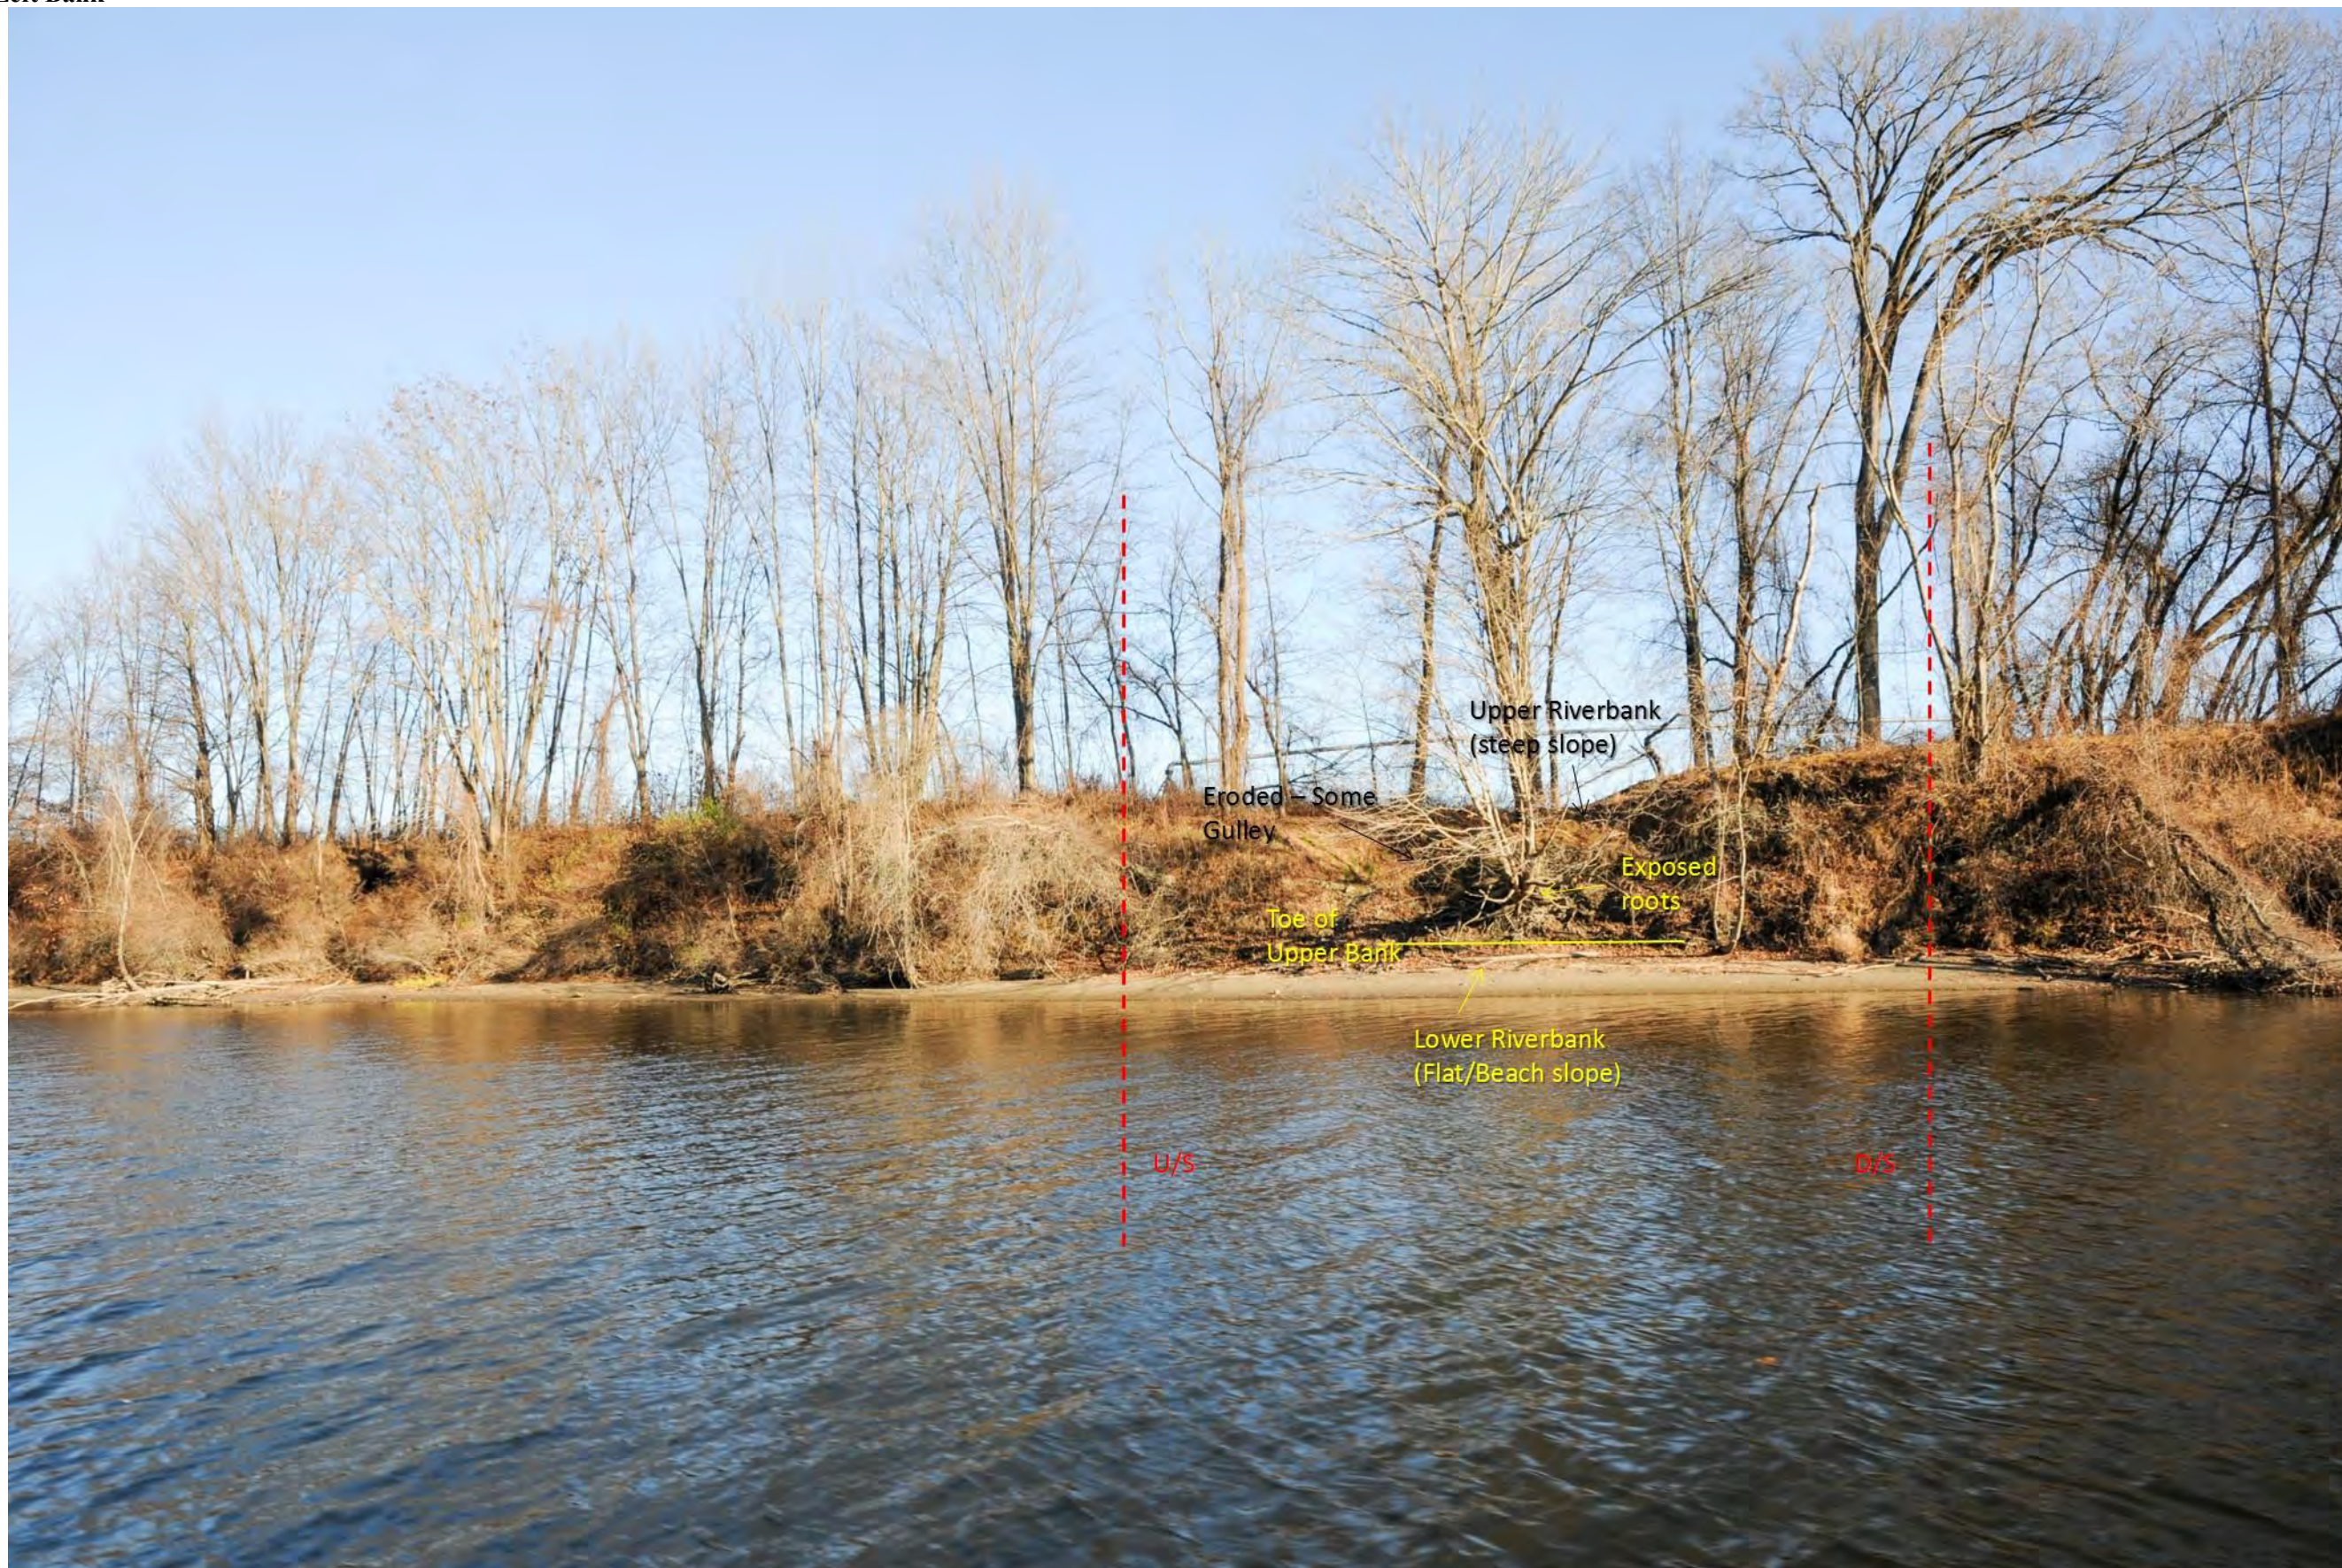
**Segment 182 – Left Bank**

Riverbank Features	Characteristics
Upper Riverbank Slope	Steep
Upper Riverbank Height	Low
Upper Riverbank Sediment	Silt/Sand
Upper Riverbank Vegetation	Sparse
Lower Riverbank Slope	Flat/Beach
Lower Riverbank Sediment	Silt/Sand
Lower Riverbank Vegetation	None to very sparse
Type of Erosion	Gully
Potential Erosion Indicators	Exposed roots
Stage of Erosion	Eroded
Extent of Erosion	Some

**QA Observations:** Upon review of the photos for this segment, classification made in the field was confirmed. Segment added to include gully.

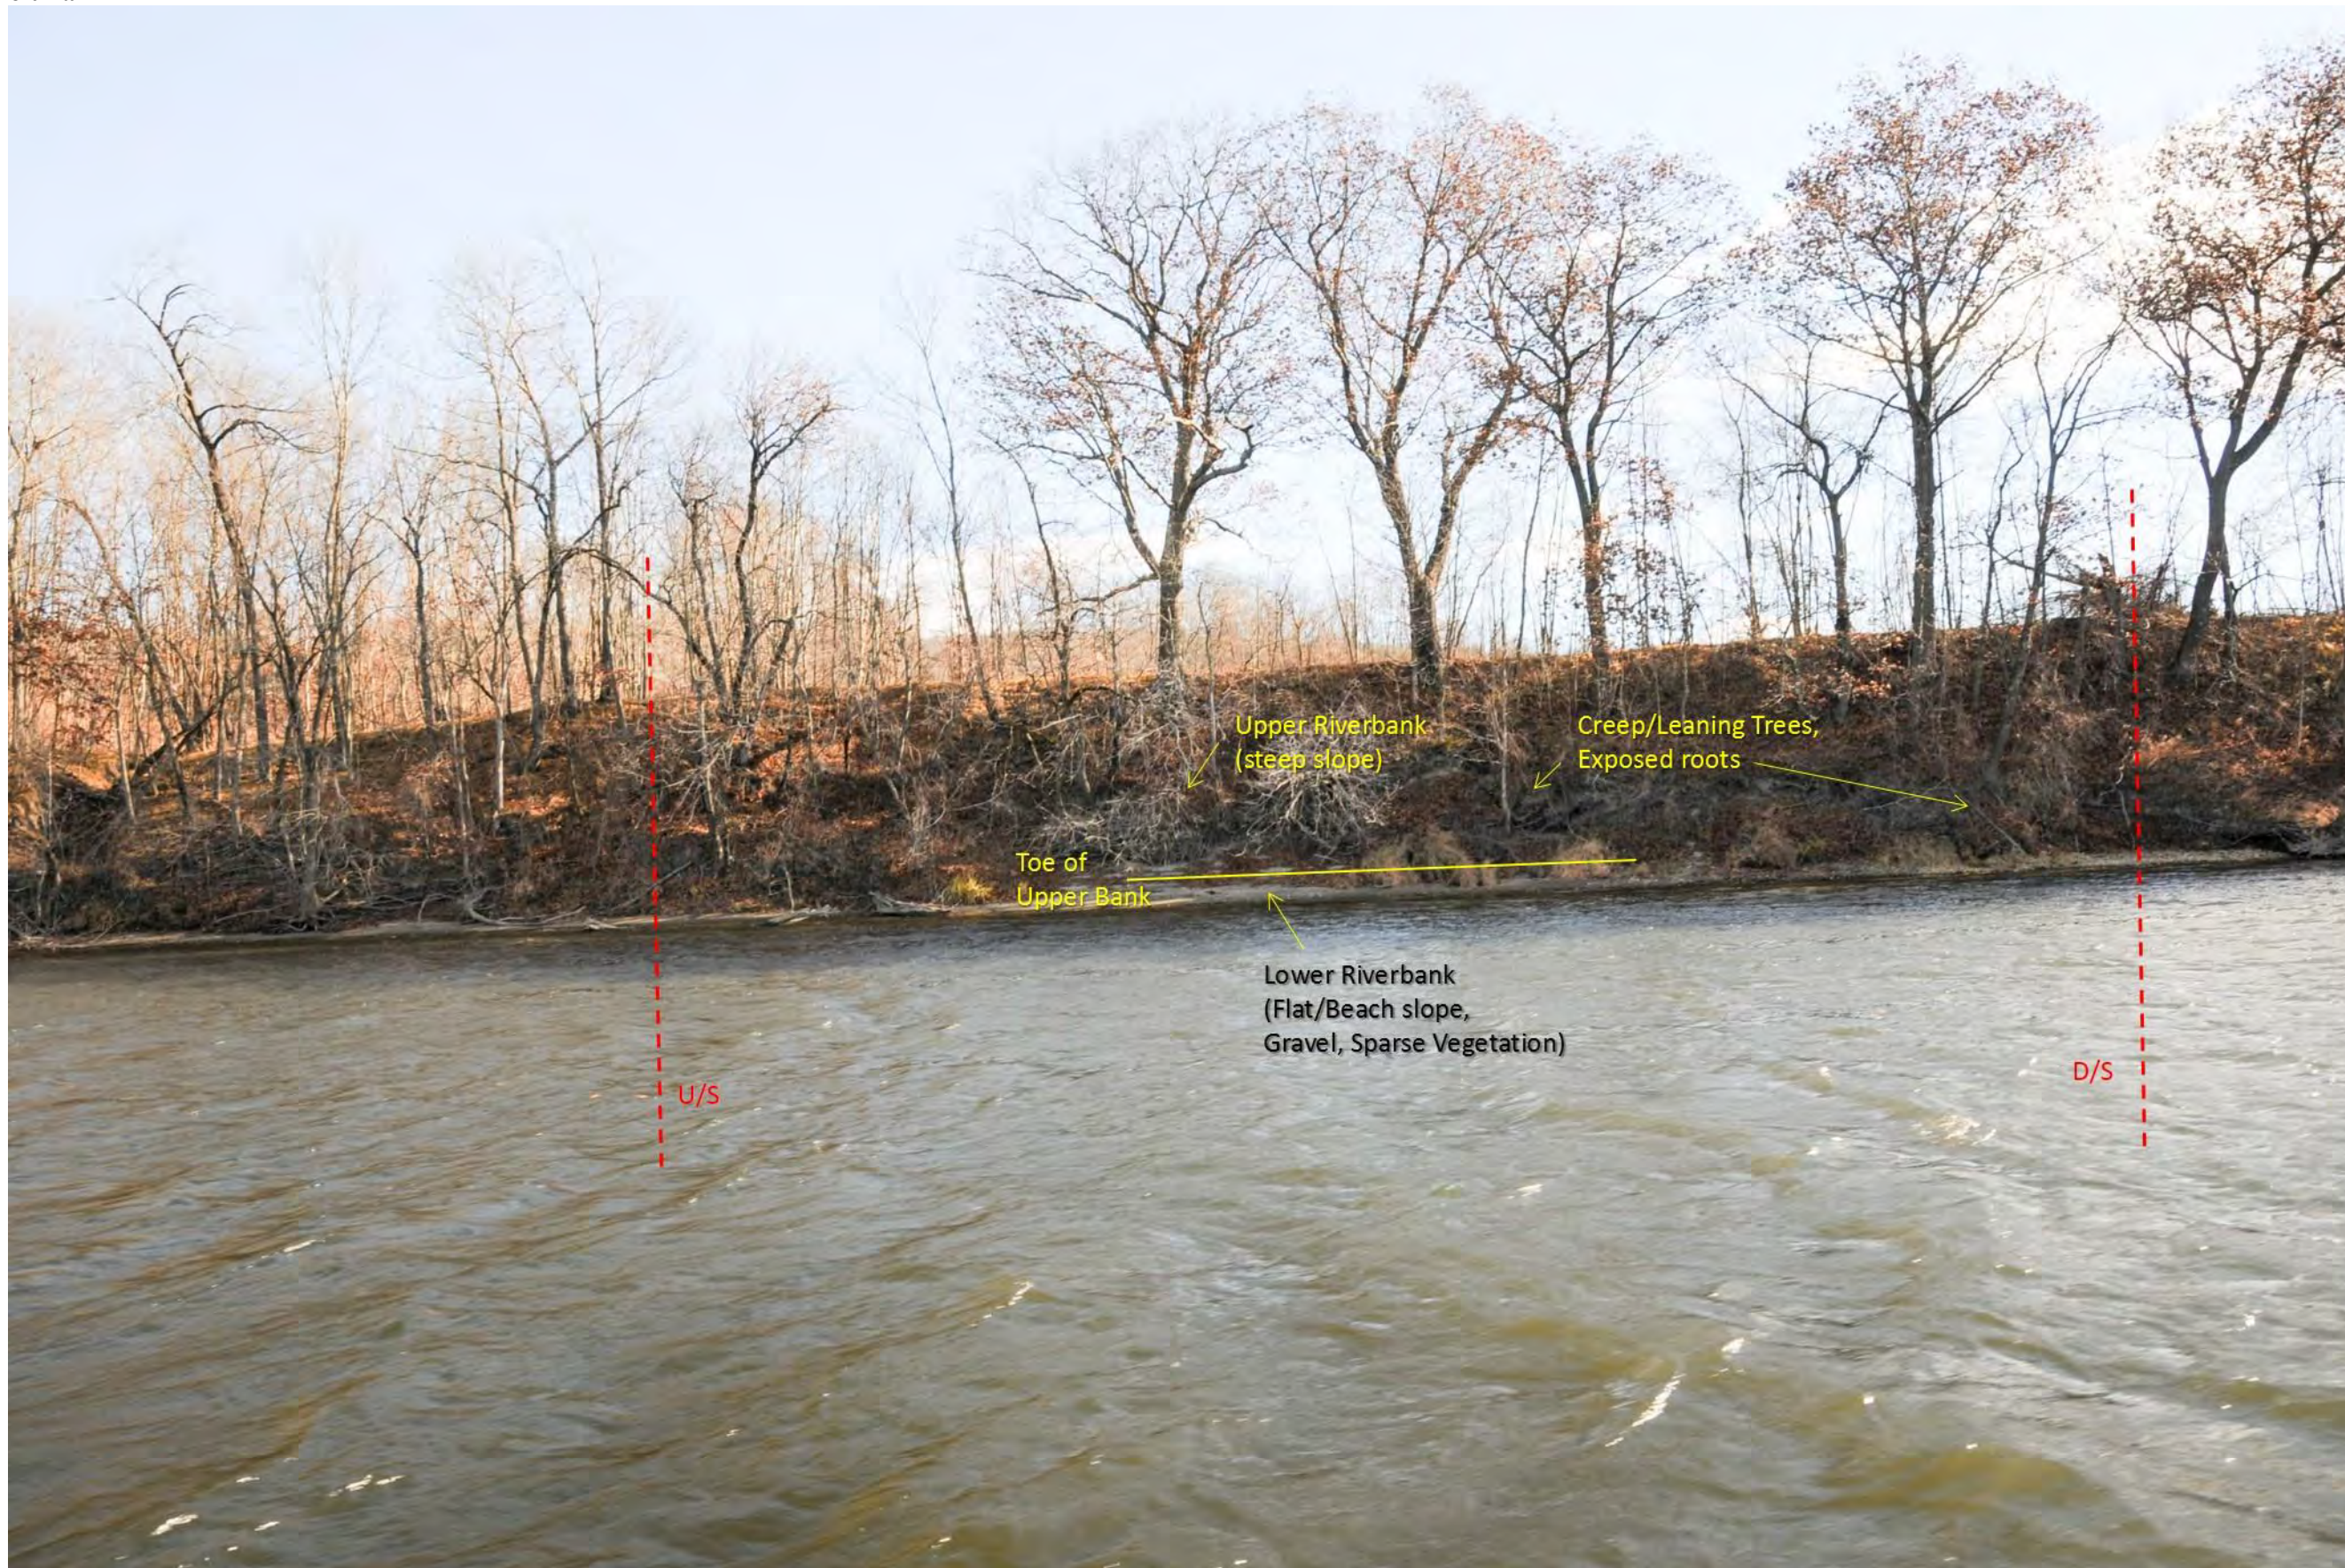
**Segment 279 – Left Bank**

Riverbank Features	Characteristics
Upper Riverbank Slope	Steep
Upper Riverbank Height	High
Upper Riverbank Sediment	Silt/Sand
Upper Riverbank Vegetation	Heavy
Lower Riverbank Slope	Flat/Beach
Lower Riverbank Sediment	Gravel
Lower Riverbank Vegetation	Sparse
Type of Erosion	Undercut
Potential Erosion Indicators	Creep/Leaning Trees, Exposed roots
Stage of Erosion	Stable
Extent of Erosion	None/Little

**QA Observations:** Upon review of the photos for this segment, classification made in the field was confirmed and additional indicators of potential future erosion were included. Segment added to include sparse lower riverbank vegetation.

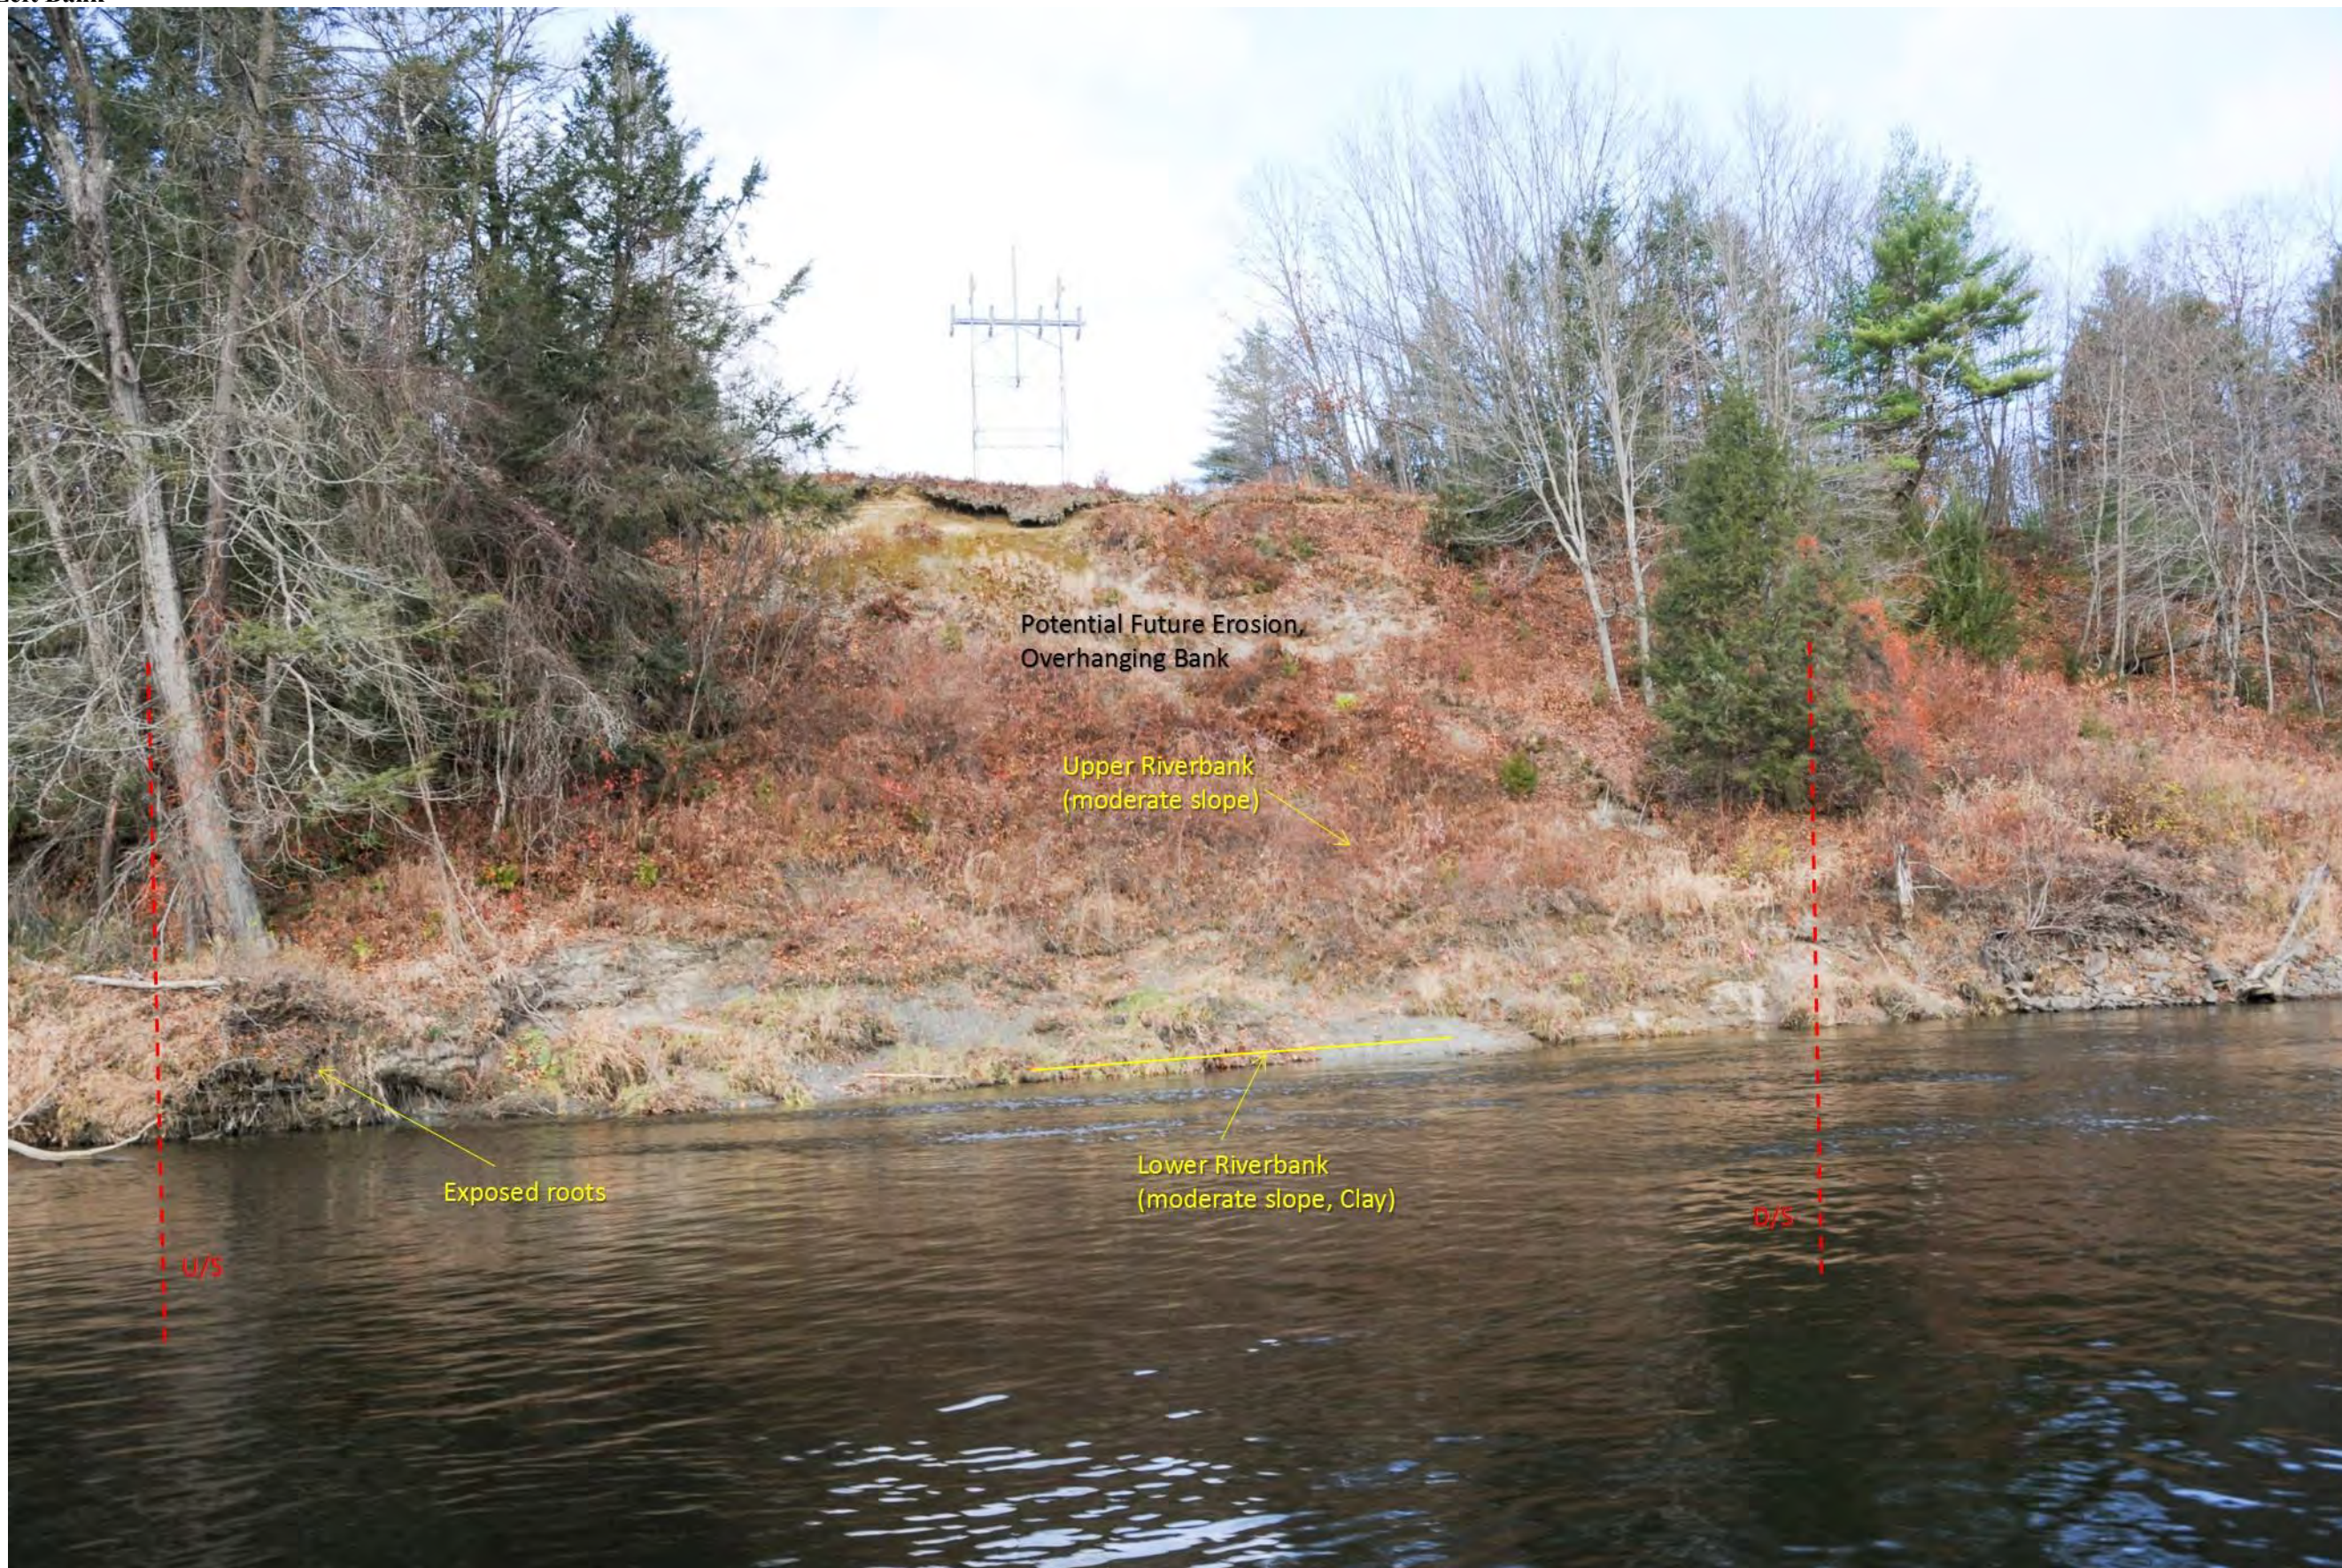
**Segment 332 – Left Bank**

Riverbank Features	Characteristics
Upper Riverbank Slope	Moderate
Upper Riverbank Height	High
Upper Riverbank Sediment	Silt/Sand
Upper Riverbank Vegetation	Moderate
Lower Riverbank Slope	Moderate
Lower Riverbank Sediment	Clay
Lower Riverbank Vegetation	None to very sparse
Type of Erosion	Slide
Potential Erosion Indicators	Overhanging, Exposed roots
Stage of Erosion	Potential Future Erosion
Extent of Erosion	Some

**QA Observations:** Upon review of the photos for this segment, classification made in the field was confirmed and additional indicators of potential future erosion were included. Segment added to include clay.
