**FIRSTLIGHT POWER RESOURCES**  
 RELICENSING STUDY 3.1.1  
 2013 FULL RIVER RECONNAISSANCE  
 TURNERS FALLS IMPOUNDMENT

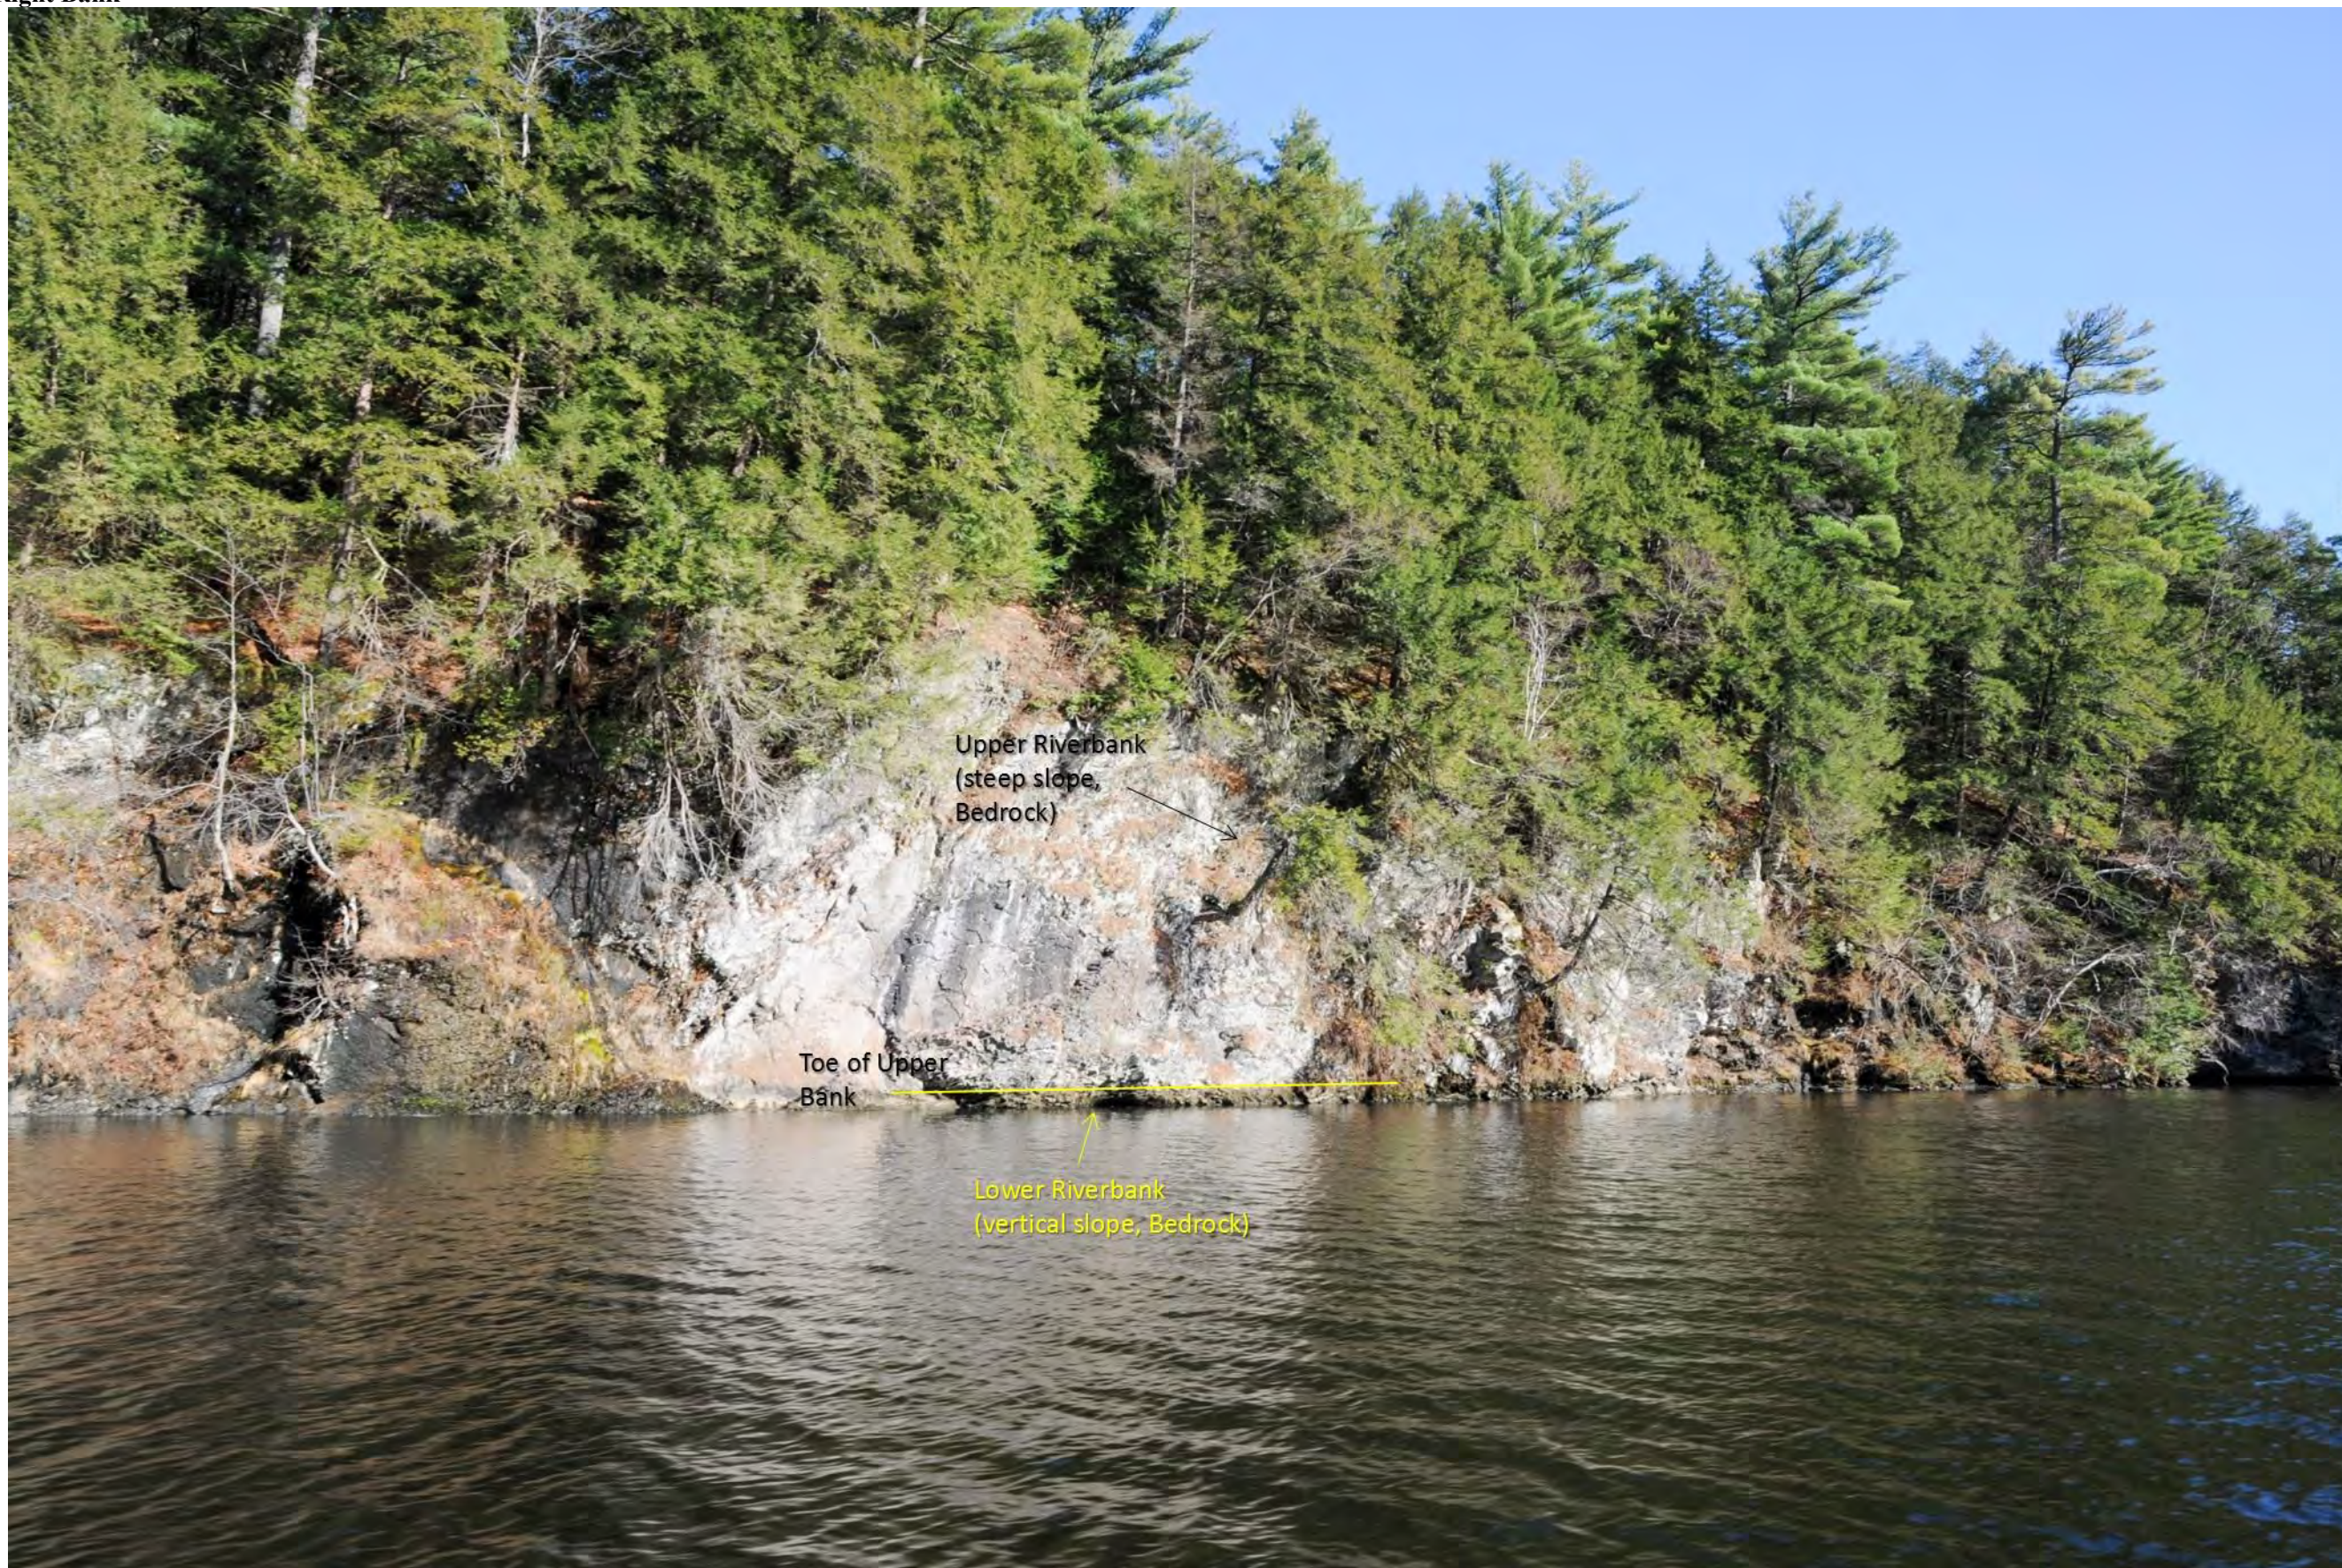
Photo ID 480 (mid-segment)

Riverbank Features	Characteristics
Upper Riverbank Slope	Steep
Upper Riverbank Height	High
Upper Riverbank Sediment	Bedrock
Upper Riverbank Vegetation	Moderate
Lower Riverbank Slope	Vertical
Lower Riverbank Sediment	Bedrock
Lower Riverbank Vegetation	None to very sparse
Type of Erosion	
Potential Erosion Indicators	None
Stage of Erosion	Stable
Extent of Erosion	None/Little

**QA Observations:** Upon review of the photos for this segment, classification made in the field was confirmed. Segment added to include vertical lower riverbank.

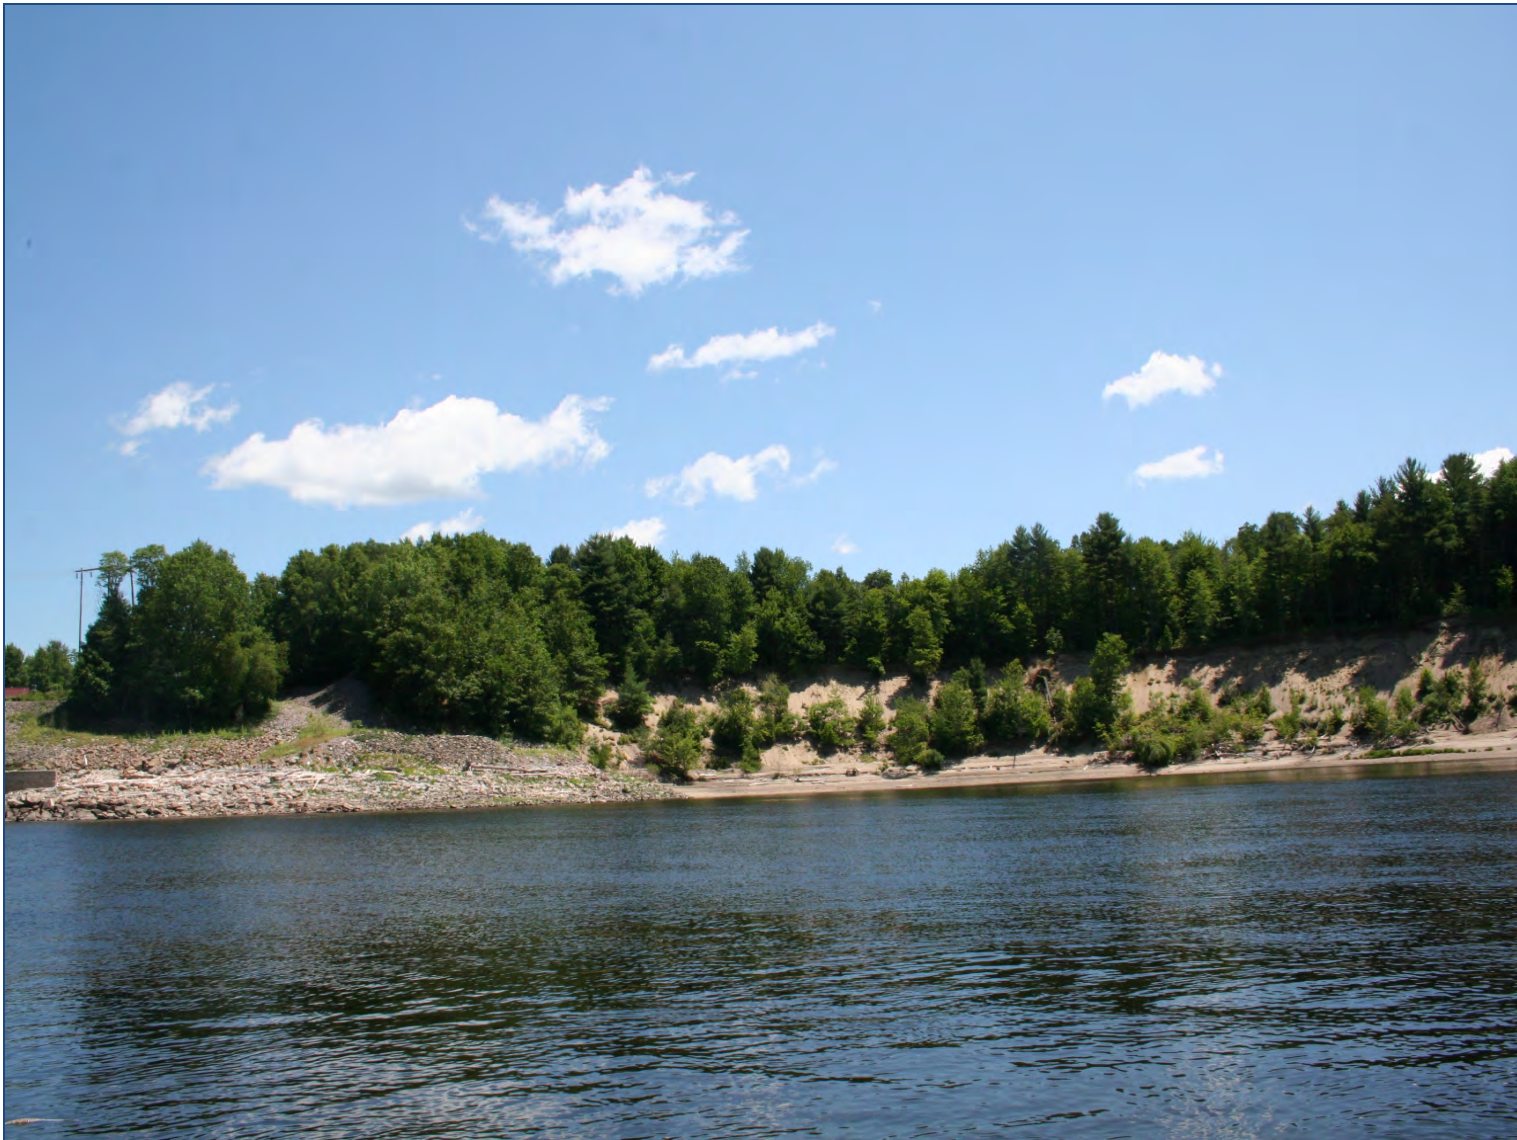
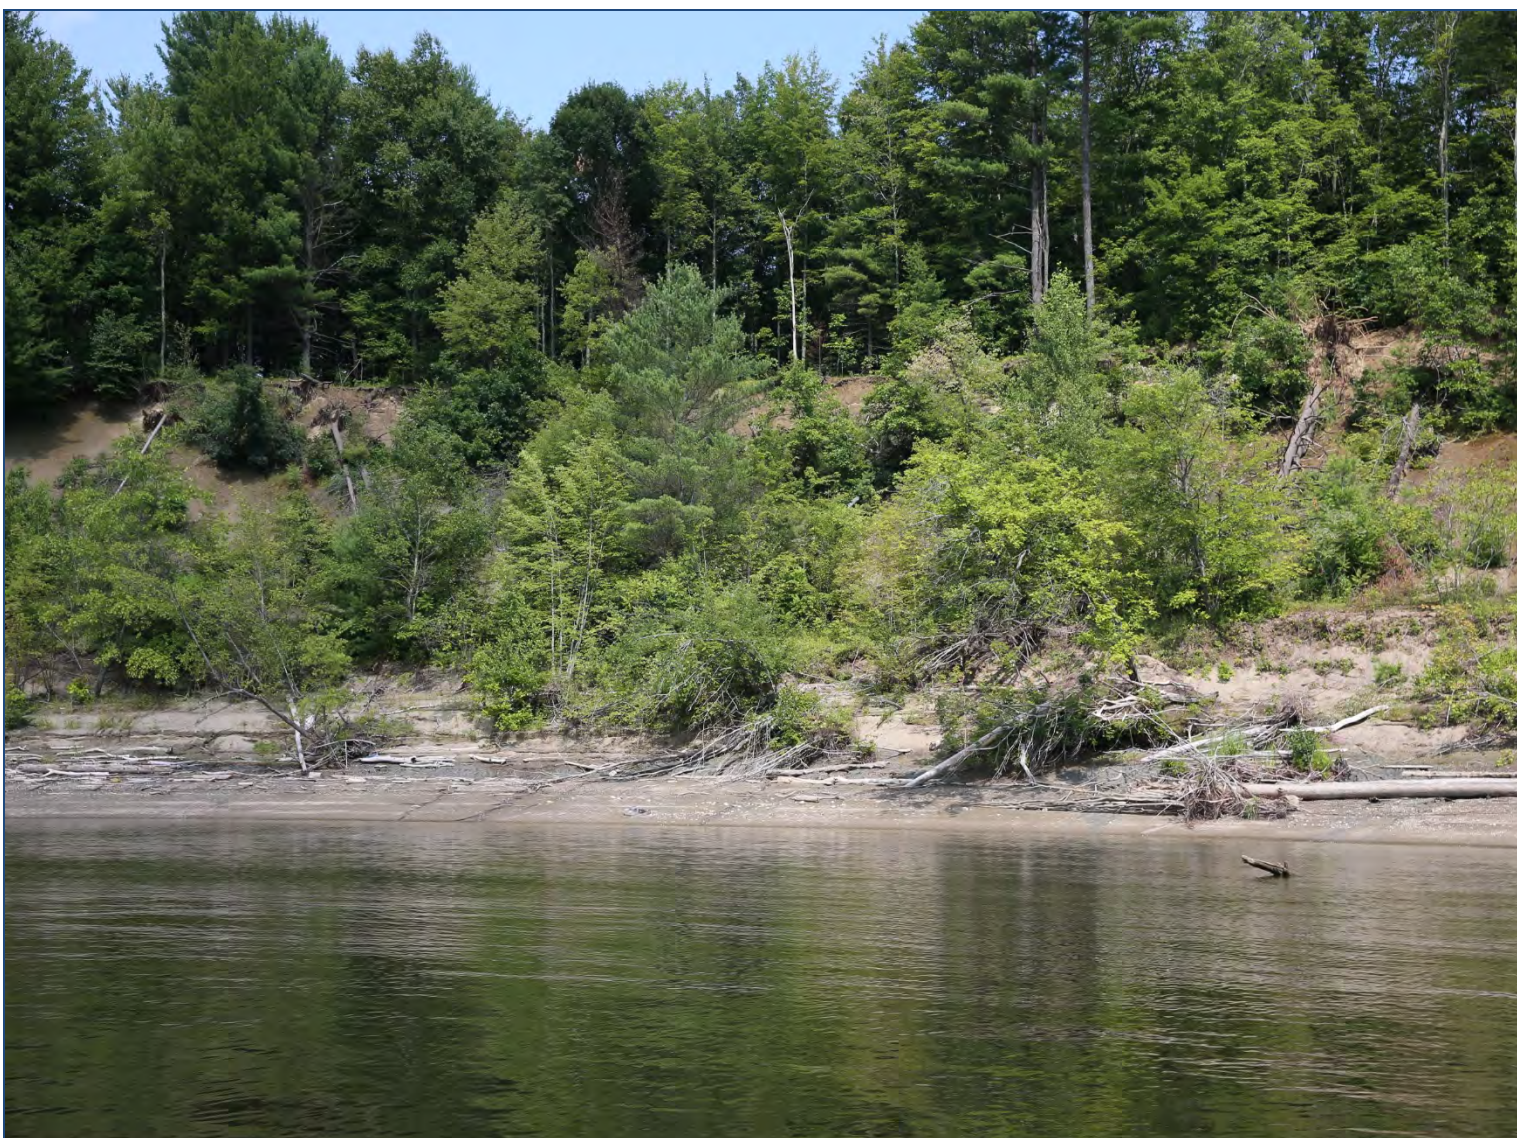
**2014 Photo:** Vernon Dam

**PHOTO SET #1****2007 Photo:** Vernon Dam: Located immediately downstream of the Vernon Dam on the left bank.

**Observations:** The young trees present in the photo from 2007 have grown, additional coarse woody debris has accumulated on the bench since the 2007 photo, and some of the trees fell since the 2007 photograph. The overhang at the top of the bank appears to have receded back indicated by the toppled trees at the top of bank but the lower bank appears to have remained in place allowing increased growth of vegetation.

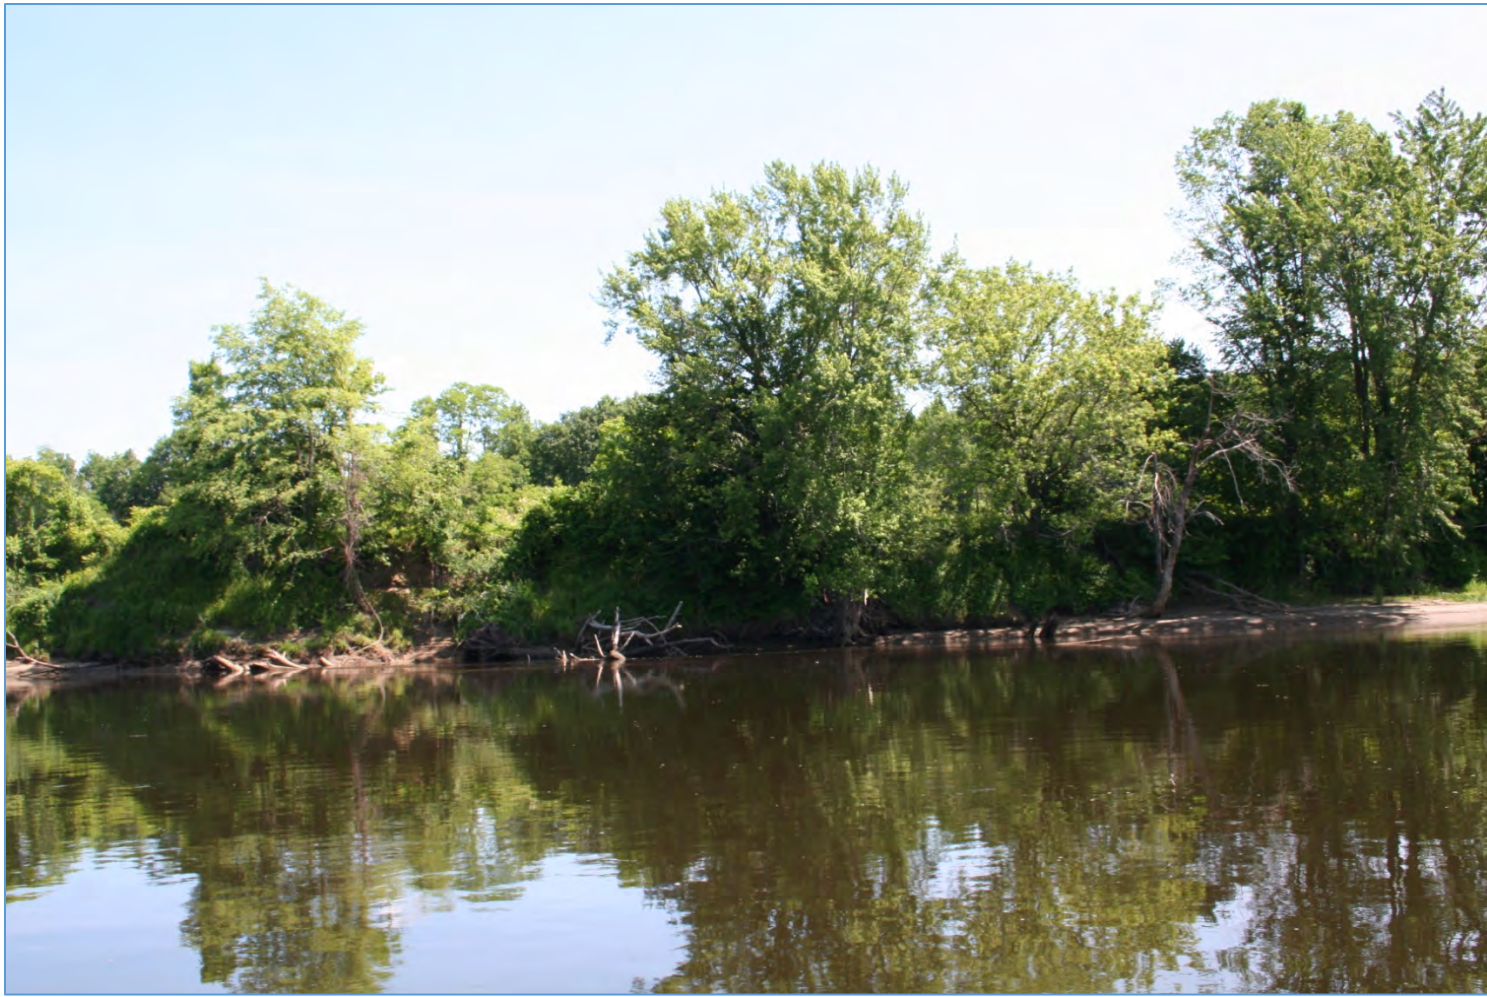
**2007 Photo:** Bonnette Farm: Located in New Hampshire on the left bank.

**Observations:** Dense and well established vegetation are observed in both photographs, indicative of relative stability. Since the 2007 photograph, the bank has become more vegetated due to the planting of hundreds of shrubs on the bank. Oriental bittersweet vines are common. There were sensitive receptor sites (kingfisher next cavity) present in 2007 and in 2014.

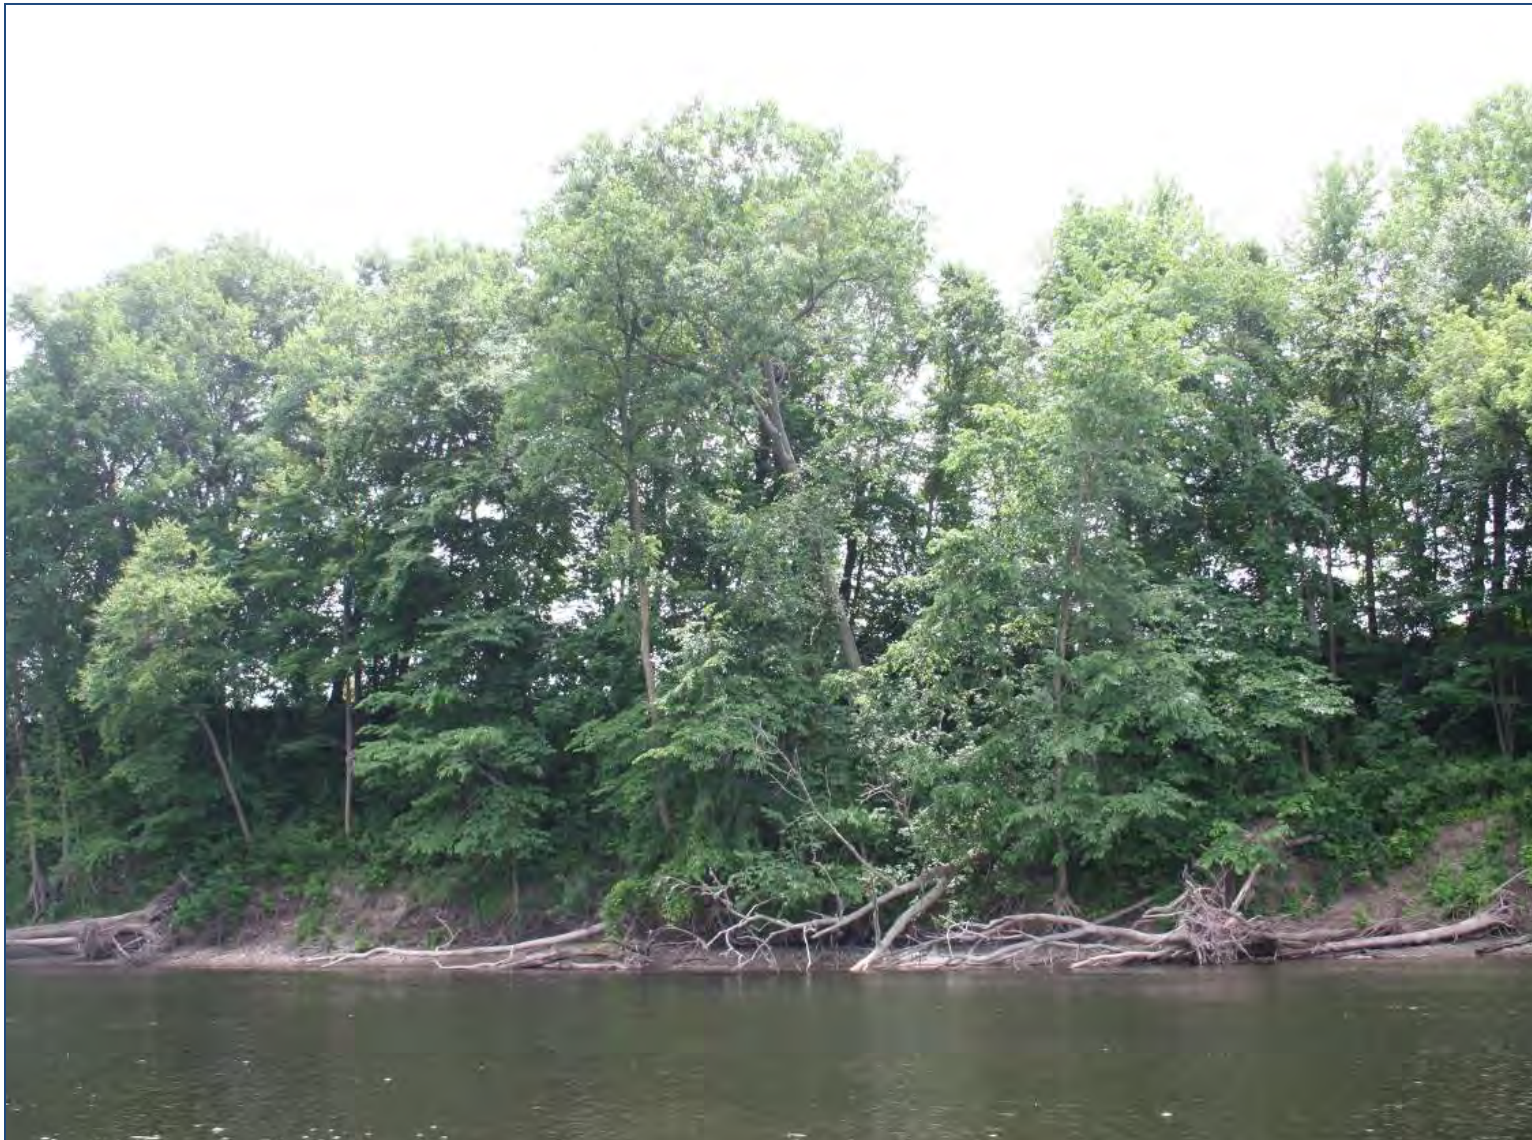
**2007 Photo:** Vermont Farm: Located in Vermont on the right bank. Note the bank is steep, and there are exposed roots at the toe.

**Observations:** Banks in both photos support a significant density of trees. An increase in lower level vegetative growth, including a patch of emergent vegetation on the bench which was not observed in the 2007 photo, can be observed in the 2014 photo.

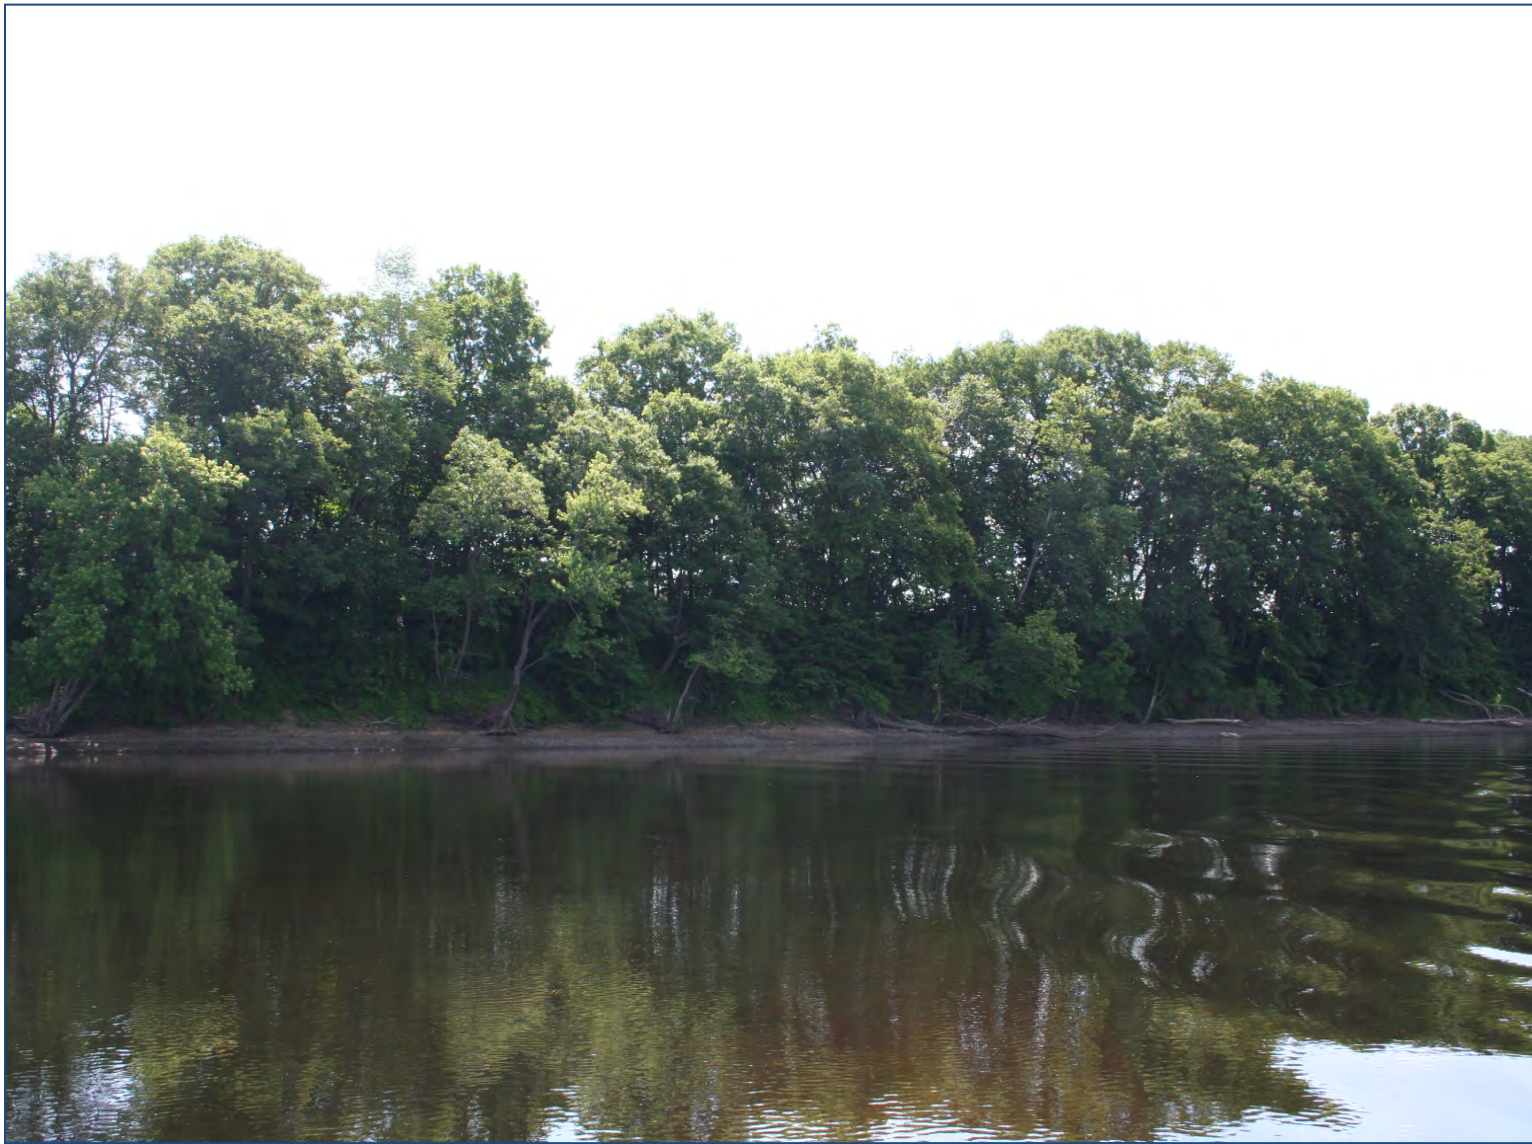
**2007 Photo:** New Hampshire Site: Located in New Hampshire on the left bank. The bench is gravelly at this site, with some areas of exposed bedrock, and some patches of emergent vegetation.

**Observations:** No significant changes in the bank at this location are observed.

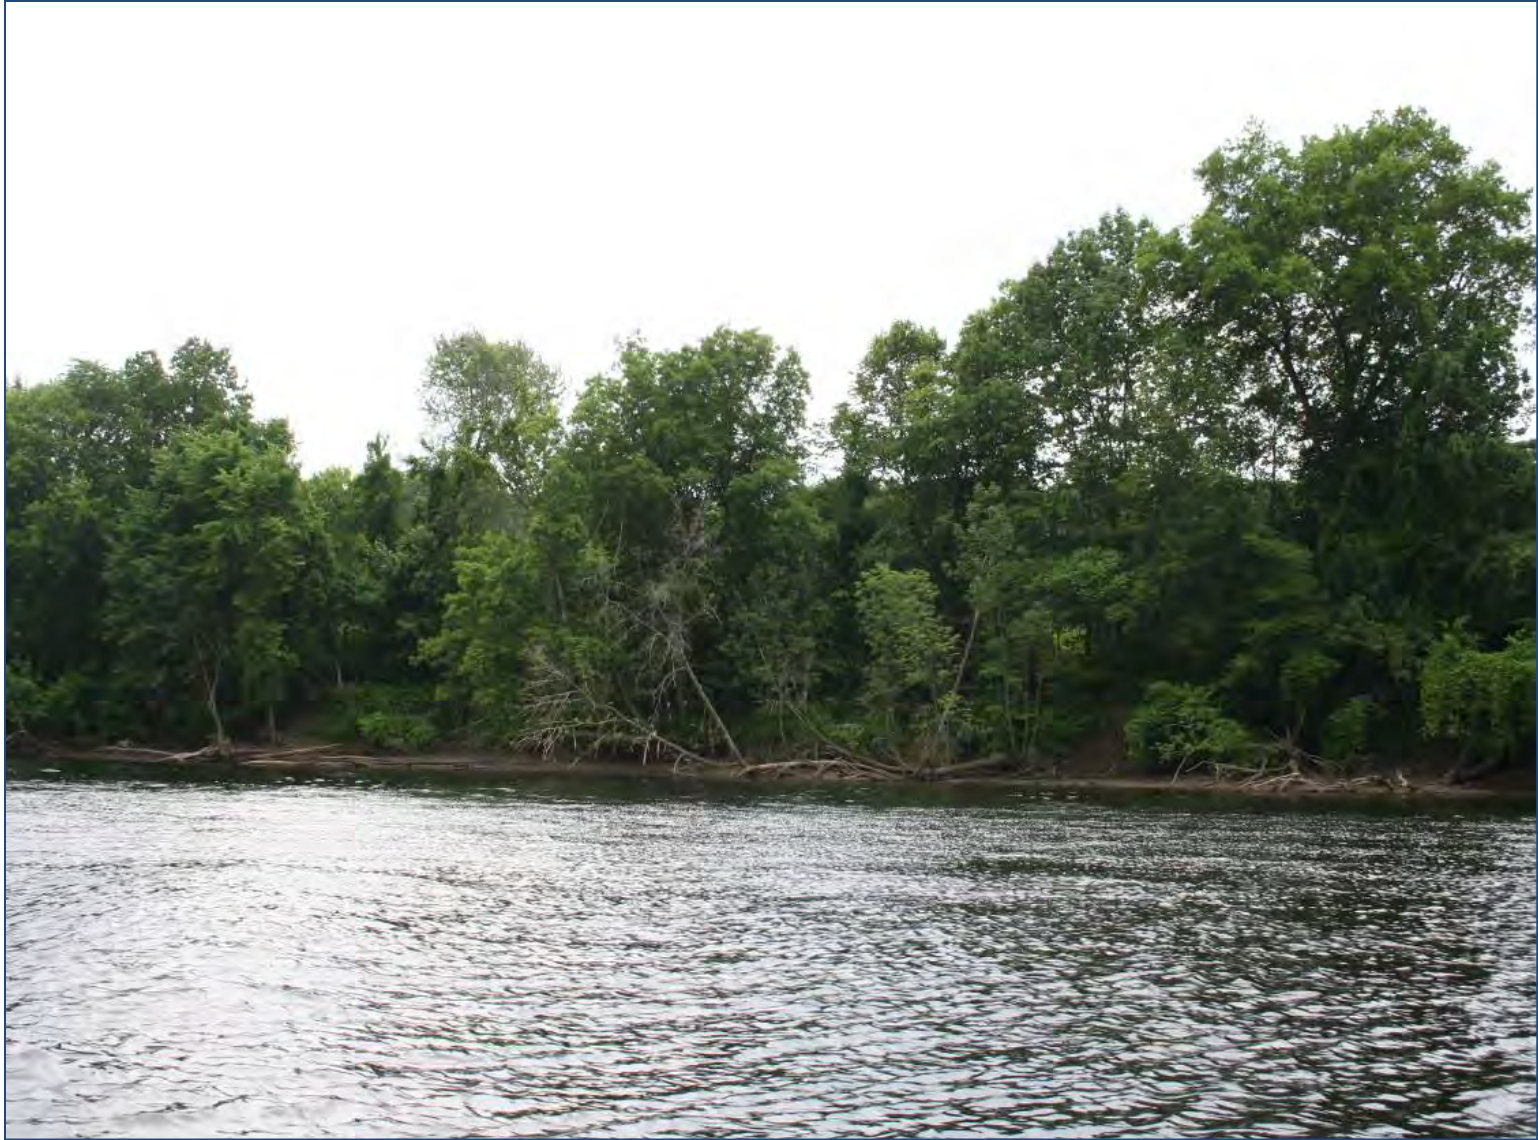
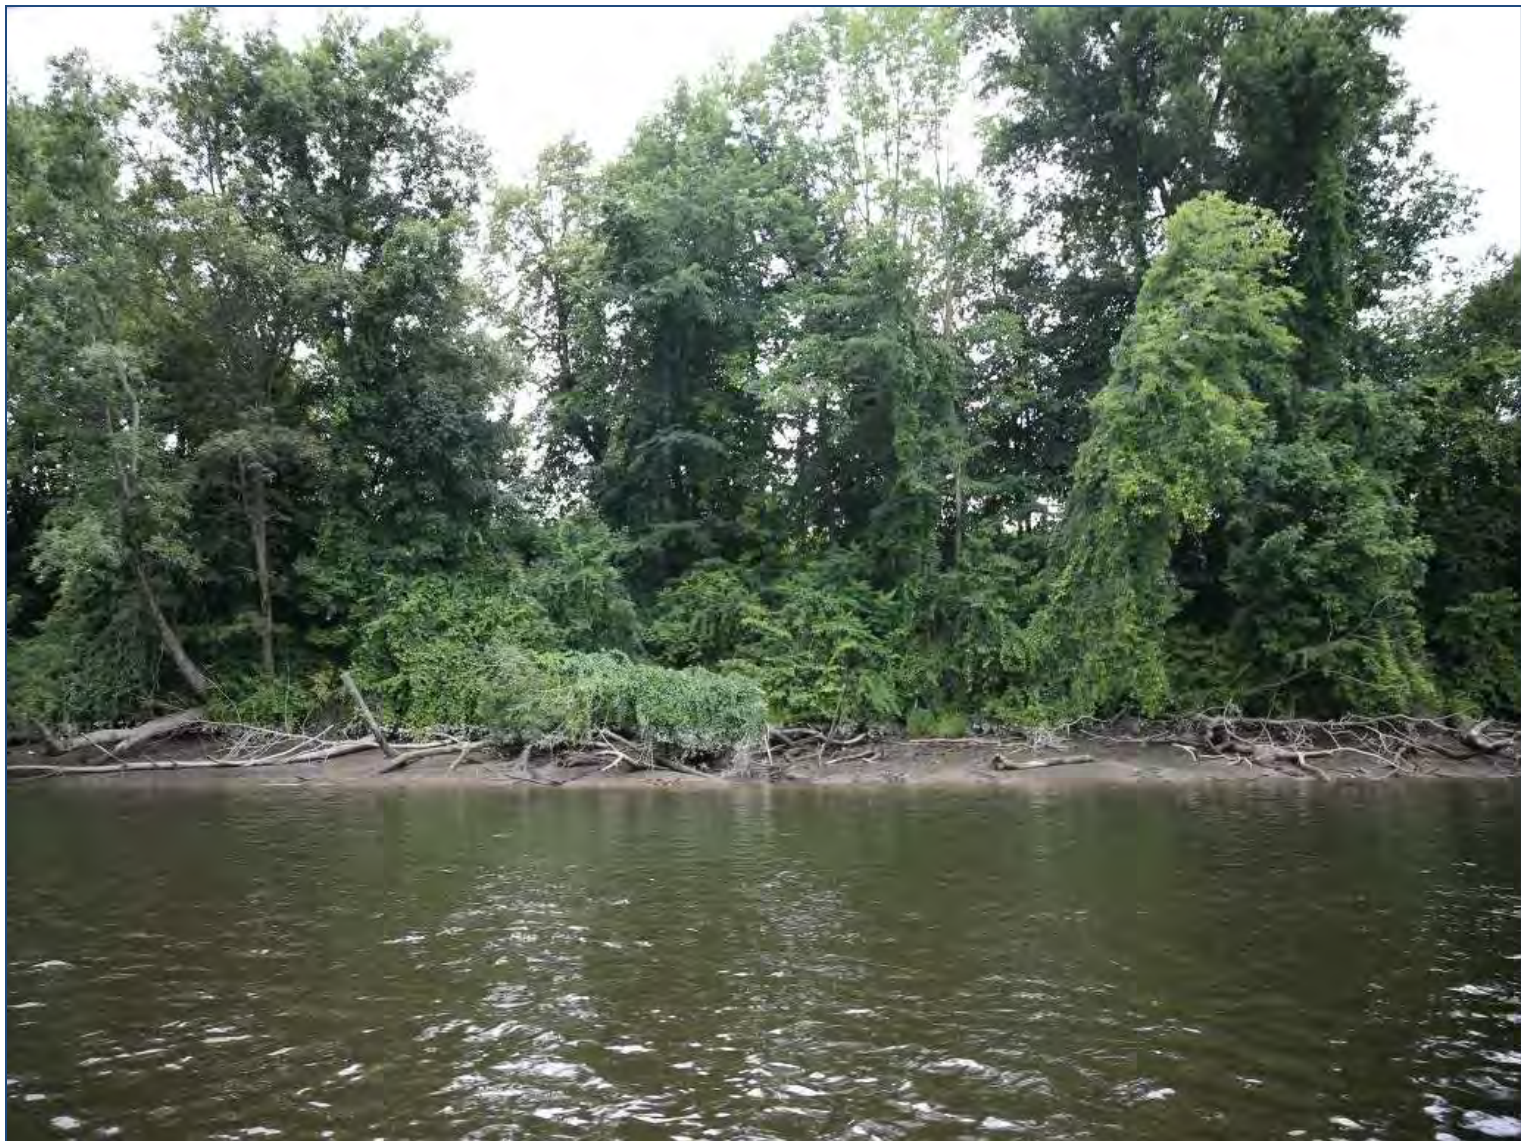
**2014 Photo:** Downstream from Kendall, Site 1

**2007 Photo:** Downstream from Kendall, Site 1: Located in Vermont on the right bank, and immediately downstream from the Kendall restoration site.

**Observations:** Banks in both photos are well-vegetated, however, since the 2007 photograph oriental bittersweet has overgrown many of the trees.

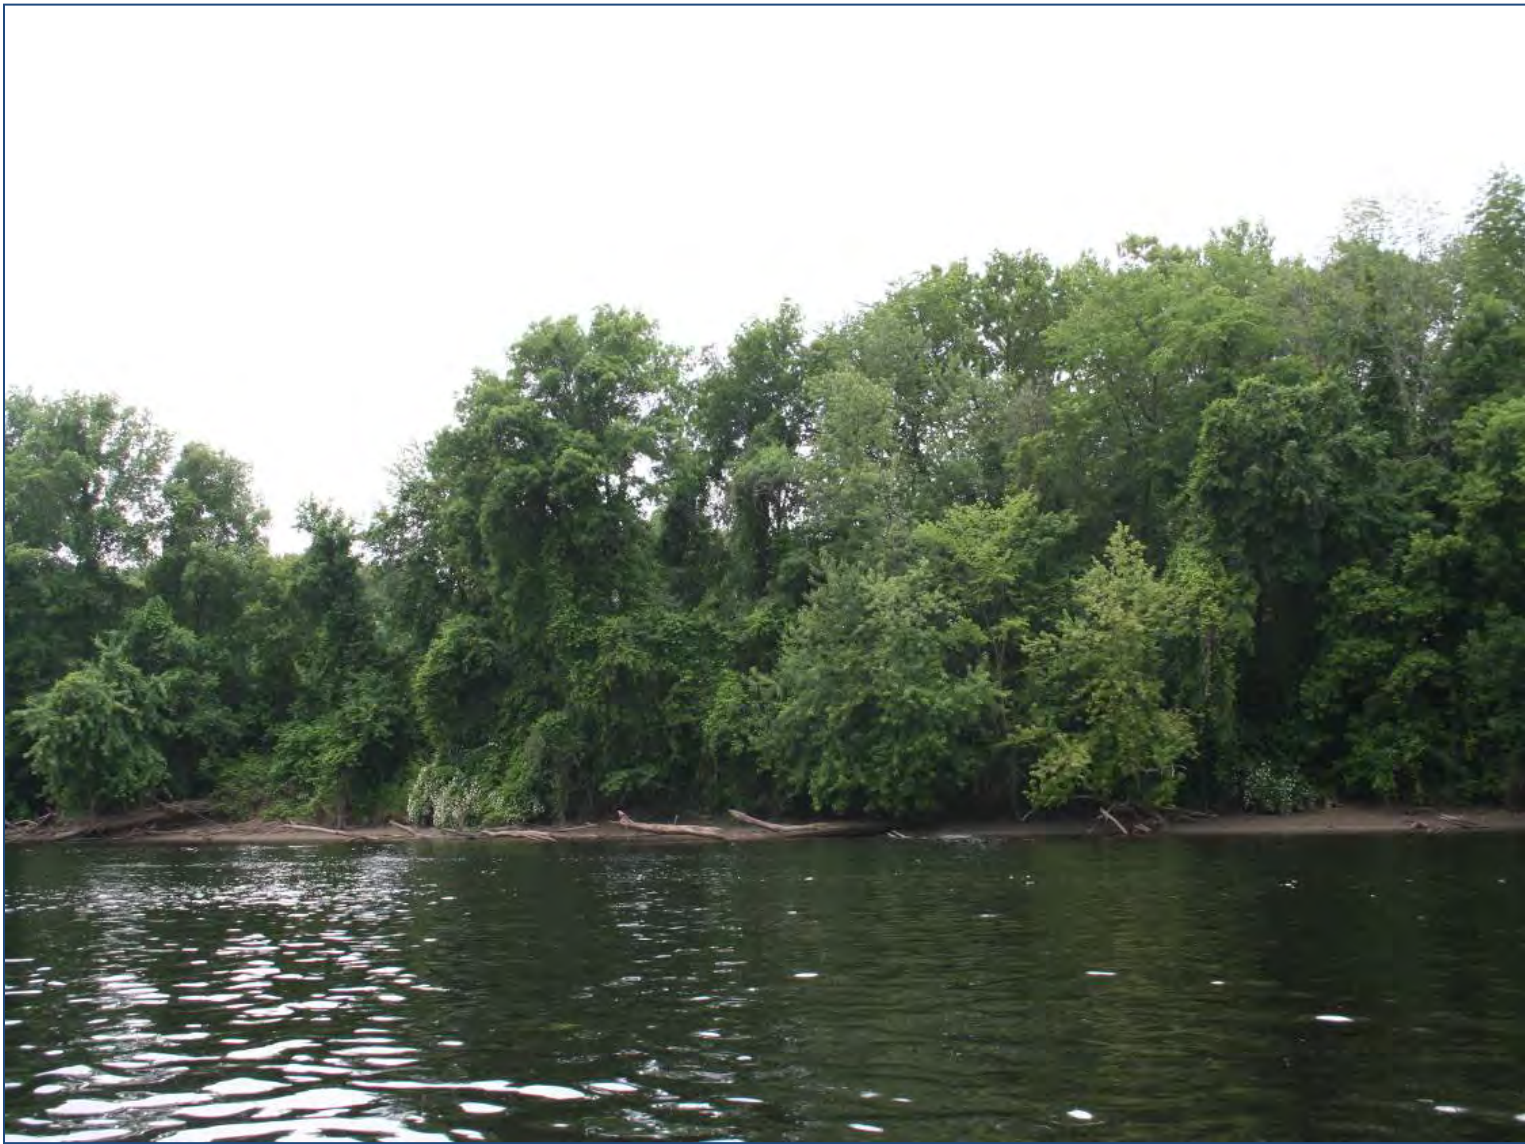
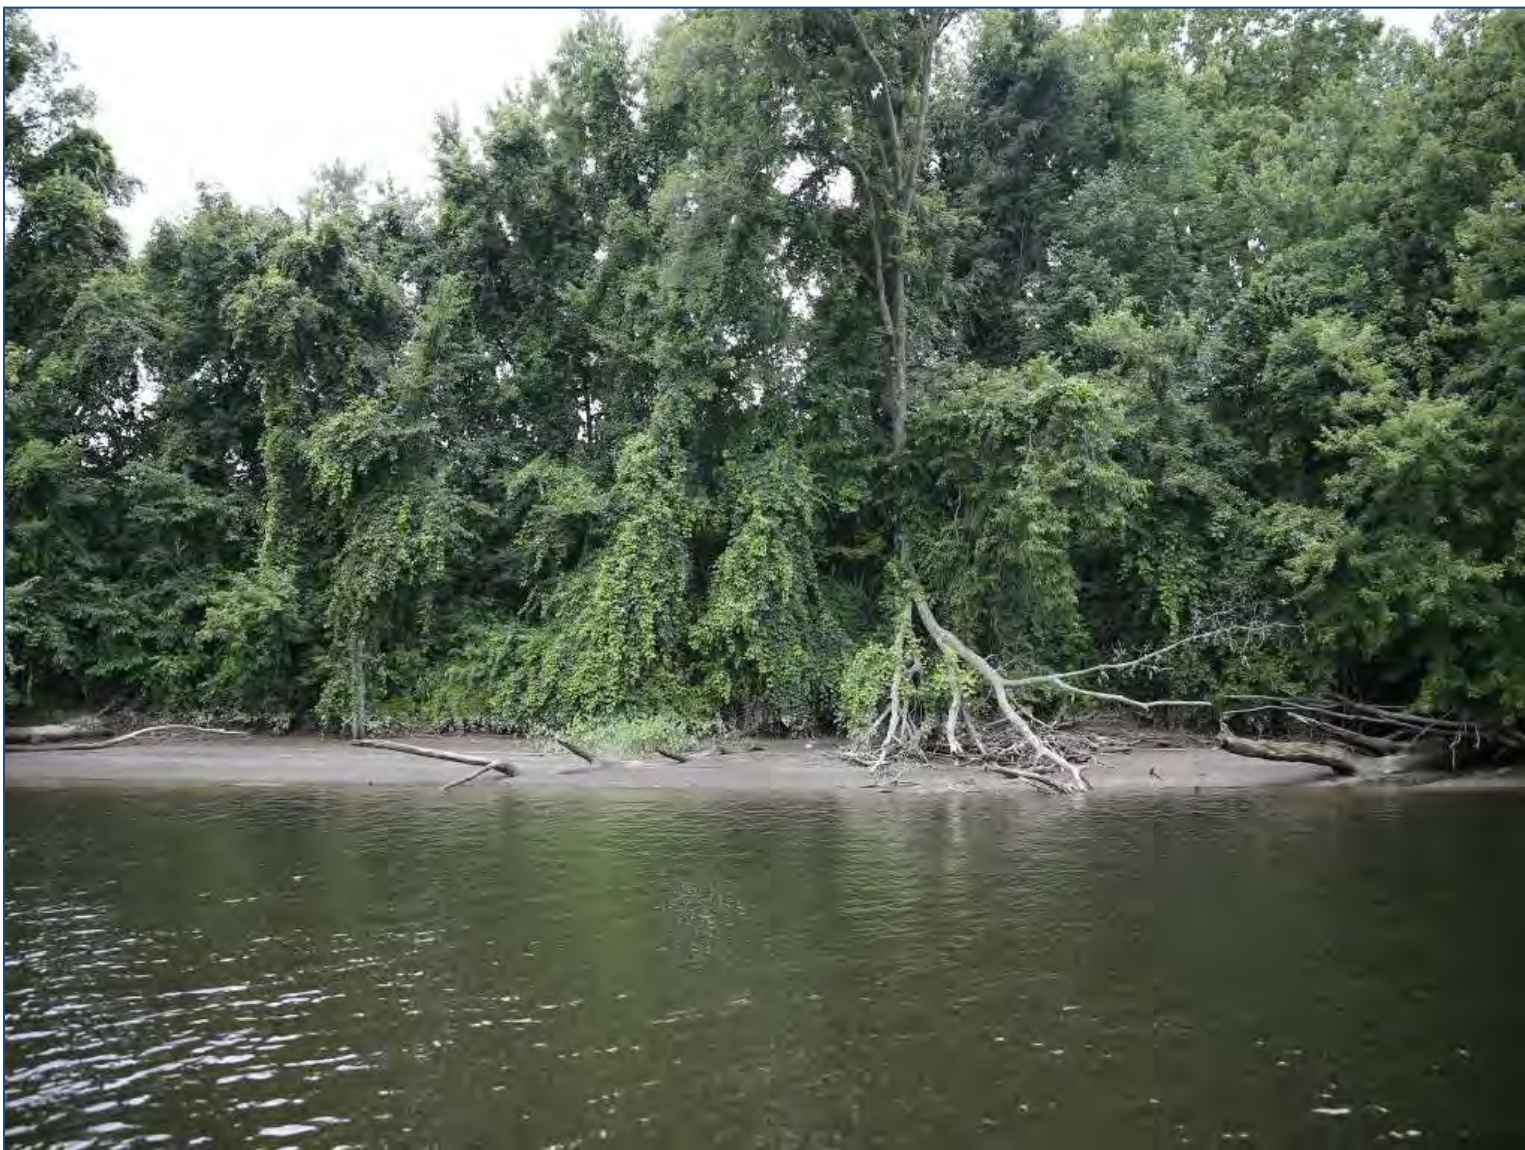
**2014 Photo:** Downstream from Kendall, Site 2

**2007 Photo:** Downstream from Kendall, Site 2: Located further downstream from the Kendall restoration site than Photo set 5, this site is located in Vermont on the right bank.

**Observations:** The banks appear to be similar in both time periods with heavy vegetation. The oriental bittersweet has become denser.
