**FIRSTLIGHT POWER RESOURCES**  
 RELICENSING STUDY 3.1.1  
 2013 FULL RIVER RECONNAISSANCE  
 TURNERS FALLS IMPOUNDMENT

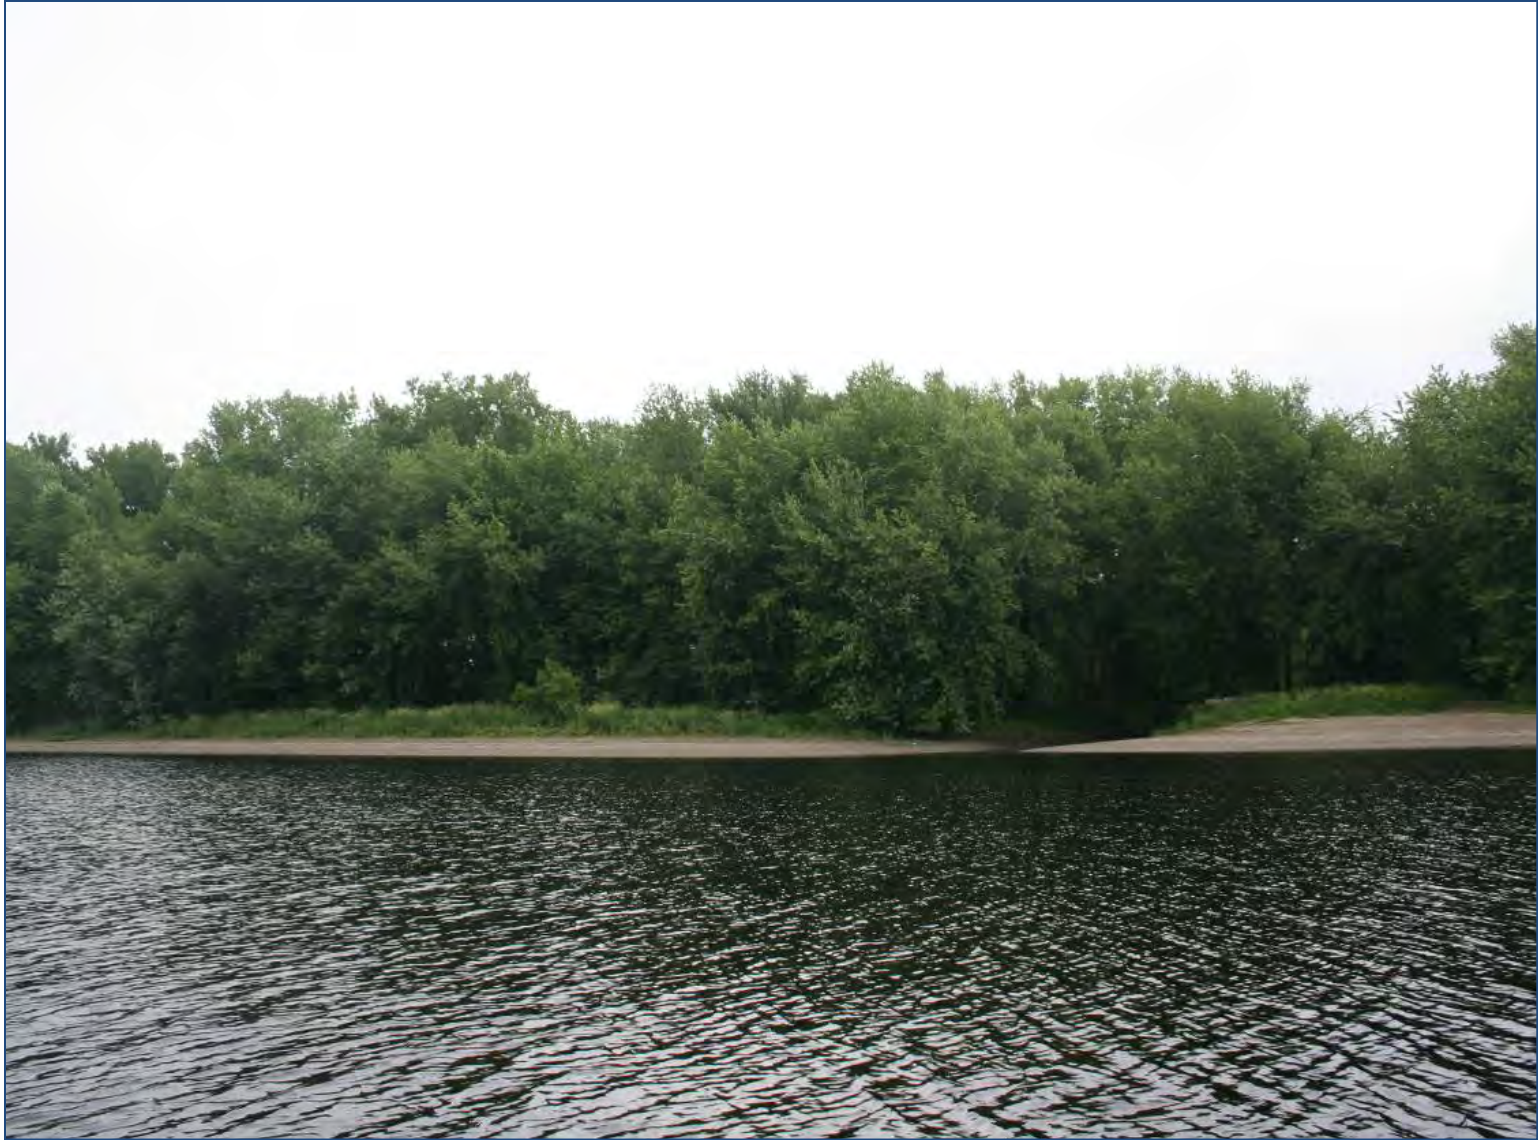
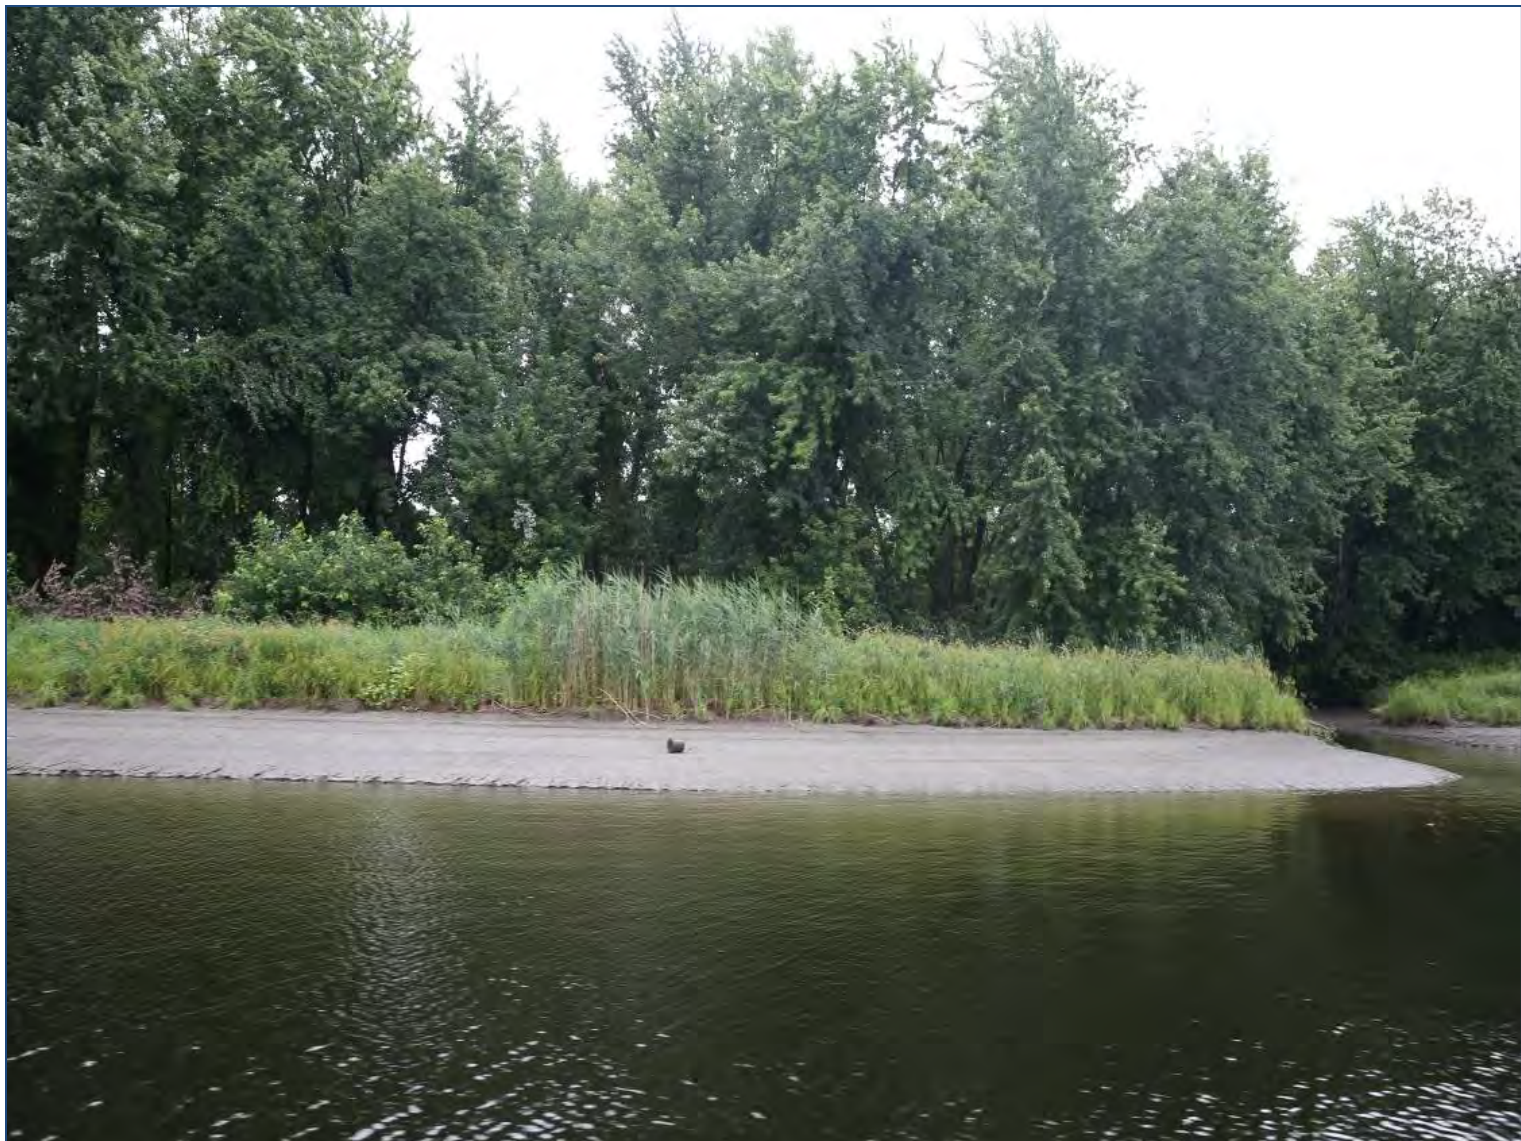
**2014 Photo:** Pauchaug

**2007 Photo:** Pauchaug: Located upstream of the Pauchaug boat launch site on the left bank of the River, in Northfield, Massachusetts.

**Observations:** Both photographs indicate dense vegetation on the upper bank as well as dense vegetation on the lower bank/beach area. Since the 2007 photograph, the bench has accumulated sediment and the emergent vegetation has become very well established. The extent of the *Phragmites* colonization has grown since 2007.

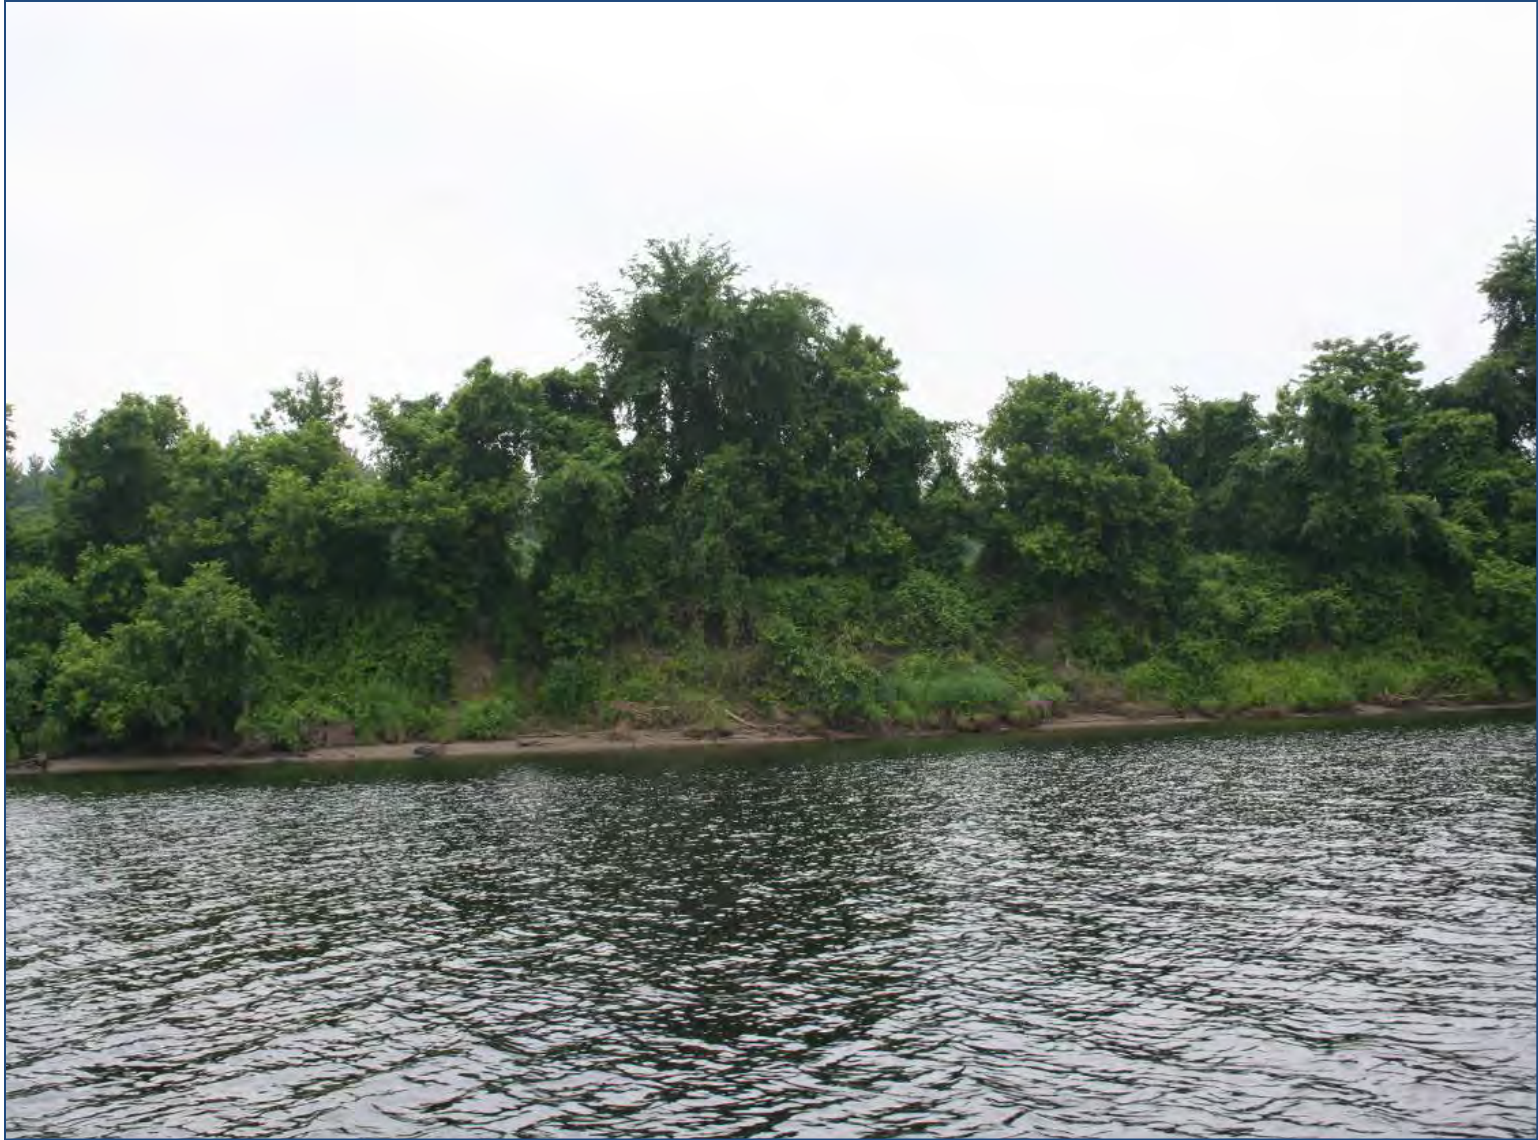
**2007 Photo:** Downstream from the old Railroad Bridge: Located on the left bank of the River.

**Observations:** Bank conditions appear similar in both sets of photographs but oriental bittersweet has become more established since 2007 at this location. There is a kingfisher nest cavity in the 2014 photograph (white arrow).

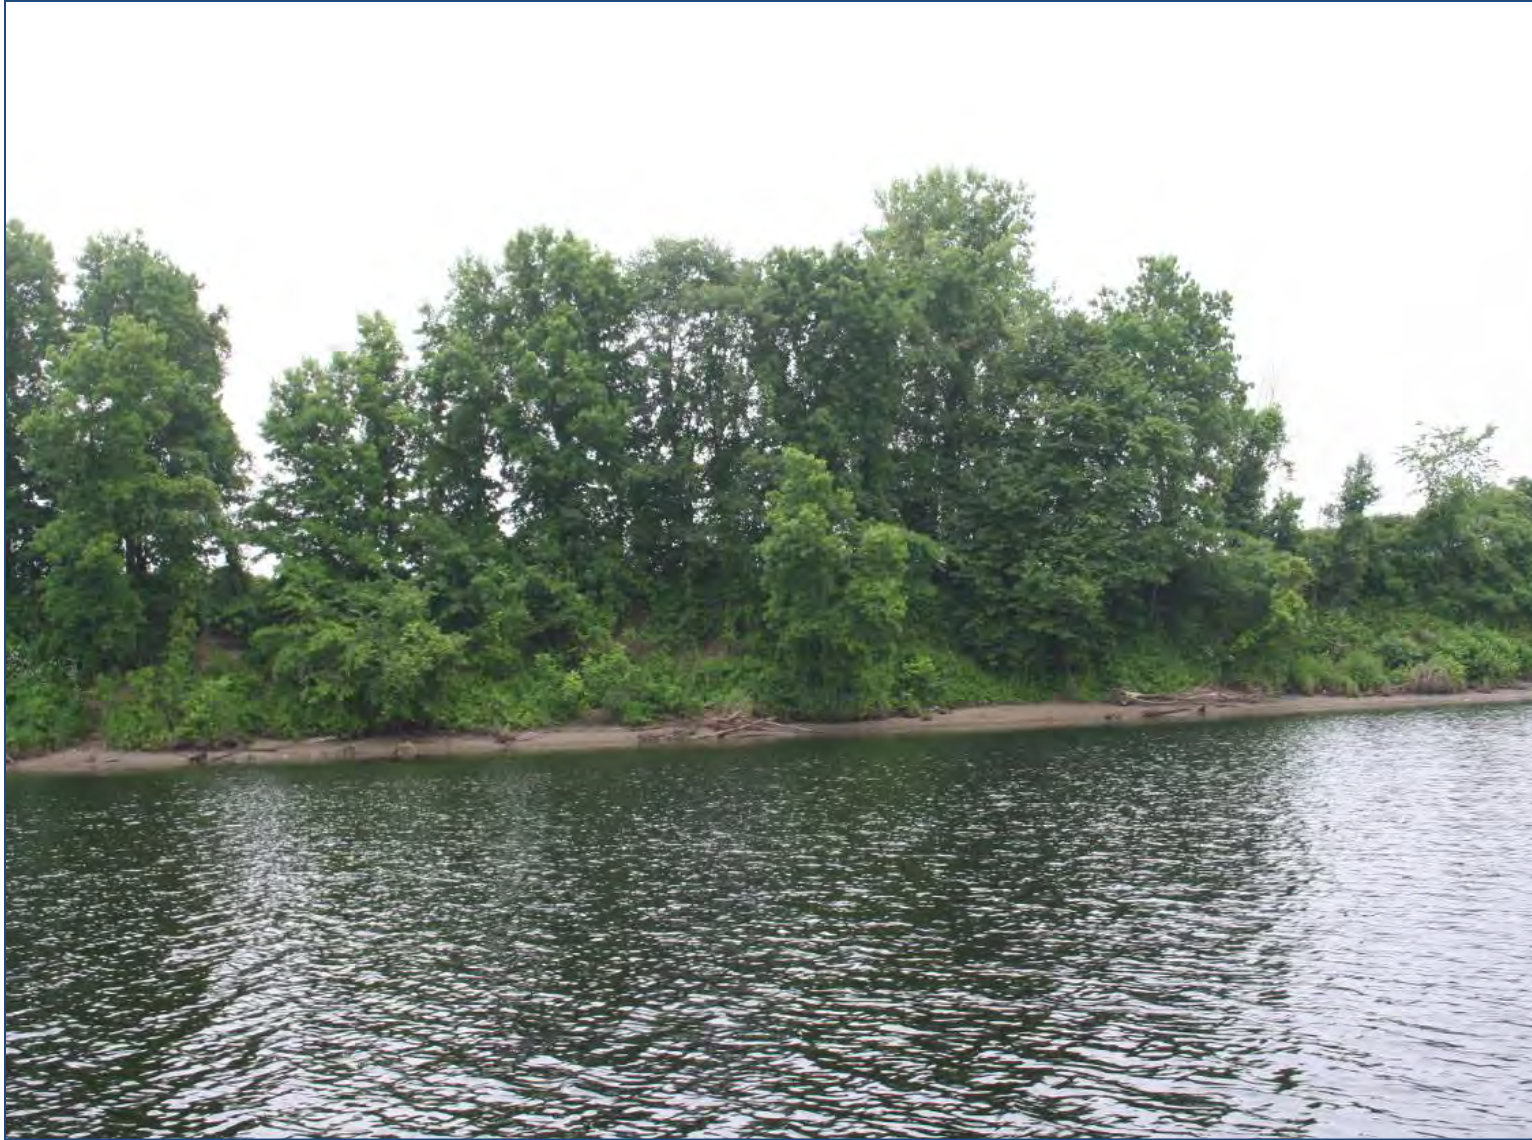
**2007 Photo:** Northfield Farm: Located in Northfield, Massachusetts, on the left bank

**Observations:** Bank conditions do not appear to have changed significantly from 2007 to 2014. The vegetated riparian buffer along this farm field is narrow, and has not changed since 2007.

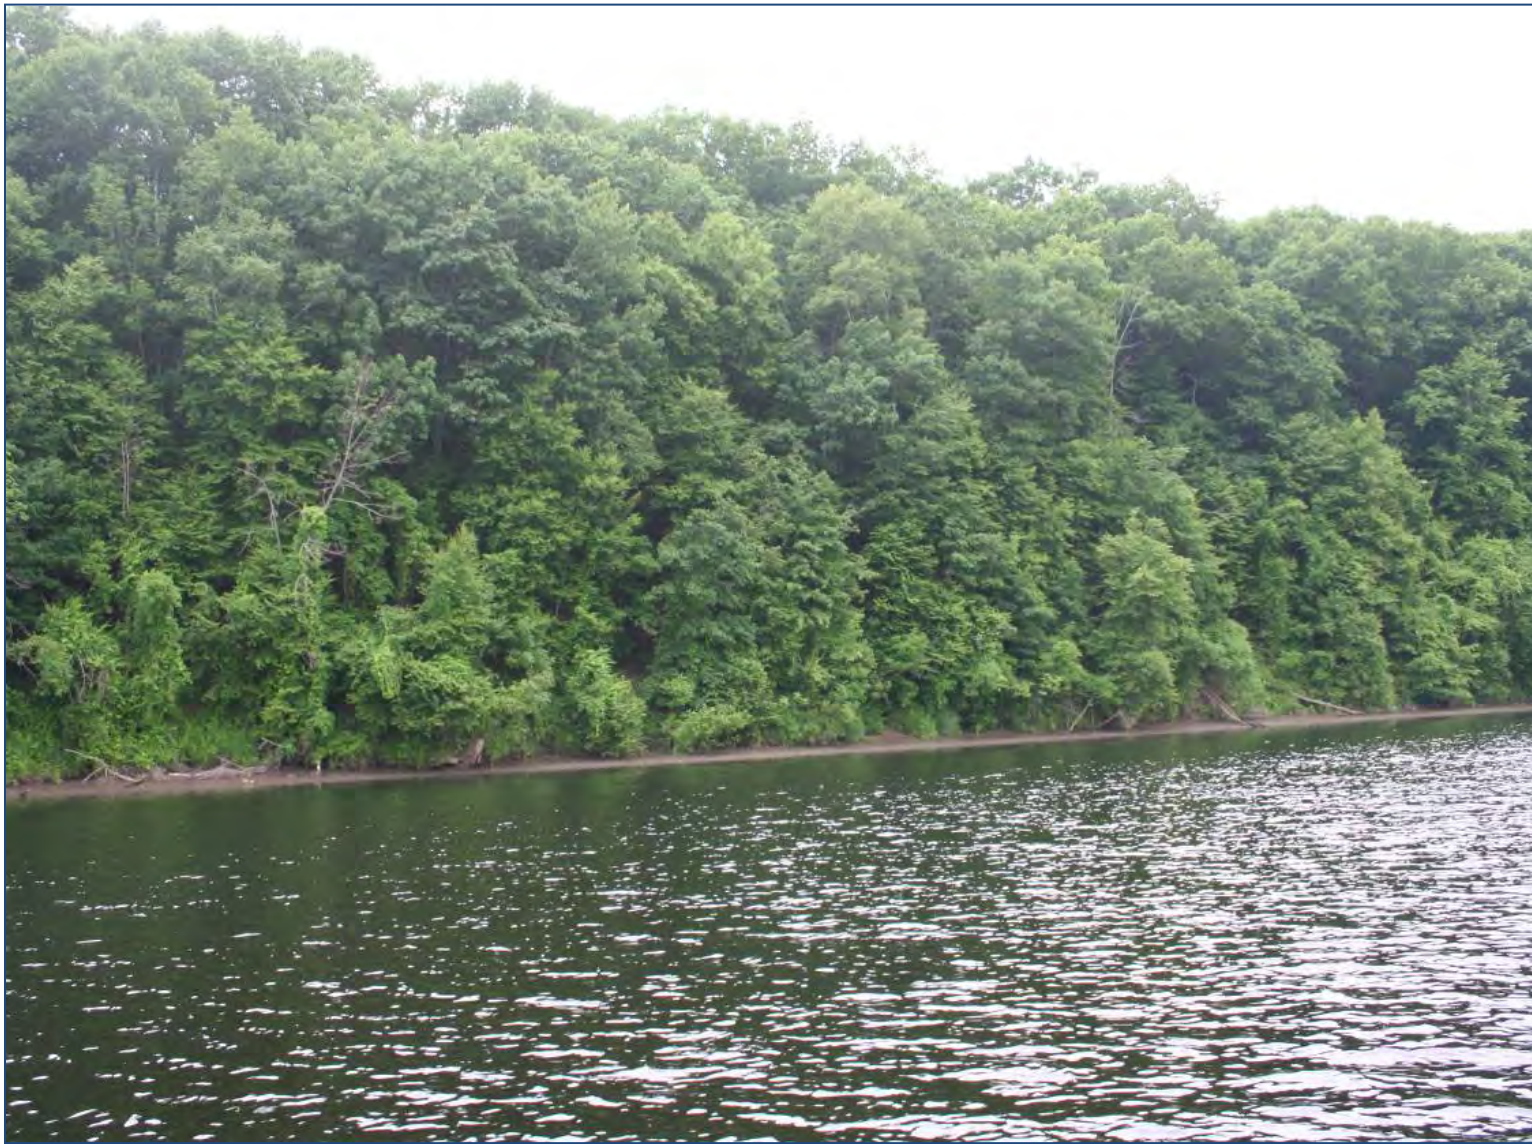
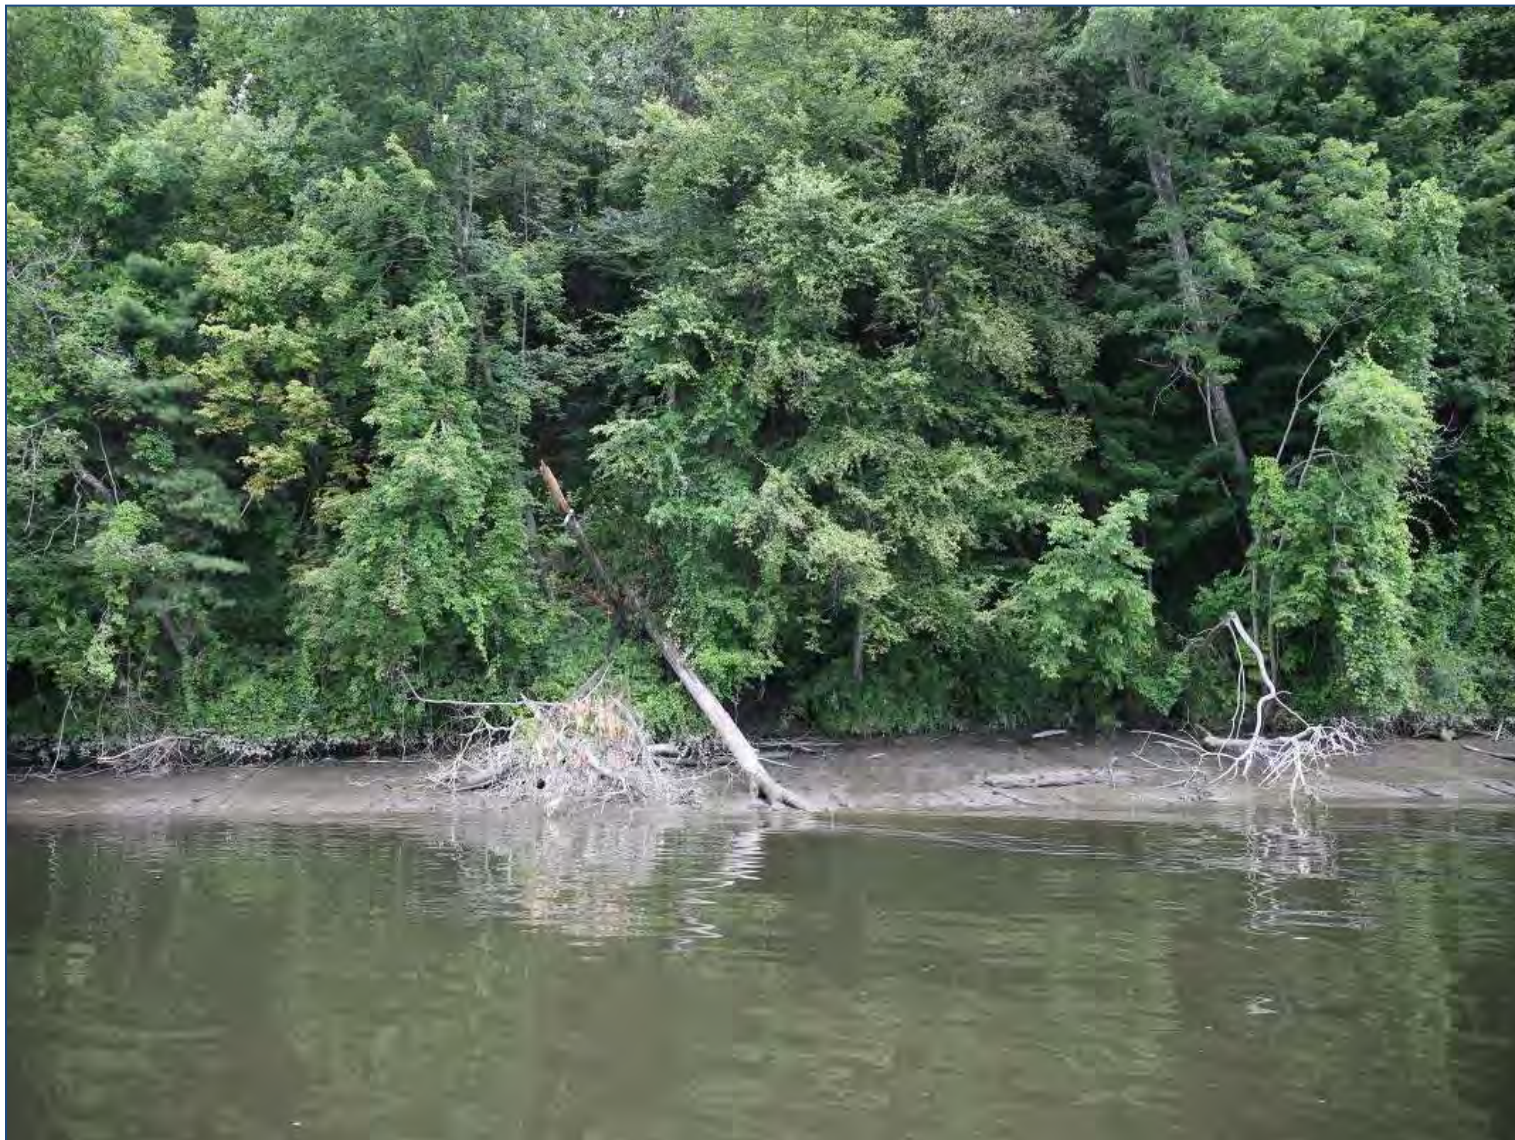
**2014 Photo:** Upstream from the Rt. 10 Bridge

**2007 Photo:** Upstream from the Rt. 10 Bridge: Located upstream of the Route 10 Bridge on the right bank in Northfield, this section of Riverbank is very steep, and is heavily forested.

**Observations:** No significant changes can be seen at this site since 2007.

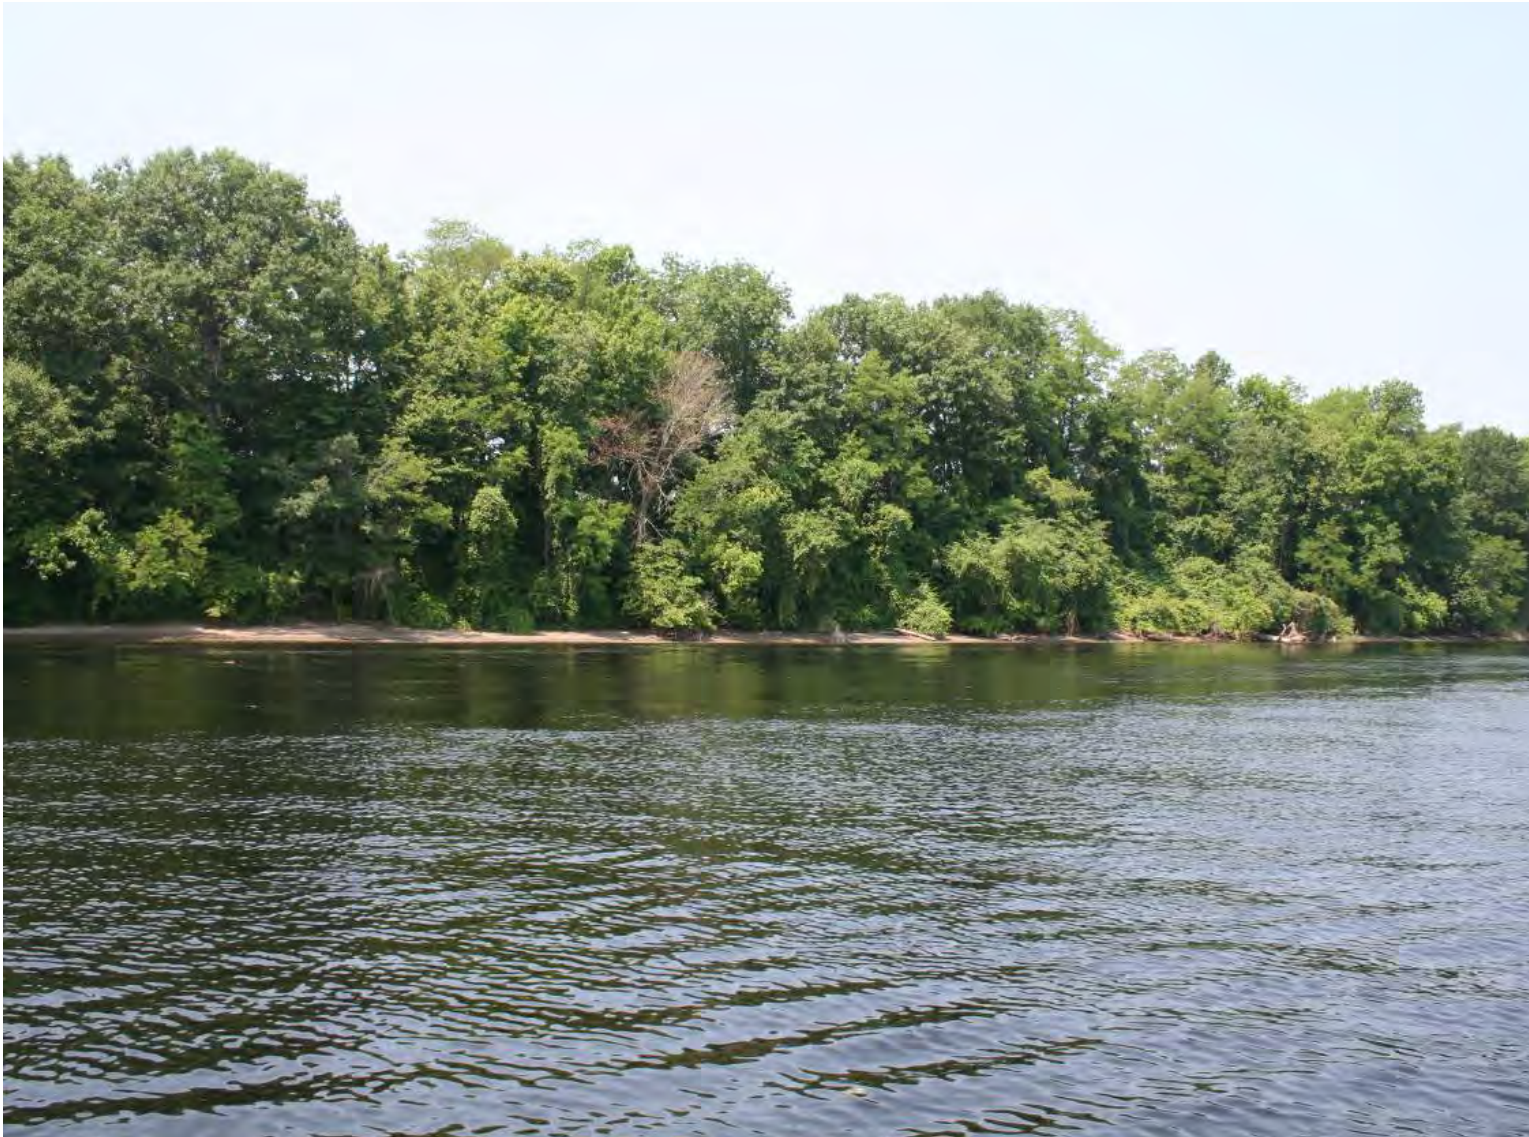
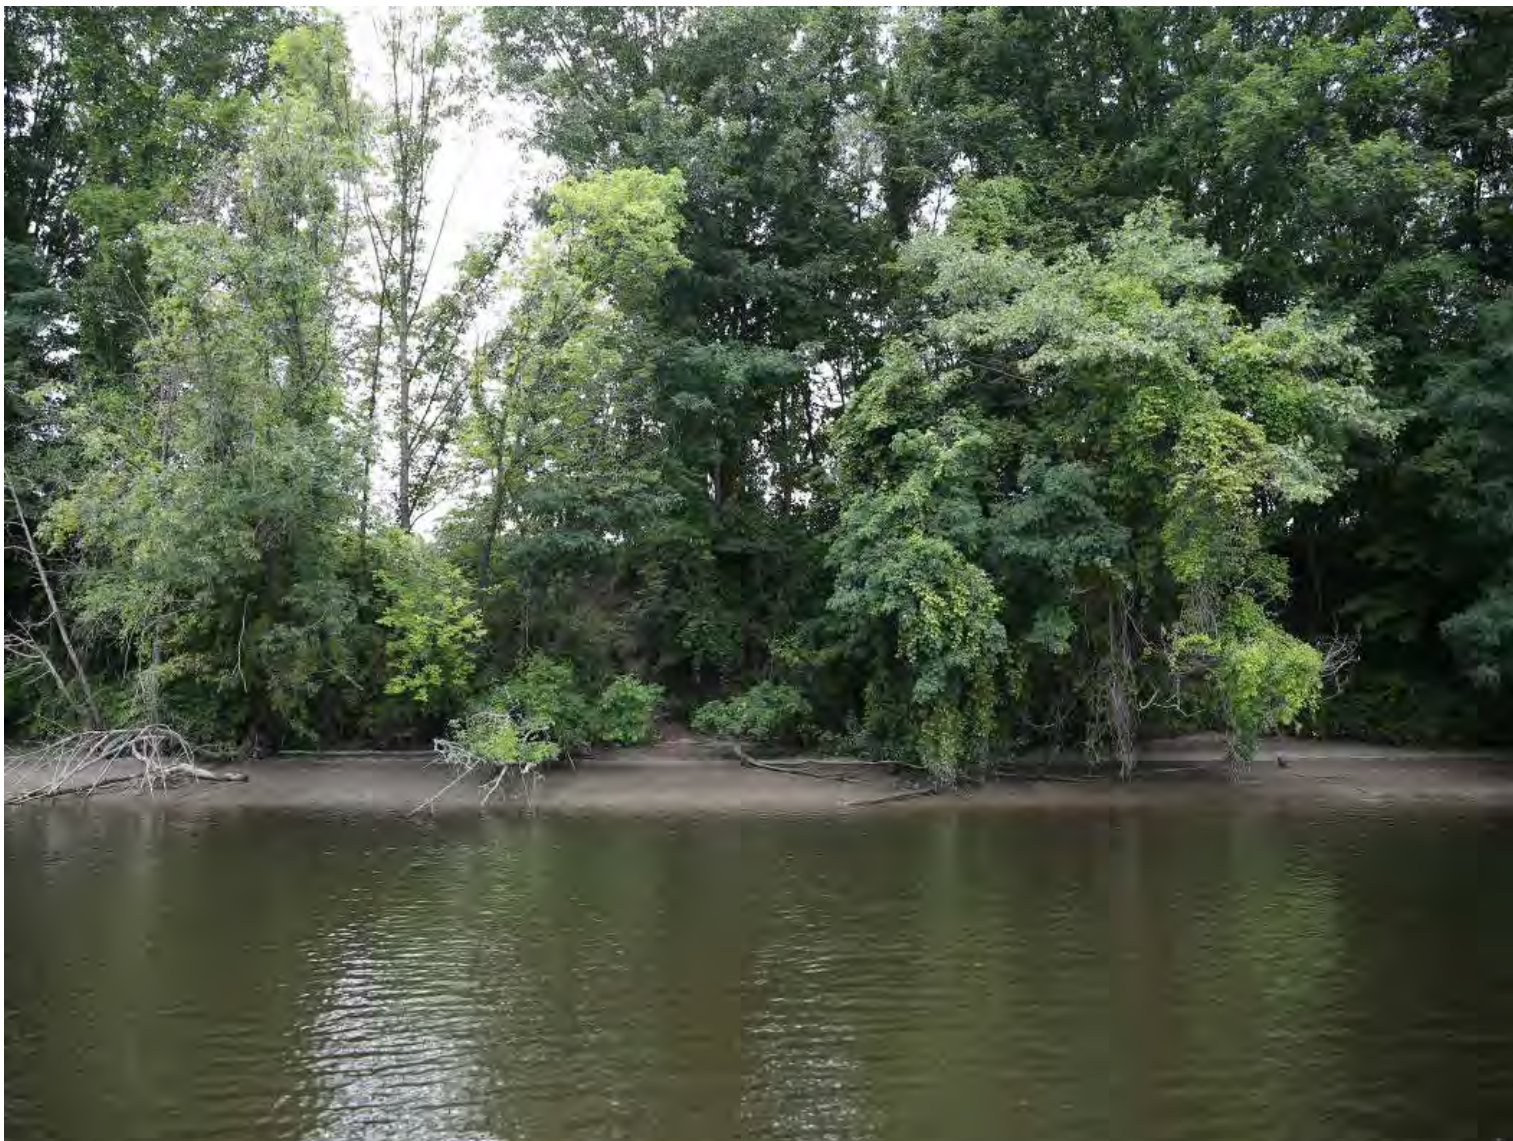
**2014 Photo:** Downstream from the Rt. 10 Bridge

**2007 Photo:** Downstream from the Rt. 10 Bridge: Located in Northfield, Massachusetts, on the right bank.

**Observations:** There are no significant changes at this photo station since 2007.

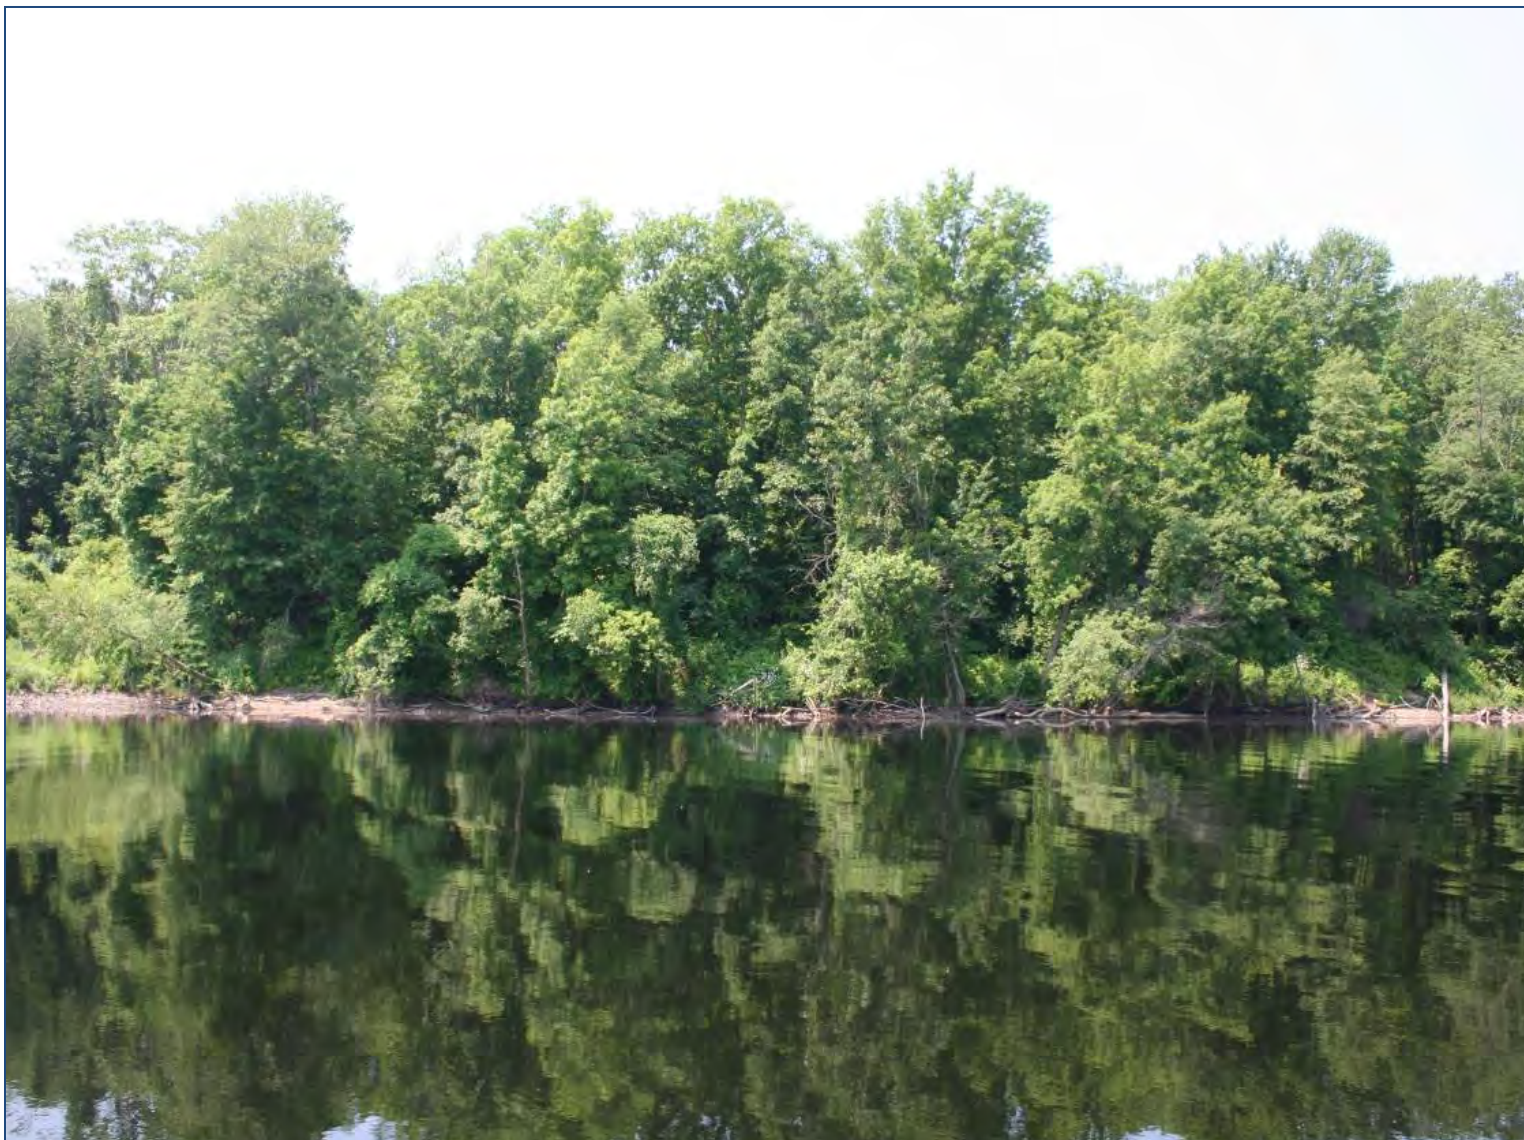
**2007 Photo:** Upstream from Urgiel (upstream) restoration site: Located in Gill, Massachusetts, on the right bank.

**Observations:** Bank conditions appear to be similar in both photographs. This photograph shows the location of a linear erosion feature with a vertical exposed face ranging from 1 to 2 feet high that extends longitudinally through part of the repaired segment (Urgiel) as well as farther upstream even crossing through a small drainage feature.

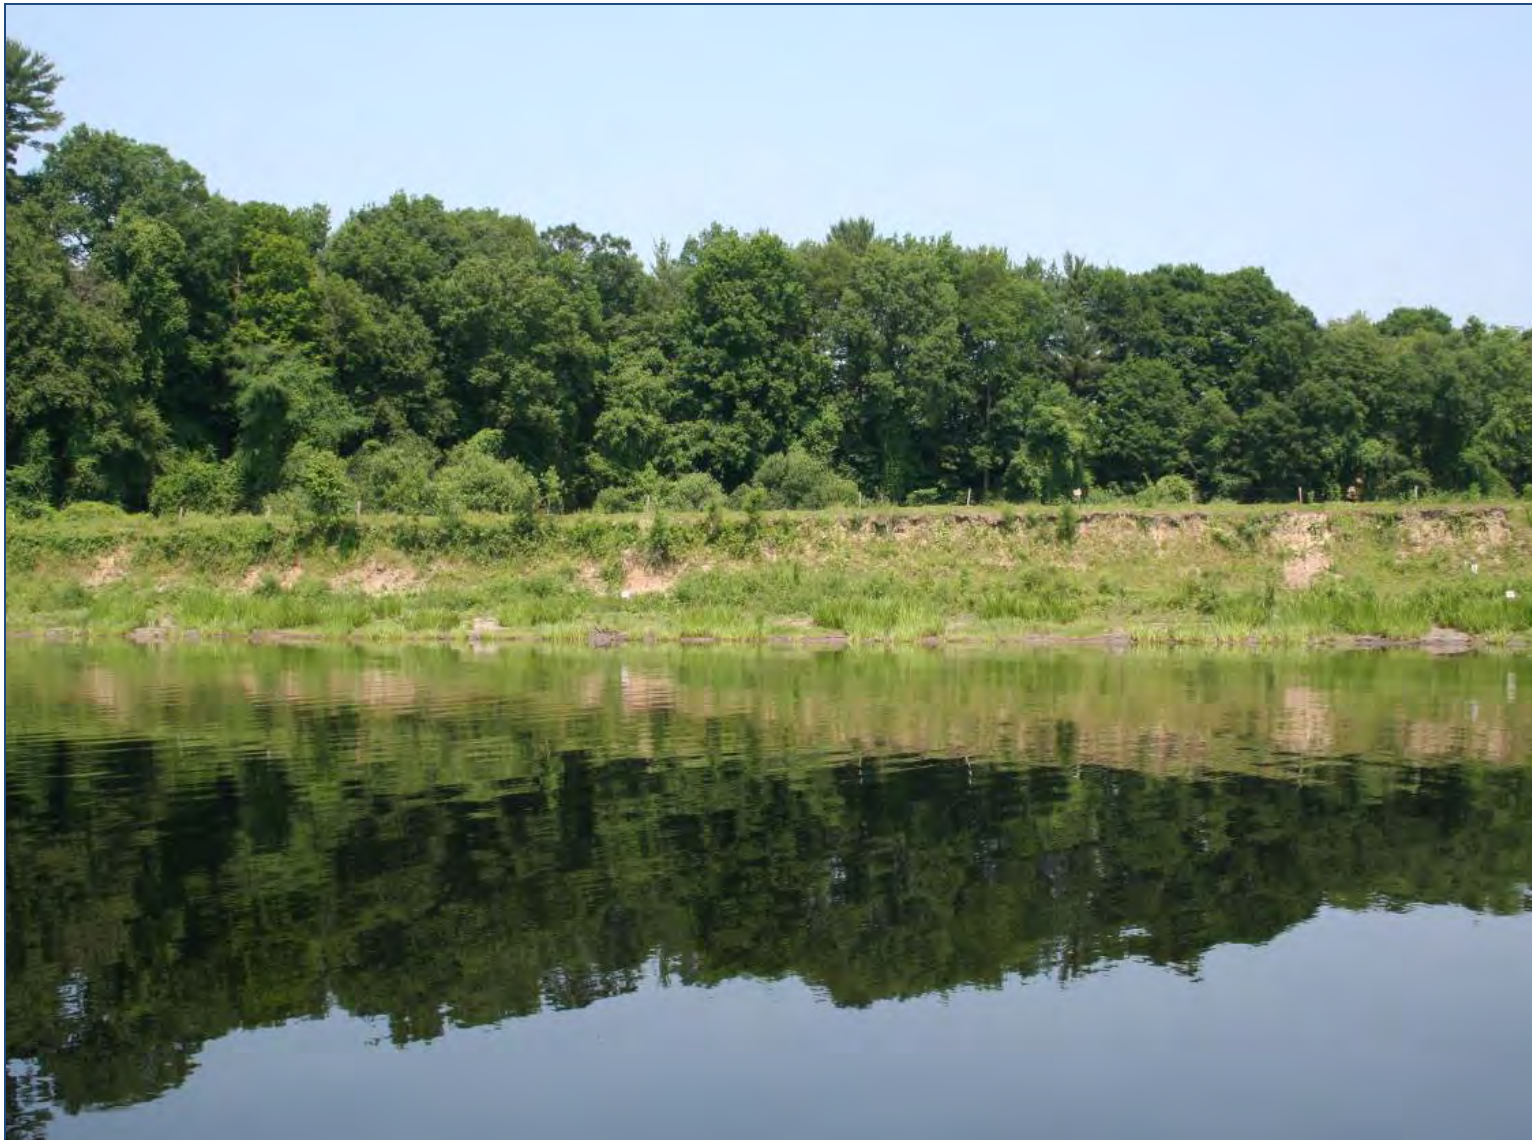
**2007 Photo:** Flagg Farm: This site is located at the downstream end of the Flagg restoration site, on the right bank, in Gill, Massachusetts.

**Observations:** Since the 2007 photograph the bank face has become more vegetated and recovering from past grazing activity by cattle since this site was restored in 1999. Sediment has deposited on the lower bank and emergent vegetation is becoming established and growing. Close observation of this site during field data collection for the erosion causation study showed that a number of cottonwood seedlings have become established on this lower bank. There were several bank swallow nest cavities observed at this site in 2007, but there were none observed in 2014.

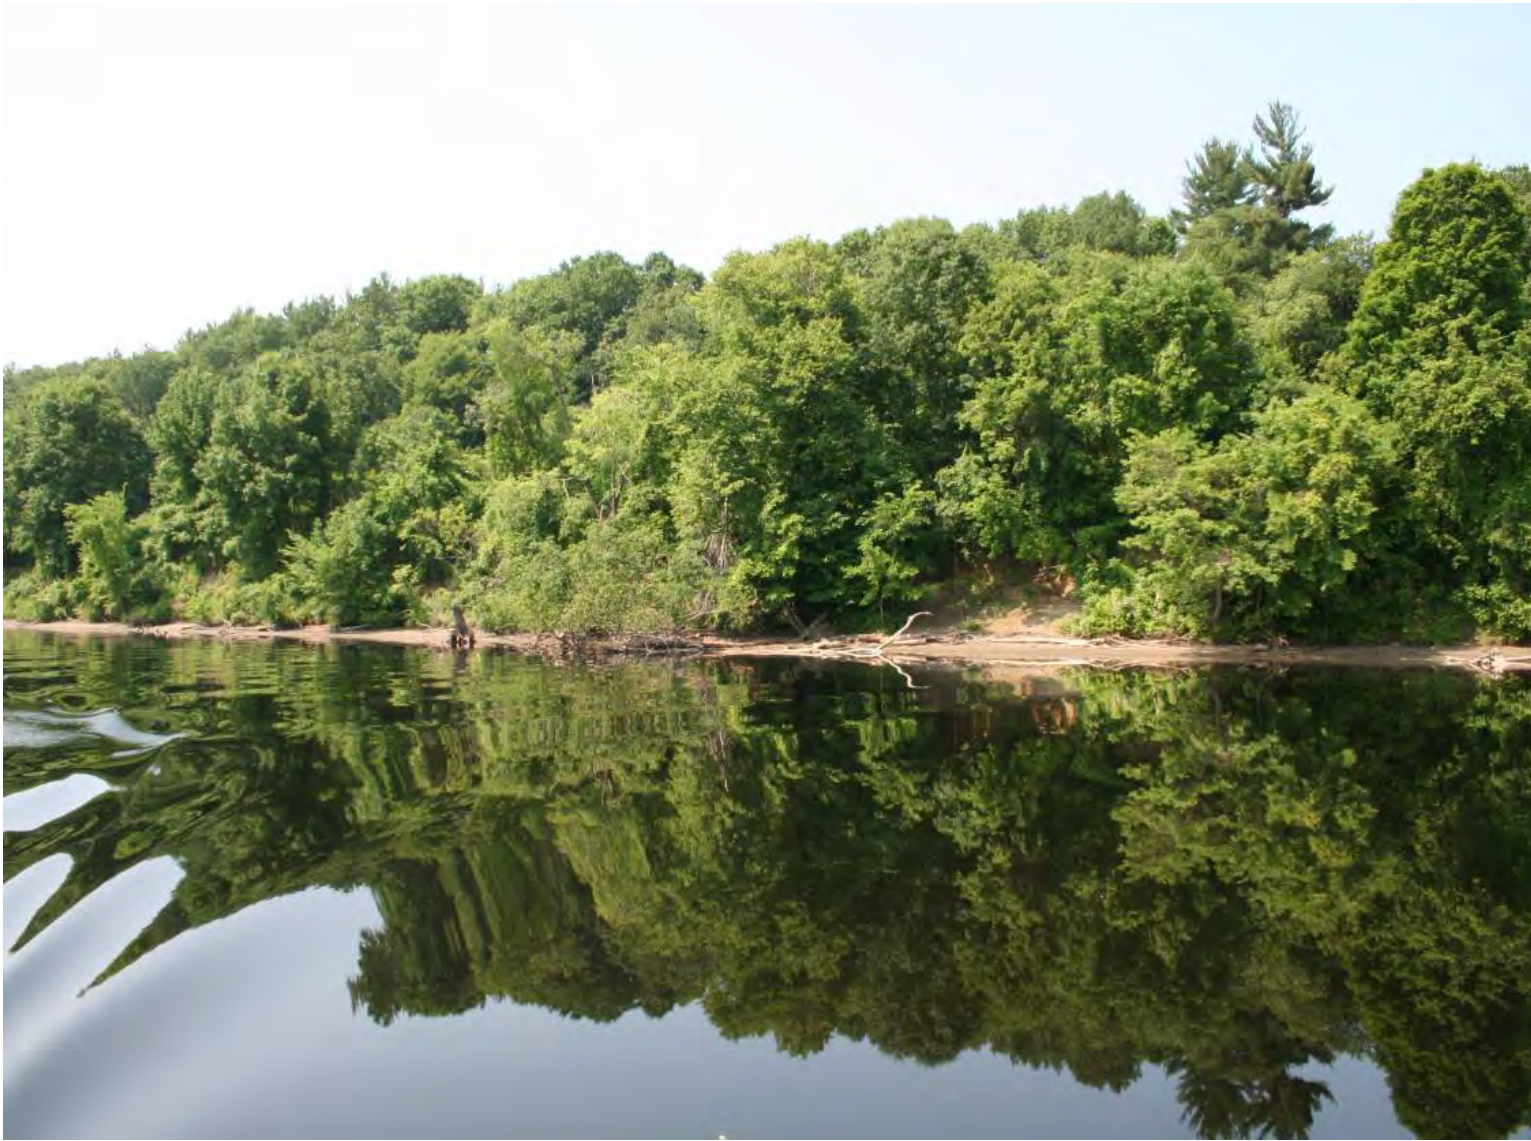
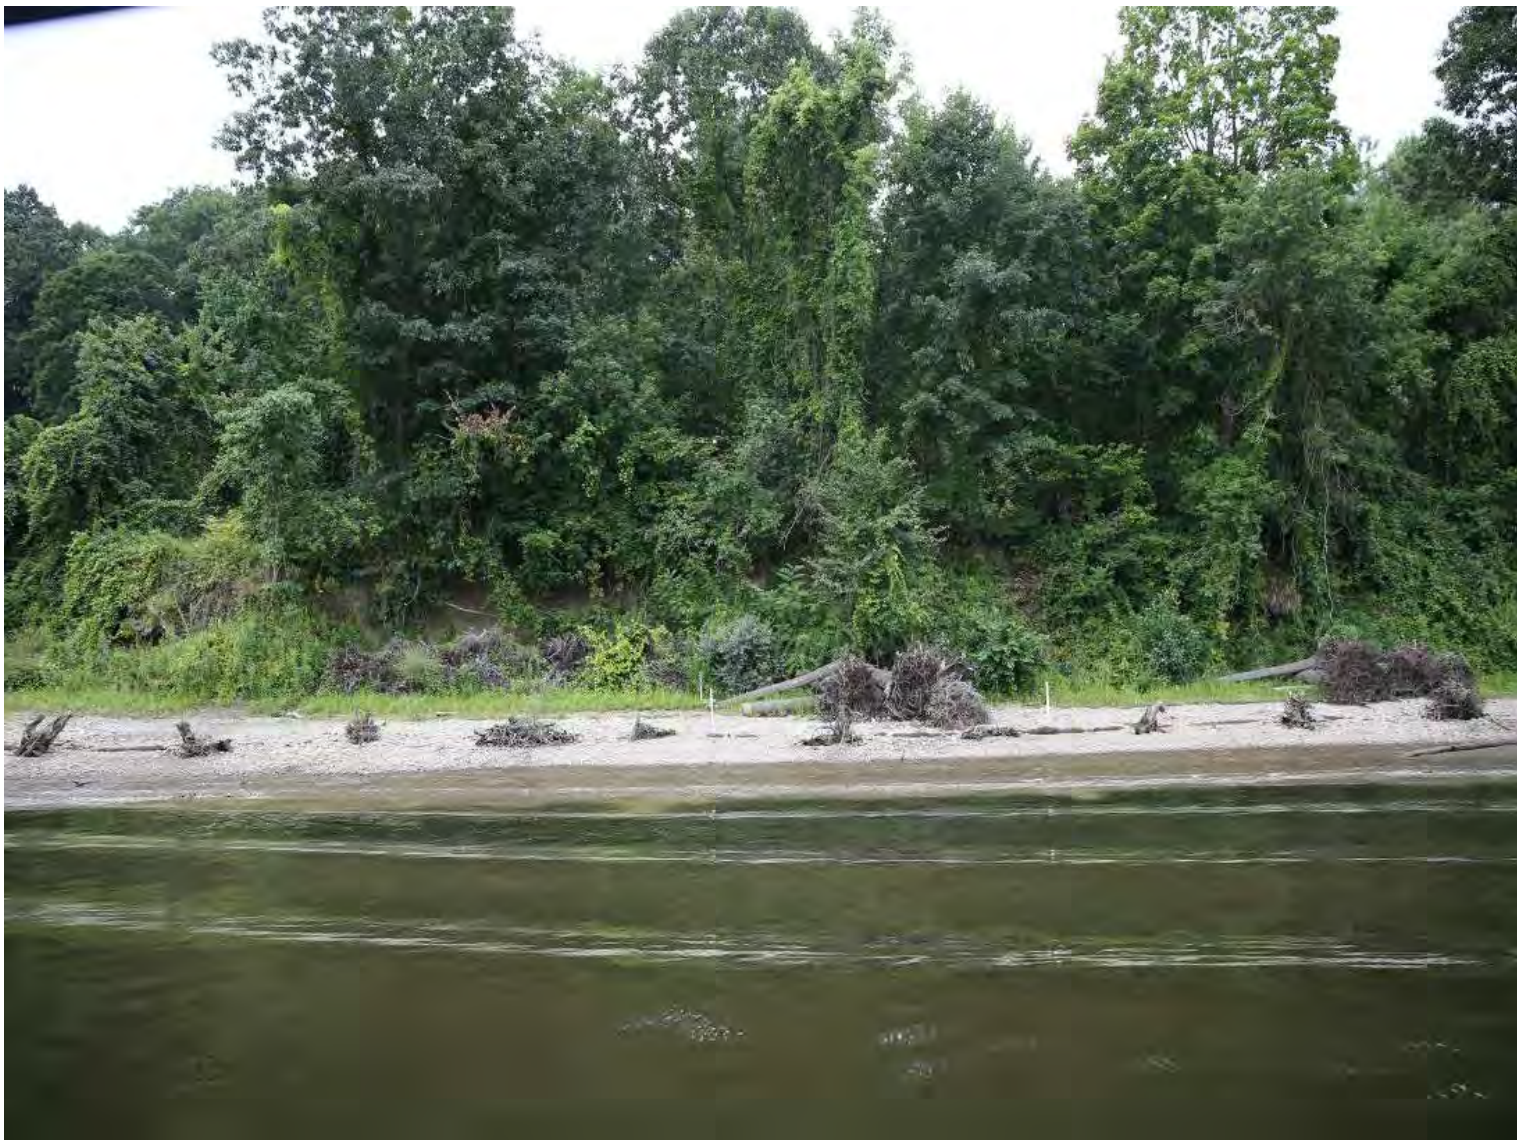
**2014 Photo:** Wallace Watson

**2007 Photo:** Wallace Watson: This photo shows a portion of the Wallace/Watson restoration site prior to restoration efforts. It is located in Gill, Massachusetts, on the right bank.

**Observations:** This site was restored using bioengineering techniques in 2013. Techniques utilized included, building up the lower bank/beach with gravel, imbedding large woody debris, and planting vegetation. Since the 2007 photo was taken, new vegetation has become established on the bench. There are bank swallow and kingfisher cavities along this section of the riverbank.
