**FIRSTLIGHT POWER RESOURCES**  
 RELICENSING STUDY 3.1.1  
 2013 FULL RIVER RECONNAISSANCE  
 TURNERS FALLS IMPOUNDMENT

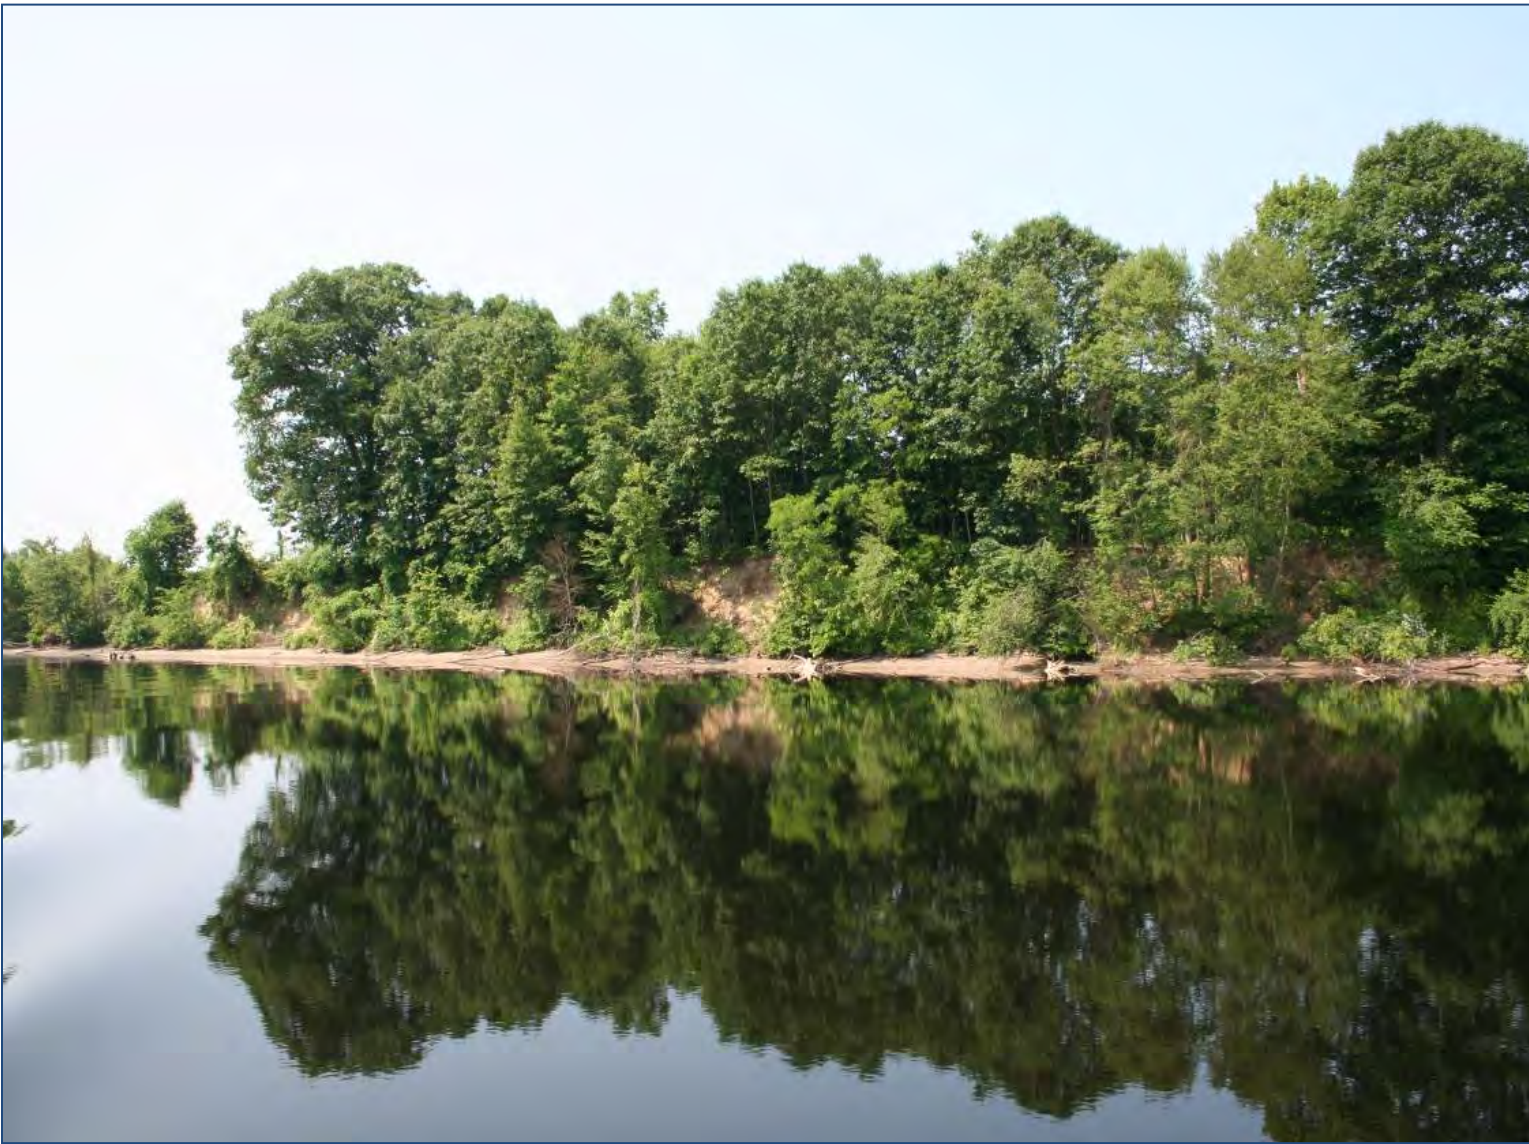
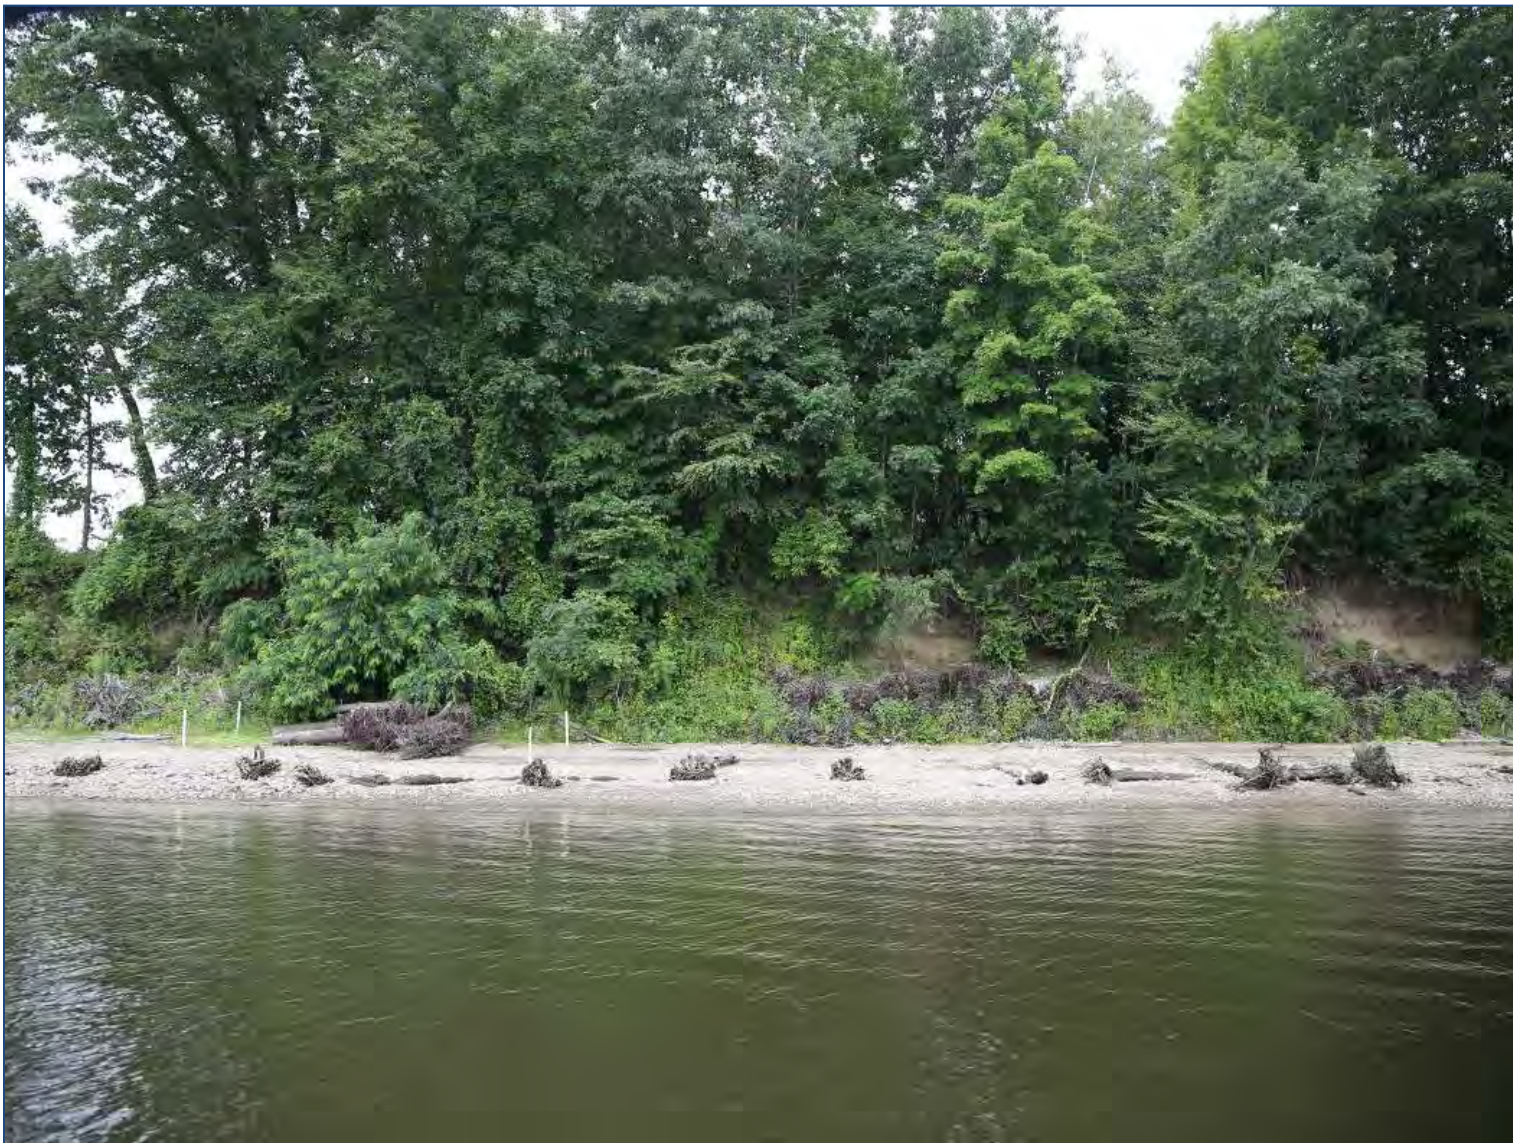
**2014 Photo:** Bathory Gallagher Oak Tree

**2007 Photo:** Bathory-Gallagher Oak Tree: This photo station is at the downstream end of the Bathory/Gallagher restoration site, prior to restoration efforts, in Gill, Massachusetts, on the right bank.

**Observations:** This site was restored using bioengineering techniques in 2013. Techniques utilized included, building up the lower bank/beach with gravel, imbedding large woody debris, and planting vegetation. Since the 2007 photo was taken, new vegetation has become established on the bench. There are bank swallow and kingfisher cavities along this section of the riverbank.

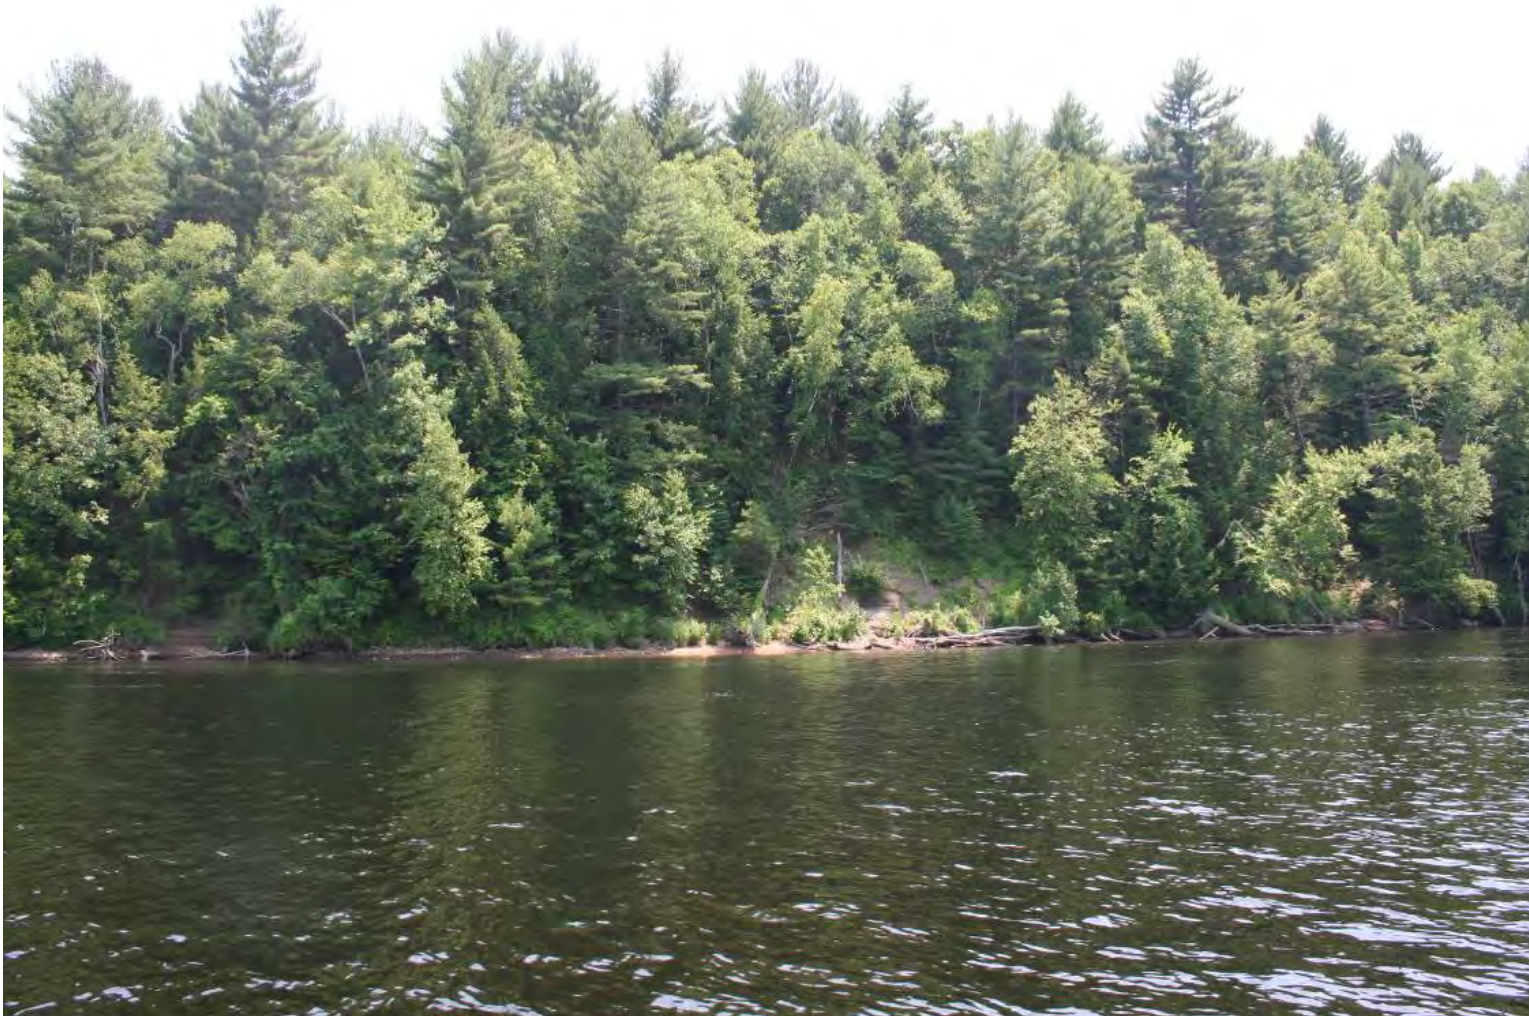
**2007 Photo:** Located downstream from the tailrace in Northfield, Massachusetts, on the left bank.

**Observations:** Erosion is occurring at this site and has been recommended for preventative maintenance and/or bank stabilization work in the 2013 FRR report.

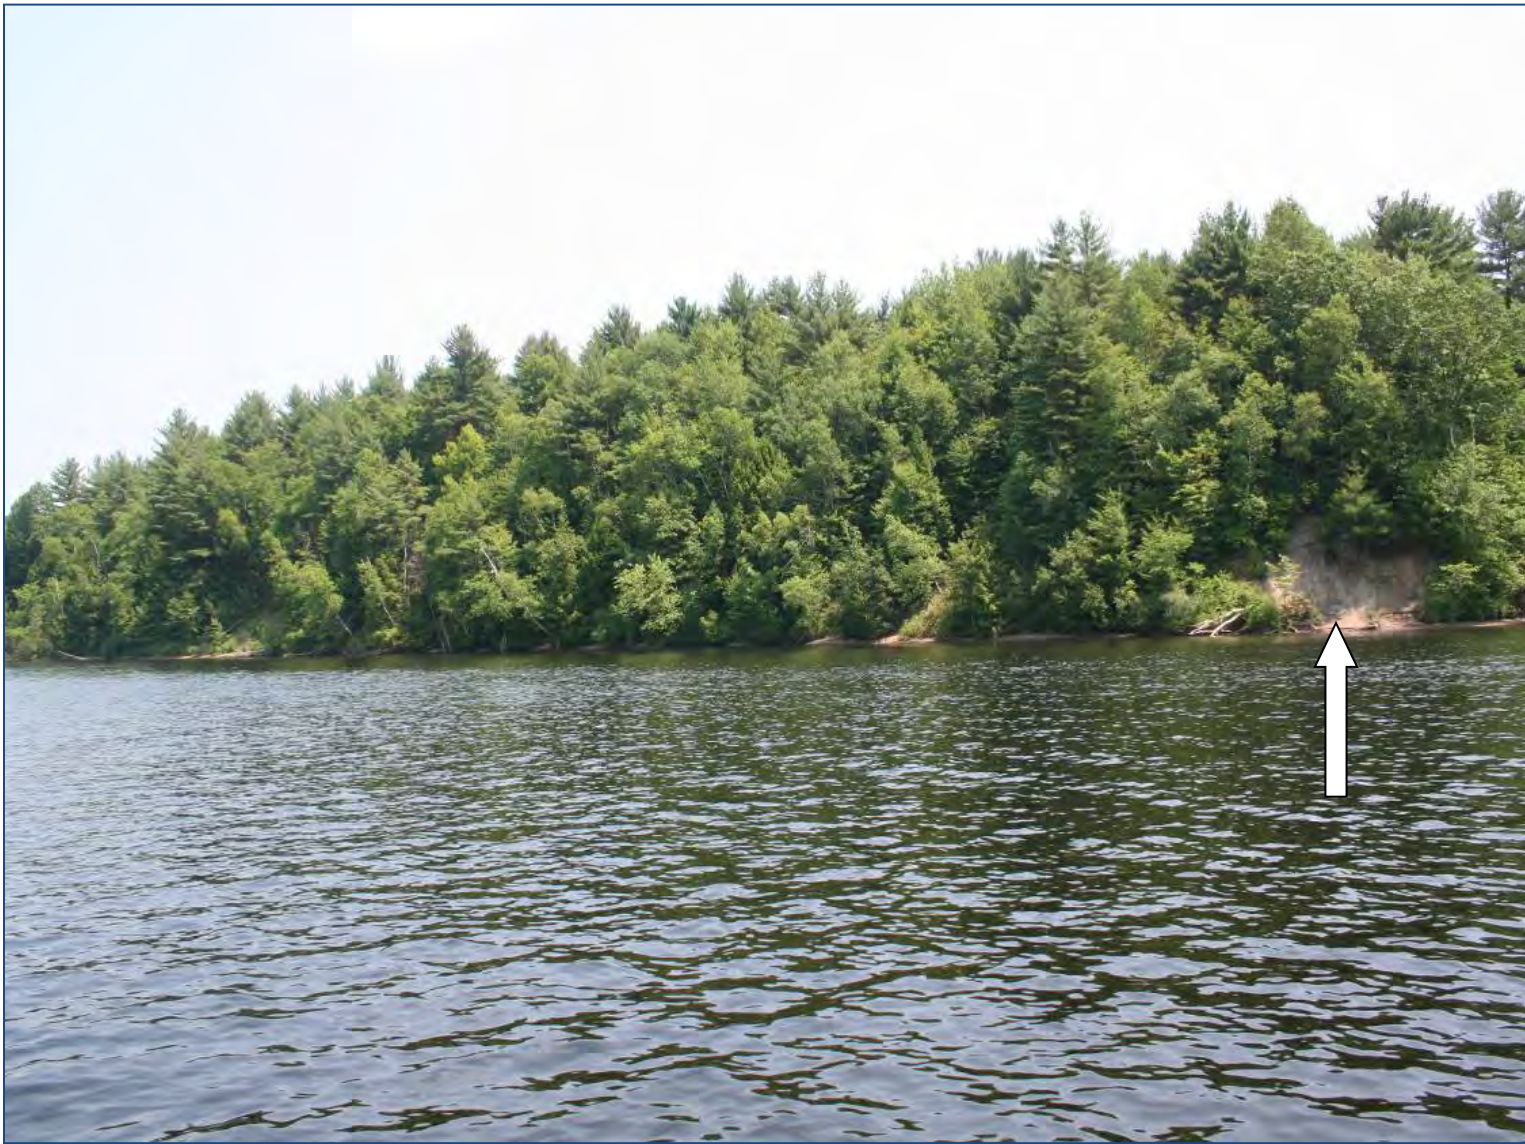
**2007 Photo:** Downstream from Tailrace at Unnamed Brook Inlet: This site is located at the mouth of an unnamed brook (USGS topographic map) near Pine Meadow Road in Northfield, MA, on the left bank.

**Observations:** This site has been eroded for some time and was recommended for preventative maintenance and/or bank stabilization work in the 2013 FRR report.

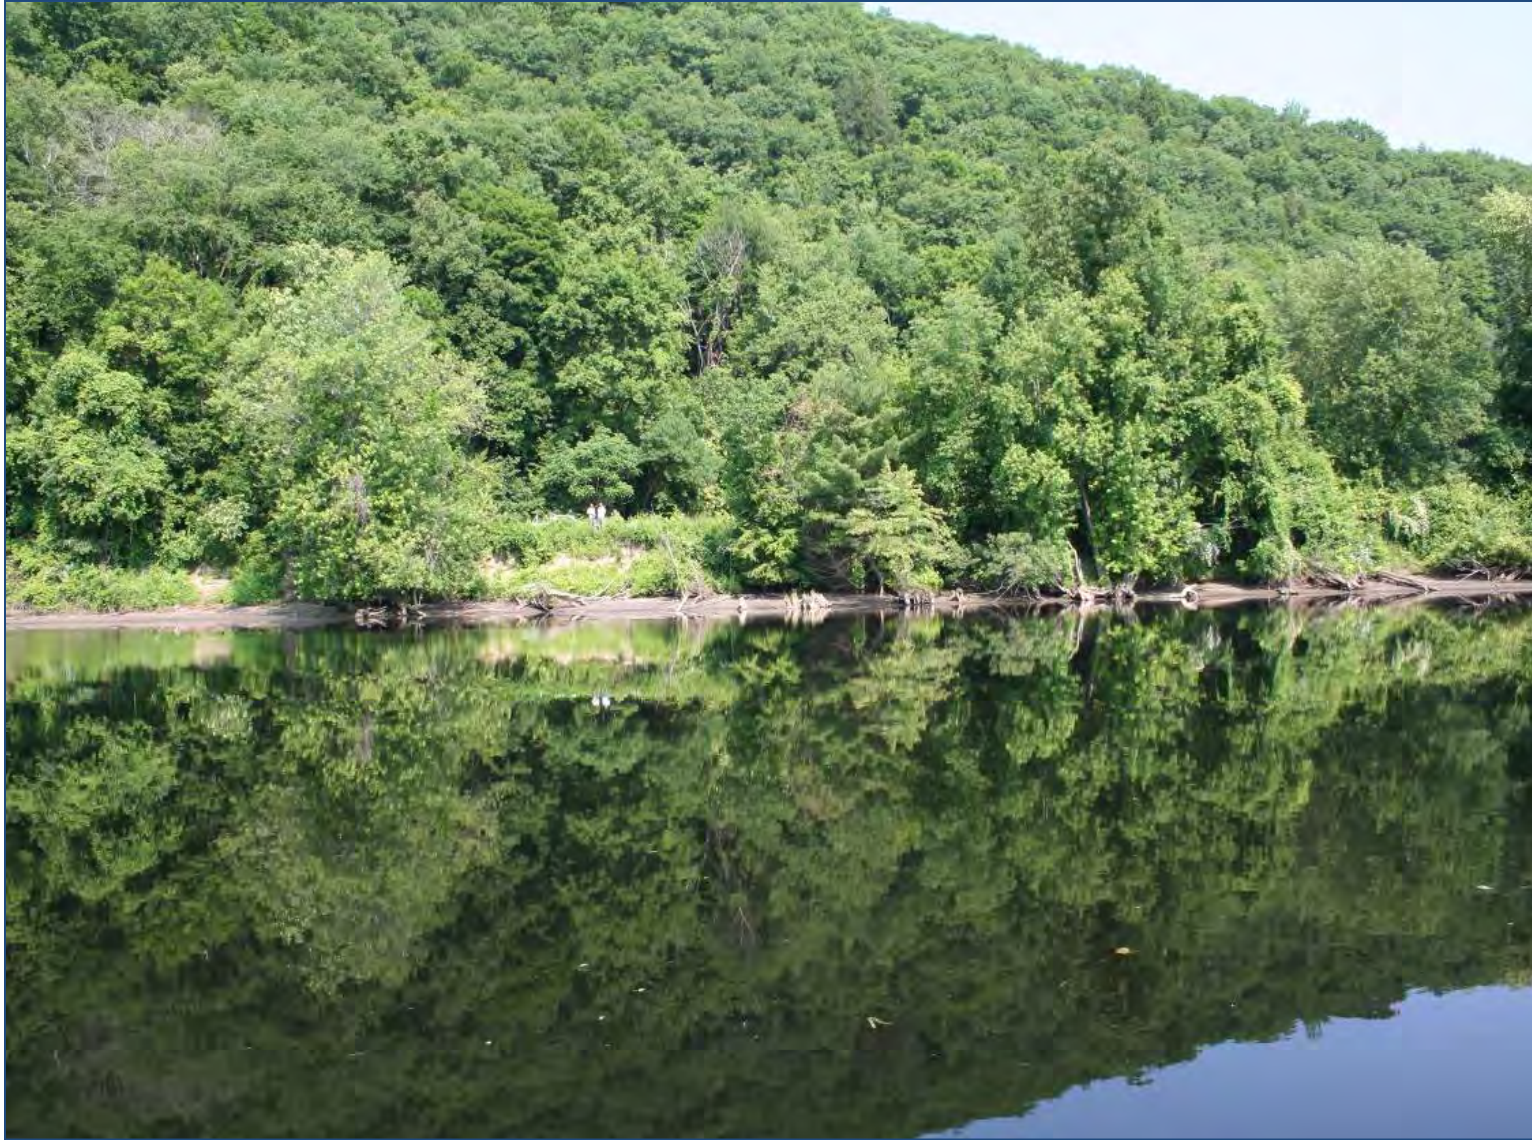
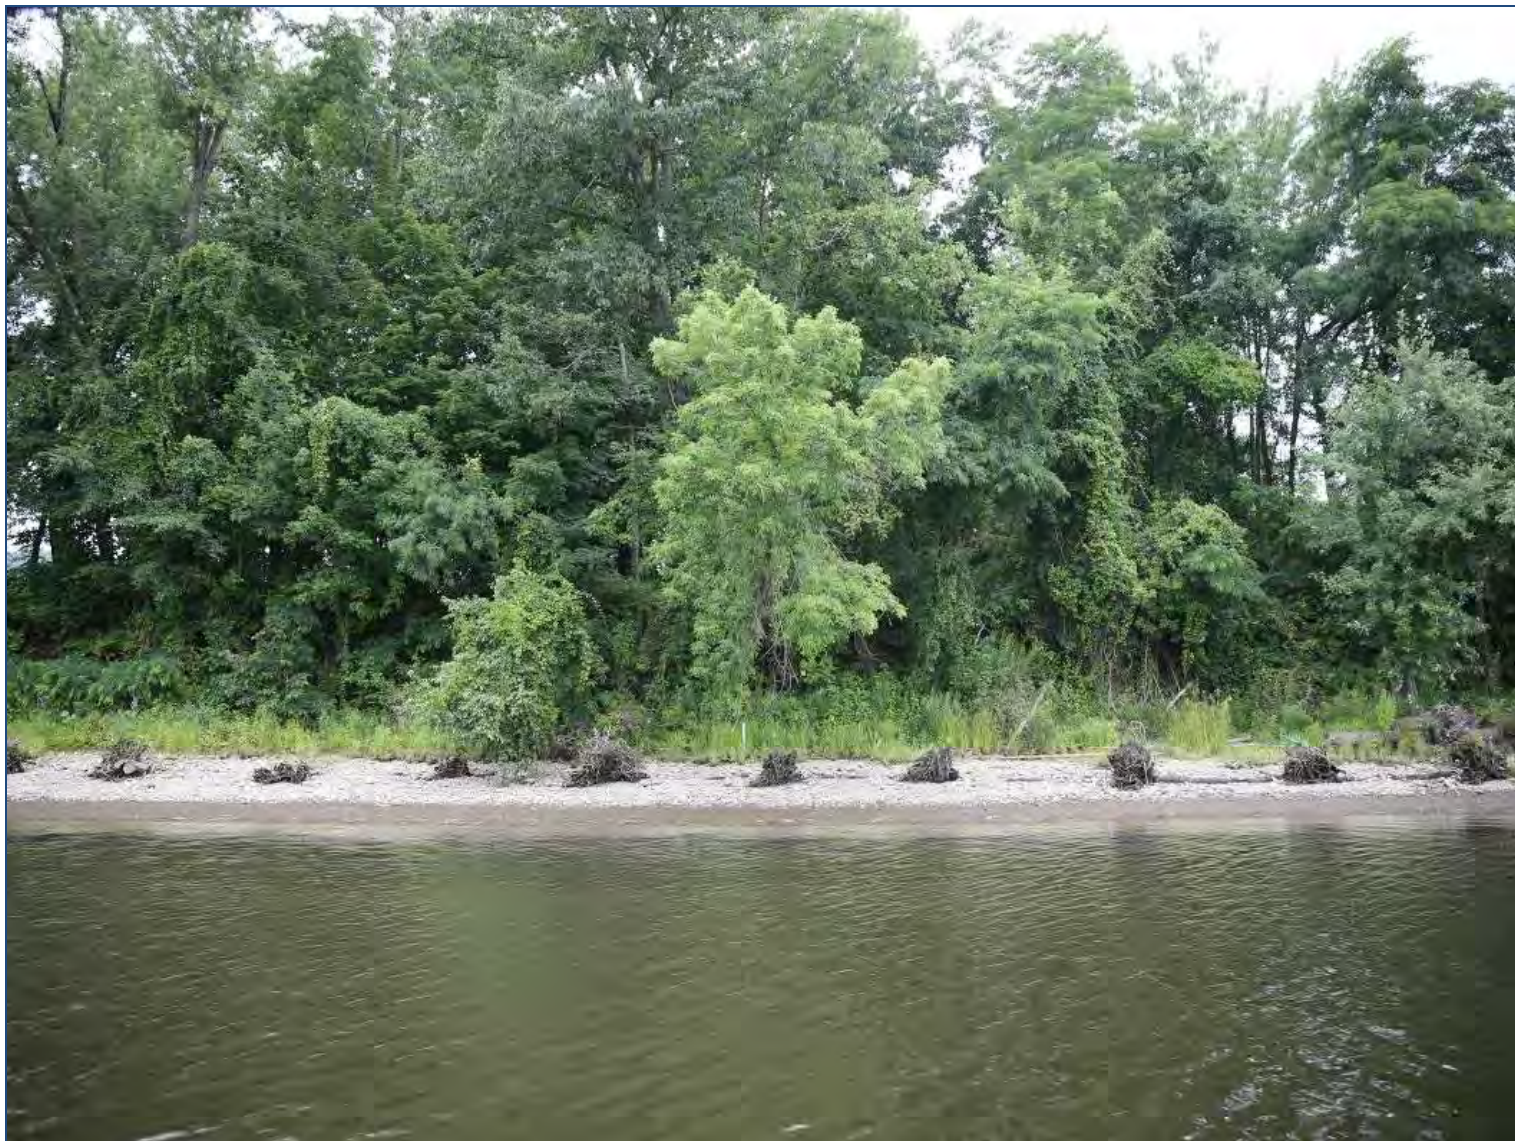
**2014 Photo:** Lower Split River Farm

**2007 Photo:** Lower Split River Farm: Located at Lower Split River Farm restoration site prior to restoration efforts, in Gill, MA, on the right bank.

**Observations:** This site was restored using bioengineering techniques in 2009. Techniques utilized included, placement of gravel on the lower bank/beach, adding large woody debris, and planting vegetation. Since the 2007 photo was taken, new emergent vegetation has become established on the bench.

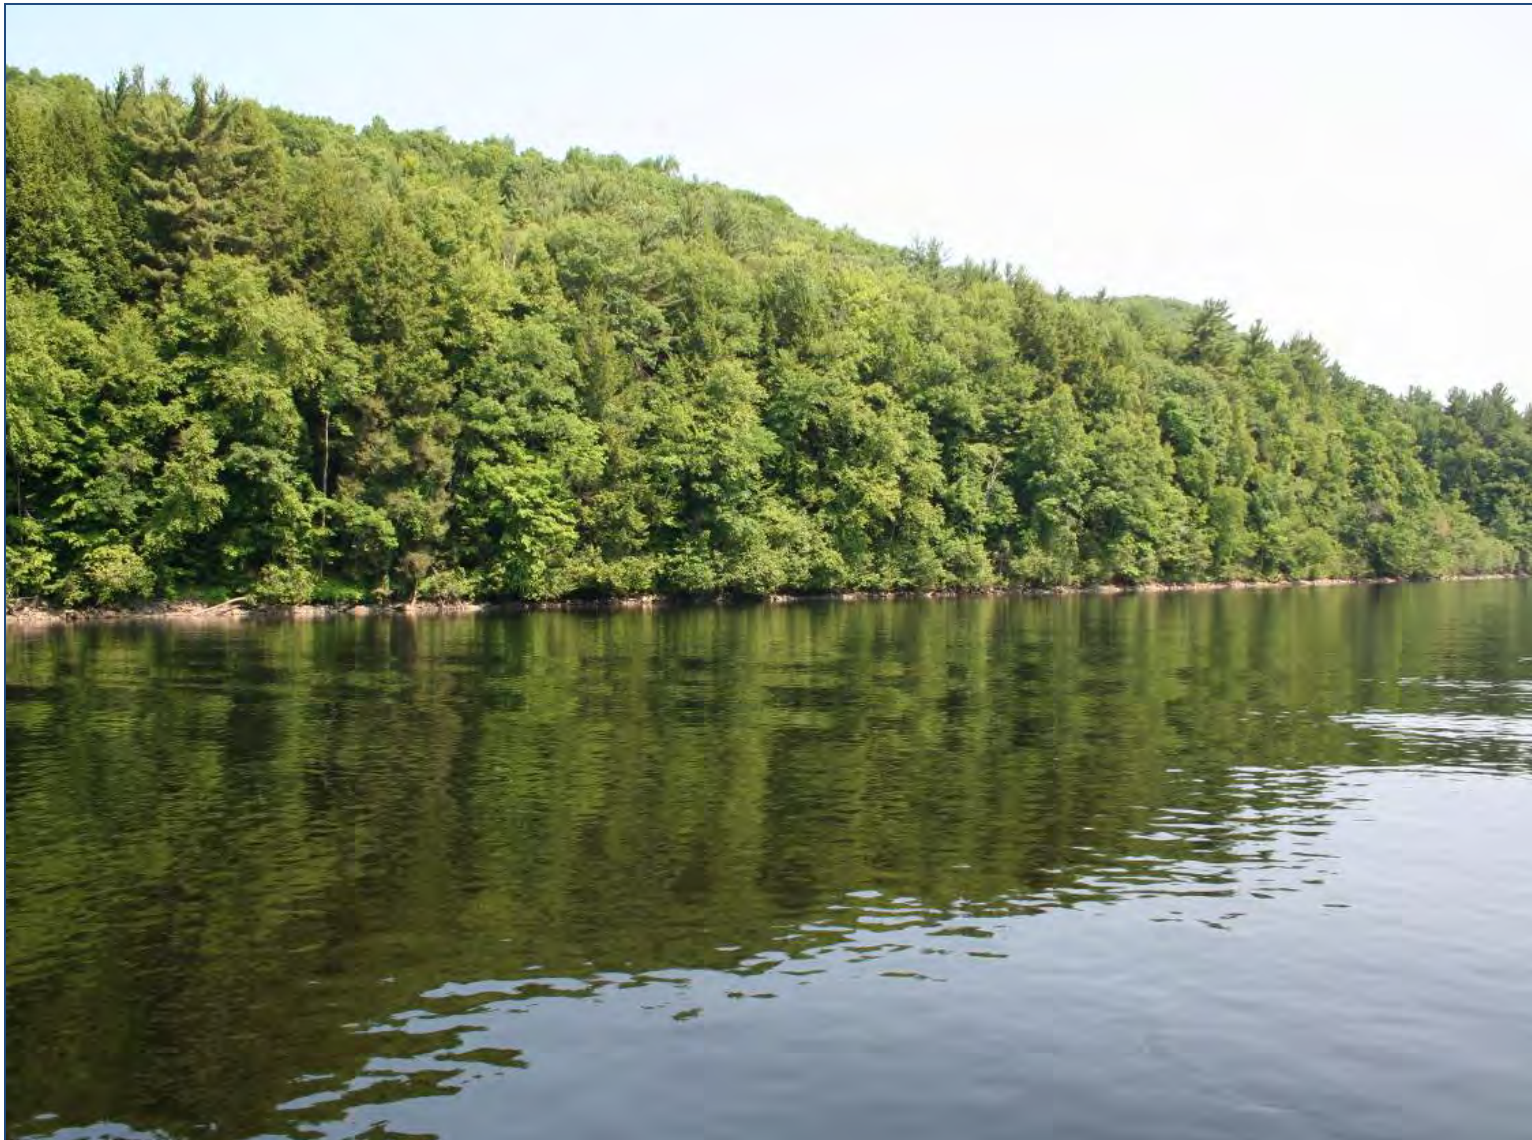
**2007 Photo:** Upstream from French King Bridge: This photo station is located upstream from the French King Bridge in Gill, MA, on the right bank.

**Observations:** This is a stable section of riverbank; no observable changes are noted between these photos.

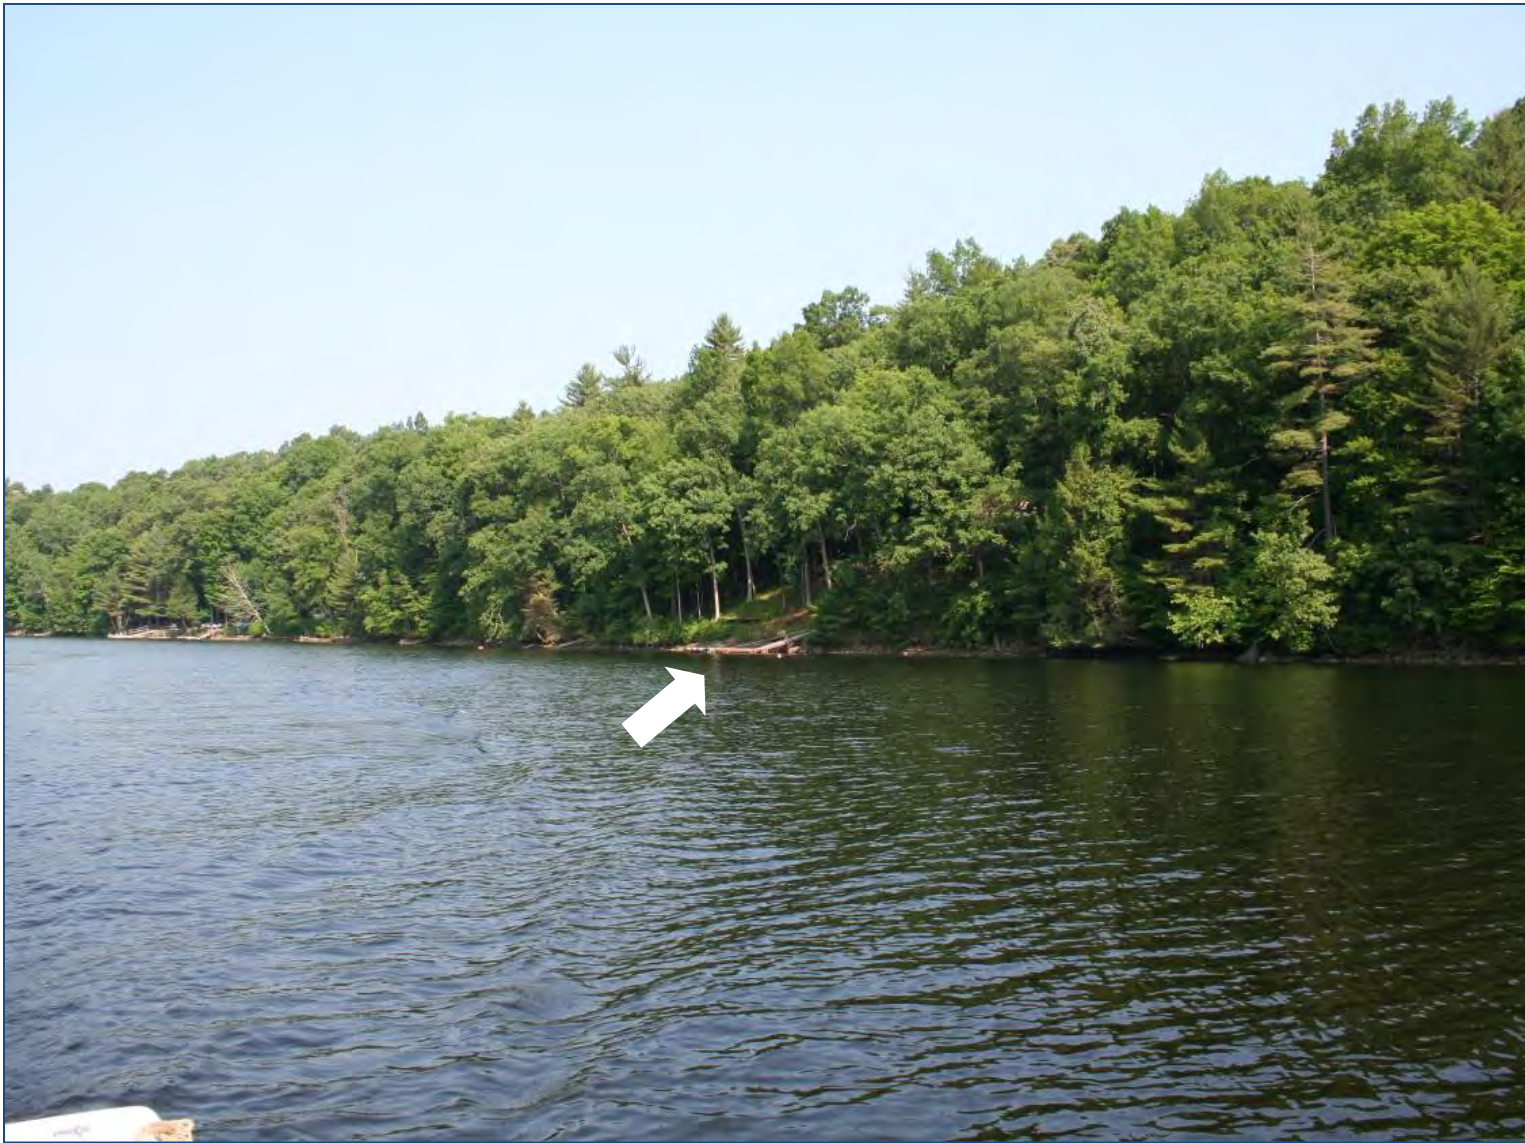
**2007 Photo:** Camp 2W: This station is located at Camp Site 2W, on the right bank, in Gill, MA.

**Observations:** This site (see white arrow location in the 2007 photo) has been recommended for preventative maintenance and/or bank stabilization work in the 2013 FRR report.

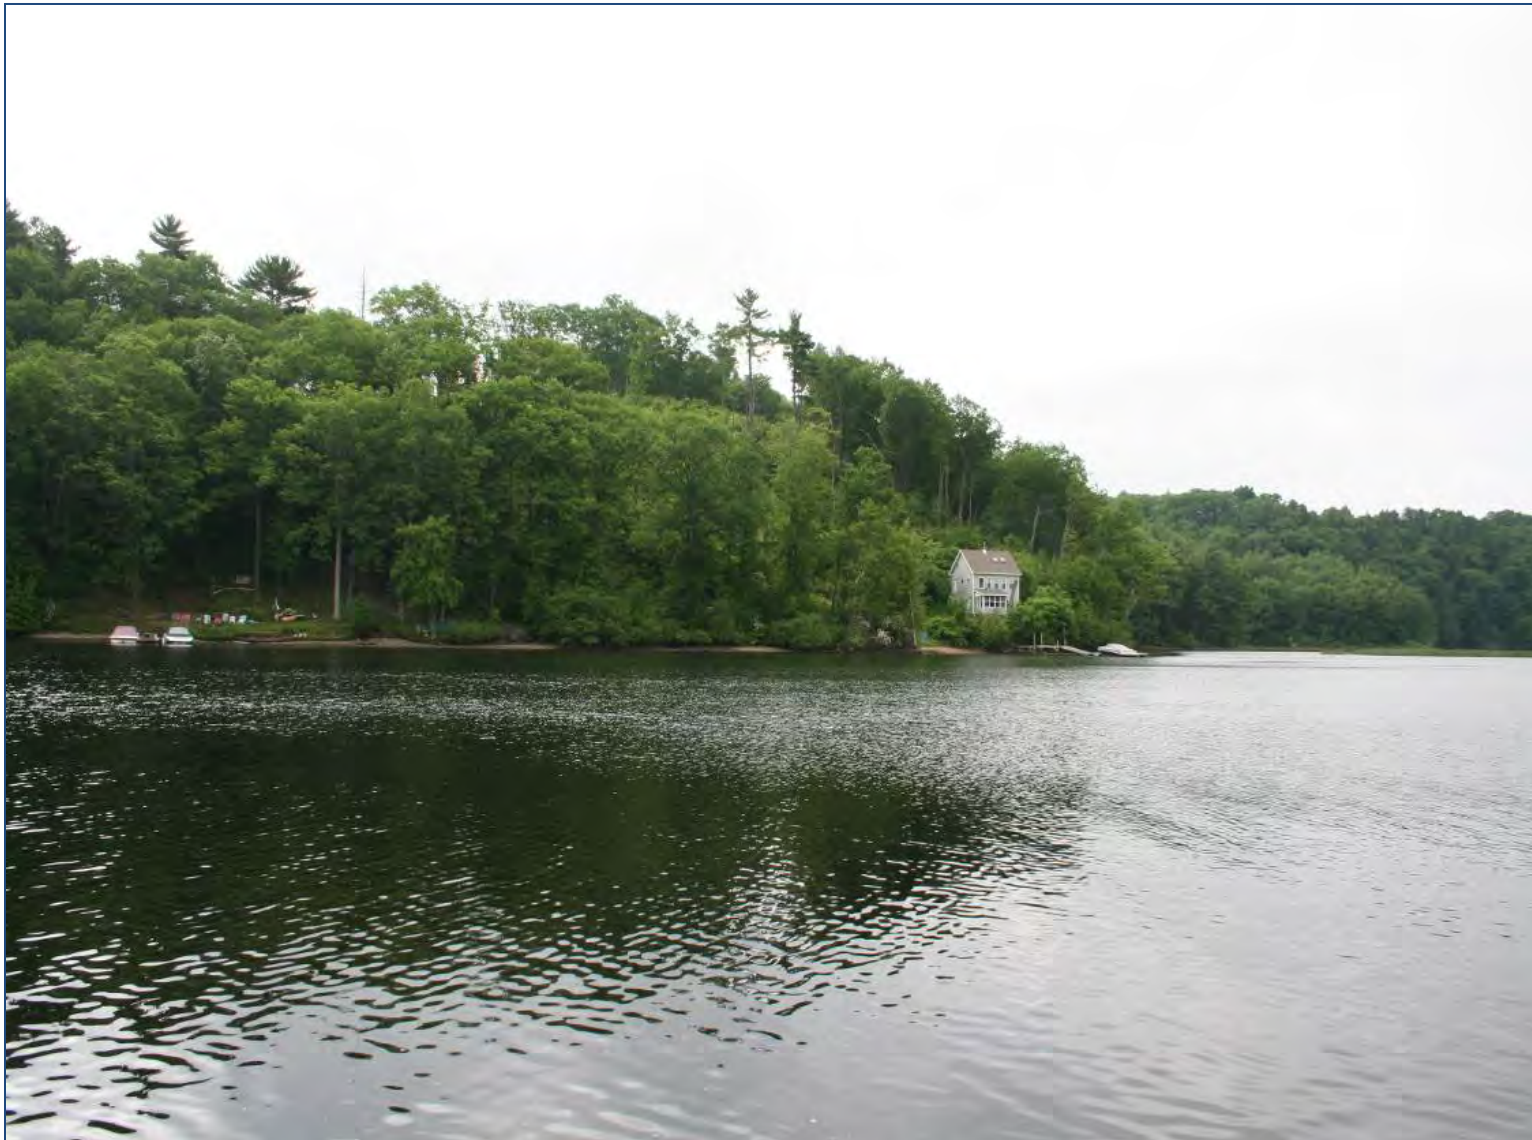
**2007 Photo:** Camp 4E: This camp is located in Montague, MA, on the left bank.

**Observations:** This camp site has been recommended for preventative maintenance and/or bank stabilization work in the 2013 FRR report.

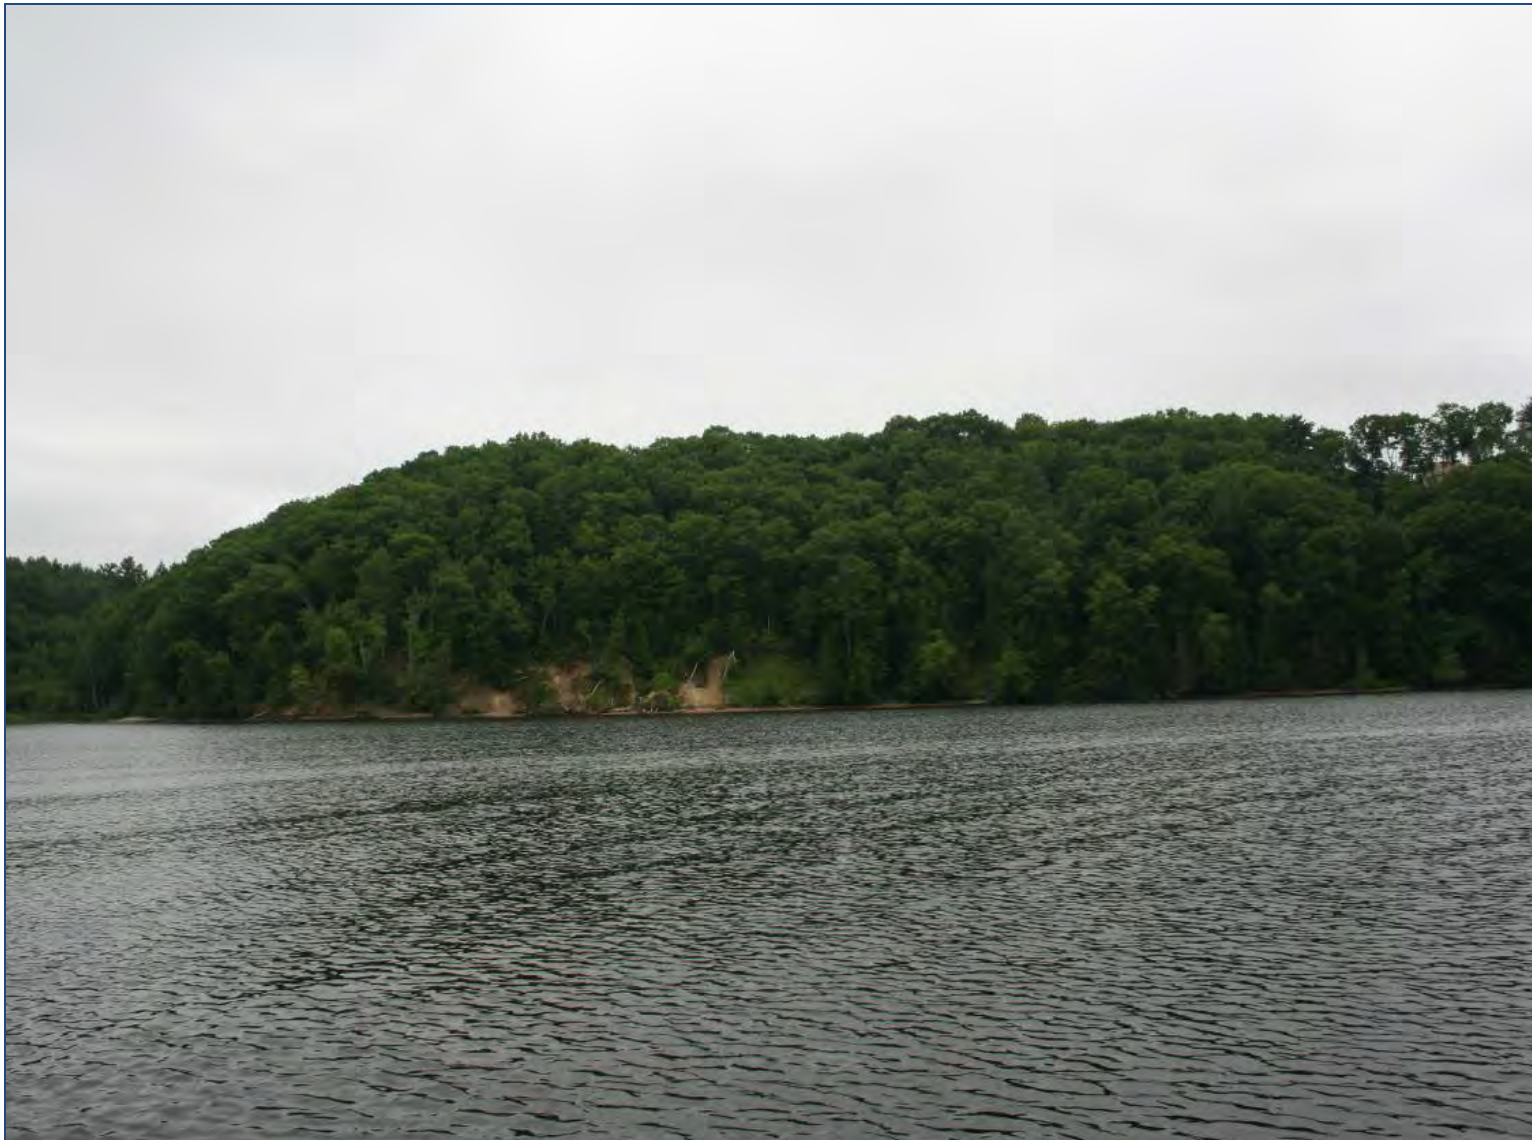
**2007 Photo:** Montague: Located downstream from the Montague Rod & Gun Club, in Montague, MA, on the left bank.

**Observations:** Erosion has been ongoing at this site for quite some time and has been recommended for preventative maintenance and/or bank stabilization work in the 2013 FRR report.

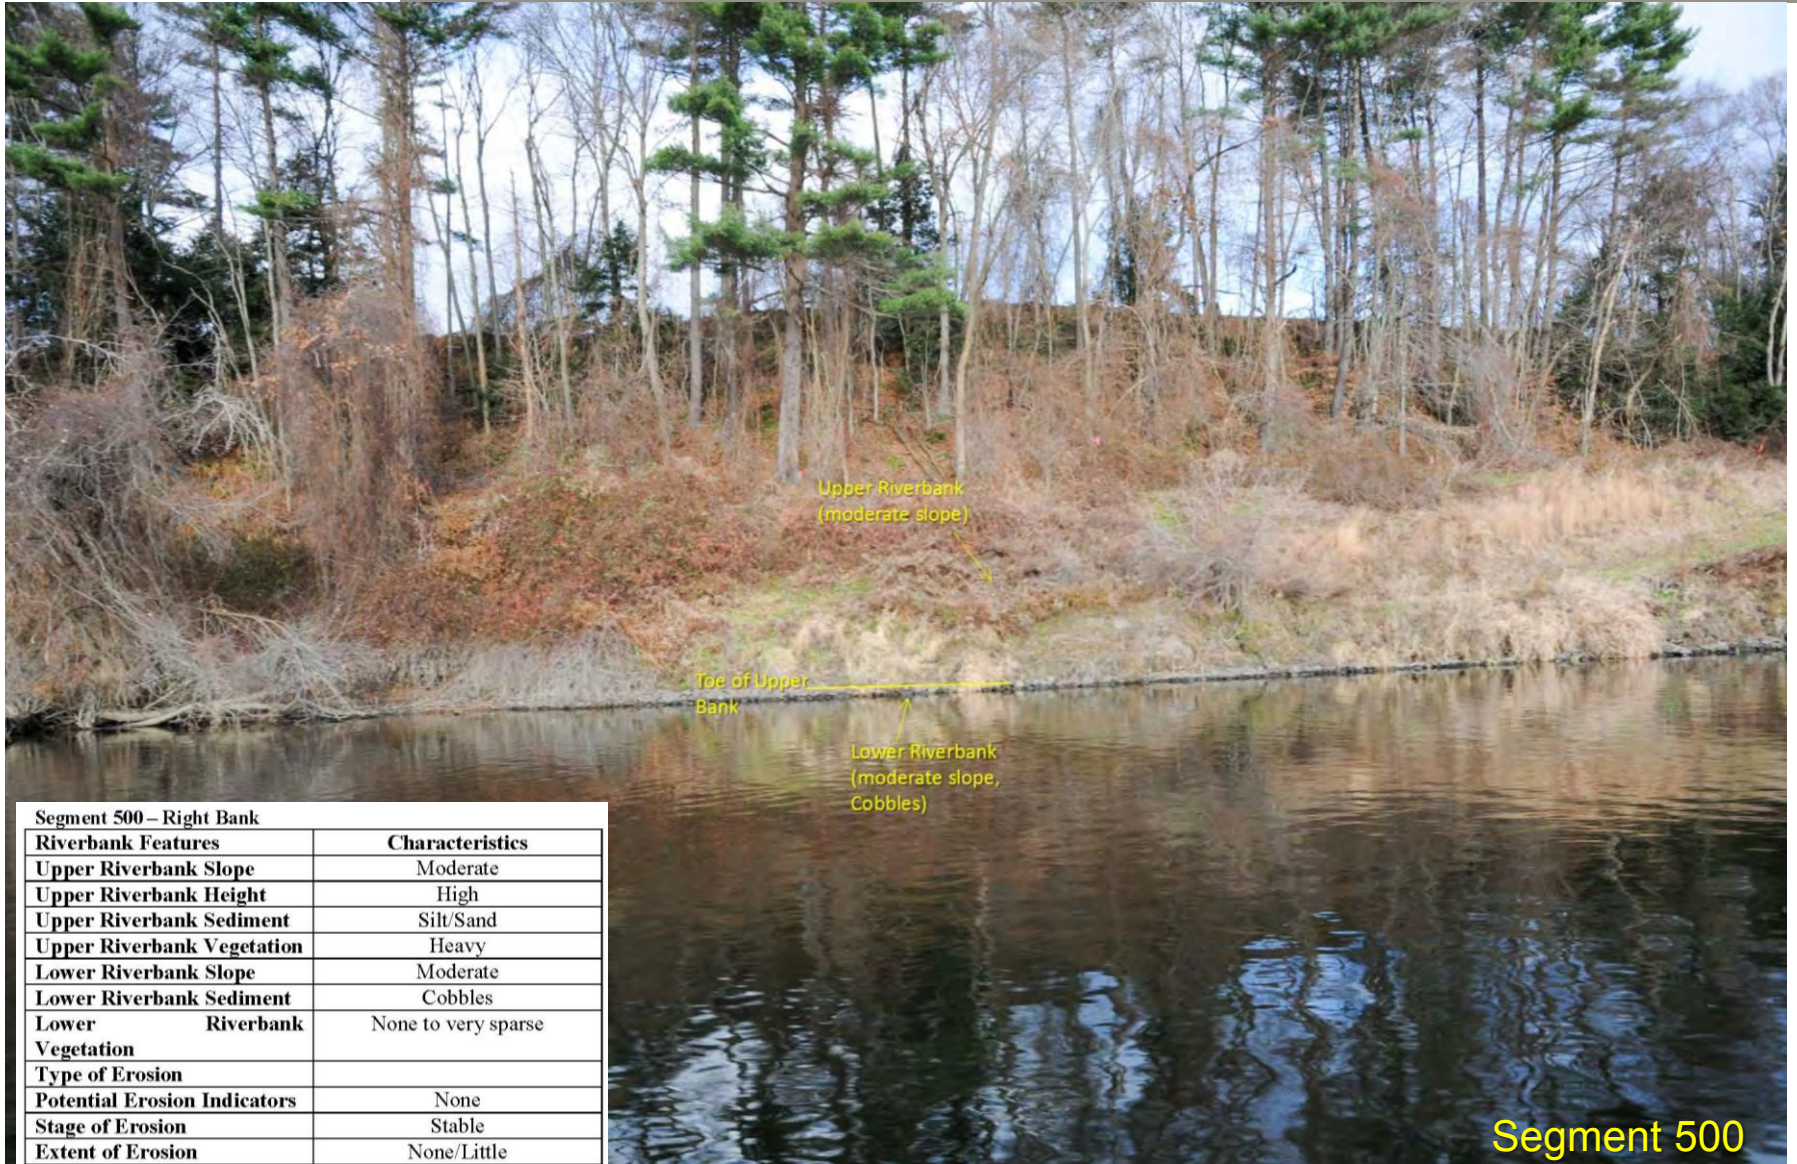
Segment 500 – Right Bank

Riverbank Features	Characteristics
Upper Riverbank Slope	Moderate
Upper Riverbank Height	High
Upper Riverbank Sediment	Silt/Sand
Upper Riverbank Vegetation	Heavy
Lower Riverbank Slope	Moderate
Lower Riverbank Sediment	Cobbles
Lower Riverbank Vegetation	None to very sparse
Type of Erosion	
Potential Erosion Indicators	None
Stage of Erosion	Stable
Extent of Erosion	None/Little

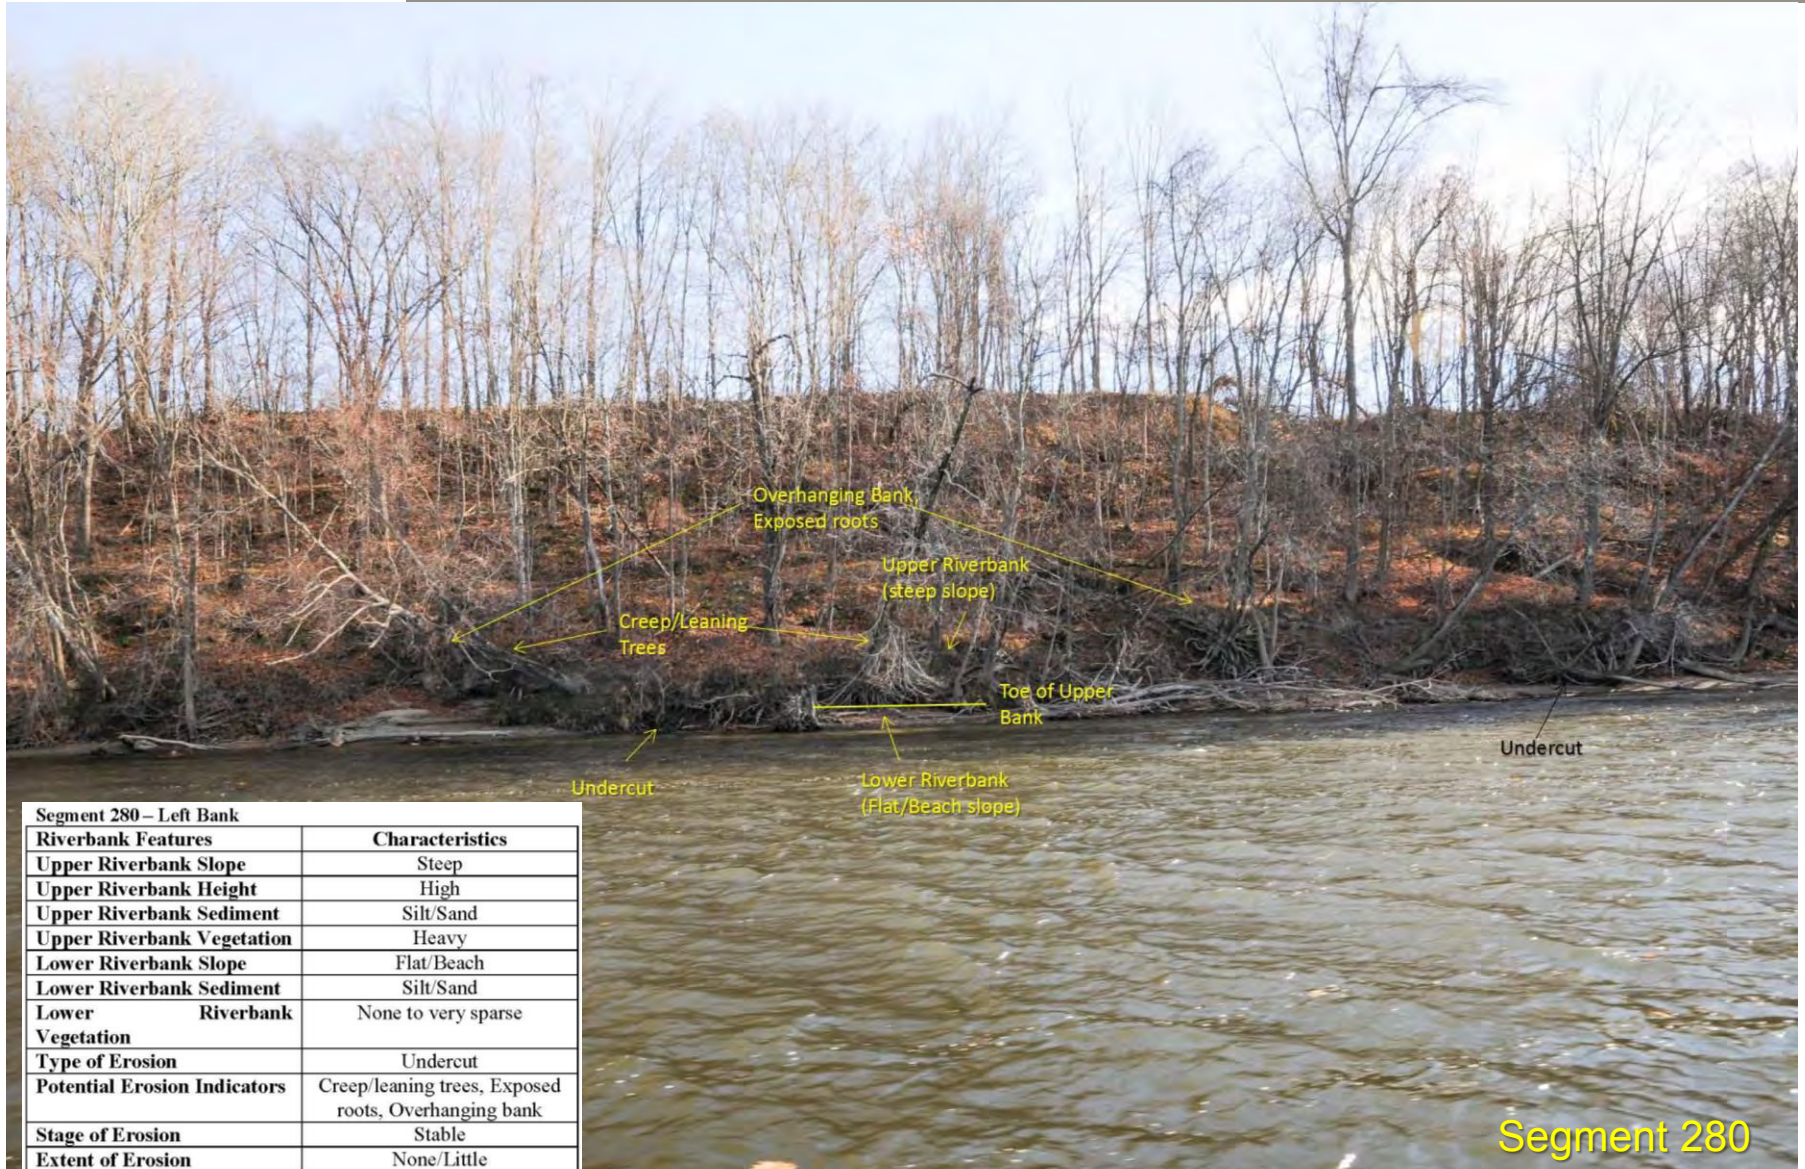
Segment 280 – Left Bank	
Riverbank Features	Characteristics
Upper Riverbank Slope	Steep
Upper Riverbank Height	High
Upper Riverbank Sediment	Silt/Sand
Upper Riverbank Vegetation	Heavy
Lower Riverbank Slope	Flat/Beach
Lower Riverbank Sediment	Silt/Sand
Lower Riverbank Vegetation	None to very sparse
Type of Erosion	Undercut
Potential Erosion Indicators	Creep/leaning trees, Exposed roots, Overhanging bank
Stage of Erosion	Stable
Extent of Erosion	None/Little
