**FIRSTLIGHT POWER RESOURCES**  
 RELICENSING STUDY 3.1.1  
 2013 FULL RIVER RECONNAISSANCE  
 TURNERS FALLS IMPOUNDMENT

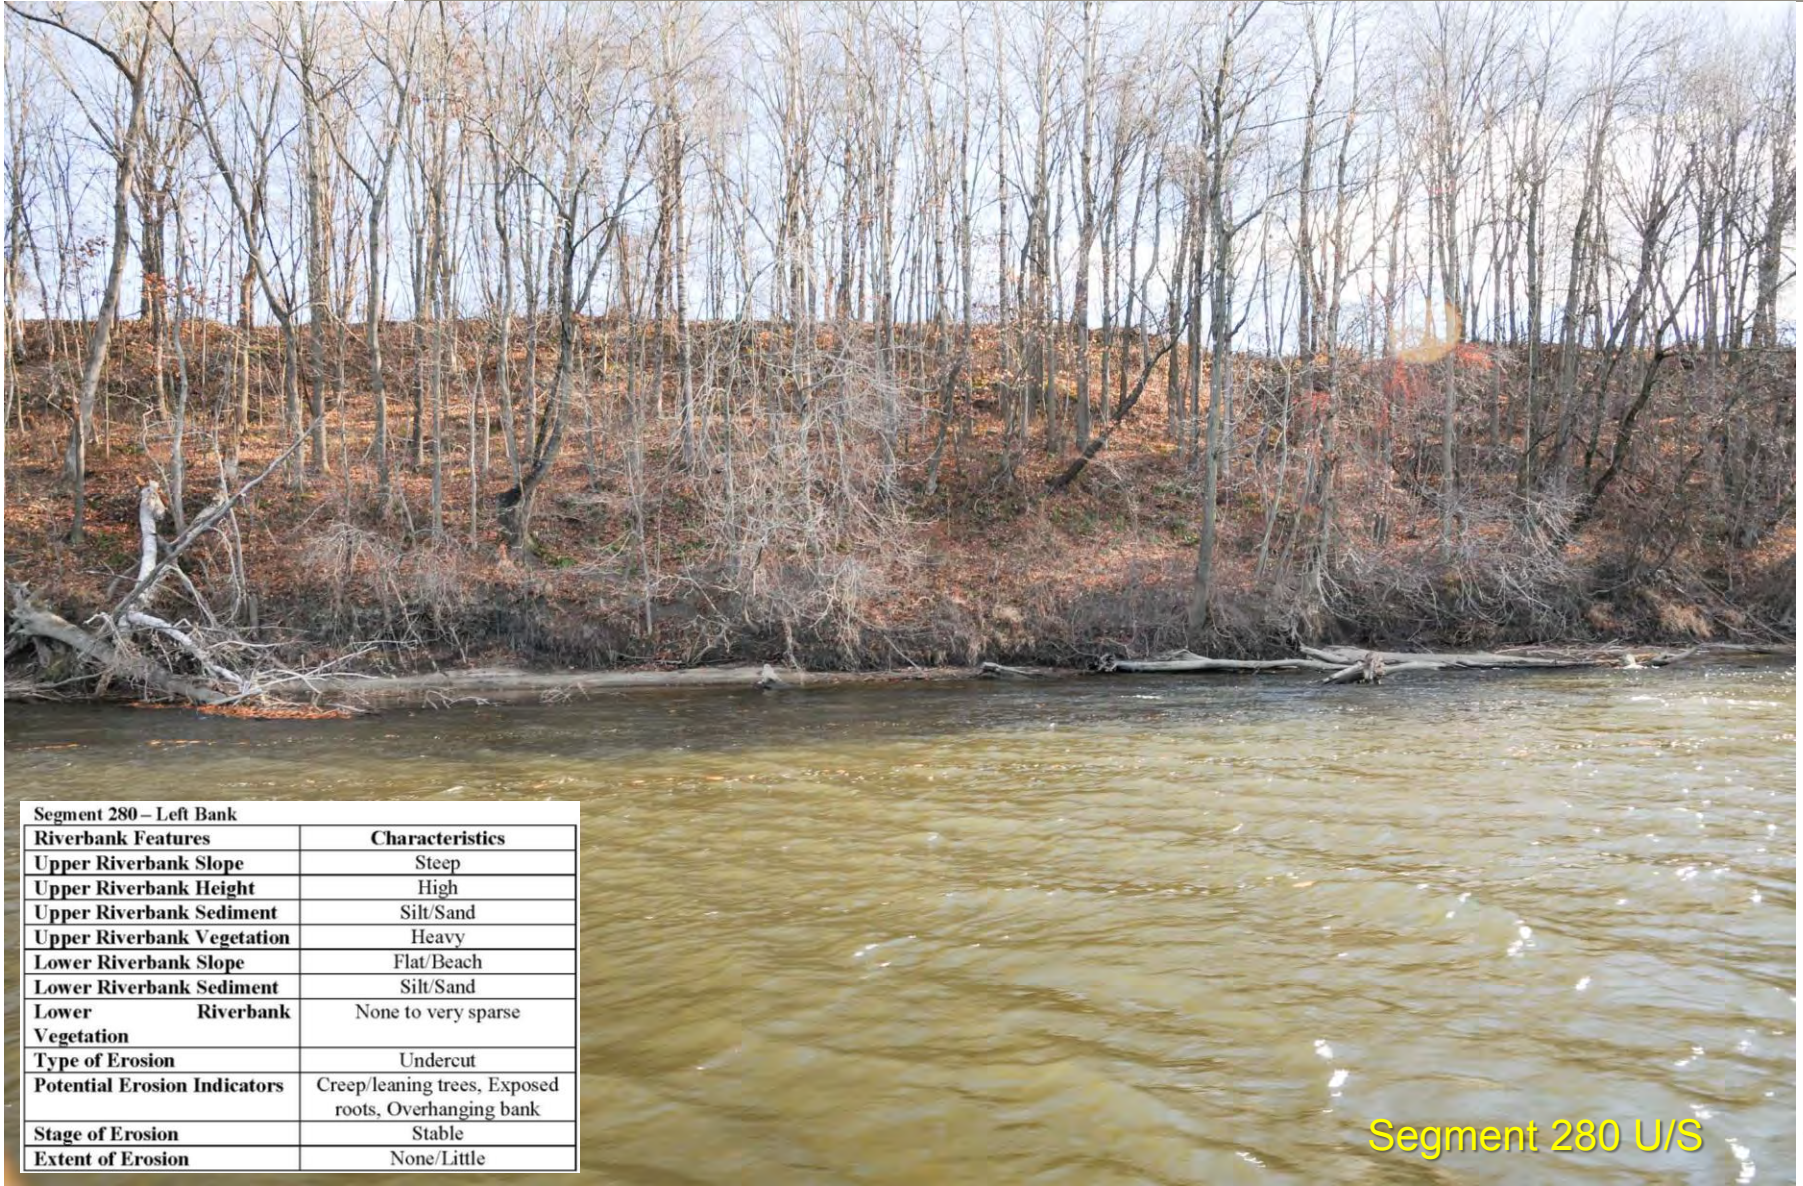
Segment 280 U/S

Segment 280 – Left Bank	
Riverbank Features	Characteristics
Upper Riverbank Slope	Steep
Upper Riverbank Height	High
Upper Riverbank Sediment	Silt/Sand
Upper Riverbank Vegetation	Heavy
Lower Riverbank Slope	Flat/Beach
Lower Riverbank Sediment	Silt/Sand
Lower Riverbank Vegetation	None to very sparse
Type of Erosion	Undercut
Potential Erosion Indicators	Creep/leaning trees, Exposed roots, Overhanging bank
Stage of Erosion	Stable
Extent of Erosion	None/Little

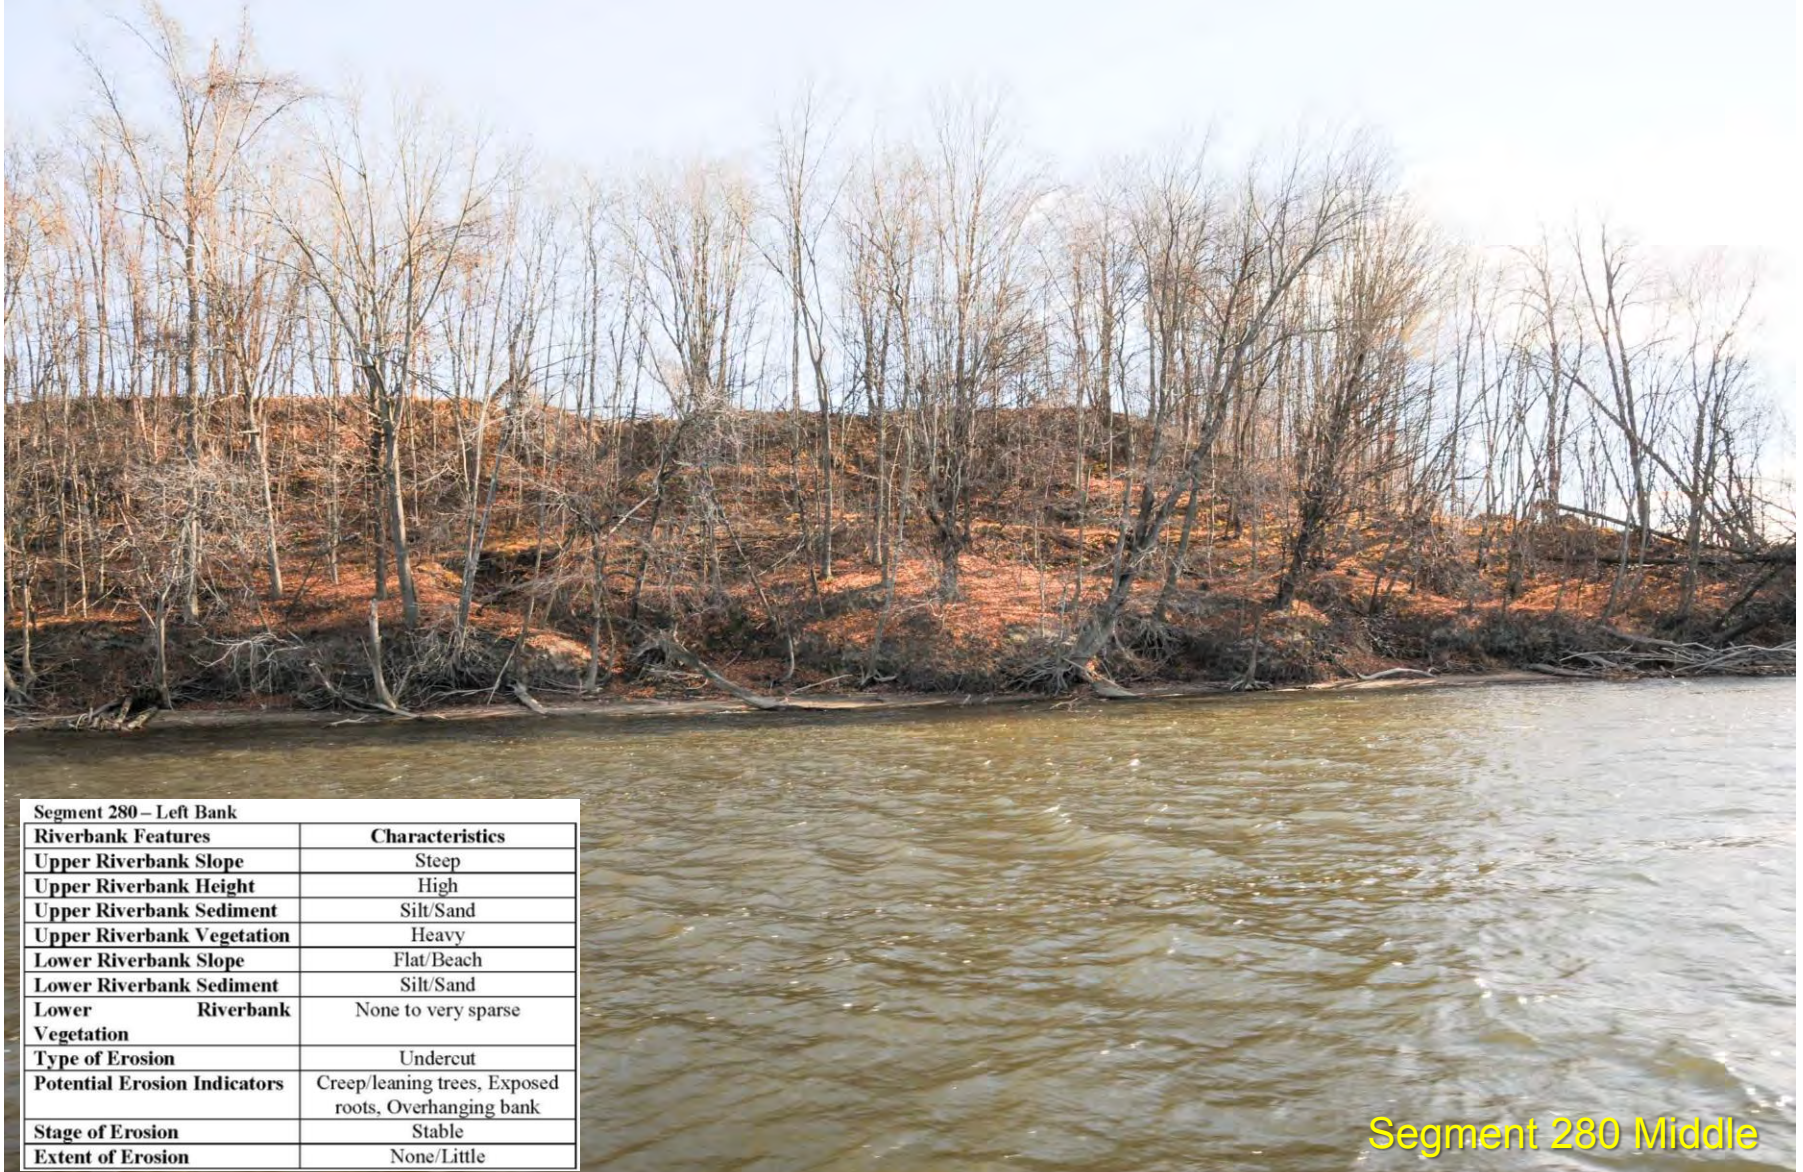
Segment 280 – Left Bank	
Riverbank Features	Characteristics
Upper Riverbank Slope	Steep
Upper Riverbank Height	High
Upper Riverbank Sediment	Silt/Sand
Upper Riverbank Vegetation	Heavy
Lower Riverbank Slope	Flat/Beach
Lower Riverbank Sediment	Silt/Sand
Lower Riverbank Vegetation	None to very sparse
Type of Erosion	Undercut
Potential Erosion Indicators	Creep/leaning trees, Exposed roots, Overhanging bank
Stage of Erosion	Stable
Extent of Erosion	None/Little

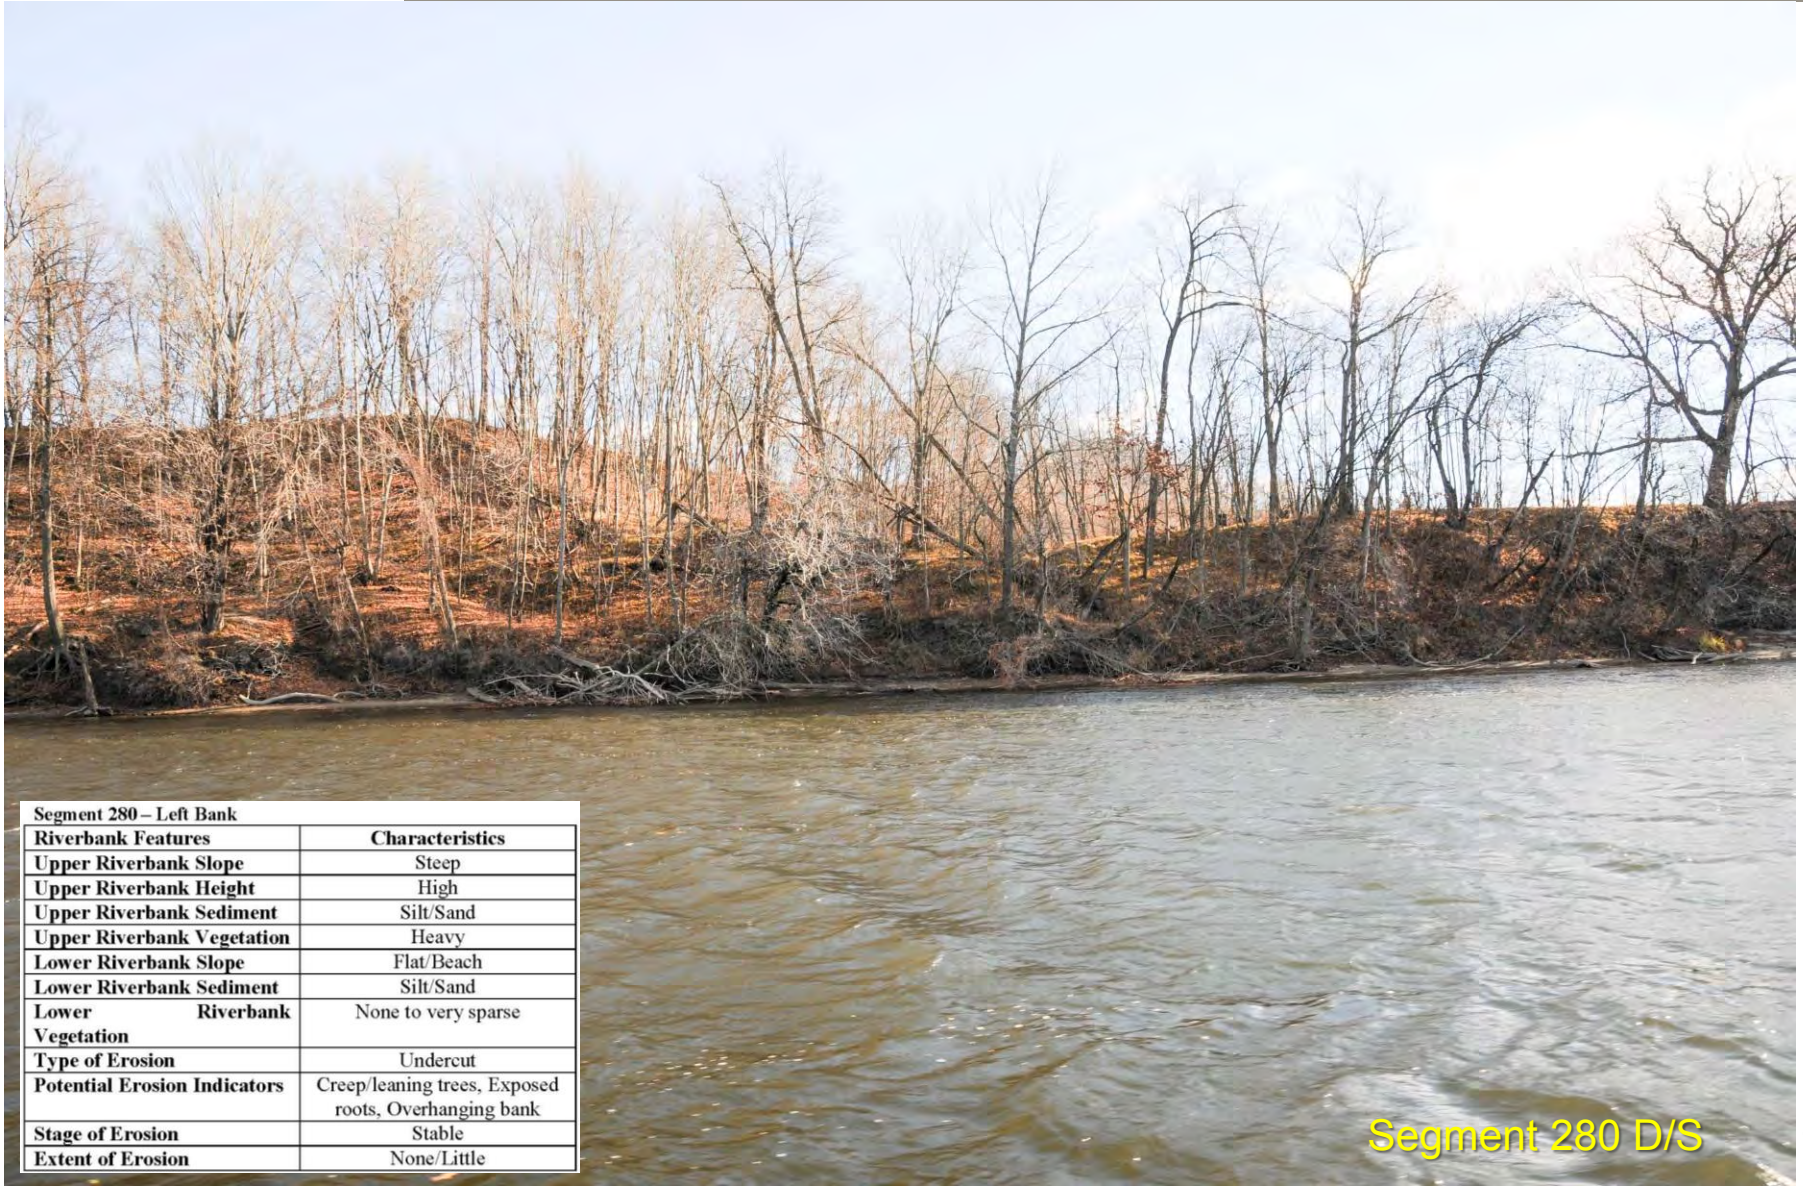
Segment 280 D/S

Riverbank Features	Characteristics
Upper Riverbank Slope	Steep
Upper Riverbank Height	High
Upper Riverbank Sediment	Silt/Sand
Upper Riverbank Vegetation	Heavy
Lower Riverbank Slope	Flat/Beach
Lower Riverbank Sediment	Silt/Sand
Lower Riverbank Vegetation	None to very sparse
Type of Erosion	Undercut
Potential Erosion Indicators	Creep/leaning trees, Exposed roots, Overhanging bank
Stage of Erosion	Stable
Extent of Erosion	None/Little

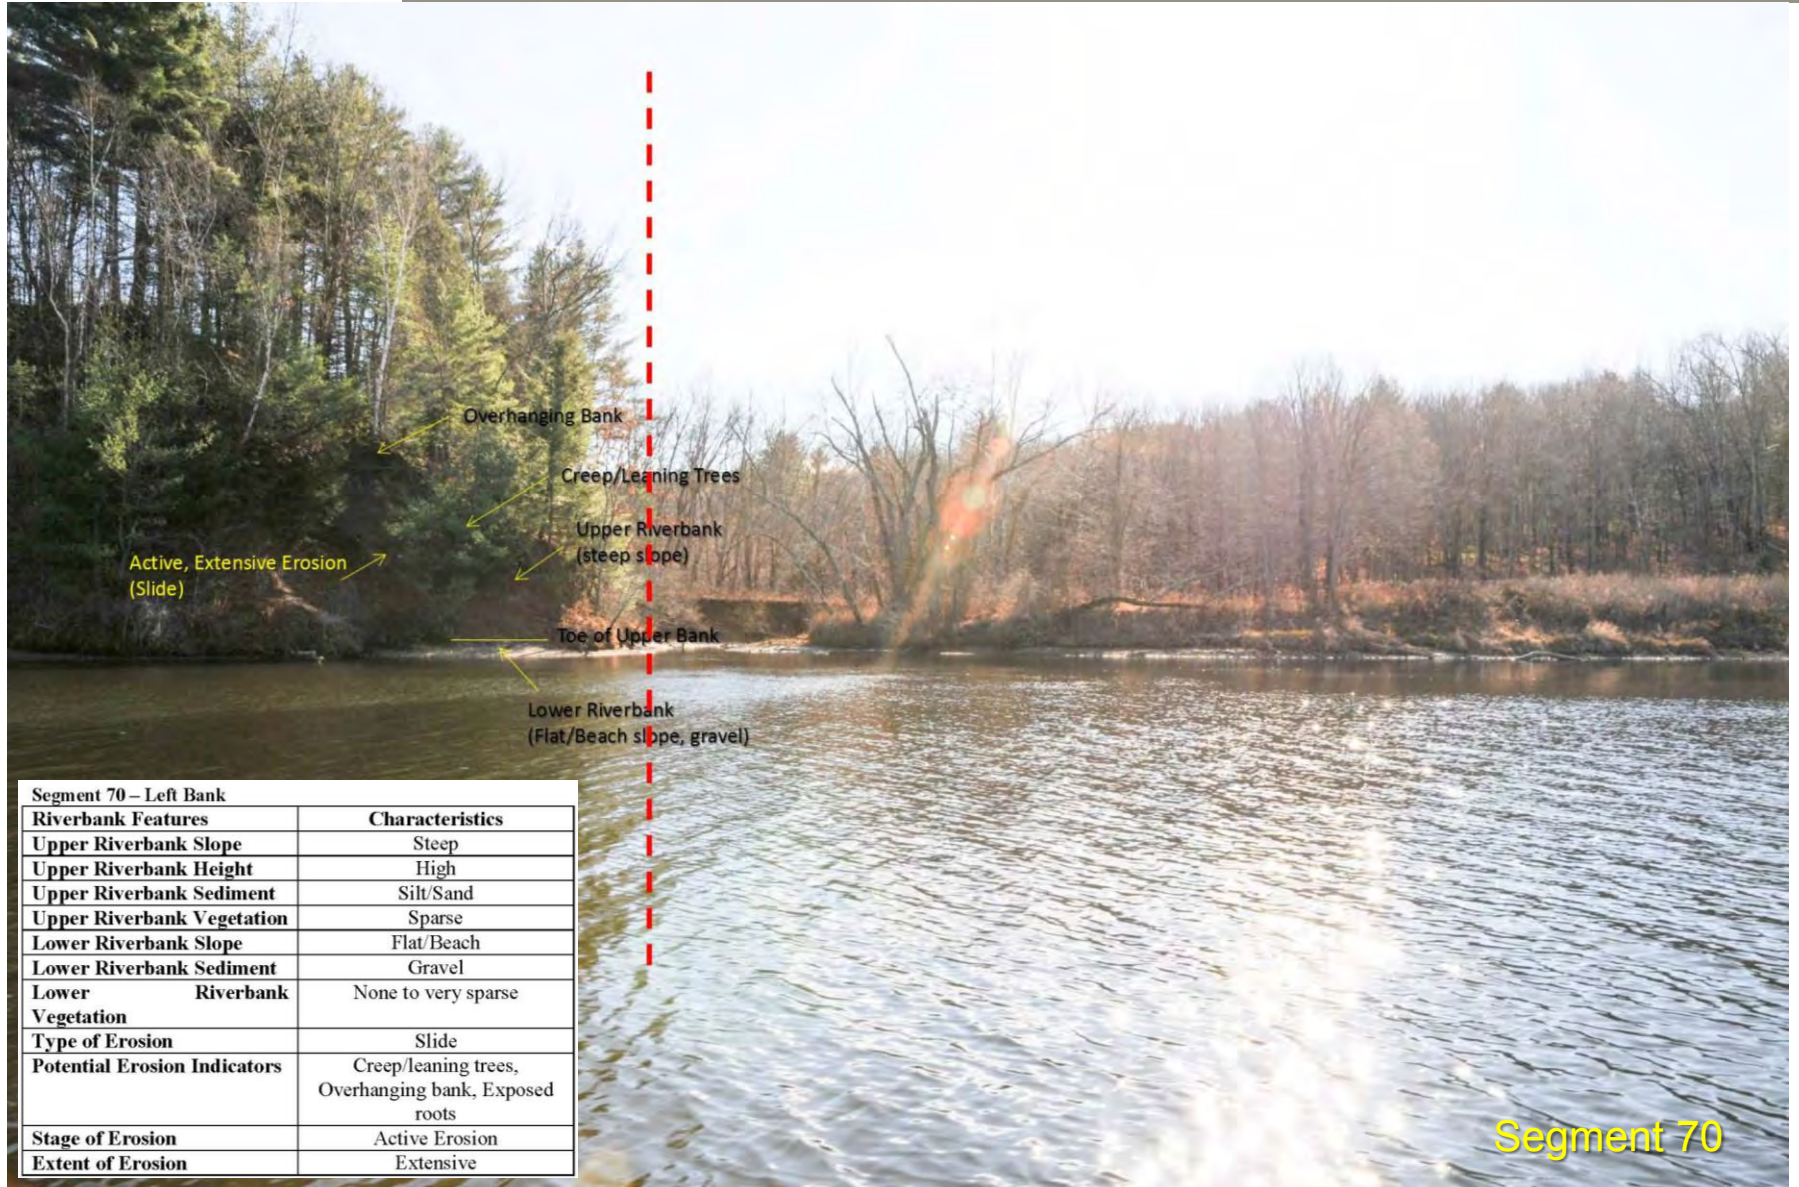
Segment 70 – Left Bank	
Riverbank Features	Characteristics
Upper Riverbank Slope	Steep
Upper Riverbank Height	High
Upper Riverbank Sediment	Silt/Sand
Upper Riverbank Vegetation	Sparse
Lower Riverbank Slope	Flat/Beach
Lower Riverbank Sediment	Gravel
Lower Riverbank Vegetation	None to very sparse
Type of Erosion	Slide
Potential Erosion Indicators	Creep/leaning trees, Overhanging bank, Exposed roots
Stage of Erosion	Active Erosion
Extent of Erosion	Extensive

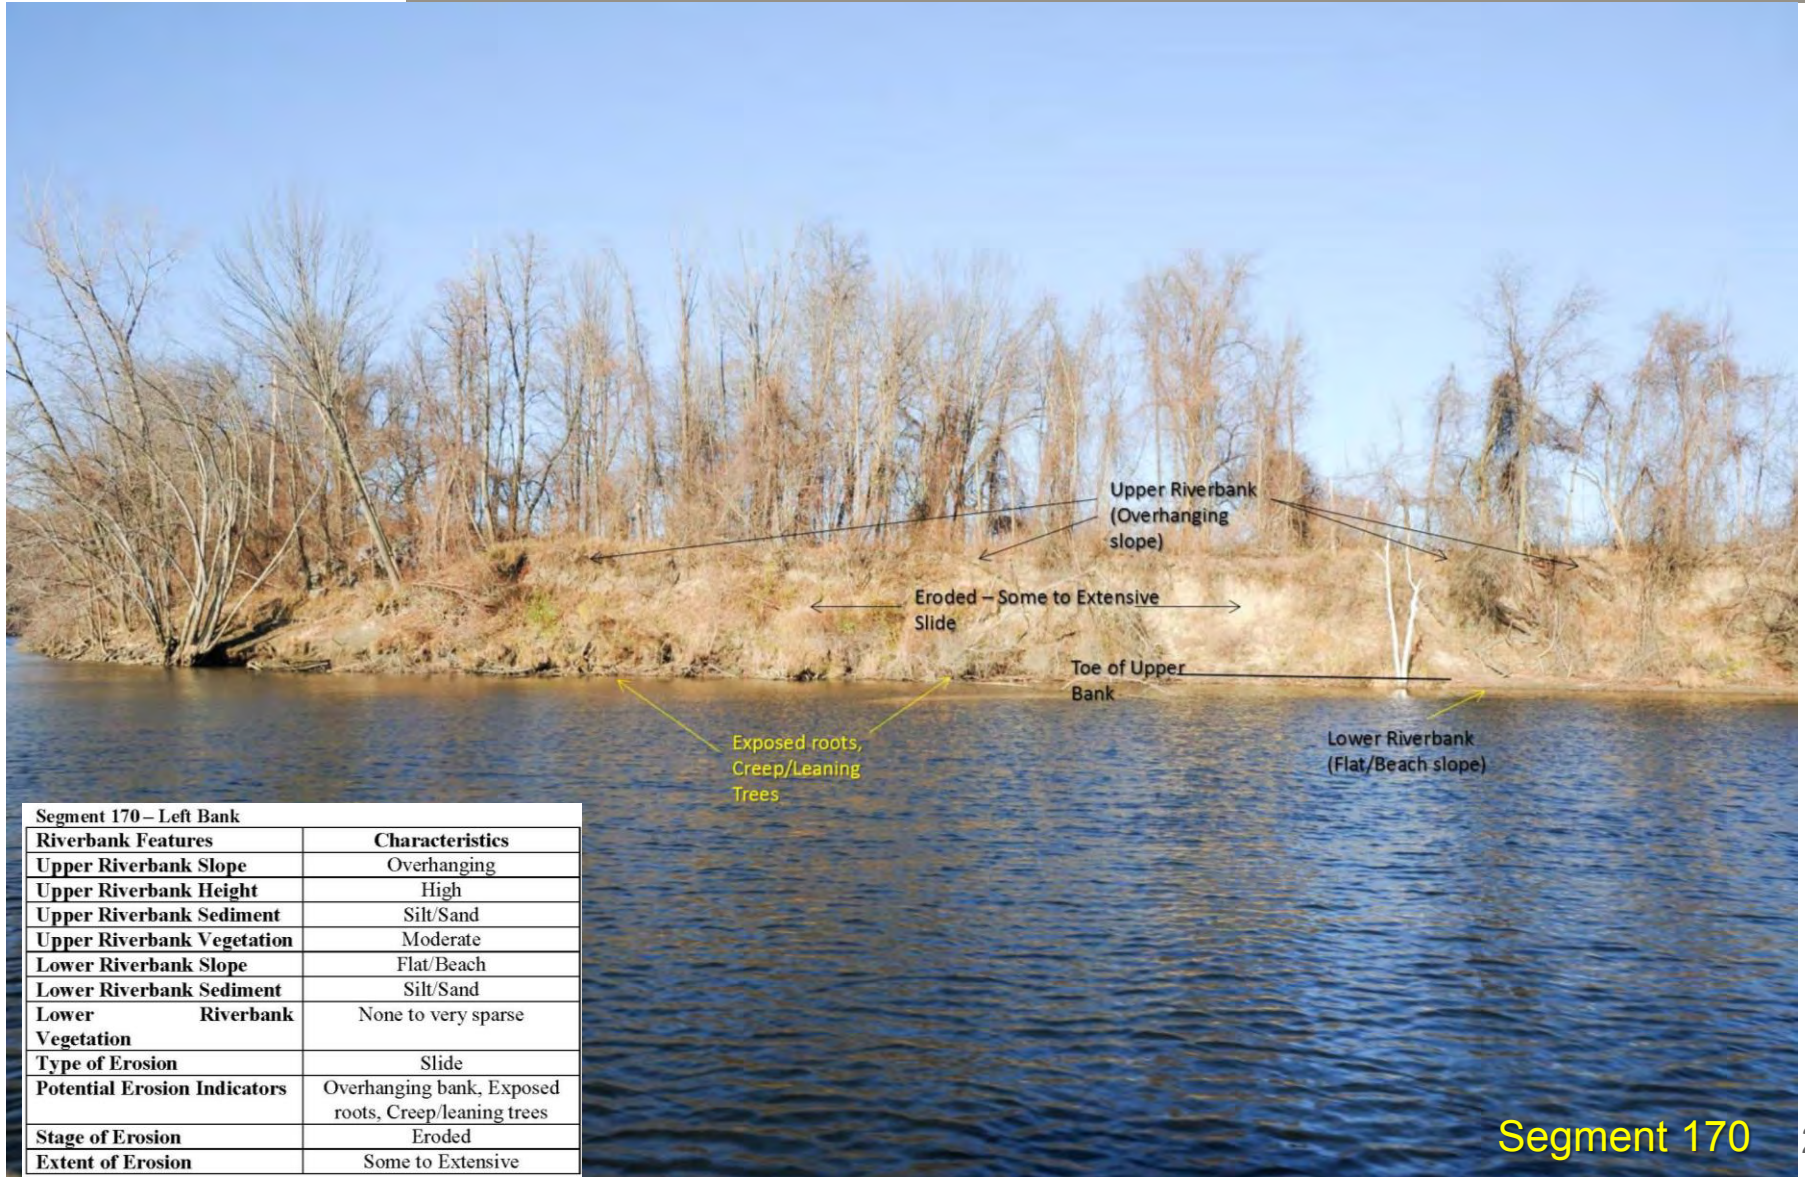
Segment 170 – Left Bank	
Riverbank Features	Characteristics
Upper Riverbank Slope	Overhanging
Upper Riverbank Height	High
Upper Riverbank Sediment	Silt/Sand
Upper Riverbank Vegetation	Moderate
Lower Riverbank Slope	Flat/Beach
Lower Riverbank Sediment	Silt/Sand
Lower Riverbank Vegetation	None to very sparse
Type of Erosion	Slide
Potential Erosion Indicators	Overhanging bank, Exposed roots, Creep/leaning trees
Stage of Erosion	Eroded
Extent of Erosion	Some to Extensive

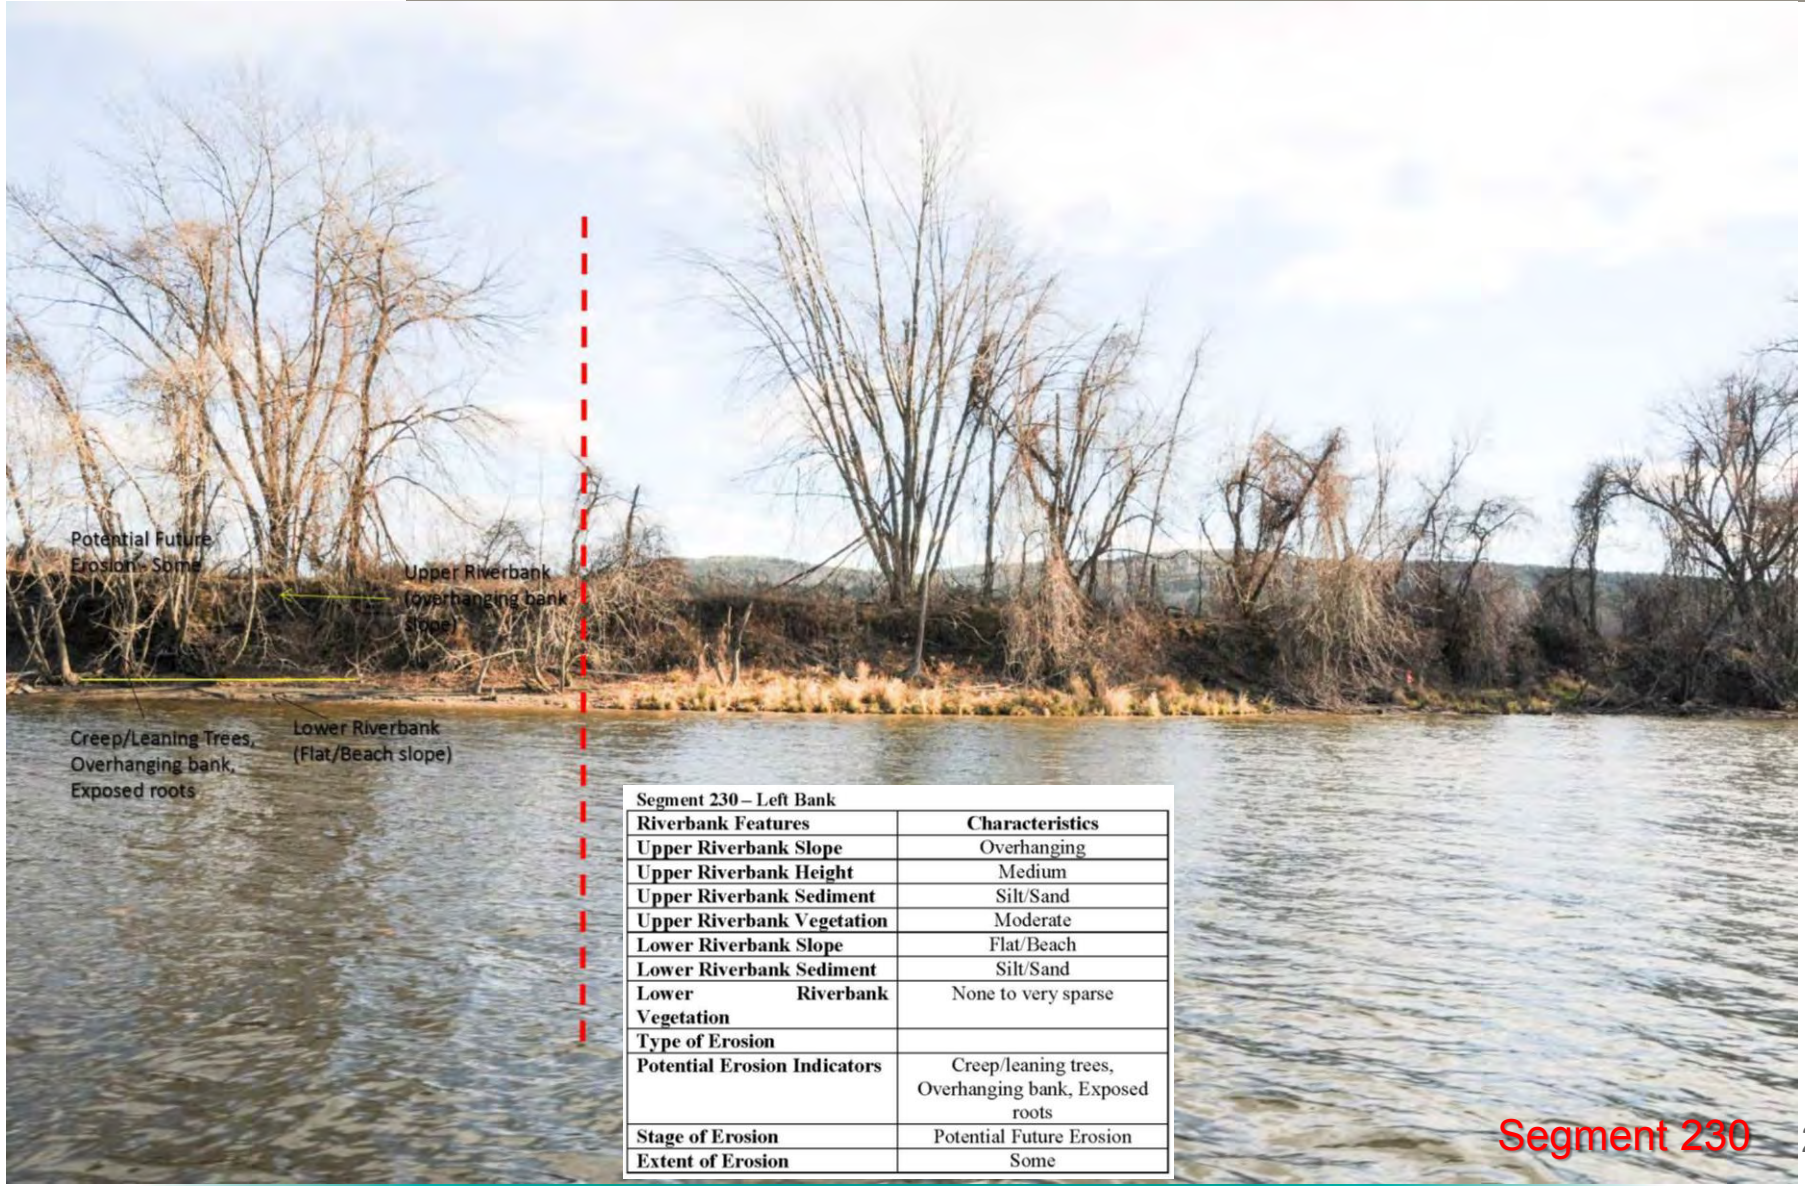
Segment 230 – Left Bank	
Riverbank Features	Characteristics
Upper Riverbank Slope	Overhanging
Upper Riverbank Height	Medium
Upper Riverbank Sediment	Silt/Sand
Upper Riverbank Vegetation	Moderate
Lower Riverbank Slope	Flat/Beach
Lower Riverbank Sediment	Silt/Sand
Lower Riverbank Vegetation	None to very sparse
Type of Erosion	
Potential Erosion Indicators	Creep/leaning trees, Overhanging bank, Exposed roots
Stage of Erosion	Potential Future Erosion
Extent of Erosion	Some

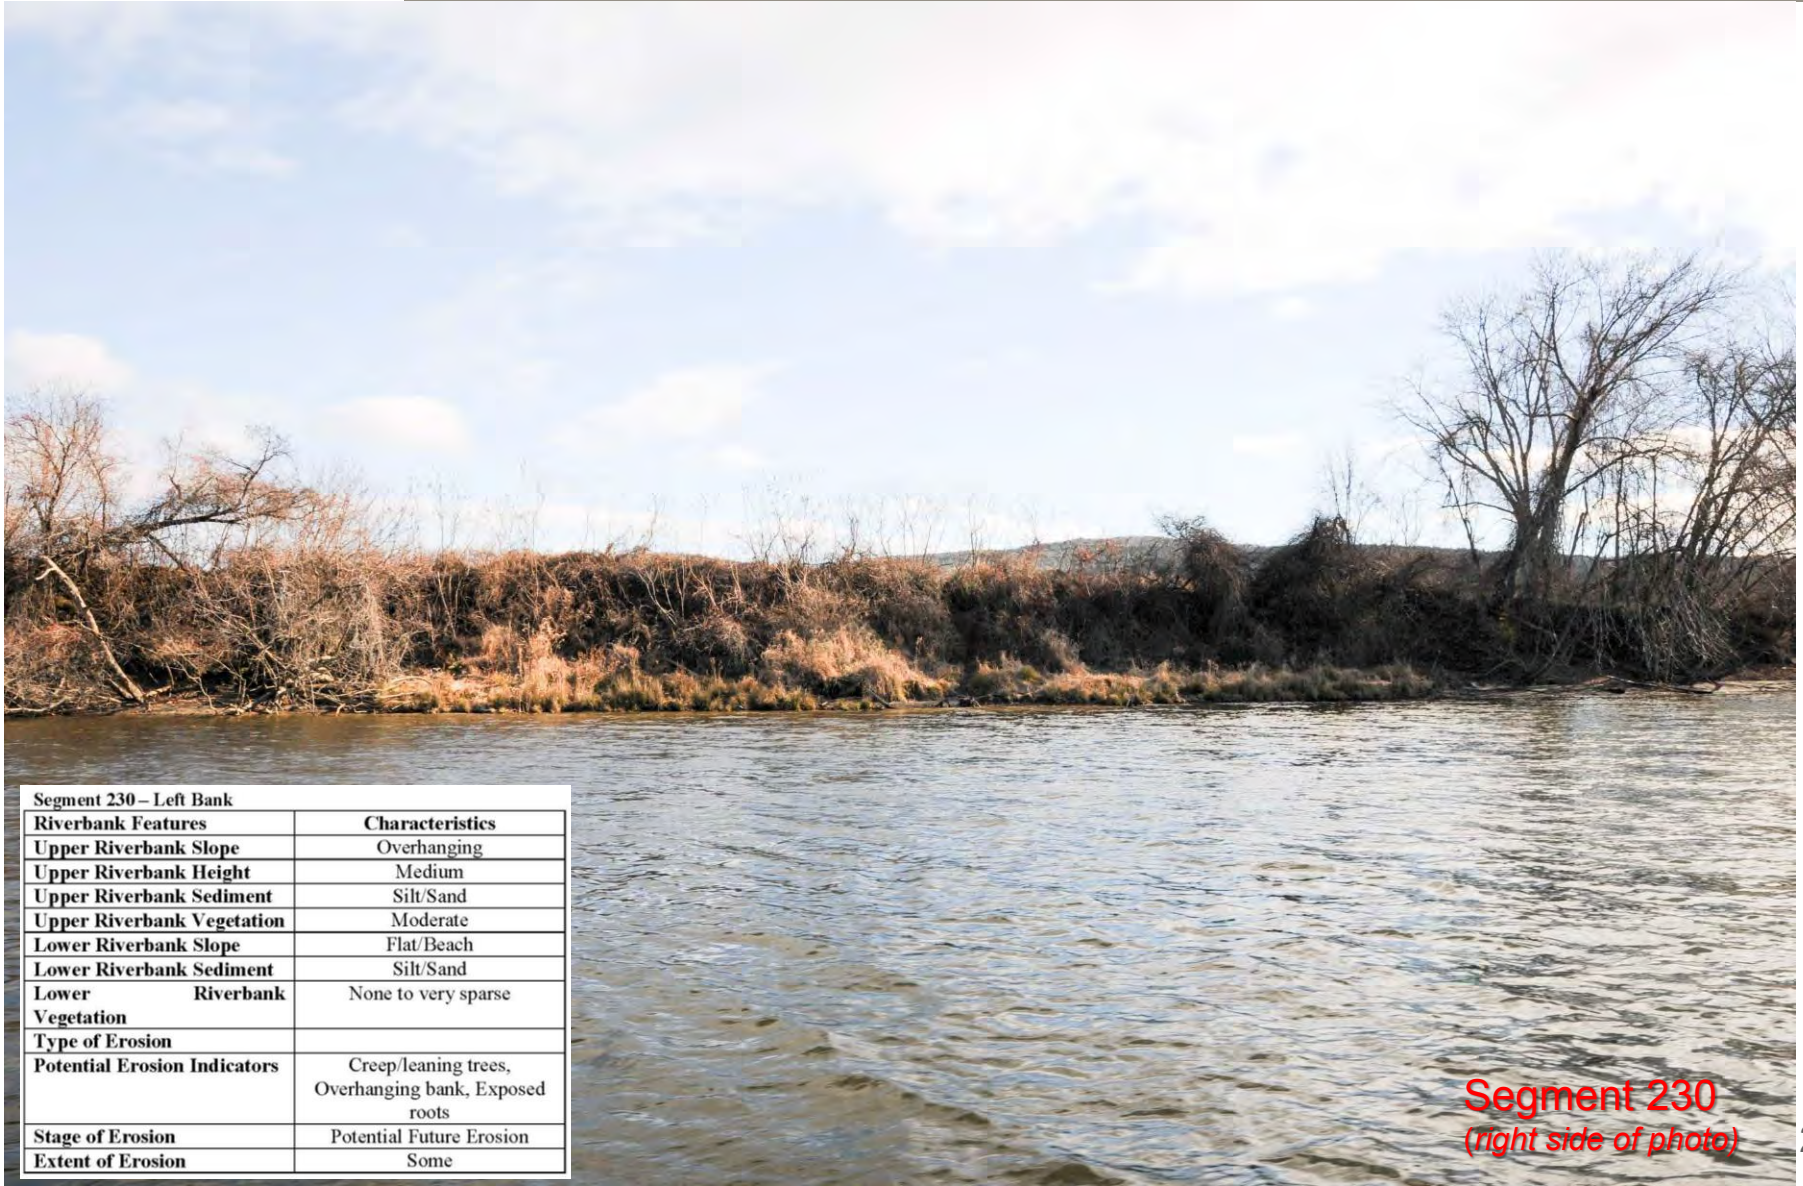
Segment 230 – Left Bank

Riverbank Features	Characteristics
Upper Riverbank Slope	Overhanging
Upper Riverbank Height	Medium
Upper Riverbank Sediment	Silt/Sand
Upper Riverbank Vegetation	Moderate
Lower Riverbank Slope	Flat/Beach
Lower Riverbank Sediment	Silt/Sand
Lower Riverbank Vegetation	None to very sparse
Type of Erosion	
Potential Erosion Indicators	Creep/leaning trees, Overhanging bank, Exposed roots
Stage of Erosion	Potential Future Erosion
Extent of Erosion	Some
