FIRSTLIGHT HYDRO GENERATING COMPANY  
 Northfield Mountain Pumped Storage Project No. 2485  
 Turners Falls Hydroelectric Project No. 1889  
 STUDY 3.1.2

*Northfield Mountain Pumped Storage Project (No. 2485) and Turners Falls Hydroelectric Project (No. 1889)*  
STUDY 3.1.2 NORTHFIELD MOUNTAIN / TURNERS FALLS OPERATIONS IMPACTS ON EXISTING  
EROSION AND POTENTIAL BANK INSTABILITY

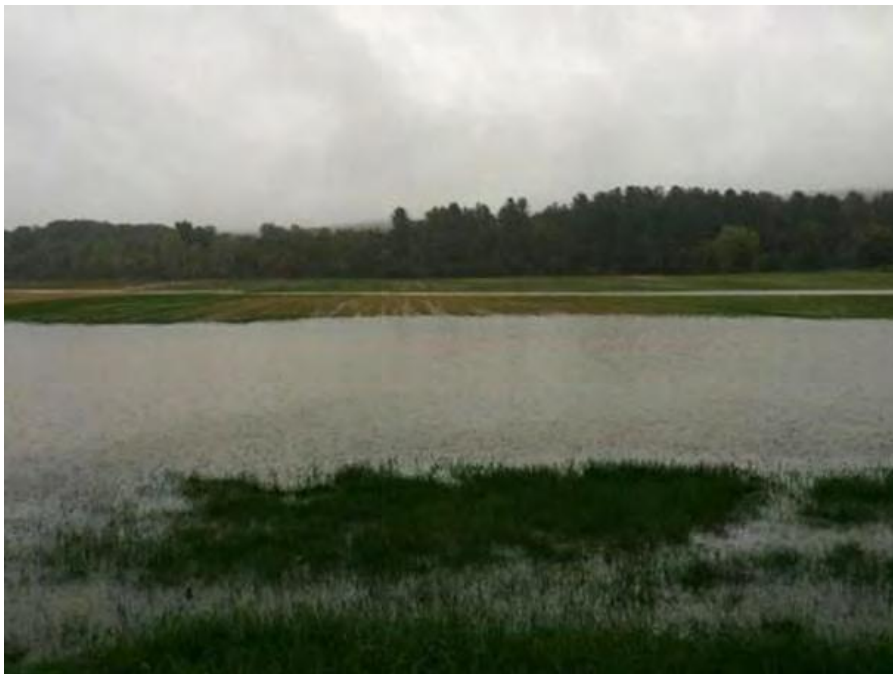
**Figure 5.5.4-8: Ponding on agricultural fields from rainfall event, September 30, 2015 (b)**

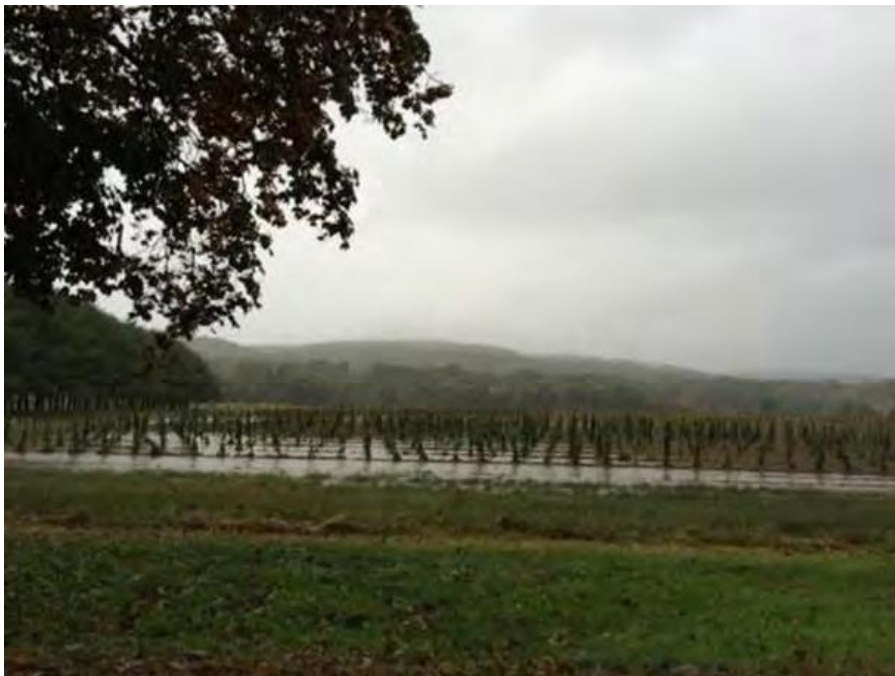
**Figure 5.5.4-10: Ponding on agricultural fields from rainfall event, September 30, 2015 (d)**

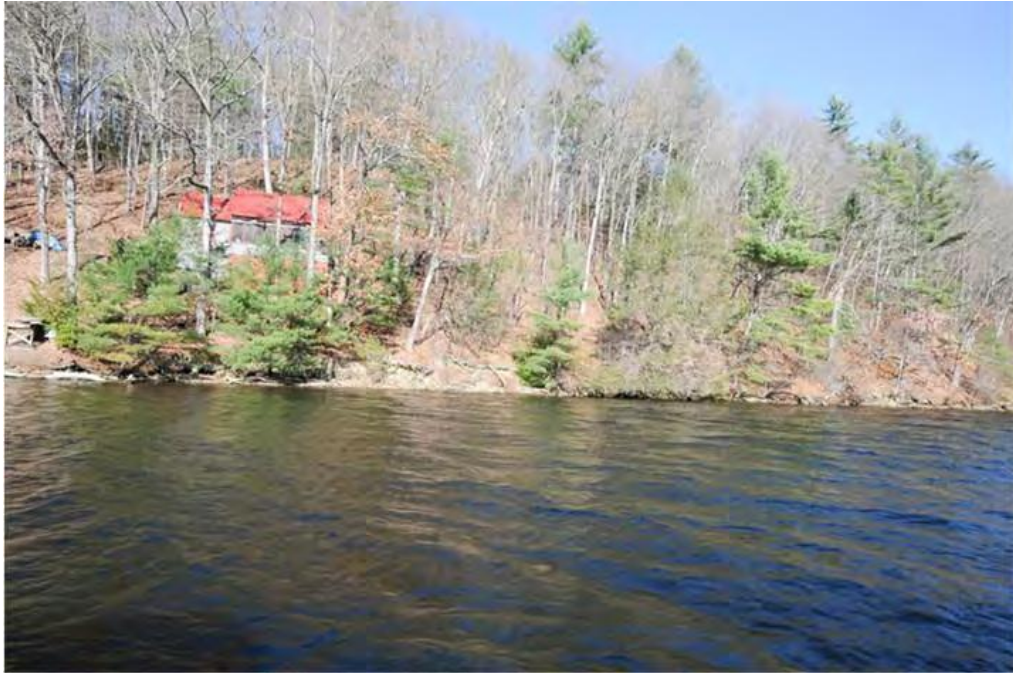
**Figure 5.5.4-14: Erosion adjacent to seasonal Camp 2-W**

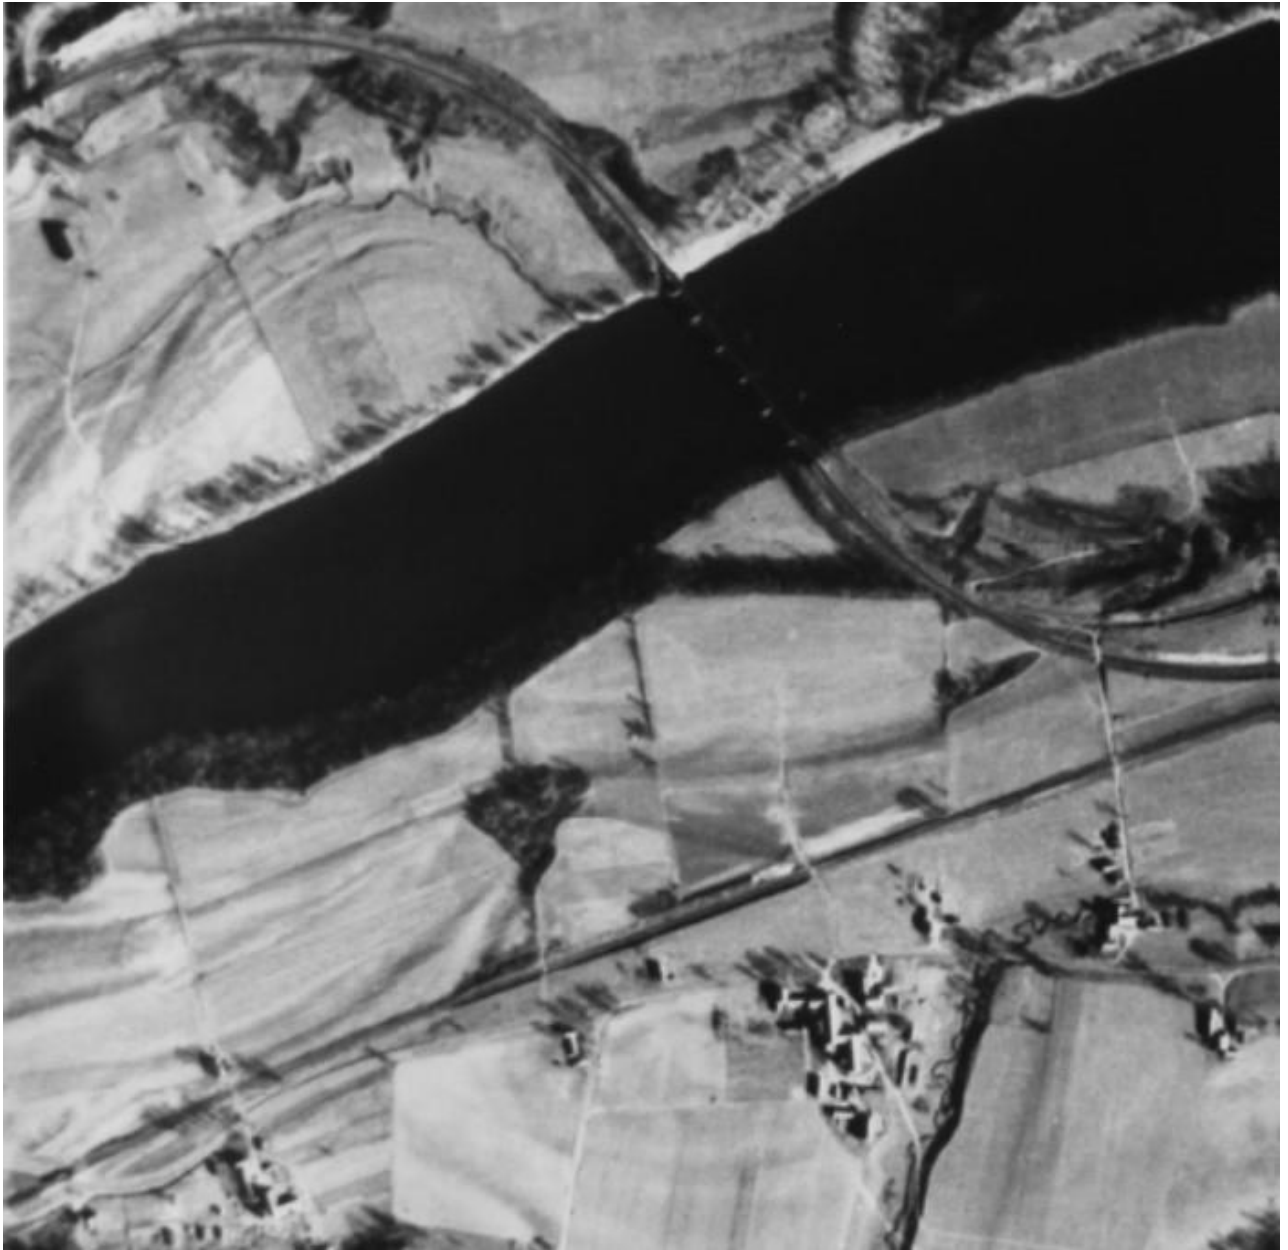
**Figure 5.5.5.5-3 Aerial Photo Showing Erosion Scars on Floodplain - 1939**

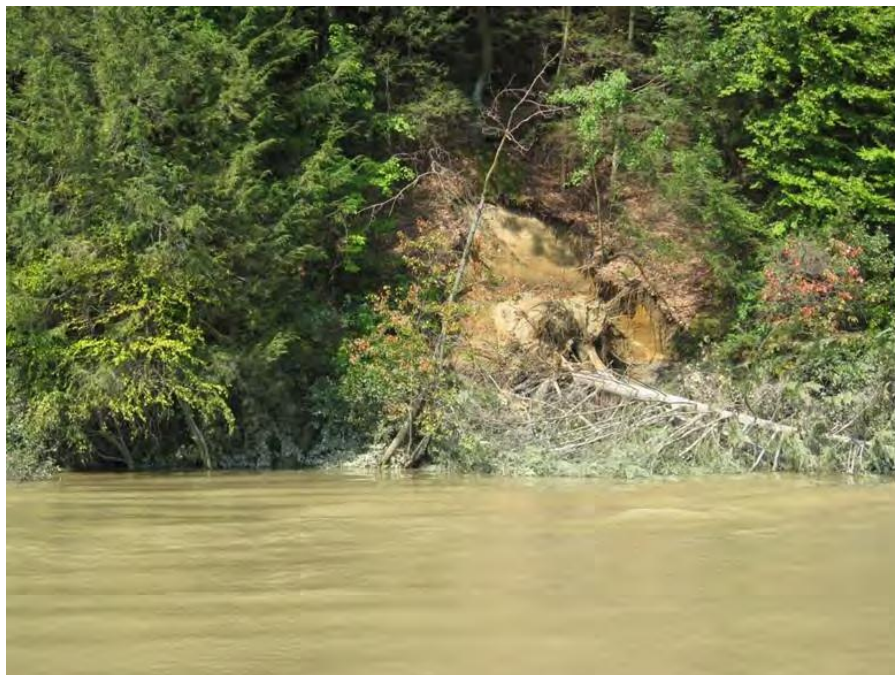
**Figure 5.5.5.5-16 Erosion Due to High Flow in 2011**

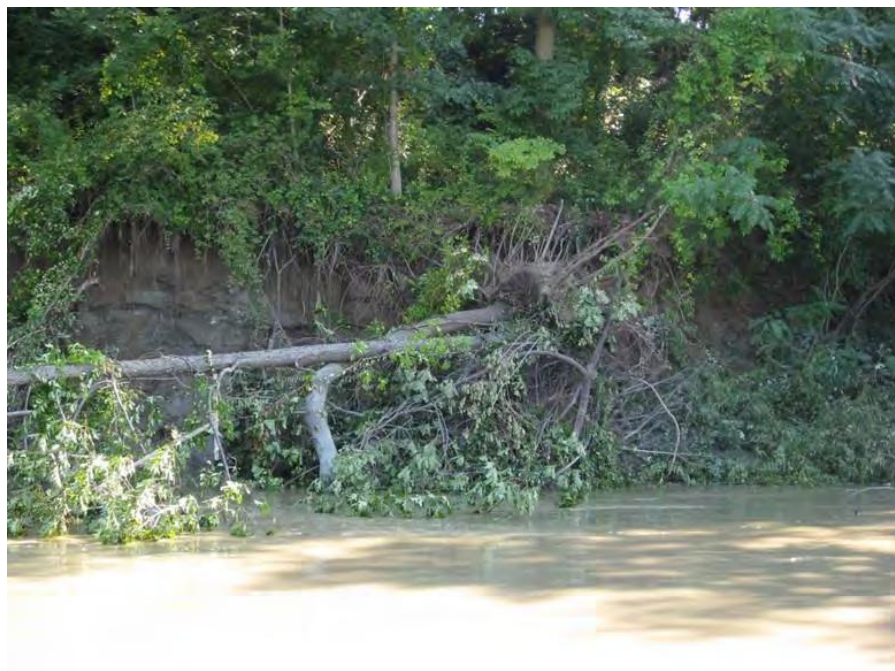
**Figure 5.5.5.5-17 Erosion Due to High Flow in 2011**

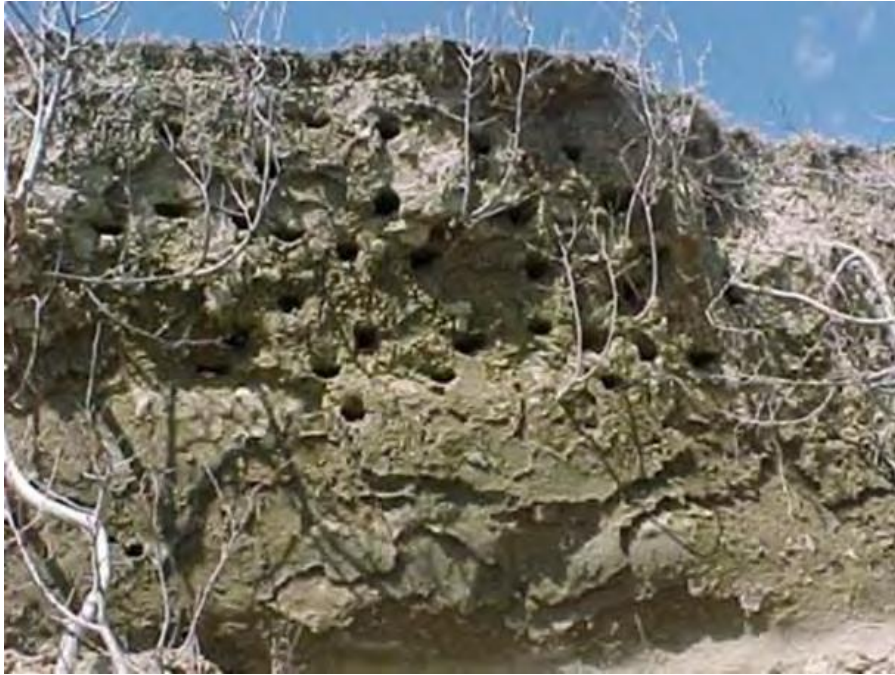
As part of the 2013 FRR, the locations of sensitive receptors found along or near the TFI riverbanks were mapped. A sensitive receptor was defined as important wildlife habitat located at or near the riverbank. Many wildlife features were observed during this survey including bank swallow and belted kingfisher nesting sites and bald eagle nest and perch sites. Of particular interest to this study were the bank swallow and belted kingfisher nesting sites since they are reliant on eroding banks for habitat. Belted kingfishers and bank swallows excavate cavities to use as nests in sheer banks lacking vegetation and containing appropriate soil conditions. [Figure 5.5.6-1](#) depicts the locations of the sensitive receptors identified during the 2013 FRR. An example of a bank swallow nesting site is found in [Figure 5.5.6-2](#).

**Figure 5.5.6-2: Bank swallow nests – Flagg erosion site near Kidds Island, Turners Falls Impoundment**

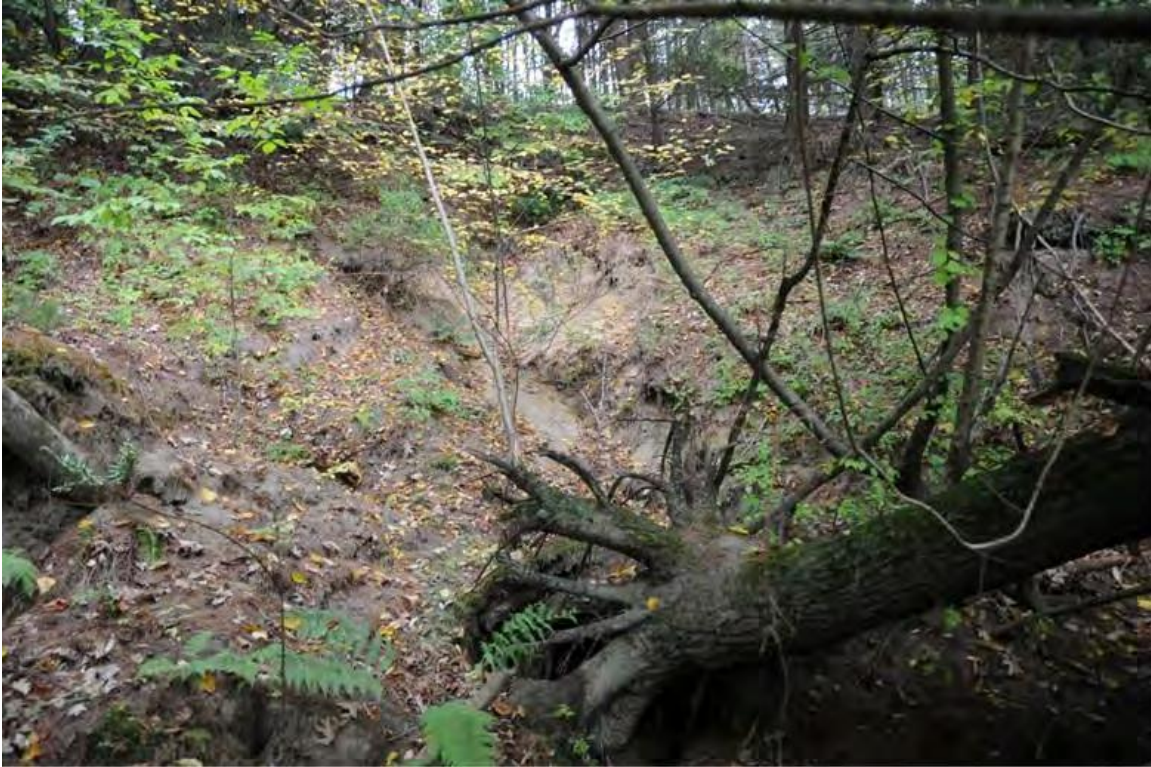
**Figure C-12 Upland erosion feature (Photo 9517)**
