Analysis of Erosion in the Vicinity of the Route 10 Bridge Spanning the Connecticut River

October 2012

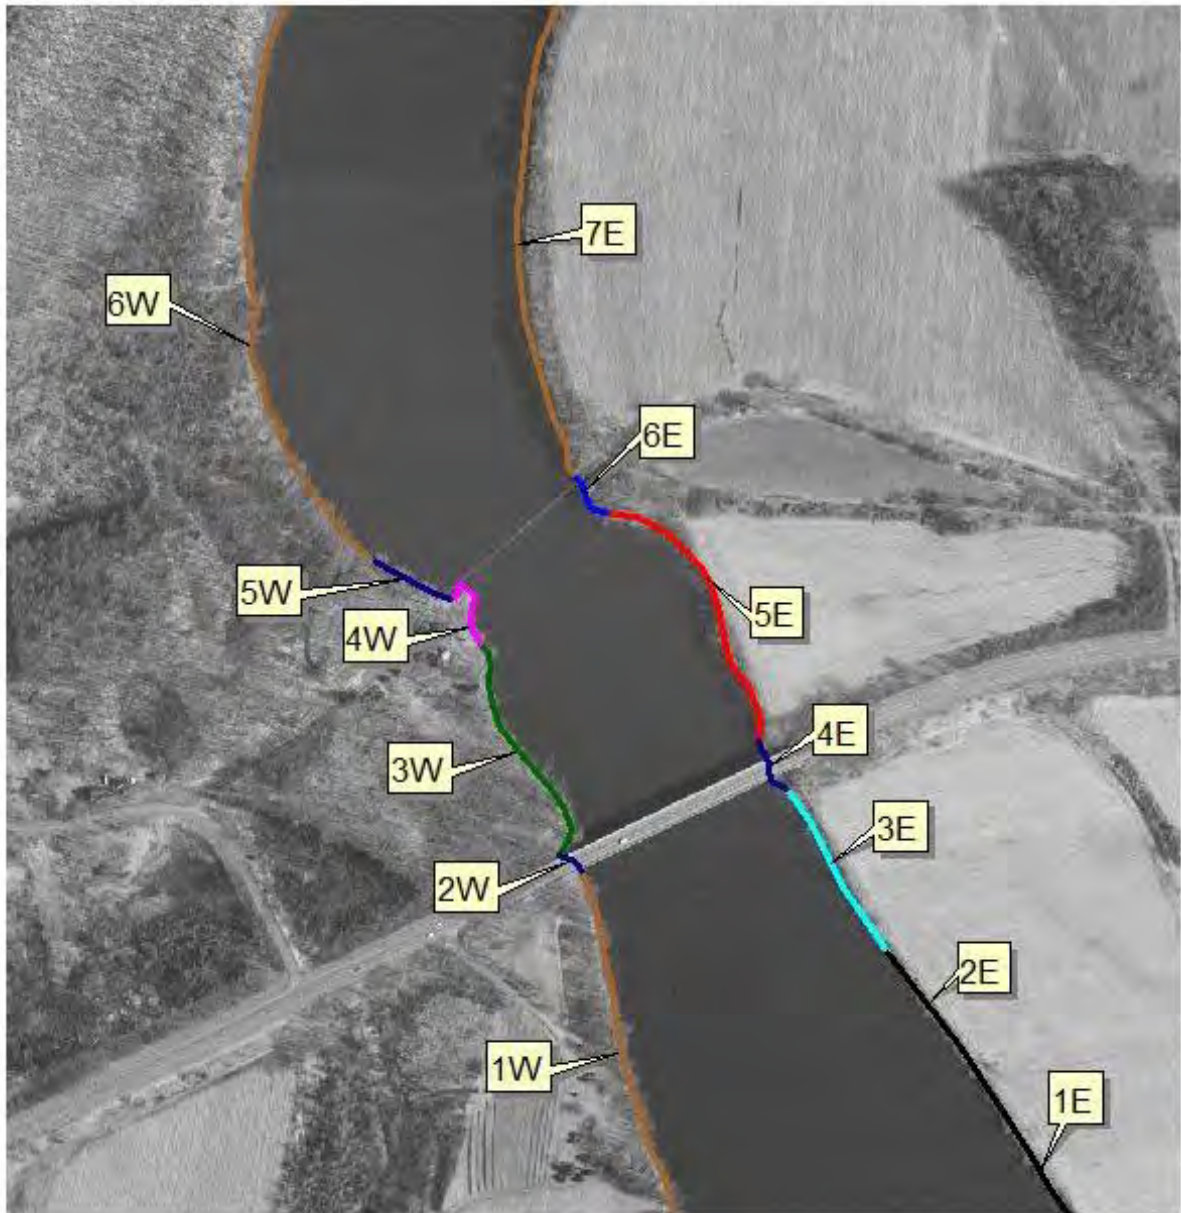
Figure 4. Riverbank Characteristics near Route 10 Bridge

On the left descending bank (east side of the river) downstream of the Route 10 Bridge, the USACE constructed experimental bank protection. The first segment consists of small concrete blocks glued on fabric placed on the lower bank (3E). The upper bank is vegetated with trees, shrubs and herbaceous vegetation. The next two segments consist of used automobile tires banded together on the lower riverbank slope with a vegetated upper bank (trees, shrubs, and herbaceous vegetation). In one of the segments, the tires are stacked and stepped back to create a moderate slope (2E). For the most downstream segment, the tires are laid on a moderate slope on their sides with tires touching at their circumference so their circular shape is visible (1E). Upstream of the bridge, the lower bank consists of sand and is relatively flat-sloped (5E). The upper riverbank is generally steep with some areas of moderate to vertical slopes. There is some vegetation but fairly limited. This segment is actively eroding and extends several hundred feet. The next segment has a rip-rapped toe, where the old Bennett Meadow Bridge used to be (6E). The upper river bank consists of silt and sand and lies on a moderate slope. It is vegetated with trees and some shrubs and herbaceous vegetation. Beyond the old segment of rip-rap, the lower riverbank consists of sand lying on a relatively flat slope (7E). The upper riverbanks continue (moderate sandy slope) with vegetation consisting of trees, shrubs and herbaceous vegetation.

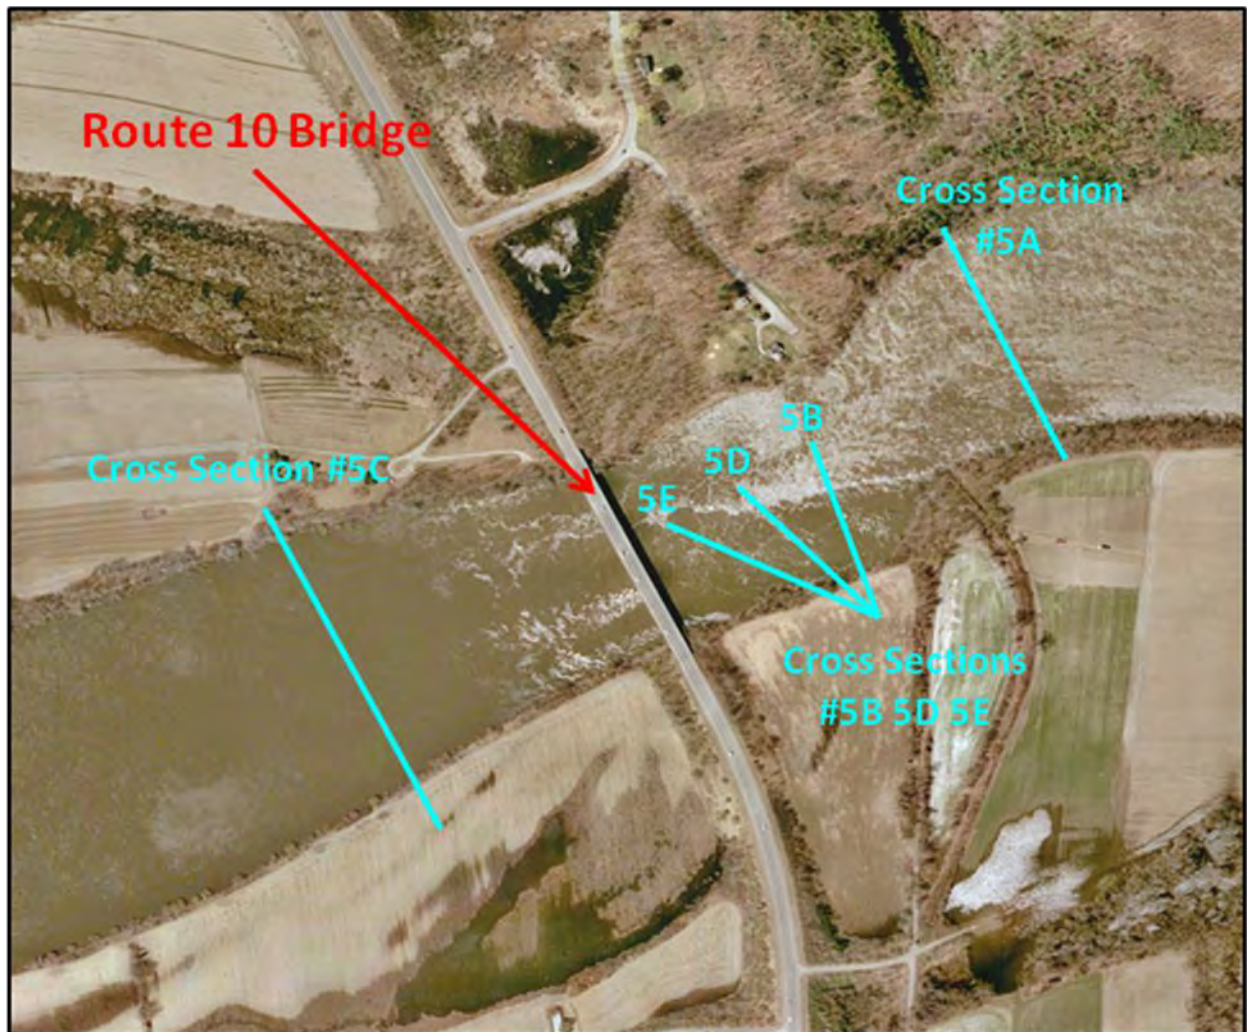
Figure 6. Cross Section Locations near Route 10 Bridge (after North by Northeast, 2004)

In addition to 2006 bathymetry and channel geometry data developed for hydraulic modeling, several cross-sections (see Figure 6) have been surveyed in the Route 10 Bridge area (cross-sections 5A, 5B, 5D, 5E, and 5C). These cross-sections are part of the set of monumented cross-sections that are surveyed routinely by a surveyor contracted by FirstLight to monitor changes in riverbank geometry. The survey of these cross-sections

began in 1990 and was repeated in 1992, 1993, 1995 – 2000 (twice each year), and 2001 – 2008 (annually). Cross-section 5A is located about 1200 feet upstream of the bridge and extends in a perpendicular direction across the river. Cross-sections 5B, 5D, and 5E start on the east bank about 500 feet upstream of the bridge. These are partial cross-sections that fan out to provide a range of locations out into the river. Cross-section 5C is located about 850 feet downstream of the bridge and extends perpendicularly across the river.

A comparison of cross-section graphs through the 1990s (1990-1997) shows changes in cross-sections at the surveyed locations (see Appendix A “Long Term Riverbank Plan for the Turners Falls Pool of the Connecticut River,” Simons & Associates, 1998). At 5A, the data show very little change in the cross-section below the typical impoundment level. Near to above the typical water level, there appeared to be some fluctuation in bank line that appears to vary with some aggradation and some degradation. At cross-section 5B on the east bank, there appears to be some bank erosion of the near vertical upper bank of something on the order of about 10 feet horizontally. 5C shows relatively

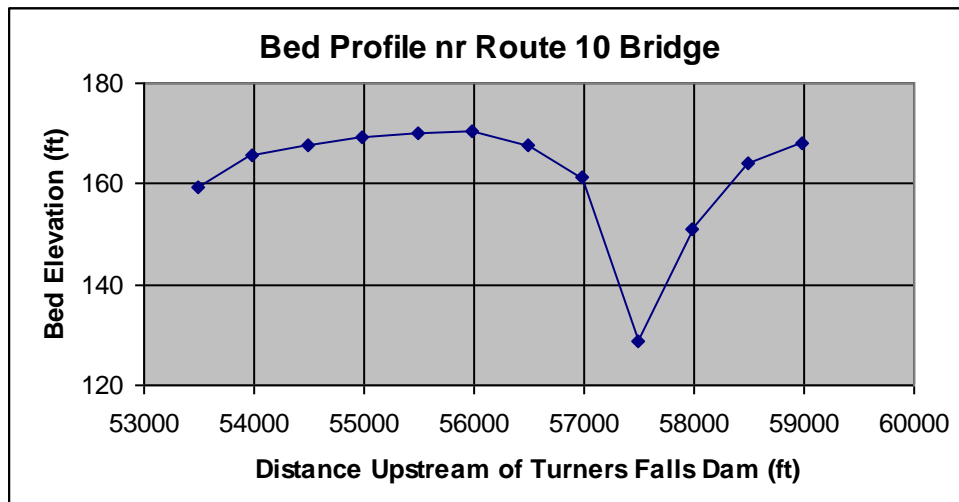
Figure 8. Riverbed Profile near Route 10 Bridge (from cross-section data in Woodlot, 2007)

- At the same time, the channel bed drops rapidly; reaching a maximum depth of about 54 feet about 500 feet upstream of the Route 10 Bridge (see Figure 8)
- Just as rapidly as the river deepens, it then shallows to a depth of about 16 feet as the river bends slightly back to the right.
- A large eddy forms along the east bank of the river between the old Bennett Meadow bridge abutment and the Route 10 Bridge abutment.
- The Route 10 Bridge Piers cause some obstruction to the flow and cause additional turbulence.

While there are several deep areas along the Turners Falls Pool, it should be noted that the deep area just upstream of the Route 10 Bridge is the deepest area over a distance from the confluence of Millers River into the Connecticut River to the Vernon Dam, a distance of approximately 16 miles.

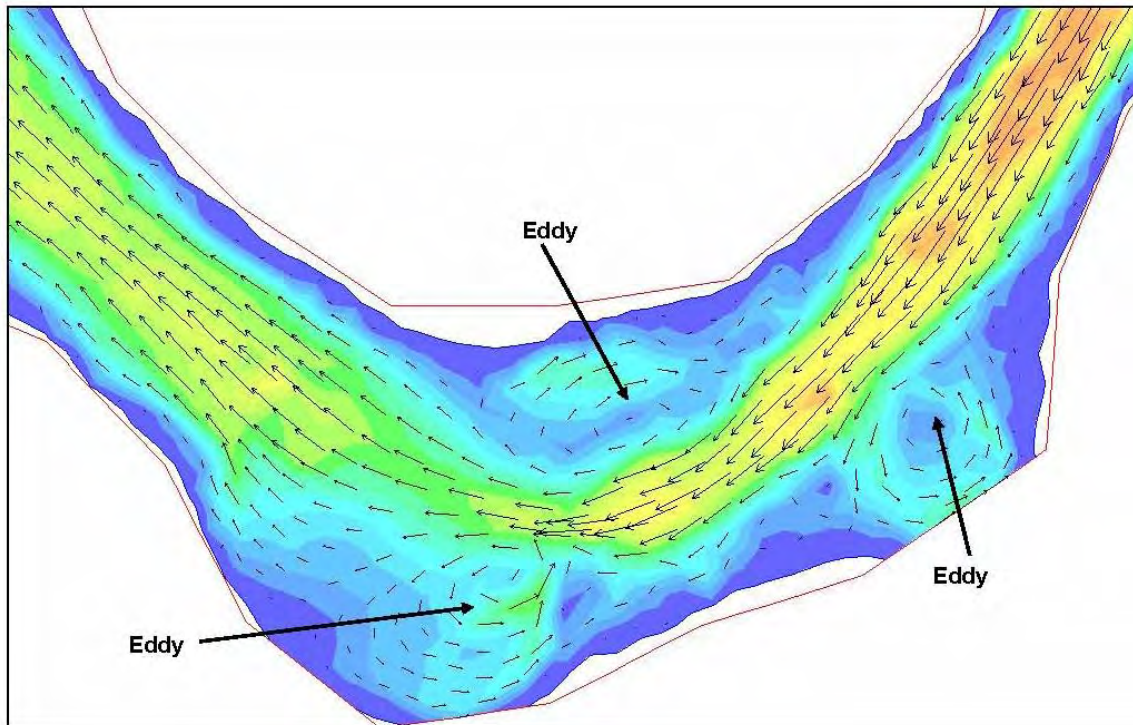
Figure 10. Eddy formation near confluence with Millers River (based on model results from Woodlot, 2007)

the formation of eddies, where flow swirls in a circular pattern counter to the river's main direction of flow – an observation of flow conditions found in the vicinity of the Route 10 Bridge. Figure 10 is an example of the simulation of eddy formation shown in the model output, in this case where Millers River discharges into the Turners Falls Impoundment. The arrows show the velocity vectors which indicate the direction and magnitude of velocity (by the length of the arrow). The magnitude of the velocity is also shown by the color, where lower velocities are blue and higher velocities are indicated by yellow, orange and red.

As noted above, an eddy is a circular pattern of flow that separates or breaks away from the main direction of flow and flows towards the riverbank, then upstream along the bank, before completing a circular pattern returning again to a downstream direction farther away from the bank. Eddies typically form when there is an obstruction in the flow pattern or a relatively abrupt change in the bank alignment such that the main current continues in its ongoing path and cannot immediately follow the obstruction or change in bank alignment.

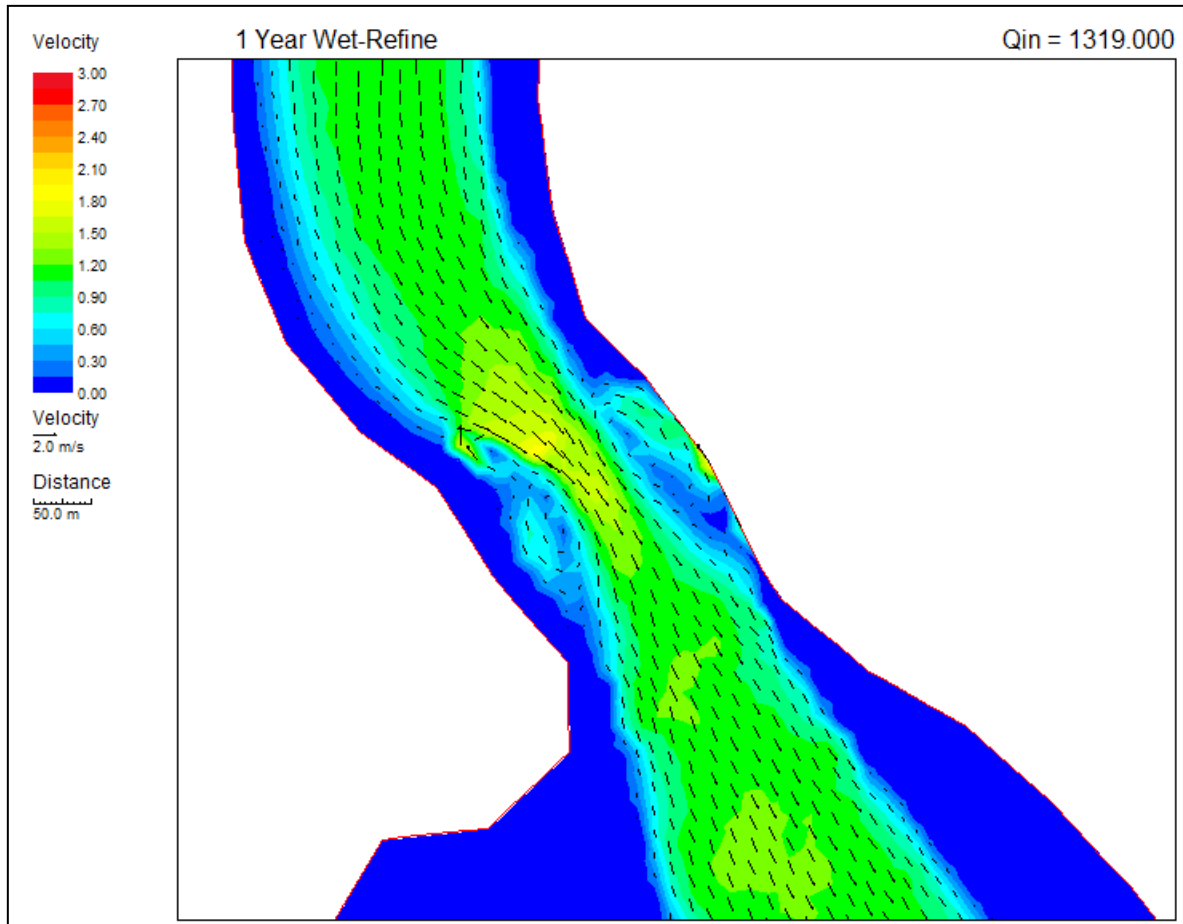
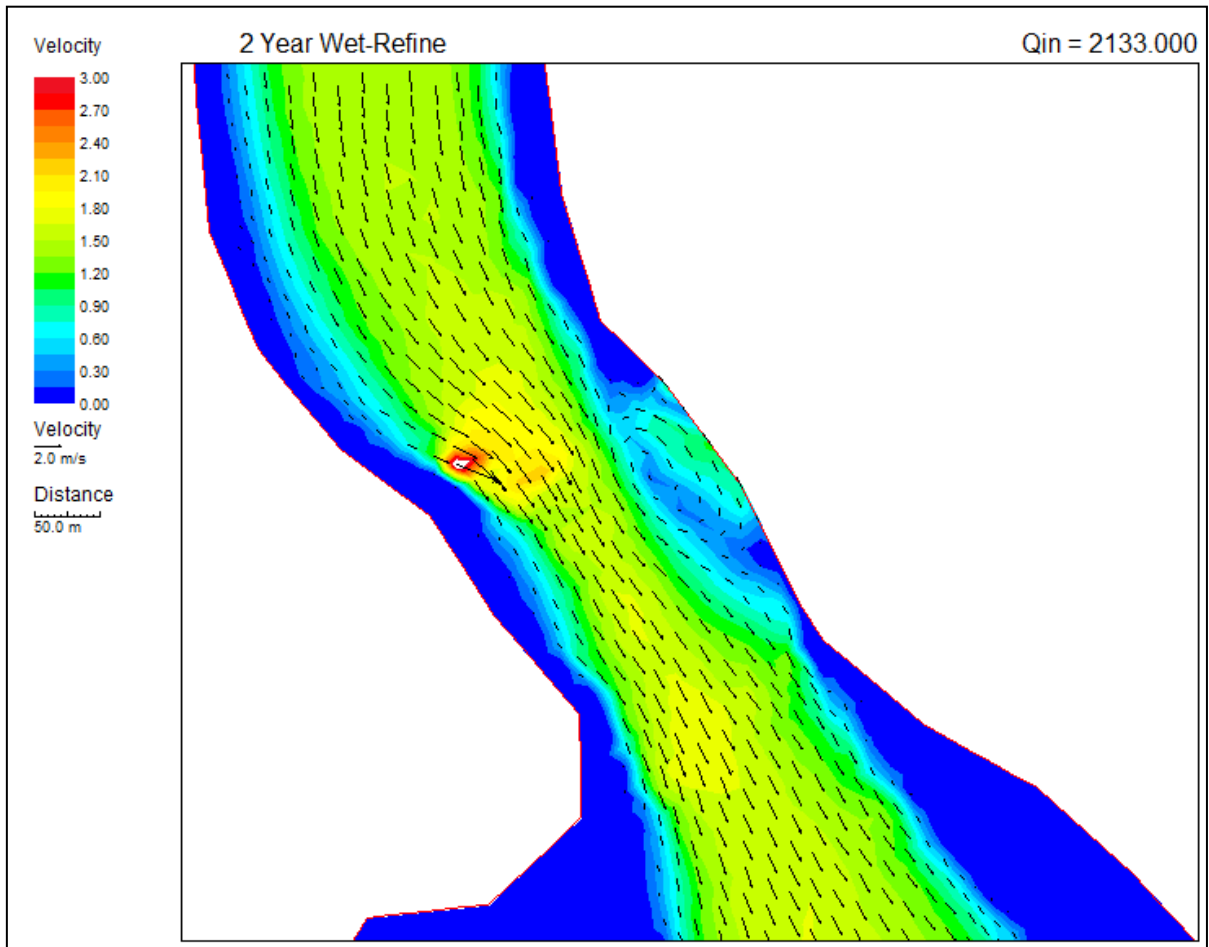
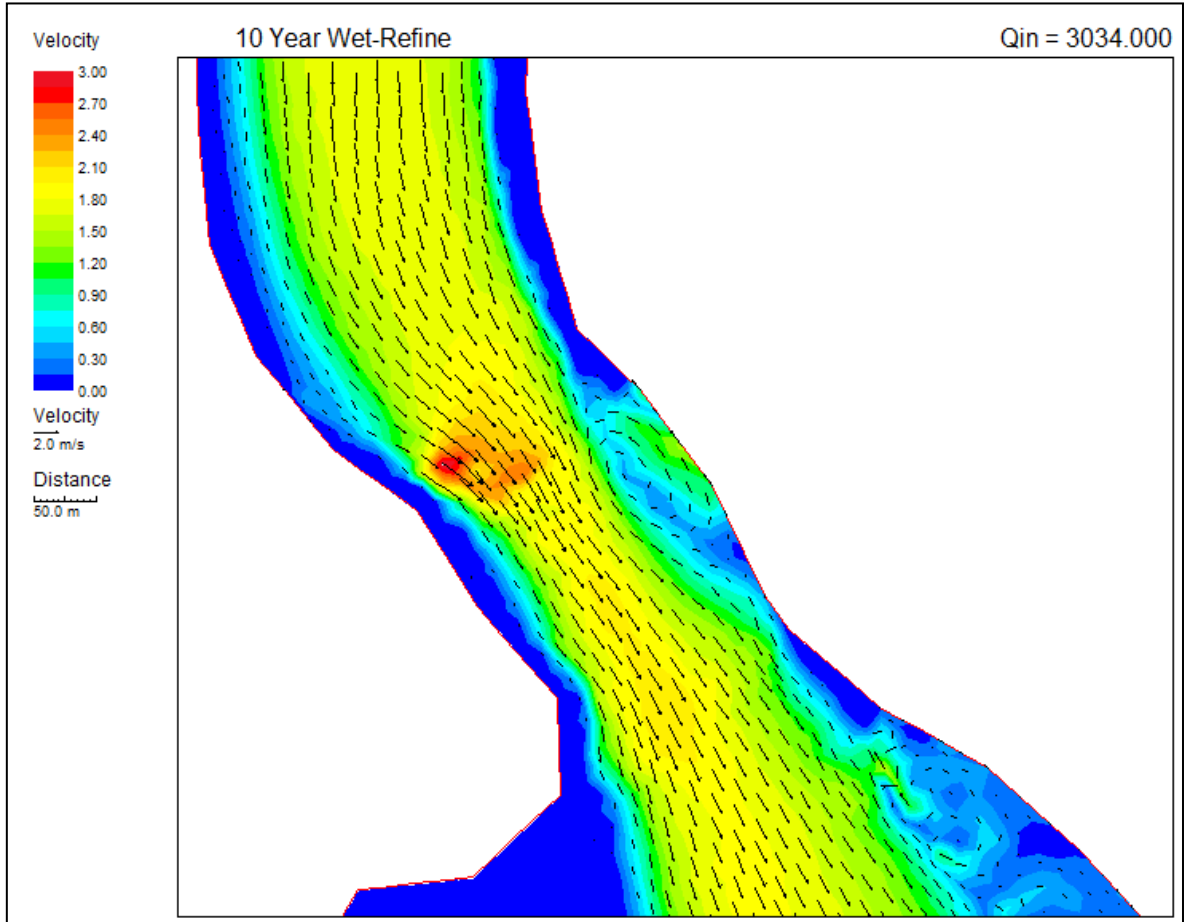
Fortunately, for much of the time, the near-bank velocities are very low and do not cause significant erosion. The two-dimensional model shows velocities of approximately 1 fps near the east bank where significant erosion is occurring for the 1 and 2-year flows and approximately 1.5 fps for the 10-year flow (see Appendix E). Near bank velocities are also approximately 1.5 fps for the 100-year flow (see Figure 6). The critical velocity when erosion would begin, based on the sizes of sediment found in the eroding area, is about 0.3 to 0.45 fps (for a range of reasonable critical shear parameters). Thus, the near bank velocities significantly exceed critical shear for the sizes of sediment found in this area thereby resulting in erosion at these higher flows. Because velocities (at high flow conditions) on the east riverbank between the Route 10 Bridge and old Bennett Meadow Bridge (Segment 5E) exceed the critical shear stress, sediment erosion and transport occurs.
