ATTACHMENT A: 2013 Full River Reconnaissance – 2015 Addendum: Riverbank Segment QA Comparison

FIRSTLIGHT POWER RESOURCES
RELICENSING STUDY 3.1.1
NORTHFIELD MOUNTAIN/TURNERS FALLS
2013 FULL RIVER RECONNAISSANCE

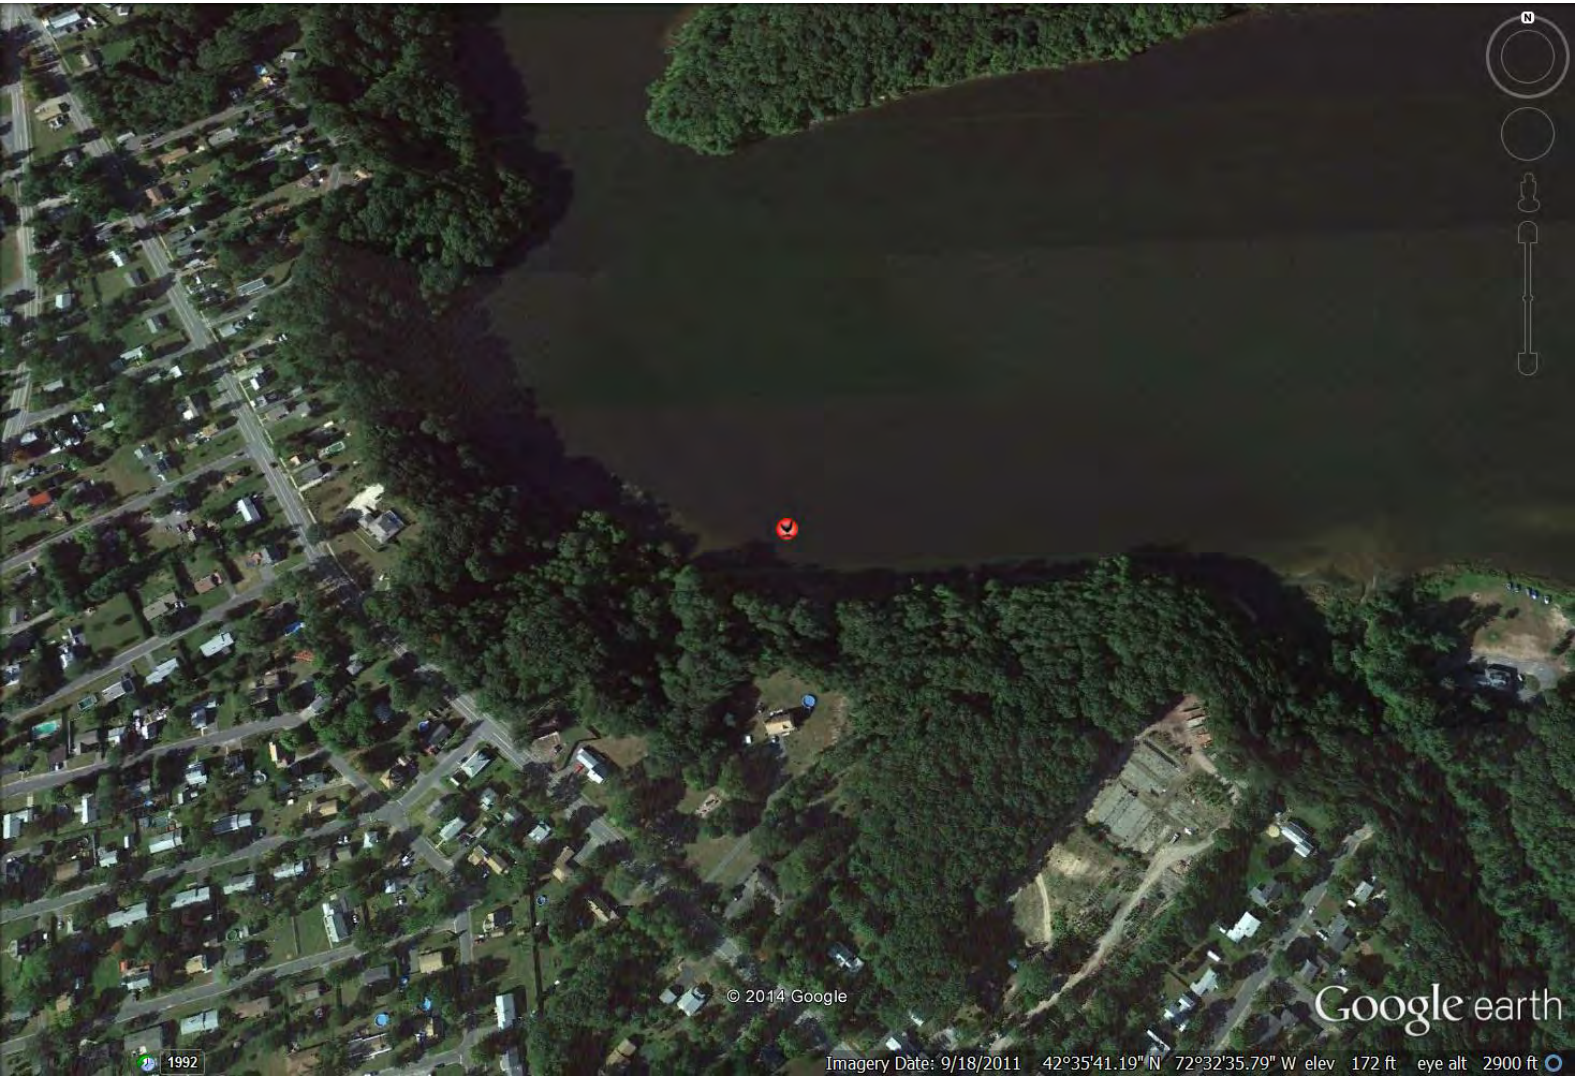
Photo 259 Location

Riverbank Features	Characteristics
Upper Riverbank Slope	Flat
Upper Riverbank Height	Low
Upper Riverbank Sediment	Silt/Sand
Upper Riverbank Vegetation	Heavy
Lower Riverbank Slope	Flat/Beach
Lower Riverbank Sediment	Silt/Sand
Lower Riverbank Vegetation	None to very sparse
Type of Erosion	
Potential Erosion Indicators	Creep/leaning trees
Stage of Erosion	Stable
Extent of Erosion	None/Little

QA Observations: Upon review of the photos for this segment, classification made in the field was confirmed.

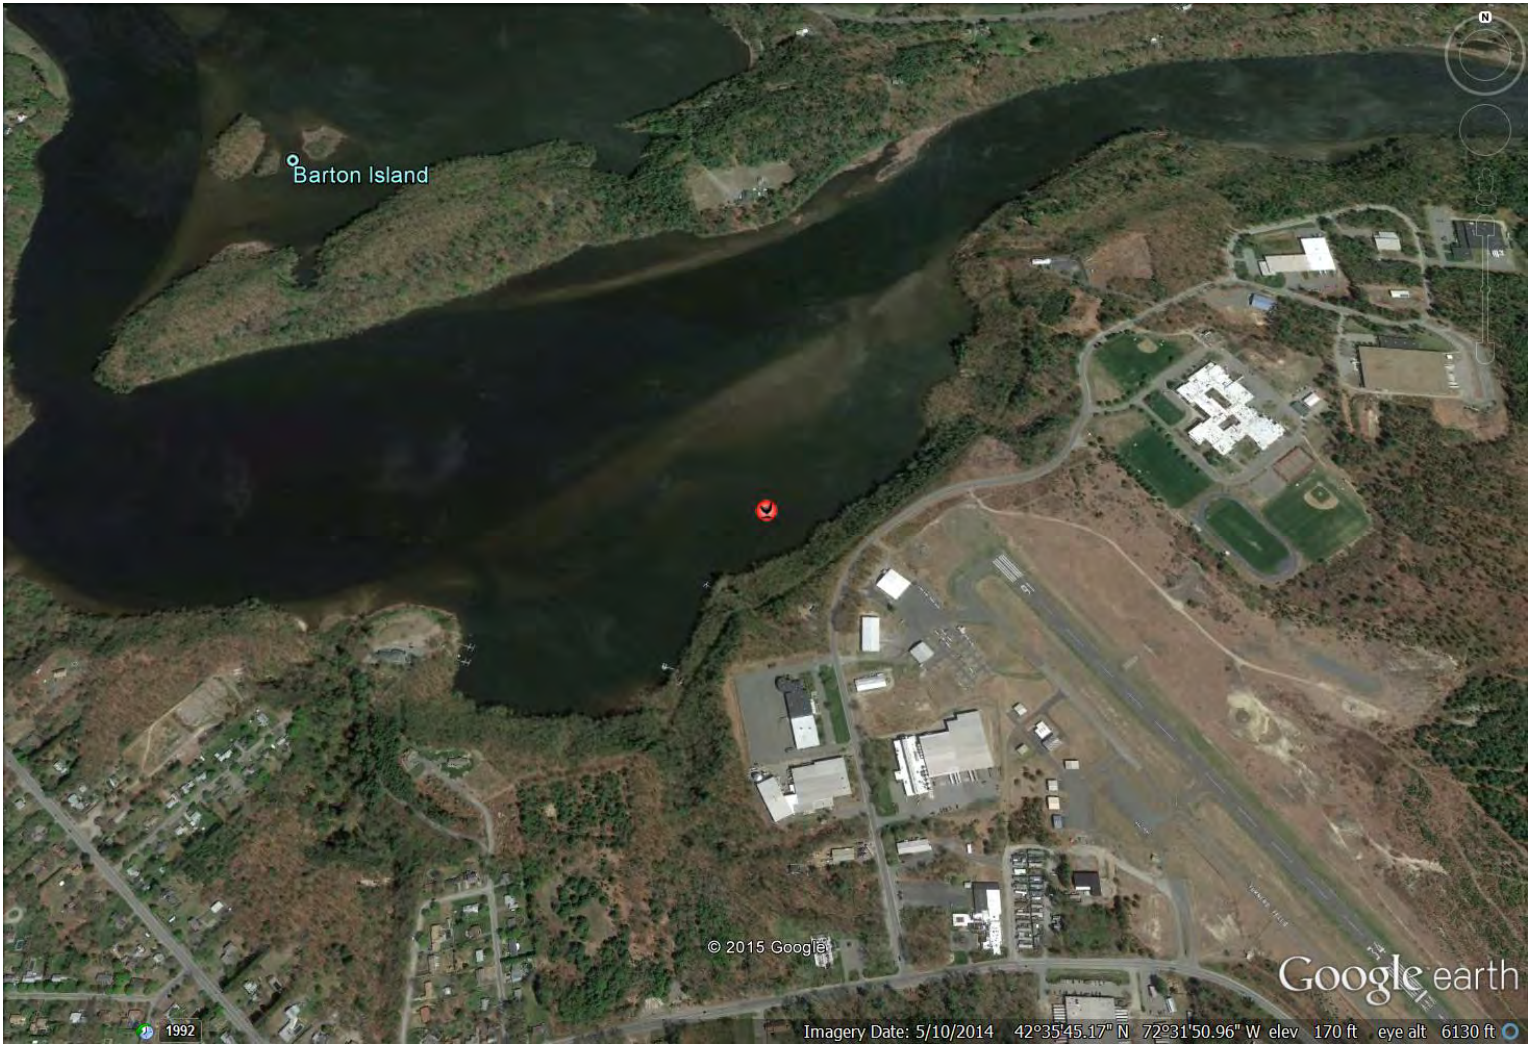
Photo 231 Location

Riverbank Features	Characteristics
Upper Riverbank Slope	Moderate
Upper Riverbank Height	Low
Upper Riverbank Sediment	Silt/Sand
Upper Riverbank Vegetation	Heavy
Lower Riverbank Slope	Flat/Beach
Lower Riverbank Sediment	Silt/Sand
Lower Riverbank Vegetation	None to very sparse
Type of Erosion	Undercut
Potential Erosion Indicators	None
Stage of Erosion	Stable
Extent of Erosion	None/Little

QA Observations: Upon review of the photos for this segment, classification made in the field was confirmed.

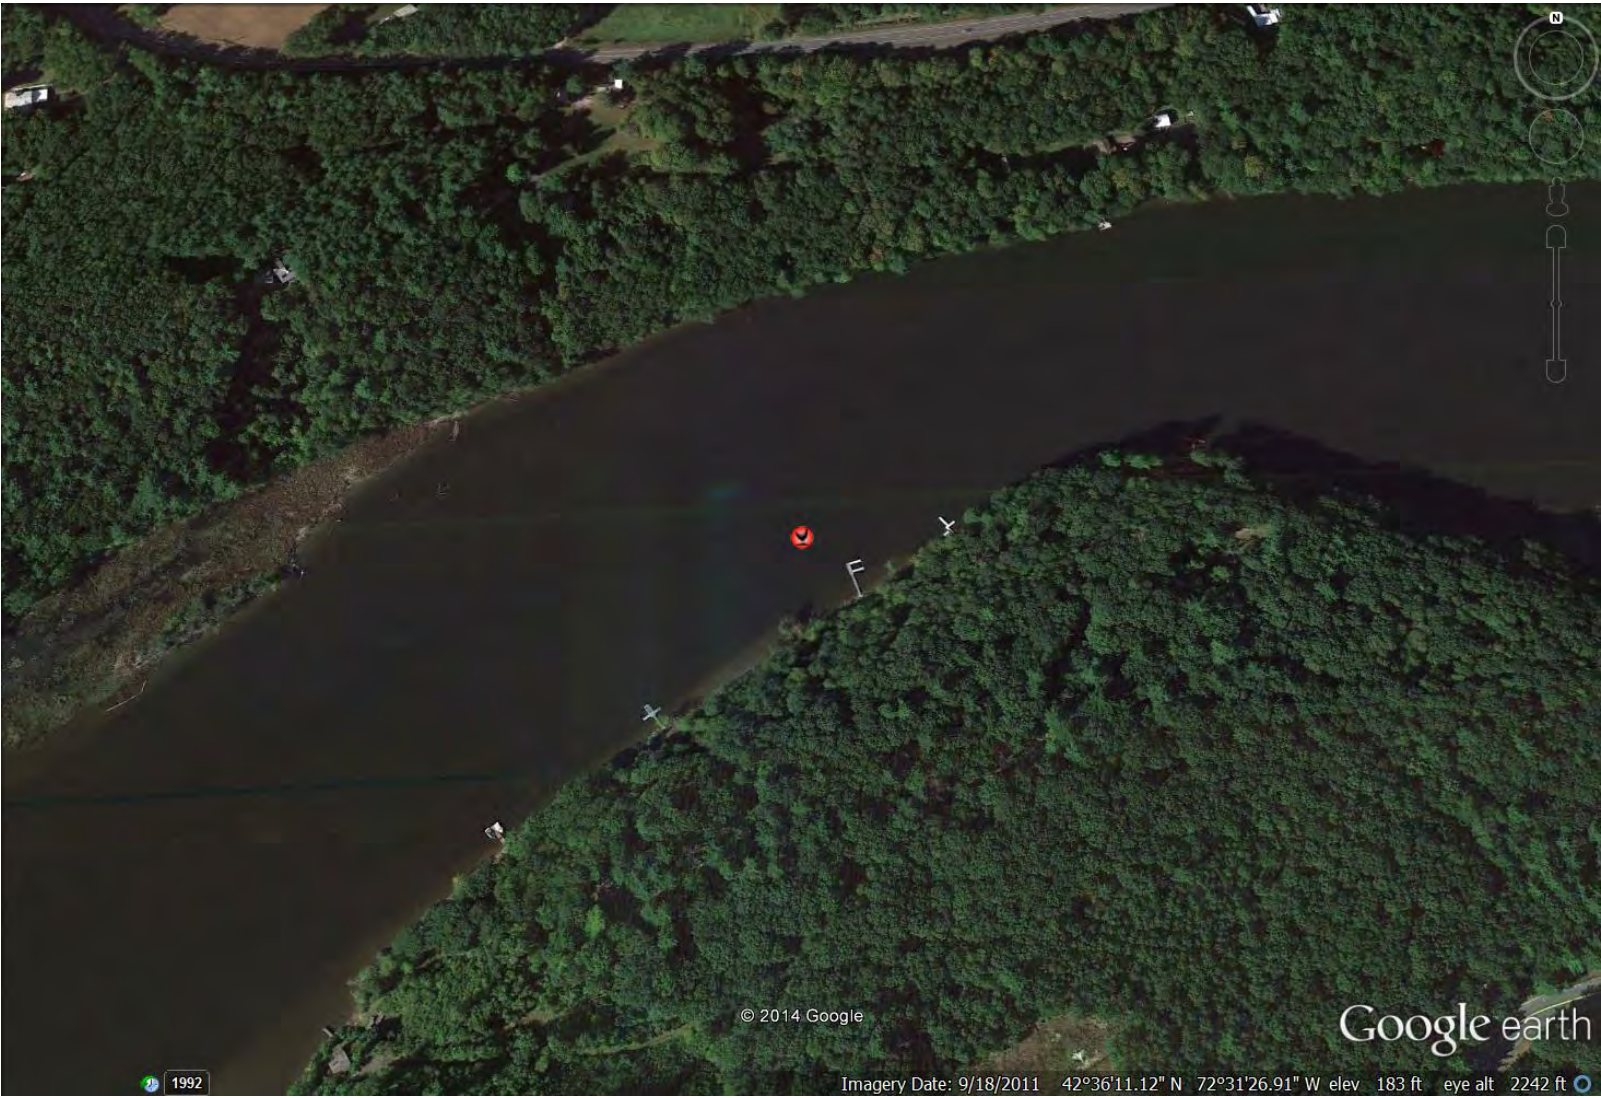
Photo 208 Location

Riverbank Features	Characteristics
Upper Riverbank Slope	Moderate
Upper Riverbank Height	High
Upper Riverbank Sediment	Silt/Sand
Upper Riverbank Vegetation	Heavy
Lower Riverbank Slope	Flat/Beach
Lower Riverbank Sediment	Silt/Sand
Lower Riverbank Vegetation	None to very sparse
Type of Erosion	Undercut
Potential Erosion Indicators	Creep/leaning trees
Stage of Erosion	Stable
Extent of Erosion	None/Little

QA Observations: Upon review of the photos for this segment, classification made in the field was confirmed.

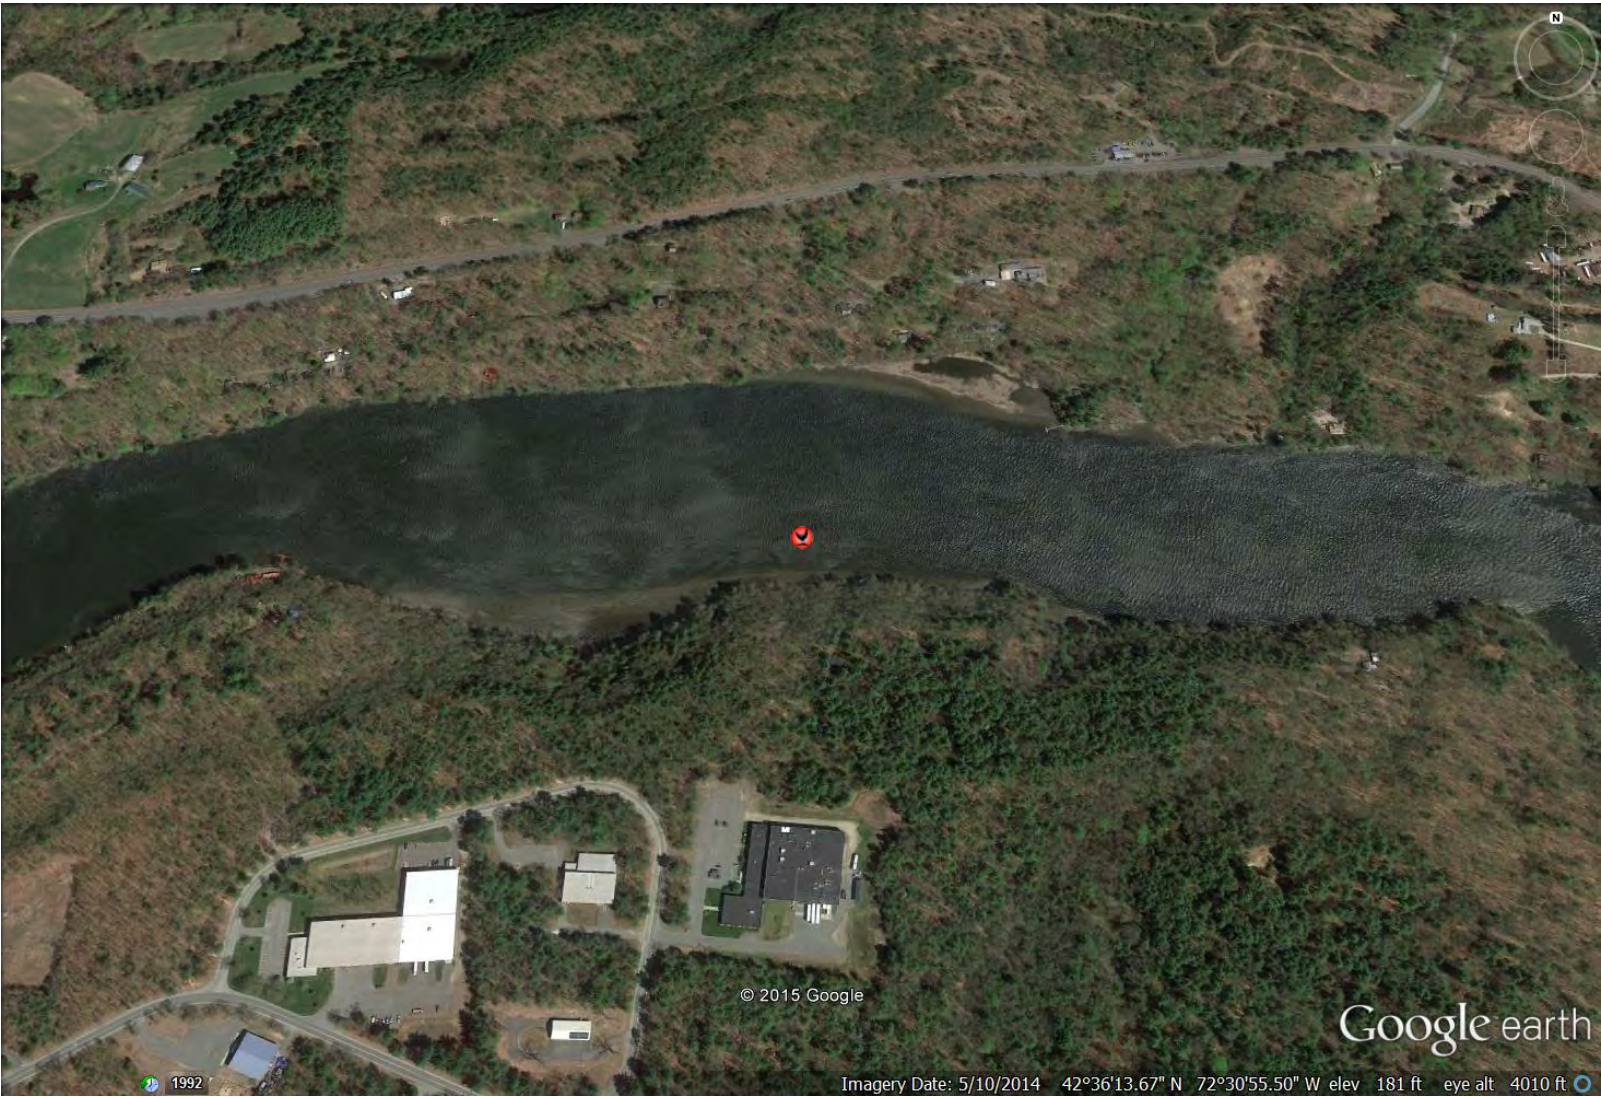
Photo 193 Location

Riverbank Features	Characteristics
Upper Riverbank Slope	Moderate
Upper Riverbank Height	High
Upper Riverbank Sediment	Silt/Sand
Upper Riverbank Vegetation	Heavy
Lower Riverbank Slope	Flat/Beach
Lower Riverbank Sediment	Silt/Sand
Lower Riverbank Vegetation	None to very sparse
Type of Erosion	Undercut
Potential Erosion Indicators	None
Stage of Erosion	Stable
Extent of Erosion	None/Little

QA Observations: Upon review of the photos for this segment, classification made in the field was confirmed.

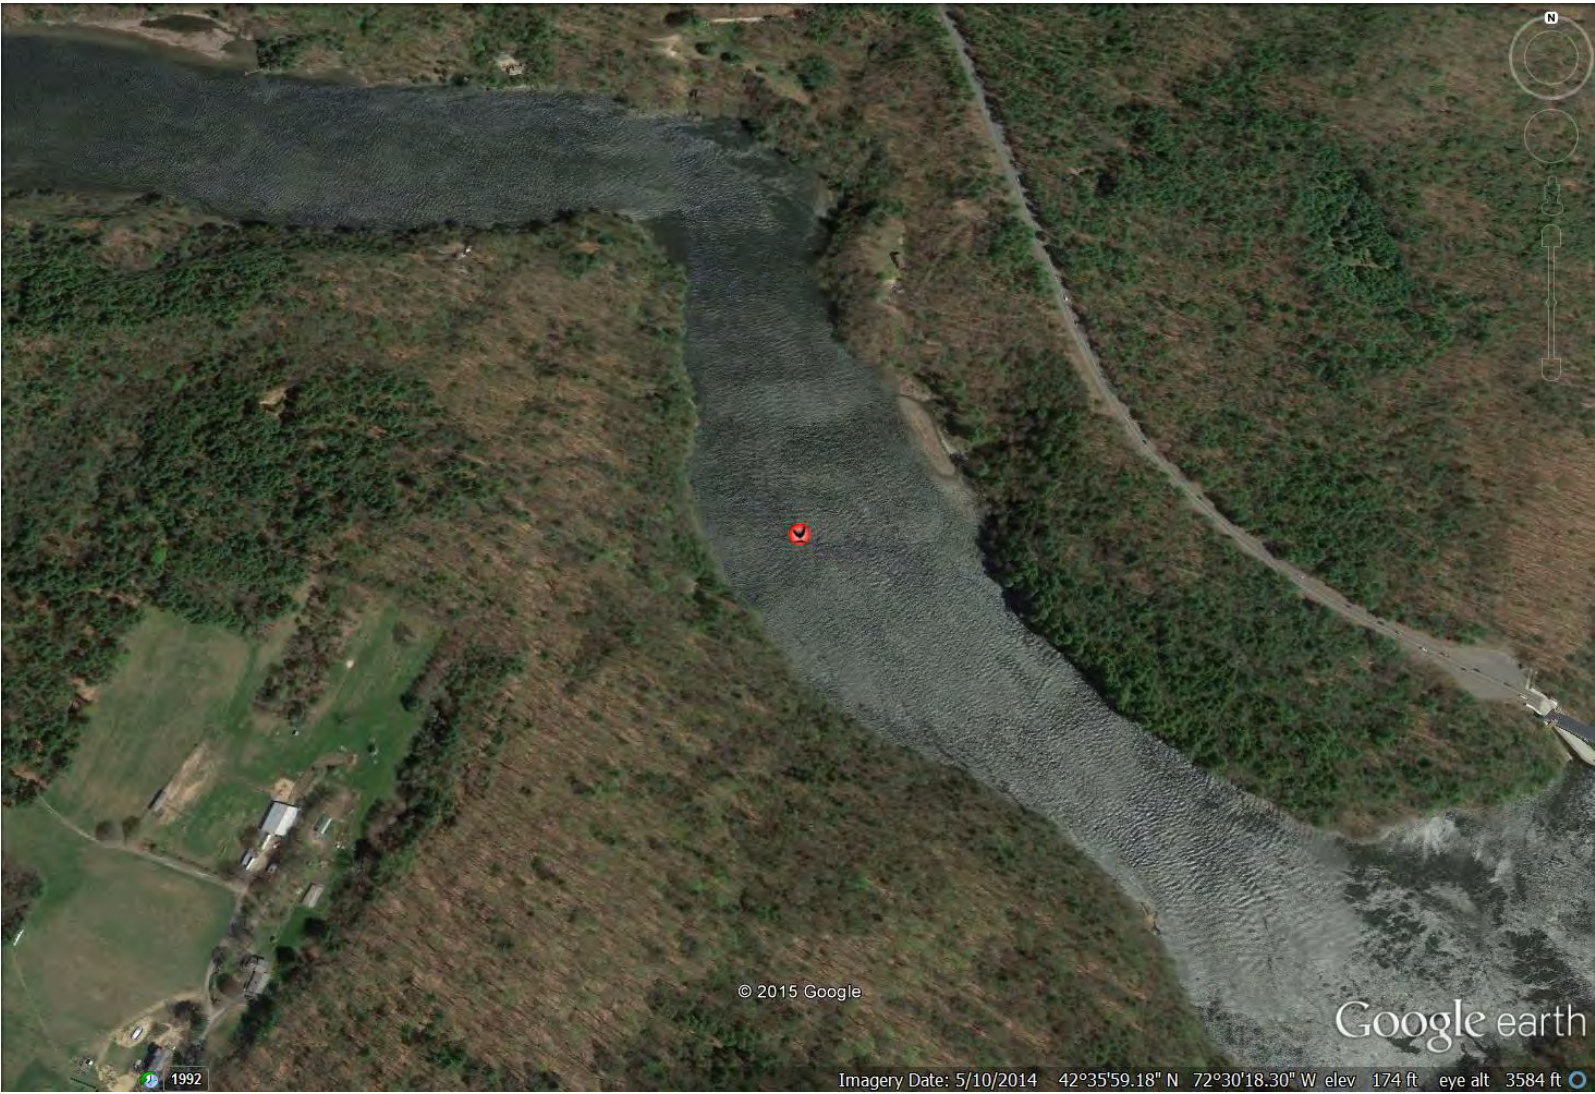
Photo 170 Location

Riverbank Features	Characteristics
Upper Riverbank Slope	Moderate
Upper Riverbank Height	High
Upper Riverbank Sediment	Silt/Sand
Upper Riverbank Vegetation	Heavy
Lower Riverbank Slope	Flat/Beach
Lower Riverbank Sediment	Gravel
Lower Riverbank Vegetation	None to very sparse
Type of Erosion	Undercut
Potential Erosion Indicators	None
Stage of Erosion	Stable
Extent of Erosion	None/Little

QA Observations: Upon review of the photos for this segment, classification made in the field was confirmed.

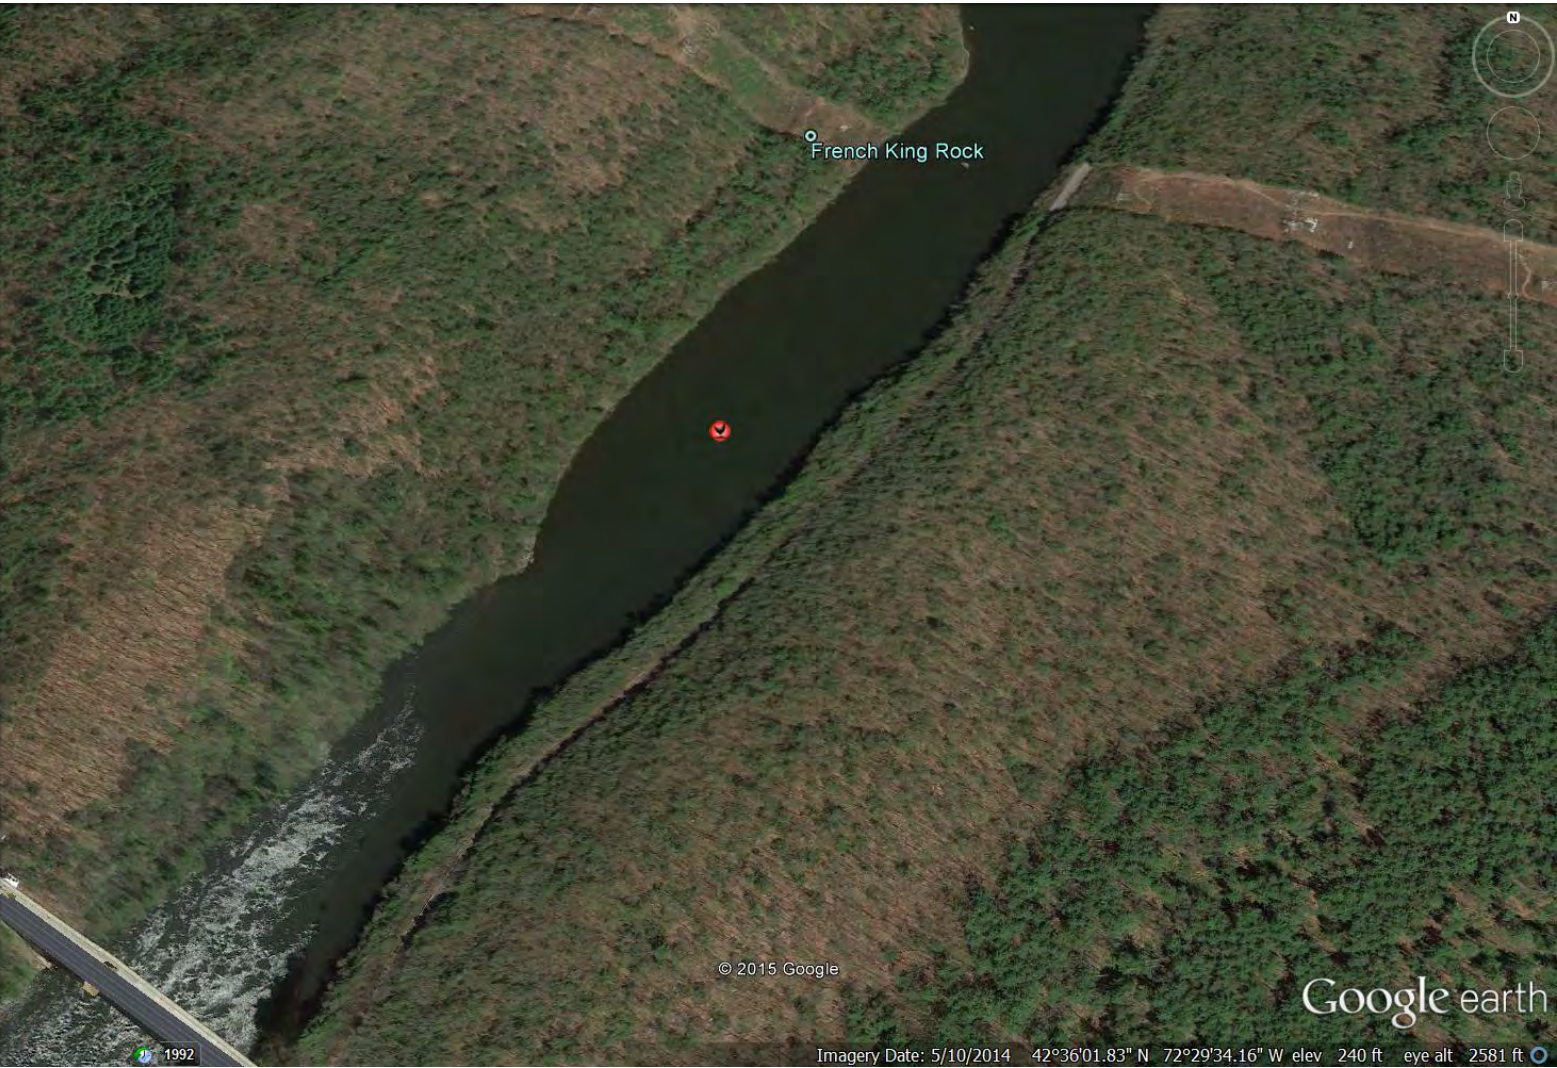
Photo 144 Location

Riverbank Features	Characteristics
Upper Riverbank Slope	Moderate
Upper Riverbank Height	High
Upper Riverbank Sediment	Silt/Sand
Upper Riverbank Vegetation	Heavy
Lower Riverbank Slope	Moderate
Lower Riverbank Sediment	Bedrock
Lower Riverbank Vegetation	None to very sparse
Type of Erosion	
Potential Erosion Indicators	None
Stage of Erosion	Stable
Extent of Erosion	None/Little

QA Observations: Upon review of the photos for this segment, classification made in the field was confirmed.

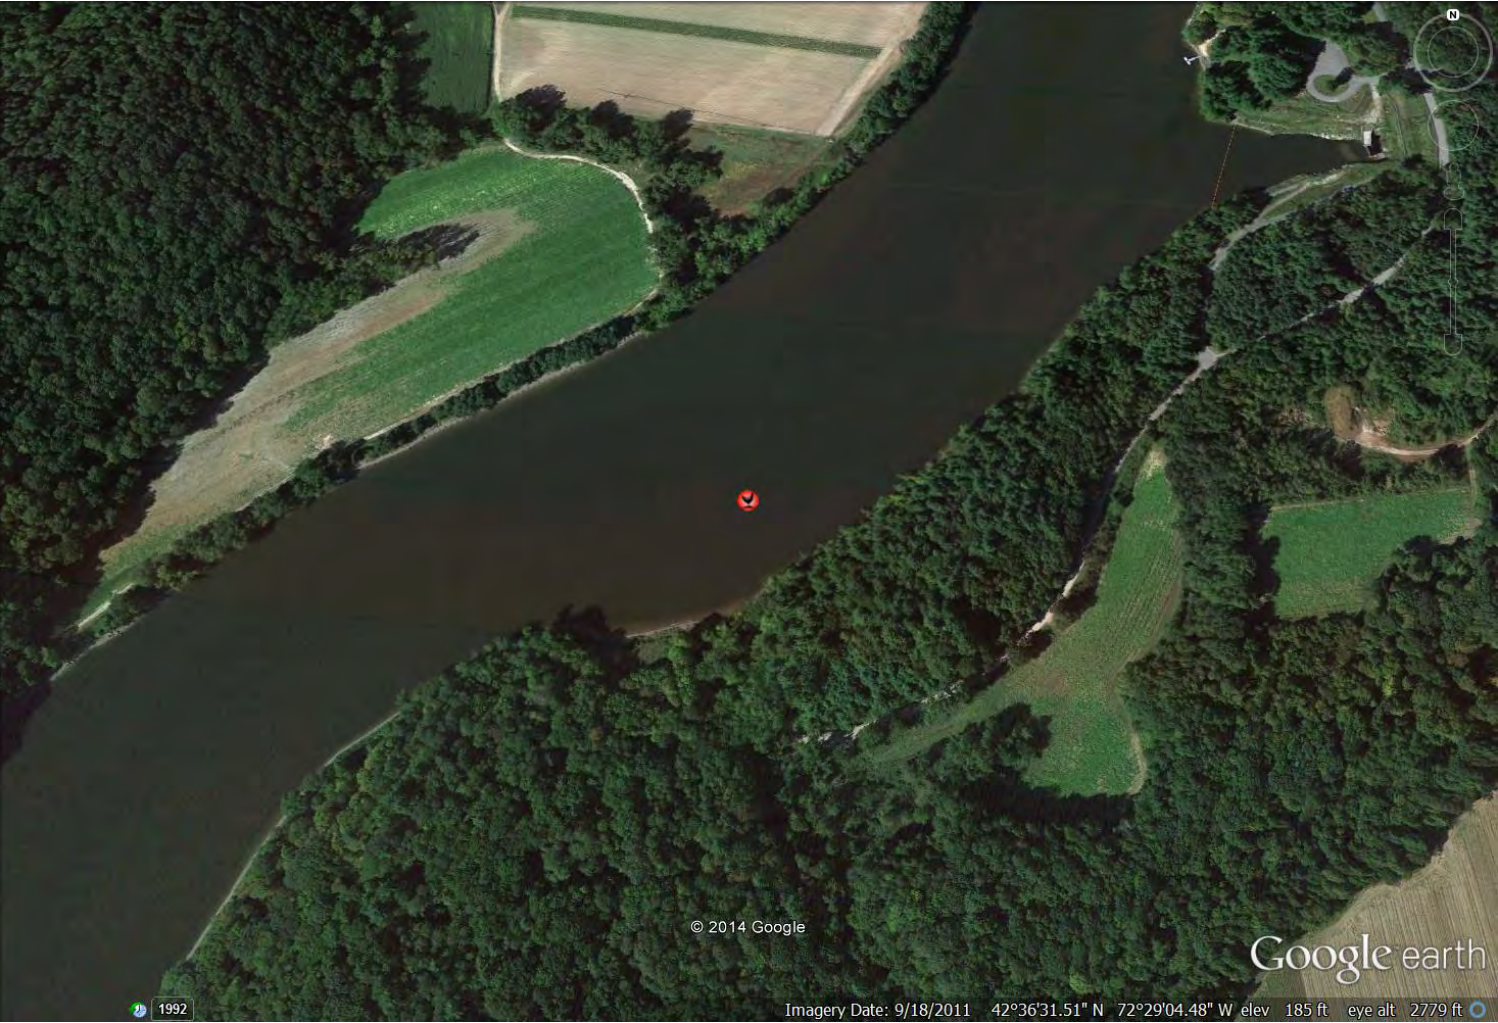
Photo 122 Location

Riverbank Features	Characteristics
Upper Riverbank Slope	Steep
Upper Riverbank Height	High
Upper Riverbank Sediment	Silt/Sand
Upper Riverbank Vegetation	Sparse
Lower Riverbank Slope	Flat/Beach
Lower Riverbank Sediment	Gravel
Lower Riverbank Vegetation	None to very sparse
Type of Erosion	Slide
Potential Erosion Indicators	Creep/leaning trees, Overhanging bank, Exposed roots
Stage of Erosion	Active Erosion
Extent of Erosion	Extensive

QA Observations: Upon review of the photos for this segment, classification made in the field was confirmed and additional indicators of potential future erosion were included.

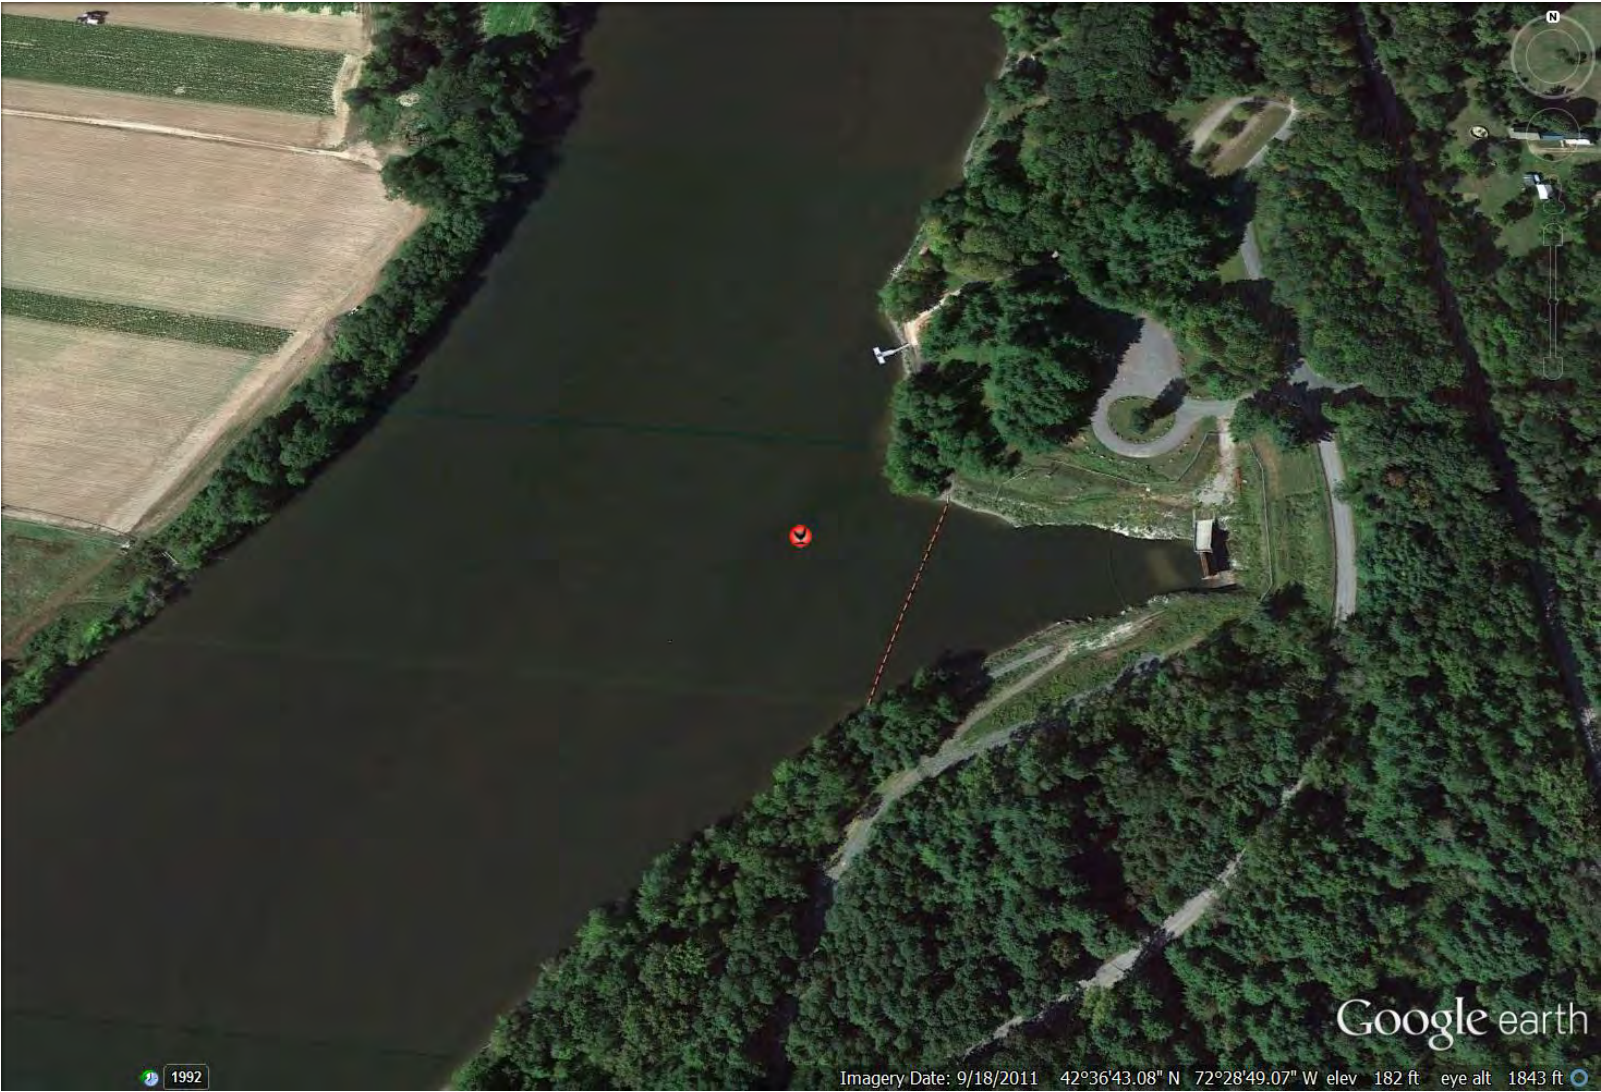
Photo 112 Location

Riverbank Features	Characteristics
Upper Riverbank Slope	Moderate
Upper Riverbank Height	High
Upper Riverbank Sediment	Silt/Sand
Upper Riverbank Vegetation	Heavy
Lower Riverbank Slope	Moderate
Lower Riverbank Sediment	Boulders
Lower Riverbank Vegetation	None to very sparse
Type of Erosion	
Potential Erosion Indicators	None
Stage of Erosion	Stable
Extent of Erosion	None/Little

QA Observations: Upon review of the photos for this segment, classification made in the field was confirmed.

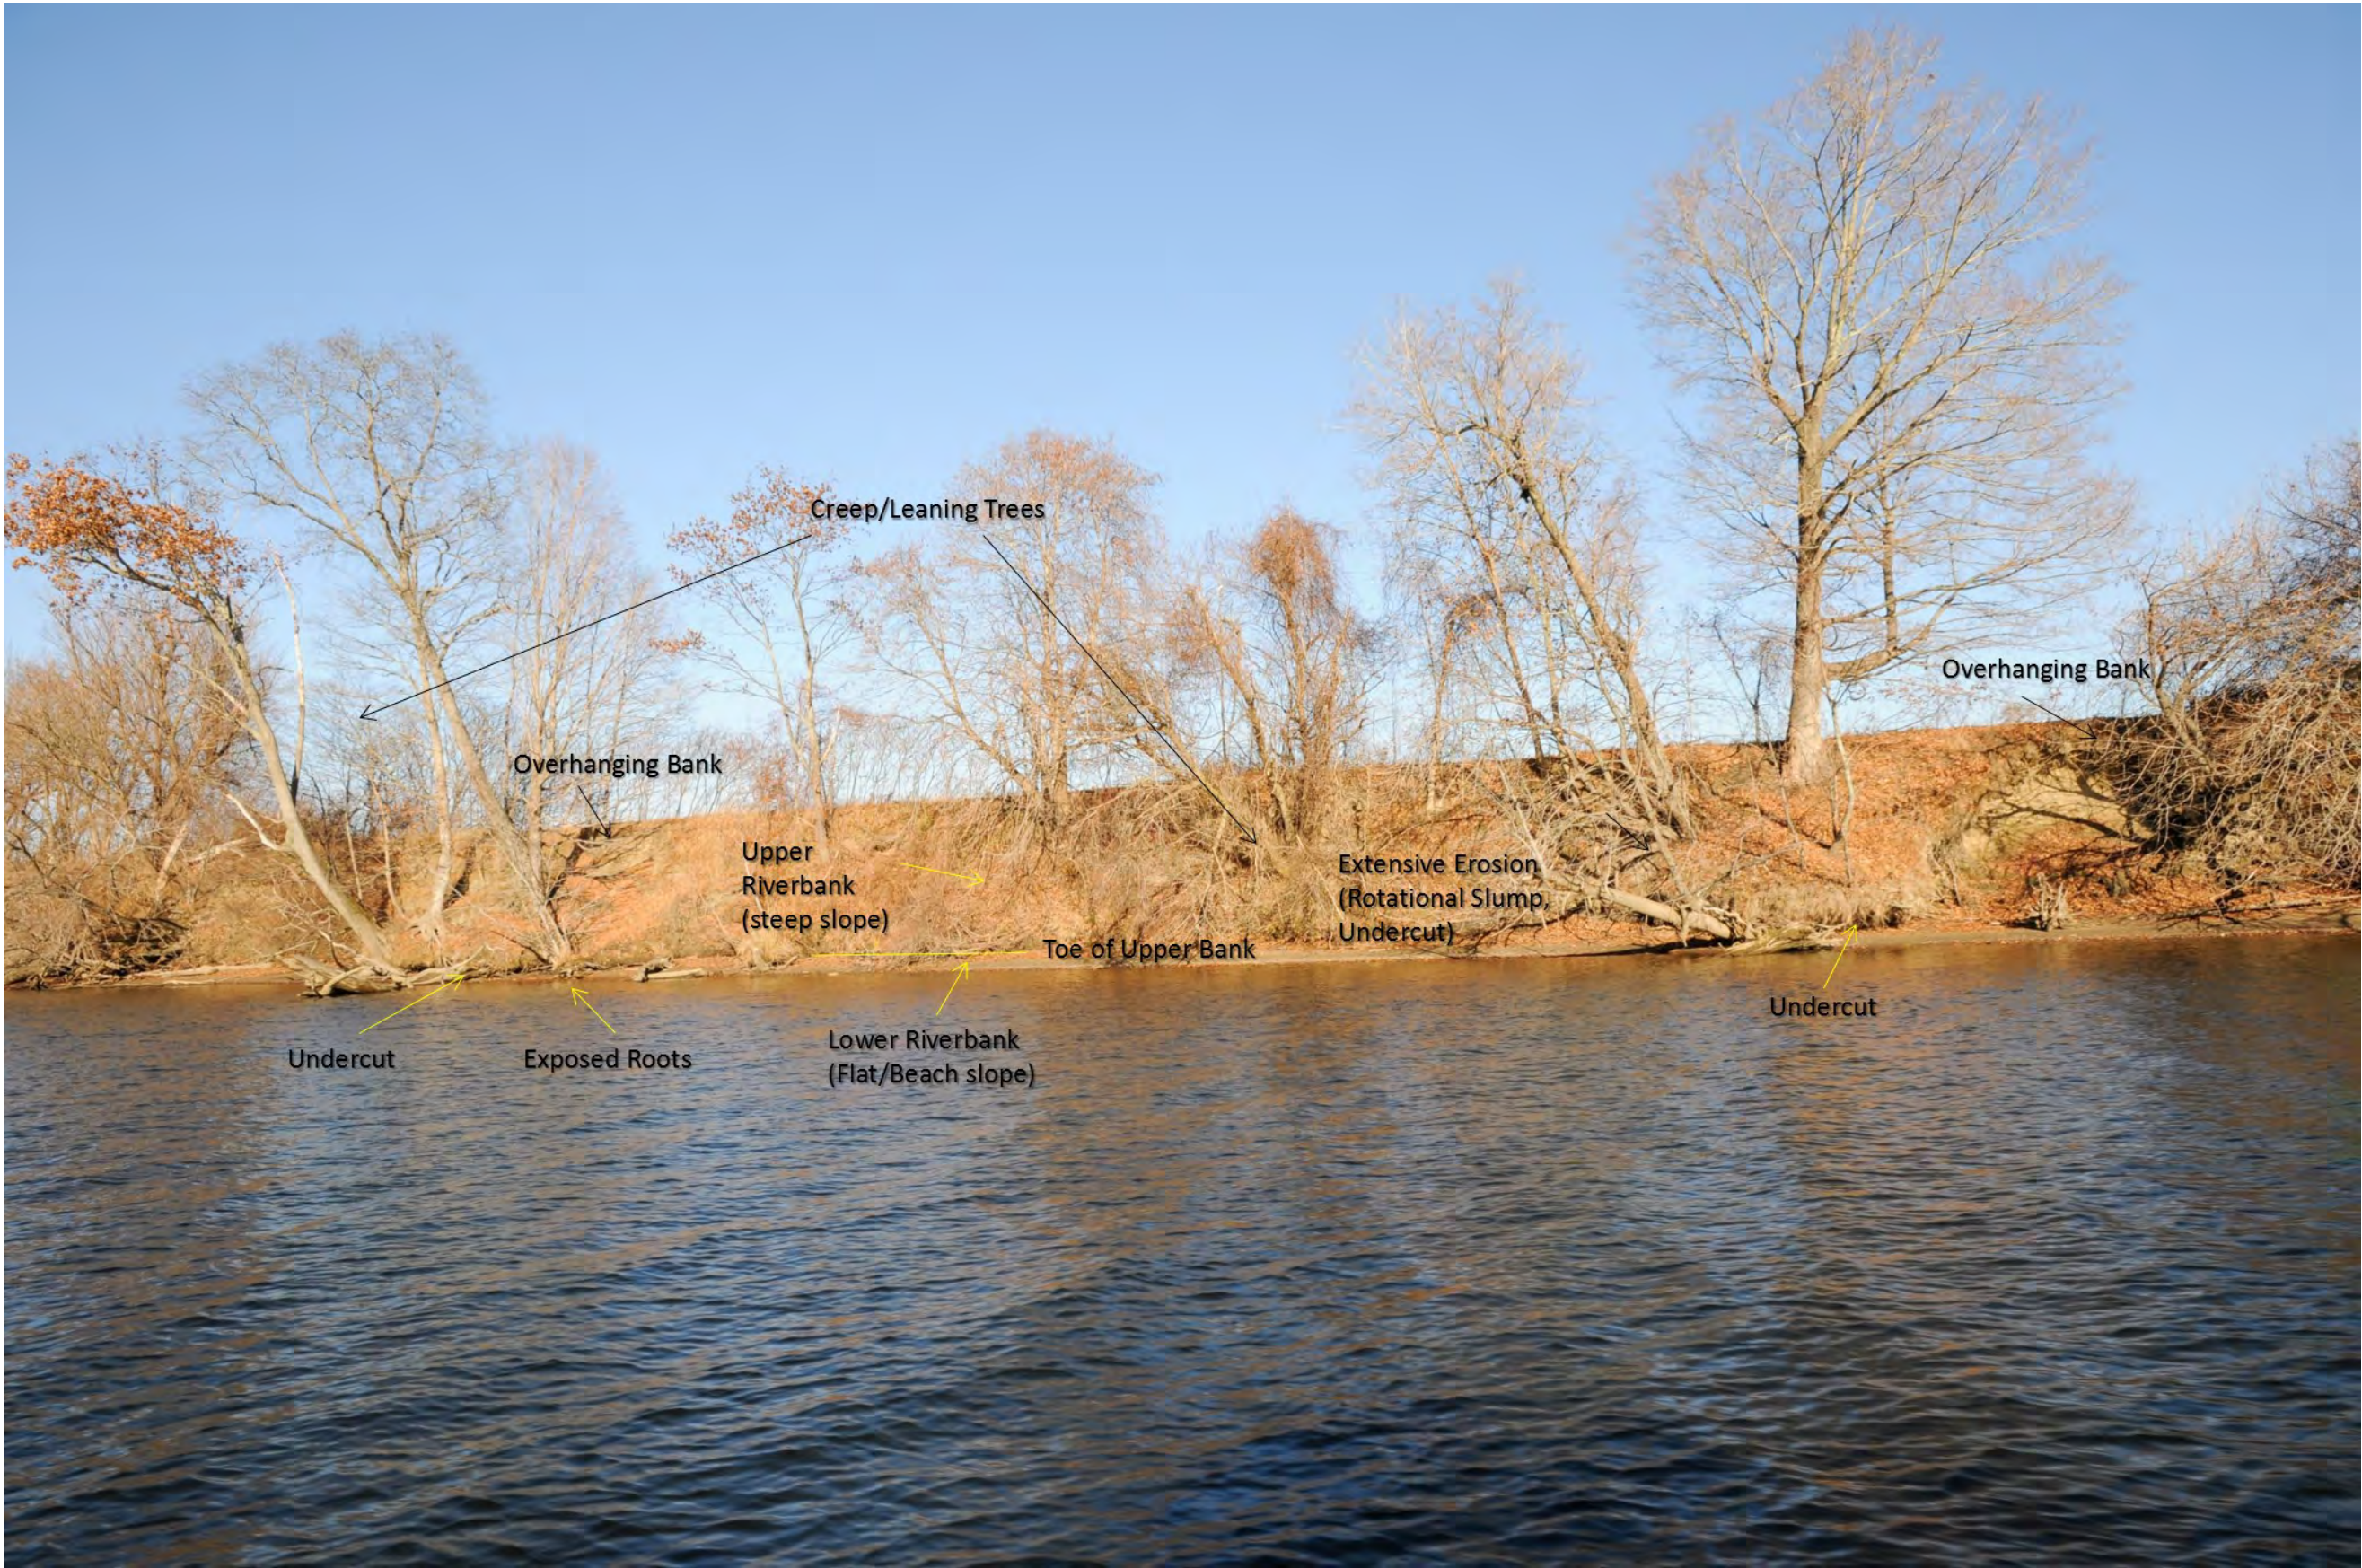
Photo ID 613 (left, U/S portion of segment)

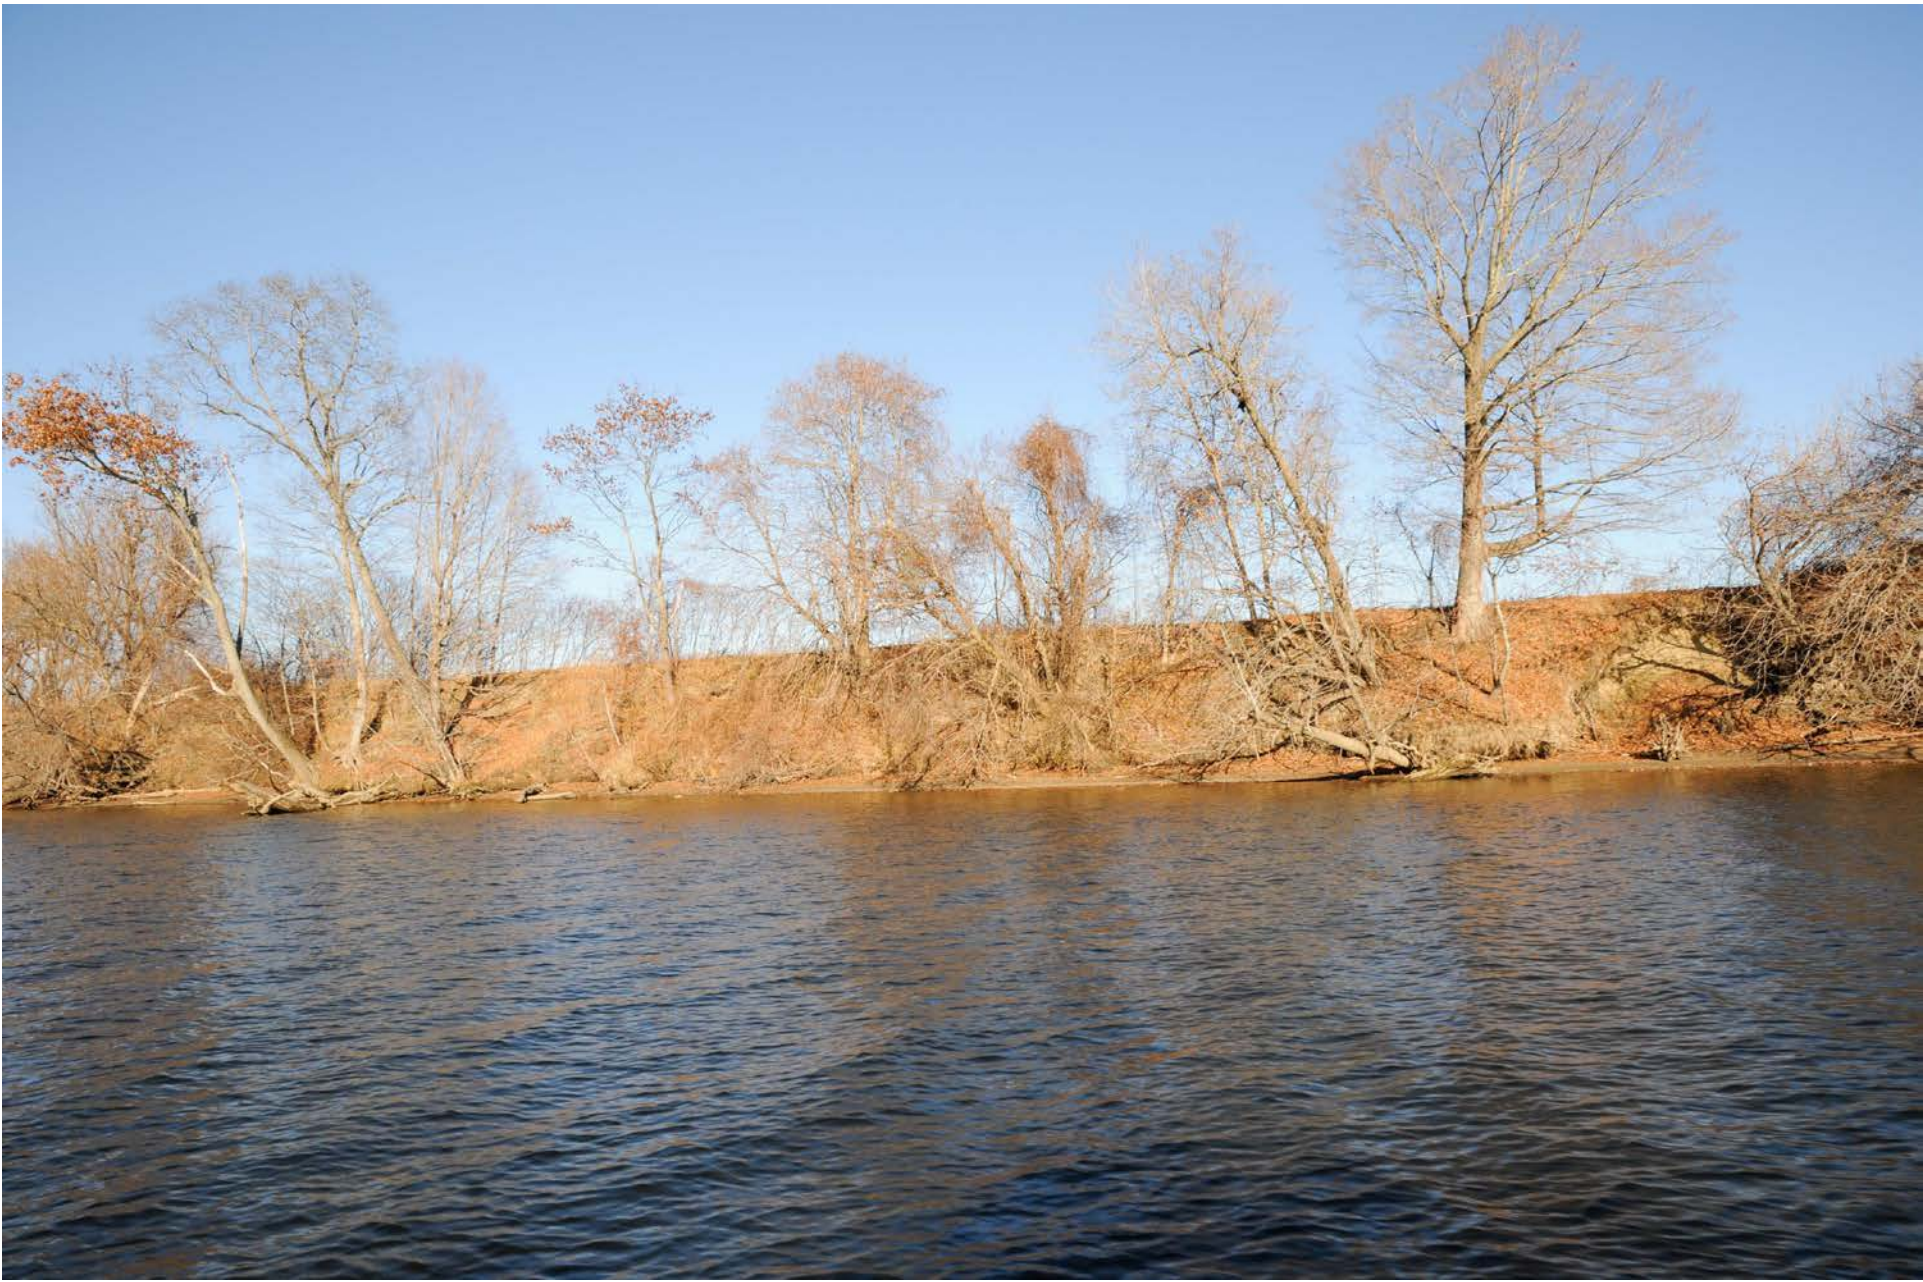
Photo ID 614 (middle)
