Segment 90 – Left Bank

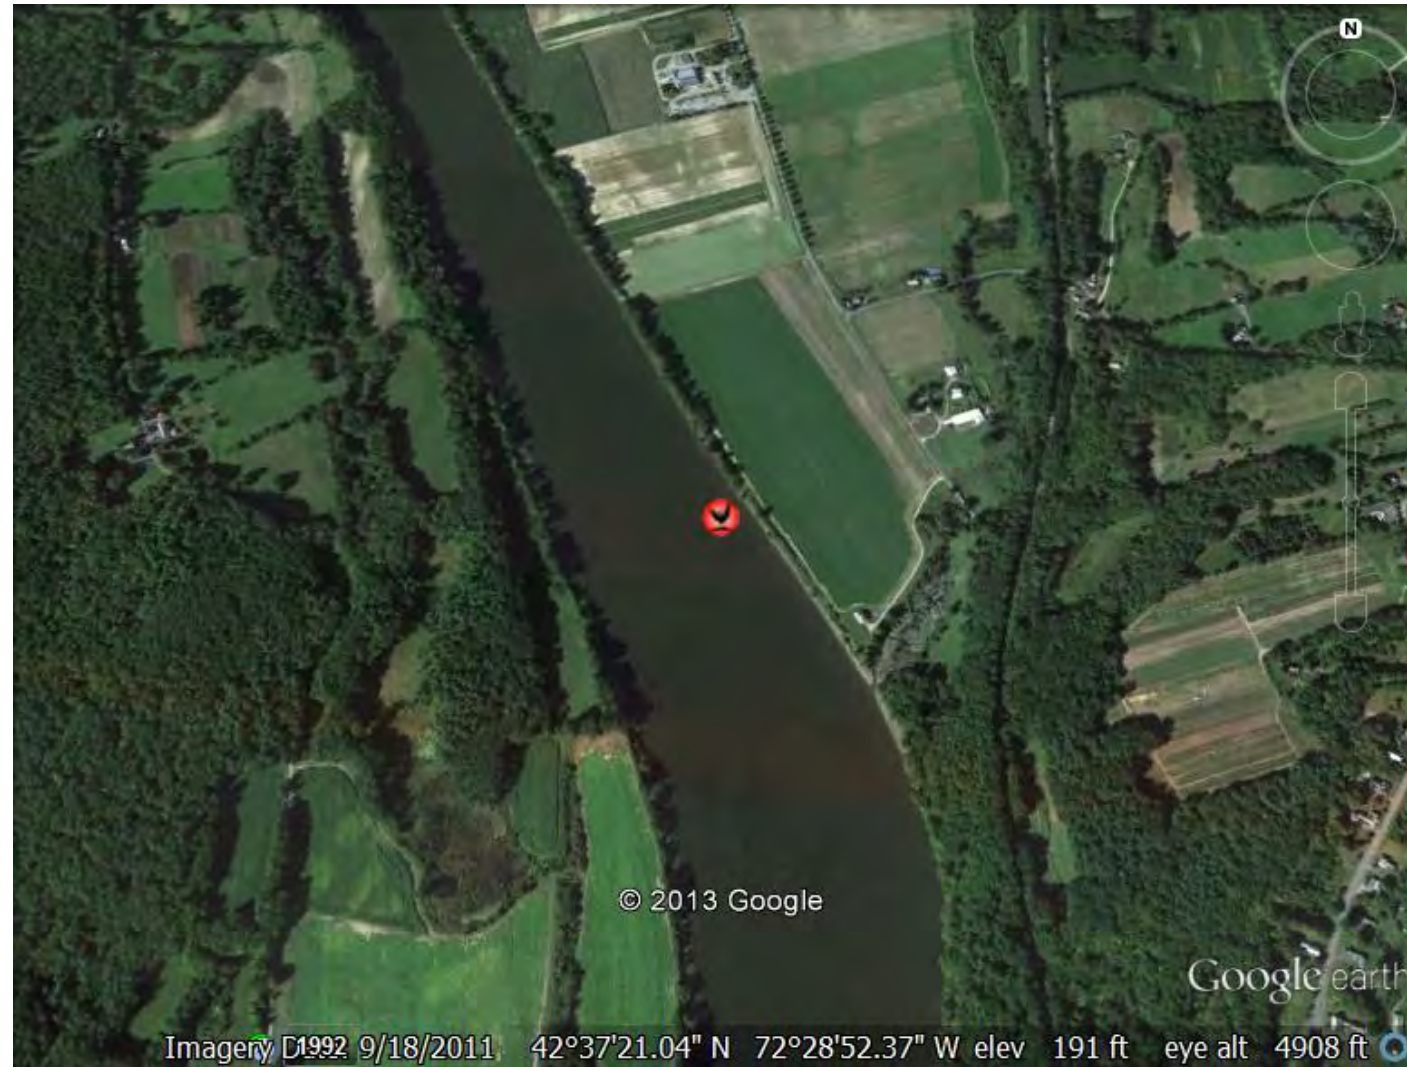
Photo 613 Location

Riverbank Features	Characteristics
Upper Riverbank Slope	Steep
Upper Riverbank Height	High
Upper Riverbank Sediment	Silt/Sand
Upper Riverbank Vegetation	Moderate
Lower Riverbank Slope	Flat/Beach
Lower Riverbank Sediment	Silt/Sand
Lower Riverbank Vegetation	None to very sparse
Type of Erosion	Rotational Slump, Undercut
Potential Erosion Indicators	Overhanging bank, Exposed roots, Creep/leaning trees
Stage of Erosion	Eroded
Extent of Erosion	Extensive

QA Observations: Upon review of the photos for this segment, classification made in the field was confirmed and additional indicators of potential future erosion were included.

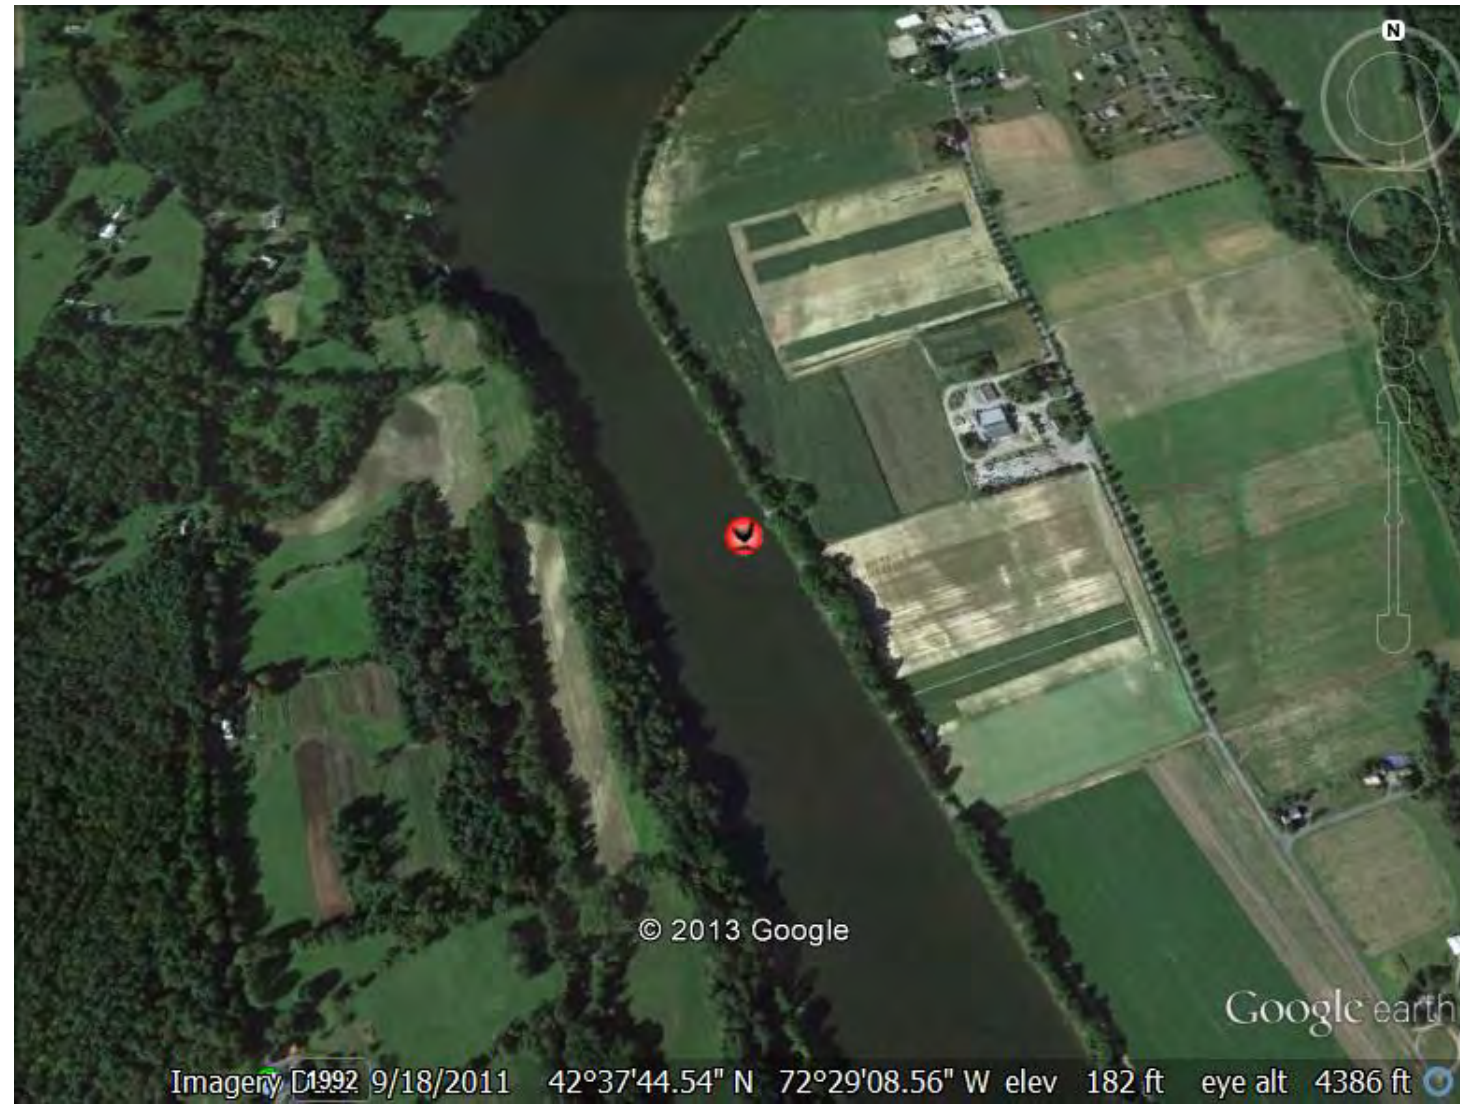
Photo 632 Location

Riverbank Features	Characteristics
Upper Riverbank Slope	Moderate
Upper Riverbank Height	Low
Upper Riverbank Sediment	Boulders
Upper Riverbank Vegetation	Moderate
Lower Riverbank Slope	Moderate
Lower Riverbank Sediment	Boulders
Lower Riverbank Vegetation	None to very sparse
Type of Erosion	None
Potential Erosion Indicators	
Stage of Erosion	Stable
Extent of Erosion	None/Little

QA Observations: Upon review of the photos for this segment, classification made in the field was confirmed.

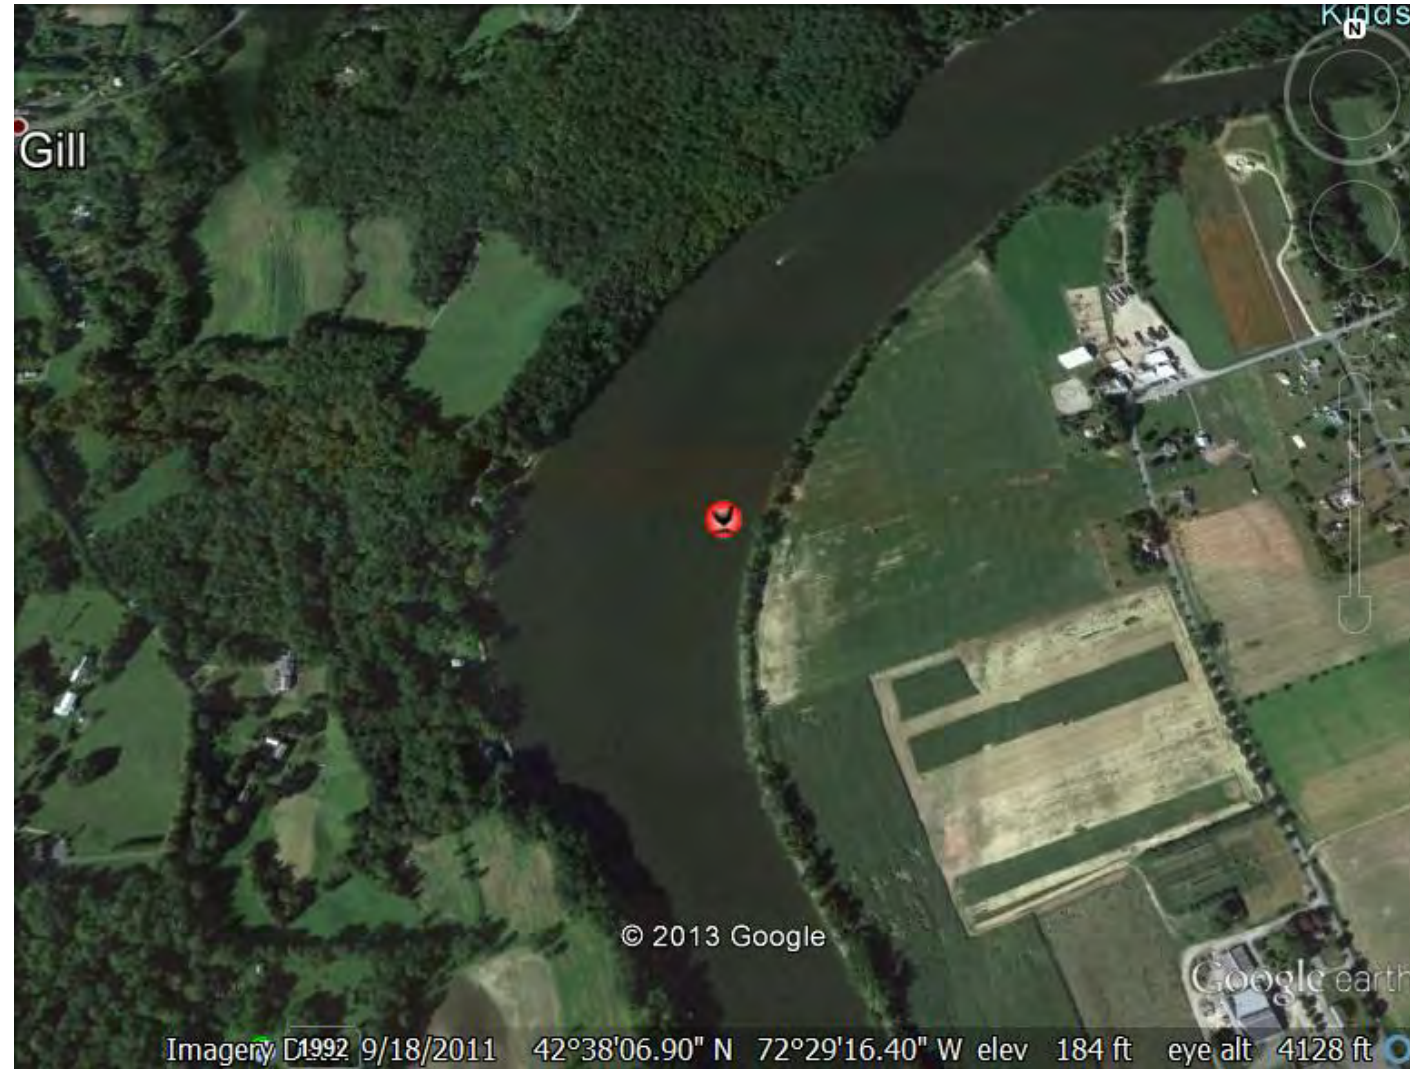
Photo 650 Location

Riverbank Features	Characteristics
Upper Riverbank Slope	Steep
Upper Riverbank Height	High
Upper Riverbank Sediment	Silt/Sand
Upper Riverbank Vegetation	Heavy
Lower Riverbank Slope	Flat/Beach
Lower Riverbank Sediment	Silt/Sand
Lower Riverbank Vegetation	None to very sparse
Type of Erosion	
Potential Erosion Indicators	Creep/leaning trees, Exposed roots
Stage of Erosion	Stable
Extent of Erosion	None/Little

QA Observations: Upon review of the photos for this segment, classification made in the field was confirmed and additional indicators of potential future erosion were included.

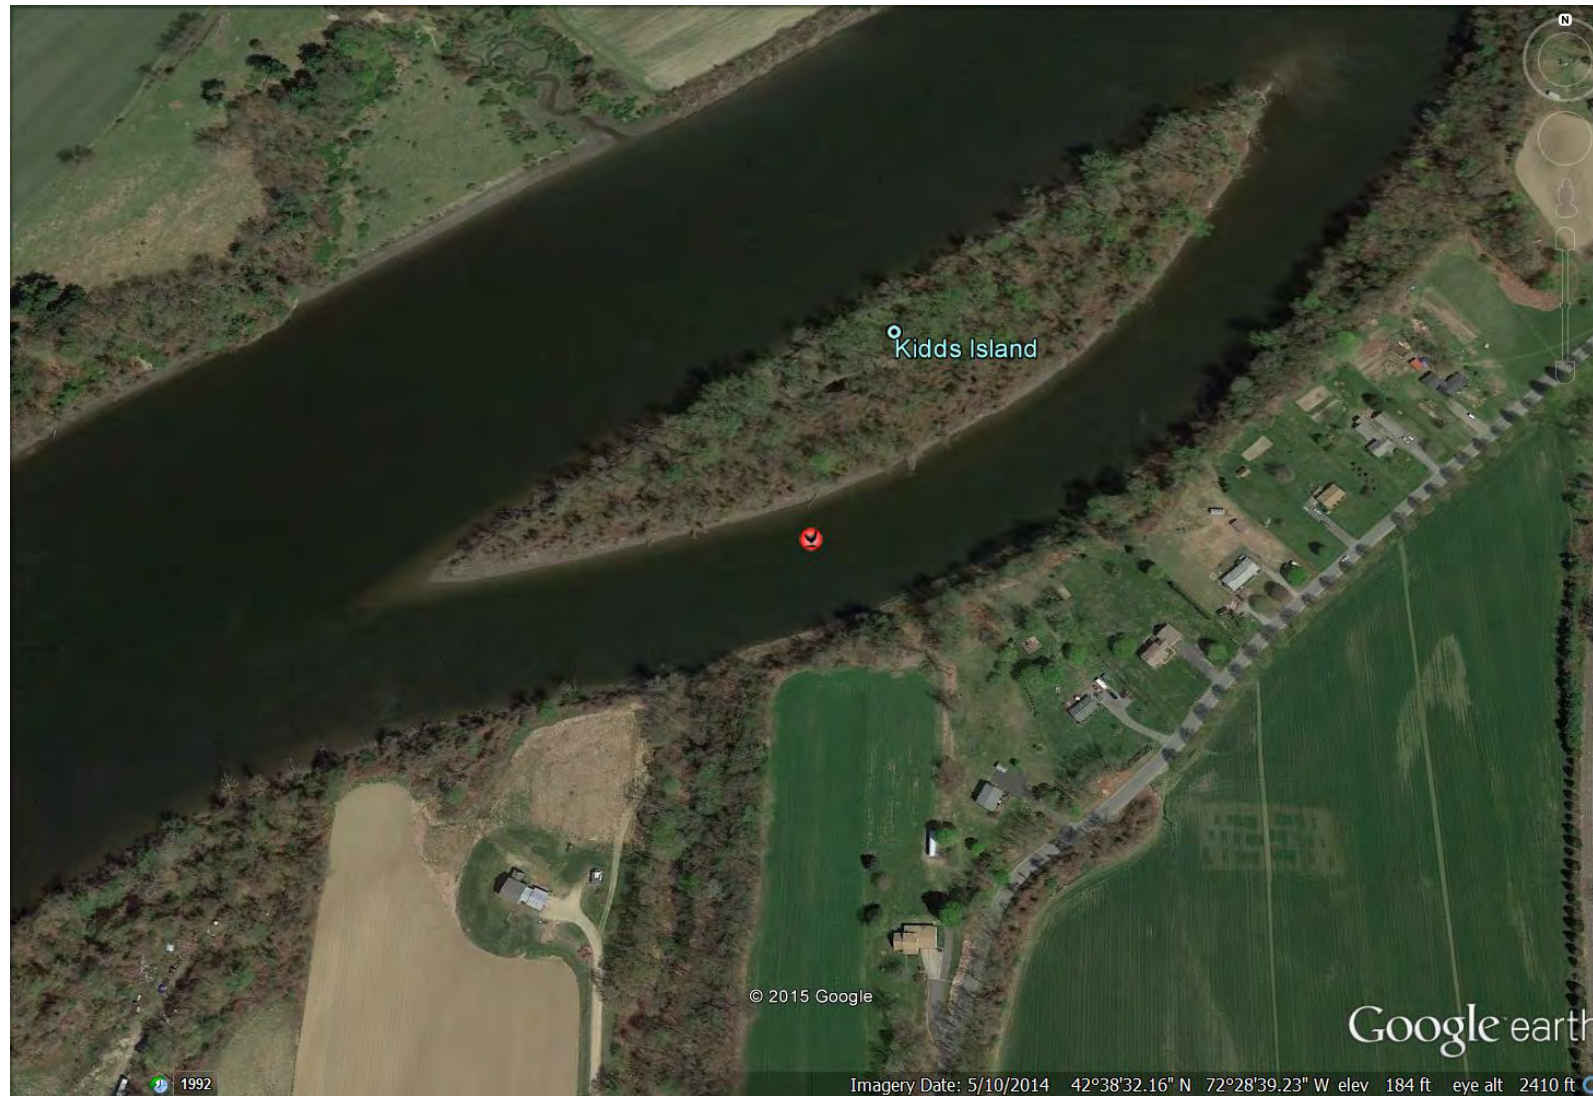
Photo 678 Location

Riverbank Features	Characteristics
Upper Riverbank Slope	Moderate
Upper Riverbank Height	High
Upper Riverbank Sediment	Silt/Sand
Upper Riverbank Vegetation	Heavy
Lower Riverbank Slope	Moderate
Lower Riverbank Sediment	Cobbles
Lower Riverbank Vegetation	None to very sparse
Type of Erosion	
Potential Erosion Indicators	None
Stage of Erosion	Stable
Extent of Erosion	None/Little

QA Observations: Upon review of the photos for this segment, classification made in the field was confirmed.

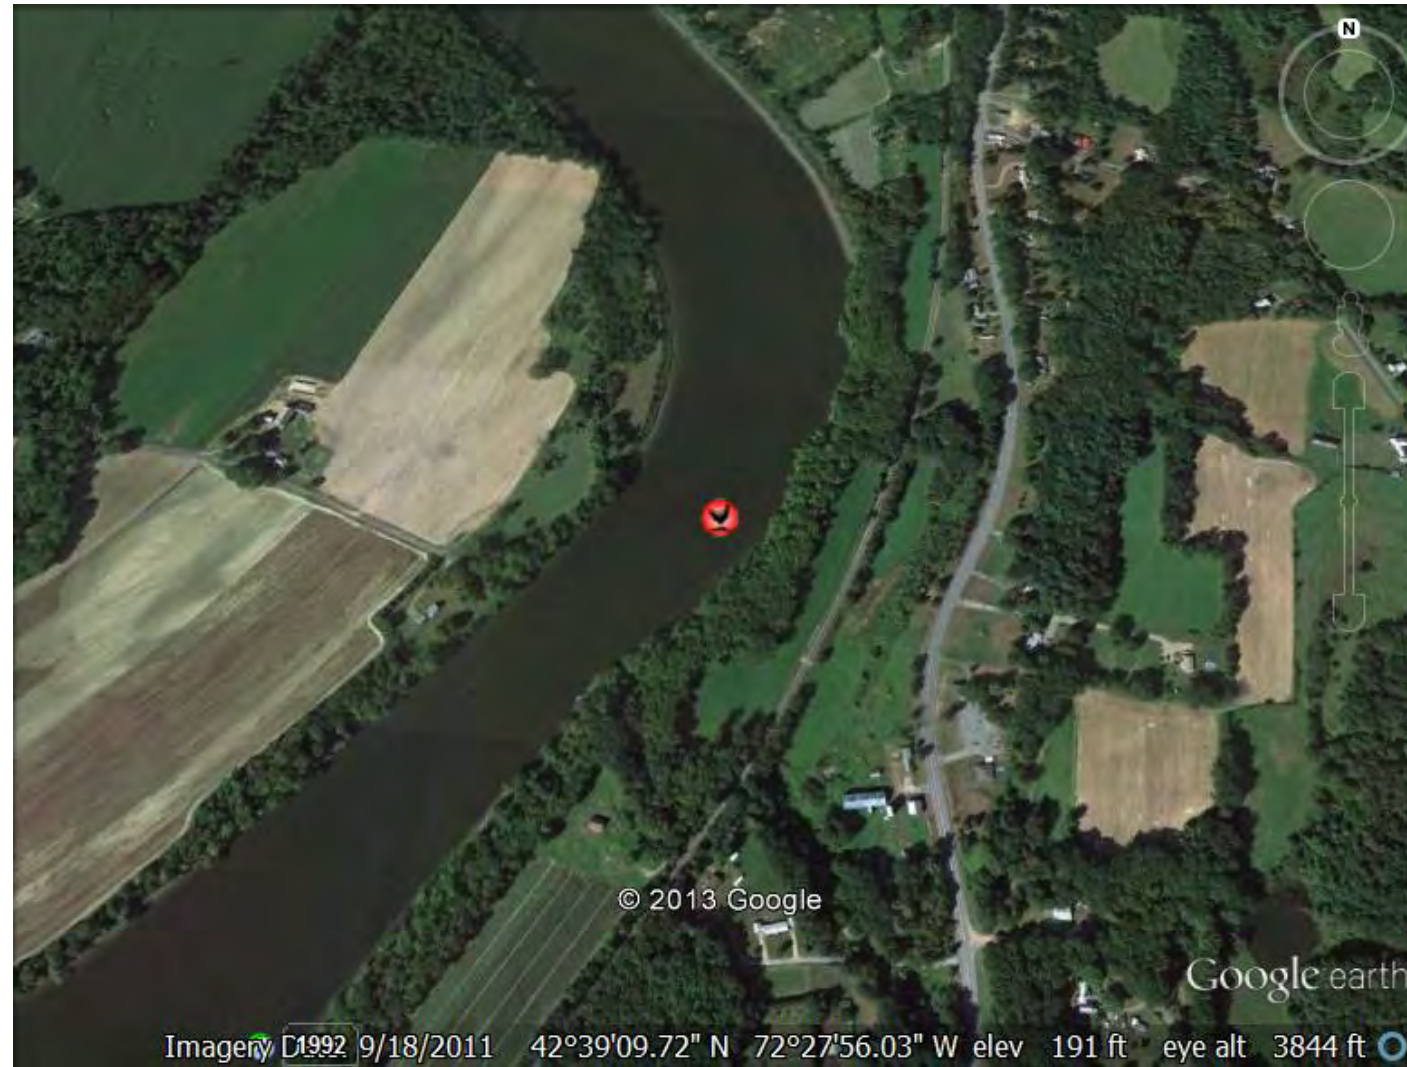
Photo 717 Location

Riverbank Features	Characteristics
Upper Riverbank Slope	Moderate
Upper Riverbank Height	High
Upper Riverbank Sediment	Silt/Sand
Upper Riverbank Vegetation	Heavy
Lower Riverbank Slope	Flat/Beach
Lower Riverbank Sediment	Boulders
Lower Riverbank Vegetation	None to very sparse
Type of Erosion	Undercut
Potential Erosion Indicators	Exposed roots, Creep/leaning trees
Stage of Erosion	Stable
Extent of Erosion	None/Little

QA Observations: Upon review of the photos for this segment, classification made in the field was confirmed and additional indicators of potential future erosion were included.

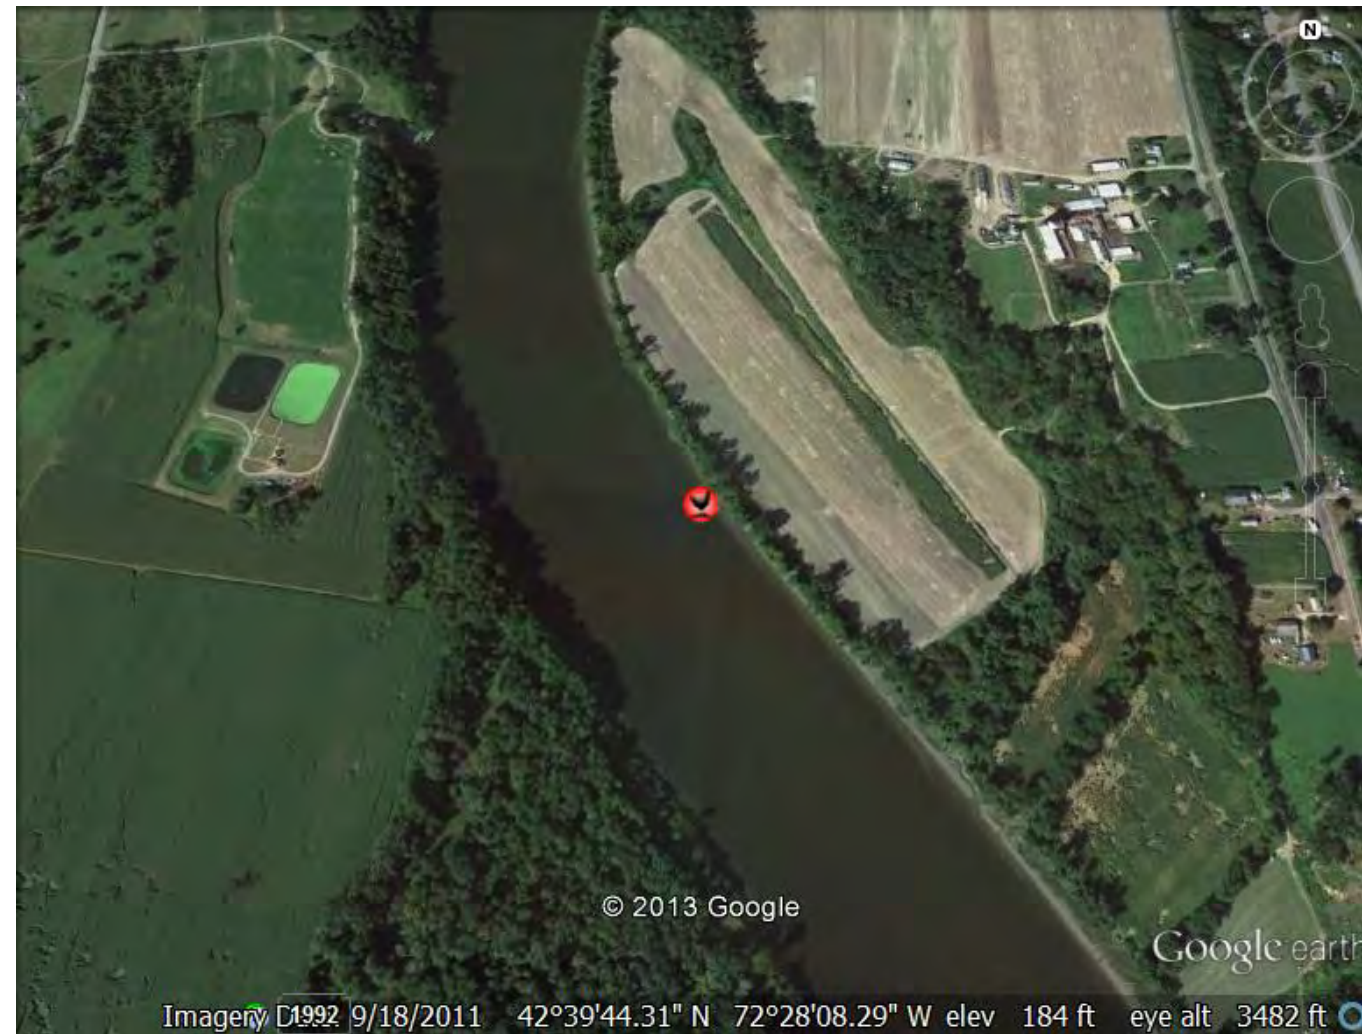
Photo 745 Location

Riverbank Features	Characteristics
Upper Riverbank Slope	Steep
Upper Riverbank Height	High
Upper Riverbank Sediment	Silt/Sand
Upper Riverbank Vegetation	Heavy
Lower Riverbank Slope	Flat/Beach
Lower Riverbank Sediment	Silt/Sand
Lower Riverbank Vegetation	None to very sparse
Type of Erosion	Slide
Potential Erosion Indicators	Exposed roots, Creep/leaning trees, Overhanging bank, Notch
Stage of Erosion	Eroded
Extent of Erosion	Some

QA Observations: Upon review of the photos for this segment, classification made in the field was confirmed and additional indicators of potential future erosion were included.

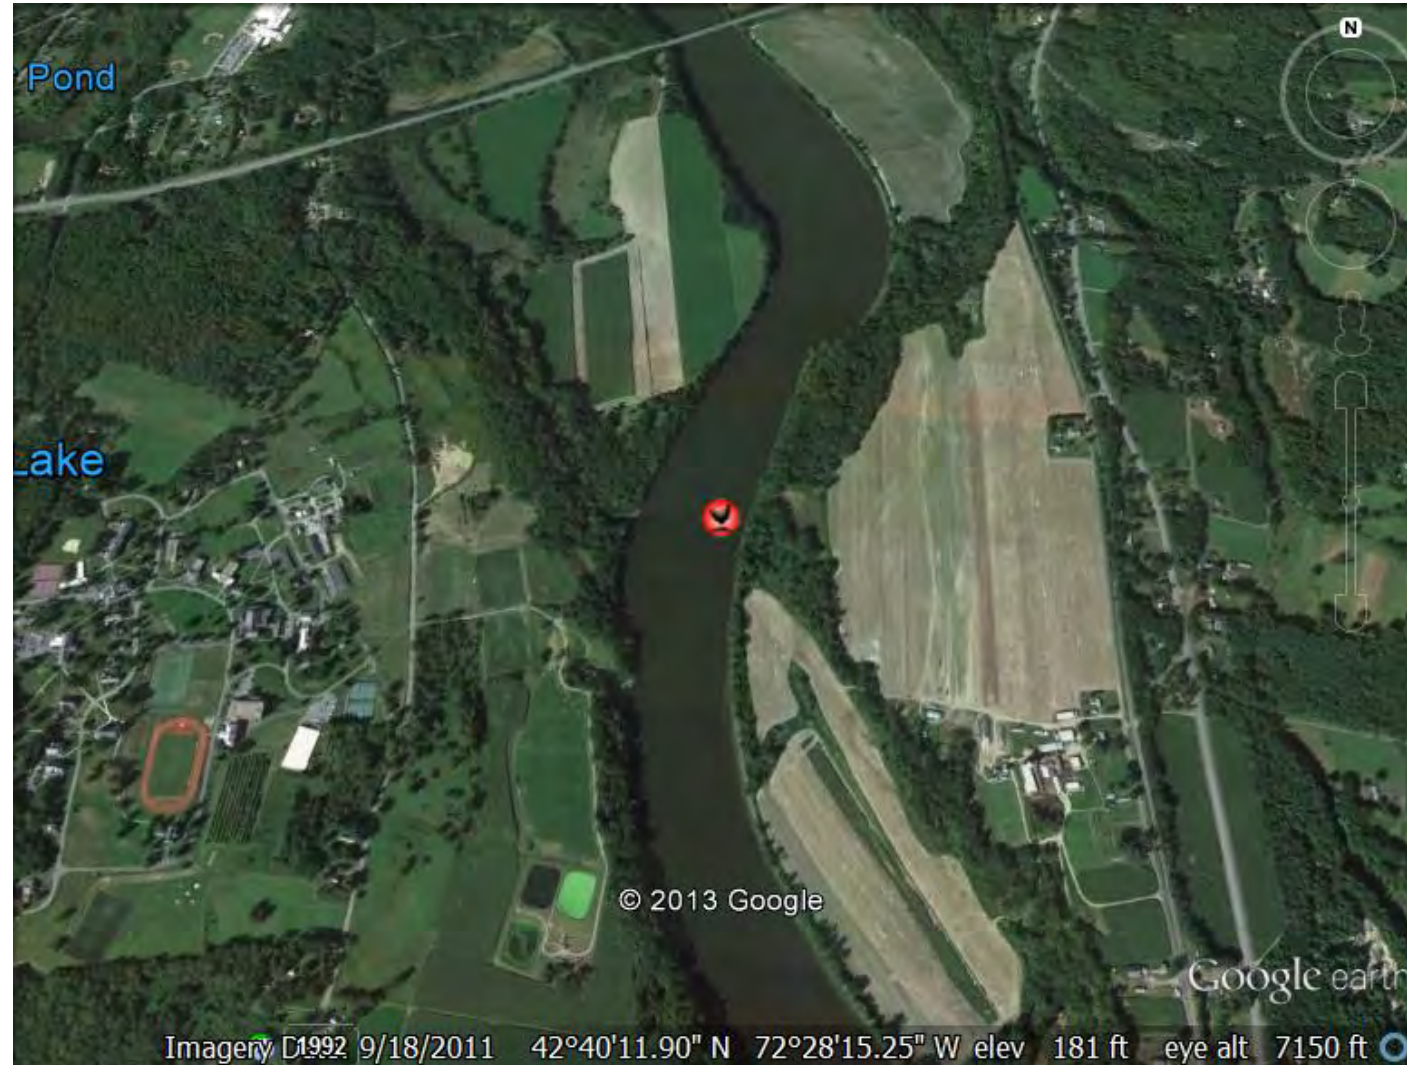
Photo 765 Location

Riverbank Features	Characteristics
Upper Riverbank Slope	Steep
Upper Riverbank Height	High
Upper Riverbank Sediment	Silt/Sand
Upper Riverbank Vegetation	Heavy
Lower Riverbank Slope	Flat/Beach
Lower Riverbank Sediment	Cobbles
Lower Riverbank Vegetation	None to very sparse
Type of Erosion	Topples, Undercut
Potential Erosion Indicators	Creep/leaning trees, Exposed roots
Stage of Erosion	Eroded
Extent of Erosion	Some

QA Observations: Upon review of the photos for this segment, classification made in the field was confirmed and additional indicators of potential future erosion were included.

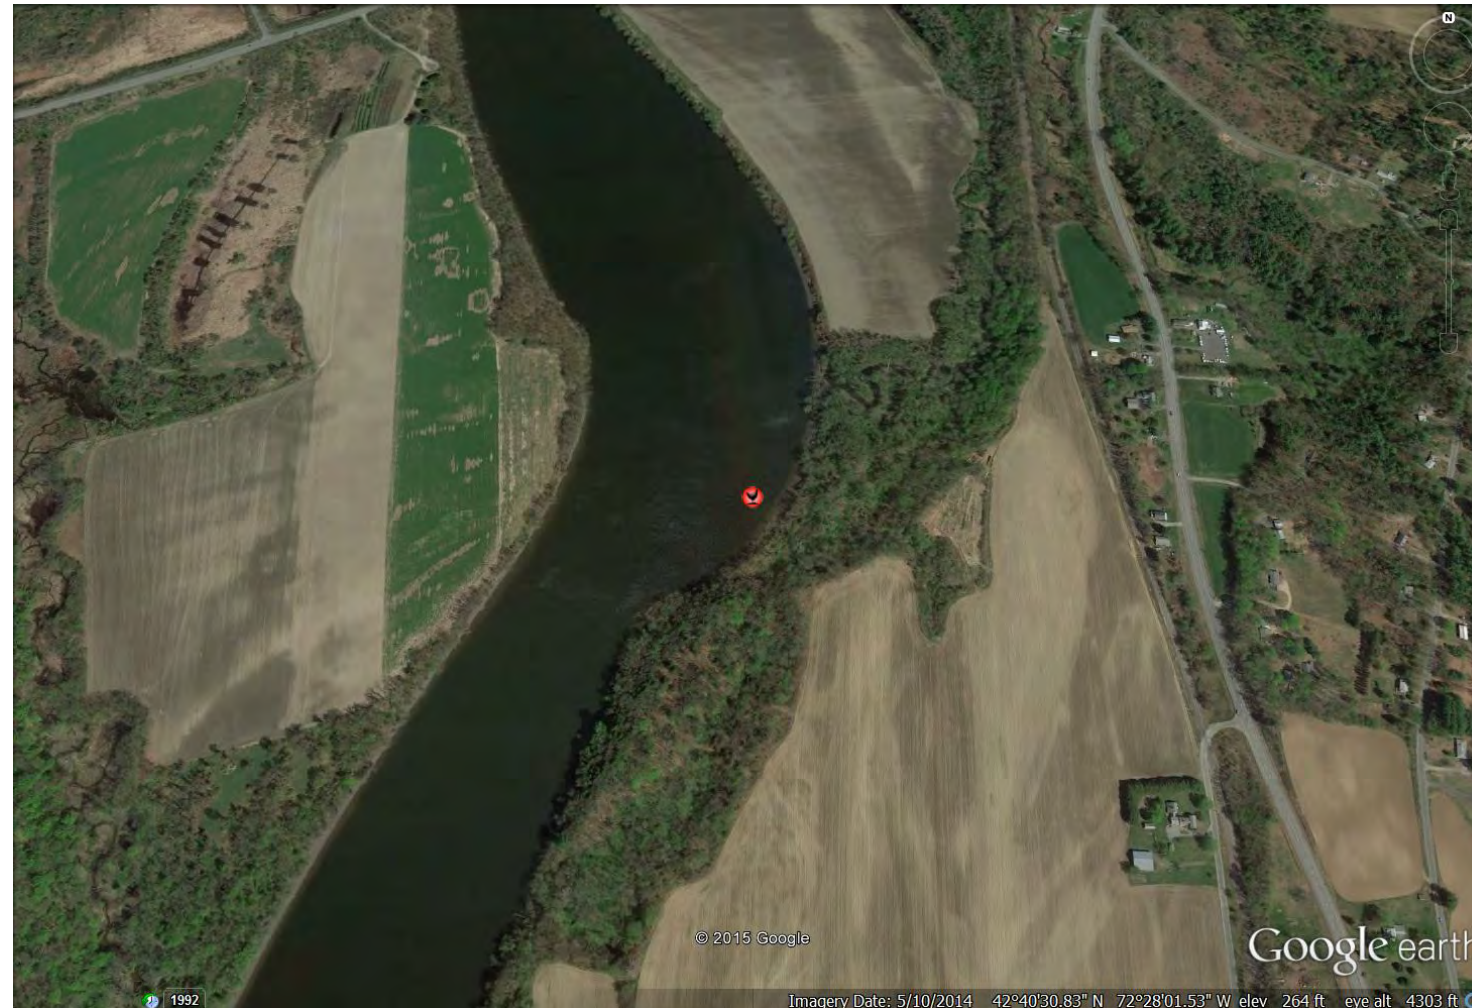
Photo 784 Location

Riverbank Features	Characteristics
Upper Riverbank Slope	Moderate
Upper Riverbank Height	High
Upper Riverbank Sediment	Silt/Sand
Upper Riverbank Vegetation	Heavy
Lower Riverbank Slope	Flat/Beach
Lower Riverbank Sediment	Silt/Sand
Lower Riverbank Vegetation	None to very sparse
Type of Erosion	Undercut
Potential Erosion Indicators	Exposed roots, Creep/leaning trees
Stage of Erosion	Stable
Extent of Erosion	None/Little

QA Observations: Upon review of the photos for this segment, classification made in the field was confirmed and additional indicators of potential future erosion were included.

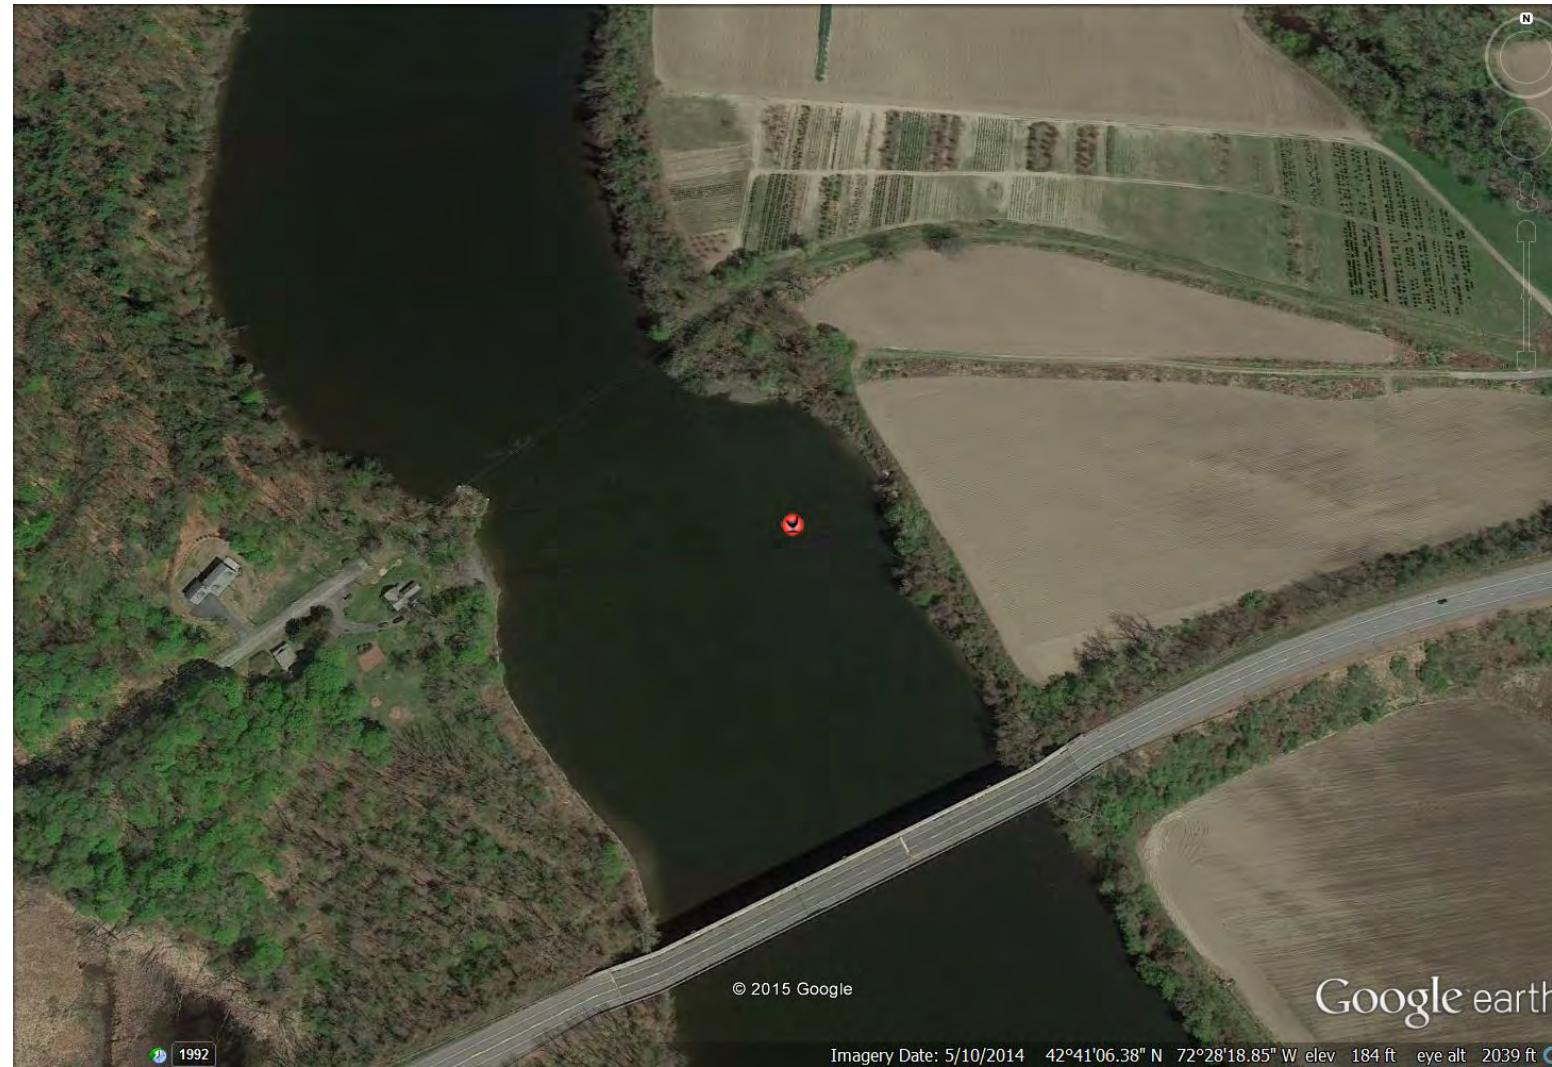
Photo 822 Location

Riverbank Features	Characteristics
Upper Riverbank Slope	Overhanging
Upper Riverbank Height	High
Upper Riverbank Sediment	Silt/Sand
Upper Riverbank Vegetation	Moderate
Lower Riverbank Slope	Flat/Beach
Lower Riverbank Sediment	Silt/Sand
Lower Riverbank Vegetation	None to very sparse
Type of Erosion	Slide
Potential Erosion Indicators	Overhanging bank, Exposed roots, Creep/leaning trees
Stage of Erosion	Eroded
Extent of Erosion	Some to Extensive

QA Observations: Upon review of the photos for this segment, classification made in the field was confirmed and additional indicators of potential future erosion were included.

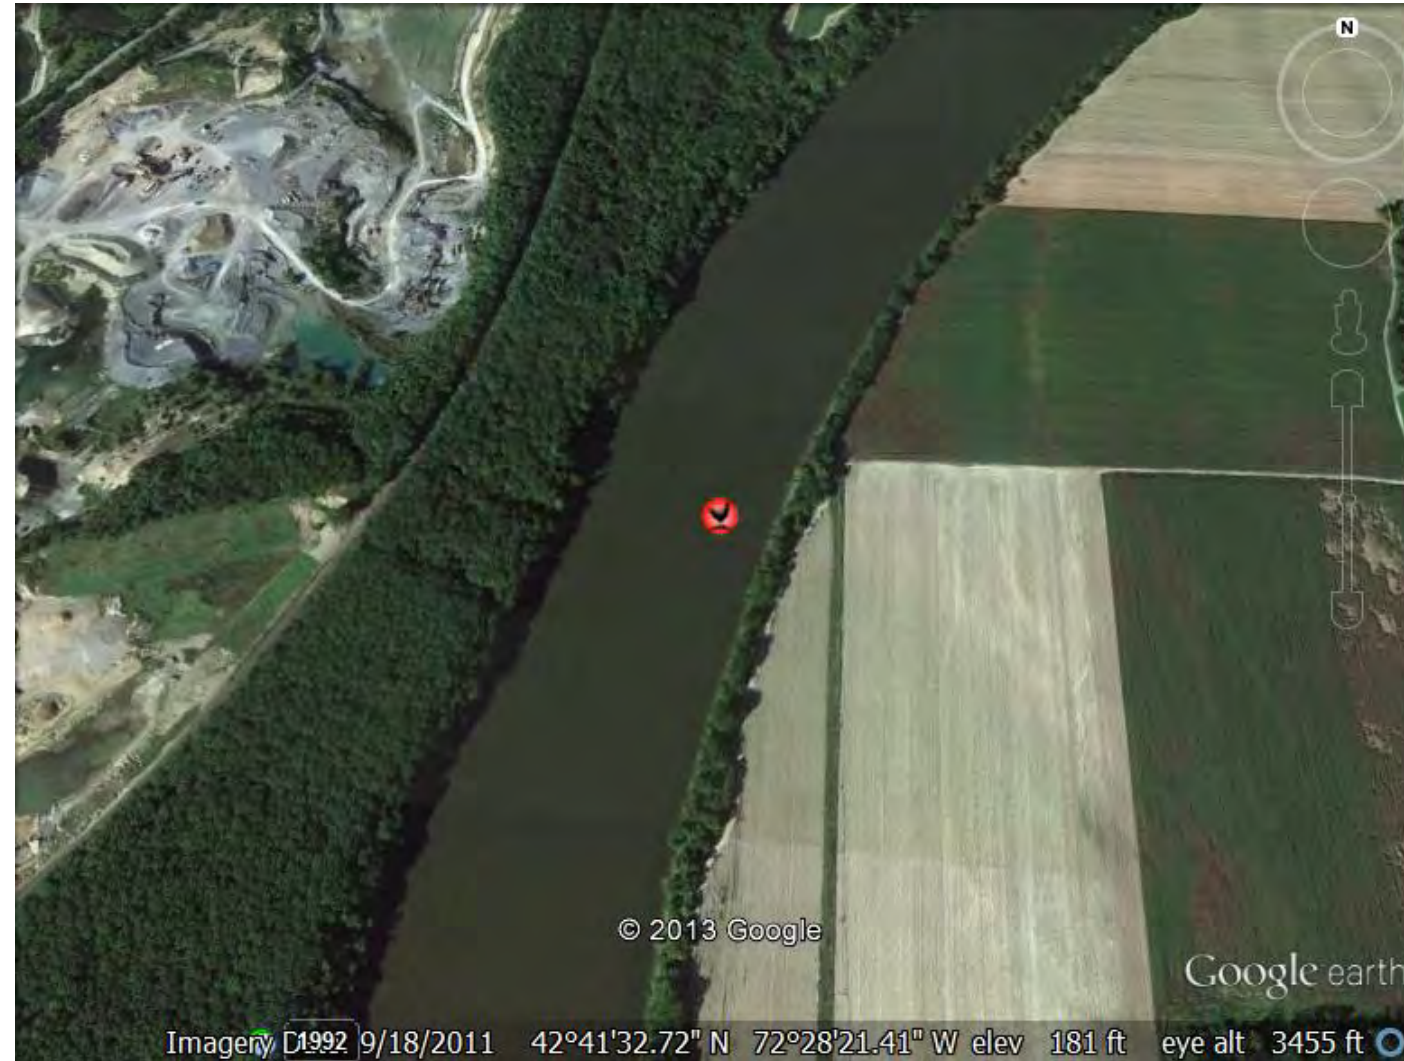
Photo 844 Location

Riverbank Features	Characteristics
Upper Riverbank Slope	Steep
Upper Riverbank Height	High
Upper Riverbank Sediment	Silt/Sand
Upper Riverbank Vegetation	Heavy
Lower Riverbank Slope	Flat/Beach
Lower Riverbank Sediment	Silt/Sand
Lower Riverbank Vegetation	None to very sparse
Type of Erosion	Undercut
Potential Erosion Indicators	Creep/leaning trees, Exposed roots
Stage of Erosion	Stable
Extent of Erosion	None/Little

QA Observations: Upon review of the photos for this segment, classification made in the field was confirmed and additional indicators of potential future erosion were included.

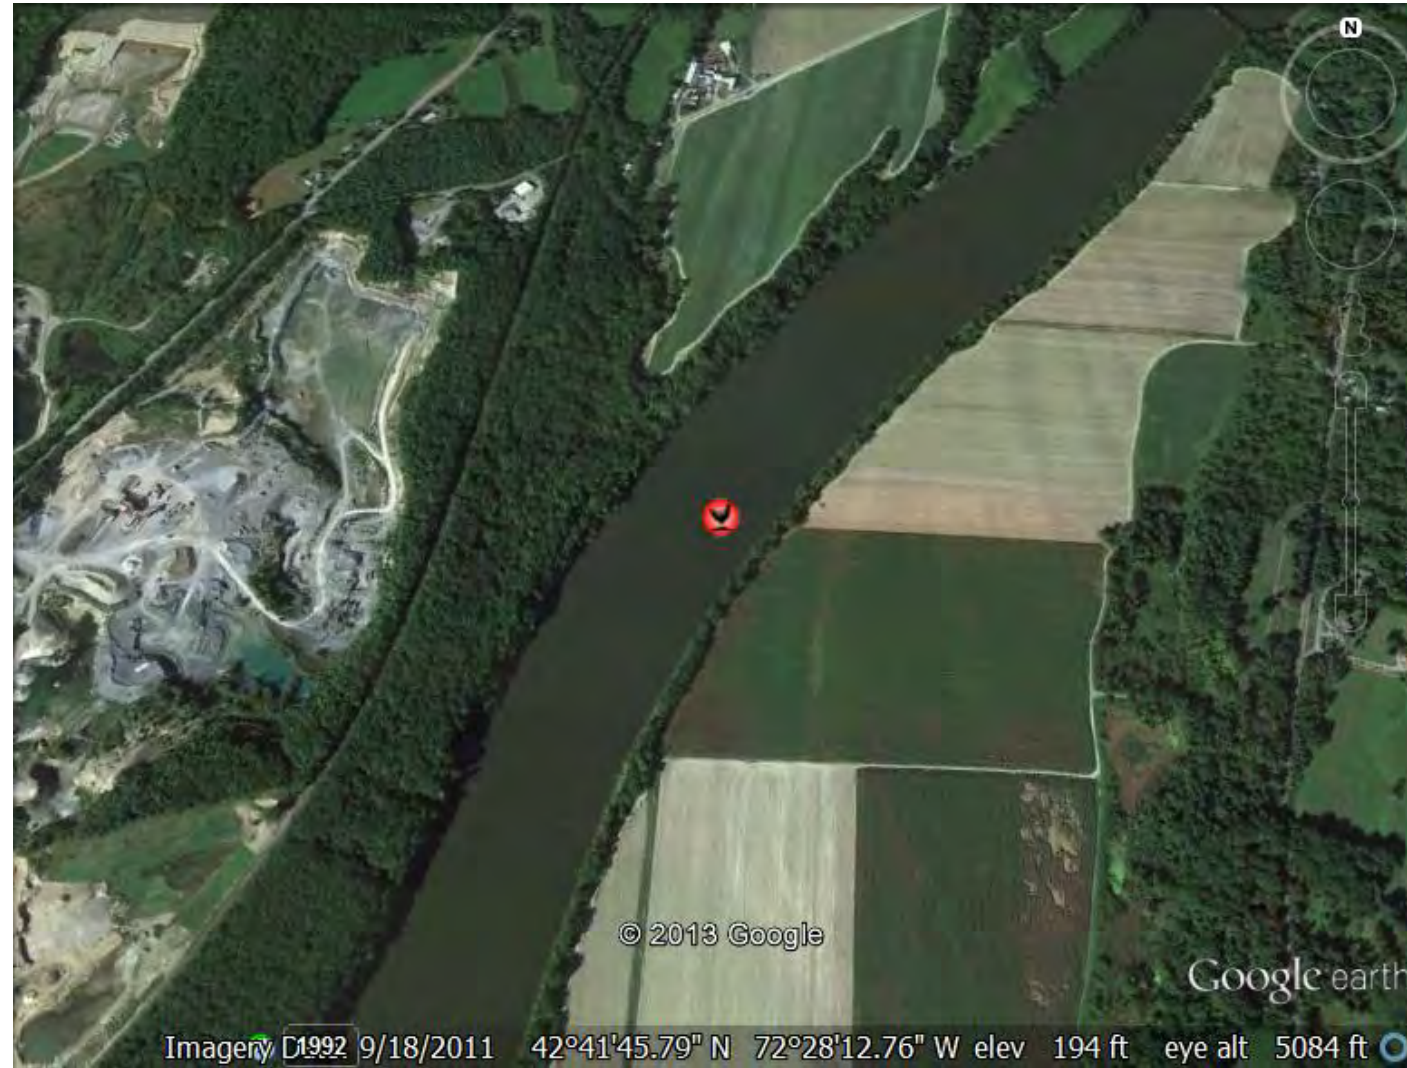
Photo 854 Location

Riverbank Features	Characteristics
Upper Riverbank Slope	Overhanging
Upper Riverbank Height	High
Upper Riverbank Sediment	Silt/Sand
Upper Riverbank Vegetation	Moderate
Lower Riverbank Slope	Flat/Beach
Lower Riverbank Sediment	Silt/Sand
Lower Riverbank Vegetation	None to very sparse
Type of Erosion	Slide, undercut
Potential Erosion Indicators	Exposed roots, Overhanging bank, Creep/leaning trees
Stage of Erosion	Eroded
Extent of Erosion	Some

QA Observations: Upon review of the photos for this segment, classification made in the field was confirmed and additional indicators of potential future erosion were included.

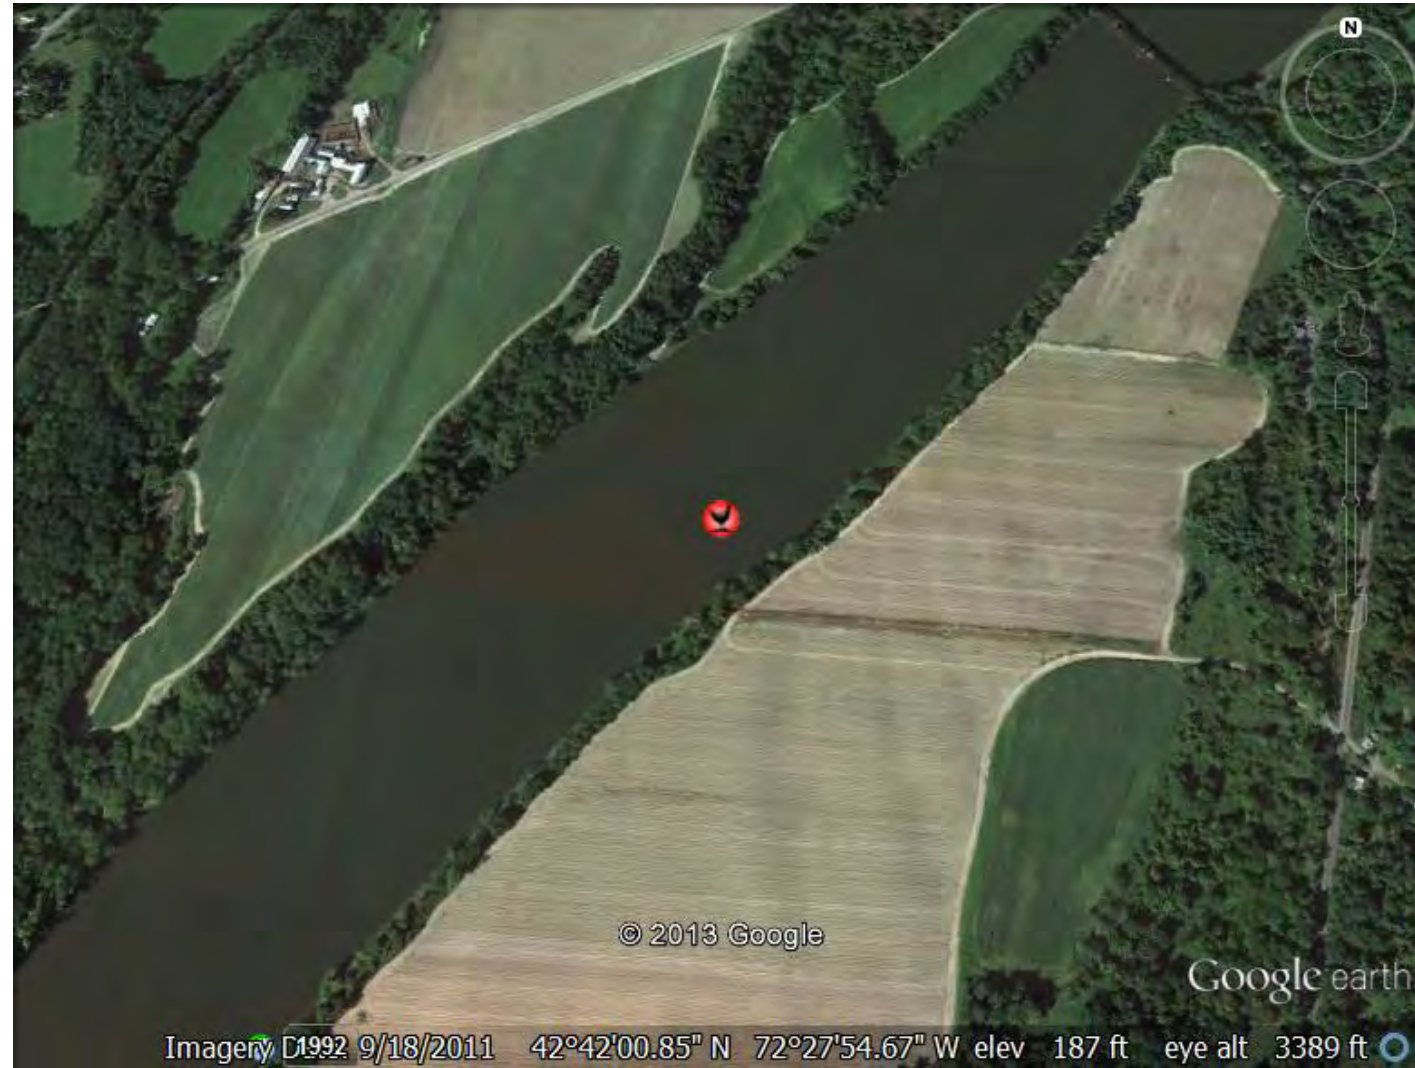
Photo 867 Location

Riverbank Features	Characteristics
Upper Riverbank Slope	Steep
Upper Riverbank Height	High
Upper Riverbank Sediment	Silt/Sand
Upper Riverbank Vegetation	Heavy
Lower Riverbank Slope	Flat/Beach
Lower Riverbank Sediment	Silt/Sand
Lower Riverbank Vegetation	None to very sparse
Type of Erosion	Undercut
Potential Erosion Indicators	Creep/leaning trees, Exposed roots, Overhanging bank
Stage of Erosion	Eroded
Extent of Erosion	Some

QA Observations: Upon review of the photos for this segment, classification made in the field was confirmed and additional indicators of potential future erosion were included.
