Segment 210 – Left Bank

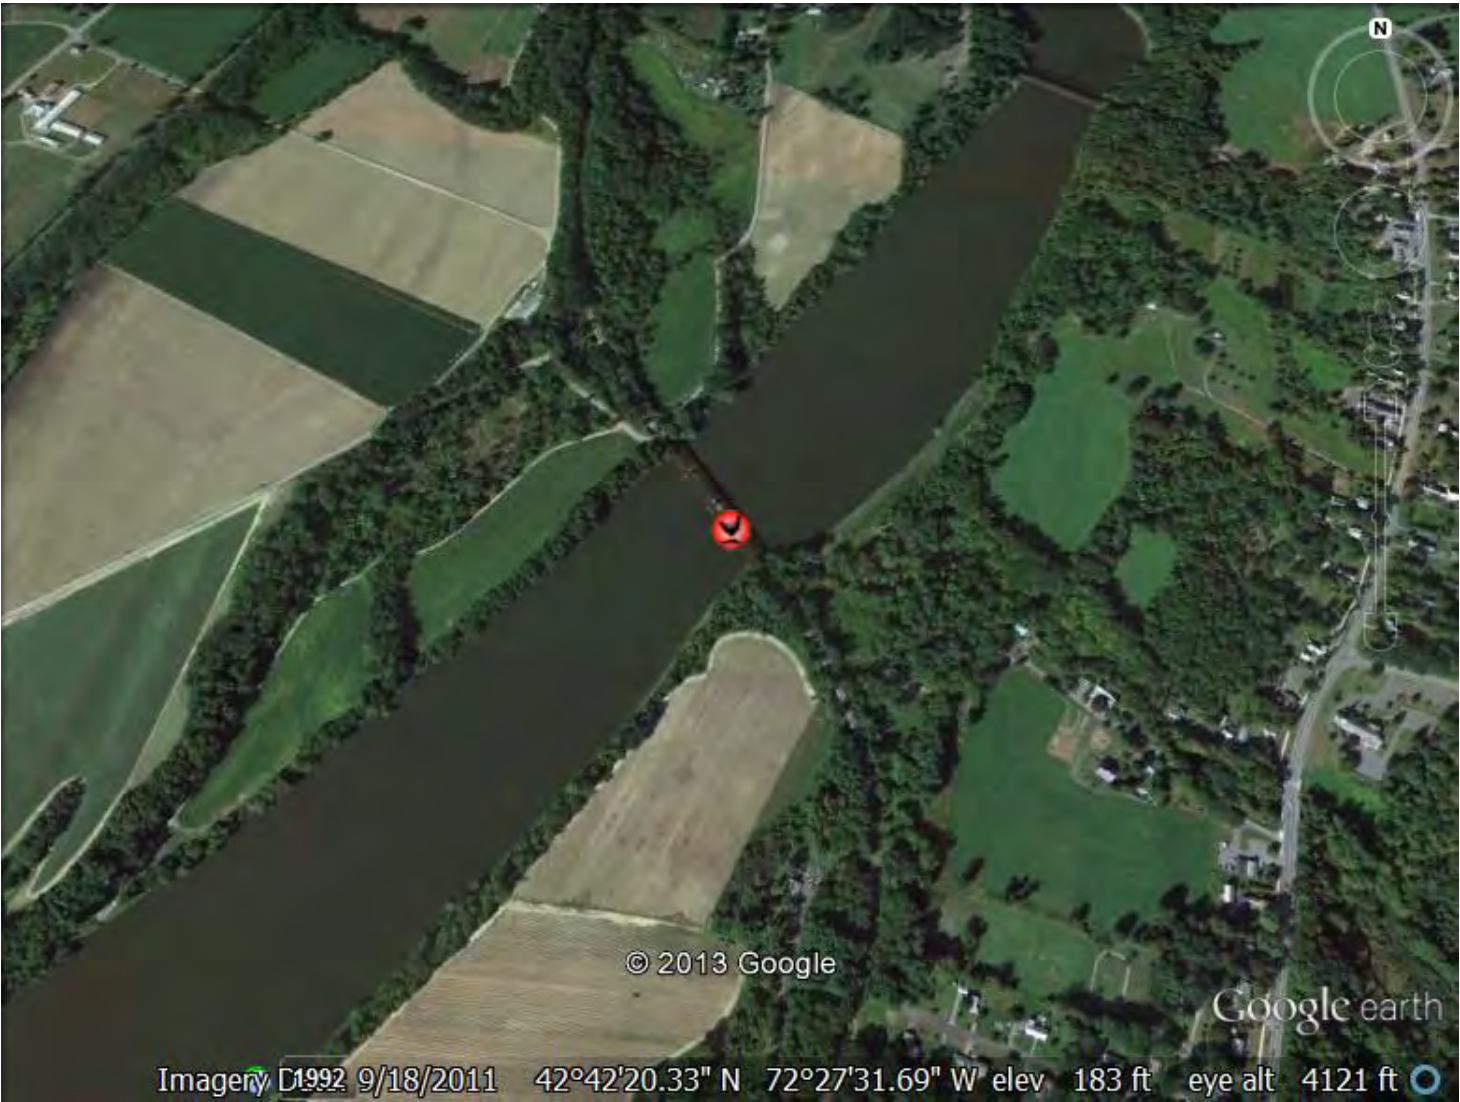
Photo 883 Location

Riverbank Features	Characteristics
Upper Riverbank Slope	Moderate
Upper Riverbank Height	Low
Upper Riverbank Sediment	Silt/Sand
Upper Riverbank Vegetation	Heavy
Lower Riverbank Slope	Moderate
Lower Riverbank Sediment	Boulders
Lower Riverbank Vegetation	None to very sparse
Type of Erosion	
Potential Erosion Indicators	Creep/leaning trees
Stage of Erosion	Stable
Extent of Erosion	None/Little

QA Observations: Upon review of the photos for this segment, classification made in the field was confirmed.

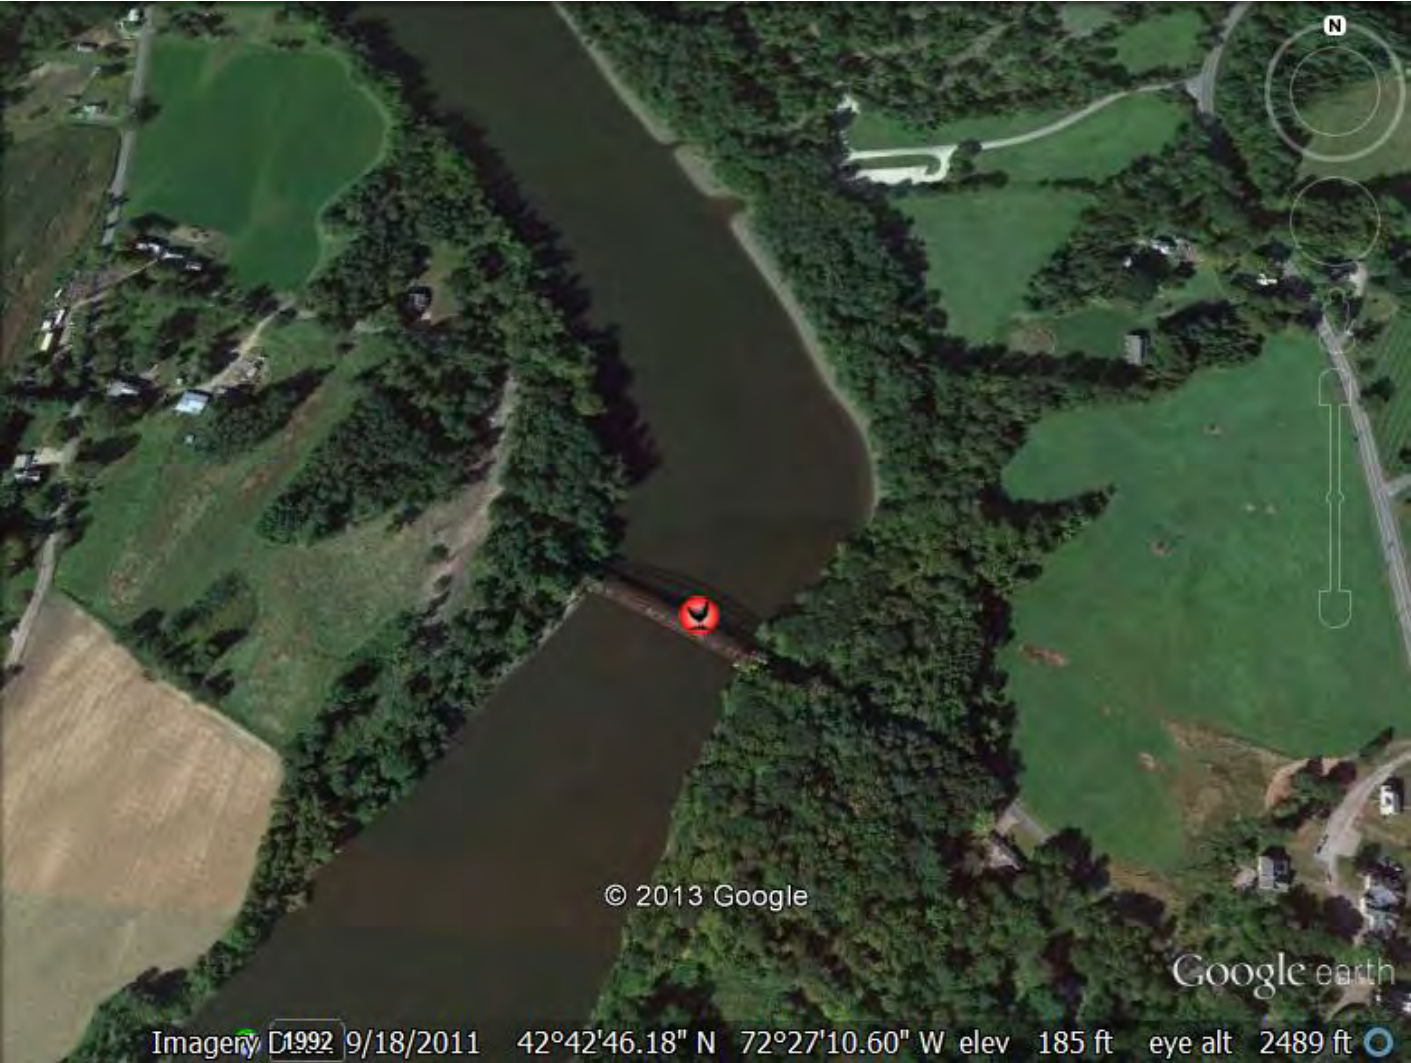
Photo 903 Location

Segment 220 – Left Bank

Riverbank Features	Characteristics
Upper Riverbank Slope	Steep
Upper Riverbank Height	High
Upper Riverbank Sediment	Silt/Sand
Upper Riverbank Vegetation	Heavy
Lower Riverbank Slope	Moderate
Lower Riverbank Sediment	Cobbles
Lower Riverbank Vegetation	None to very sparse
Type of Erosion	Undercut
Potential Erosion Indicators	Creep/leaning trees, Exposed roots
Stage of Erosion	Potential Future Erosion
Extent of Erosion	Some

QA Observations: Upon review of the photos for this segment, classification made in the field was confirmed and additional indicators of potential future erosion were included.

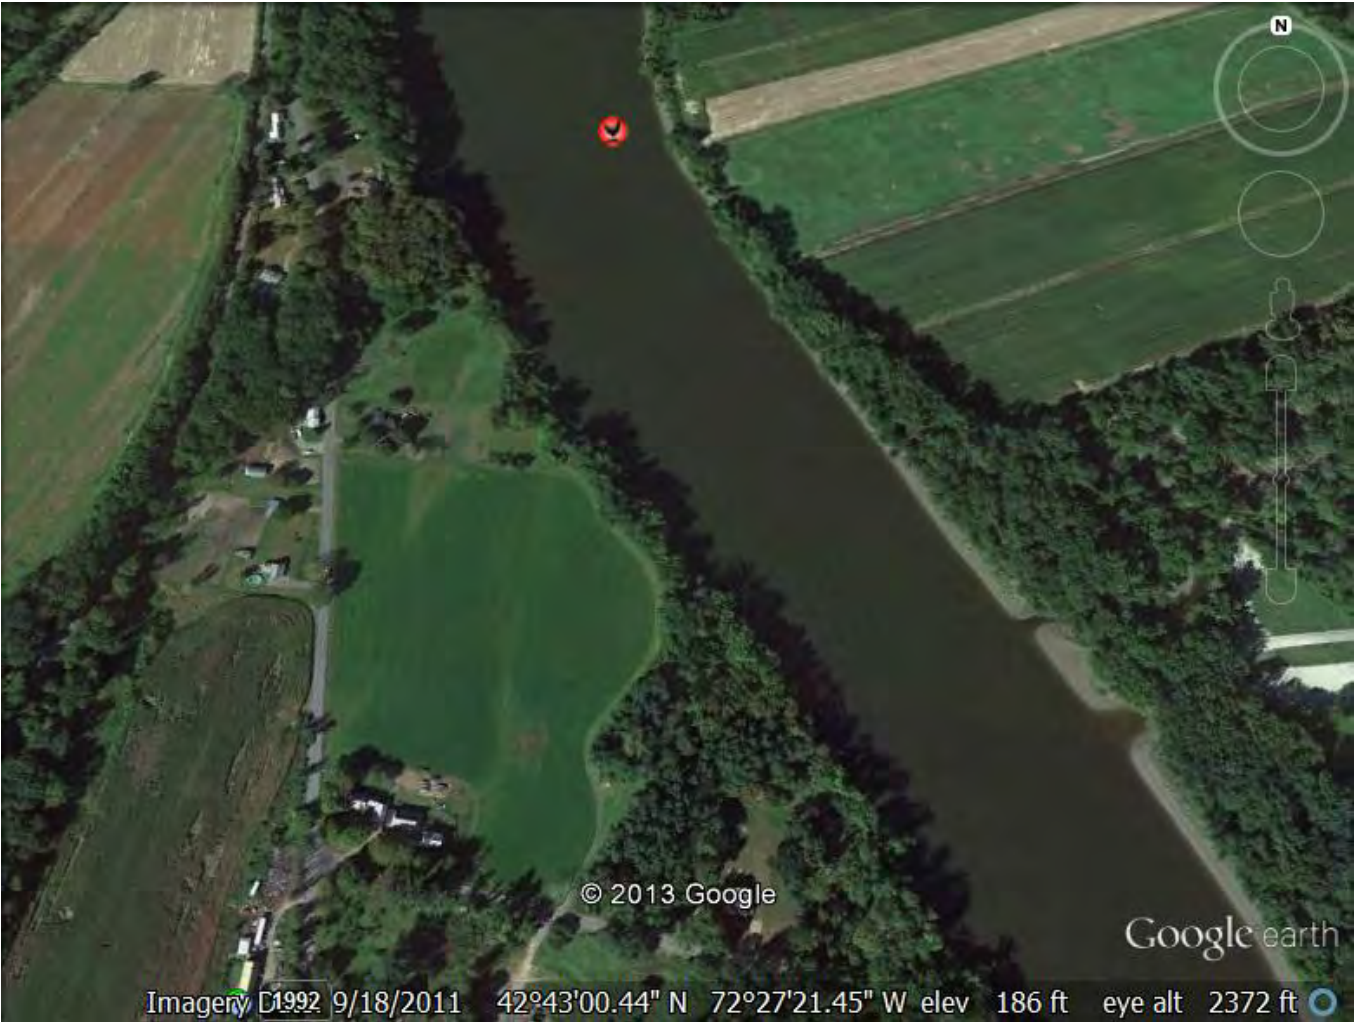
Photo 1707 Location

Segment 230 – Left Bank

Riverbank Features	Characteristics
Upper Riverbank Slope	Overhanging
Upper Riverbank Height	Medium
Upper Riverbank Sediment	Silt/Sand
Upper Riverbank Vegetation	Moderate
Lower Riverbank Slope	Flat/Beach
Lower Riverbank Sediment	Silt/Sand
Lower Riverbank Vegetation	None to very sparse
Type of Erosion	
Potential Erosion Indicators	Creep/leaning trees, Overhanging bank, Exposed roots
Stage of Erosion	Potential Future Erosion
Extent of Erosion	Some

QA Observations: Upon review of the photos for this segment, classification made in the field was confirmed and additional indicators of potential future erosion were included.

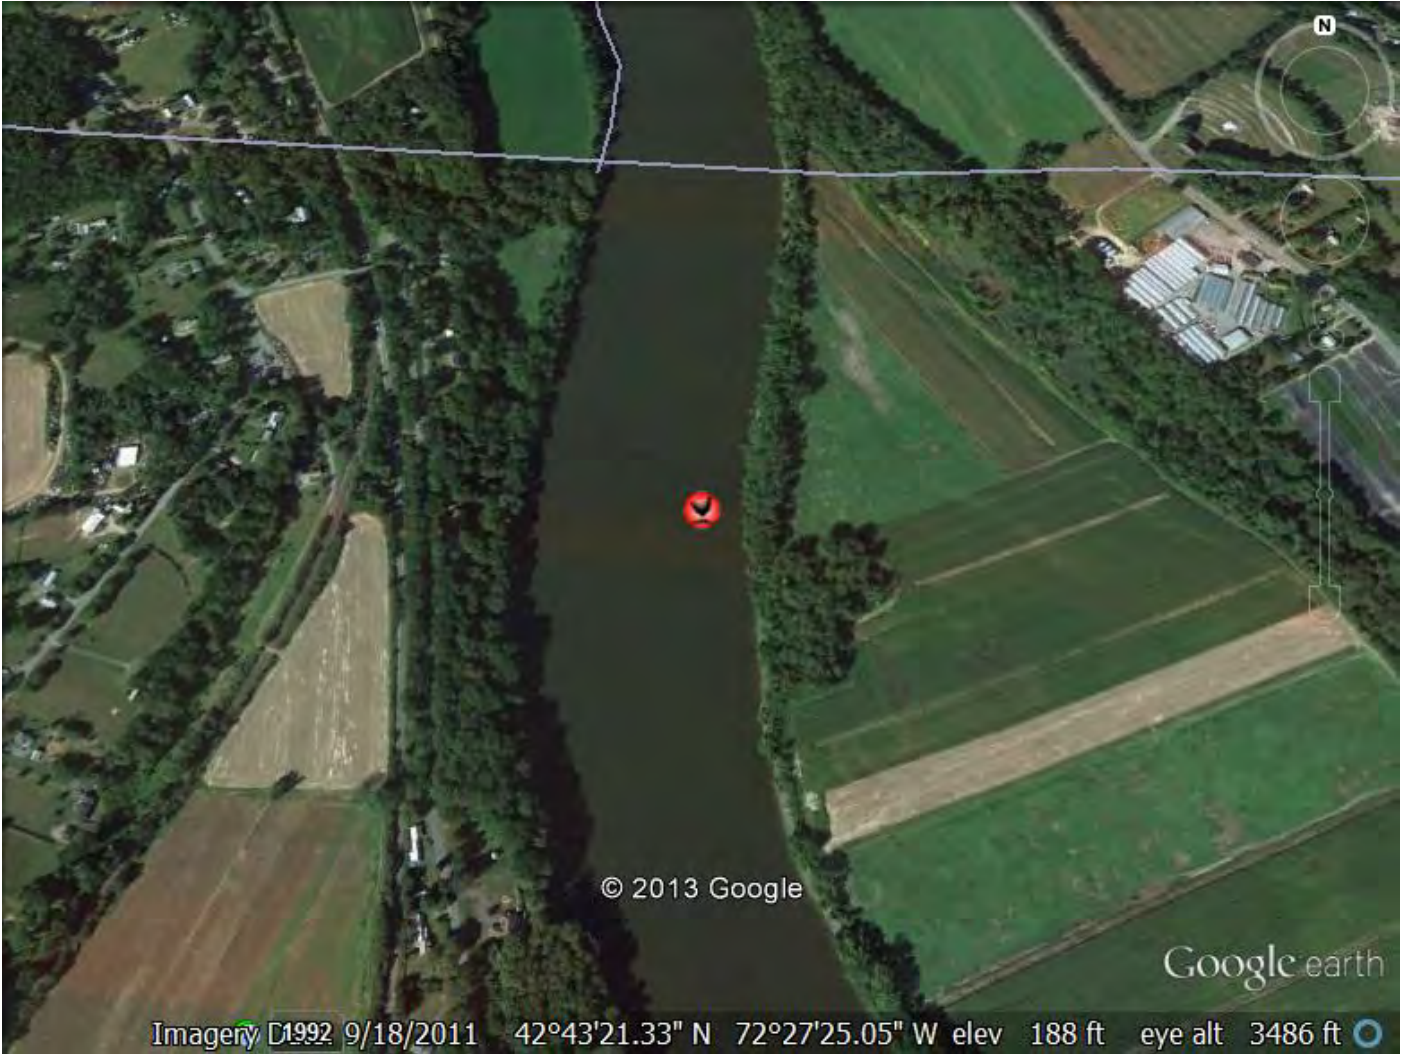
Photo 1702 Location

Segment 240 – Left Bank

Riverbank Features	Characteristics
Upper Riverbank Slope	Vertical
Upper Riverbank Height	Low
Upper Riverbank Sediment	Silt/Sand
Upper Riverbank Vegetation	Moderate
Lower Riverbank Slope	Flat/Beach
Lower Riverbank Sediment	Silt/Sand
Lower Riverbank Vegetation	None to very sparse
Type of Erosion	Undercut
Potential Erosion Indicators	Creep/leaning trees, Exposed roots, Overhanging bank
Stage of Erosion	Eroded
Extent of Erosion	Some

QA Observations: Upon review of the photos for this segment, classification made in the field was confirmed and additional indicators of potential future erosion were included.

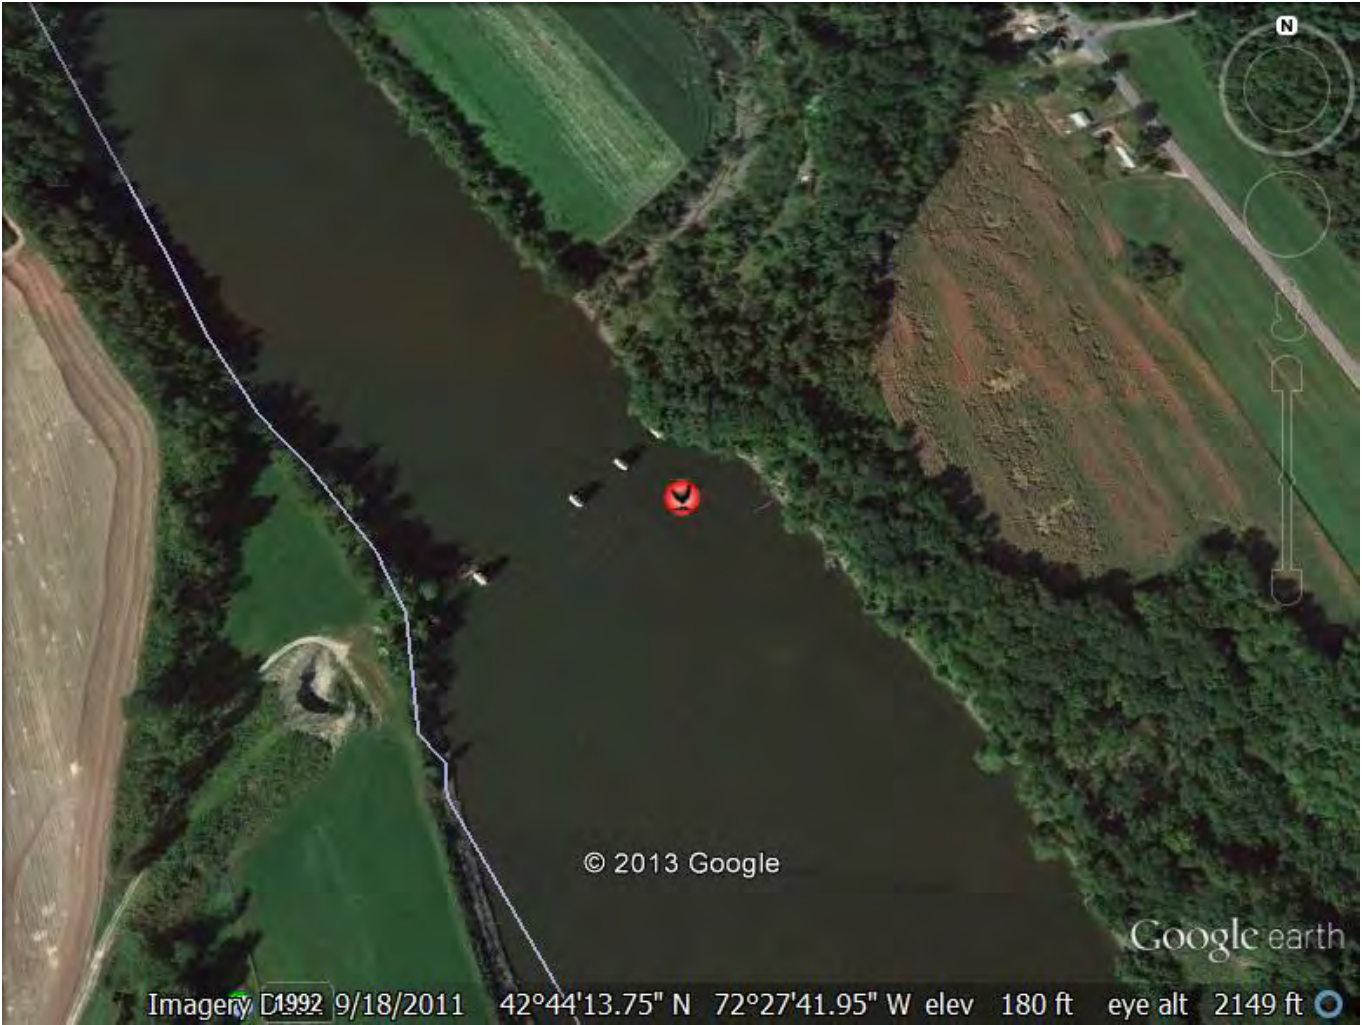
Photo 1670 Location

Segment 250 – Left Bank

Riverbank Features	Characteristics
Upper Riverbank Slope	Overhanging
Upper Riverbank Height	High
Upper Riverbank Sediment	Silt/Sand
Upper Riverbank Vegetation	Moderate
Lower Riverbank Slope	Flat/Beach
Lower Riverbank Sediment	Silt/Sand
Lower Riverbank Vegetation	None to very sparse
Type of Erosion	Slide, Rotational Slump
Potential Erosion Indicators	Overhanging bank, Creep/leaning trees, Exposed roots,
Stage of Erosion	Eroded
Extent of Erosion	Some

QA Observations: Upon review of the photos for this segment, classification made in the field was confirmed and additional indicators of potential future erosion were included.

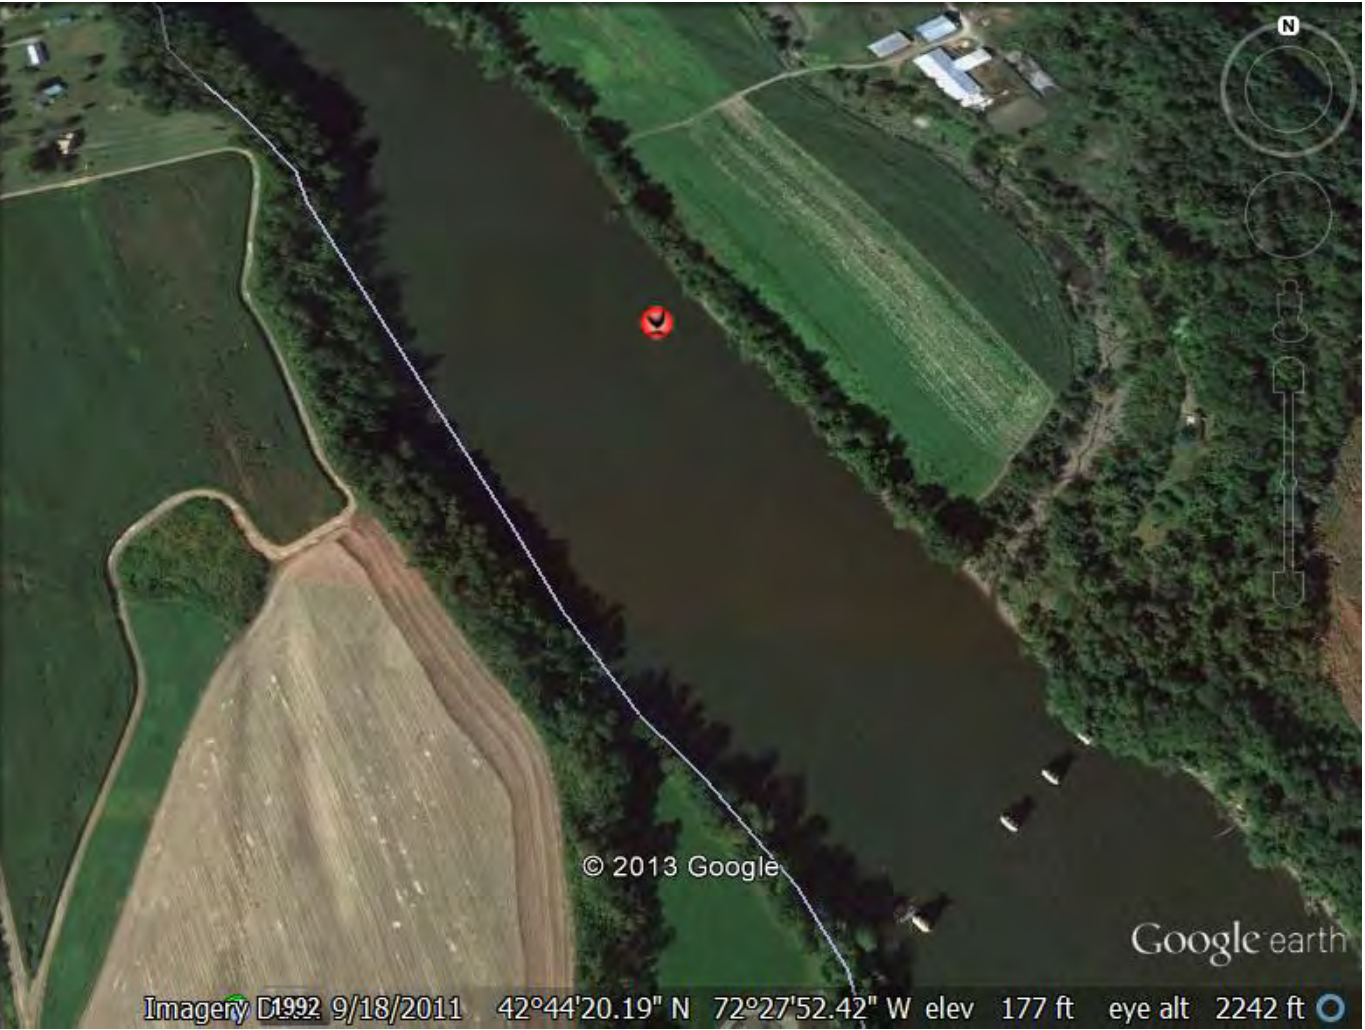
Photo 1661 Location

Segment 260 – Left Bank

Riverbank Features	Characteristics
Upper Riverbank Slope	Steep
Upper Riverbank Height	High
Upper Riverbank Sediment	Silt/Sand
Upper Riverbank Vegetation	Moderate
Lower Riverbank Slope	Flat/Beach
Lower Riverbank Sediment	Boulders
Lower Riverbank Vegetation	None to very sparse
Type of Erosion	Rotational Slump, Undercut
Potential Erosion Indicators	Creep/leaning trees, Overhanging bank, Exposed roots
Stage of Erosion	Eroded
Extent of Erosion	Some

QA Observations: Upon review of the photos for this segment, classification made in the field was confirmed and additional indicators of potential future erosion were included.

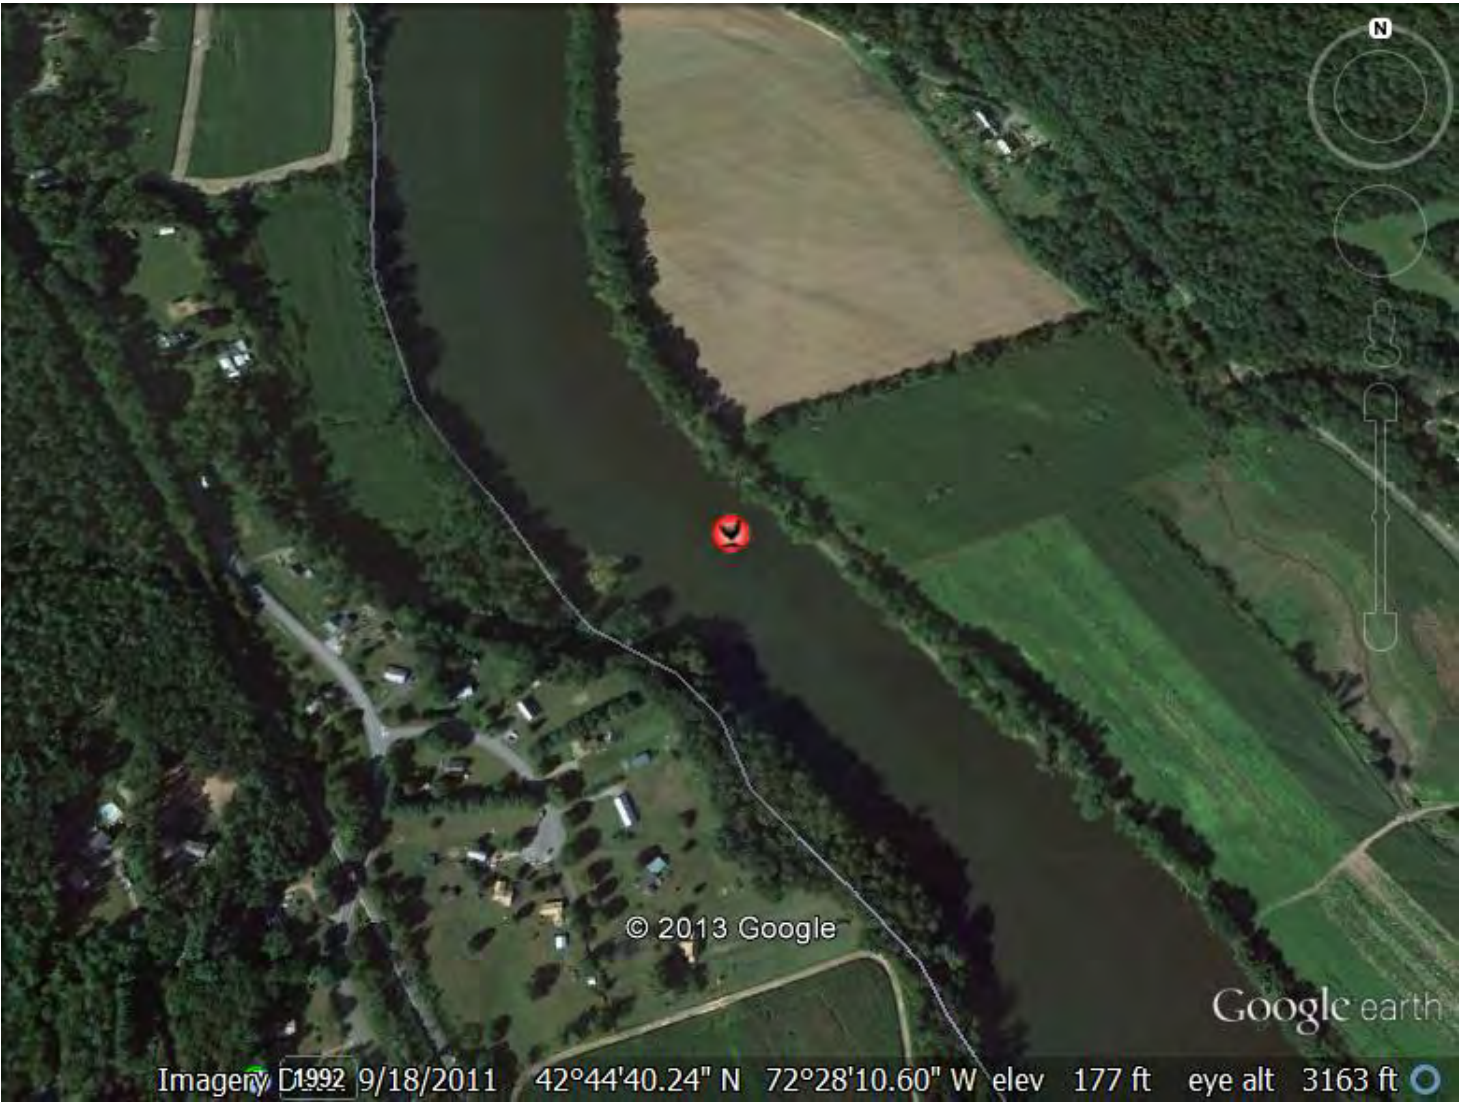
Photo 1647 Location

Segment 270 – Left Bank

Riverbank Features	Characteristics
Upper Riverbank Slope	Steep
Upper Riverbank Height	High
Upper Riverbank Sediment	Silt/Sand
Upper Riverbank Vegetation	Heavy
Lower Riverbank Slope	Flat/Beach
Lower Riverbank Sediment	Silt/Sand
Lower Riverbank Vegetation	None to very sparse
Type of Erosion	
Potential Erosion Indicators	None
Stage of Erosion	Stable
Extent of Erosion	None/Little

QA Observations: Upon review of the photos for this segment, classification made in the field was confirmed.

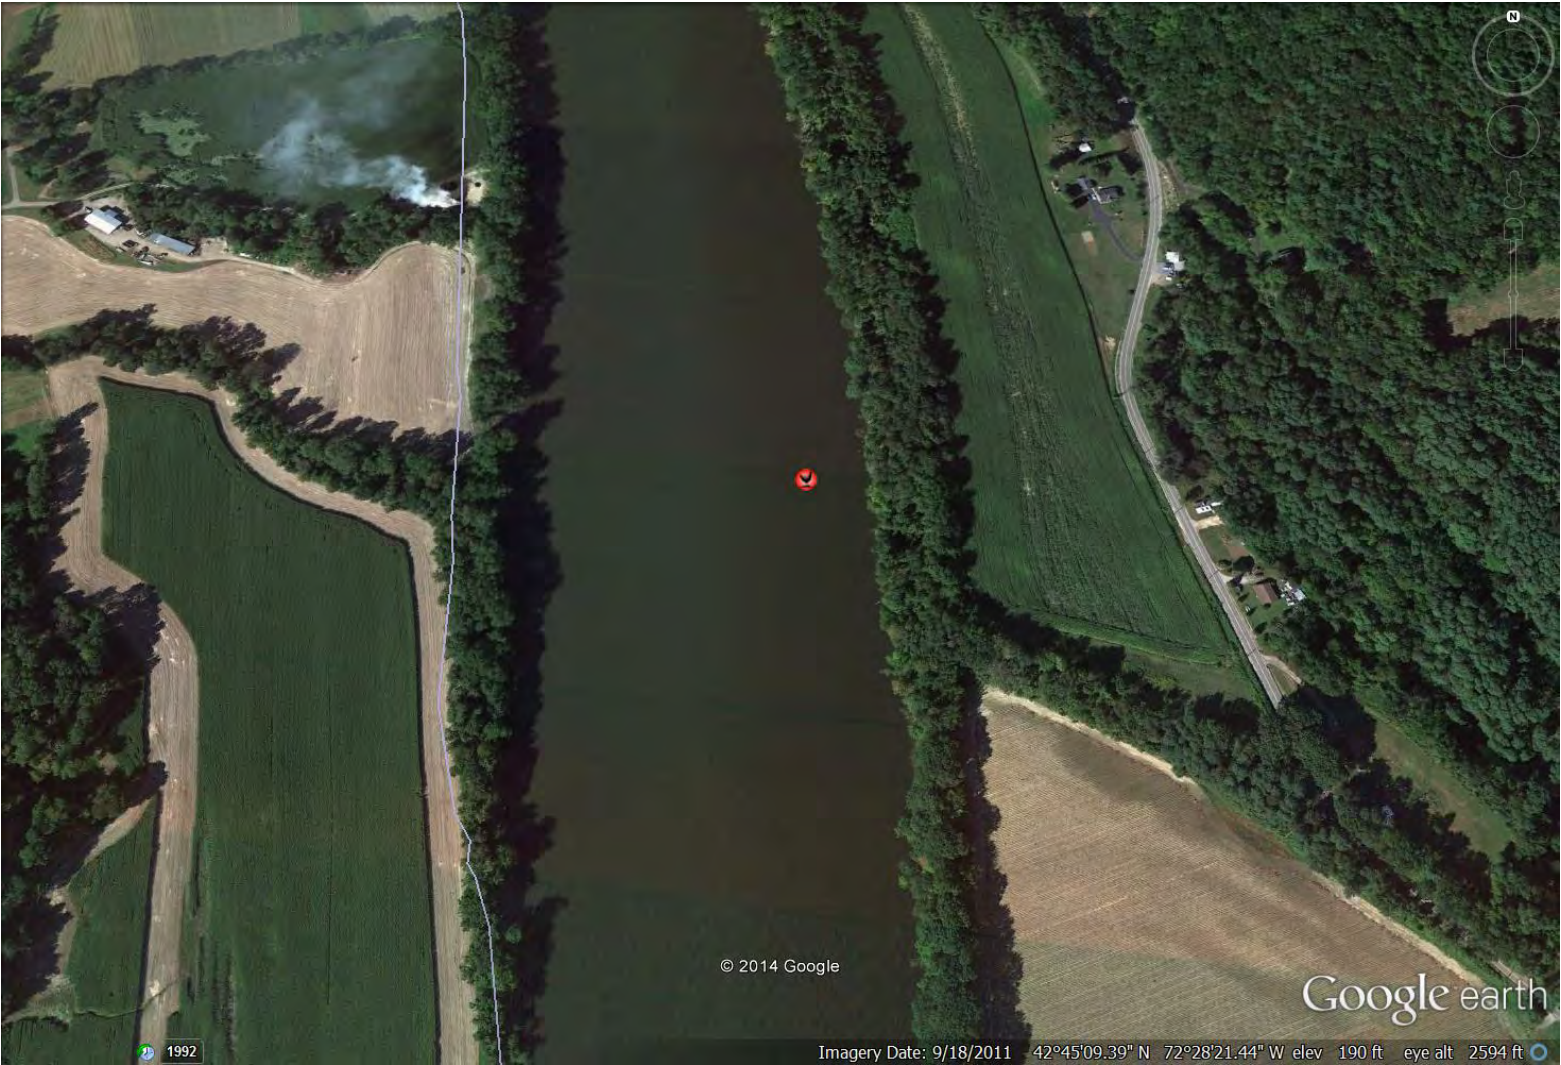
Photo 1628 Location

Segment 280 – Left Bank

Riverbank Features	Characteristics
Upper Riverbank Slope	Steep
Upper Riverbank Height	High
Upper Riverbank Sediment	Silt/Sand
Upper Riverbank Vegetation	Heavy
Lower Riverbank Slope	Flat/Beach
Lower Riverbank Sediment	Silt/Sand
Lower Riverbank Vegetation	None to very sparse
Type of Erosion	Undercut
Potential Erosion Indicators	Creep/leaning trees, Exposed roots, Overhanging bank
Stage of Erosion	Stable
Extent of Erosion	None/Little

QA Observations: Upon review of the photos for this segment, classification made in the field was confirmed and additional indicators of potential future erosion were included.

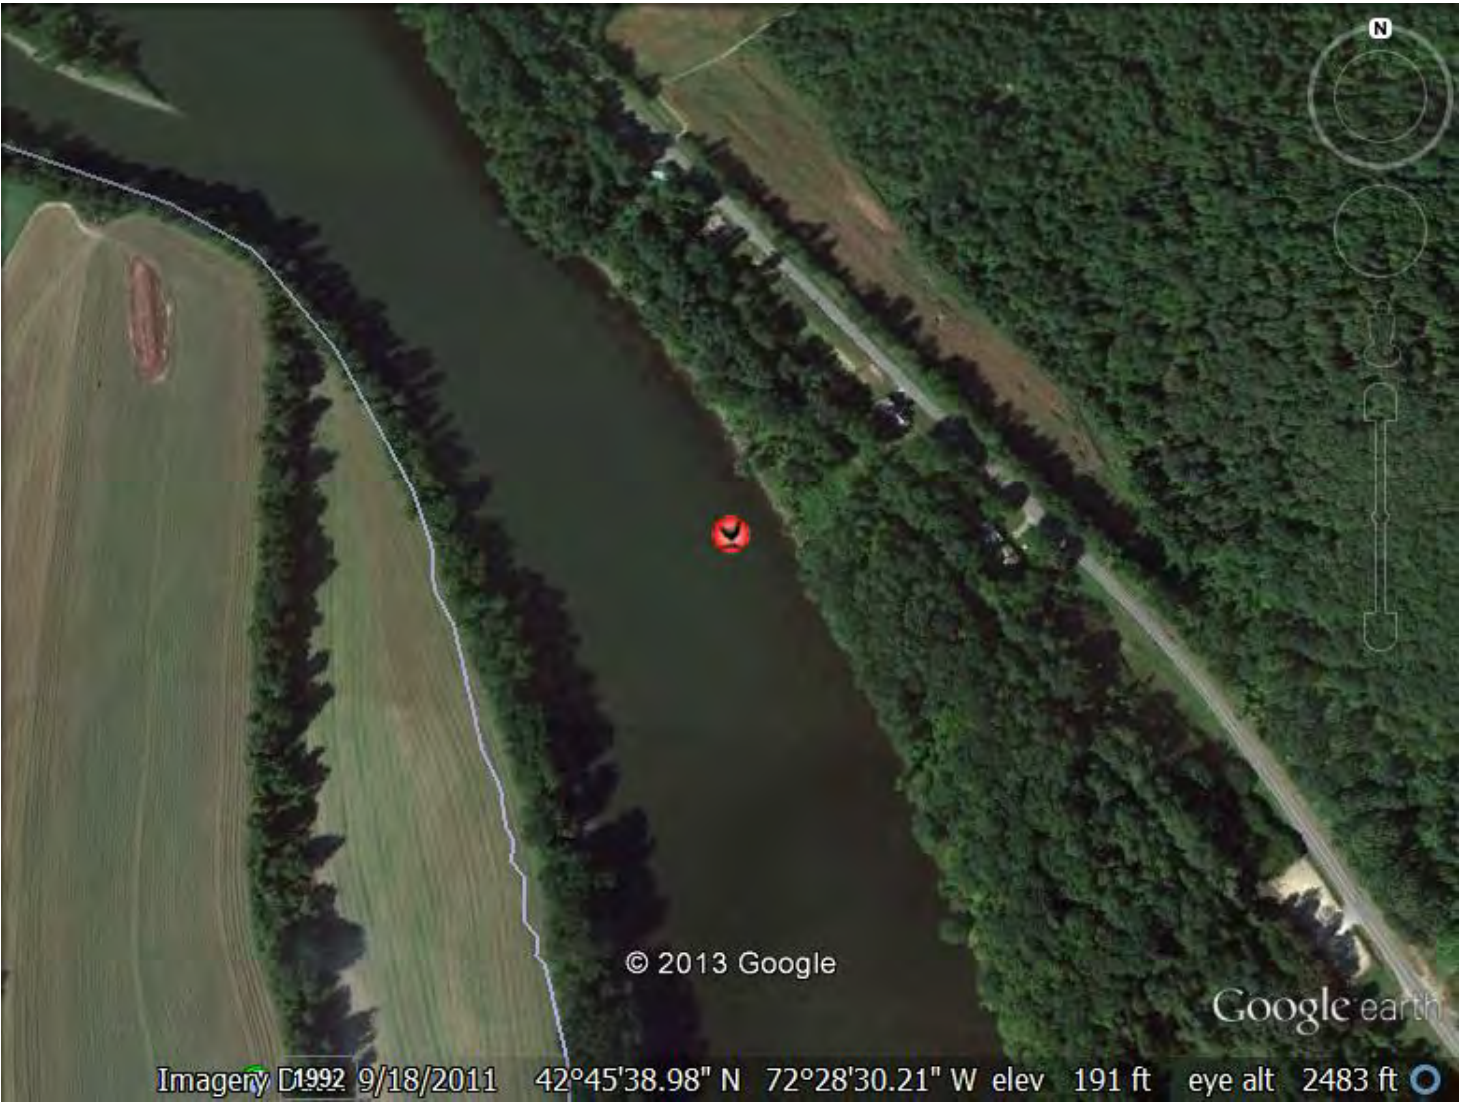
Photo 1605 Location

Segment 290 – Left Bank

Riverbank Features	Characteristics
Upper Riverbank Slope	Moderate
Upper Riverbank Height	High
Upper Riverbank Sediment	Silt/Sand
Upper Riverbank Vegetation	Heavy
Lower Riverbank Slope	Flat/Beach
Lower Riverbank Sediment	gravel
Lower Riverbank Vegetation	None to very sparse
Type of Erosion	Undercut
Potential Erosion Indicators	Creep/leaning trees
Stage of Erosion	Stable
Extent of Erosion	None/Little

QA Observations: Upon review of the photos for this segment, classification made in the field was confirmed.

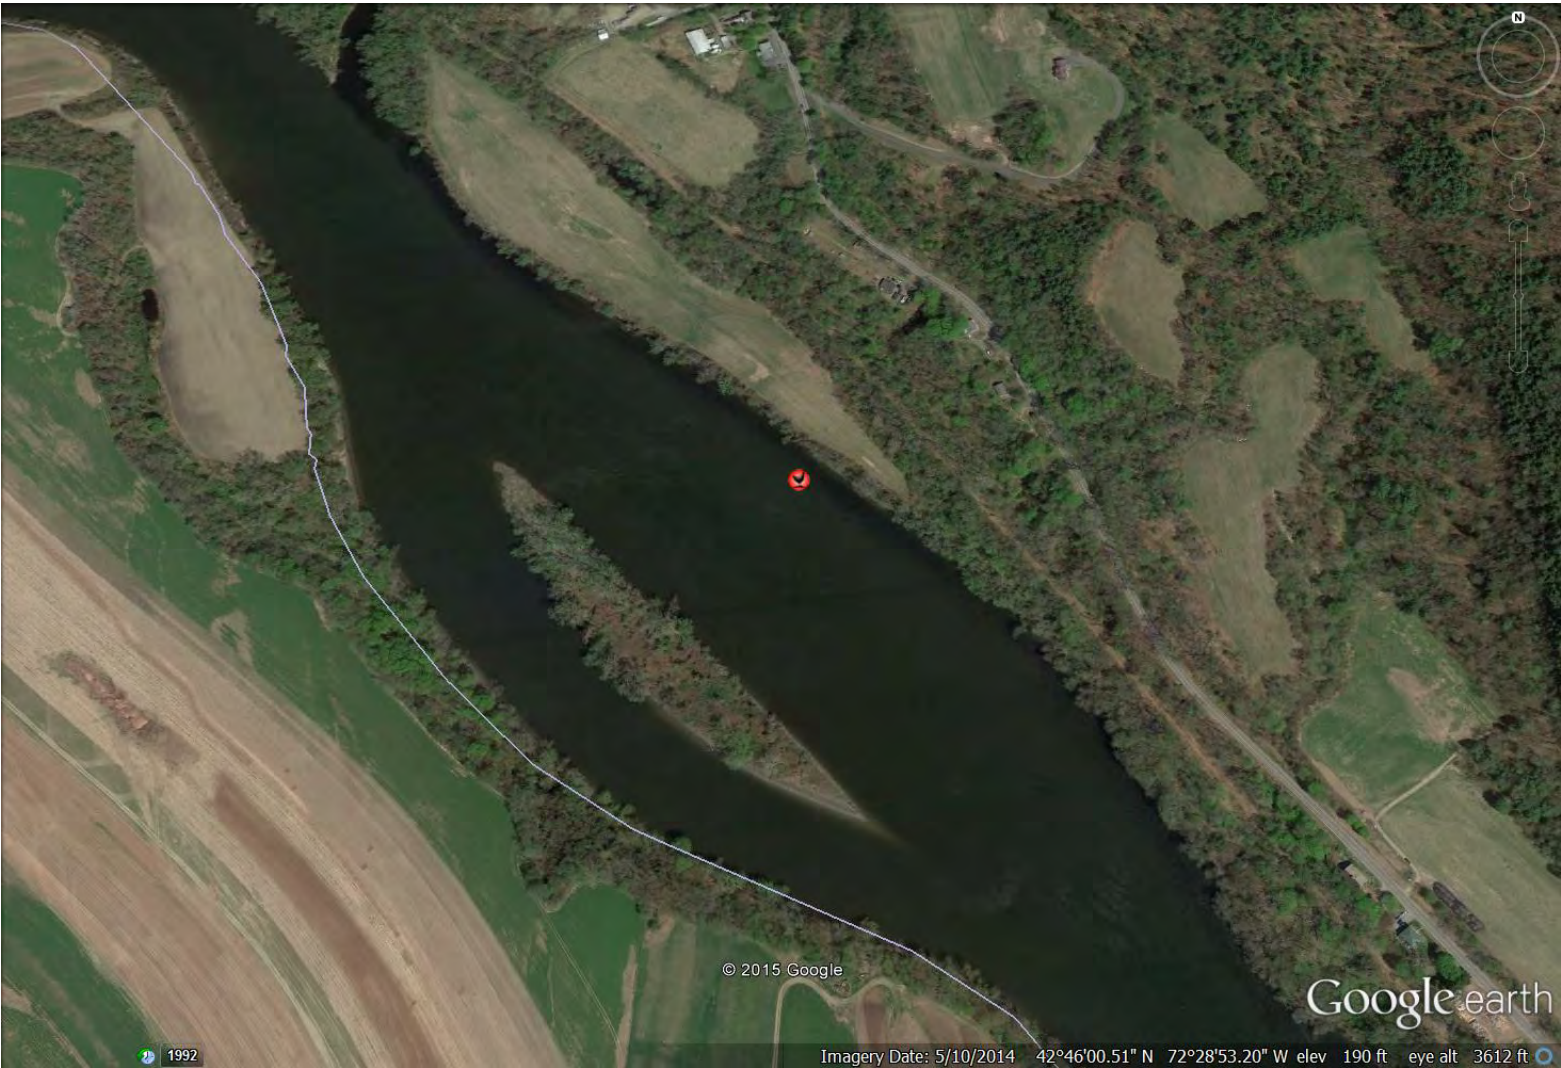
Photo 1586 Location

Segment 300 – Left Bank

Riverbank Features	Characteristics
Upper Riverbank Slope	Moderate
Upper Riverbank Height	High
Upper Riverbank Sediment	Silt/Sand
Upper Riverbank Vegetation	Heavy
Lower Riverbank Slope	Flat/Beach
Lower Riverbank Sediment	Silt/Sand
Lower Riverbank Vegetation	Moderate
Type of Erosion	
Potential Erosion Indicators	None
Stage of Erosion	Stable
Extent of Erosion	None/Little

QA Observations: Upon review of the photos for this segment, classification made in the field was confirmed.

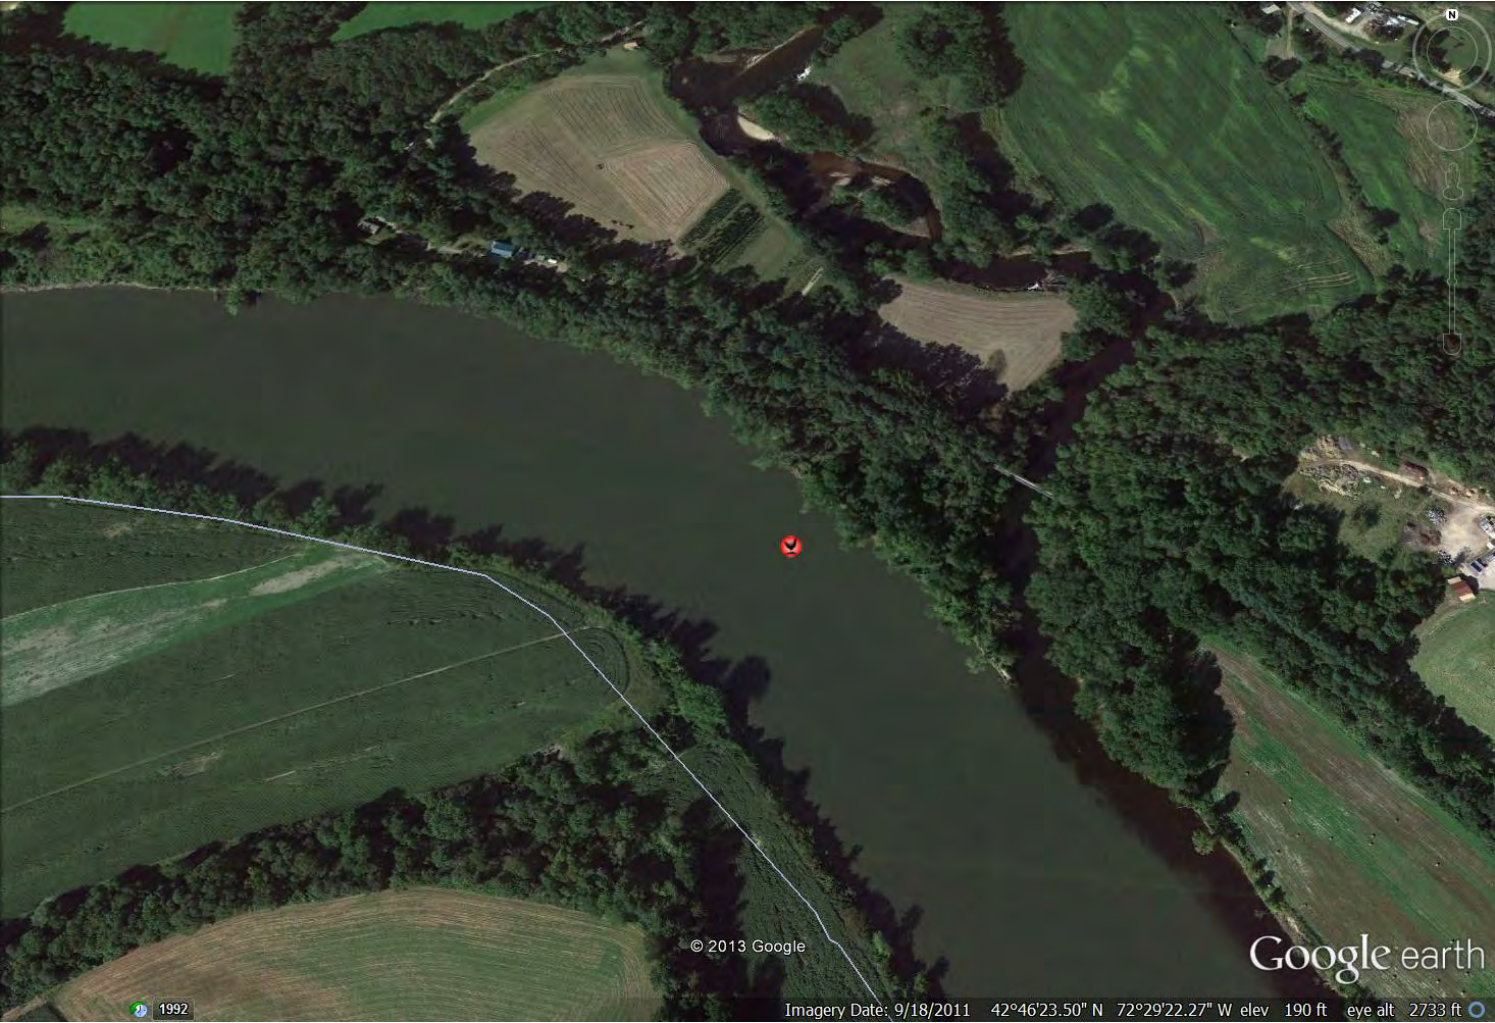
Photo 1564 Location

Segment 310 – Left Bank

Riverbank Features	Characteristics
Upper Riverbank Slope	Steep
Upper Riverbank Height	Medium
Upper Riverbank Sediment	Silt/Sand
Upper Riverbank Vegetation	Moderate
Lower Riverbank Slope	Flat/Beach
Lower Riverbank Sediment	Silt/Sand
Lower Riverbank Vegetation	None to very sparse
Type of Erosion	Slide
Potential Erosion Indicators	Other, Creep/leaning trees, Exposed roots, Overhanging bank
Stage of Erosion	Eroded
Extent of Erosion	Some

QA Observations: Upon review of the photos for this segment, classification made in the field was confirmed and additional indicators of potential future erosion were included.
