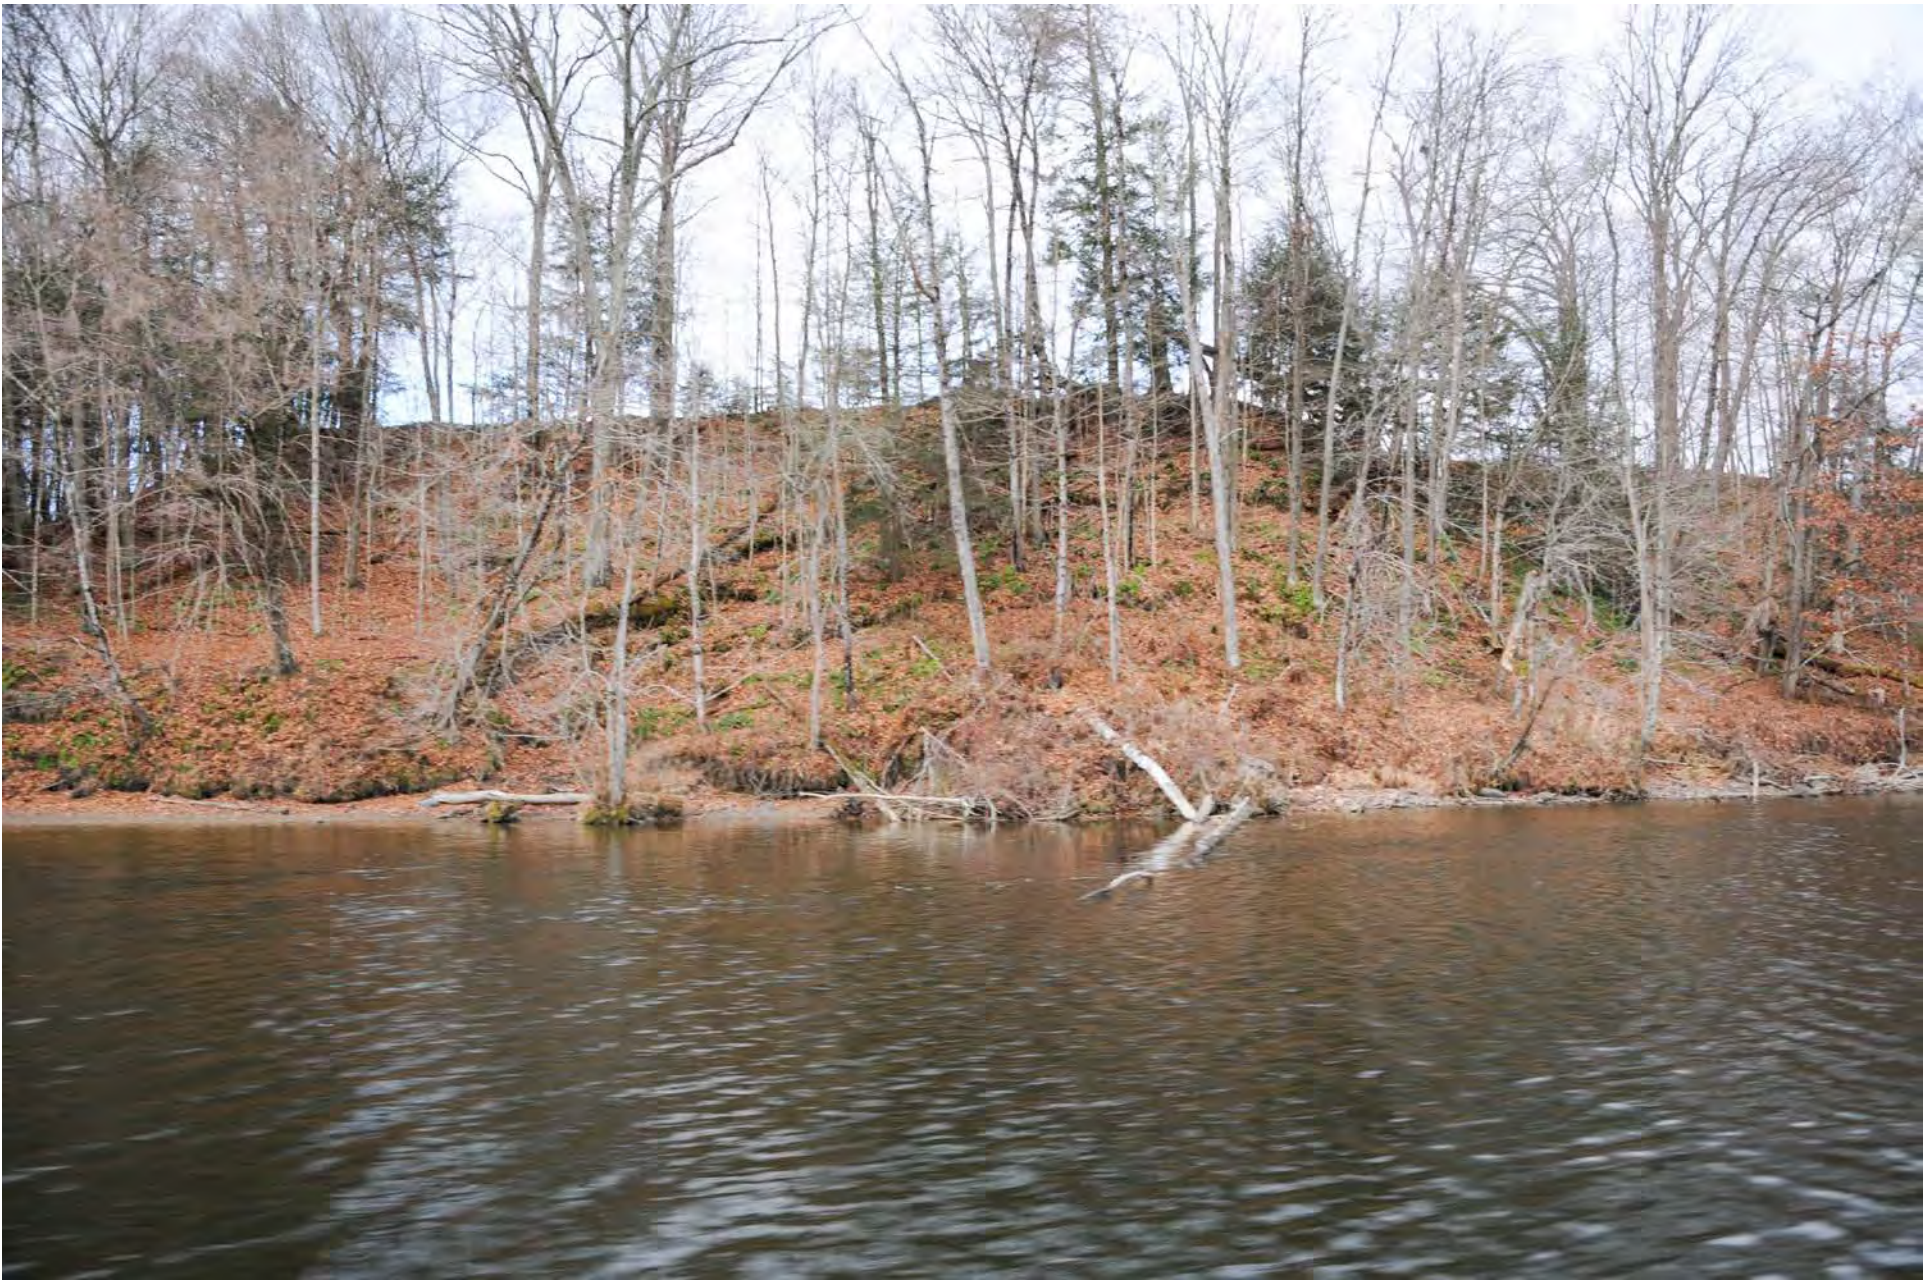
Photo ID 965 (D/S)

Riverbank Features	Characteristics
Upper Riverbank Slope	Moderate
Upper Riverbank Height	High
Upper Riverbank Sediment	Silt/Sand
Upper Riverbank Vegetation	Heavy
Lower Riverbank Slope	Flat/Beach
Lower Riverbank Sediment	Cobbles
Lower Riverbank Vegetation	None to very sparse
Type of Erosion	Undercut
Potential Erosion Indicators	Creep/Leaning trees, Exposed roots
Stage of Erosion	Stable
Extent of Erosion	None/Little

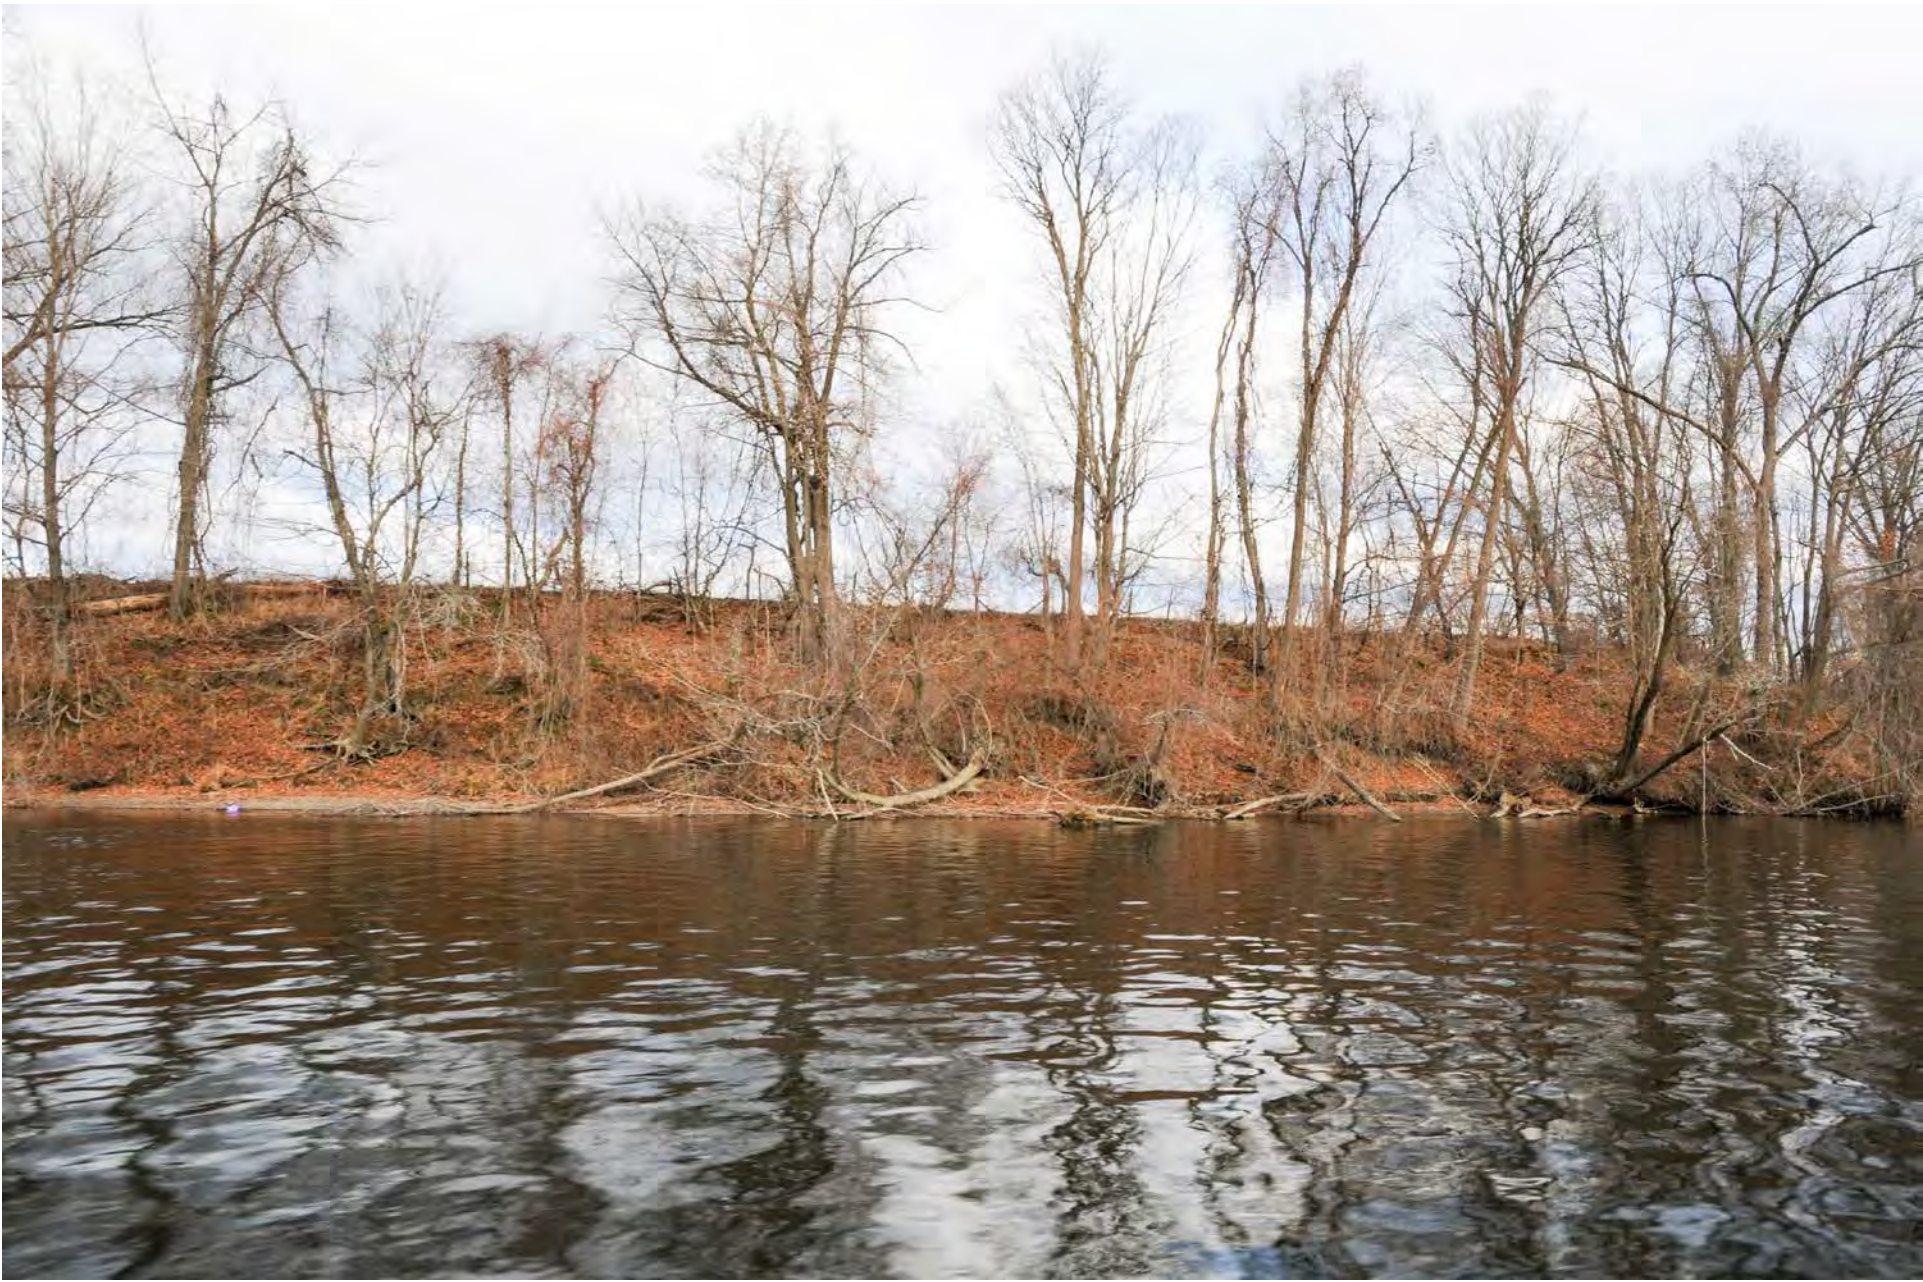
Photo ID 1035 (D/S)

Riverbank Features	Characteristics
Upper Riverbank Slope	Moderate
Upper Riverbank Height	High
Upper Riverbank Sediment	Silt/Sand
Upper Riverbank Vegetation	Heavy
Lower Riverbank Slope	Flat/Beach
Lower Riverbank Sediment	Silt/Sand
Lower Riverbank Vegetation	None to very sparse
Type of Erosion	Undercut
Potential Erosion Indicators	Creep/Leaning trees, Exposed roots
Stage of Erosion	Stable
Extent of Erosion	None/Little

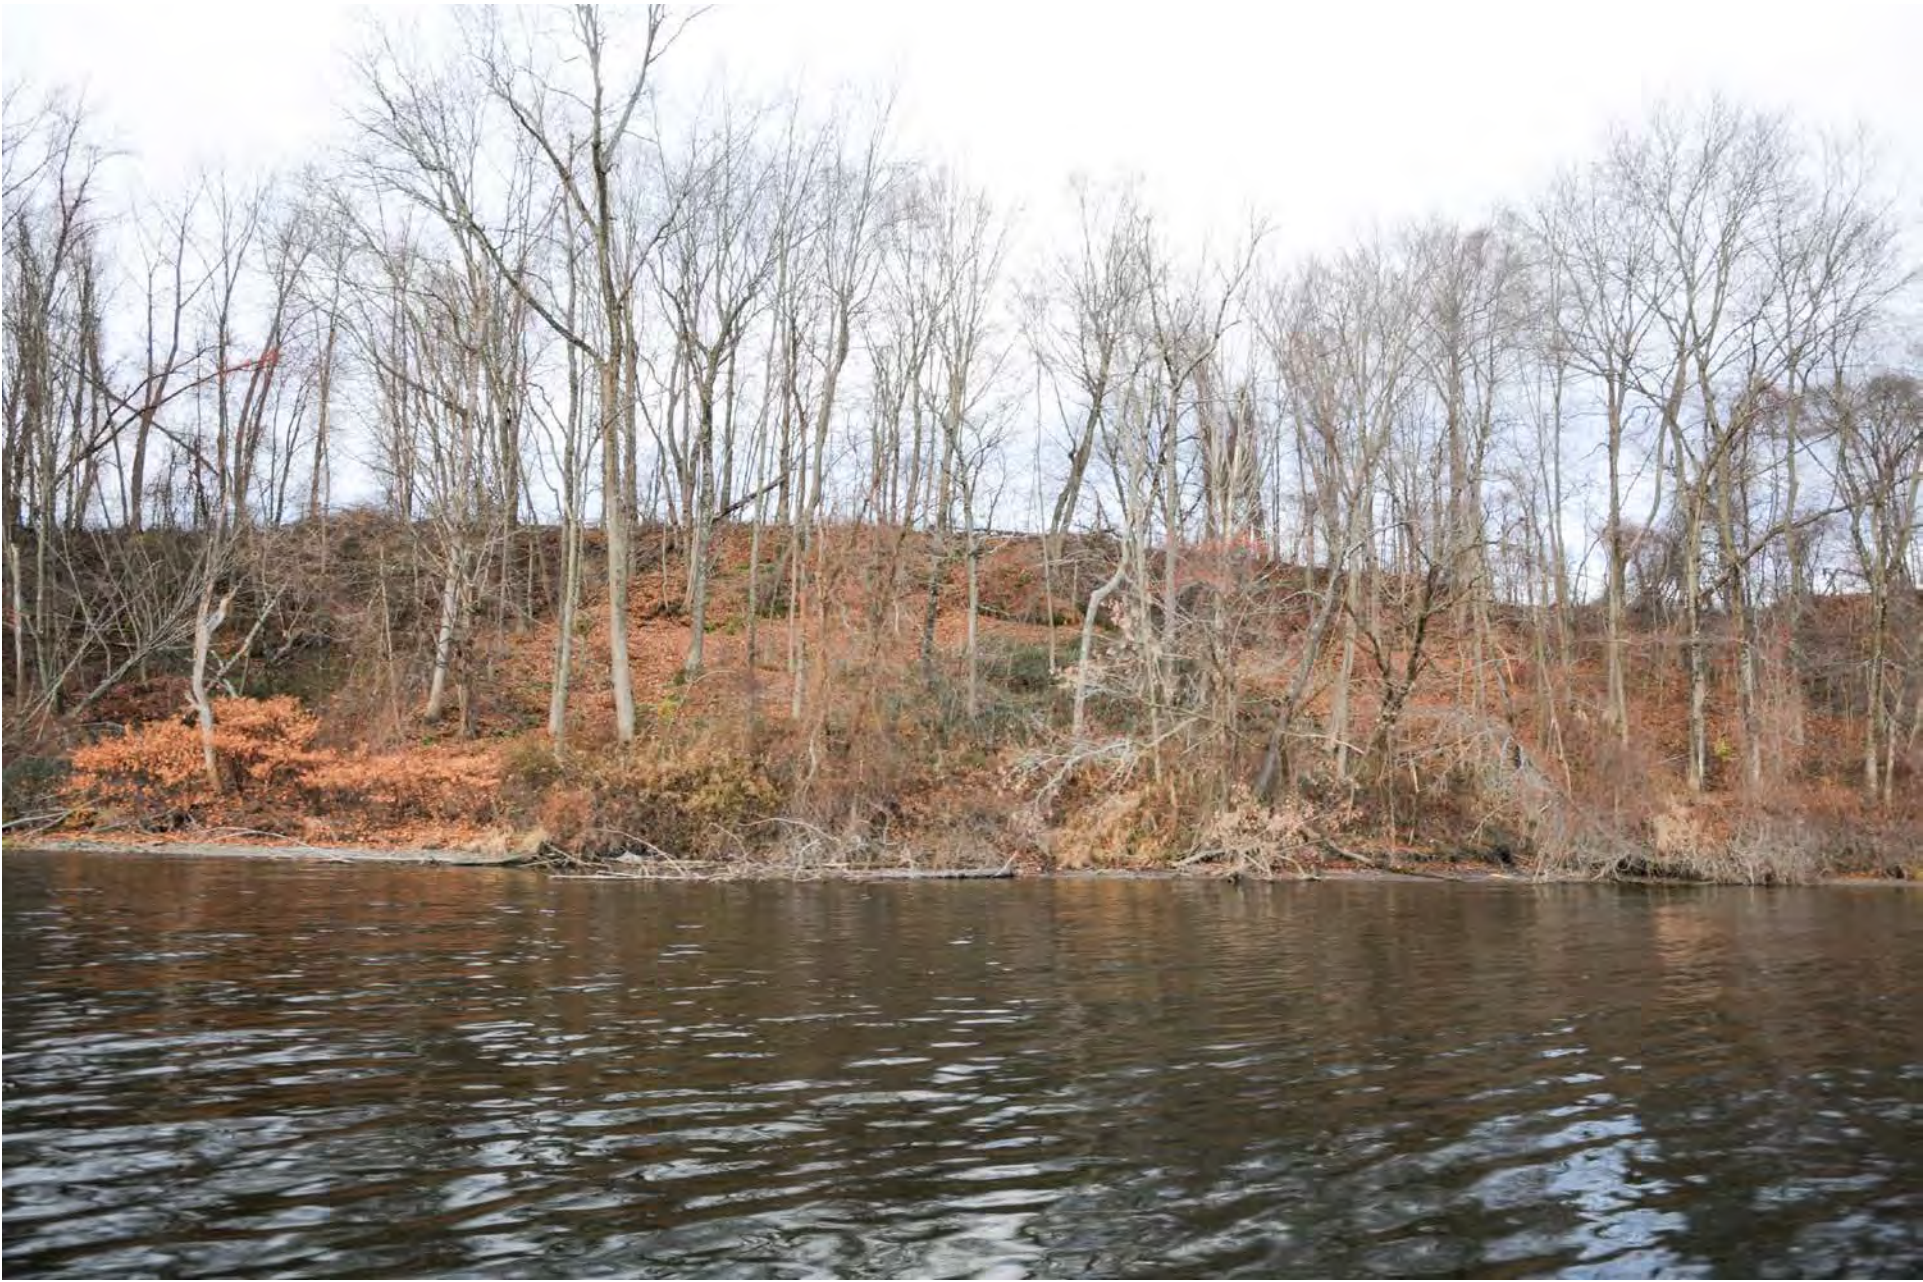
Photo ID 1064 (D/S)

Riverbank Features	Characteristics
Upper Riverbank Slope	Moderate
Upper Riverbank Height	High
Upper Riverbank Sediment	Silt/Sand
Upper Riverbank Vegetation	Heavy
Lower Riverbank Slope	Flat/Beach
Lower Riverbank Sediment	Silt/Sand
Lower Riverbank Vegetation	None to very sparse
Type of Erosion	Undercut
Potential Erosion Indicators	Creep/Leaning trees, Exposed roots
Stage of Erosion	Stable
Extent of Erosion	None/Little

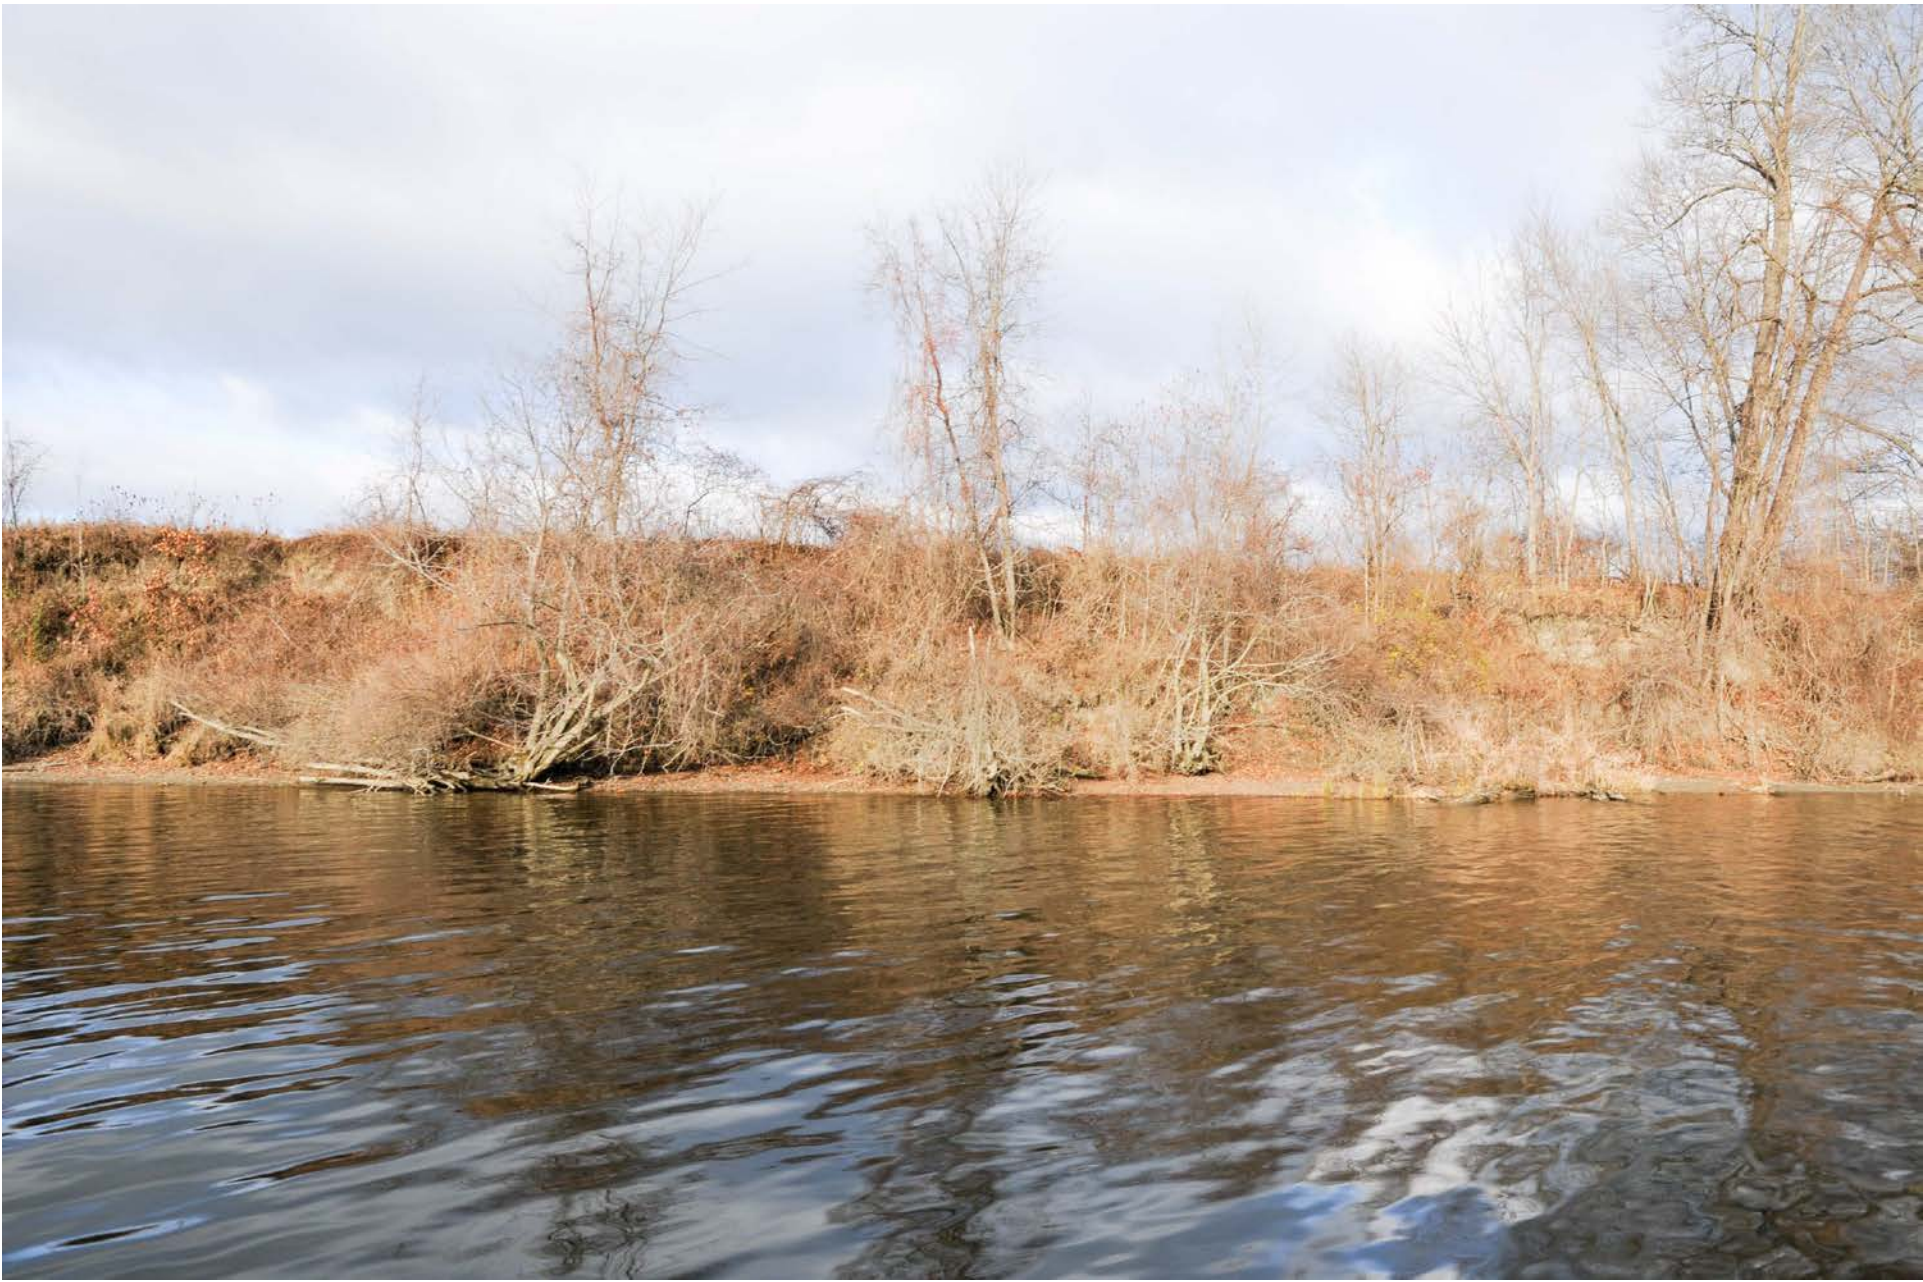
Photo ID 1090 (D/S)

Riverbank Features	Characteristics
Upper Riverbank Slope	Overhanging
Upper Riverbank Height	High
Upper Riverbank Sediment	Silt/Sand
Upper Riverbank Vegetation	Heavy
Lower Riverbank Slope	Flat/Beach
Lower Riverbank Sediment	Silt/Sand
Lower Riverbank Vegetation	None to very sparse
Type of Erosion	Slide
Potential Erosion Indicators	Overhanging bank, Exposed roots, Creep/leaning trees
Stage of Erosion	Eroded
Extent of Erosion	Some

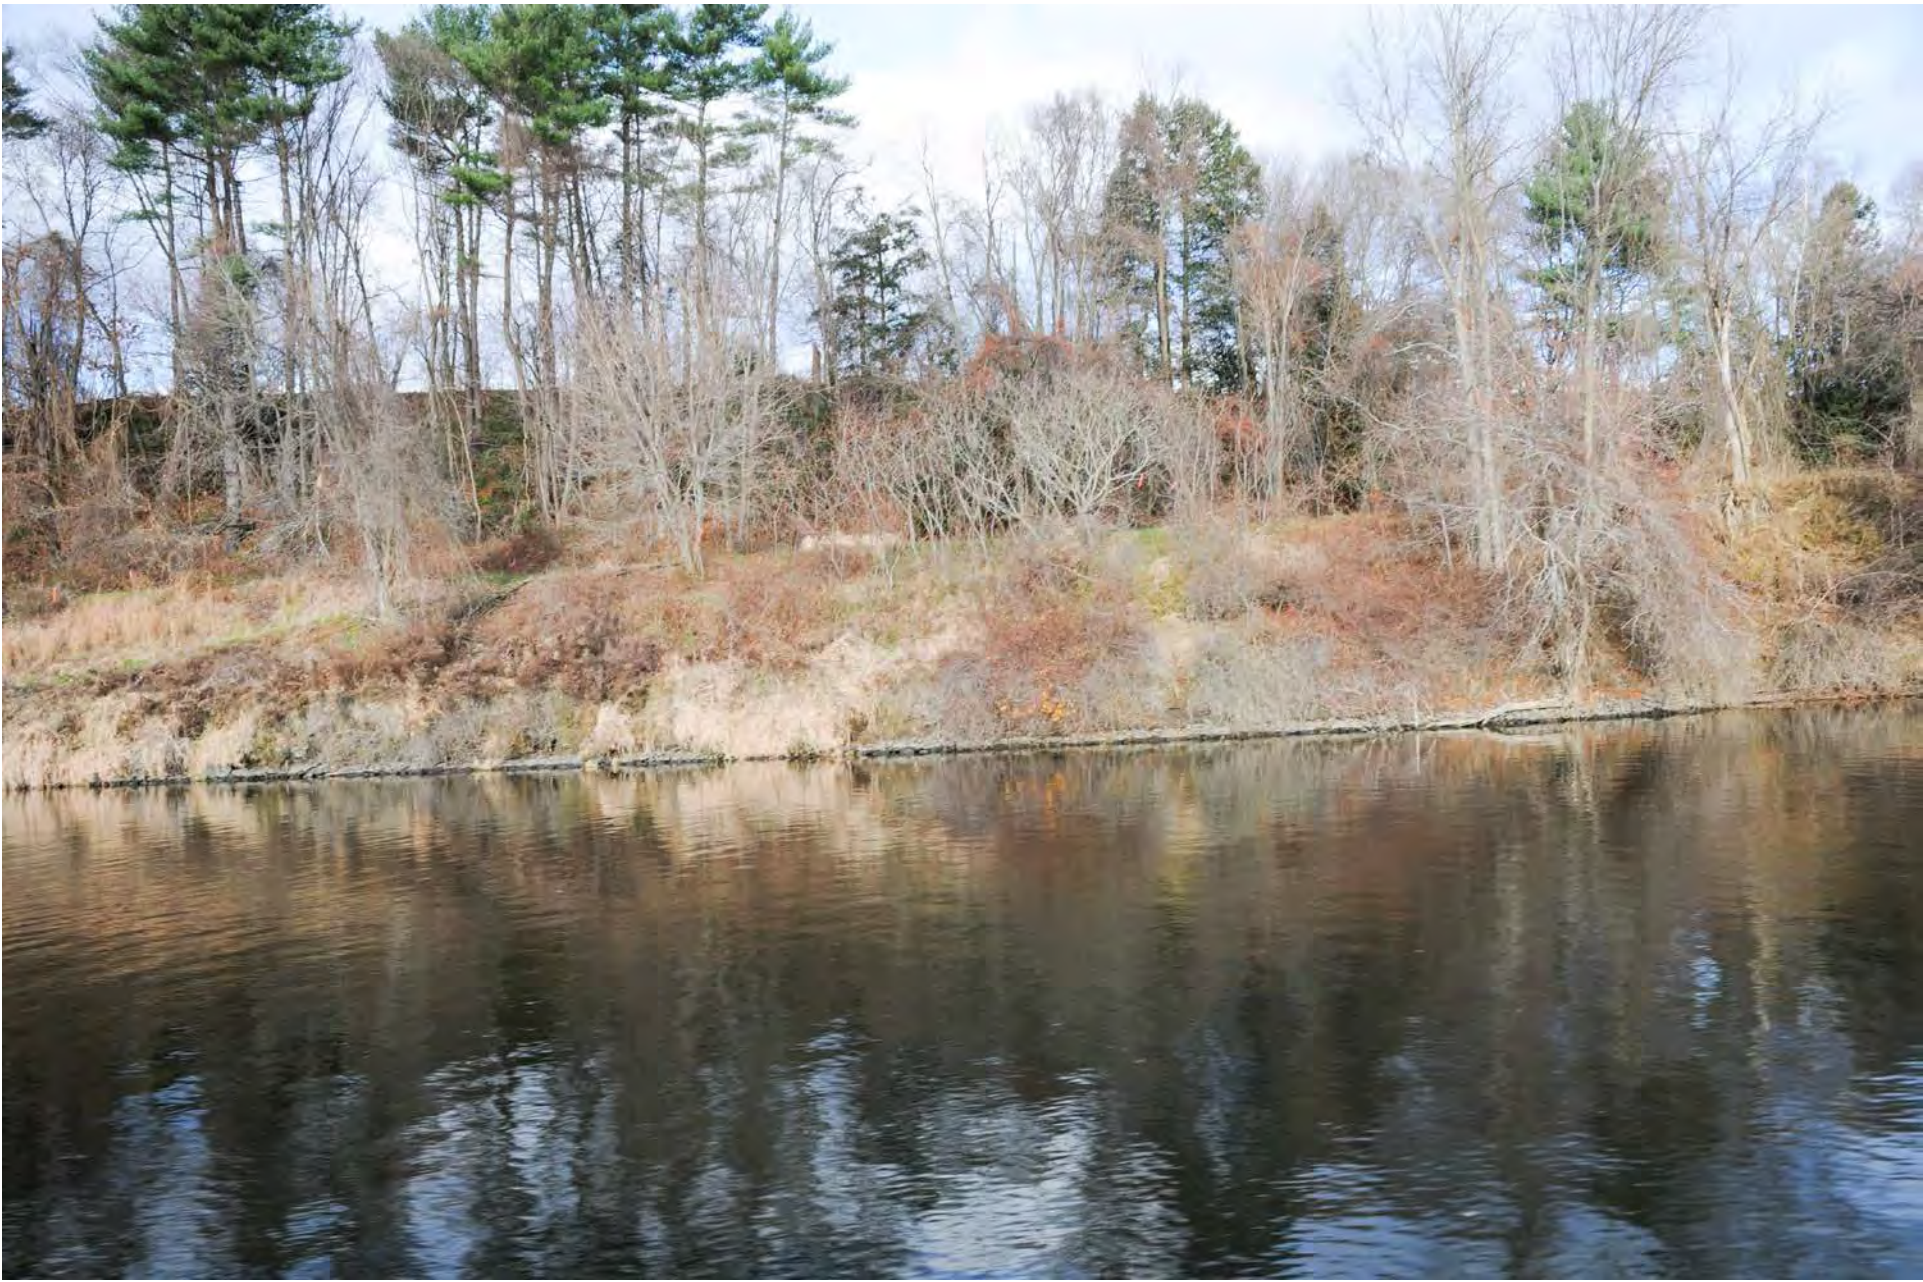
Photo ID 1156 (U/S)

Riverbank Features	Characteristics
Upper Riverbank Slope	Moderate
Upper Riverbank Height	High
Upper Riverbank Sediment	Silt/Sand
Upper Riverbank Vegetation	Heavy
Lower Riverbank Slope	Moderate
Lower Riverbank Sediment	Cobbles
Lower Riverbank Vegetation	None to very sparse
Type of Erosion	
Potential Erosion Indicators	None
Stage of Erosion	Stable
Extent of Erosion	None/Little
