Riverbank Erosion Comparison along the Connecticut River

October 2012

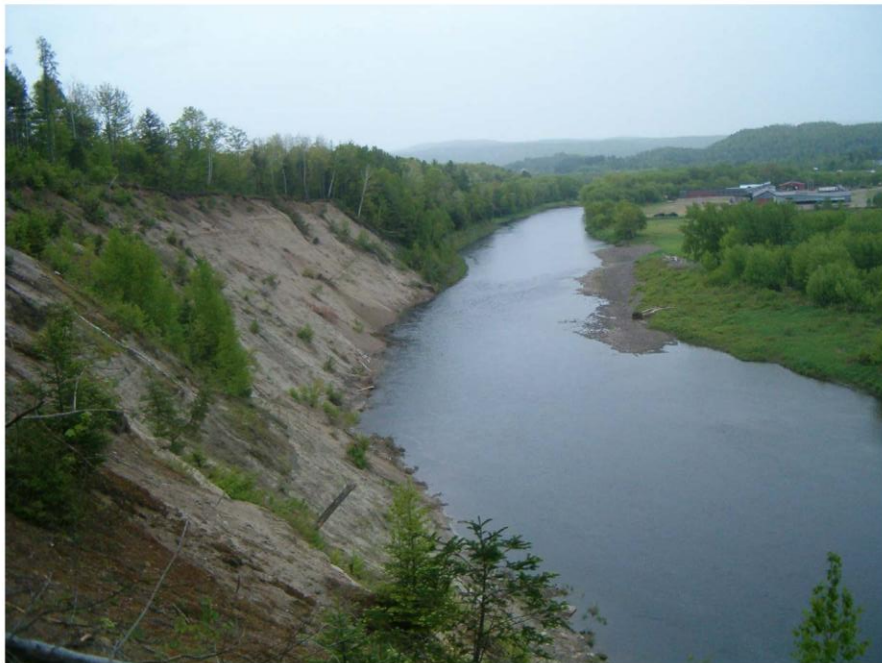
Figure 6. Erosion of glacial outwash deposit (after Field, 2004)

High Eroding Bank of Glacial Outwash Deposits – Reach 8

Note: Near Brunswick Springs, VT

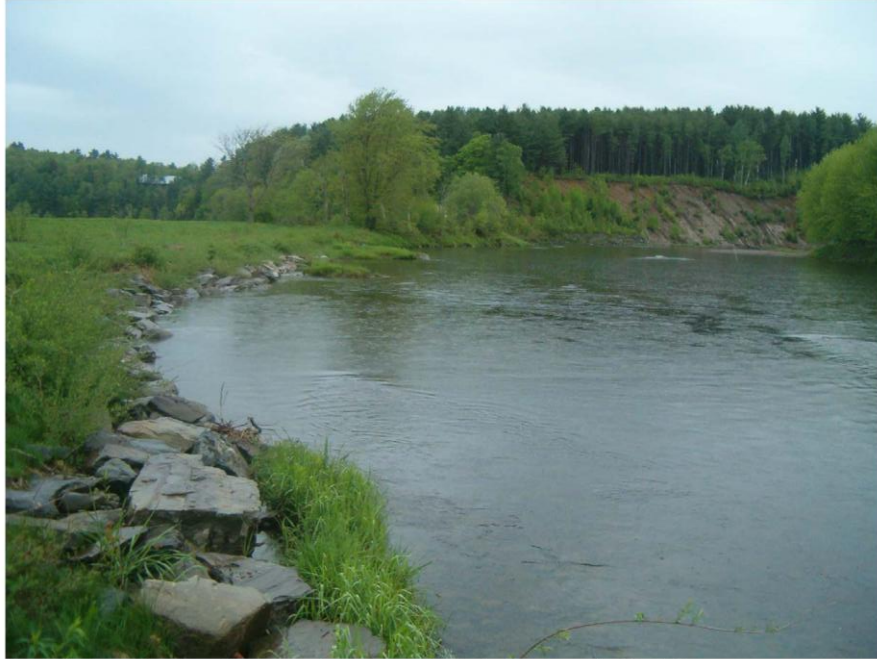
Figure 7. Erosion due to bar formation (after Field, 2004)

Scalloped Bank Line Due to Erosion by Flow Diverted Around Mid - Channel Bar

Note: Mid - channel bar migrated downstream after riprap was placed on bank to stop erosion (Reach 8)

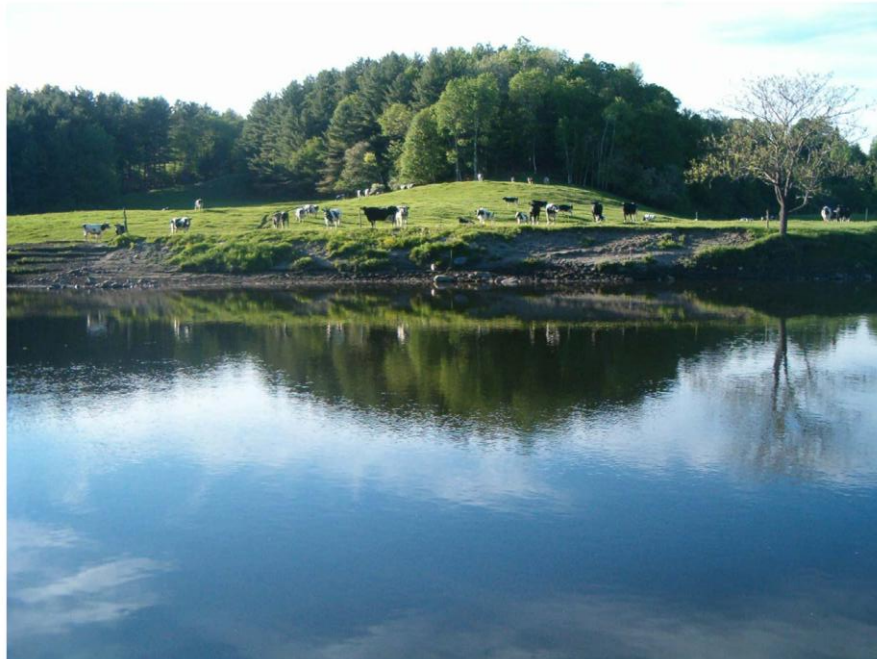
Figure 8. Erosion due to agricultural practices (after Field, 2004)

Agricultural Practices Decreasing Bank Stability – Reach 13

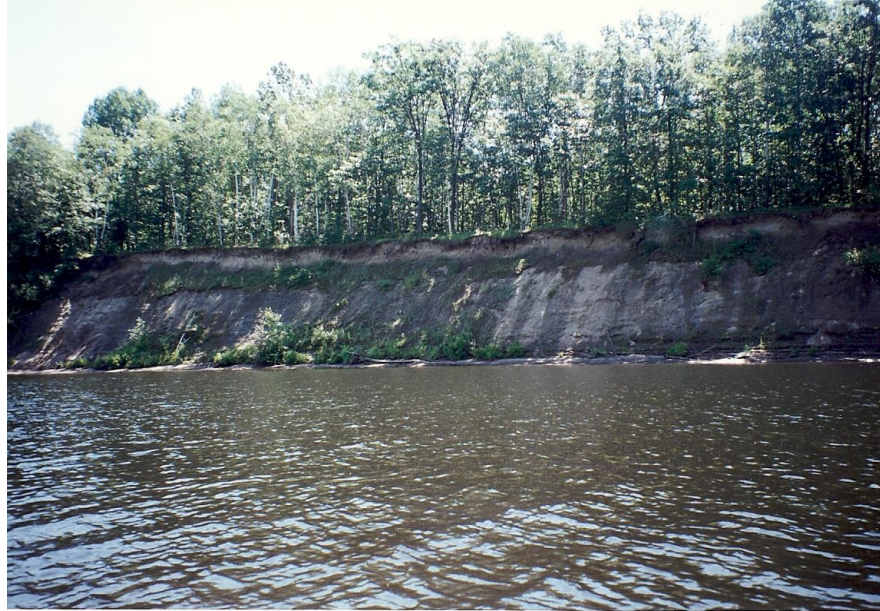
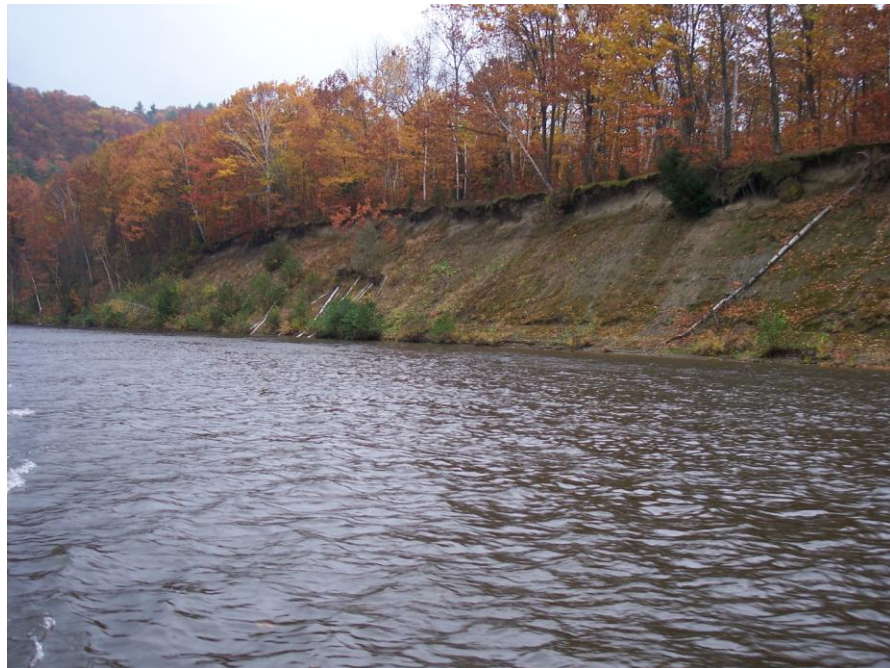
Figure 12. Riverbank erosion comparison, Bellows Falls Impoundment – Location 8

Bellows Falls Pool – Location 8

- While some localized riverbank stabilization exists, almost all erosion sites identified in 1997 appeared to be in essentially the same condition in 2008 indicating that these sites of significant erosion continue to experience erosion.

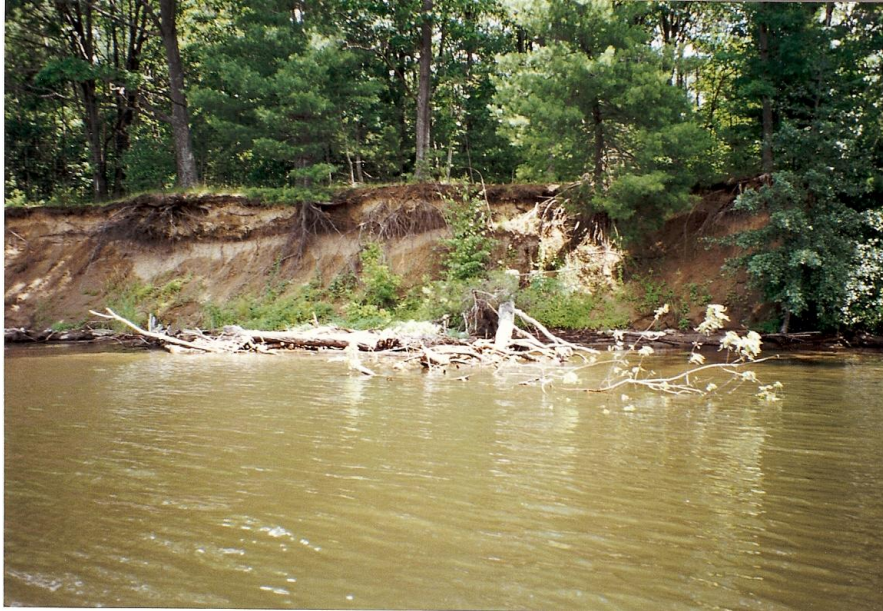
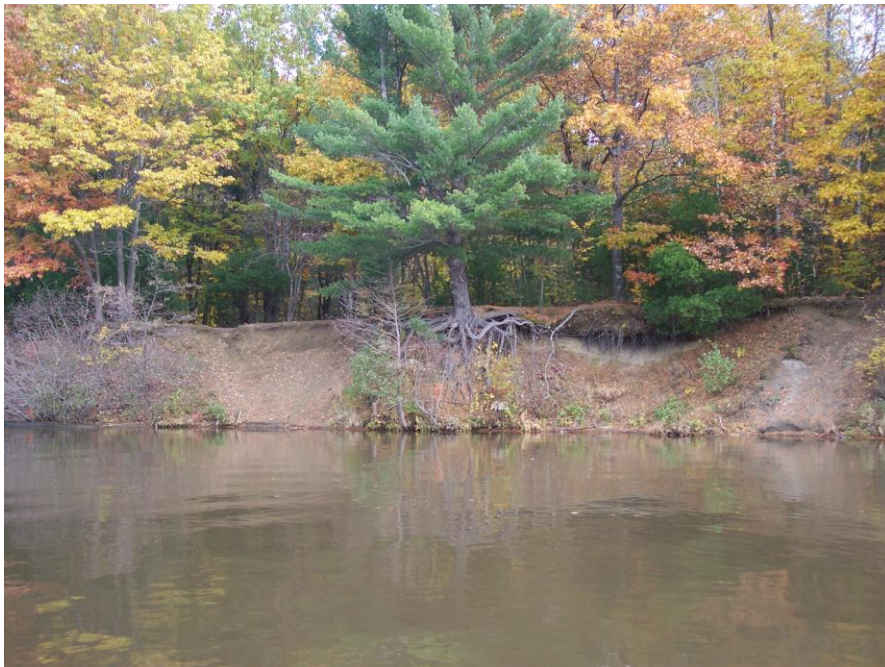
Figure 14. Riverbank erosion comparison, Vernon Impoundment, 1997-2008, Location I

Similar to the Bellows Falls Impoundment, erosion sites along the Vernon Impoundment were also photographed in 1997 and again in 2008. The locations of the erosion sites and images of the sites are shown in Figure 13. Figure 14 presents a comparison of erosion at a location in the Vernon Impoundment in 1997 and 2008, and shows that there are similar erosion and riverbank characteristics over this decade (see Appendix E for a comparison of photos of erosion sites from 1997 to 2008 in the Vernon Impoundment). The various sites that had documented erosion in 1997 were still eroding in 2008. While no evaluation of the extent or percentage of riverbanks experiencing erosion is available, geo-referenced video tapes were taken to document riverbank conditions for this reach of river in 2008.

Vernon Pool – Location I

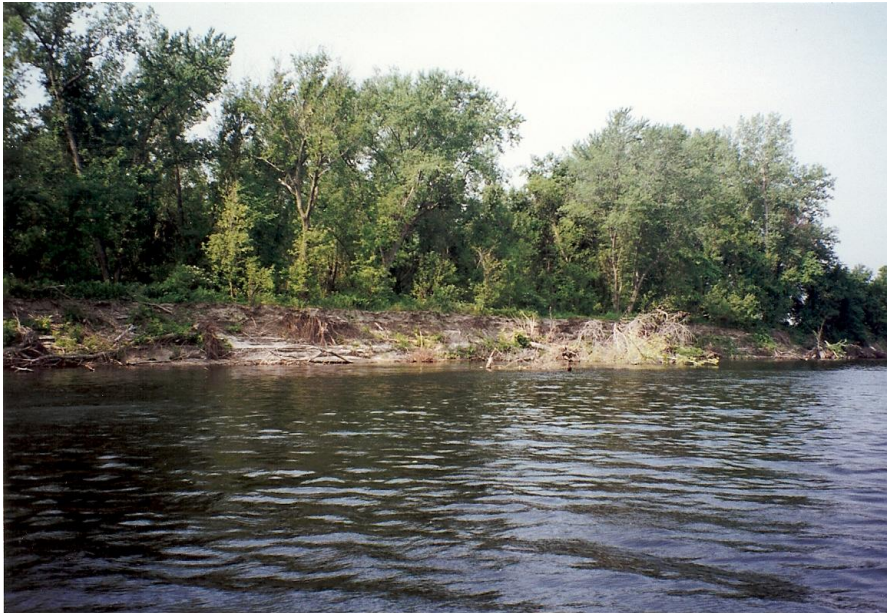
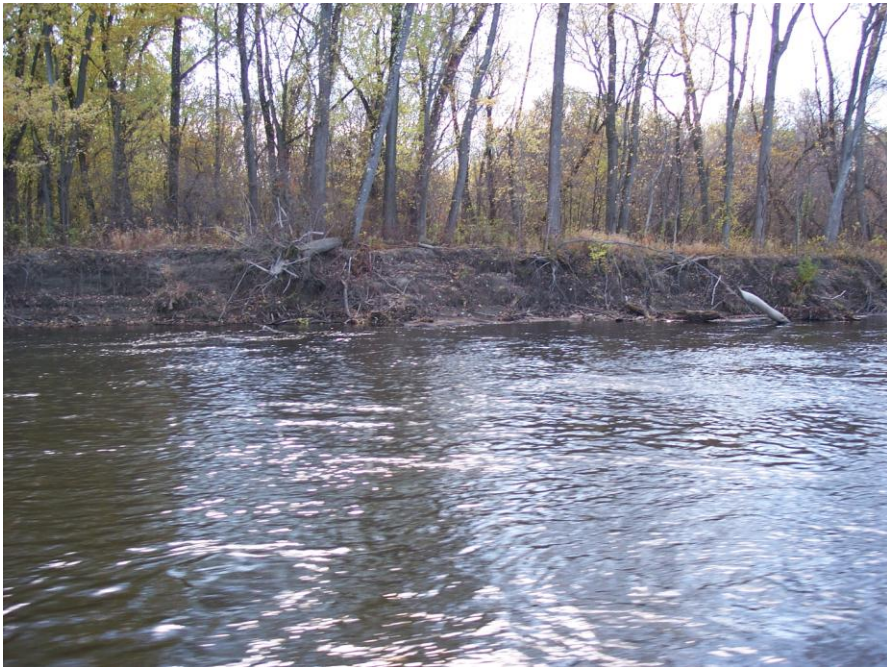
Figure 20. Riverbank Erosion Holyoke Impoundment, Site D 1997-2008

Erosion sites identified in the Holyoke Impoundment were photographed in 1997 and again in 2008. The locations of the erosion sites are shown in Figure 19. An example of riverbank erosion in the Holyoke Impoundment from 1997 to 2008 is shown in Figure 20. The extent and severity of erosion is similar and has continued over this 11-year time period (see Appendix J for a comparison of photos of the various erosion sites from 1997 to 2008 in the Holyoke Impoundment). The various sites eroding in 1997 were still eroding in 2008. While no evaluation of the extent or percentage of riverbanks experiencing erosion is available, geo-referenced video tapes were taken to document riverbank conditions for this reach of river in 2008.

Holyoke Pool – Location D

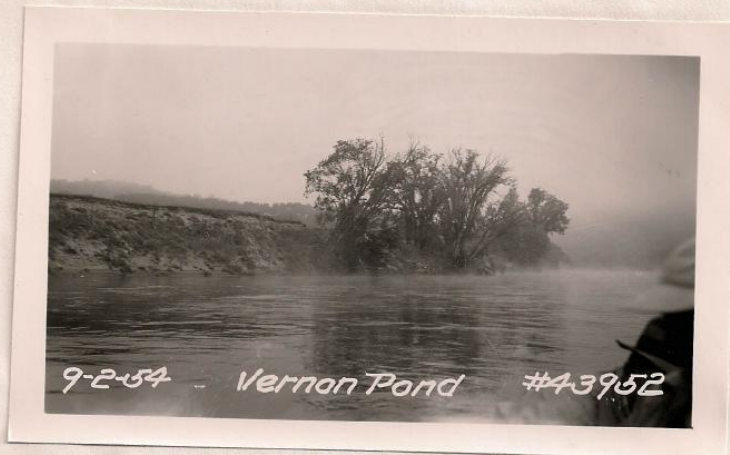
Picture No. 43952

Vt. bank
Mile 30.5
W. S. Powers
V-409

Looking upstream

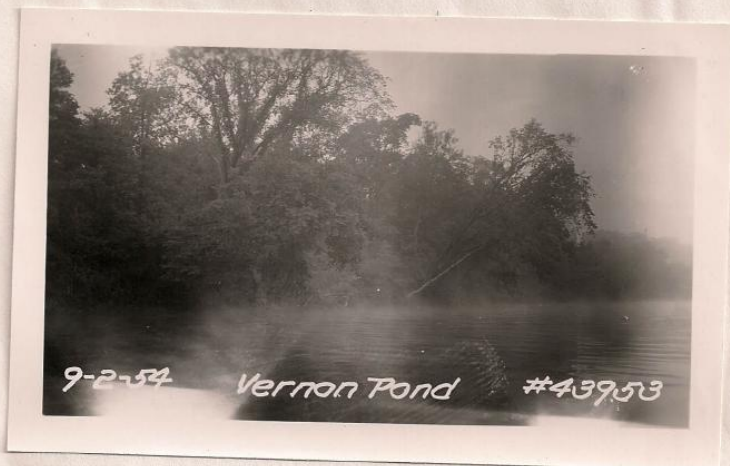
Picture No. 43953

Vt. bank
Mile 28.35
Abenague Machine Co.
V-395

Looking upstream

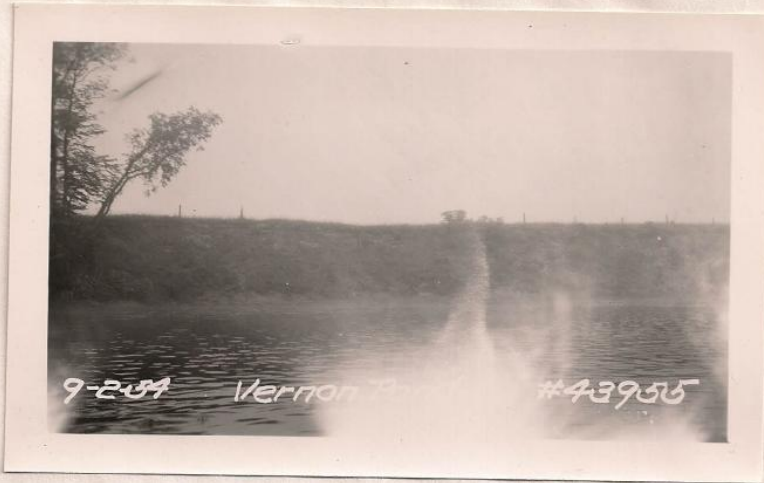
Picture No. 43955

Vt. bank
Mile 28.0
Anders Nelson
V-394

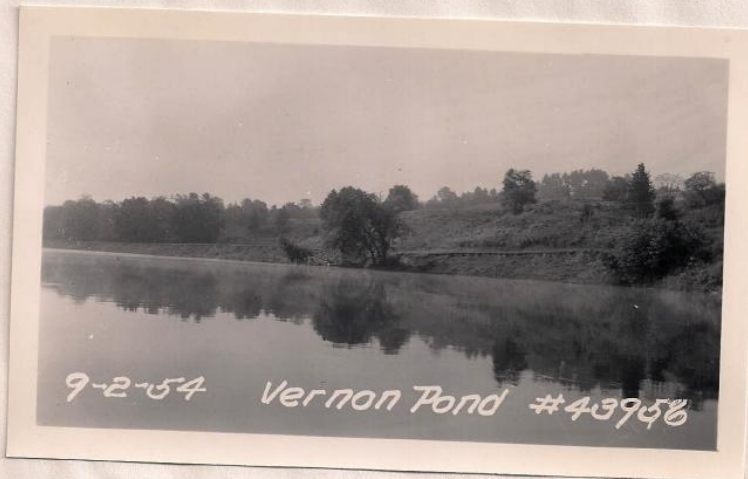
Picture No. 43956

Vt. bank
Mile 25.0
John Trybulski
V-381

Looking downstream
(upper end of property)

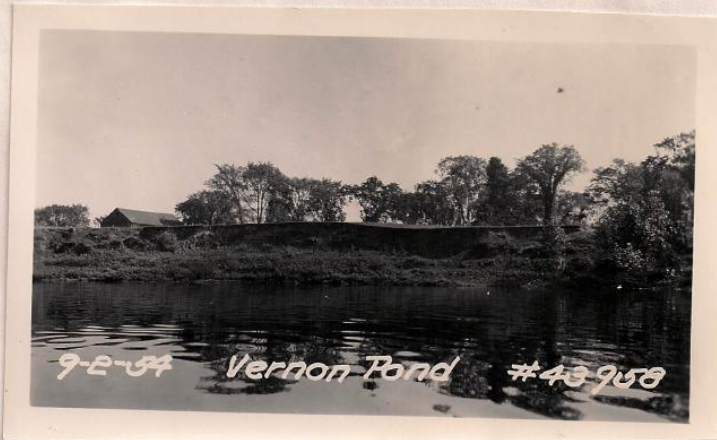
Picture No. 43958

N. H. bank
Mile 24.5
Fanny Mason
V-431

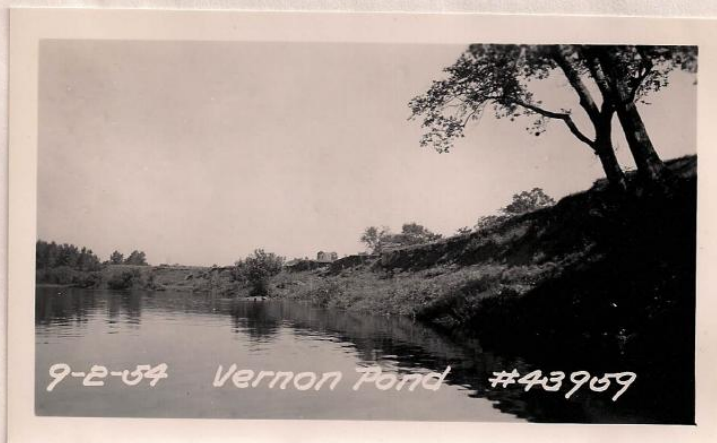
Picture No. 43959

Same
Looking upstream
(From mouth of Great Brook)

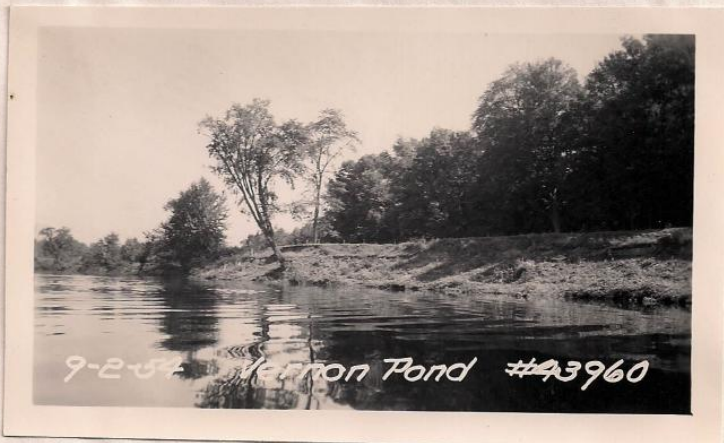
Picture No. 43960

N. H. bank
Mile 24.0
E. B. Knapp
V-429

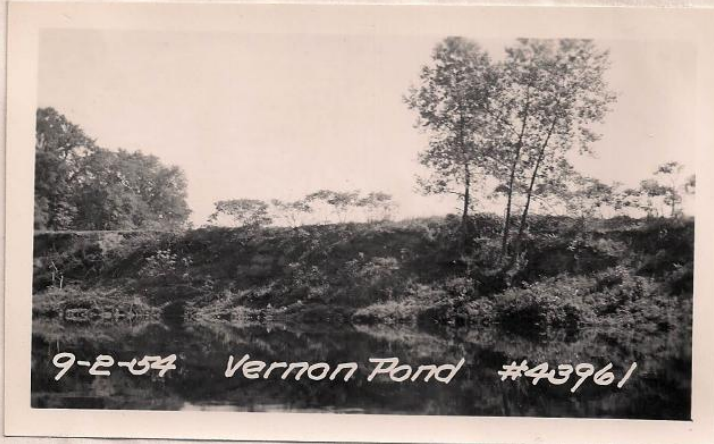
Picture No. 43961

N. H. bank
Mile 23.2
S. J. Chickering
V-425

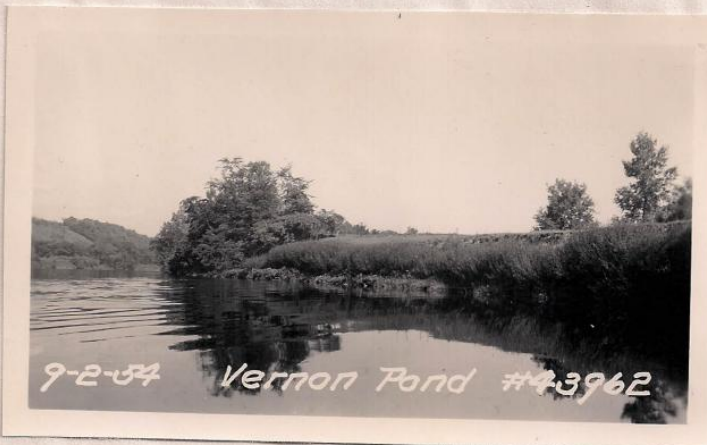
Picture No. 43962

N. H. bank
Mile 23.0
Same

(above Houghton Brook)

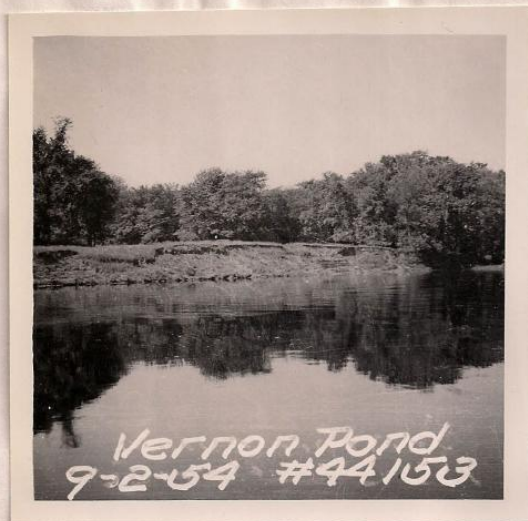
Picture No. 44153

Vt. bank Mile 22.5
E. T. Hubbard V-338
Looking upstream
(Just below mouth of Chase brook)

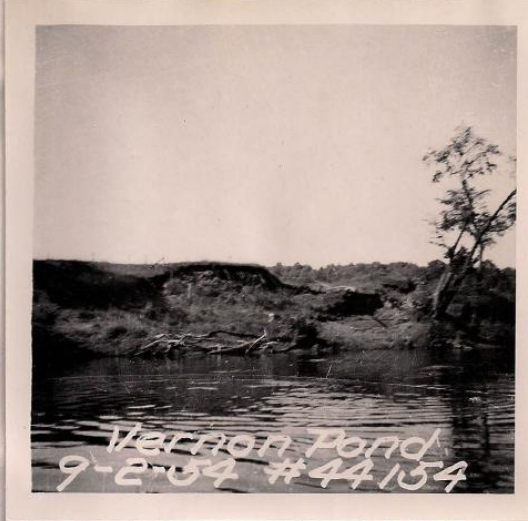
Picture No. 44154

The banks below the mouth of Chase Brook had not changed and at this flow the large gully at the head of "The Meadows" contained water. This is the gully caused by the swirl pool in the 1936 flood.

Vt. bank Mile 22.4
Same
Looking at bank below mouth to
gully caused by swirl pool

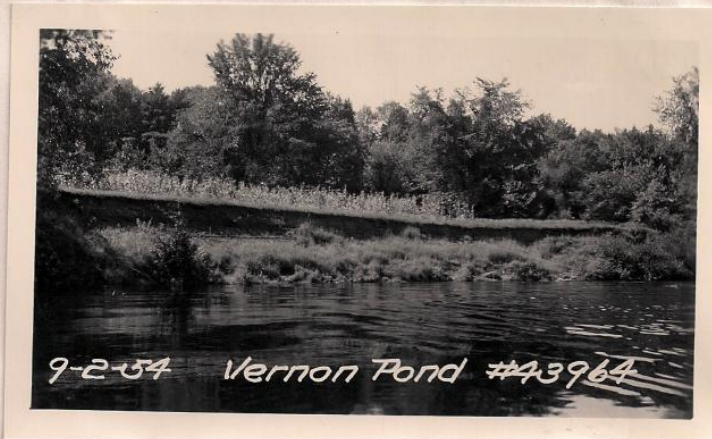
Picture No. 43964

N. H. bank
Mile 20.9
S. J. Chickering
V-243

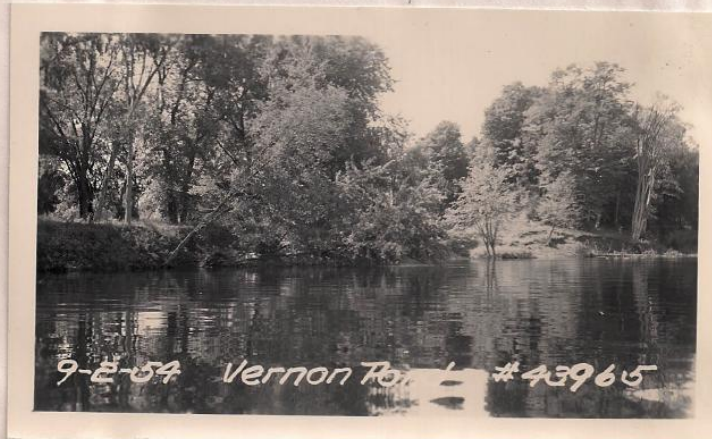
Picture No. 43965

N. H. bank
Mile 20.7
Peter P. Action
V-241

(Formerly C. M. Moore)

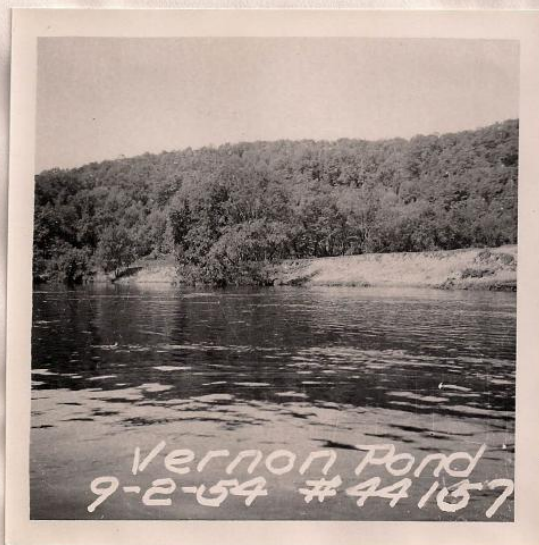
Picture No. 44157

Vt. bank
Mile 20.6
E. T. Hubbard
V-337

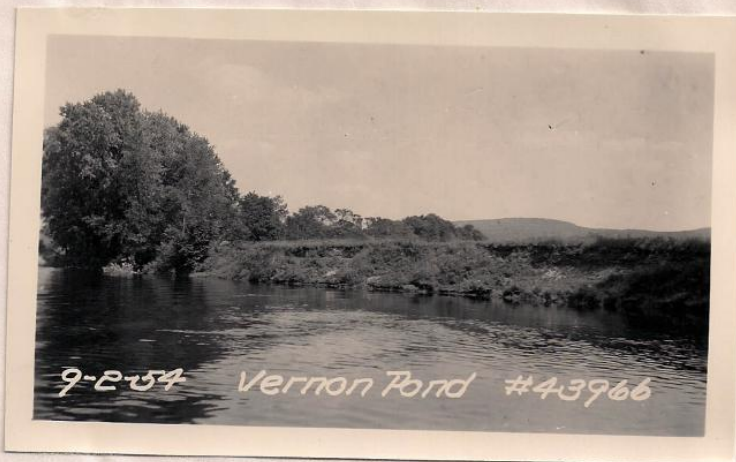
Picture No. 43966

N. H. bank
Mile 20.2
P. P. Action
V-241

Looking upstream

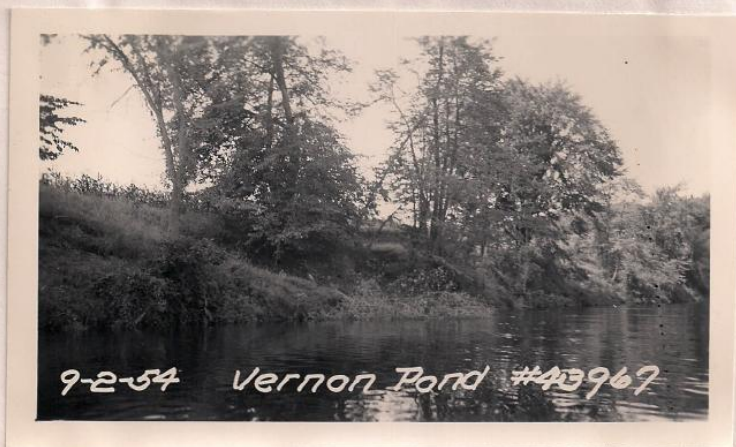
Picture No. 43967

Vt. bank
Mile 19.6
H. W. Frost
V-335

Looking upstream

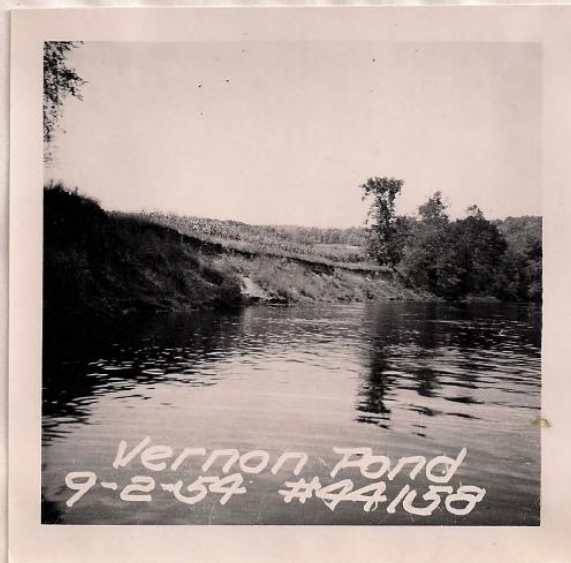
Picture No. 44158

Vt. bank
Mile 19.5
H. W. Frost
V-335

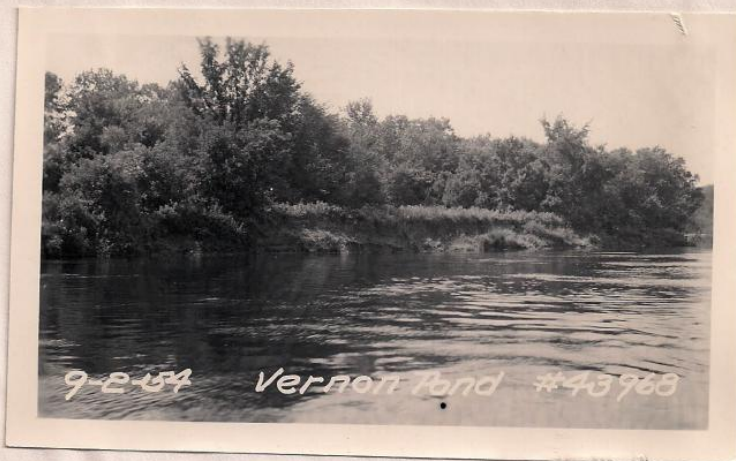
Picture No. 43968

The meadow bank below the brook mouth is quite active with large sods having broken off recently. See picture No. 43968 page 4-D, looking upstream.

Vt. bank
Mile 19.2
H. W. Frost
V-333

Looking upstream
(below E. Putney Brook)

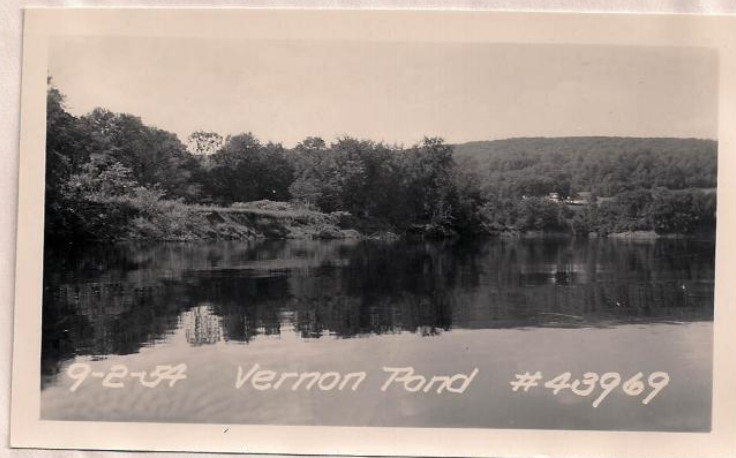
Picture No. 43969

The high slide reported at lower end of V-236, upon further inspection was found to be about on the property line and mostly below it.

N. H. bank
Mile 17.8
Cheshire County Farm
V-236

(formerly Blood property
below Ox Brook)

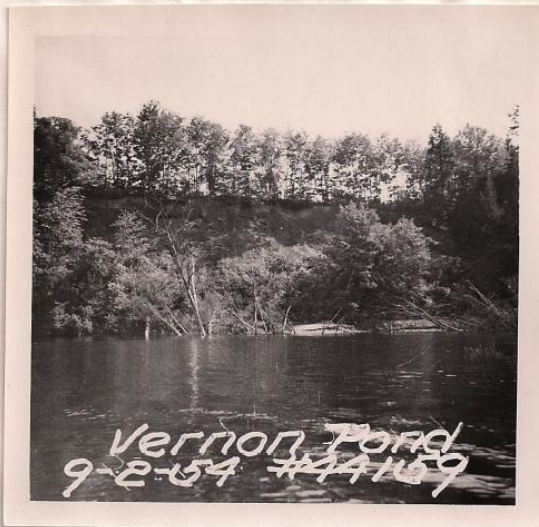
Picture No. hh159

N. H. bank Mile 17.4
O. H. Moore V-235

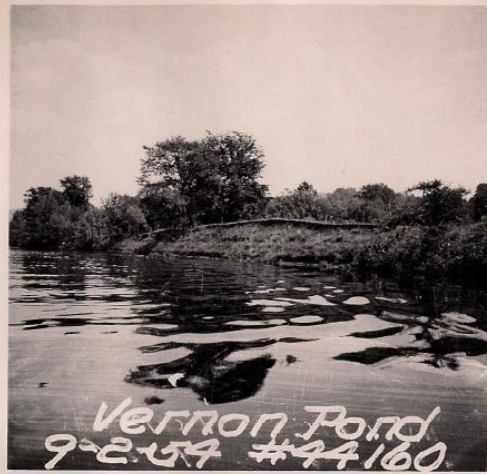
Picture No. hh160

N. H. bank Mile 16.2
S. B. Lund V-232

Looking upstream

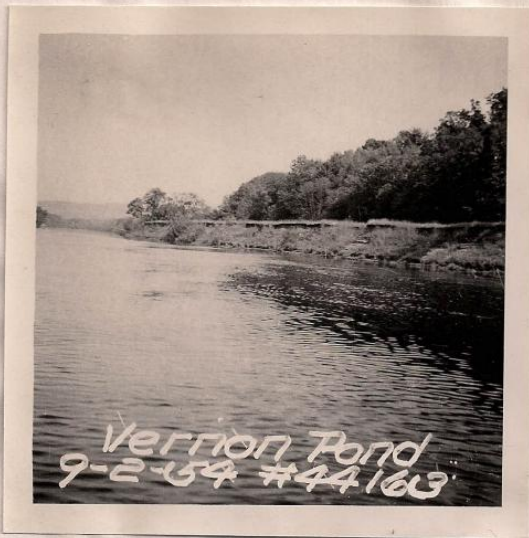
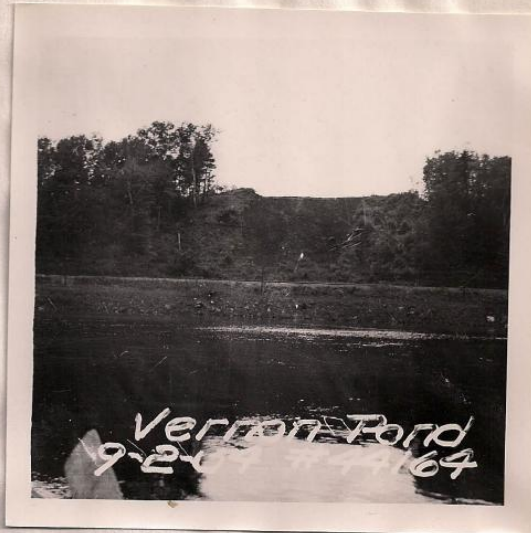
N. H. bank Mile 15.6
L. W. Churchill V-231
(opposite Putney Station)

Vt. bank Mile 14.2
Vt. Valley R.R. V-284
(above Canoe Brook)

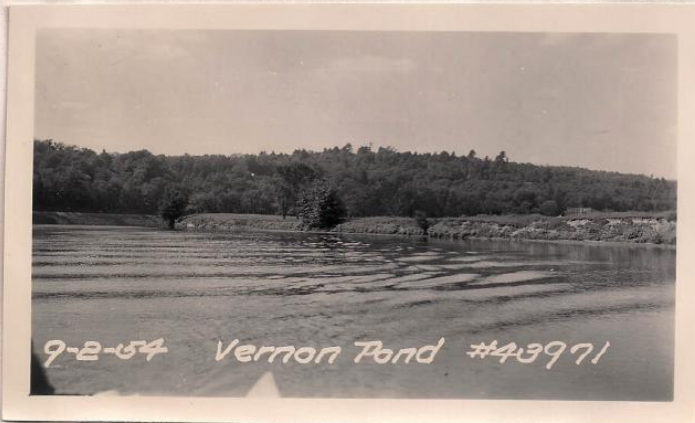
Picture No. 43971

N. H. bank
Mile 14.0
L. W. Churchill
V-226

(opposite Canoe Brook)

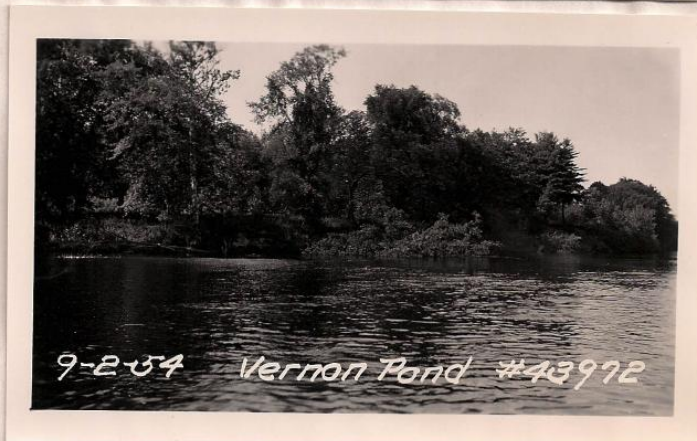
Picture No. 43972

Vt. bank
Mile 13.2
A. M. Bennett
V-283

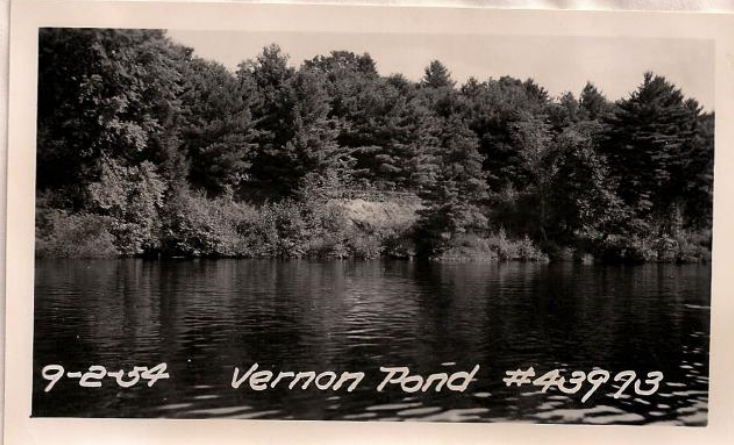
Picture No. 43973

N. H. bank
Mile 12.95
E. J. Willette
V-197

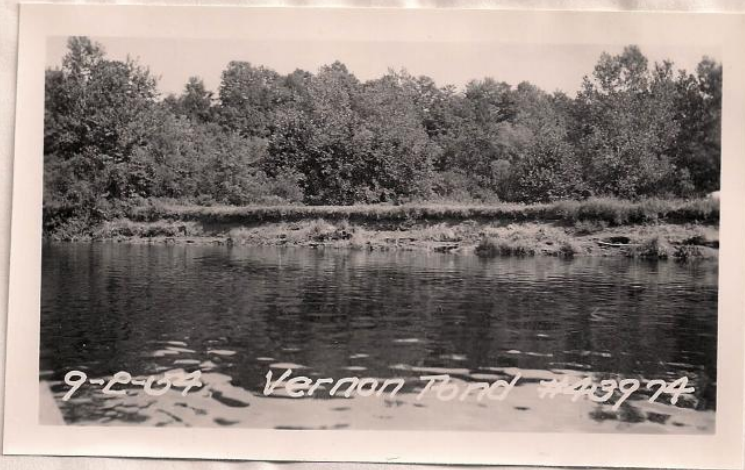
Picture No. 43974

N. H. bank
Mile 11.5
C. T. Chase
V-191

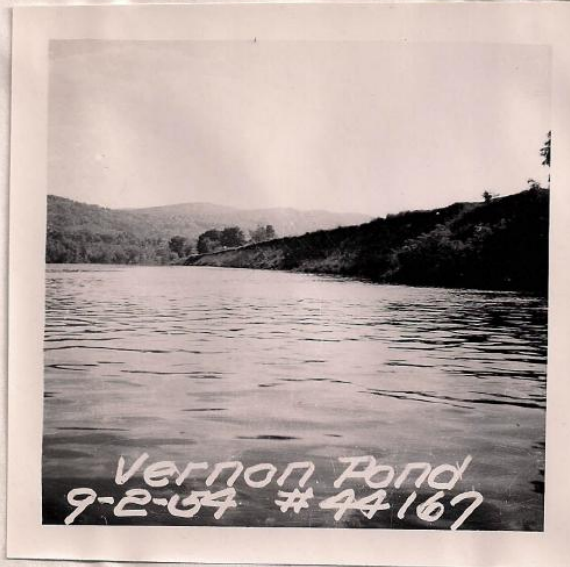
Picture No. 44167

Vt. bank
Mile 10.7
R. M. Peltier
V-275

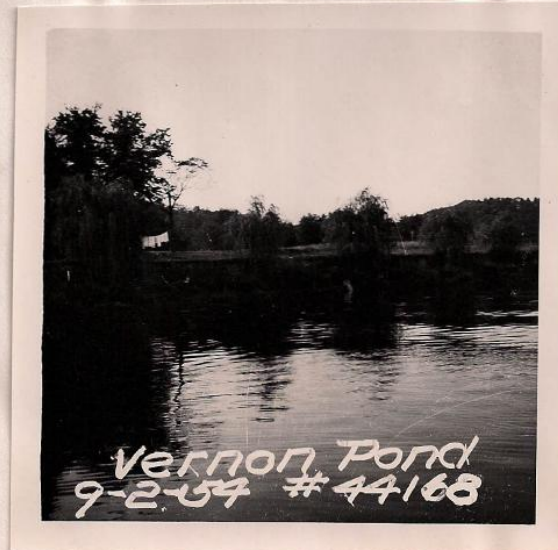
Picture No. 44168

Vt. bank
Mile 10.4
H. M. Chatterton, Jr.
V-275

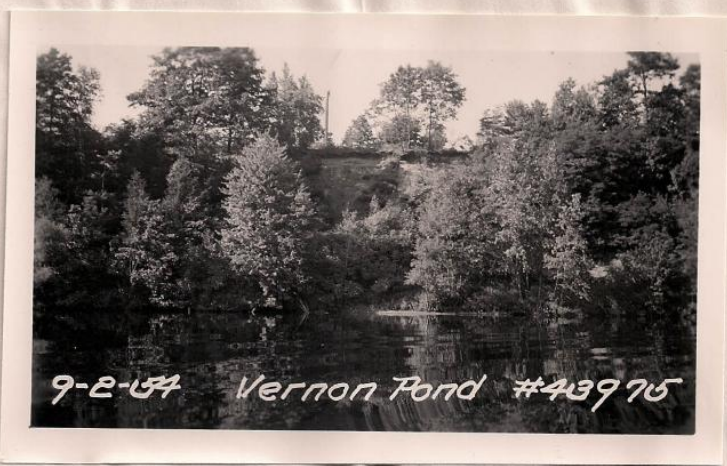
Picture No. 43975

Vt. bank
Mile 9.0
American Optical Co.
V-86

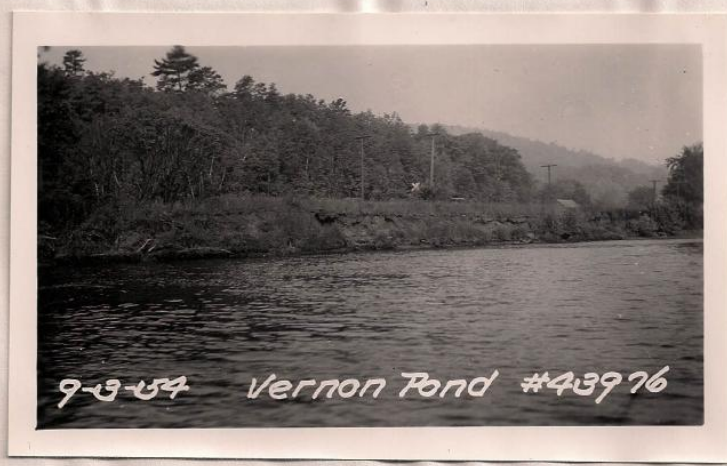
Picture No. 43976

Vt. bank
Mile 4.4
Woodward Lumber Co.
V-23

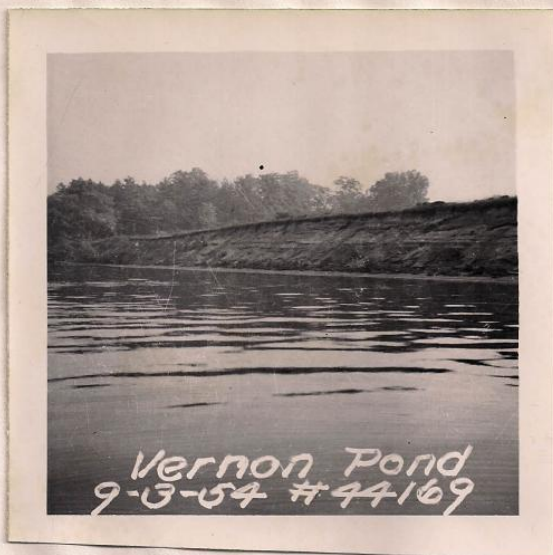
Picture No. 44169

N. H. bank Mile 3.9
Conn. River R.R. V-115

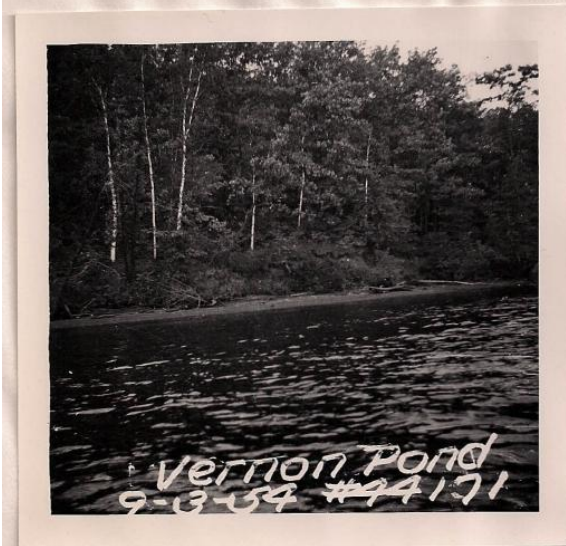
Picture No. 44171

Vt. bank Mile 3.35
C.V.R.R. V-20

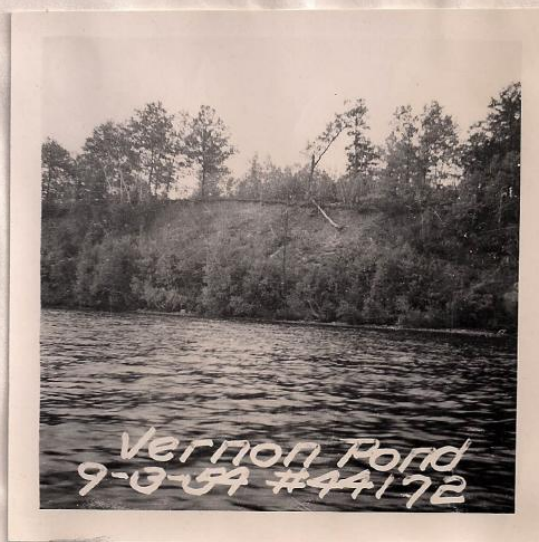
Picture No. 44172

Vt. bank Mile 3.2
Same

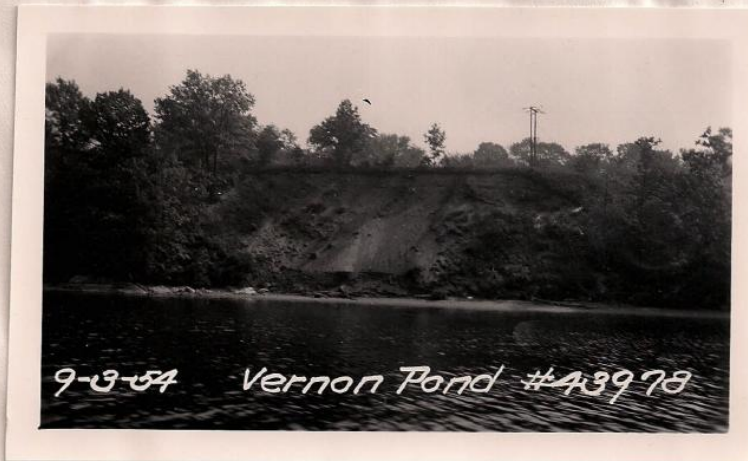
Picture No. 43978

N. H. bank
Mile 0.6
Conn. River R.R.
V-101

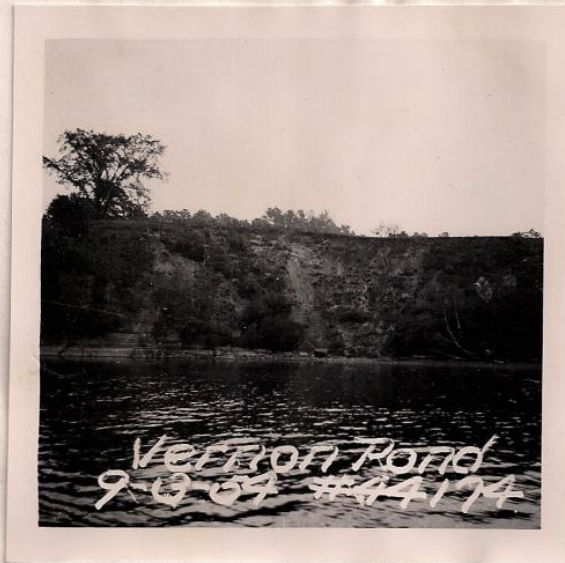
Picture No. hh174

N. H. bank
Mile 0.6
C.R.P. Co.

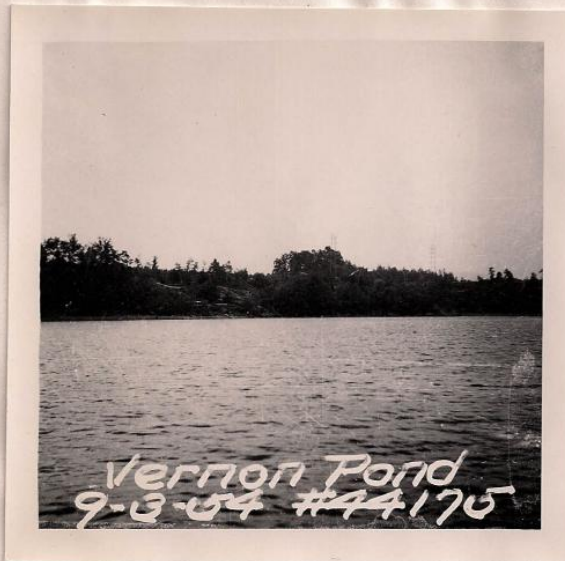
Picture No. hh175

N. H. bank
"Vernon Neck"
Looking downstream

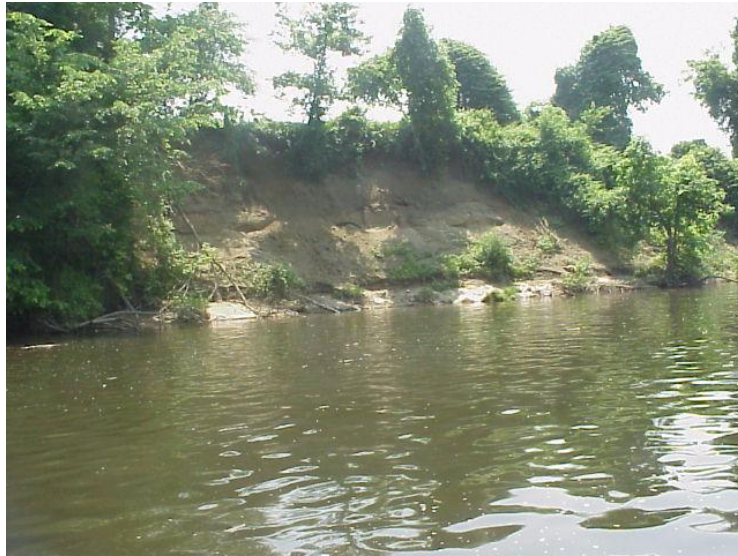
Site 6 – Skalski, prior to 2004

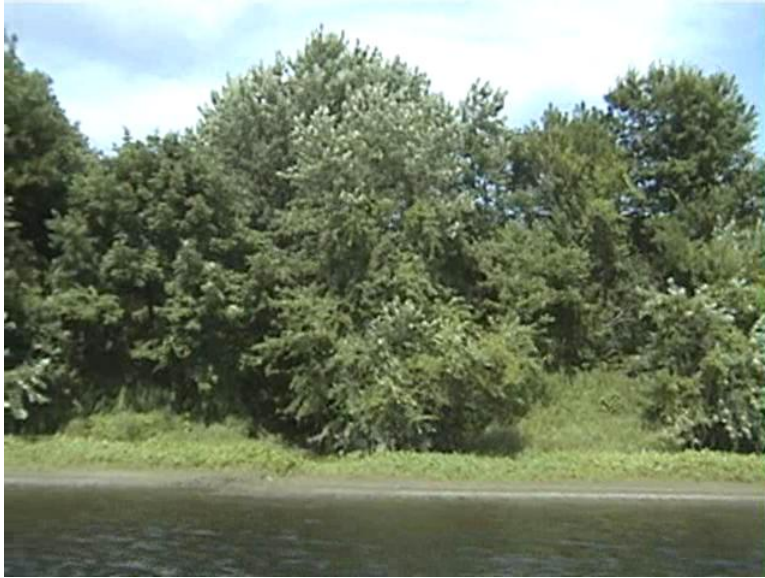
Riverbank Segment with some low bank vegetation - 1998

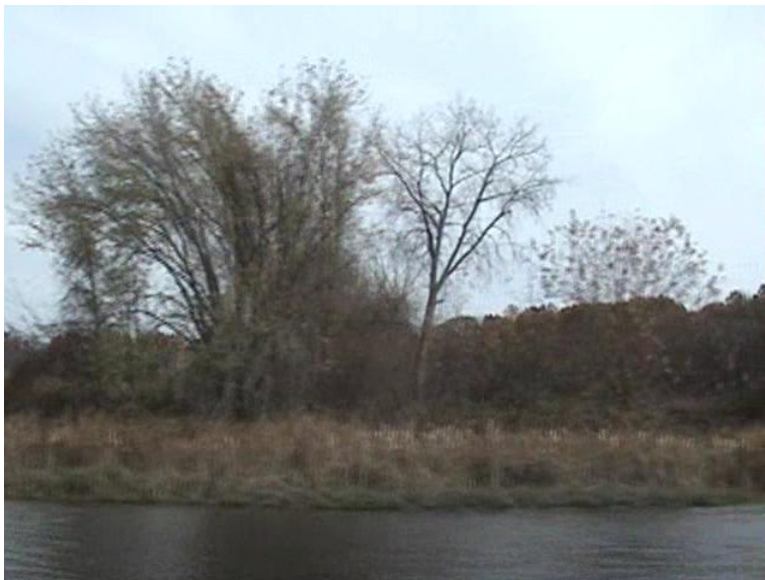
Riverbank Segment with dense low bank vegetation - 2008

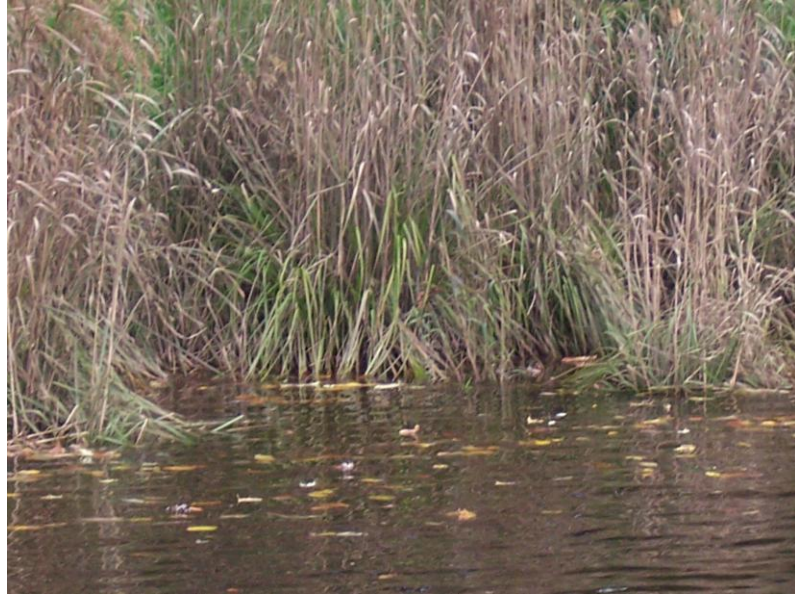
Close-up of low bank aquatic vegetation - 2008
